PERFORMANCE AUDIT  
CITY OF OCEANSIDE  
MYER'S PROPERTY  
GRANT 5001329

March 2, 2011

Katie Levy  
SANDAG  
Environmental Planning Intern  
Land Use & Transportation Planning

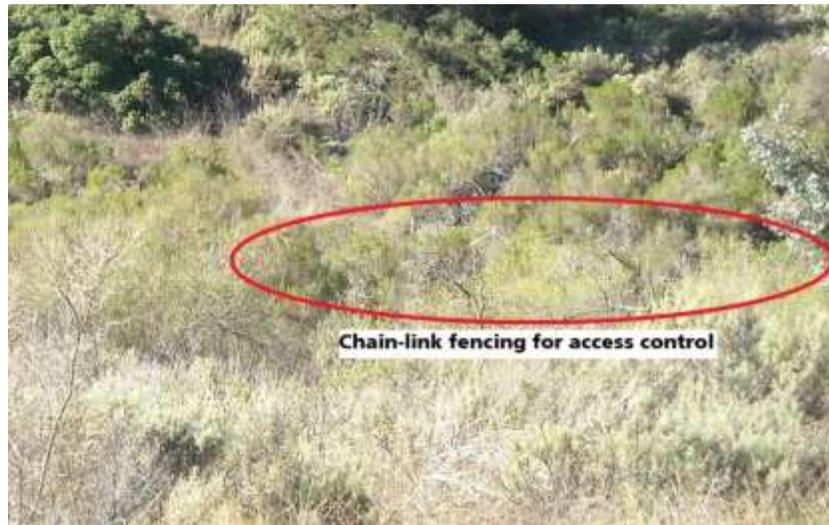
SANDAG staff was able to visually confirm a section of the 5-ft high chain-link fence that was installed along the western property line. **This was reflected in D & D's invoice** (included as an attachment). Mr. Gurley noted that the access control measures have resulted in success with a reduction of unauthorized access for biking and illegal waste dumping.

Figure 1  
Section of Chain Link Fence

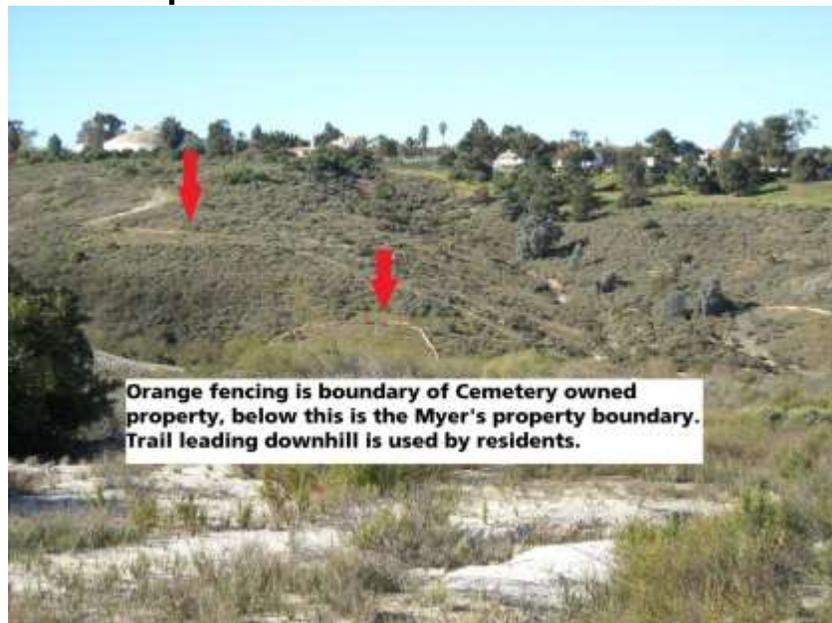
However, he stated there is one main issue he continues to observe. Local residents with dogs come down from the top of the hill above the western property line. They are gaining illegal access to the **Myer's property** by walking down the road and crossing the creek at the cemetery owned portion of the southern property line.

Figure 2  
**Top View of Local Residents' Access Route**

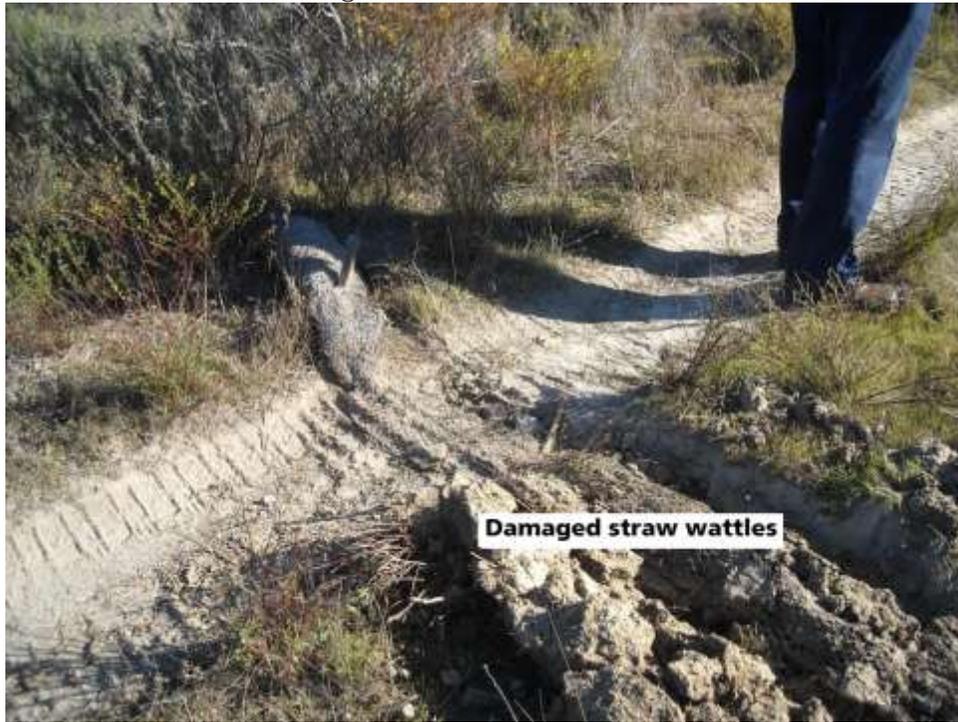
It was confirmed by Mr. Gurley that stabilization of unauthorized trails was completed by both D & D and ROL. **This was reflected in D & D and ROL's invoices** (included as attachments) to TAIC and the City of Oceanside respectively. SANDAG staff observed evidence of both damaged and intact straw and coconut fiber wattles that were placed as erosion control devices prior to the Winter 2010 storms. The damaged erosion control devices are currently being replaced and SANDAG staff observed D & D laborers with straw wattles supplies, Figure 4. In Figure 5 – Intact Erosion Control, the growth of native plants on the slope behind the straw wattles indicated that with these measures, natural erosion control is developing. Mr. Gurley stated that repairs are usually made to erosion control devices twice a year in the Spring and Fall. However, due to the heavy Winter 2010 storms, repair has started earlier this year.

Figure 3  
Damaged Erosion Control Device

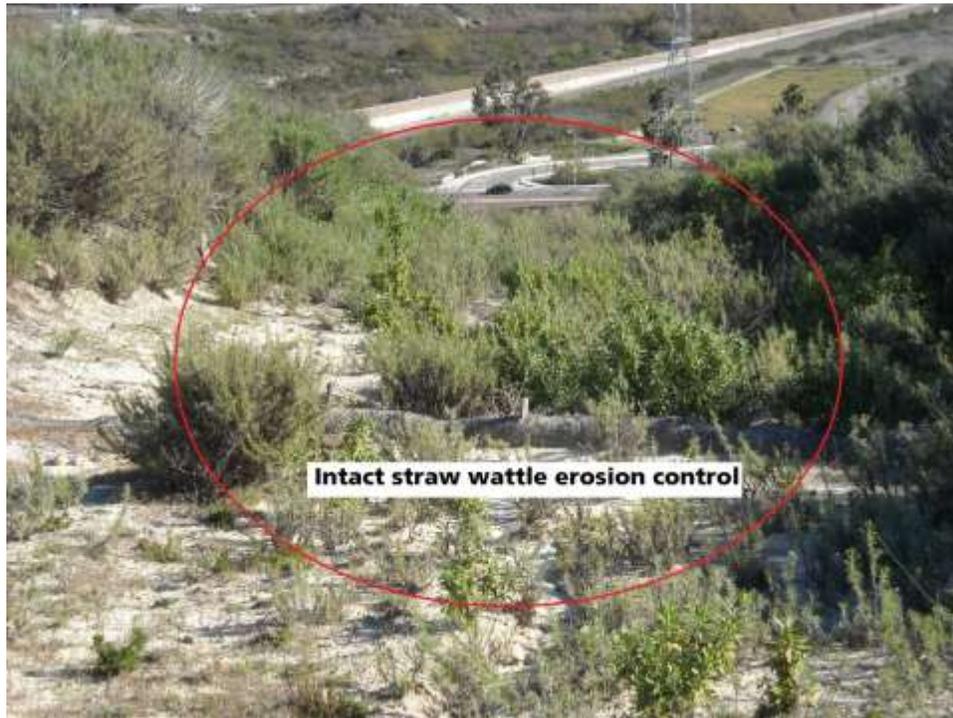
Figure 5  
Intact Erosion Control Device

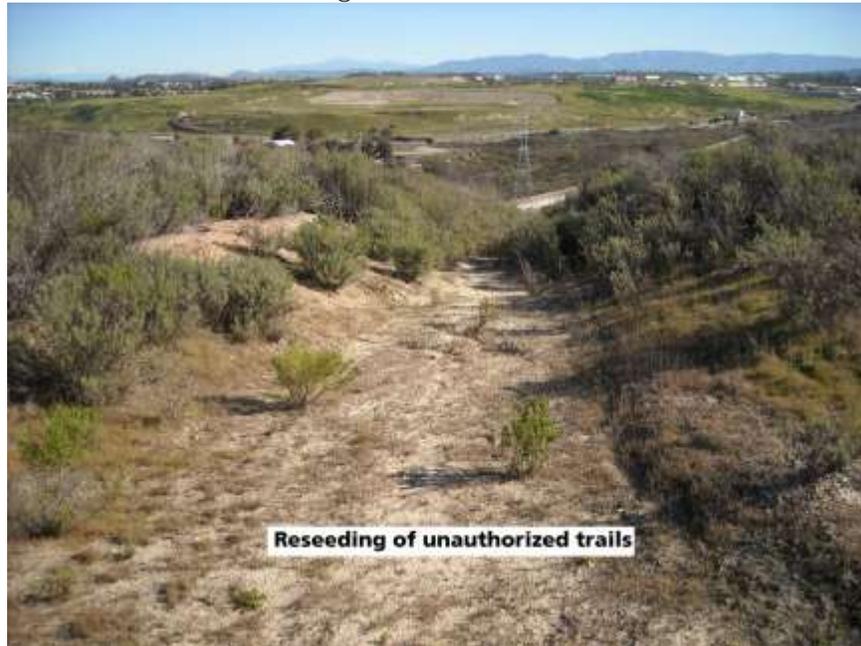
It was confirmed by Mr. Gurley that reseeded of previously seeded unauthorized trails was completed by D & D and was reflected in their invoice (included as an attachment) to TAIC. Additionally, SANDAG staff observed an unauthorized trail which exhibited indicators of growth occurring as a result of reseeded measures.

Figure 6  
Reseeding of Unauthorized Trails

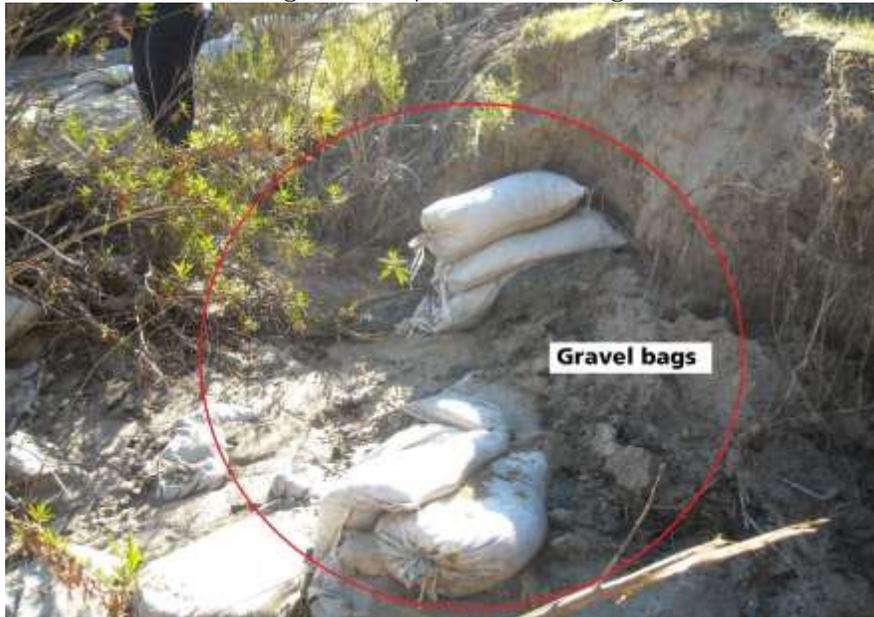
Mr. Gurley guided SANDAG staff to visually examine log dam repair that was completed by both D & D and ROL. There were multiple points along the accessible rill erosion area where gravel bags were observed and one point where the fortified log dam was viewed. This was also reflected in **D & D and ROL's invoices to TAIC and the City of Oceanside respectively.**

Figure 7  
Log Dam Repair-Gravel Bags

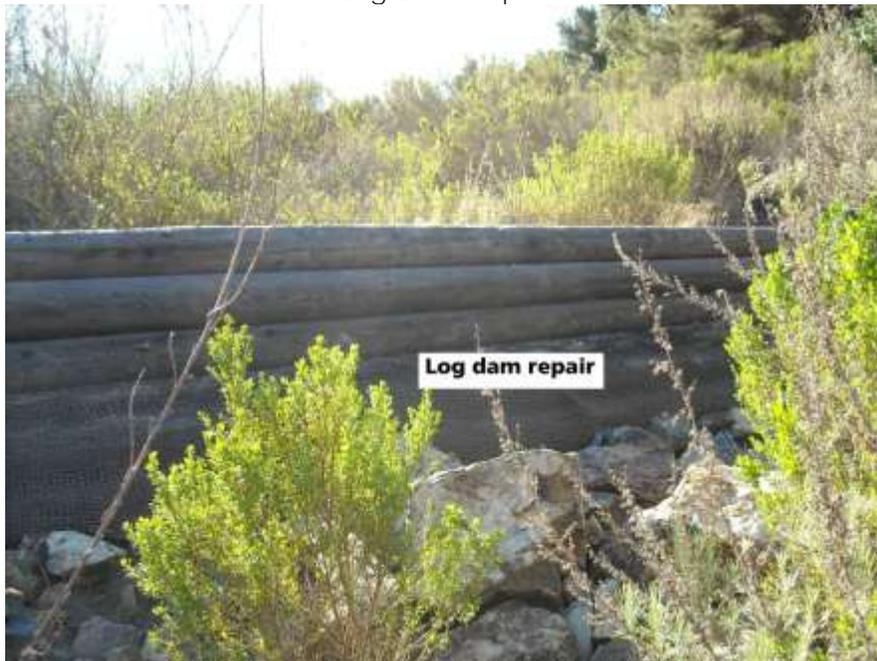
Figure 8  
Log Dam Repair
