SA-PAL survey

| Project | SA-PAL project |
| ID | 42130 |
| Survey Date | 04/03/2019 |

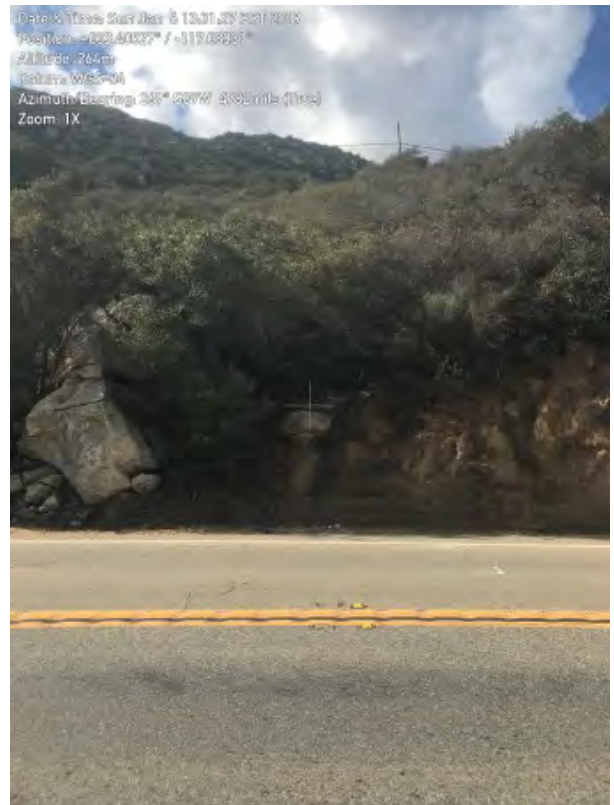
50-100 meters north much better corridors on both sides of the road including culverts at these better corridors

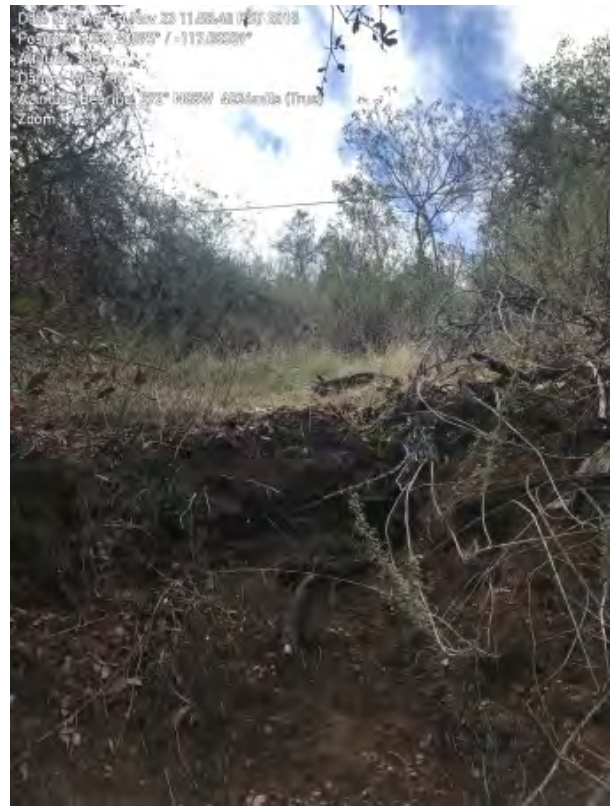
Dangerous curve at crossing on west side. Blind spot on west side. Small drainage culvert that slopes down from west to east from 2' below road on west to about 25' below road on east. Sharp slope on west side at shoulder for about 25m to south and a couple hundred meters to north. Better corridor on west side to the south at Mt. Olympus service rd entrance.

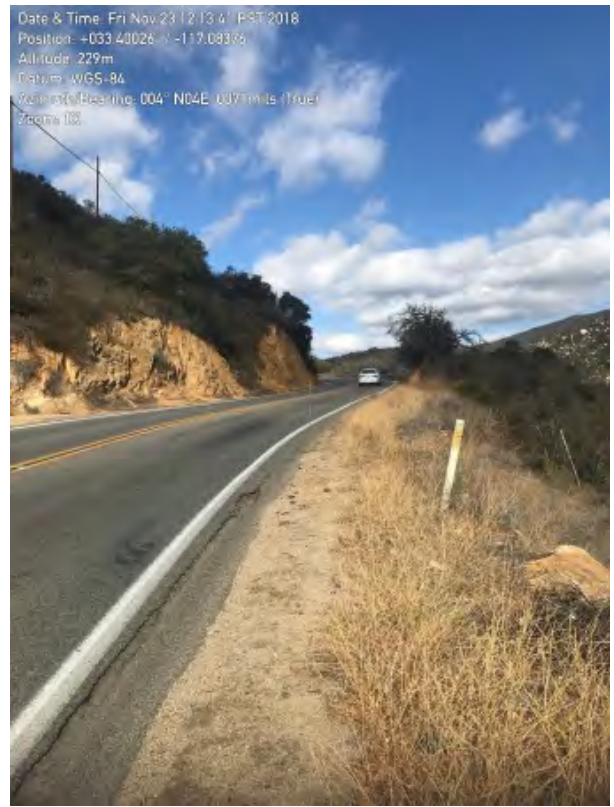
Located approx 25m south of A50. Good corridor on both sides. Spray painting on road at culvert indicates future road work.

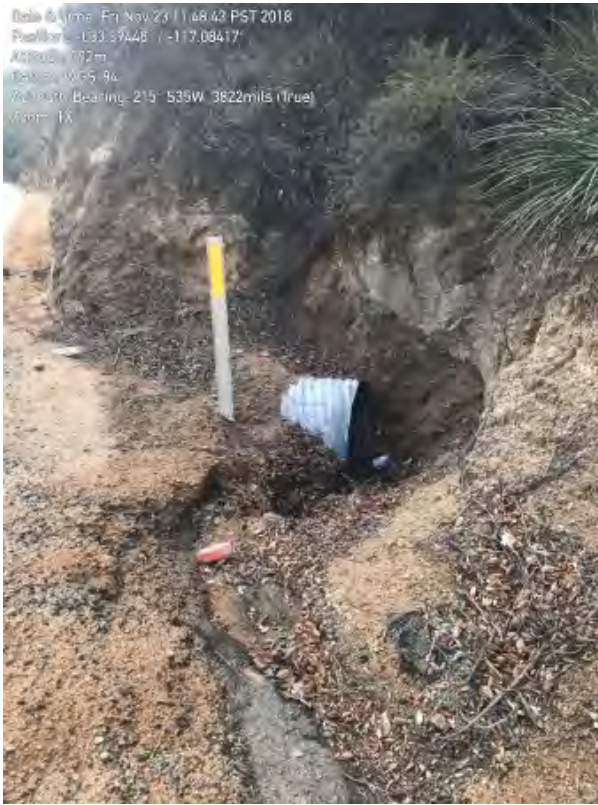
| Comments | Good corridors on both sides of road 2' drainage culvert approx 25m south of crossing. West side culvert opening is against rock face, provides drainage, does not provide connectivity to any corridor. |

| Management recommendations | Large culvert and directional fencing. |

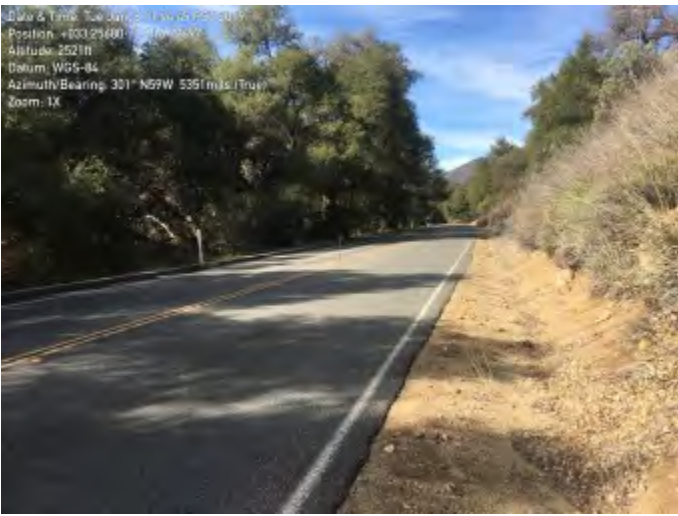
| Comments | This location is 20 meters east of P91. There is a small culvert there, but currently inadequate for wildlife transit. Due to steep embankment on westbound side, this location not readily amenable to placement of north-south culvert. |

| Management recommendations | Barrier fencing. Rumble strip. Wildlife crossing signs. |

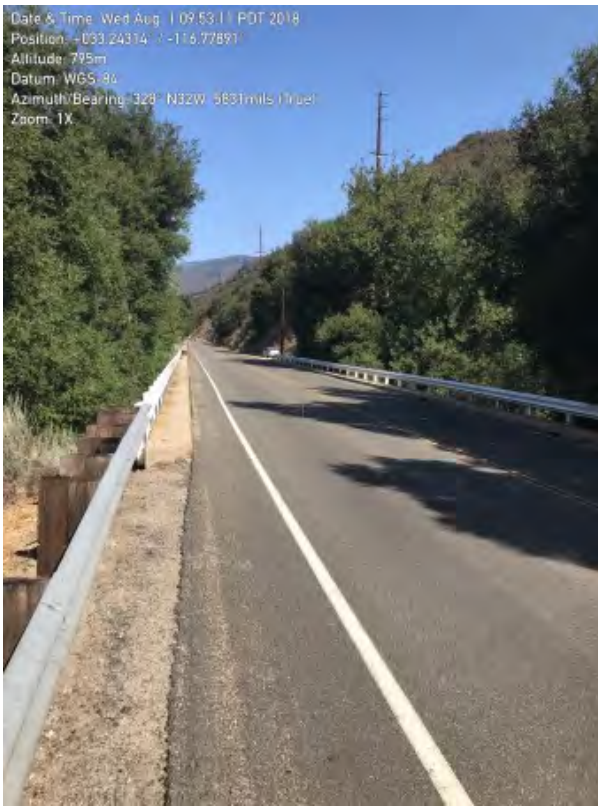
| Comments | Bridge over San Luis Rey. Good undercrossing. |

| Management recommendations | Directional fencing. Occasional security patrol to deter trespassing. |

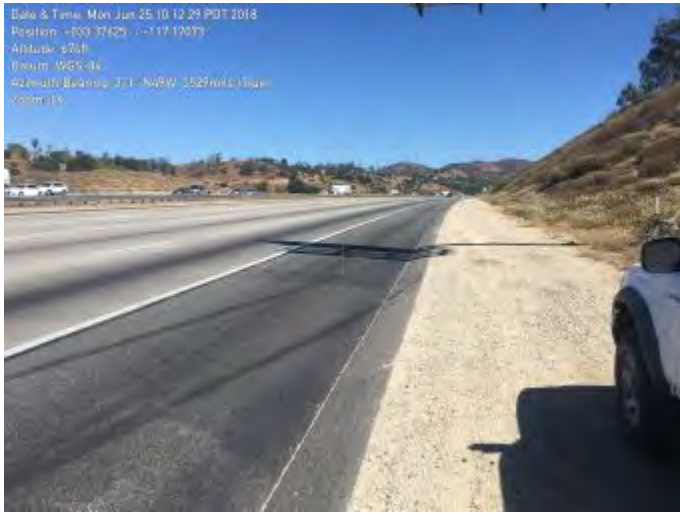
northbound I 15

| Comments | <p>Site is located .25 mile south of WS10. Obvious travel corridor from west to east. Upon inspecting western approach, observed 3 foot culvert at base of slope. Western culvert location 33.3753,-117.1713. Culvert is approx 100 feet from road and at least 50 feet below grade. Western access to the western approach is more difficult via the 395 than WS10 in this location. East side culvert approx 60 from road and 20 feet below grade. Steep culvert gradient below road. East canyon/corridor terminates into agricultural land based on satellite and onsite survey, limited practical travel corridor to the East.</p> |

| Management recommendations | <p>In terms of I-15 undercrossing in this vicinity, due to presence of culvert this has potential for undercrossing, however due to culvert gradient and east canyon corridor, there are limitations for undercrossing. Directional fencing required both sides.</p> |

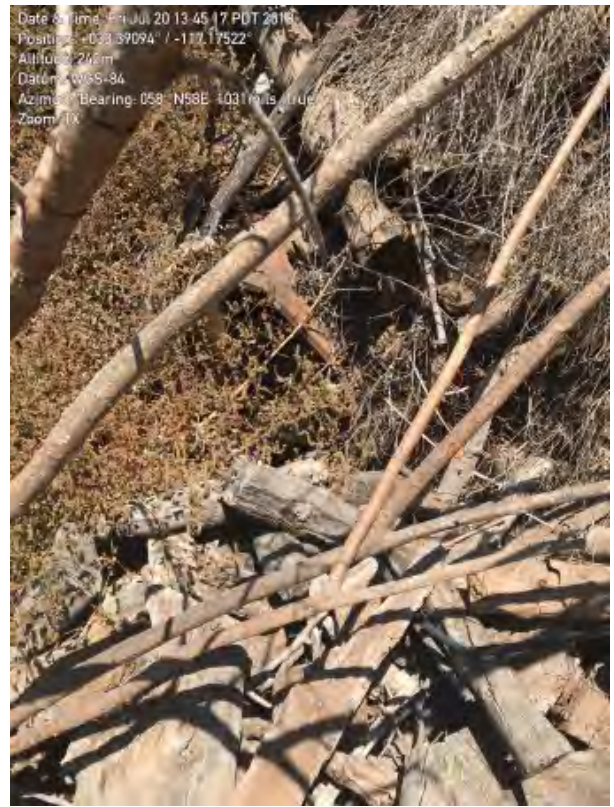
Obstructed culvert

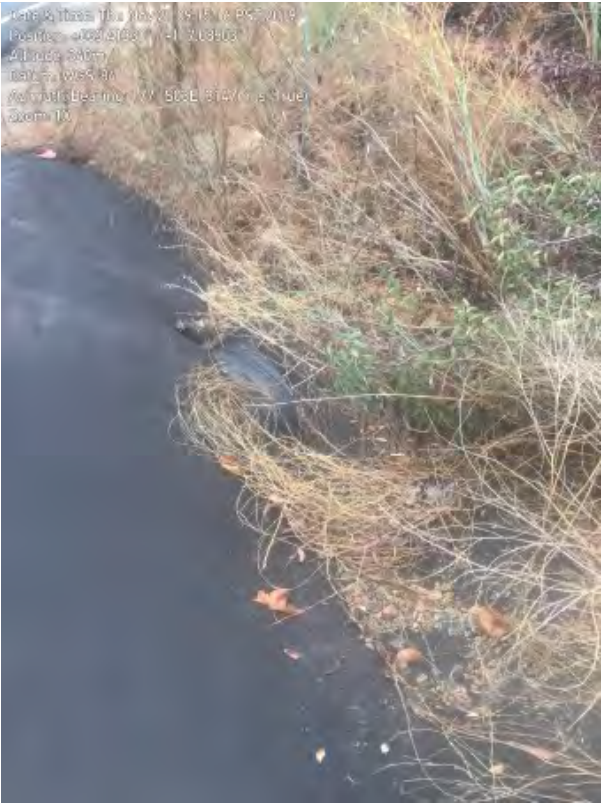
| Comments | East side is near termination of eastern canyon and good corridor. West side is near plateau of the this cross canyon. Good location of crossing structure as most northern feasible crossing location in vicinity. All other sites north on Pala Temecula rd at grade near various housing. |

| Management recommendations | Culvert and fencing. |

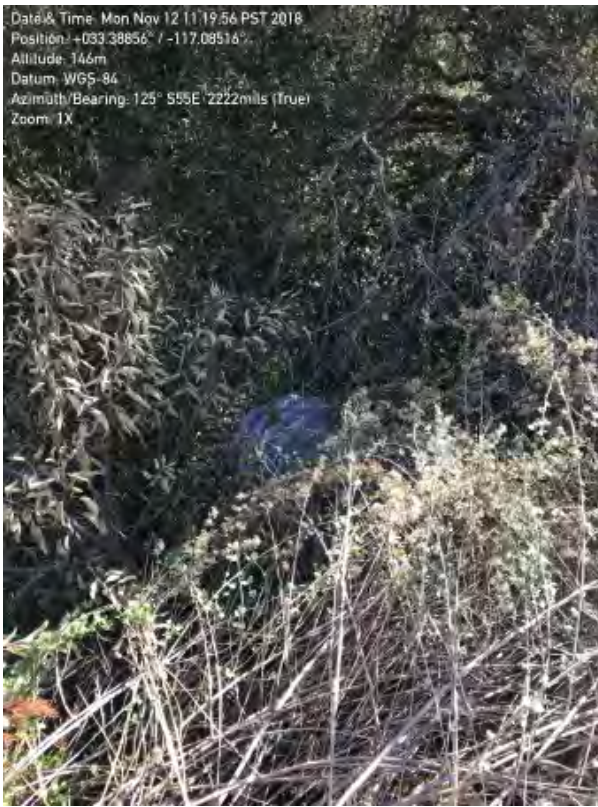
| Comments | Seasonal runoff provides some access to road west to east. Only likely travel, doubtful from East West. But would only be at road level. |

| Management recommendations | Fencing that prevents access to road. |

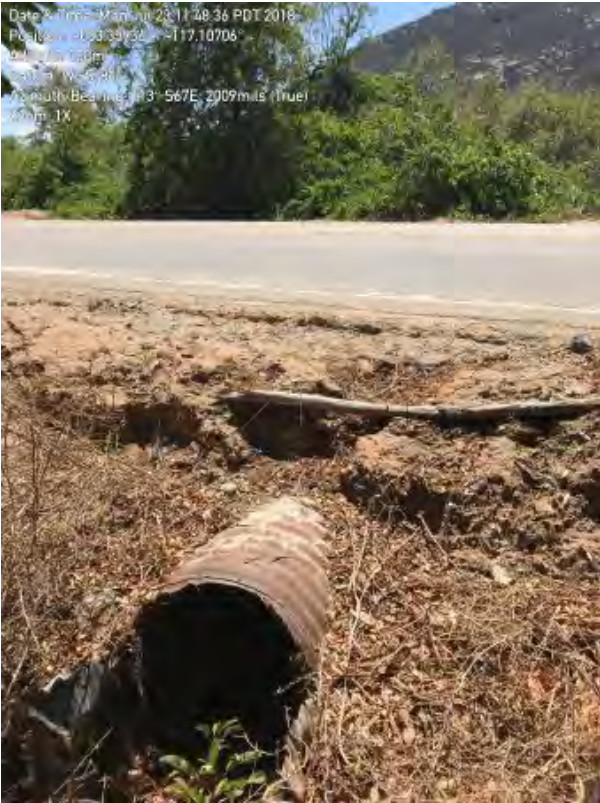
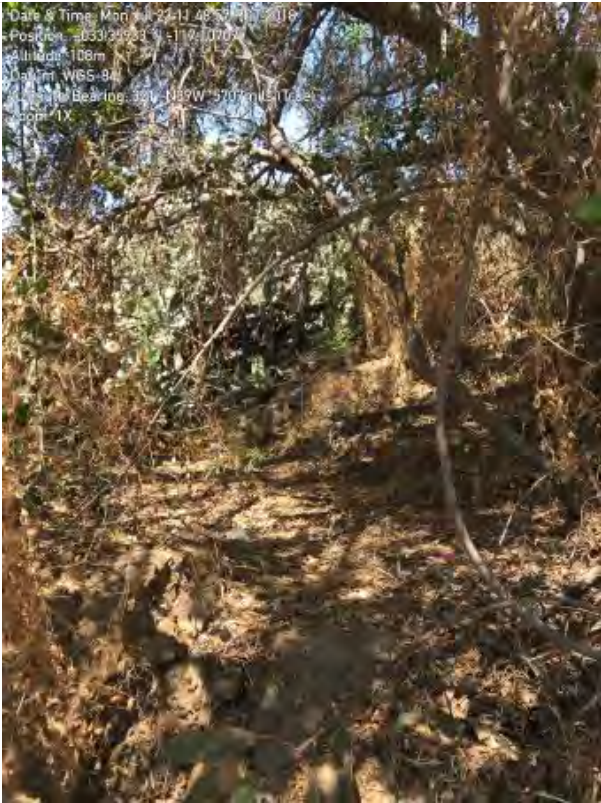
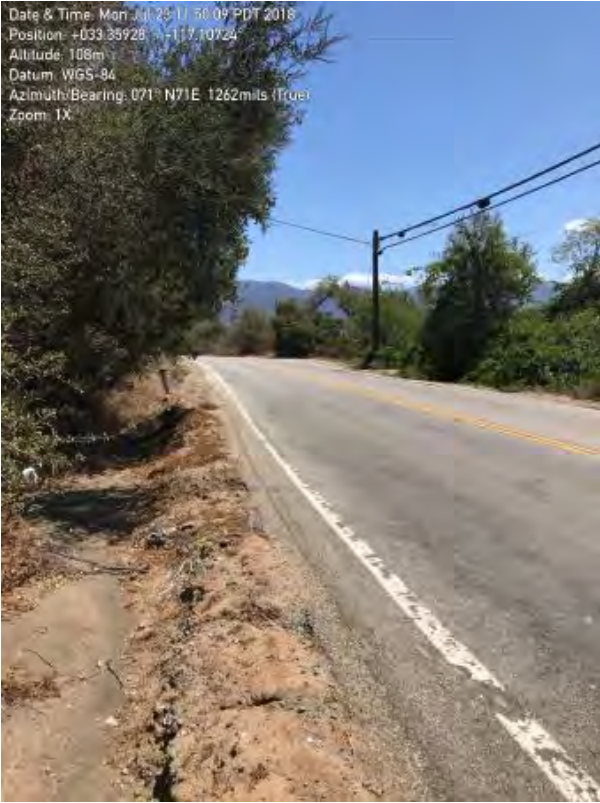
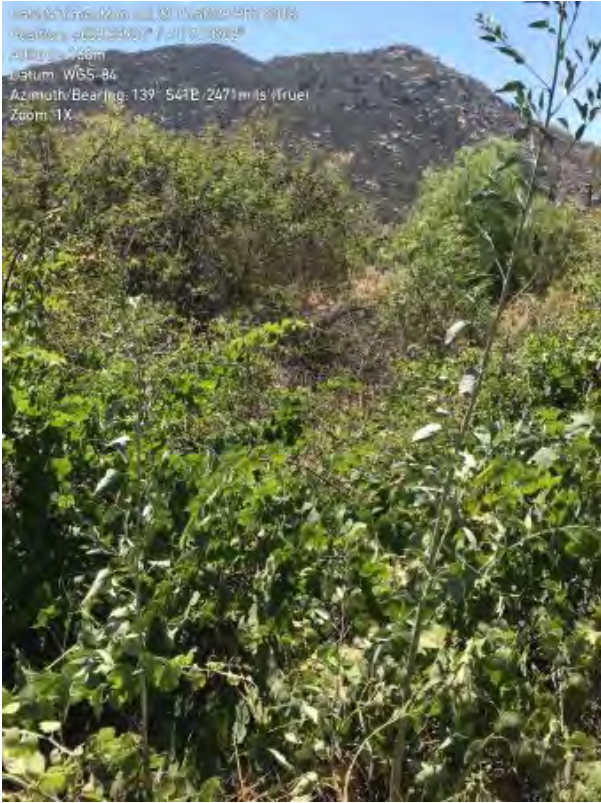
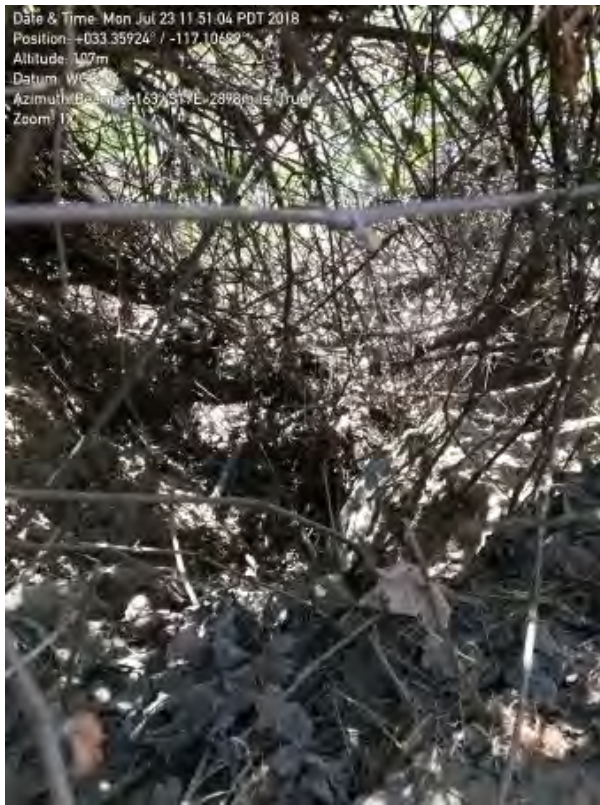
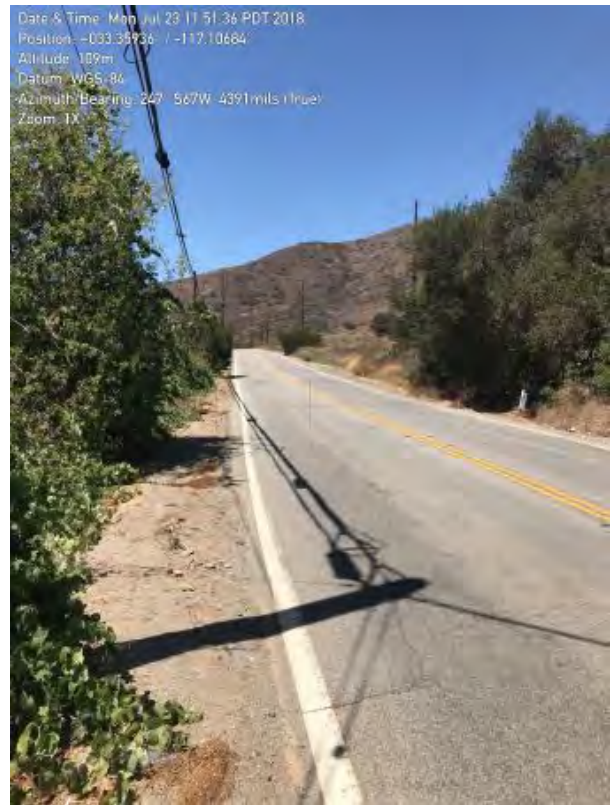
| Comments | Blind curve just East of culvert. Dangerous crossing point at grade. Lake/reservoir (Pala water supply?) just south of culvert which is likely attractant for all wildlife. |

| Management recommendations | Directional fencing. Expand culvert. |

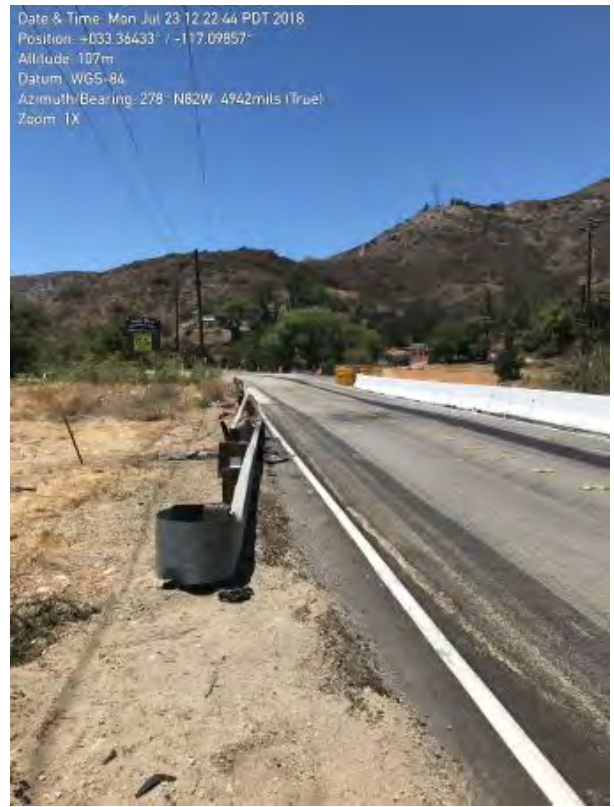
Adequate wildlife under crossing. Corridor to south may end in agricultural and/or private land. Game trails come out of the creek bed and lead up highway grade.

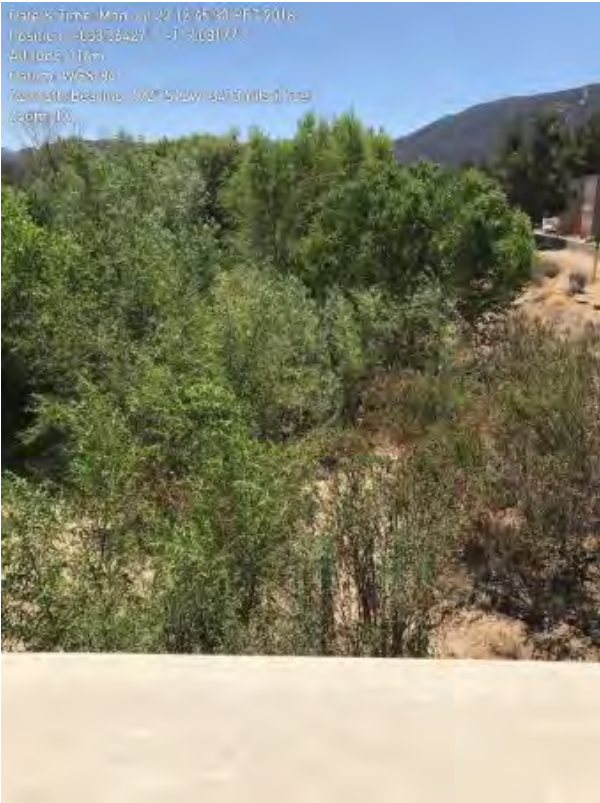
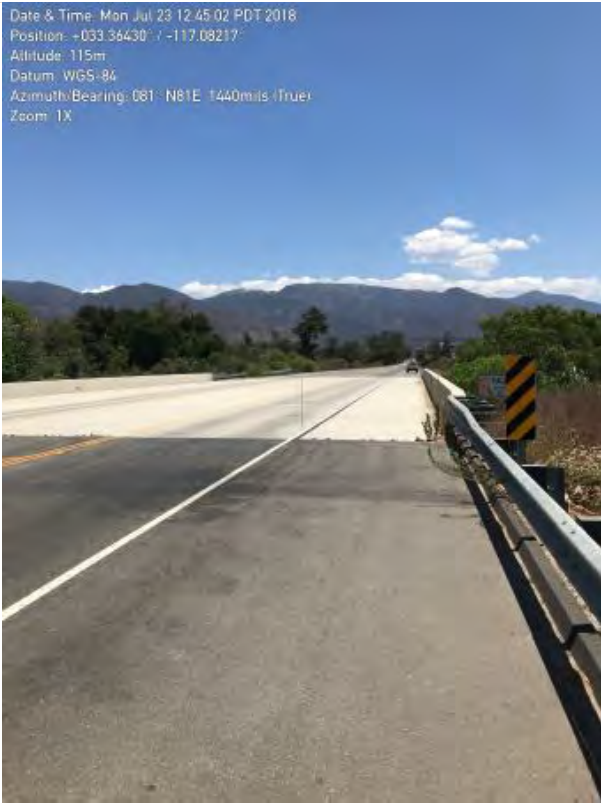
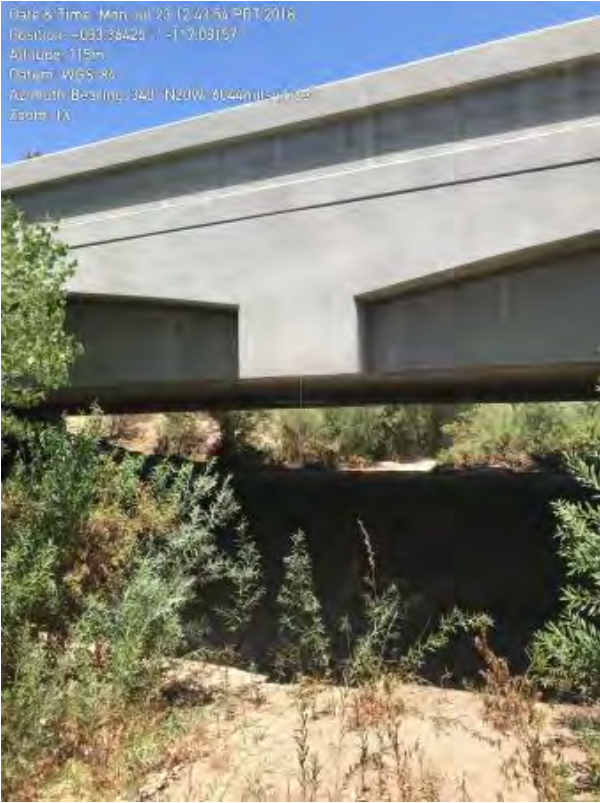
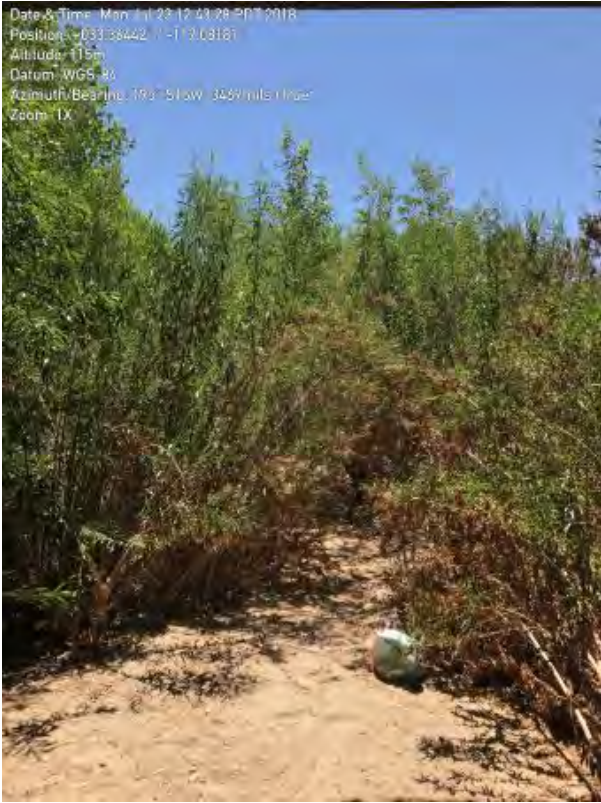
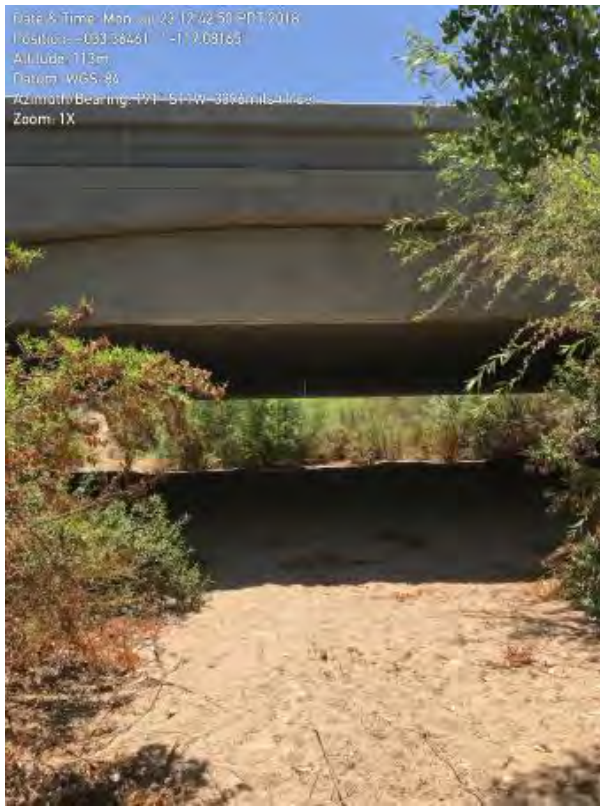
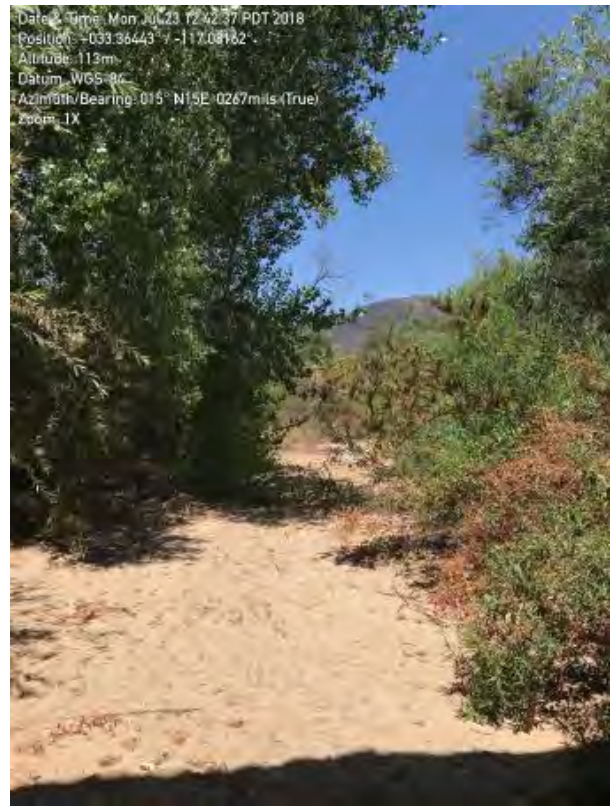
Pala Creek bridge. Adequate animal under crossing. Good vegetation on both sides. Creek bed is adjacent to Casino's parking garage.

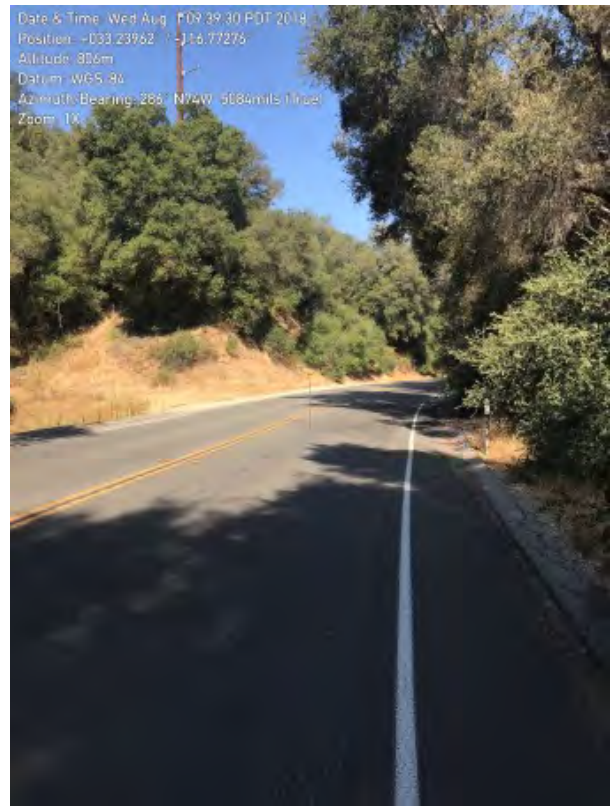
Due to culvert constraints, crossing will be at road.

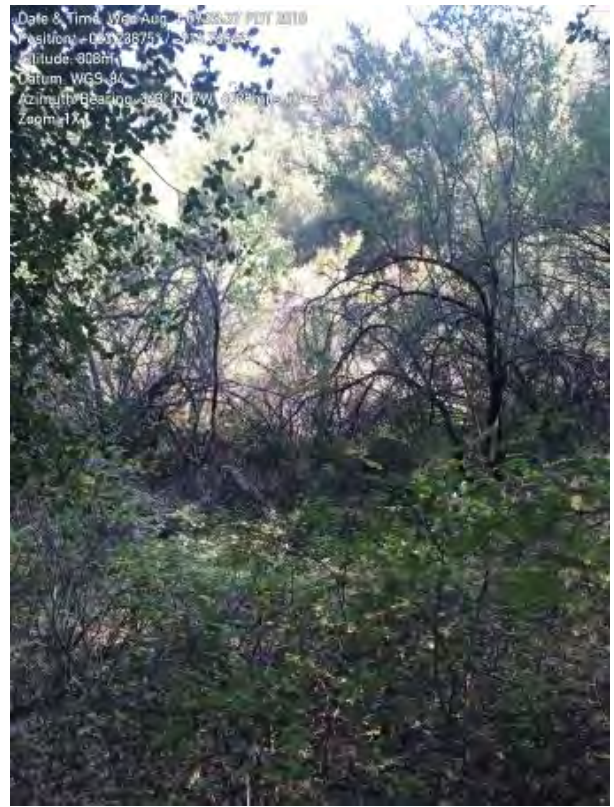
Culvert and access good.

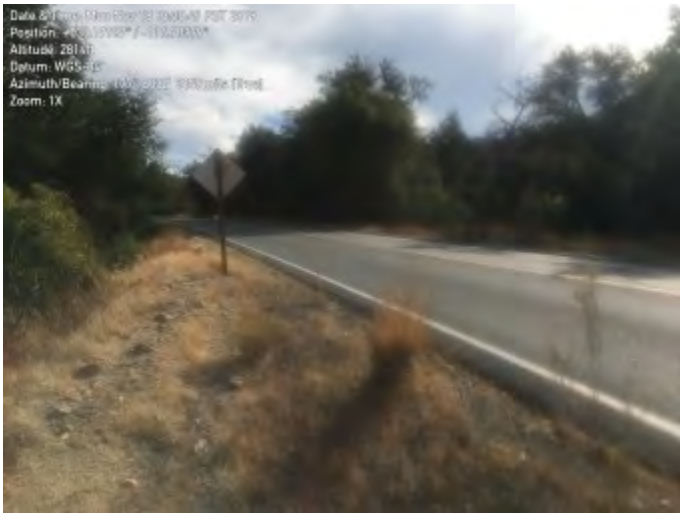
| Comments | Currently inadequate corridor due to lack of crossing structure. Traffic is fairly light in this area, although traveling at high speeds. Good crossing at P100 approx. 300 meters north. Embankment too shallow on northbound side to consider construction of wildlife undercrossing here. |
