**Manchester Avenue  
Conservation Bank  
Preliminary Hydrology &  
Design Alternatives  
Final Report**

**March 2007**

**Mark Seits, P.E., C.F.M., & Garrett Higerd, P.E.  
HDR Engineering, Inc.  
8690 Balboa Avenue, Suite 200  
San Diego, CA 92123**

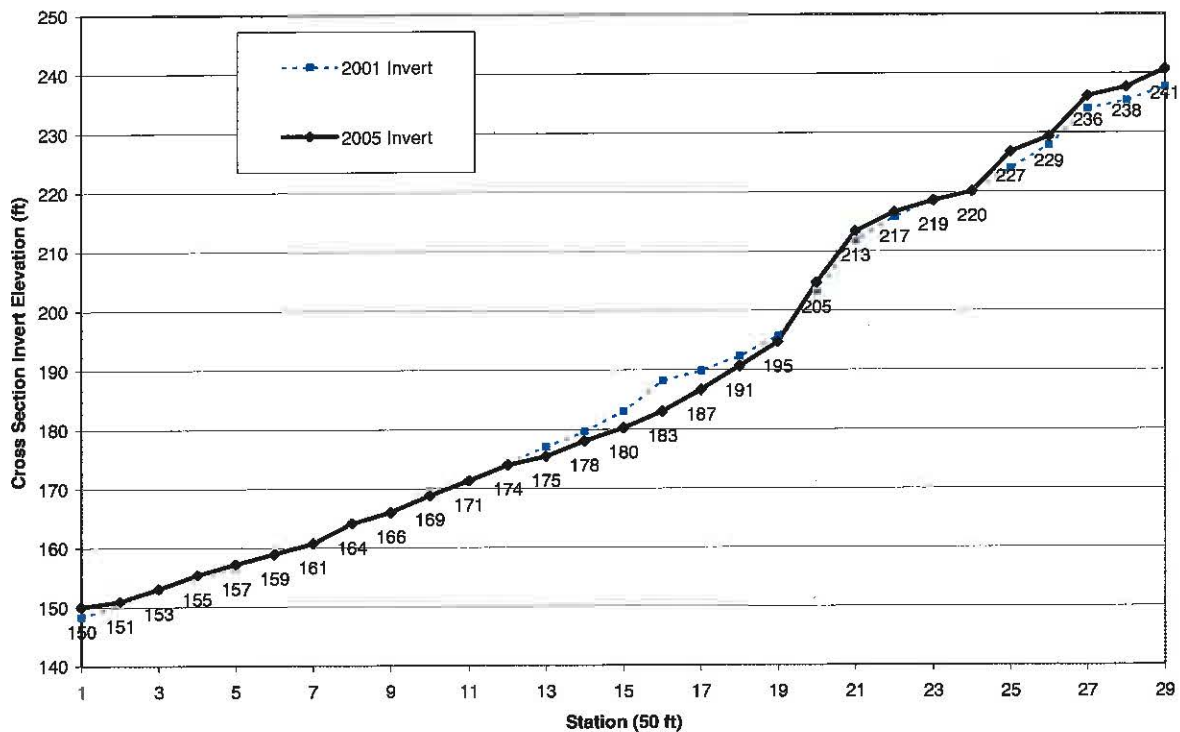
**Figure 3. Stream Invert Profile**

Figure 3 shows profiles of the stream invert along the project reach from the 2001 and 2005 data. The profile shows that the most severe erosion has occurred from cross section 20 approximately 900 feet downstream to cross section 12. In this reach high flow velocities are contributing to erosion at the toe of the channel which is resulting in the problematic sloughing of the banks shown in the pictures in Appendix A. The reach downstream from cross section 12 is also experiencing velocities that will cause scour; however, the stream bed degradation is less pronounced during the window of time shown in the profile.

From the Encinitas Landfill (cross section 29) down to the foot bridge (Cross-section 21) the channel appears to have been fairly stable during the four year window, despite seeing high flow velocities (see Figures 5 and 6). This may be due to the presence of harder, more erosion resistant materials at the channel toe in this reach.

Through interpretation of the topographic data from 2005 and 2001 (see Figure 3), we can see that the most severe scour in recent years has occurred between cross sections 19 and 12. This reach should have the highest priority for installing grade control structures. Alternative 3 proposes installing approximately six structures 3- to 6-feet deep in this reach. This preliminary recommendation is based on conservative assumptions due to incomplete information. Final design and siting of the proposed grade control structures will require additional geotechnical and sediment transport analysis. More information may allow a less conservative design, or it could warrant extending the grade control structures further downstream. Each grade control structure would occupy approximately 60 square feet of channel bottom.

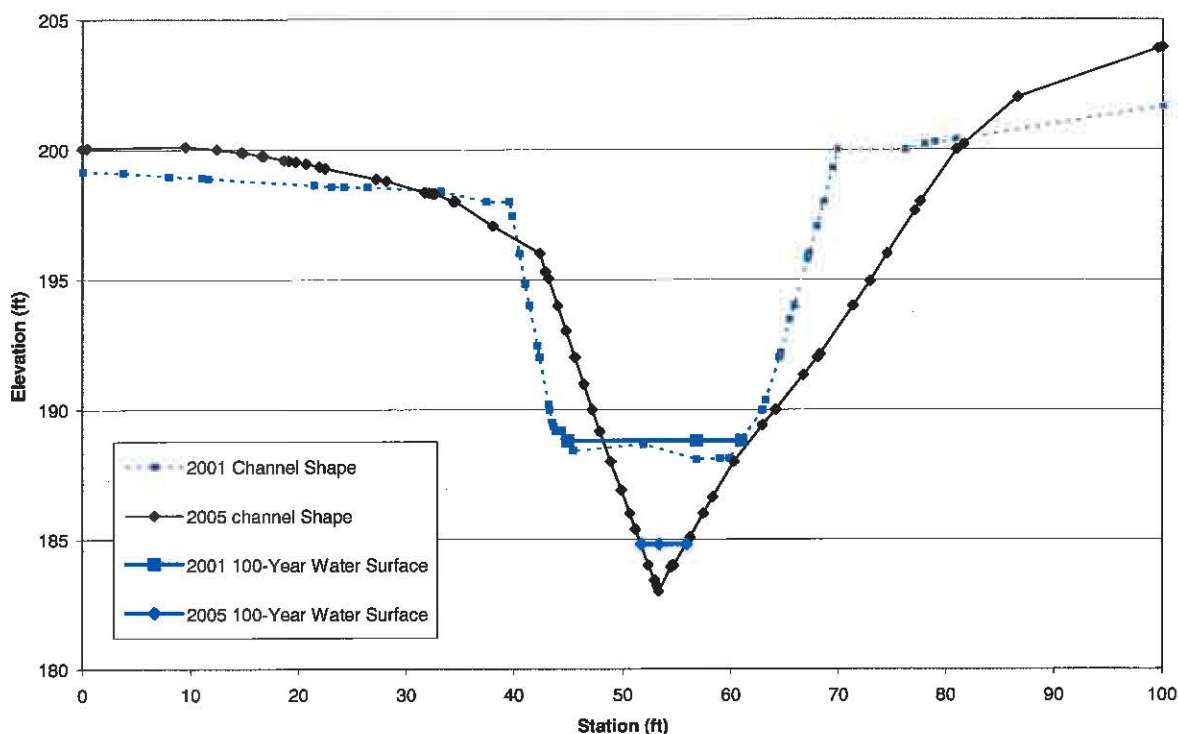
**Figure 4. Example Cross Section (Cross Section 16)**

Figure 4 shows cross section 16 and the 100-year water surface elevations for both the 2001 and the 2005 models. Models were built from cross sections from both the topographic data sets because there was a significant difference between the two regarding the channel shape. See Figure 4 for reference. The 2005 data appears to have one elevation point along the stream invert that forms a triangular channel shape with the banks, while the 2001 data shows very steep banks with a relatively flat bottom. This difference is probably due to the 2005 data set having less elevation data points from the channel bottom than the 2001 data set.

Building HEC-RAS models from both showed that the difference in the two geometries did not significantly change the flow conditions in the channel. Even for the 100-year flood, the main channel fully contains the flow for the entire project reach. Figure 4 also shows the significant scour that occurred between 2001 and 2005 at cross section 16.

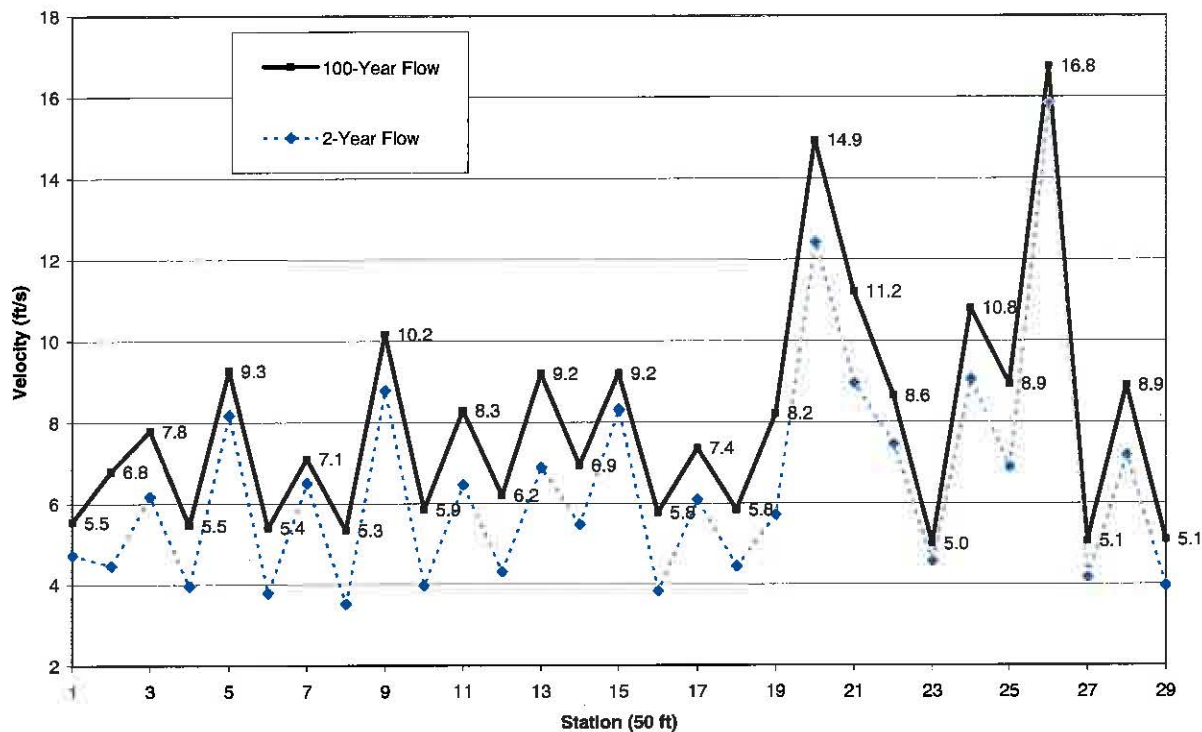
**Figure 5. Velocity Analysis (2001 Topo, n=0.03)**

Figure 5 shows the channel velocity from the 2001 model at each cross section for both the 100-year and 2-year frequency floods. The n-value was taken to be 0.03 to be on the conservative side for calculating velocity. Additional data for intermediate floods (5-, 10-, 25-, 50-year) was not included for clarity. Figure 5 shows that downstream from cross section 20, the flow velocities vary from 4 to 10 ft/s for all storms considered and velocities only increase by approximately 1 to 2 feet per second between the 2-year and the 100-year storm.

Scour potential in streams is a complex phenomenon affected by water velocity, water depth, soil characteristics, the sediment loading of the water, and the localized effects of bends and obstructions. While a complete scour analysis would require more information and is beyond the scope of this report, there are suggested maximum velocities that have been published for various soil types and sediment loading conditions. The soils in the project reach are defined as Soil Mapping Unit CsD (loamy sand) by the San Diego County Hydrology Manual. The range of maximum permissible velocities for this soil varies from 1.7 to 2.5 ft/s. This data shows that scour will occur in the stream during regular events. Because the additional costs for materials will be small, we propose designing the project for a 100-year flood.

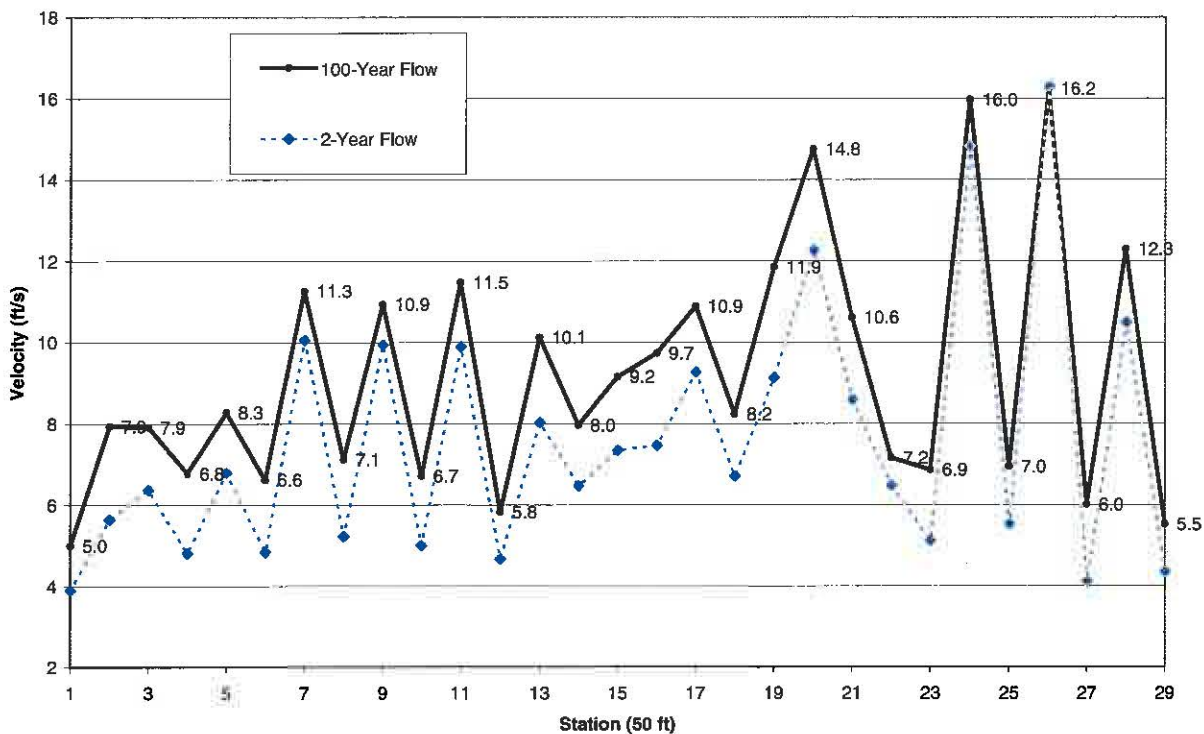
**Figure 6. Velocity Analysis (2005 Topo, n=0.03)**

Figure 6 shows the channel velocity from the 2005 model at each cross section for both the 100-year and 2-year frequency floods. The n-value was taken to be 0.03 to be on the conservative side for calculating velocity.

Figure 6 shows that the flow velocities are relatively consistent between the 2001 and 2005 HEC-RAS models. Downstream from cross section 20, the flow velocities vary from 5 to 11.5 ft/s for all storms considered and velocities only increase by approximately 1 to 2 feet per second between the 2-year and the 100-year storm.

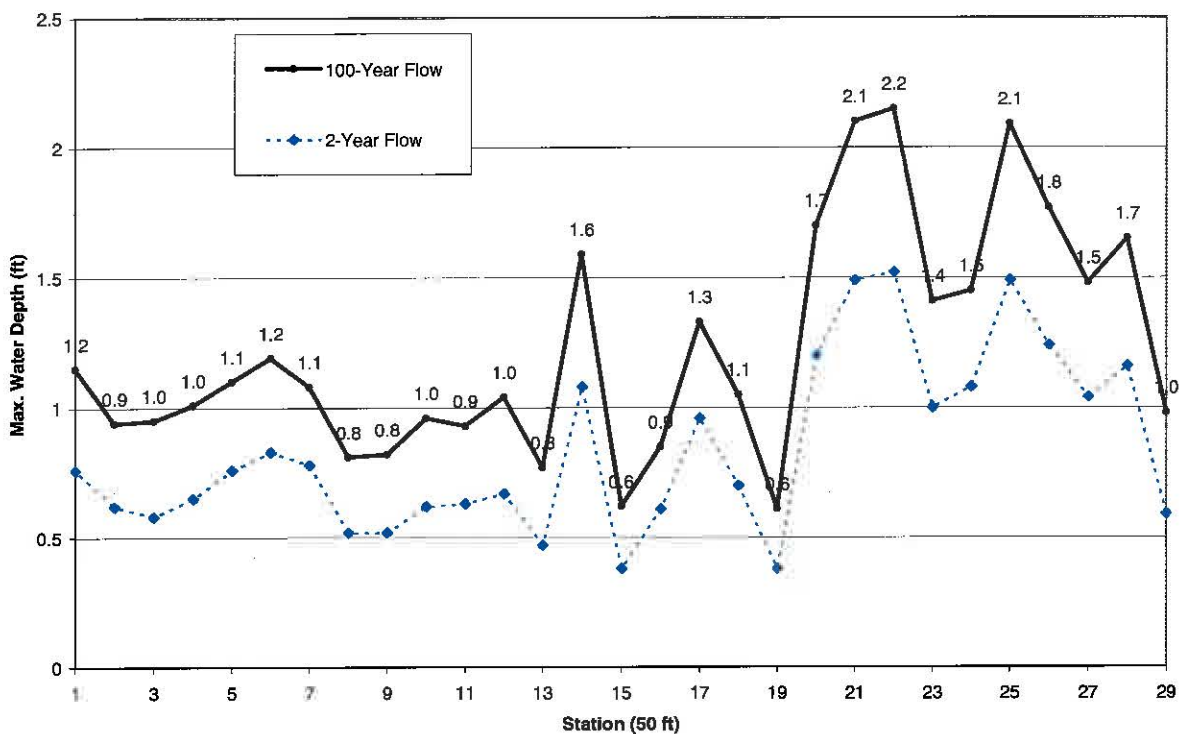
**Figure 7. Water Depth Analysis (2001 Topo, n=0.05)**

Figure 7 shows the water depth at each cross section for both the 100-year and 2-year frequency floods. The n-value was taken to be 0.05 to be on the conservative side for calculating water depth. Downstream of cross-section 20, the water depth varies from 0.75 feet to 1.5 feet for a 100-year flood. The height of longitudinal toe protection would only need to be raised by 0.5 feet to increase from 2-year to 100-year flood protection.

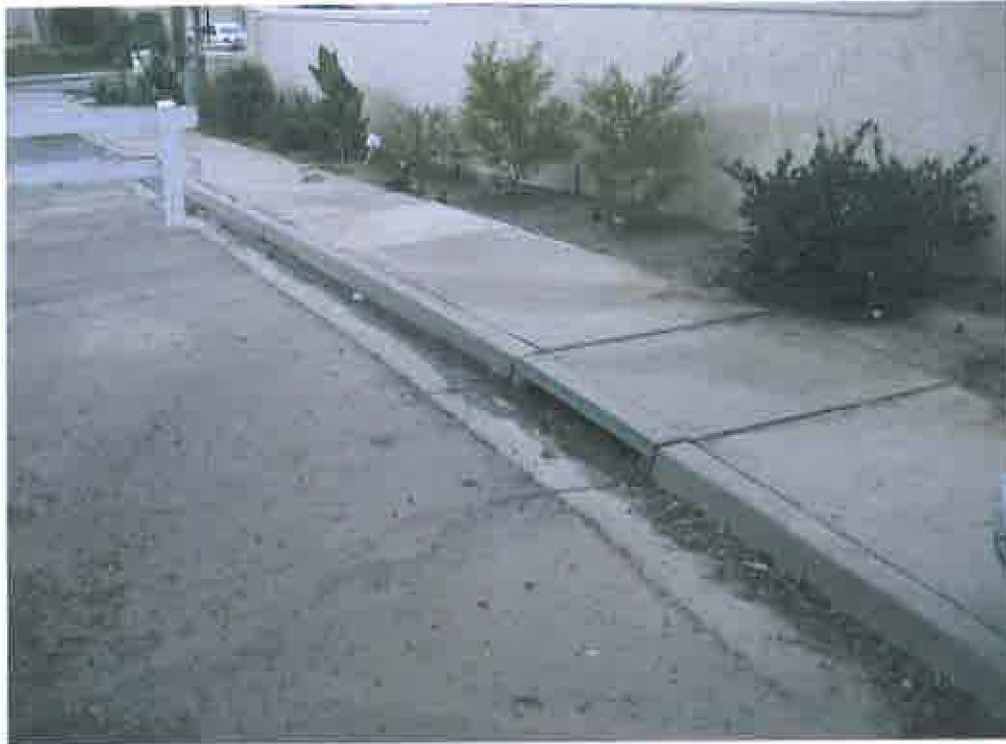
1. Storm drain at the end of Taegan Lane (Does not flow into the Conservation Bank watershed.) – Looking West

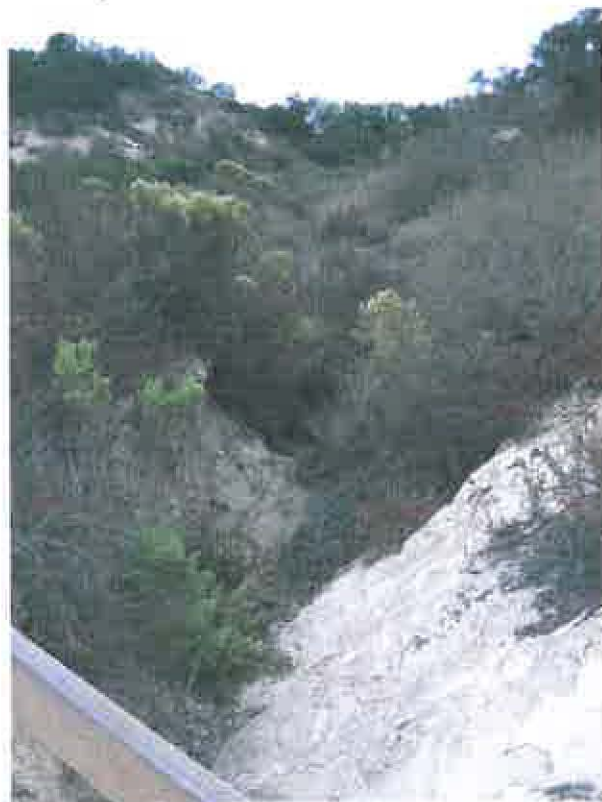
2. Upstream approach to the pedestrian bridge. – Looking Northwest

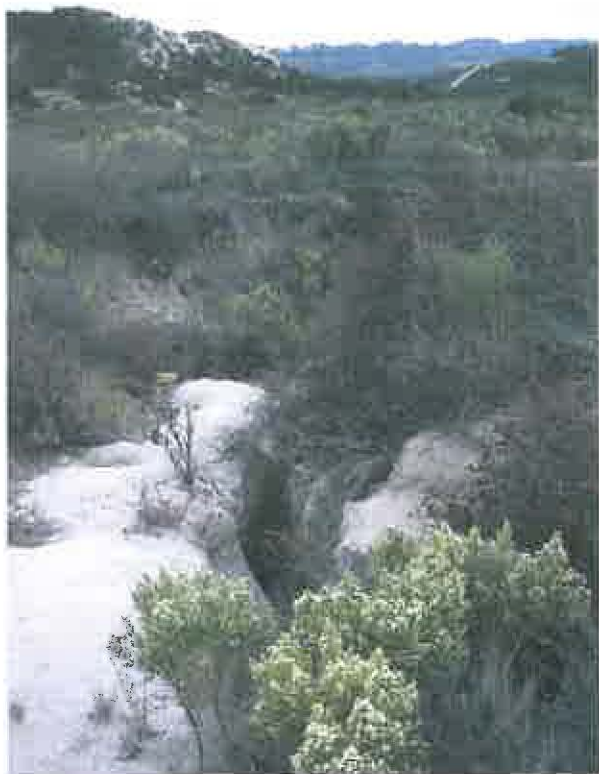
3. Downstream of the pedestrian bridge – Looking South

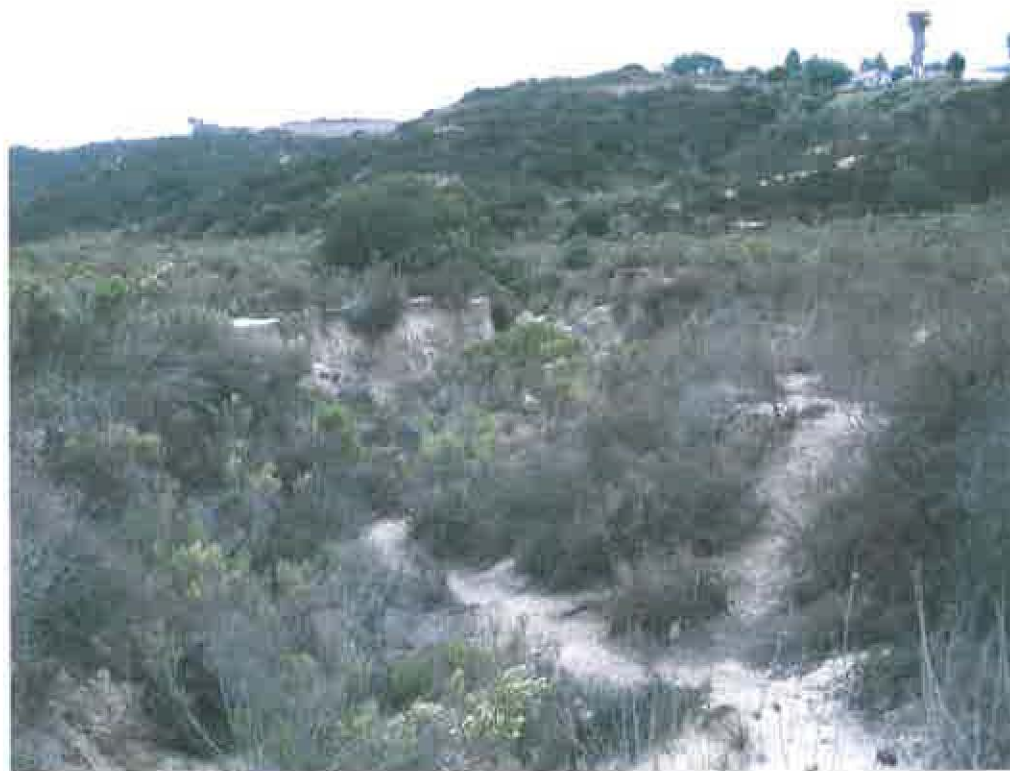
4. Downstream of the pedestrian bridge. – Looking South

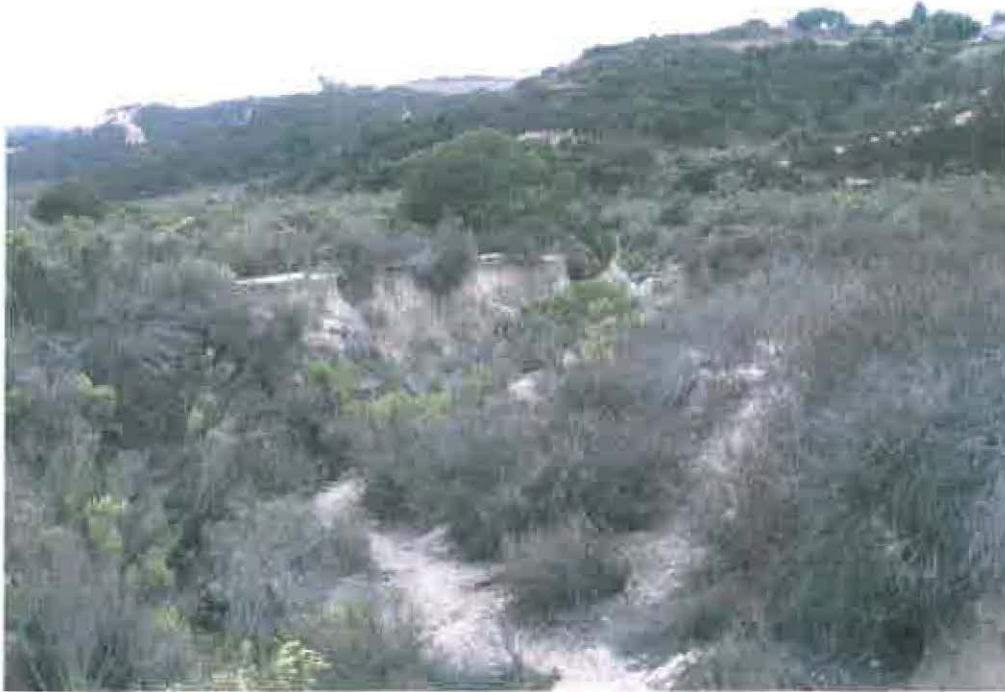
5. Downstream of the pedestrian bridge. – Looking South

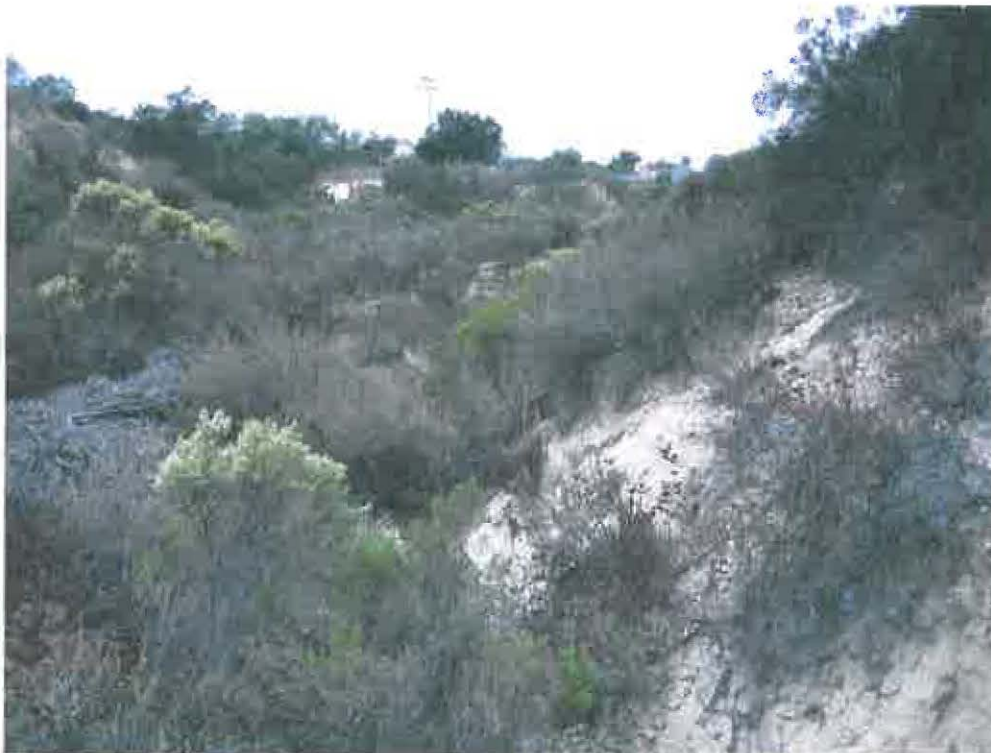
6. Upstream approach to the pedestrian bridge. – Looking Northwest

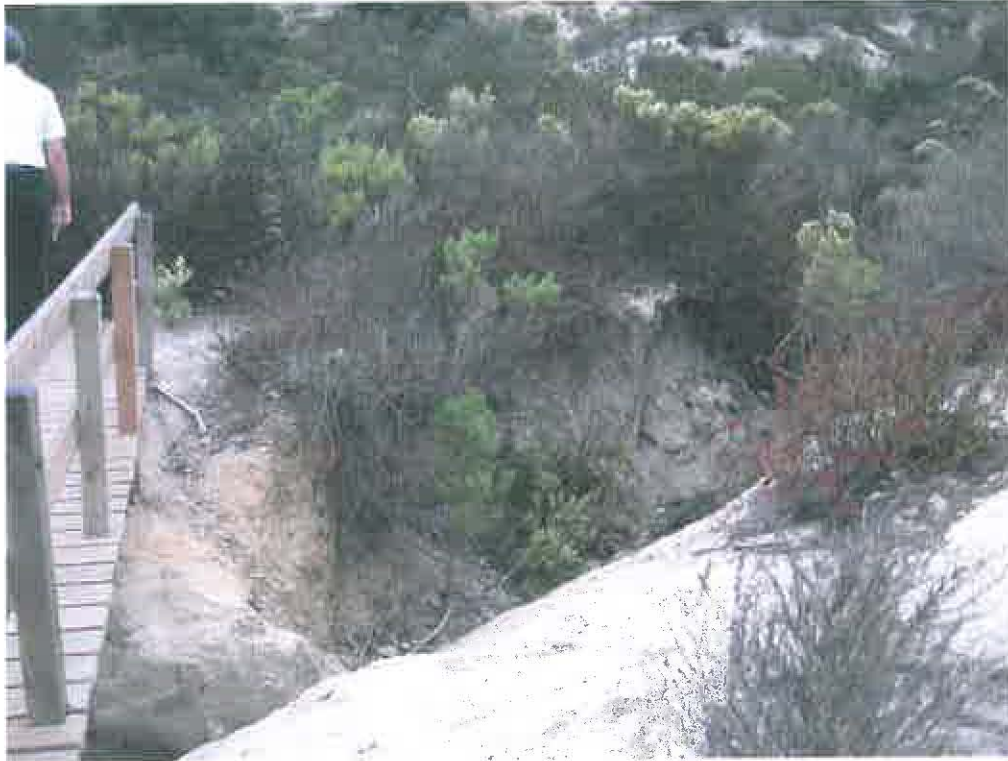
7. Upstream approach to the pedestrian bridge. - Looking West

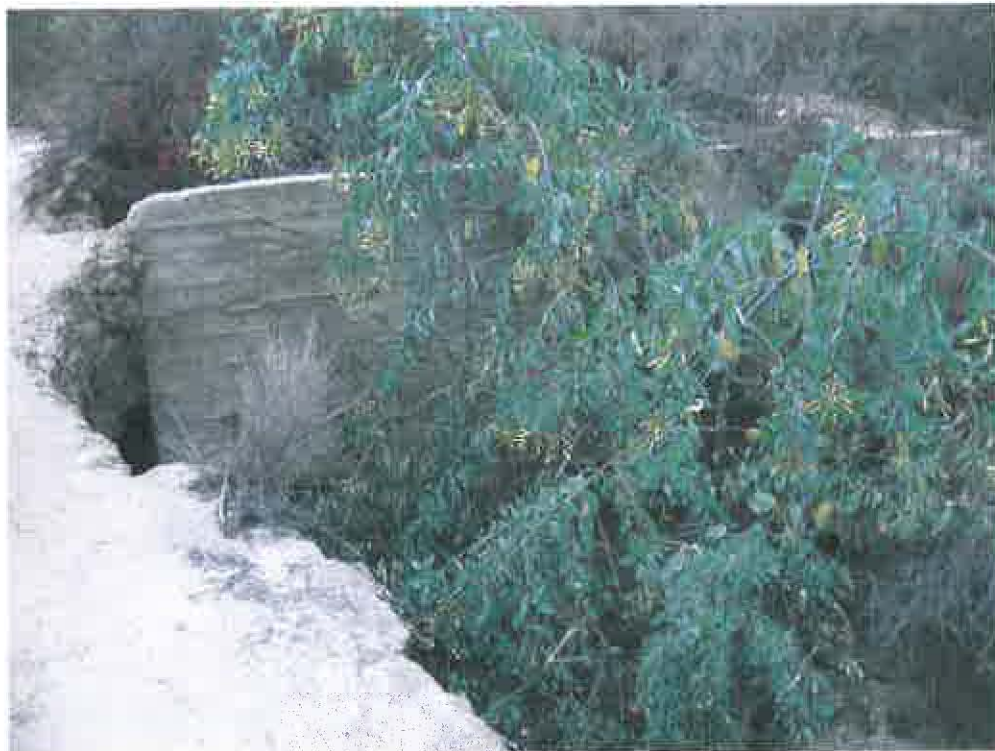
8. First existing grade control structure. - Looking North

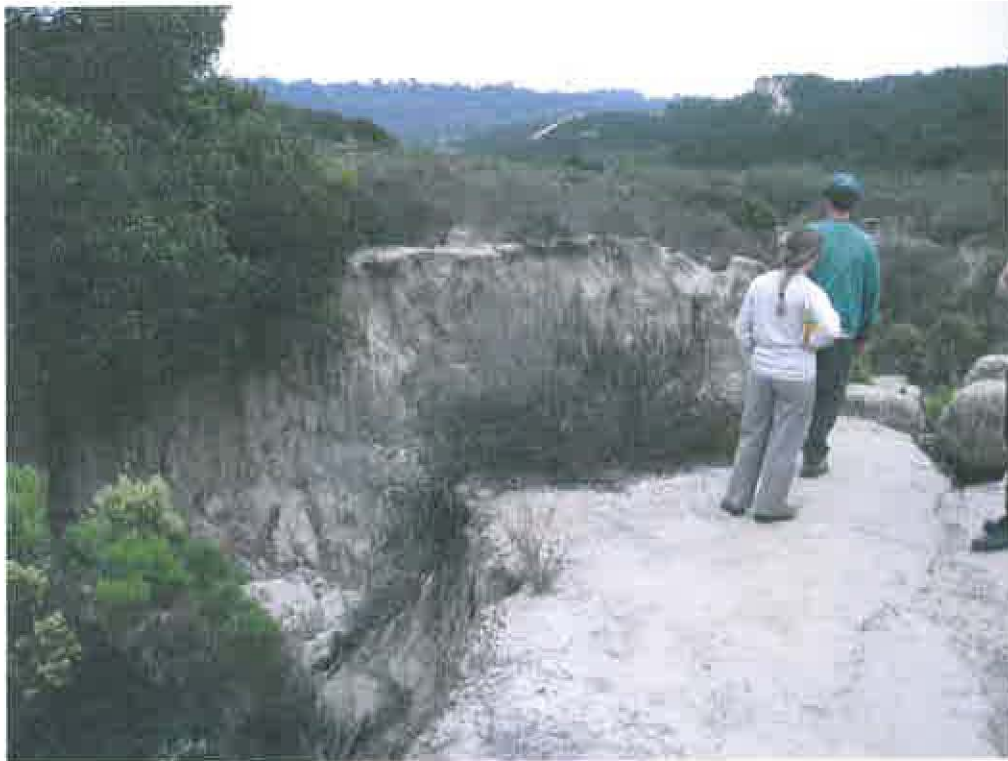
9. Downstream of first existing grade control structure. - Looking South

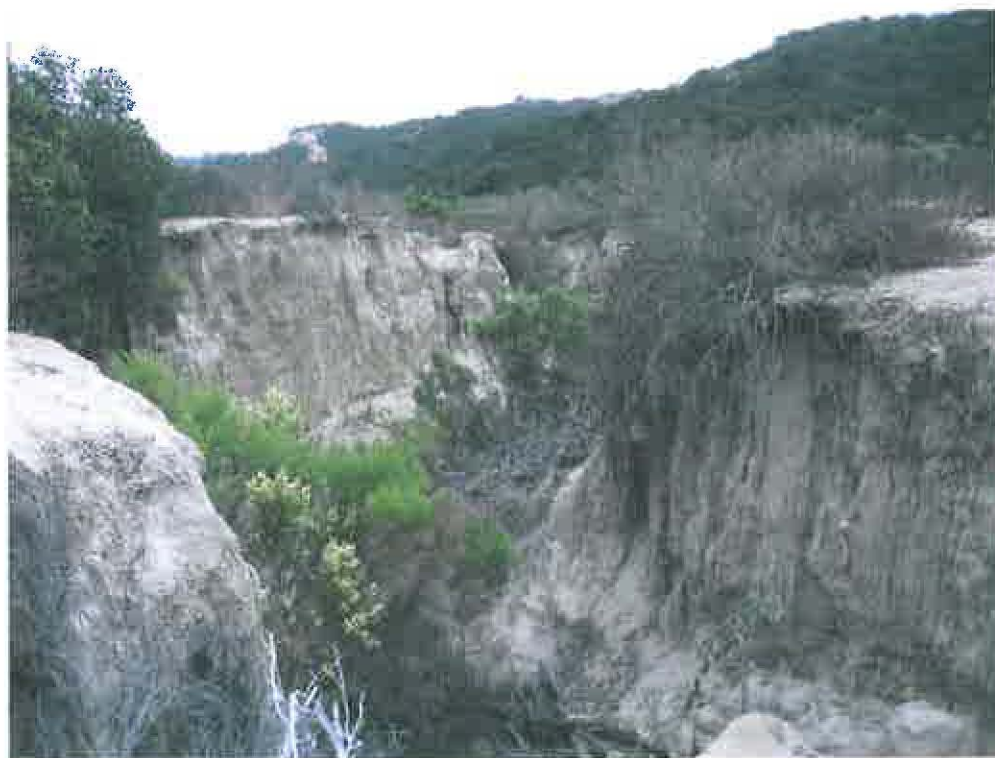
10. Downstream of first existing grade control structure. - Looking South

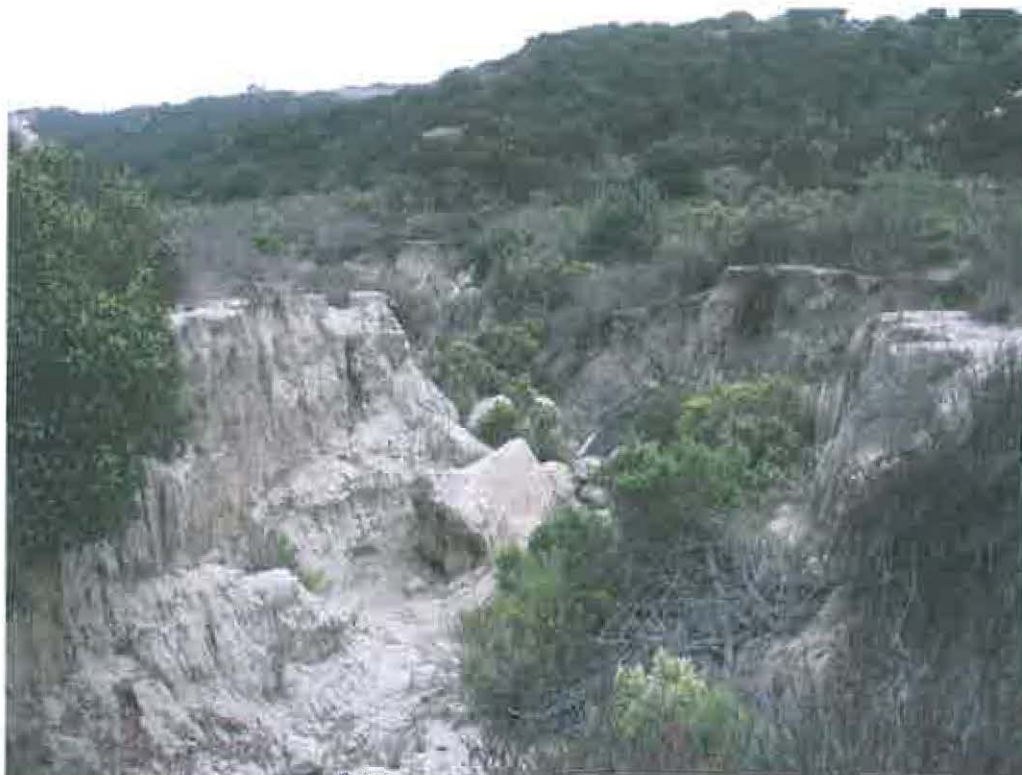
11. Downstream of first existing grade control structure. - Looking South

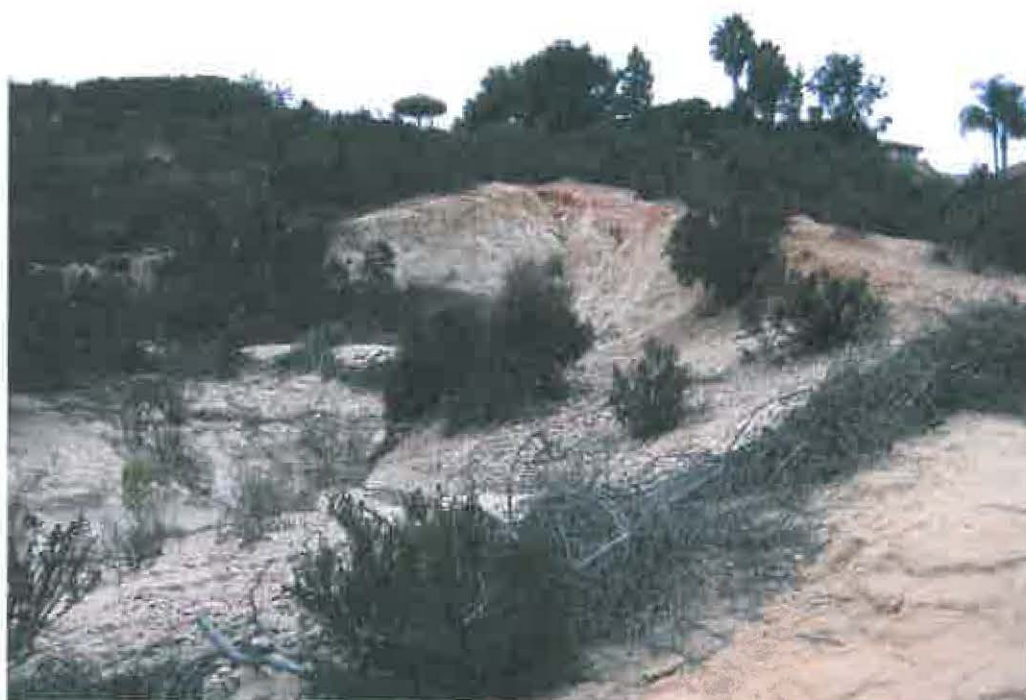
12. A drainage path on the west slope of the drainage area. - Looking West

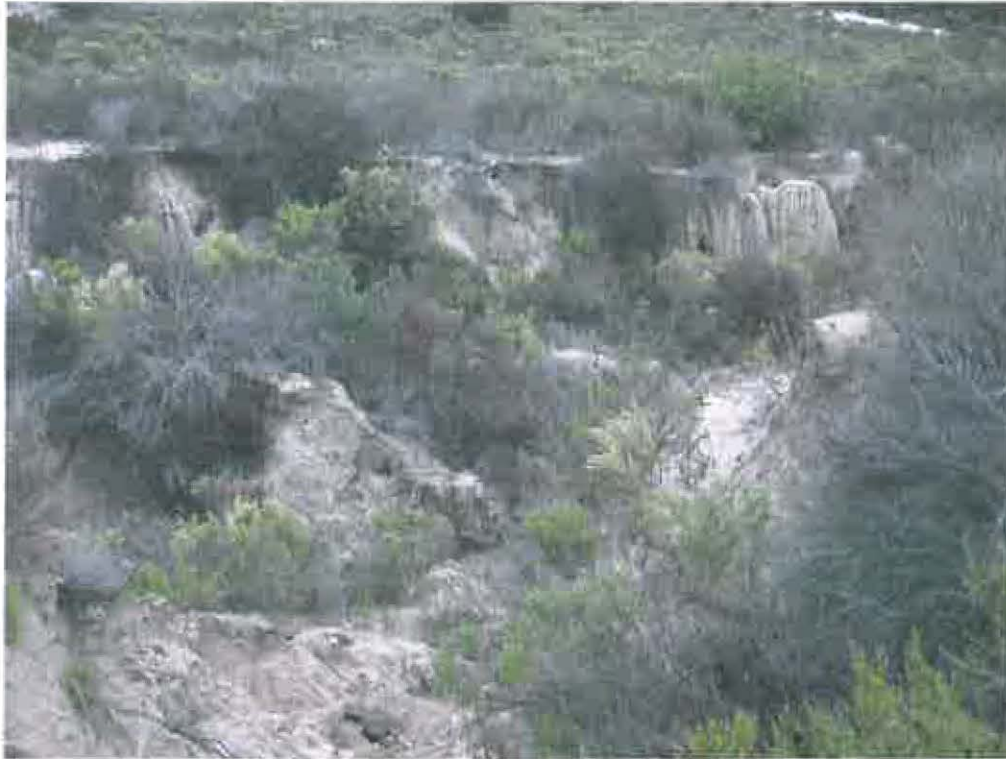
13. Head cutting on the west bank. - Looking Southeast

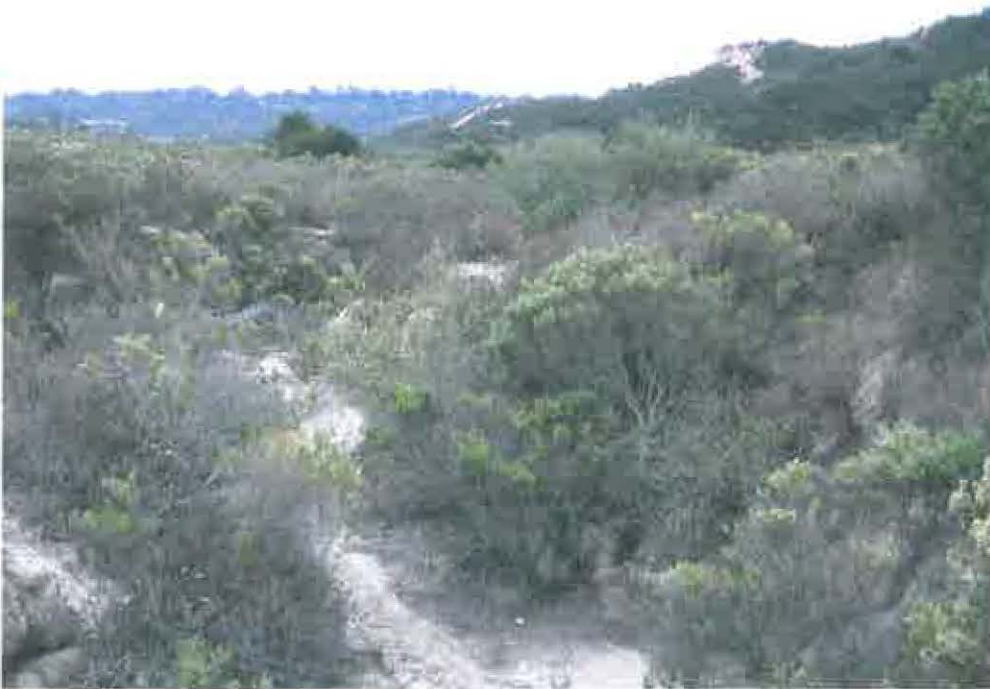
14. Upstream of second grade control structure. - Looking South

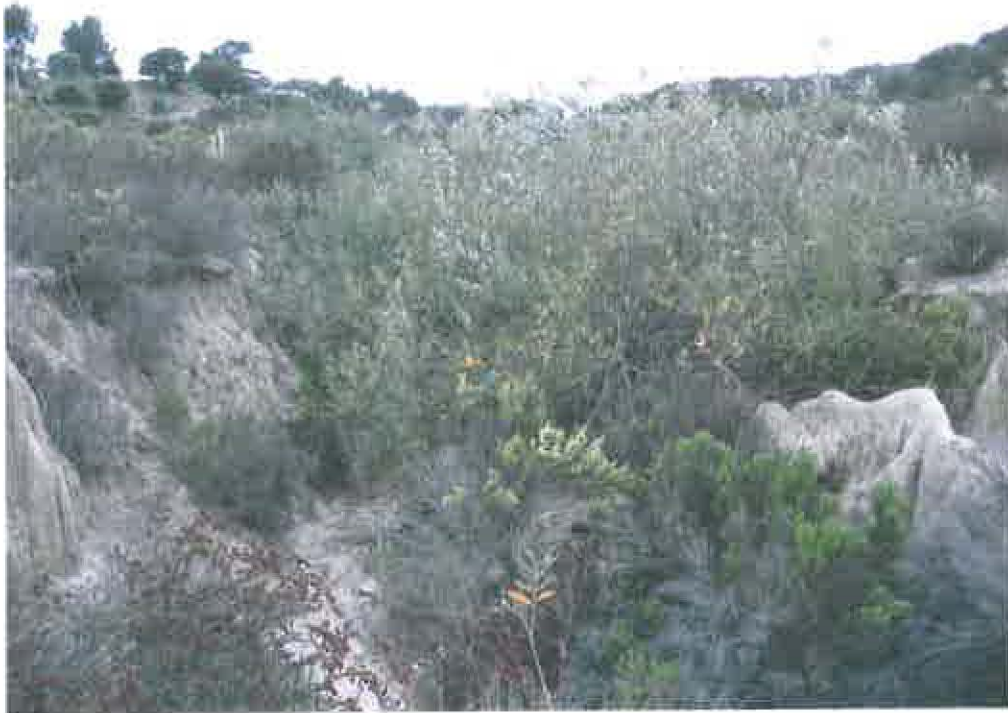
15. Second existing grade control structure (covered by willows). - Looking North

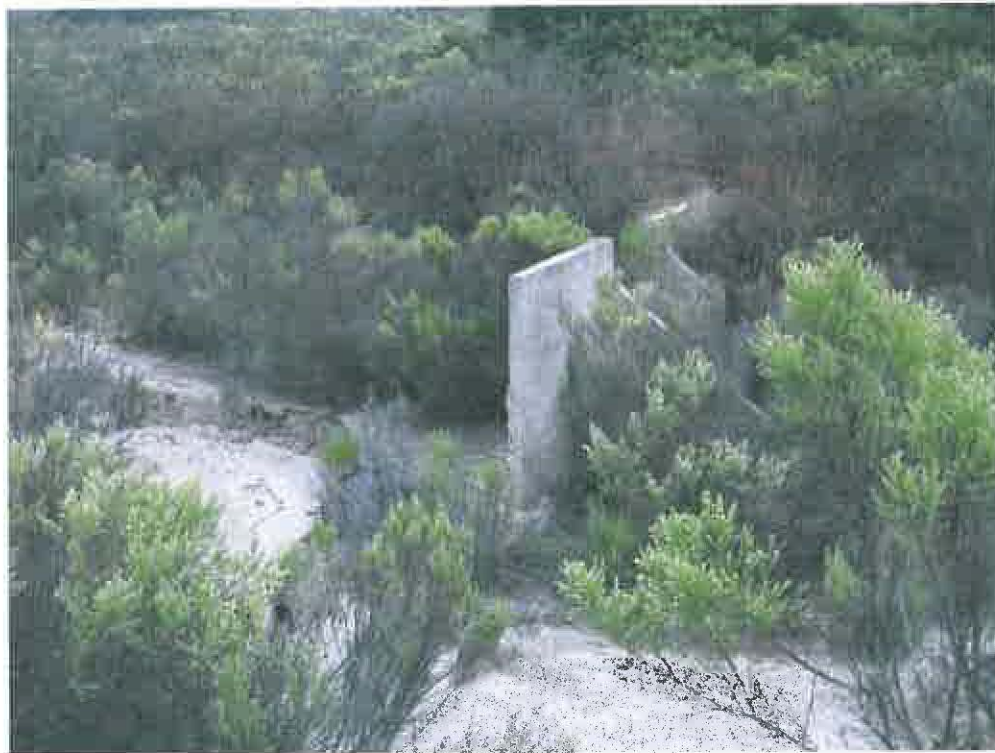
16. Third existing grade control structure. - Looking Northeast

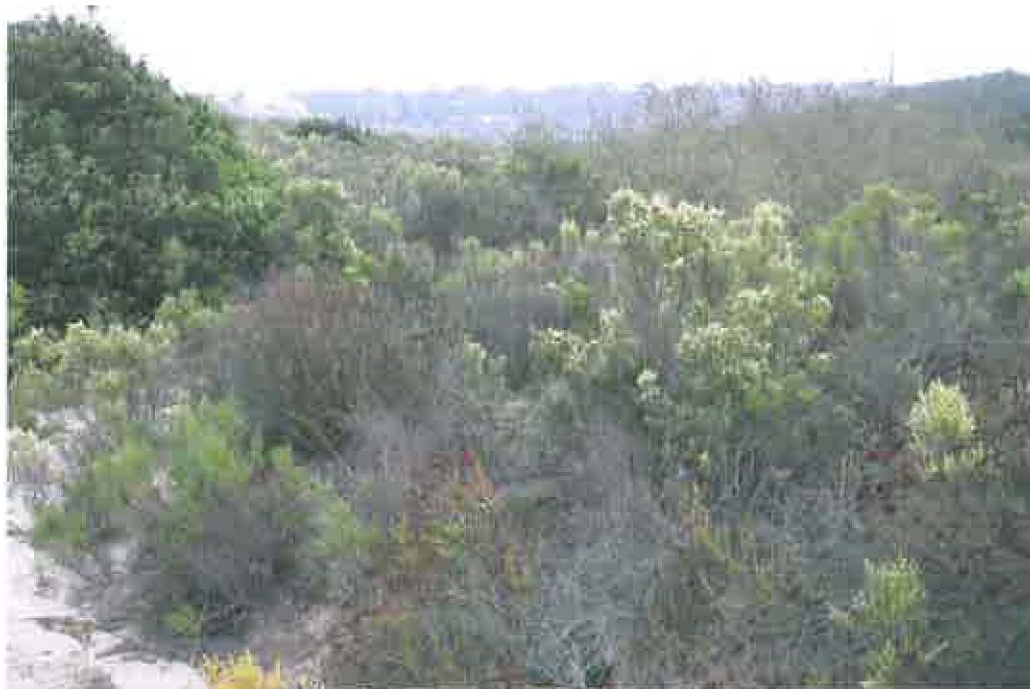
17. Downstream of the major erosion problems. - Looking South

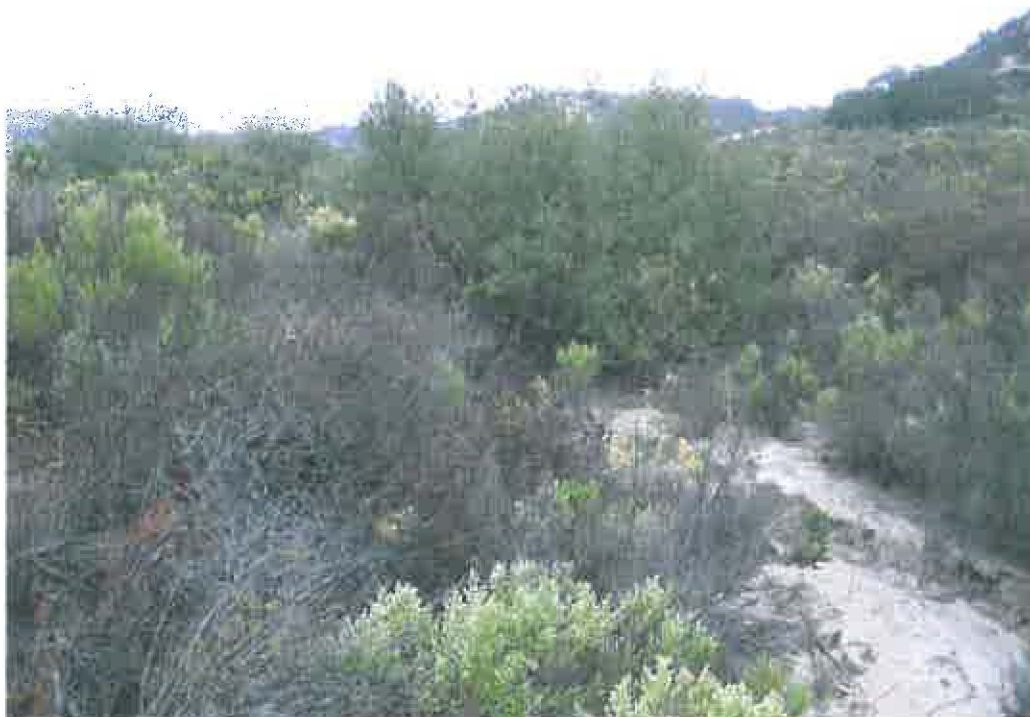
18. Downstream of the erosion problems. - Looking South

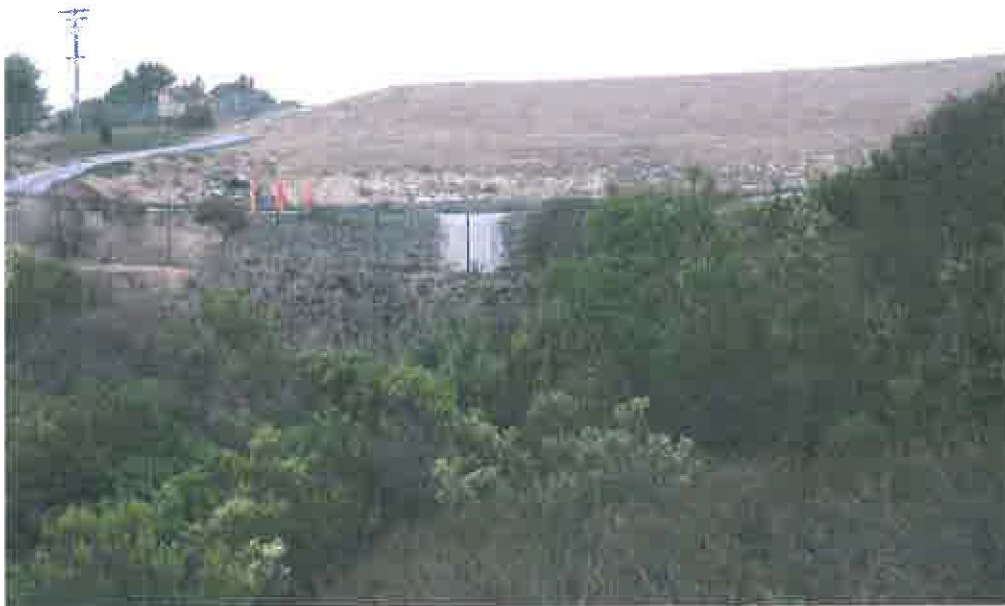
19. The existing landfill detention basin and spillway. - Looking North

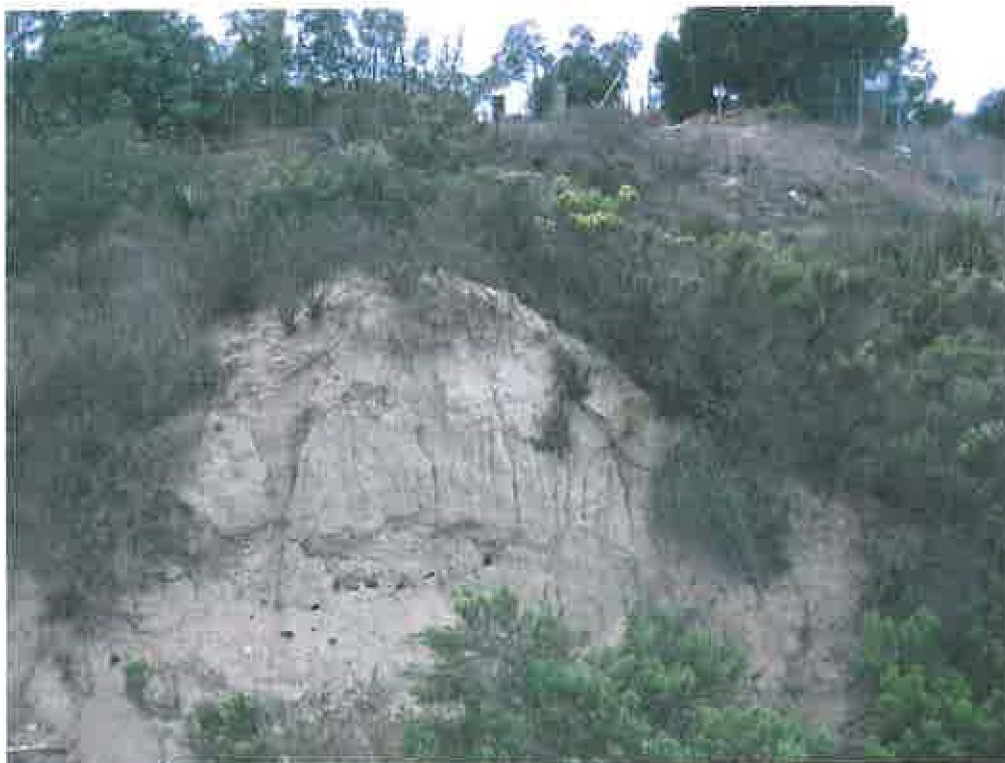
20. Scour through the embankment of a historical detention basin near the landfill. - Looking West

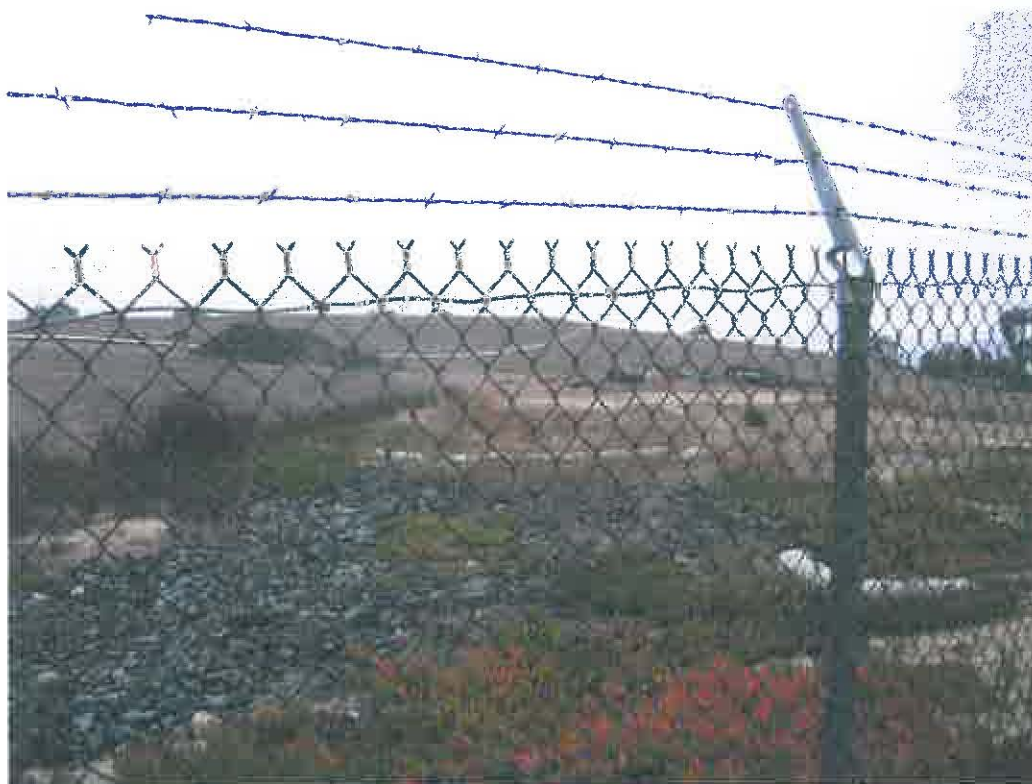
21. Encinitas Landfill - Looking Northeast
