**San Diego Association of Governments
Otay Water District San Miguel Habitat Management
Area Perimeter Fencing Restoration and Threat
Reduction Project
Otay Water District
Quarterly Progress Report
Reporting Period: April 21, 2023 – June 30, 2023
Submission Date: July 20, 2023
SANDAG Contract Number: S1125497**

Photo Page, Baseline Photos During Installation of Baseline Camera Stations

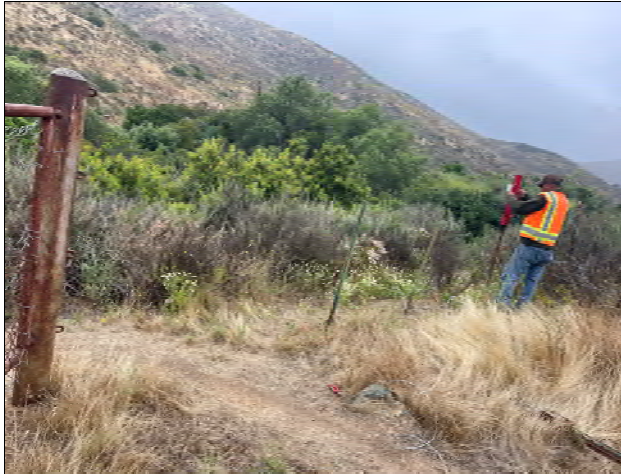
Photo 1 – Illegal Entry Point West 1a. Photo during fence repair. Date: 6/15/23. Time: 7:11am. Photo directed: North toward USFWS lands (beyond the t-posts).

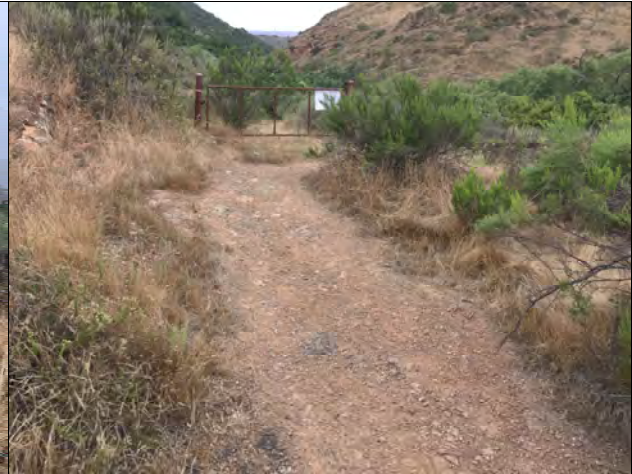
- West 1a – Fencing repaired and cameras deployed on June 15 by 9:06am. Camera inspected on June 16 and no issues noted. Camera inspected on June 26 and camera gone and fencing cut.

Photo 2 – Illegal Entry Point West 1a. Photo after completion of fence repair and installation of baseline camera (hidden in vegetation on t-post). Date: 6/15/23. Time: 9:06am. Photo directed: West to USFWS lands (beyond the gate).

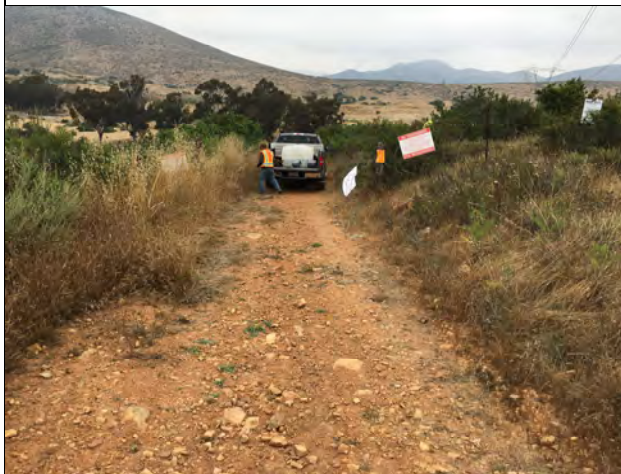
Photo 3 – Illegal Entry Point West 1b (SDG&E easement). Photo during gate repair (gate is comprised of t-posts and barbed wire fence). Date: 6/15/23. Time: 9:11am. Photo directed: East toward the HMA (beyond the fencing).

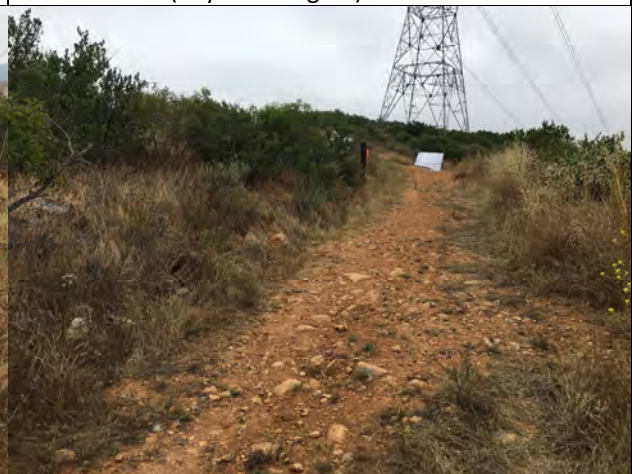
Photo 4 – Illegal Entry Point West 1b (SDG&E easement). Photo after completion of fence repair and installation of baseline camera (hidden in vegetation on t-post). Date: 6/15/23. Time: 9:21am. Photo directed: West toward USFWS lands (beyond the gate/signs).

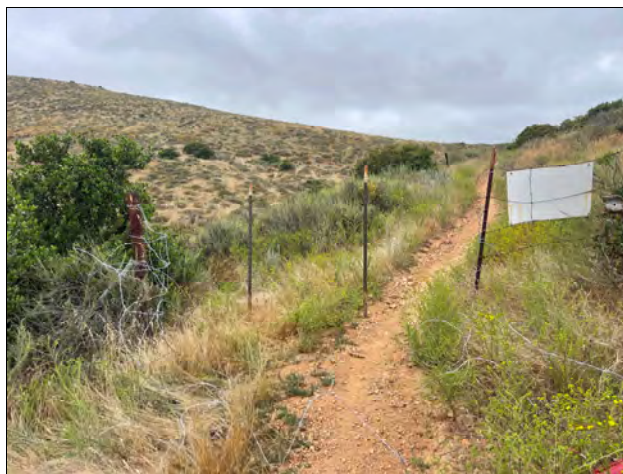
Photo 5 – Illegal Entry Point North 2b. Photo during fence repair. Date: 6/15/23. Time: 9:50am. Photo directed: North toward USFWS lands (beyond the fencing).

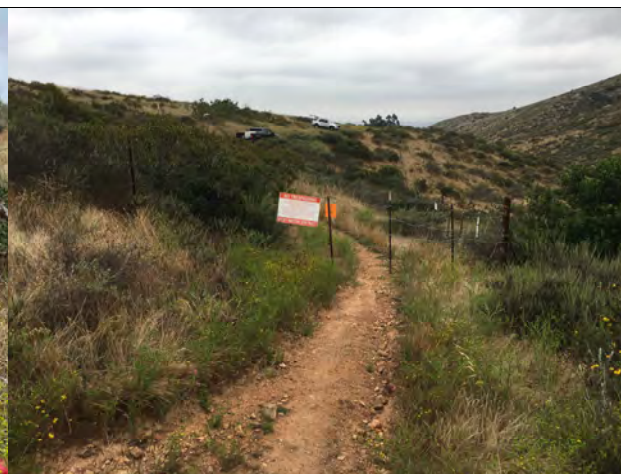
- North 2b – Fencing repaired and cameras deployed on June 15 by 10:52am. Illegal trail user first captured on camera on June 15 at 7:03pm (1 bicyclist). Based on photo and site inspection on June 16, it is anticipated that the user cut the fence.

Photo 6 – Illegal Entry Point North 2b. Photo after completion of fence repair and installation of baseline camera (hidden in vegetation on t-post). Date: 6/15/23. Time: 10:52am. Photo directed: South toward HMA (beyond the fencing).

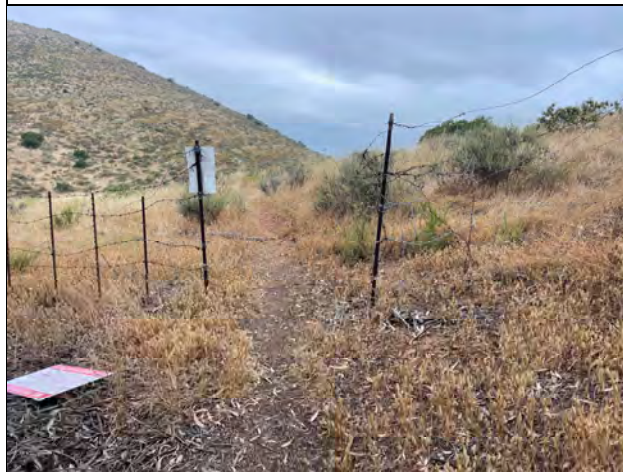
Photo 7 – Illegal Entry Point North 2a. Photo prior to fence repair. Date: 6/15/23. Time: 9:55am. Photo directed: North into USFWS lands (beyond the fencing).

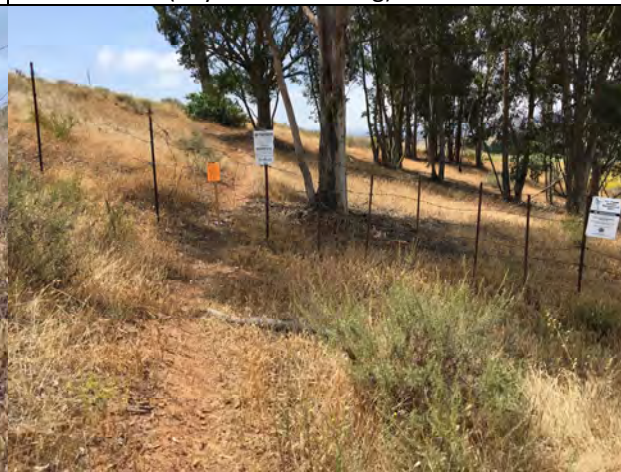
Photo 8 – Illegal Entry Point North 2a. Photo after completion of fence repair and installation of baseline camera (hidden in vegetation). Date: 6/15/23. Time: 11:32am. Photo directed: South into HMA.

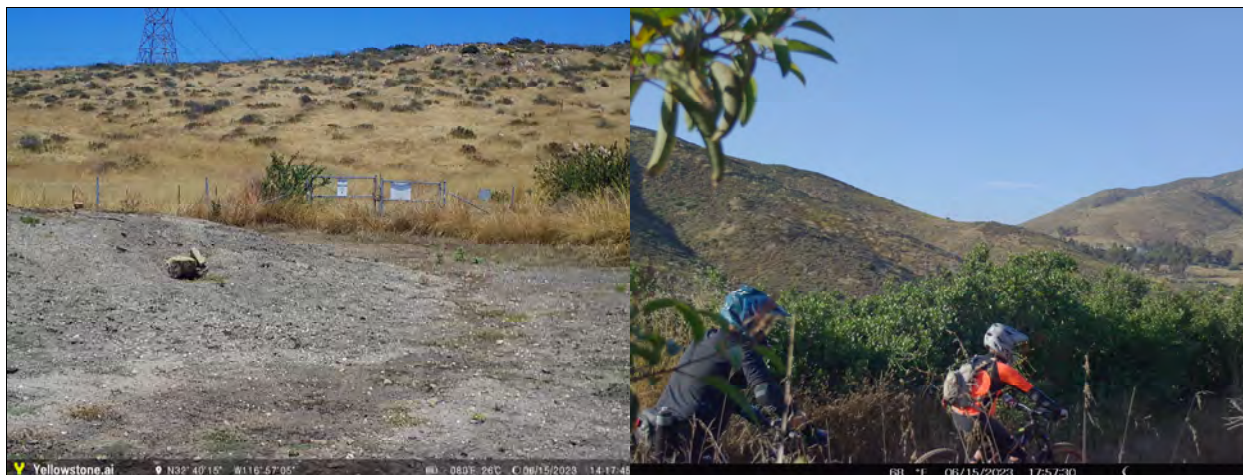
Photo 9 – Illegal Entry Point East 3b (SDG&E easement road beyond gate). No fence repairs necessary on 6/15/23 and no gate repairs implemented. No trespassers were captured on camera between 6/15/23 and 6/30/23. Date: 6/15/23. Time: 2:17pm. Photo directed: East.

Photo 10 – Illegal Entry Point West 1b (SDG&E easement road). Photo of first illegal trail users captured on the baseline camera after same day deployment (3 bicyclists). Suggests that the repaired gate was removed and reset by the users. Date: 06/15/23. Time: 5:57pm. Photo directed: North.

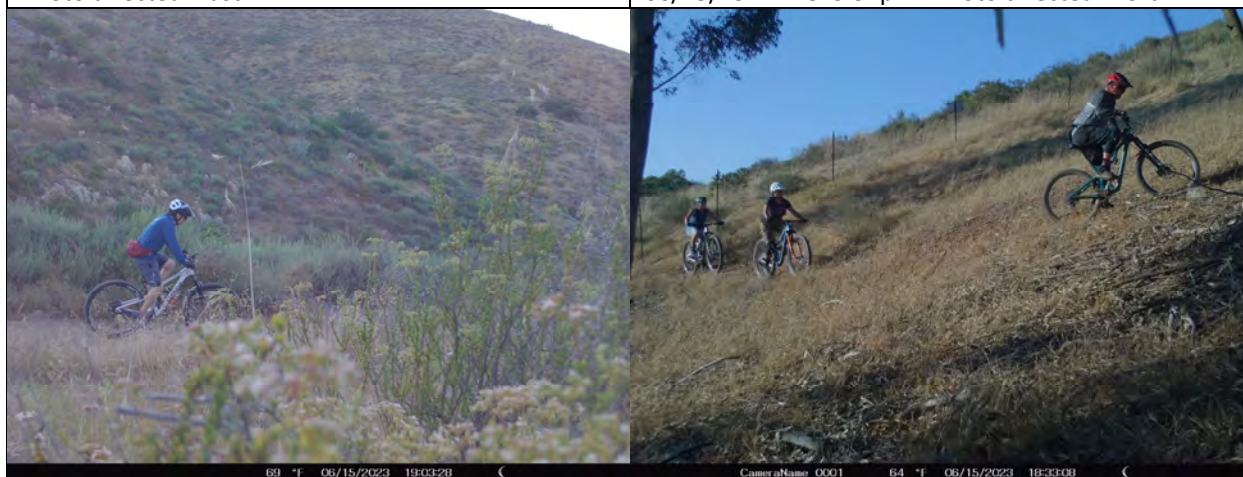
Photo 11 – Illegal Entry Point North 2b. Photo of first illegal trail user captured on the baseline camera after same day deployment (1 bicyclist). Suggests that repaired fencing was cut by this user on this day. Date: 6/15/23. Time: 7:03pm. Photo directed: Northwest.

Photo 12 – Illegal Entry Point North 2a. Photo of first illegal trail users captured on the baseline camera after same day deployment (4 bicyclists). Camera detected users cutting the repaired fence. Date: 6/15/23. Time: 6:33pm. Photo directed: North/northeast.
