VISTA DEL MAR ELEMENTARY SCHOOL PROJECT

Year 5 California Rapid Assessment Method (CRAM) Report for Vernal Pool Systems

July, 2016

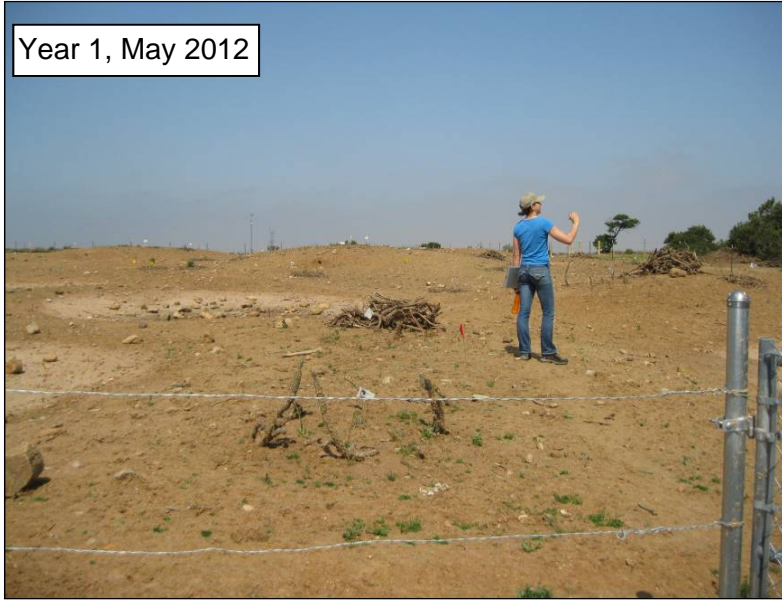
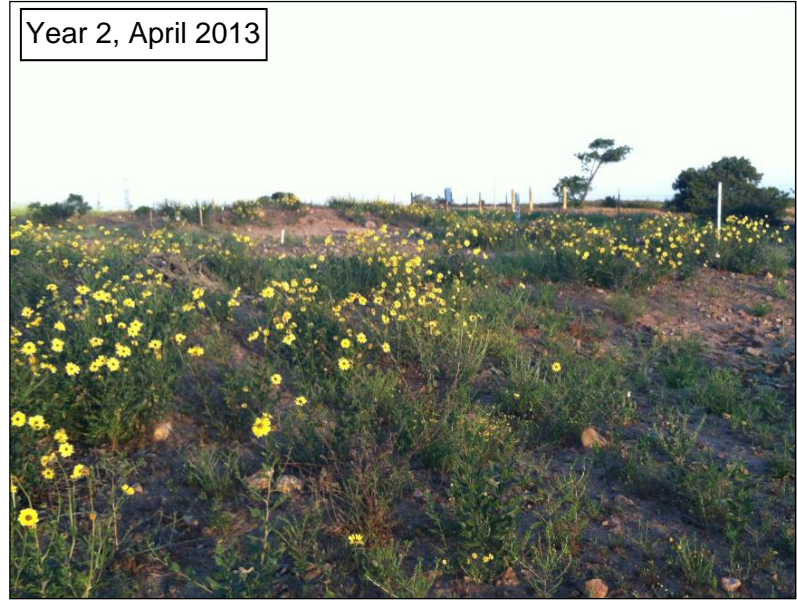
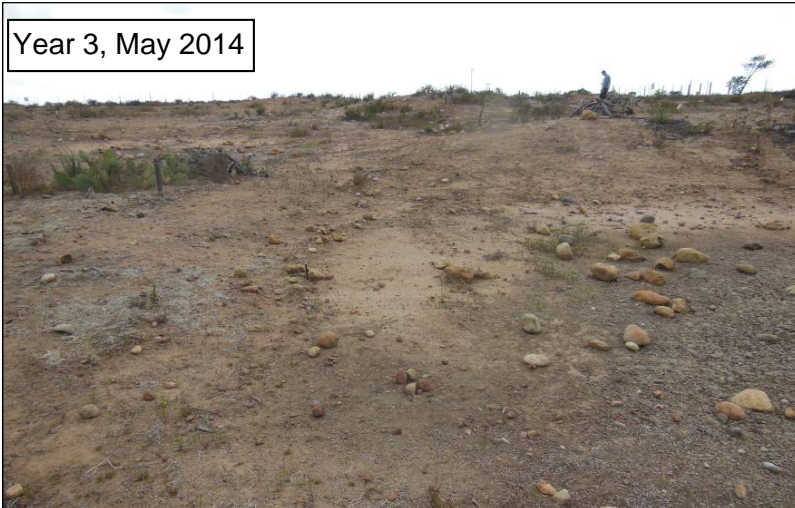
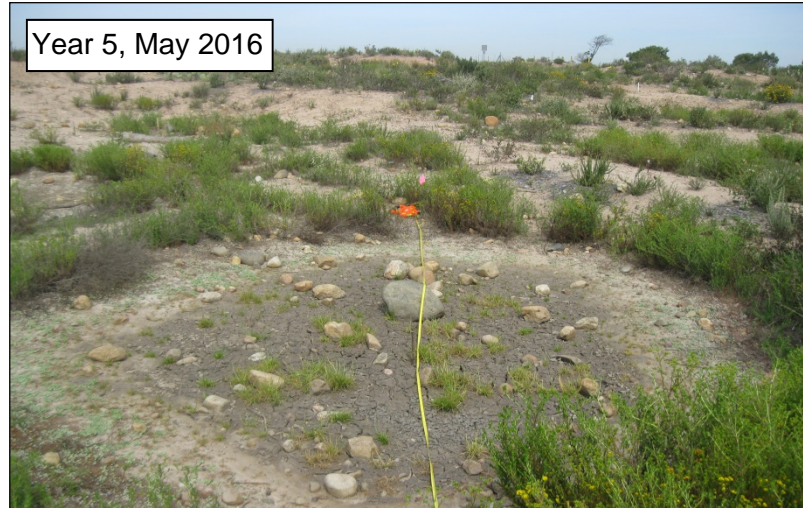
Photos taken during Years 1, 2, 3, and 5 (2012 – 2016) from the east side facing northwest. CRAM assessments were conducted during Years 1, 3 and 5. Note that the vegetation onsite was much more robust in 2013 than in 2014 due to the severe drought conditions and high temperatures experienced during the 2014 growing season (photo of Year 2 is included to illustrate this). Note that photos are not taken from the exact same vantage point.

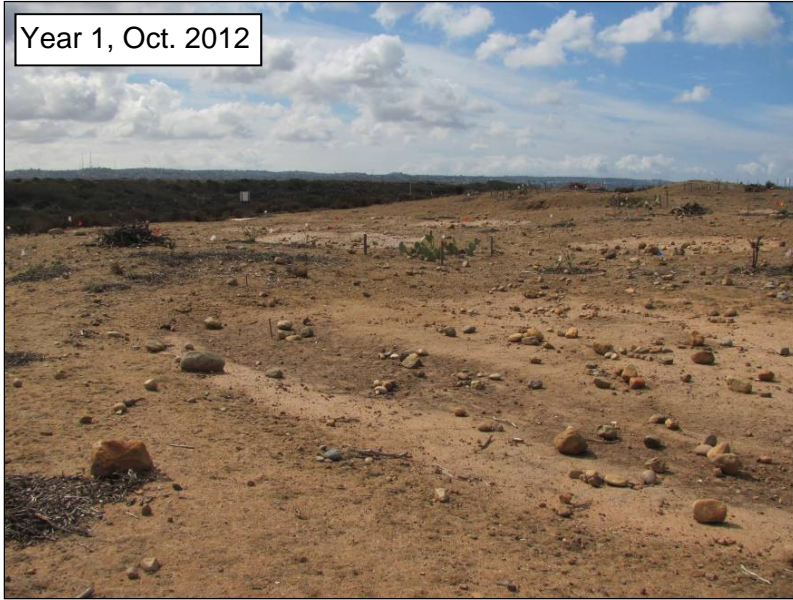
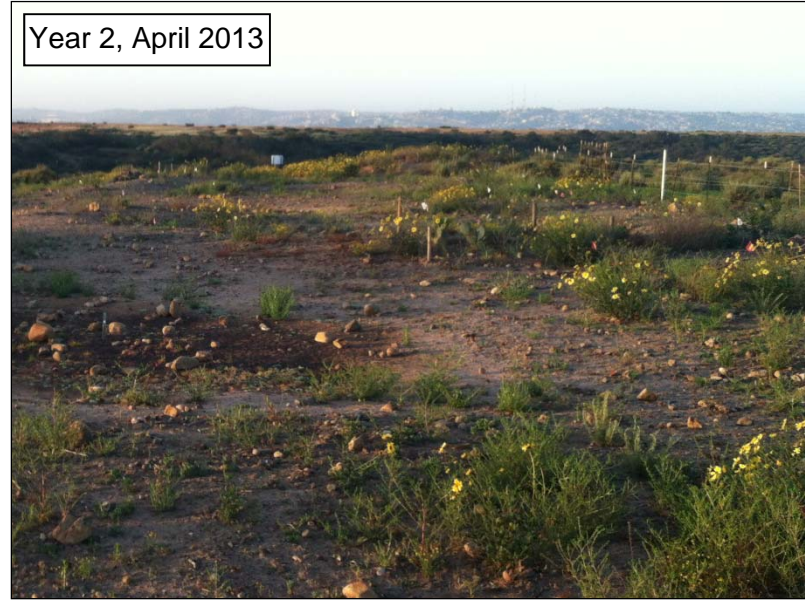
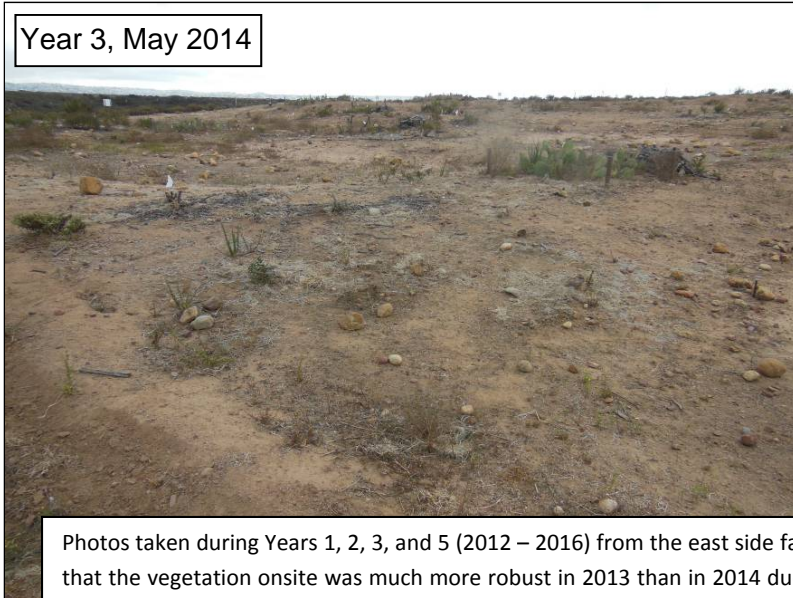
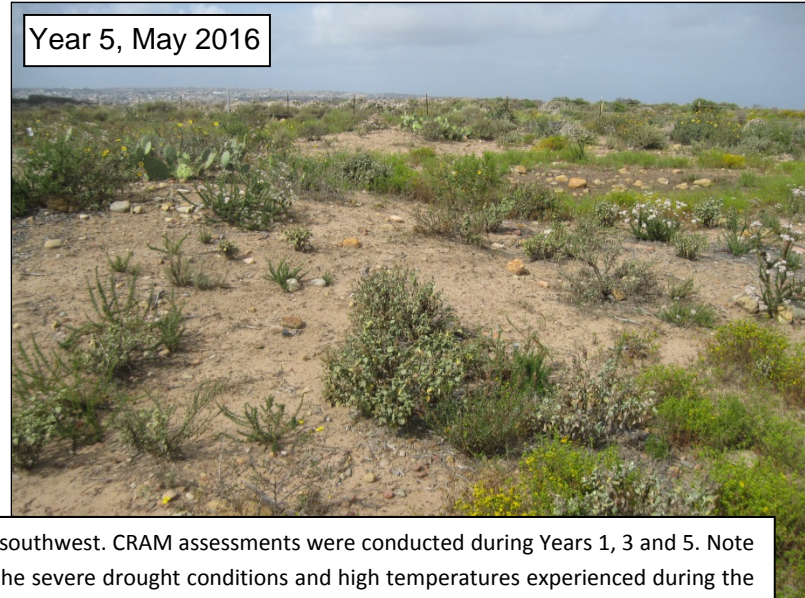
Photos taken during Years 1, 2, 3, and 5 (2012 – 2016) from the east side facing southwest. CRAM assessments were conducted during Years 1, 3 and 5. Note that the vegetation onsite was much more robust in 2013 than in 2014 due to the severe drought conditions and high temperatures experienced during the 2014 growing season (photo of Year 2 is included to illustrate this). Note that photos are not taken from the exact same vantage point.
