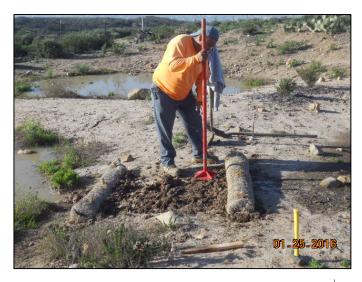
Photo 1. Fixing erosion problem near vernal pools 22 and 23, March 2016.

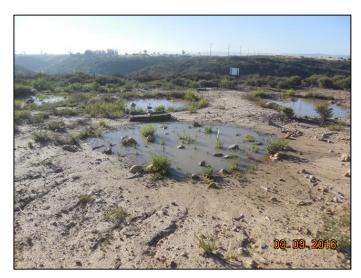
Photo 3. Southeast corner of restoration area, facing east, March 2016.

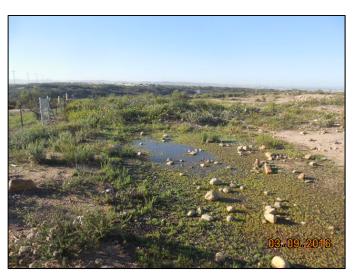
Photo 2. Southern edge of restoration area, facing west, March 2016.

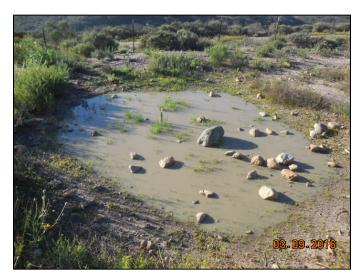
Photo 4. Full vernal pool with flowering quillwort (*Lilaea scilloides*), March 2016.

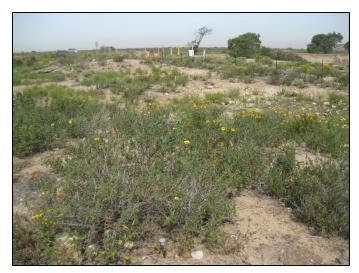
Photo 5. Coastal sage scrub habitat surrounding vernal pool basins, April 2016.

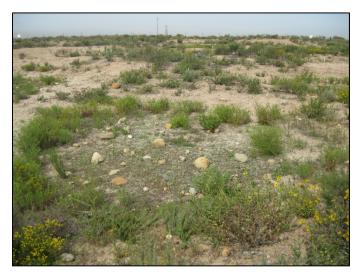
Photo 7. Vernal pool basin with surrounding upland habitat, April 2016.

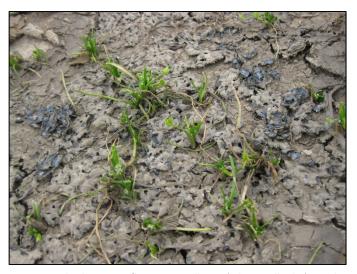
Photo 6. Minor herbivory on flowering quillwort (Lilaea scilloides), April 2016.

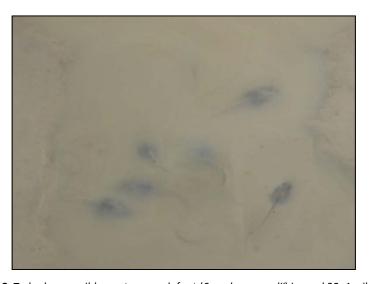
Photo 8. Tadpoles, possibly western spadefoot (*Spea hammondii*) in pool 22, April 2016.

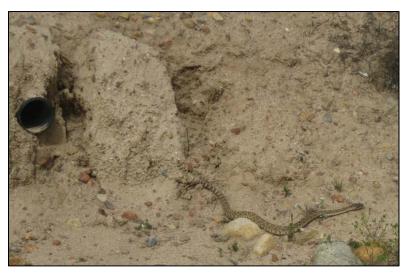
Photo 9. Southern pacific rattlesnake (*Crotalus oreganus helleri*) that recently vacated tunnel to artificial burrowing owl burrow on the left side of the photograph, April 2016.

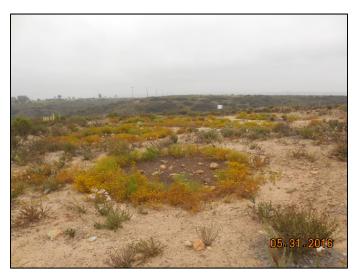
Photo 11. Southeastern portion of restoration site, May 2016.

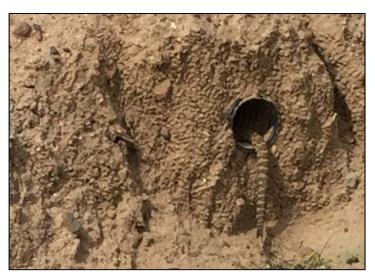
Photo 10. Rattlesnake from Photo 9 entering adjacent tunnel to artificial burrowing owl burrow, April 2016.

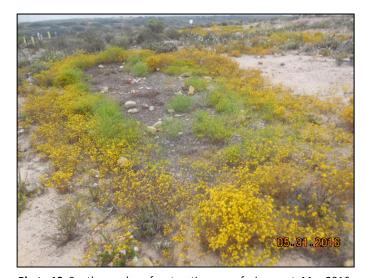
Photo 12. Southern edge of restoration area, facing west, May 2016.

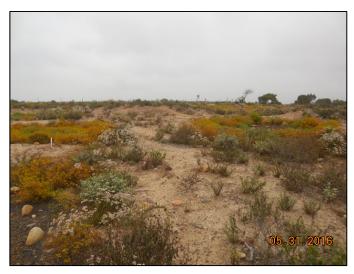
Photo 13. Upland habitat surrounding vernal pool basins, May 2016.

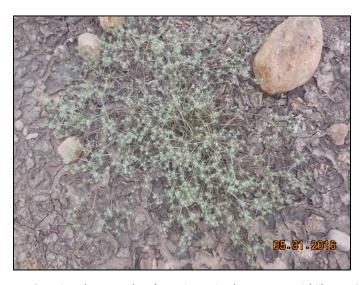
Photo 15. San Diego button-celery (Eryngium aristulatum var. parishii), May 2016.

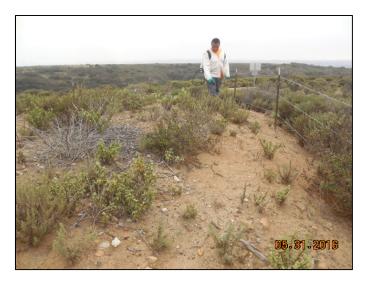
Photo 14. Weed abatement on the restoration site, May 2016.

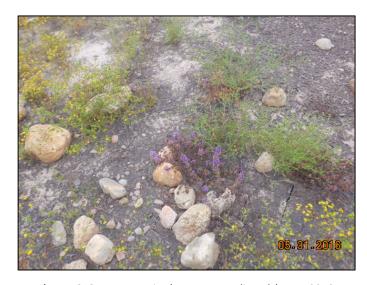
Photo 16. Otay Mesa Mint (Pogogyne nudiuscula), May 2016.

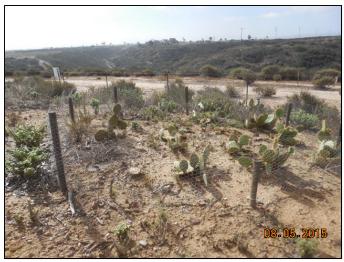
Photo 17. Southern portion of site, showing herbicide cages around cactus plants, August 2016.

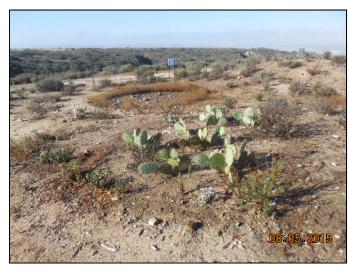
Photo 19. Vernal pools and upland habitat in summer dormancy, August 2016.

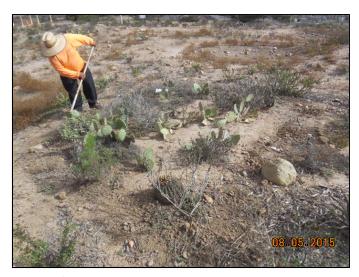
Photo 18. Site maintenance activities, August 2016.

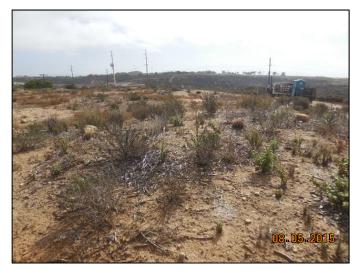
Photo 20. Vernal pools and upland habitat in summer dormancy, August 2016.
