# City of San Diego

## Vernal Pool And Quino Habitat Restoration Project Implementation Report

January 2010

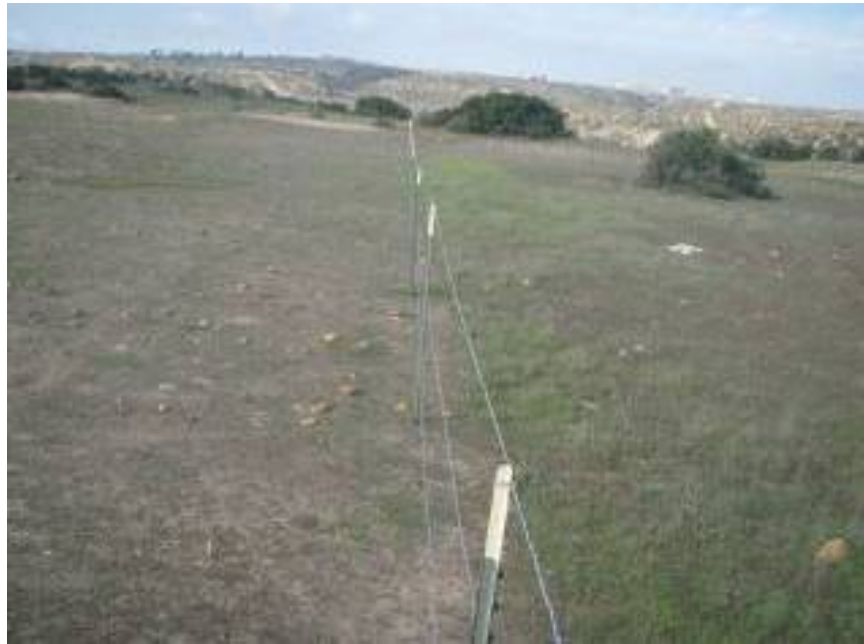
**Figure 7. Fence separating dethatched area (left) from undethatched area (right)**

Because of the goat grazing, most of the vernal pools at the Goat Mesa upper pool area did not have extensive weed cover. The exception was the slump pools on the west side of the site, where grazing did not appear to commonly occur. The lower slump pool had extensive cover of Italian ryegrass (*Lolium perenne* ssp. *multiflorum*) and curly dock, both nonnative species. The upper slump pool was also covered with nonnative species, including soft chess (*Bromus mollis*) and tocalote (*Centaurea melitensis*). Nonnative species in the slump pools were removed with dethatching. Figure 7 shows the results of dethatching on the left side of the fence. In addition, approximately 3 cubic yards of trash from an abandon campsite under laurel sumac (*Malosma laurina*) shrubs was removed for off-site disposal at a landfill.

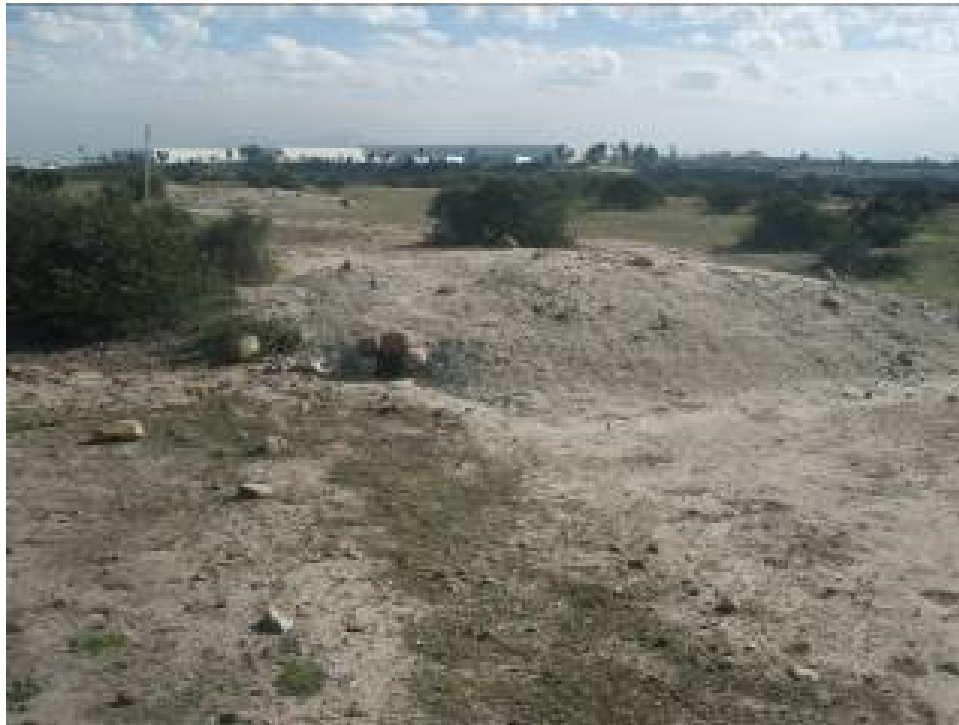
**Figure 8. Artificial burrowing owl burrow**

Although owls are not known from the site, burrowing owls are known from numerous nearby historical and current localities. The Otay Mesa area is believed to support the largest remaining population of burrowing owls on the coast in southern California, but surveys in recent years have found the species to be declining in distribution. Efforts are underway to establish multiple artificial owl burrow sites in Otay Mesa, and the Goat Mesa site was identified as an excellent addition to that program. Accordingly, four burrows were installed in conjunction with the topographic reconstruction of the basins (Figure 3). Figure 8 is a photograph showing one of the artificial burrows following installation. For a detailed description of artificial burrowing owl burrow construction methods, refer to the final Recommendations Report (EDAW 2007).

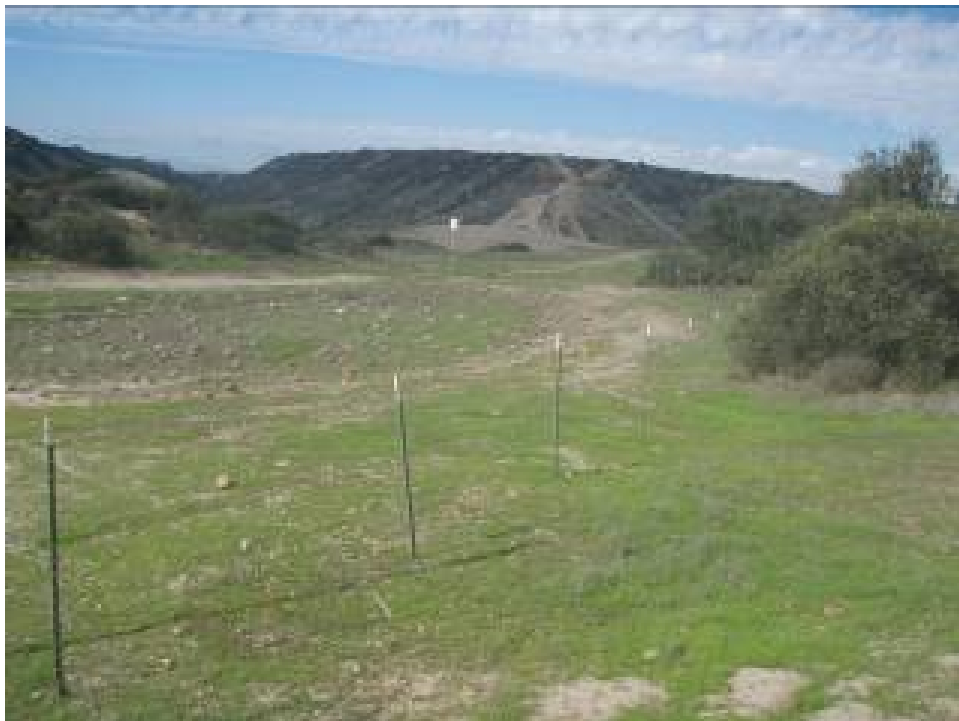
**Figure 9. A fenced vernal pool**

To redirect ORV activity away from the pools at Goat Mesa and to restrict grazing by goats, approximately 4,562 linear feet of three-strand barbless wire fencing was installed around the basin areas, including the slump pools (Figures 3 and 9). AECOM's restoration ecologist supervised installation to minimize disturbance to the habitat. During 2008, there were several incidents of vandalism damaging the fencing (i.e., portions of the fence were cut with wire cutters). Damaged sections were repaired and no additional vandalism has been observed.

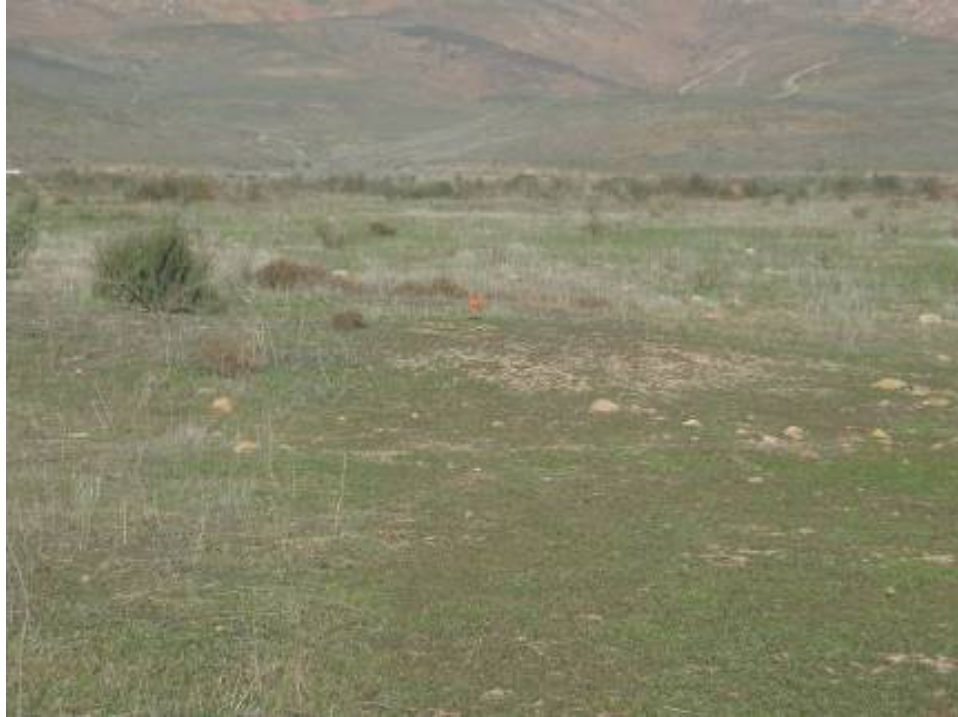
**Figure 10. A dethatched vernal pool**

*tragus*), which needed to be removed prior to seed drop. More than 16 tons of tumbleweed and other weed biomass was removed off-site for green waste recycling.

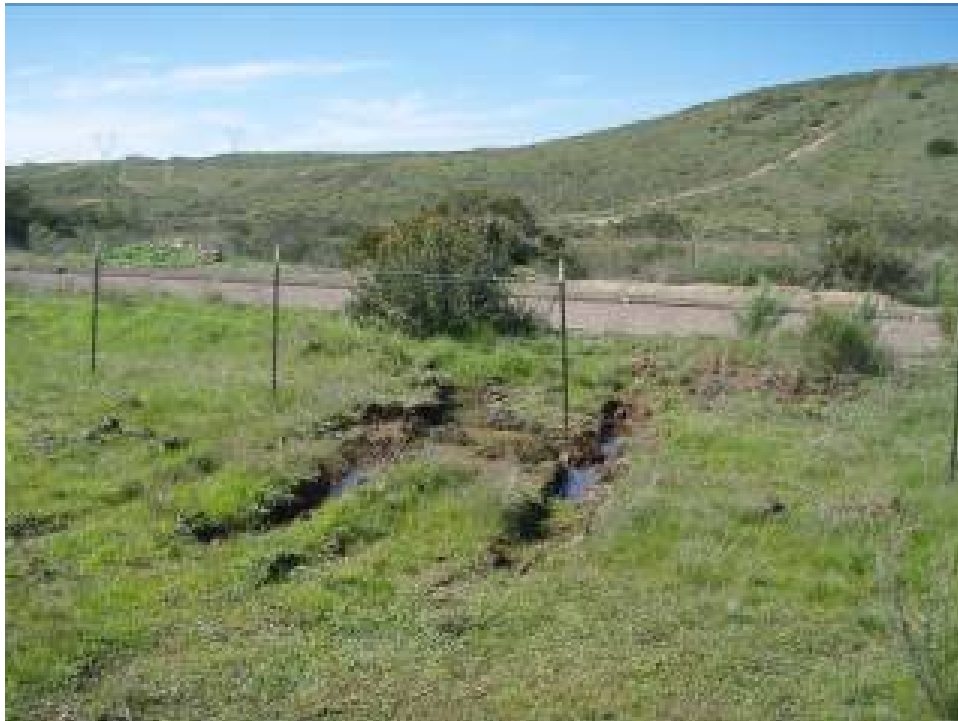
**Figure 11. Tire damage in the vernal pool restoration area**

The pools at the Proctor Valley (Figure 5) site have suffered extensively from off-road activities, especially those on the west side of Proctor Valley Road. This site had been used as a staging area for ORV use and had almost no vegetation (native or nonnative) on the west side. Not only had the vegetation been completely removed, but the basin areas were heavily impacted by vehicle ruts and excavation. Figure 11 shows impacts to the vernal pool restoration area resulting from ORV use.

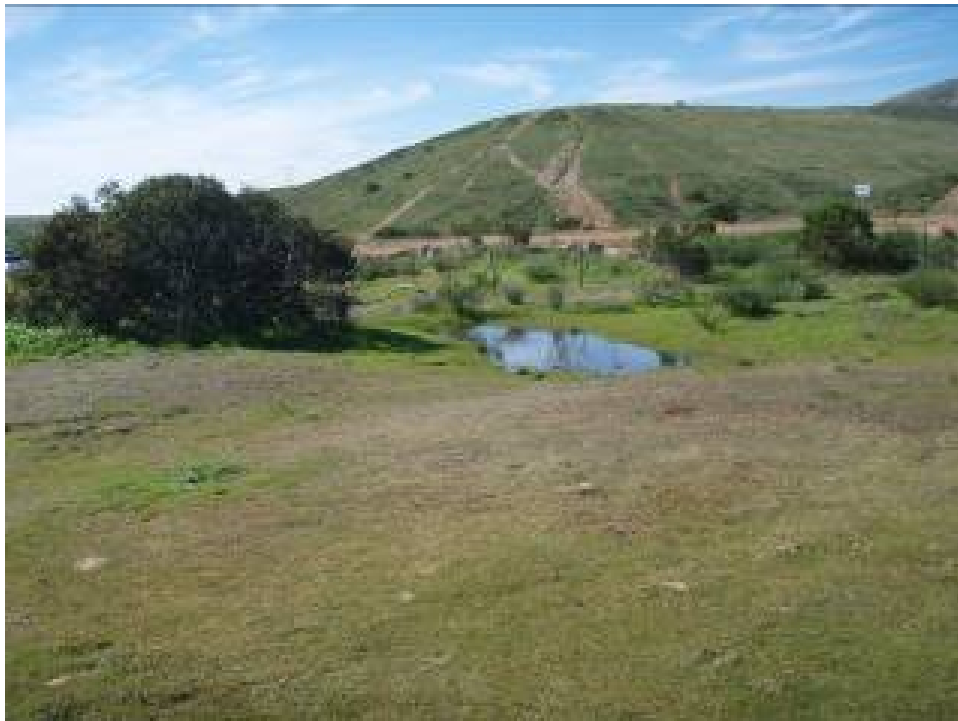
**Figure 12. A dethatched vernal pool at Proctor Valley**

Dethatching was conducted in the nine vernal pools at Proctor Valley, as well as the upland buffer area surrounding the pools. Figure 12 shows a dethatched vernal pool following a rain event in February 2009. The area was dethatched by the field crew using weed eaters to cut the nonnative plant material. Rakes and gas-powered blowers were used to concentrate and collect the weed biomass material. The material was then hauled off-site for green waste recycling.

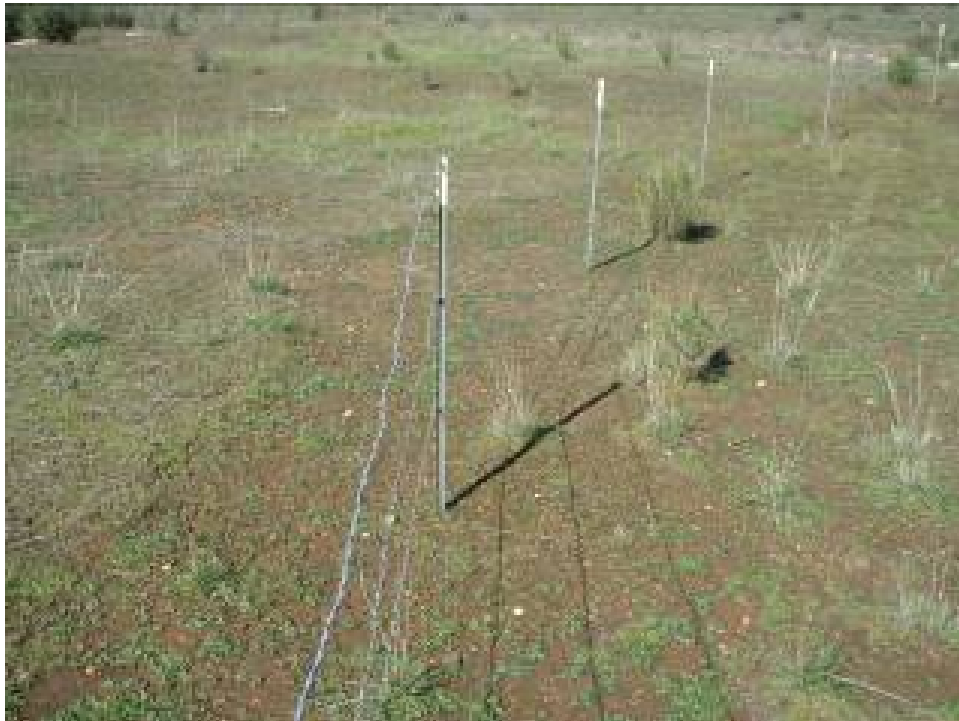
**Figure 12. Fence separating dethatched area (right) from nondethatched area (left)**

All of the vernal pools at the Marron Valley site were dethatched, along with most of the upland watershed. Figure 12 shows a dethatched area compared to a nondethatched area. The primary nonnative plants removed in the dethatching work was filaree or storksbill (*Erodium cicutarium*) and soft chess. These species were removed with weed eaters, raking, and gas-powered blowers to remove unwanted biomass. Weed biomass was hauled off-site for green waste recycling. Dethatching the pools will help to stabilize populations of the existing of San Diego fairy shrimp and little mousetail, while dethatching the upland watershed areas will help to recover habitat for the Quino. Figure 13 shows a dethatched vernal pool that ponded following a rain event in February 2009.

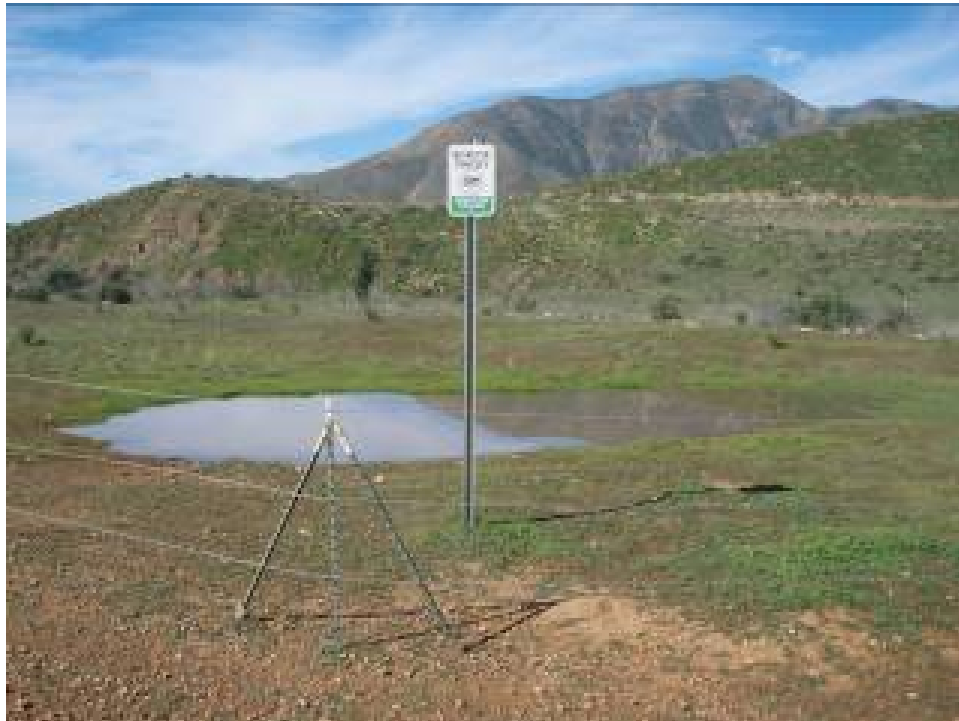
**Figure 14. Signage and fencing around a dethatched vernal pool**

Cattle grazing was the primary threat to the sensitive resources at Marron Valley, so a three-strand barbless wire fence was installed around the pools (approximately 2,900 linear feet). This fence can be removed in the future if the threat of cattle grazing is eliminated. Bilingual signs were installed at the site, as shown in Figure 6, to indicate that the area is off limits (refer to Section 3.1.6 for a description of the language). Figure 14 shows a fenced vernal pool with a sign.
