**San Diego Association of Governments**  
**San Diego National Wildlife Refuge - Mother Miguel Mountain**  
**Final Report**

**Project Period: 12/01/2015 – 6/01/2019**

**SANDAG Contract Number: 5004736**

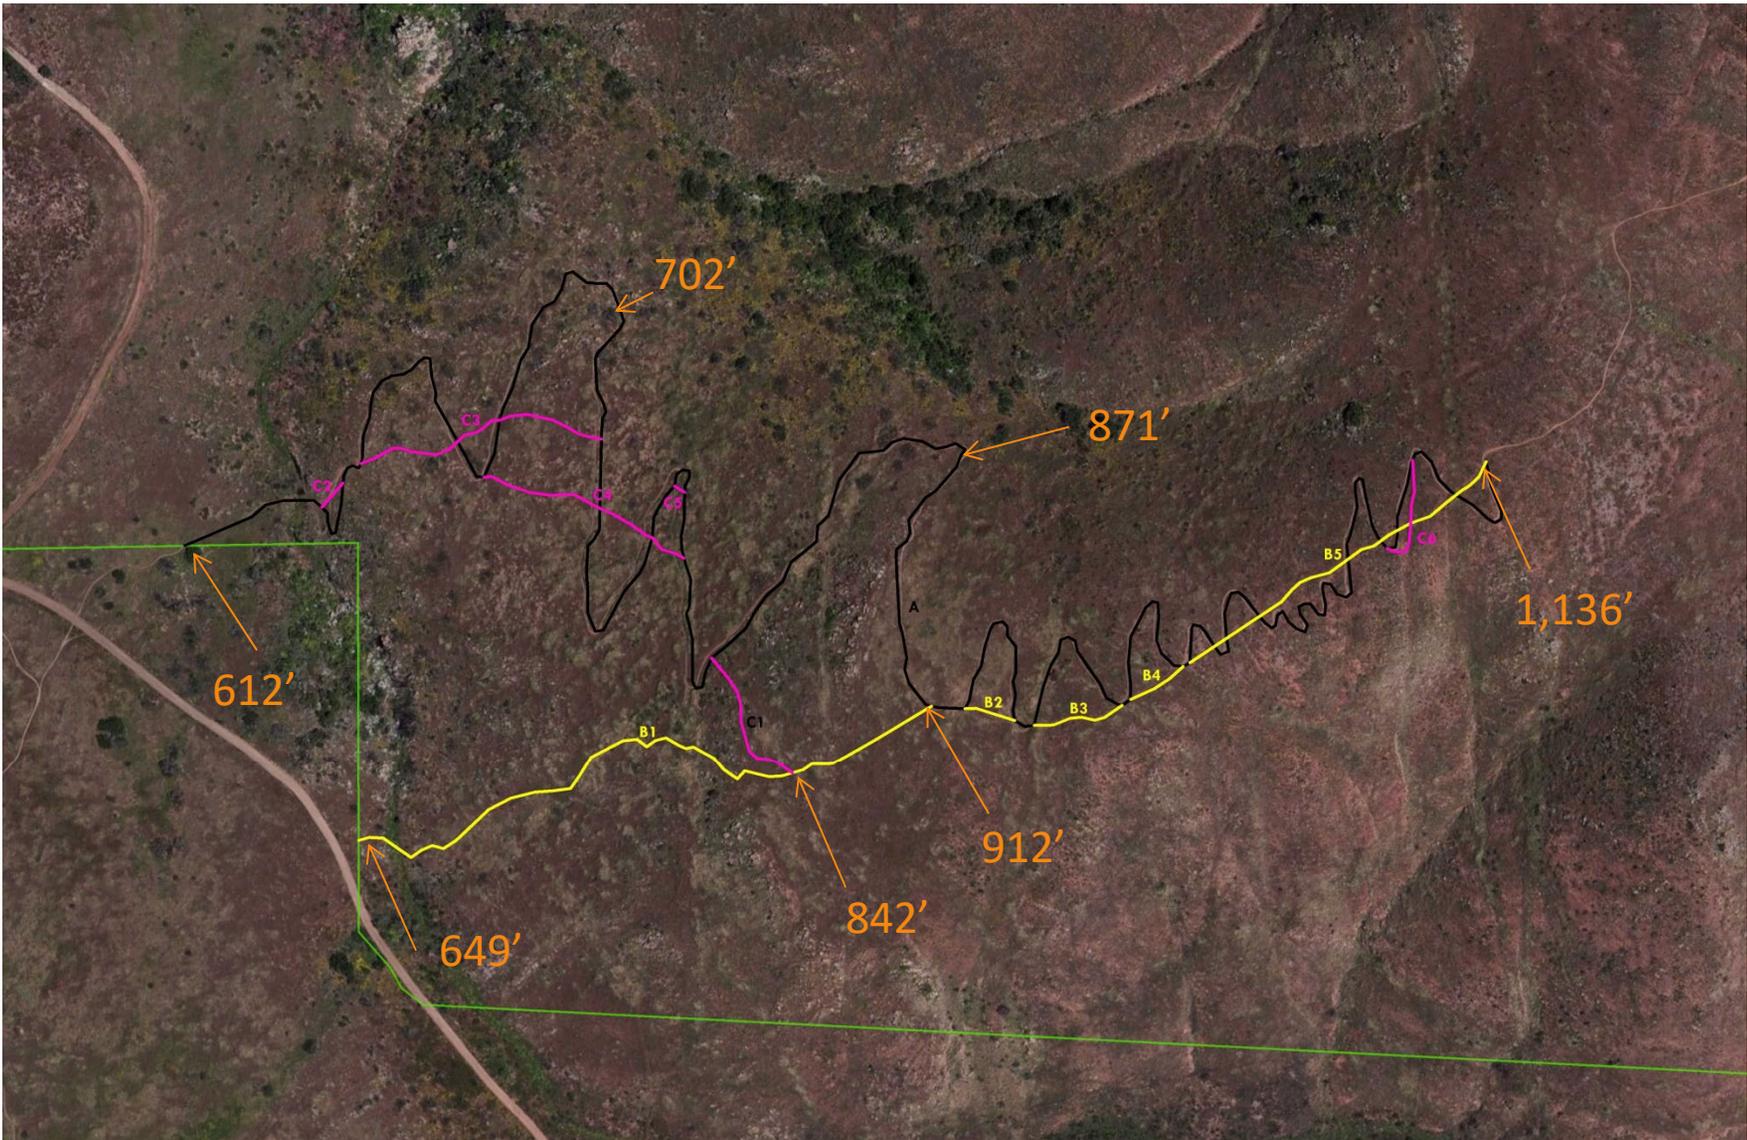
Figure 2 - Original and Current Trail Patterns (The black line depicts the original switchback trail; pink segments are where the switchbacks have been cut; and the yellow line is the user created fall line trail).

The fall line trail starts near the pink dot on Figure 1 and extends straight up the mountain, as indicated in yellow in Figure 2. Figure 3 illustrates the impacts to the habitat of this user-created trail. The blue dot on Figure 1 indicates where the original user-created switchback trail enters the Refuge. The trail extends for approximately 6,240 feet from the Refuge boundary up to elevation 1,136 feet above MSL; at that point, the original user-created trail and the fall line trail merge and continue to the top of the mountain.

The primary focus of this project was the area between the trailhead and elevation 1,136 feet. There are approximately 2,436 linear feet of user-created trail cuts along the switchback trail (shown in pink [“C” segments] on Figure 2). The fall line trail (shown in yellow on Figure 2) includes 1,533 feet of user-created trail.

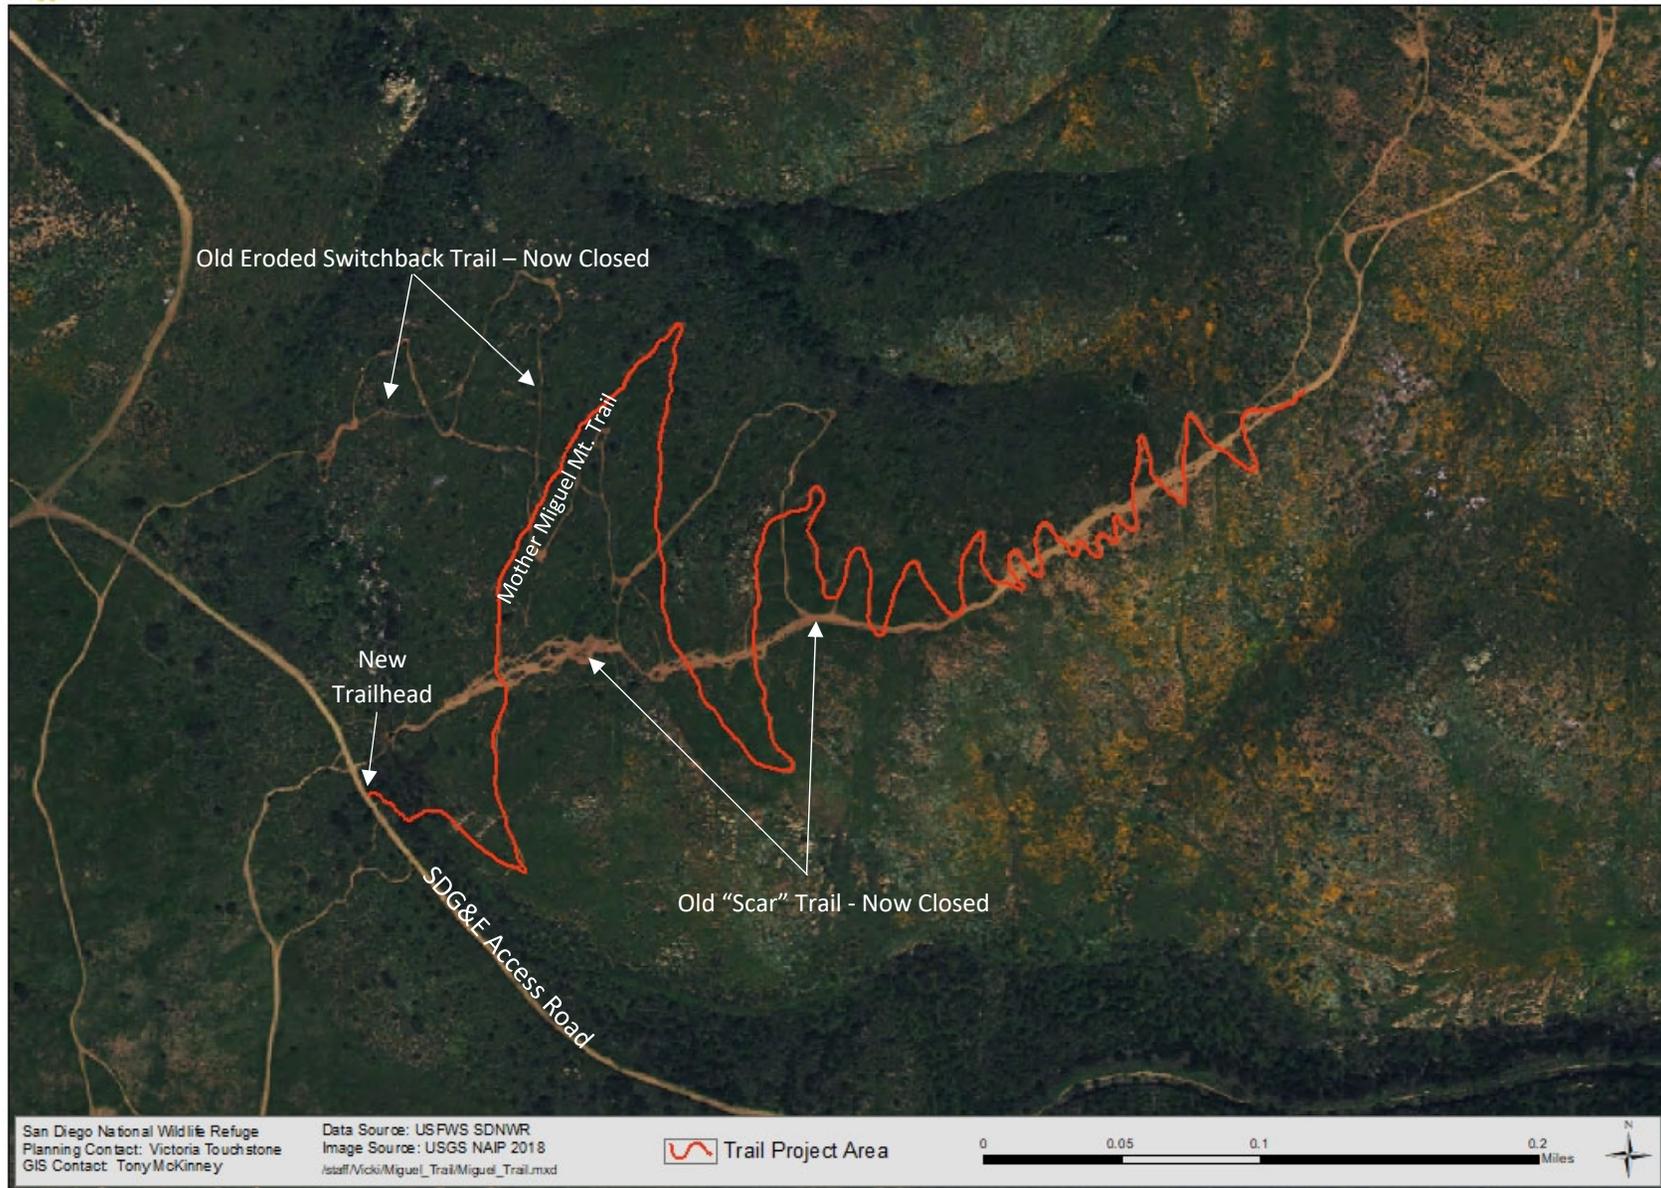
Figure 4. New Alignment for the Mother Miguel Mountain Trail (1.13 miles)

At the end of March 2019, we installed trail signage for the bottom section of the trail and with assistance from the Eastlake Youth Bicycle Team we delineated the upper portion of the trail, which was part of the original switchback trail, with rock in an effort to keep users on the trail (Appendix 3). The new trail entrance was completed at the end of March and the old scar trail entrance was blocked off with fencing on the same day. Once completed, the trail was mapped and a map of the 1.13-mile route was prepared (Figure 4).
