Wildlife Linkages within the San Diego County Preserve System.

Data Summary

By: Carlton J. Rochester¹ and Robert N. Fisher¹

MSCP Linkage Evaluation

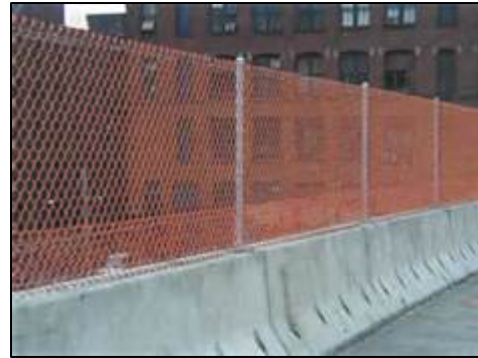
Based on a preliminary review of the wildlife linkages within San Diego County, there are several early actions that can be taken to protect wildlife and promote connectivity across the preserve. Many of the recommendations here involve fencing to guide wildlife away from roadways and towards appropriate crossing structures where they exist. Due to the wide ranging characteristics of the intended focal species, fencing should include design elements to exclude both large and small animals from the roadway, while still allowing continued vehicle and pedestrian access. And, where possible, fencing should incorporate some level of fire ignition reduction technique. Fence design may include a Jersey rail with chain-link fence above. The Jersey rail along the lower edge would prevent small wildlife from entering the roadway. And the fencing along the upper portion should deter larger animals. Additionally, the Jersey rail should intercept sparks from passing cars and potentially blowing embers, reducing the number of ignitions along the roadside. An alternate fence design may include a chain-link fence with 36 inches of metal flashing along the lower edge, with six inches of both buried below the surface. Neither of these fencing designs has been confirmed to reduce ignitions along roadsides, further research into the practicality of fences as barriers to fire is needed. Surface drainage from the roadway should include structural elements that would reduce the likelihood that wildlife could access the road through drainage structures.

Vehicle and pedestrian access across the wildlife fencing can be accomplished with cattle grates and self closing gates where needed. Where driveways join the main road, cattle grates should be installed to deter wildlife from going around the end of the fence onto the road. Visual and real cattle grates should be considered and evaluated for effectiveness, but the expectation is that real cattle grates should be more effective across the range of animals sizes the fences are expected to protect. Where real cattle grates are used, the design should include a mechanism to return any animal that falls into the grate to the correct side of the fence. The pedestrian gates should include steps on the road side of the fence to go over the height of the metal flashing while maintaining the flashing as a barrier on the wildlife side of the fence.

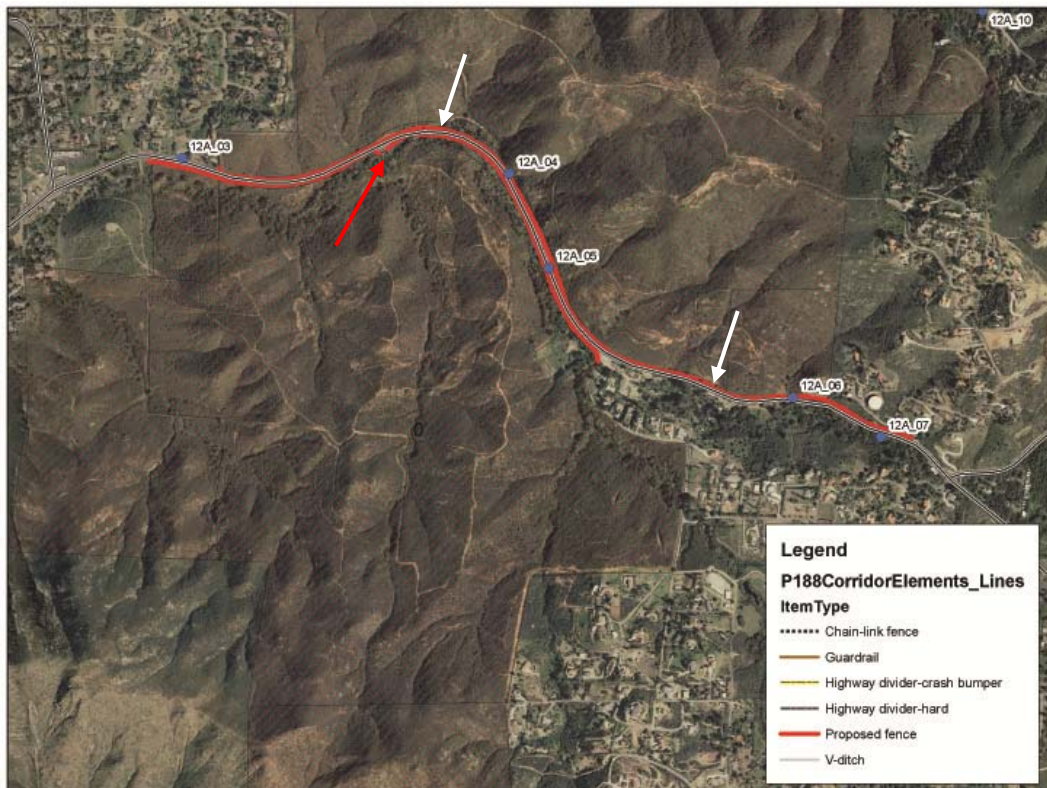
There are two possible lines of improvements that could be made in the area of Rancho Jamul to increase the success of the linkage between Core Area 1 and 2 along SR-94, near the U.S. Fish and Wildlife Services' Las Montañas property. As an early action item, fencing should be installed along both sides of the roadway to reduce the likelihood of wildlife – automobile interactions and to funnel animal movements towards any existing culverts and tunnels. The red arrow shows where the fencing will need to be tied into the water station. The white arrows indicate access points along SR-94 that will need cattle grates to prevent wildlife from enter the road at driveways. The vegetation at both ends of culvert 12A_04 needs to be cleared to increase the usefulness of this passage. A more extensive project would be the re-alignment of SR-94, straightening out the curve and adding several bridges to carry traffic over the riparian habitat and allow passage for wildlife underneath (see Appendix for image of possible re-alignment).

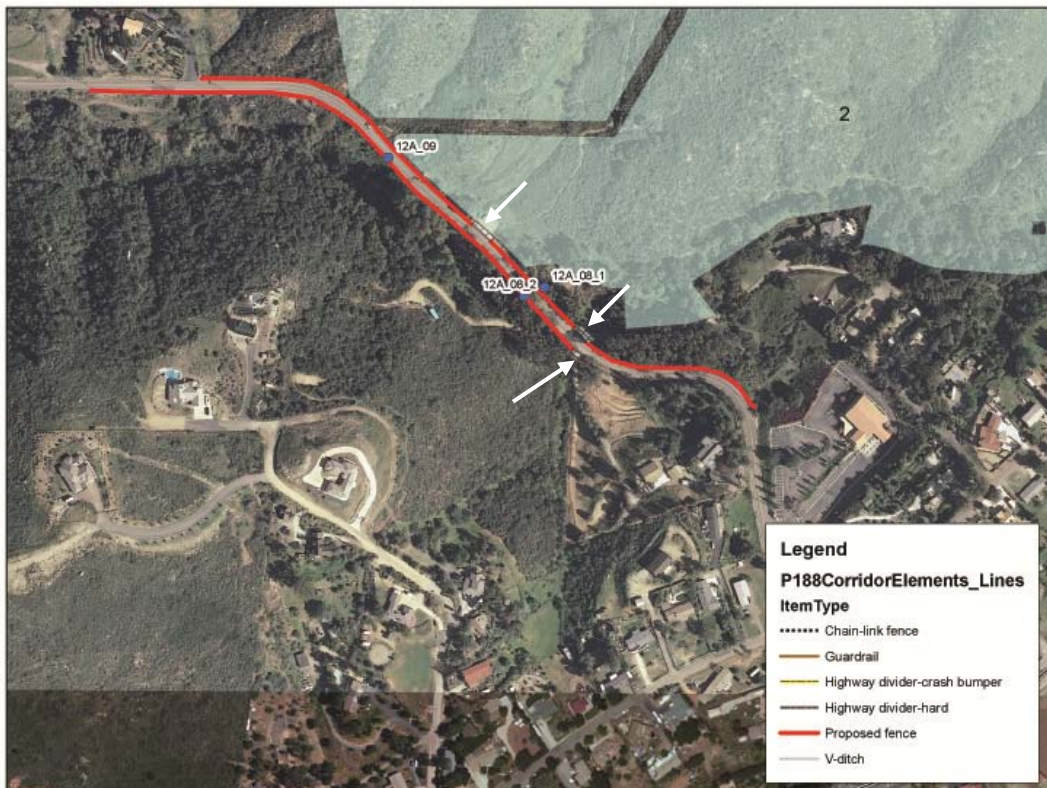
Jamul Drive near Mexican Canyon already has some fencing on both sides of the road, but this needs to be extended and upgraded to prevent wildlife – automobile interactions in the area. The white arrows indicate access points along Jamul Drive that will need cattle grates to prevent wildlife from enter the road at driveways. The double box culvert at 12A_08 will need to have the vegetation at both ends thinned. Within the culvert, the sediment depth should be evaluated and cleared out if it is excessively deep. A more extensive project would be to rebuild the bridge at the stream crossing. The roadway could be raised with the installation of a more significant bridge, this would remove the dip in the road as it crosses the creek and allow for a more open passage underneath. The addition of a larger structure would also allow for a widening of the riparian zone.
