VISTA DEL MAR ELEMENTARY VERNAL POOL MITIGATION SITE

Annual Report Year 2

Prepared for
RBF Consulting

October 2013

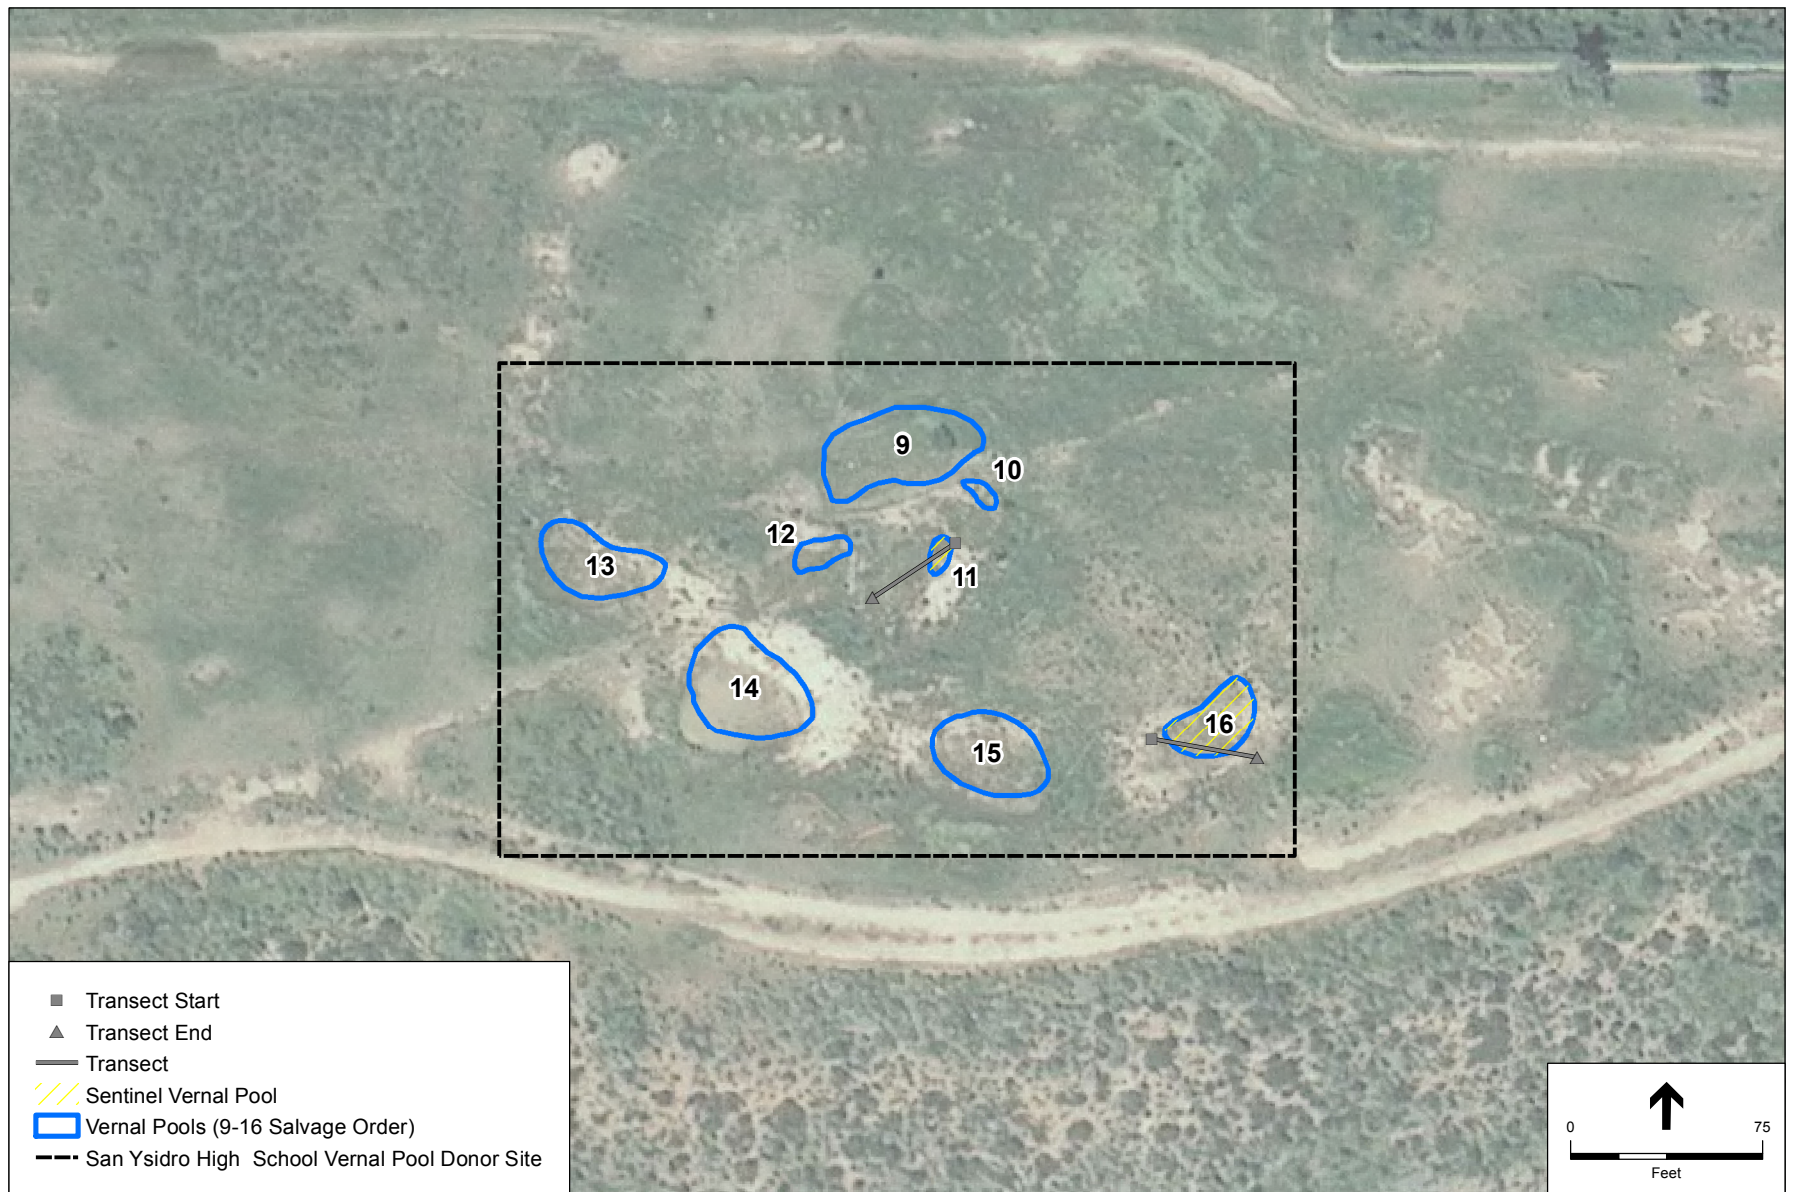
Figure 4
San Ysidro High School Vernal Pool Donor Site Vegetation Monitoring Transects

Three distinct vernal pool indicator species were recorded during transect monitoring conducted within adjacent San Ysidro High School reference site pools. Indicator species were observed within both San Ysidro High School reference site transects, including two within pool 11, and three within pool 16.

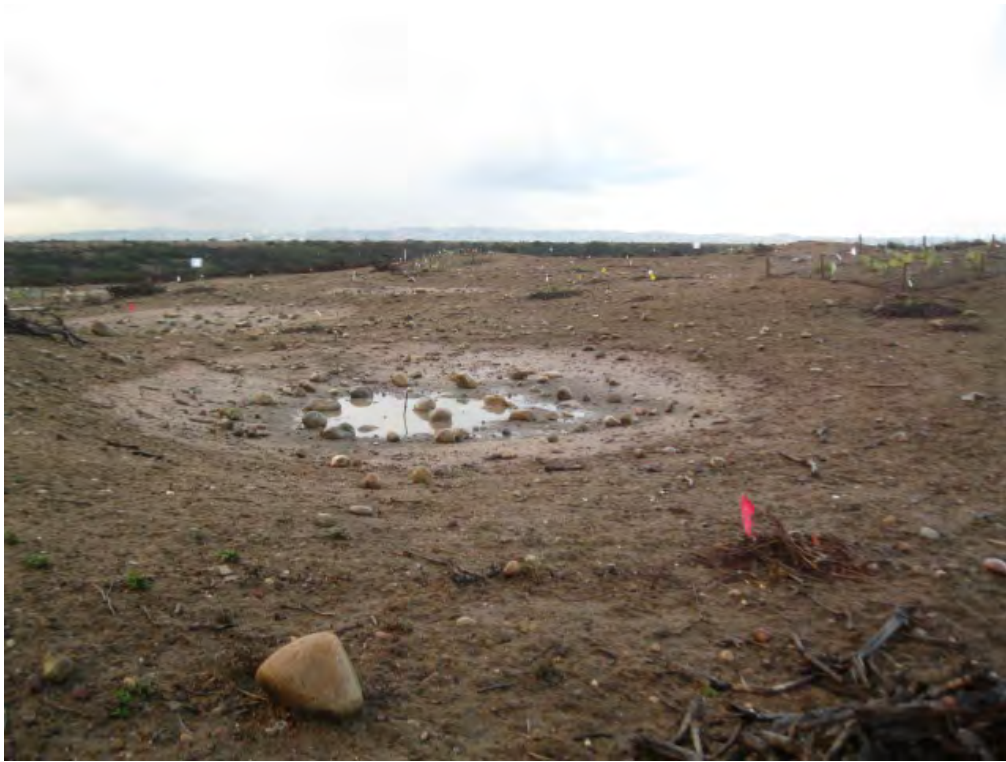
Photograph 1: General site conditions following first rain event of the season (October 2012)

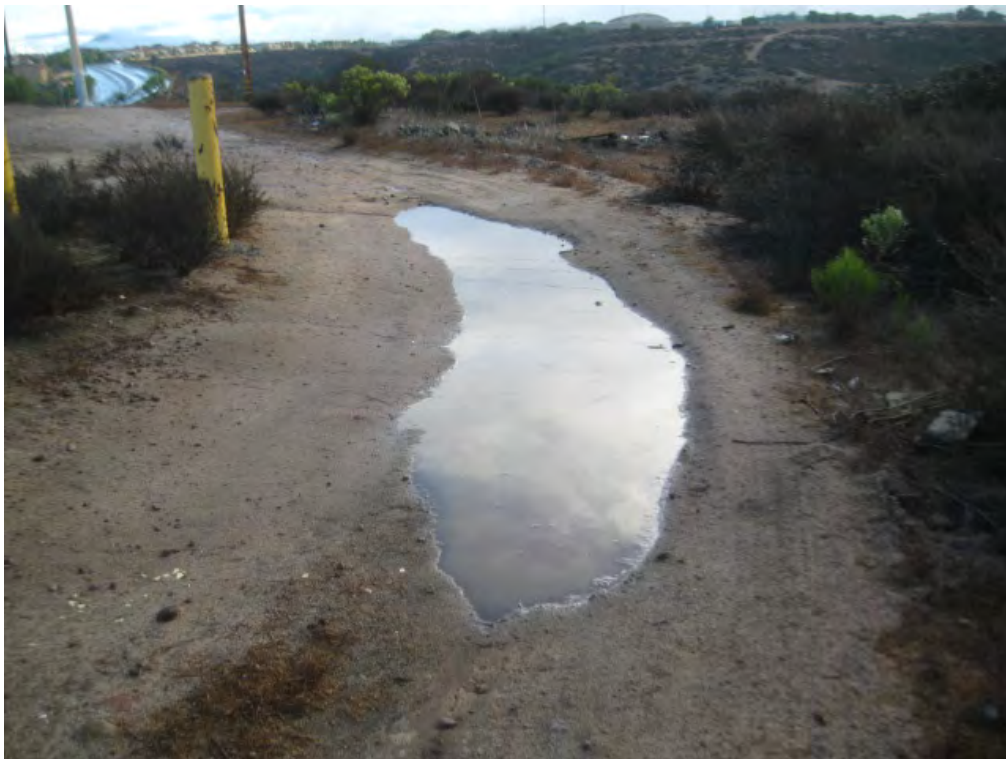
Photograph 2: Road rut pool adjacent to Restoration Site following first rain event of the season (October 2012)

Qualitative monitoring efforts within the vernal pool restoration areas yielded increased wildlife observations within the immediate vicinity of the vernal pool basins when compared to the Year 1 monitoring period. Sign of several species, including coyote, common raven, and striped skunk, was observed within and around the vernal pool basins. Additionally, a Cooper's hawk was observed bathing within the road rut pool. Sub-adult and adult fairy shrimp were observed within

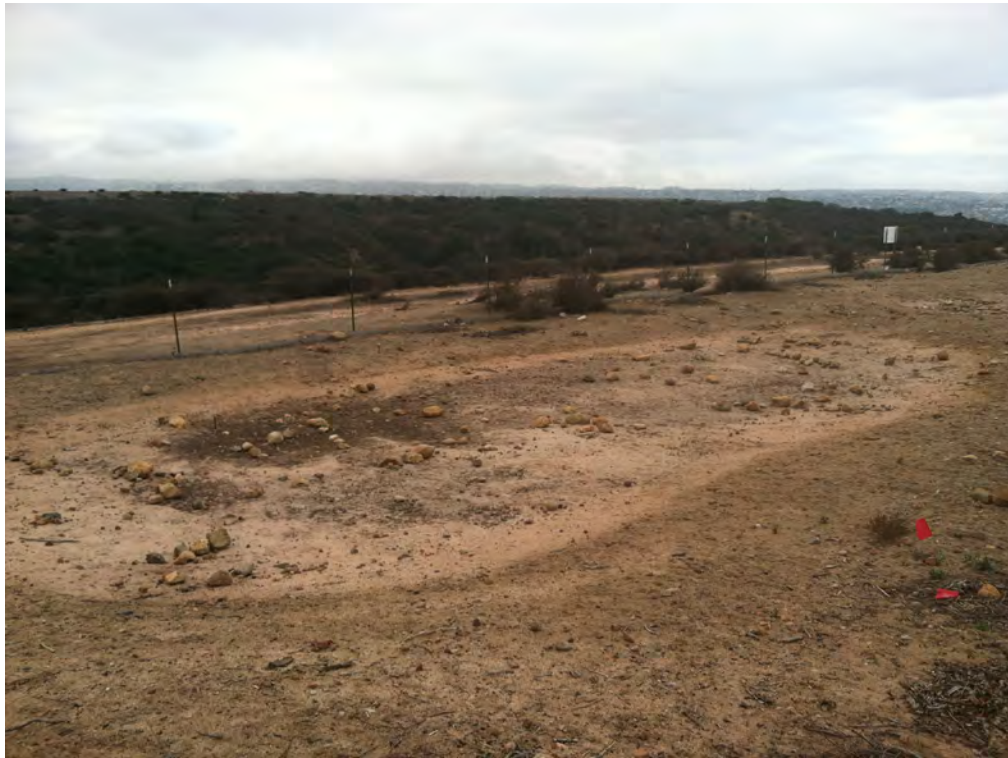
Photograph 3: Pool 30 within the Restoration Site (December 2012)

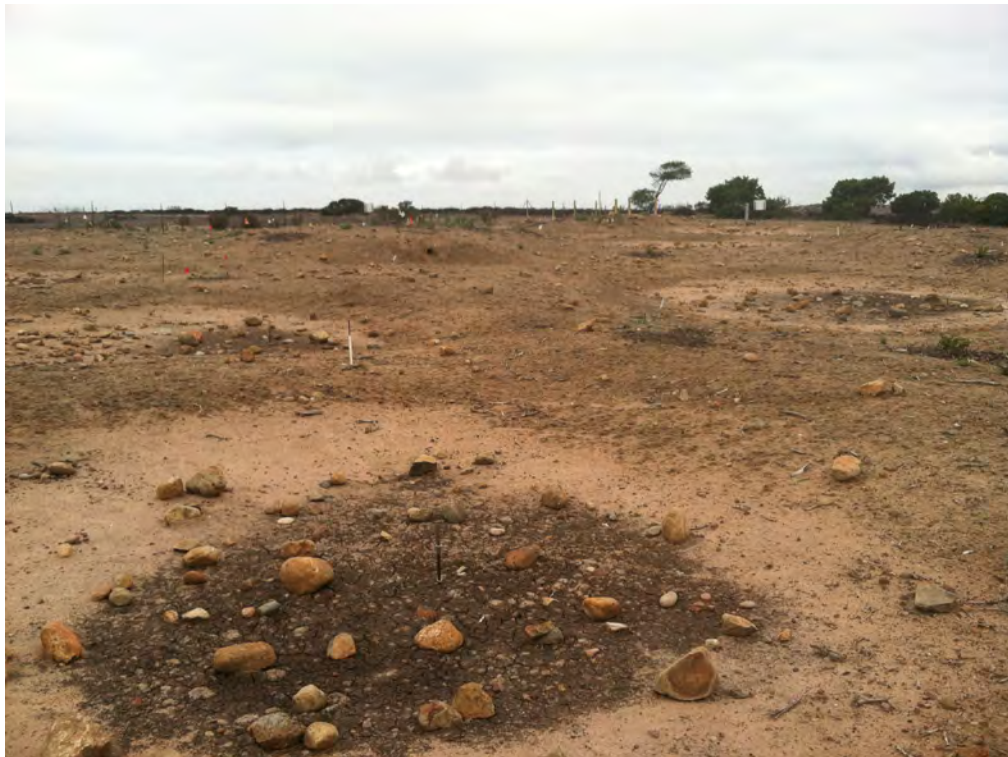
Photograph 4: General site conditions within the Restoration Site (December 2012)

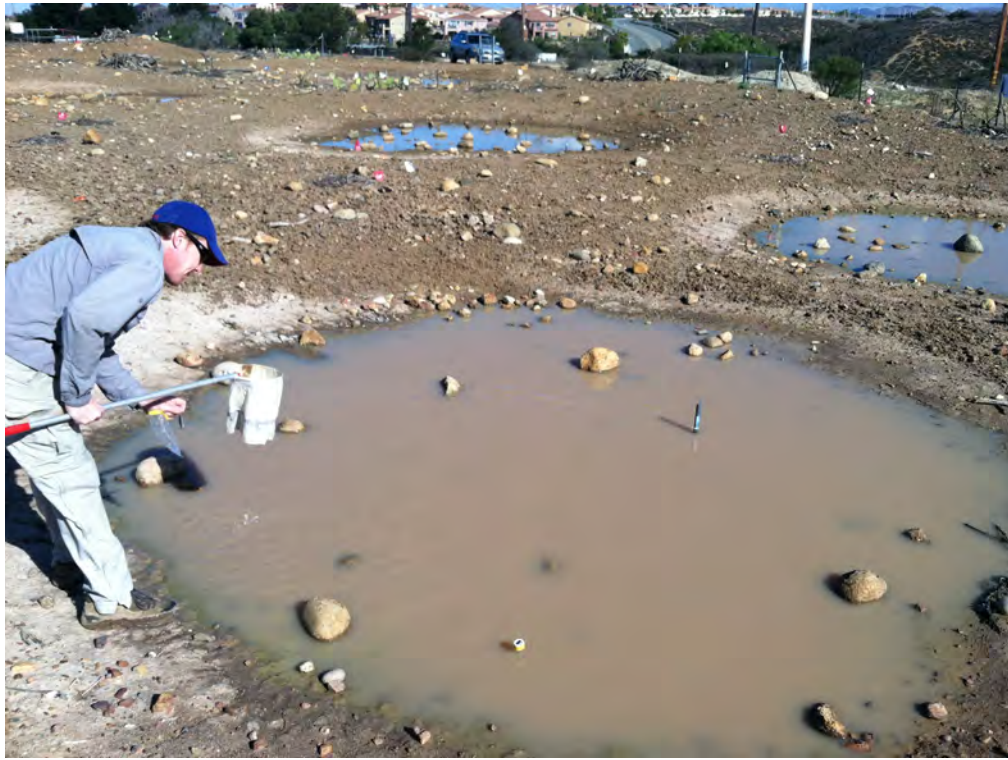
Photograph 5: Fairy shrimp sampling conducted within the Restoration Site (December 2012)

Vernal pool branchiopod sampling was conducted on December 27, 2012, February 20, 2013, and March 6, 2013 (Table 2). Thirty-one restoration site pools and the adjacent road rut pool were sampled during the Year 2 monitoring period. Pool 23 was not inundated at the time of any of the surveys, as was therefore not sampled. Of the 32 pools sampled, 31 were confirmed to contain the federally-listed San Diego fairy shrimp. Only one sampled pool (pool 8) was not confirmed to contain San Diego fairy shrimp, although fairy shrimp were observed within this pool during several qualitative site visits conducted during the Year 2 monitoring period. No versatile fairy shrimp (*Branchinecta lindahli*) were identified within any of the sampled pools during the Year 2 surveys. Within the 32 sampled pools, maximum depths ranged from 4.4 to 14.6 centimeters. Water temperatures in the sampled pools ranged from 11.6 to 17.4 degrees Celsius. Concentrations of fairy shrimp within sampled pools varied between very low and medium densities, with population estimates of less than ten in one pool (pool 22), tens in 26 pools (pools 1 through 4, 6, 9 through 12, 14 through 21, and 24 through 32), and hundreds in four pools (pools 5, 7, 13, and the adjacent road rut pool). The collected voucher specimens will be accessioned to the Los Angeles Natural History Museum.

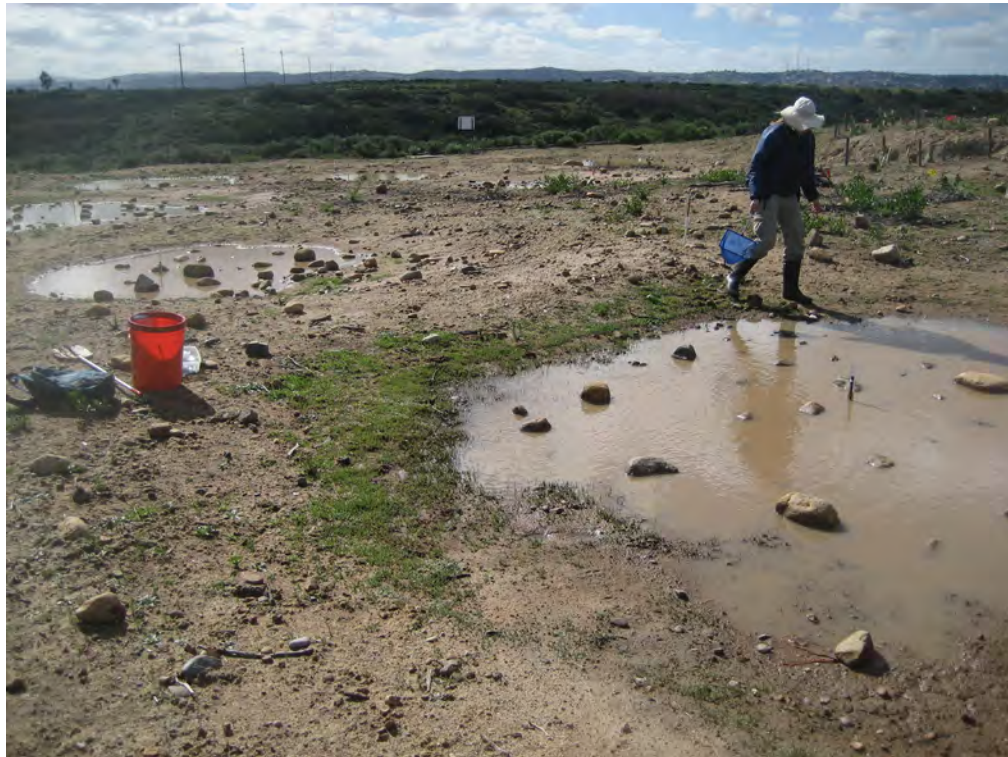
Photograph 6: Fairy shrimp sampling conducted within the Restoration Site (February 2013)

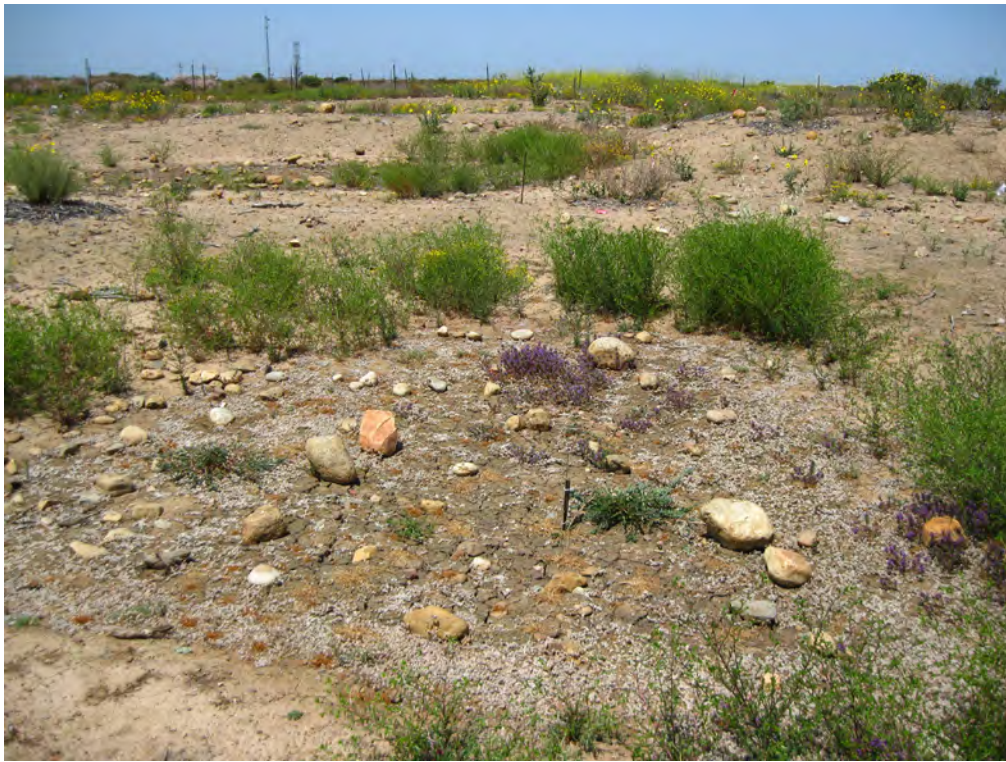
Photograph 7: General site conditions within the Restoration Site (April 2013)

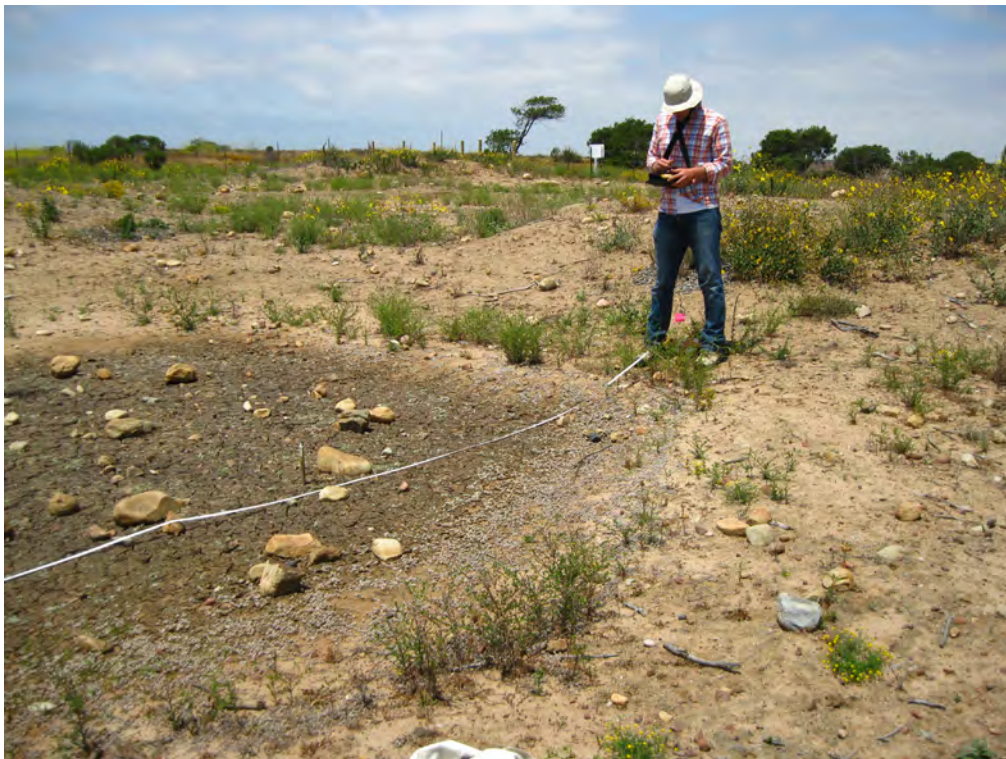
Photograph 8: Vegetation Monitoring conducted within Pool 14 of the Restoration Site (April 2013)

Photo-monitoring shows that there was more robust growth of vegetation overall in 2013 than in 2012 (Appendix F). Five distinct vernal pool indicator species were recorded during transect monitoring conducted within restoration site pools. Indicator species were observed within all restoration site transects as follows: five within pool 18; four within pools 5, 7, and 30; two within pool 14; and one within pool 13.

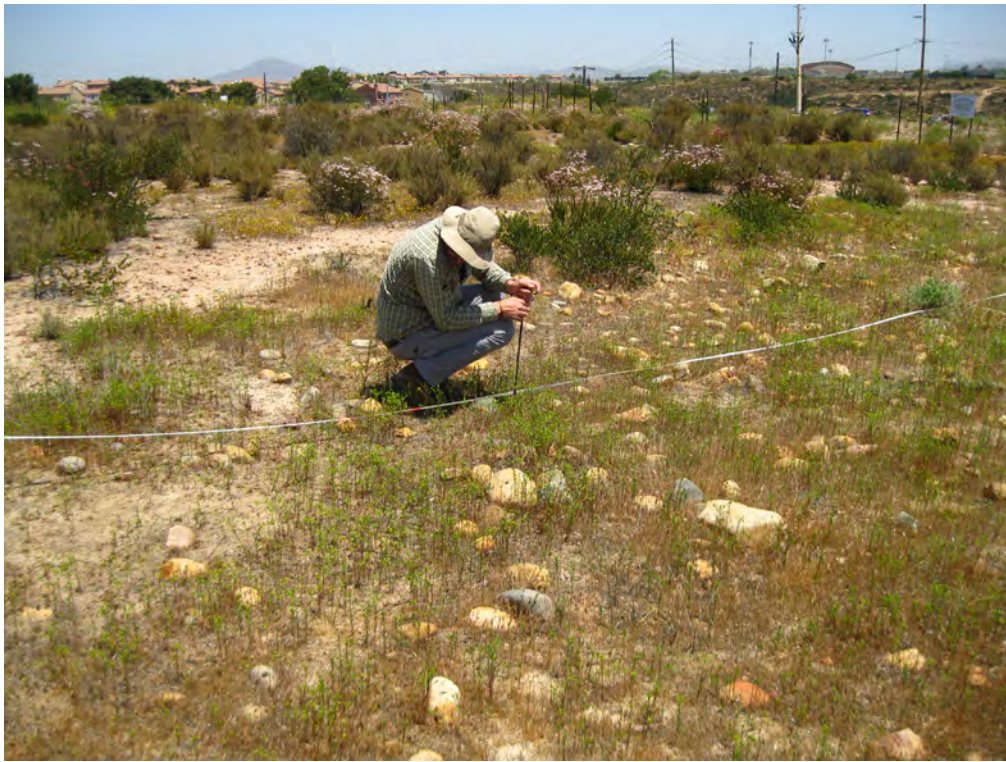
Photograph 9: Vegetation monitoring conducted within the San Ysidro High School Site (May 2013)

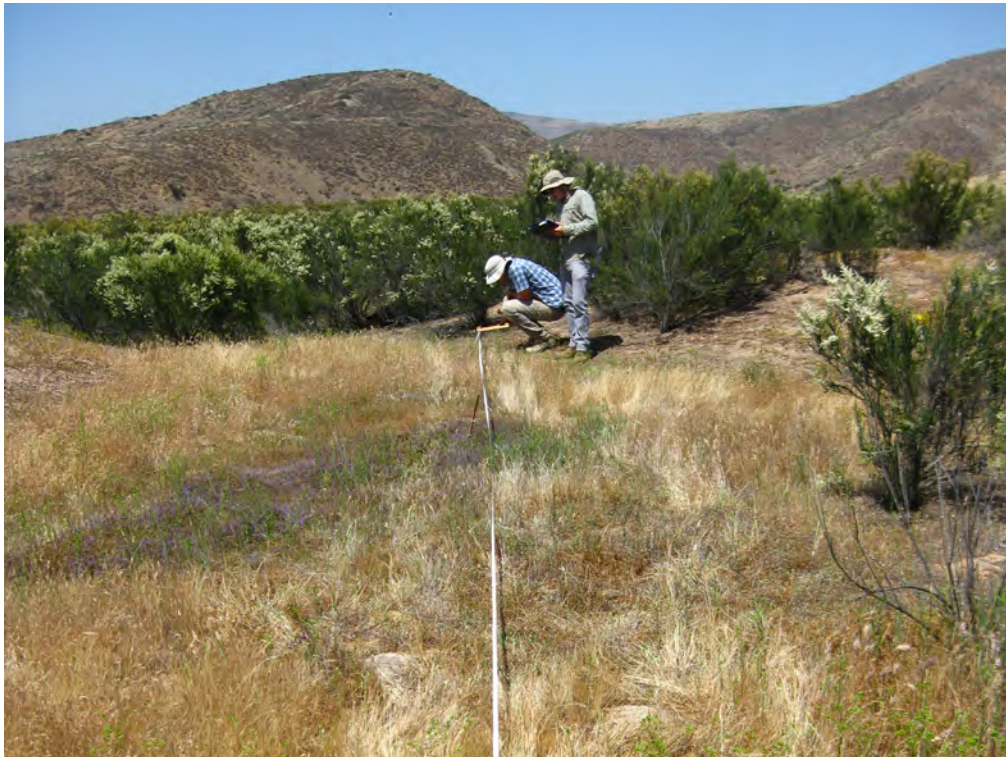
Photograph 10: Vegetation Monitoring conducted within the J26 Complex (May 2013)

Three distinct vernal pool indicator species were recorded during transect monitoring conducted within J26 complex reference site pools. Indicator species were observed within J26 complex reference site transects as follows: three within pools 9 and 14, and two within pools 17 and 18.

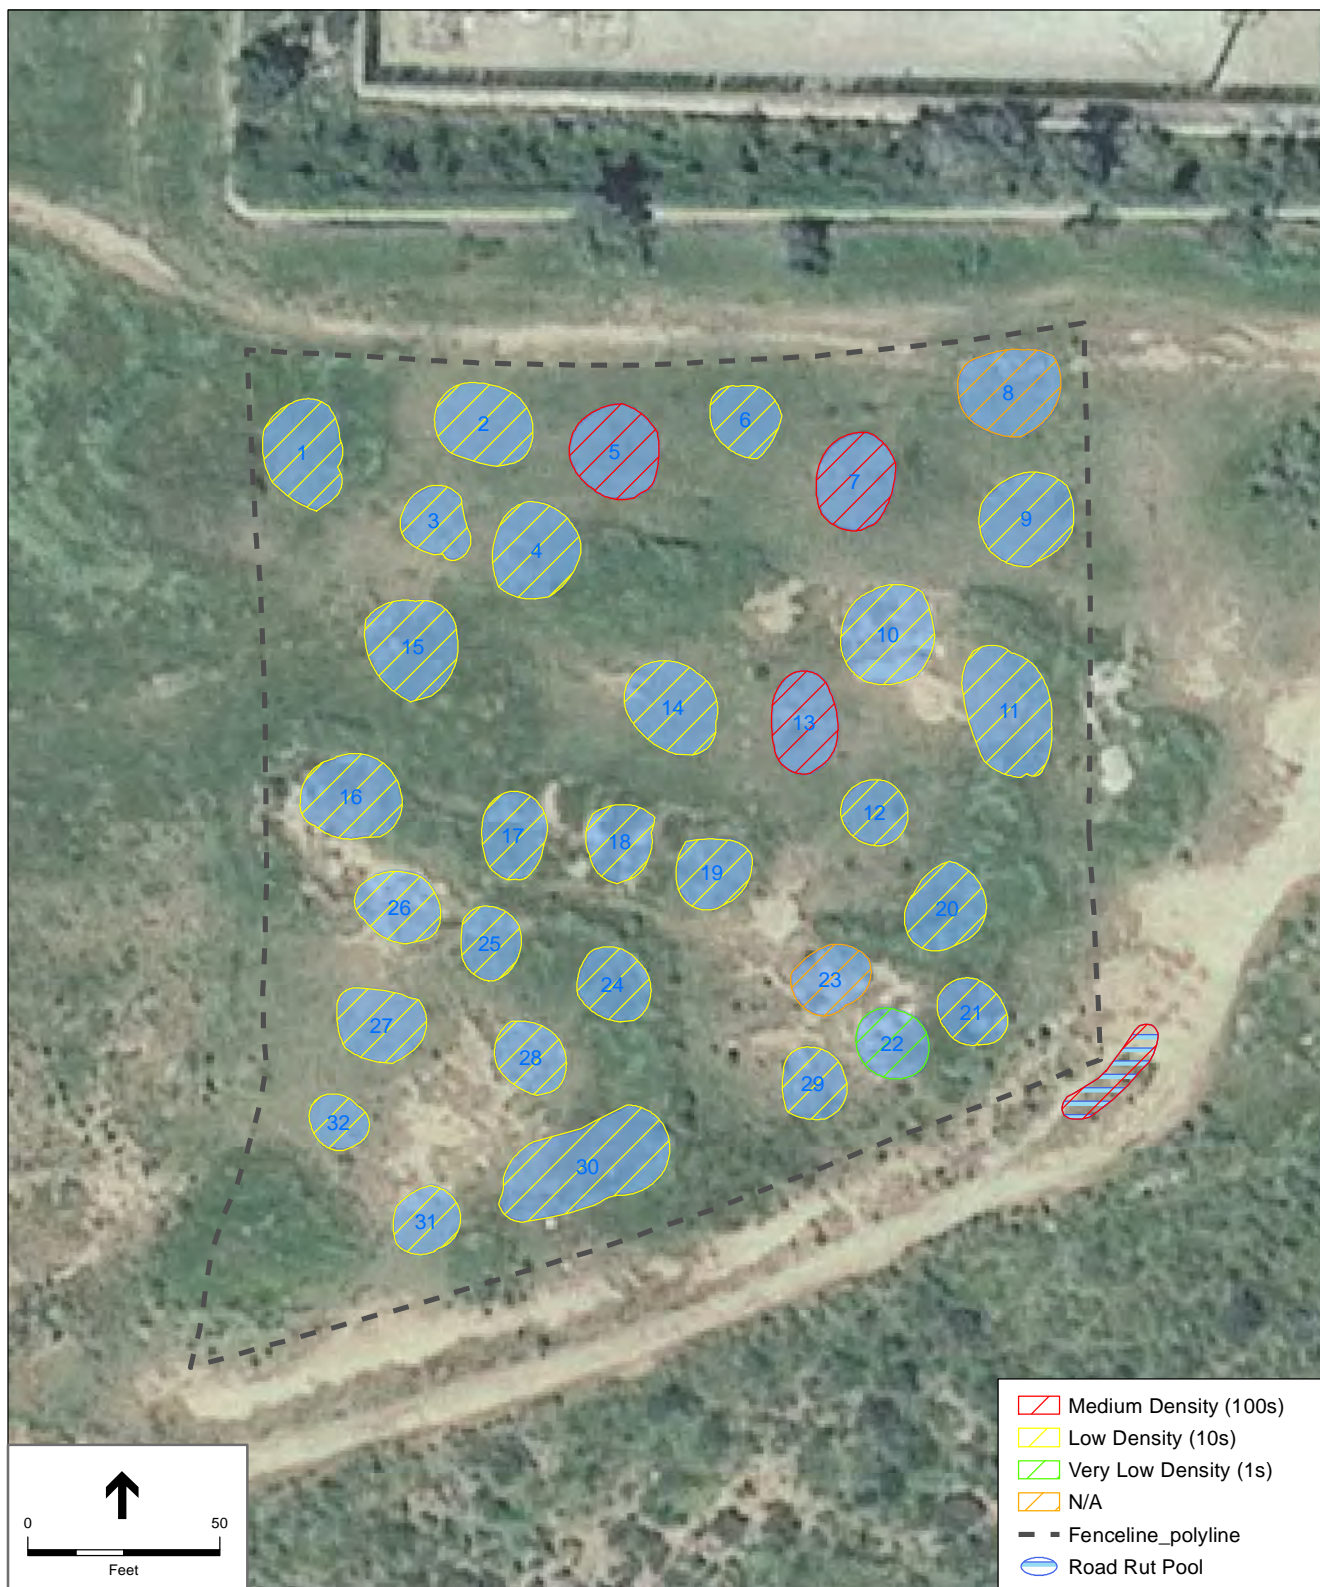
Figure 2
Fairy Shrimp Presence and Density
within Restoration Area Pools

Protocol level branchiopod surveys were conducted throughout the 2012/2013 wet season when pools were inundated for durations sufficient to support fairy shrimp. Thirty restoration site pools and the road rut pool were confirmed to support San Diego fairy shrimp. These results are an improvement from the Year 1 fairy shrimp surveys, which identified San Diego fairy shrimp within two pools, and unidentifiable juvenile *Branchinecta* fairy shrimp within 24 pools. Only two pools were not observed to support fairy shrimp during the Year 2 surveys, compared to seven pools during the Year 1 surveys. As a note, versatile fairy shrimp were not identified within any restoration site pools during the Year 1 or Year 2 monitoring periods. The Year 2 results exceeded the target for fairy shrimp occupancy within the restoration site. The restoration site is anticipated to continue to support San Diego fairy shrimp at occupancy rates meeting or exceeding the success criteria.

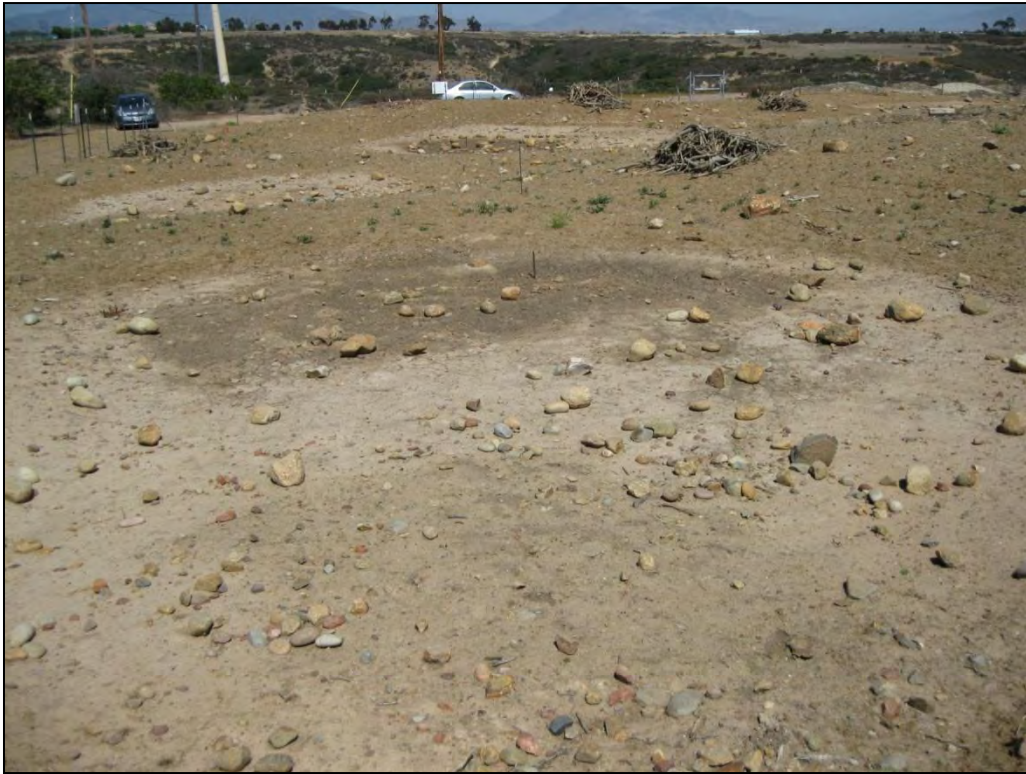
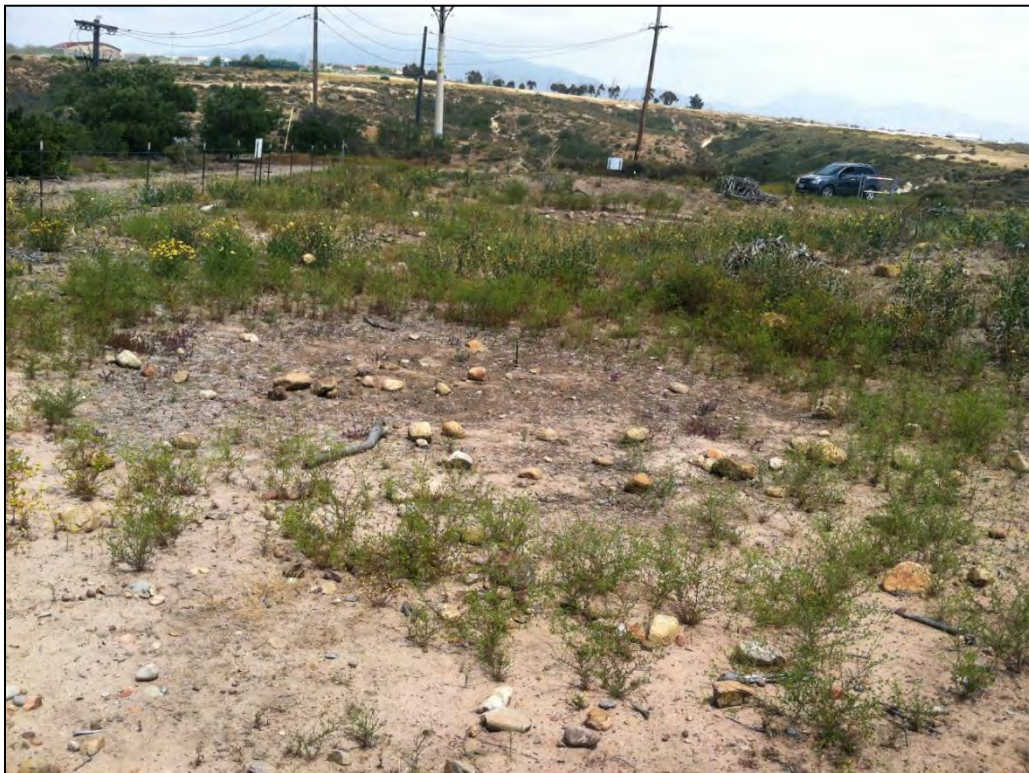
Restoration Site, sentinel pool, number 5 (VDM-Resto-S-5), July 2012.

Restoration Site, sentinel pool, number 5 (VDM-Resto-S-5), May 2013.

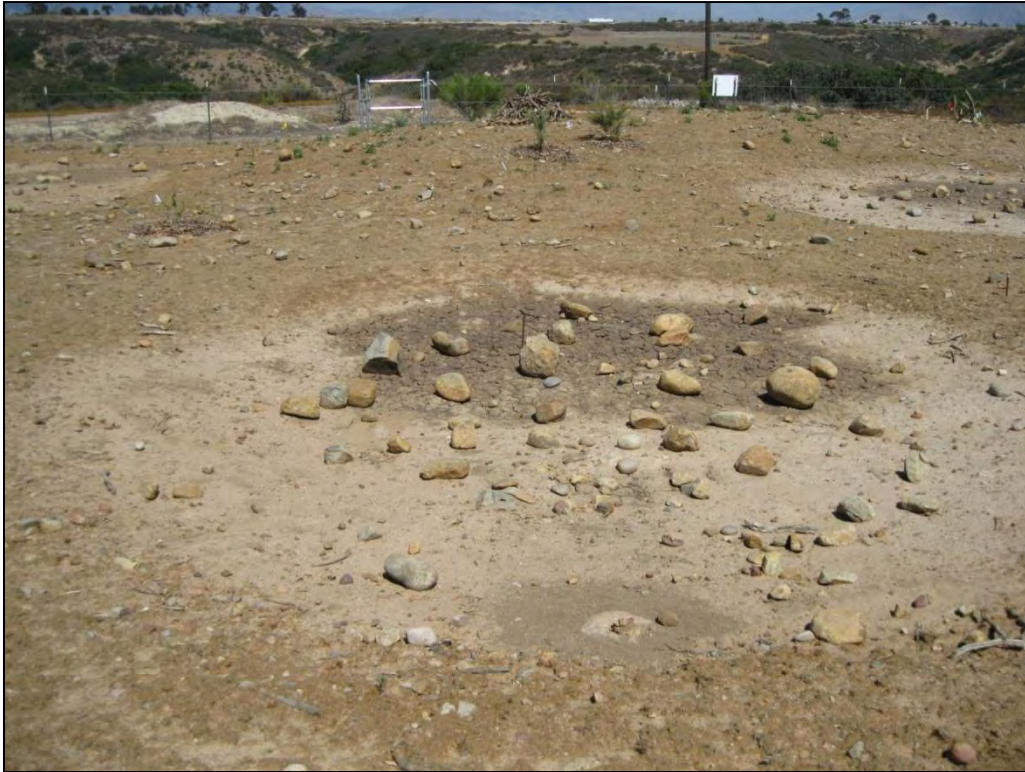
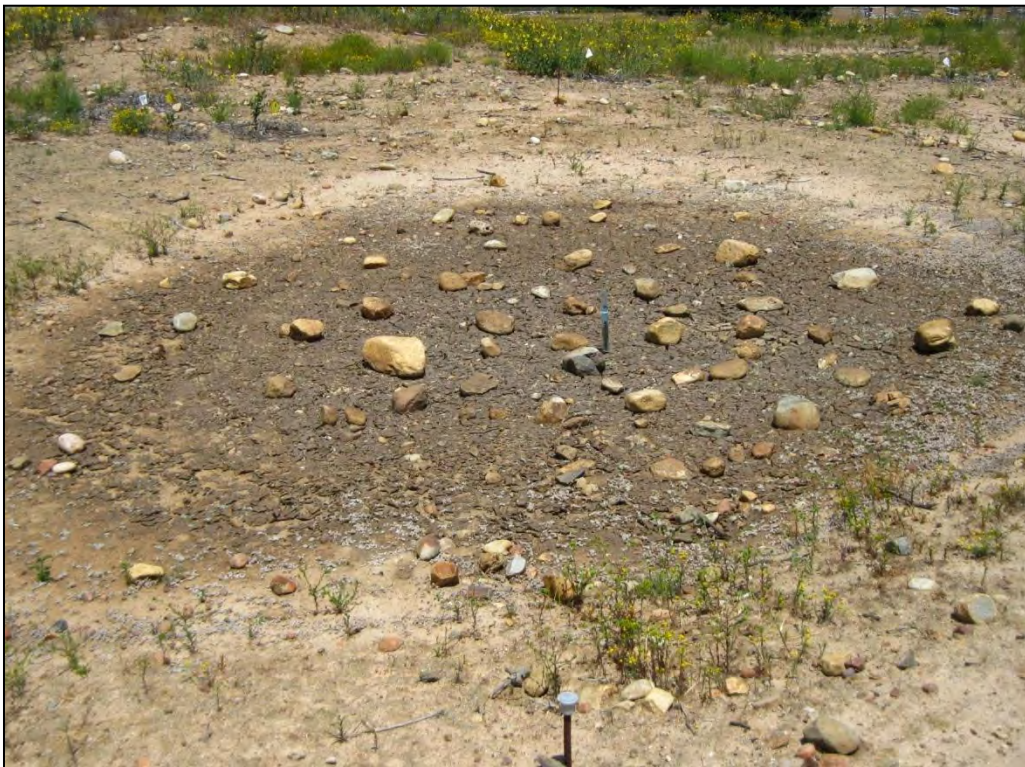
Restoration Site, sentinel pool, number 13 (VDM-Resto-S-13), July 2012.

Restoration Site, sentinel pool, number 13 (VDM-Resto-S-13), May 2013.

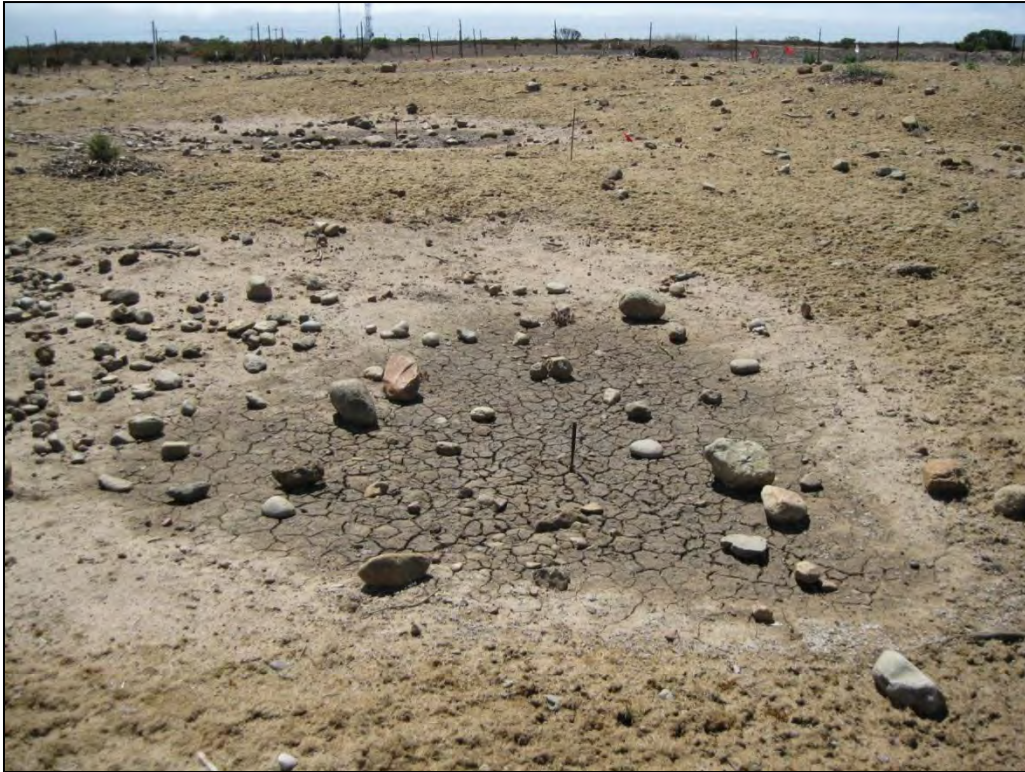
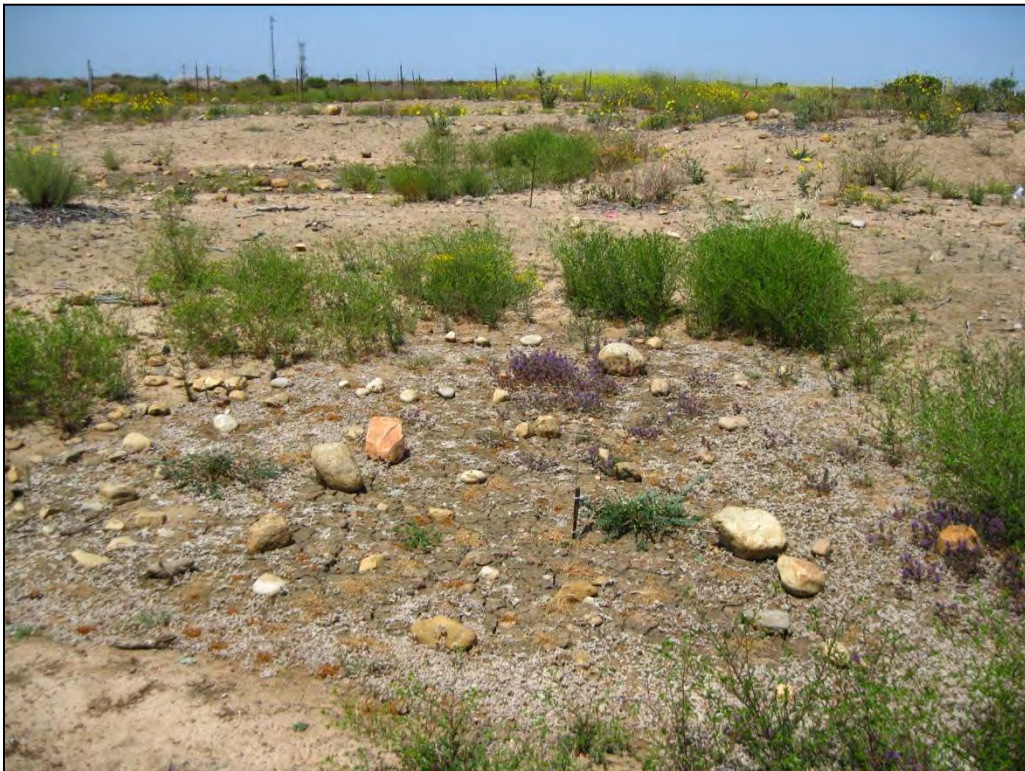
Restoration Site, sentinel pool, number 18 (VDM-Resto-S-18), July 2012.

Restoration Site, sentinel pool, number 18 (VDM-Resto-S-18), May 2013.

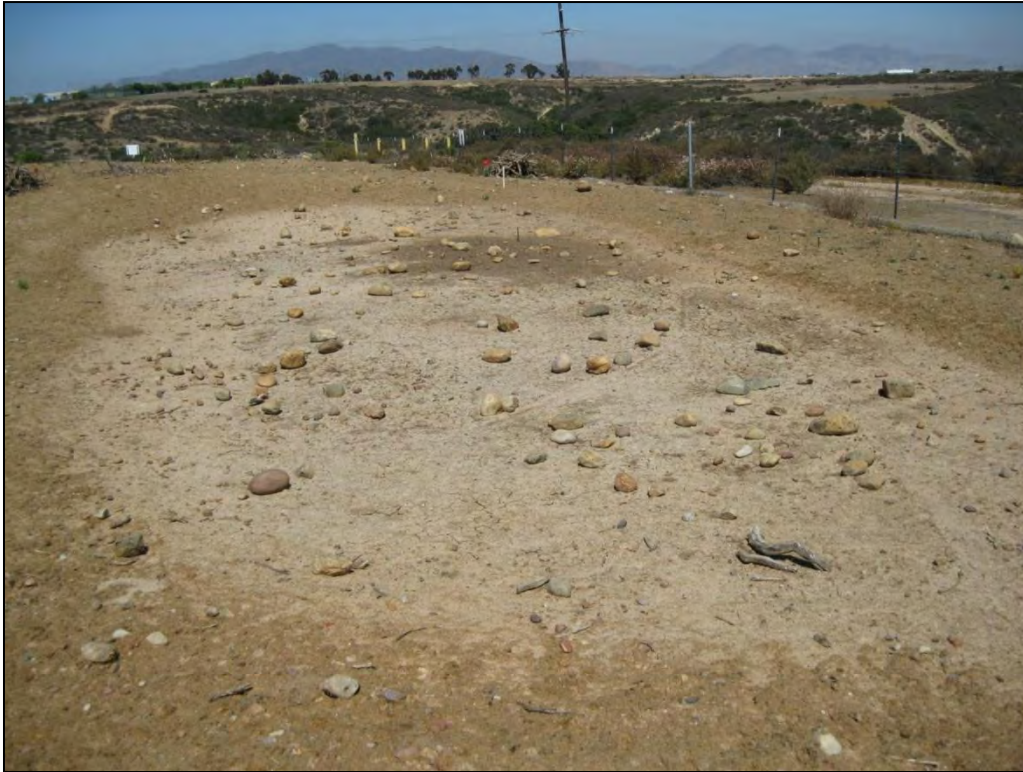
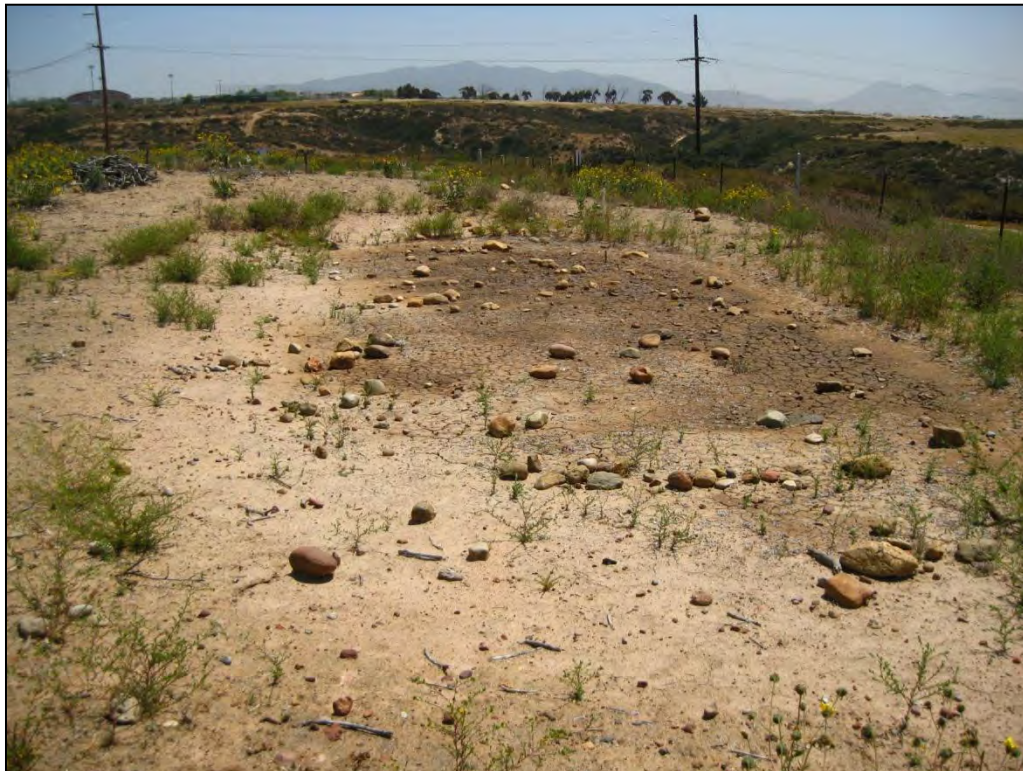
Restoration Site, sentinel pool, number 30 (VDM-Resto-S-30), July 2012.

Restoration Site, sentinel pool, number 30 (VDM-Resto-S-30), May 2013.

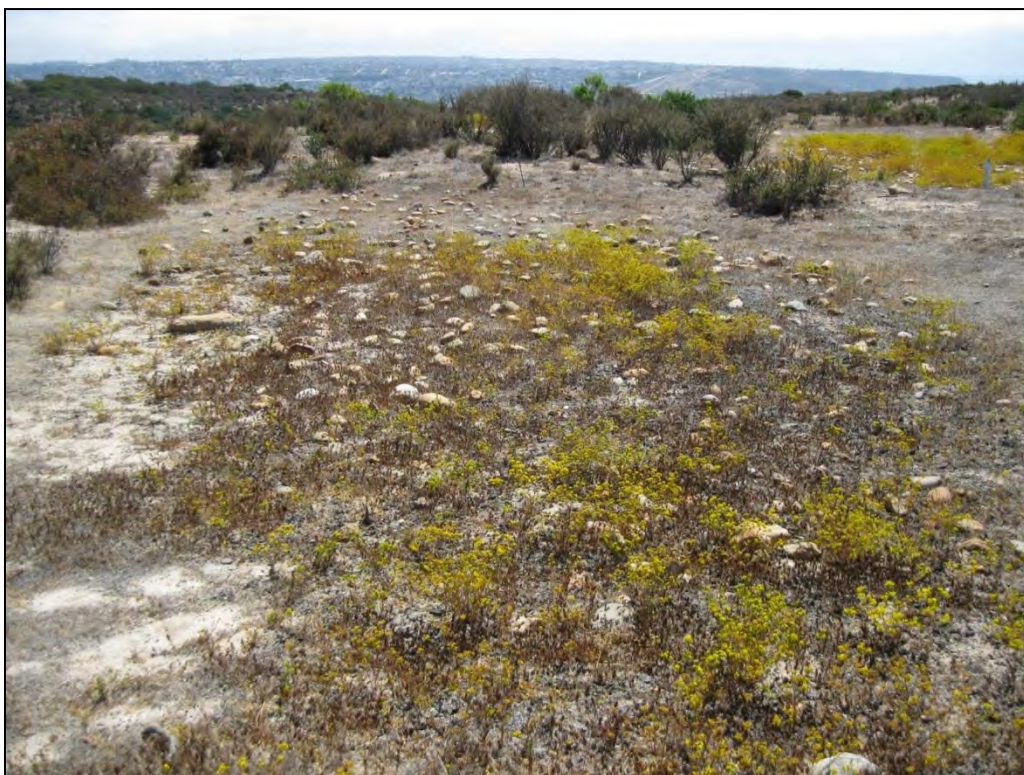
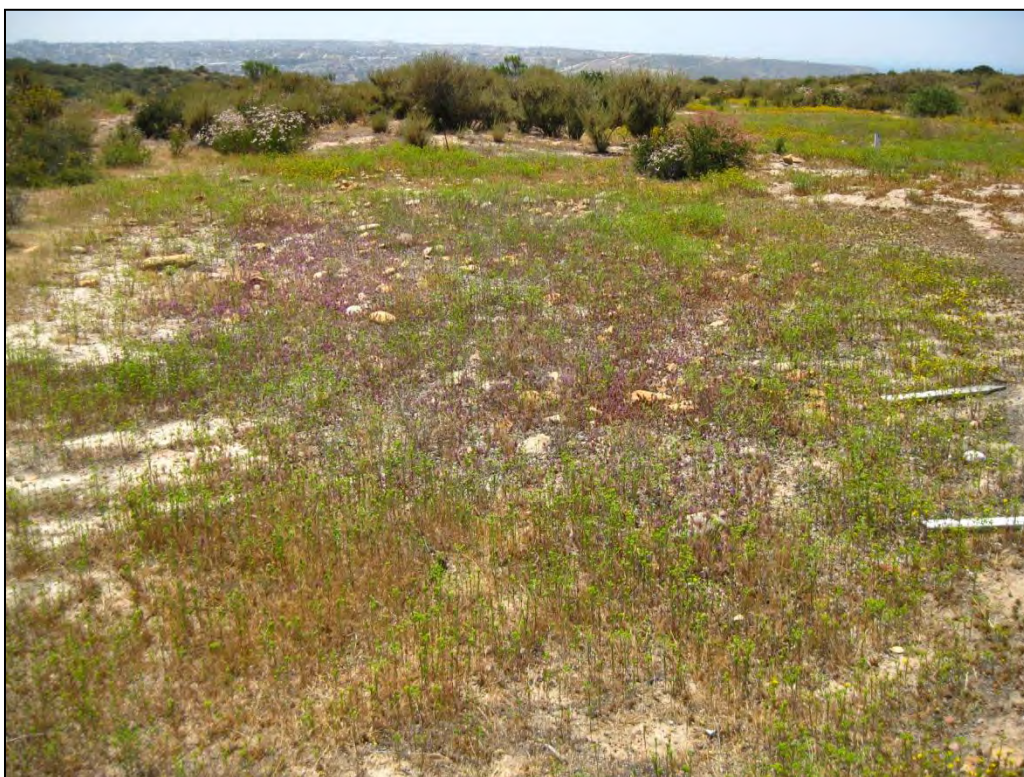
Adjacent reference site, sentinel pool, number 11 (VDM-RefA-S-11), July 2012.

Adjacent reference site, sentinel pool, number 11 (VDM-RefA-S-11), May 2013.

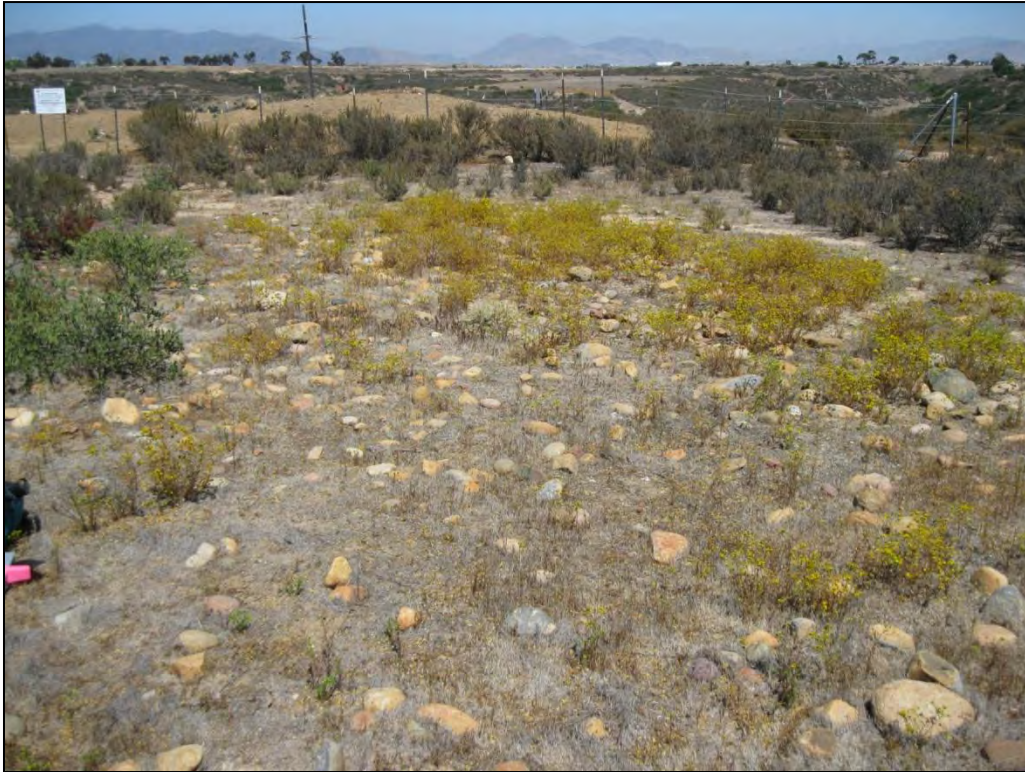
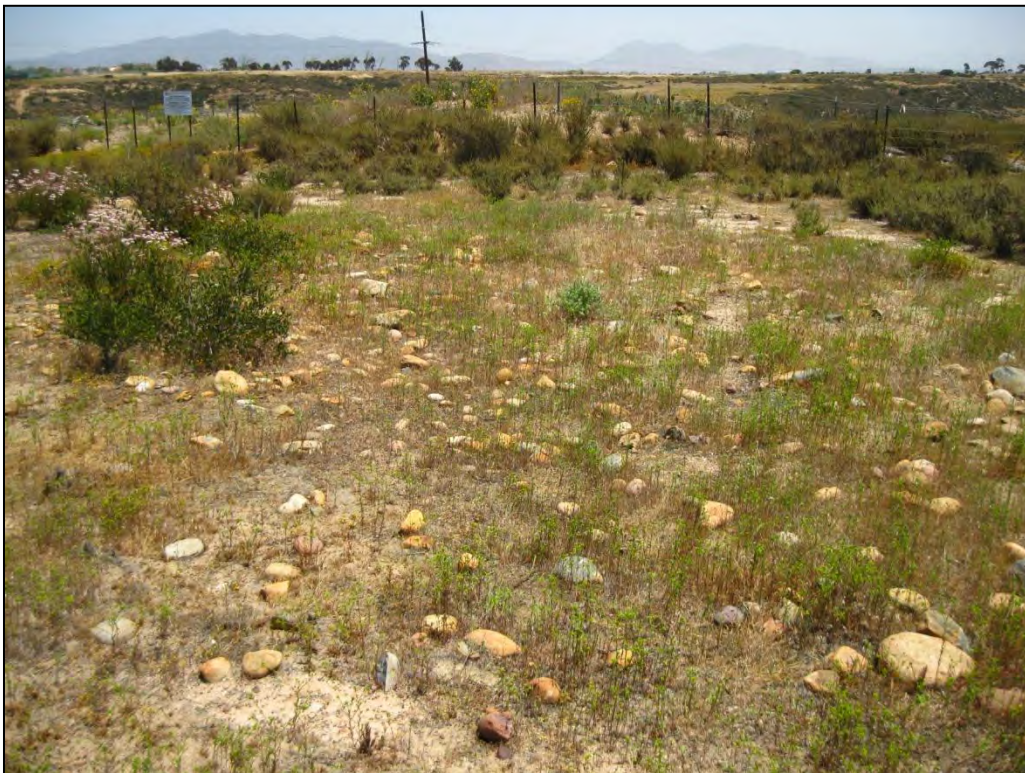
Adjacent reference site, sentinel pool, number 16 (VDM-RefA-S-16), July 2012.

Adjacent reference site, sentinel pool, number 16 (VDM-RefA-S-16), May 2013.
