VISTA DEL MAR ELEMENTARY VERNAL POOL MITIGATION SITE

Annual Report Year 2

Prepared for
RBF Consulting

October 2013

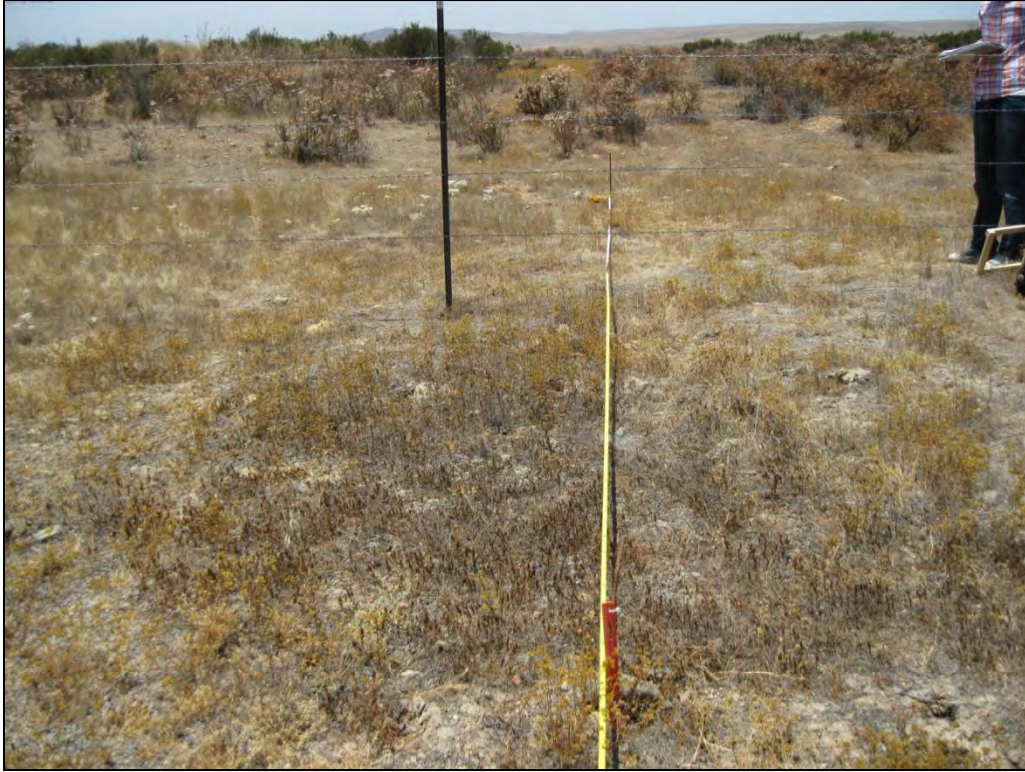
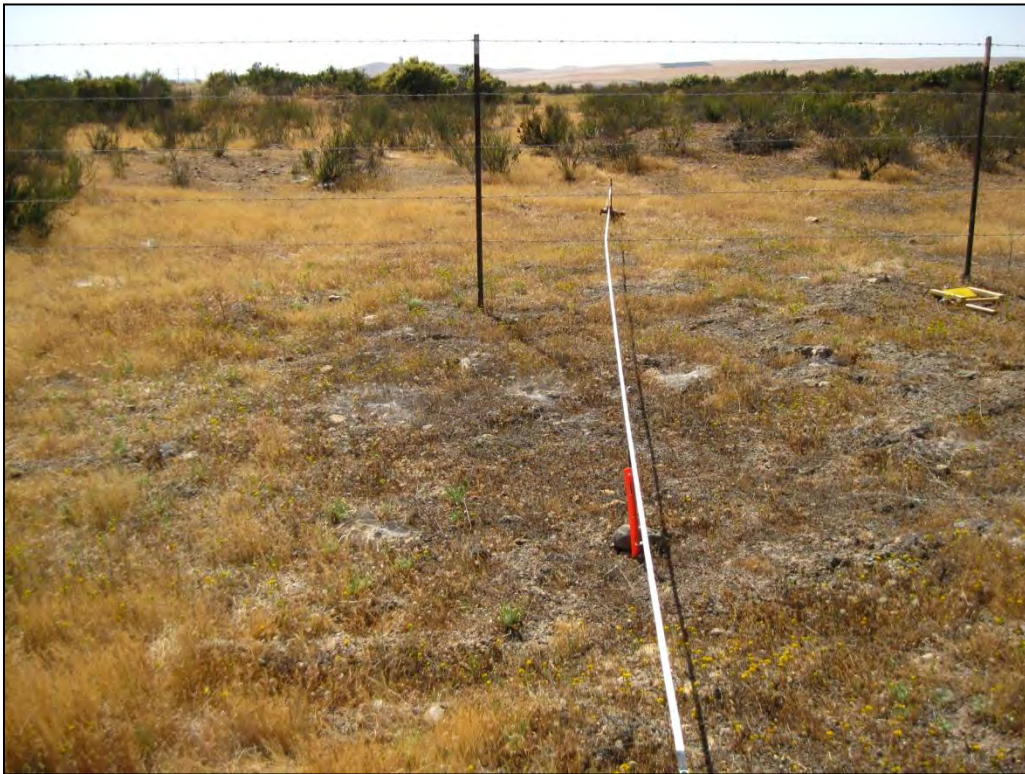
J26 Reference Site, sentinel pool, number 9 (VDM-J26-S-9), July 2012.

J26 Reference Site, sentinel pool, number 9 (VDM-J26-S-9), May 2013.

Three distinct vernal pool indicator species were recorded during transect monitoring conducted within J26 complex reference site pools. Indicator species were observed within J26 complex reference site transects as follows: three within pools 9 and 14, and two within pools 17 and 18.

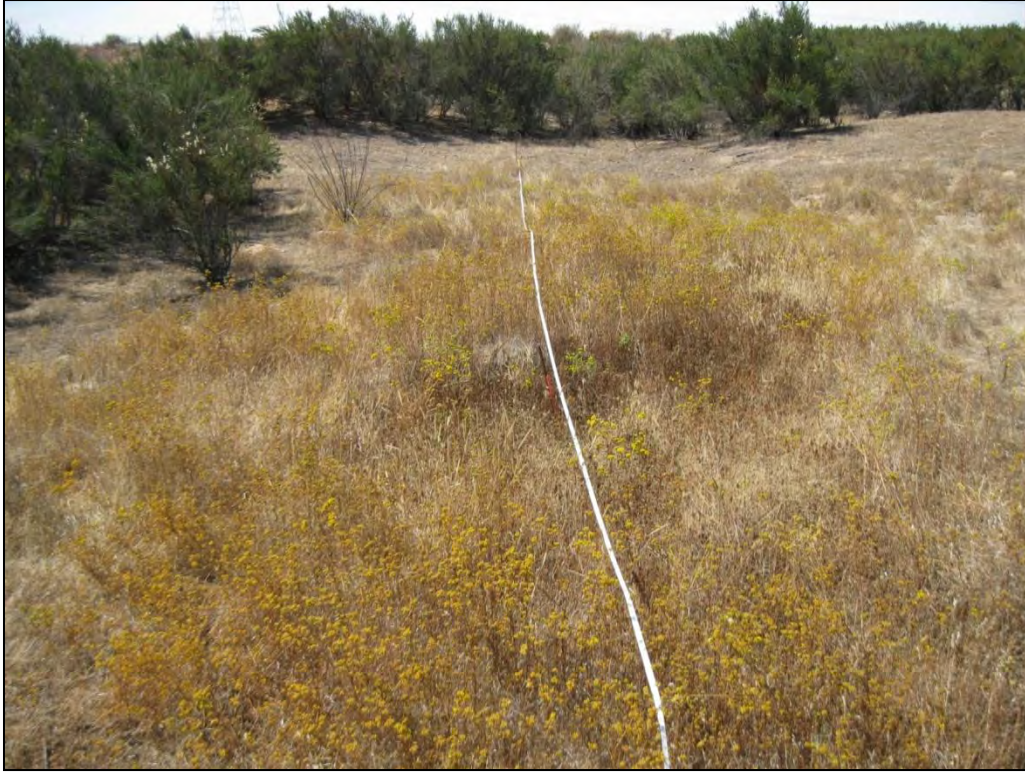
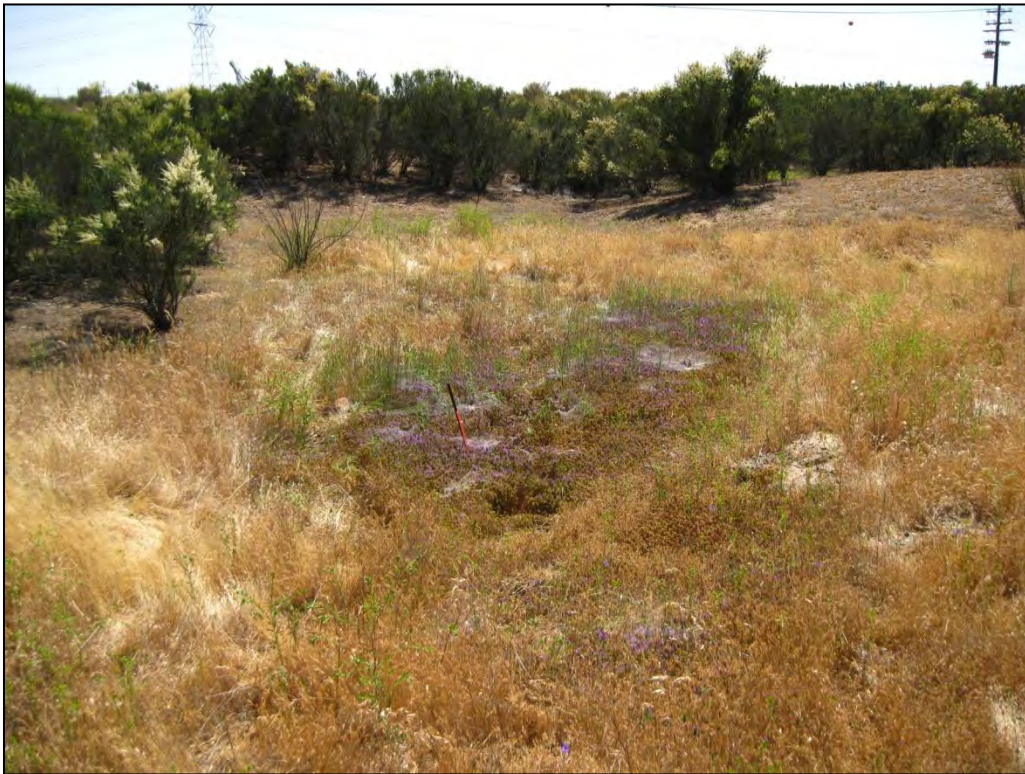
J26 Reference Site, sentinel pool, number 18 (VDM-J26-S-18), July 2012.

J26 Reference Site, sentinel pool, number 18 (VDM-J26-S-18), May 2013.
