Torrey Pines State Reserve Trails Management Plan

**~ Draft ~
December 15, 2005**

**By
California State Parks
San Diego Coast District
And
Torrey Pines State Reserve**

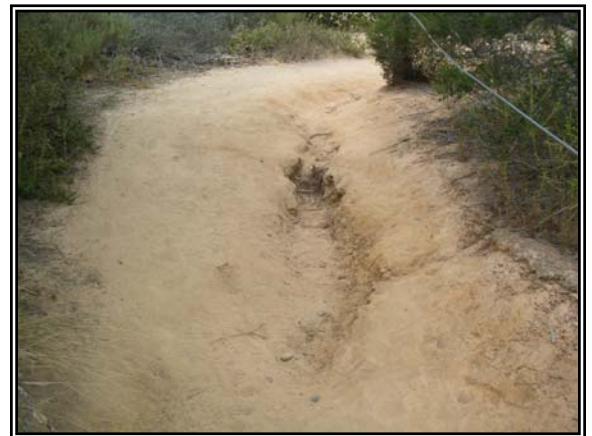
Erosion gully on Beach Trail

Annual trail maintenance is crucial at TPSR because of high use, eroding soils, and poor or lack of initial design of some trails. Trails can quickly become entrenched and act as water courses. Occasionally high winter rainfall can accelerate erosion and lead to gulying of trail surfaces. Annual maintenance can alleviate many of these problems and prolong a trail's durability, as well as avoid future deferred maintenance costs.

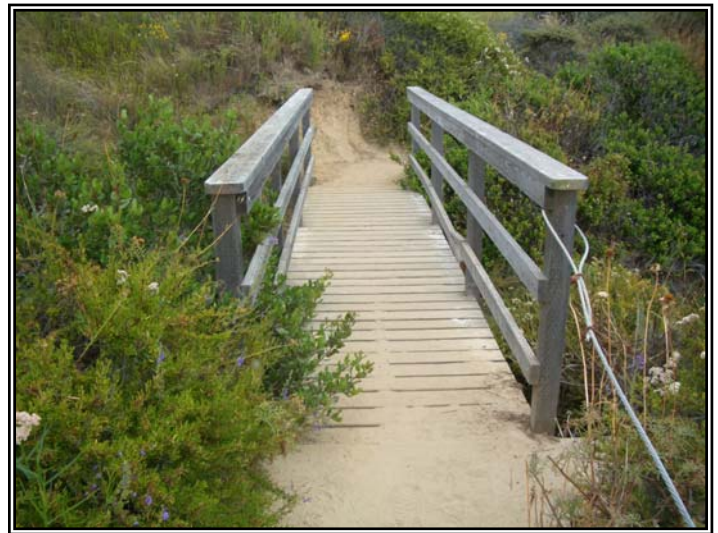
Bridge on Razor Point Trail

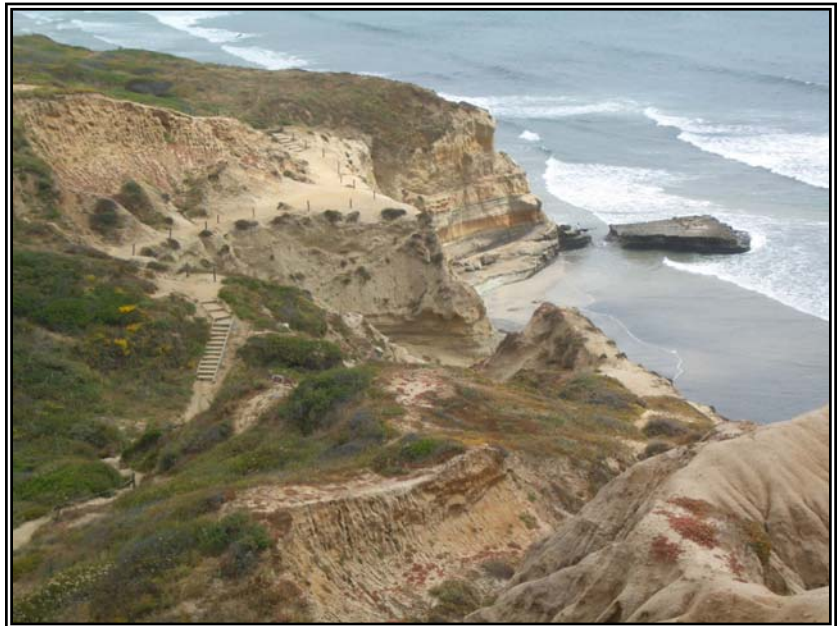
Beach Trail (Terminus)

The terminus of the Beach Trail offers the only beach access from the uplands area of TPSR, and vice versa. For this reason, it is one of the Reserve's most popular trails. The trail's condition has been affected through the years by eroding soils and periods of heavy rainfall. Sloughing of soil materials adjacent to and above the trail has been a perennial problem in keeping the trail maintained and open. The trail terminus has a section elevated approximately 15 feet above the beach that has a sheer drop off on one side. For this reason, this trail section is precarious and intimidates some visitors.

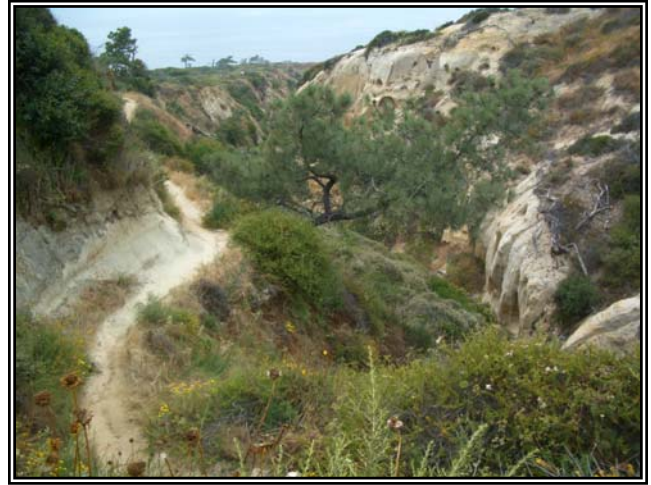
Canyon of the Swifts Trail

A portion of the trail has an elevated wood deck that is in disrepair and the retaining wall near its footings has failed, compromising the structural integrity of the deck. The trail is located on a geologically unstable hillside and is susceptible to soil movement during wet periods. Because of this, the trail will continue to require a high degree of maintenance and may pose risks to visitor safety.

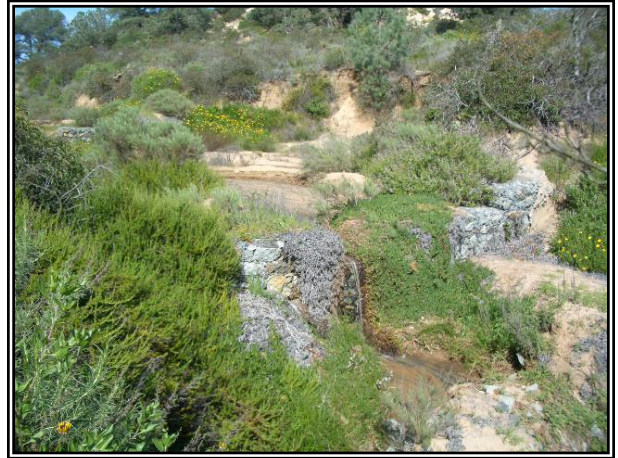
Drainage channel at Mar Scenic Trail with weir

The Mar Scenic Trail runs alongside and, at times, into the major drainage channel for the Extension Area. This drainage carries water from within the extension and also handles runoff from the adjacent city streets. 21 gabion weirs that were built in the 1970's to contain sediment have failed and have increased the problem of water side cutting the channel. Sedimentation at the downstream end of the drainage continues to be a problem as it enters the adjacent private property.
