Final report re NCCP-Local Assistance Grant # P1750301 from California Dept. of Fish and Wildlife and SANDAG – UCD agreement #A37682/MOU #5005298 Awarded to the University of California, Davis Wildlife Health Center.

Project Title: Santa Ana Mountains to eastern Peninsular Range Conservation Connectivity Infrastructure Planning Project for Interstate 15 and Closely Associated Roadways

Date of original report: March 31, 2020

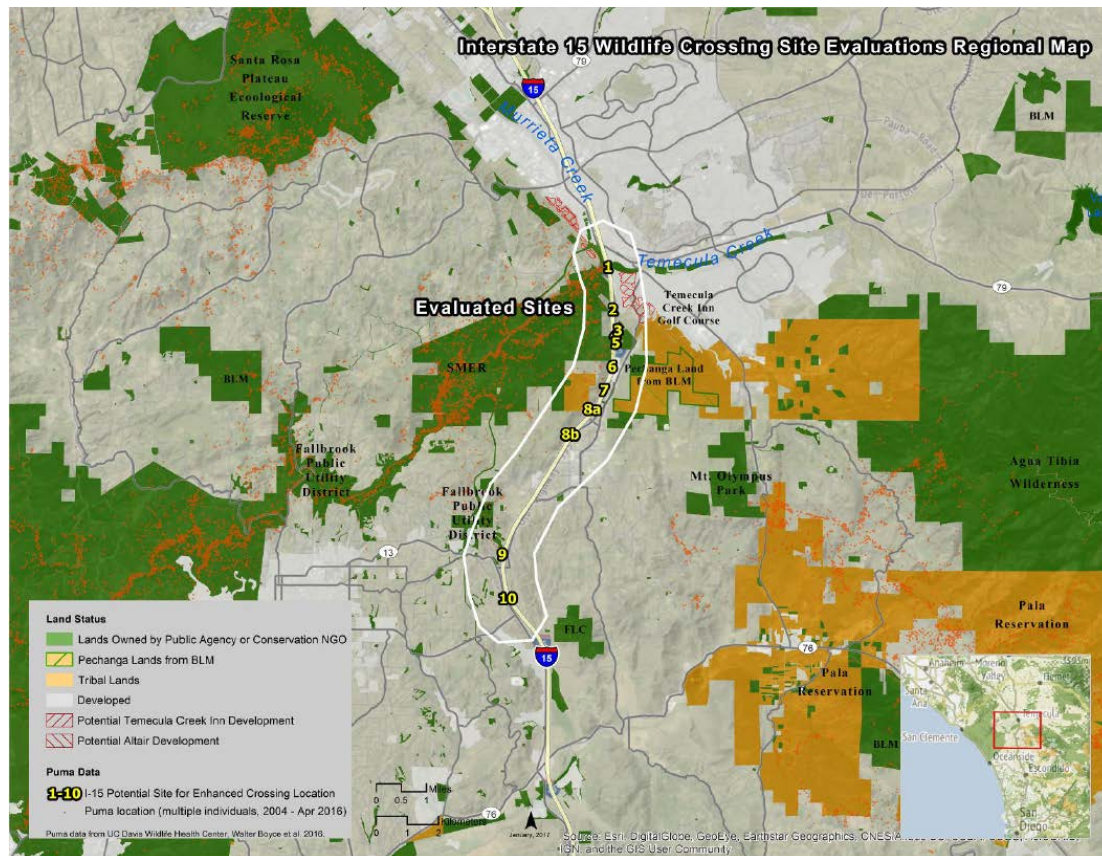
Map 3. Section of I-15 examined in Riley et al. 2018.

The experts were asked to evaluate this section of freeway where wildlife studies have indicated that some connectivity potential remains due to the presence of natural habitat on both sides of the interstate, but where new or enhanced structures are likely required to restore lost connectivity. In addition to expert opinion we also developed and implemented an evaluation tool based on landscape characteristics and wildlife data to further help prioritize locations for wildlife crossing infrastructure. Multiple specific sites were examined and both landscape and expert scoring indicated that retention and enhancement of function under the Temecula Creek Bridge, and construction of a new under or overpass south of the bridge, were both likely needed for long term connectivity and gene exchange for mountain lions and other wildlife. The experts also agreed that accompanying measures, such as effective wildlife fencing to funnel animals to crossing points and appropriate vegetative cover on and near structures were also important.

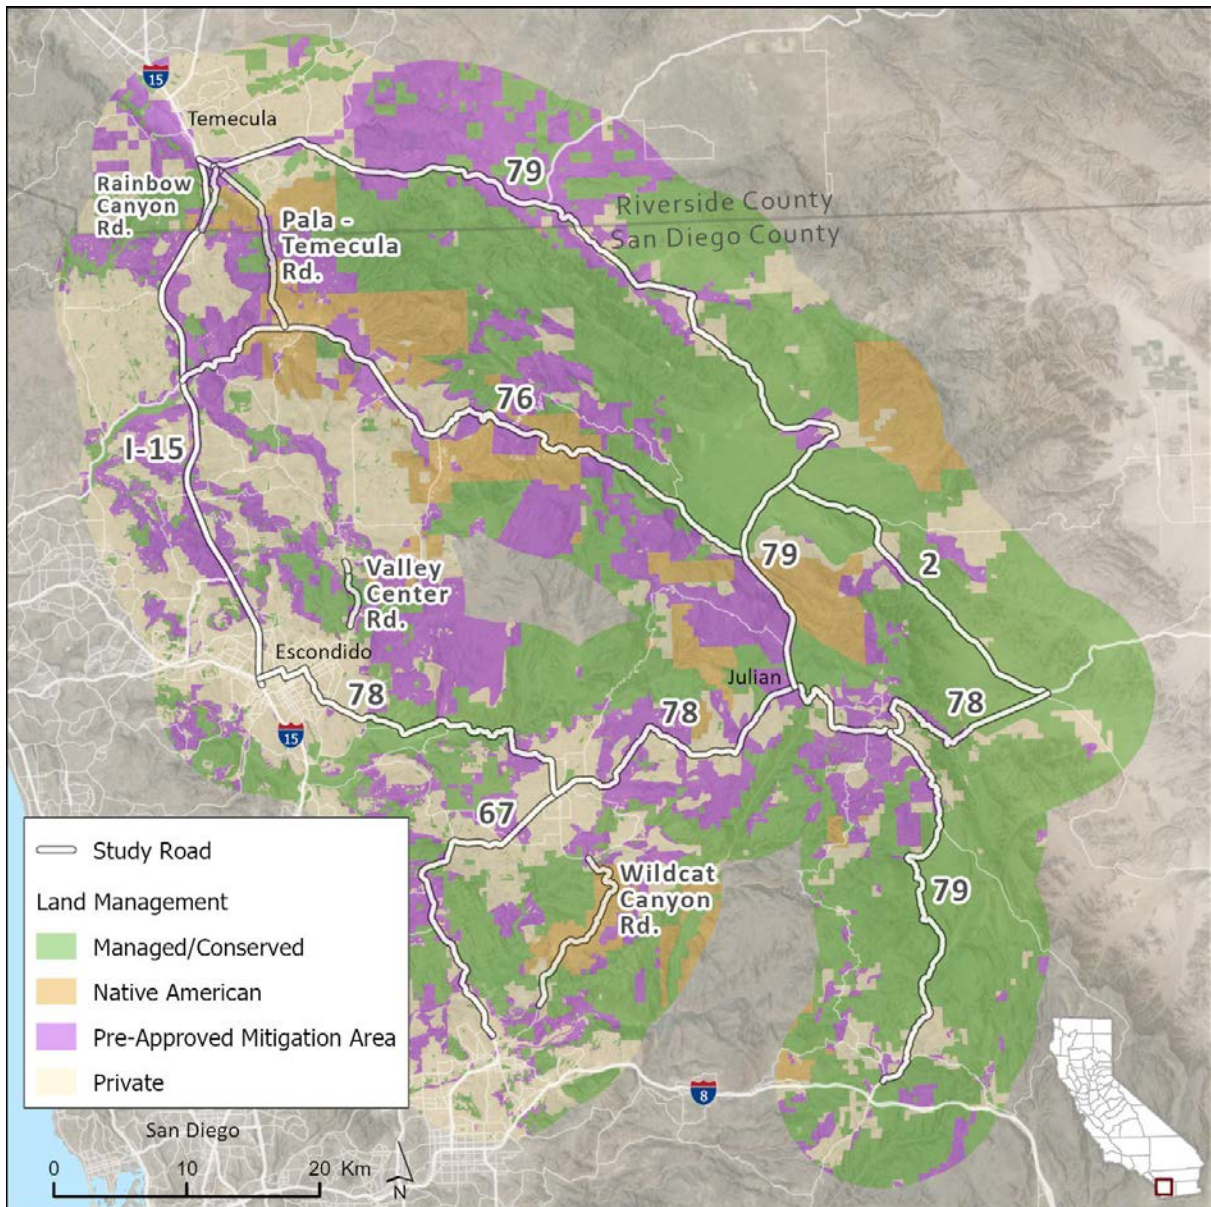
Map 4. Study area with Conserved, Native American, and Pre-Approved Mitigation Area lands (inclusive of Riverside County MSHCP lands – hereafter referred to collectively as PAMA lands), along with Private lands outside of PAMA's, and larger regional highways depicted. Five mile buffers were created around each highway to better define the immediate environments of regional highways. Areas outside the 5 mile buffers are depicted as light gray.

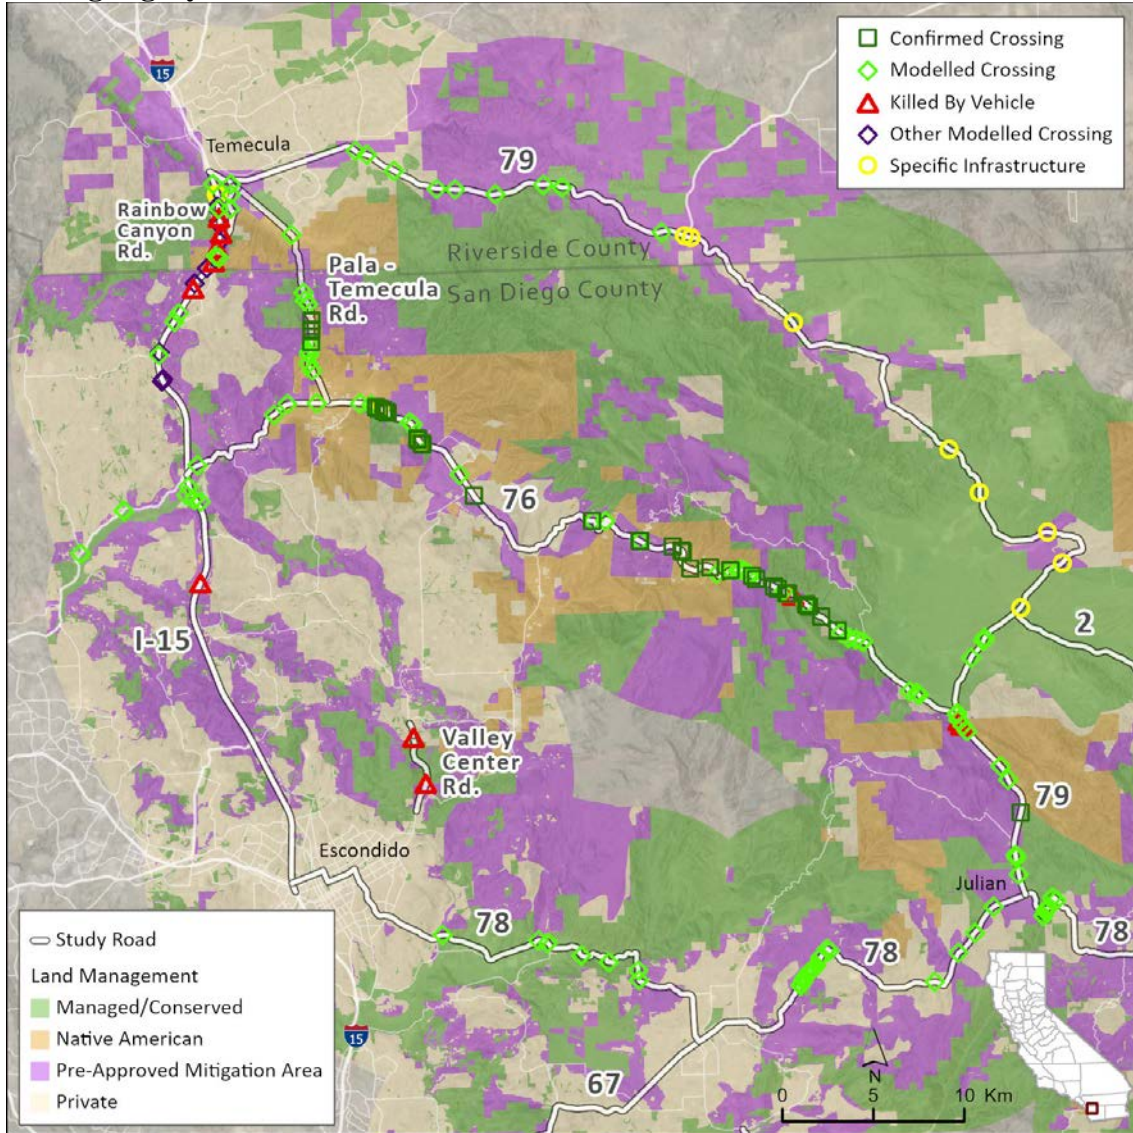
Map 5. Individual sites (n=186) that were examined on-the-ground and included in the analysis. Conserved, Native American, and PAMA lands, along with Private lands outside PAMA's, and larger regional highways depicted. Five mile buffers were created around each highway to better define the immediate environments of regional highways. Areas outside the 5 mile buffers are depicted as light gray.

Sites where mountain lions are confirmed to have crossed or attempted to cross the different roadways in the study (Sites with A, M, F, or U designations) were identified by utilizing high frequency (5 and 15 minute temporally spaced) GPS collar locations and mountain lion vehicle collision mortality sites. These sites were regarded by the study team as the “gold standard” of the 185 crossing sites studied in terms of understanding characteristics of the landscape where successful crossings as well as road mortalities were most likely to occur (Map 5). Most of the sites identified by GPS locations were

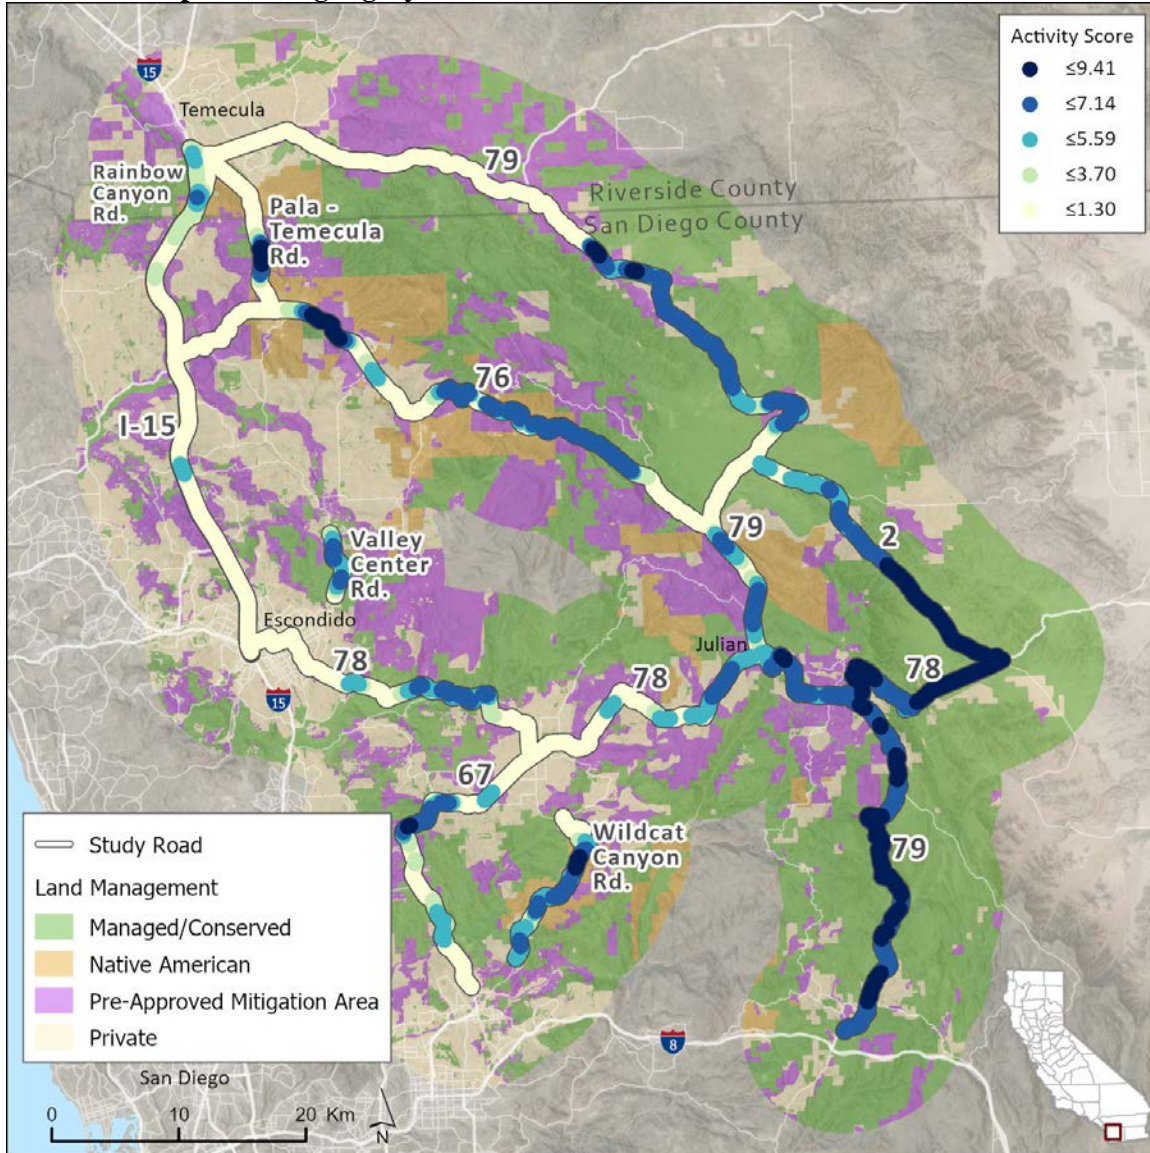
Map 6. Activity scores based on data from GPS-collared mountain lions for all points along the regional highways at 100 meter intervals. Conserved, Native American, and PAMA lands, along with Private lands outside PAMA's, and larger regional highways depicted. Five mile buffers were created around each highway to better define the immediate environments of regional highways. Areas outside the 5 mile buffers are depicted as light gray.

As noted earlier, points at 100 meter intervals were generated along all the highways surveyed, as well as other regional highways (Wildcat Canyon Road, SR67, S2). Display of Activity and Movement Scores for all of the 4,378 points illustrates the general sections of the regional highways where maintenance of connectivity for mountain lions is most indicated, and maintenance or creation of safe road crossing infrastructure at regular intervals is most important (Map 6). Activity scores were highest for parallel sections of SR76 and SR79 on either side of the Palomar Range, S2 in San Felipe Valley, SR78 and SR79 south and east of Julian, the section of Wildcat Canyon Rd. near and south of the Barona Casino, SR 67 west of Ramona, SR 78 east of Ramona, Pala-Temecula Rd., and I-15 at and just south of Temecula Creek (Map 6). Certain sections of SR79 and I-15 had very low or zero activity scores due to poor habitat around those sections or absence of GPS collaring activity in the past near those sections, or mountain lion use of the habitat being further from the highway than in other areas.

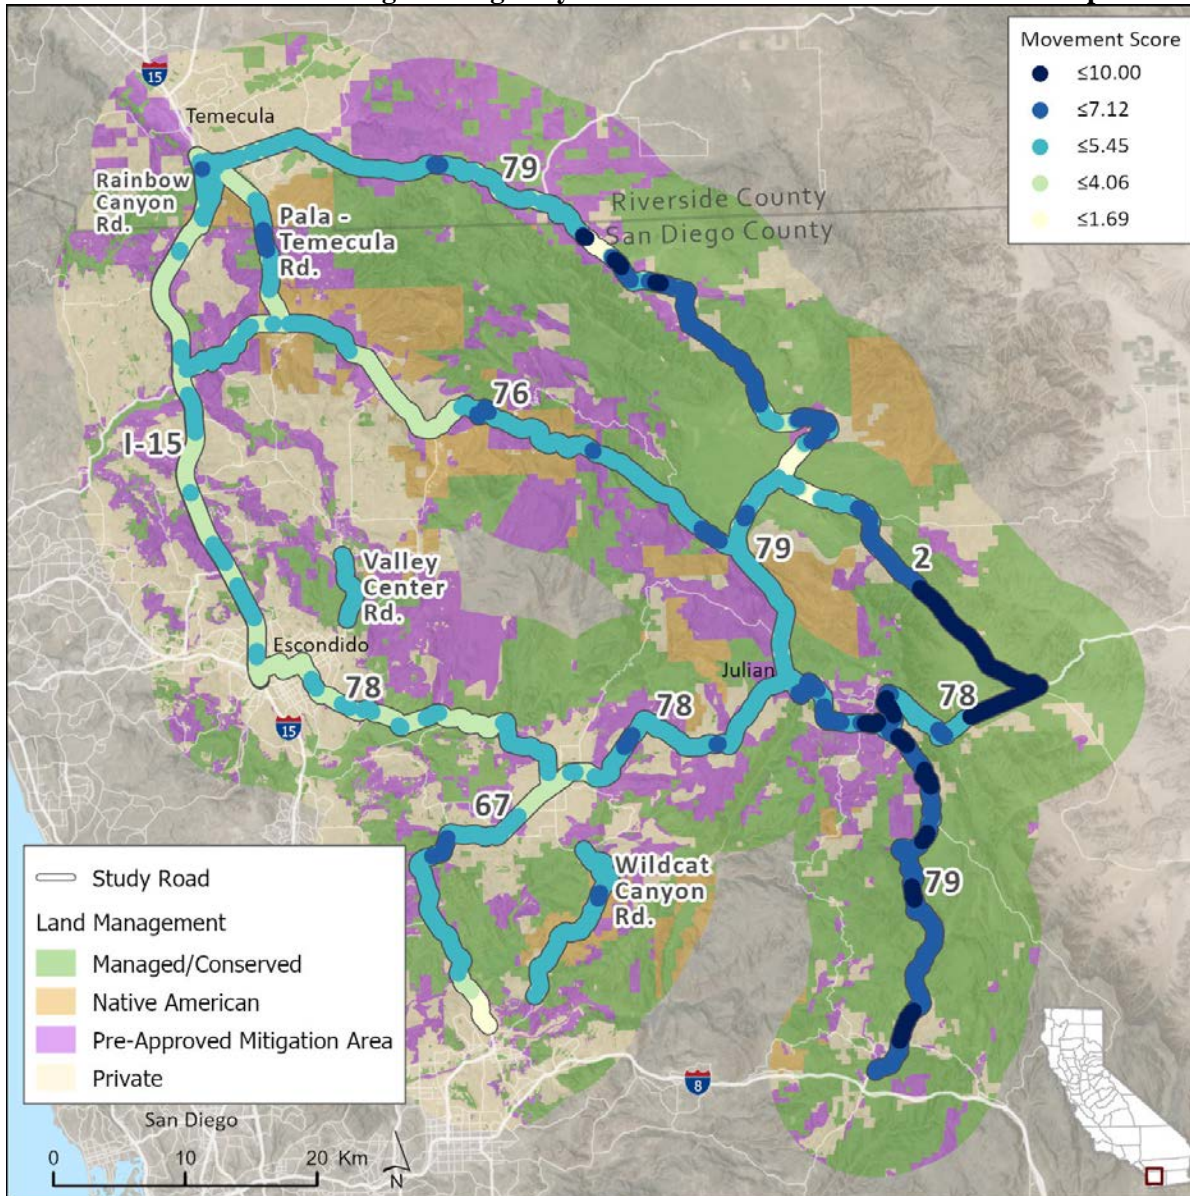
Map 7. Blended movement and activity scores for points along the highways at 100 meter intervals. Conserved, Native American, and PAMA lands, along with Private lands outside PAMA's, and larger regional highways depicted. Five mile buffers were created around each highway to better define the immediate environments of regional highways. Areas outside the 5 mile buffers are depicted as light gray.

no data was available from the models for that section. In order to be able to map the overall movement potential for mountain lions across the region, collar-based activity scores were substituted where no modeling-based scores existed. This resulted in a blended dataset used to generate the combined movement and activity map below for all the datapoints along the highways in the study (Map 7).

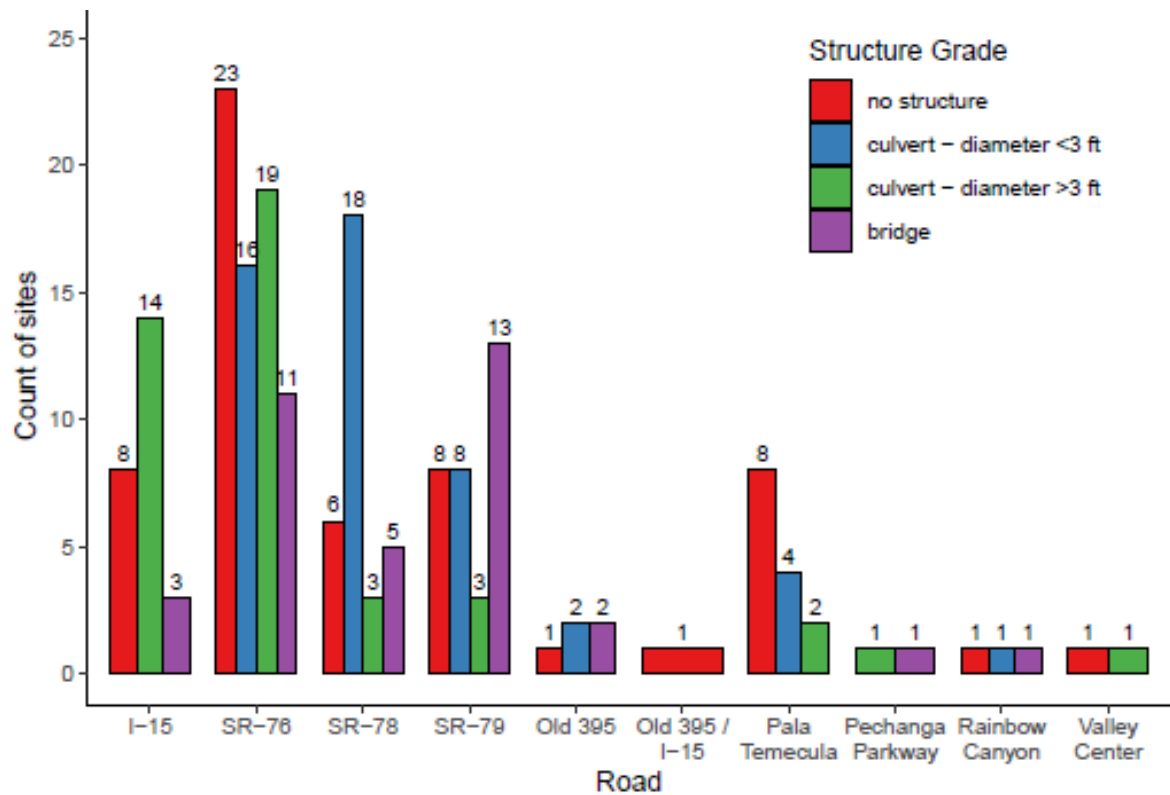
Figure 1a. Distribution of potential wildlife crossing structures types by highway and structure type as recorded in ground surveys. Each color represents a structure type, each bar represents the count on that highway (X axis) of structures of the given type.

Thus, over the entire 185 sites examined where mountain lions were known or projected to potentially attempt to cross the named highways, 53 sites (33 bridges, 20 culverts; 23%; Table 4; Appendix C) were found to potentially accommodate mountain lions crossing safely, with the 33 bridge sites also able to accommodate mule deer crossing. Analysis of these 53 sites in relation to mountain lion use specifically indicated that only 39 of the 53 have relatively high potential for regular use, though the other 14 may be used at times.

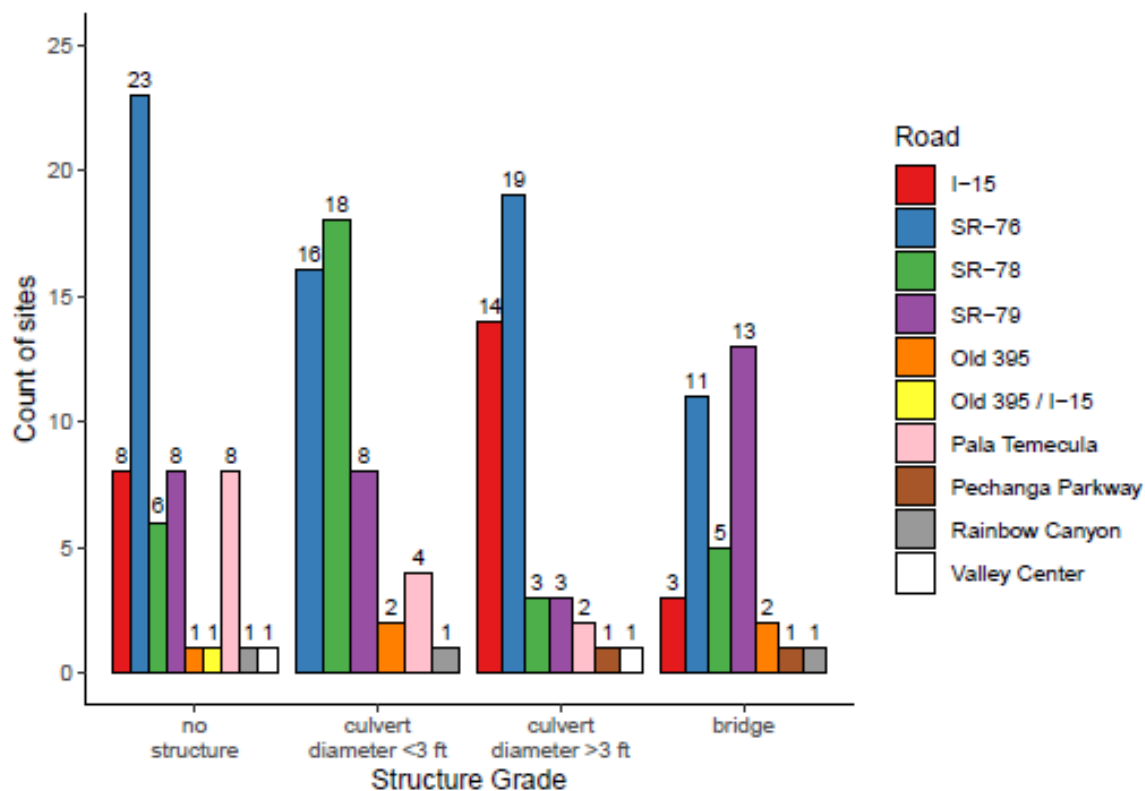
Figure 1b. Distribution of potential wildlife crossing structures types by highway and structure type as recorded in ground surveys. Each color represents a highway, each bar represents the count on that highway of structures of the given type (X axis).

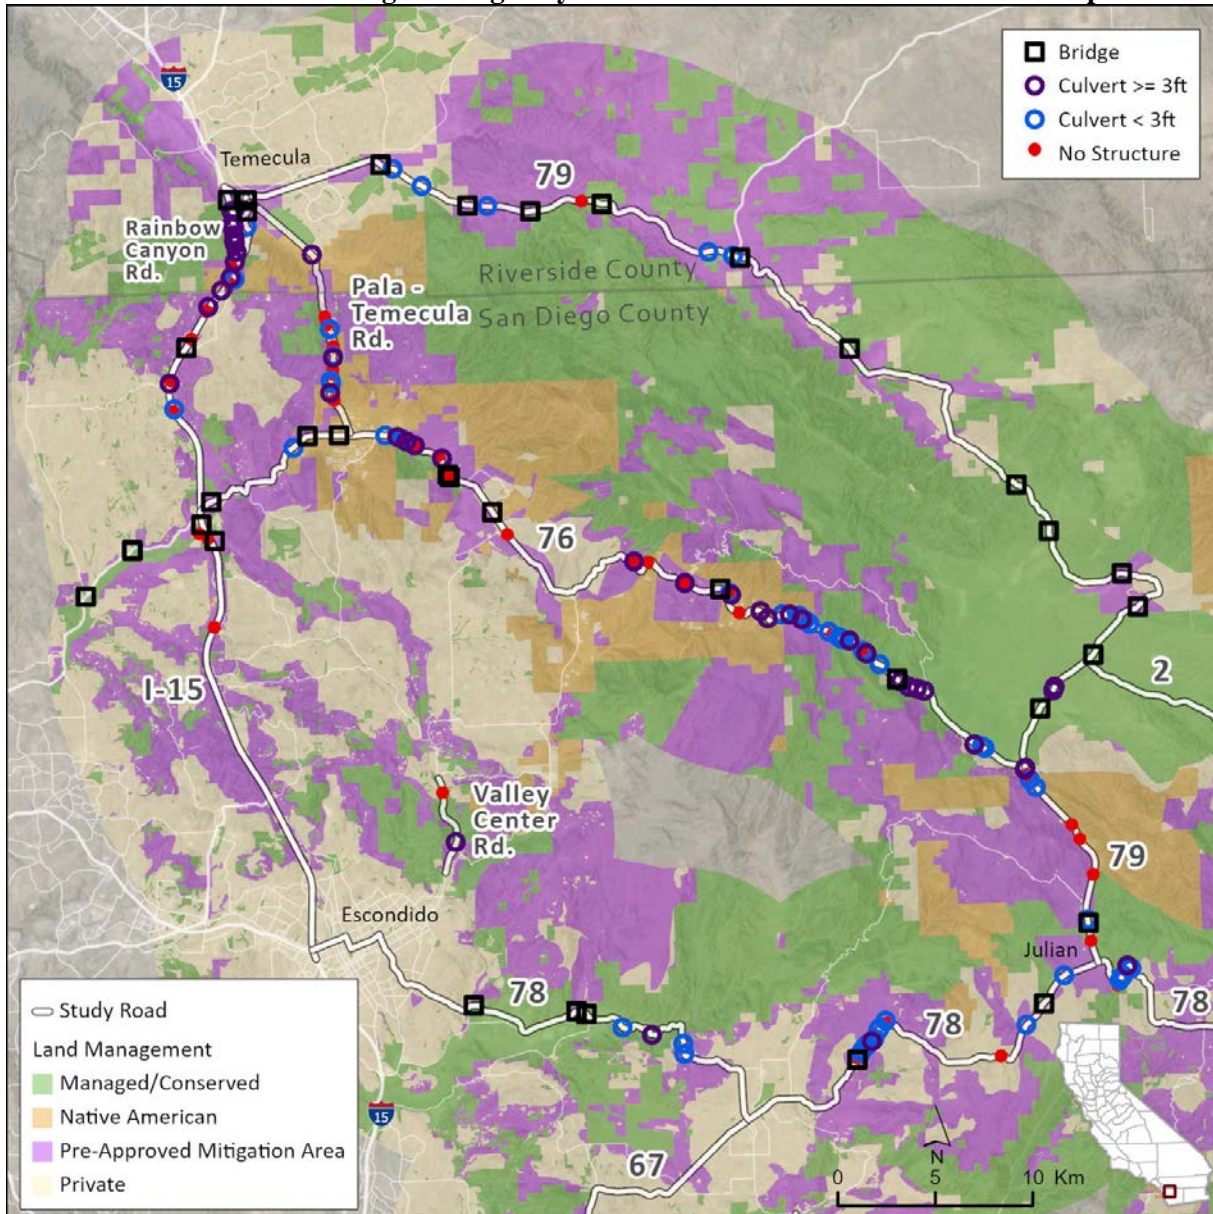
Map 8. Sites examined with structure type denoted. Structure scores are: Bridge (3), Culvert over 3 ft. diameter (2), Culvert less than 3 ft diameter (1), No structure (0)
Conserved, Native American, and PAMA lands, along with Private lands outside PAMA's, and larger regional highways depicted. Five mile buffers were created around each highway to better define the immediate environments of regional highways. Areas outside the 5 mile buffers are depicted as light gray.

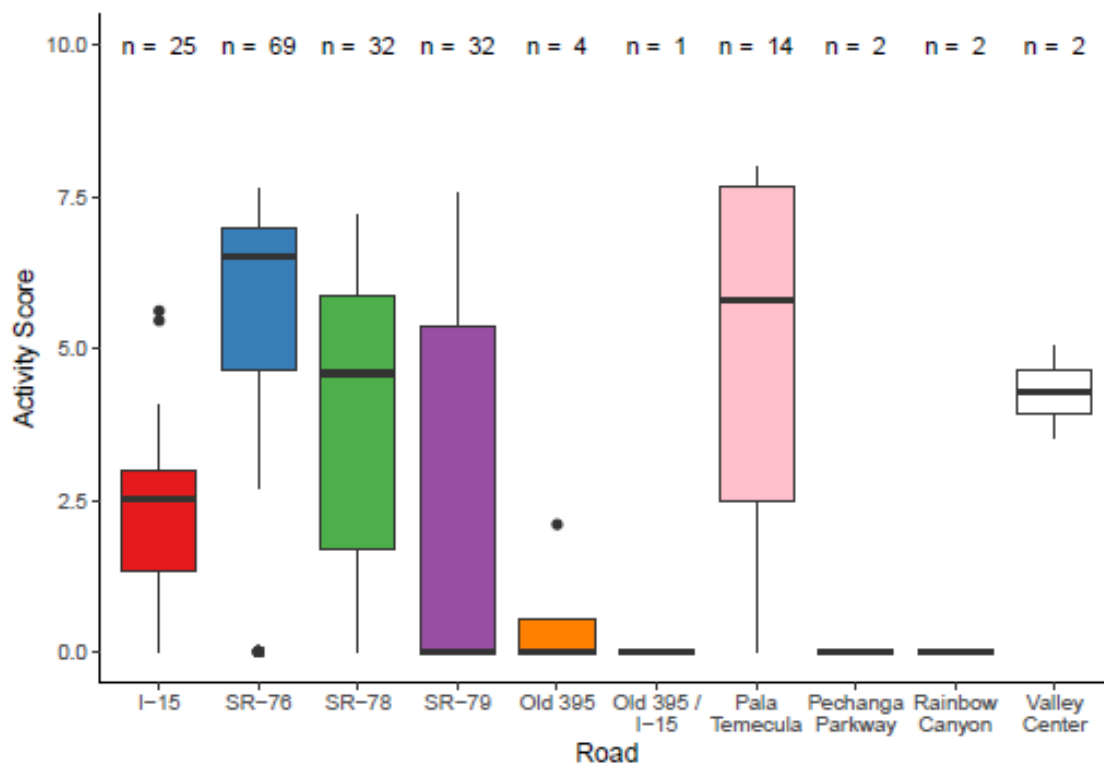
Figure 2. Activity scores of surveyed sites by highway.

Boxplots of Activity and Movement Scores of the different highway survey sites illustrate the differences between the two methods of assessing movement potential across the highways, specifically at the crossing sites surveyed (Figures 2,3). These charts illustrate that Activity scoring based on specific mountain lion GPS collars are much more variable than Movement scores when assessed by highway. Median Activity scores were highest at the surveyed sites along SR76, and median Movement scores were highest along SR78. Sites surveyed with color coding of the sites by Activity score are illustrated in Map 9 below.

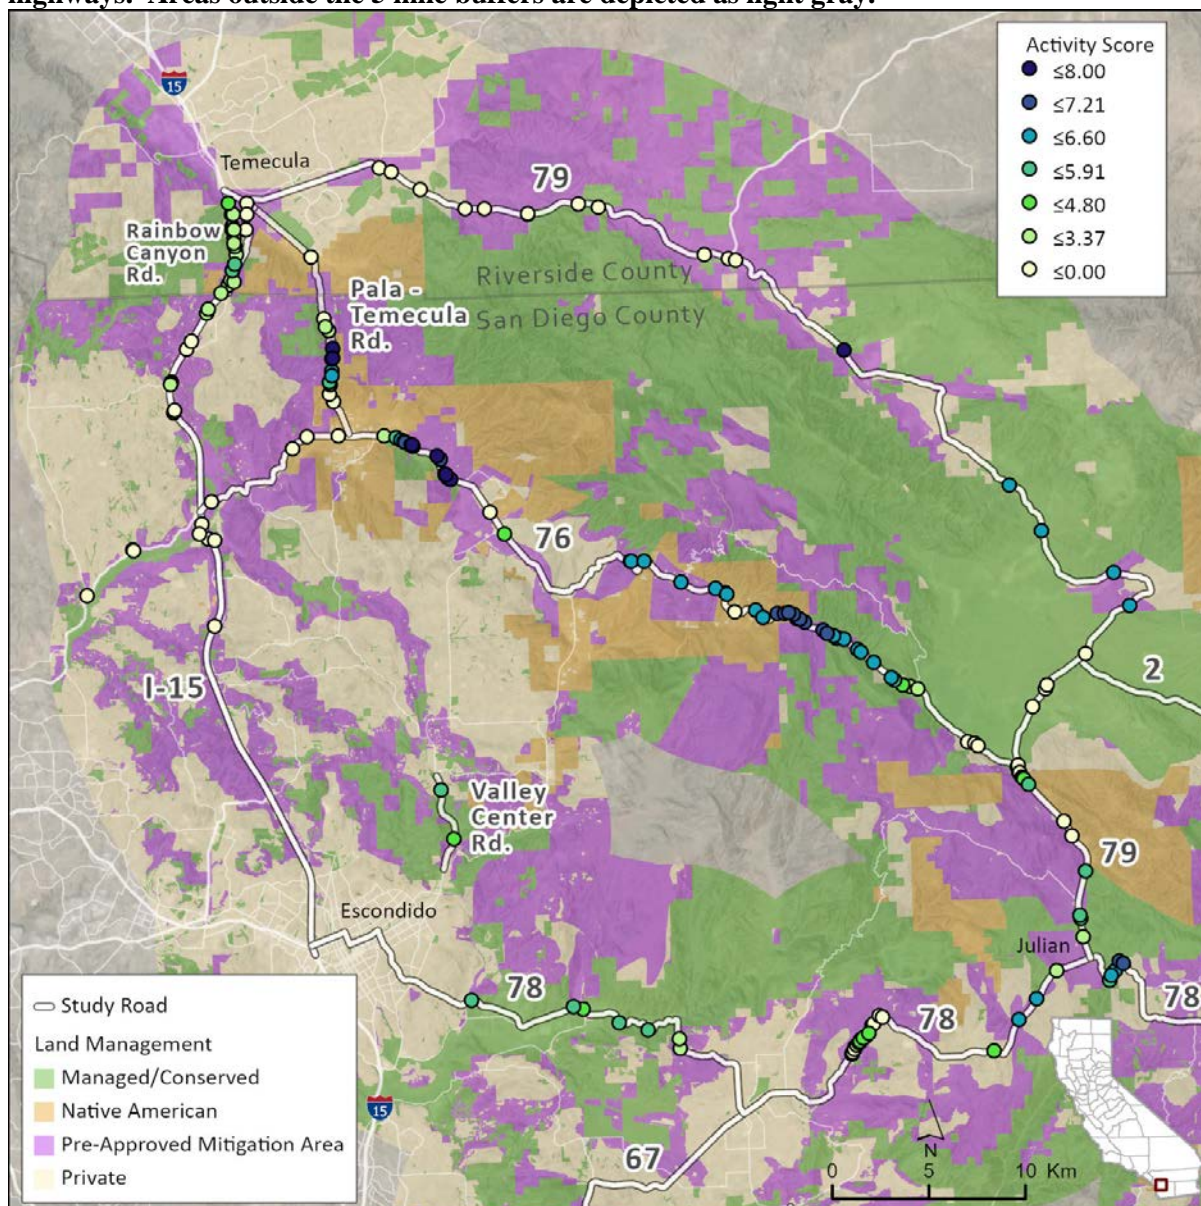
Map 9. Activity Scores across the regional highway sites surveyed. Conserved, Native American, and PAMA lands, along with Private lands outside PAMA's, and larger regional highways depicted. Five mile buffers were created around each highway to better define the immediate environments of regional highways. Areas outside the 5 mile buffers are depicted as light gray.

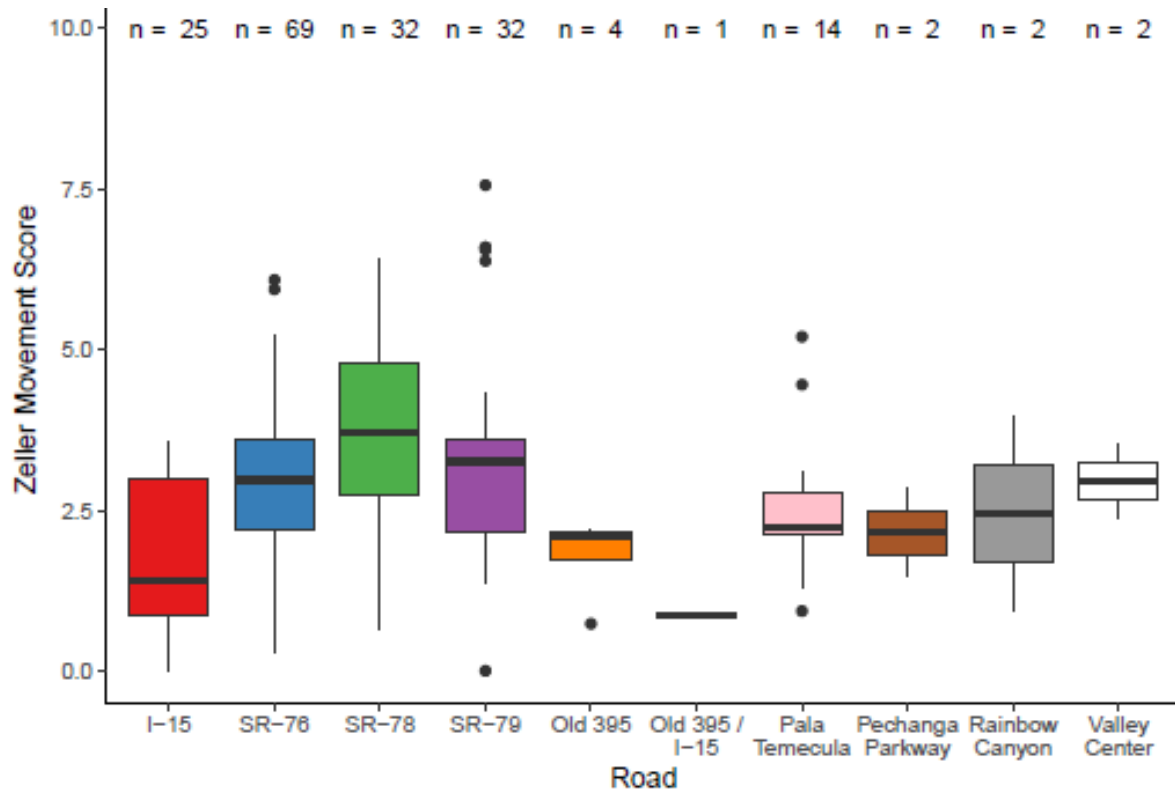
Figure 3. Movement scores of surveyed sites by highway.

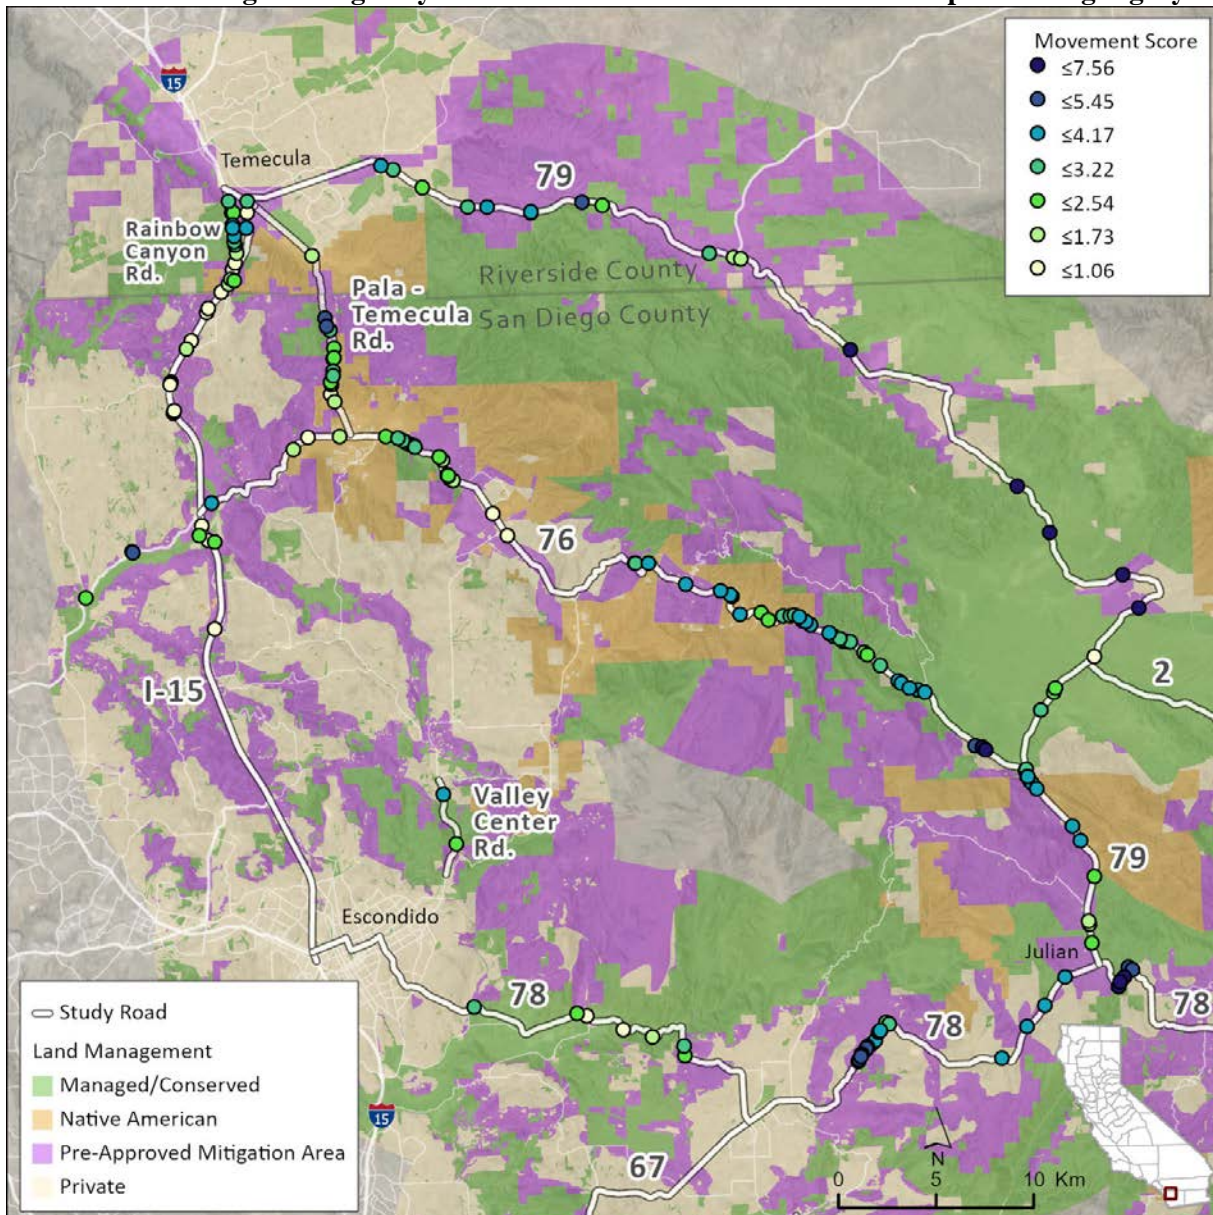
Map 10. Blended movement and activity scores for the regional highway sites surveyed. Conserved, Native American, and PAMA lands, along with Private lands outside PAMA's, and larger regional highways depicted. Five mile buffers were created around each highway to better define the immediate environments of regional highways. Areas outside the 5 mile buffers are depicted as light gray.

Both scores afford different ways to assess and prioritize sites in general. Sites with high scores by either measure were considered by the Project Team to be priority locations, but sites with high scores on both measures were considered to be especially notable. As noted above, for certain short highway segments no Movement data was available, and in some areas no Activity data was available due to vagaries of where mountain lions were captured and collared. In those areas, scores from the other data set were substituted to produce a blended picture of all known likelihood of mountain lion use of specific sites for crossing the roads. Map 10 illustrates the individual surveyed sites that had the highest scores by the blended scoring system. Zoomed in maps for each highway with sites named are attached to this report as Appendix E.

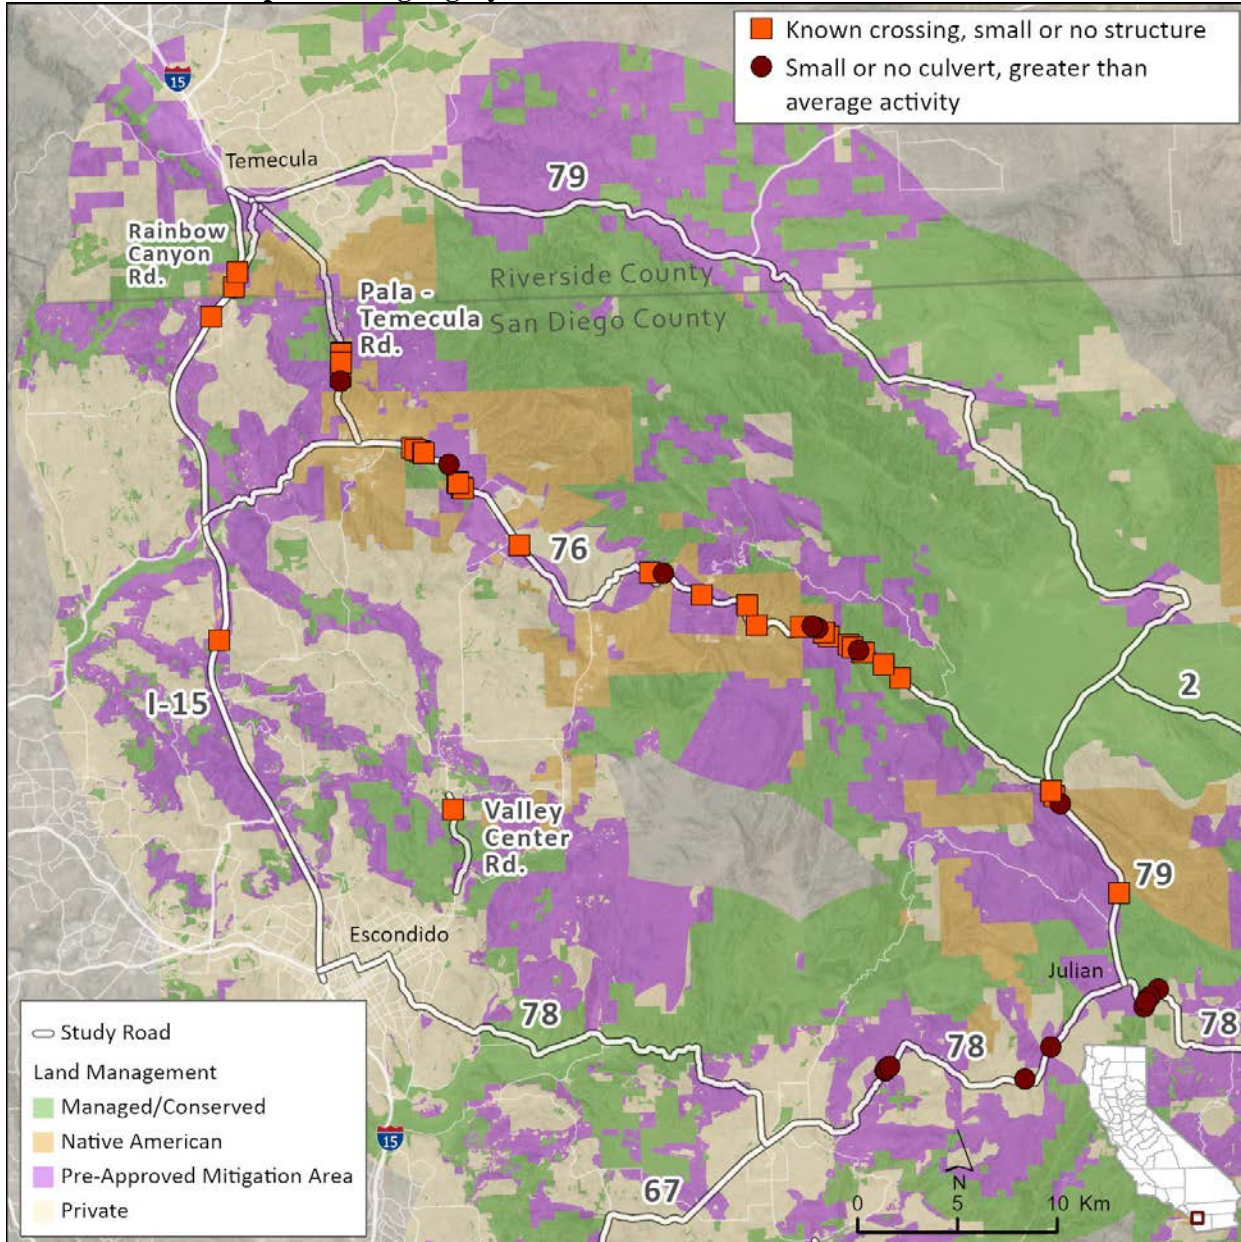
Map 11 – Known mountain lion crossing sites, and sites with greater than average Activity scores, but without adequate crossing structures present. Conserved, Native American, and PAMA lands, along with Private lands outside PAMA's, and larger regional highways depicted. Five mile buffers were created around each highway to better define the immediate environments of regional highways. Areas outside the 5 mile buffers are depicted as light gray.

Of the sites where mountain lions were confirmed to have crossed roads successfully or been killed in the attempt (n=64 sites), 32 (50%) had no infrastructure present and 12 (19%) had only small culverts (Appendices C, D; Map 11). Of these known crossing locations, bridges were present at 6 sites (10%) and larger culverts were present at 14 sites (21%), however 4 of the 14 larger culverts were constrained in some way as noted above. Thus, over two-thirds (69%) of sites where crossings or attempted crossings occurred had no adequate structures. This necessitated animals crossing at grade, and suggests a need for infrastructure improvement at those locations – either fencing to funnel animals to nearby locations with adequate crossing structures or new structure construction if adequate land conservation is present at the sites. We take that into account in prioritization of sites detailed later in the results.

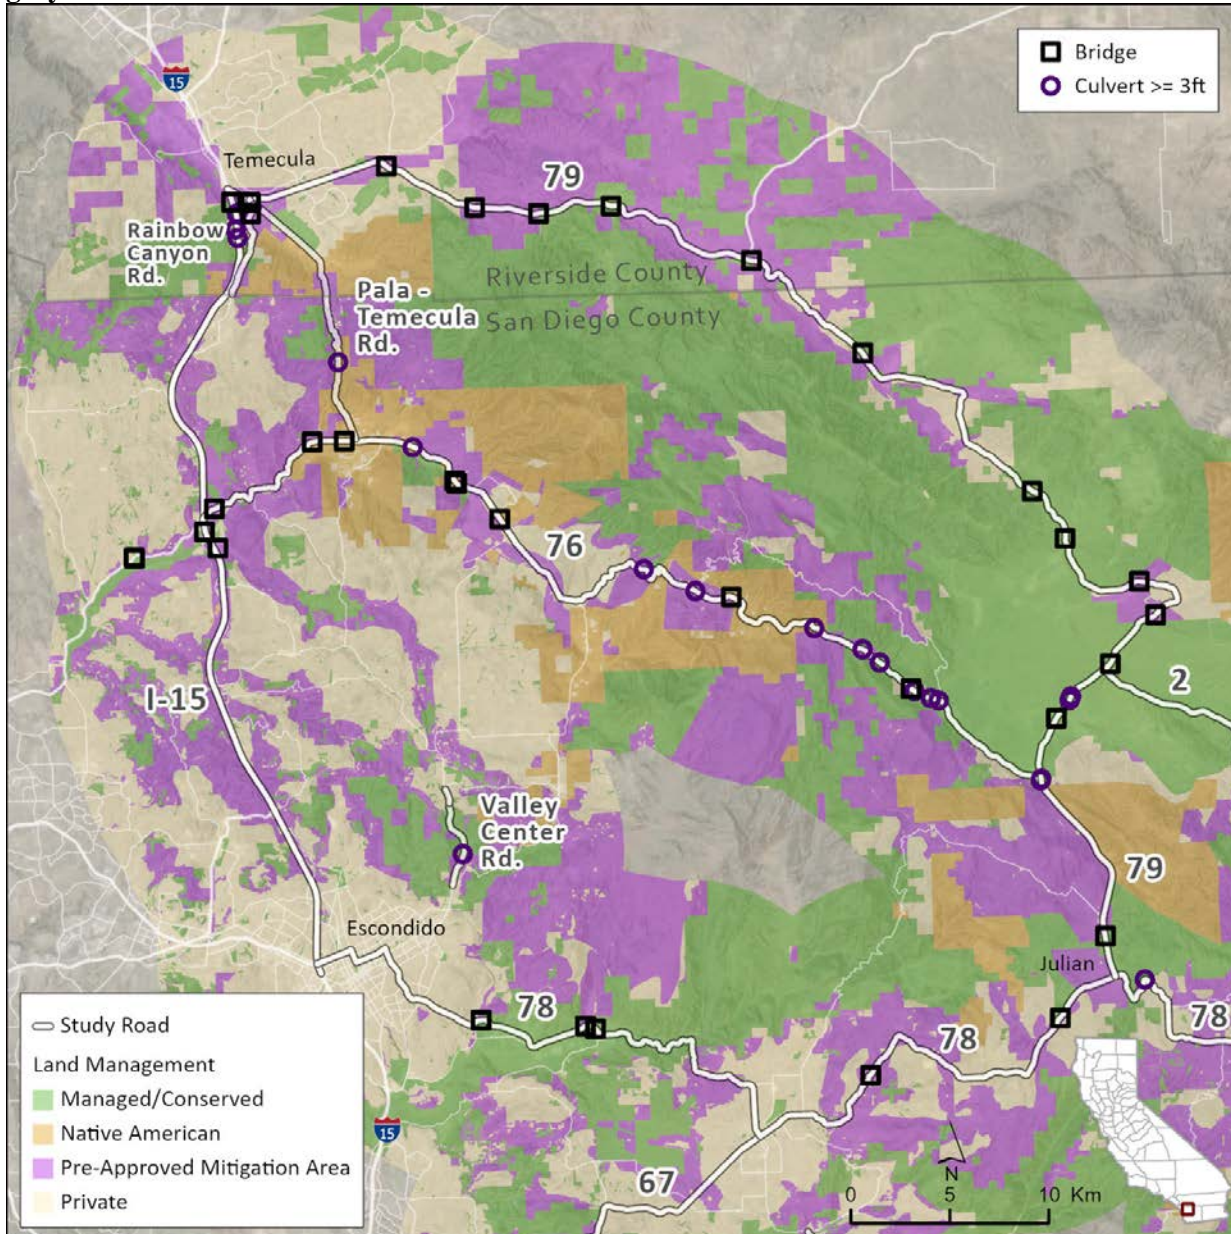
Map 12 – Sites where existing infrastructure is of adequate size to support mountain lion movement across highways. Conserved, Native American, and PAMA lands, along with Private lands outside PAMA's, and larger regional highways depicted. Five mile buffers were created around each highway to better define the immediate environments of regional highways. Areas outside the 5 mile buffers are depicted as light gray.

Culverts greater than 3 feet in diameter that were unconstrained, and bridges that were unconstrained, were present at 53 of the 185 sites examined (29%; Table 5; Map 12). Mountain lions were known to have crossed the road at 13 of these sites, and 23 of the sites had higher than average activity and / or movement levels. Three of the sites were mountain lion mortality sites from vehicle collisions despite adequate infrastructure for safe crossing being present. Thus 39 of the 185 sites investigated have both adequate infrastructure to support long term connectivity and a high potential for mountain lion use of the sites as those areas now exist (Table 5, Map 13).

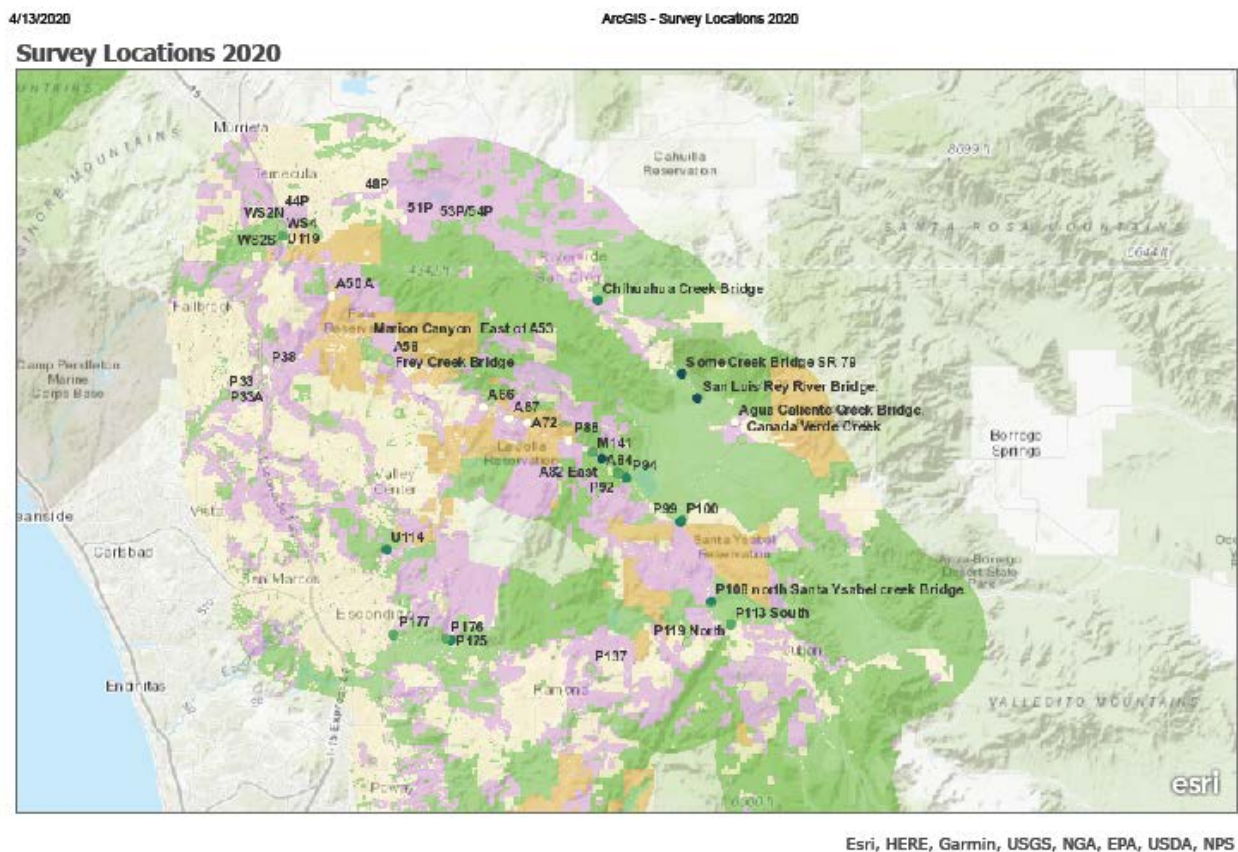
Map 13. Sites (n=39) where mountain lions have crossed the road or with high Activity and Movement Scores with adequate infrastructure present. Site symbols are colored by Conservation score.

We regard these 39 sites as highest priority for maintaining their current function for mountain lion connectivity (Appendix C, D). This means maintaining them as free as possible from debris and other obstructions, as well as preventing excessive human presence especially at night. The primary infrastructure change to consider for these sites is fencing to funnel animals to them from other nearby sites where crossing at grade may occur, and to reduce human incursion from the roadway into the area of the crossing structure which would reduce its function for wildlife.

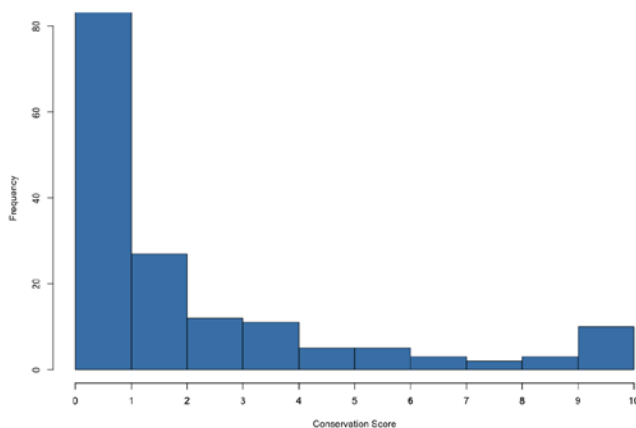
Figure 4. Distribution of Conservation Scores across all surveyed sites.
0 = 0% conserved, 10 = 100 % conserved

The average conservation percentage within the 500 meter radius of all sites that were examined was 17.2 % conserved (score of 1.72) but the median percentage was only 7.8% (score of 0.78), with a score of zero at 48 sites (26% of sites). Scores indicated that 116 sites (63% of sites) had conservation percentages between 1% - 50% conserved (Conservation score 0.01-5.0), and only 21 sites had over 50% of the land in the 500 meter radius around the site (Conservation score > 5.0). Thus the vast majority of sites where mountain lions might approach the regional highways have minimal conserved lands in the immediate vicinity of the crossings (Appendix C; Figures 4, 5; Map 14). This contrasts with the 50-60% of overall lands that are projected to be mountain lion habitat in the study region that were classified in previous research as conserved (Vickers et al. 2017-Appendix B, Zeller et al 2017, Dellinger et al. 2019).
