Final report re NCCP-Local Assistance Grant # P1750301 from California Dept. of Fish and Wildlife and SANDAG – UCD agreement #A37682/MOU #5005298 Awarded to the University of California, Davis Wildlife Health Center.

Project Title: Santa Ana Mountains to eastern Peninsular Range Conservation Connectivity Infrastructure Planning Project for Interstate 15 and Closely Associated Roadways

Date of original report: March 31, 2020

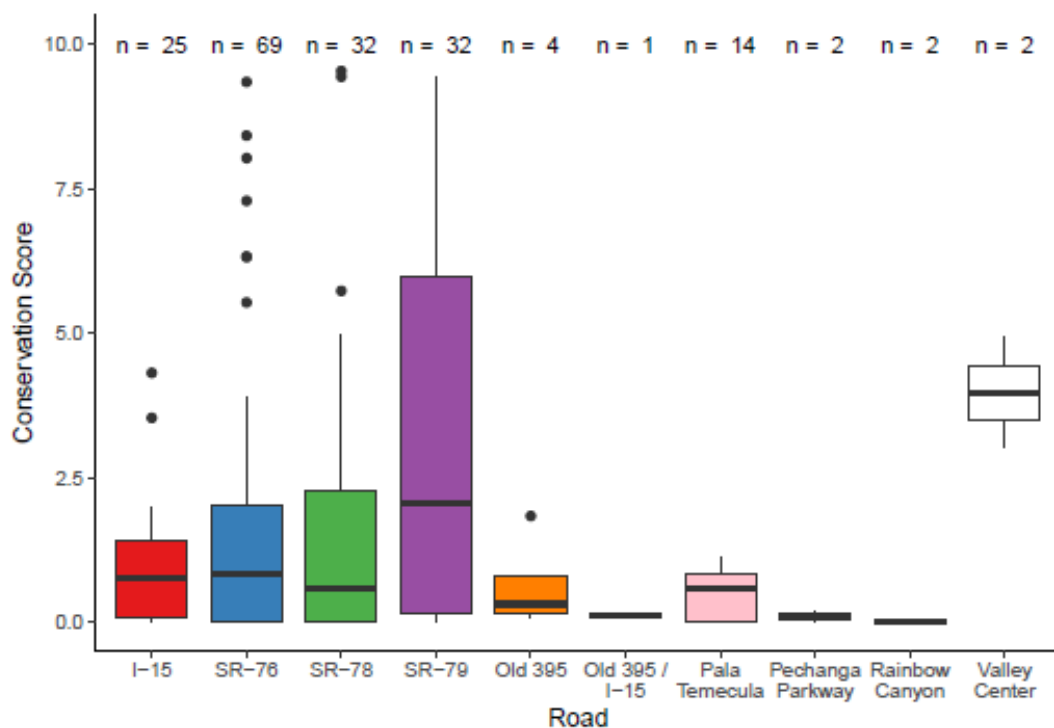
Figure 5. Boxplots of Conservation Scores by highway. Each box represents the middle 50% of scores for examined sites along that highway. The median score is represented by the horizontal line in the box, with the quartiles above and below the median above and below the line. The upper and lower quartiles are represented by the “whiskers” above and below the box. Individual dots represent significant outliers. Numbers of sites documented for each highway are noted above each boxplot.

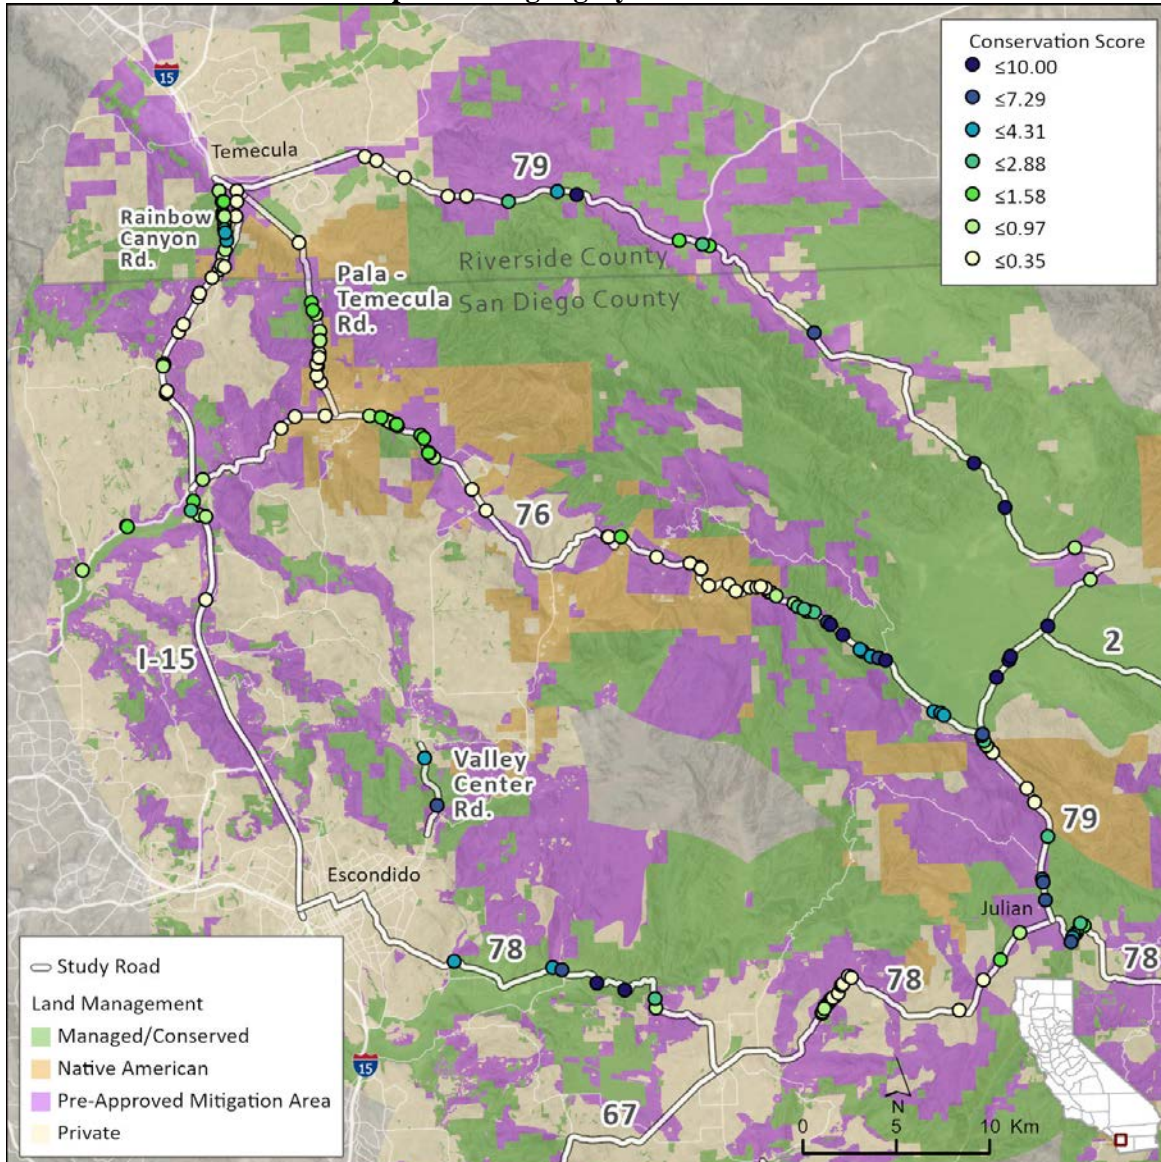
Map 14 - Surveyed sites with Conservation Scores – scores are based on the percentage of land that is conserved that is within a 500 meter radius of each survey site. Conserved, Native American, and PAMA lands, along with Private lands outside PAMA's, and larger regional highways depicted. Five mile buffers were created around each highway to better define the immediate environments of regional highways. Areas outside the 5 mile buffers are depicted as light gray.

Higher conservation scores imply a lower risk of mortality for mountain lions in the vicinity of that crossing (Burdett et al. 2010, Dellinger et al. 2019), and would be expected to reduce the likelihood of development blocking access to the highway at any given point

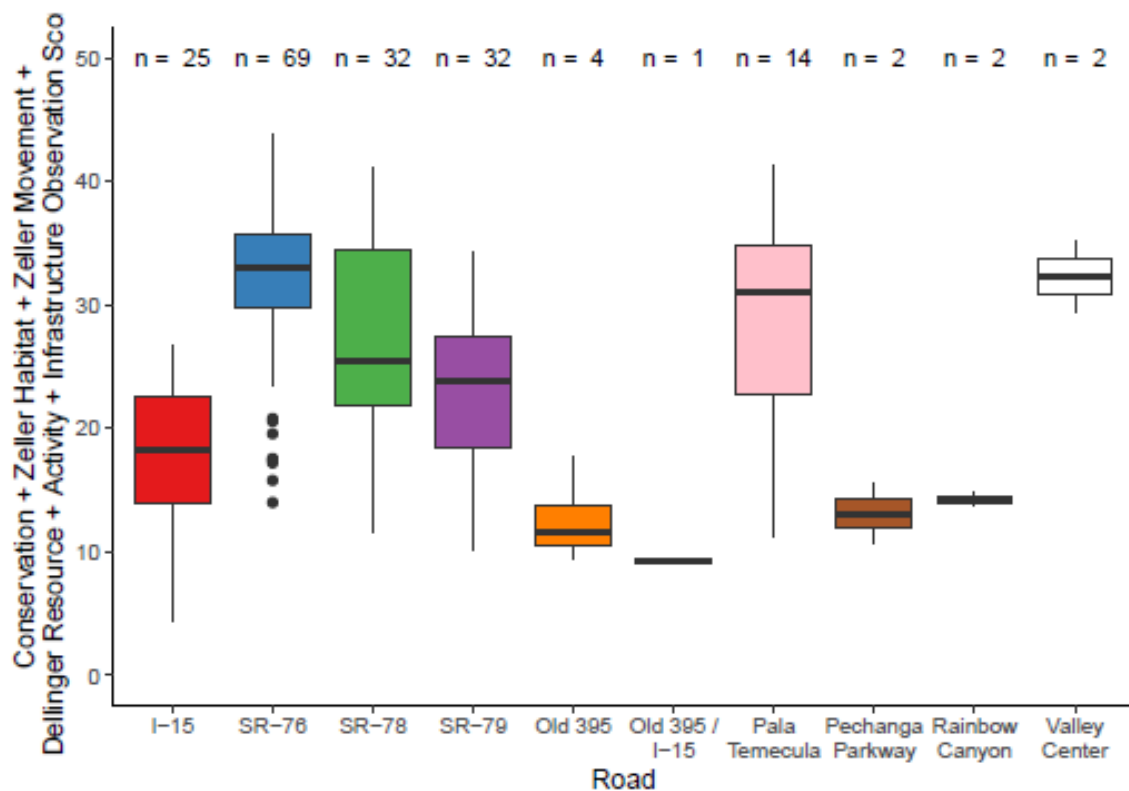
Figure 6. Box plots of Total Scores (all six scores combined for all 183 examined sites – two sites were not scored on all parameters) for each road in the study. Each box represents the middle 50% of scores for examined sites along that highway. The median score is represented by the horizontal line in the box, with the quartiles above and below the median above and below the line. The upper and lower quartiles are represented by the “whiskers” above and below the box. Individual dots represent significant outliers. Numbers of sites documented for each highway are noted above each boxplot.

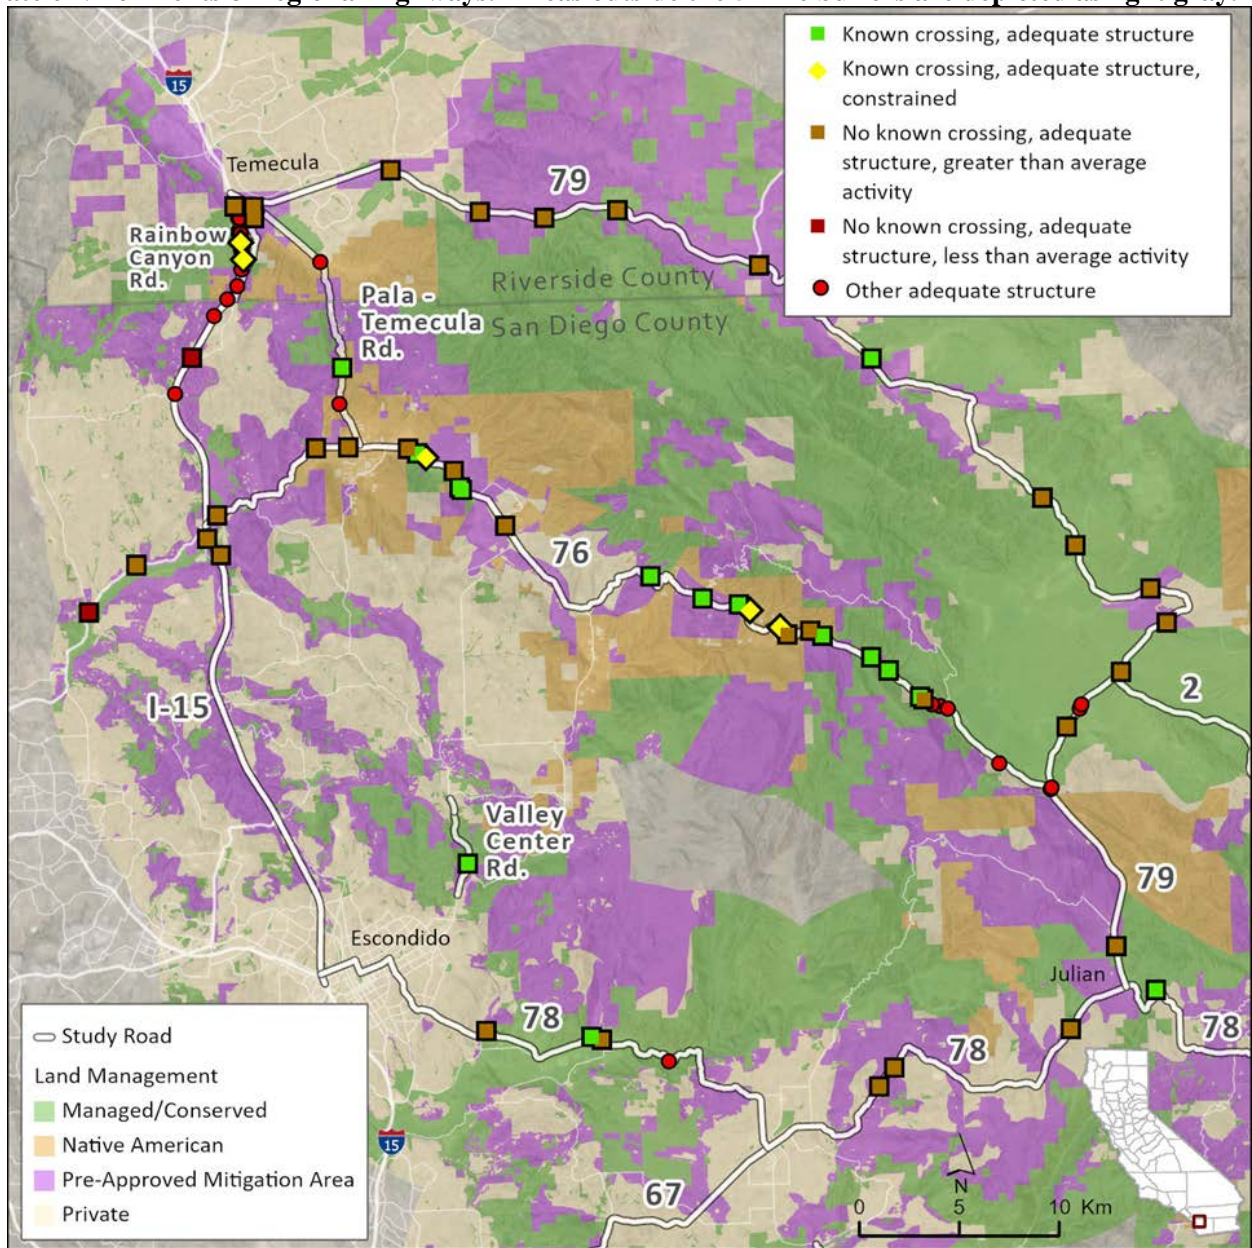
Map 16 – Sites where known crossings and high crossing potential exists with infrastructure noted. Conserved, Native American, and PAMA lands, along with Private lands outside PAMA's, and larger regional highways depicted. Five mile buffers were created around each highway to better define the immediate environments of regional highways. Areas outside the 5 mile buffers are depicted as light gray.

Our first method for characterizing the sites overall as to most important to long term mountain lion connectivity focused first on where mountain lions had crossed roads or had high Activity and Movement scores, and eliminated sites that had no known crossings and lower than average scores. This left 98 sites to prioritize, broken into four groups as listed below (Maps 16, 17; Table 6).

3. Sites where bridges are present but activity and movement scores are below the average for sites where crossings have occurred (n = 21).
4. Sites where mountain lions are known to have crossed or attempted to cross highways, and adequate crossing infrastructure is NOT present or is too small (n = 48). New infrastructure should be considered at these sites as culvert or highway projects are planned, and fencing is indicated to funnel mountain lions and other wildlife to those structures.

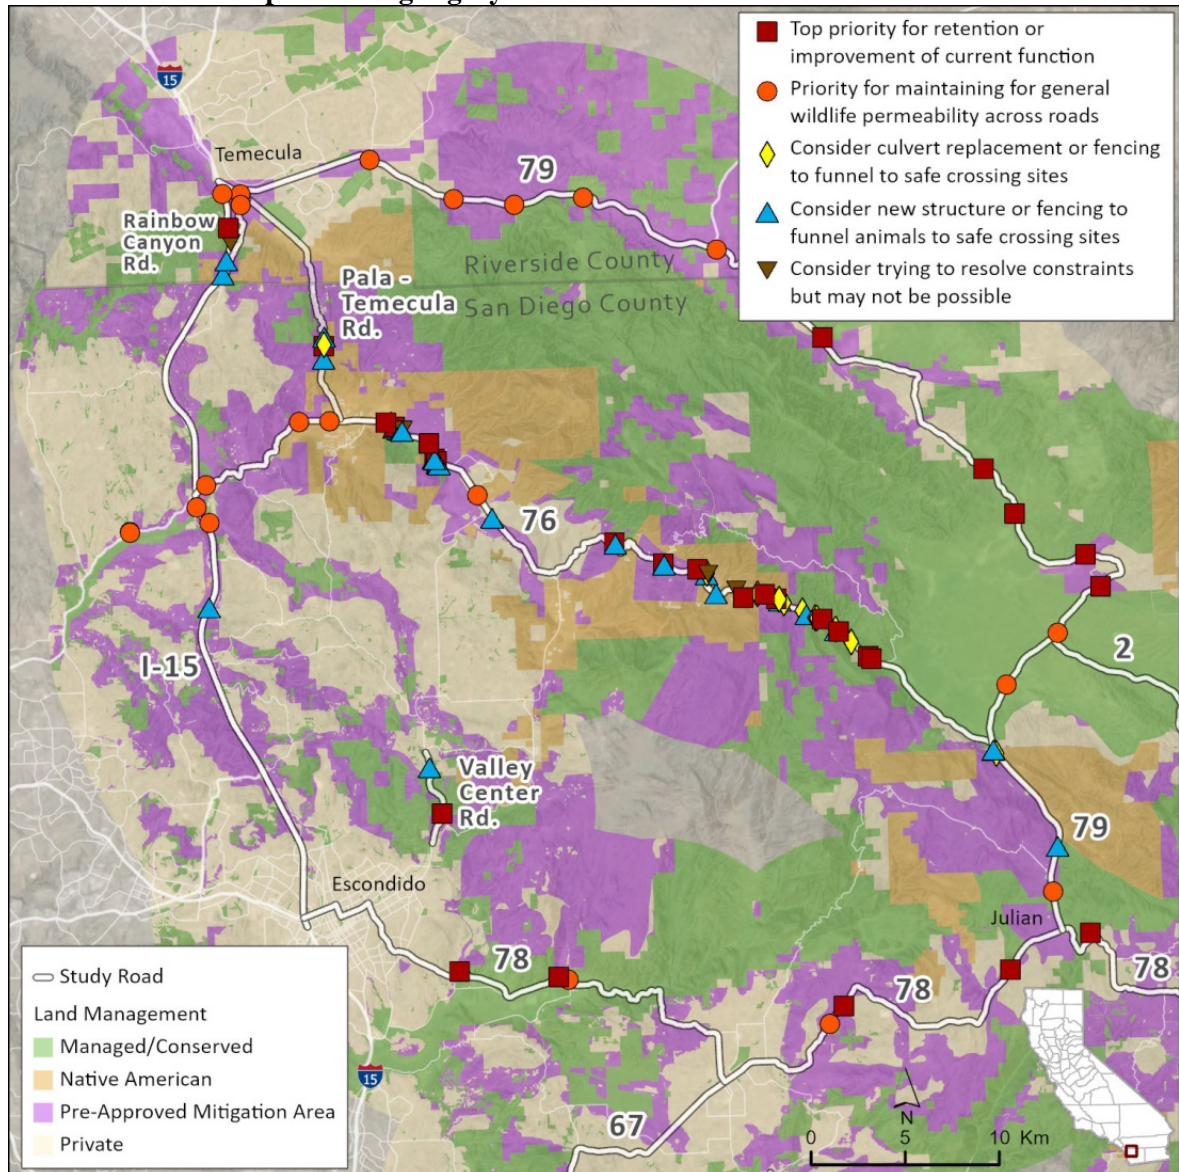
Map 17 – Recommendations for actions at different sites. Conserved, Native American, and PAMA lands, along with Private lands outside PAMA's, and larger regional highways depicted. Five mile buffers were created around each highway to better define the immediate environments of regional highways. Areas outside the 5 mile buffers are depicted as light gray.

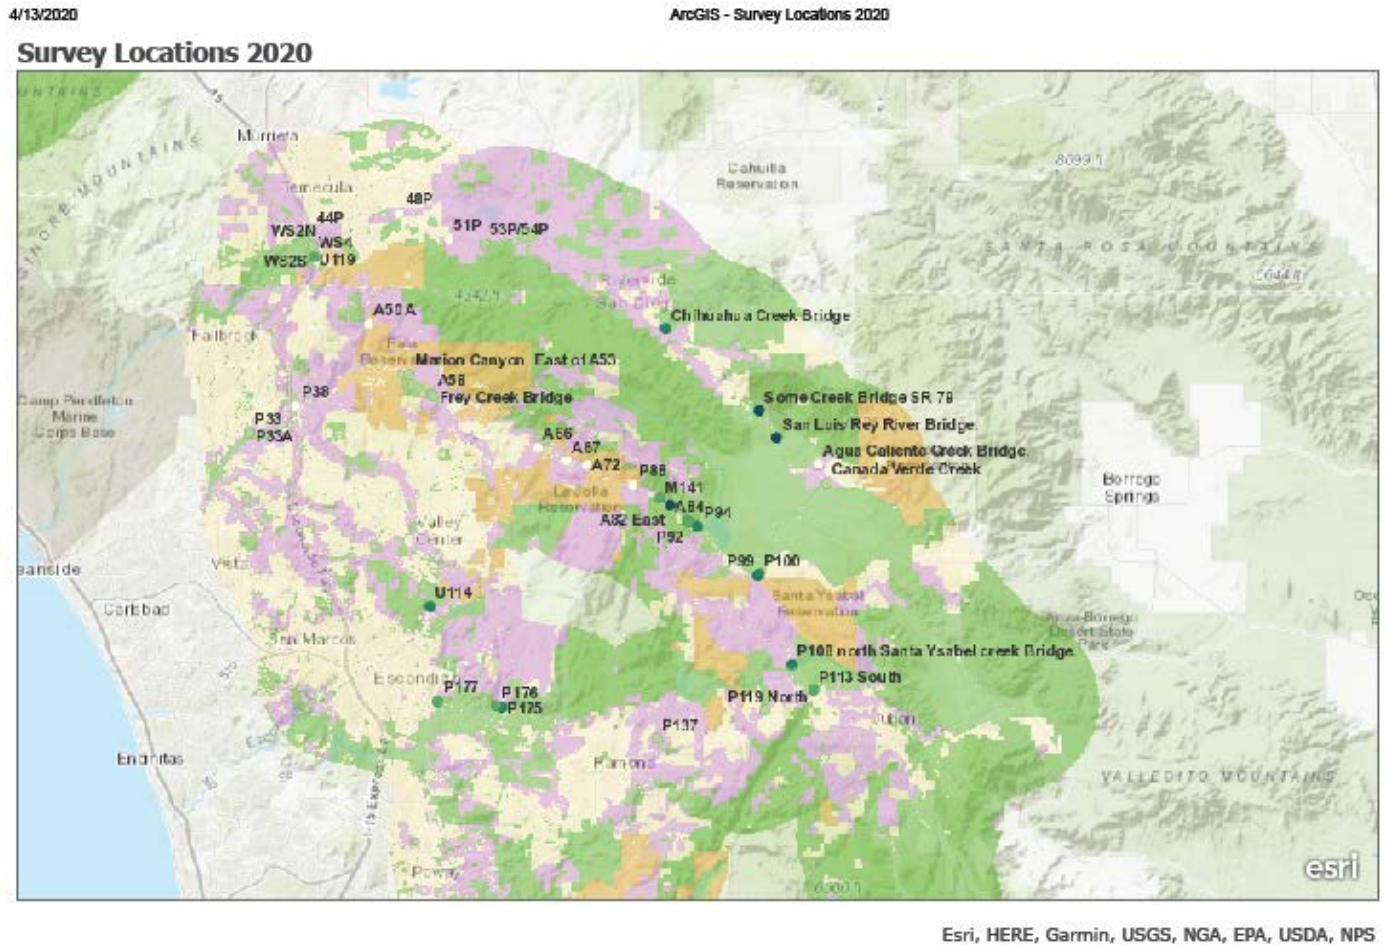
Map 18. Group 1 priority sites. Adequate infrastructure is present (bridges or larger culverts that are unconstrained) and either known crossings occurred at those sites or they have high Activity and / or Movement scores

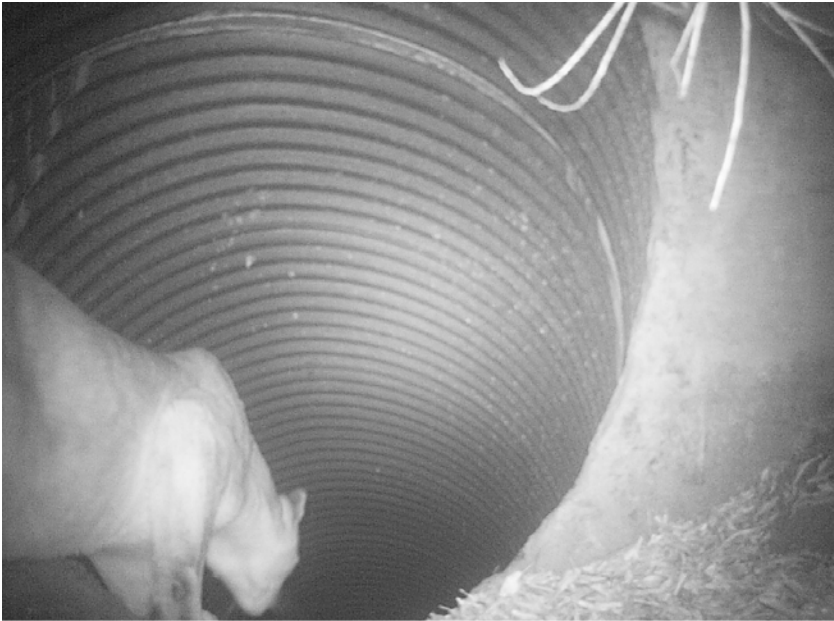
Picture 2. Mountain lion looking into I-15 culvert at site WS4 from the west side

Monitoring of the existing large culverts under I-15 and adjacent drainages and conserved lands, as well as the Temecula Creek Bridge area, with trail cameras (n = 41 locations) for a total of 7,568 camera nights was also done during the study, and cameras confirmed periodic mountain lion activity at 7 camera locations on 10 occasions (Table 8; Appendix F). Camera sites that recorded mountain lion activity included ones near the Temecula Creek Bridge (west side), within meters of the roadway at several locations on either side of the freeway between the Temecula Creek Bridge and the Border Patrol Check Station just north of the County Line, and on conserved lands (TNC's Rainbow Property) abutting the freeway on the east side (Table 8, Map 19, Appendix F). Pictures 2 and 3 below are example pictures from the cameras.

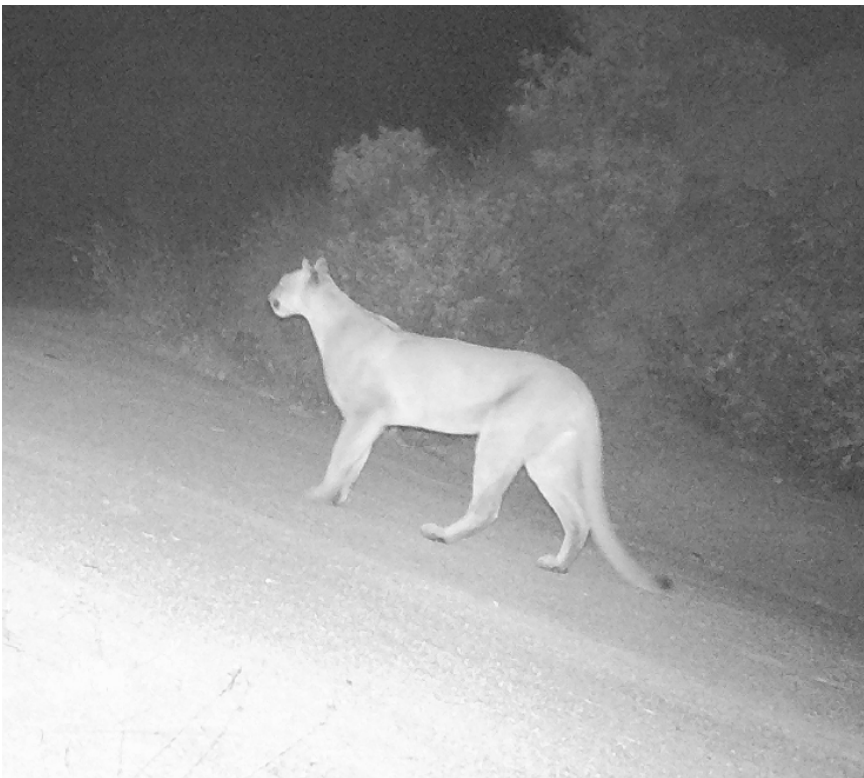
Picture 3. Mountain lion on the TNC Rainbow Property adjacent to the east side of I-15

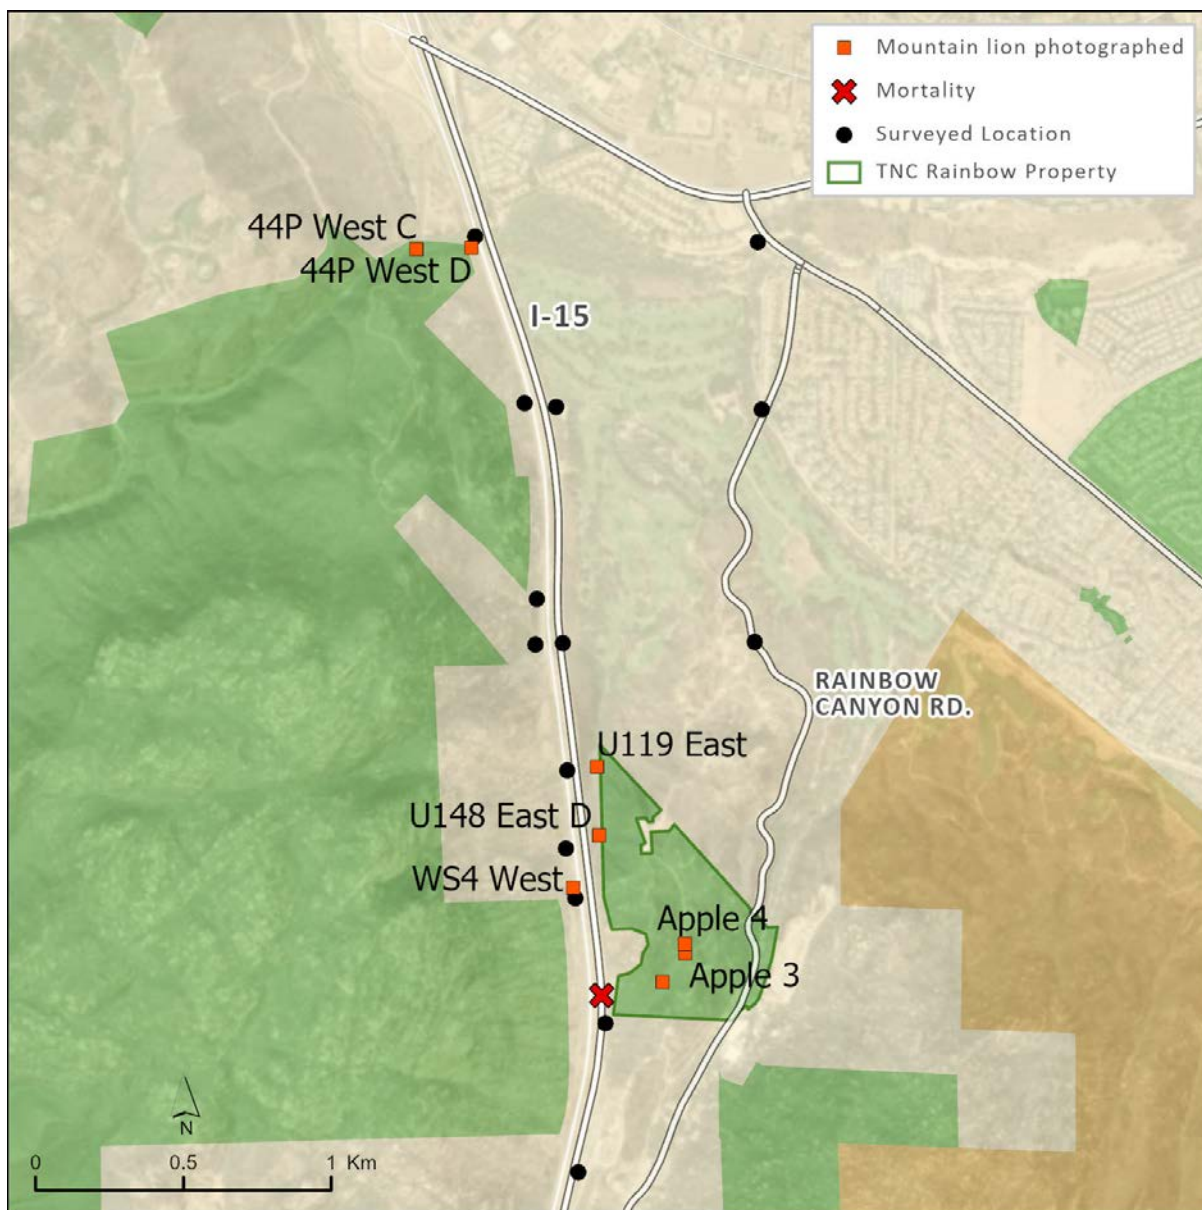
Map 19 – Locations where mountain lions were photographed along I-15 between December 2018 and March 2020, and location of the December 2018 mountain lion mortality (M233). The TNC Rainbow Property that was purchased in order to have conserved land on both sides of I-15 at a viable location for a potential new crossing structure is outlined in green on the east side of the freeway. Several of the mountain lion photos have been taken on that property.

In addition, a young male mountain lion was killed by a car in late December 2018 during the study period very near several of the potential crossing points and locations where cameras had recorded mountain lions earlier in the same month (Table 8, Map 19). That individual was designated M233 for study purposes and has had DNA sampling done to determine whether his genetic origin was from the population east or west of I-15. That information will be known late in 2020.

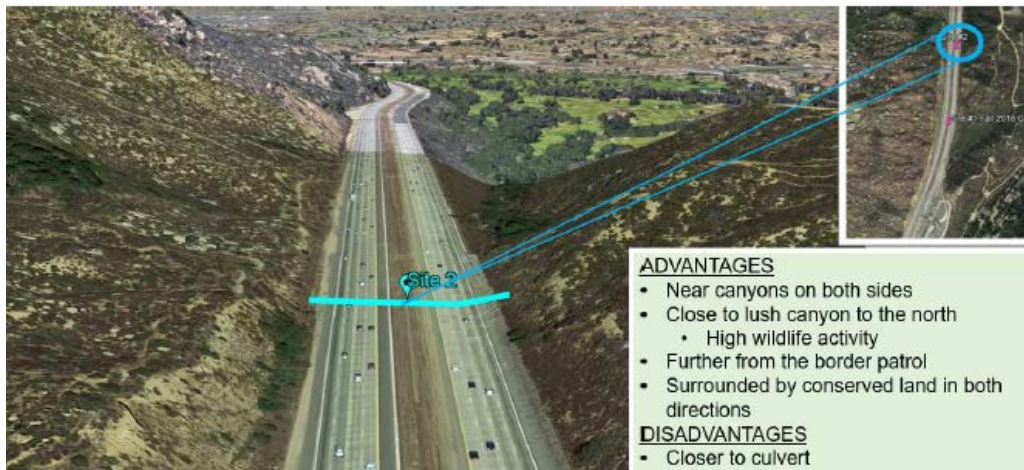
Figure 7. Site projected by the CPP team to be the best site for a new wildlife overcrossing. View is looking north – the Temecula Creek Golf Course is visible on the right side of the Freeway upper portion of the Figure (east side of the Freeway)

The CPP teams found that new crossing structures (a large culvert or a wildlife bridge) were technically feasible for construction just north of the Border Patrol check station near the Riverside-San Diego County Line (Figures 7 – 10). The most feasible locations for construction of either an overcrossing or undercrossing structure are at or very near the WS3, WS4, WS5-Center, and U148 sites. These location choices are also supported by the GPS and photo evidence of mountain lion activity in that area. (Appendix G; Table 8; Map 18) and light measurements (Map 19). Additionally, specific modifications of Temecula Creek and the Temecula Creek Bridge, including sound dampening measures that were indicated by Dr. Collins's work (Figure 11; Table 7) were proposed by the CPP teams to improve function of that passageway. Detailed descriptions of the CPP Team's proposed new structures and bridge modifications, as well as preliminary cost estimates, are included in the full CPP technical report that is incorporated here as Appendix G.

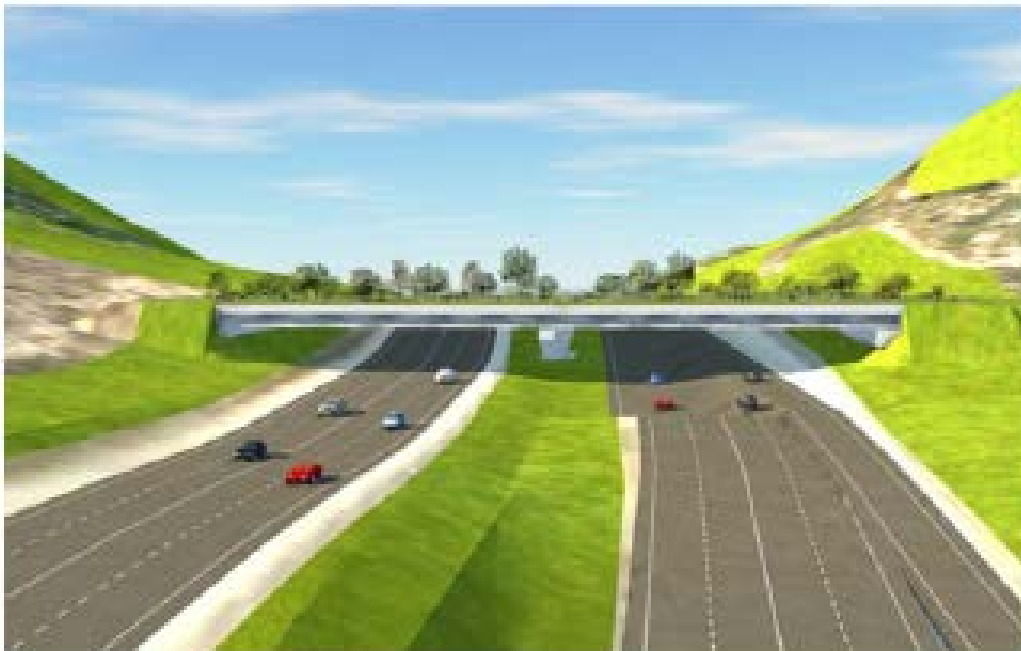
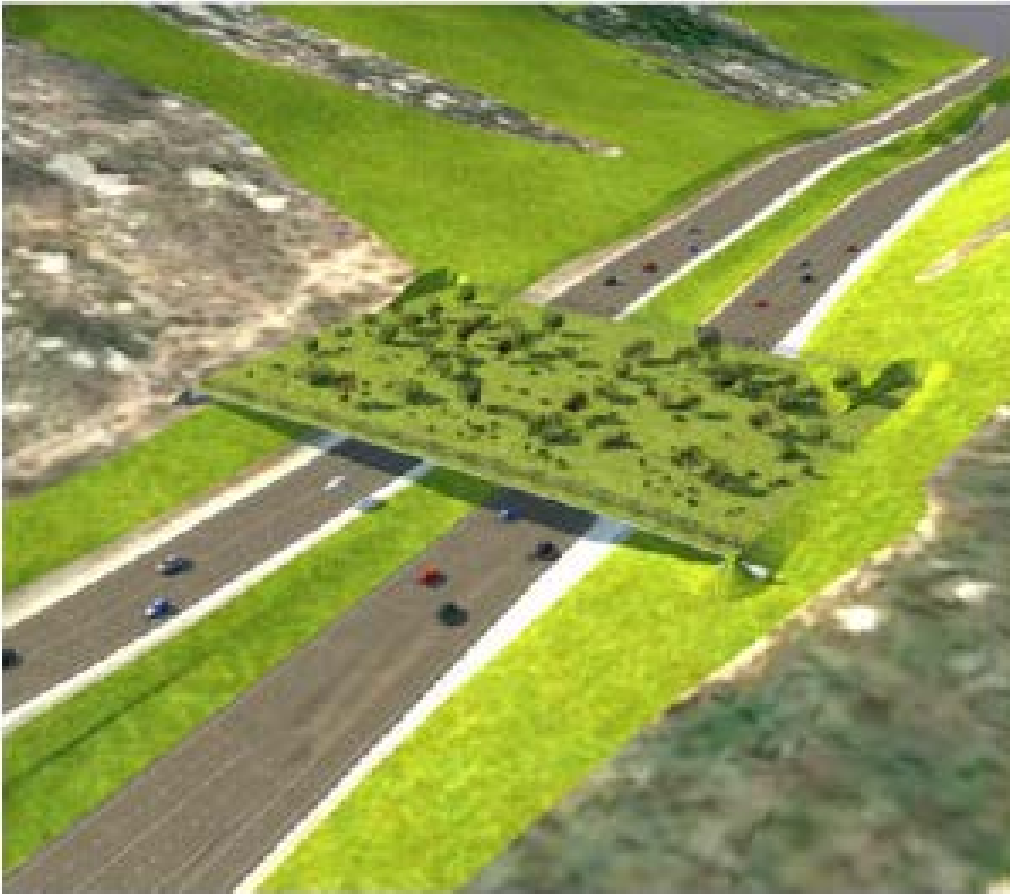
Figures 8 and 9. Preferred designs for an overcrossing structure

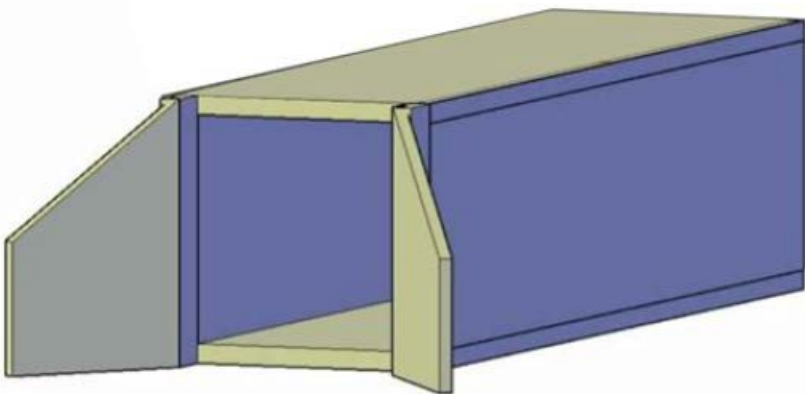
Figure 10 – Preferred alternative for a new undercrossing structure type – a 12x12 ft concrete box structure to be installed just to the north of the proposed site of an overcrossing.

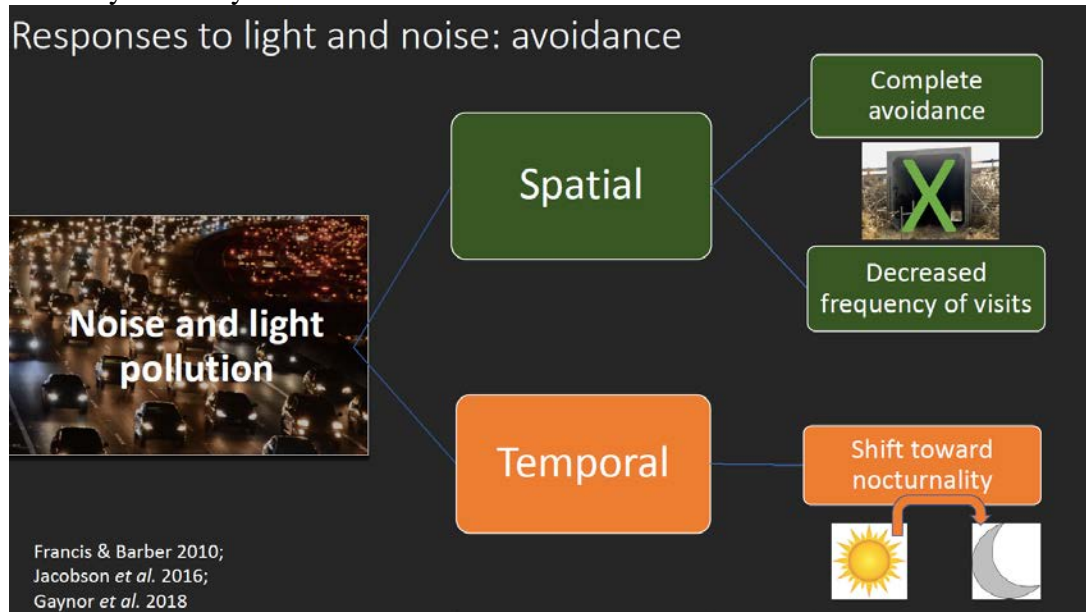
Figure 11. Impacts of sound and light on wildlife.

Light and noise have been recognized for many years as contributors to the negative effects of highways on wildlife (Figure 11).

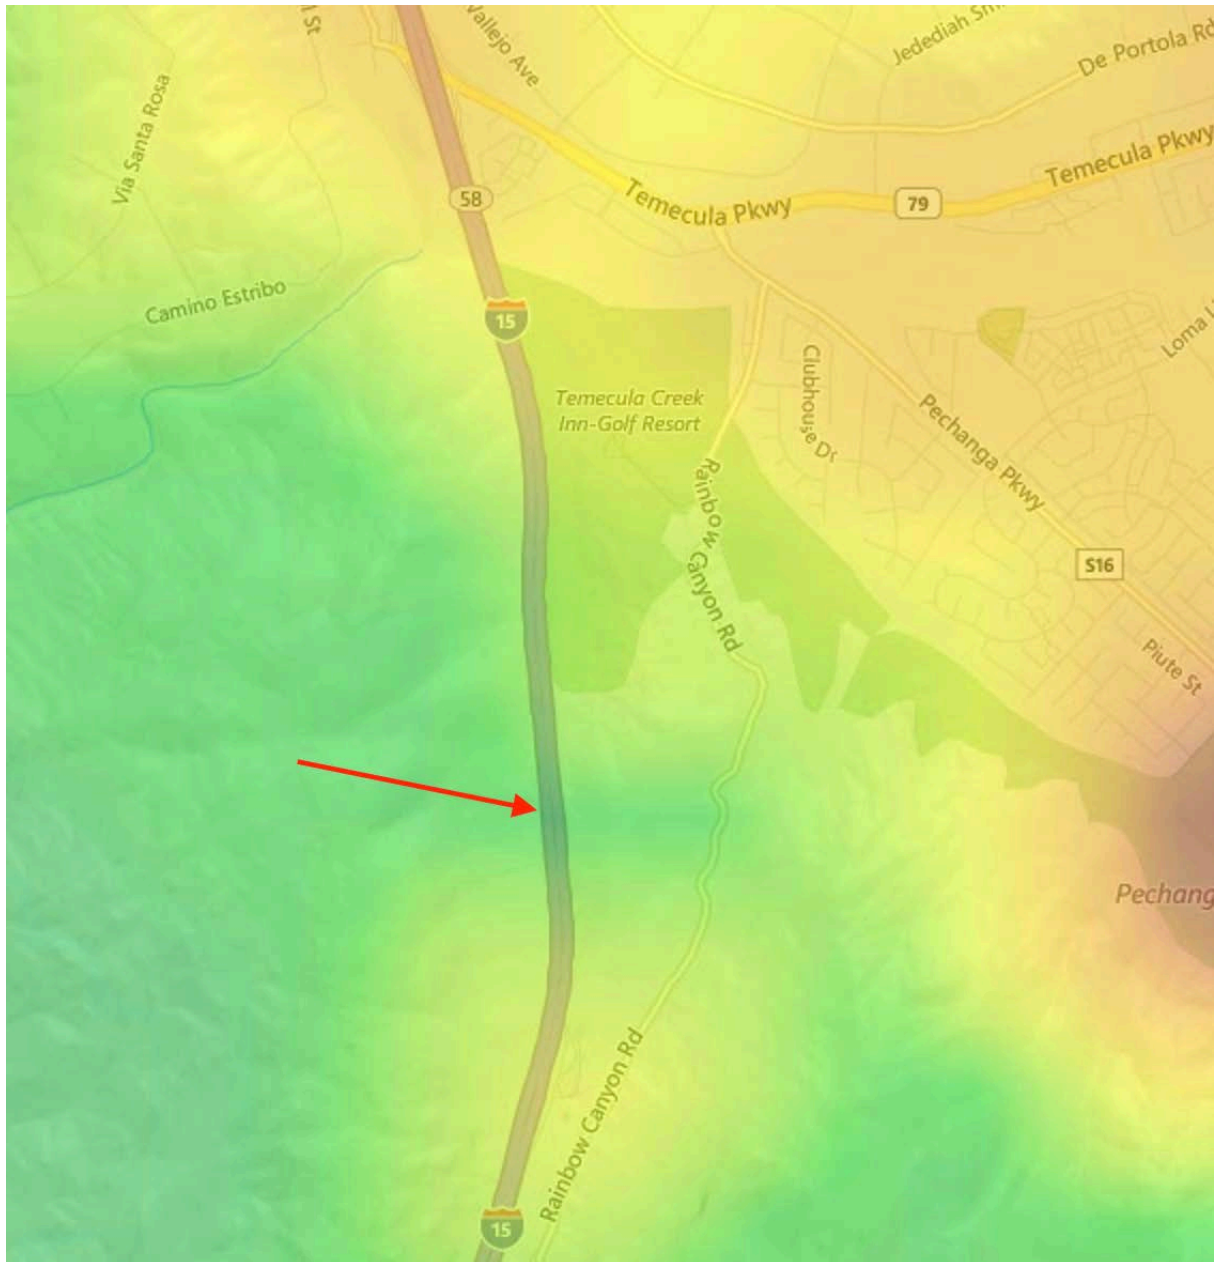
Map 19 – Measurement of light along I-15 in the study area from space. Areas with the most light are the most yellow to white, and areas with less light are more green to blue. The red arrow indicates the area of lowest light along that section of freeway as seen from space. This location corresponds to the area of I-15 where new crossing structures have been proposed in the CPP report (Appendix G), as well as the portion of the highway where mountain lion activity has been confirmed by trail cameras near the highway on both sides.

Preliminary measurements of light have been done along I-15 at some of the crossing sites we have evaluated, but additional measurements are ongoing and analyses will be completed and reported later in 2020 and 2021. Map 19 illustrates one tool for measuring light remotely and inferring potential impacts, though light level measurements at ground level are also necessary to properly evaluate the levels of light that the animal is perceiving.
