Los Peñasquitos Management

FINAL REPORT

TRANSNET ENVIRONMENTAL MITIGATION PROGRAM FY 2013

PREPARED BY:
LOS PEÑASQUITOS LAGOON FOUNDATION

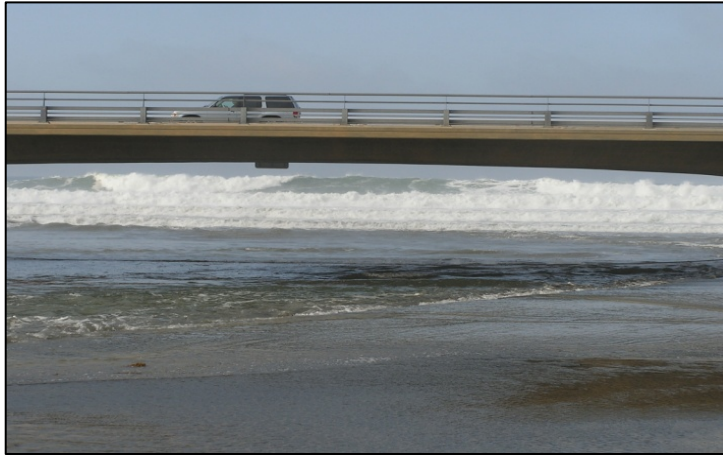
Figure 4. Large Winter Waves (~ 20 feet) off Torrey Pines State Beach. Photo by Mike Hastings.

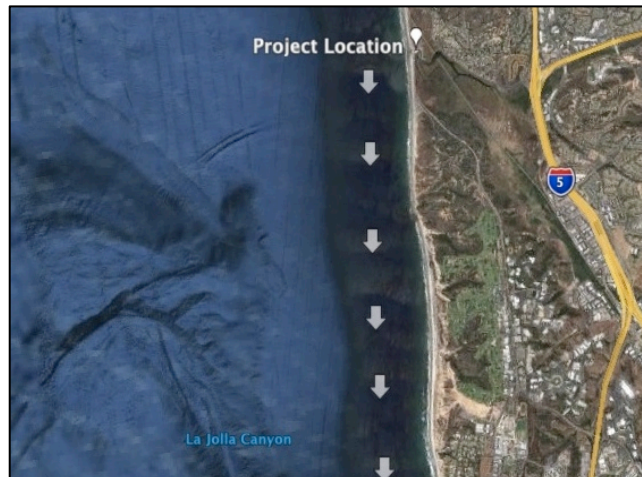
Figure 5. Predominant Current and Sediment Movement along Torrey Pines State Beach.
Google Earth 2010.

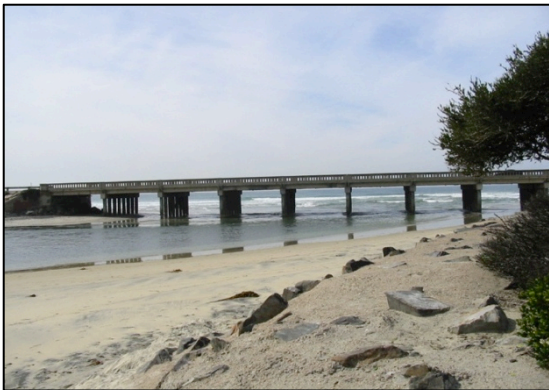
Since 1983, LPLF has been adaptively managing the inlet at LPL. From 1983 to 2005, efforts focused on mechanical excavation under the lower bridge that has spanned the lagoon mouth since 1932. This was due in most part to the original lower bridge having 74 support columns that trapped most of the cobbles and sand under the bridge span (Figure 9). As sand and cobble piled up under the bridge, a

Figure 9. Original Highway 101 Lower Bridge. Photo by Mike Hastings.

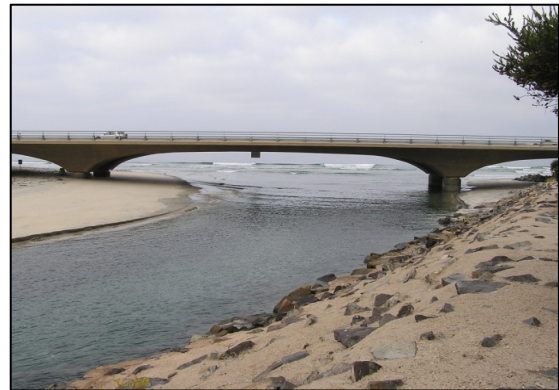
berm often developed that blocked the ocean from the lagoon. Lagoon inlet closures during the period were a frequent occurrence, often occurring two to three times a year or spanning an entire year. The lower bridge was replaced by the City of San Diego in 2005 with construction completed in 2007. The new bridge was designed to have a slightly wider span and only four support columns to reduce the frequency and volume of sediment deposition under the bridge (Figure 10). While this design has been successful in reducing the frequency of extended inlet closures, it has, at times, resulted in a higher rate of marine sediment deposition east of the bridge. Storm surges and waves can now carry sediment past the bridge and into the lagoon as sediment transport rates are not decreased by hardened structures (i.e. 74 cement support columns). Though the Lagoon inlet tends to remain open for longer periods of time, the tidal prism can still be reduced as sand and cobbles occlude and sometimes block the main channels from the ocean and tidal mixing.

Figure 10. New Highway 101 Lower Bridge. Photo by Mike Hastings.

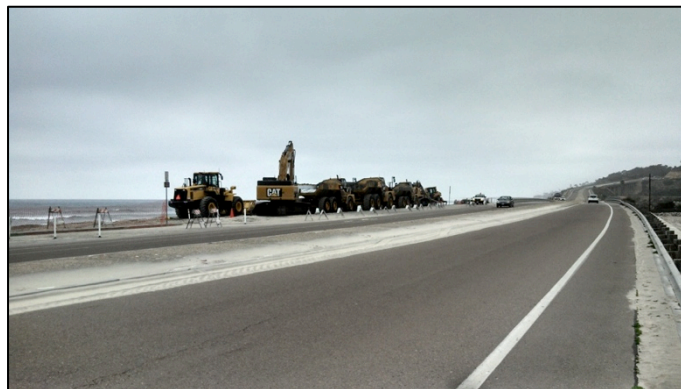
Figure 14. Equipment Staging Area Project Area, viewing north along N. Torrey Pines Road. Photo by Mike Hastings.

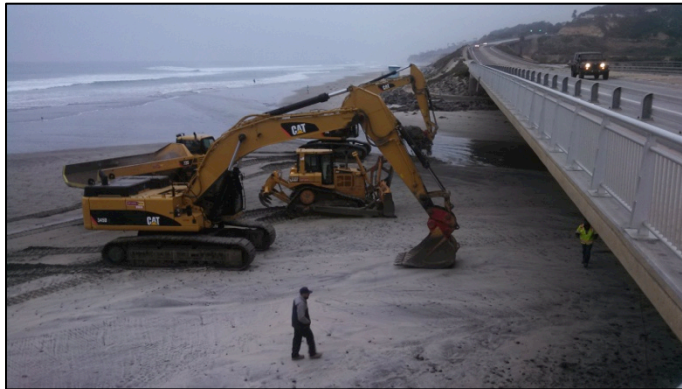
Figure 16. Equipment getting ready to enter LPL under the lower bridge along N. Torrey Pines Road. Photo by Mike Hastings.

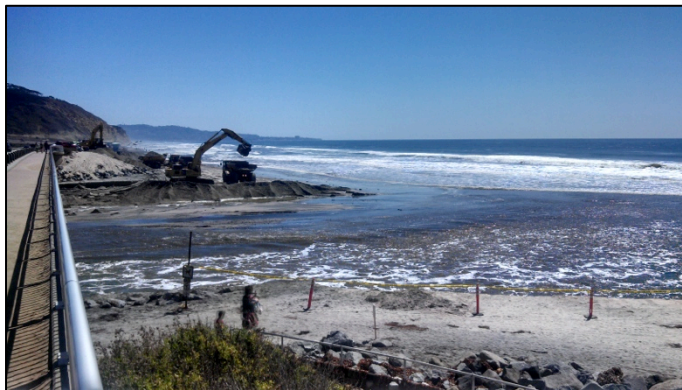
Figure 17 Excavating the channel between Transect A1 and Transect A2. Photo by Mike Hastings.

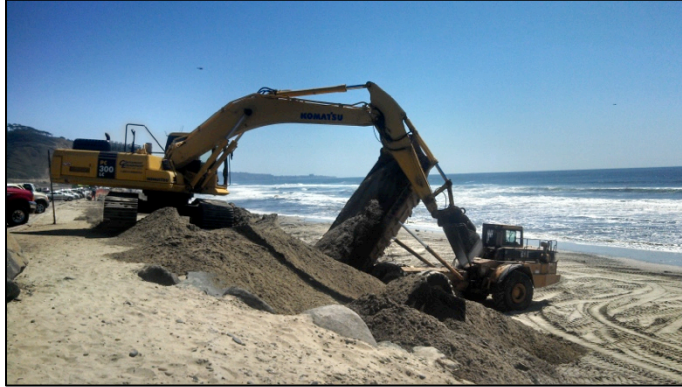
Figure 18. Dumping excavated sand along the eroded bluff used for the heavy equipment staging area. Photo by Mike Hastings.

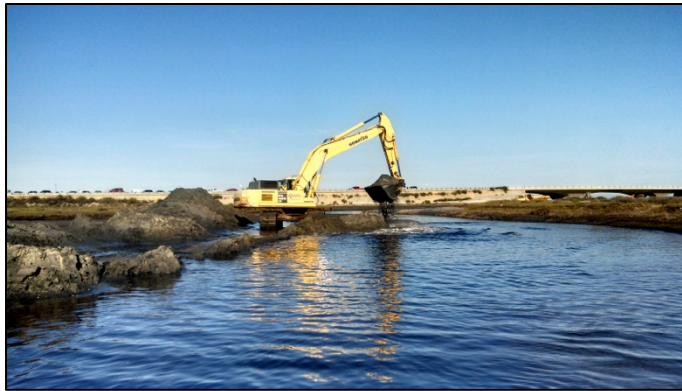
Figure 19. Excavating near the deep-water mark just west of Transect E2. Photo by Mike Hastings.

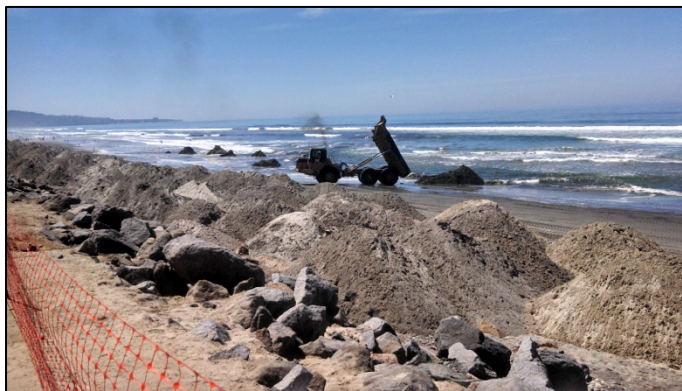
Figure 20. Placing excavated spoils along the waterline on Torrey Pines State Beach. In the foreground are sediment piles placed in front of the eroded bluff along N. Torrey Pines Road. Photo by Mike Hastings.

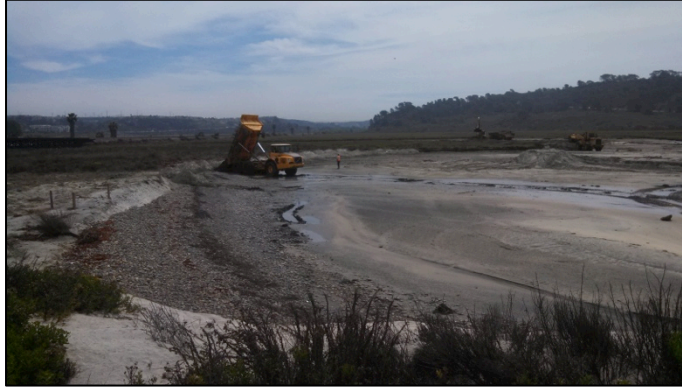
Figure 21. Placing excavated spoils along the eroded embankment to restore the remnant dune area eroded over the previous years. Photo by Mike Hastings.

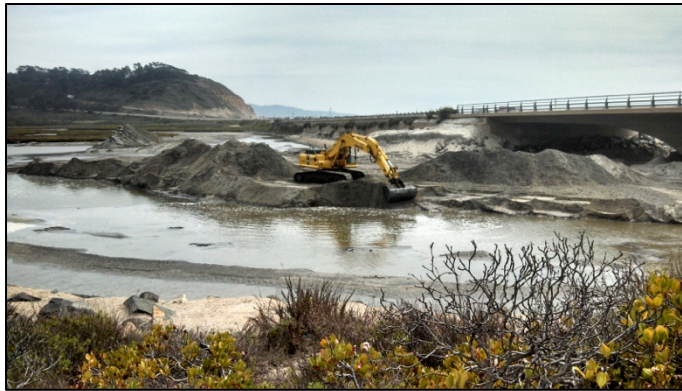
Figure 22. Excavating near Transect A3 to widen and deepen the main channel. Photo by Mike Hastings.

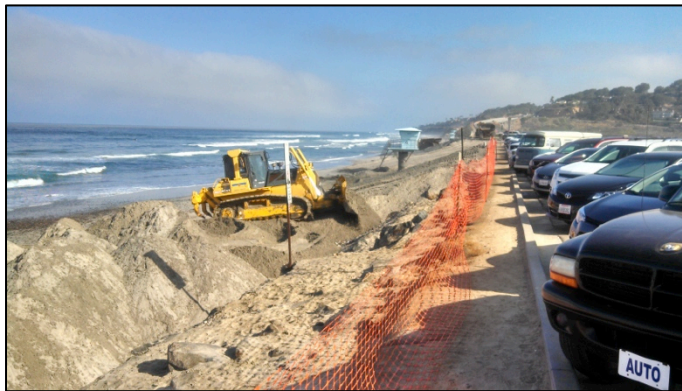
Figure 23. Re-contouring sand piles placed along the eroded bluff adjacent to N. Torrey Pines Road. Photo by Mike Hastings.

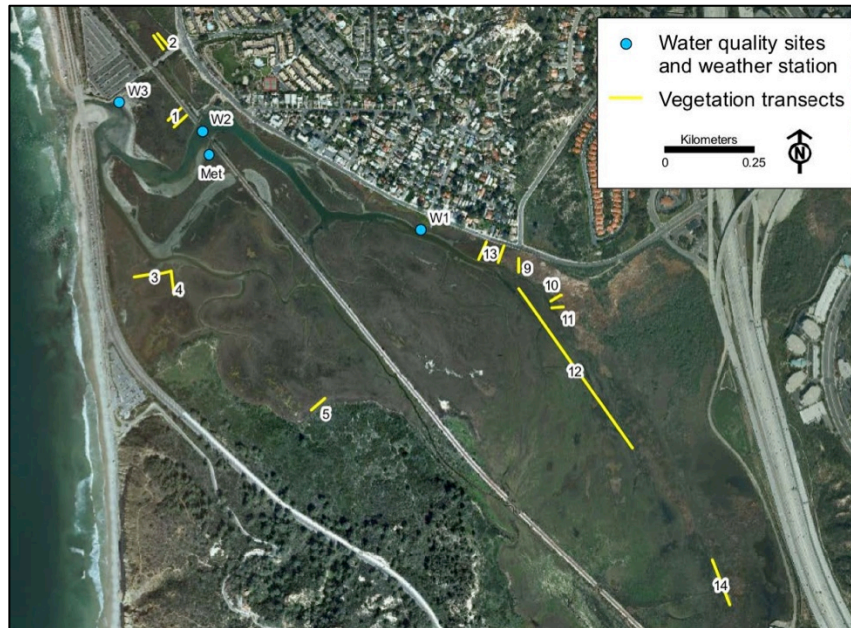
Figure 25. Water quality monitoring stations (W1-W3) and vegetation transects at Los Peñasquitos Lagoon. Southwest Wetlands Interpretive Association.

Figure 25 provides the locations of water quality monitoring stations and vegetation transects located within LPL. Water quality data indicated decreasing dissolved oxygen (DO) levels within the Lagoon during the extended closure that lasted from March 11th to April 7th. DO levels quickly dropped below 5 mg/l on March 11th (See Figure 26), indicating stressful conditions for aquatic species and triggering the project's special biological conditions set by its Coastal Development Permit (6-07-021-A1) that allow for mechanical excavation of the inlet. DO eventually hit 0 mg/l around March 18th before it temporarily rebounded most likely due to over wash from wave activity during a spring high tide event. However, DO continued to degrade until it reached and stayed at 0 mg/l until the inlet was breached on April 7th. Once tidal circulation was restored within Lagoon channels, water quality parameters quickly improved (See Figure 27).

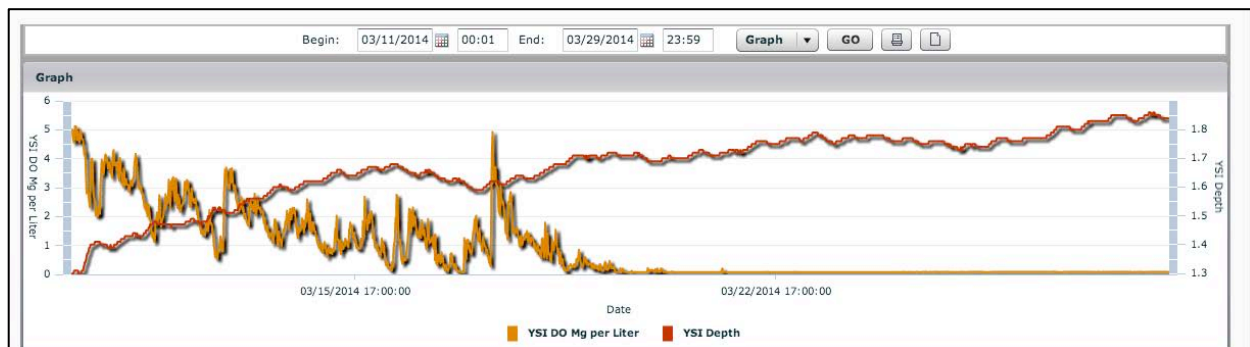
Figure 26. Water Quality Data: dissolved oxygen (yellow) and depth (red) prior to the 1st inlet opening on April 7th. Note how water levels rise in conjunction with declining dissolved oxygen. Data taken from monitoring station W2, shown in Figure 25.

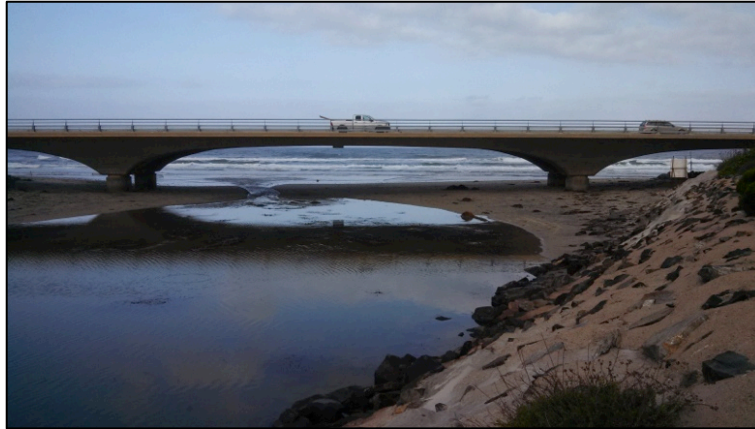
Figure 28. View of occluded inlet at Los Peñasquitos Lagoon with impounded water east of the lower bridge on May 7th.
 Photo by Mike Hastings.

The mouth at LPL closed again on May 8th due to shoaling of sand within the entrance of the inlet area (See Figure 28). DO quickly dropped below 5 mg/l, rebounding periodically due most likely to oxygen-rich ocean waters overtopping the berm during periods of high tide (See Figure 29). Healthy water quality parameters then improved after adequate tidal circulation had been restored within Lagoon channels (See Figure 30).

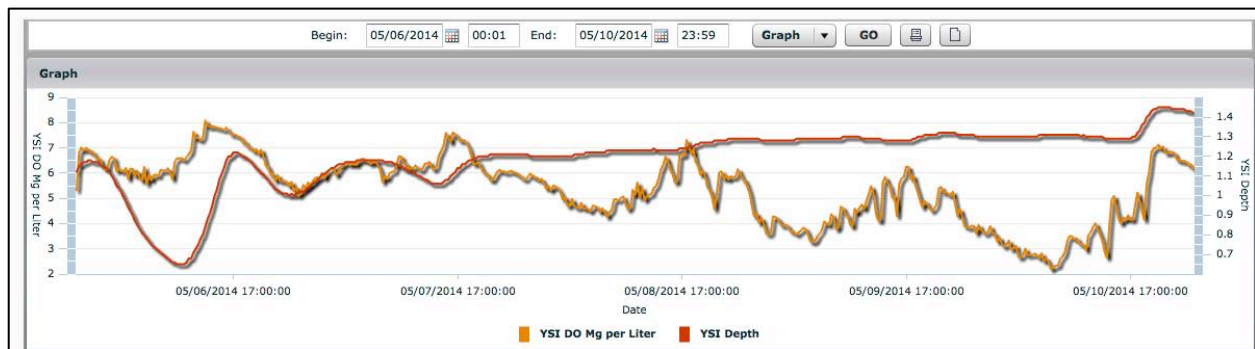
Figure 29. Water Quality Data: dissolved oxygen (yellow) and depth (red) after the closure on 5/8/14. Note the rising water levels due to perennial dry weather inputs of freshwater from the Lagoon's tributaries in conjunction with declining dissolved oxygen due to the lack of tidal mixing from ocean waters. Data taken from monitoring station W2, shown in Figure 25.

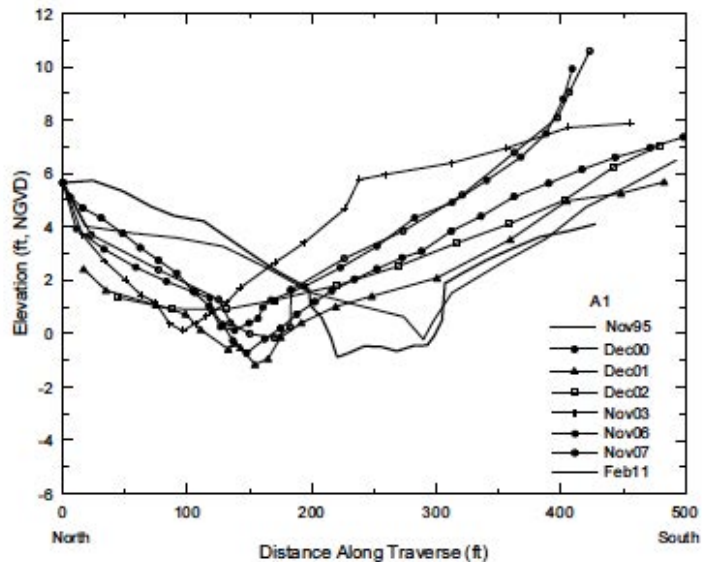
Figure 36. Changes in channel morphology at the ocean inlet along Transect A1. Coastal Environments.

Surveys of channel bathymetry and inlet elevation profiles were conducted in May, after inlet excavation had been completed. Surveys were conducted along transects that were established in 1995 and monitored annually thereafter (See Figure 35). Results of the surveys indicate that channel configuration becomes relatively stable as you move east, away from the ocean inlet (Figure 36 and Figure 37). This demonstrates the dominance of the ocean processes (e.g. tides, storm surges) over lagoon outflows with regard to channel morphology west of the railway berm. Several lines of evidences indication the muting effects that the railway berm has on the effectiveness of large storm events in scouring lagoon channels through to the inlet from storm runoff discharged from the three lagoon tributaries and deposition of watershed sediments west of the railway.

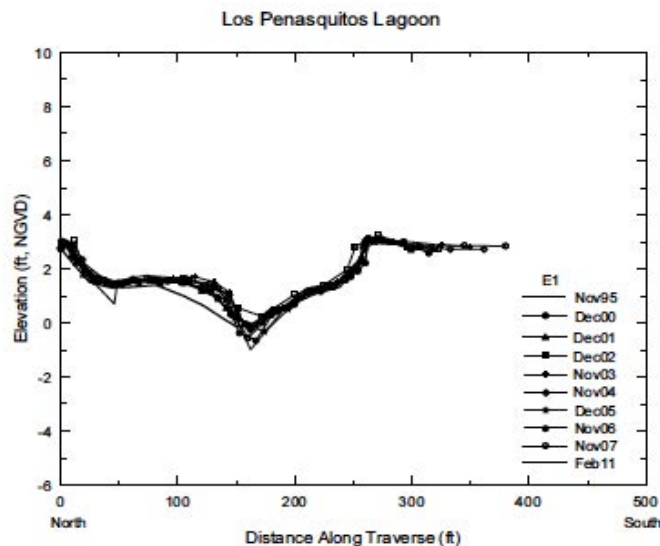
Figure 37. Changes in channel morphology at the ocean inlet along Transect E1. Coastal Environments.

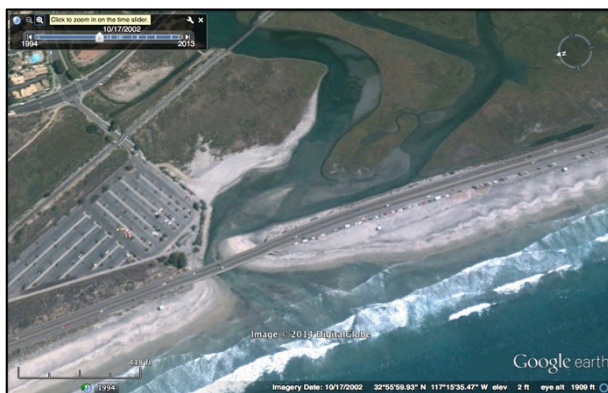
Figure 44. Inlet at Los Peñasquitos Lagoon in 2002. Note the remnant dune system to the east of the main channel. Google Earth.

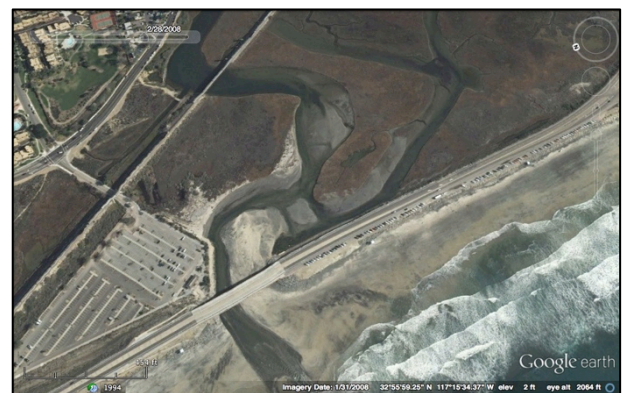
Figure 45. Inlet at Los Peñasquitos Lagoon in 2008. Note the loss of the remnant dune system as the main channel shifts to the northeast. Google Earth.

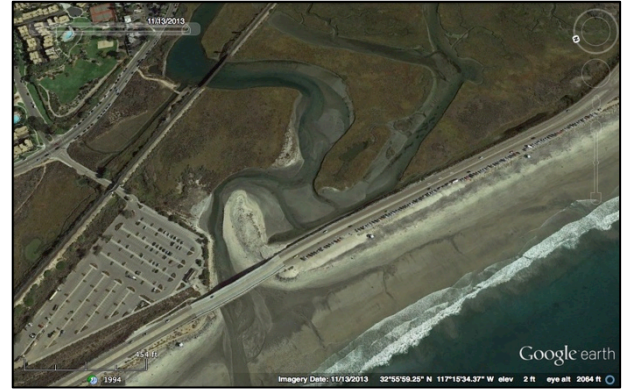
Figure 47. Inlet at Los Peñasquitos Lagoon in 2013. Note the almost complete loss of the remnant dune system as the main channel shifts to the northeast. Google Earth.

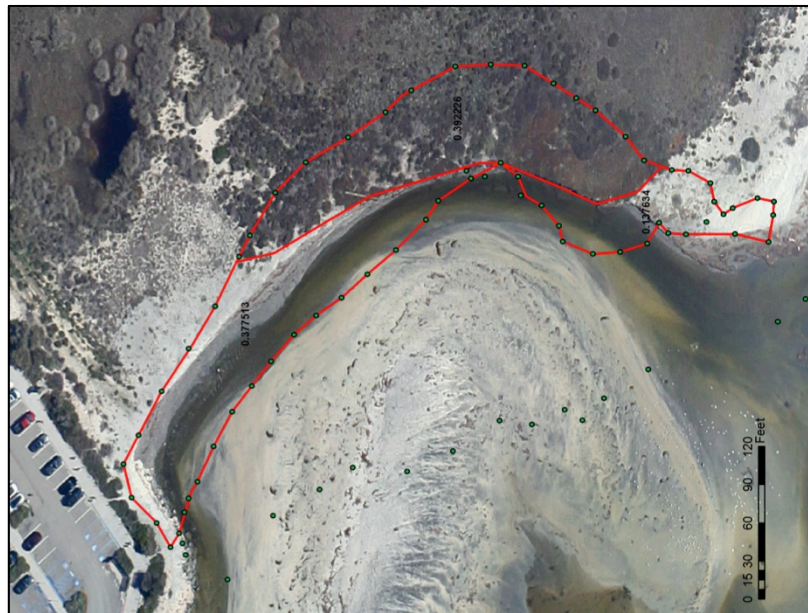
Figure 48. Delineation of the newly created 0.91 acres dune and beach area at the inlet of Los Peñasquitos Lagoon. The cell at the top of the photo delineates an area of vegetation that is no longer there due to undercutting and scour. No sand was placed on vegetated areas within the Lagoon inlet area.

Project benefits also include the creation of just less than 1 acre (i.e. 0.91 acres) of remnant dune that had been lost to erosion over the previous decade due to lagoon outflows and increased inflows of storm surge and bores from the ocean due to the new lower bridge that spans the inlet. Completed in 2006, the new bridge provides a less obstructive span over the inlet, replacing the seventy-four columns used to support the old bridge with just four. As result, waves, bores and storm surges can enter the Lagoon inlet area relatively unobstructed due the lack of energy dissipation caused by the new bridge. Figure 44 to Figure 47 show the gradual loss of the remnant dune system adjacent to the north parking lot and east of the main tidal channel.

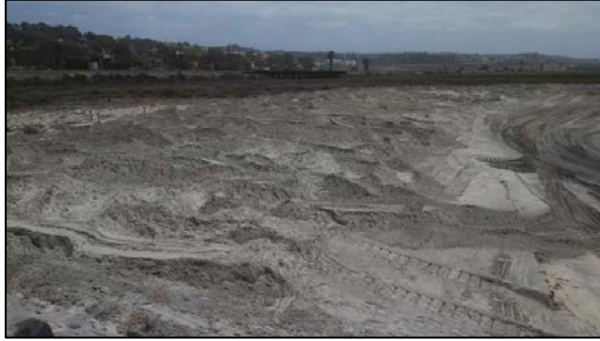
Figure 49. Viewing the restored dune area from the north parking lot (looking east). Photo by Mike Hastings.

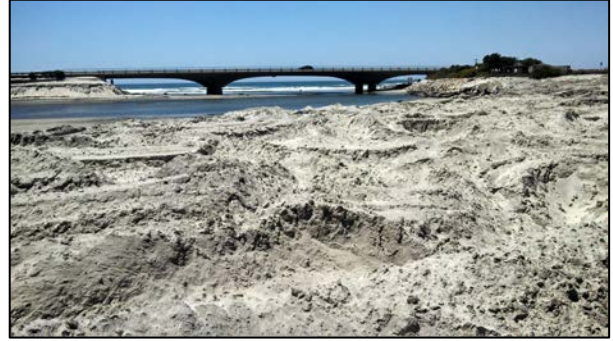
Figure 50. Viewing the lagoon inlet from the restored dune area (looking west). Photo by Mike Hastings.

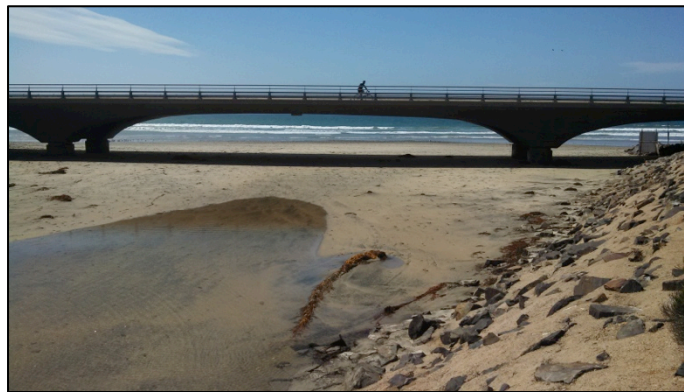
Figure 51. View of the closed inlet at Los Peñasquitos Lagoon on 3/12/14. Photo by Mike Hastings.

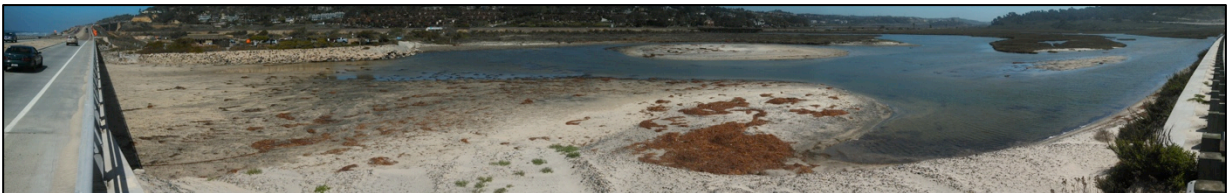
Figure 52. Panoramic view of the closed inlet at Los Peñasquitos Lagoon on 3/12/14. Photo by Mike Hastings.

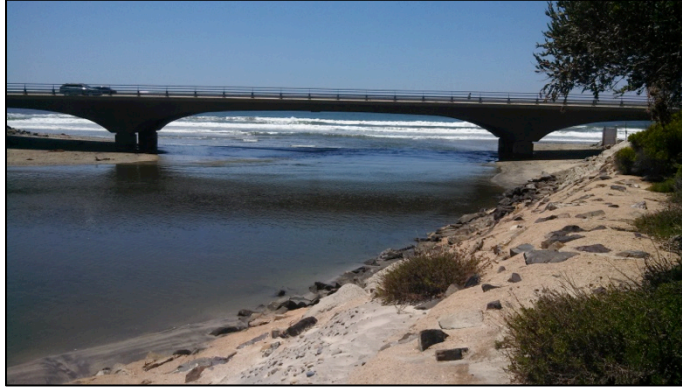
Figure 53. View of the open inlet at Los Peñasquitos Lagoon on 4/29/14 after tidal circulation was restored during Phase 2. Photo by Mike Hastings.

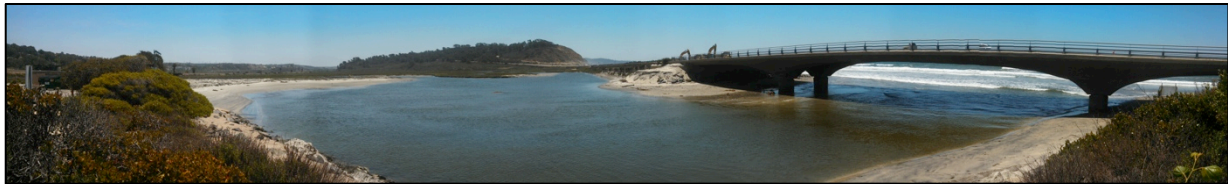
Figure 54. Panoramic view of the open inlet at Los Peñasquitos Lagoon on 4/29/14 after tidal circulation was restored during Phase 2. Photo by Mike Hastings.

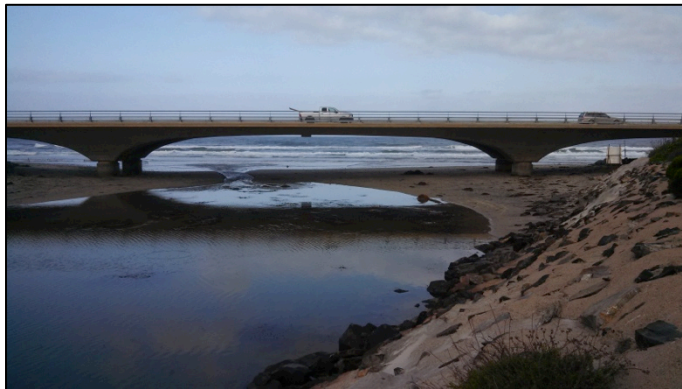
Figure 55. View of occluded inlet at Los Peñasquitos Lagoon on 5/7/14, prior to its closure on 5/8/14. Photo by Mike Hastings.

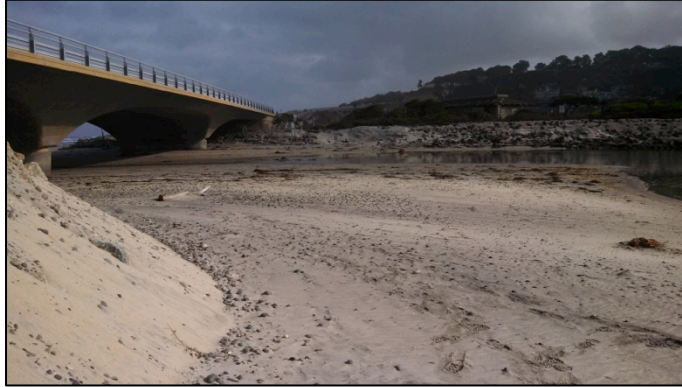
Figure 56. Side view of occluded inlet at Los Peñasquitos Lagoon on 5/7/14, prior to its closure on 5/8/14. Photo by Mike Hastings.

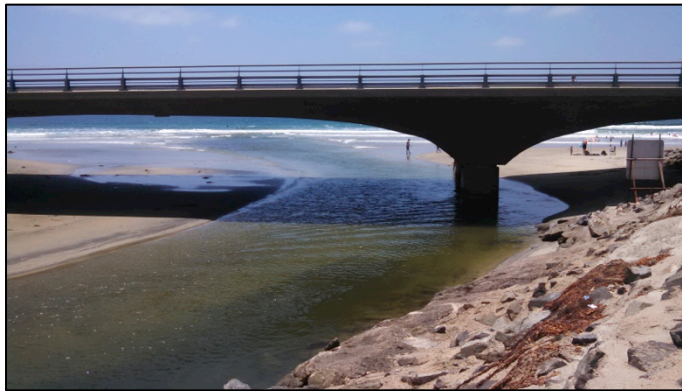
Figure 57. View of the open inlet at Los Peñasquitos Lagoon on 6/24/14 after tidal circulation was restored during Phase 3. Photo by Mike Hastings.

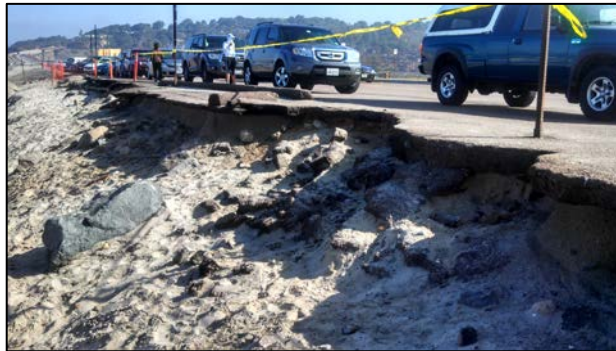
Figure 59. Evidence of coastal erosion and undercutting of N. Torrey Pines Road. Photo by Mike Hastings.

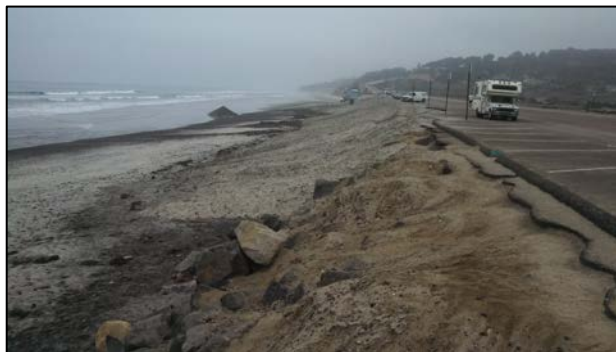
Figure 60. Soft-armoring of N. Torrey Pines Road and improved public access/safety using sand removed from the inlet at Los Peñasquitos Lagoon. Photo by Mike Hastings.

- Re-contouring of sand placed along the upper beach to mimic the profile of a coastal dune extending from the lower beach to the bluffs to increase the total area of available beach for public use and improved access from N. Torrey Pines Road.
- Creation of potential spawning habitat for grunion caused by sand placement along portions of the lower beach that had been predominately cobblestones.
- Improved beach safety along Torrey Pines State Beach through the creation of a beach access ramp for emergency vehicles traveling on N. Torrey Pines Road.
