Draft Final: Associations Between Arroyo Toads, Nonnative Species, Drought, and Impervious Surfaces in San Diego County

Data Summary

By: Chris Brown¹, Emily Perkins¹, Cynthia Hitchcock², Angelica Aguilar Duran¹, Lizzie Grolle¹, Elise Watson¹, and Robert N. Fisher¹

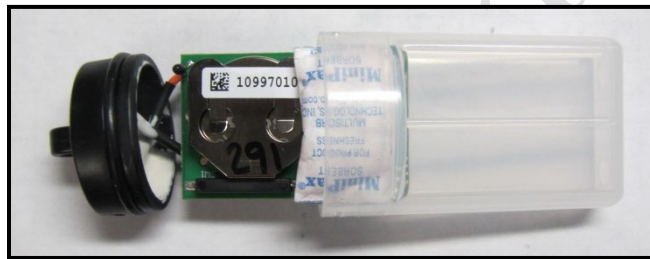
16. Apply a thin layer of silicon grease to the rubber O-ring on the cap. Firmly press the cap into the plastic housing and replace the two set screws. The data logger has now been transformed into a STIC.
