Reference: Final Report for the Rice Canyon Sensitive Plant Species Management Project (SANDAG Grant Number 5005508; RECON Number 9429)

Executive Summary

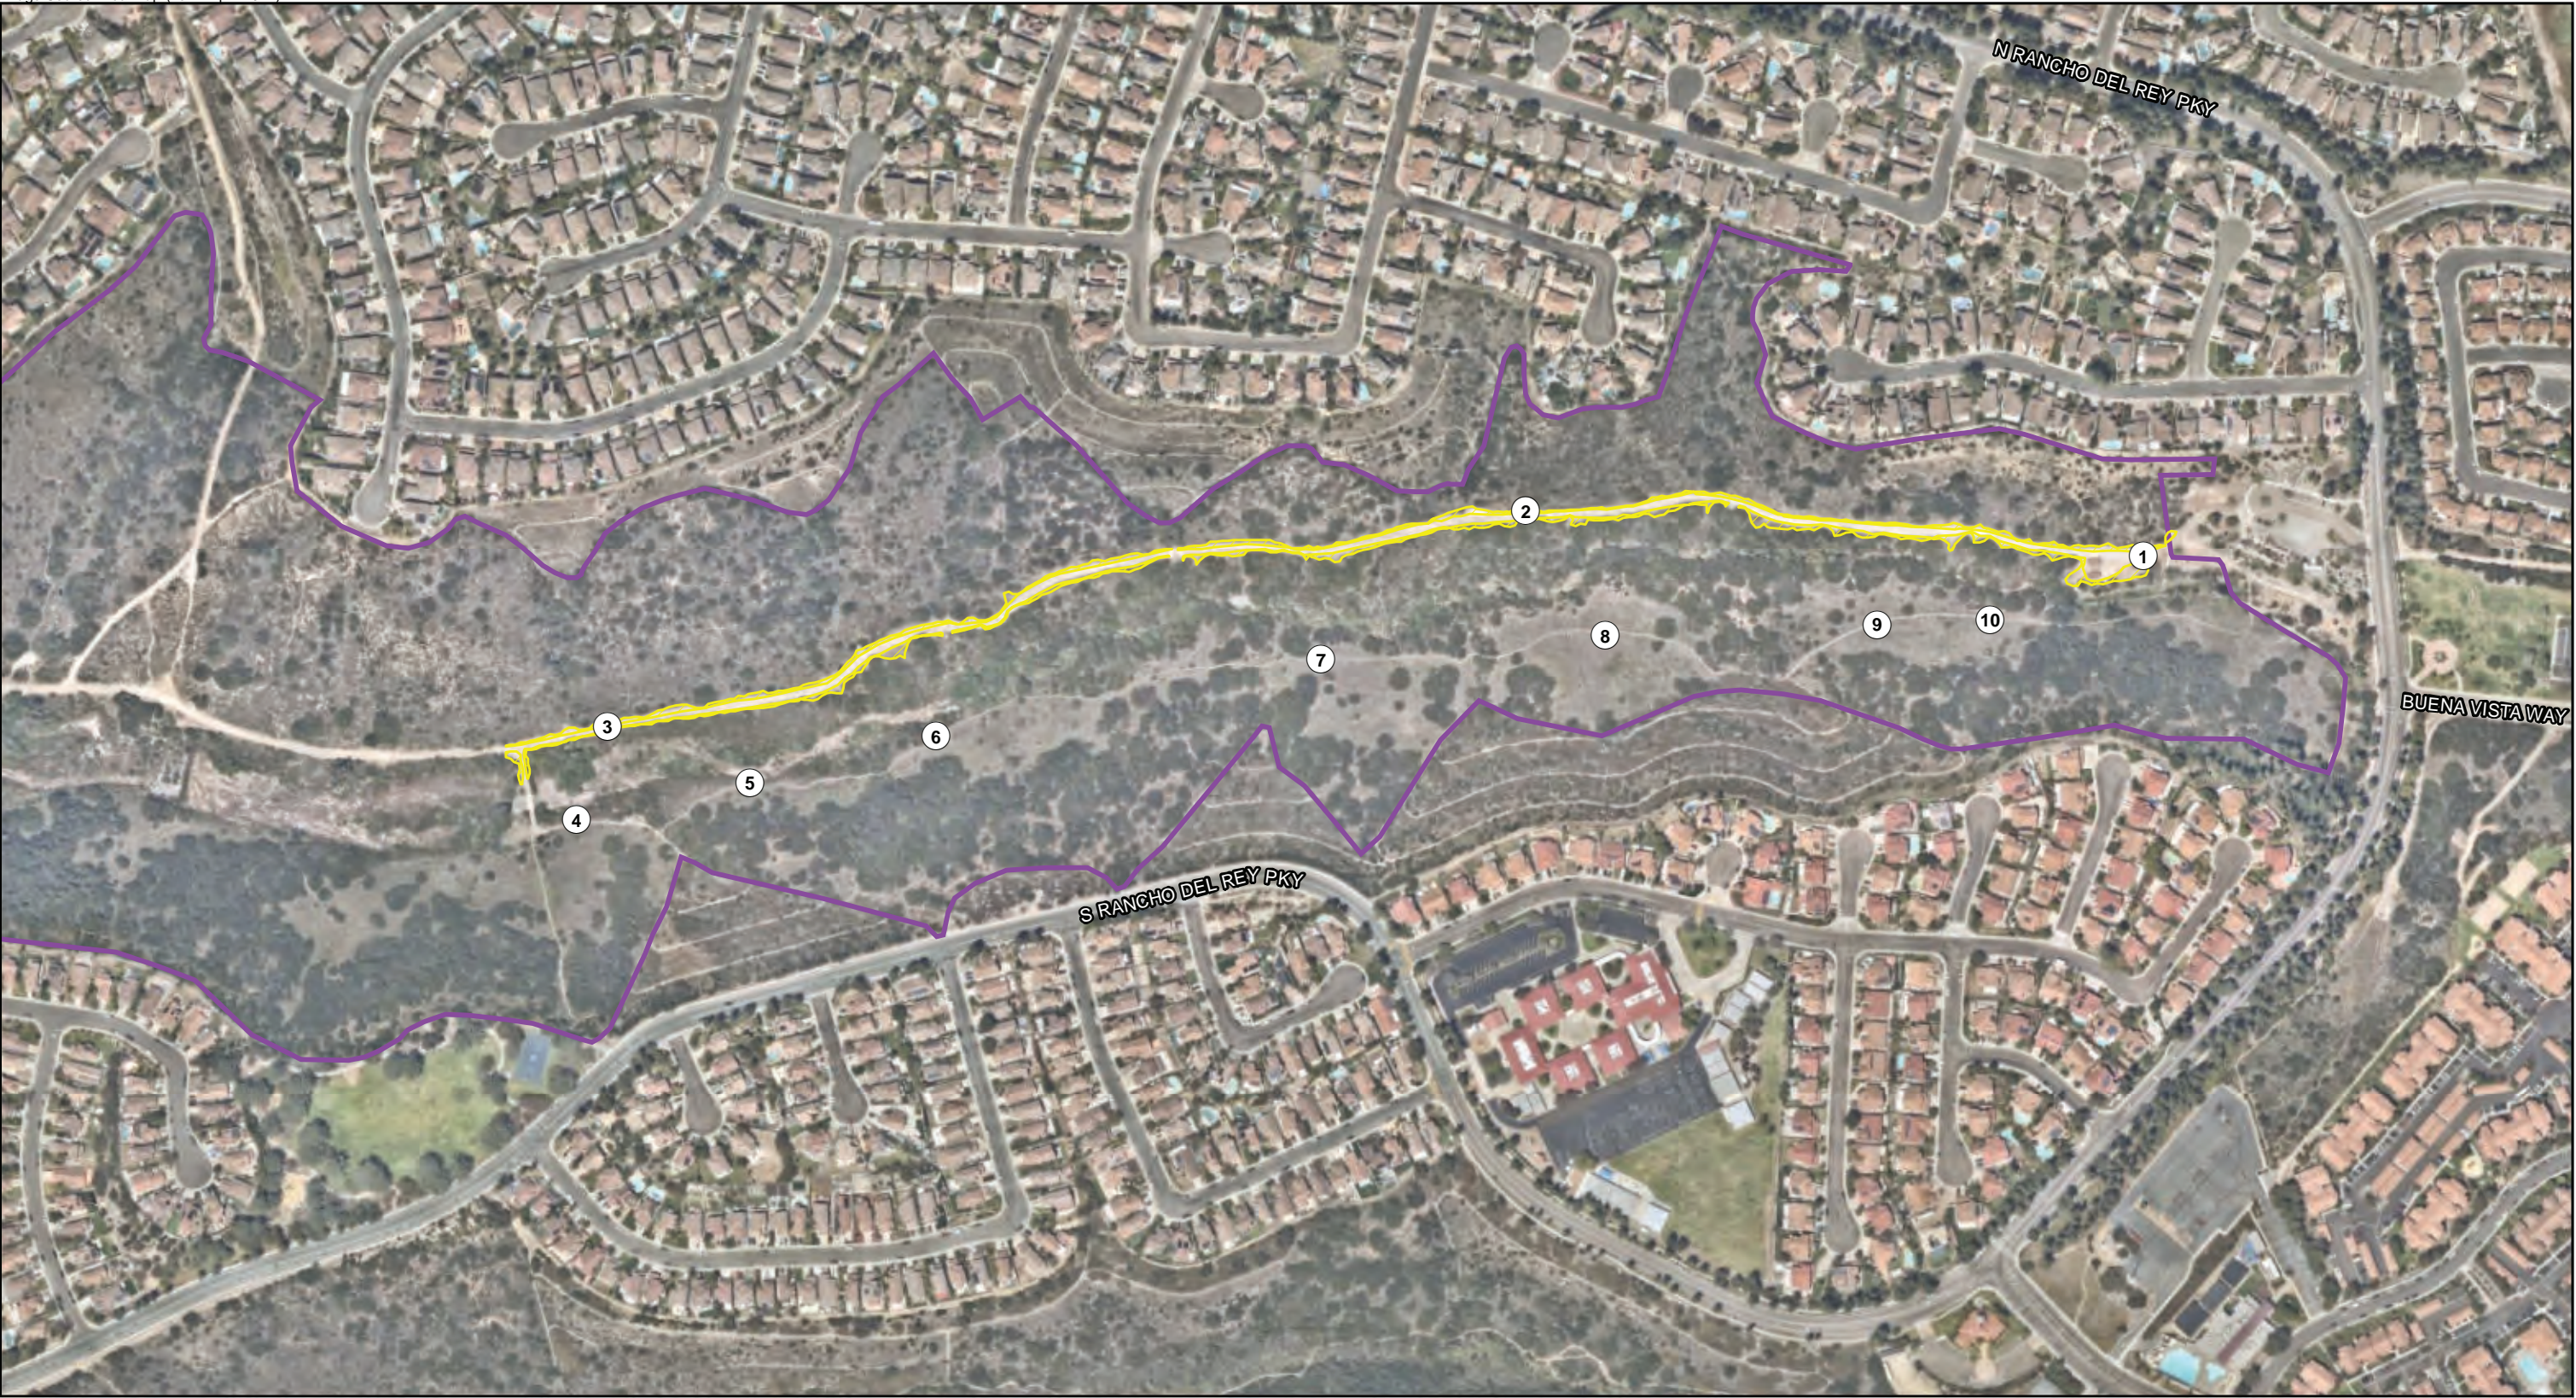
FIGURE 4
Photo Point Locations

- PMA Subunit 1-2b
- Stinknet Treatment Area
- Photo Point

Pre-implementation photo monitoring was conducted on November 6, 2020, when ten photo points were established at the known previous locations of stinknet along the Rice Canyon access road and along the trail where fencing would be installed. Repeat photo point photos were taken on June 5, 2021. The repeat photos taken along the access road show very little change from November 2020 to June 2021 because the 2020 stinknet had mostly been removed by the City's landscape crew. The little change in the repeat photographs along the access road are also due to the fact that by the time the photos were repeated in June 2021, all of the stinknet had been successfully treated and therefore was not visible. Photo monitoring points are shown on Figure 4. Repeat photo points are presented in Attachment 2.

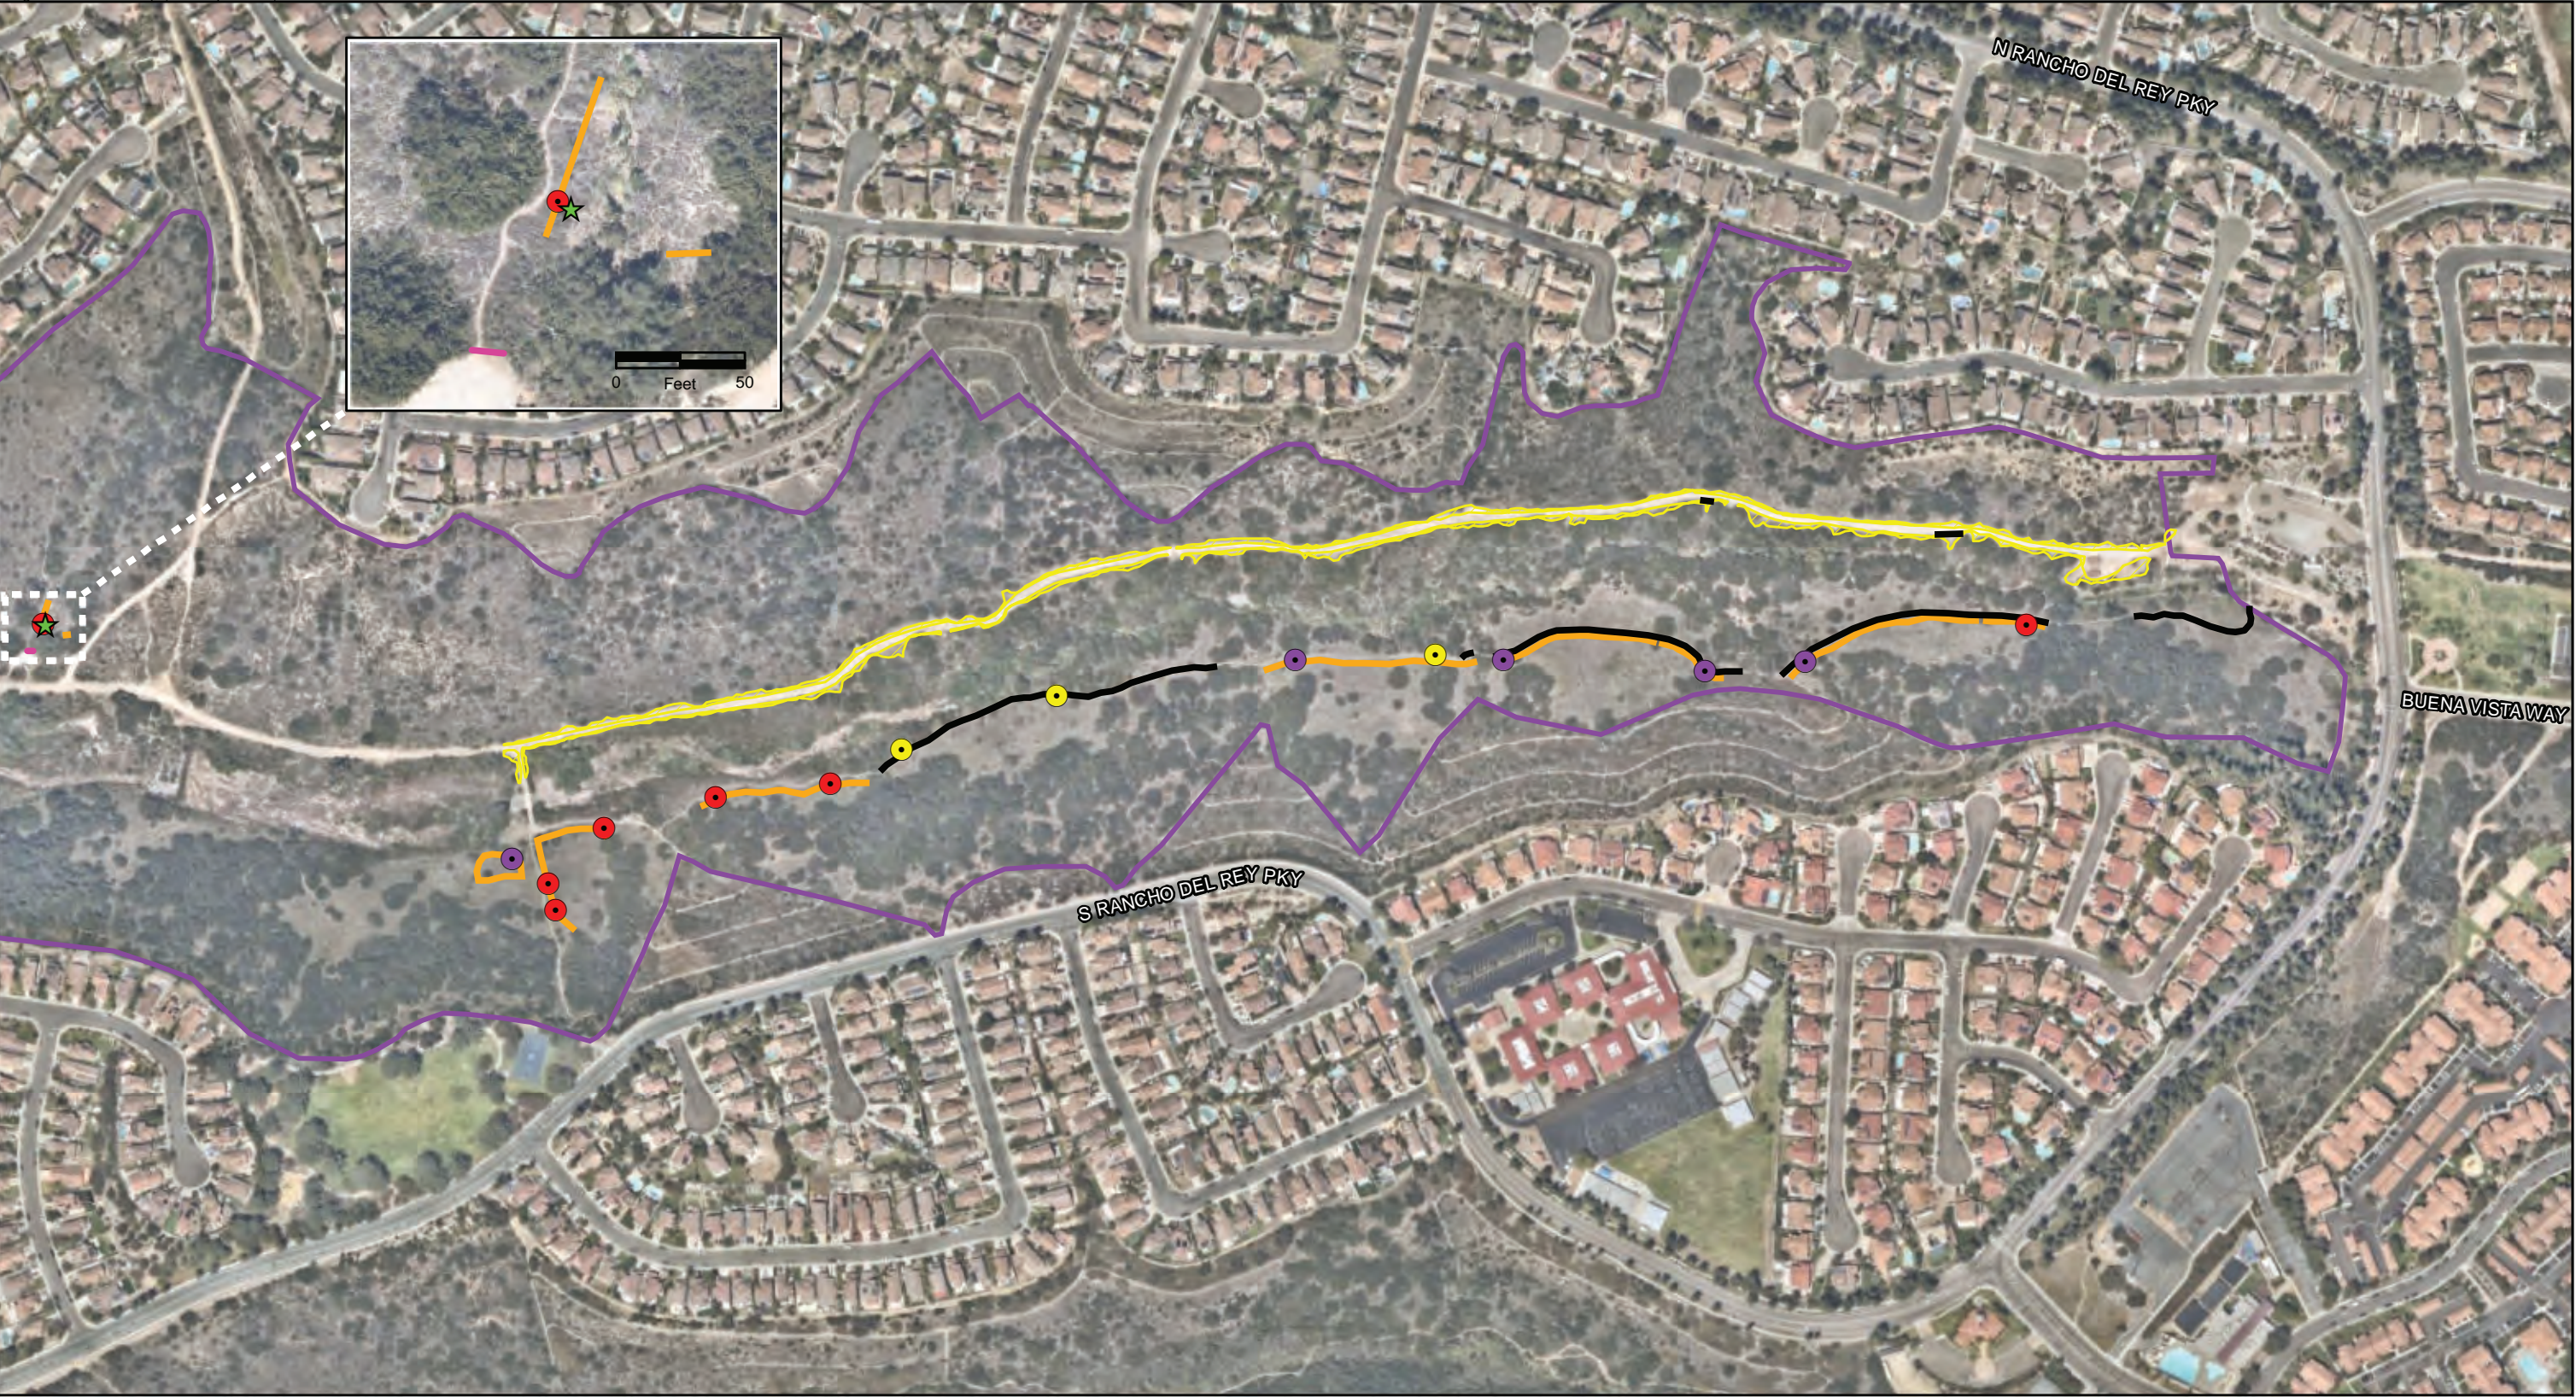
FIGURE 5
Locations of Fences and Signs

| PMA Subunit 1-2b | Previously Installed Fence (2011) - 2,371 feet | Existing Sign |
| Stinknet Treatment Area | New Fence - 2,648 feet | Newly Installed Sign |
| Orcutt's Bird's-beak | City fence - 13 feet | Replaced Sign |

and existing fencing is shown in Figure 5. Approximately 2,648.5 feet of new fencing were installed, approximately 2,371 feet of existing fence were repaired. The fence lengths presented here and shown on Figure 5 differ somewhat from the lengths listed in the SANDAG proposal because they were measured using a GPS device while the lengths in the proposal were not.

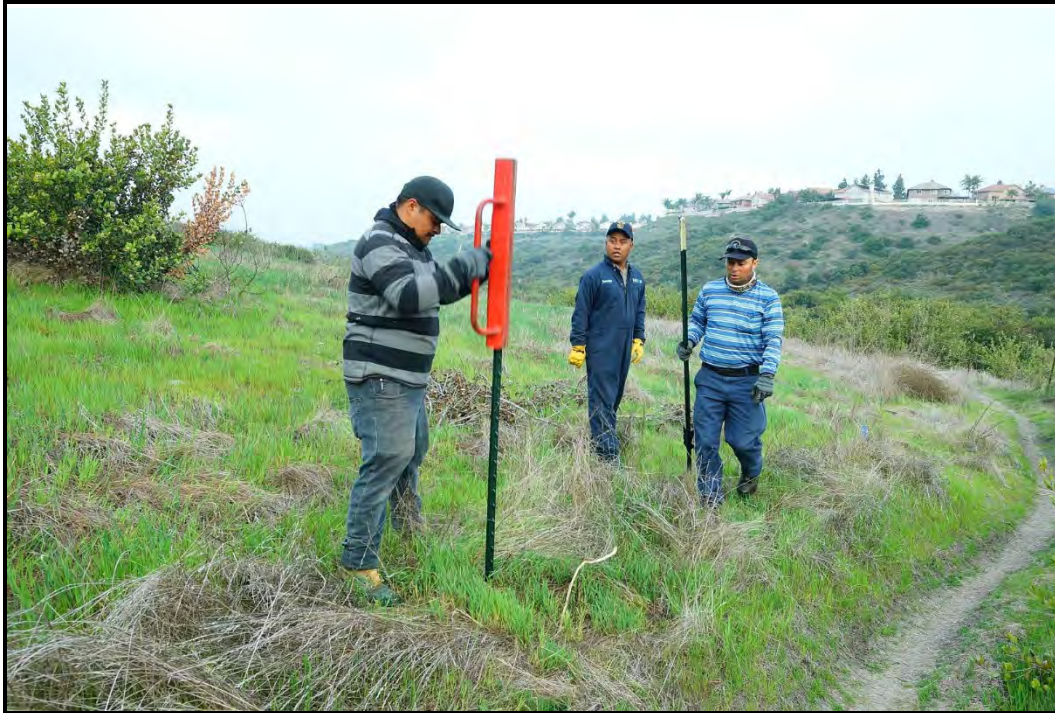
PHOTOGRAPH 1
RECON Crew Installing New Fence in Rice Canyon–March 2021

The new fence installation and existing fencing repair started the week of March 20, 2021 and was completed June 21, 2021. The RECON maintenance staff installed the new fencing (Photographs 1–3). The previously existing fencing was also repaired by the RECON crew (Photographs 4–5) and seven new informational signs were installed and three vandalized or stolen signs were replaced (Photographs 6–10). The new fencing along the trail adjacent to the Otay tarplant and San Diego thornmint was installed per plan in the SANDAG proposal. The location of the newly installed

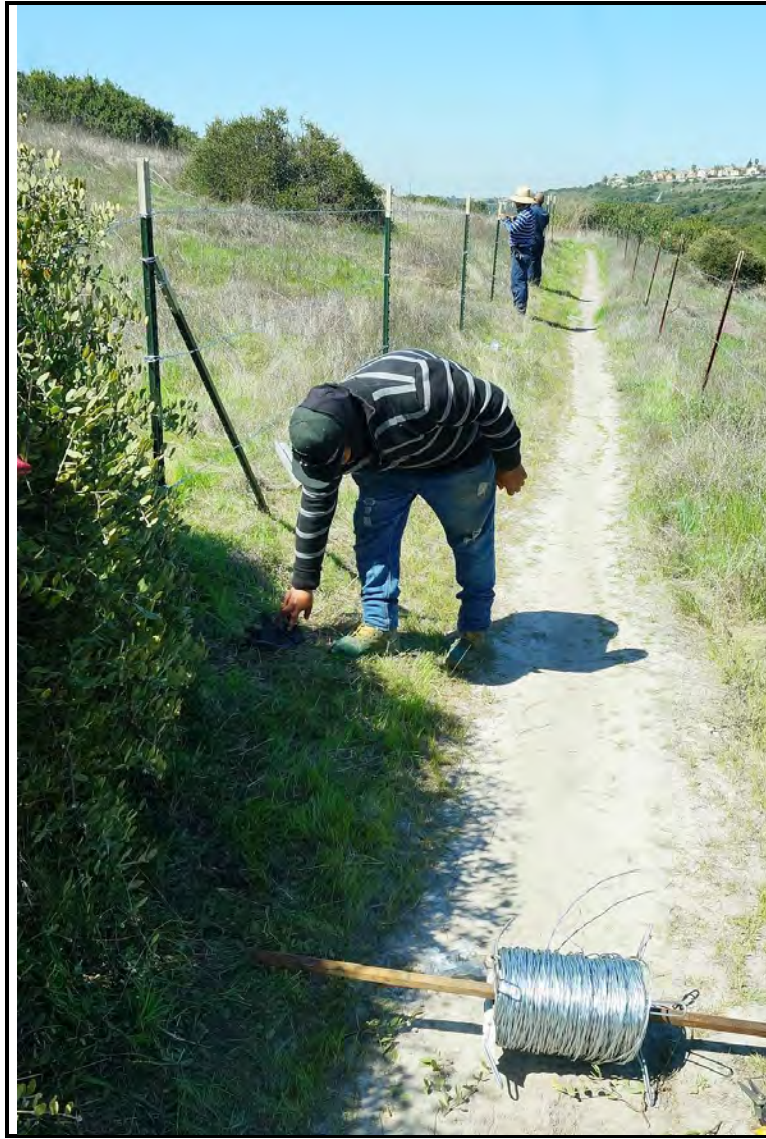
PHOTOGRAPH 2
RECON Crew Installing New Fence in Rice Canyon–
March 2021

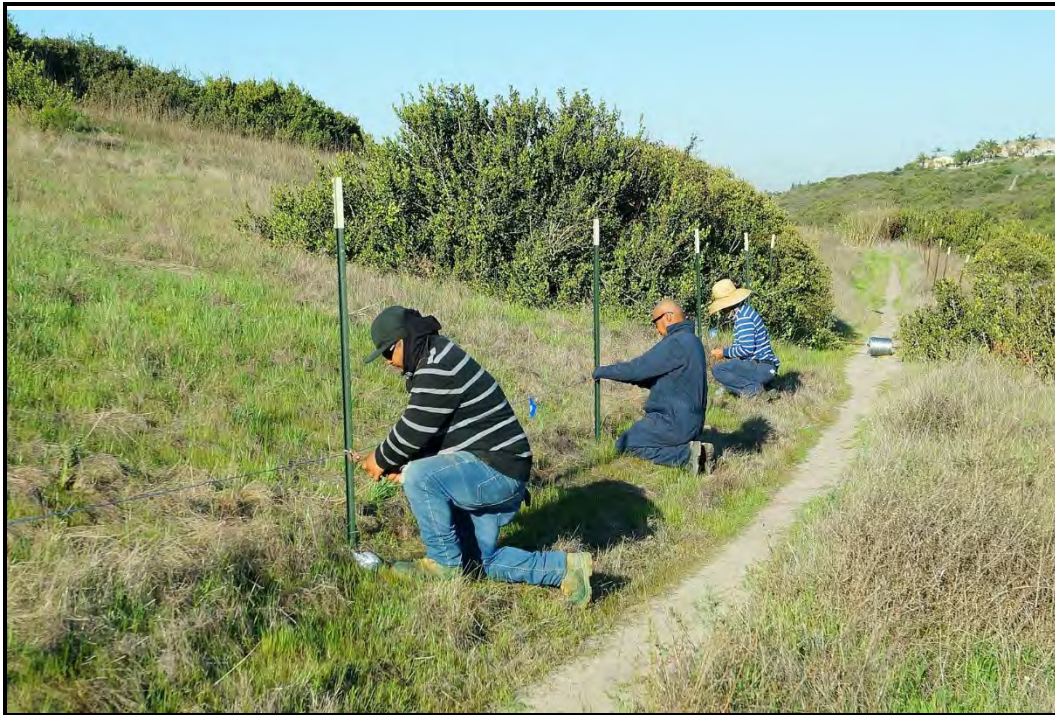
PHOTOGRAPH 3
RECON Crew Attaching New Fence Lines in Rice Canyon–March 2021

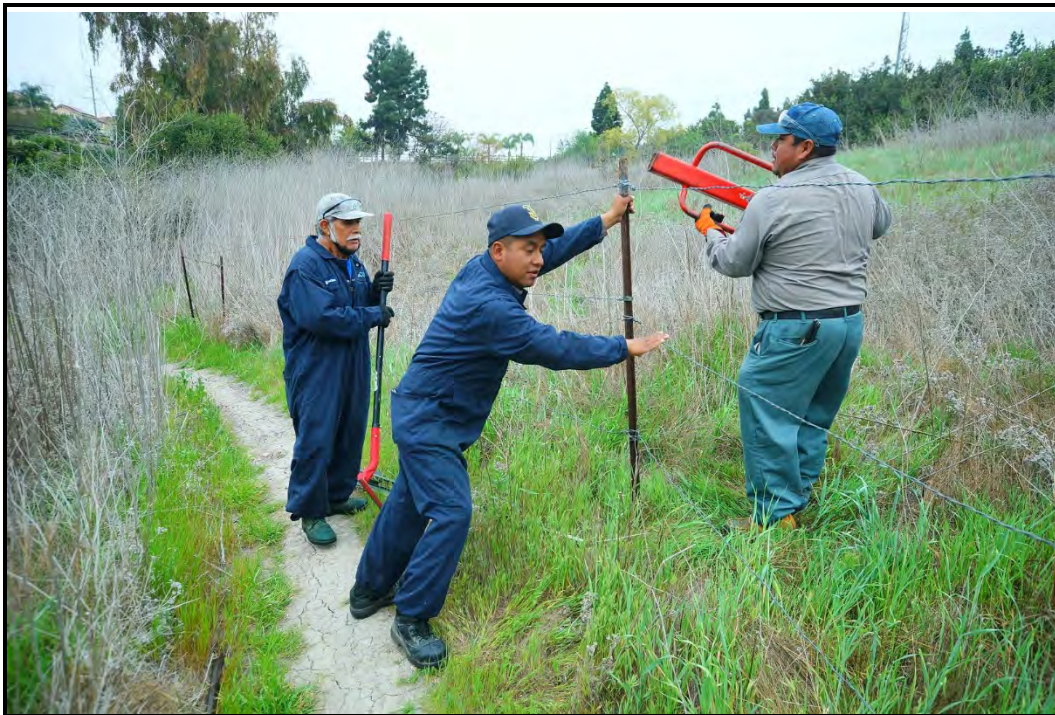
PHOTOGRAPH 4
RECON Crew Repairing Existing Fence in Rice Canyon–April 2021

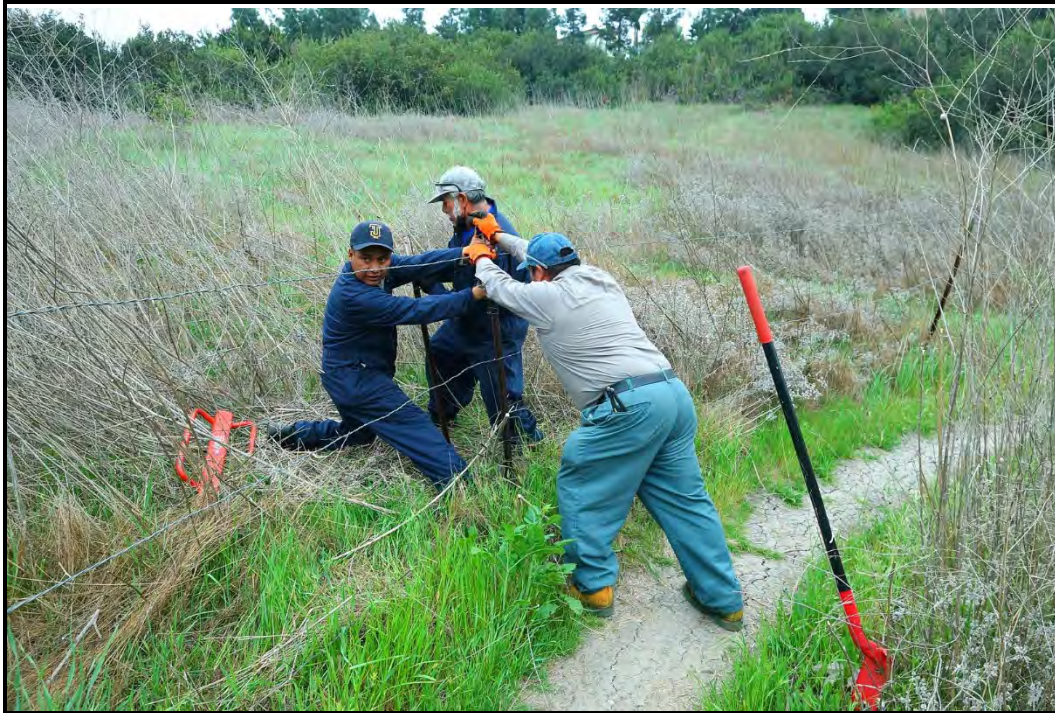
PHOTOGRAPH 5
RECON Crew Repairing Existing Fence in Rice Canyon–April 2021

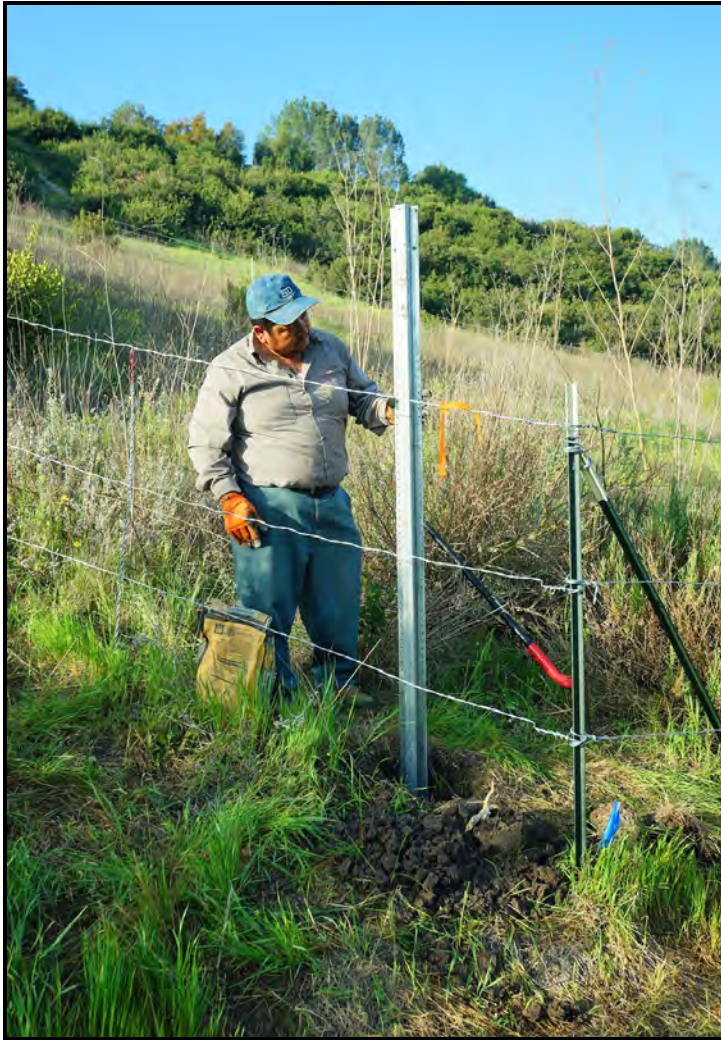
PHOTOGRAPH 6
RECON Crew Installing New Signpost in
Rice Canyon–April 2021

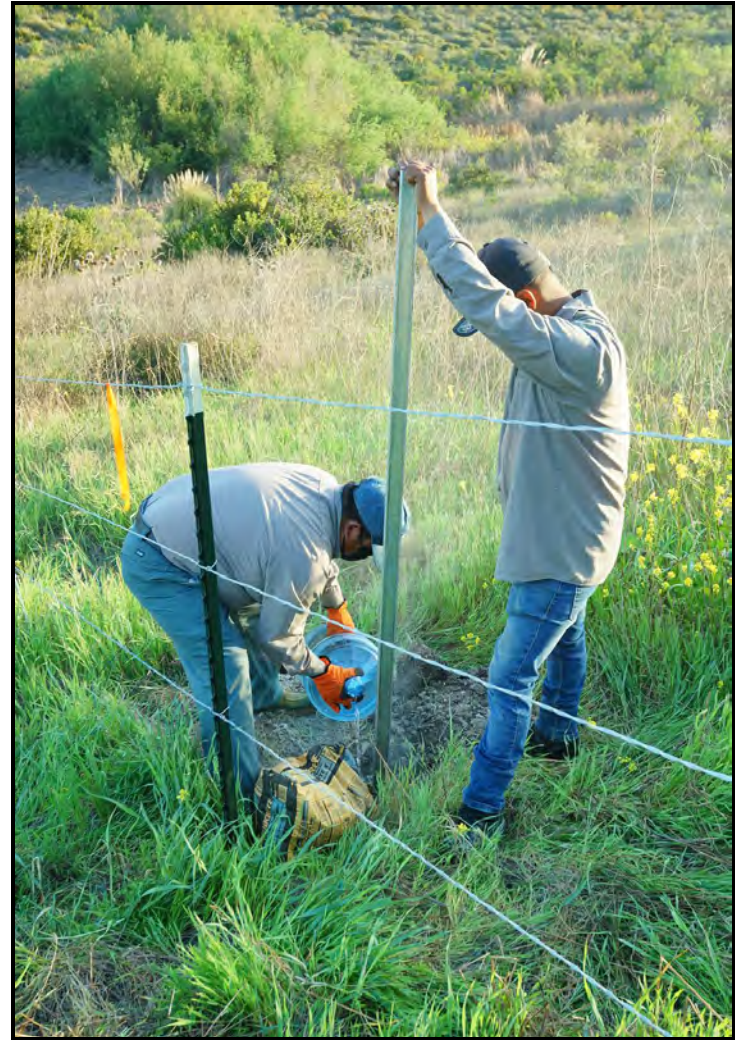
PHOTOGRAPH 7
RECON Crew Cementing in New Signpost in
Rice Canyon–April 2021

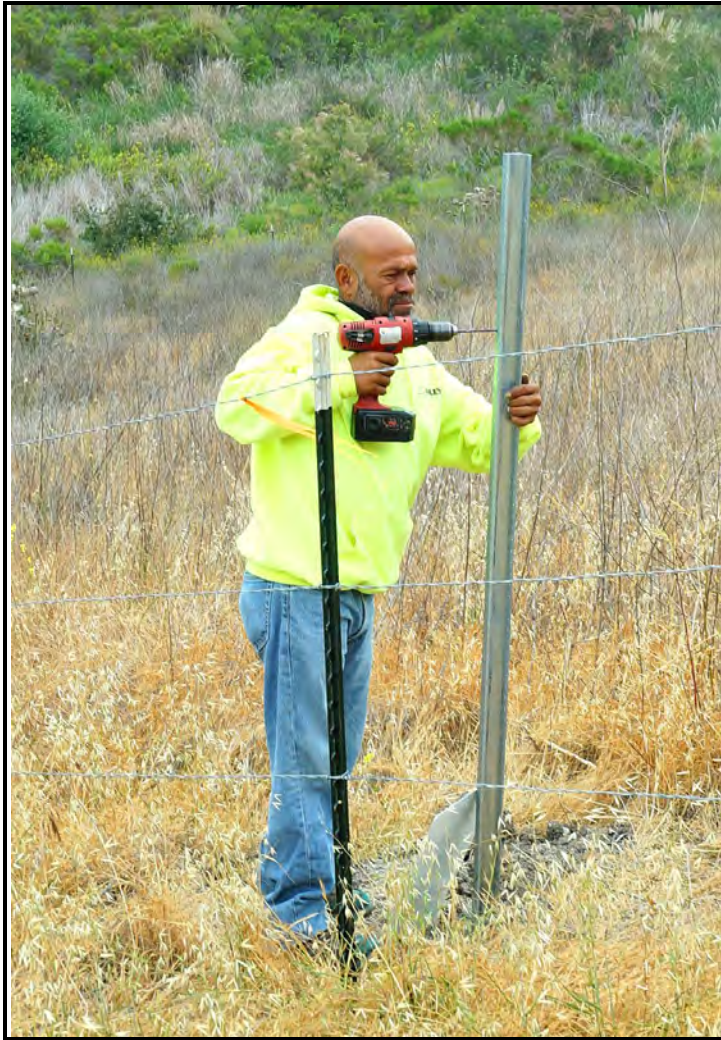
PHOTOGRAPH 8
RECON Crew Drilling Holes to Attach New Sign in
Rice Canyon–May 2021

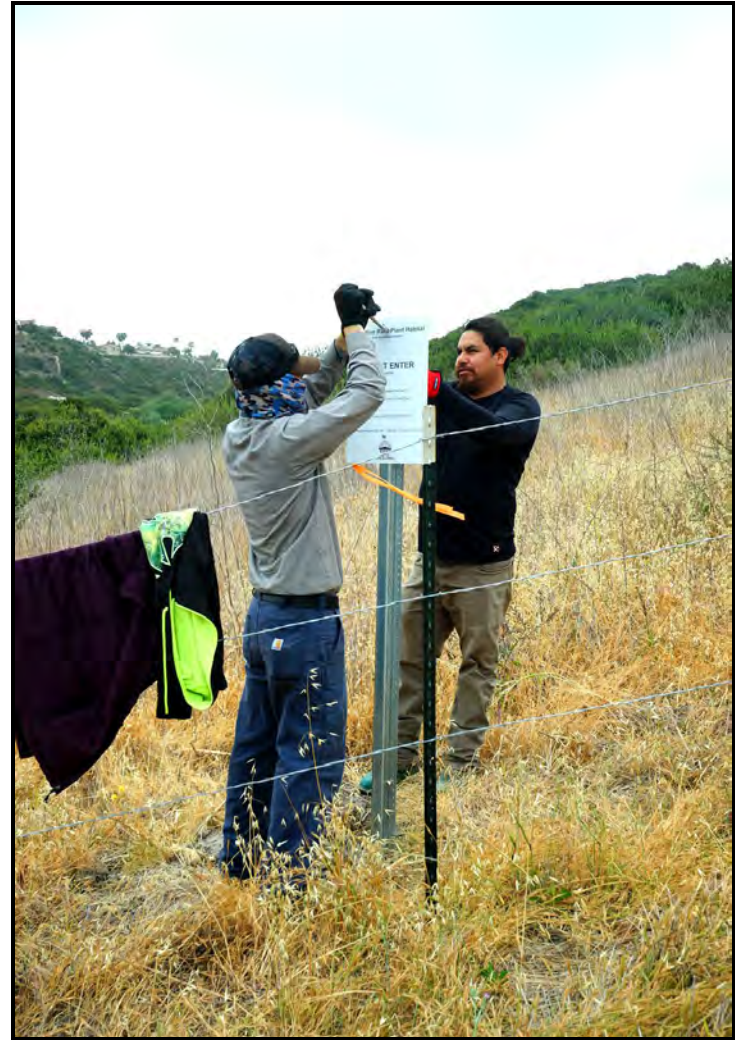
PHOTOGRAPH 9
RECON Crew Attaching New Sign in
Rice Canyon–May 2021

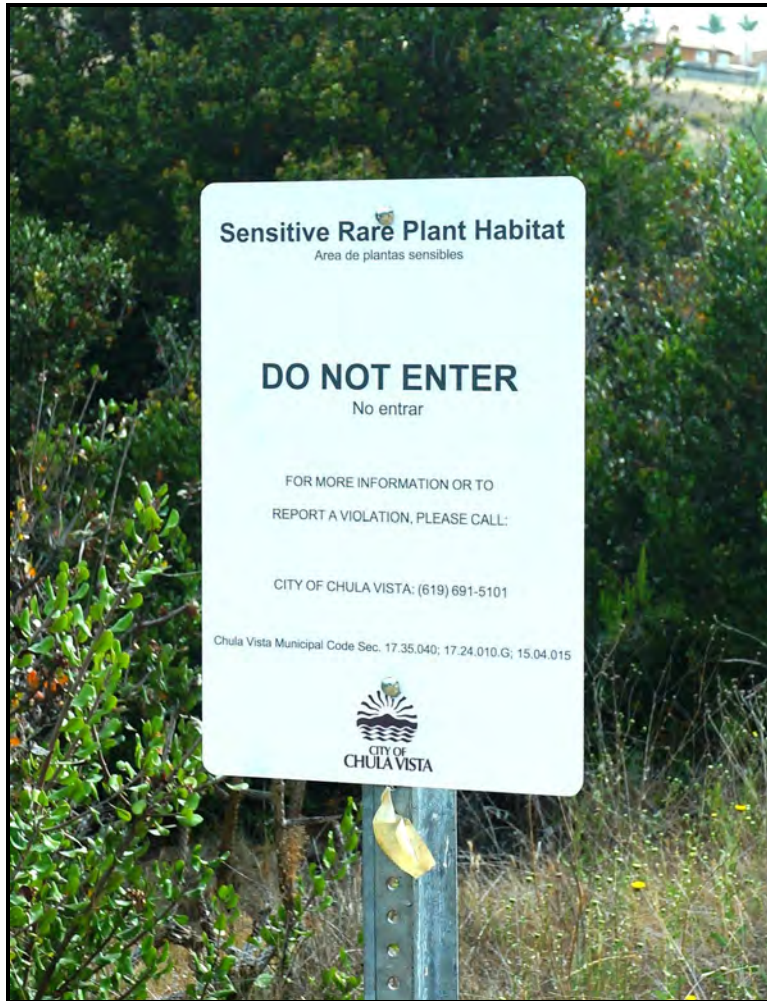
PHOTOGRAPH 10
New Replacement Sign Along Trail in Rice Canyon–
May 2021

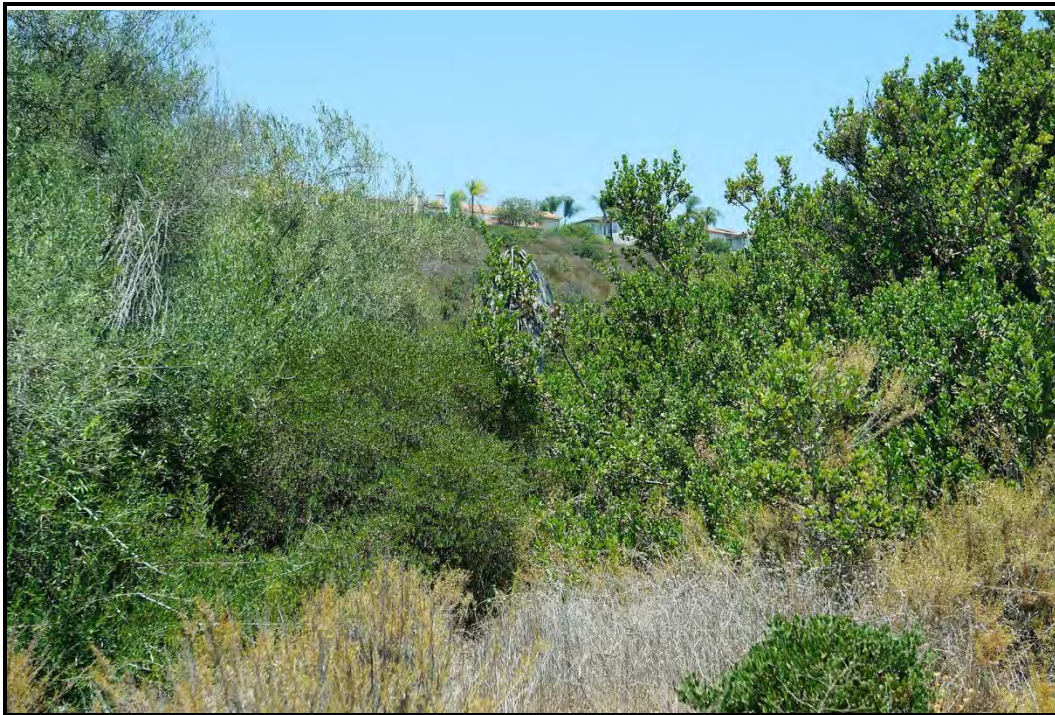
PHOTOGRAPH 11

View of Former Trail Through Orcutt's Bird's-beak Population Closed by Shrub Growth—June 2021

The fencing adjacent to the Orcutt's bird's-beak was modified from the proposed design to address the current trail conditions of the site. The trail that had been located on the eastern side of the small drainage and traversed directly through the Orcutt's bird's-beak is no longer open to foot traffic due to the growth of shrubs, including lemonadeberry (*Rhus integrifolia*) and jojoba (*Simmondsia chinensis*) (Photograph 11). A small section of fencing was installed behind the shrubs to further discourage any foot traffic (Photograph 12). No Orcutt's bird's-beak was observed in 2021 east of the drainage.

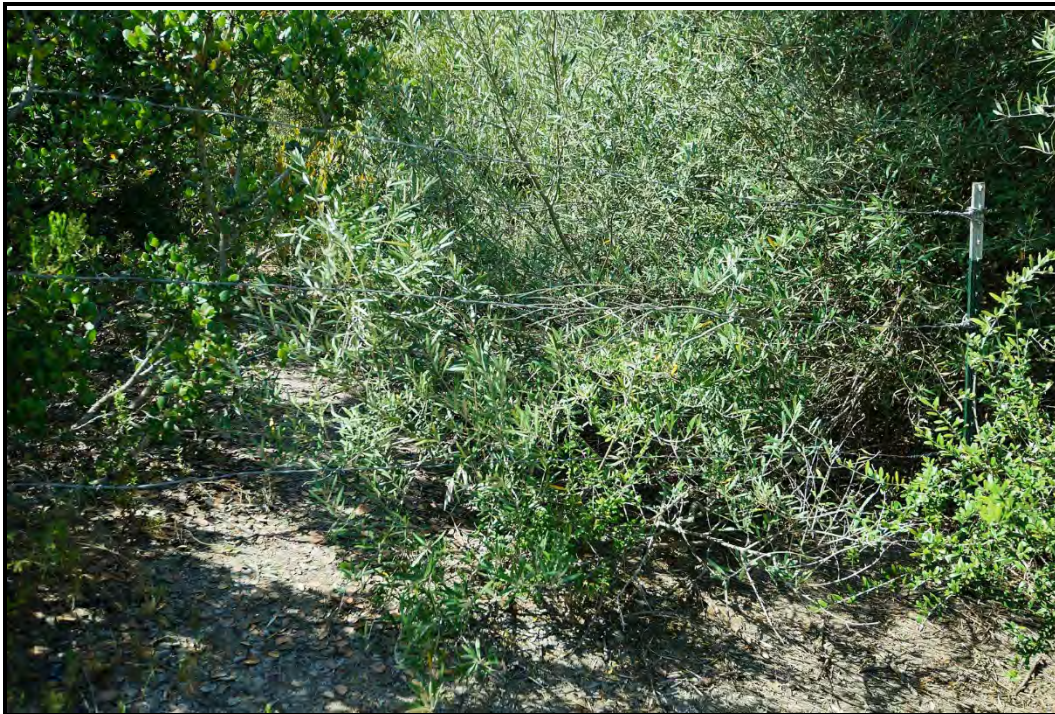
PHOTOGRAPH 12

Newly Installed Fence Section South of the Orcutt's Bird's-beak Population—June 2021

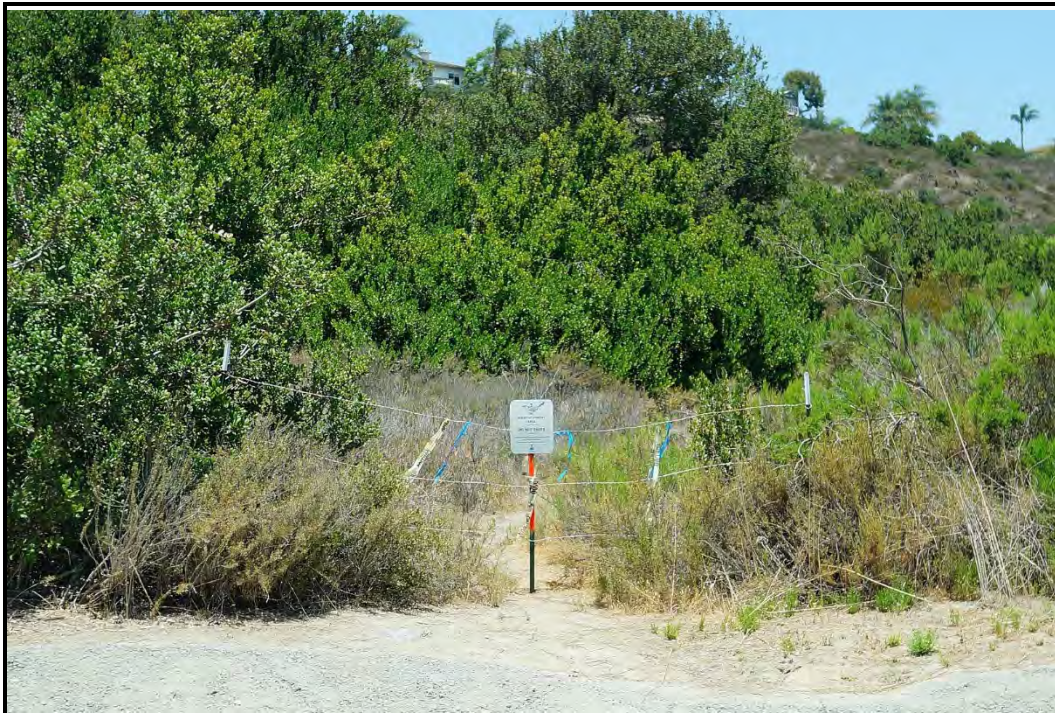
PHOTOGRAPH 13
Protective Fence Installed by the City to Close Trail Adjacent to Orcutt's
Bird's-beak Population—June 2021

There is an active trail on the west side of the small drainage. The entrance to this unauthorized trail has already been fenced by the City (Photograph 13). Approximately five Orcutt's bird's-beak were observed in flower east of this trail in 2021 (Photograph 14). A new section of fence was installed behind the City's fence between the unauthorized trail and the bird's-beak population (Photograph 15). A sign stating that the area is closed to foot traffic was also installed (Photograph 16). This should further reduce threats of trampling of the bird's-beak plants.

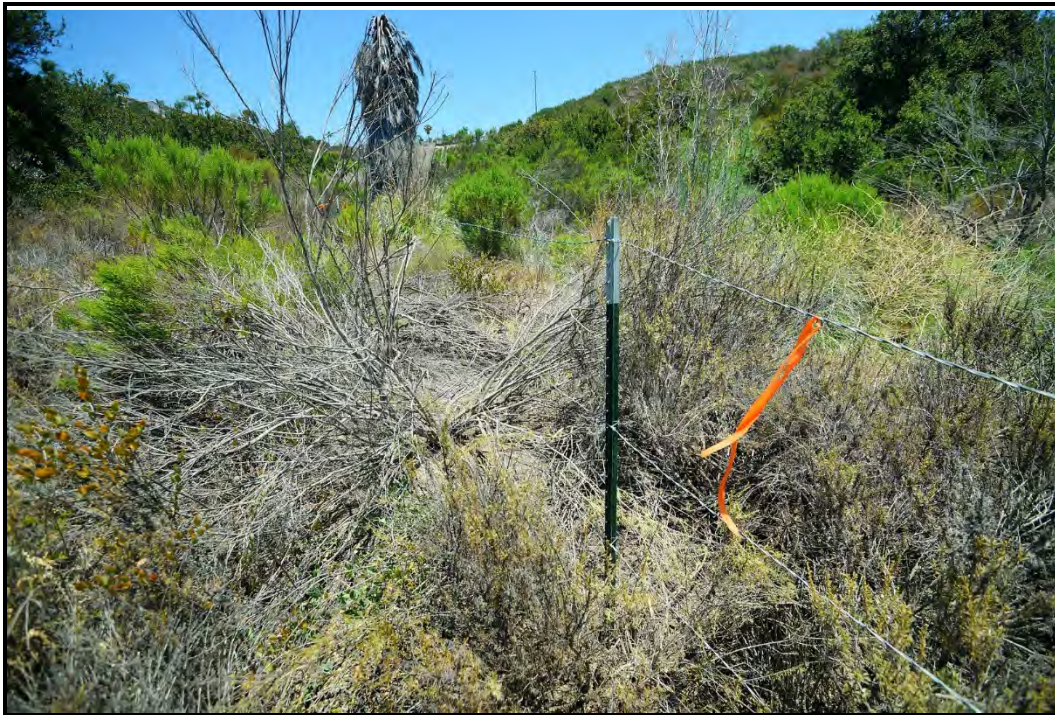
PHOTOGRAPH 15
Newly Installed Fence Between the Unauthorized Trail and
Orcutt's Bird's-beak Population–June 2021

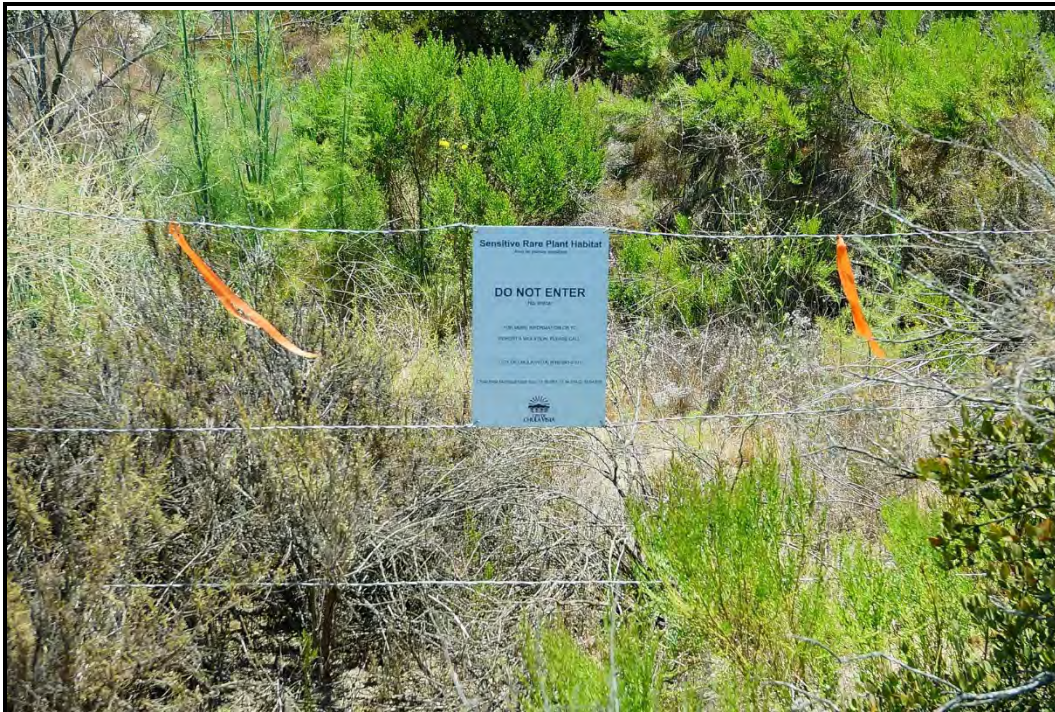
PHOTOGRAPH 16
Newly Installed Fence and Sign Adjacent to the
Orcutt's Bird's-beak Population–June 2021

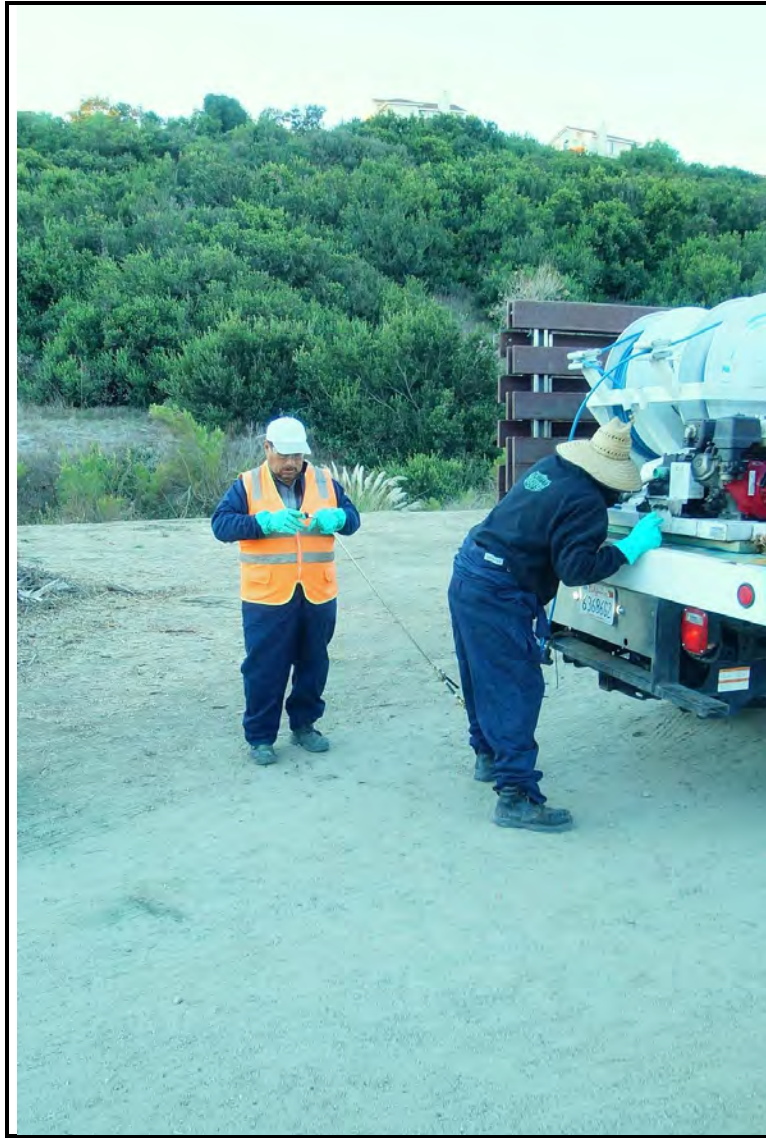
PHOTOGRAPH 17
RECON Crew Preparing to Spray Pre-emergent
Herbicide to Control Stinknet Germination in Rice
Canyon–December 2020

Spraying of pre-emergent herbicide (Surflan®) was completed by the RECON maintenance staff on December 16, 2020. The application of pre-emergent was monitored by the project biologist. The maintenance crew sprayed areas where stinknet had previously grown to prevent stinknet seedlings from germinating after rainfall (Photographs 17–19). Over one-half inch of rain fell on December 28, 2020, which activated the pre-emergent spray to prevent germination of stinknet.

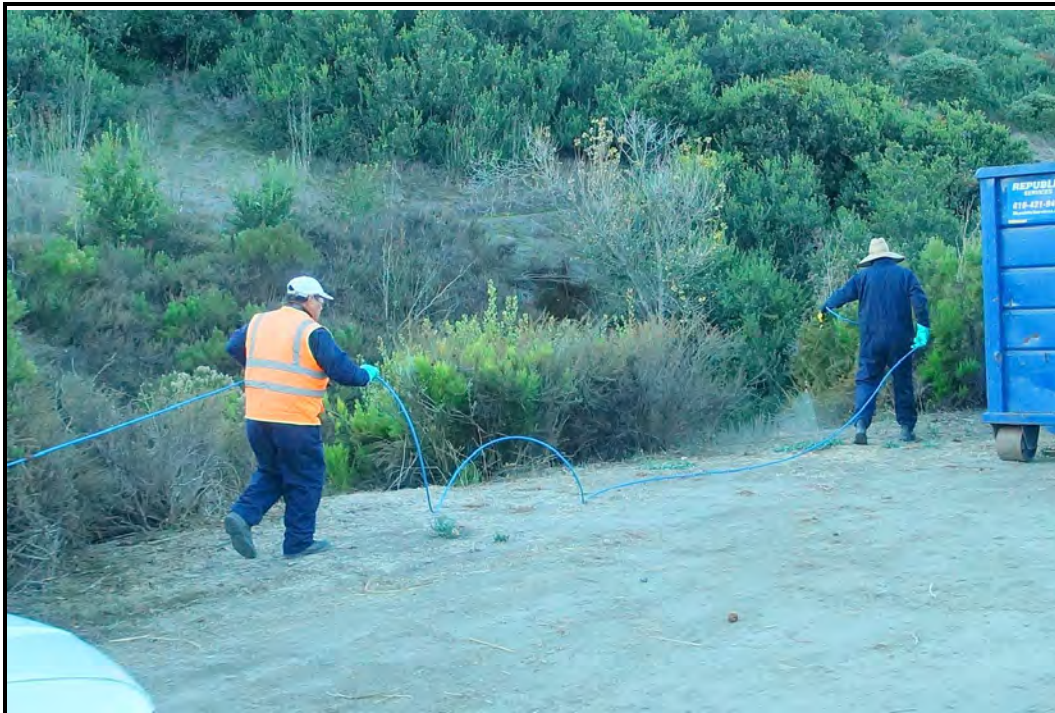
PHOTOGRAPH 18
RECON Crew Spraying Pre-emergent Herbicide to Control Stinknet Germination in Rice Canyon–December 2020

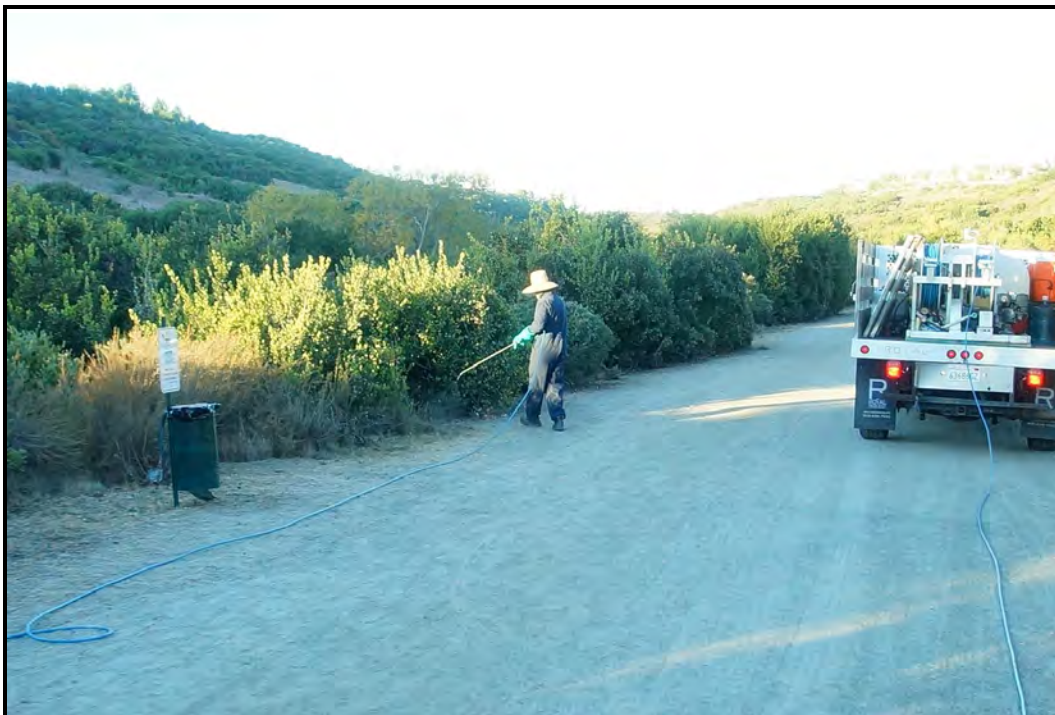
PHOTOGRAPH 19
RECON Crew Spraying Pre-emergent Herbicide to Control Stinknet Germination in Rice Canyon–December 2020
