Reference: Final Report for the Rice Canyon Sensitive Plant Species Management Project (SANDAG Grant Number 5005508; RECON Number 9429)

Executive Summary

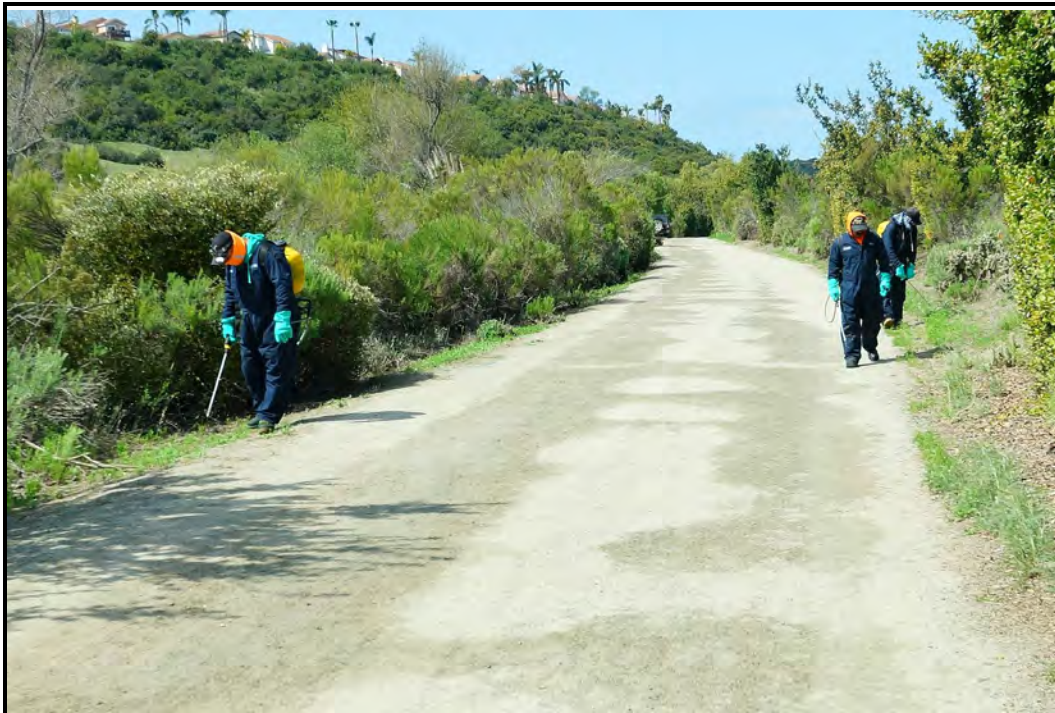
PHOTOGRAPH 20
RECON Crew Follow-up Spraying Glyphosate Herbicide to Control Stinknet
in Rice Canyon–March 2021

the RECON crew sprayed newly germinated stinknet that had not been controlled by the pre-emergent herbicide (Photographs 20–22). The small number of stinknet present were sprayed with a glyphosate-based herbicide. The project biologist supervised the crew during the follow-up spraying.

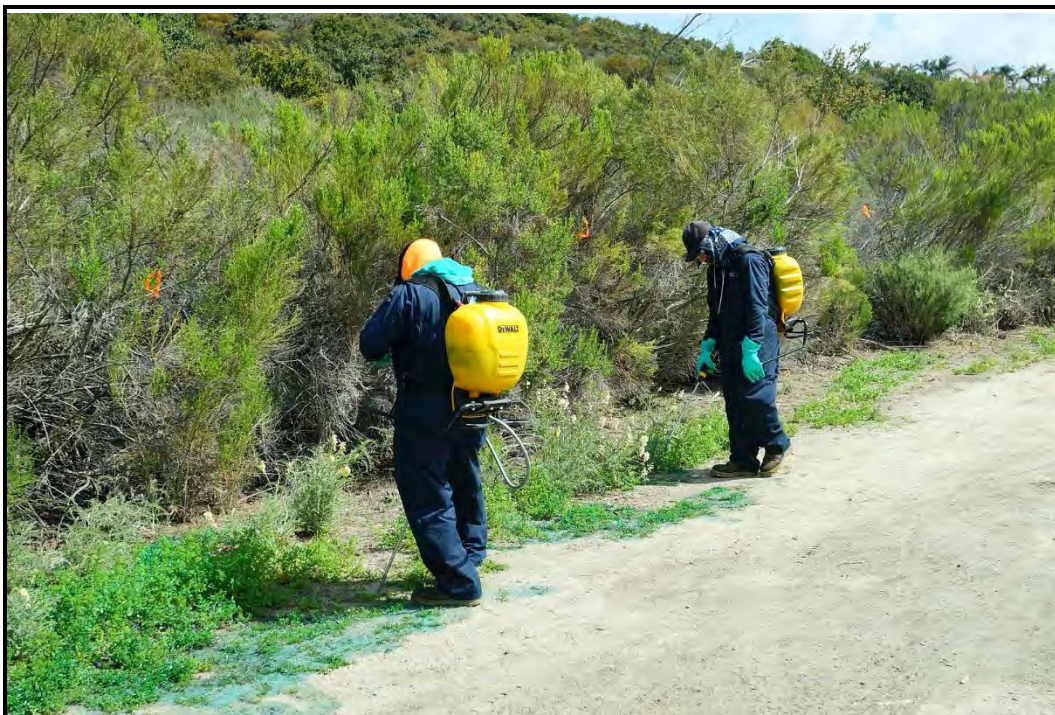
PHOTOGRAPH 21
RECON Crew Follow-up Spraying Glyphosate Herbicide to Control Stinknet
in Rice Canyon–March 2021

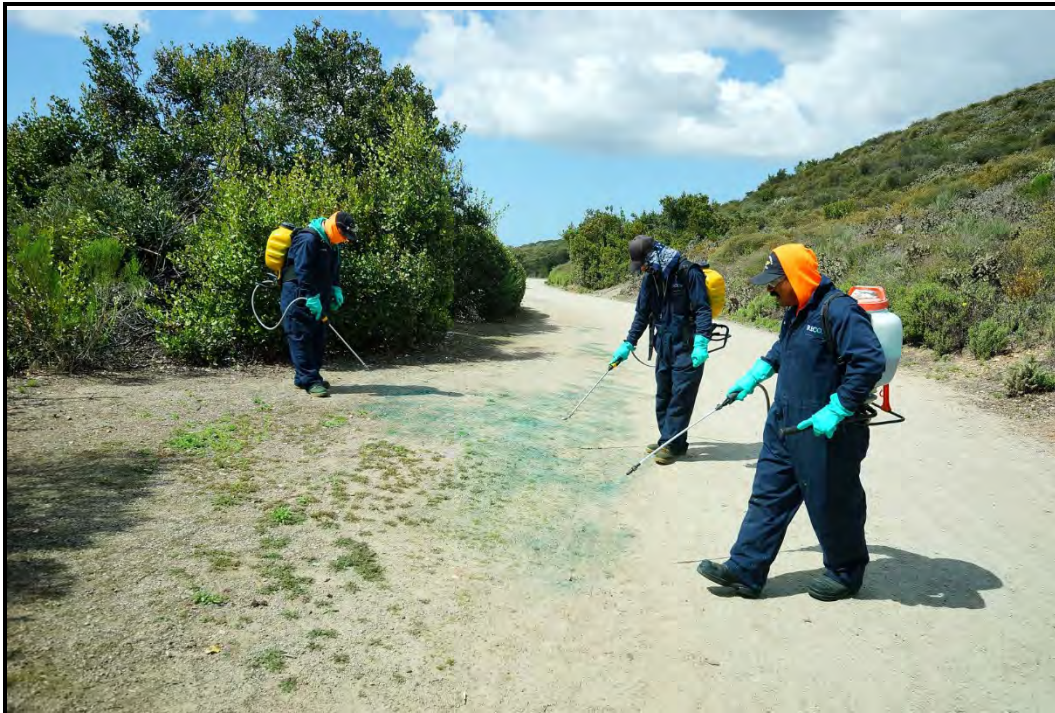
PHOTOGRAPH 22

RECON Crew Follow-up Spraying Glyphosate Herbicide to Control Stinknet in Rice Canyon–March 2021

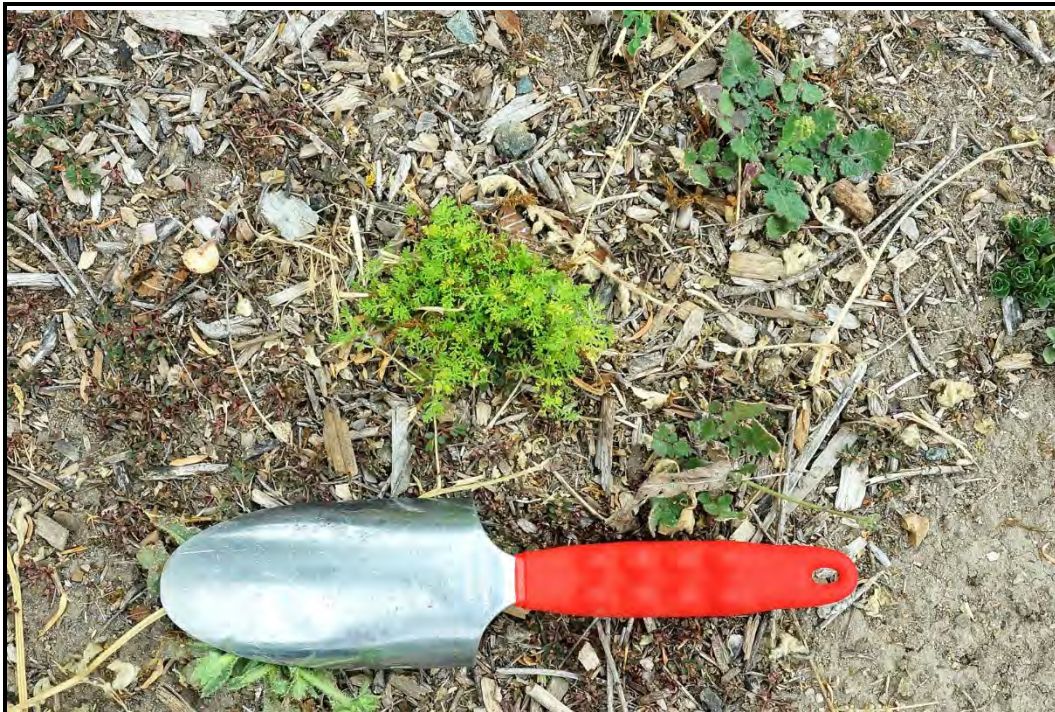
PHOTOGRAPH 23

A Single Individual Stinknet Plant Prior to Removal in Rice Canyon–May 2021

The project biologist also checked the canyon access road for additional stinknet plants on April 23, 2021. A few widely scattered stinknet plants were found by the biologist and removed from the site. Another check for stinknet was conducted on May 11, 2021 and only one plant was observed and this plant was also removed prior to setting seeds (Photograph 23).

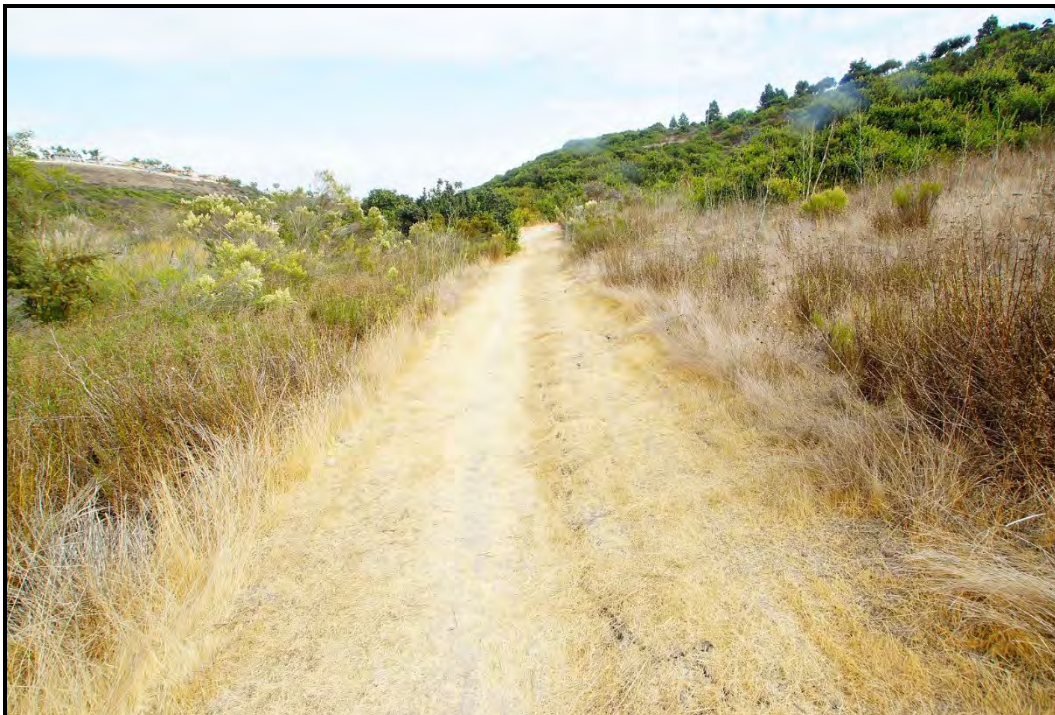
PP4 11.6.20

Photo Point 4 taken November 6, 2020–Rice Canyon Trail–Prior to Fence Installation

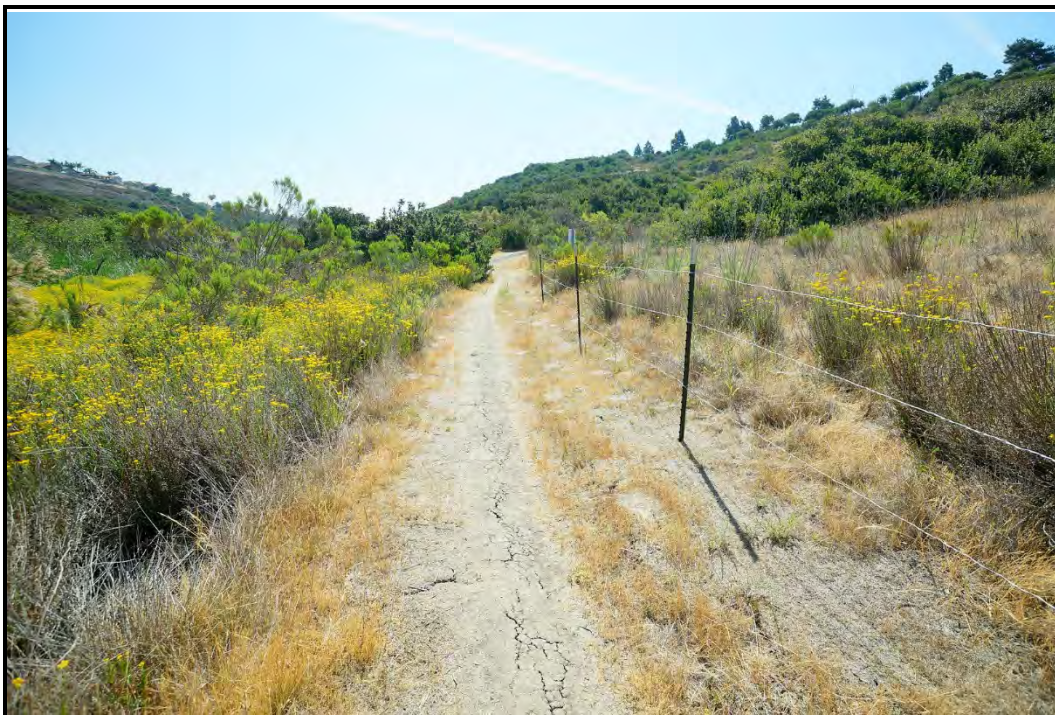
PP4 6.5.21

Photo Point 4 taken June 5, 2021–Rice Canyon Trail–Showing New Fence

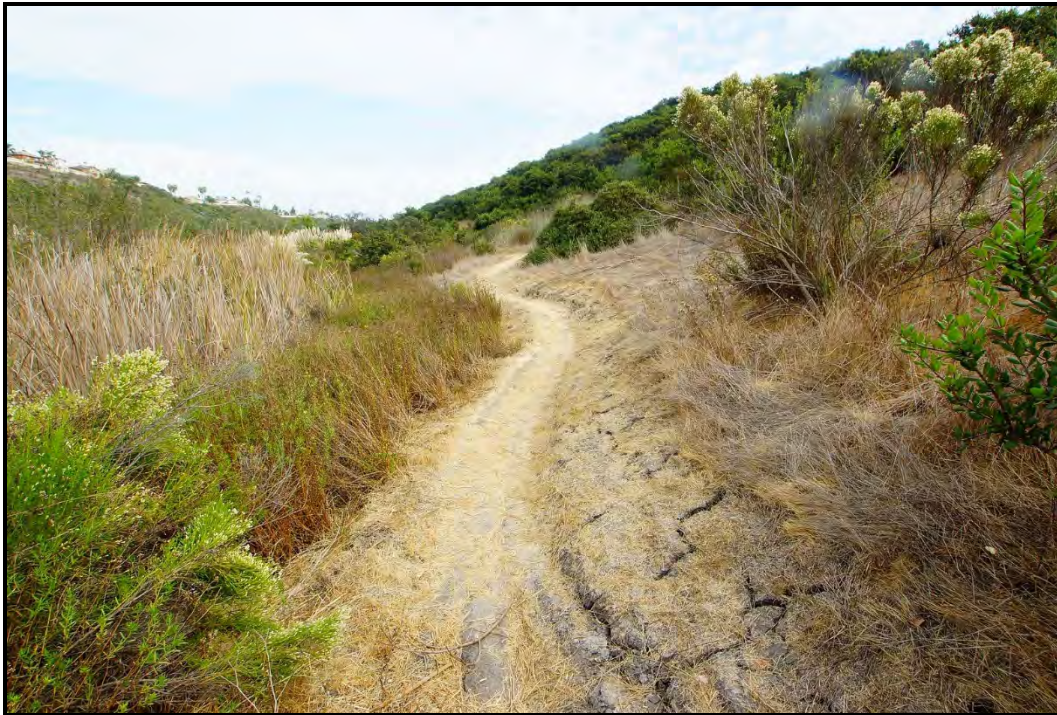
PP5 11.6.20

Photo Point 5 taken November 6, 2020–Rice Canyon Trail–Prior to Fence Installation

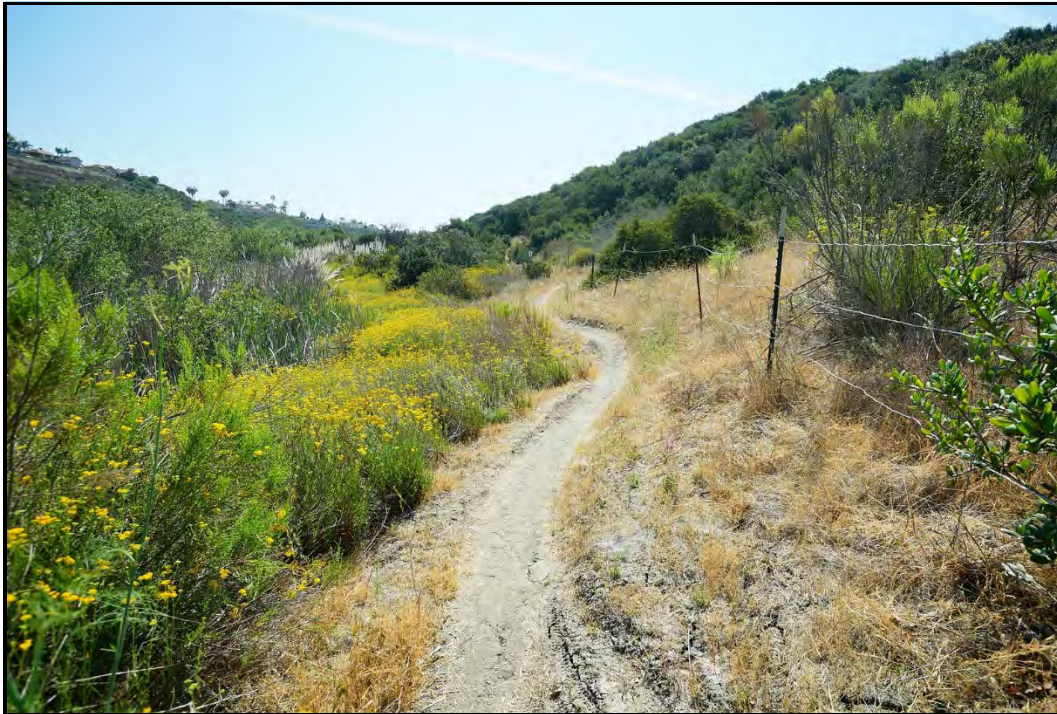
PP5 6.5.21

Photo Point 5 taken June 5, 2021–Rice Canyon Trail–Showing New Fence

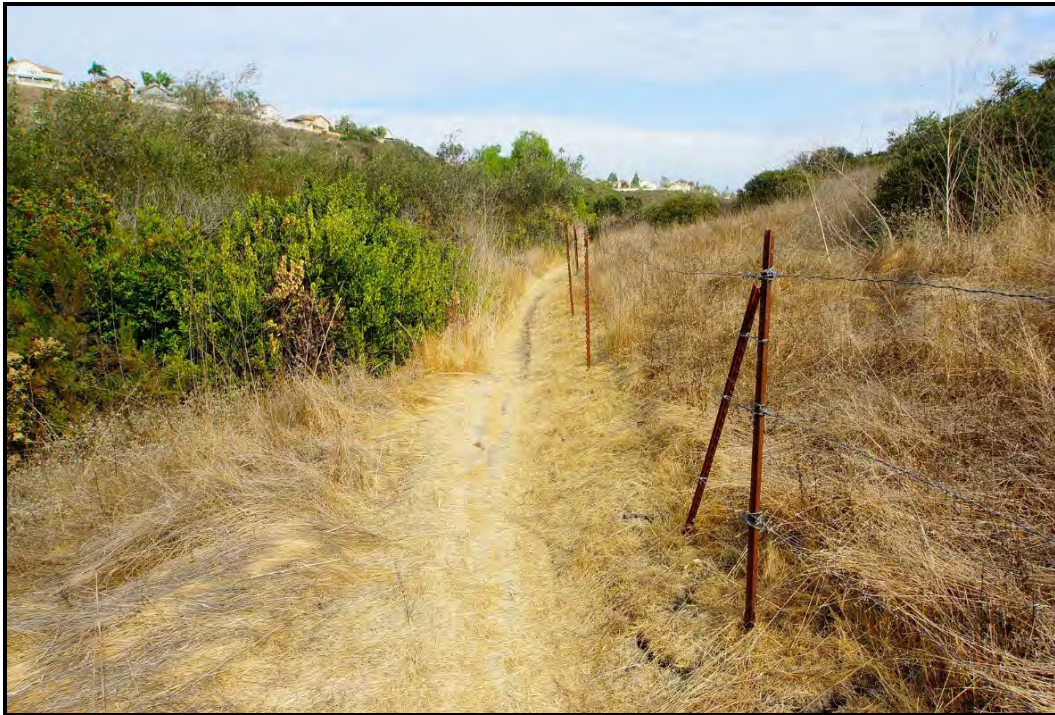
PP6 11.6.20

Photo Point 6 taken November 6, 2020–Rice Canyon Trail–Prior to Fence Repair

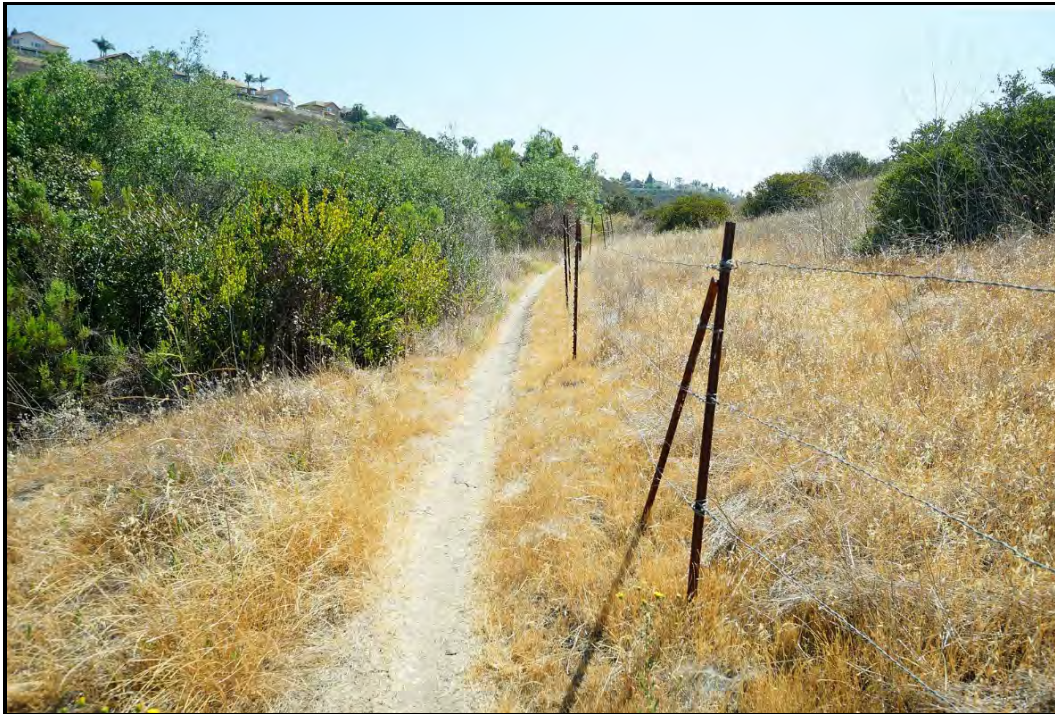
PP6 6.5.21

Photo Point 6 taken June 5, 2021–Rice Canyon Trail–After Fence Repair

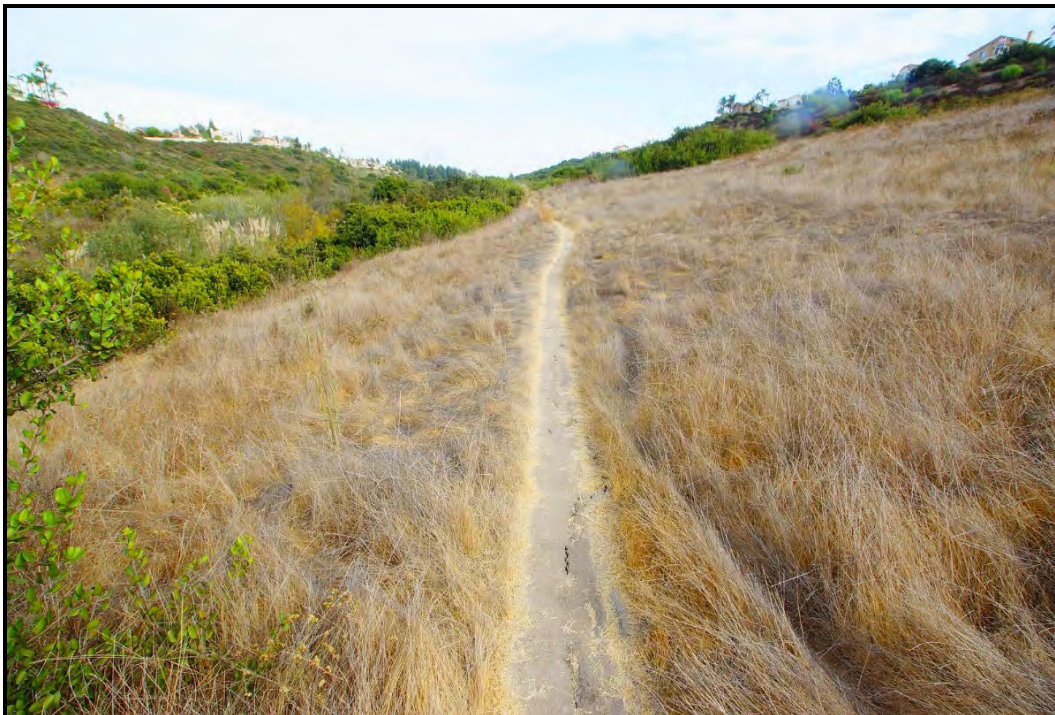
PP7 11.6.20

Photo Point 7 taken November 6, 2020–Rice Canyon Trail–Prior to Fence Installation

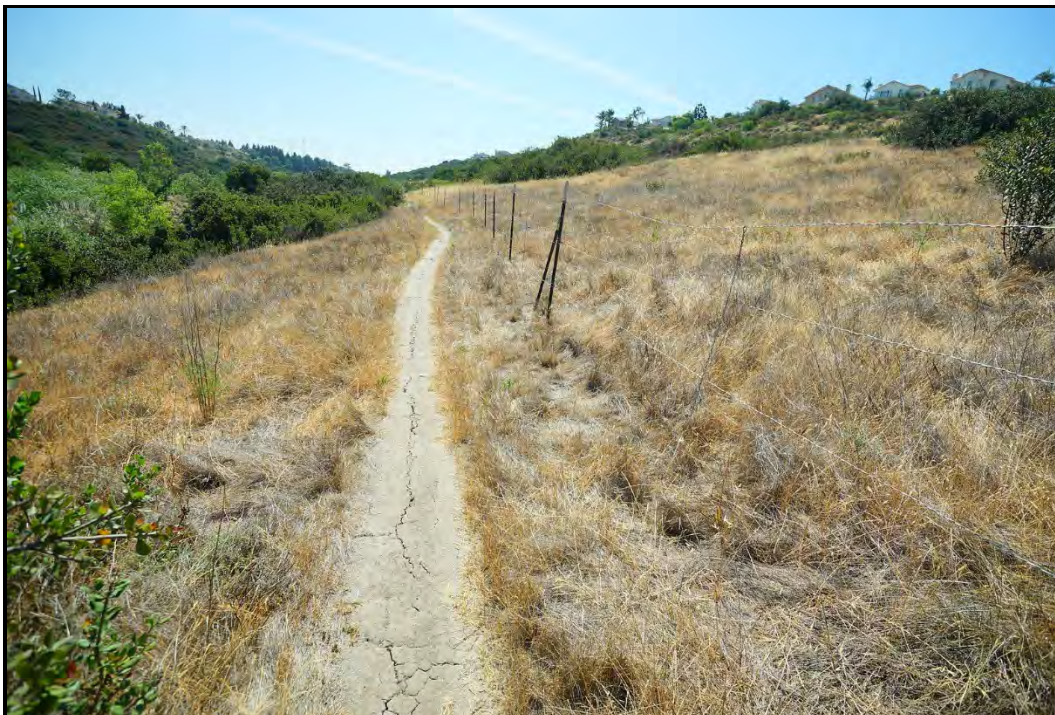
PP7 6.5.21

Photo Point 7 taken June 5, 2021–Rice Canyon Trail–Showing New Fence

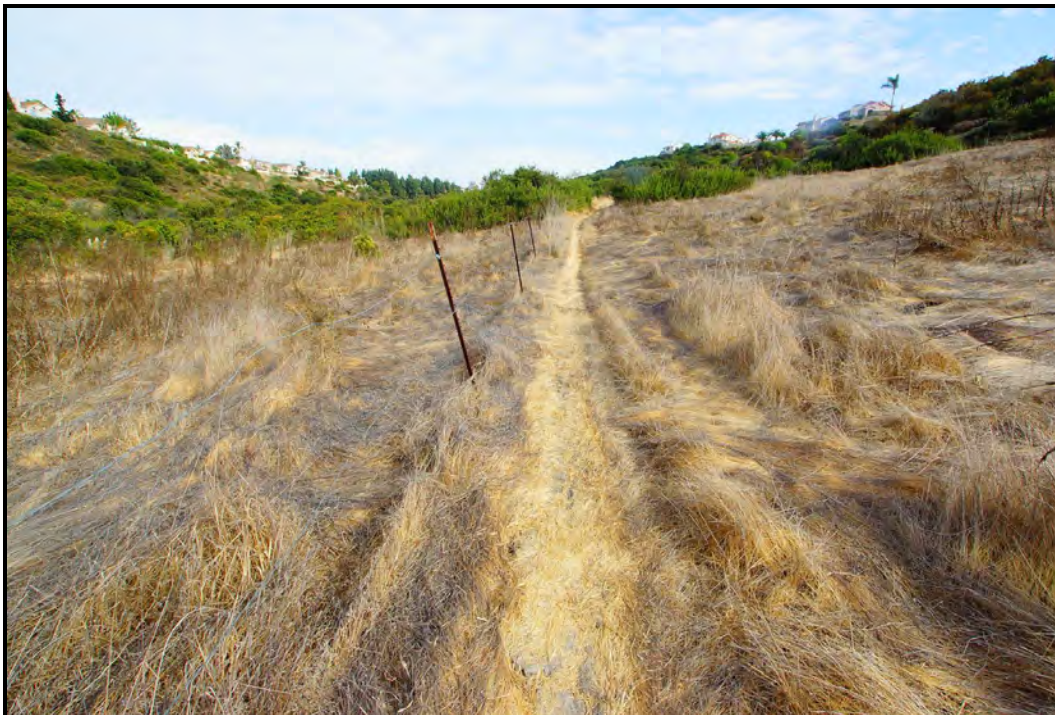
PP8 11.6.20

Photo Point 8 taken November 6, 2020–Rice Canyon Trail–Prior to Fence Installation

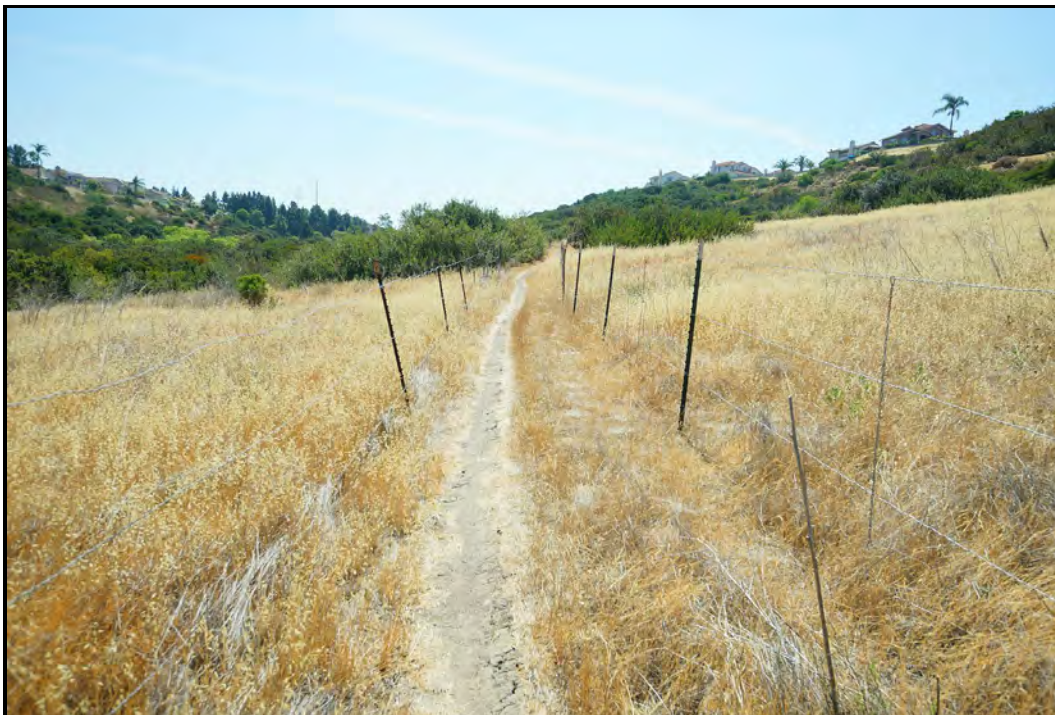
PP8 6.5.21

Photo Point 8 taken June 5, 2021–Rice Canyon Trail–Showing New Fence

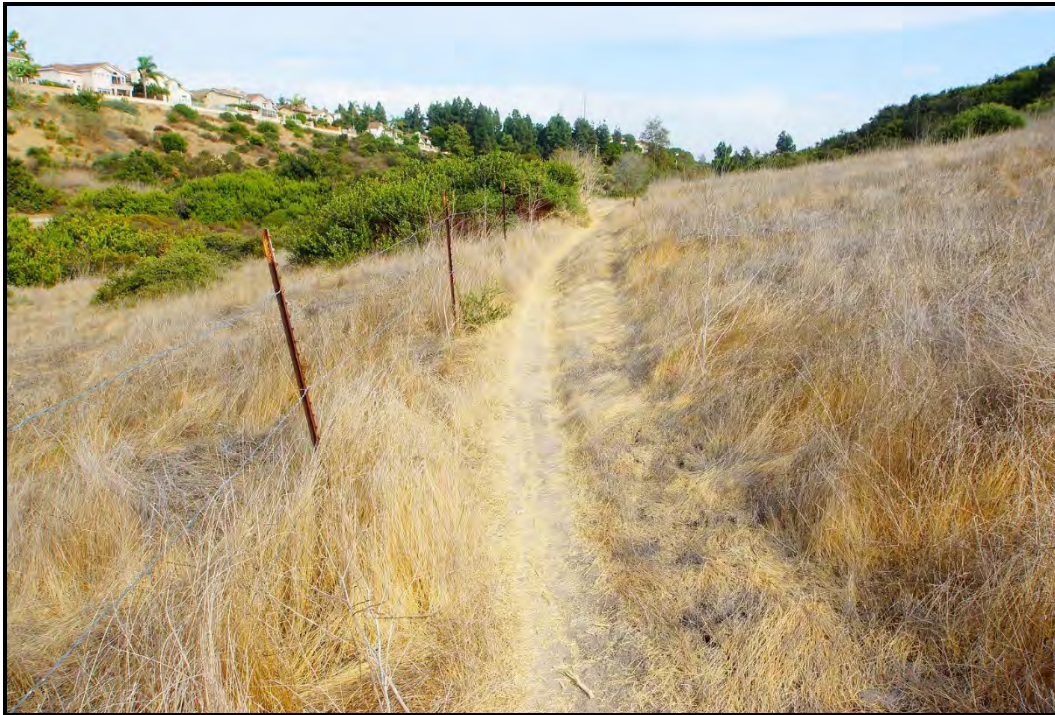
PP9 11.6.20

Photo Point 9 taken November 6, 2020–Rice Canyon Trail–Prior to Fence Installation

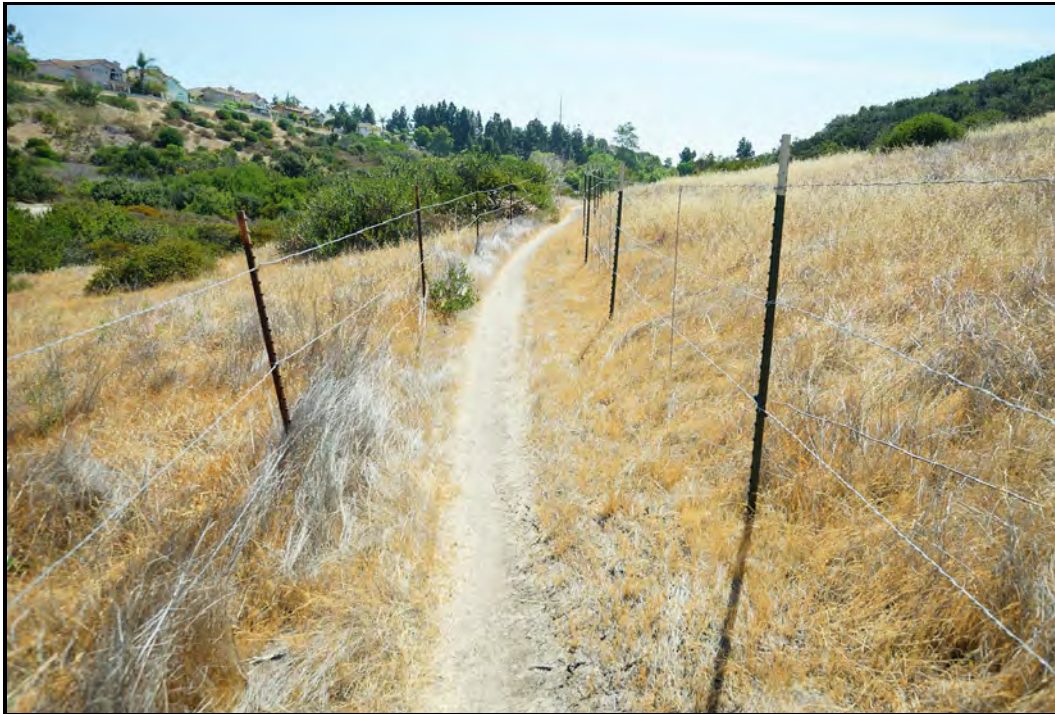
PP9 6.5.21

Photo Point 9 taken June 5, 2021–Rice Canyon Trail–Showing New Fence

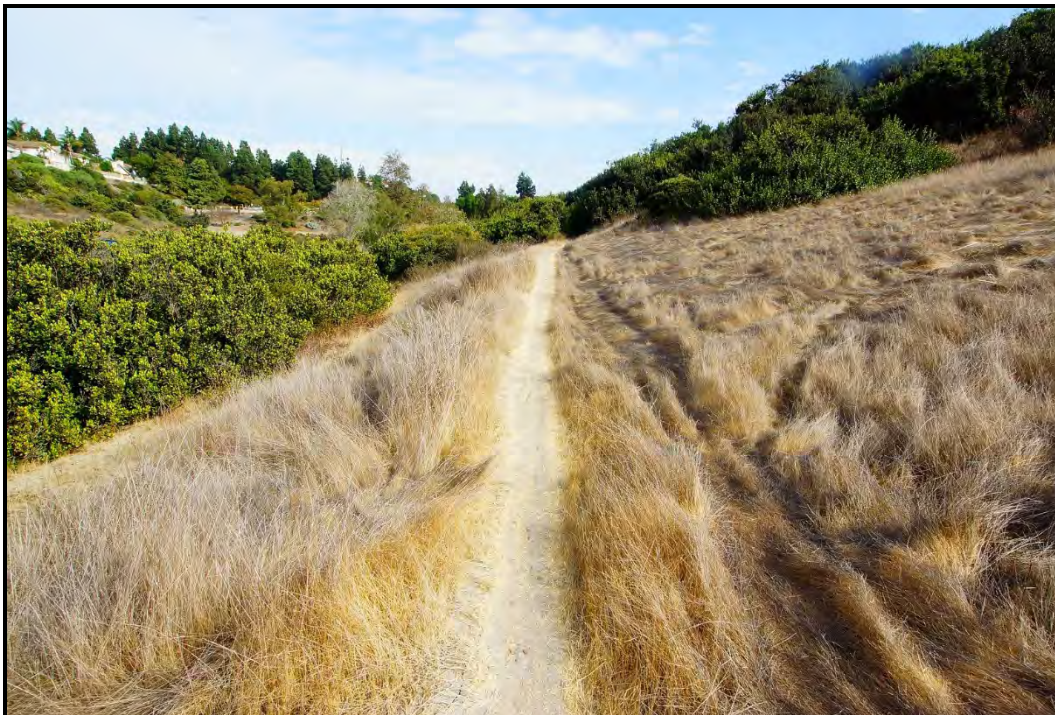
PP10 11.6.20

Photo Point 10 taken November 6, 2020–Rice Canyon Trail–Prior to Fence Installation

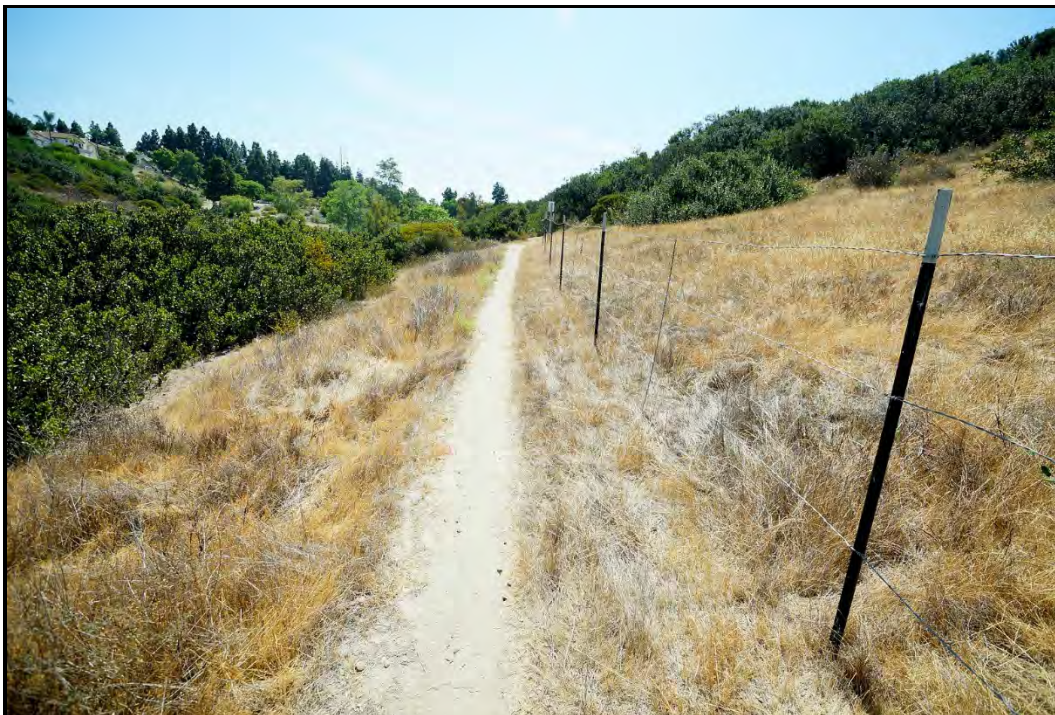
PP10 6.5.21

Photo Point 10 taken June 5, 2021–Rice Canyon Trail–Showing New Fence
