# Draft Final: Aseasonal Flow and Associated Nonnative Species in San Diego

Data Summary

U.S. GEOLOGICAL SURVEY  
WESTERN ECOLOGICAL RESEARCH CENTER

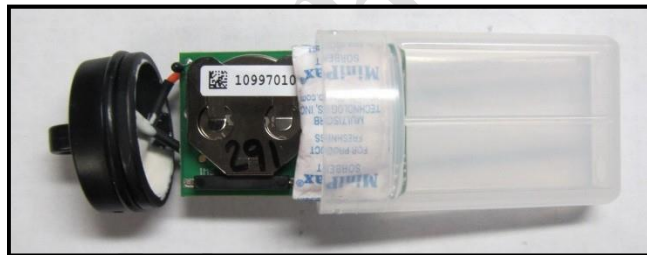
18. Apply a thin layer of silicon grease to the rubber O-ring on the cap. Firmly press the cap into the plastic housing and replace the two set screws. The data logger has now been transformed into a STIC.
