San Diego Association of Governments
Florida Canyon Habitat Restoration
Final Report
Project Period: 11/8/2018 – 11/7/2020
SANDAG Contract Number: 5005502

Terrestrial Revegetation - Site 1

Terrestrial Revegetation - Site 2

Riparian Exotic & Invasive Species Removal - Site 3

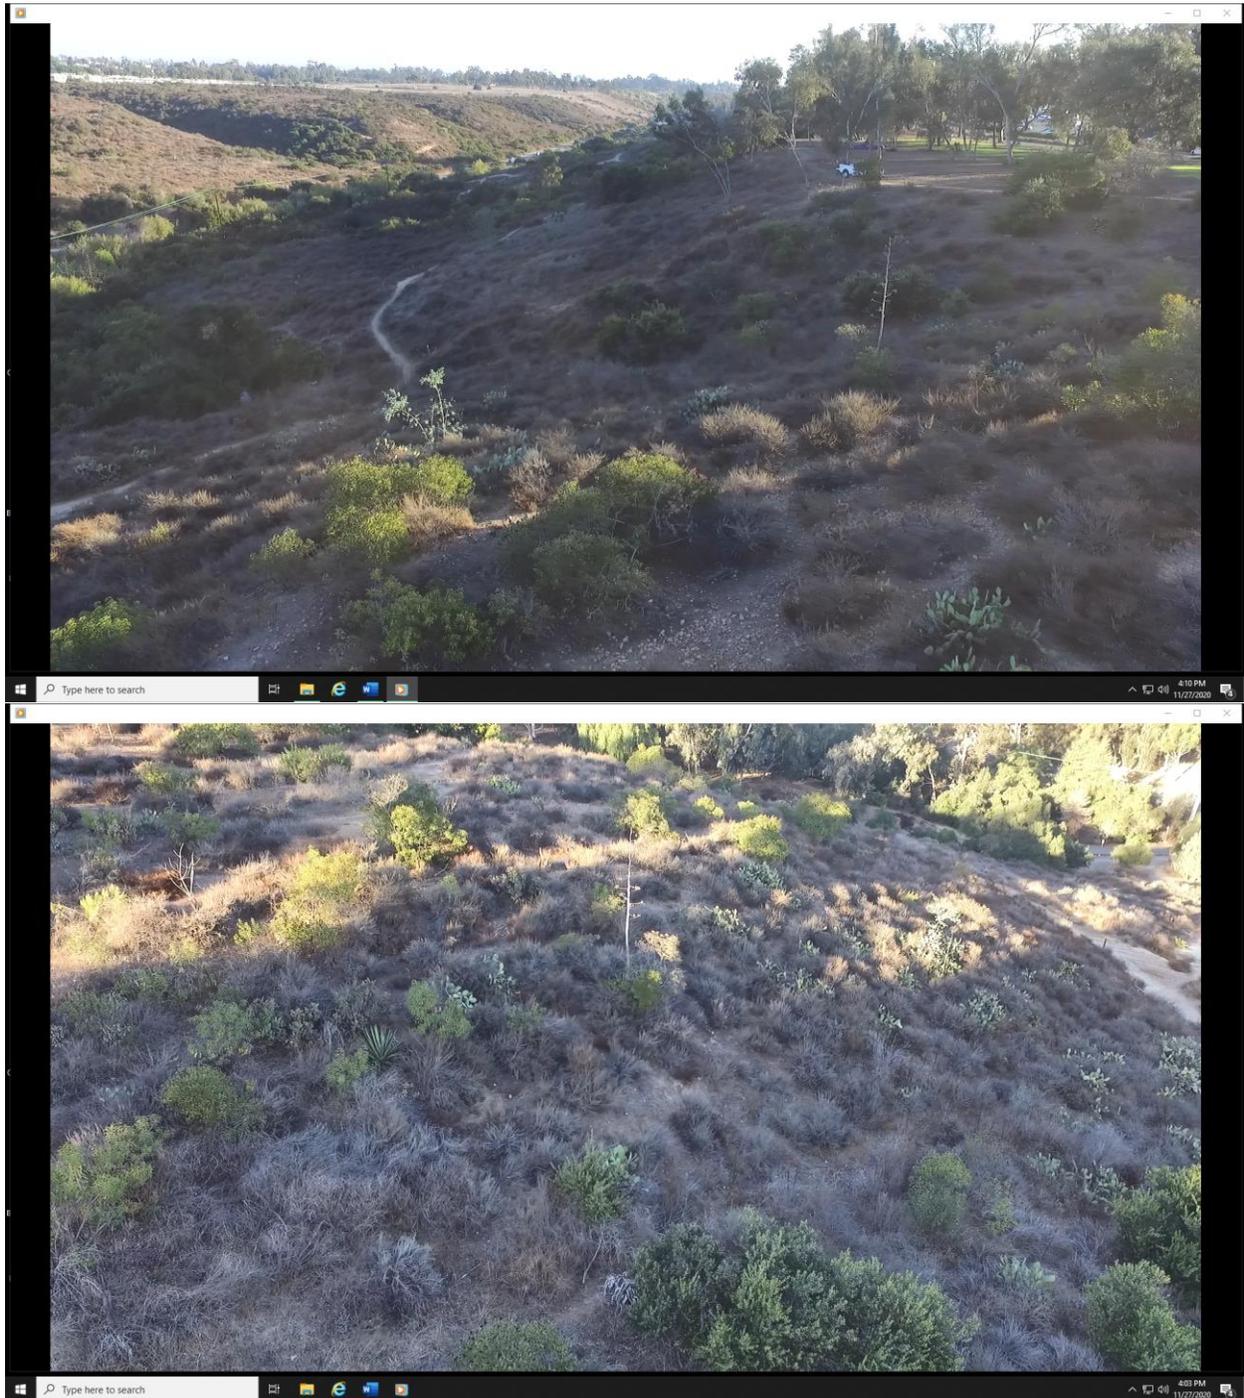
TERRESTRIAL REVEGETATION SITE 1:

November 2020 – Drone footage showing reduction in bare soil (increase in vegetation establishment).

The south-eastern area of the Site 1 is being filled in nicely by *Deinandra increscens* (tarweed), in the majority of the old trafficked rouge trails in the areas. The erosion below the sight was also not as heavy as years past and the continued growth will continue to retain the hydrodynamics down slope. The existing native plants in the site responded with significant growth from the seasonal winter and spring rains. The ability to control and manage the invasive weeds proved to be a significant step in the revegetation process. The native plants that were planted along the western banks unfortunately suffered a 65% mortality rate. However, the plants that were planted that did survive are becoming well-established and are connecting with established vegetation in the site.

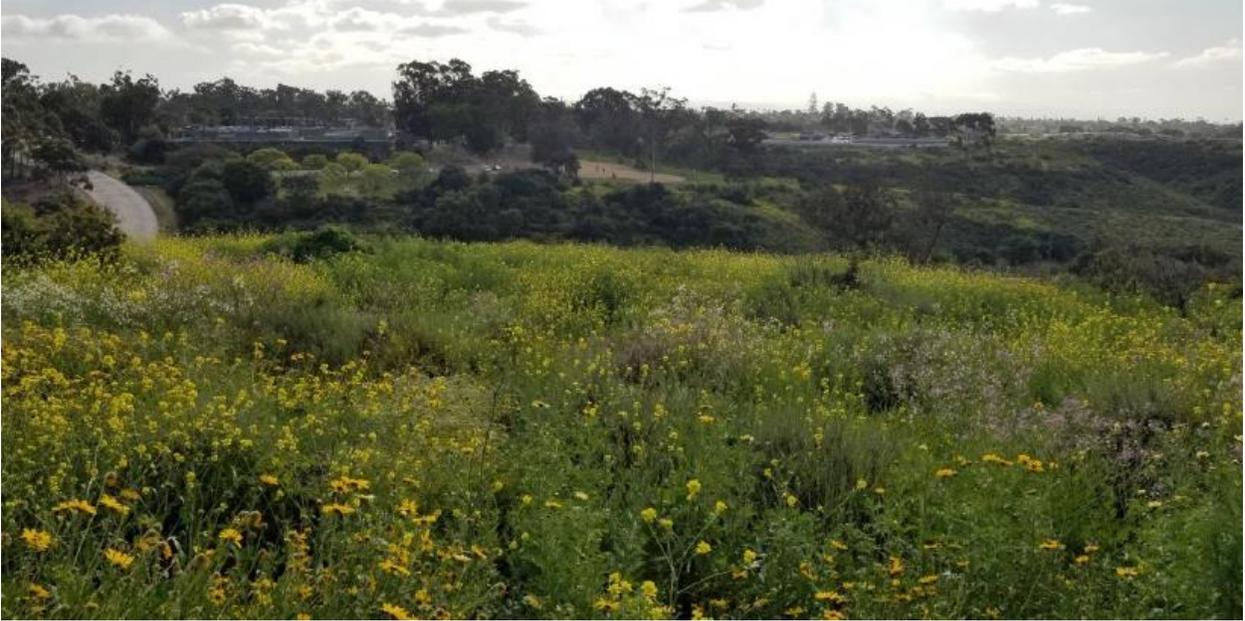
Terrestrial Site 1. Before restoration. Many Invasive species present.

Site 1 was the heaviest used site of the 3 restoration sites, and therefore needed the most pre-restoration work completed. The site was cleared of trash and debris prior to the start of restoration work. Fencing and signage was established around the site to secure it during work. Green lath fencing was originally used, though it was discovered by using hemp or cotton rope a perimeter could be established and managed easily. This site is adjacent to one of the most widely used encampment areas in the entirety of Balboa Park. The area was patrolled daily and constant repairs to the fencing took place.

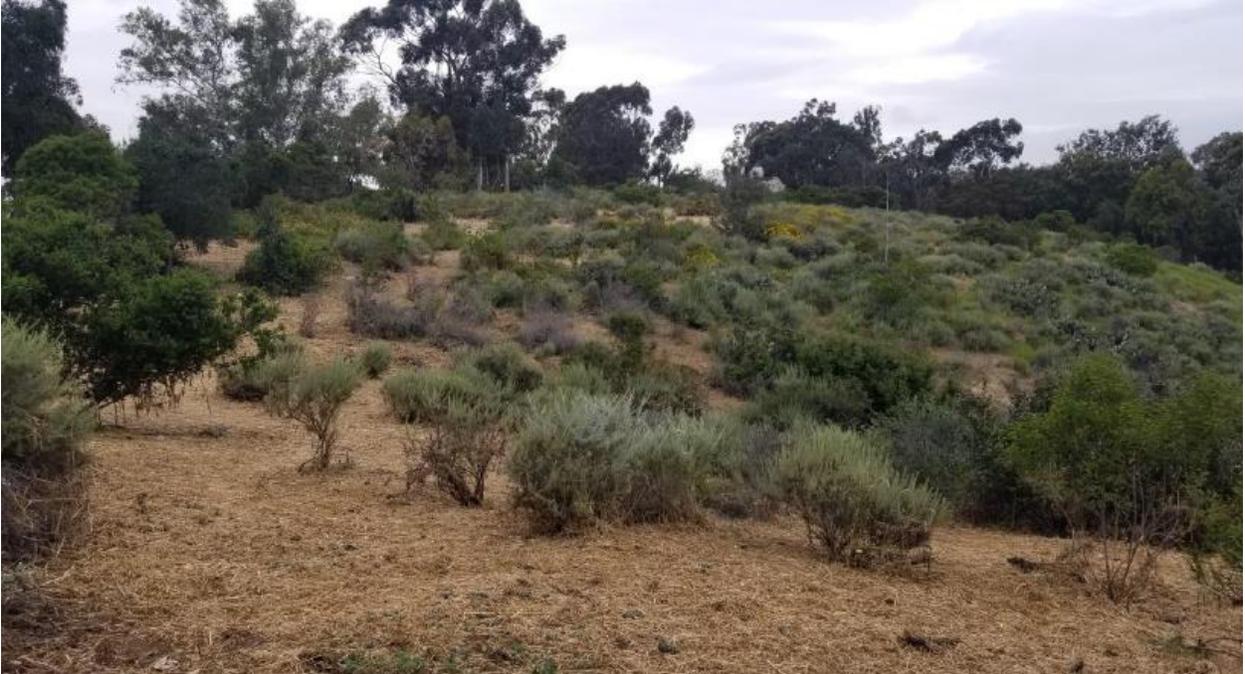
Terrestrial Site 1. After restoration.

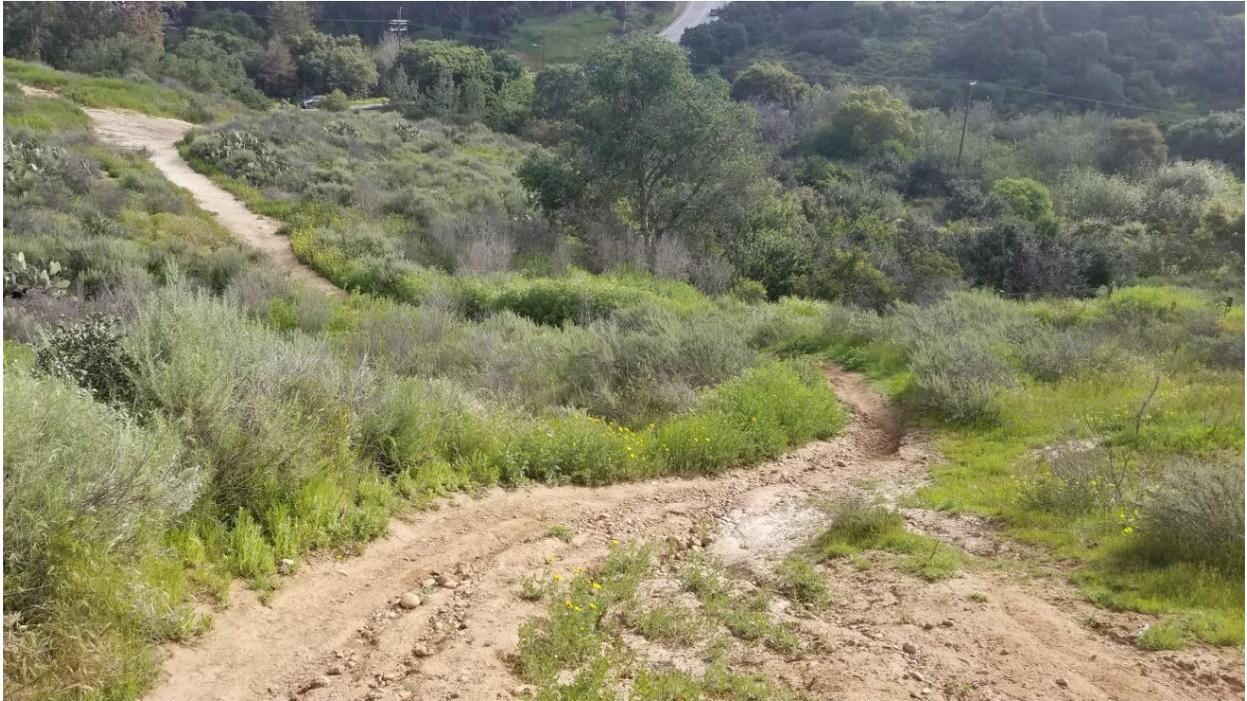
Terrestrial site 1- Before implementation. 2019.

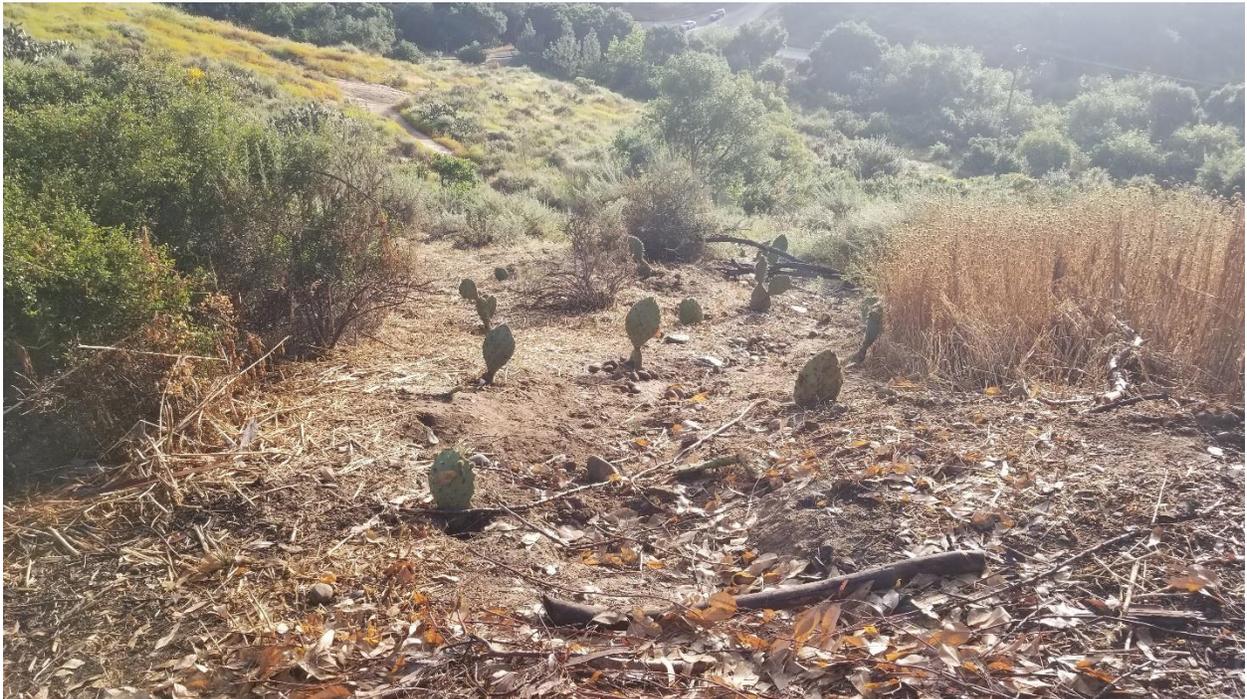
Terrestrial Site 1. Newly installed *Opuntia* cuttings. November 2020

Cactus cuttings were collected from the site in April 2019. Species collected from the site include coast prickly pear cactus *Opuntia littoralis* and coast cholla cactus *Cylindropuntia prolifera*. They would be allowed to scar for 7 to 10 days, then installed along with native plant container stock in strategic areas for revegetation, closure of rouge trails and erosion control.

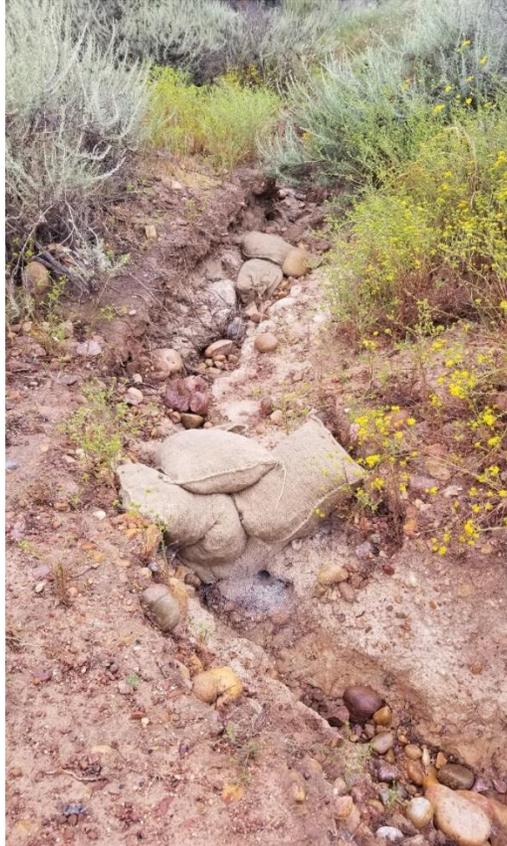
Terrestrial Site 2- view of erosion control measures & vertical mulch July 2019

Erosion sites were properly filled and leveled accordingly. Logs were used to help re-define approved trails adjacent to the restoration area. Vertical mulch was installed to control future erosion. Native plants that suit the restoration area were planted in the site. 200, 1-gallon container plants were installed & thoroughly watered in the entirety of the project. Fiber rolls, vertical mulch and gravel bag check dams were installed in addition to the plants. More recently, loose mulch (using chips

There has been significant growth in and around the large erosion pattern identified in Site 2. As well in this site, the natural vegetation growth has been aided by the routine weeding. As this area has larger sections of hard-pan soil exposed, there was concern regarding the establishment of native vegetation, however, the native plants that did take are establishing themselves just fine. The erosion pattern also had a considerable amount of checks and retention installed to prevent further erosion.

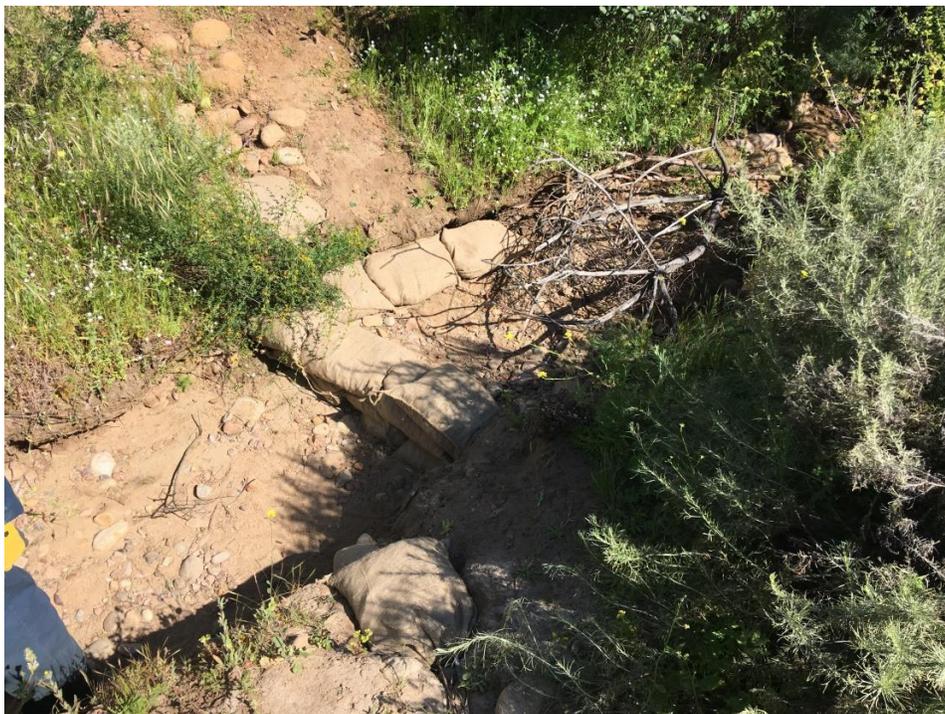
Terrestrial Site 2- view of erosion control measures & vertical mulch – July 2019

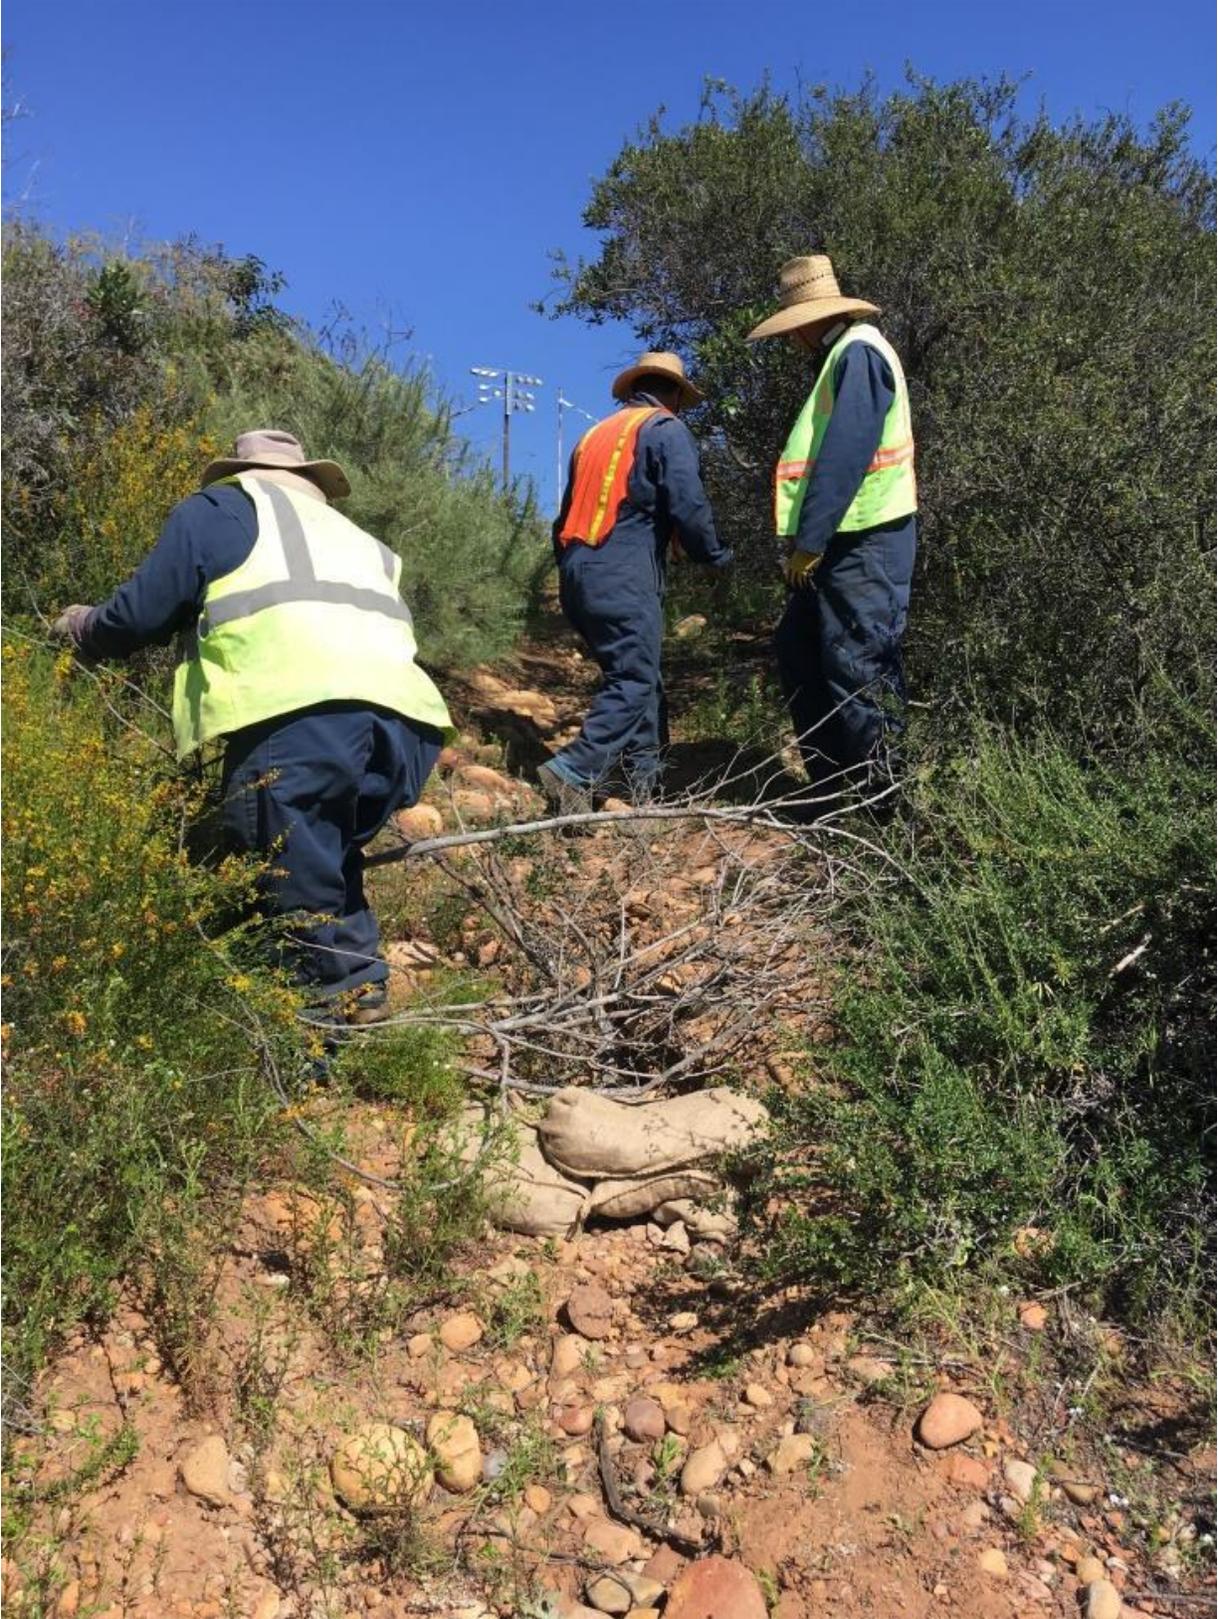
Representative view of gravel bag check dam & vertical mulch. July 2019

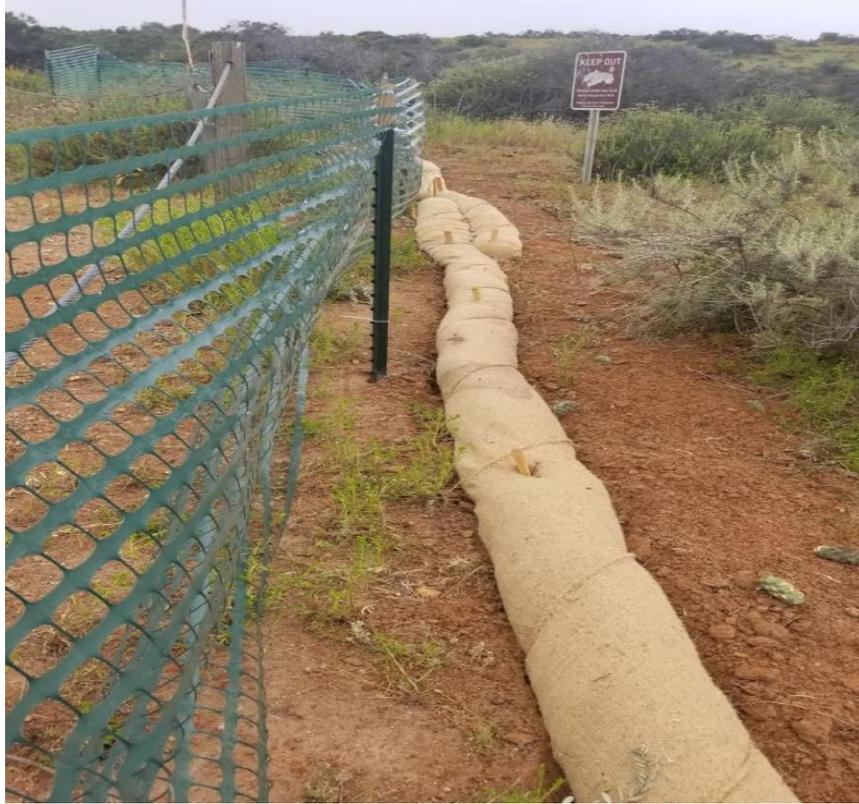
Representative view of installed fiber rolls July 2019

from fallen trees that are not eucalyptus) was utilized after having problems with rodents tearing through fiber rolls that were used initially; mulch spreading at eroding sites helps to combat the problem.

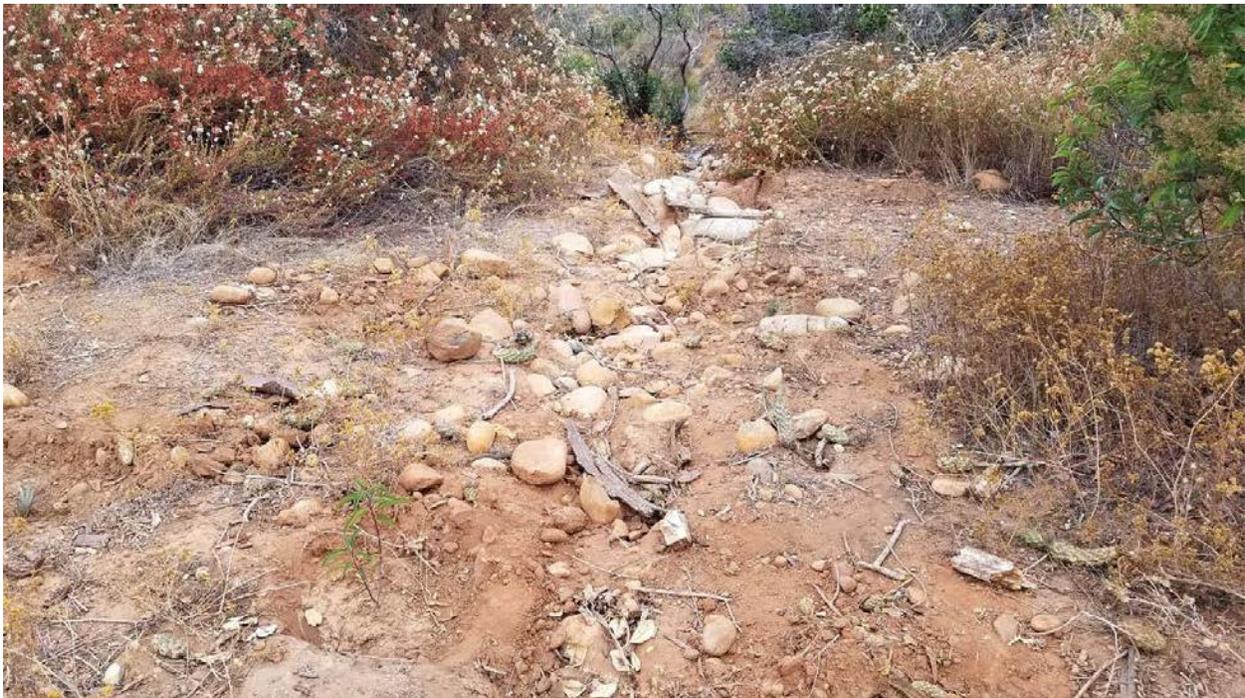
New plants becoming established 2020.

The erosion measures that were put in place limited the significance of the erosion of Site 2. Some of the plants that were planted in Site 2 were having a hard time establishing themselves due to the exposure of the hard-pan soil at the top of the slope. However, the ones that are thriving are decreasing access to area both physically and visually. This area had a much lower mortality rate than Site 1. The fencing and signage in place had significantly minimized off-trail use on the main erosion feature. However, it was noticed that other sections that parallel the erosion started to develop. A ranger was able to increase enforcement, and erected additional signage to mitigate this issue. The success of this area is just as noticeable to the unaided eye as in Site 1.

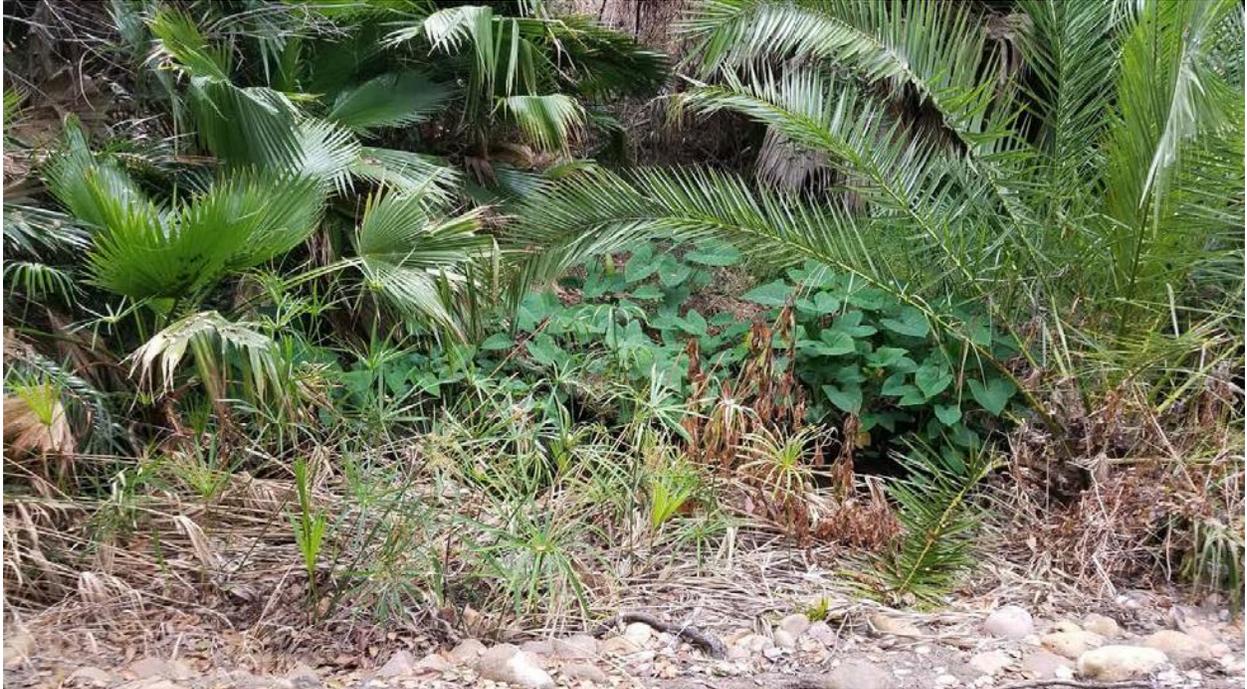
Riparian Site 3 - April 2019. Many exotic and invasive species present.

Non-native invasive species (NNIS) that had been identified were carefully removed from the restoration site. Targeted non-natives were treated with herbicide in the Riparian site. The Drill & Kill method was used to treat non-native trees in the Riparian site. Since removing many of the exotic and invasive species, there is more light that migrates into the riparian area and it has a better ratio of spread amongst the native willows and coastal live oak trees. Park Rangers have also noticed less invasive plants to the south of the micro riparian that connects hydrologically under Morley Field Drive. The wind is also allowed to flow through the area with less obstruction, and this enhances the intrinsic recreational experience in the area.

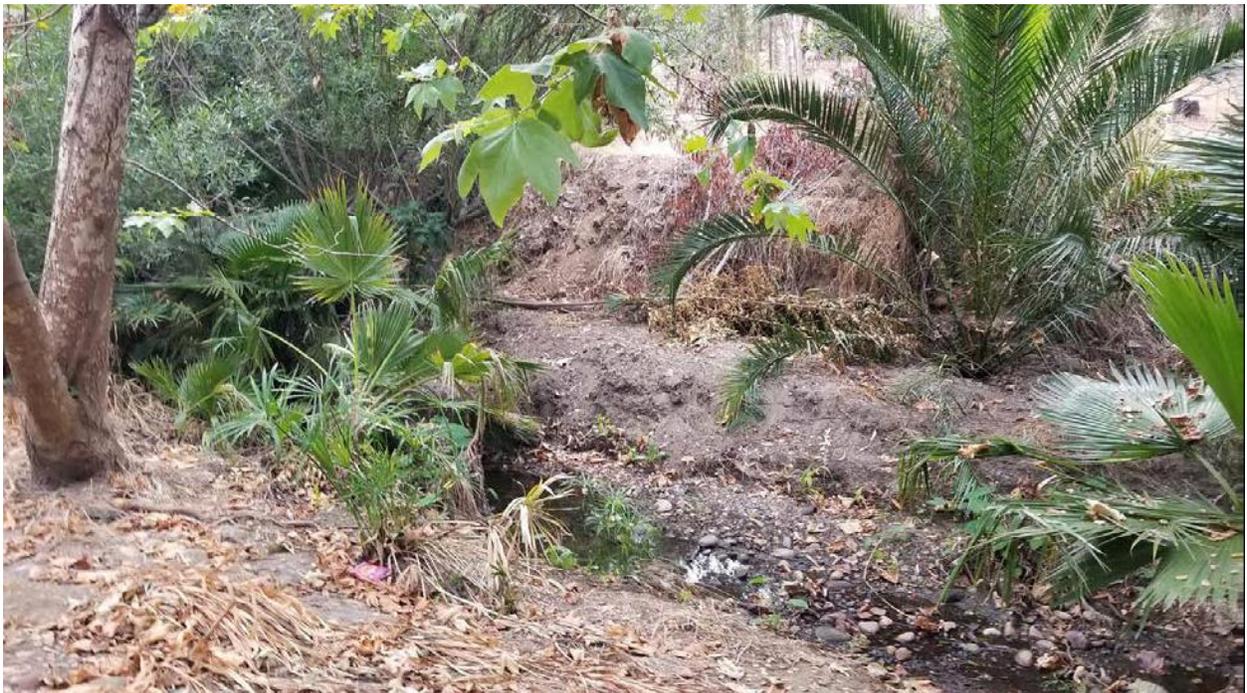
Riparian Site 3 - April 2019. Many exotic and invasive species present.

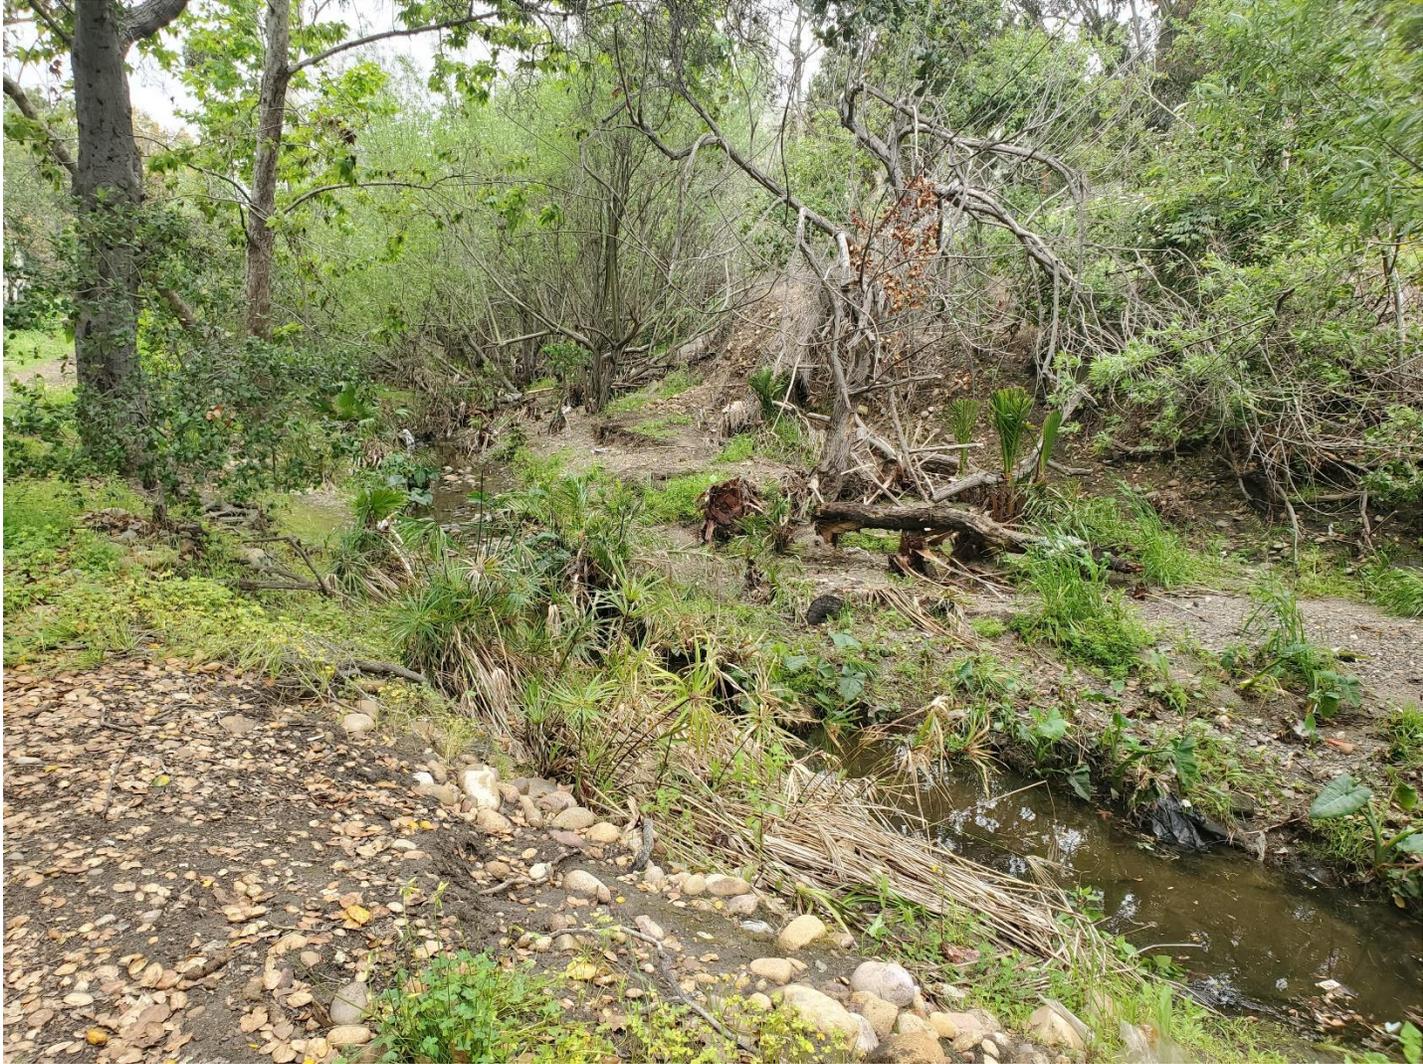
Riparian Site 3 - April 2019. Many exotic and invasive species present.

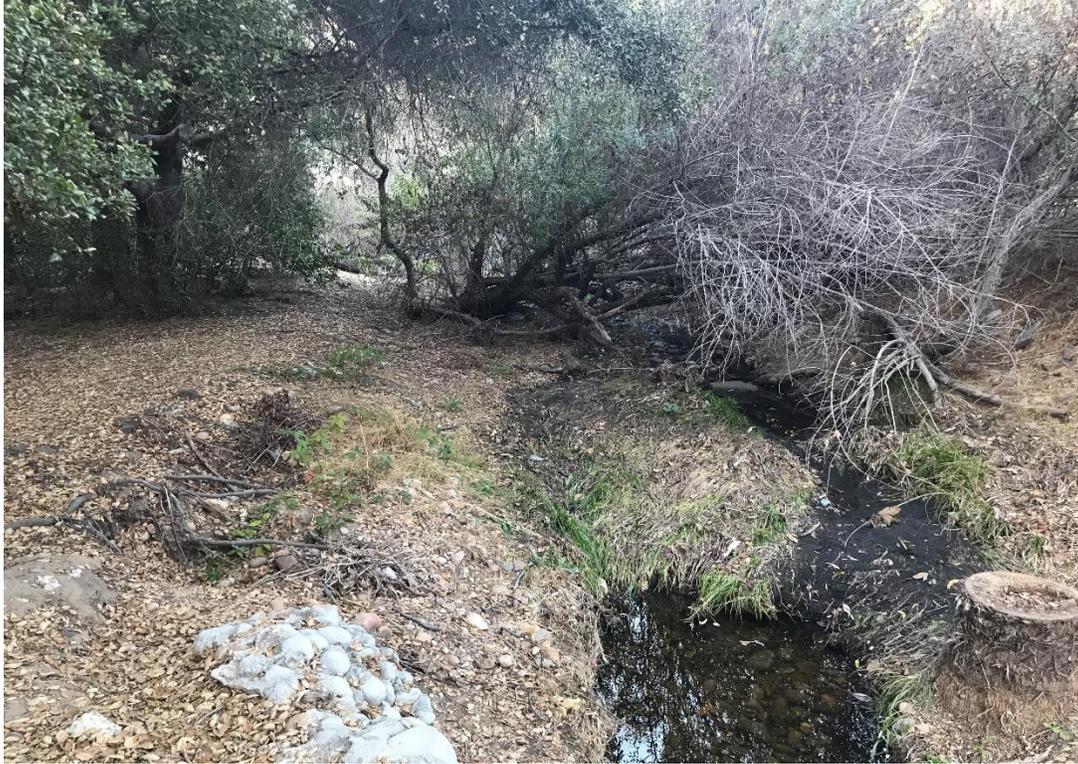
Riparian Site 3 – November 2020. Exotic and Invasive species removal.

Site 3, the riparian restoration site, has had significant improvement. The majority of the target exotic and invasive species have been removed or treated and are awaiting re-treatment. Although not part of the Grant funding, all the larger palm trees at the site have been removed by SDG&E contractors, and the smaller ones have been cut and have received initial treatment. The density of invasive plants during the COVID 19 gap of our contractor's ability to treat the site lent to a larger rate of spread of the invasive plants, since they were cut and treated last.
