**San Diego Regional Habitat Enhancement  
SANDAG *TransNet* Grant Agreement  
FINAL REPORT  
September 2015**

**Project Name:** San Diego Regional Habitat Enhancement

**Project Type:** Invasive species control and habitat enhancement

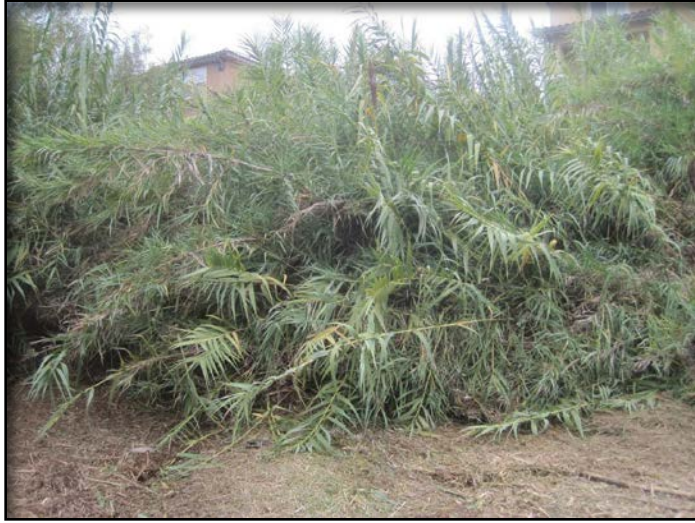
**Figure 1.** Stands of giant reed (*Arundo donax*) cause sediment buildup and create flood hazards potentially destroying property and putting lives at risk. Cal-IPC estimated one acre of giant reed can consume more than 20 acre feet of water a year (2011).

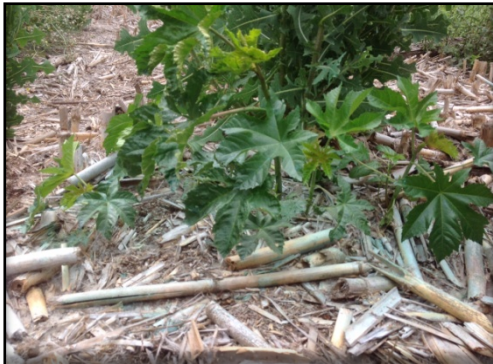
**Figure 2.** Castor bean (*Ricinus communis*) has been documented to contain a toxic chemical – ricin – which is fatal a certain dosages to organisms when consumed (Cornell University, ).

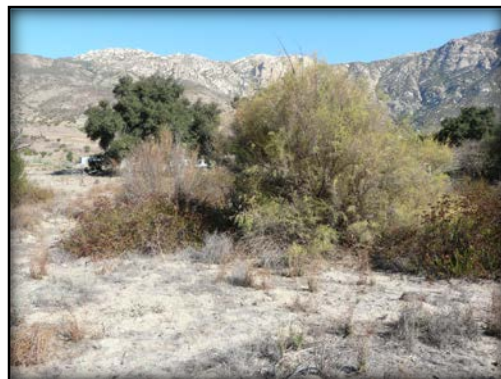
**Figure 3.** Saltcedar (*Tamarix* spp.) can withstand high alkaline soils, of which native species cannot, thus displacing substrate and habitat for sensitive species which rely on natives for nesting and foraging.

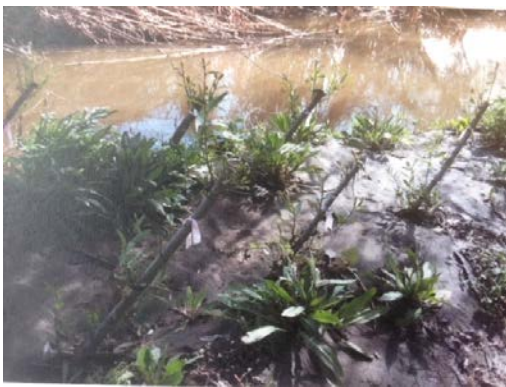
**Figure 5.** Additional follow up re-treatment was implemented and evidence of successful application is apparent for re-vegetation of willows.

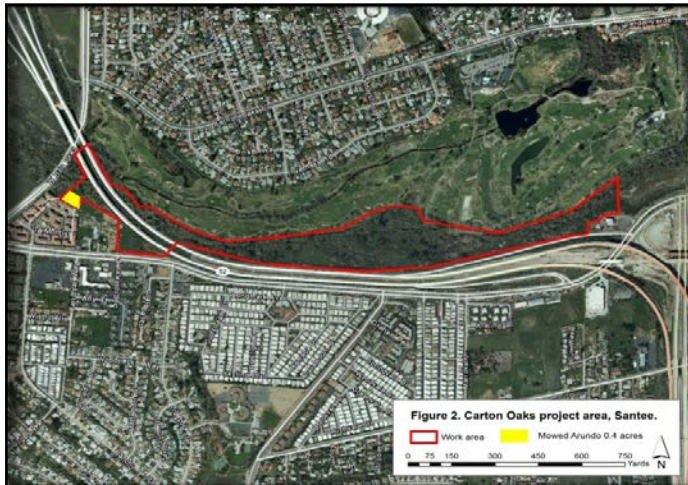
**Figure 5.** Carlton Oaks Project Area (Site A) located north of Highway 52 in the city of Santee, CA.

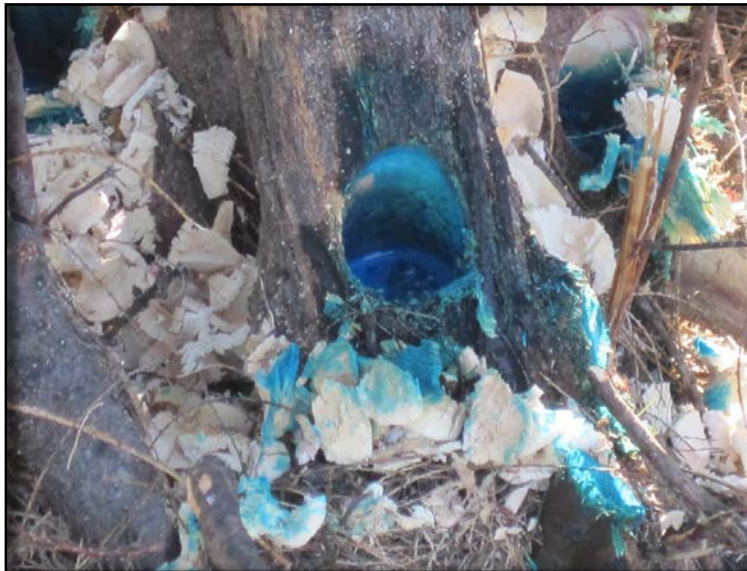
**Figure 10.** Drill and kill herbicide treatment. Pictured above is a saltcedar trunk, which was drilled and filled with and herbicide, reaching the root system eventually leading to plant death.

This site primarily needed biomass reduction and initial treatment – re-treatment was implemented as necessary. Different methodologies such as drill and kill (**Figure 10**) were species specific. Throughout the project timeline, this site was visited frequently following the terms of agreement to inhibit invasive non-native plant growth.

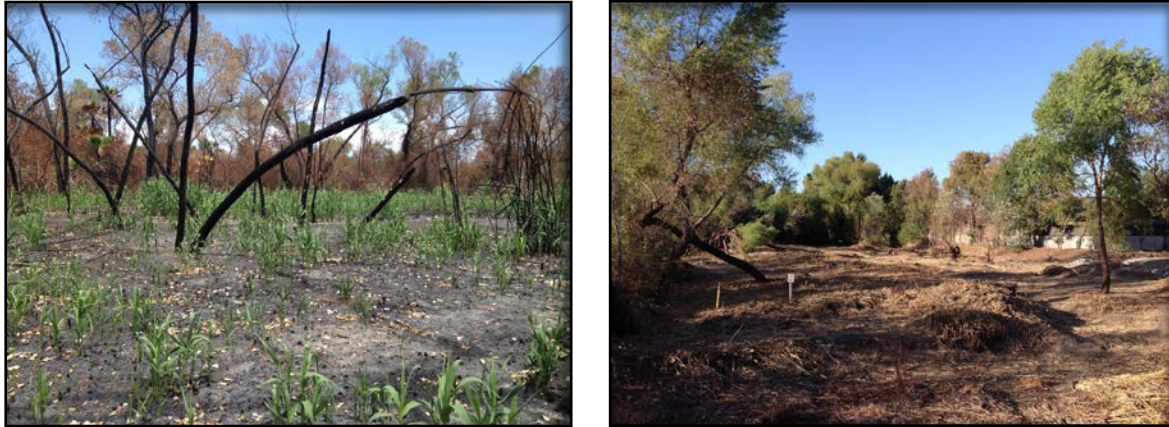
**Figure 11.** The figure on the left depicts a recent burn site (Mast Park West). Tree trunks were burned and ash left behind. The green sprouts in the foreground are invasive non-native giant reed prior to re-treatment. The figure on the right is Mast Park West (post fire) with nearly 100% native vegetative cover.

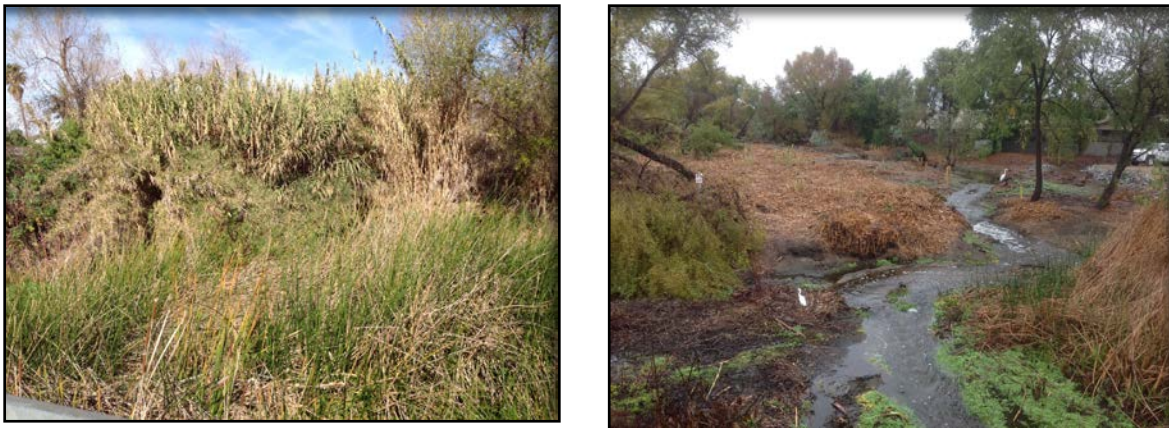
**Figure 12.** Sycamore Creek before (left) and after (right) biomass and treatment. The stream bed was not visible through the thick brush prior to removal.

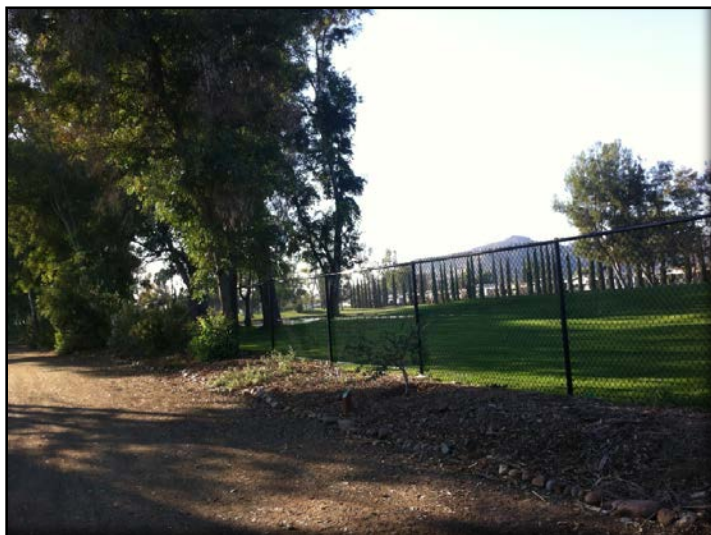
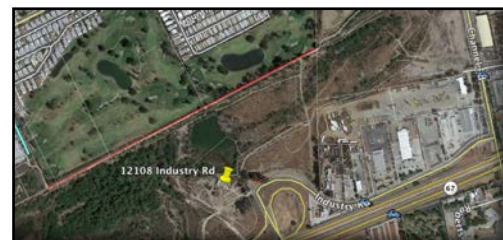
**Figure 13.** Fencing installed at Santee, CA demonstrates how the project constructed fencing to prevent access by the public. The figure on the right is a location reference of the image on the left. Not only were there chain link fence, but in certain locations lodge pole fencing was installed as visual enhancements.

Lakeside’s River Park Conservancy (LRPC) led efforts for fencing to better focus the access control. LRPC installed up to 6,200 linear feet of lodge pole fencing and 3,500 linear feet of 9” gauge chain link fence to control access to habitat areas along the San Diego River. **Task 2** also included maintaining fencing in working condition for three years post installation.

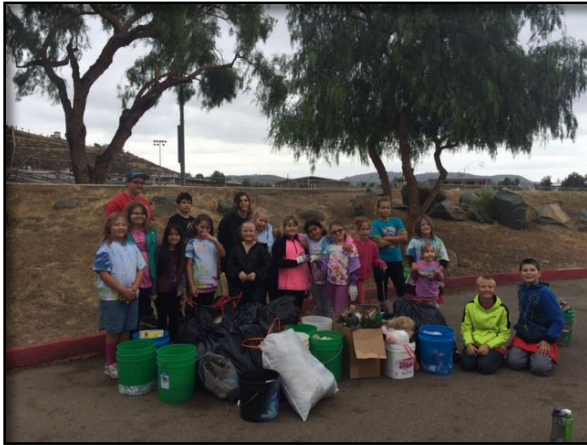
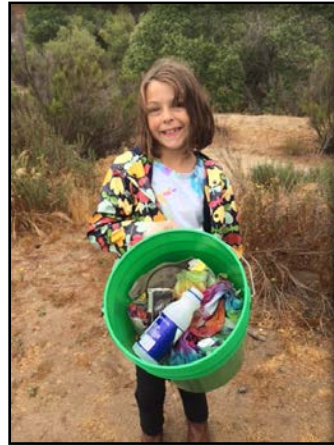
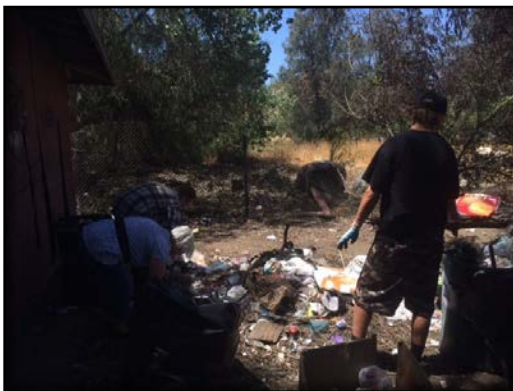
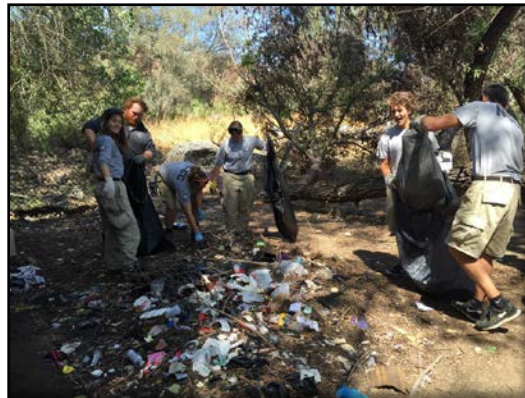
**Figure 14.** River park patrol and cleanup at various sites were not limited to trash pickup, but also included moving encampments offsite. Participation of a broad range of participants from youth to adults addressed critical issues to restoring the riparian habitat such as land disturbance and human induced debris.

These efforts removed up to 10 encampments where transients often left behind trash including furniture, tents, bicycles, carts, clothes, personnel items, camp stoves, cooking areas and increased the potential of spreading fires to public parks and private residences.

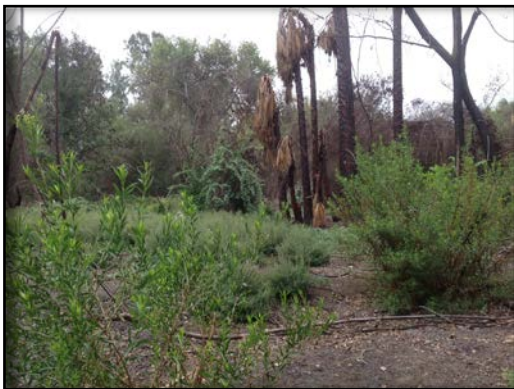
**Figure 15.** Site A after biomass removal and re-treatment. Native vegetation is present in the background with willows and shrubs thriving re-emerging in the foreground.
