Cactus Baseline Survey Report

San Diego Management and Monitoring Program (SDMMP)

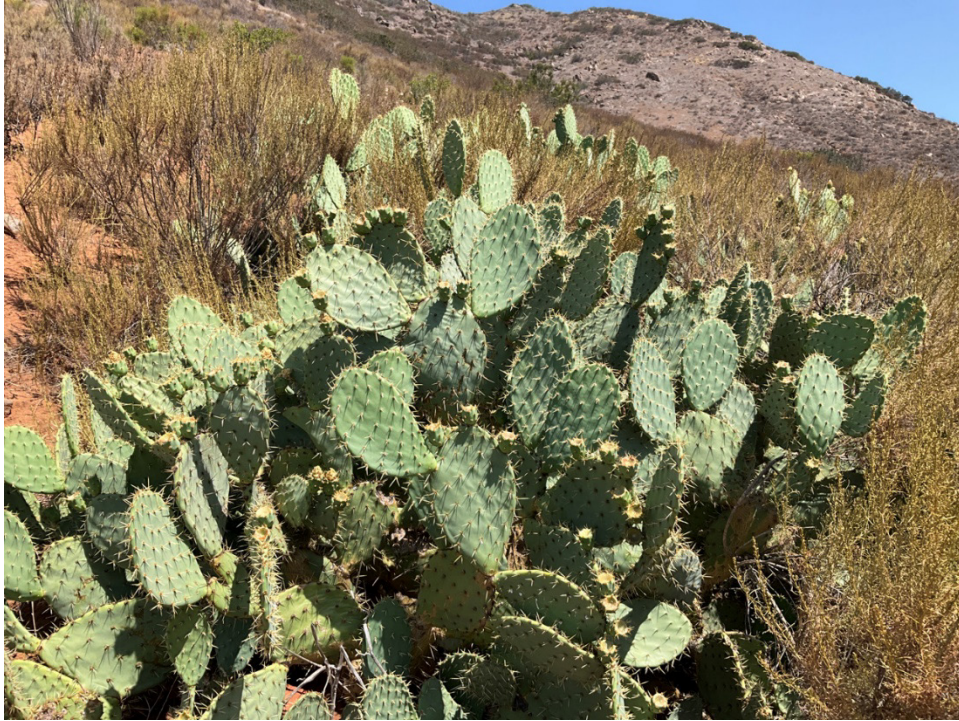
Photograph 3. Representative photo of healthy Source population observed at Bernardo Mountain survey area.

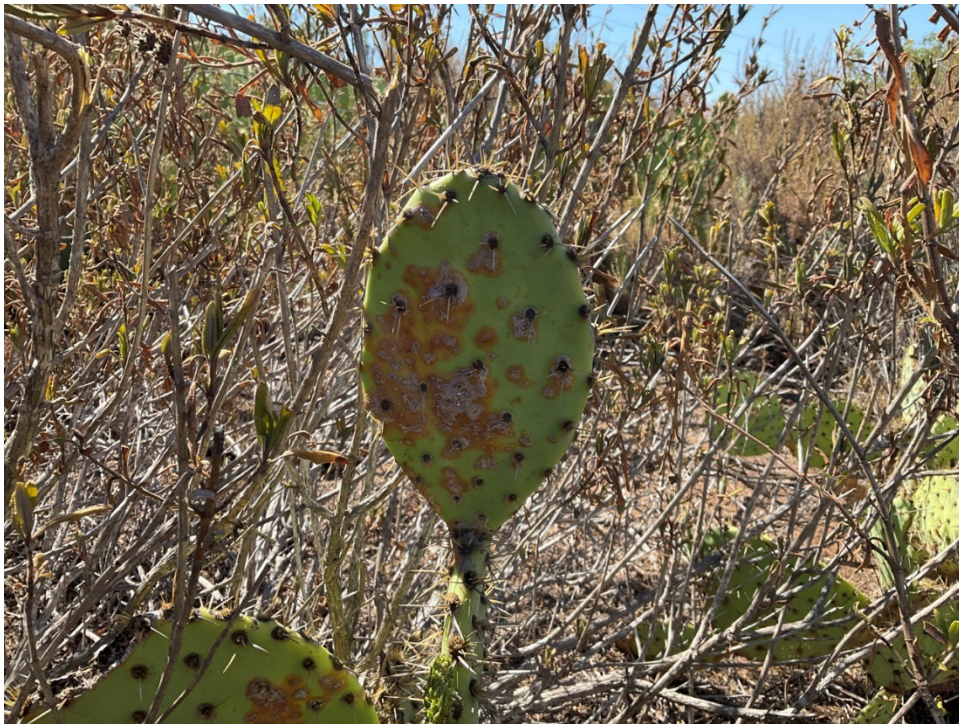
Photograph 4. Representative photo of symptomatic cactus in Bernardo Mountain survey area.

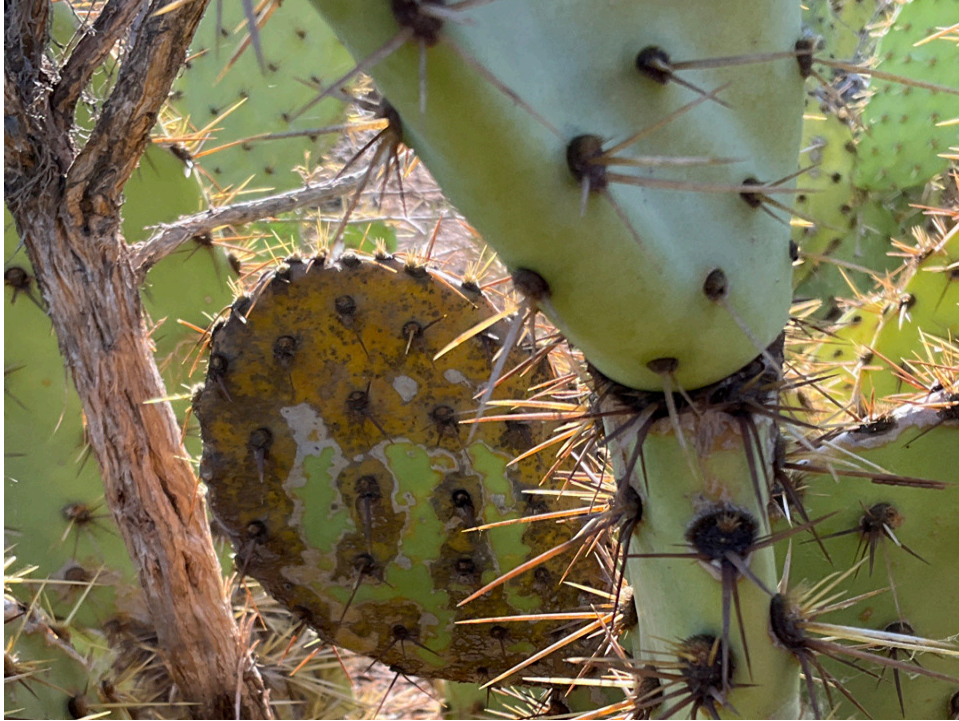
Photograph 7. Representative photo of symptomatic cactus observed at Bandy Canyon survey area.

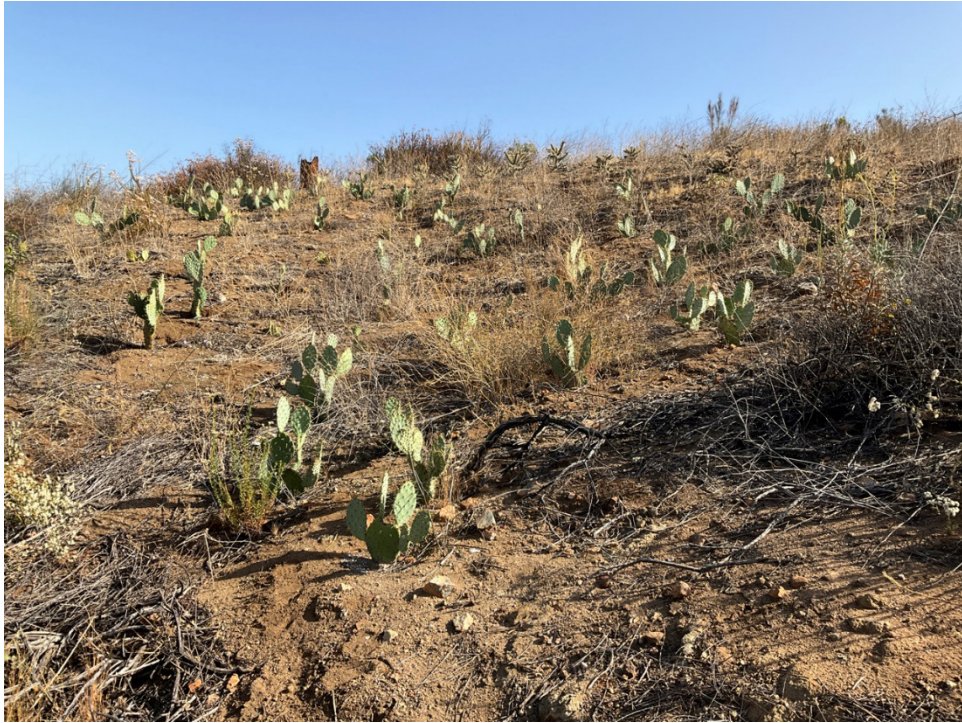
Photograph 8. Cactus Nursery Out-planting population at Woodridge Preserve survey area.

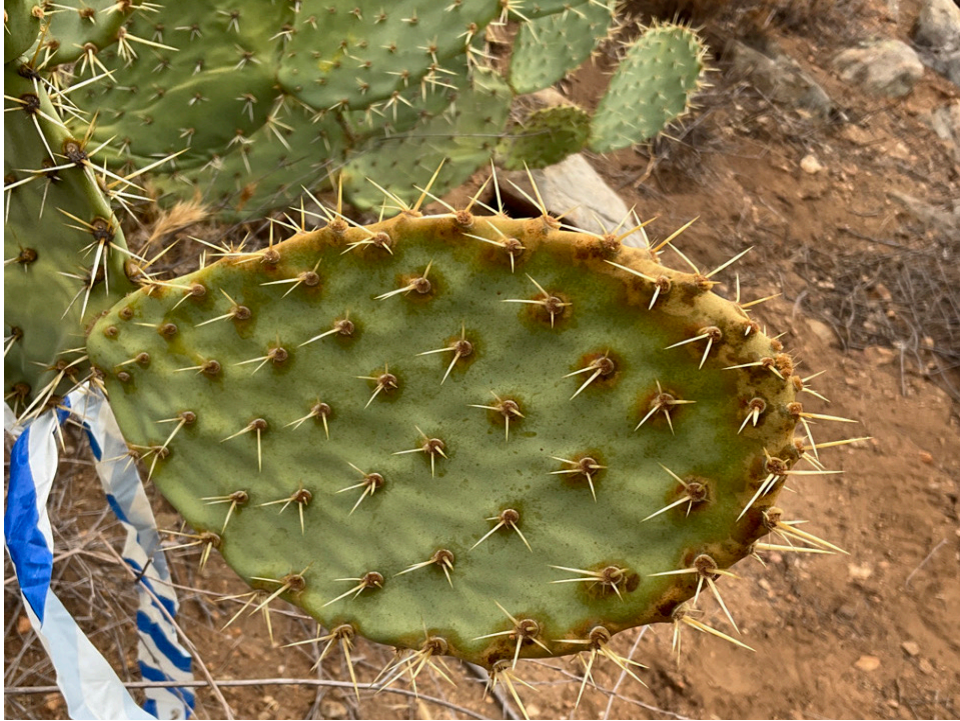
Photograph 9. Representative photo of symptomatic cactus observed at Woodridge Preserve survey area.

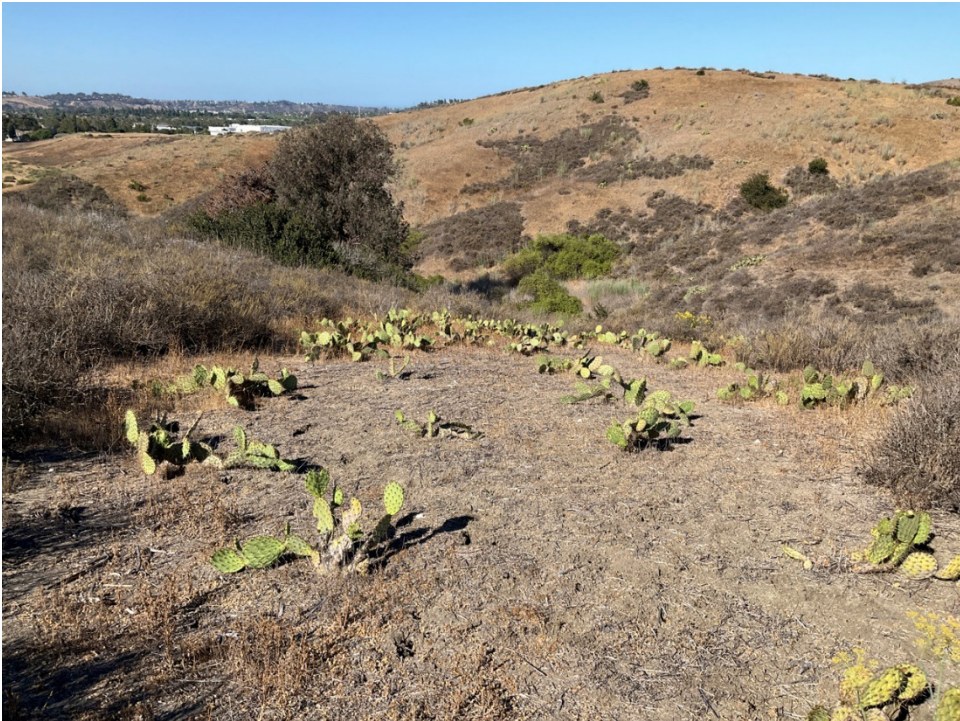
Photograph 10. Cactus Nursery Out-planting population at Whelan Ranch Preserve survey area.

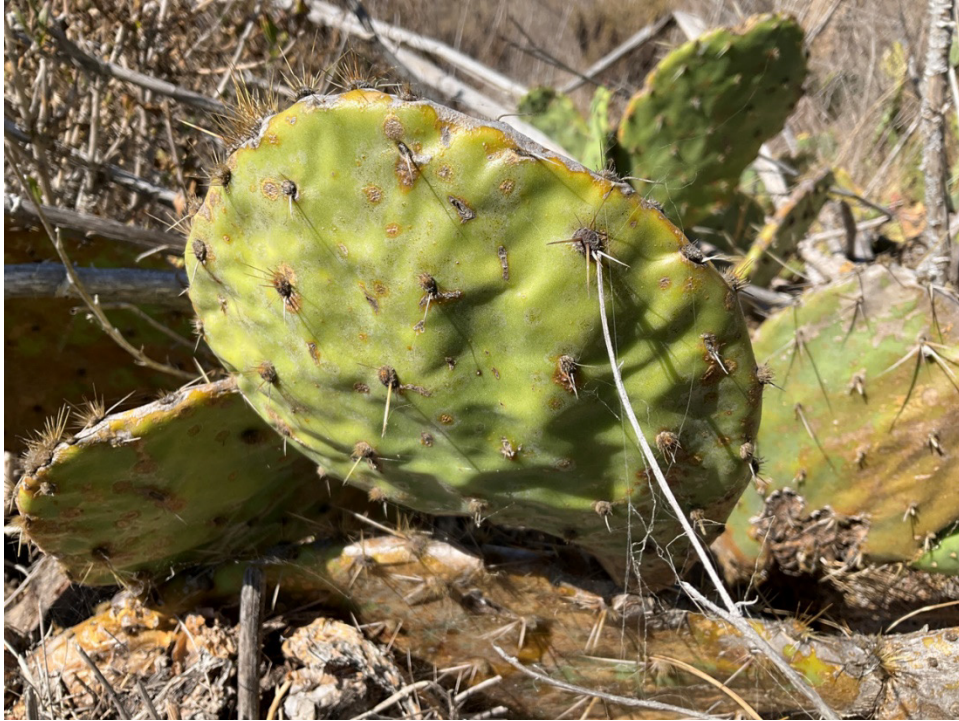
Photograph 11. Representative photo of symptomatic cactus observed at Whelan Ranch Preserve survey area.

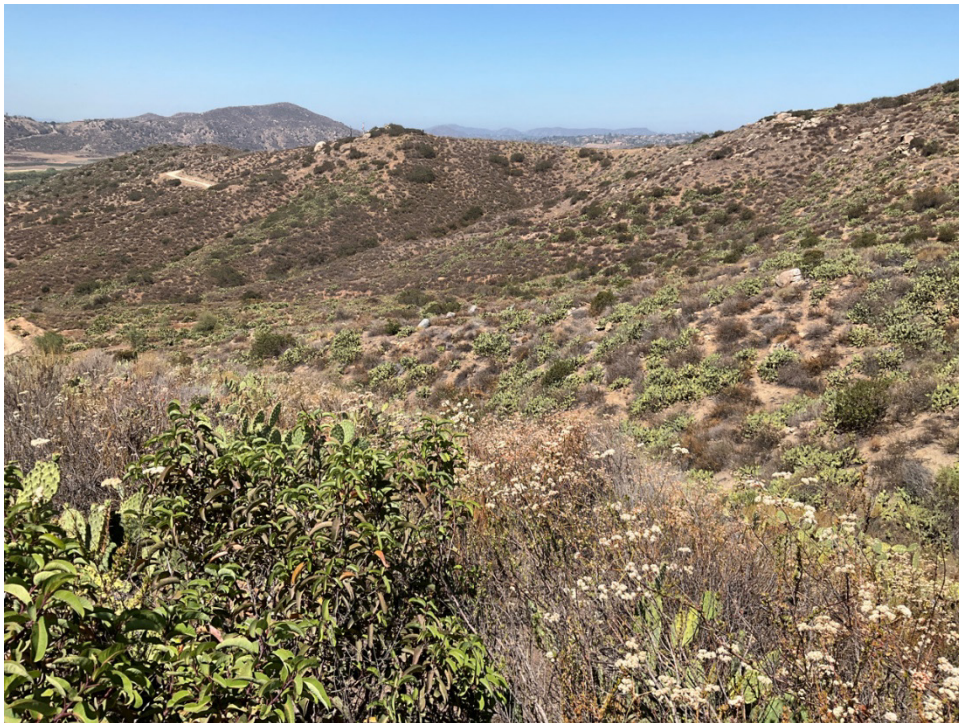
Photograph 12. Representative landscape level photo of healthy Safari Park Biodiversity Preserve population.

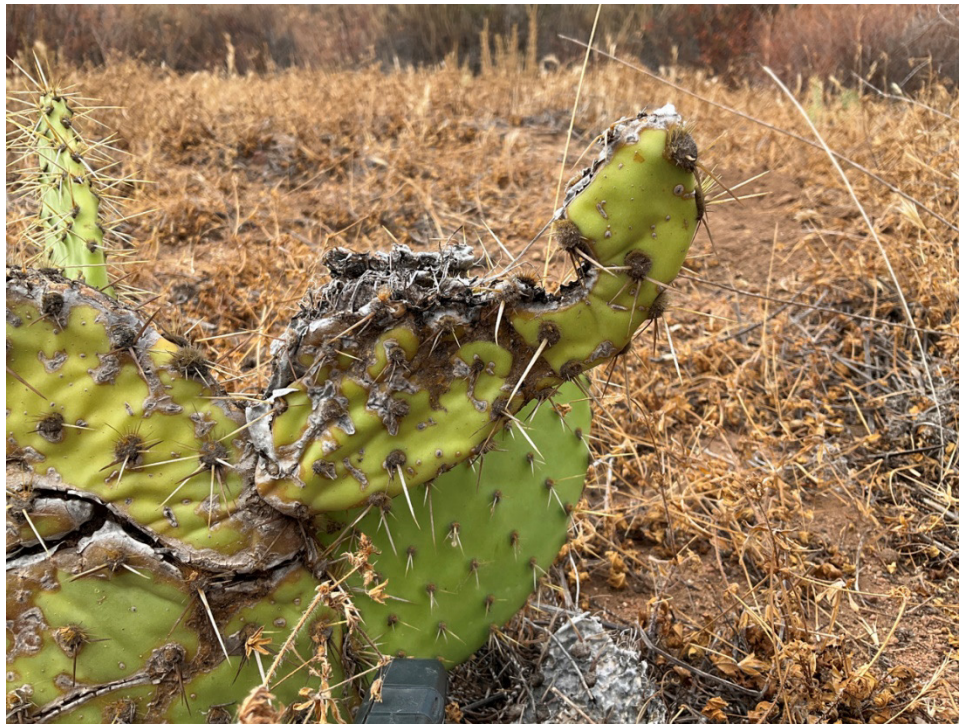
Photograph 14. Representative photo of symptomatic cactus showing advanced decay at Ysabel Creek Road survey area.

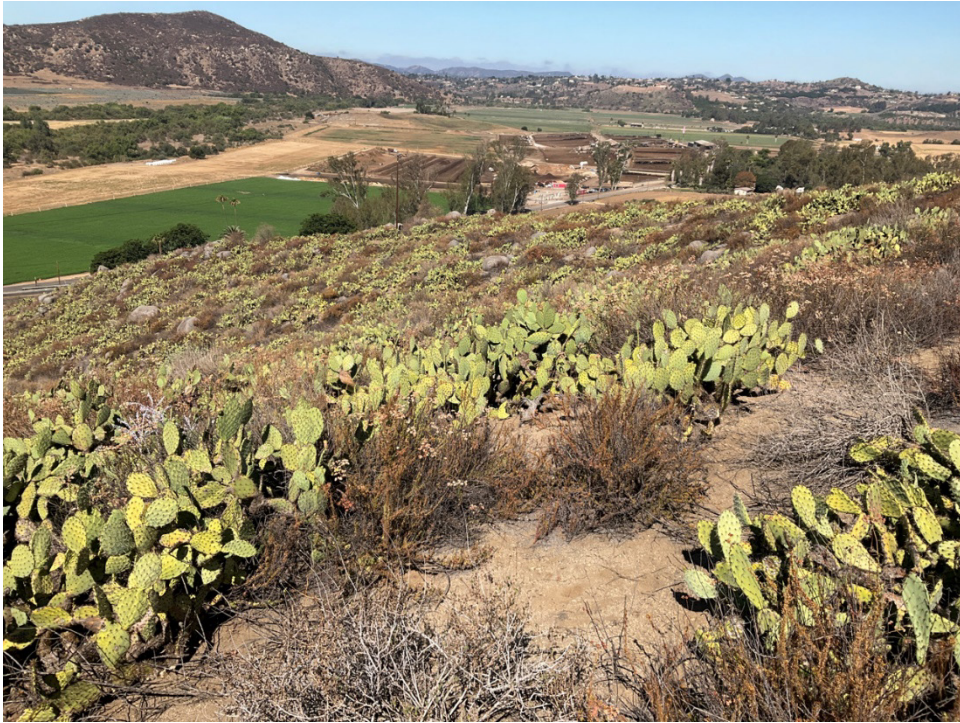
Photograph 15. Representative landscape level photo at San Pasqual Battlefield State Historical Park.

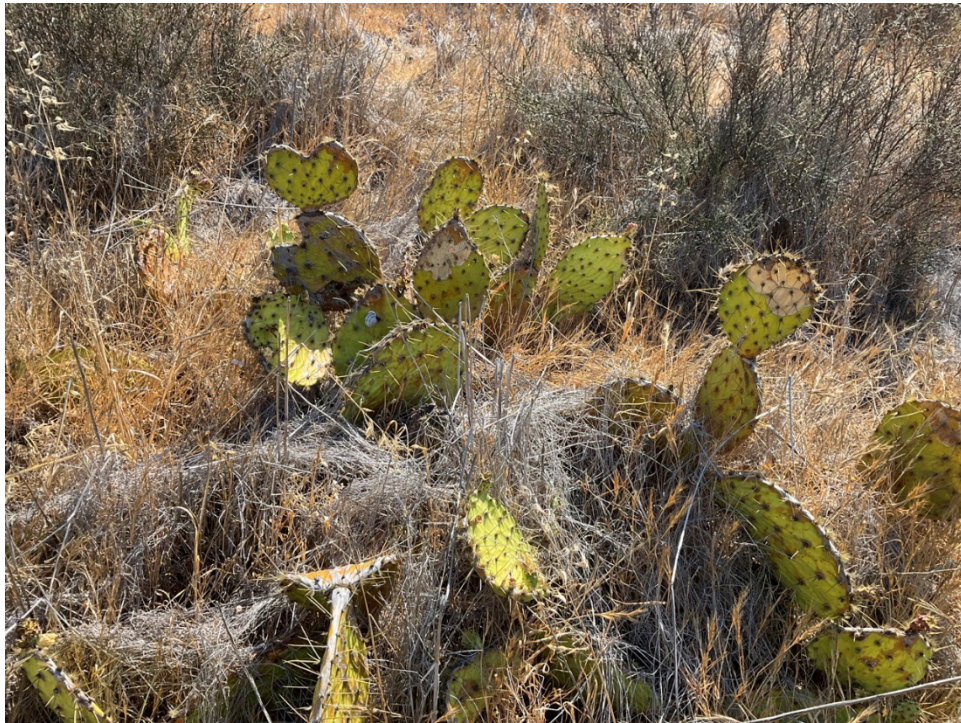
Photograph 17. Symptomatic Individual showing discoloration and rust-colored spots observed at Lusardi Creek County Preserve.

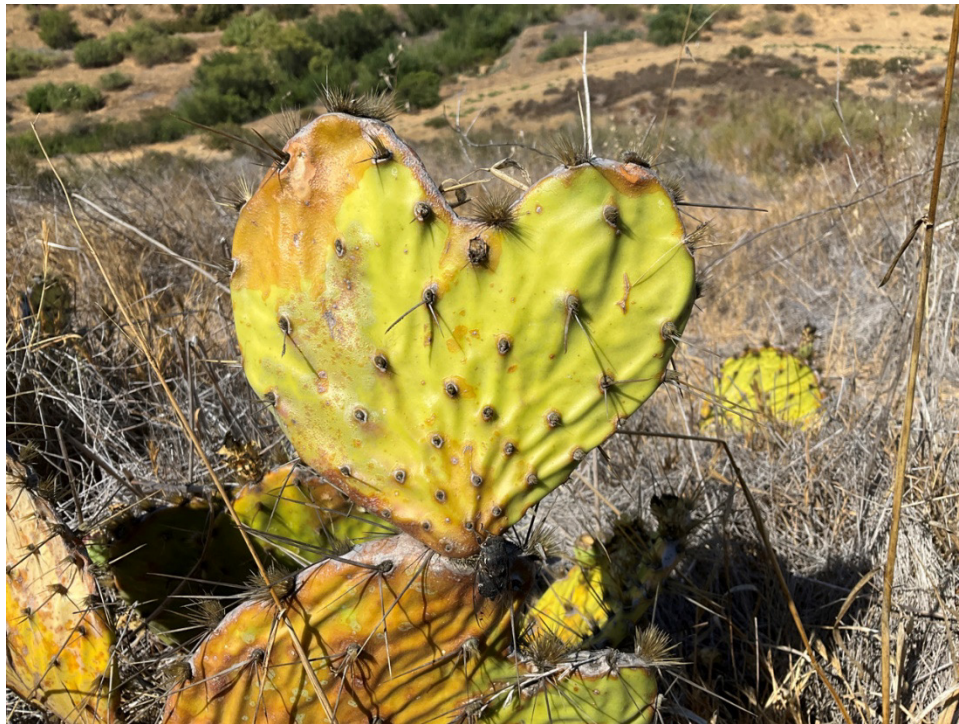
Photograph 18. Representative photo of symptomatic cactus observed at Lusardi Creek County Preserve survey area.

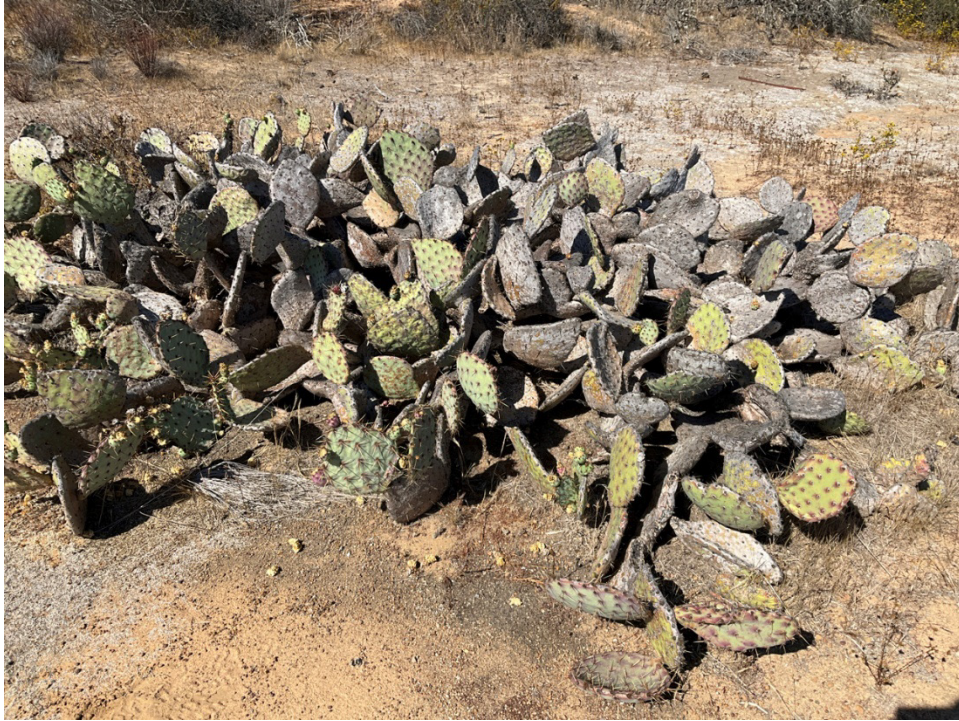
Photograph 19. Symptomatic and discolored cactus patch at Torrey Pines State Natural Reserve survey area.

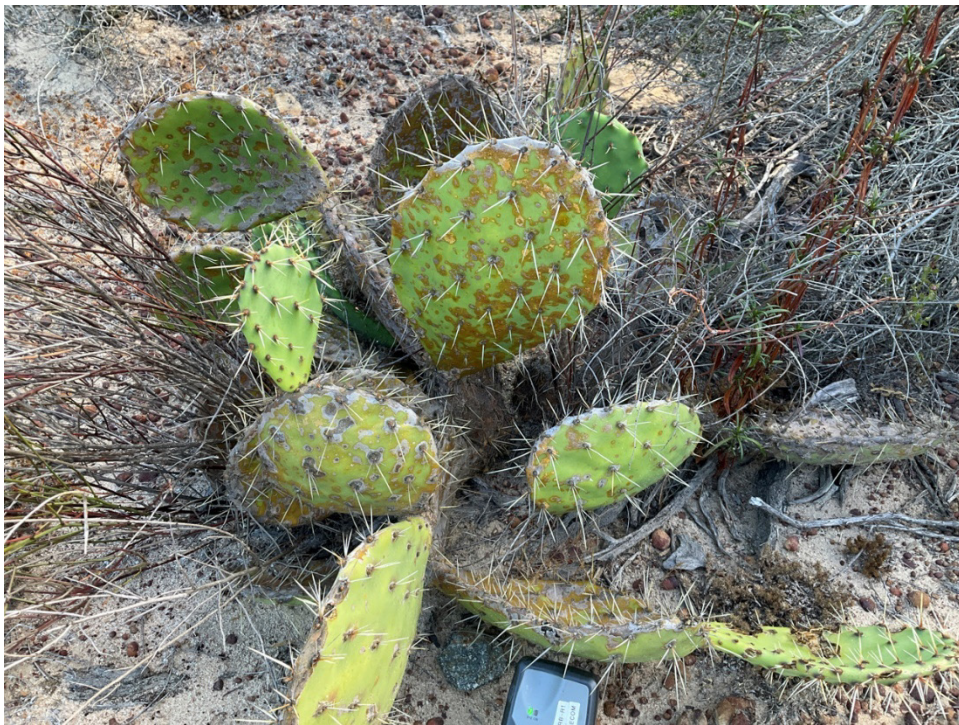
Photograph 20. Representative photo of symptomatic cactus observed at Torrey Pines State Natural Reserve survey area.
