**San Diego Association of Governments  
Otay Ranch Preserve Enhancement Project  
County of San Diego Department of Parks and Recreation  
Final Report  
Project Period: July 1, 2023 – August 13, 2024  
Submission Date: September 23, 2024  
SANDAG Contract Number: S1125469**

#### *Otay Ranch Preserve Enhancement Project (SANDAG Contract Number S1125469)*

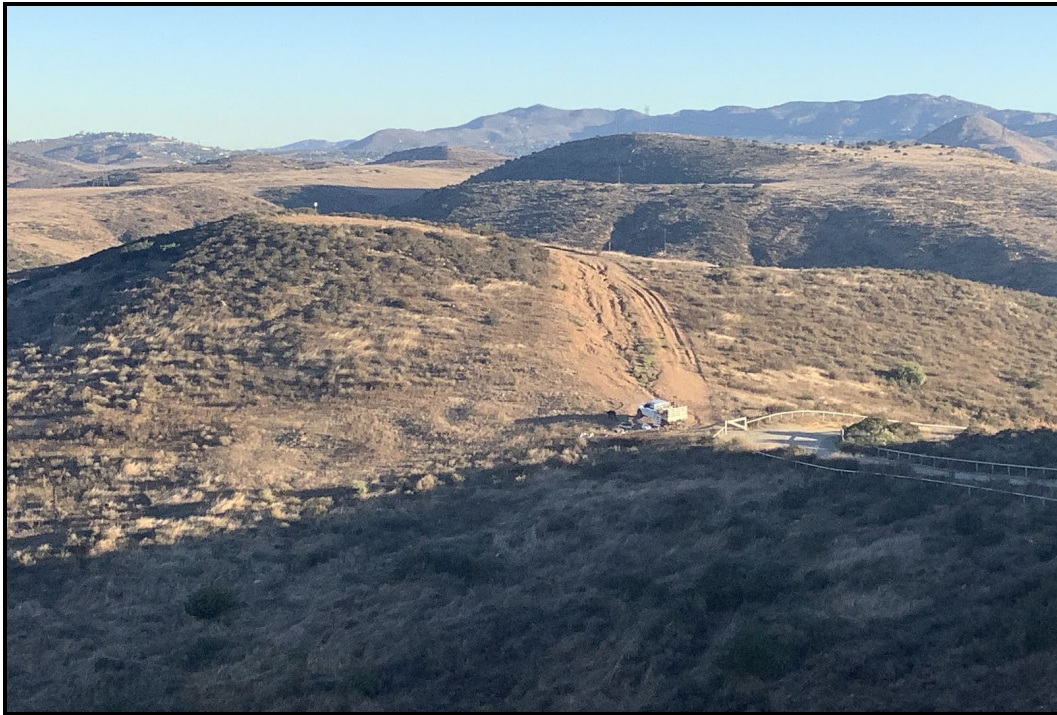
PHOTOGRAPH 1

Overview of the Project Site Prior to Implementation, October 4, 2023

scrub, chamise chaparral, and non-native grassland habitat with a dirt road that leads to a hilltop (Appendix A, Photographs 1 and 2).

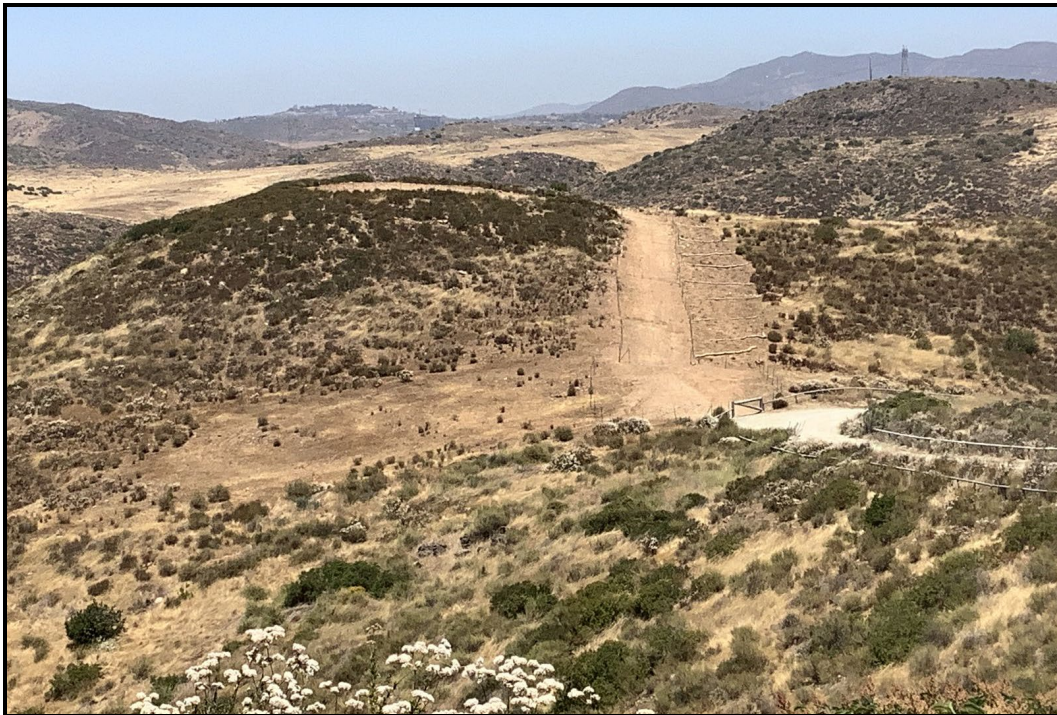
PHOTOGRAPH 2

Overview of the Project Site After Implementation, June 21, 2024

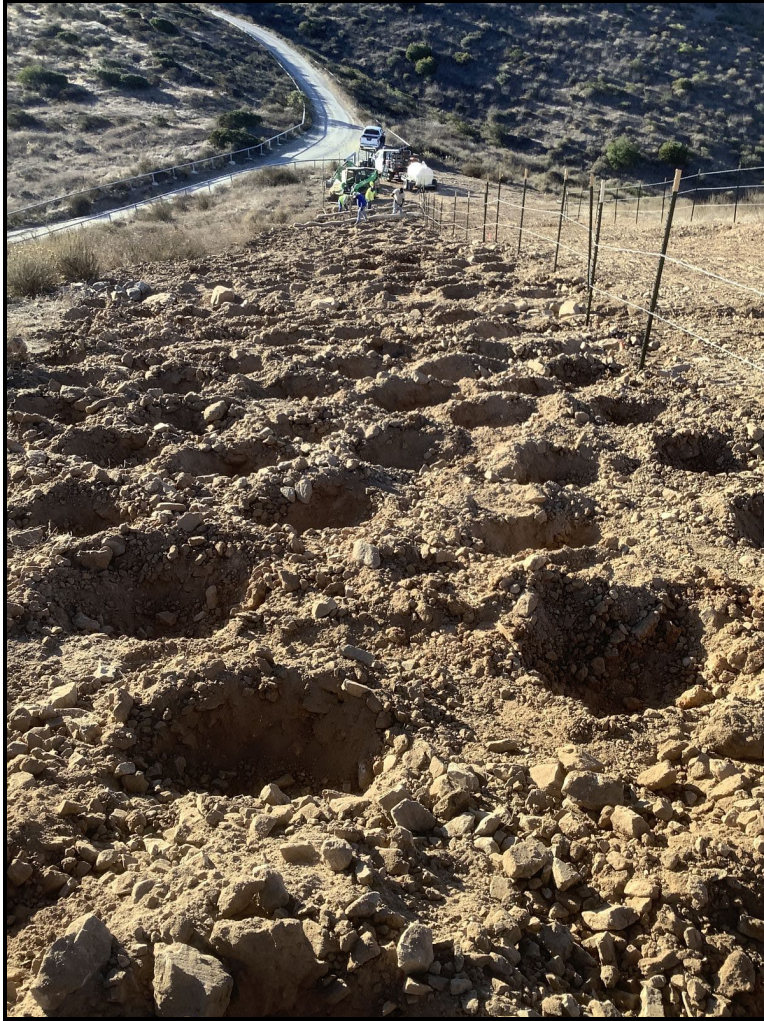
PHOTOGRAPH 3  
Holes Were Dug Prior to Planting, November 9, 2023

Starting on September 6, 2023, the project biologist began coordinating the purchase of plants and seed from Native West Nursery, project materials, and RECON restoration crew (field crew) scheduling. From November 6 through 9, 2023, the field crew dug 400 holes using a mini excavator to prepare for the installation of 1-gallon plants (Appendix A, Photograph 3).

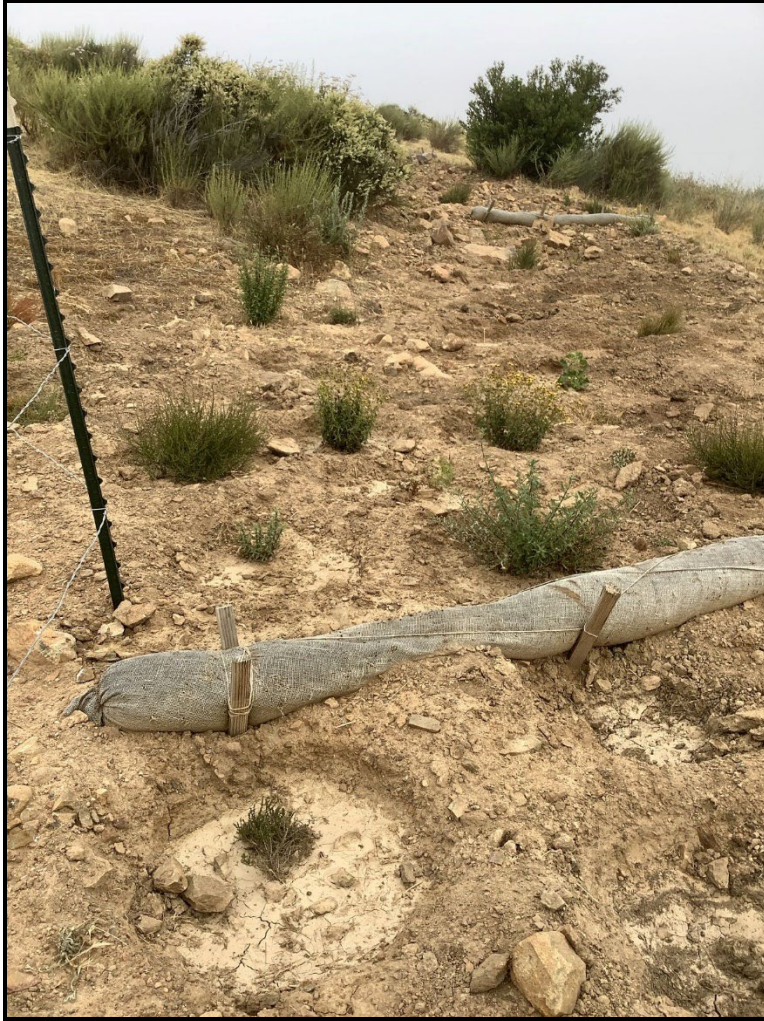
PHOTOGRAPH 9

A Section of the Slope with Healthy Plants That Were  
Installed Previously in Early December 2023.  
Photo Taken June 5, 2024

installed around the plants to deter herbivory. Appendix A, Photograph 9, shows a section of the slope with healthy plants that were installed previously in early December. On June 28, 2024, a RECON biologist conducted a site assessment to qualitatively assess the health of the installed plants.

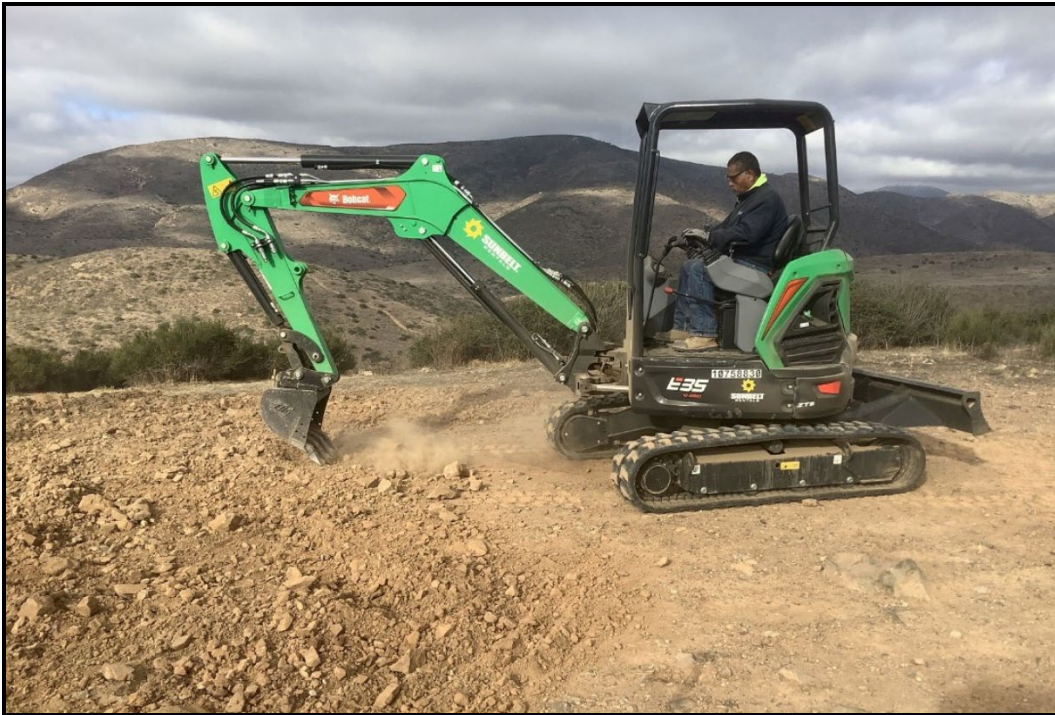
PHOTOGRAPH 10

The Mini-Excavator was Used to Scratch the First Few Inches of the Compacted Hilltop in Preparation of Seeding, November 7, 2023

On November 6 through 9, 2023, the field crew used a mini excavator to decompact the soil surface of the hilltop to prepare for seeding. The mini excavator was used to scratch the first few inches of the compacted hilltop (Appendix A, Photograph 10).

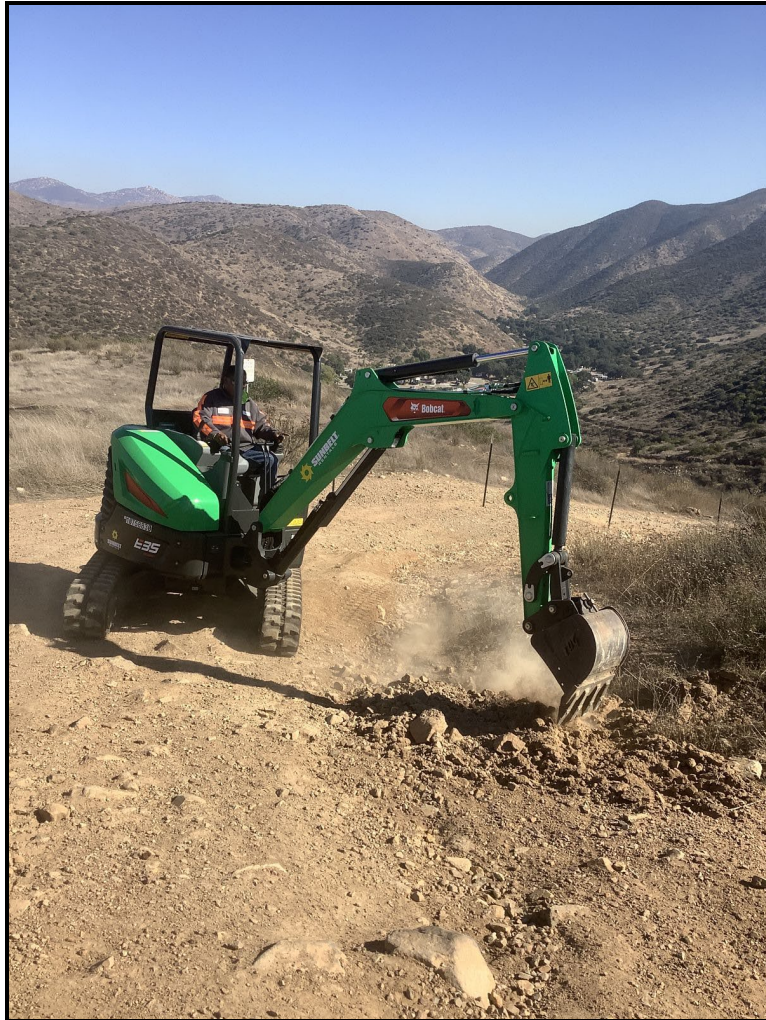
PHOTOGRAPH 21

The Crew Filled Ruts in Preparation for Grading with the Skid Steer, November 6, 2023

From November 6 through 9, 2023, the field crew recontoured the access road and filled in rills. A mini excavator was used to remove rocks and loosen the soil to prepare the site for grading with the skid steer (Appendix A, Photographs 21 through 23). The work area was wetted with a portable water tank to minimize dust and to prepare the site for compaction with the skid steer (Appendix A, Photograph 24). Water bars were created to direct the flow of water (Appendix A, Photograph 25). Appendix A, Photograph 26, shows the water bars and road after grading. The water bars located outside the road were lined with rocks to help direct and slow the flow of water, thereby reducing the potential for erosion (Appendix A, Photograph 27). Biodegradable wattles were installed to also direct the flow of water in areas outside of the road (Appendix A, Photographs 28 and 29).

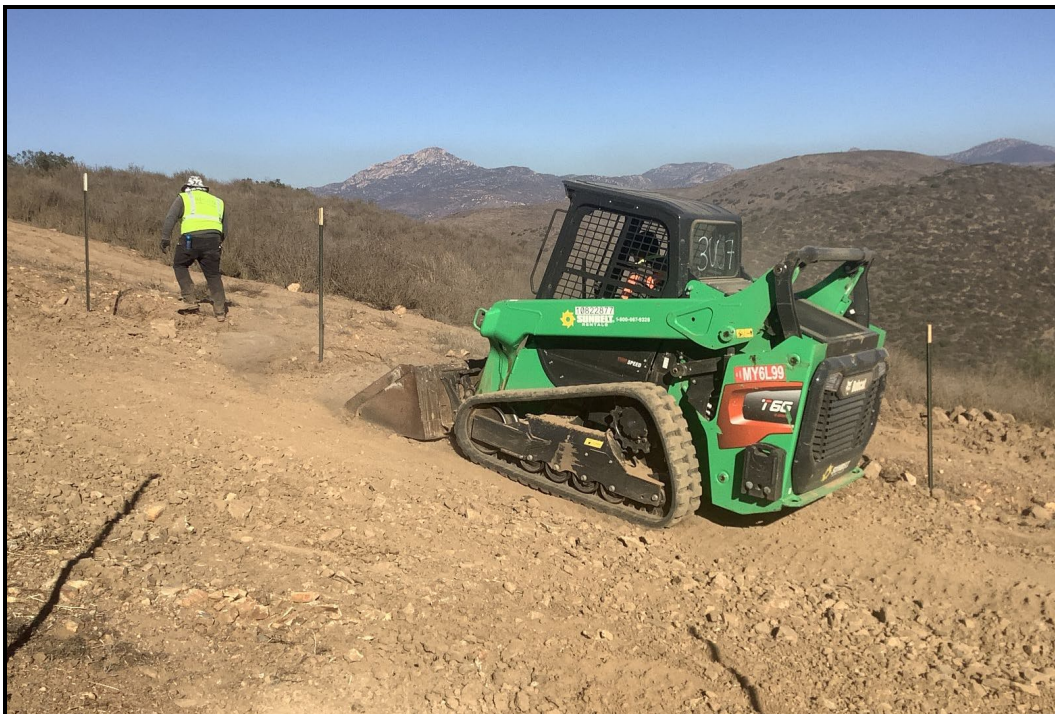
PHOTOGRAPH 23

The Crew Smoothed the Road with the Skid Steer, November 6, 2023

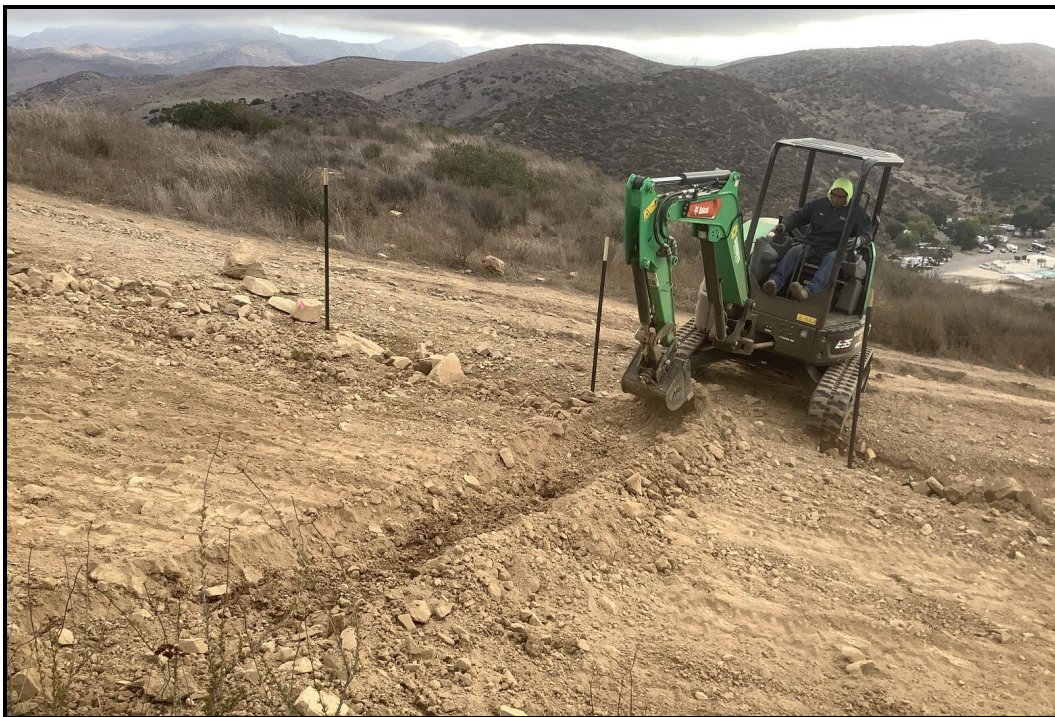
PHOTOGRAPH 25

Water Bars Were Created to Direct the Flow of Water, November 7, 2023

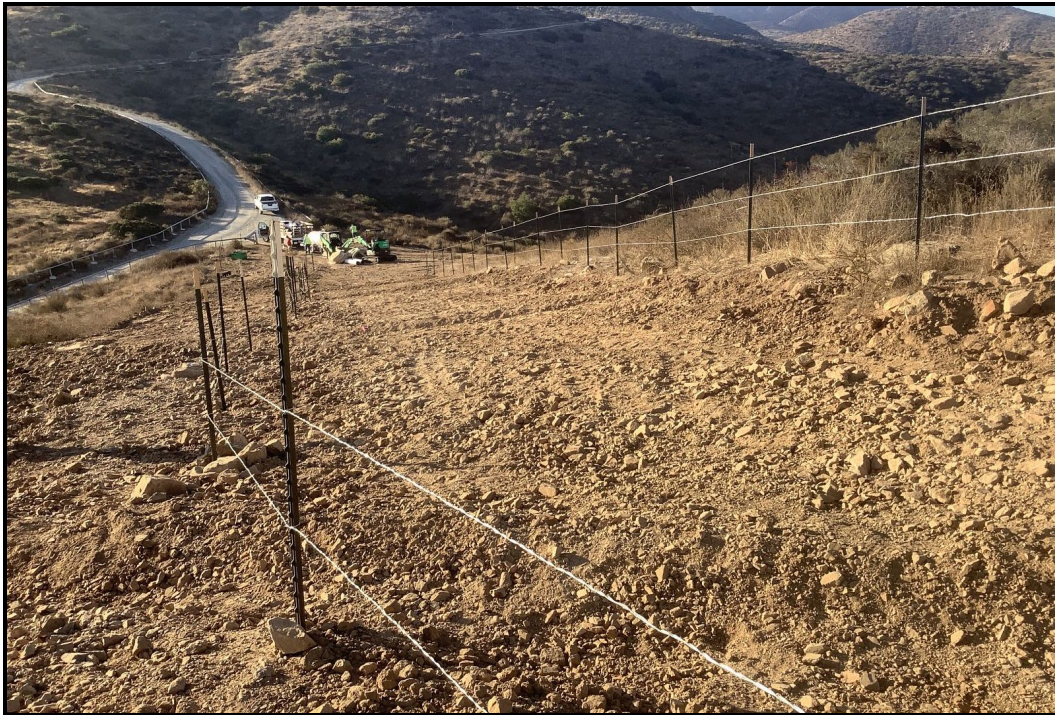
PHOTOGRAPH 26

The Road and the Water Bars After Grading, November 8, 2023

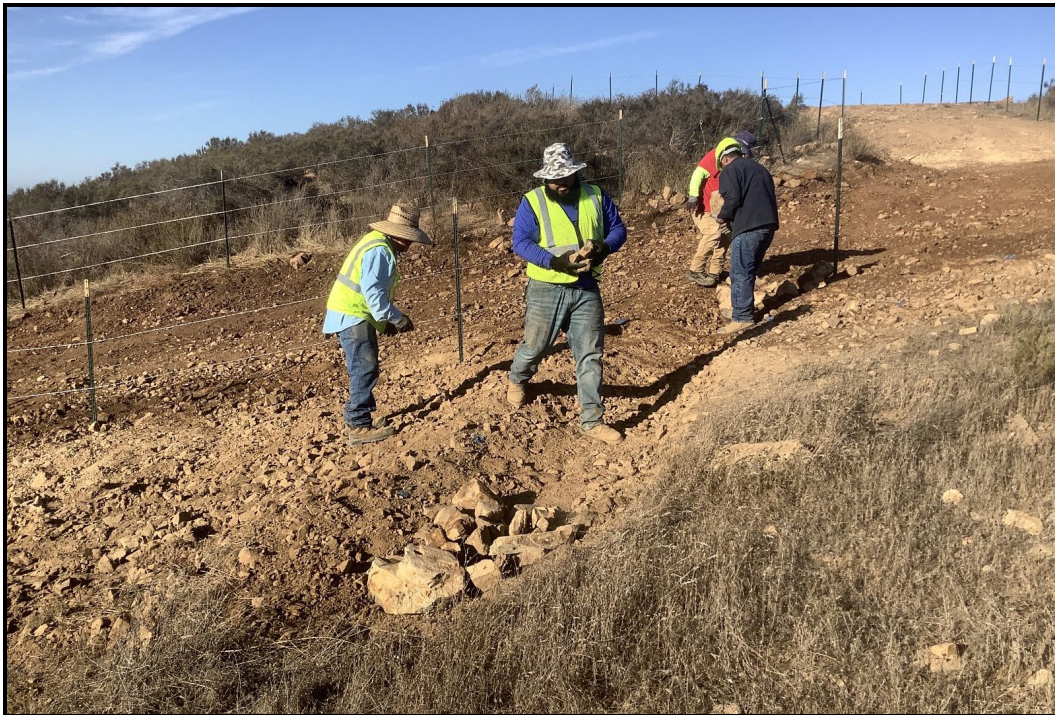
PHOTOGRAPH 27

The Water Bars Were Lined with Rocks to Help Direct and Slow the Flow of Water, November 8, 2023

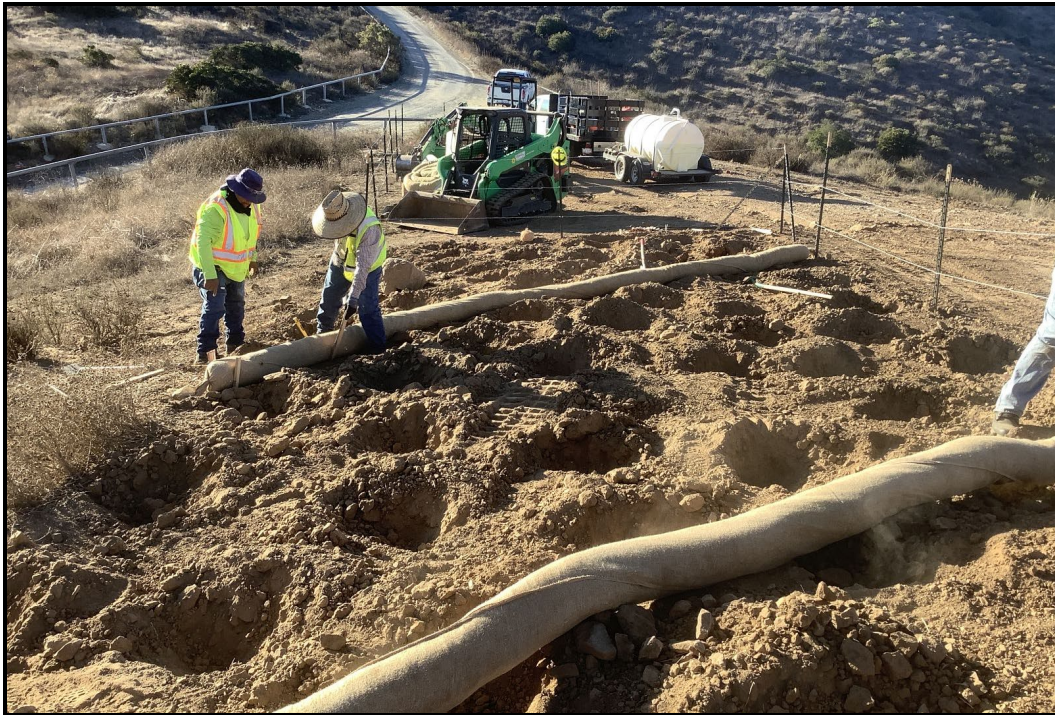
PHOTOGRAPH 28

The Crew Laid Out and Installed Biodegradable Wattles, November 9, 2023

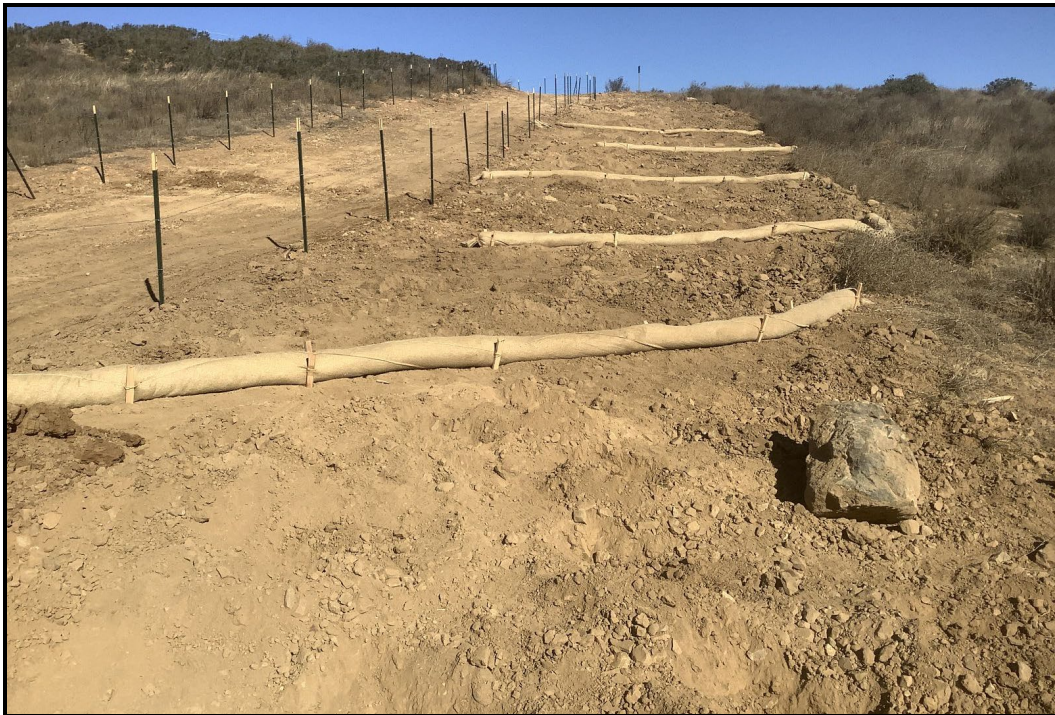
PHOTOGRAPH 29

View of the Wattles from the Bottom of the Hill, November 9, 2023

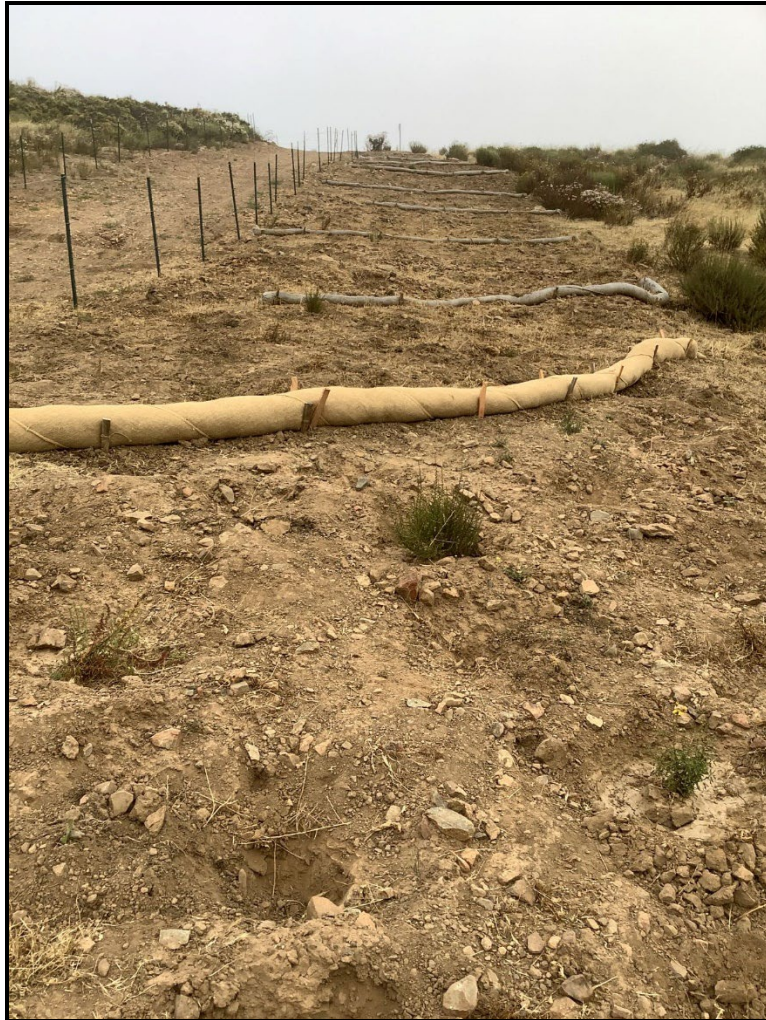
PHOTOGRAPH 30

On May 31, Minor Erosion Repairs Were Made Including  
Replacing a Wattle, June 5, 2024

A RECON biologist conducted a site visit on December 29, 2023, to qualitatively monitor erosion. During the site visit, no obvious erosion issues were observed, and the erosion control measures appeared to be functioning. Minor erosion was later documented after significant rain events that occurred in January 2024. On May 7, 2024, SANDAG approved the request to reallocate budget to allow for additional minor erosion repairs. On May 31, 2024, the field crew repaired areas with minor erosion where water had undercut the wattles (Appendix A, Photograph 30). During the additional four-year post-grant period, erosion issues will continue to be repaired, as needed. Qualitative monitoring will occur during bi-weekly site visits. Erosion control will be included as a task in the Otay Ranch Preserve fiscal year annual work plan.

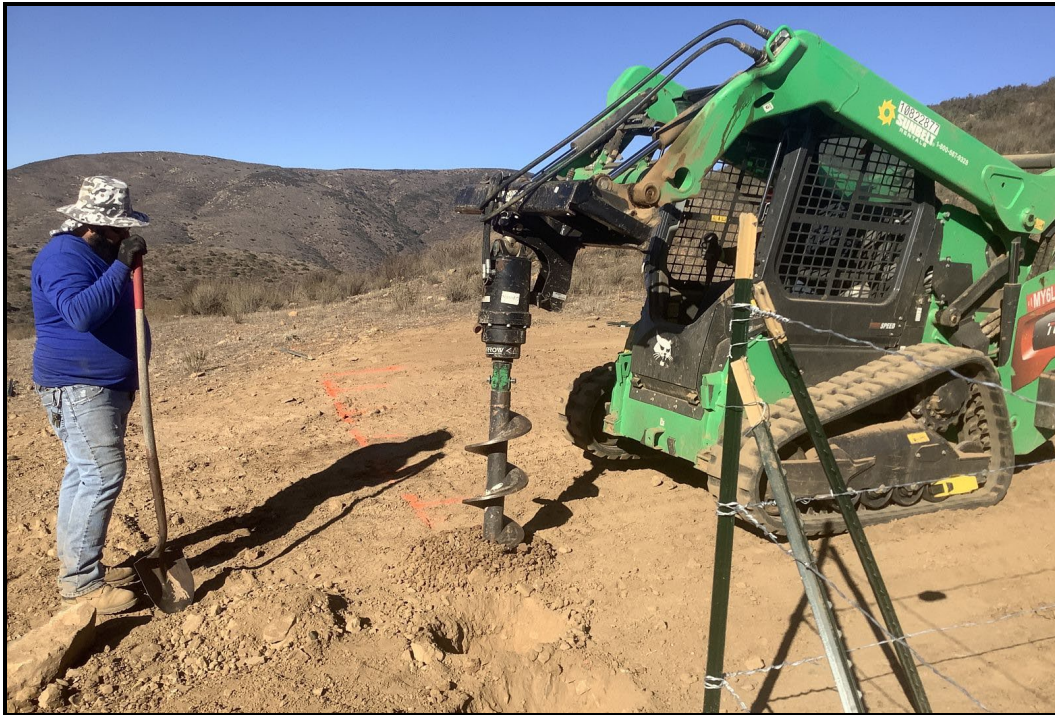
PHOTOGRAPH 31  
Digging Holes for the Bollards Using the Skid Steer Mounted Auger,  
November 9, 2023

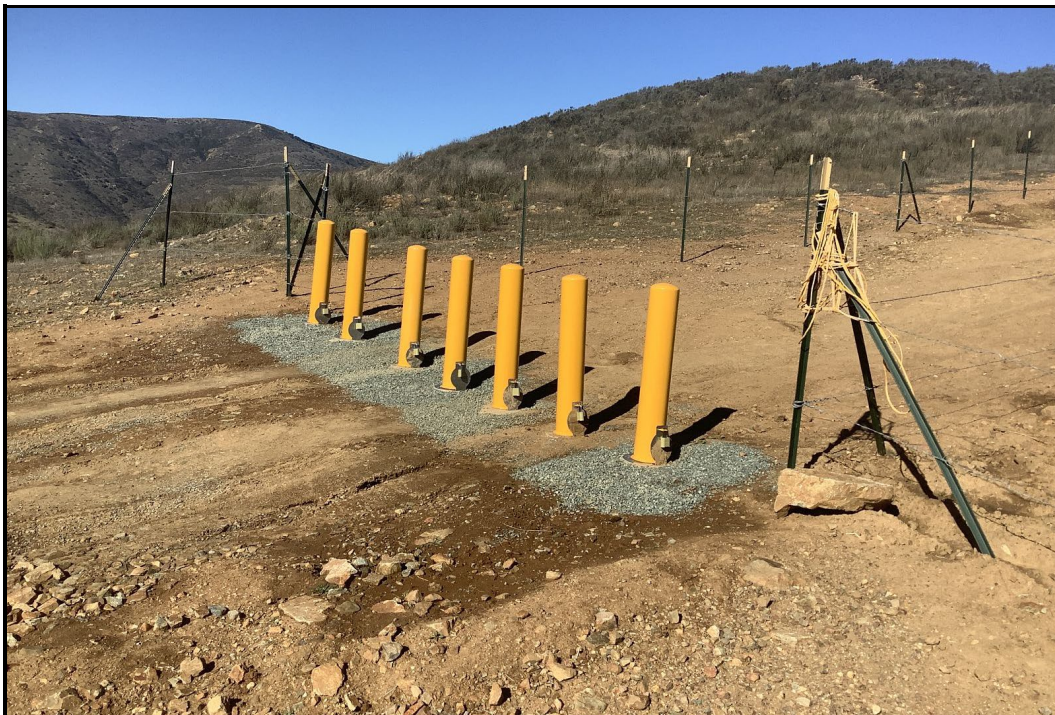
PHOTOGRAPH 32  
The Removable Bollards Were Installed in Their Bases and Locked,  
January 12, 2024

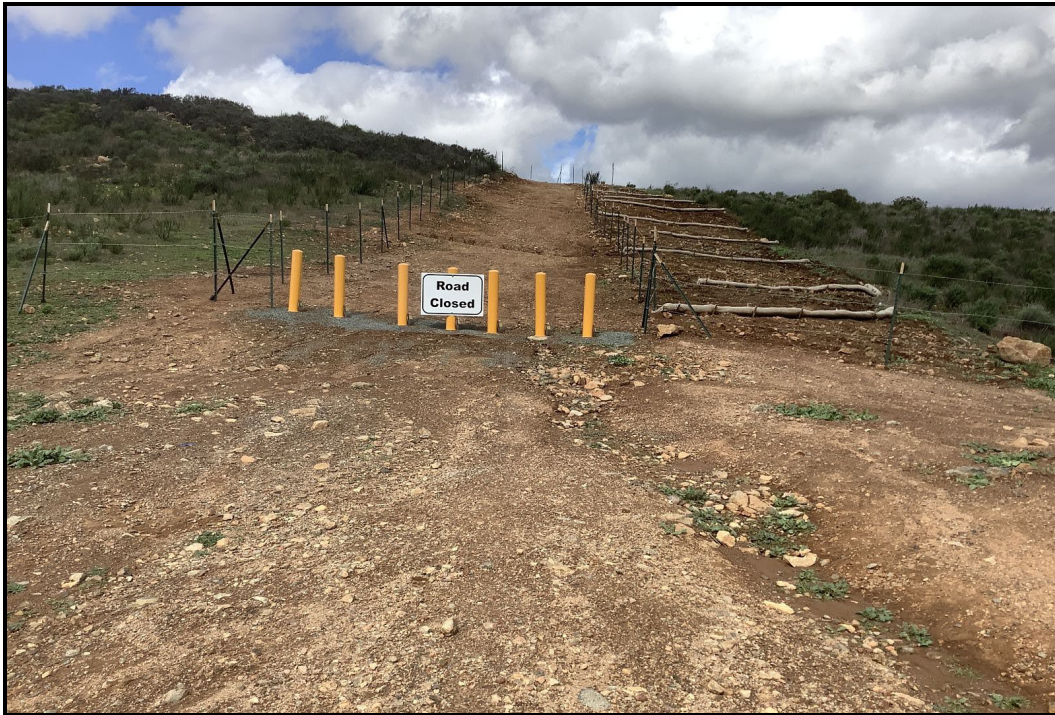
PHOTOGRAPH 33  
A "Road Closed" Sign Was Installed, February 21, 2024

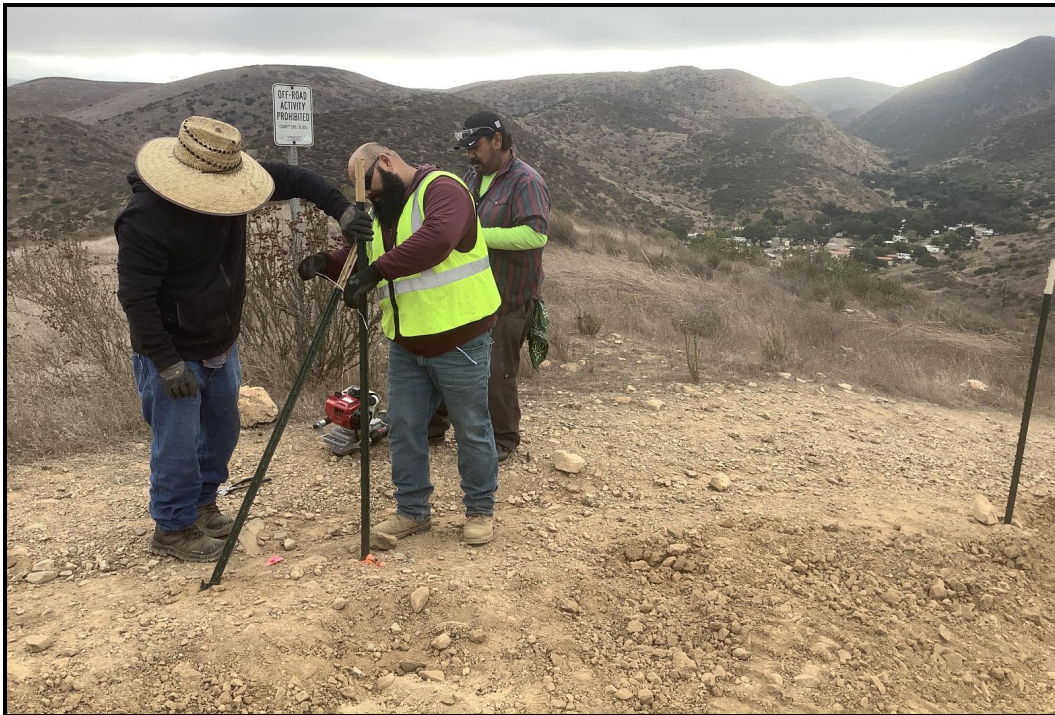
PHOTOGRAPH 34  
The Crew Securing Angled Braces Before Stringing Wire Fencing,  
November 7, 2023

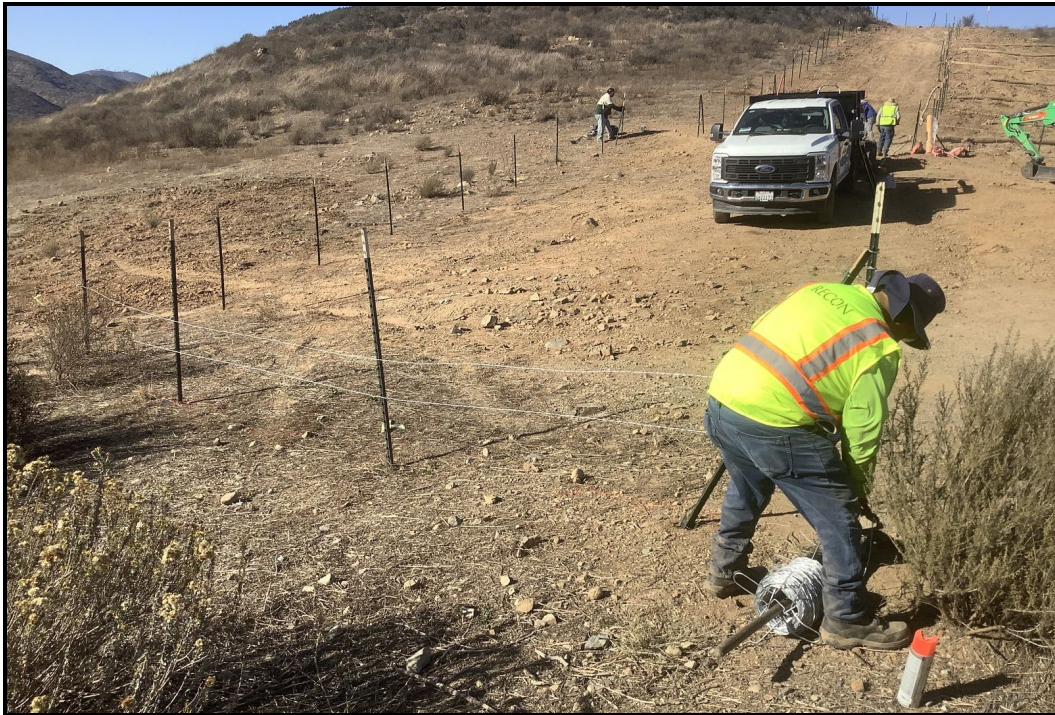
PHOTOGRAPH 36  
The Crew Pulling the Fence Wire Tight, November 9, 2023

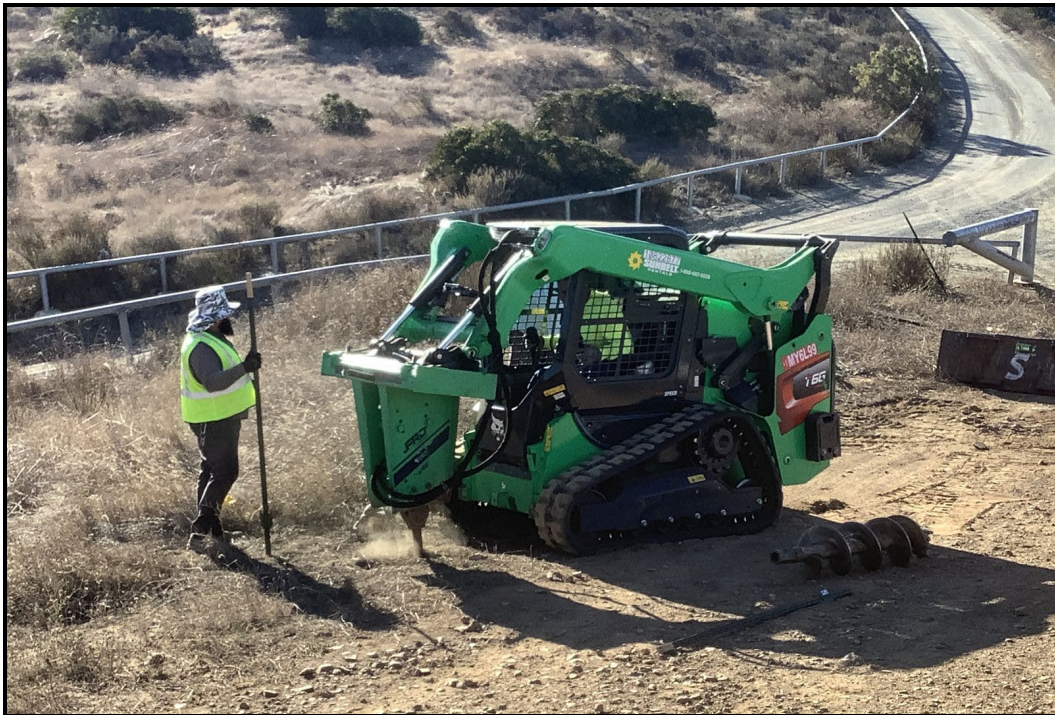
PHOTOGRAPH 37  
A Jackhammer Attachment on the Skid Steer Was Used to Drill Holes for the T-posts, November 6, 2023

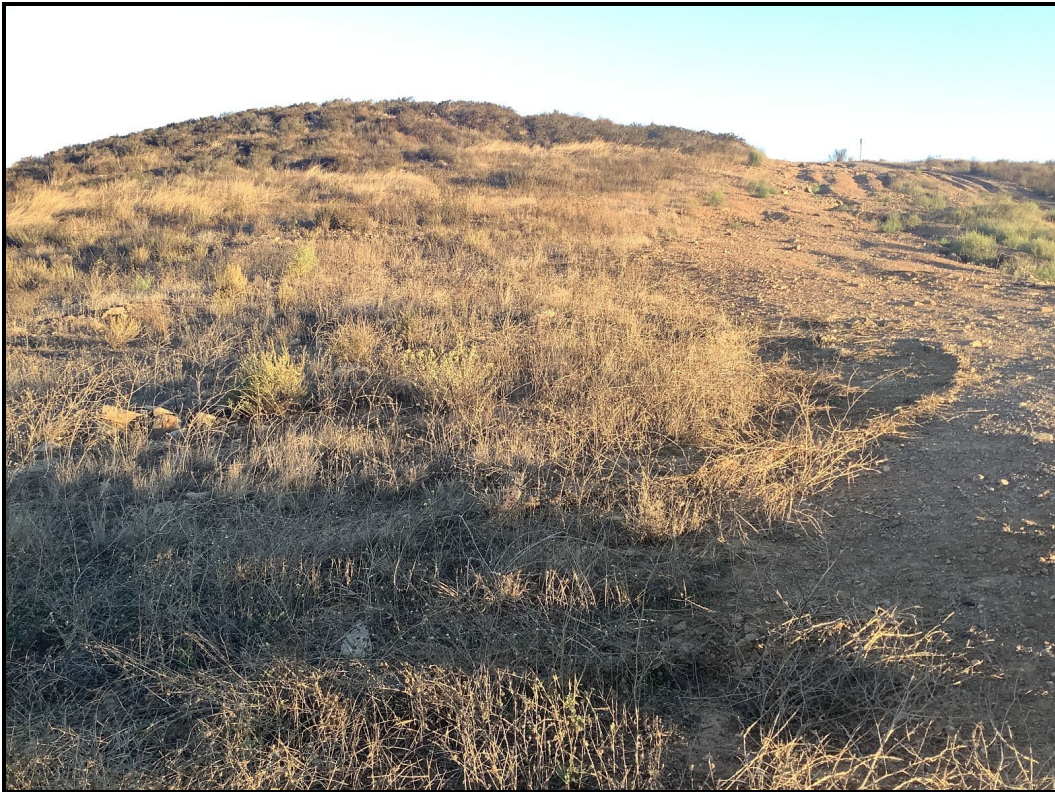
PHOTOGRAPH 38

Standing Dead Non-native Plants to Be Hand Pulled to Reduce Spreading  
Seed, October 4, 2023

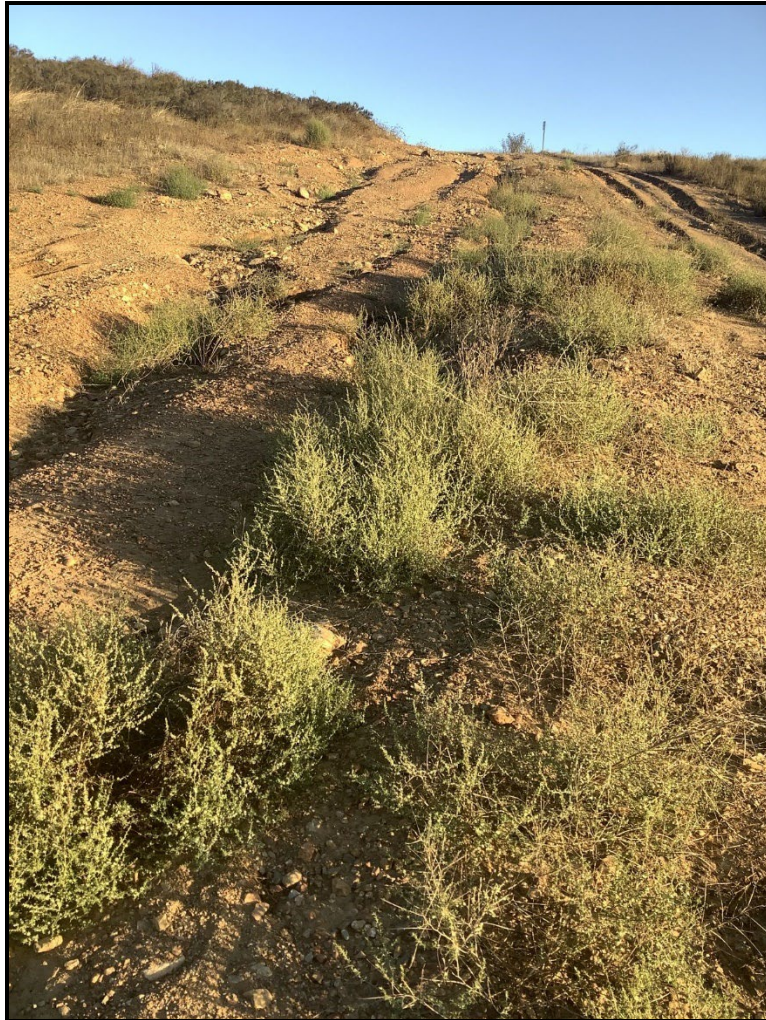
PHOTOGRAPH 39  
Tumbleweed (*Salsola* sp.) Along the Future Road Will  
Be Sprayed with Herbicide, October 4, 2023

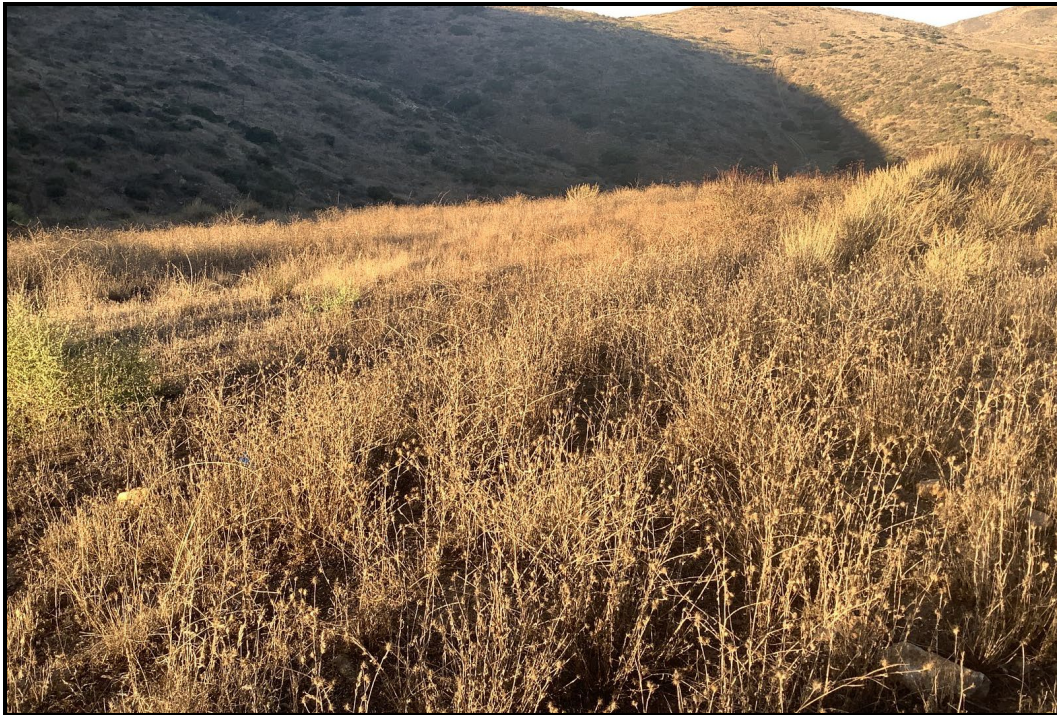
PHOTOGRAPH 40  
Tocalote (*Centaurea melitensis*) to Be Hand Pulled to Reduce Spreading  
Seed, October 4, 2023
