## **Quarterly Status Report Overview**

**PLEASE DO NOT CHANGE OR ALTER THE FORMATTING OF THIS DOCUMENT!**

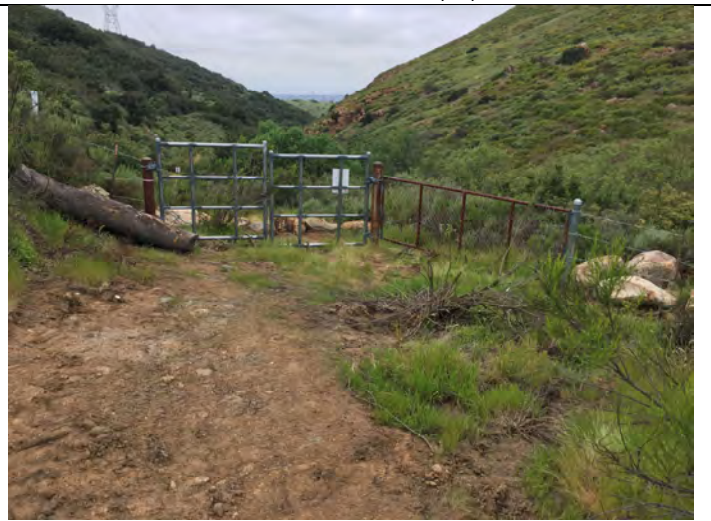
Photo 6 – After installation of all site deterrents: new gate, cell-enabled project monitoring camera (along the edge of the trail), new signage, and cactus cuttings. Other perimeter repairs were completed as part of the regular HMA responsibilities (not funded by the Grant). Date: 4/12/2024.

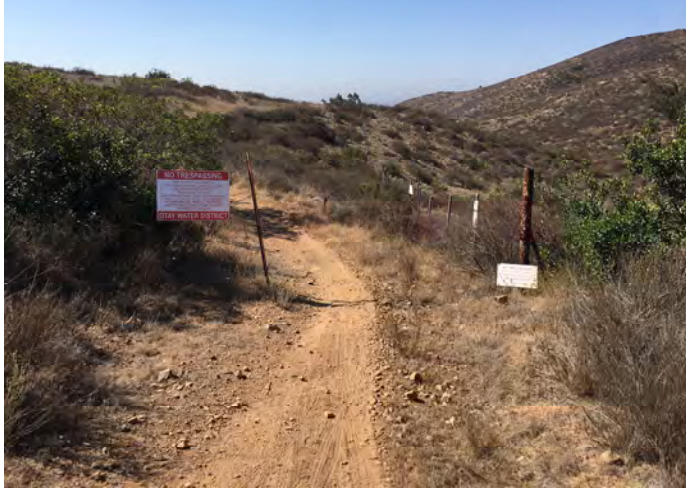
Photo 7 – Illegal Entry Point North 2b. Photo taken prior to installation of deterrents. Photo taken from USFWS lands and directed into the HMA. Date: 9/10/2021 and directed south.

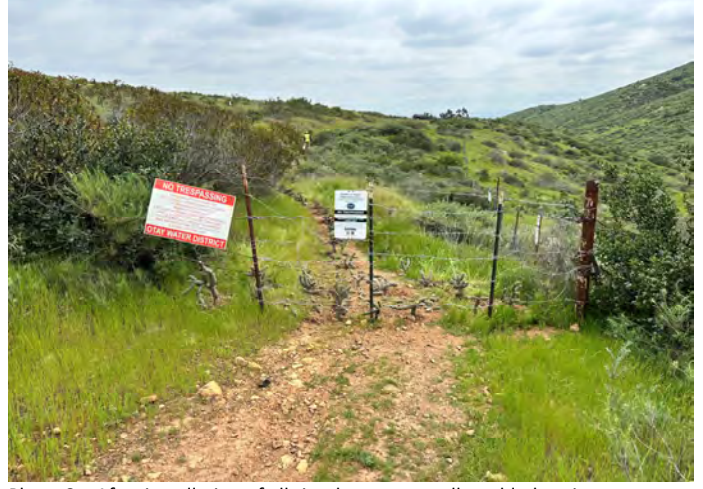
Photo 8 – After installation of all site deterrents: cell-enabled project monitoring camera (in the HMA along the edge of the trail), new signage, and cactus cuttings. Fencing repaired as part of the regular responsibilities of the Otay Water District Lands (not funded by the SANDAG grant). Date: 4/12/2024.

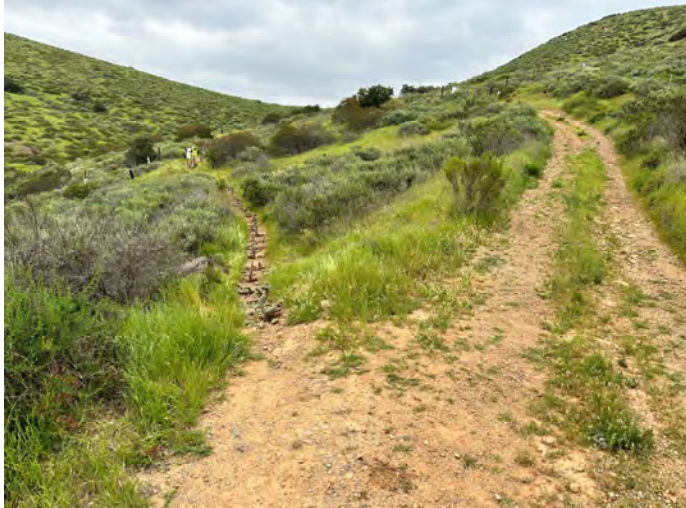
Photo 9 – Illegal Entry Point North 2b. After installation of cactus within the illegally created trail. Photo taken from Otay Water District lands and directed north. Date: 4/12/2024.

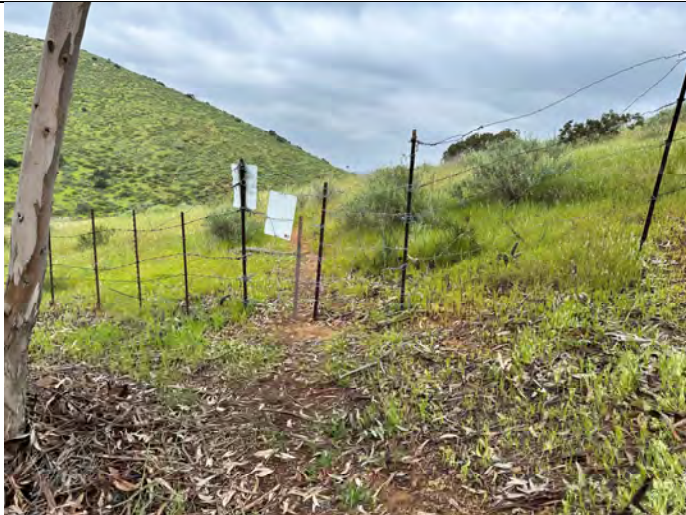
Photo 11 – Illegal Entry Point North 2a. After installation of deterrents: new signage and cactus. Fencing repaired as part of the regular responsibilities of the HMA (not funded by the SANDAG grant). Date: 4/12/2024.

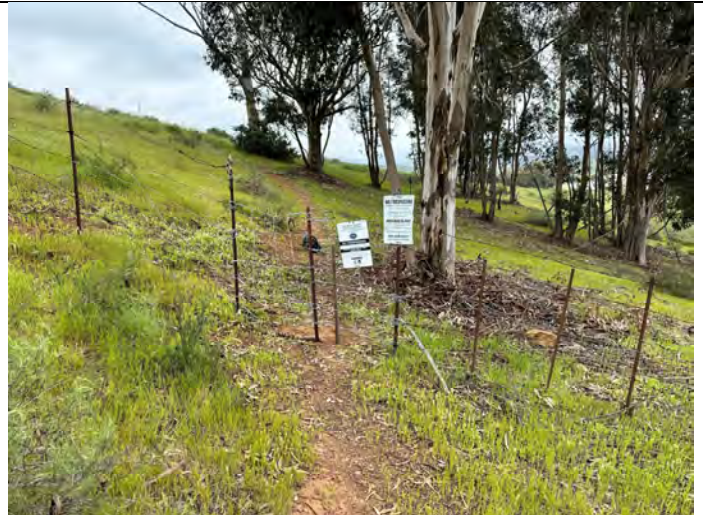
Photo 12 – Same as Photo 11 but taken from USFWS lands and directed south into the HMA.

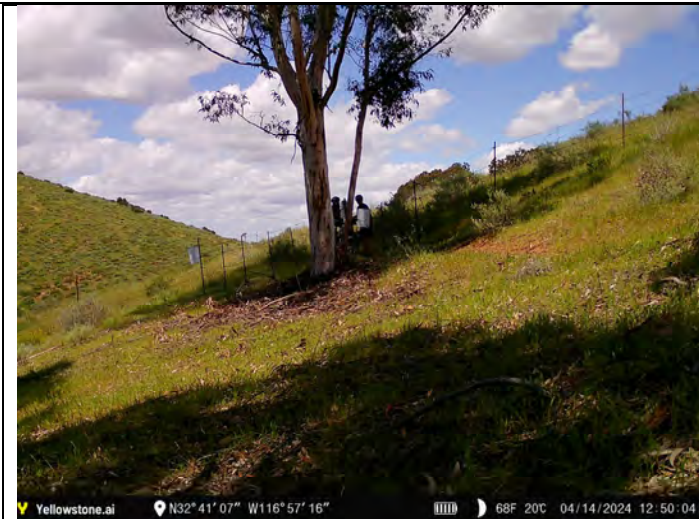
Photo 25 – Illegal Entry Point North 2a. Date: 4/14/2024. Time: 12:50pm. Trespasser: Biker. Observed at the perimeter fence but not in the HMA.

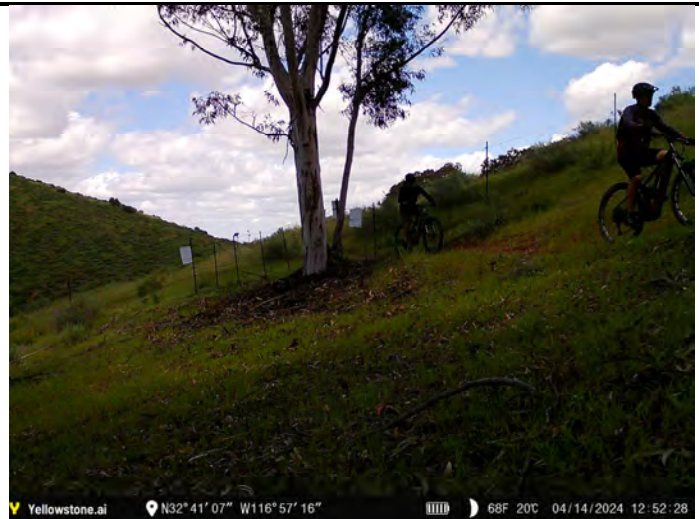
Photo 26 – Same bikers as seen in Photo 25. Observed on the HMA. Date: 4/14/2024. Time: 12:52pm. Trespasser: Biker

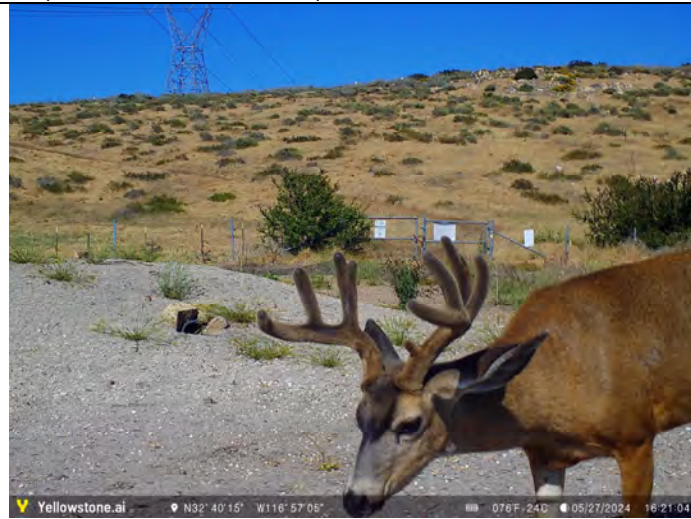
Photo 27 – Illegal Entry Point East 3b. No trespassers were detected on camera during the first project monitoring timeframe. However, wildlife was commonly detected. Date: 5/27/2024. Time: 4:21pm. Wildlife: Mule deer

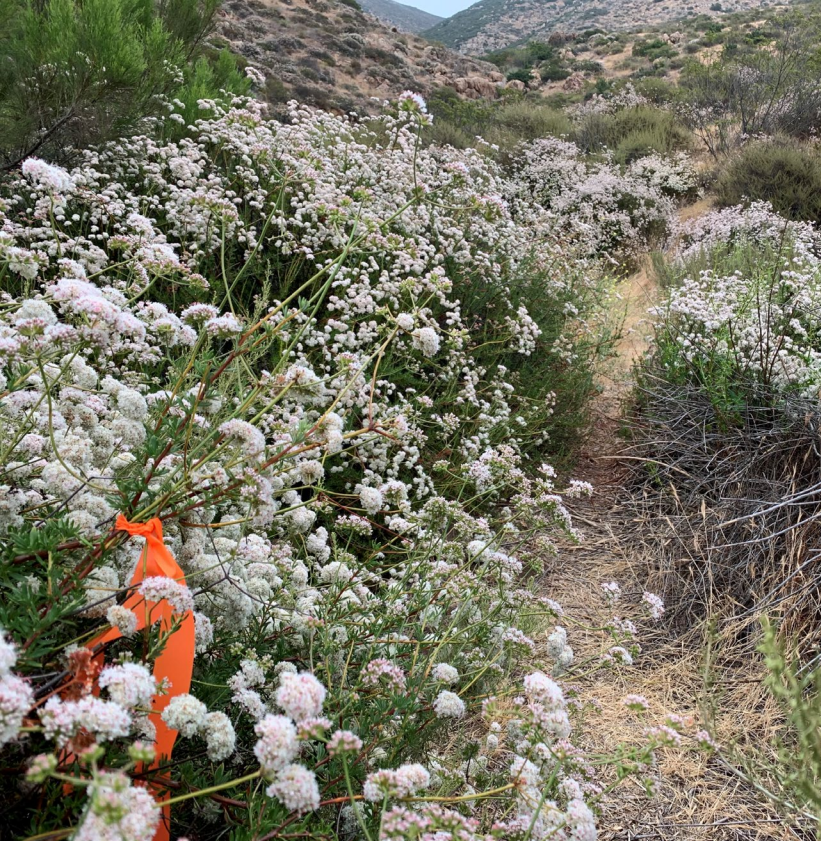
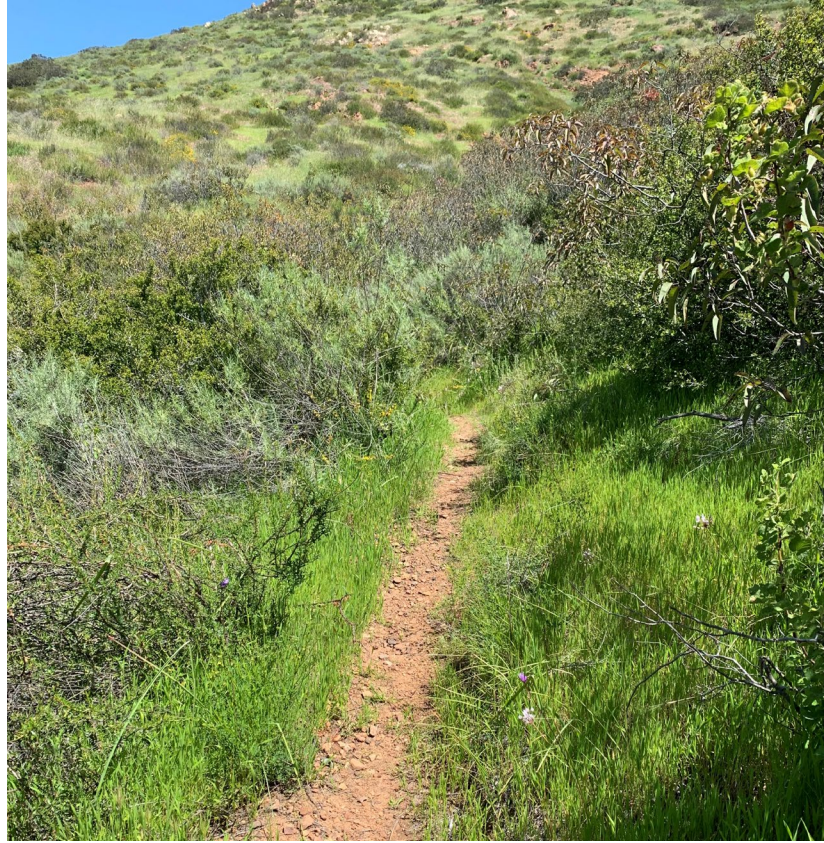
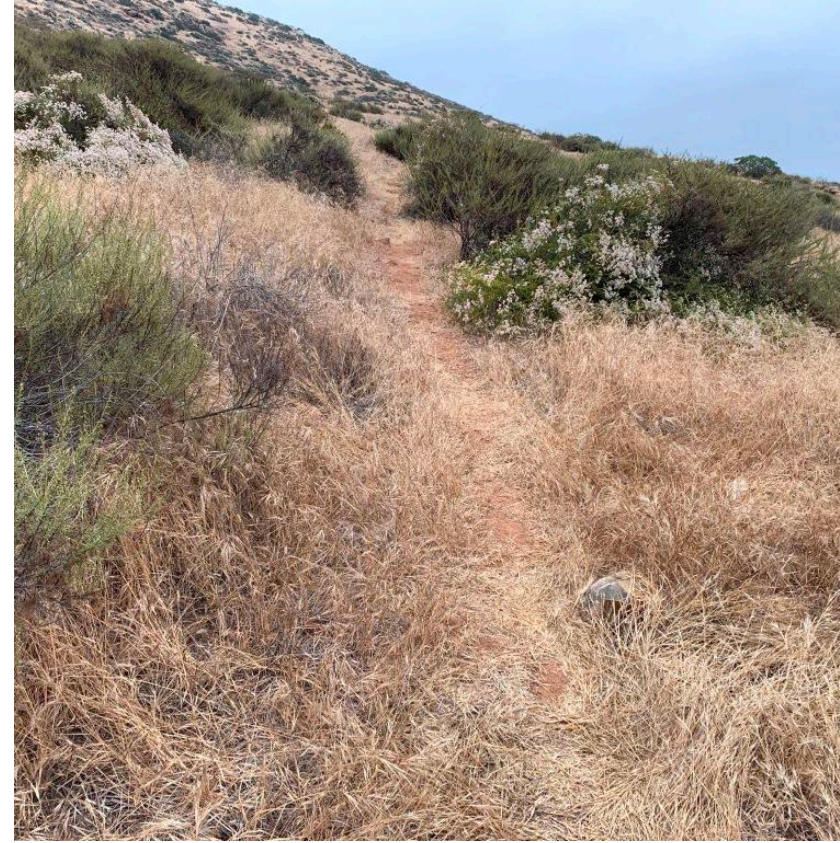
## Trespassing & Vandalism
