**South San Diego Bay  
Coastal Wetland Restoration  
and Enhancement Project**

**Year 1 Postconstruction Monitoring Report**

**July 2013**

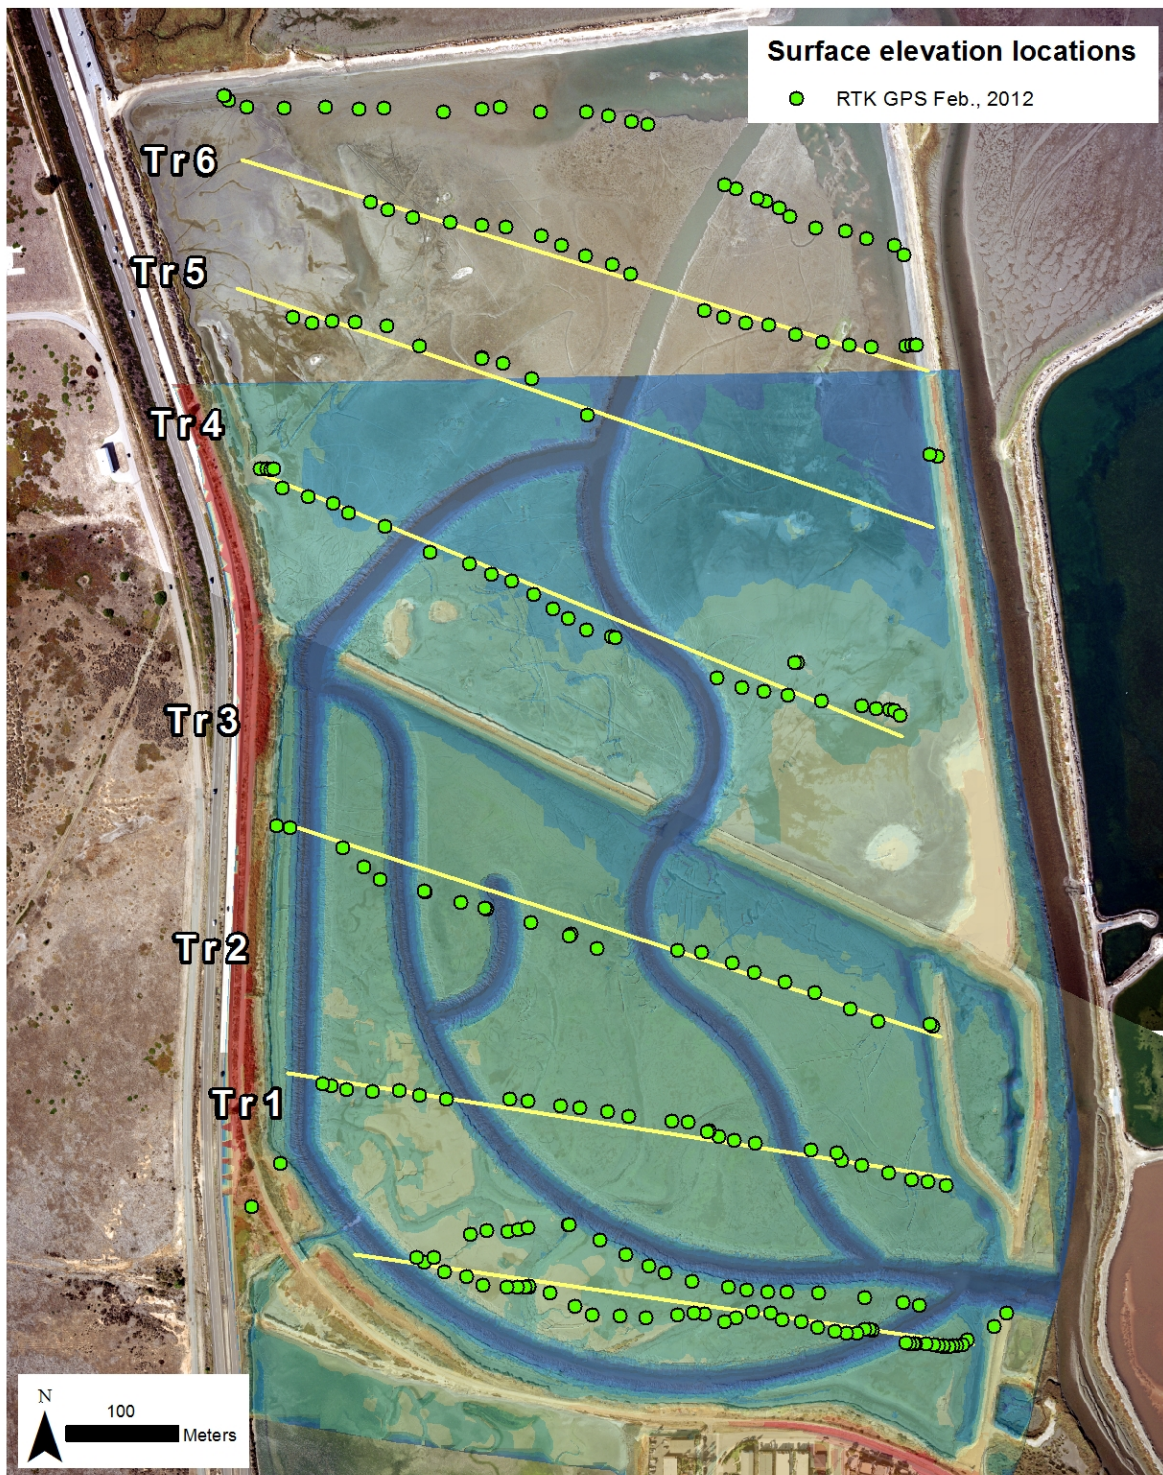
**Figure 3. Real Time Kinematics Transects and Data Points Taken for Marsh Plain Topography February 2013.**

The RTK data were taken along eight transects running roughly east to west (Figure 3). Four transects were located in Pond 11 and four transects were located in Pond 10. Tidal conditions prevented any data collection in Pond 10A. The survey was controlled for accuracy using two benchmarks located near the project that had previously been differentially leveled to NAVD88 vertical datum. The estimated accuracy of the equipment and procedure was +/- 3cm.

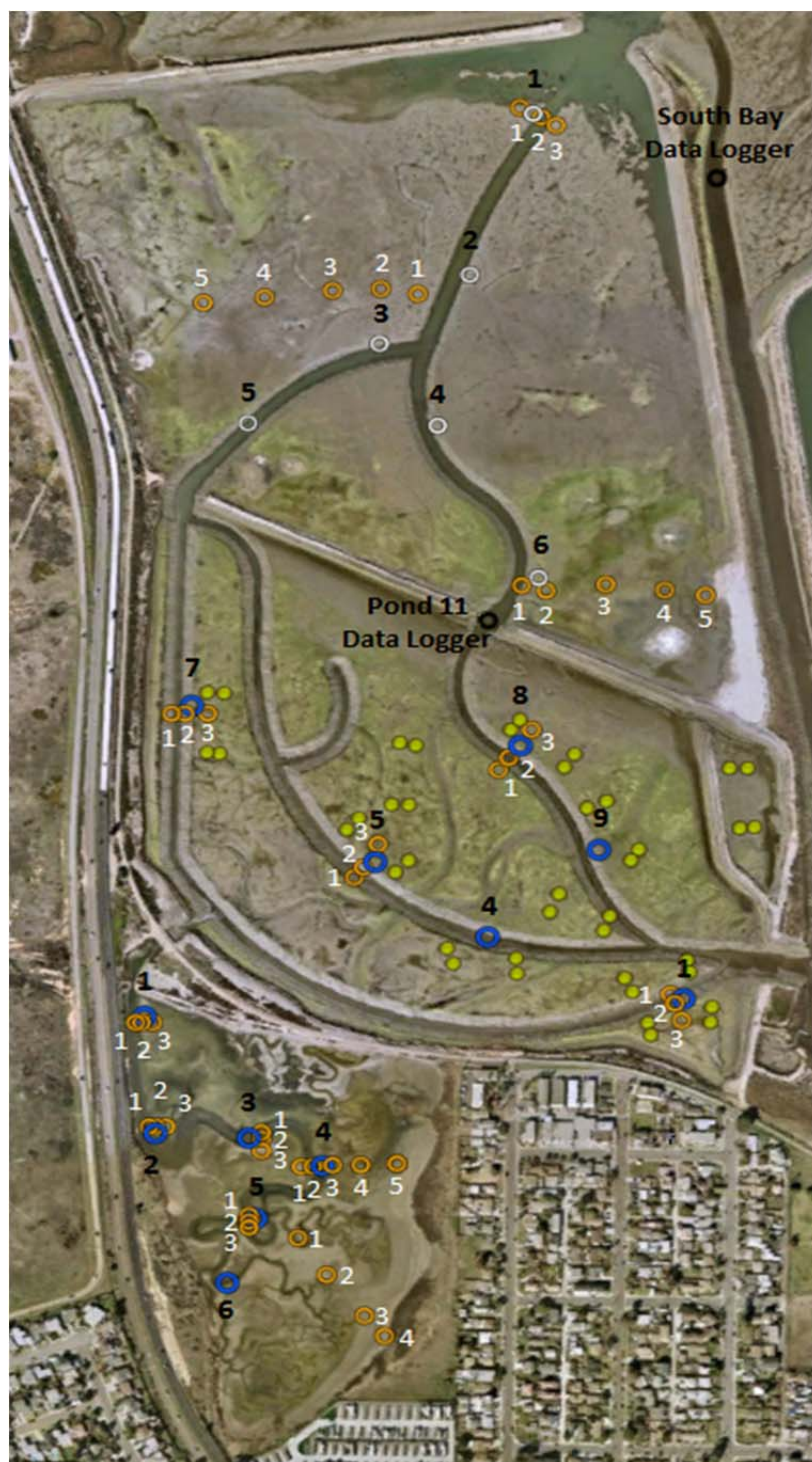
Beginning January 2012, tidal amplitude of the western salt ponds was measured using YSI model 6600 EDS Sonde dataloggers deployed at the eastern breach of the internal levee between Ponds 10 and 11 and at the mouth of the Otay River (Figure 7). The datalogger at the Pond 11

**Figure 7. Monitoring Stations Western Salt Ponds. Locations of water quality data-loggers are shown in black. Green dots = corners of experimental vegetation plots. Blue circles = enclosure traps and invertebrates. White circles = invertebrates only, both channel-bottom and tidal flat. Brown circles = sediment.**

Soils of Ponds 10, 11 and 10A were collected at the stations shown in Figure 7 on DATE. Soil sampling locations were designed to correlate with experimental planting blocks in Pond 10 and fish enclosure traps/invertebrate sampling stations. Soils were collected using a 6 cm long PVC pipe with an interior diameter of 4.8 cm and were analyzed in the laboratory for grain size, salinity, and organic content. Dried sediment was wet-sieved through 2 mm and 63 µm mesh screens to obtain percent weight of silt-clay, sand, and cobbles/ shell hash. Soil salinity was

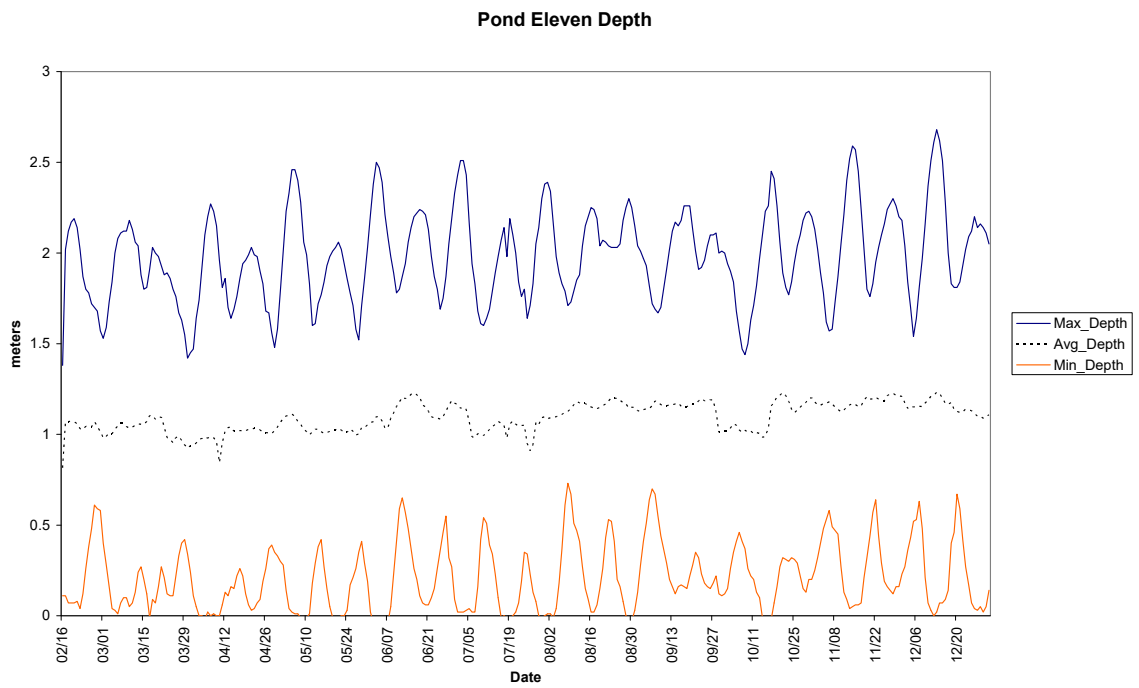
Water Quality monitoring results as measured by the datalogger in the eastern breach between Ponds 10 and 11 (Pond 11) and the Otay River Mouth (Otay River) during 2012 are presented in figures 10 through 18. Water depths were similar at both sites with similar maximum and minimum readings (Figure 10). Gaps in Otay River water quality data during January and February were the result of failure of the temperature/conductivity probe. This probe affects all other sensors and all data collected during that time period were rejected.

**Figure 10. Water Depth in Pond 11 (above) and at the Otay River Mouth (below).**

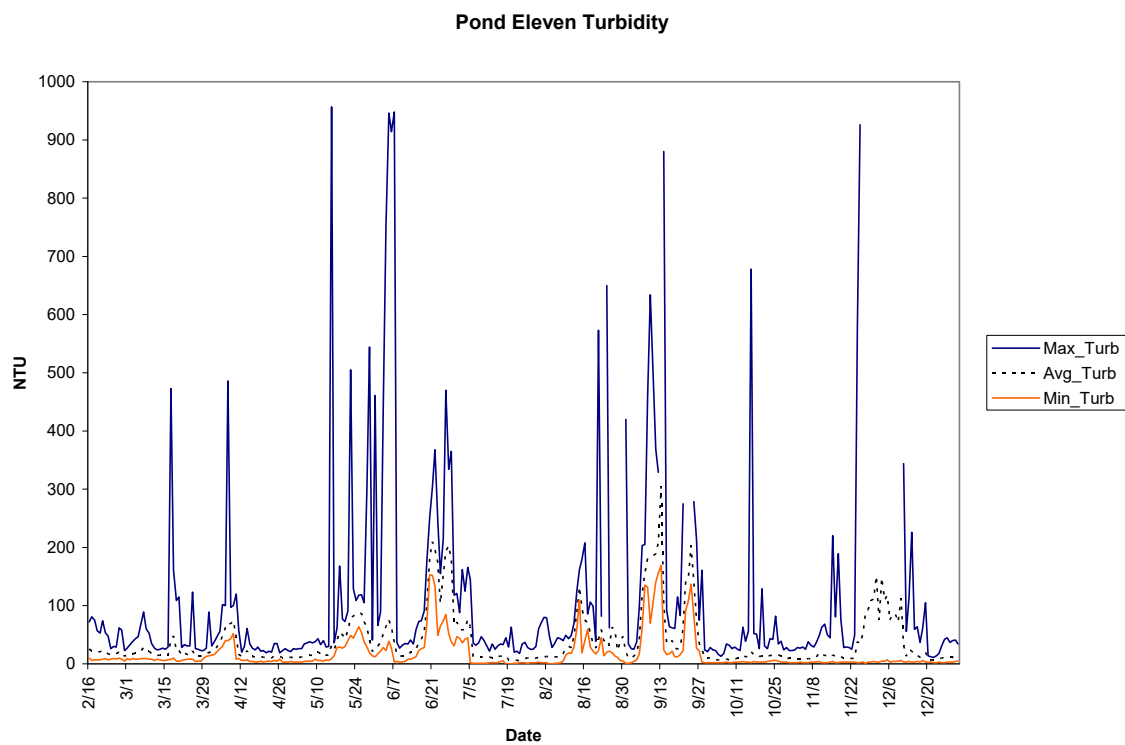
Maximum chlorophyll levels as measured by the data logger were generally higher within Pond 11 compared to the Otay River (Figure 13) and maximum turbidity levels were substantially higher in Pond 11 than in the Otay (Figure 14). Higher turbidity within Pond 11 might be expected as the sediment deposited in the pond as slurry during construction has not yet consolidated and is subject to suspension in the water column by tidal action. However, elevated turbidity levels were attributed to biofouling of the LED sensor on the Pond 11 datalogger (5/11-6/7) as well as failure (loss) of the LED sensor wiper (6/7-7/5, 8/2-8/31, 8/31-9/28). With the removal of those peaks, turbidity levels in Pond 11 more closely resemble the turbidity levels in the Otay River, although levels in the ponds remained higher.

**Figure 14. Water Turbidity in Pond 11 (above) and the Otay River Mouth (below).**

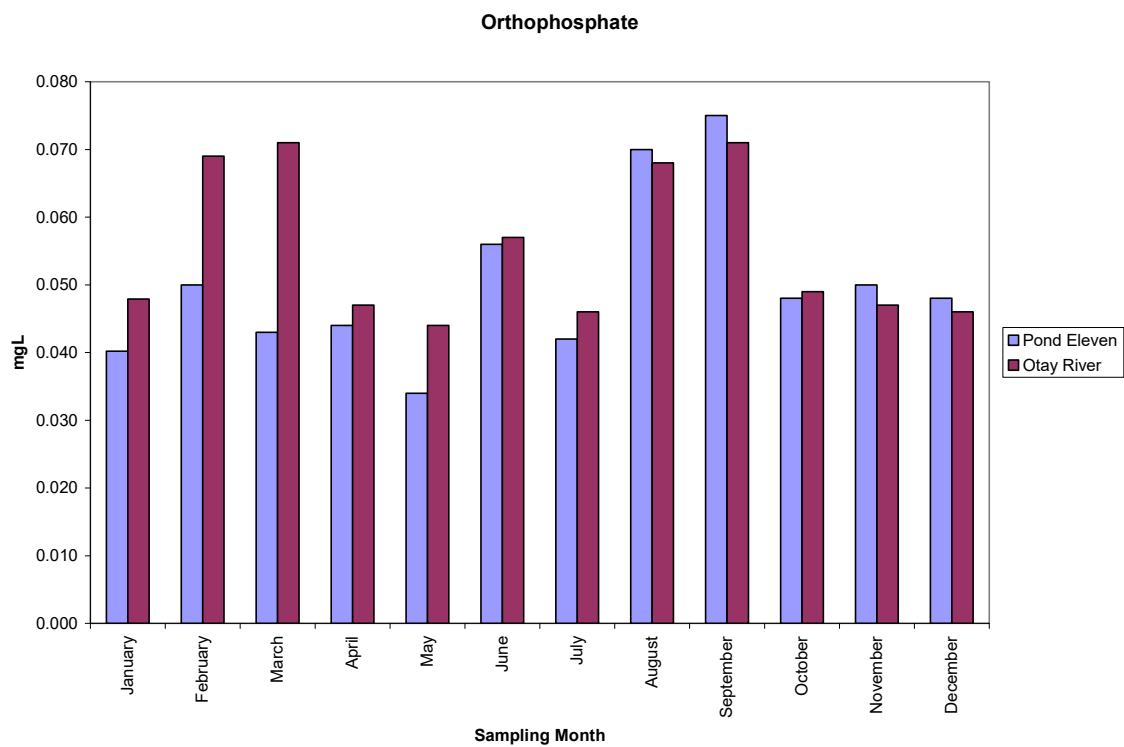
Orthophosphate, ammonia and nitrate/nitrite levels varied considerably but were generally similar in Pond 11 and the Otay River (Figures 17 and 18). Chlorophyll levels as measured in the laboratory also varied substantially but with no apparent pattern between the two sites.

**Figure 17. Orthophosphate (above) and Ammonia (below) in Pond 11 and the Otay River Mouth.**

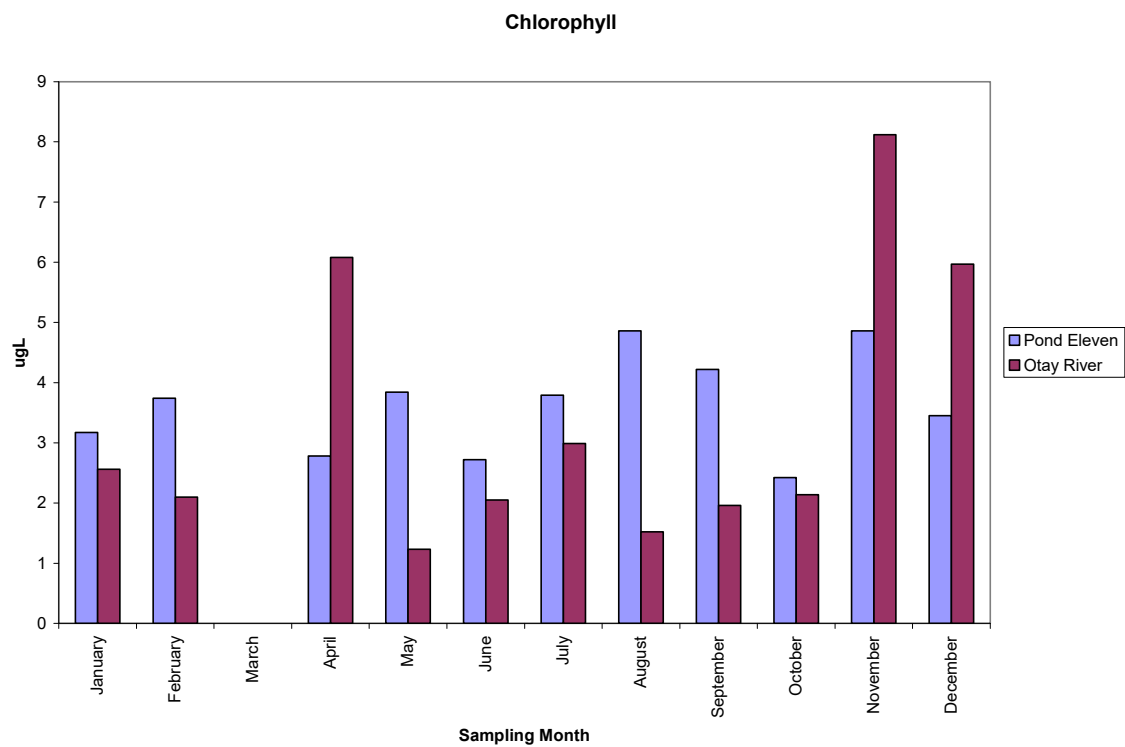
**Figure 18. Nitrate/Nitrite (above) and Chlorophyll (below) in Pond 11 and the Otay River mouth.**

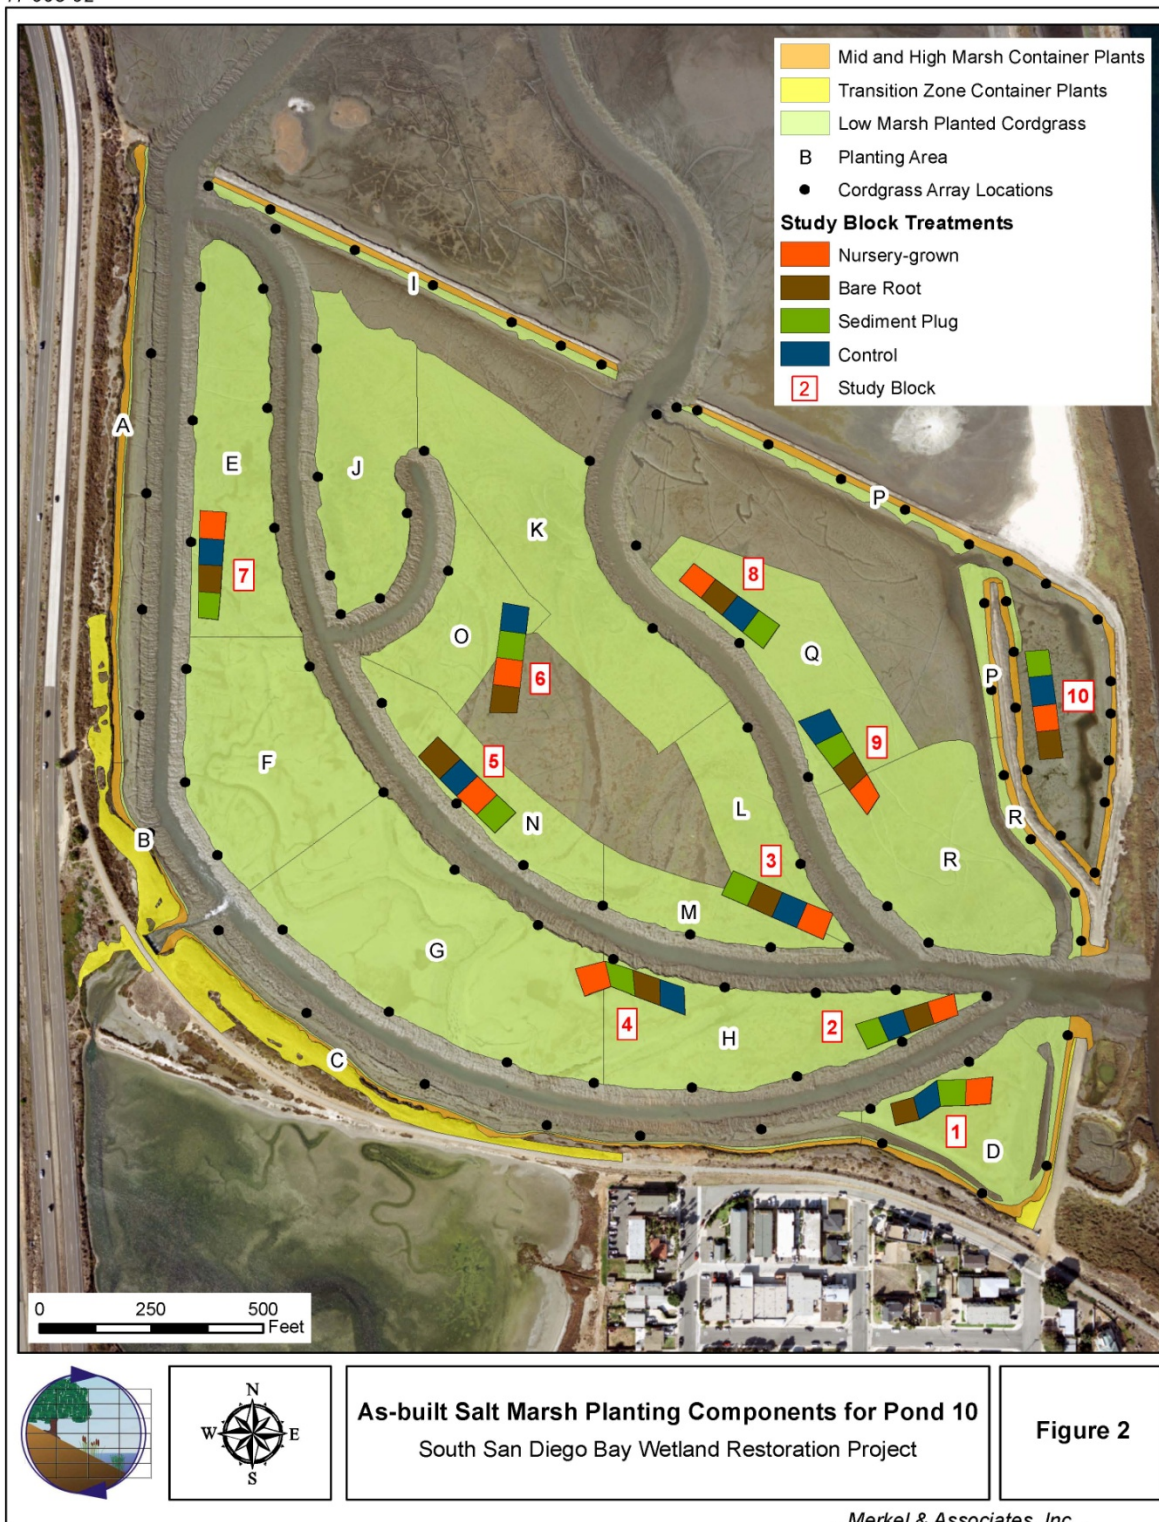
During Phase II, conducted between November 17 and December 3 2011, 35,700 individual cordgrass were planted. These consisted of additional nursery grown plants as well as plants harvested from a donor site immediately adjacent to Ponds 10 and 11 in the salt marsh of the Otay River. Of these 35,700 individuals 2,800 were nursery grown; 1,000 were harvested "plugs" of cordgrass and sediment defined as a small sod-like block about 6 inches deep and 4 – 6 inches in diameter containing substantial amounts of rhizomes and native soil that serves to buffer the plants during transplanting; and 31,900 plants were planted as "bare root planting units" defined as a ramet of 2 - 3 aerial stems of cordgrass with 2 – 6 inches of rhizome with a minimal amount of native soil attached to the rhizomes.

Figure 20. As-built Salt Marsh Planting in Pond 10 (Figure 2 from As-built Report)

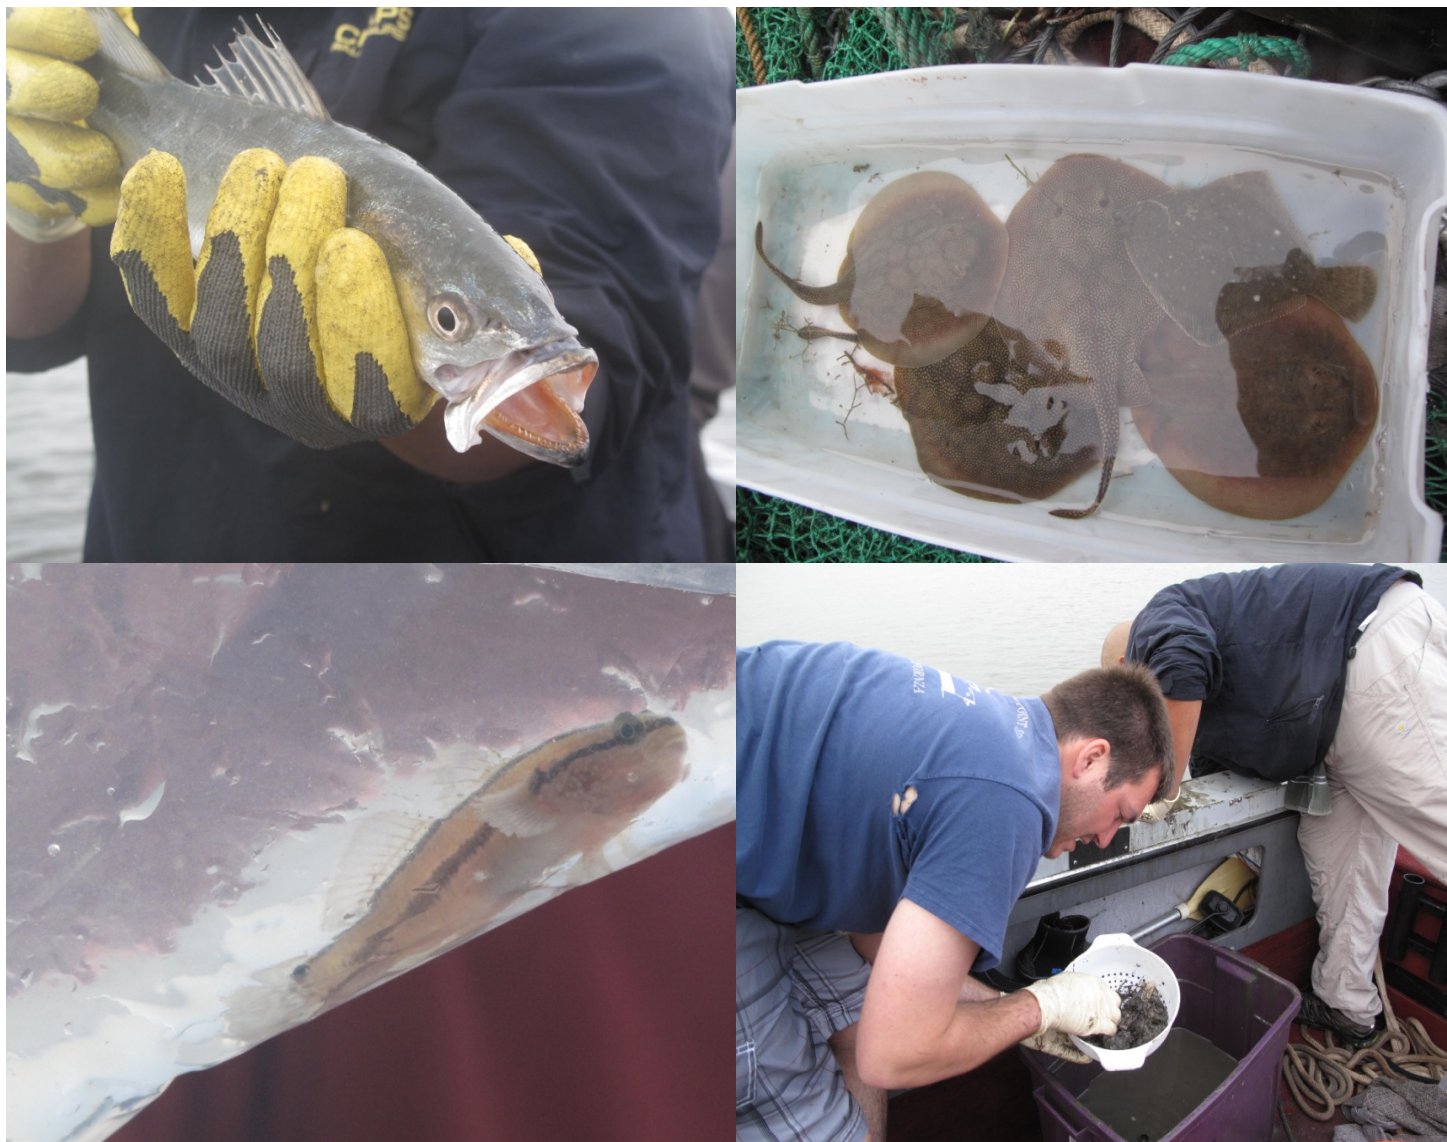
**Figure 22. Photograph of shortfin corvina top left, round stingrays and a diamond turbot (top right), chameleon goby (bottom left), and a trawl sample being sorted for fish and invertebrates (bottom).**

Otter trawls captured a total of 501 individuals representing 7 families in 11 trawls for an average capture of 45.5 fish per effort. In terms of relative abundance, otter trawls were dominated by juvenile slough anchovy (267) and juvenile topsmelt (212). The majority of slough anchovy and topsmelt measured approximately 3 - 4 cm and weighed approximately 0.5 gm. Round stingrays dominated the otter trawls in terms of biomass. The two beam trawls conducted in the bay captured two shiner surfperch, one bay pipefish and one slough anchovy. No shiner surfperch or bay pipefish were collected within the ponds. Similarly, the 2 otter trawls conducted in the bay captured 5 slough anchovy, 4 round stingray, 1 diamond turbot and 172 topsmelt. Thus, only 40 of the total 212 topsmelt were collected in the ponds and the only diamond turbot collected was from the bay. Photographs of representative fish species collected during the trawling effort are presented in Figure 22.

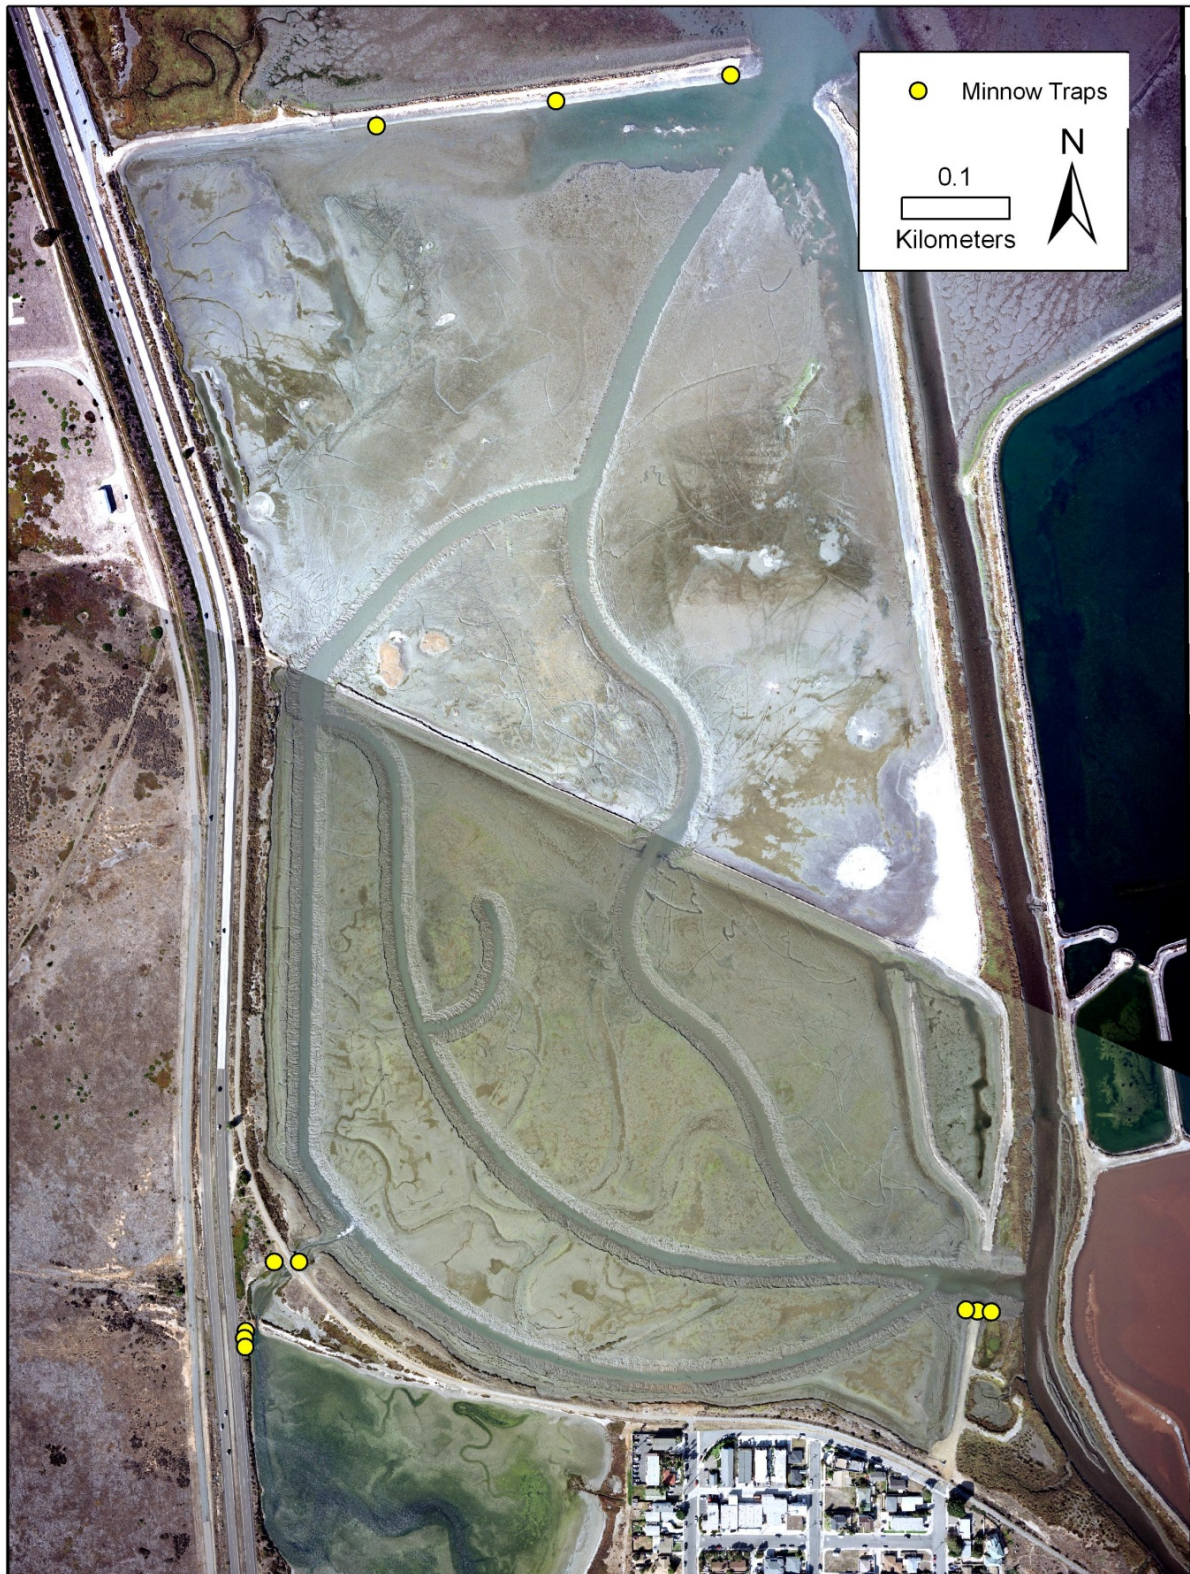
**Figure 23. Minnow Trap Sampling Stations Western Salt Ponds.**

In order to provide a general characterization of fish populations in the salt ponds, minnow traps were deployed in Ponds 10A, 10, and 11 (Figure 23). The traps were deployed just offshore at low tide to a depth of complete submersion and left for 24 hours. Due to the traps resting on the substrate, the fish sampled were limited to those that reside or feed in the benthic zone. The locations of trap deployment were based on the availability to safely walk without disturbing bird nesting areas along the levees.

The majority of all individuals were collected from Pond 10A (97%) compared to approximately 2.9% in Pond 10 and approximately 0.1% (1 individual) in Pond 11. This bias was likely caused by the location of the traps. The traps in Pond 10A were restricted to the narrow inlet in the northwest corner through which fish must traverse to enter the pond. Three of the 4 traps in pond 10 were located in the farthest southeast corner of the pond and all of the Pond 11 traps were located along the northern most shore of the pond. Fish populations, particularly benthic fishes, are likely still adjusting to the sediment movement in both ponds. Populations are expected to increase as the sediment consolidates. Future monitoring will determine whether this hypothesis is valid.

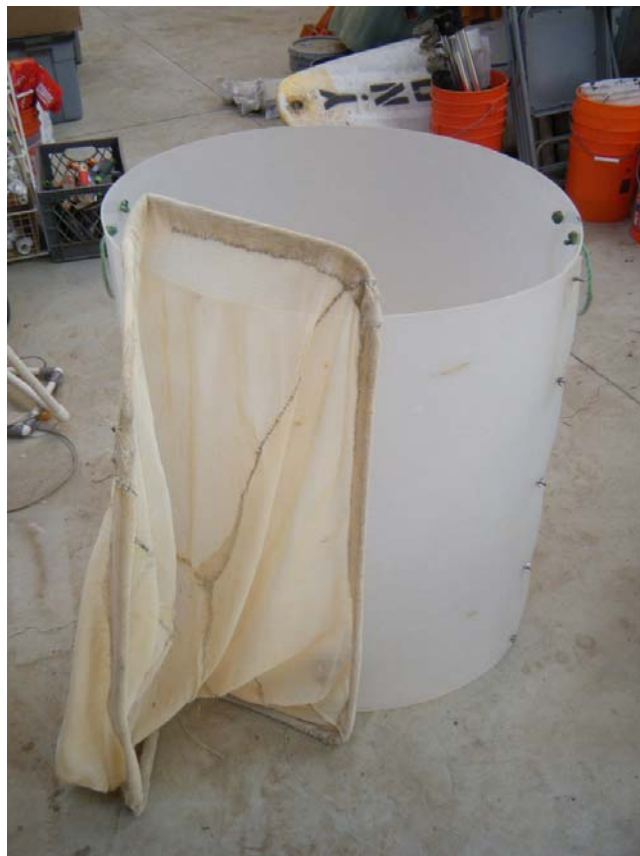
The results of enclosure trap sampling in the western salt ponds are presented in Table 10. No fish were captured at the 6 stations within Pond 10A. The enclosure traps deployed in Pond 10 caught a total of 18 fish; 16 arrow goby (*Clevelandia ios*) and 2 slough anchovy (*Anchoa delicatissima*). There were also 14 Asian mussels (*Musculista senhousia*) captured in Pond 10.

**Figure 24 - Enclosure Trap.**

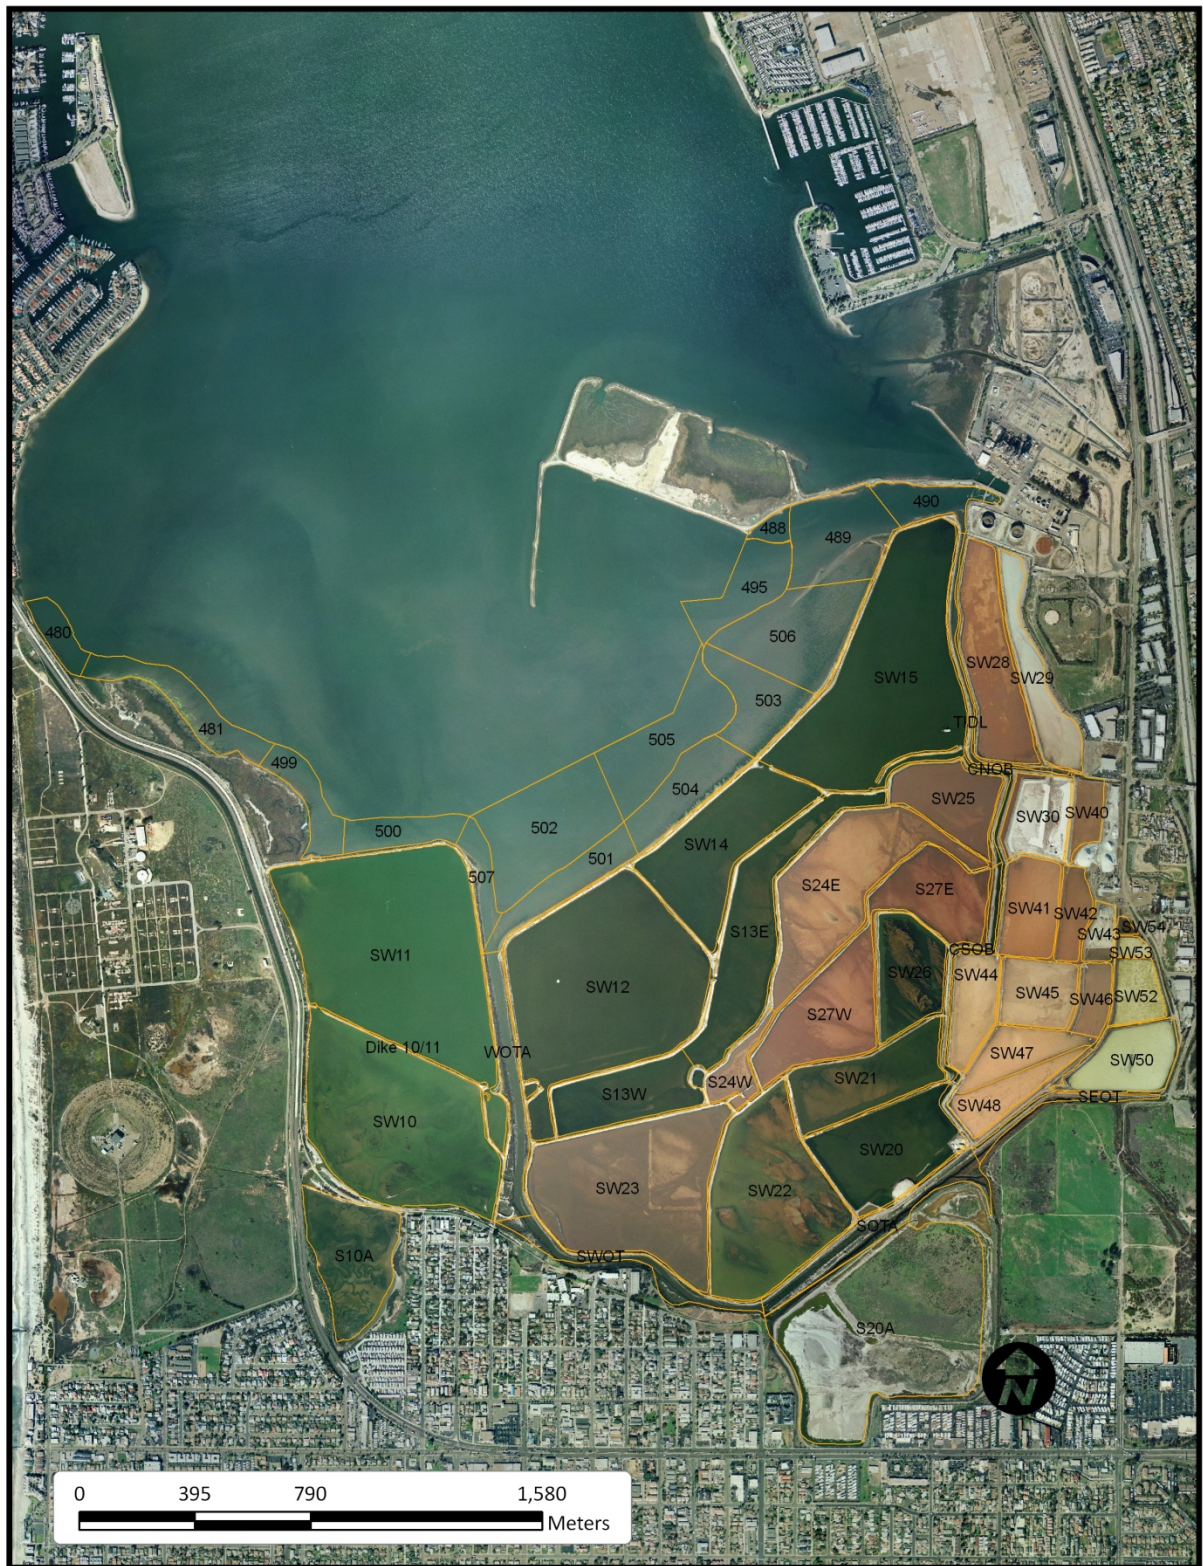
**Figure 25. Avian Monitoring Grid – South San Diego Bay and Salt Works - Preconstruction.**

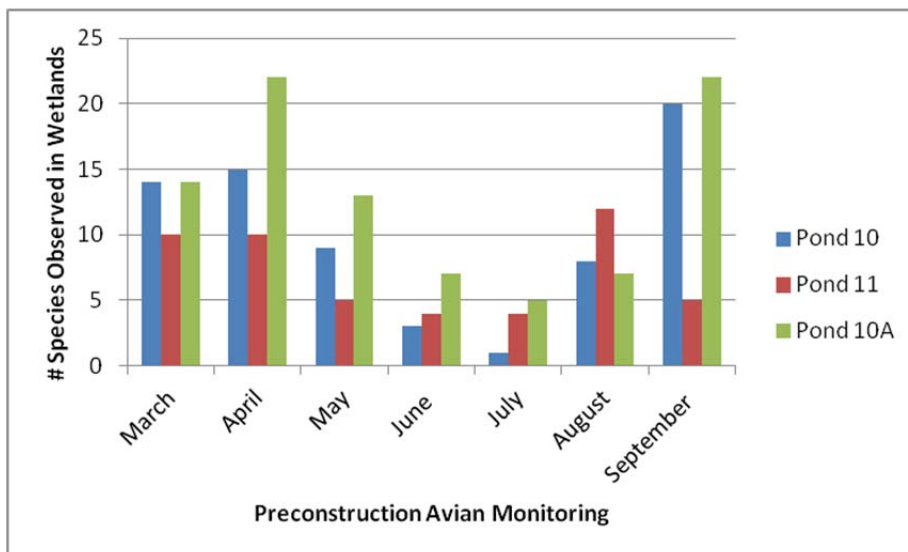
The number of avian species observed in wetland habitat during the preconstruction surveys varied seasonally with peaks in April and September (Figure 27). A high of 23 species was recorded in April and September and low of 2 species was recorded in Pond 10 during July. The mean number of species over the seven-month preconstruction monitoring period was 13 species in Pond 10A, 10 species in Pond 10, and 7 species in Pond 11.

**Figure 27. Number of Avian Species Observed in Wetland Habitats – Preconstruction**

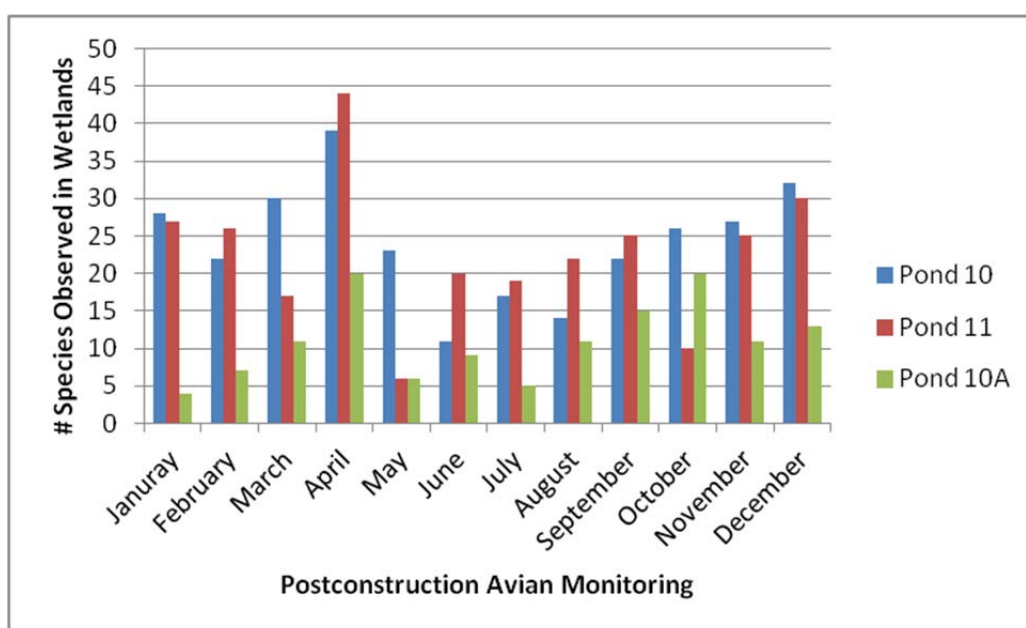
The number of species observed in wetland habitats during the 2012 postconstruction monitoring is illustrated in Figure 29. The number of species peaked again in April with a lesser peak in December. Numbers of species observed ranged from 44 in Pond 11 in April to 4 species in Pond 10A in January. The number of species present was generally greatest in ponds 10 and 11 and less in Pond 10A. The mean number of species in Pond 10 was 24 with a mean of 23 in Pond 11. The mean number of species in Pond 10A was 11. A comparison of the 7-month preconstruction monitoring period with the same months postconstruction indicates that the number of species observed in ponds 10 and 11 were higher following pond restoration. These data suggest that avian usage was improved by converting ponds 10 and 11 to intertidal and subtidal habitats. The number of species observed in Pond 10A were similar during both 7-month intervals with the exception of September 2010.

**Figure 29. Number of Avian Species Observed in Wetland Habitats – Postconstruction**

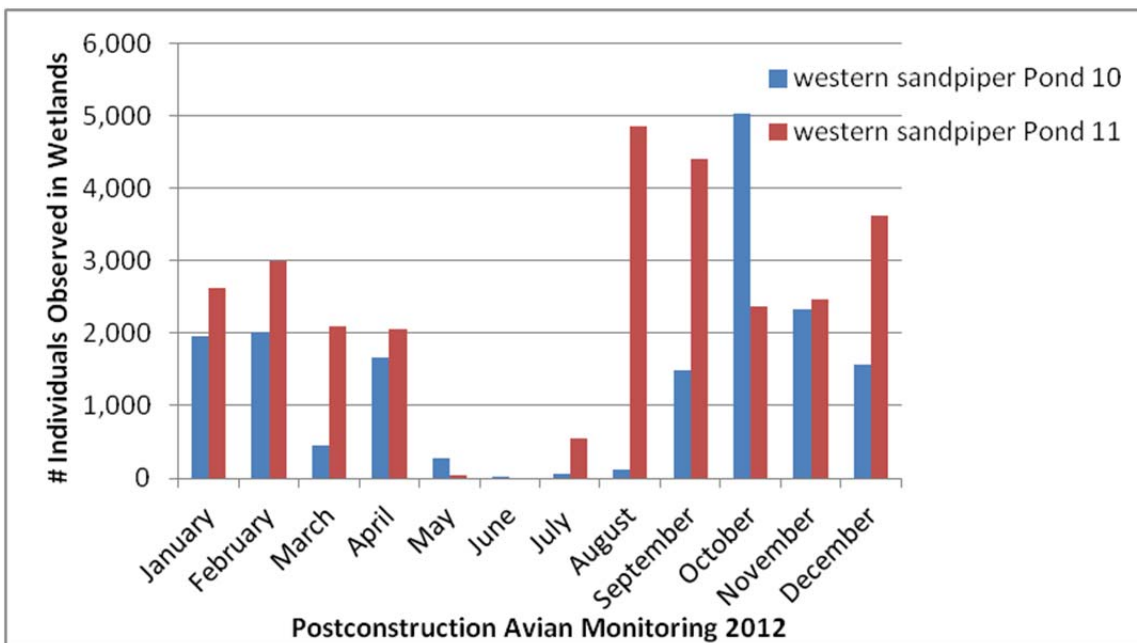
The numbers of western sandpiper observed postconstruction in Ponds 10 and 11 closely mirrored the overall numbers of individuals observed (Figures 31 and 32). This species was by far the numerically dominant species during postconstruction surveys (Table 15). While western sandpipers were also among the numerically dominant species in 2010, numbers observed in Ponds 10 and 11 during postconstruction monitoring were an order of magnitude greater.

**Figure 31. Number of Individual Western Sandpiper Observed in Wetland Habitats in Ponds 10 and 11 Postconstruction.**
