RE: LUSARDI CREEK PRESERVE; FINAL MONITORING REPORT

## **Lusardi Creek – May 2014 Bernardo Fire Damager Restoration Recommendations**

Subject: Quarterly Monitoring Log for the Lusardi Creek Project

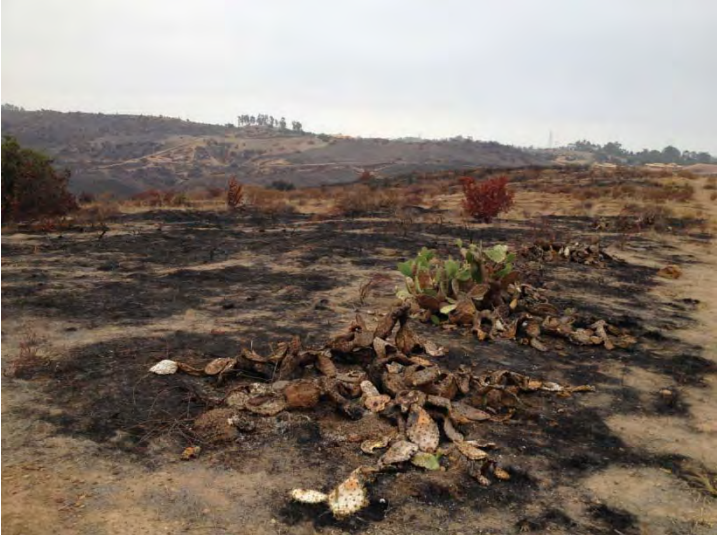
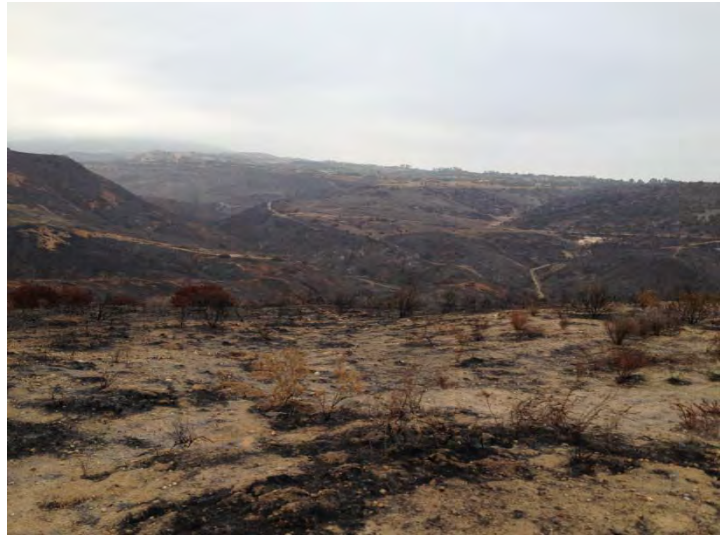
**Upper Enhancement Area**

- Approximately 1/3 of the upper enhancement area was burned during the fire. The burned area is concentrated in the northeast and southeast area.
  - Restoration concerns include the reduction in native shrub cover outside of the dethatched area, lack of native germination within the dethatched area, and the introduction and increase in non-native species.
- Recommendations
  - Mow or treat non-natives with an appropriate herbicide in August, September, and October
  - Install a native seed mix in late October following a weeding event within the upper enhancement area (approximately 9.75 acres)

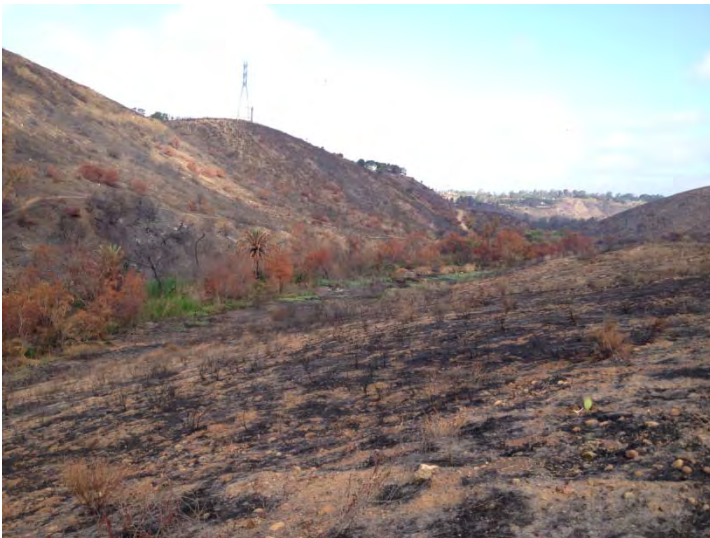
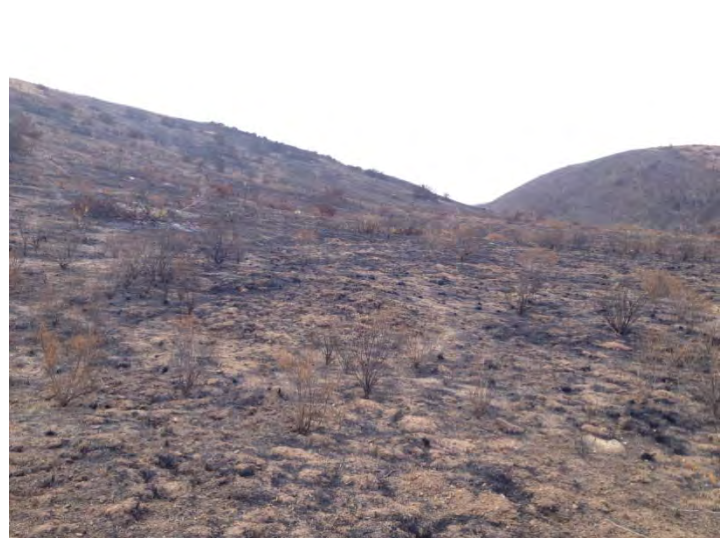
**Lower Enhancement Area**

- The entire lower enhancement area was burned during the fire. Approximately 50 percent of the cacti cuttings were burned. Non-native grasses and native shrubs throughout the lower enhancement areas were also burned.
  - Restoration concerns include the loss of cacti cuttings, reduction in native cover, and reemergence of non-native grasses.
- Recommendations
  - Mow or treat non-native grasses with an appropriate herbicide in August, September, and October
  - Install a native seed mix in late October following a weeding event in the lower enhancement area (Approximately 4.76 acres)
  - Replace dead cacti cuttings

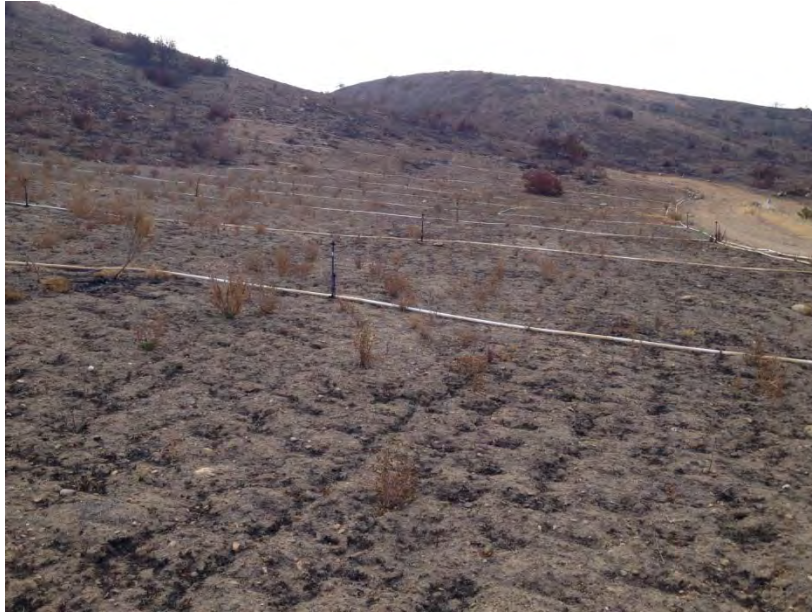
**CSS Restoration Area**

- The entire CSS restoration was burned. The majority of native seedlings and young plants were killed or damaged. Non-native grasses were also burned leaving lots of bare ground. Total cover of the restoration area was estimated to be 15 percent.
  - Restoration concerns include the lack of native shrubs and seedlings and reemergence of non-native grasses.
- Recommendations
  - Mow or treat non-native grasses with an appropriate herbicide in August, September, and October
  - Install a native seed mix and container stock in late October following a weeding event (see below for recommended plantings and seed mix)

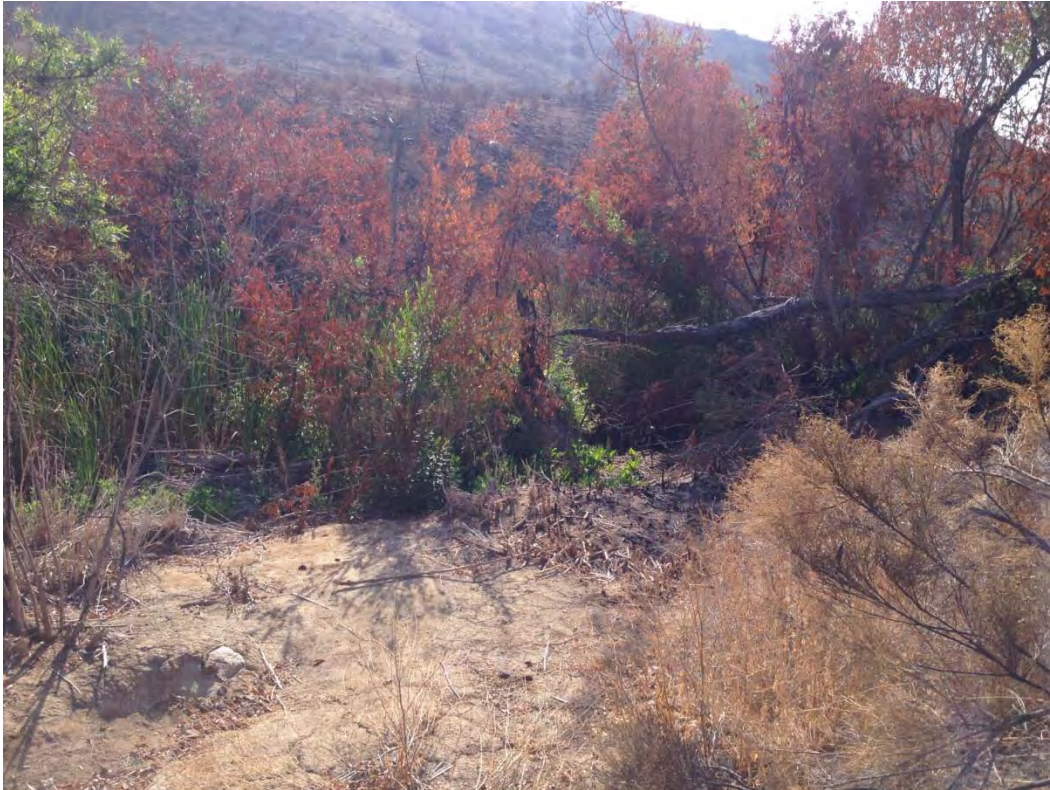
**Photo Point 1-Far upstream Lusardi Creek Target Control Area**

No resprouting arundo was observed within the treatment area.

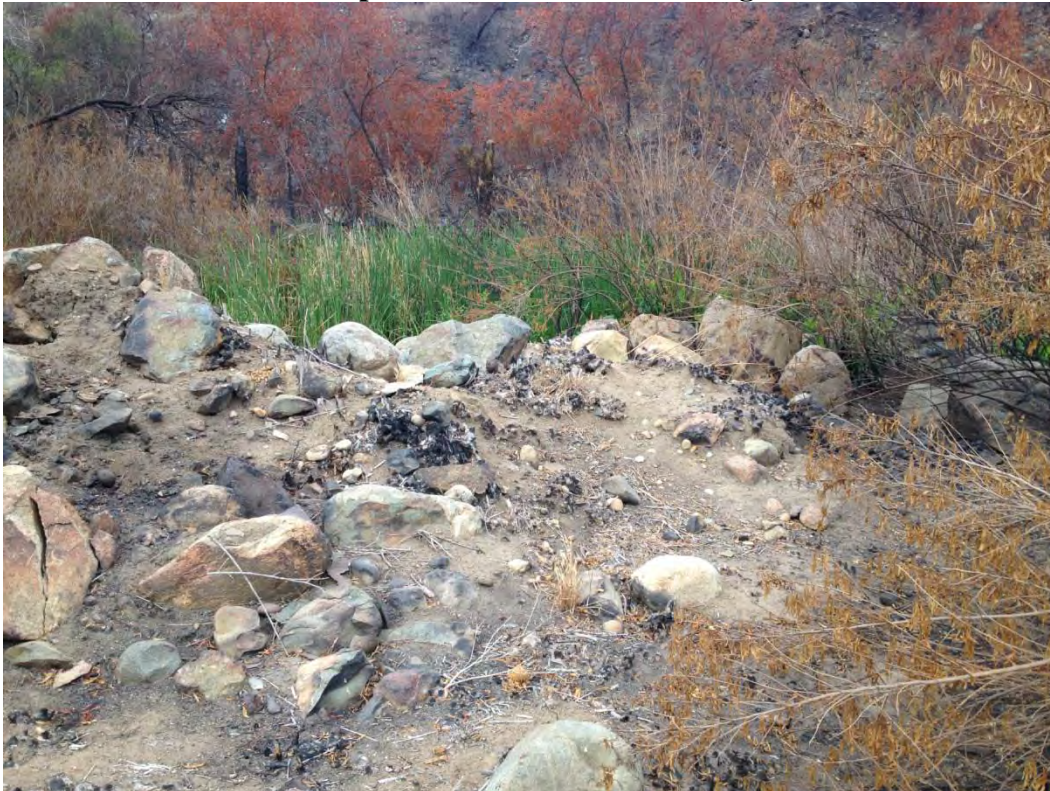
**Photo Point 2-Northeastern Lusardi Creek Target Control Area**

No resprouting arundo was observed within the treatment area.

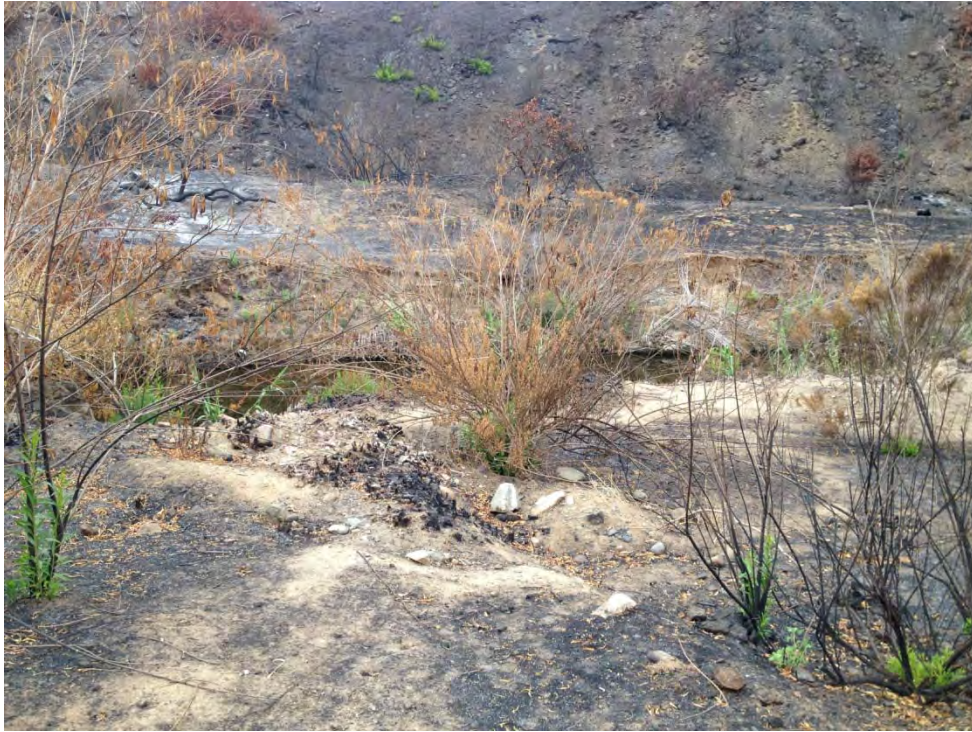
**Photo Point 3-Lusardi Creek Target Control Area (downstream of Arizona crossing)**

A few resprouts of arundo were observed within the treatment area. Resprouts were between 1 and 3 feet tall. Resprouts should be cut at the base and treated with an appropriate herbicide to ensure control.

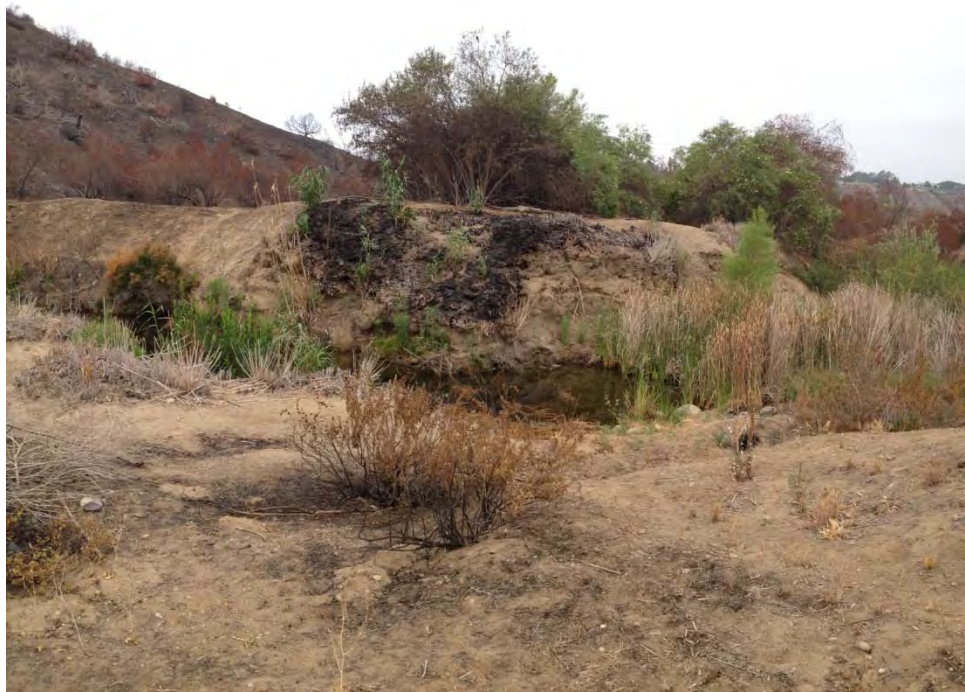
**Photo Point 4-Downstream Lusardi Creek Target Area**

A few resprouts of arundo were observed within the treatment area. Resprouts were between 1 and 3 feet tall. Resprouts should be cut at the base and treated with an appropriate herbicide to ensure control.

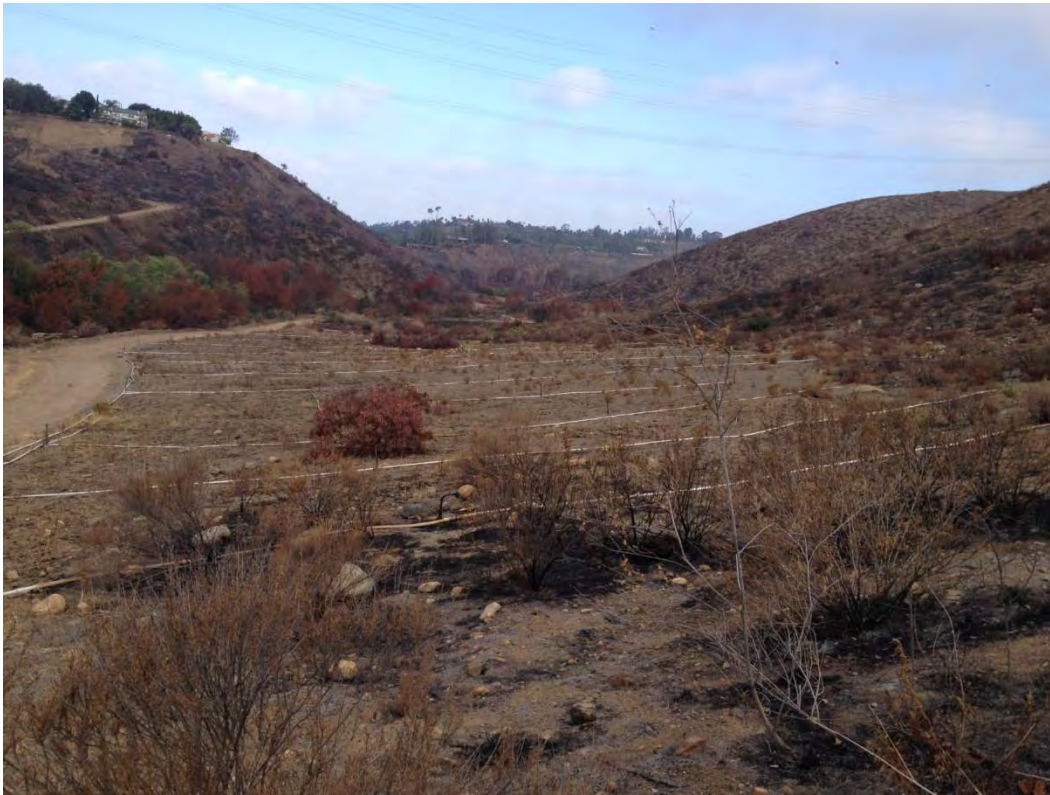
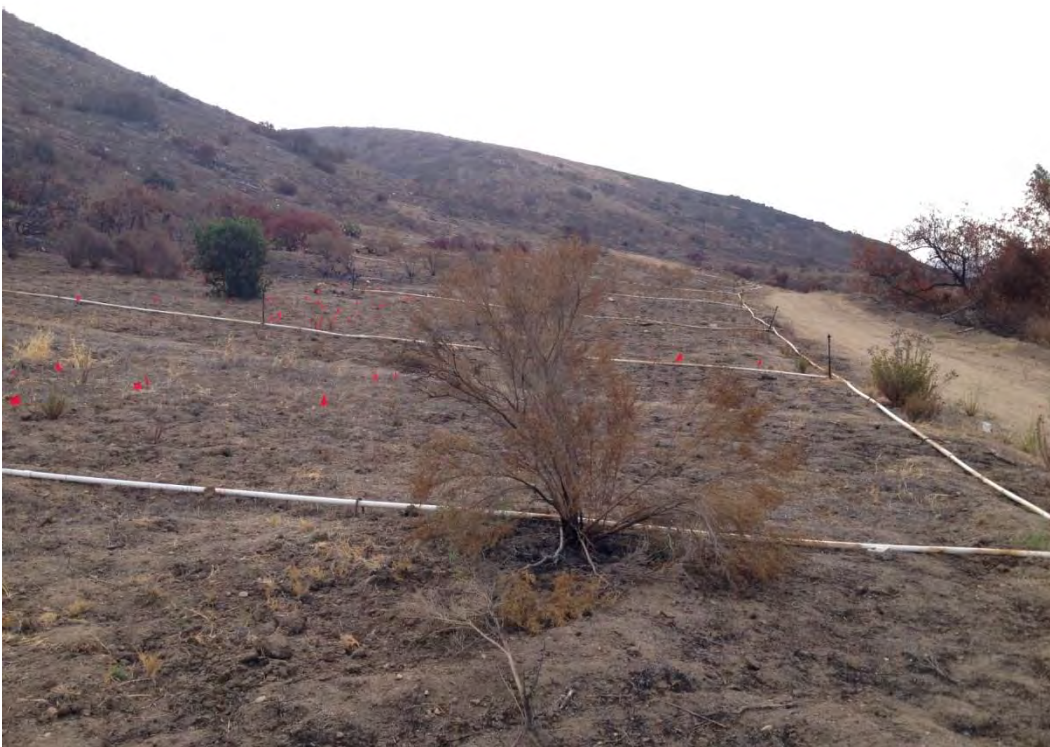
The entire 1.35 acre CSS restoration site was burned during the Bernardo Fire. The majority of native seedlings and young plants were killed or damaged. Total cover was visually estimated to be 15 percent during the visit with native cover at 10 percent and non-native cover at 5 percent. While non-native cover has decreased due to the fire, the majority of the restoration site is currently bare. Reemergence of non-natives within the restoration site is a high concern.

**Photo Point 5-Facing west across CSS restoration area**

**Photo Point 6-Facing east across CSS restoration area**

Regular maintenance of the restoration site should continue. Maintenance activities should focus on controlling the reemergence of non-natives following the fire. Non-natives should either be handpulled or treated with an appropriate herbicide prior to plants setting seed. Any flower or seed heads present should be cut and removed from the site to prevent the distribution and spread of non-native species within the restoration site.

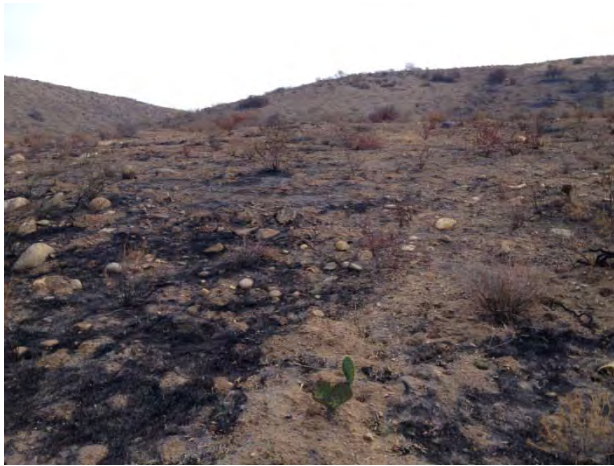
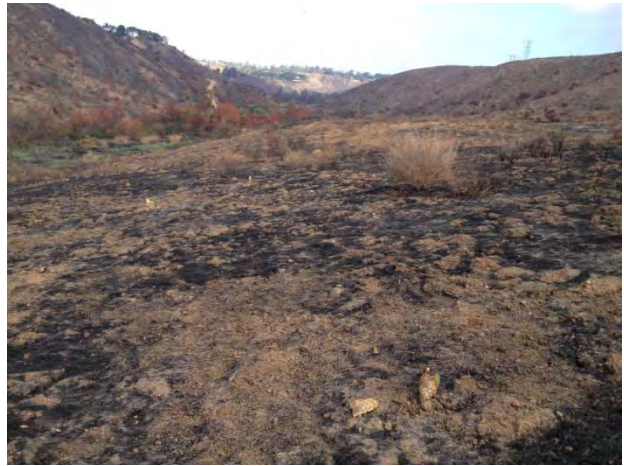
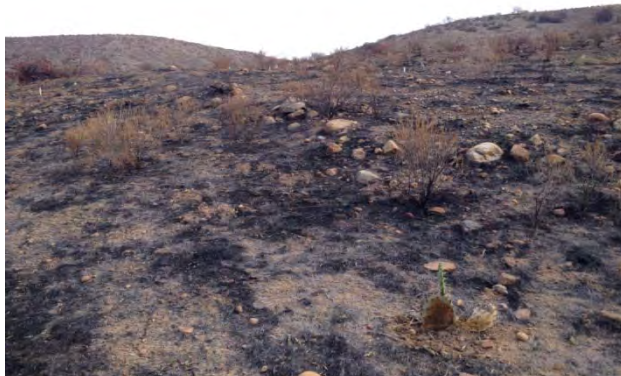
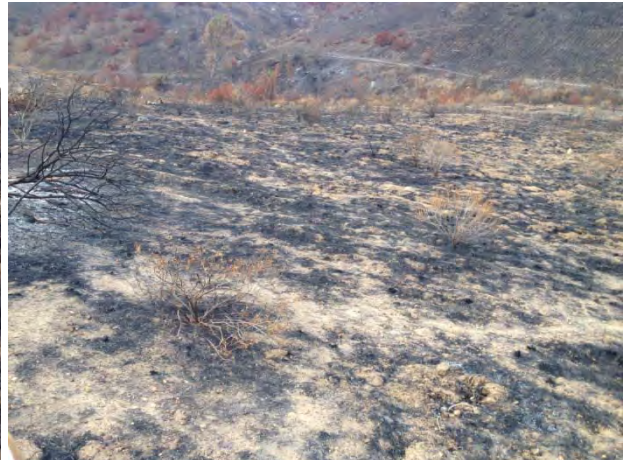
The entire lower enhancement area was burned during the Bernardo Fire. Approximately 50 percent of the cacti cuttings with either burned or damaged. The health of the cuttings will continue to be monitored during future visits.

**Photo Point 13: Cacti cuttings at Plot 2**

**Photo Point 14: Cacti cuttings at Plot 3**

**Photo Point 15: Cacti cuttings at Plot 5**

**Photo Point 16: Cacti cuttings at Plot 7**

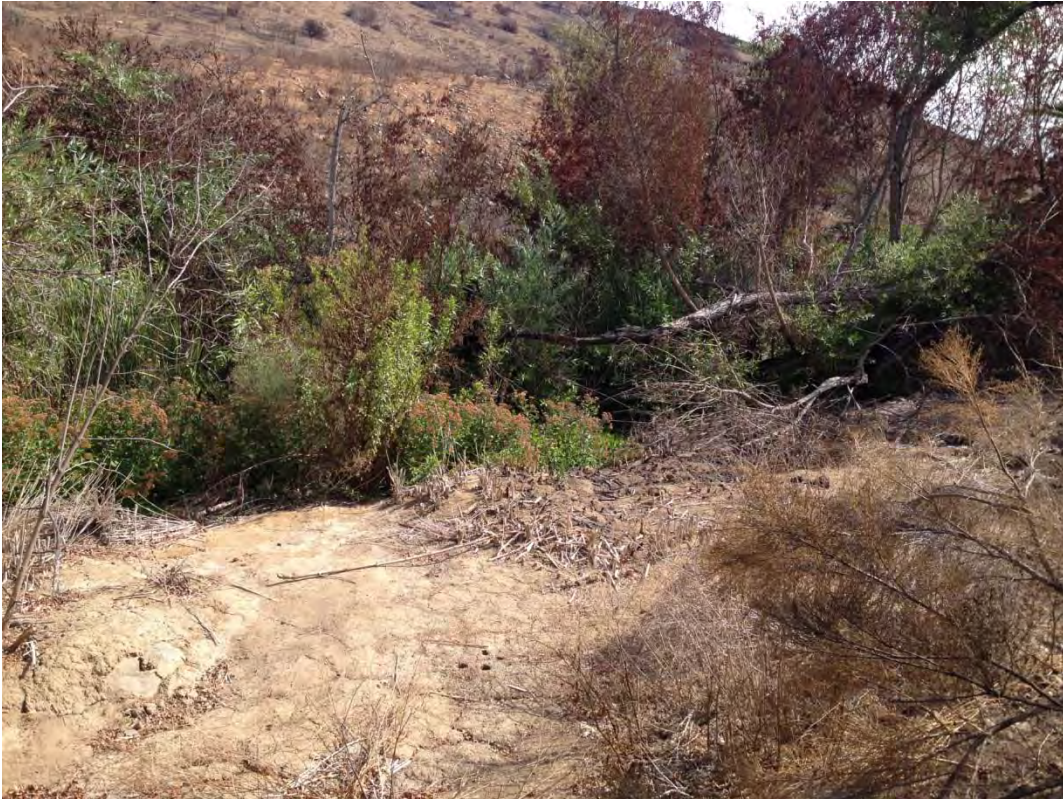
**Photo Point 1-Far upstream Lusardi Creek Target Control Area**

No resprouting arundo was observed within the treatment area.

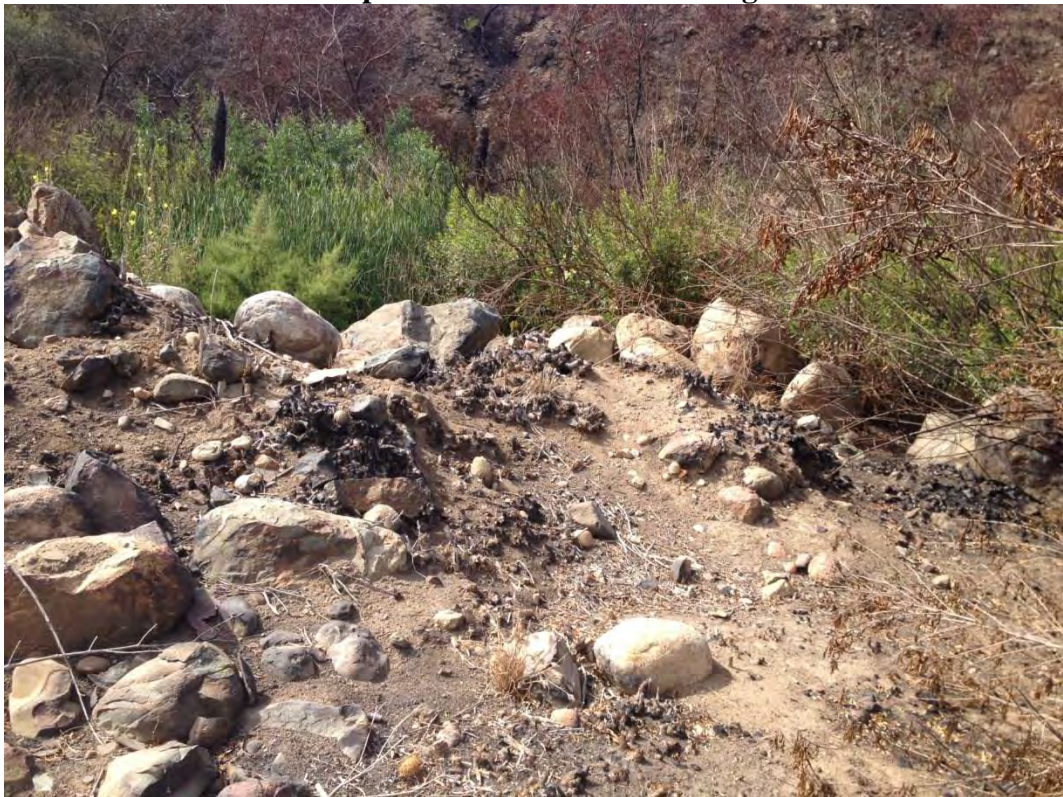
**Photo Point 2-Northeastern Lusardi Creek Target Control Area**

No resprouting arundo was observed within the treatment area.

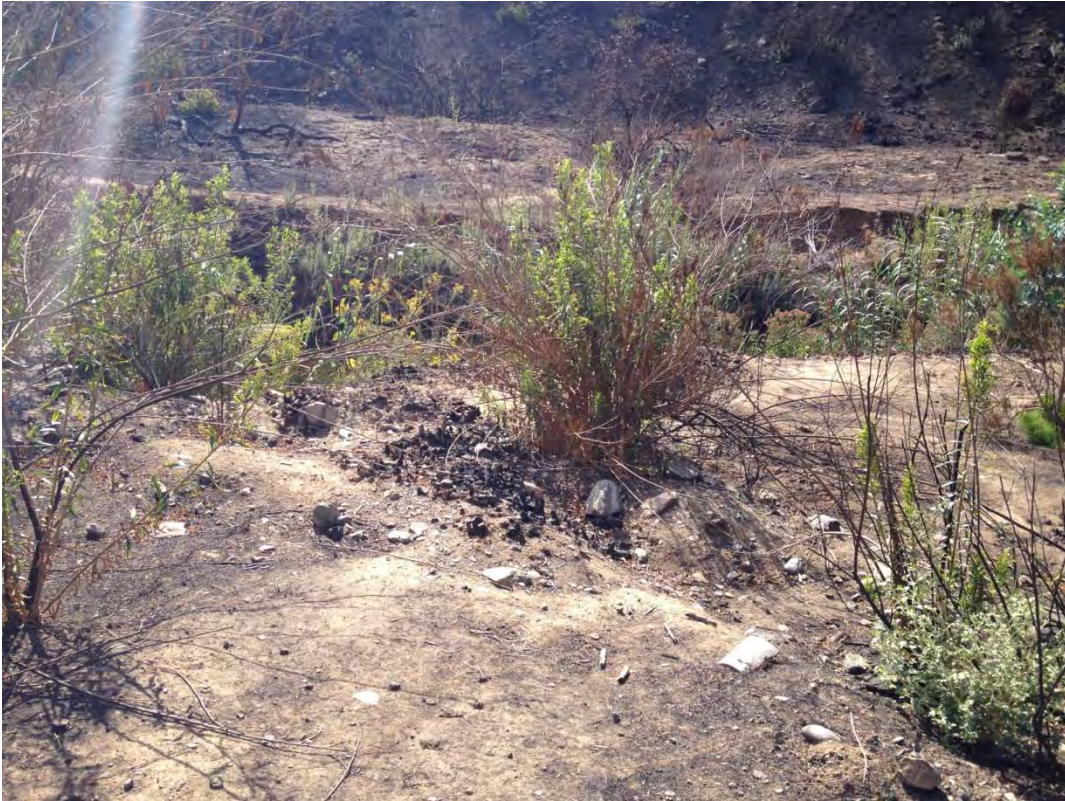
**Photo Point 3-Lusardi Creek Target Control Area (downstream of Arizona crossing)**

A fair amount of resprouting arundo was observed within the treatment area. Resprouts were between 3 and 6 feet tall. Resprouts should be cut at the base and treated with an appropriate herbicide to ensure control.

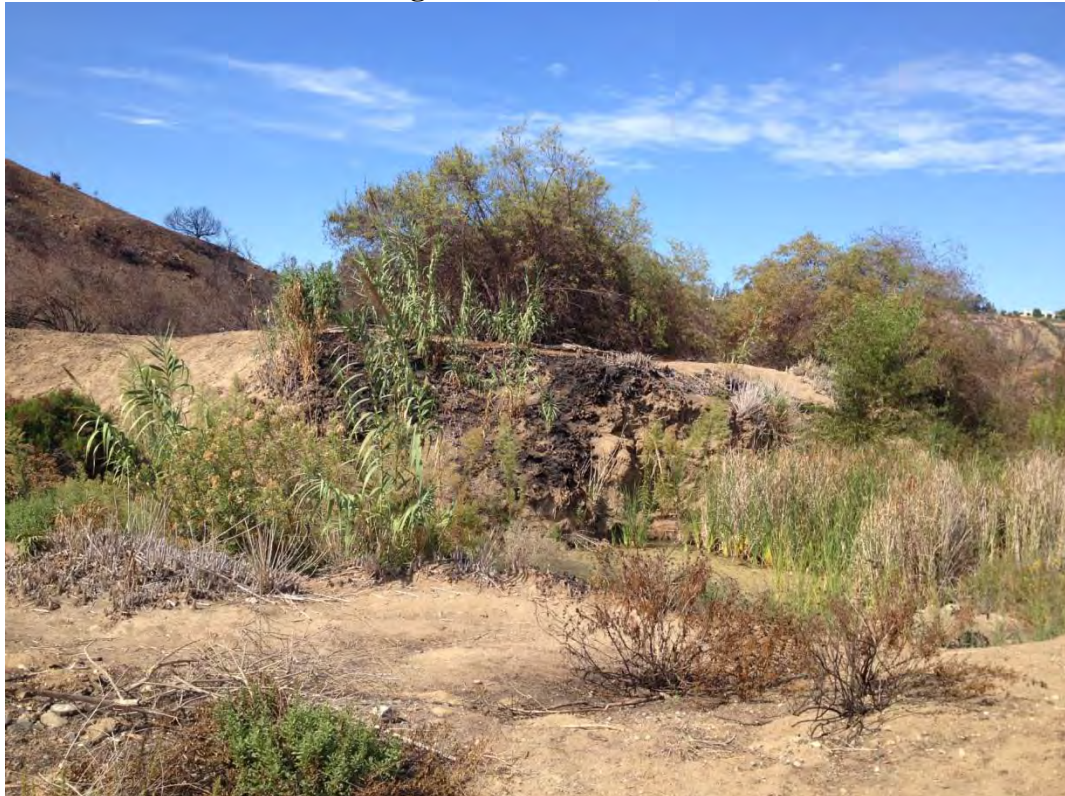
**Photo Point 4-Downstream Lusardi Creek Target Area**

A fair amount of resprouting arundo was observed within the treatment area. Resprouts were between 4 and 6 feet tall. Resprouts should be cut at the base and treated with an appropriate herbicide to ensure control.

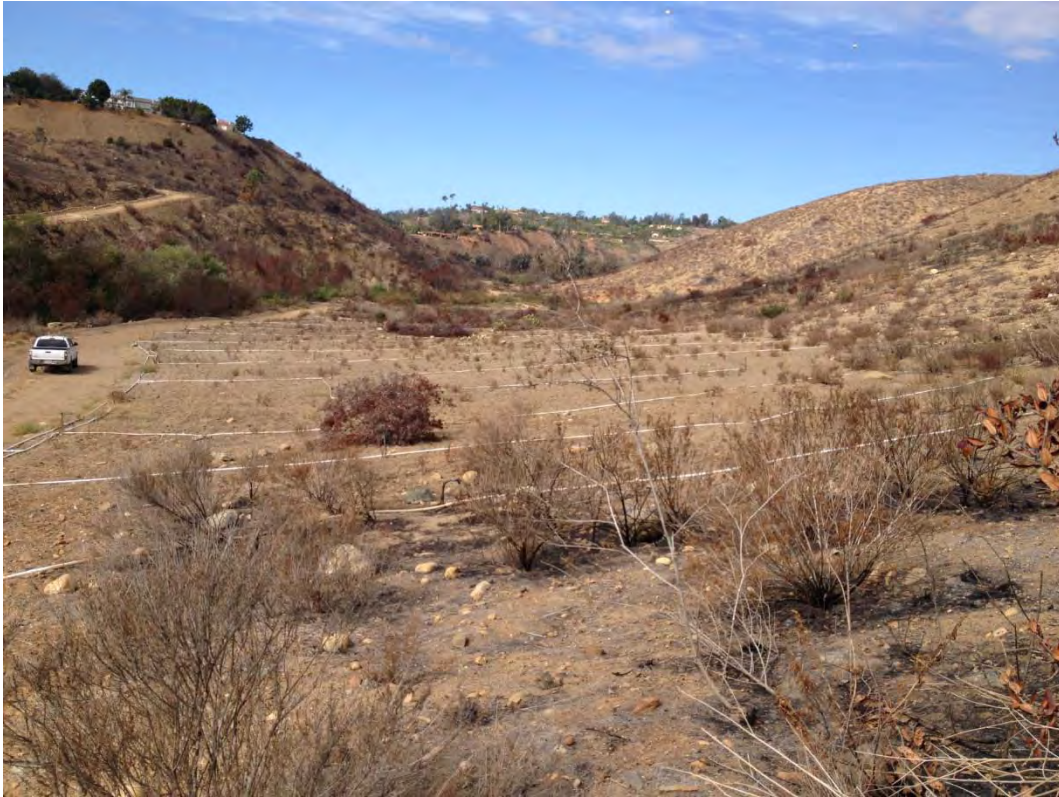
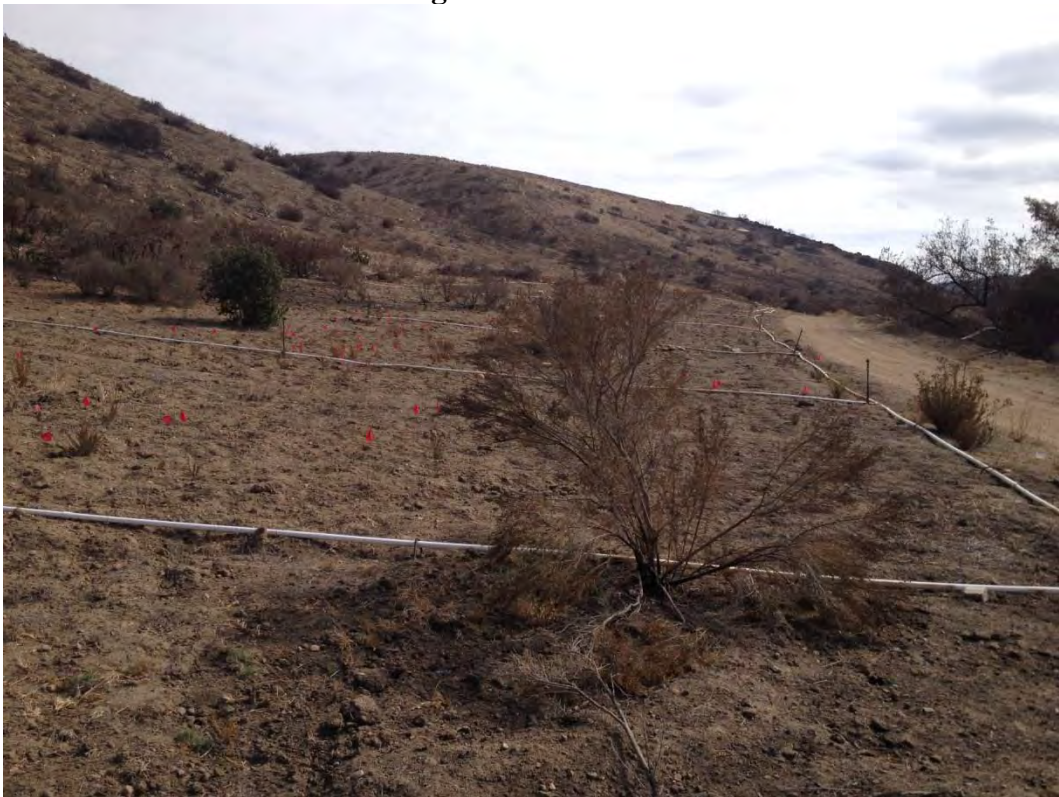
The entire 1.35 acre CSS restoration site was burned during the Bernardo Fire. The majority of native seedlings and young plants were killed or damaged. Total cover was visually estimated to be 15 percent during the visit with native cover at 10 percent and non-native cover at 5 percent. While non-native cover has decreased due to the fire, the majority of the restoration site is currently bare. Reemergence of non-natives within the restoration site remains a high concern. Emerging Russian thistle (*Salsola tragus*) was observed along the irrigation piping bordering the road and one Mexican fan palm (*Washingtonia robusta*) seedling was detected in the southern portion of the site.

**Photo Point 5-Facing west across CSS restoration area**

**Photo Point 6-Facing east across CSS restoration area**

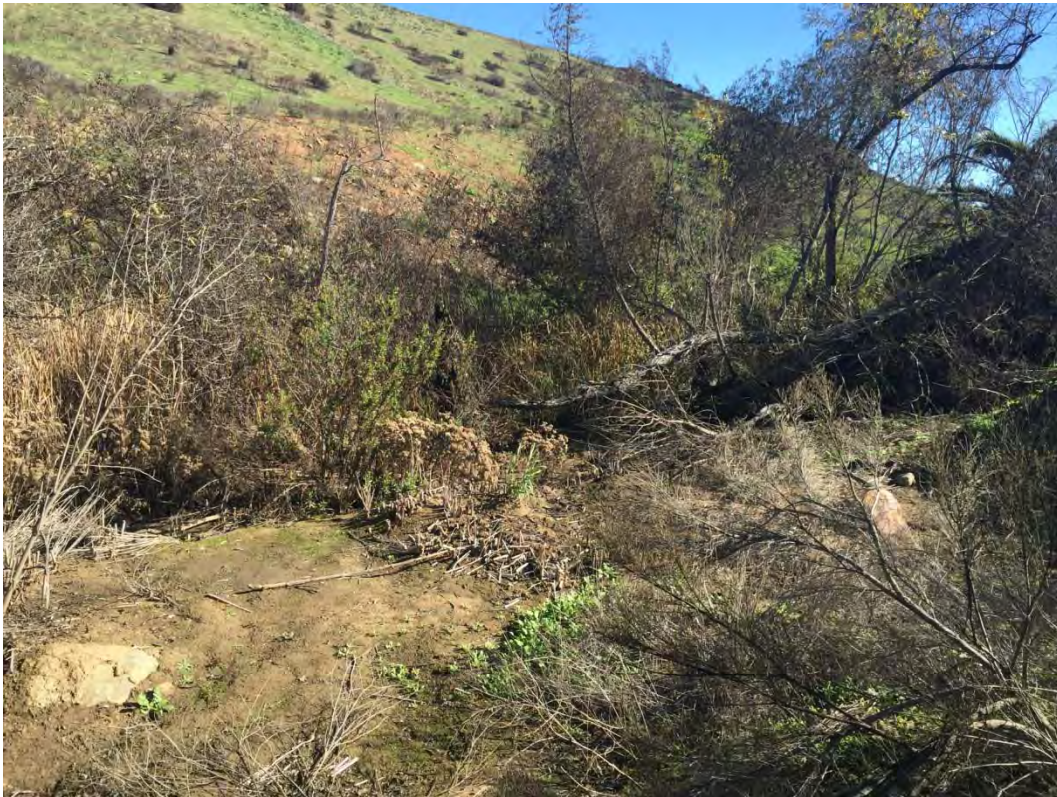
**Photo Point 1-Far upstream Lusardi Creek Target Control Area**

A few resprouts of giant reed were observed within the treatment area.

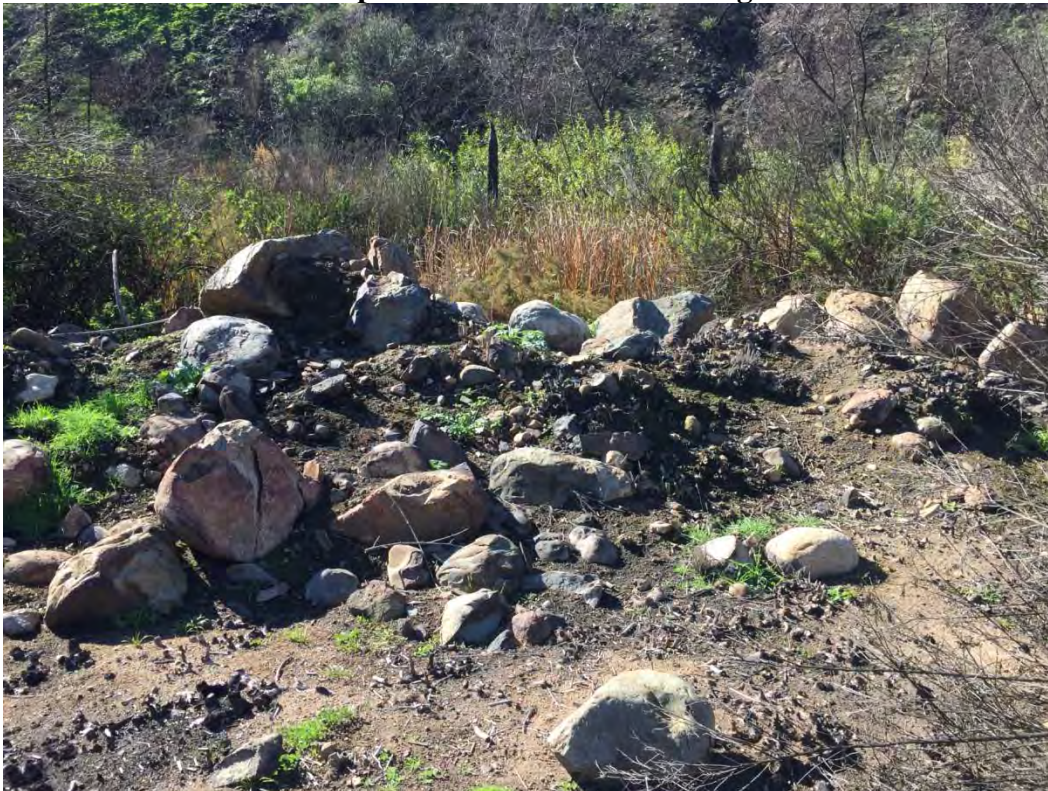
**Photo Point 2-Northeastern Lusardi Creek Target Control Area**

No resprouting giant reed was observed within the treatment area.

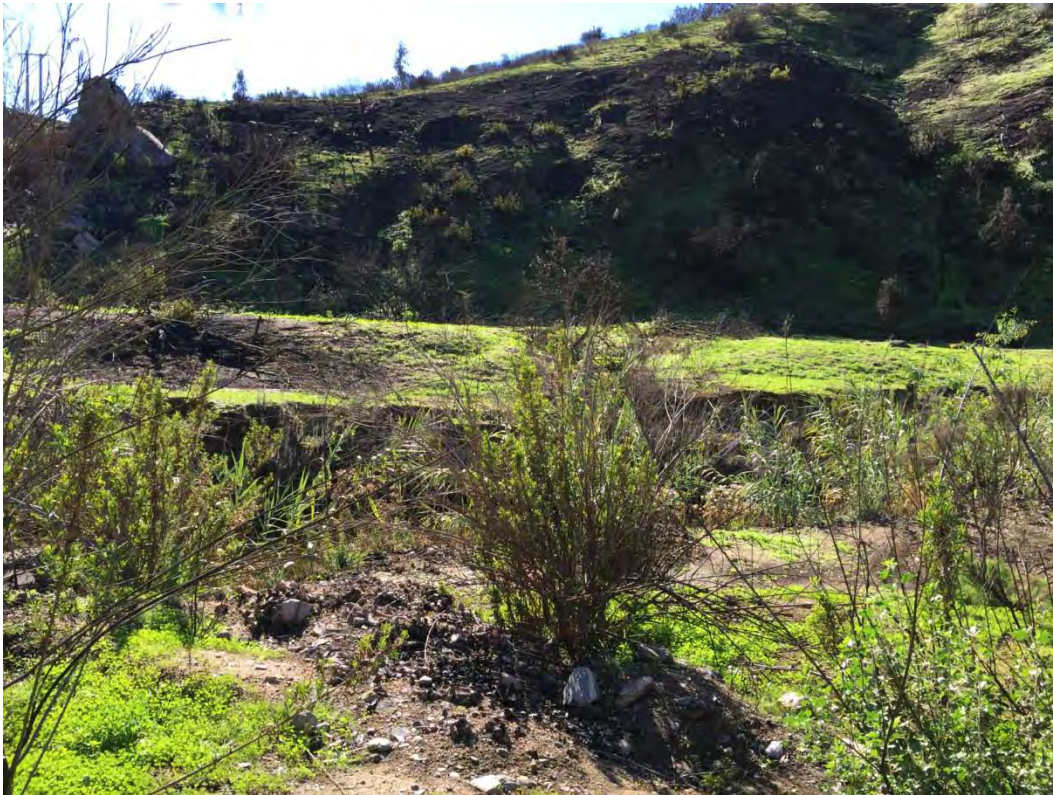
**Photo Point 3-Lusardi Creek Target Control Area (downstream of Arizona crossing)**

Multiple resprouts of giant reed were observed within the treatment area. Resprouts were between 3 and 7 feet tall. Resprouts should be cut at the base and treated with an appropriate herbicide to ensure control.

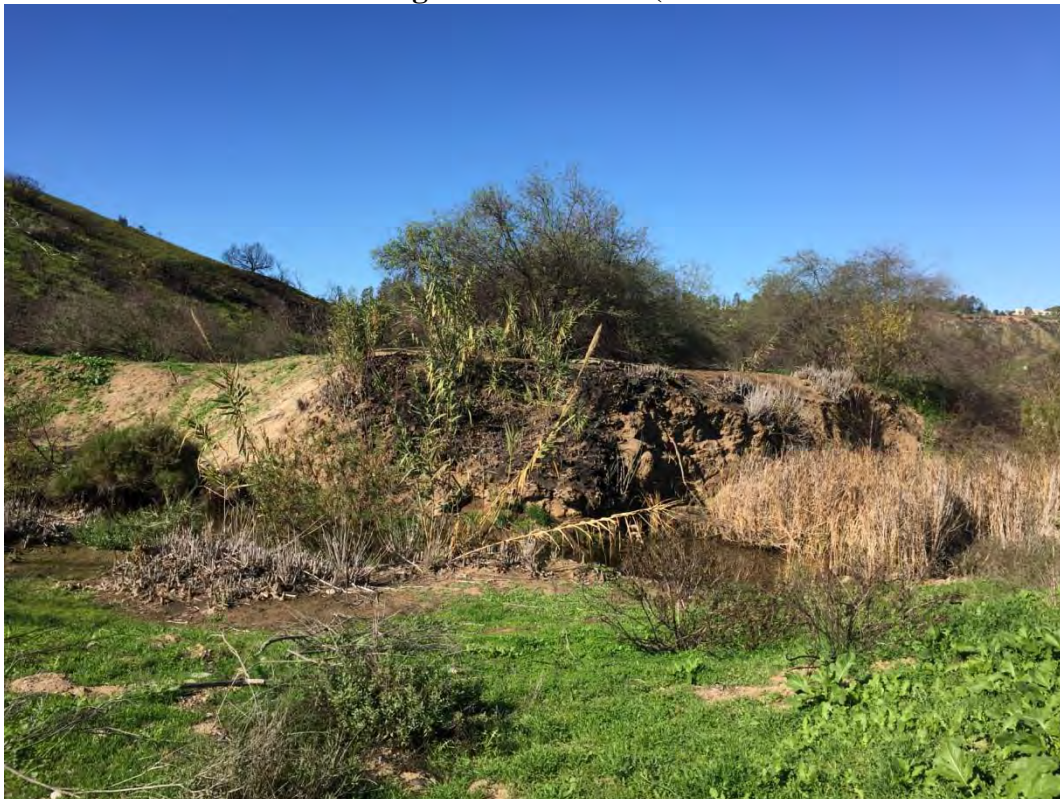
**Photo Point 4-Downstream Lusardi Creek Target Area**

Multiple patches of resprouting giant reed were observed within the treatment area. Resprouts were between 4 and 8 feet tall. Resprouts should be cut at the base and treated with an appropriate herbicide to ensure control.

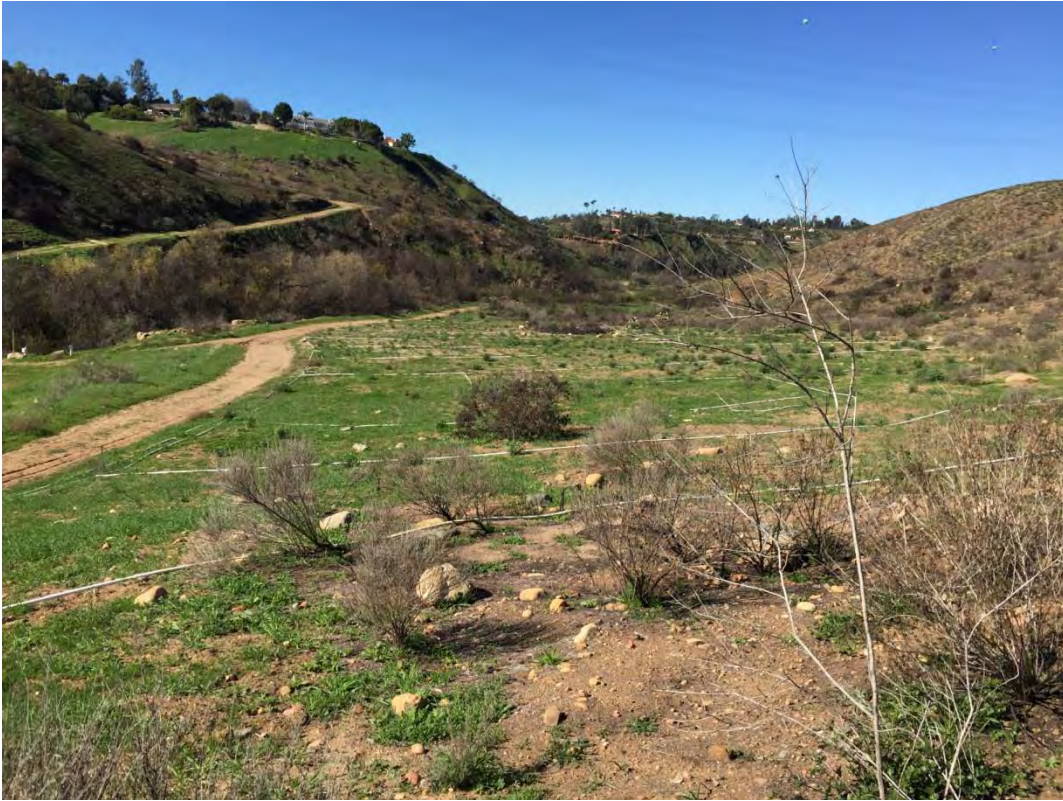
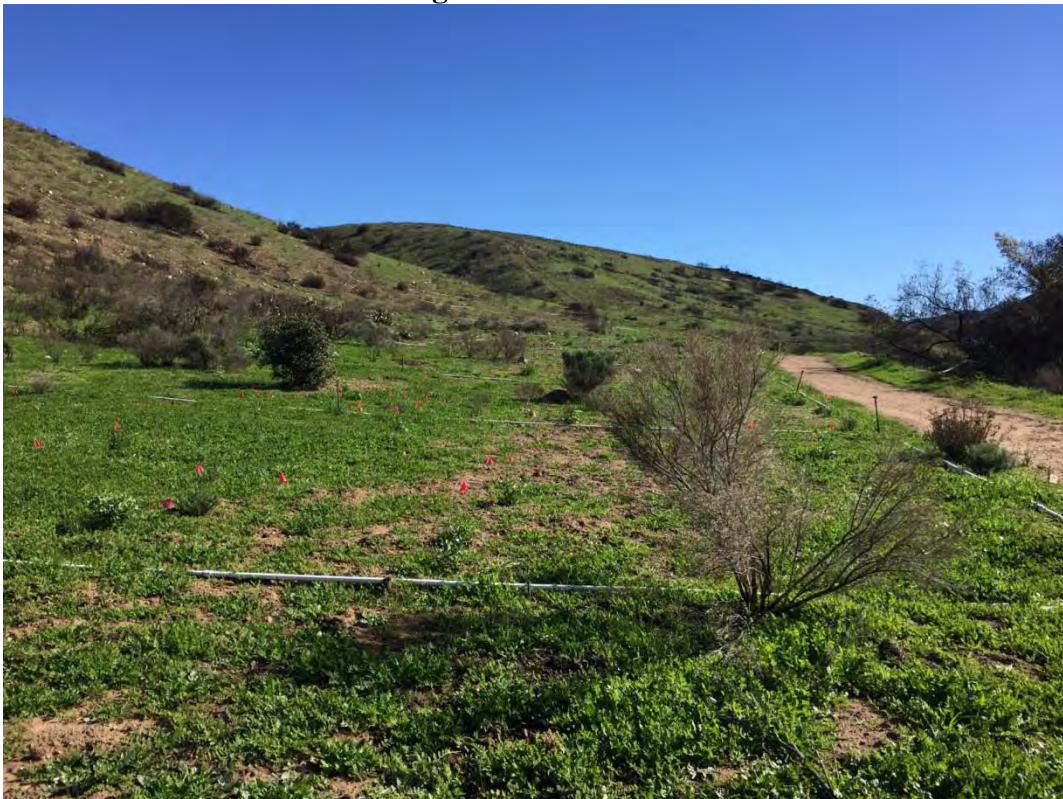
The entire 1.35 acre CSS restoration site was burned during the Bernardo Fire. The majority of native seedlings and young plants were killed or damaged. However, during the January monitoring several plants, mostly bush sunflower (*Encelia californica*) and coast prickly pear were observed resprouting. Total cover was visually estimated to be 70 percent during the visit with native cover estimated at 15 percent and non-native cover estimated at 85 percent. Non-native cover primarily consisted of wild oat (*Avena* sp.) and filaree (*Erodium* spp.) with several Russian thistle (*Salsola tragus*) present along the access road and irrigation pipes. No flowers or seed heads were observed.

**Photo Point 5-Facing west across CSS restoration area**

**Photo Point 6-Facing east across CSS restoration area**

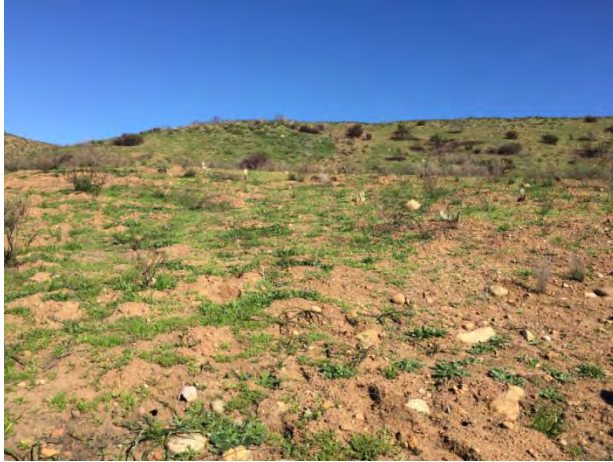
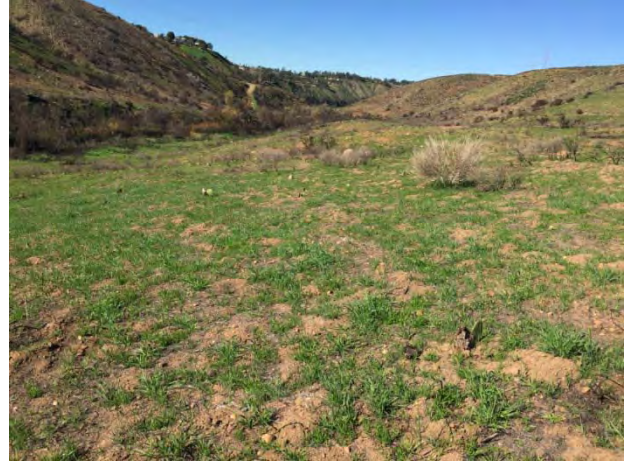
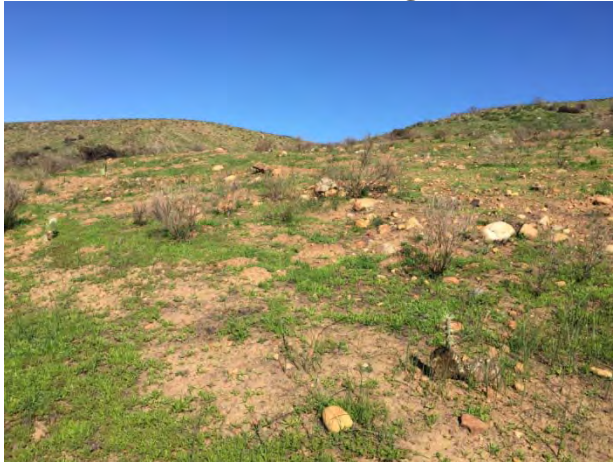
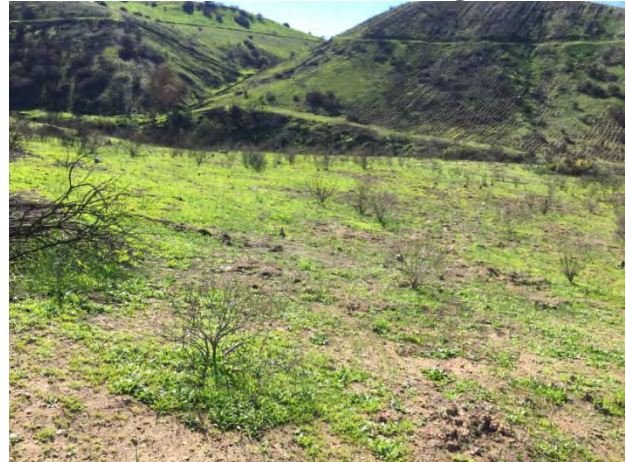
The entire lower enhancement area was burned during the Bernardo Fire. However, the majority of cacti cuttings have resprouted if they were burned or remain healthy with several new growth segments observed. Non-native cover within the lower enhancement area has significantly increased with the emergence of non-native grasses following the winter rains.

**Photo Point 13: Cacti cuttings at Plot 2**

**Photo Point 15: Cacti cuttings at Plot 5**

**Photo Point 16: Cacti cuttings at Plot 7**
