# Preliminary Actions to Improve the Function of Wildlife Linkages within the San Diego County Preserve System.

## Data Summary

San Diego Association of Governments

U.S. DEPARTMENT OF THE INTERIOR  
U.S. GEOLOGICAL SURVEY  
WESTERN ECOLOGICAL RESEARCH CENTER

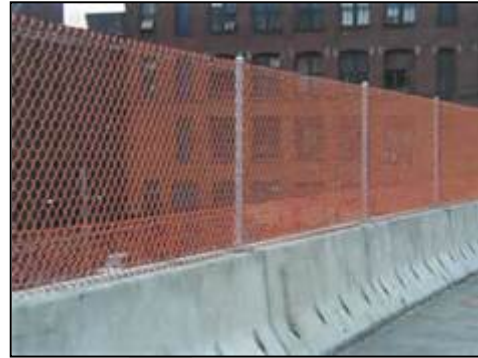
Many of the recommendations here involve fencing to guide wildlife away from roadways and towards appropriate crossing structures where they exist. Due to the wide ranging characteristics of the intended focal species, fencing should include design elements to exclude both large and small animals from the roadway, while still allowing continued vehicle and pedestrian access. And, where possible, fencing should incorporate some level of fire ignition reduction technique. Fence design may include a Jersey rail with chain-link fence above. The Jersey rail along the lower edge would prevent small wildlife from entering the roadway. And the fencing along the upper portion should deter larger animals. Additionally, the Jersey rail should intercept sparks from passing cars and potentially blowing embers, reducing the number of ignitions along the roadside. An alternate fence design may include a chain-link fence with 36 inches of metal flashing along the lower edge, with six inches of both buried below the surface. Neither of these fencing designs has been confirmed to reduce ignitions along roadsides, further research into the practicality of fences as barriers to fire is needed. Surface drainage from the roadway should include structural elements that would reduce the likelihood that wildlife could access the road through drainage structures.

Vehicle and pedestrian access across the wildlife fencing can be accomplished with cattle grates and self closing gates where needed. Where driveways join the main road, cattle grates should be installed to deter wildlife from going around the end of the fence onto the road. Visual and real cattle grates should be considered and evaluated for effectiveness, but the expectation is that real cattle grates should be more effective across the range of animals sizes the fences are intended to protect. Where real cattle grates are used, the design should include a mechanism to return any animal that falls into the grate to the correct side of the fence. The pedestrian gates should include steps on the road side of the fence to go over the height of the metal flashing while maintaining the flashing as a barrier on the wildlife side of the fence.

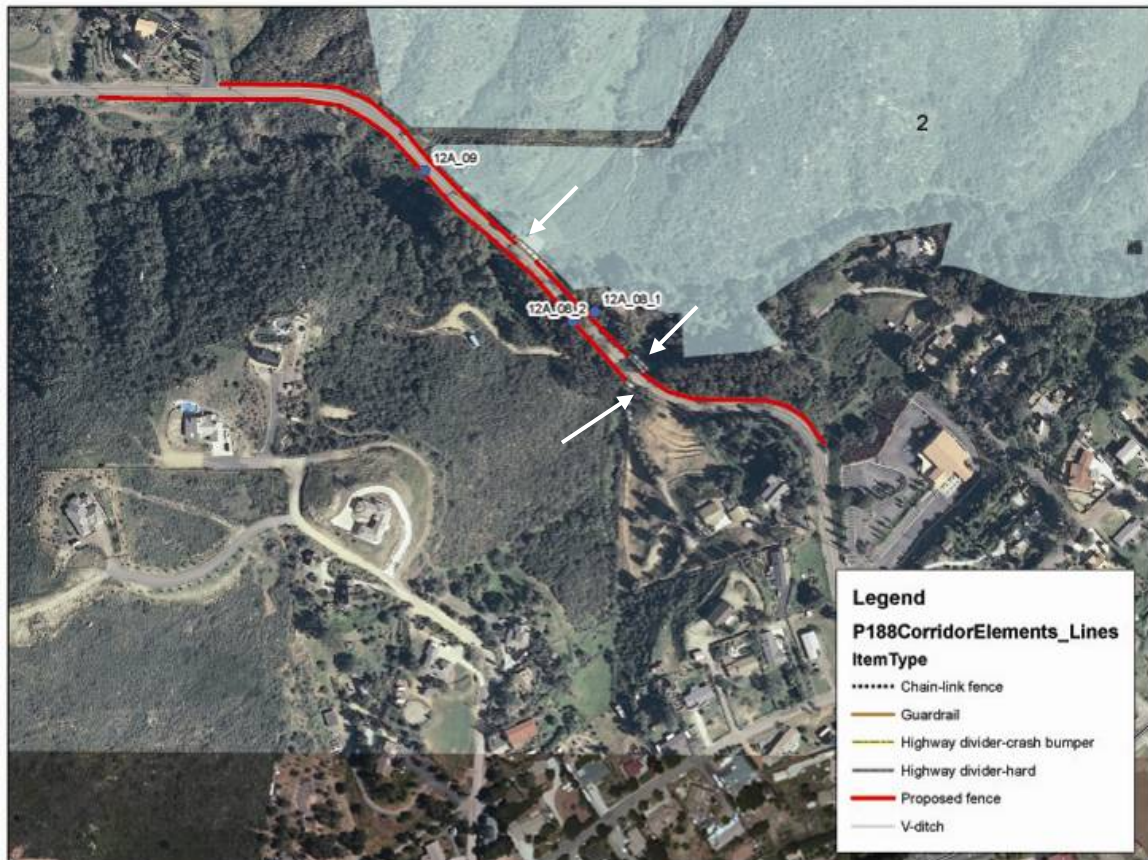
## Linkage 1 – 2A Mexican Canyon

Jamul Drive near Mexican Canyon already has some fencing on both sides of the road, but this needs to be extended and upgraded to prevent wildlife – automobile interactions in the area. The white arrows indicate access points along SR-94 that will need cattle grates to prevent wildlife from entering the road at driveways. The double box culvert at 12A\_08 will need to have the vegetation at both ends thinned. Within the culvert, the sediment depth should be evaluated and cleared out if it is excessively deep.

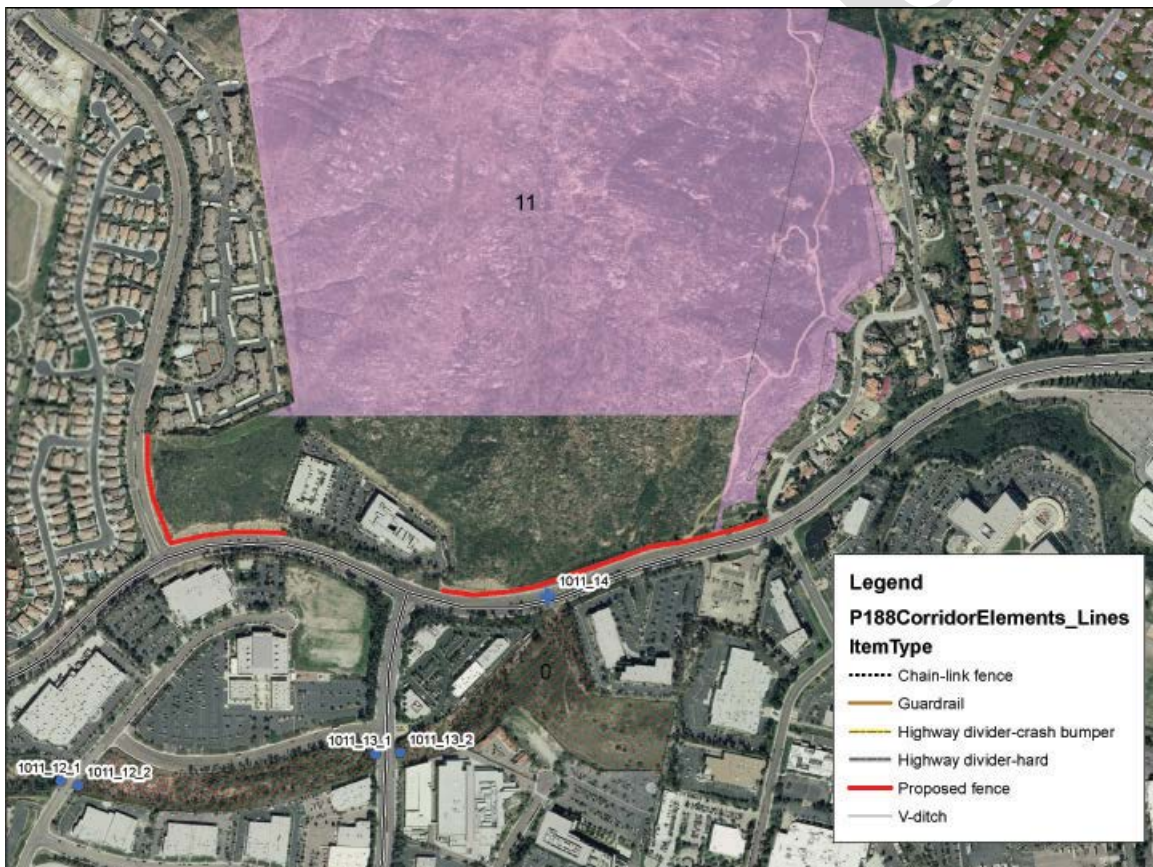
## Linkage 10 – 11

The linkage between Core Area 10 and Core Area 11 through the chain of non-core conserved lands is most likely non-functional for any species except the most commensal, disturbance tolerant species. The section of Rancho Bernardo Road just south of CA-11 at the east end should be fenced to prevent wildlife access to the roadway. There is no significant wildlife crossing structure at this location to guide wildlife towards, the fence would solely be to keep animals away from the road.

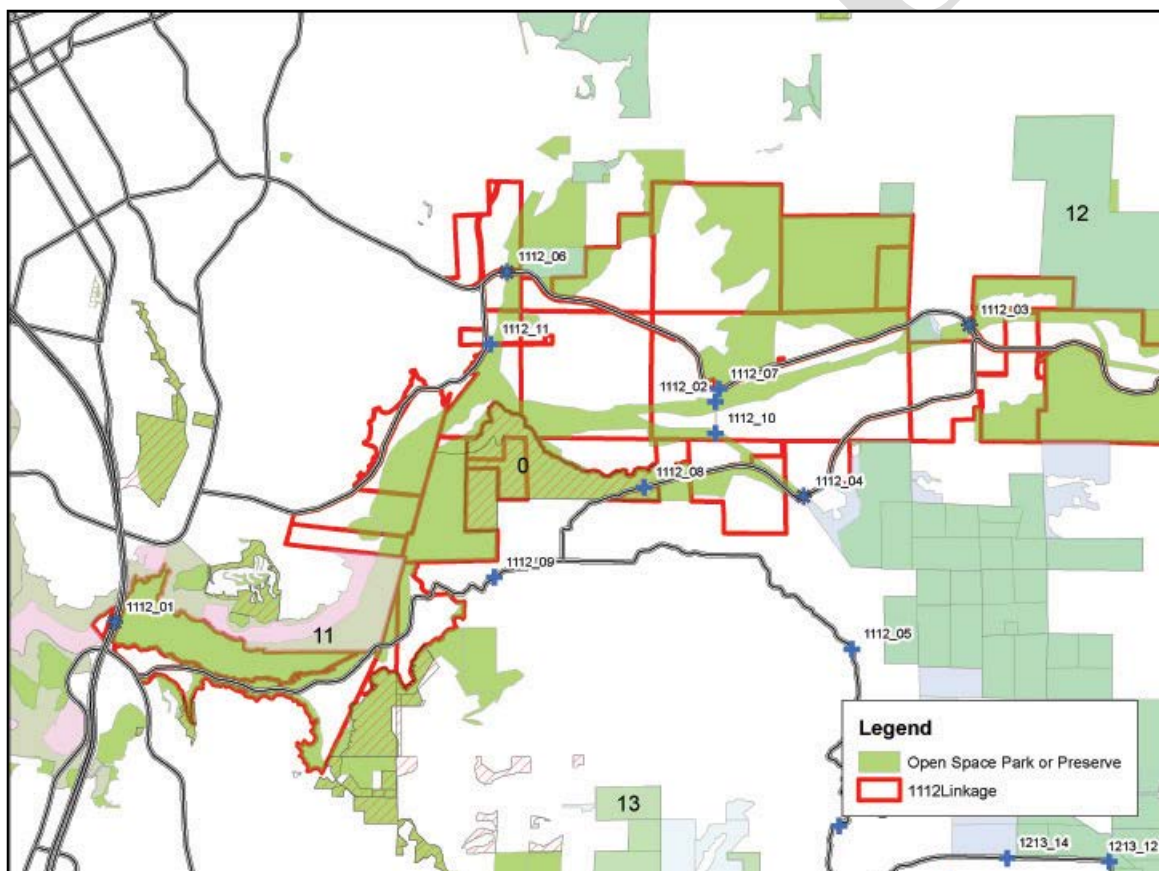
Our understanding of the linkages within the reserve system would be improved by a thorough review of the available information. There are many properties that are identified as conserved that may hold little to no value to wildlife. These should be evaluated and a decision made as to whether or not we continue to include these in the reserve design. There are also many properties that are publicly held lands with “Open space park or preserve” status that are not included in the Conserved Lands files. Including these properties will help evaluate what is protected and what isn’t. San Pasqual Valley is an example. There are many properties held by the City of San Diego or the County of San Diego (outlined in red in the map) where the land use is categorized as open space. If these lands can be identified and managed as conserved lands, the linkage between Core Area 11 and Core Area 12 would appear more robust and easily identifiable.
