REVIEW OF REGIONAL HABITAT LINKAGE MONITORING LOCATIONS

Multiple Species Conservation Program

January 2003

California Department of Fish and Game

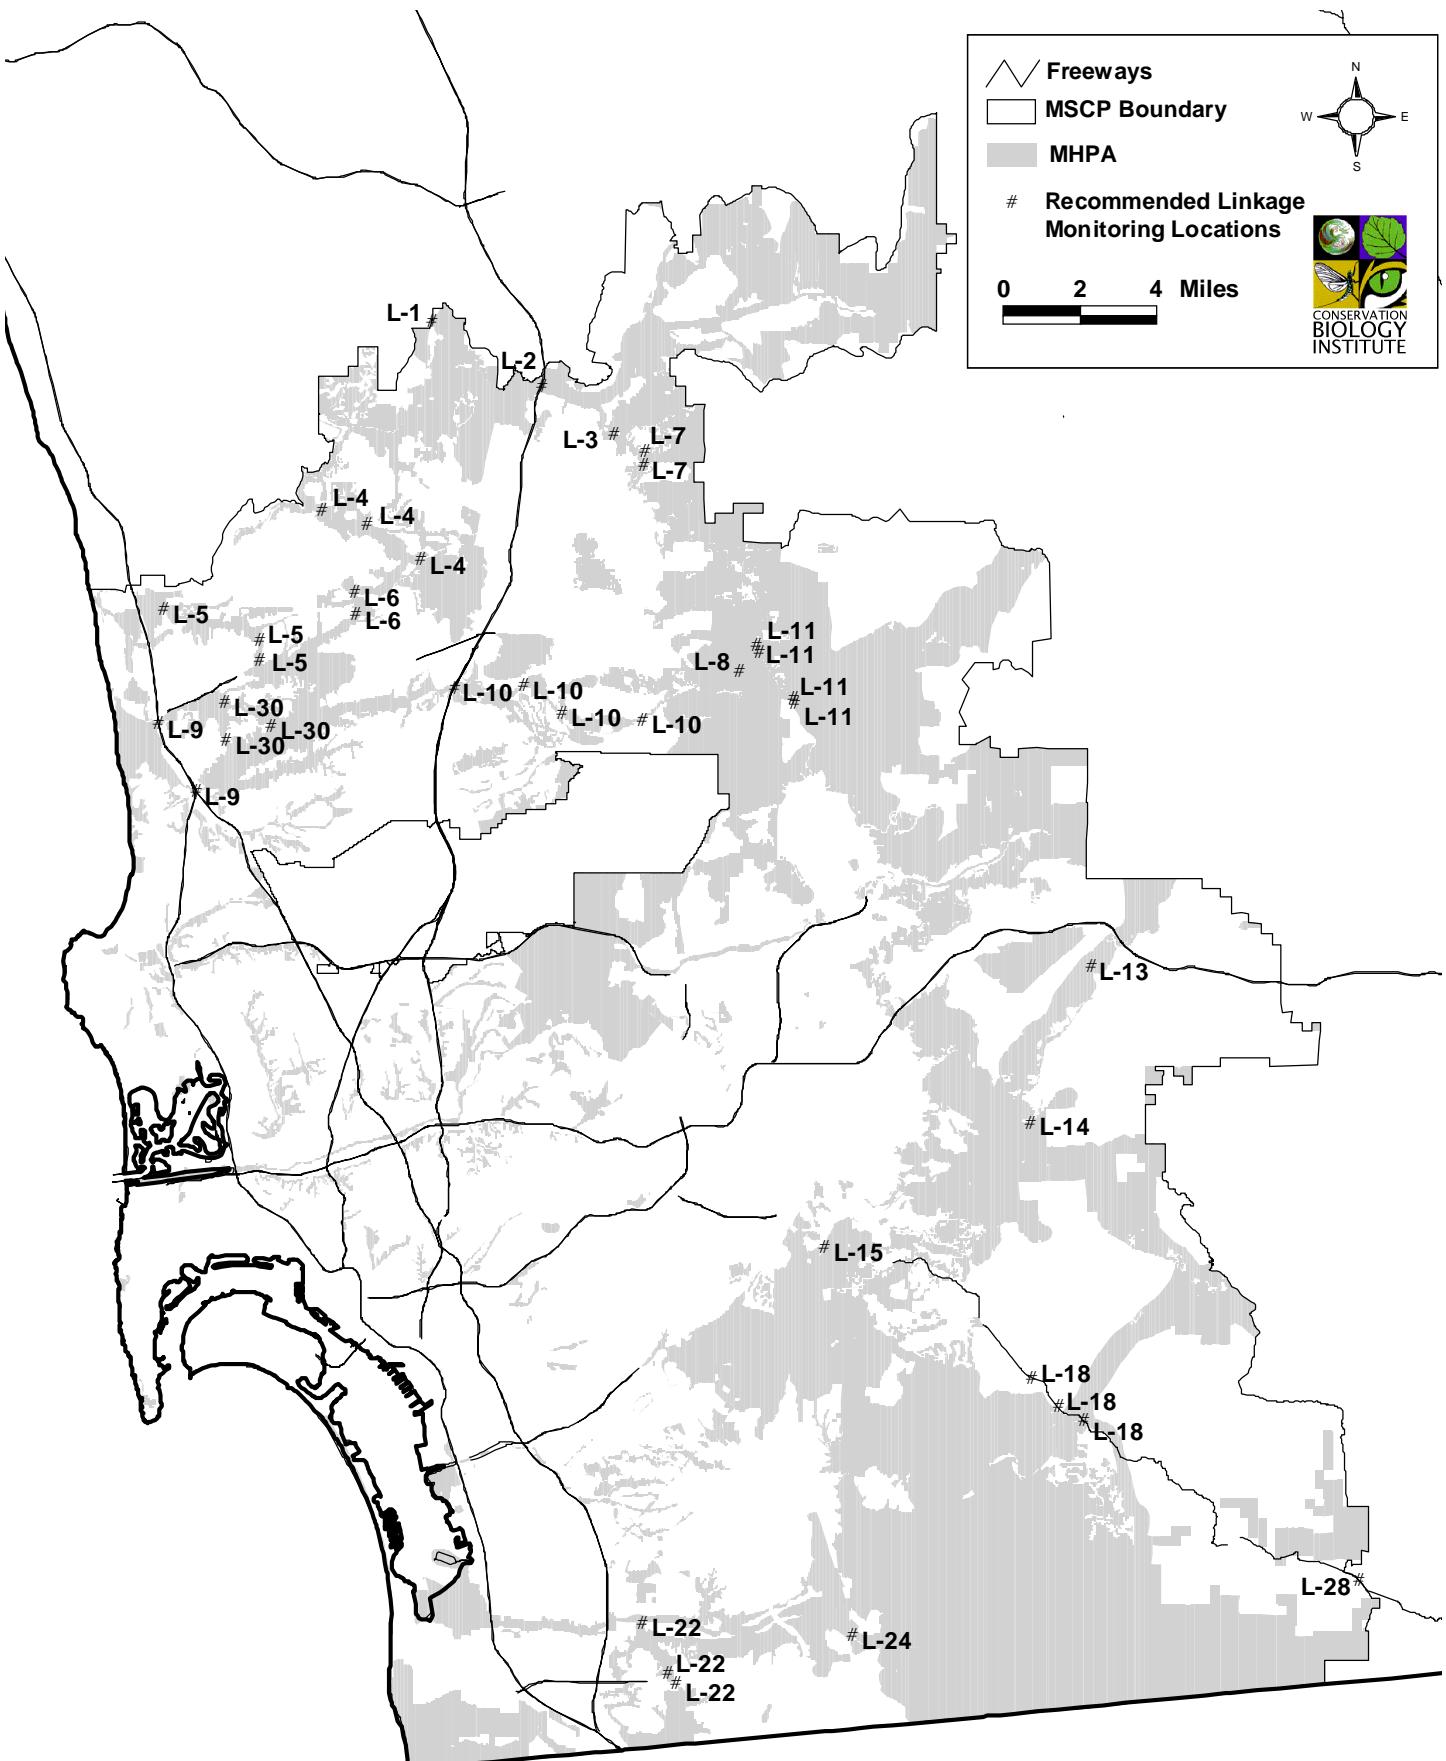
Figure 2. Recommended regional linkage monitoring locations. Note: This map does not show monitoring locations that should be considered once development and conservation plans are resolved for specific areas. See text and individual figures.

CBI recommends 22 locations for monitoring MSCP regional habitat linkages (Table 2, Figure 2), including new sites at Del Mar Mesa. We recommend multiple transects or monitoring sites at many of these locations. In addition, several potential monitoring locations should be reevaluated in the field once development and conservation plans are finalized, both within the MSCP area and between the MSCP area and other NCCP subregions.

L-10	Los Peñasquitos - South Poway at (A) Los Peñasquitos Creek at I-15, (B) Los Peñasquitos Creek at Sabre Springs, (C) Lower Beeler Canyon at Pomerado Road and Scripps-Poway Parkway, and (D) Upper Beeler Canyon upstream of quarry
L-11	South Poway - Santee at (B) culverts under SR-67 (requires future evaluation at potential Sycamore Canyon chokepoint)
L-13	Crestlake Canyon at Bullard Lane (requires future evaluation)
L-14	Southern Harbison Canyon at (A) Dehesa Road school and (B) transmission line easement north of Dehesa Road (requires future evaluation)
L-15	McGinty Mesa - Rancho San Diego - middle Sweetwater River at SR-94 bridge (requires future evaluation at potential chokepoints east of SR-94).
L-17	Proctor Valley at future chokepoint (requires future evaluation)
L-18	Hollenbeck Canyon - Rancho Jamul at (C) Jamul Creek at SR-94 bridge, (D) Hollenbeck Canyon drainage at SR-94, and (E) Dulzura Creek at SR-94 bridge

L-20	Dulzura Creek future chokepoint (requires future evaluation)
L-21	Little Cedar Canyon at Otay Lakes Road (requires future evaluation)
L-22	Dennery Canyon at (A) Otay River Valley (new road), (B) Otay Mesa Road, and (C) upstream end of Dennery Canyon (C requires future evaluation)
L-24	O'Neal Canyon at Alta Road
L-28	Cottonwood Creek at SR-94 bridge
L-30	Del Mar Mesa at (A) Little Shaw Valley, (B) Big Shaw Valley, and (C) lower Shaw Valley

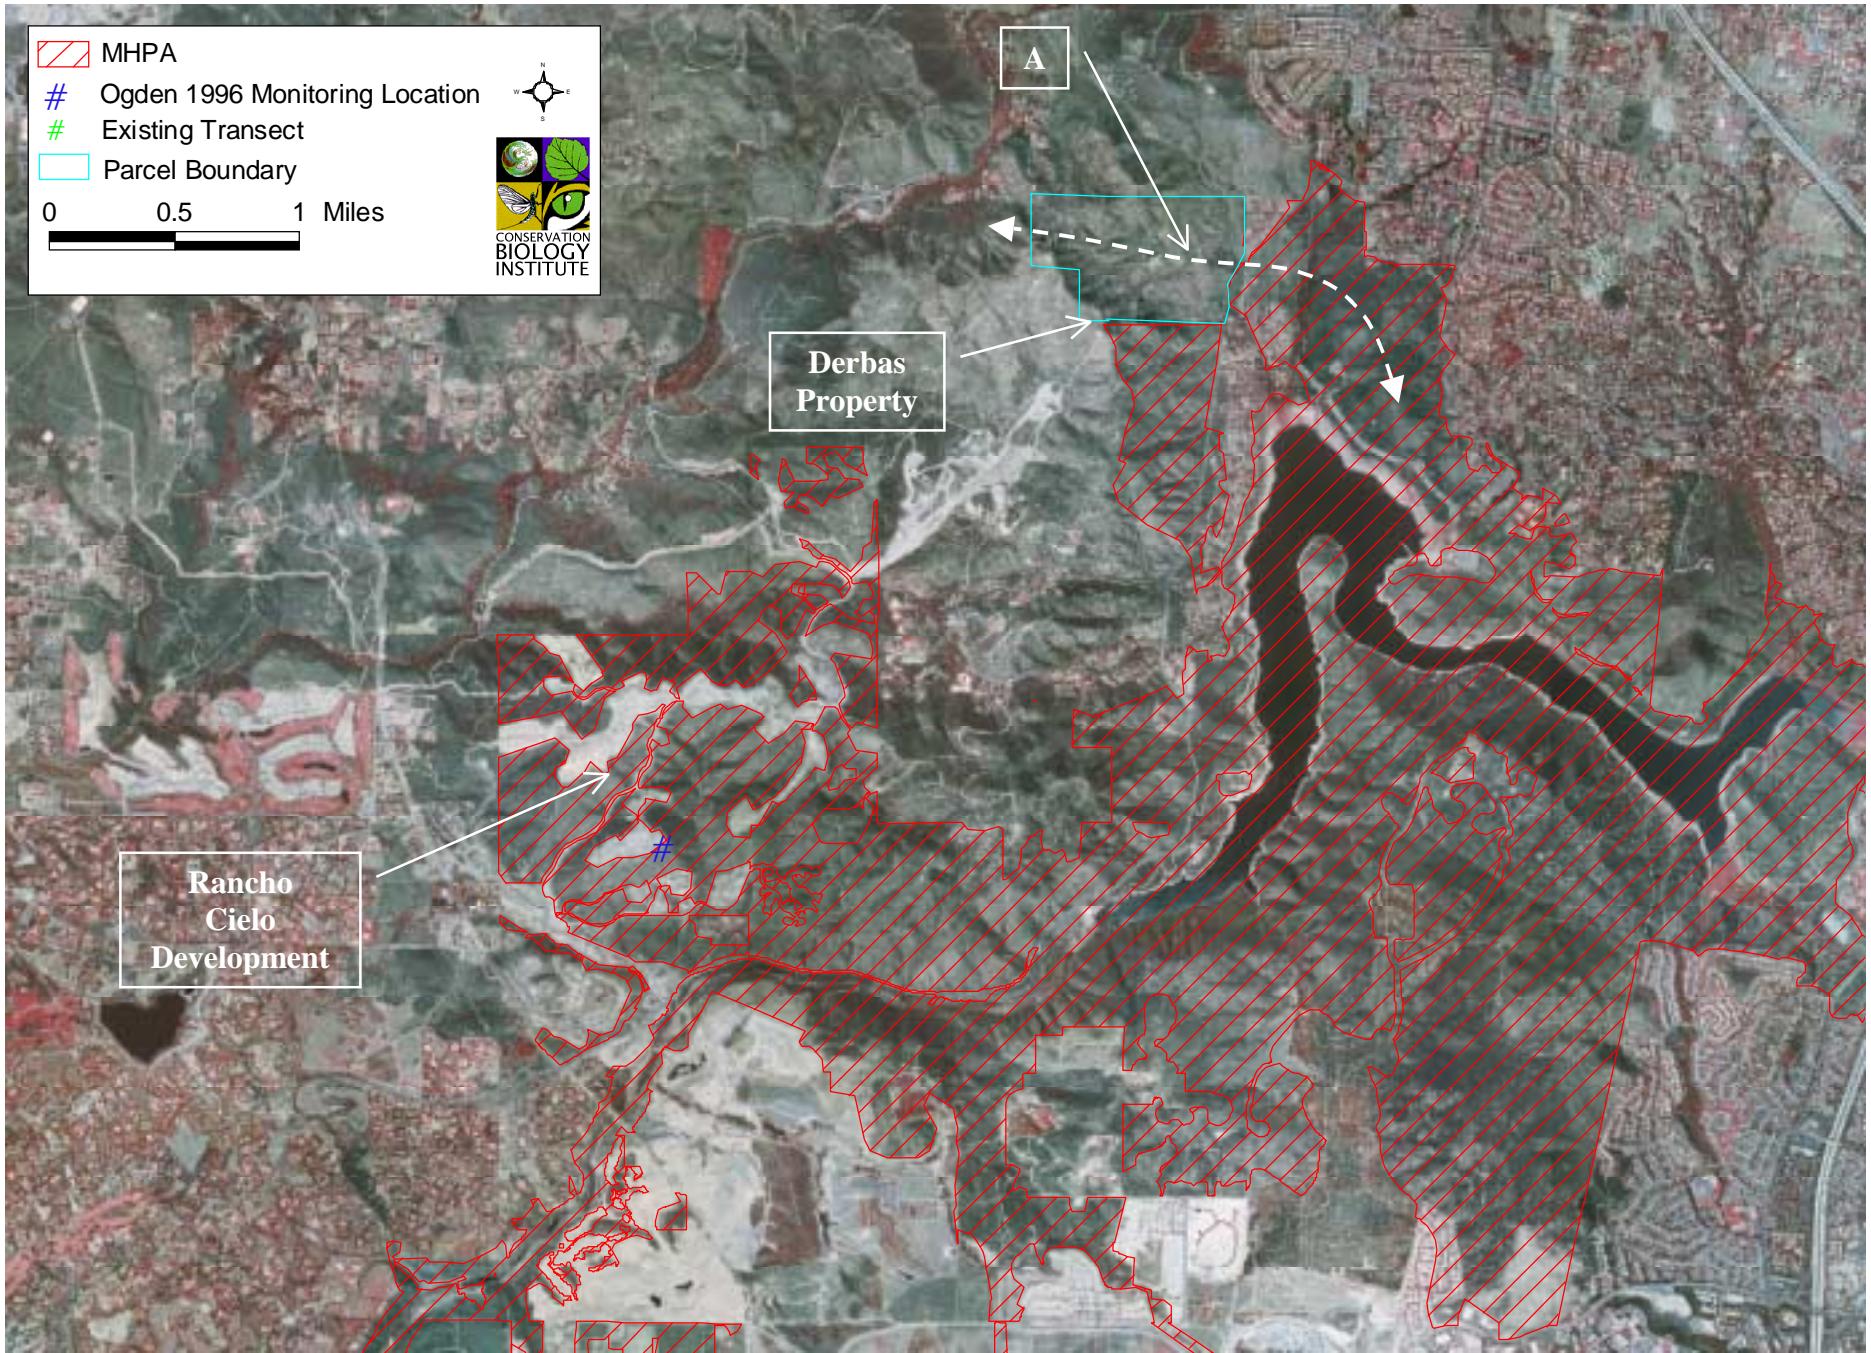
Figure L-1. Rancho Cielo - San Dieguito River. The site-specific monitoring location on the Derbas Property (A) has not been identified.

This area is part of the coastal sage scrub linkage between Lake Hodges and the Multiple Habitat Conservation Program (MHCP) subregional planning area. It has been fragmented by the Rancho Cielo development and the roads within the development (Figure L-1). While patches of habitat remain, the terrain is steep, and large mammals are not expected to use this area as a linkage between the San Dieguito River Valley and open space in the MHCP, such as the Escondido Creek valley. CBI does not recommend this location for monitoring large mammal movement. The area may allow coastal sage scrub bird dispersal.

Alternative Location. Wildlife movement between the San Dieguito River Valley and the MHCP could be monitored on the Derbas property, which was recently purchased for conservation by the San Dieguito River Valley Conservancy and is part of the Escondido Subarea Plan of the MHCP. It is hypothesized that wildlife using the open space bordering Lake Hodges could cross Del Dios Highway and then move up the canyon on the Derbas property (Figure L-1, Location A). CBI recommends monitoring at this location.

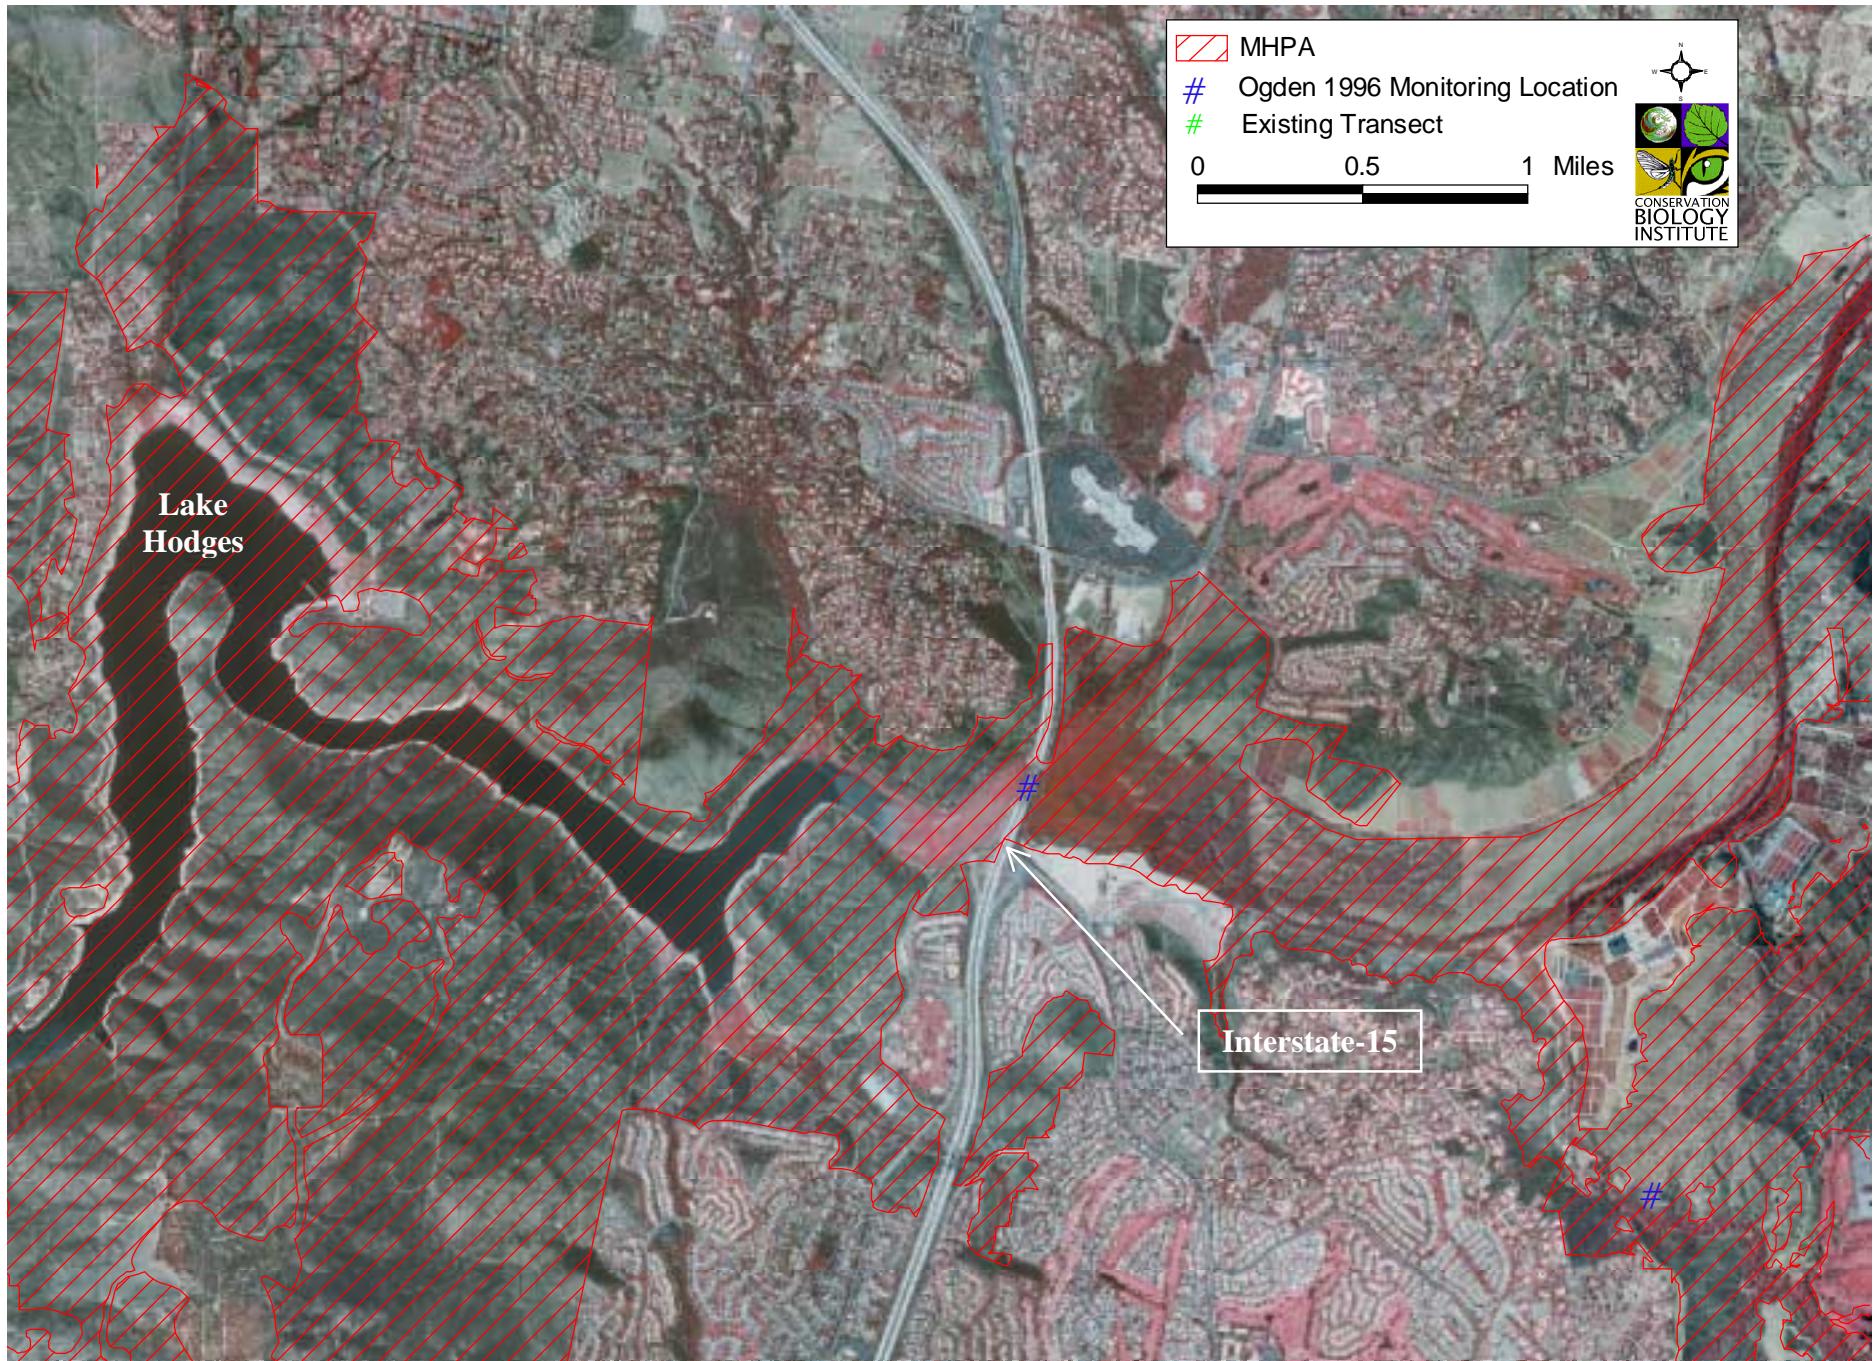
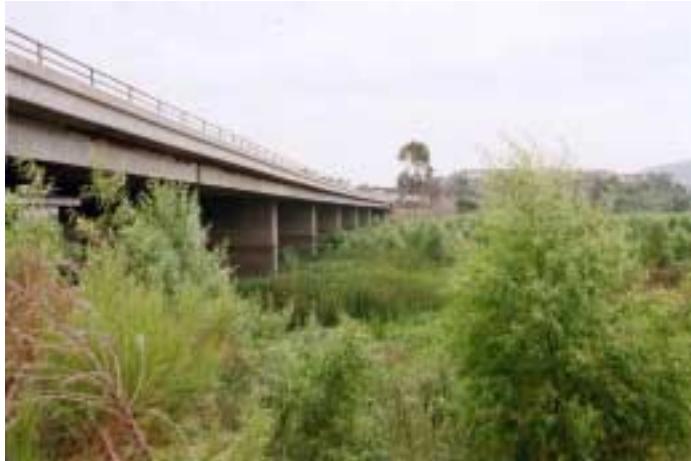
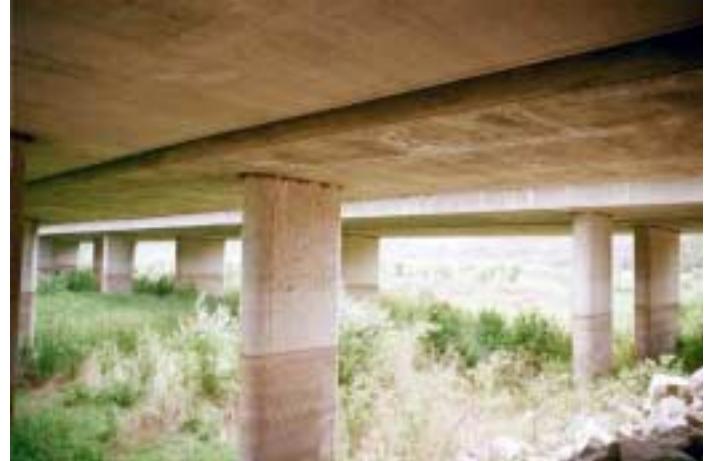
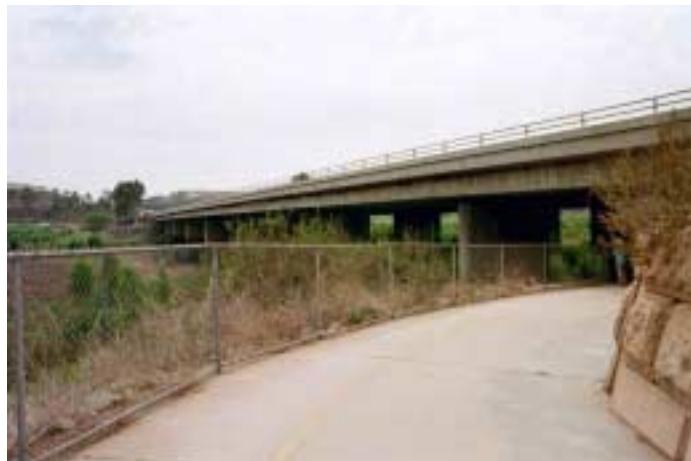
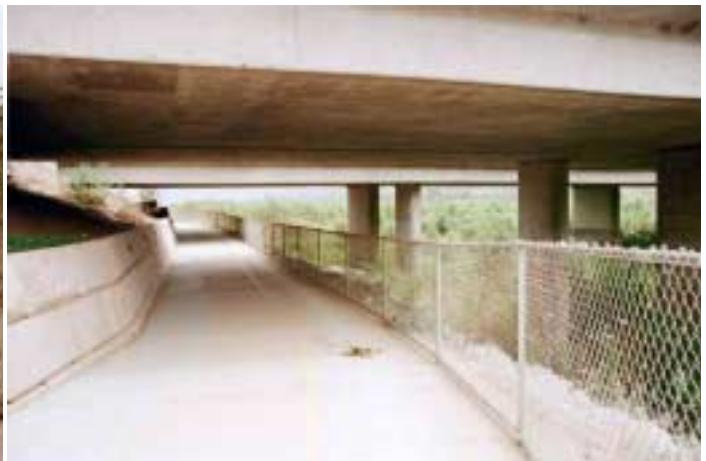
Figure L-2. Lake Hodges – San Pasqual Valley at I-15 bridge.

The San Pasqual/San Dieguito River Valley is one of only two remaining significant east-west connections linking coastal habitat preserves west of I-15 with inland preserve areas east of I-15. The I-15 undercrossing of the bridge at Lake Hodges appears to be functional for large mammal movement only during low lake levels, such as current conditions. When the lake is full and extends east of I-15, there is no access for large mammal movement, other than the fenced pedestrian walkway (part of the Coast-to-Crest trail) along the north shore and the rip-rapped slopes at the base of the bridge abutments. Thus, at high lake levels, I-15 completely severs the wildlife movement corridor.

I-15 bridge over Lake Hodges/San Dieguito River, looking south from north side.

I-15 bridge over Lake Hodges/San Dieguito River, looking southwest from north side paved trail.

I-15 bridge over Lake Hodges/San Dieguito River, looking east from north side paved trail.

transition into adjacent open space areas outside of the Caltrans right-of-way. The paths could be vegetated along the margins to provide cover. Such design modifications would be a very small fraction of overall project costs and would greatly improve the wildlife corridor function of this chokepoint. CBI recommends these newly created paths under the new bridge for corridor monitoring, once the bridge is completed (Figure L-2).

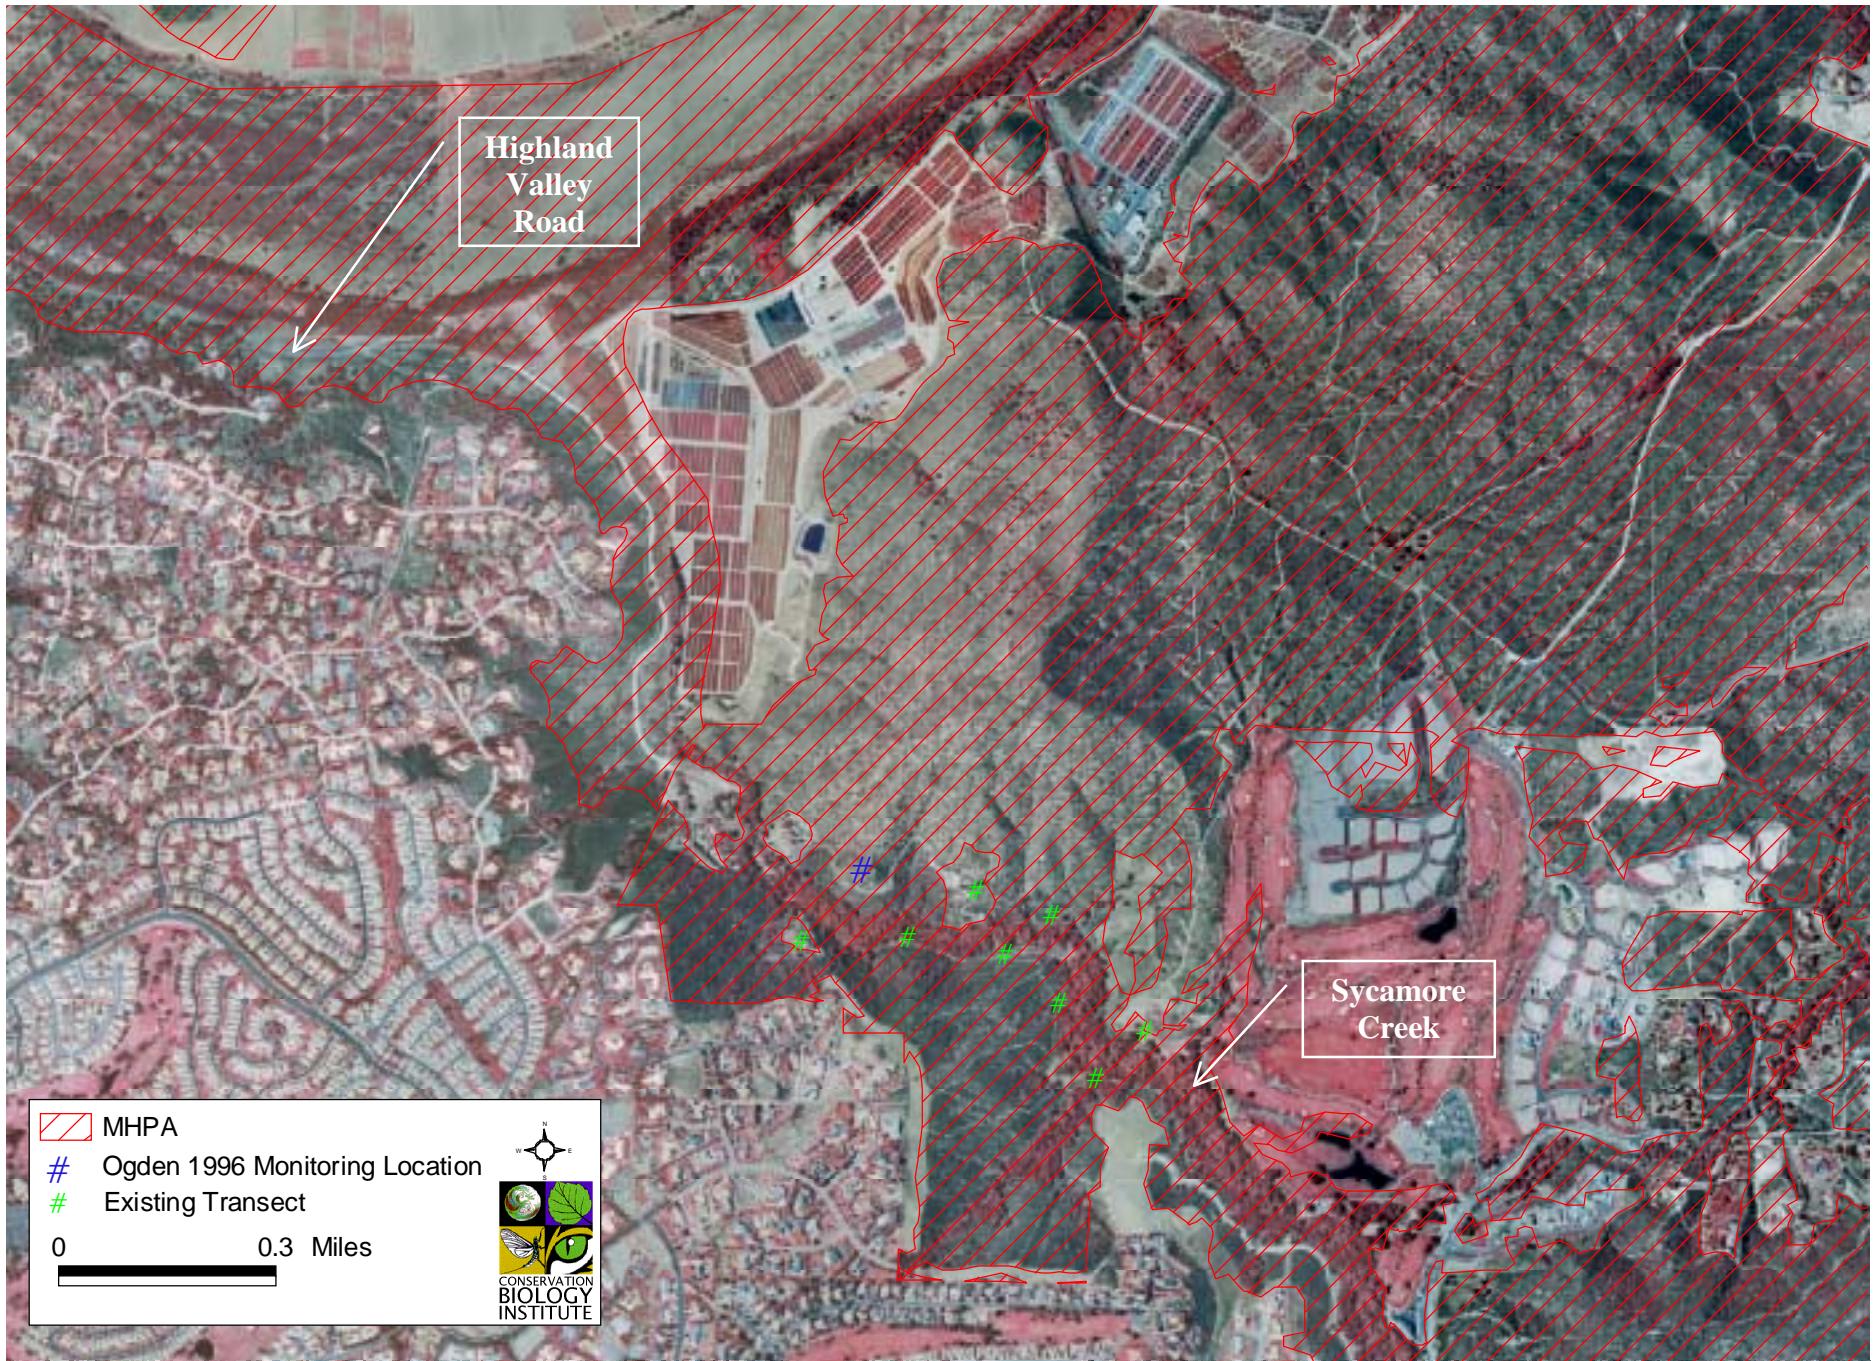
Figure L-3. San Pasqual Valley – North Poway (Sycamore Creek)

CBI (2002b) established and monitored a transect in 2001 and 2002 for this landscape linkage between the Blue Sky Reserve and San Pasqual Valley along Sycamore Creek, and the SDTT has monitored this location quarterly since spring 1999 (Figure L-3). CBI recommends this location for continued monitoring.

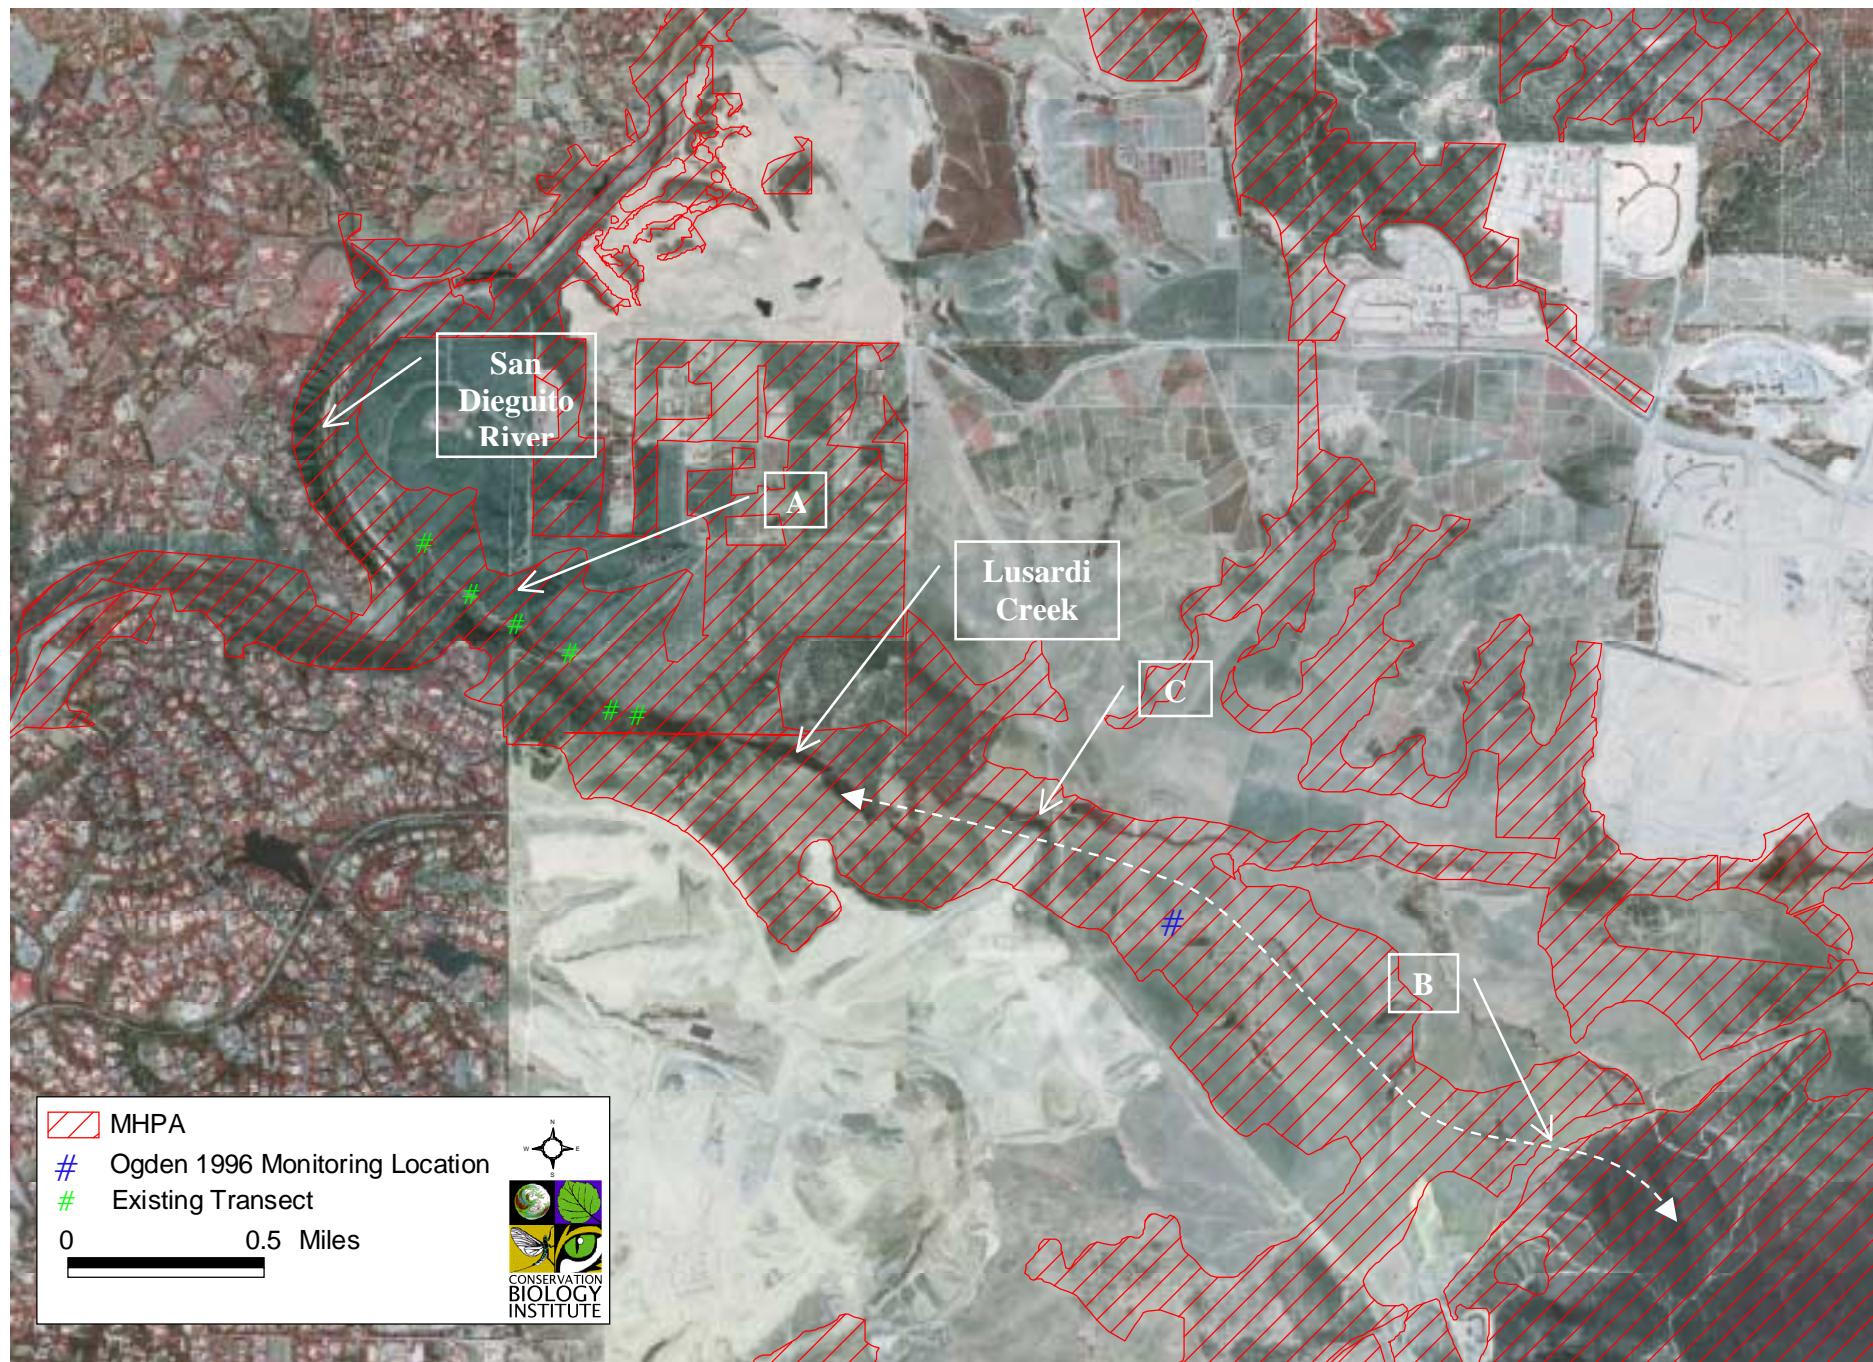
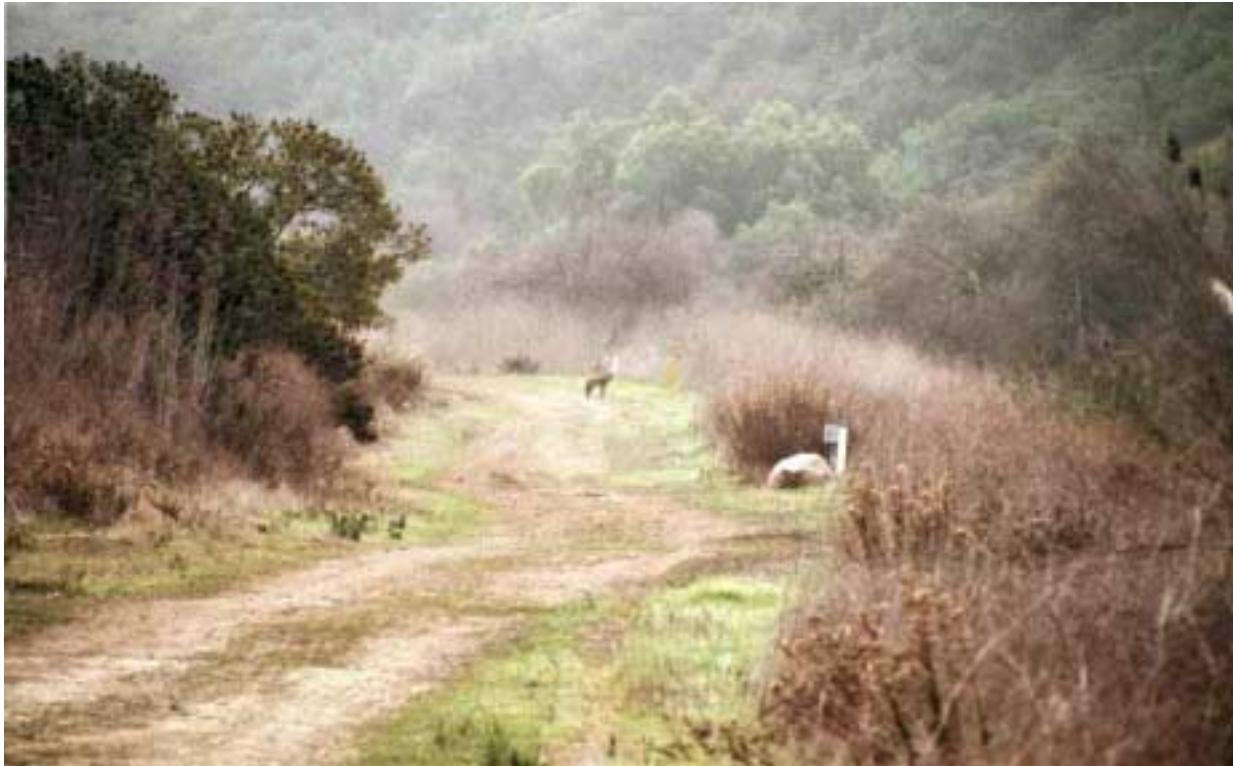
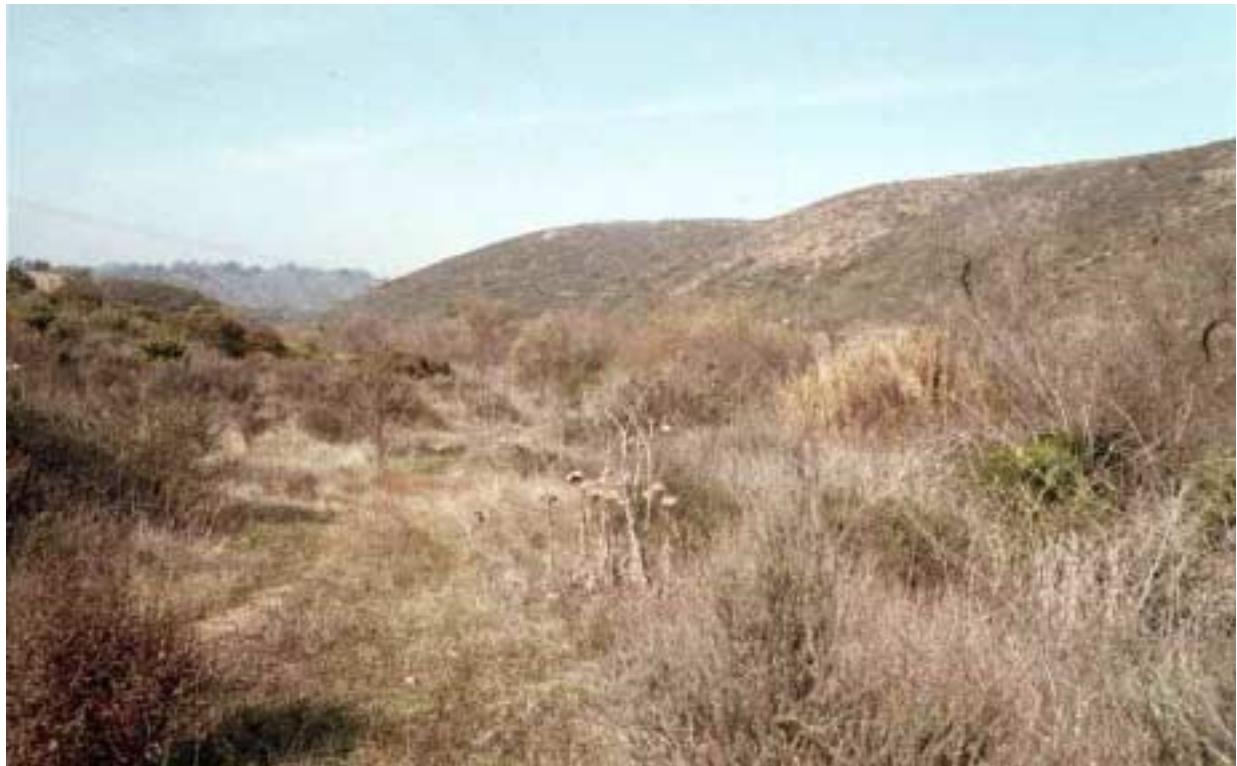
Figure L-4. Lusardi Creek. **A** – west end of Lusardi Creek at San Dieguito River, **B** – at future Carmel Valley Road, and **C** – future Camino Ruiz.

CBI and the SDTT established a transect location at the west end of the canyon, near the mouth of Lusardi Creek at the San Dieguito River (Figure L-4, Location A), and the SDTT monitored this location, from the mouth into the canyon, quarterly in 2002. This transect starts at the mouth of the La Jolla Valley and extends along and adjacent to Lusardi Creek, upstream to a narrowing of the canyon. CBI recommends this location for continued monitoring.

Dirt road at lower end of La Jolla Canyon (Lusardi Creek) looking southeast.

Looking west from south wall of La Jolla Canyon towards San Dieguito River valley.

Photo L-4. Lusardi Creek, Location A—west end near confluence with San Dieguito River.

Additional Locations. In addition, CBI recommends placement of monitoring transects at the connection of the eastern Lusardi Creek open space to Black Mountain open space at the future undercrossing of Carmel Valley Road (Location B) and the future undercrossing of Camino Ruiz (Location C, Figure L-4). These sites should be reviewed once construction activities have been completed.

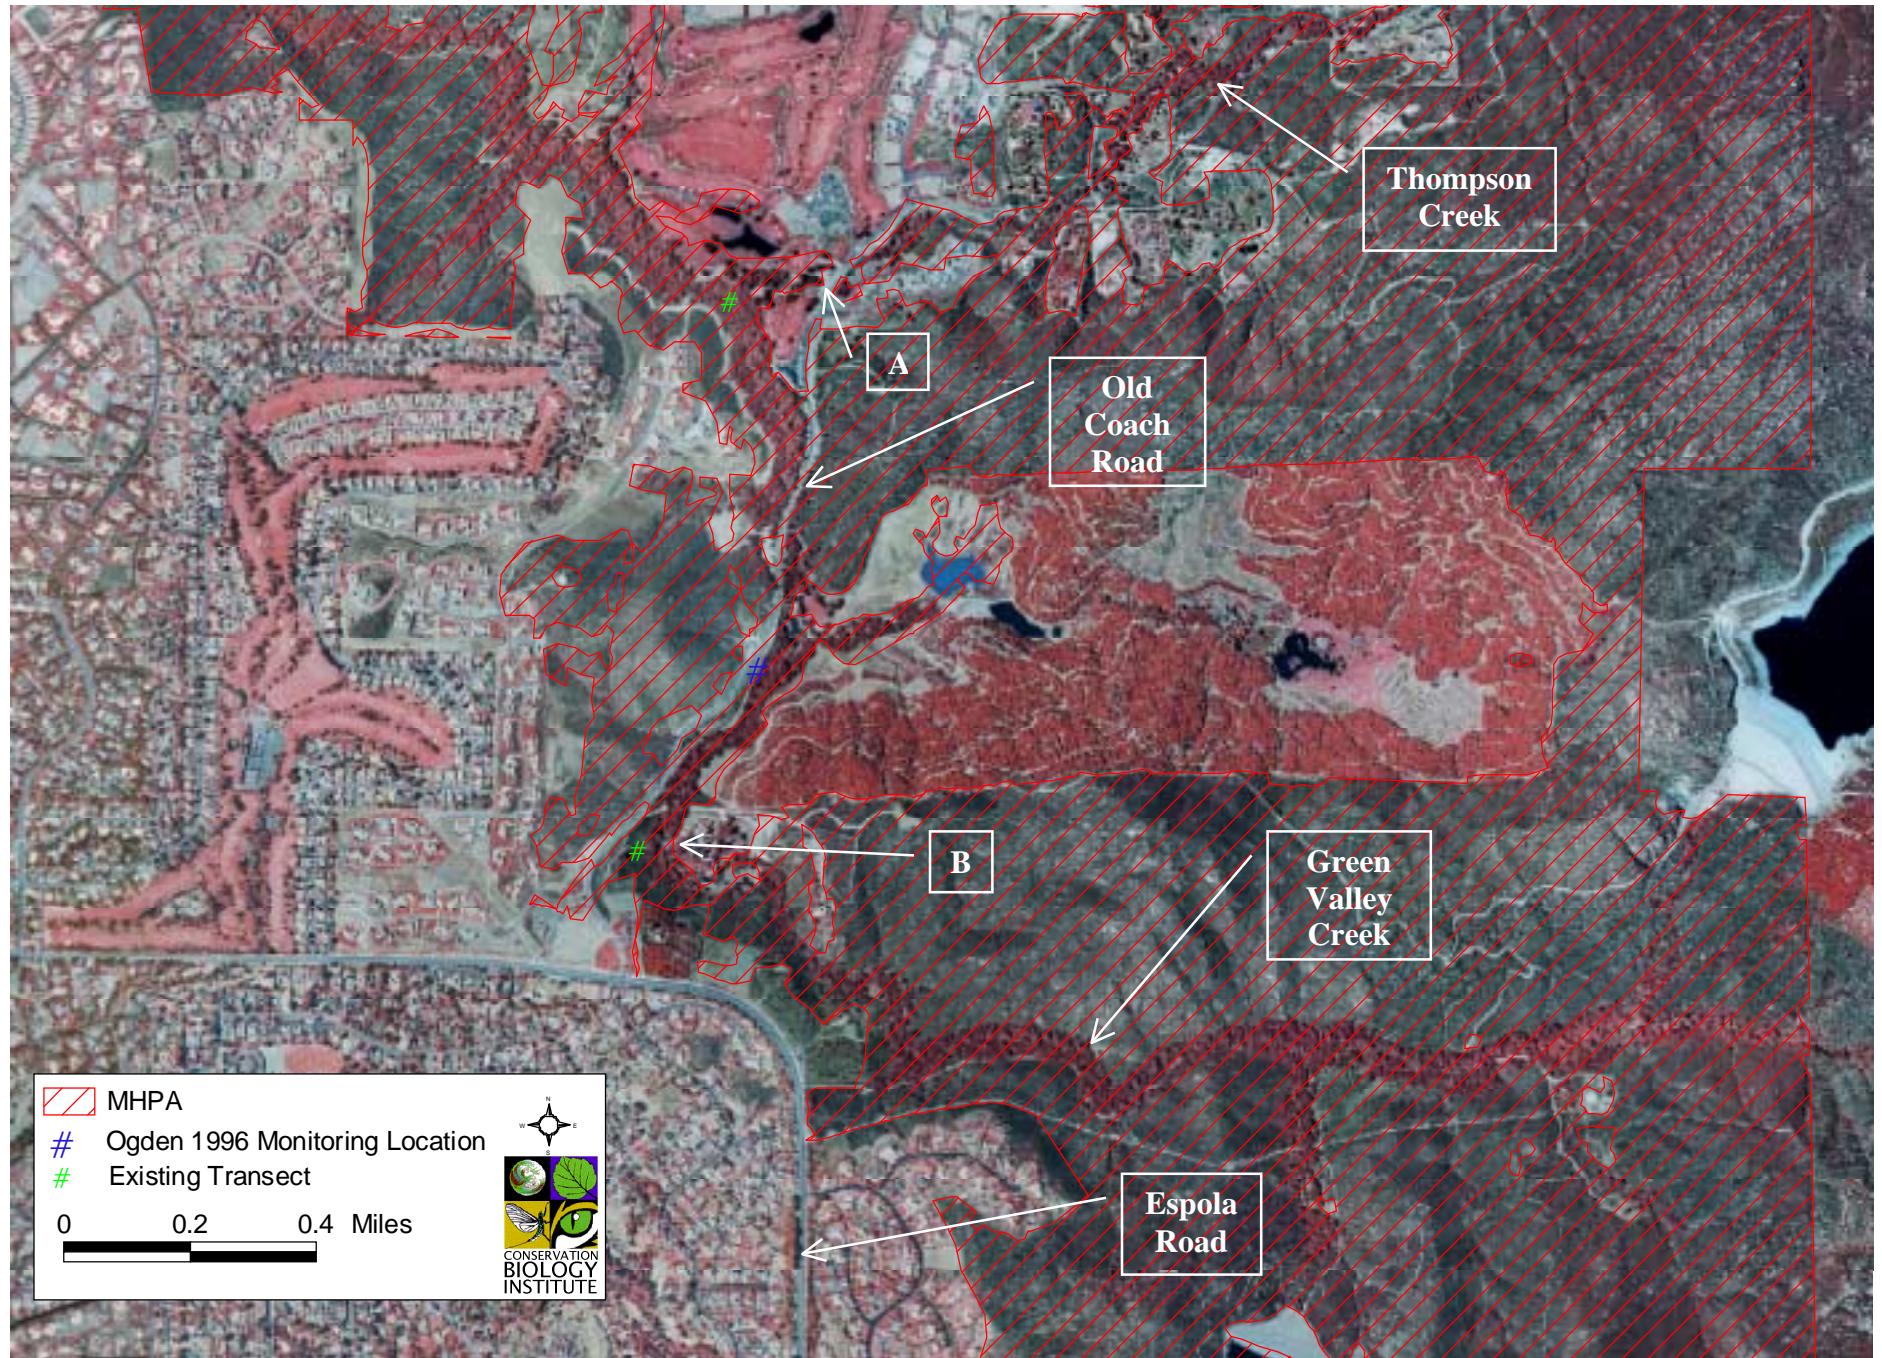
Figure L-7. Old Coach Road – Blue Sky Reserve. **A** – confluence of Green Valley and Thompson Creeks and **B** – Green Valley Creek at Old Coach Road.

CBI (2002b) established and monitored transects in 2001 and 2002 at the confluence of Green Valley Creek and Thompson Creek (Figure L-7, Location A) and along Green Valley Creek at the Old Coach Road bridge (i.e., the Butcher Property, Figure L-7, Location B). CBI recommends these two sites for continued monitoring.

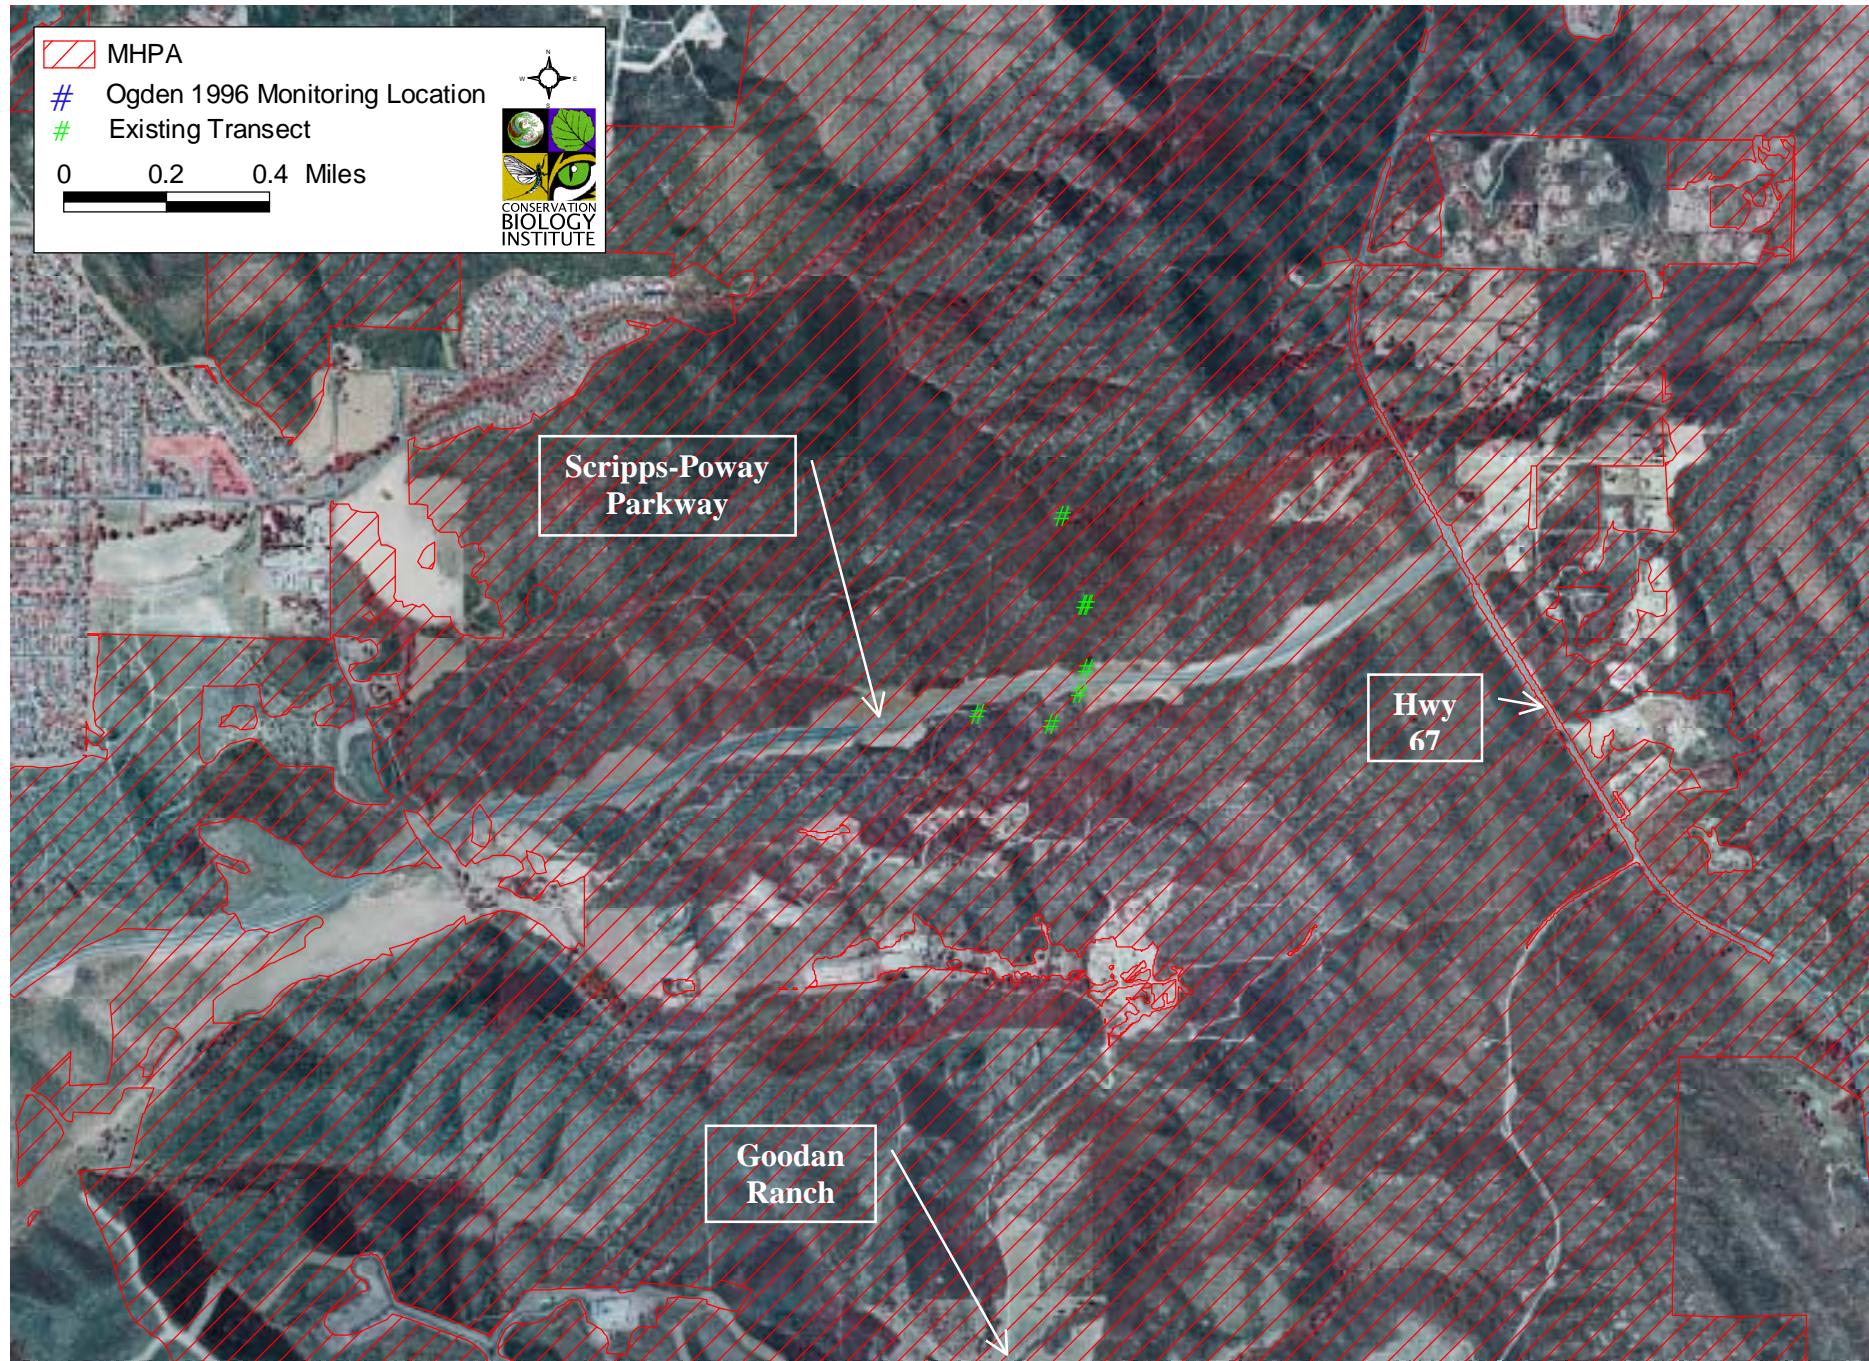
L-8. Central Poway at Scripps-Poway Parkway undercrossing.

CBI (2002b) established and monitored a transect for the Scripps-Poway Parkway wildlife crossing in 2001 (Figure L-8). The SDTT also monitored this site quarterly for CBI in 2002. (The SDTT has monitored this site quarterly since the spring quarter of 1999). The wildlife crossing allows wildlife movement between currently undeveloped areas north and south of Scripps-Poway Parkway. CBI recommends this location for continued monitoring.

Alternative Location. CBI does not recommend an alternative location at this time. An alternative location should be reevaluated if new residential growth south of Scripps-Poway Parkway begins to impede movement between Scripps-Poway Parkway and the Sycamore Canyon/Goodan Ranch open space preserves.
