REVIEW OF REGIONAL HABITAT LINKAGE MONITORING LOCATIONS

Multiple Species Conservation Program

January 2003

California Department of Fish and Game

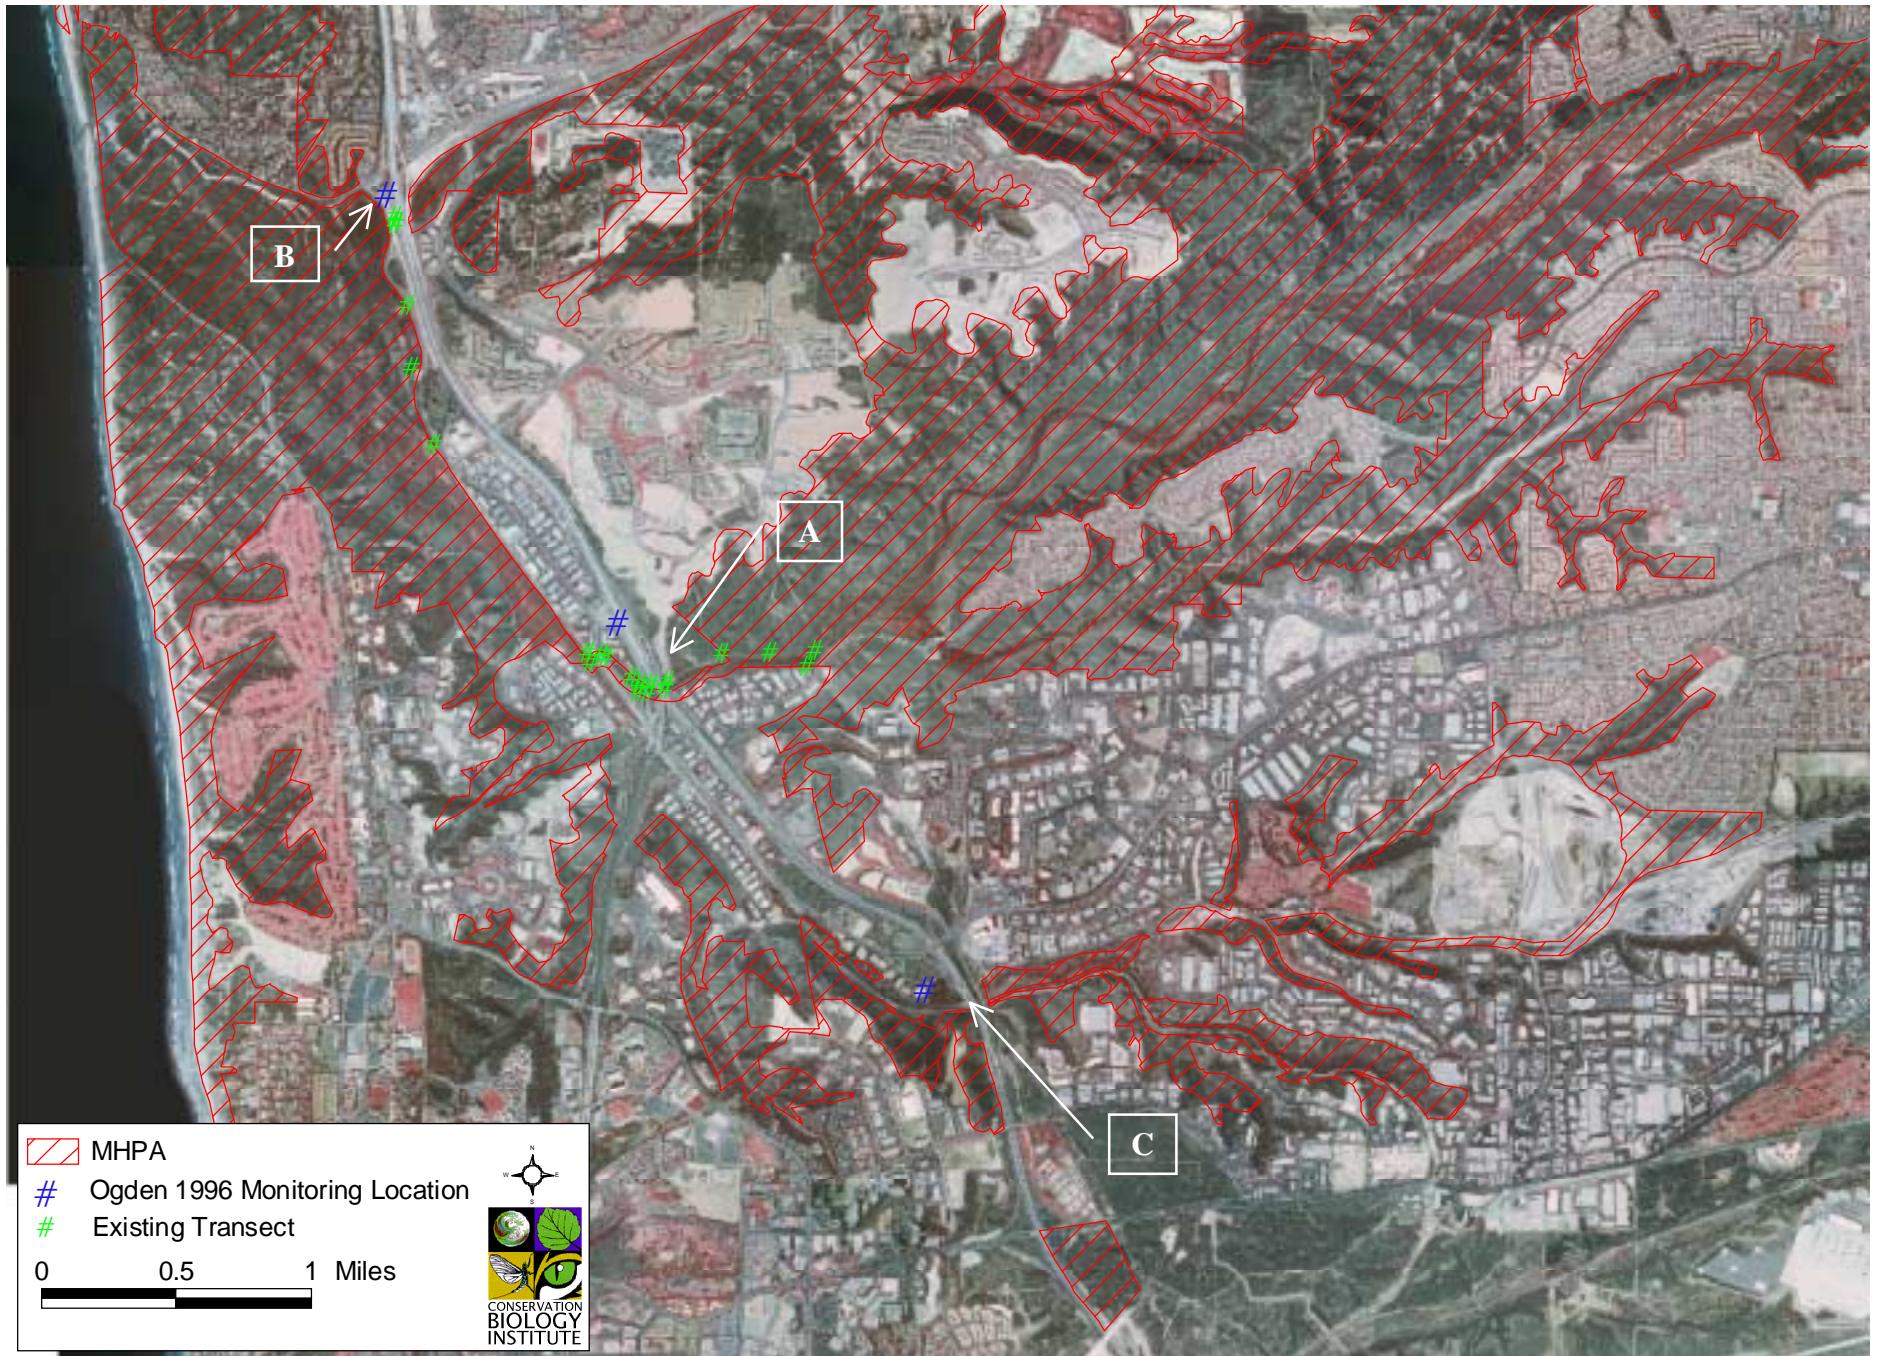
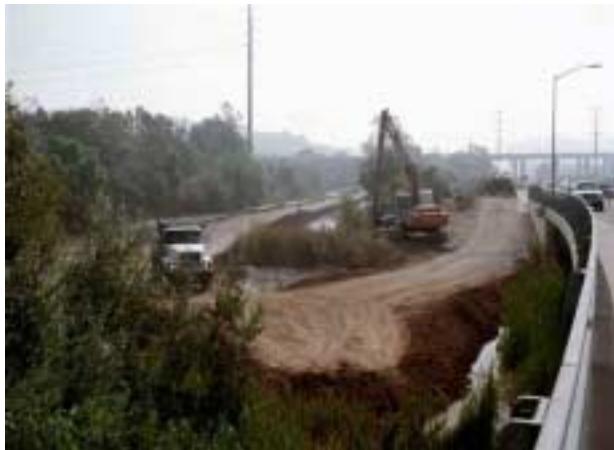
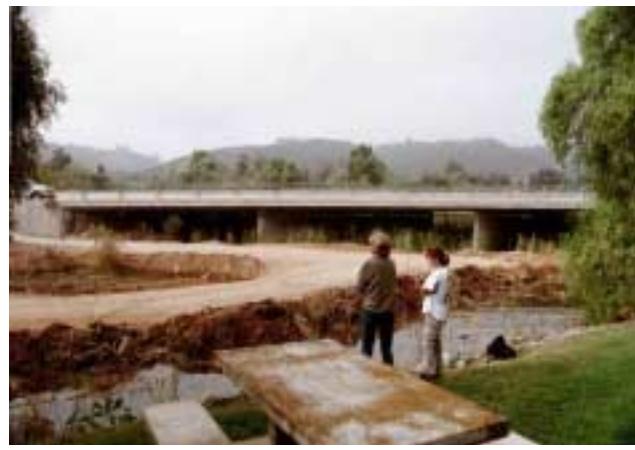
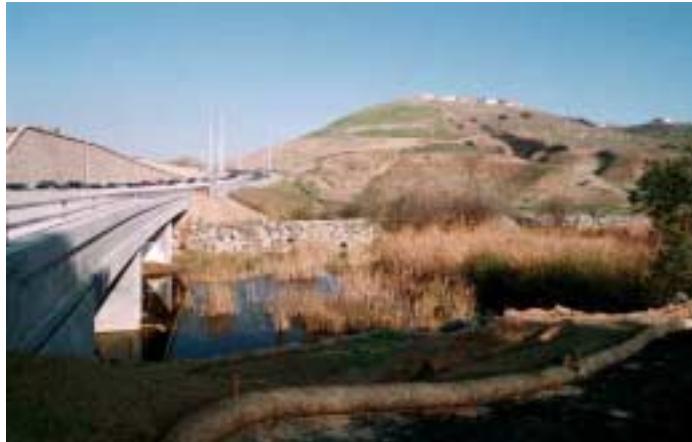
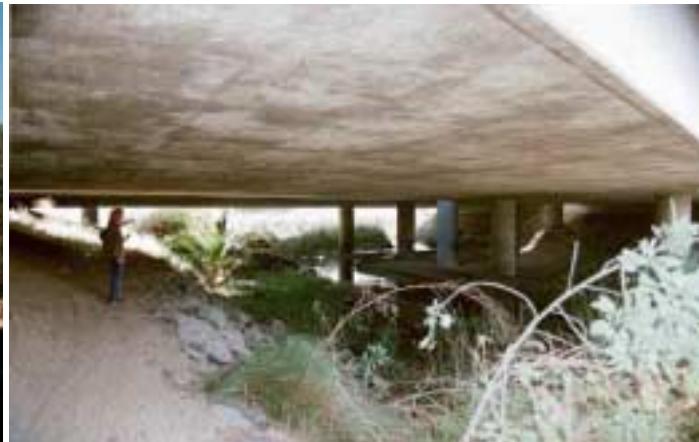
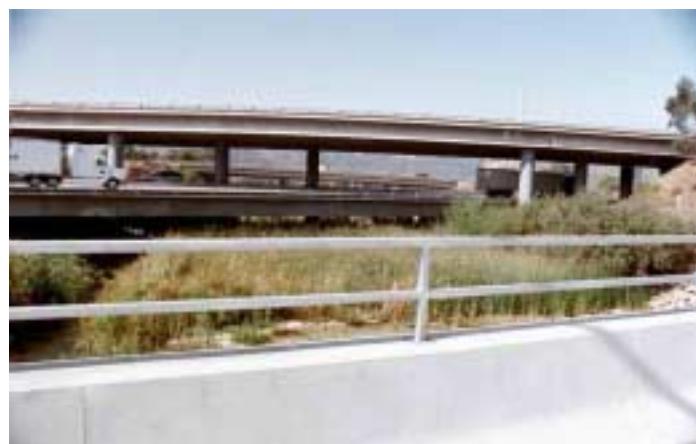
Figure L-9. Torrey Pines State Reserve – Los Peñasquitos Canyon. **A** – at I-5/805 merge, **B** – at I-5 overpass of Carmel Creek, and **C** – Carroll Canyon.

CBI (2002b) established and monitored in 2001 and 2002 transects at the chokepoint between Torrey Pines State Reserve and Los Peñasquitos Canyon Preserve at the I-5/I-805 merge (Location A) and at Carmel Creek at the I-5 bridge (Location B, Figure L-9). The SDTT has monitored these locations quarterly since summer 1996. There is continued construction for new development and for widening I-5 at Location A. This undercrossing also is highly constrained by the height of the bridges, length of the undercrossing, amount of water in the creek, and dense vegetation. CBI recommends these sites for continued monitoring. CBI (2002b) recommendations regarding the need for fencing and removal of obstructions to wildlife movement have not been implemented and are critical to maintaining these corridors.

Dredging project in L-9 linkage, looking south from Sorrento Valley Rd bridge.

Sorrento Valley Rd bridge over Peñasquitos Creek looking west.

Vista Sorrento Pkwy bridge over Peñasquitos Creek looking north.

Vista Sorrento Pkwy bridge over Peñasquitos Creek looking east.

I-5/805 merge bridges, looking west from Vista Sorrento Pkwy bridge.

Alternative Location. The MSCP Biological Monitoring Plan (Ogden 1996) recommended a corridor monitoring location at the connection into Carroll Canyon (Figure L-9, Location C). This area represents a steppingstone corridor of coastal sage scrub connecting the Los Peñasquitos Canyon Preserve with MCAS Miramar, presumably intended primarily for California gnatcatcher dispersal. CBI does not recommend this location for monitoring movement of large mammals.

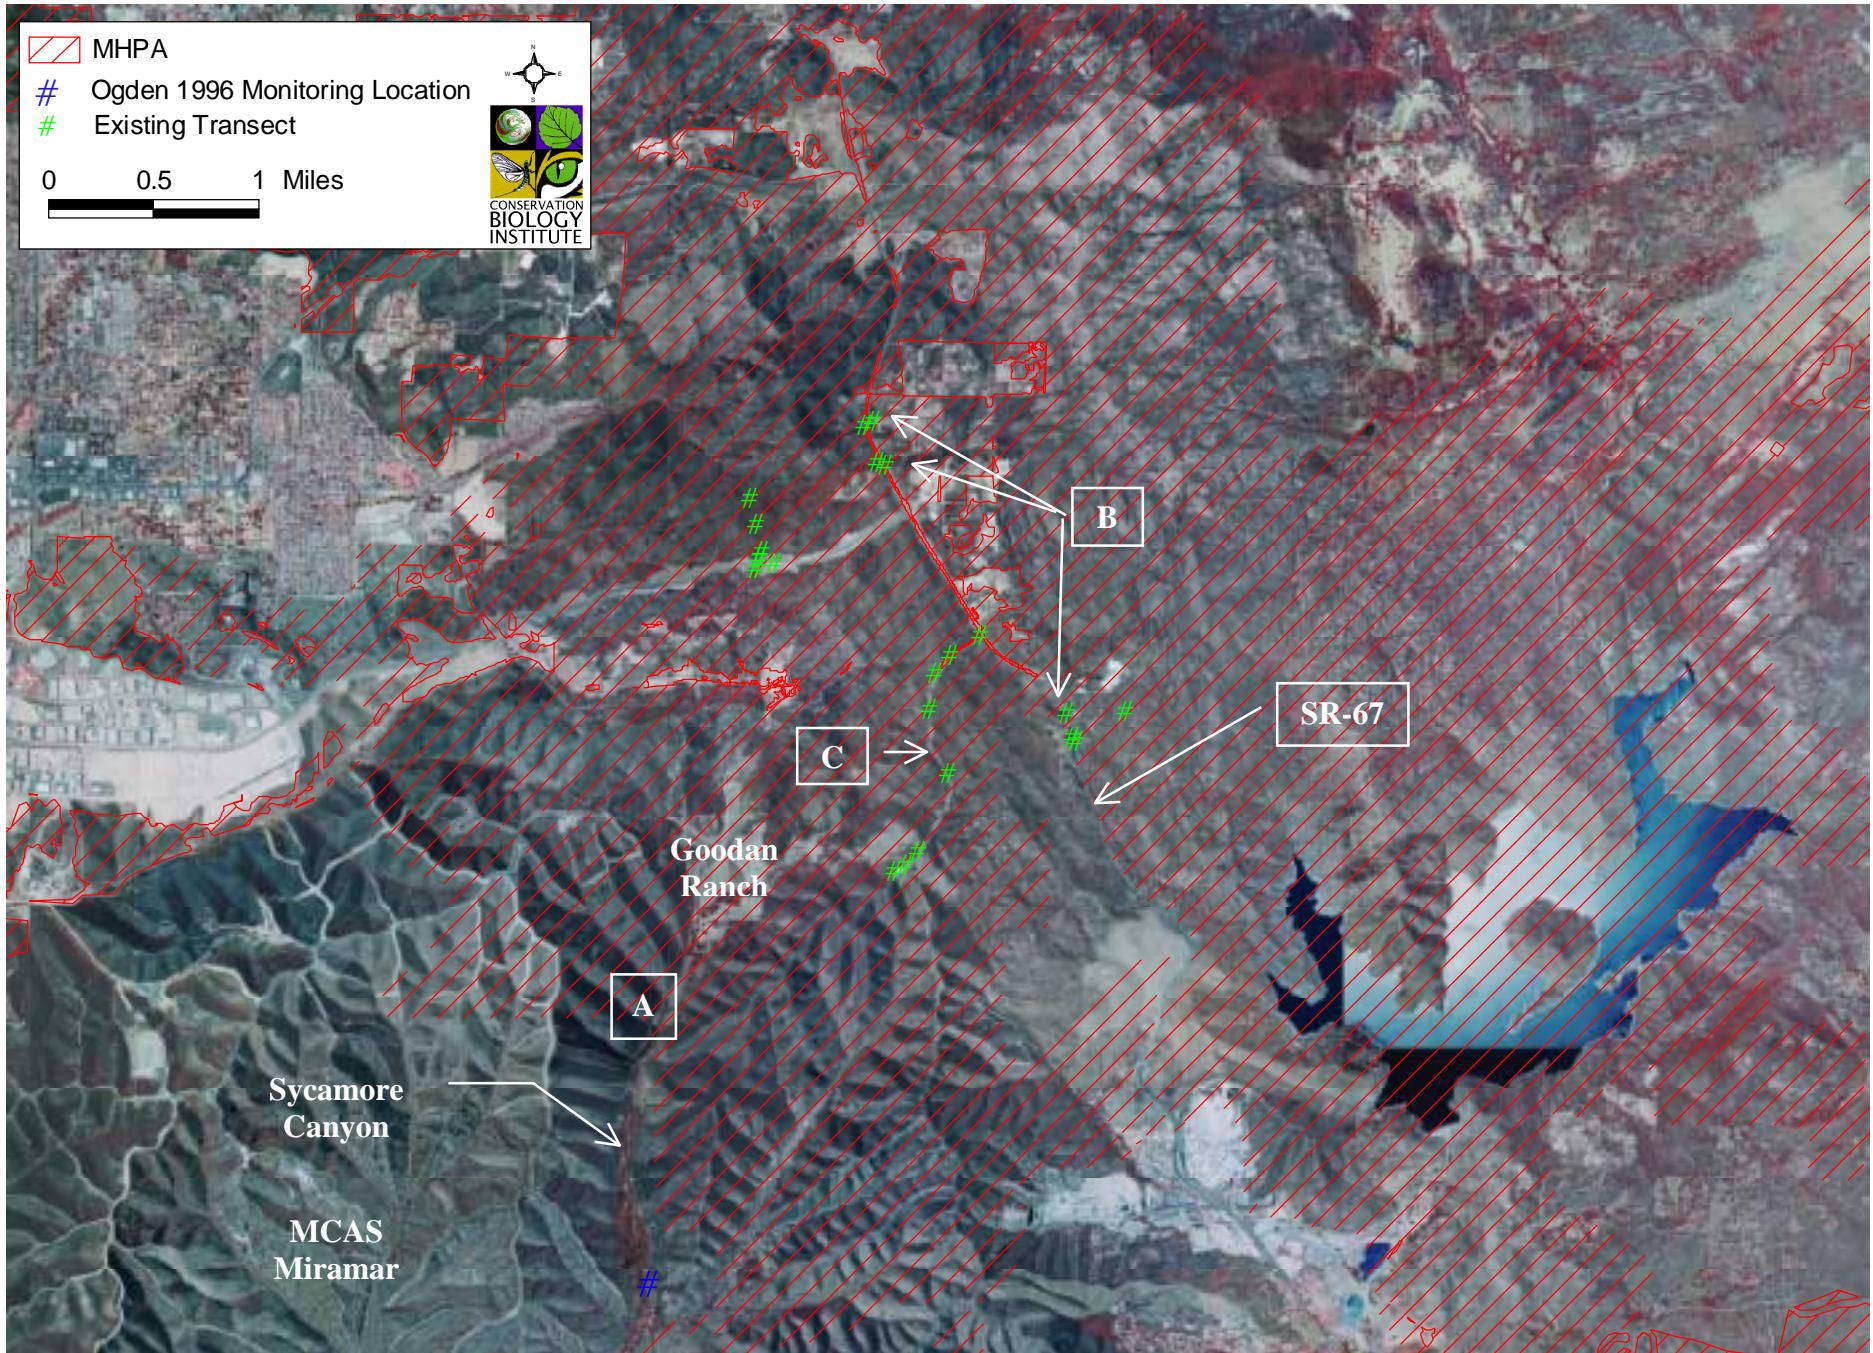
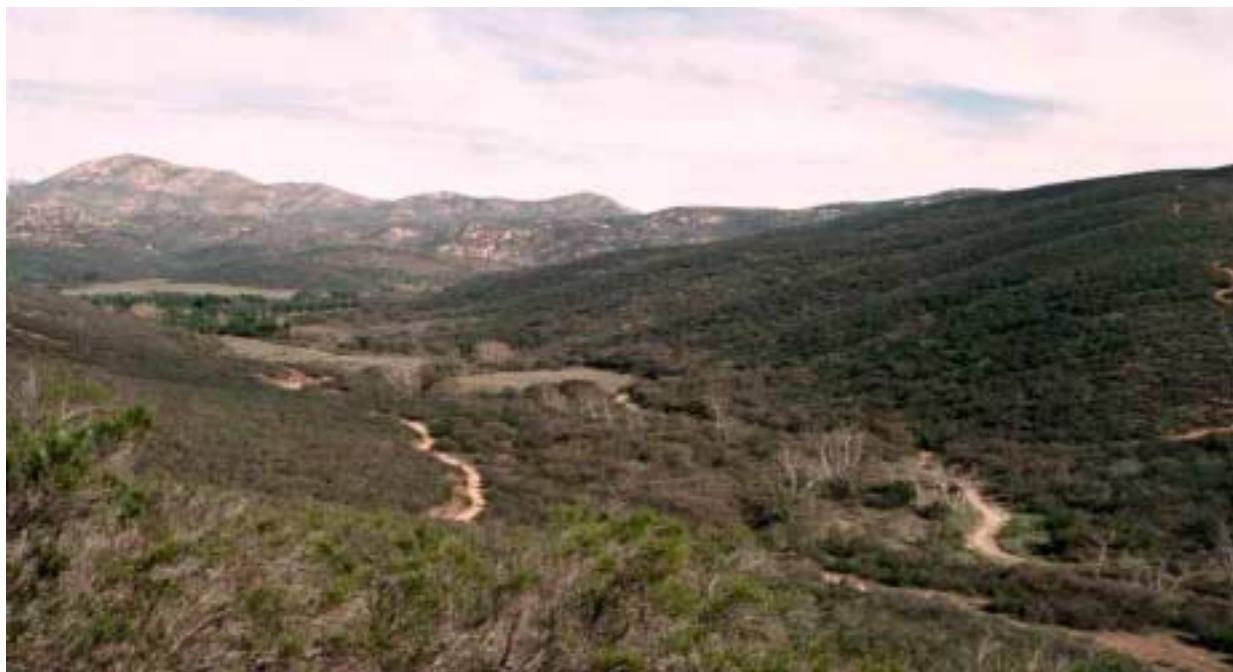
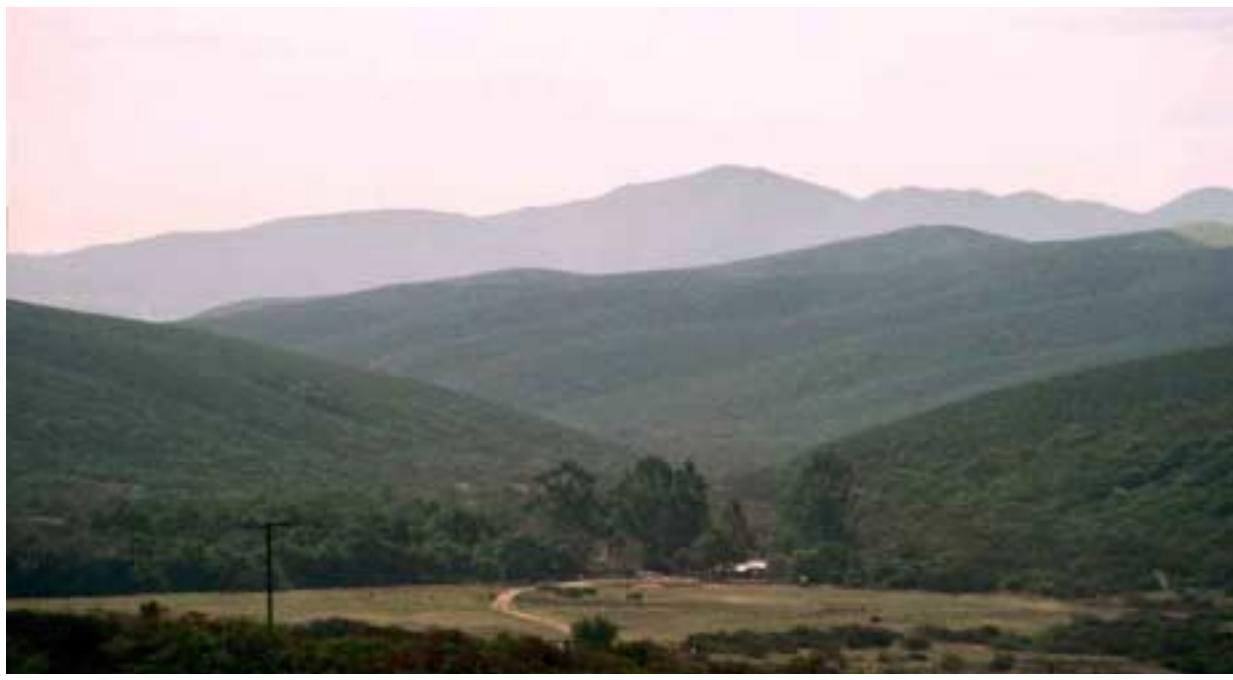
Figure L-11. South Poway - Santee (Sycamore and Clark Canyons). **A** – Sycamore Canyon, **B** – culverts under SR-67, and **C** – Sycamore Park Drive.

Sycamore and Clark Canyons connect the Sycamore Canyon/Goodan Ranch Open Space Preserves with MCAS Miramar, East Elliott, and Fanita Ranch. While these canyons likely do function as wildlife corridors, they are also part of a large, core block of habitat that includes MCAS Miramar. CBI recommends that transects be established in Sycamore Canyon (Location A) to inform habitat management decisions at the preserves. CBI does not recommend this location as a regional linkage monitoring location unless it becomes constrained by future development.

Sycamore Canyon looking northeast from west wall of canyon.

Sycamore Canyon looking south from north side of Goodan Ranch. Goodan Ranch is visible in the foreground.

Alternative Locations. CBI and the SDTT established transects and cameras at culverts under SR-67, north and south of Scripps-Poway Parkway (Figure L-11, Location B). The SDTT monitored these transects quarterly in 2002. The SR-67 culverts south of Scripps-Poway Parkway connect the Sycamore Canyon/Goodan Ranch Open Space Preserves with the San Vicente Highlands open space (formerly known as the Boys and Girls Club property) east of SR-67. These culverts have been used by large mammals (e.g., bobcats) as well as humans. CBI recommends continued monitoring at these culverts as part of regional linkage monitoring.

The SDTT also established and has monitored a transect quarterly along Sycamore Park Drive, off of SR-67 since winter quarter 2000 (Figure L-11, Location C). This transect serves to monitor wildlife use within the Goodan Ranch Open Space Preserve. CBI does not recommend continued monitoring at Sycamore Park Drive as part of regional wildlife corridor monitoring, but does recommend continued monitoring at this location to inform preserve management.

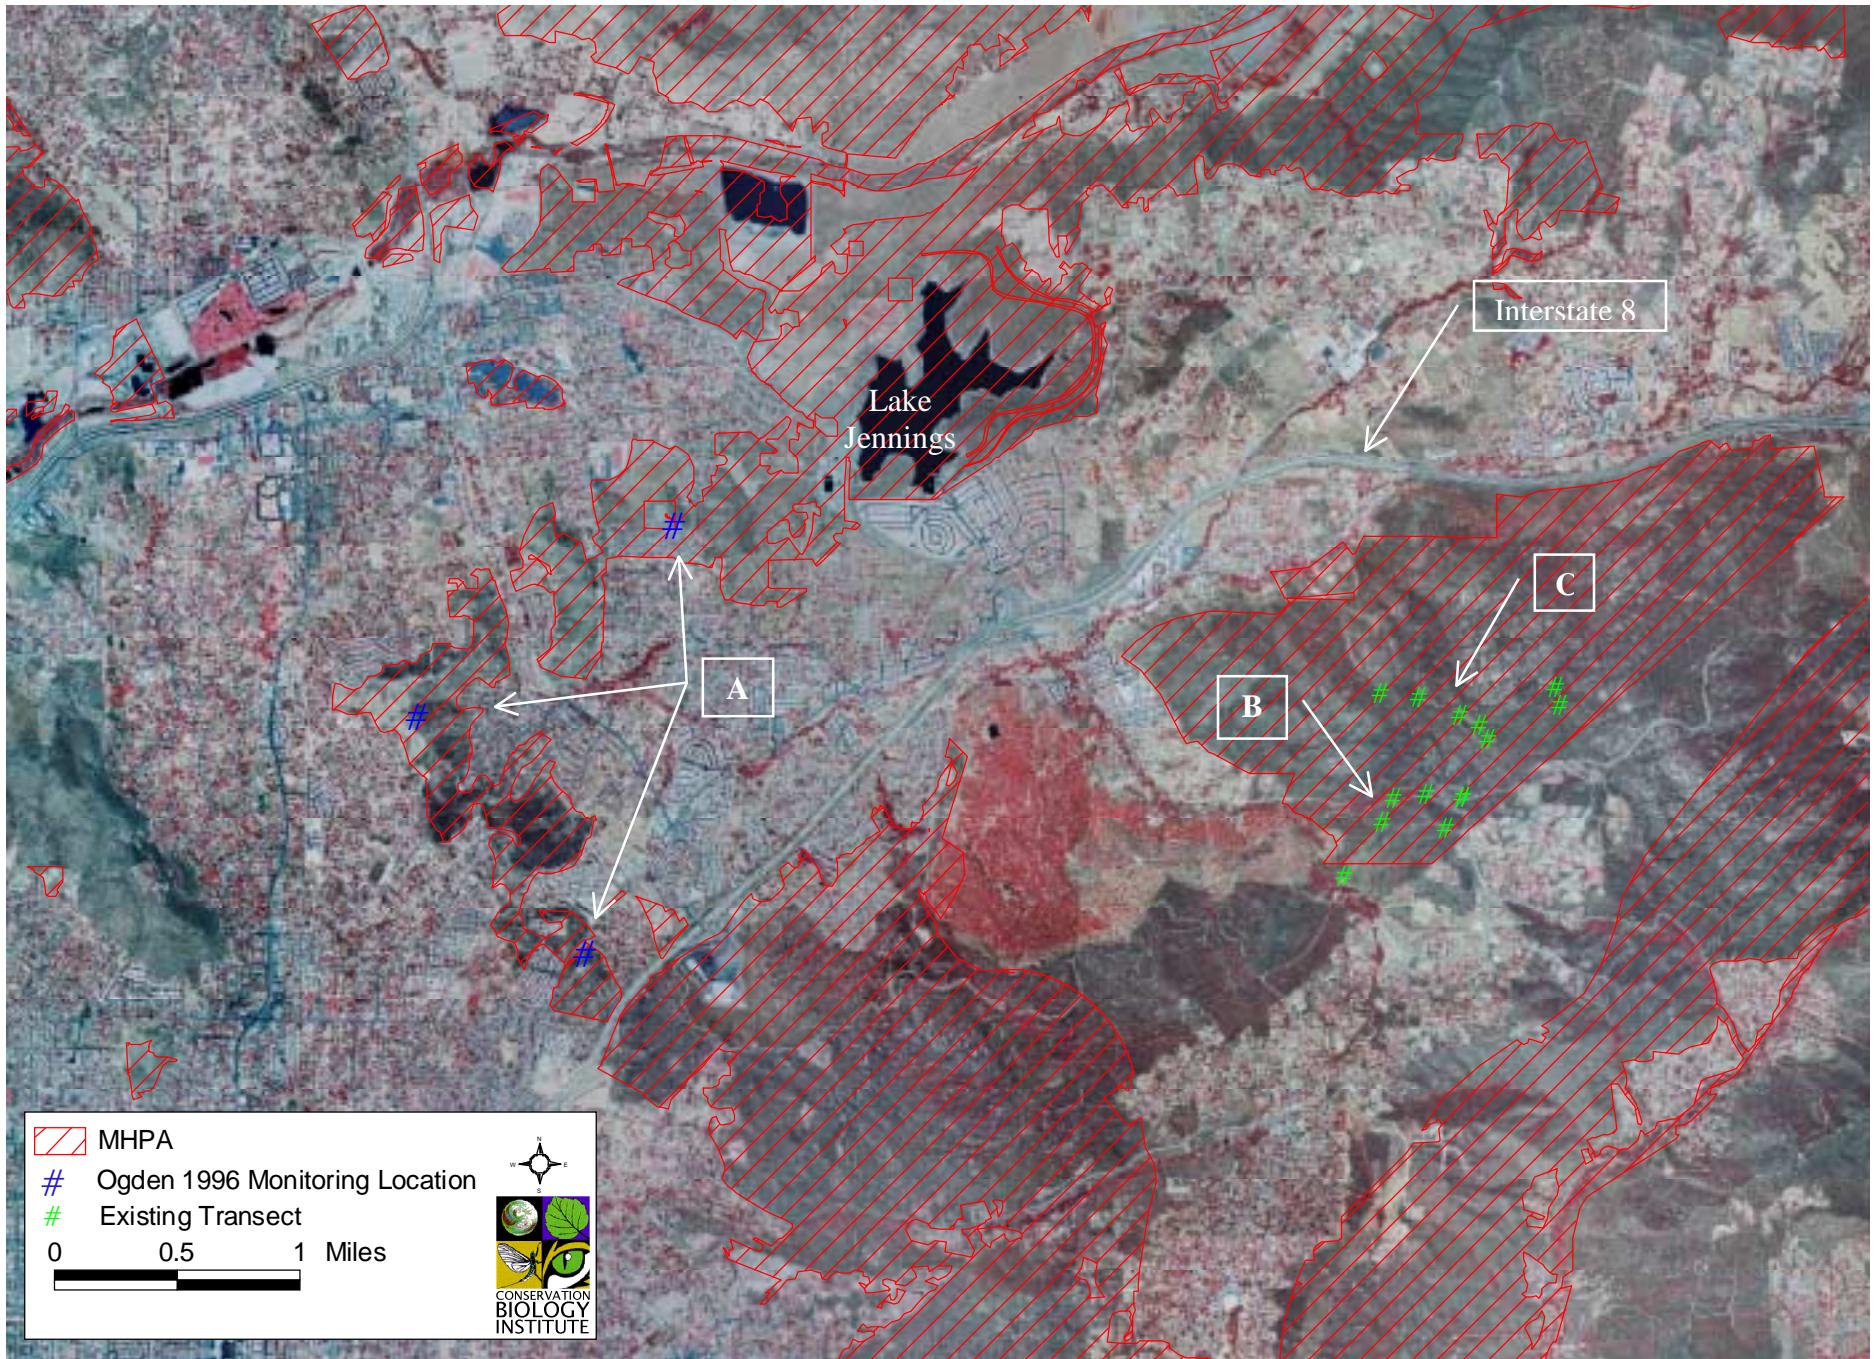
Figure L-12. Lakeside - Crest - El Cajon. **A** – Lakeside Archipelago, and **B, C** – SDTT transects at Crestridge Ecological Reserve.

This area is an archipelago of coastal sage scrub habitat fragments that link open space north and south of I-8 (Figure L-12, Location A). This area of fragmented open space, roads, and rural residential development likely supports dispersal of birds and flying invertebrates. Regular movement by large mammals through this area is unlikely. The MSCP Plan hypothesizes that these habitat islands are used by California gnatcatchers to disperse between larger, core habitat areas. The County of San Diego has initiated monitoring of dispersing birds through this area. We do not recommend establishing a corridor monitoring location for large mammals in the archipelago.

Alternative Location. The SDTT established two transects at the Crestridge Ecological Reserve in this area, just south of I-8 (one in spring 1999 and one in spring 2002) and has monitored them quarterly through 2002 (Figure L-12, Locations B and C). Data collected at Crestridge will be valuable to understanding the degree of isolation of this reserve, which is largely surrounded by residential development and roads. Crestridge likely functions more as a core resource area rather than a linkage. CBI recommends continued monitoring at Crestridge to inform habitat management decisions on the reserve, but CBI does not recommend these locations as regional habitat linkage monitoring locations for large mammals.

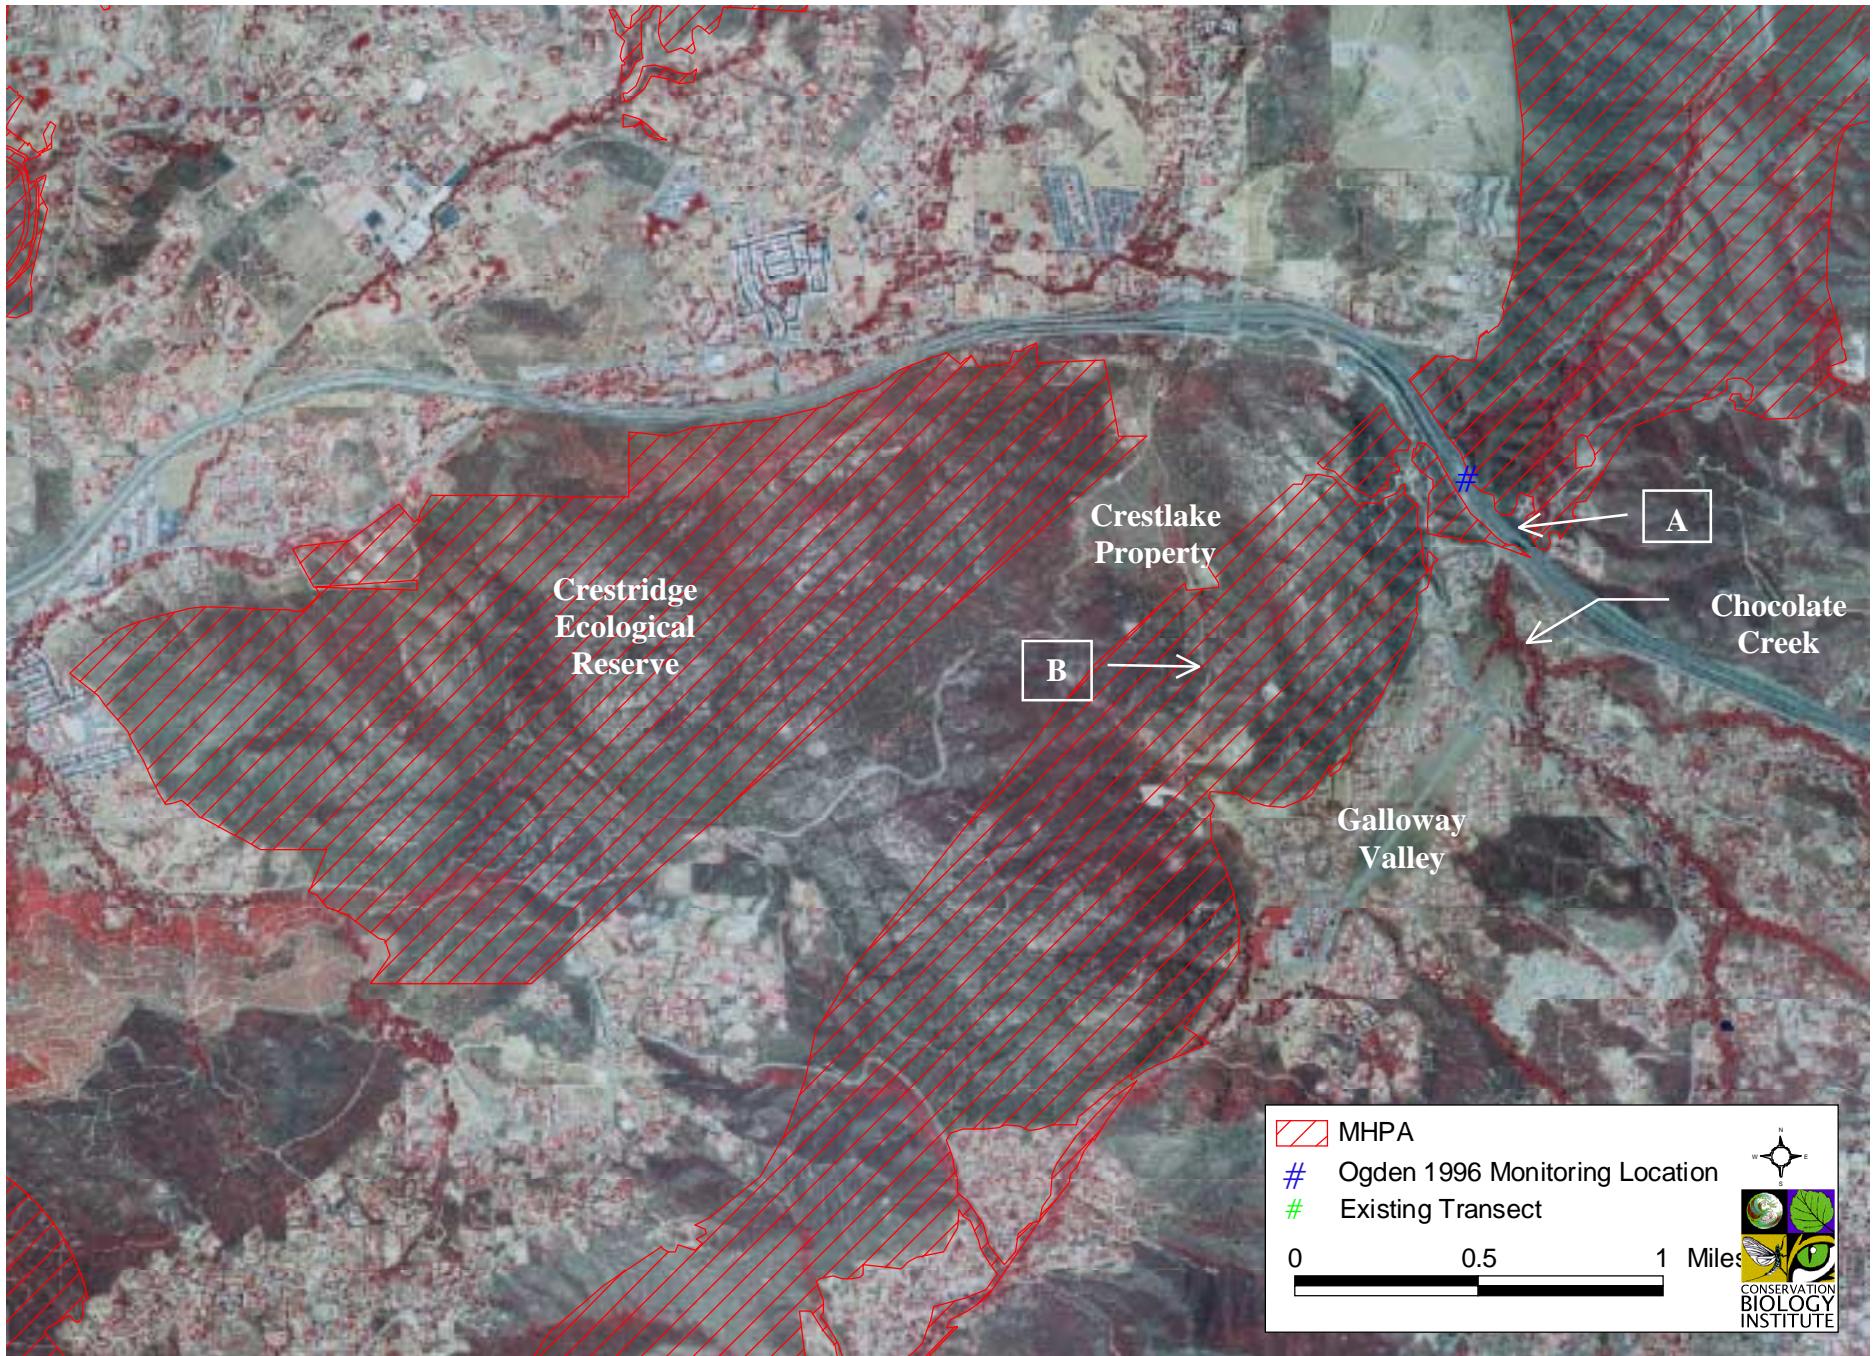
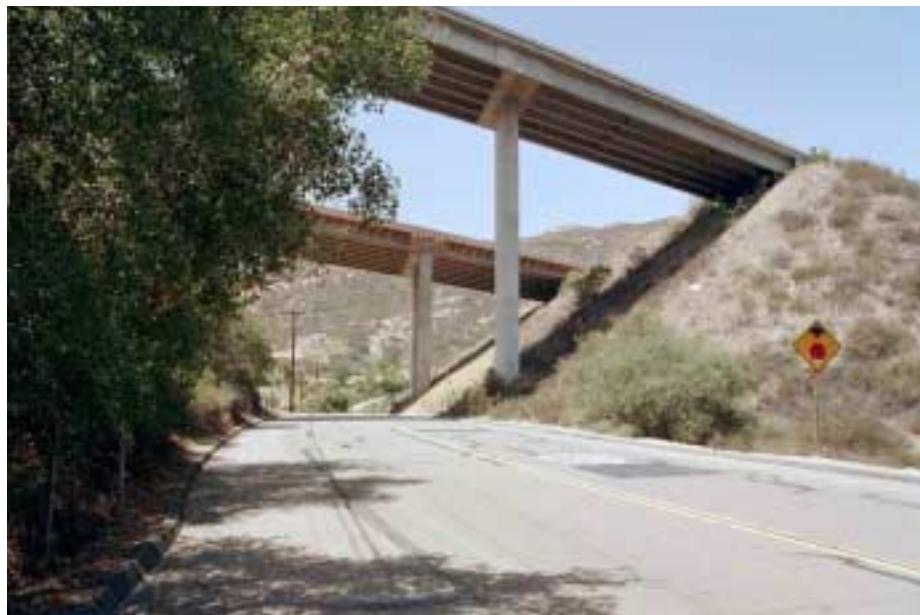
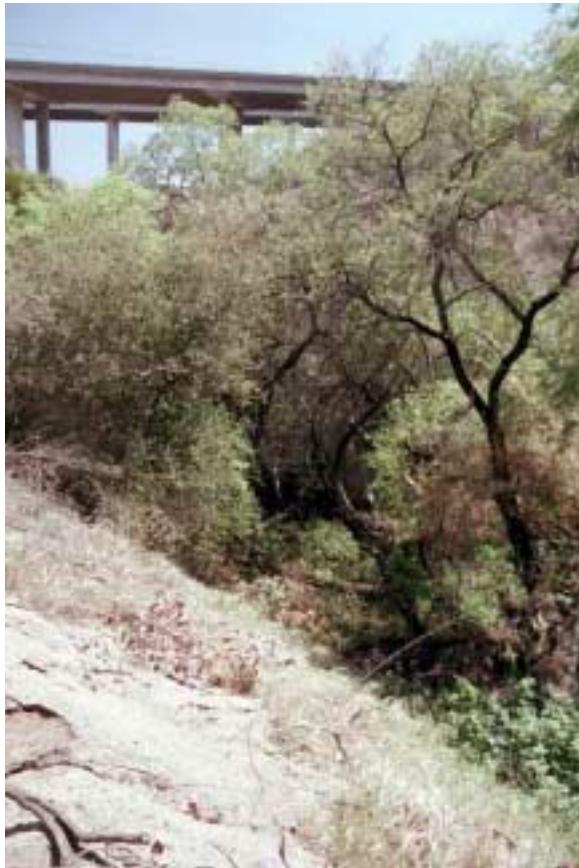
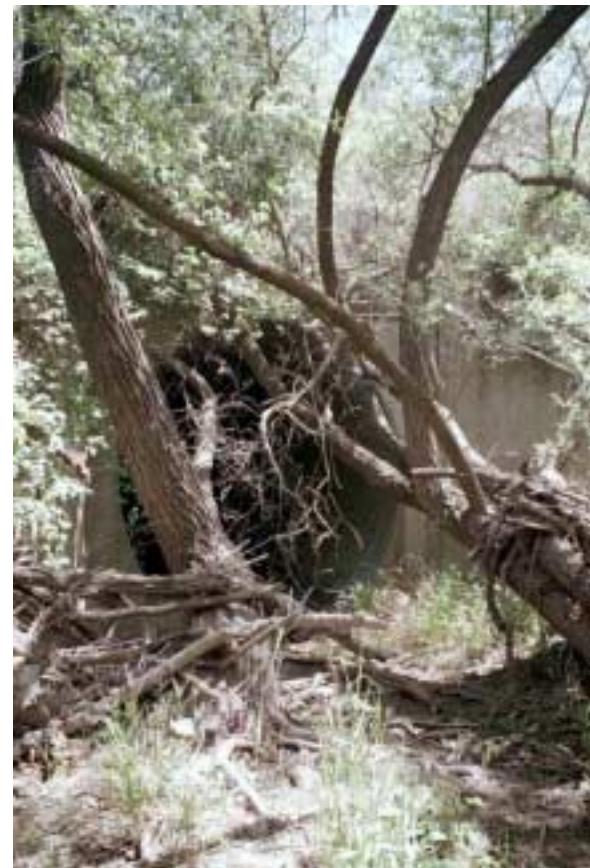
Figure L-13. Harbison Canyon at Interstate-8. **A** – Peutz Valley Road at I-8 and **B** – canyon through Crestlake.

Peutz Valley Road under I-8 overpass, looking north.

Chocolate Creek with I-8 overpass in background.

Chocolate Creek culvert under Peutz Valley Rd, looking north.

Alternative Location. In a separate report, CBI evaluated potential habitat linkages to the Crestridge Ecological Reserve (CBI 2002c). The Crestlake property borders the eastern boundary of Crestridge. The westernmost portion of the Crestlake property is a fairly flat mesa and currently serves as an extension of the Crestridge habitat (primarily chaparral). A pond drains to a gently sloping, oak-riparian canyon leading down into Galloway Valley (Figure L-13, Location B). Bullard Lane, a paved road, is at the mouth of this canyon. CBI recommends that a transect(s) be established along this canyon through the Crestlake property, if all or a portion of it is conserved. This connection is potentially critical to maintaining the integrity of the Crestridge Ecological Reserve.

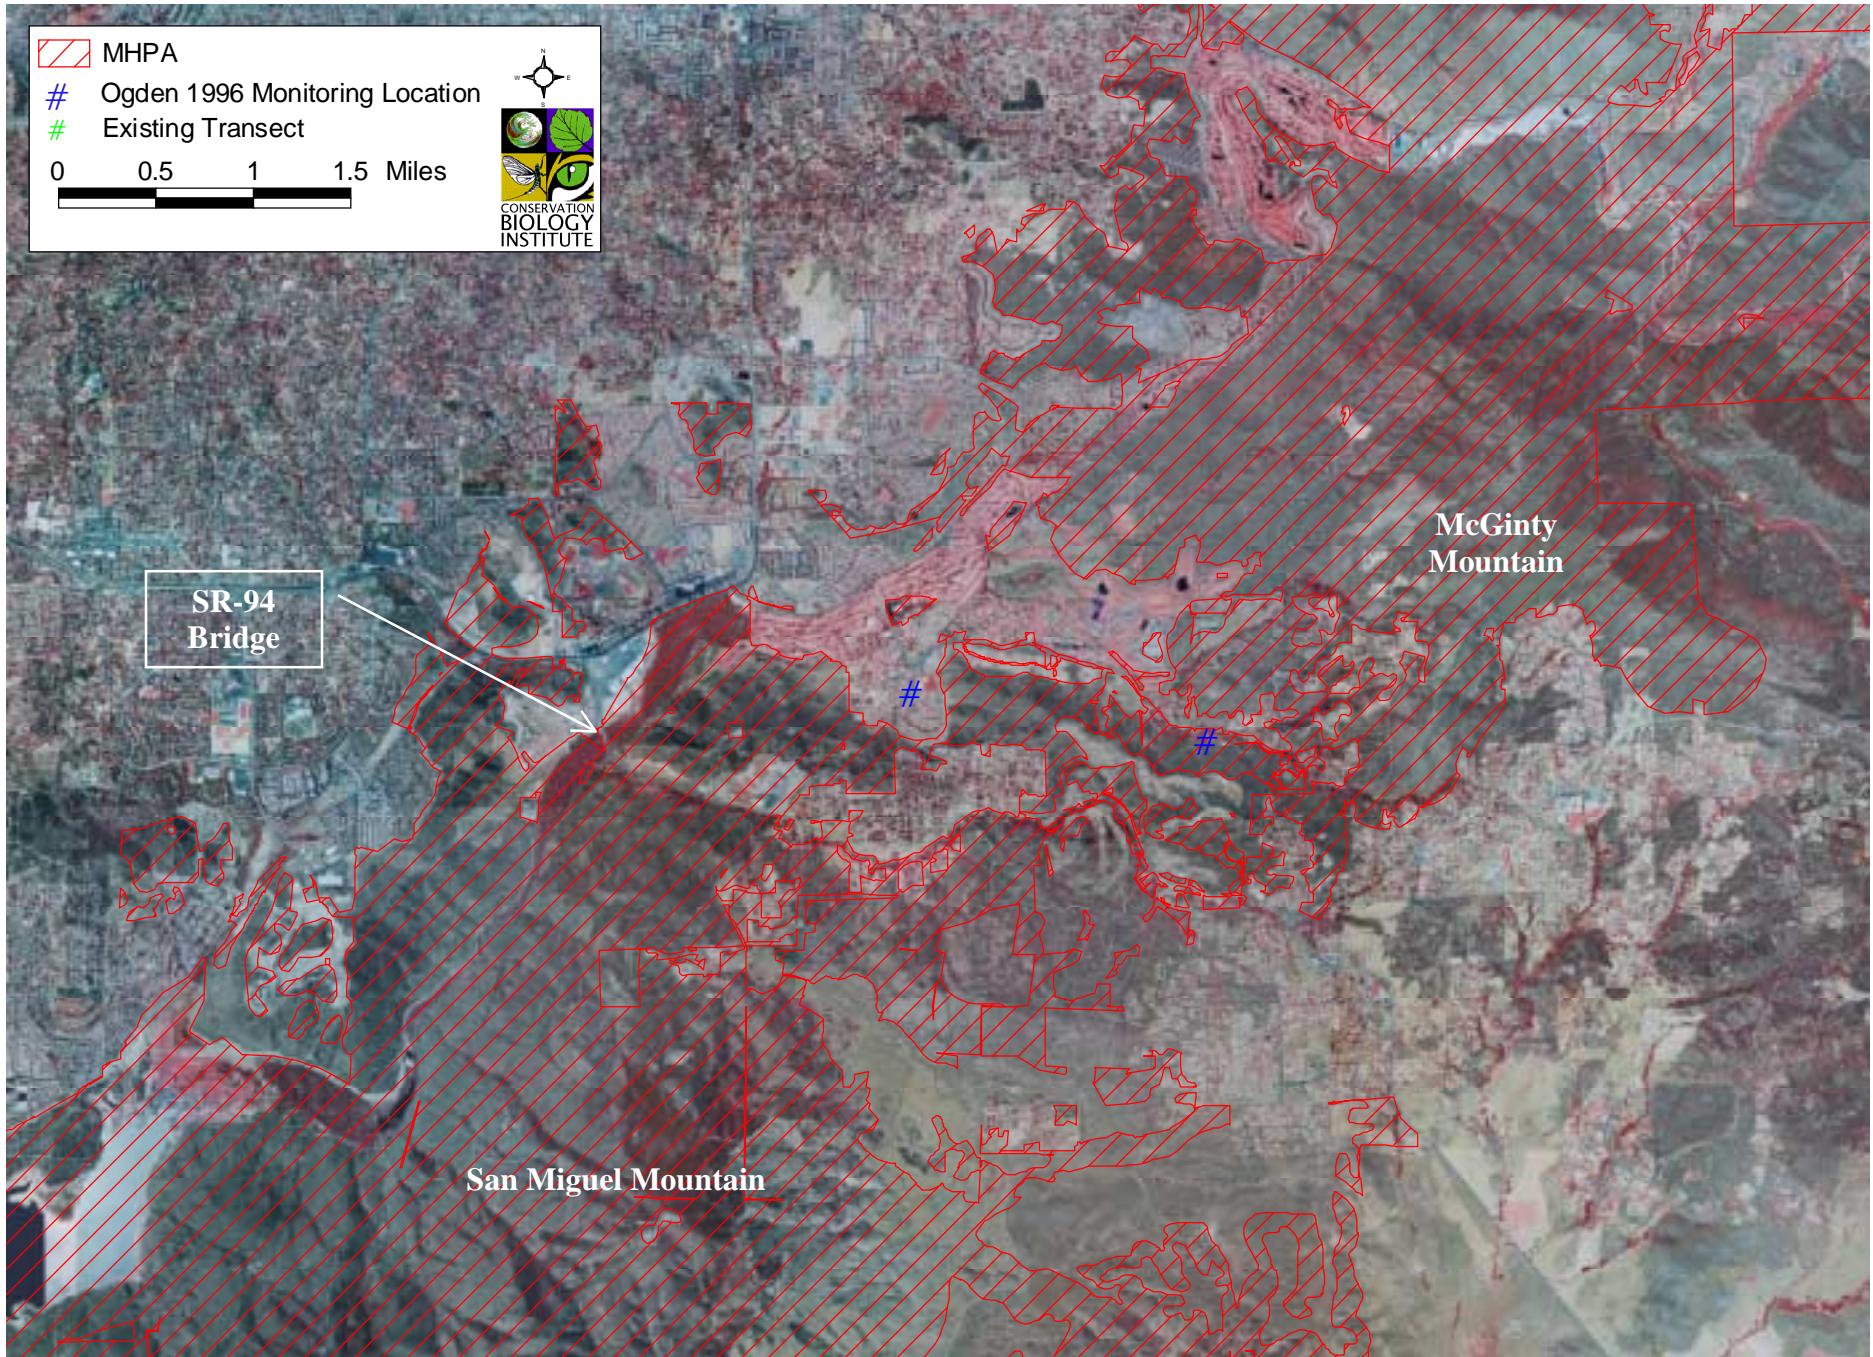
Figure L-15. McGinty Mesa - Rancho San Diego (middle Sweetwater River) at SR-94 bridge.

Mountain), through Cottonwood and Singing Hills golf courses, to Sloan Canyon and adjacent upland habitats (e.g., McGinty Mountain, Sycuan Peak). The linkage supports a variety of habitats, from high quality riparian woodlands to a highly disturbed stream channel through the golf courses. SR-94 has a new bridge (20-ft high, 600 ft wide) over the river that allows wildlife movement, although the riparian corridor may be impassable during high flow periods. CBI recommends this location at the bridge for MSCP monitoring (L-15).

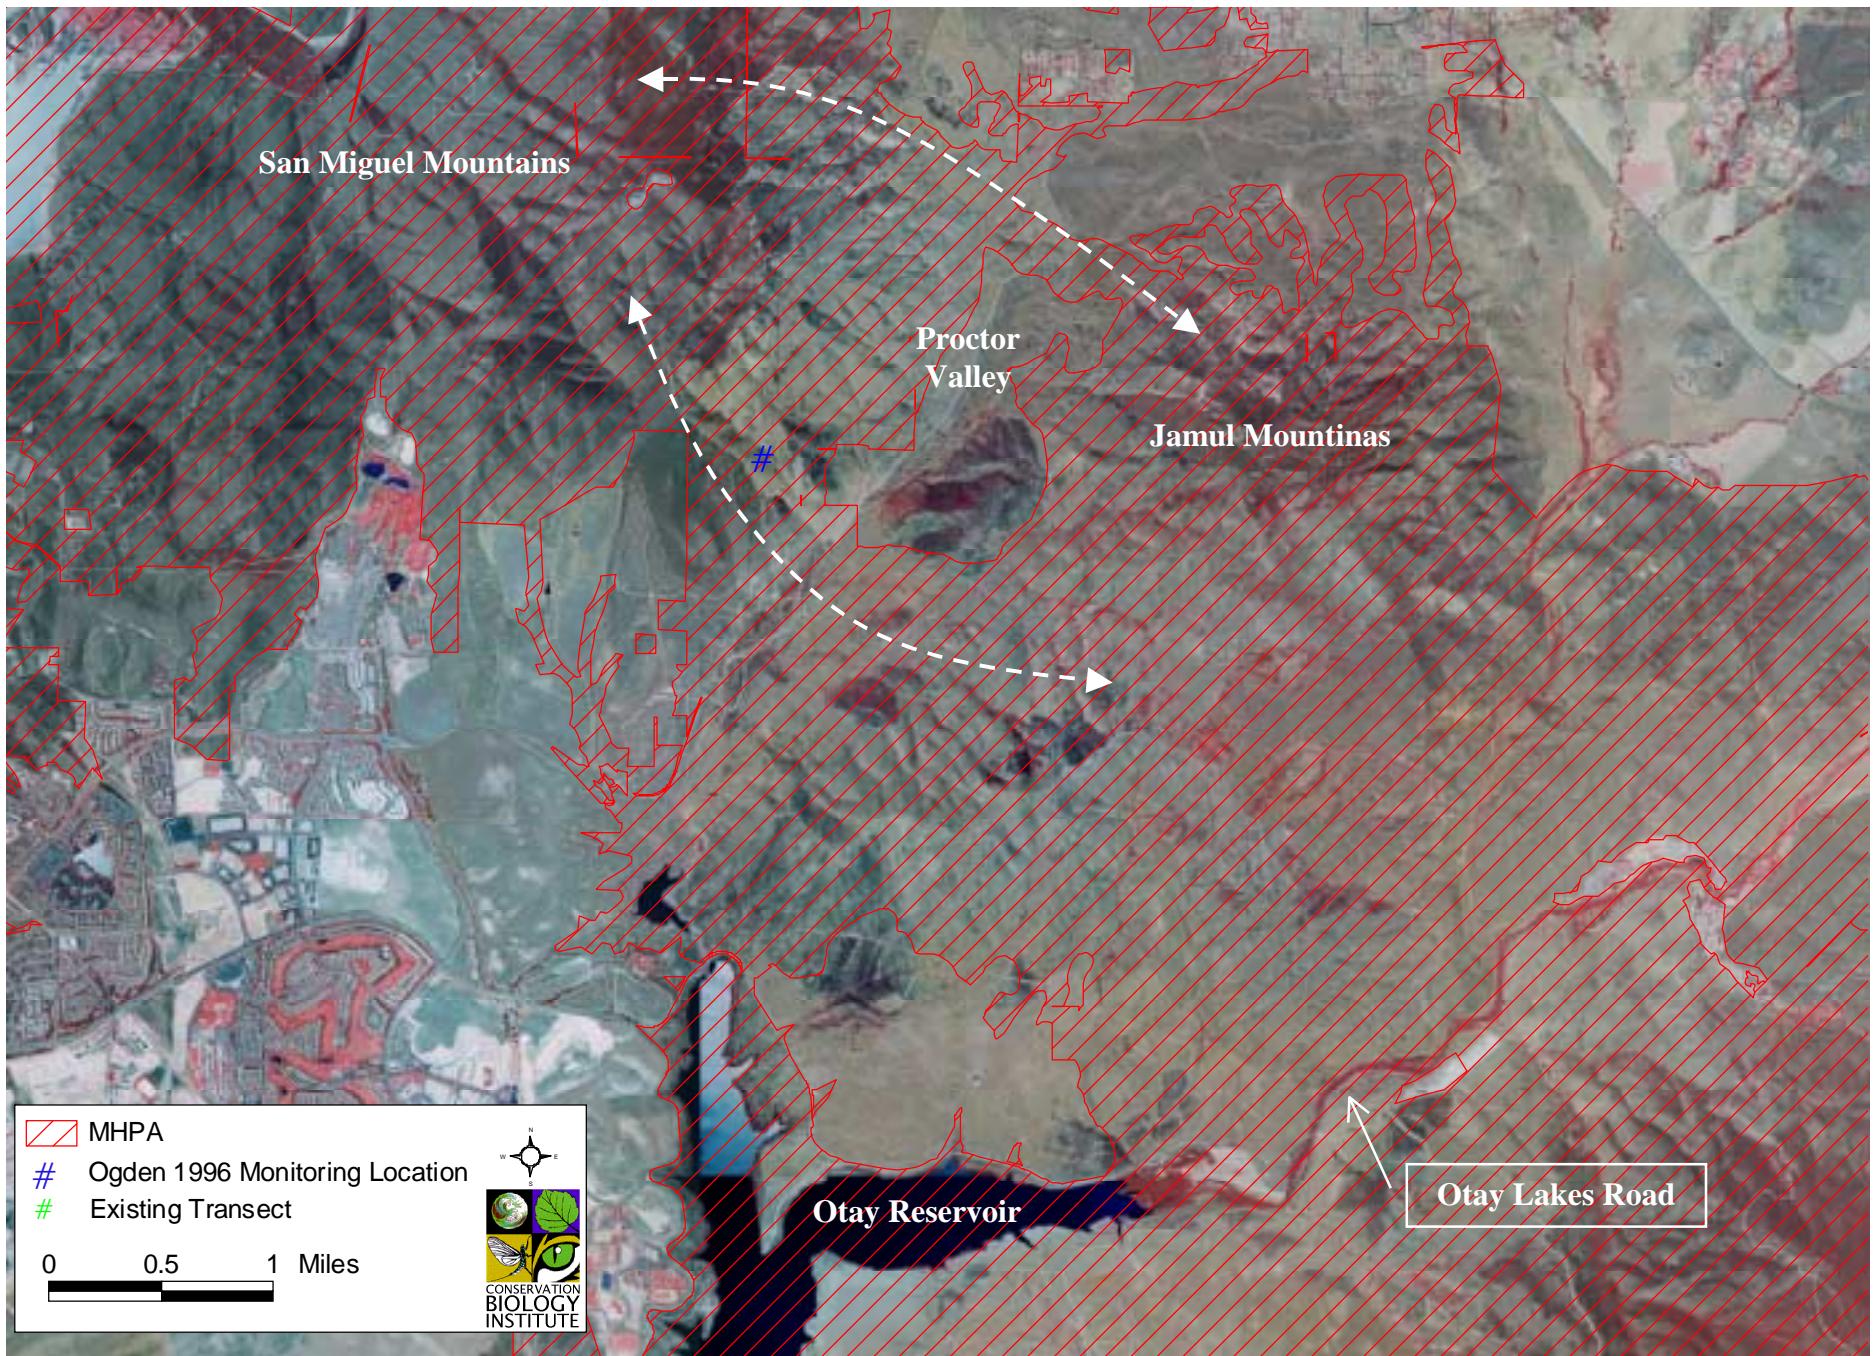
Figure L-17. San Miguel Mountains - Proctor Valley - Jamul Mountains (Otay Ranch). Reevaluate monitoring locations once development and conservation plans are approved.

CBI does not recommend this location through Proctor Valley for corridor monitoring at this time because wildlife movement is not constrained by current land use (Figure L-17). However, it is likely that this area will be important for monitoring once a conservation strategy and land use design are finalized, and this area should be reevaluated at that time.
