REVIEW OF REGIONAL HABITAT LINKAGE MONITORING LOCATIONS

Multiple Species Conservation Program

January 2003

California Department of Fish and Game

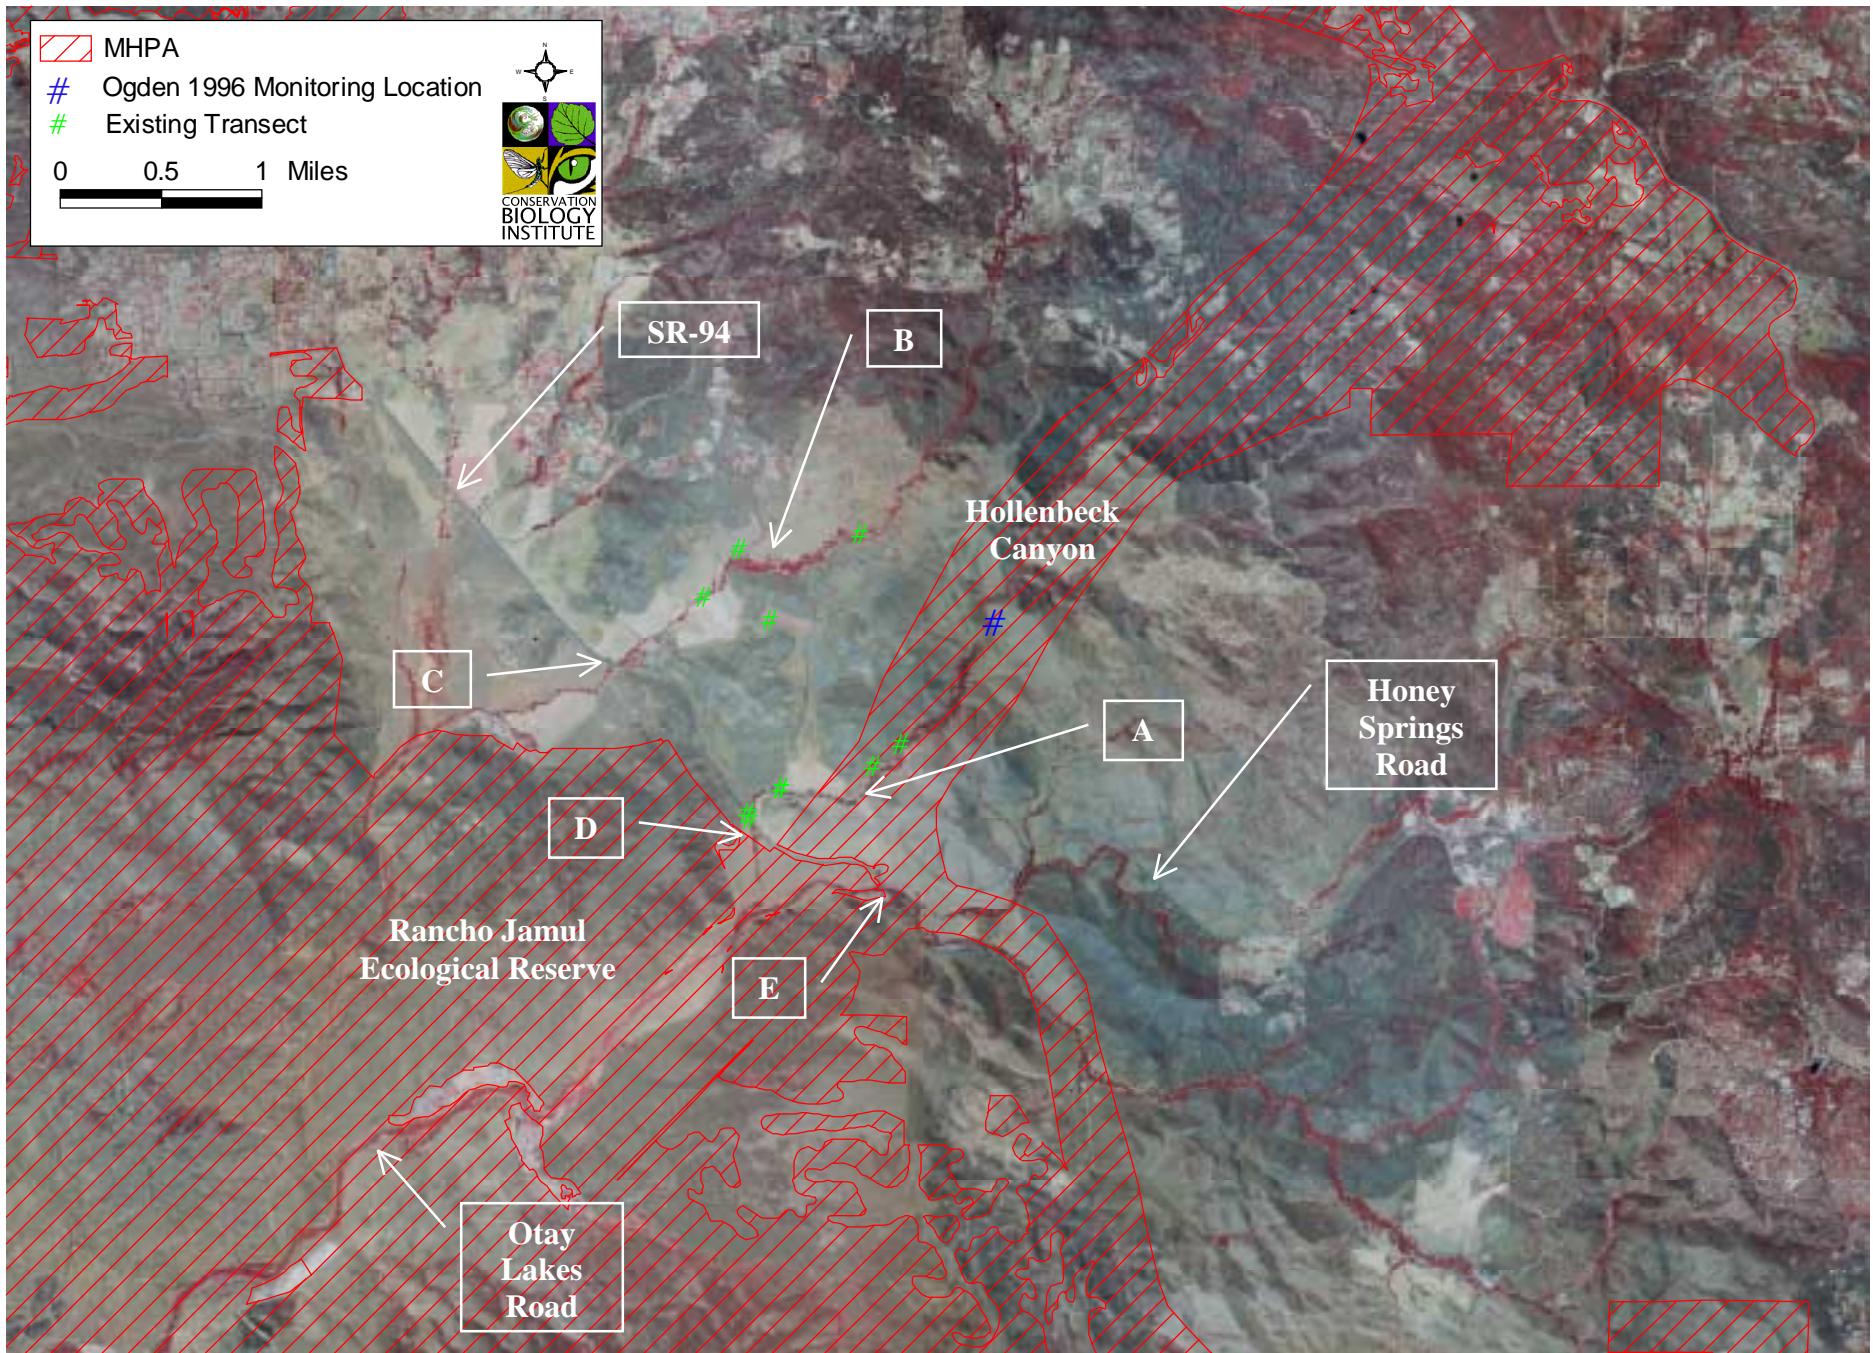
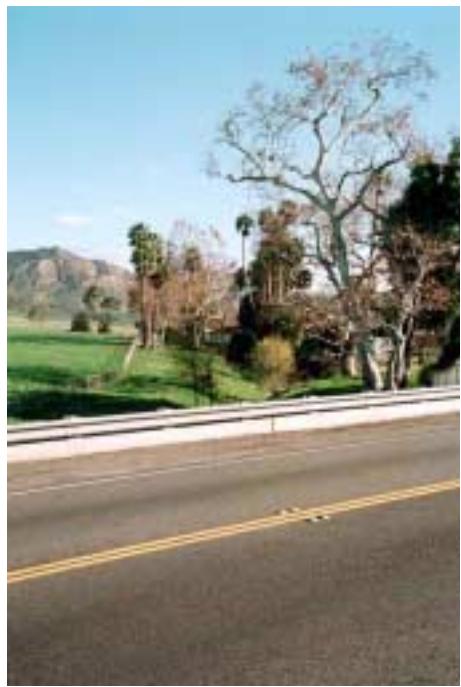
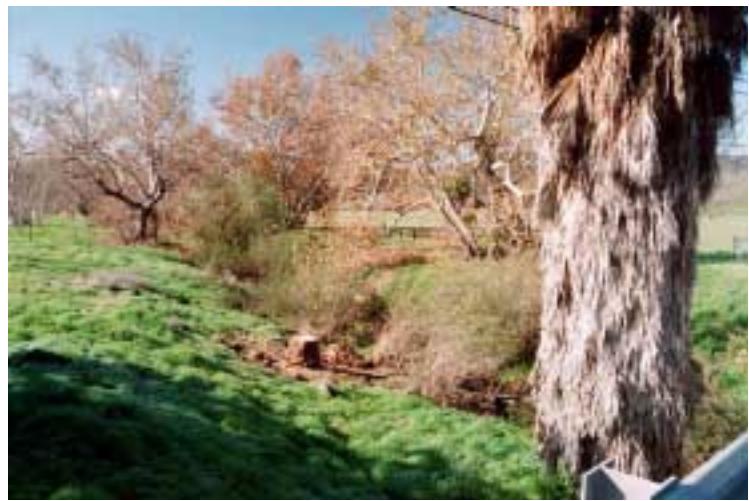
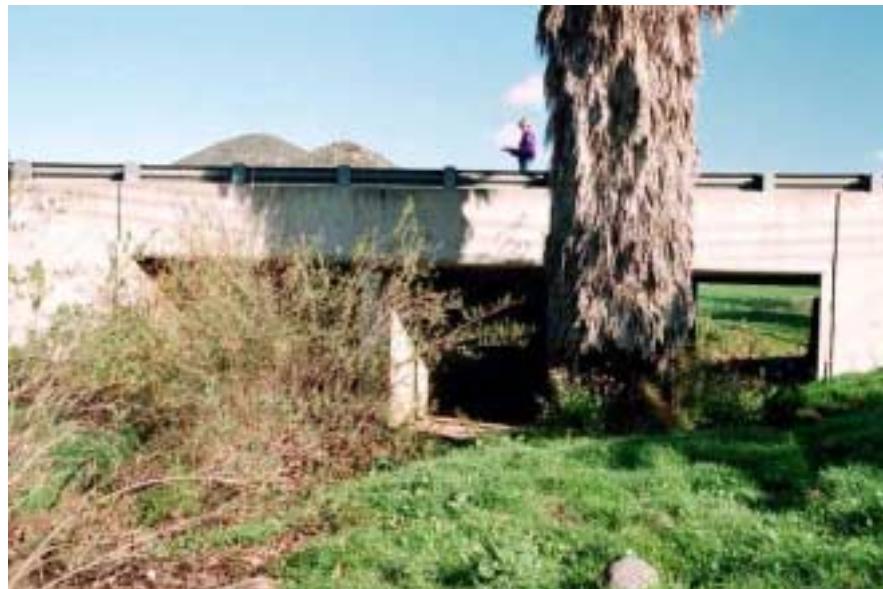
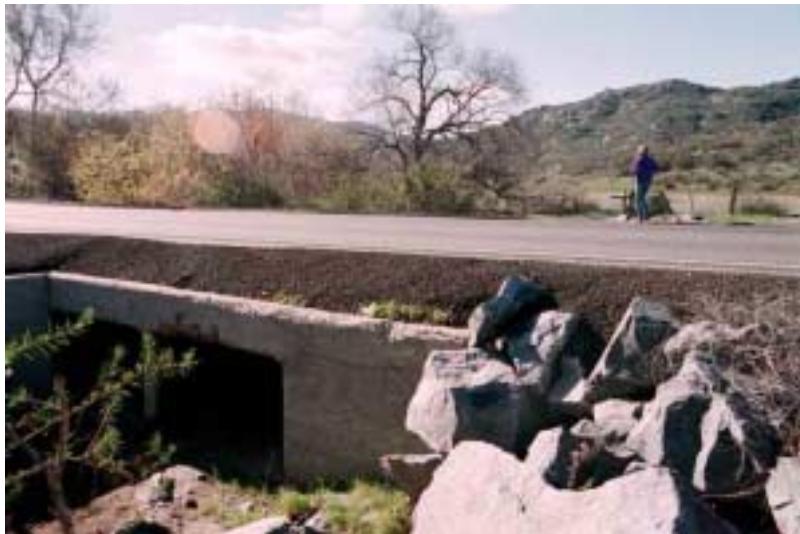
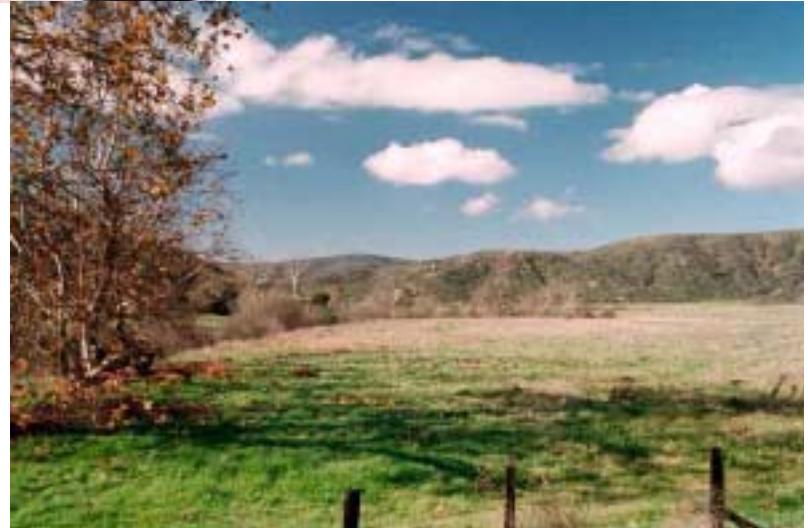
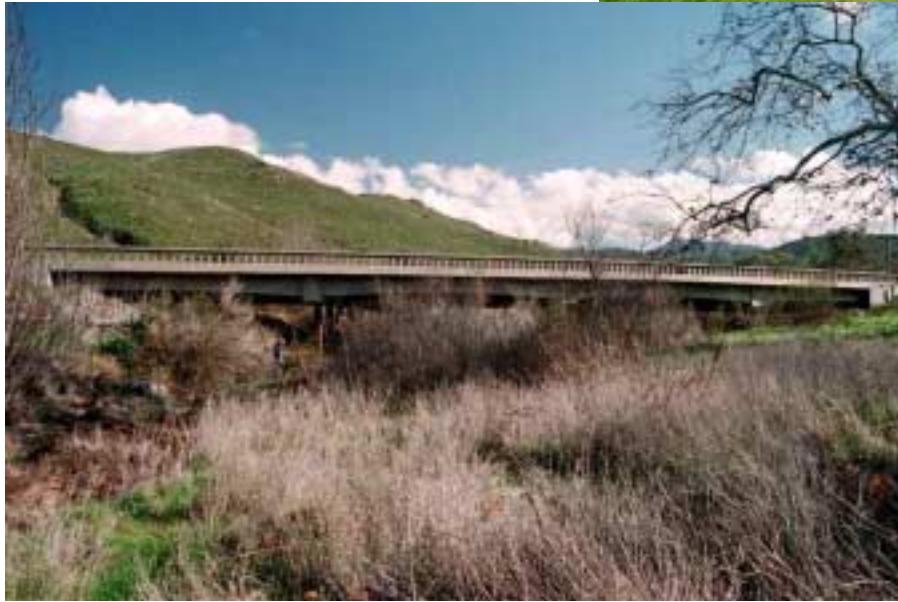
Figure L-18. Hollenbeck Canyon. **A, B** – SDTT transects in Hollenbeck Canyon preserve area, **C** - Jamul Creek culverts at SR-94, **D** - Hollenbeck Canyon culverts at SR-94, and **E** – SR-94 bridge at Dulzura Creek.

Looking north up Jamul Creek from SR-94 bridge.

Looking south down Jamul Creek from SR-94 bridge.

SR-94 bridge over Jamul Creek, looking north.

Hollenbeck Canyon drainage culvert under SR-94 looking south.

Looking west from SR-94 bridge along Dulzura Creek.

SR-94 bridge over Dulzura Creek, looking east from downstream side.

Additional Locations. The Rancho Jamul and Hollenbeck Canyon reserves are bisected by SR-94, which is heavily used through this area. The highway is fenced along both sides by a combination of barbed wire, chain link, and mesh fencing. There are at least five locations between Jamul and Otay Lakes Road where wildlife could move under SR-94 or cross at-grade. CBI recommends establishing transects at three of these locations, in combination with collecting road-kill data along SR-94 (Figure L-18):

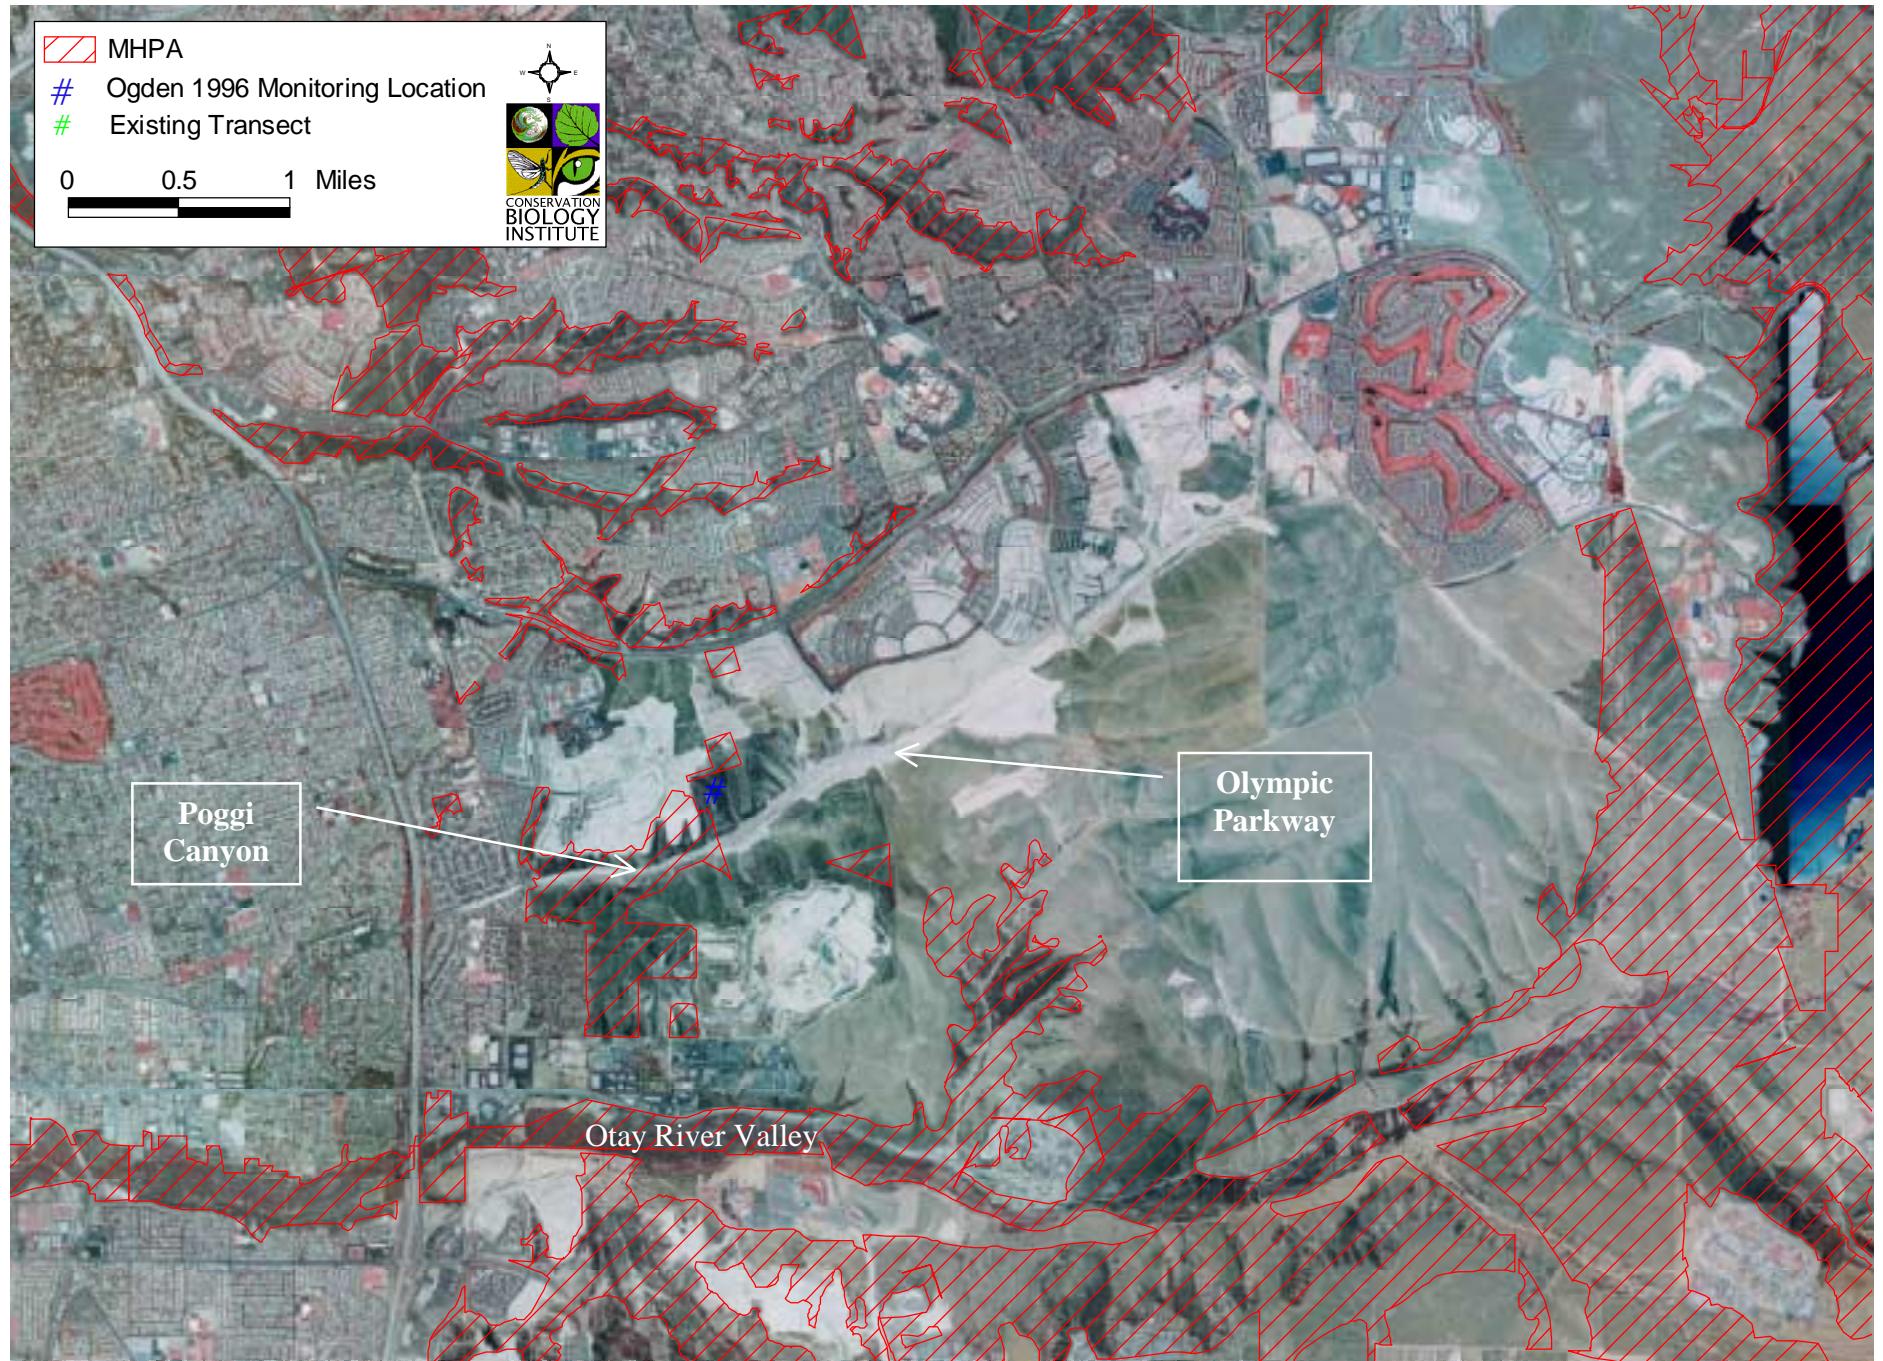
Figure L-19. Poggi Canyon.

CBI does not recommend this location for monitoring regional wildlife movement as the habitat is isolated and Olympic Parkway now bisects the canyon (Figure L-19). Poggi Canyon may be used for bird dispersal.

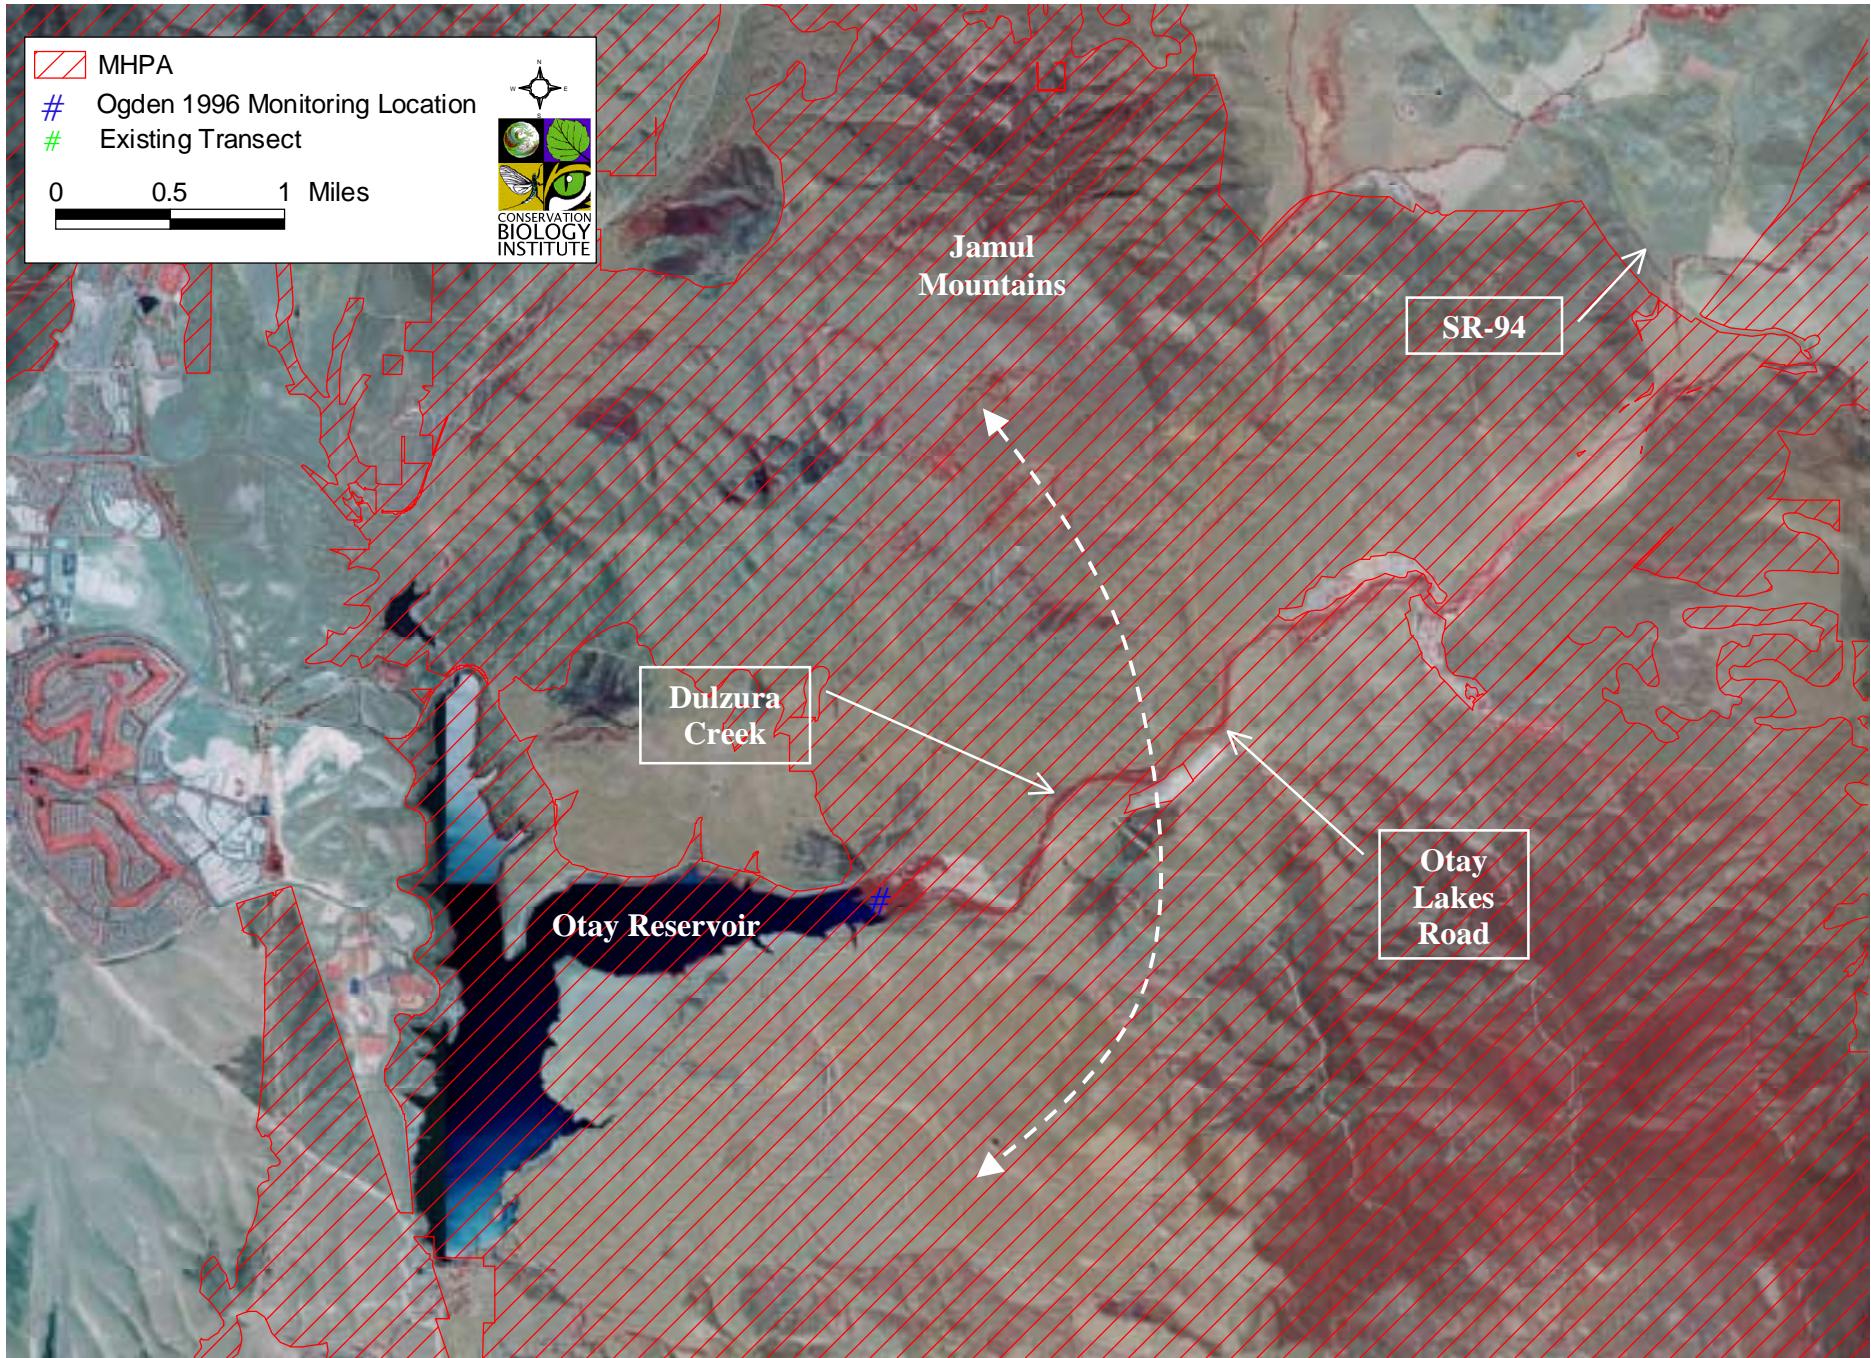
Figure L-20. Jamul Mountains - Southeast Side of Lower Otay Reservoir.

CBI does not recommend this location for corridor monitoring at this time because large mammal movement is not constrained by current land use (Figure L-20). However, the area along Dulzura Creek is a Major Amendment Area and, as such, future development and conservation designs are unknown at this time. Therefore, the need for a monitoring location in this area should be reevaluated after conservation plans are finalized.

Alternative Location. CBI recommends conducting road-kill surveys along Otay Lakes Road between SR-94 and Otay Lakes to identify areas of high mortality due to road-kill and high-use road-crossing areas.

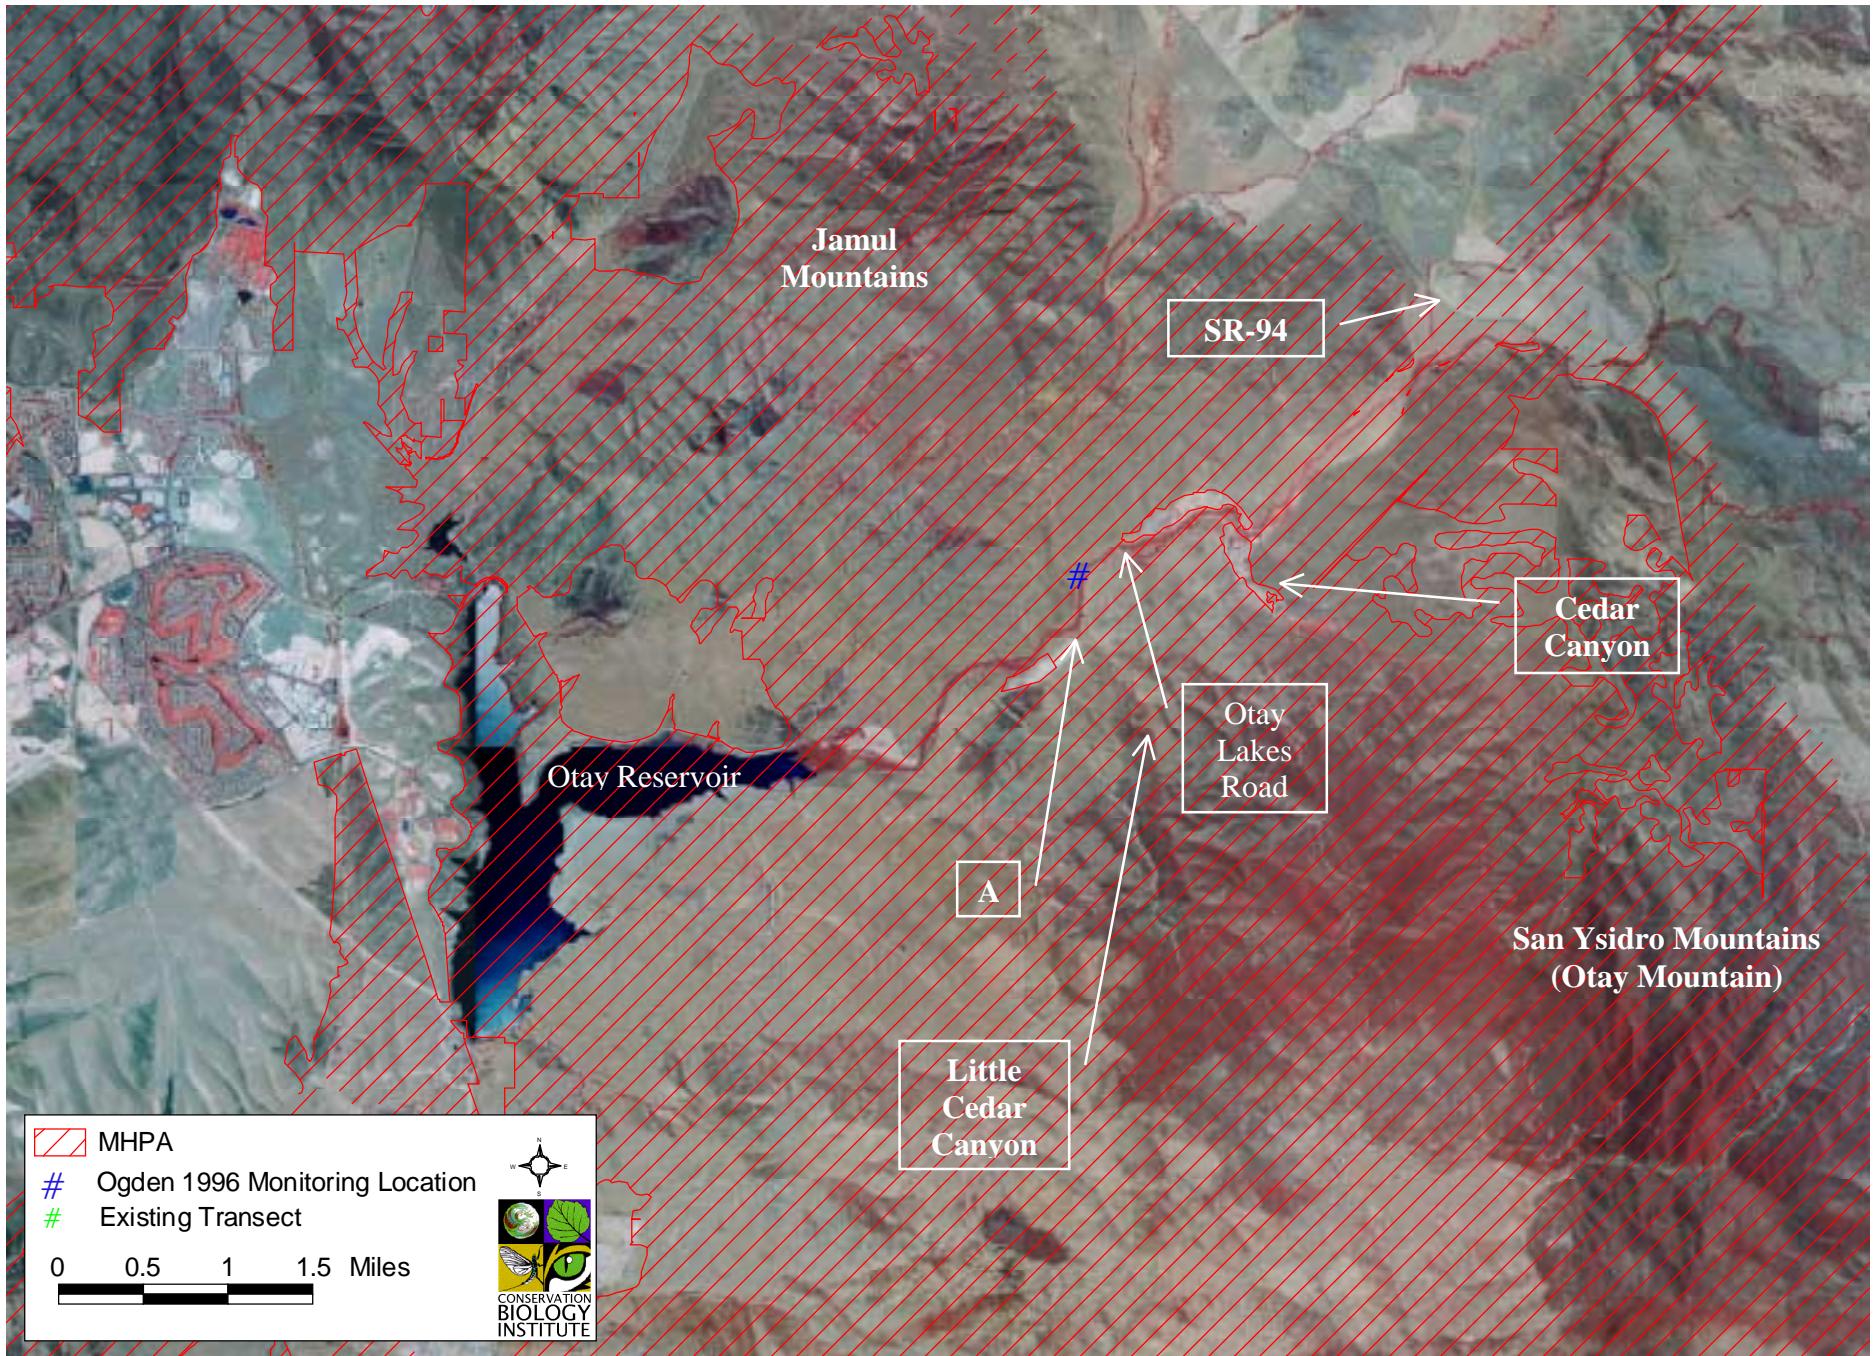
Figure L-21. Jamul Mountains - San Ysidro Mountains (Little Cedar and Cedar Canyons). A – mouth of Little Cedar Canyon at Otay Lakes Road.

CBI does not recommend this location for corridor monitoring at this time because movement is not constrained by current land use (Figure L-21). Much of Little Cedar and Cedar Canyons is conserved as part of the MSCP and administered by the BLM. However, the mouth of Little Cedar Canyon at Dulzura Creek (Location A) is a Major Amendment Area and, as such, future development and conservation designs are unknown at this time. Therefore, the need for a monitoring location in this area should be reevaluated after conservation plans are finalized.

Alternative Location. CBI recommends conducting road-kill surveys along Otay Lakes Road between SR-94 and Otay Lakes to identify areas of high mortality due to road-kill and high-use road crossing areas.

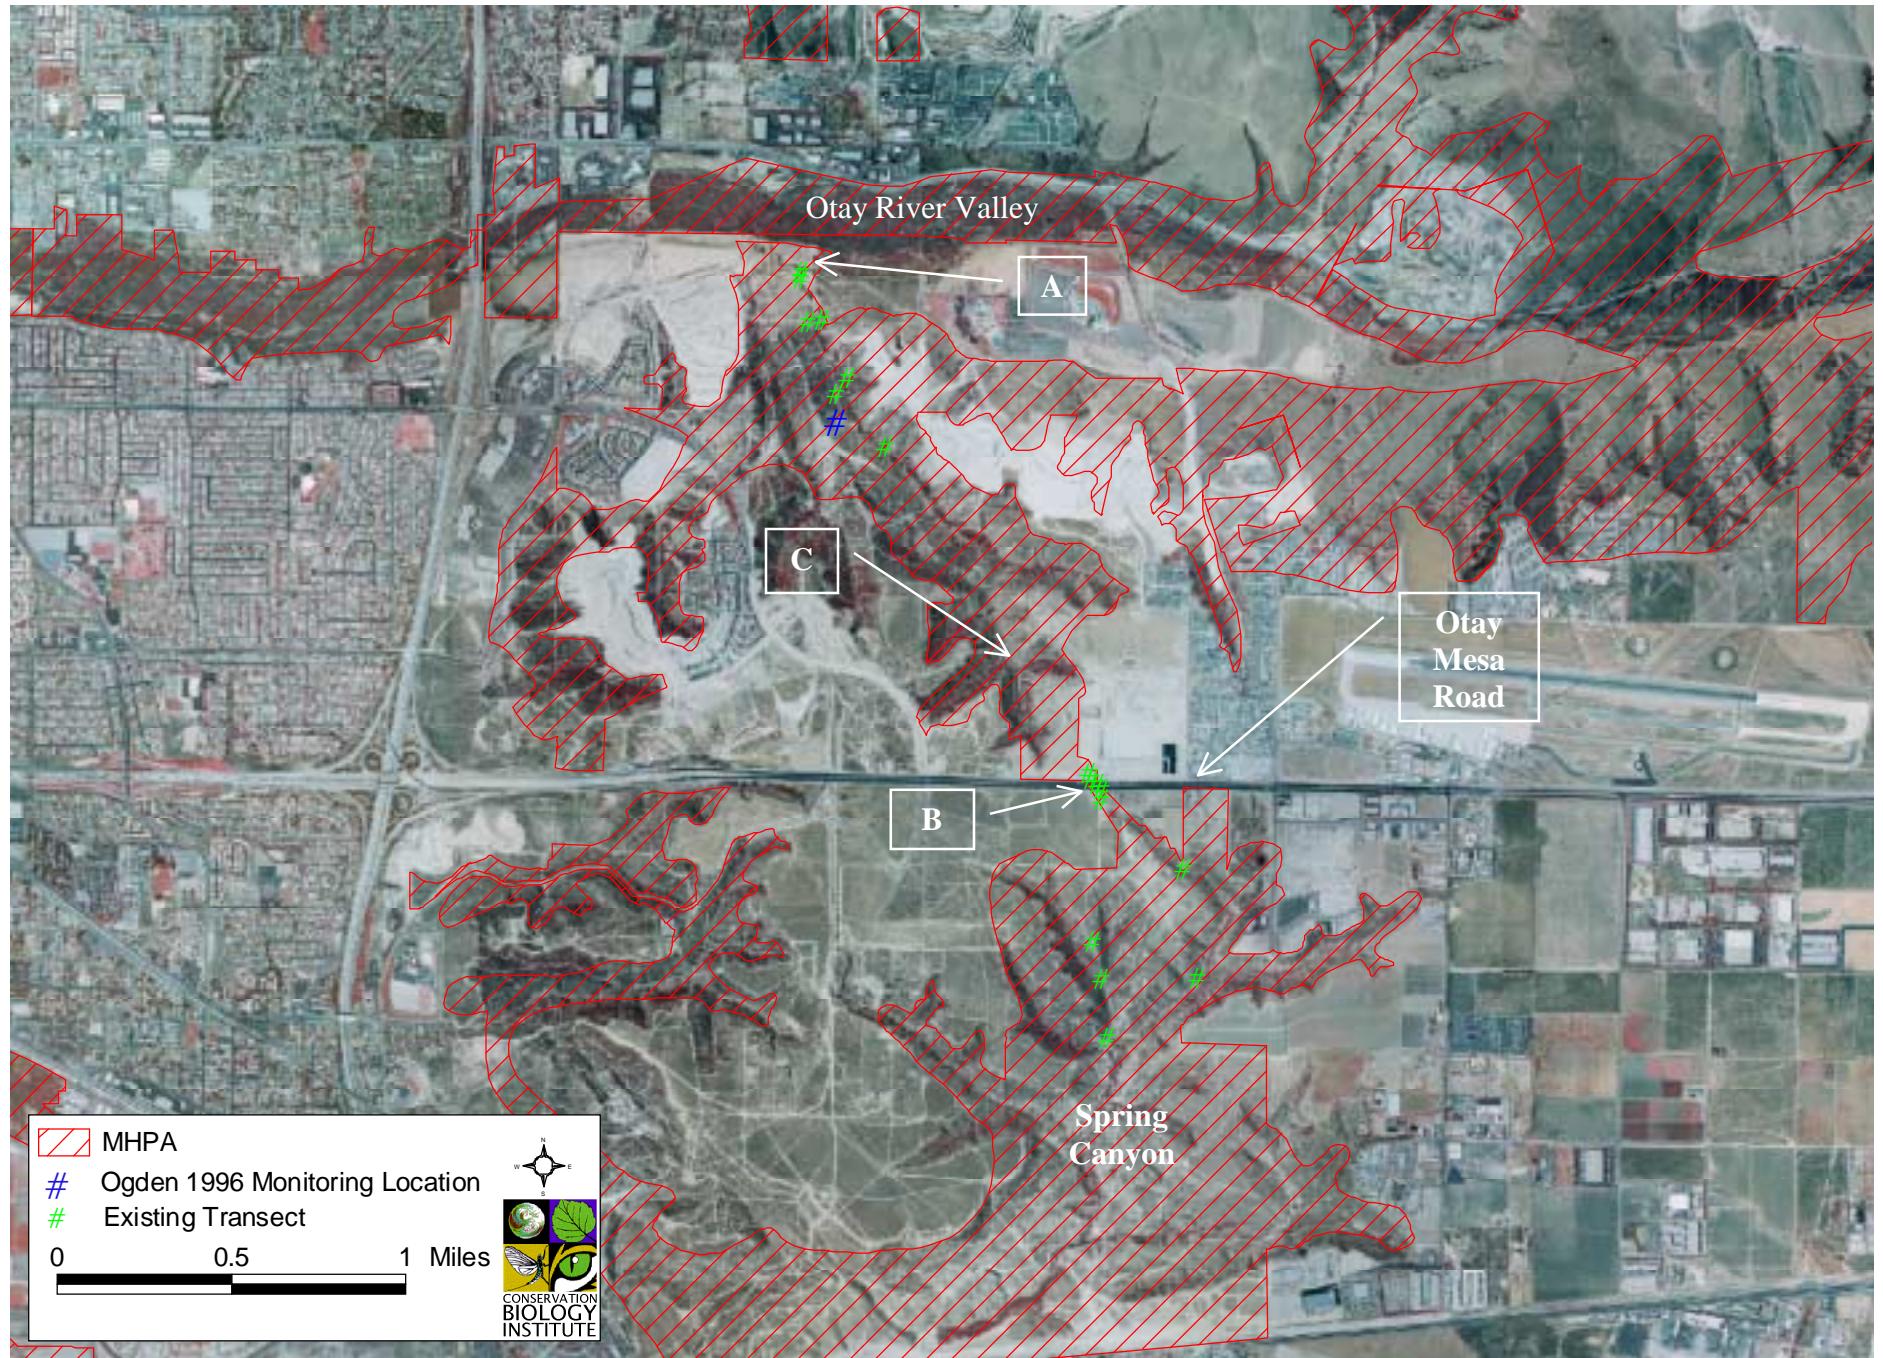
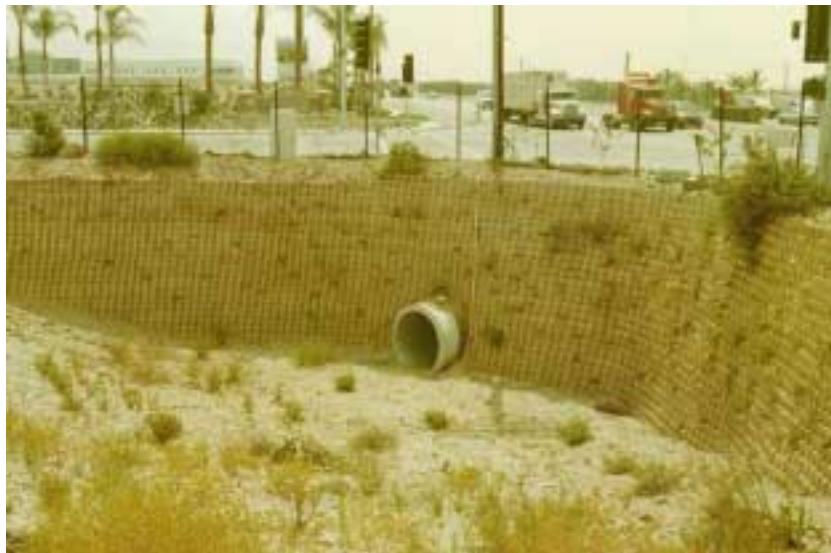
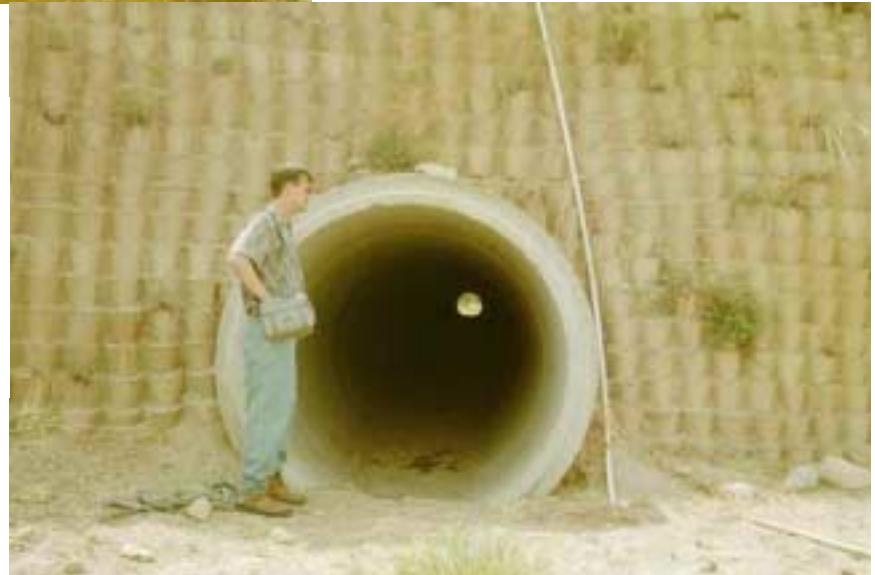
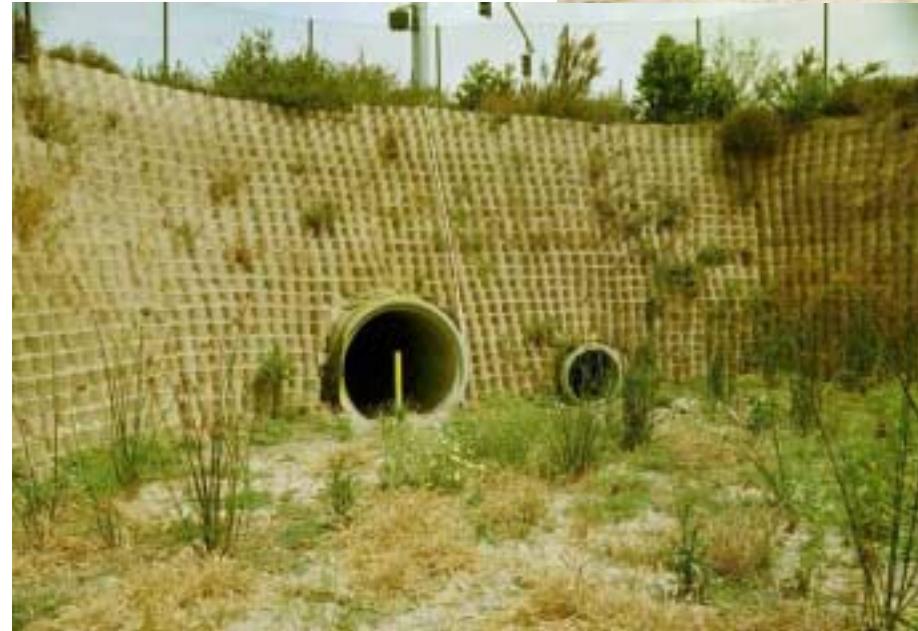
Figure L-22. Otay River Valley - West Otay Mesa (Dennery Canyon). **A** – mouth of Dennery Canyon at new road, **B** – culvert under Otay Mesa Road, and **C** – upper Dennery Canyon.

Culvert under Otay Mesa Rd. from the north side of the culvert, looking east.

Culvert under Otay Mesa Rd from the south side looking north.

Additional Locations. CBI recommends that additional monitoring be conducted in Dennery Canyon, both at the mouth of the canyon at the Otay River Valley (Location A, at the new road) and at the upstream end of the canyon (Location C) (Figure L-22), once access is allowed.

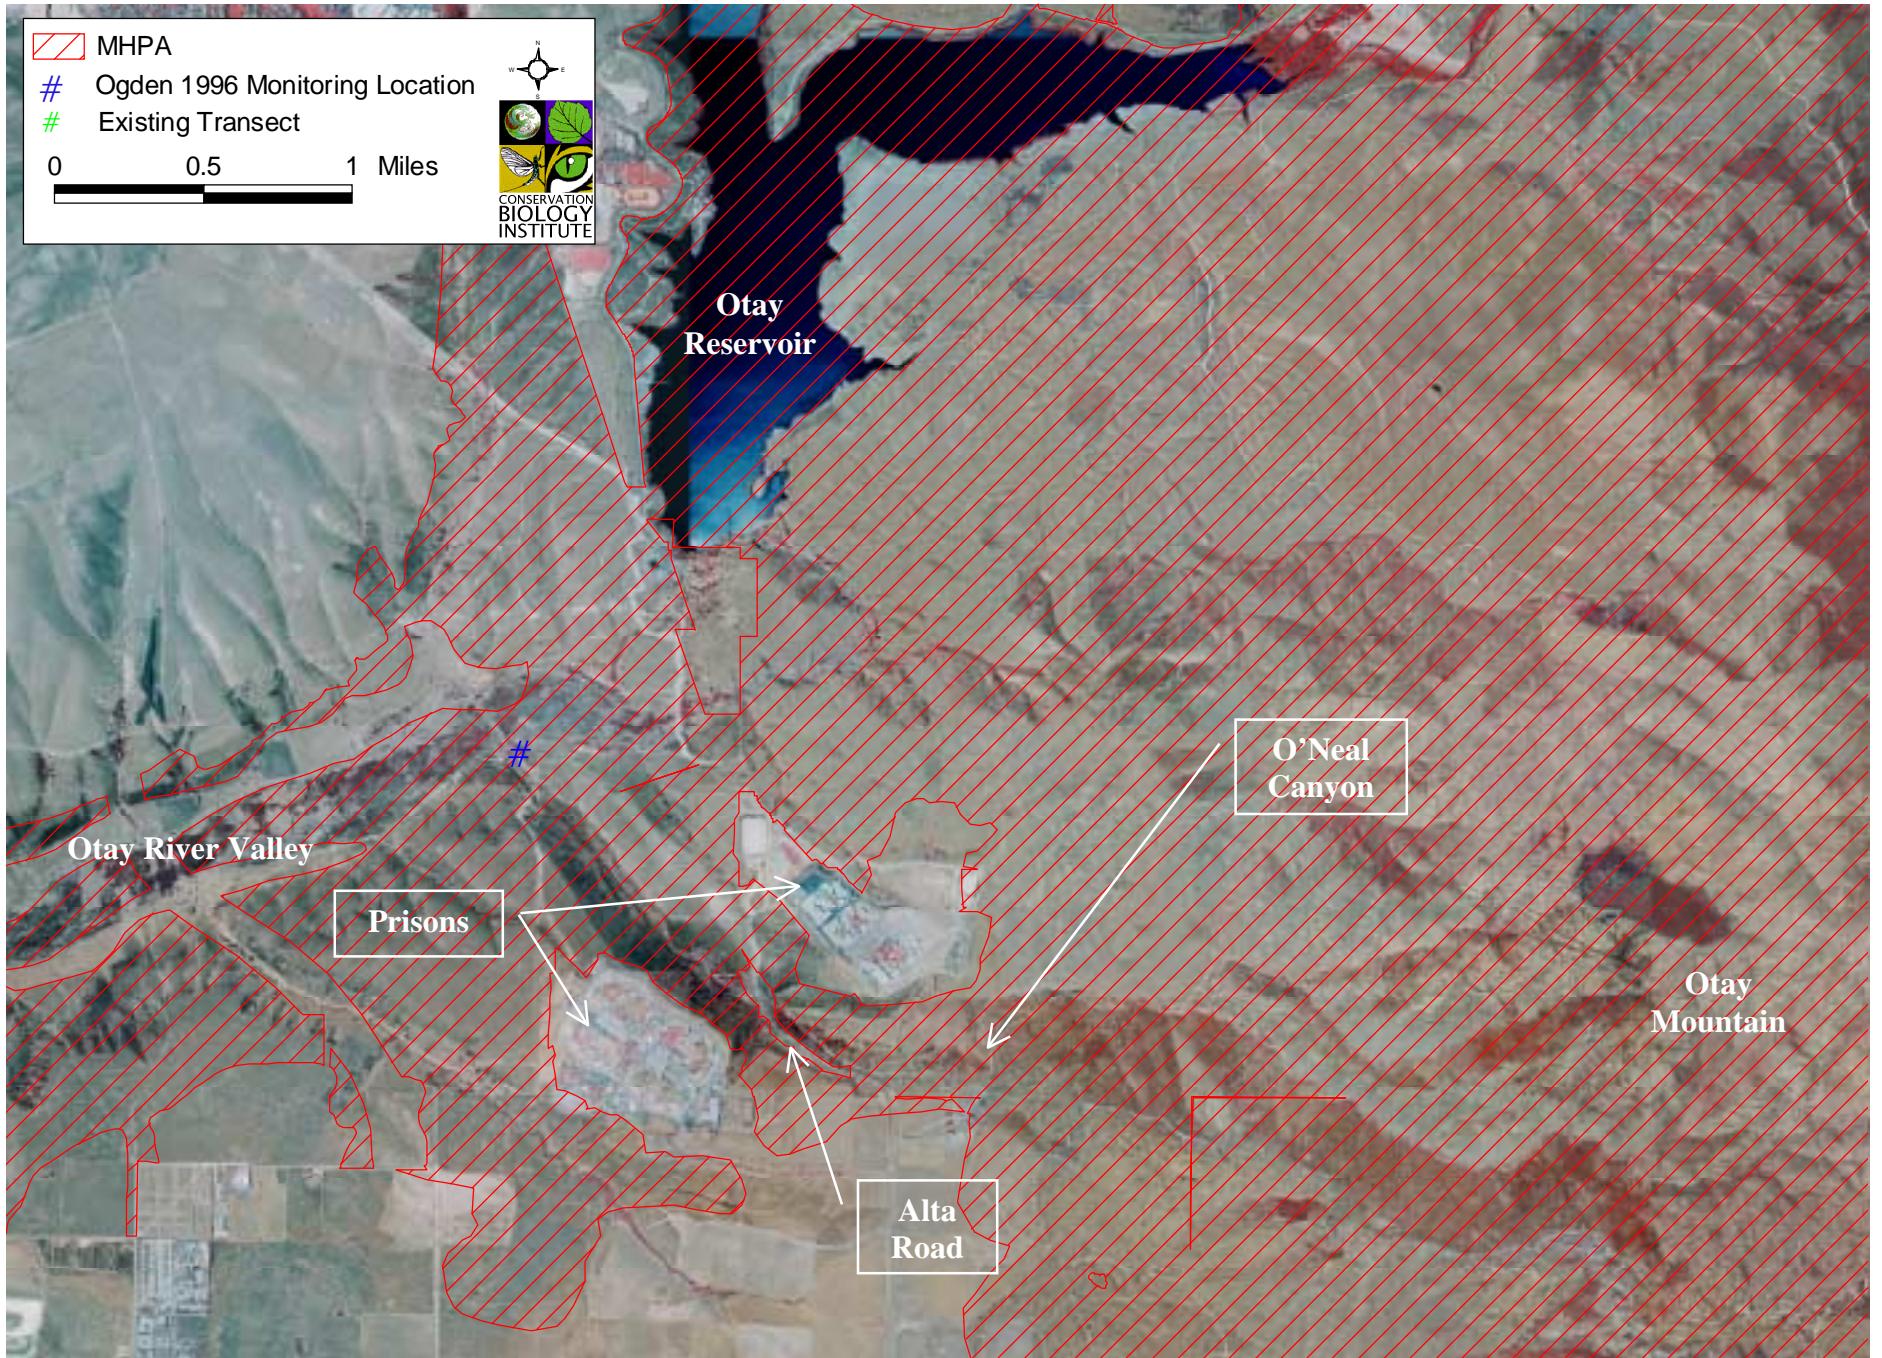
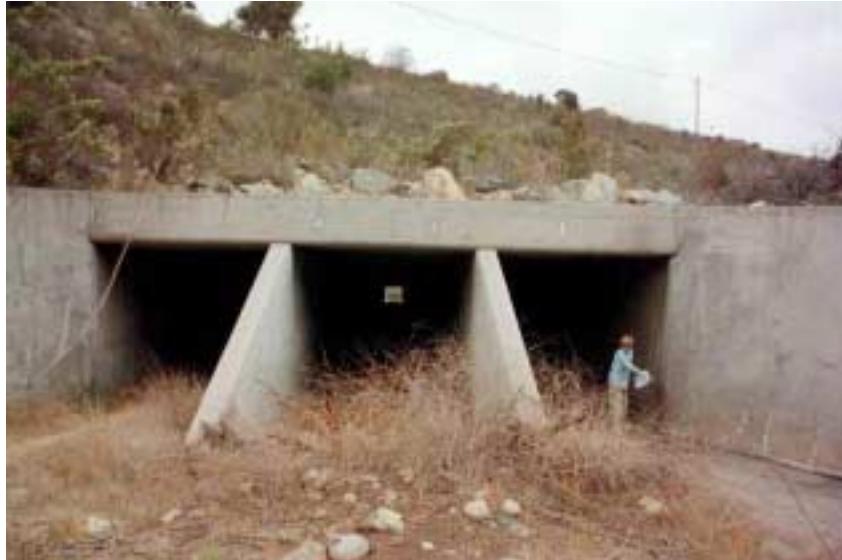
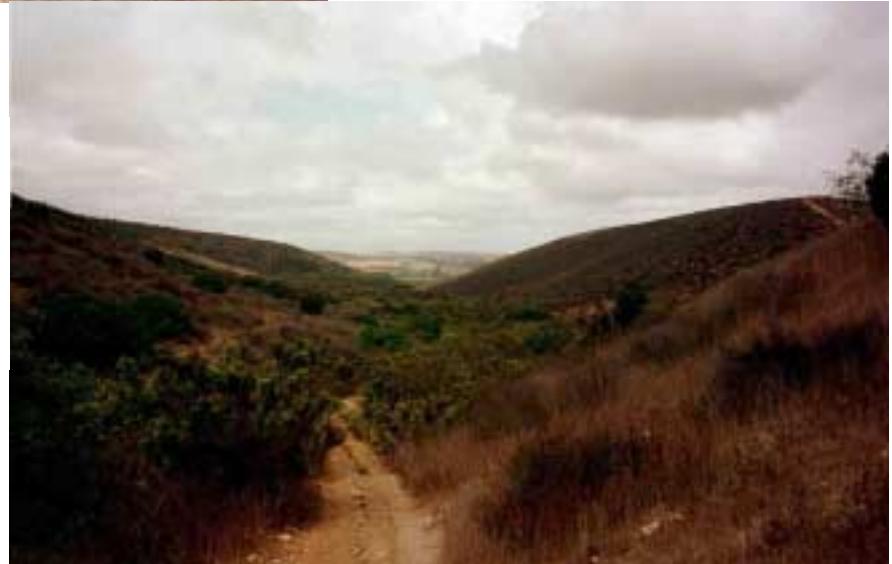
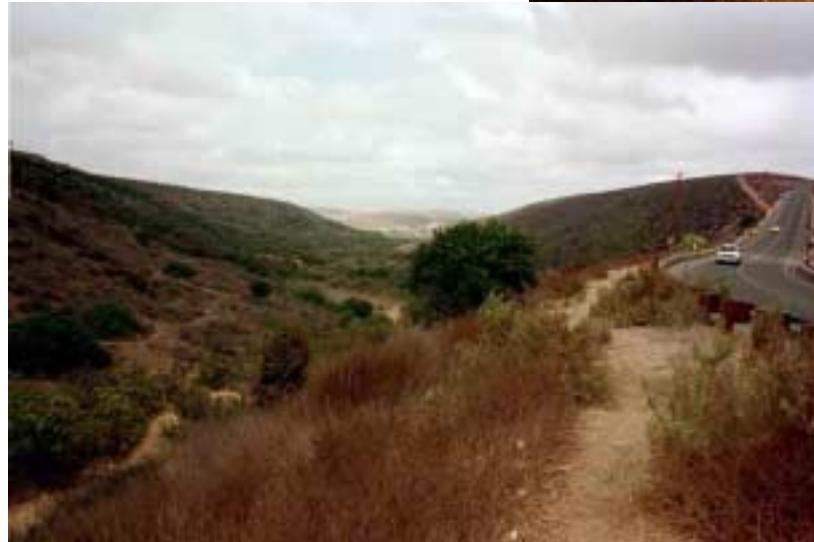
Figure L-24. O'Neal Canyon at Alta Road.

O'Neal Canyon culverts under Alta Rd looking northwest (downstream).

O'Neal Canyon west of Alta Rd looking northwest (downstream) towards Otay River Valley.

O'Neal Canyon looking northwest towards Otay River Valley. Alta Rd in the right side of photo.

Alternative Location. CBI recommends that transects be established in O'Neal Canyon (see L-24).
