REVIEW OF REGIONAL HABITAT LINKAGE MONITORING LOCATIONS

Multiple Species Conservation Program

January 2003

California Department of Fish and Game

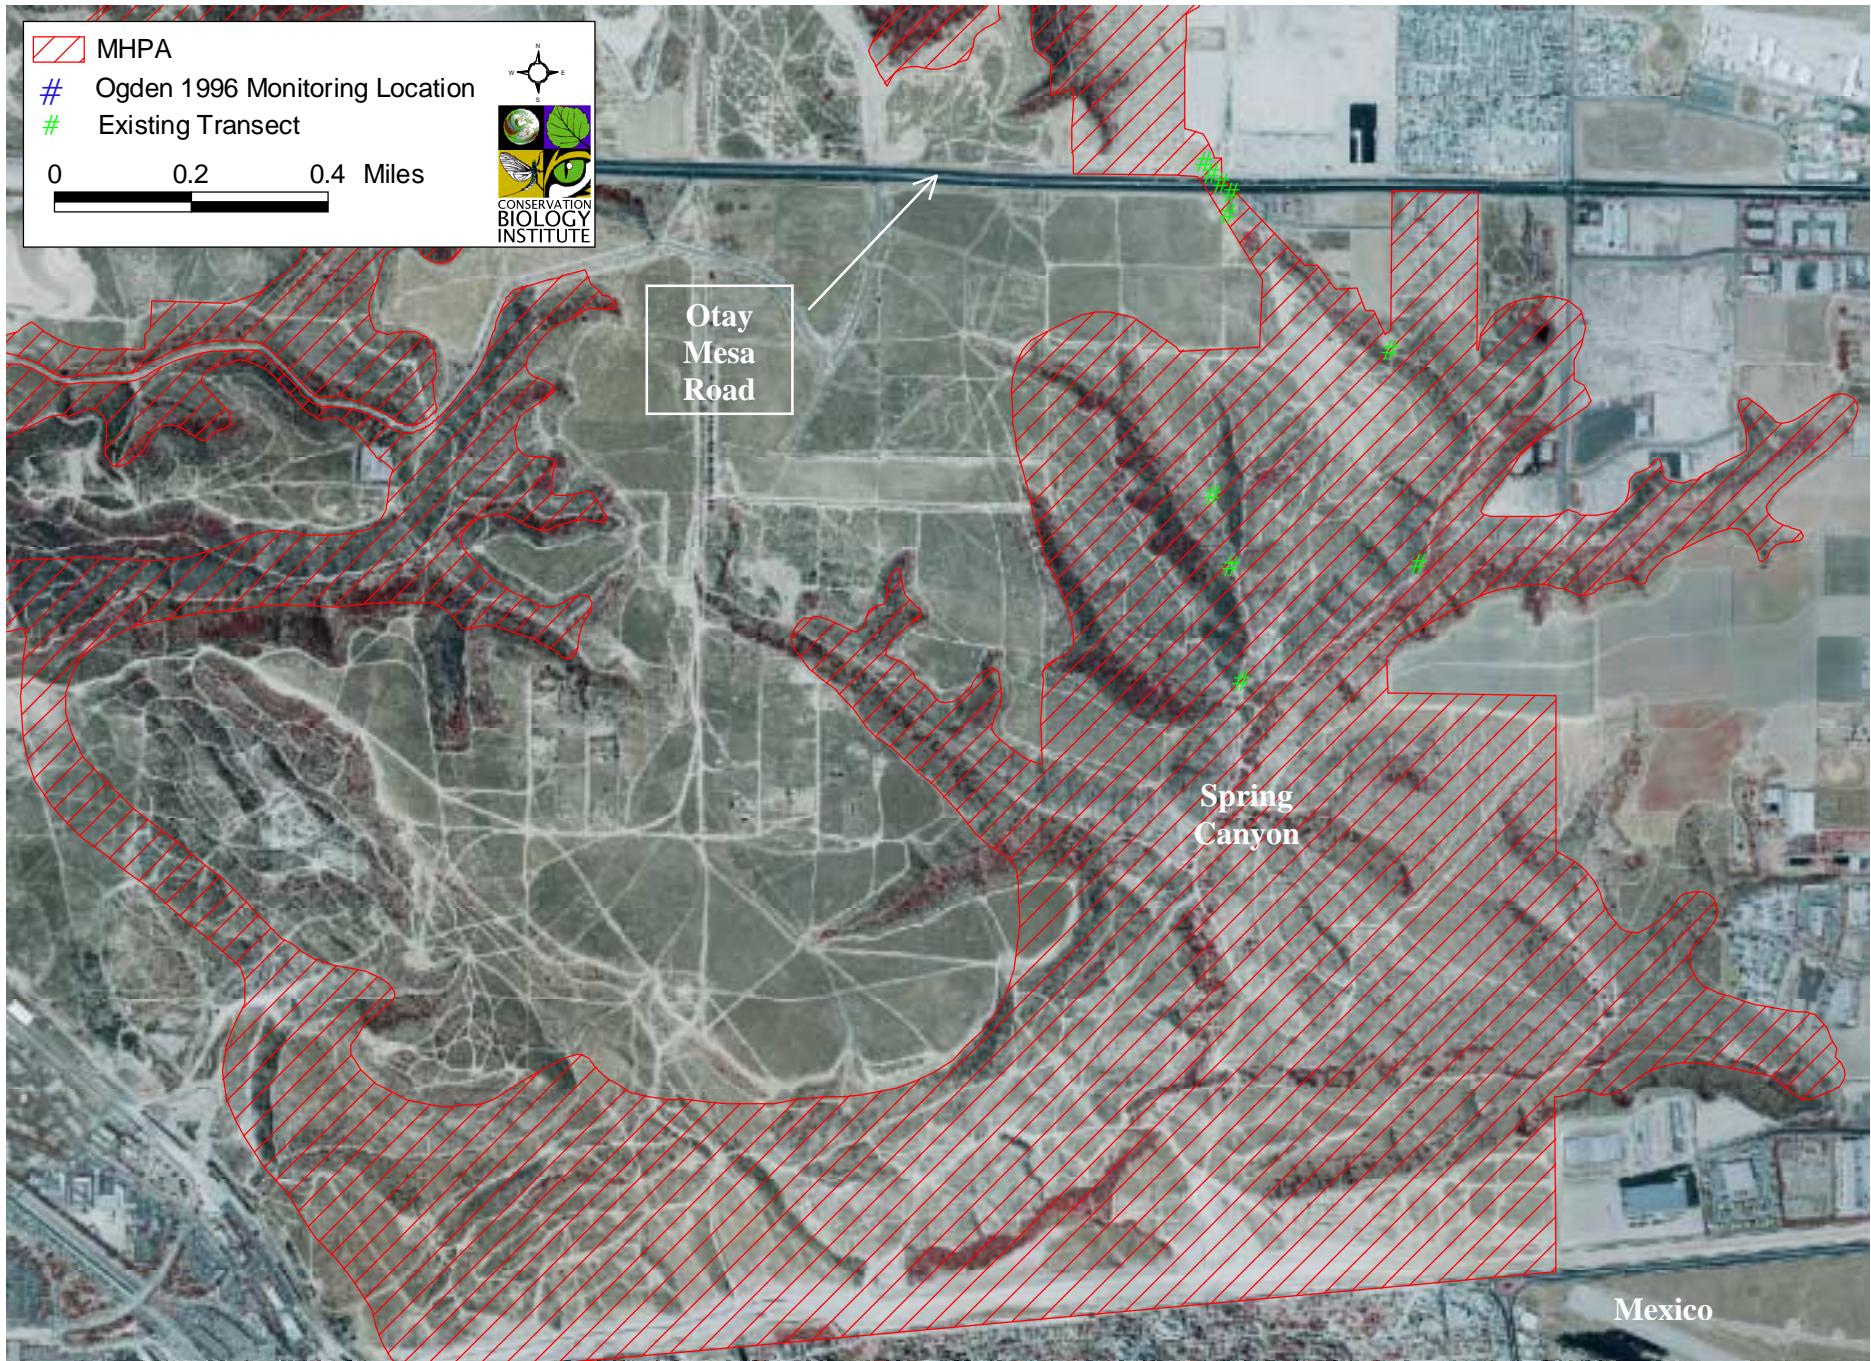
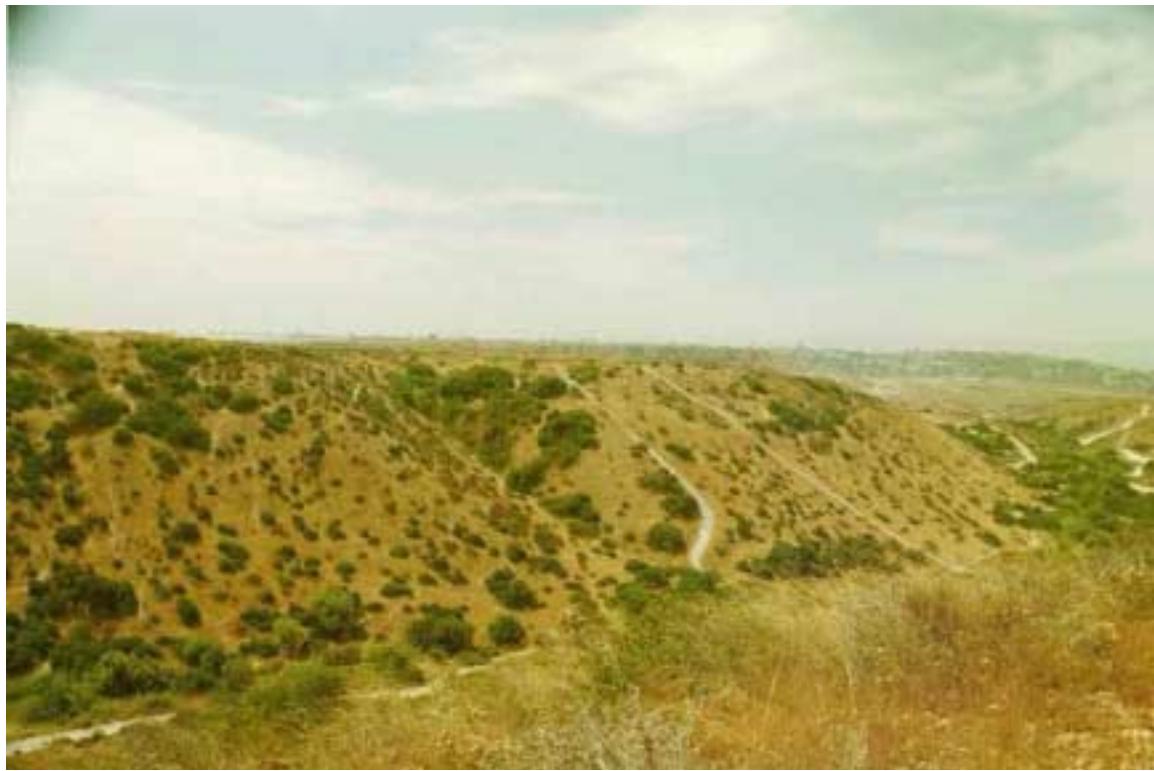
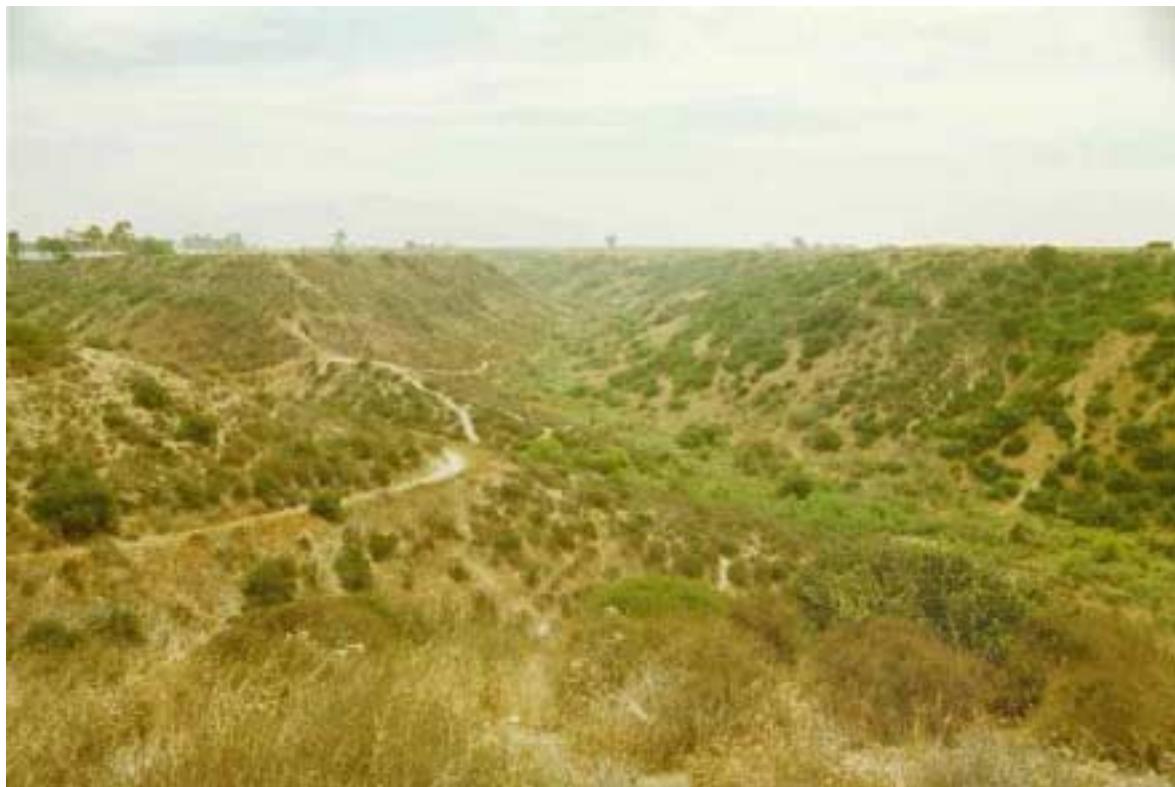
Figure L-25. Spring Canyon.

are maintained by the U.S. Border Patrol. Although much of Spring Canyon is proposed for conservation under the MSCP, only a small portion is currently conserved and available for monitoring. CBI and the SDTT established a transect on City-owned lands in Spring Canyon, and the SDTT monitored this transect quarterly through 2002. We do not recommend this location as a regional corridor monitoring location, but the area should be monitored as part of habitat management efforts in Spring Canyon to determine use by wildlife.

Finger canyon of Spring Canyon system looking south.

Finger canyon of Spring Canyon system looking east.

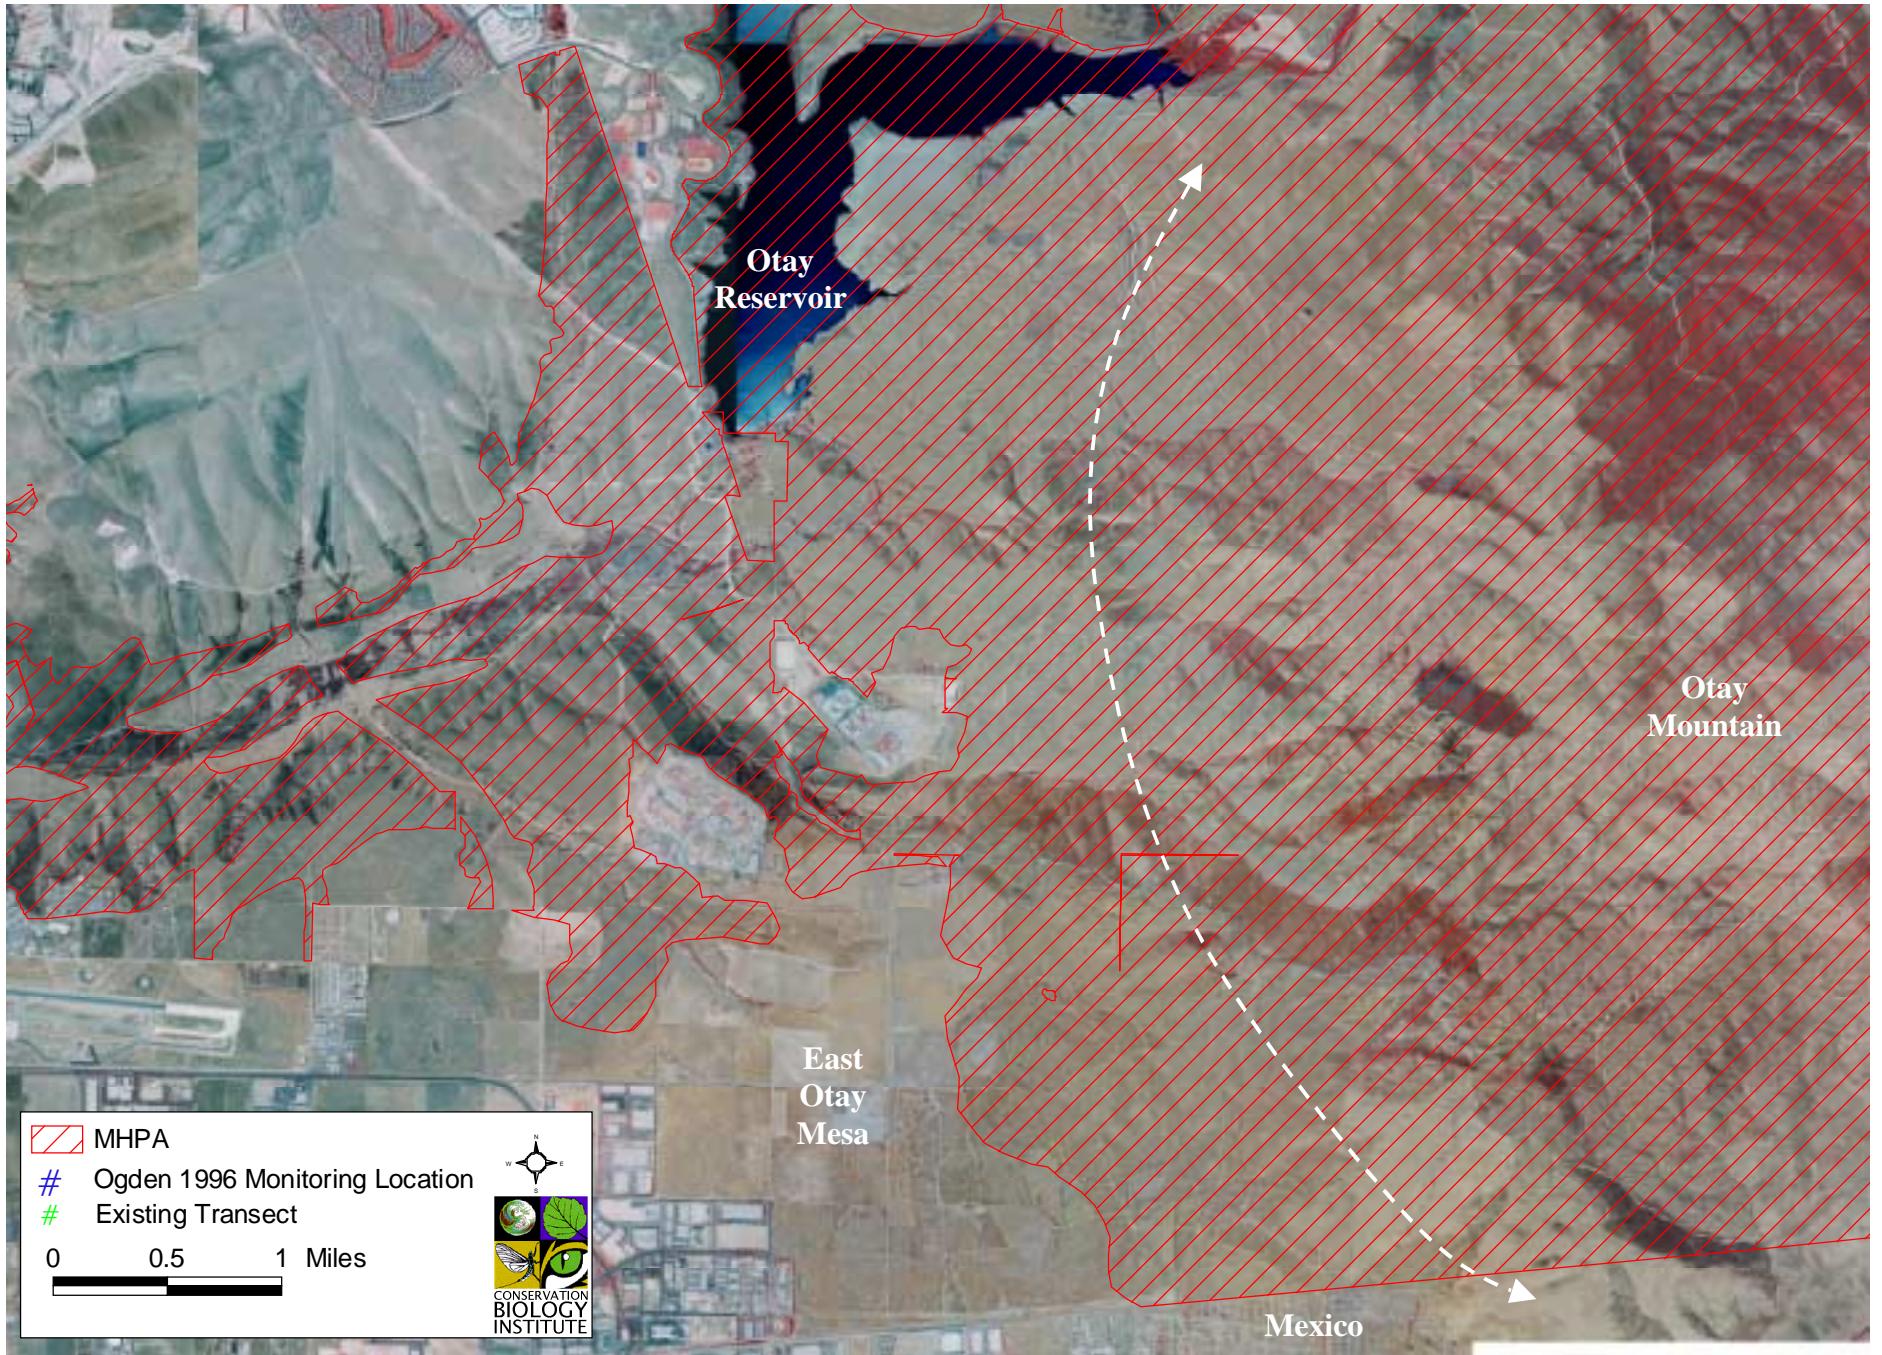
Figure L-27. East Otay Mesa.

The coastal sage scrub on the western slopes of Otay Mountain is the westernmost of two remaining coastal sage scrub linkages between the U.S. and Mexico (Figure L-27) and is being studied as part of the South Coast Wildlands Missing Linkages project. The other sage scrub linkage to Mexico is through Marron Valley. The East Otay Mesa linkage is currently part of a Major Amendment Area and is extremely tenuous because of development encroaching from Tijuana and Otay Mesa and proposed construction of the new border road and fence. CBI did not have field access to this area. Although this is a critical, binational linkage for coastal sage scrub species, we do not recommend this area for regional habitat linkage monitoring for large mammals.

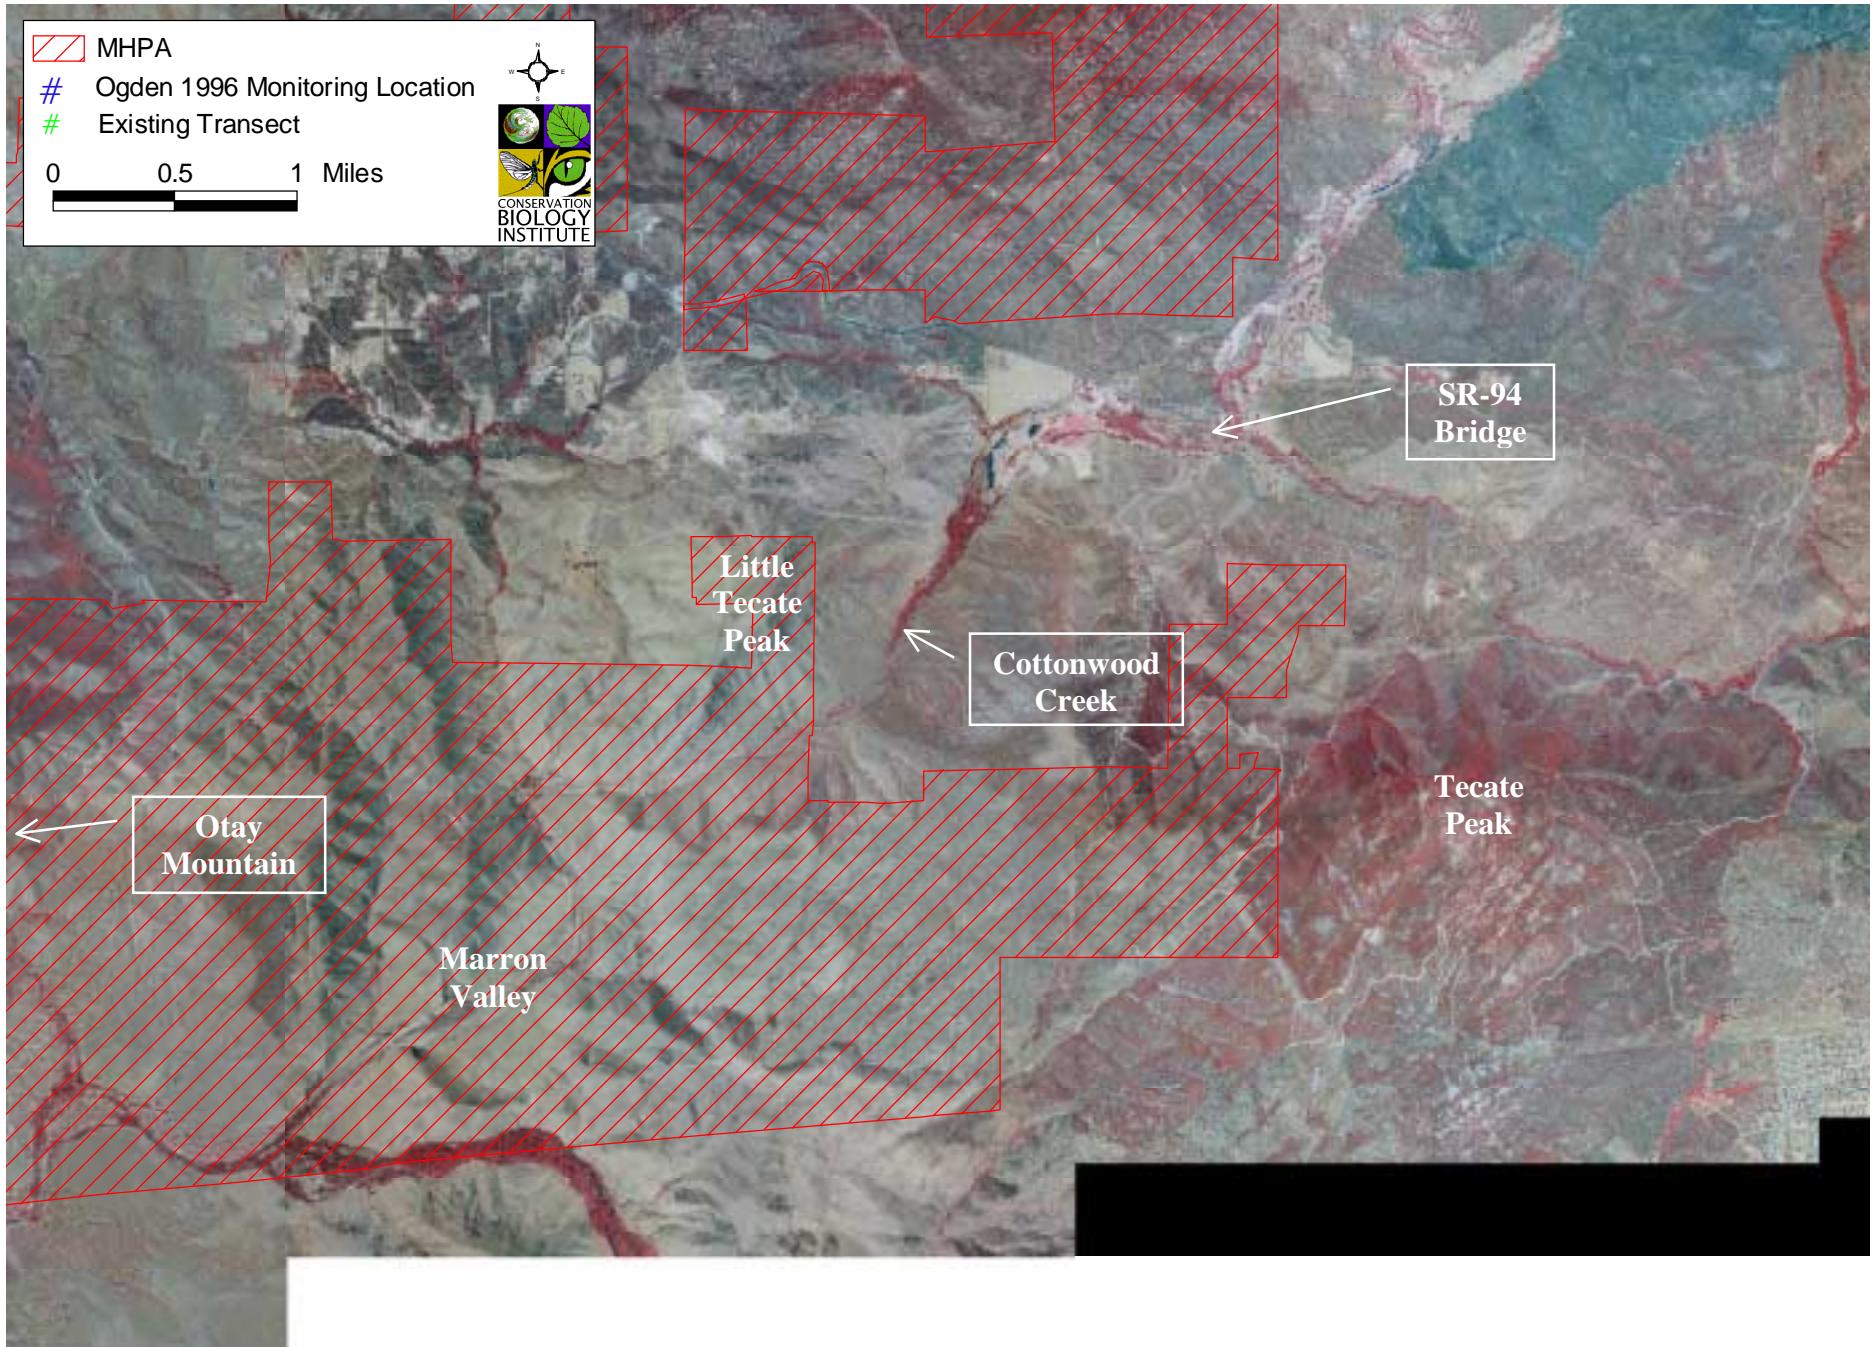
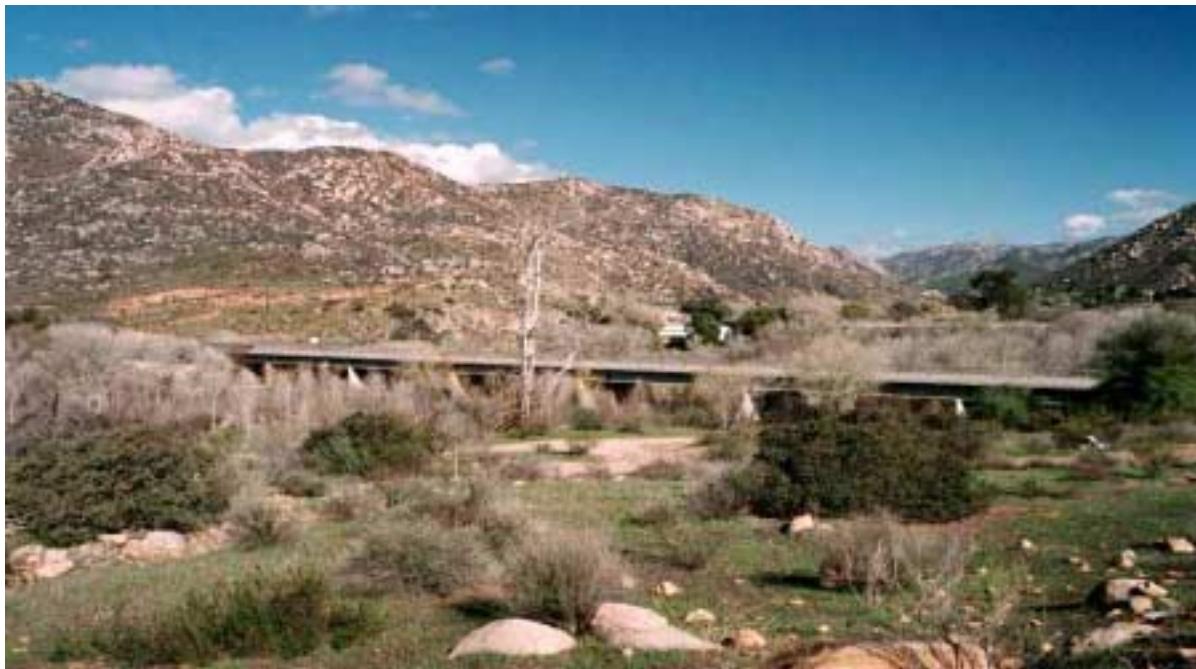
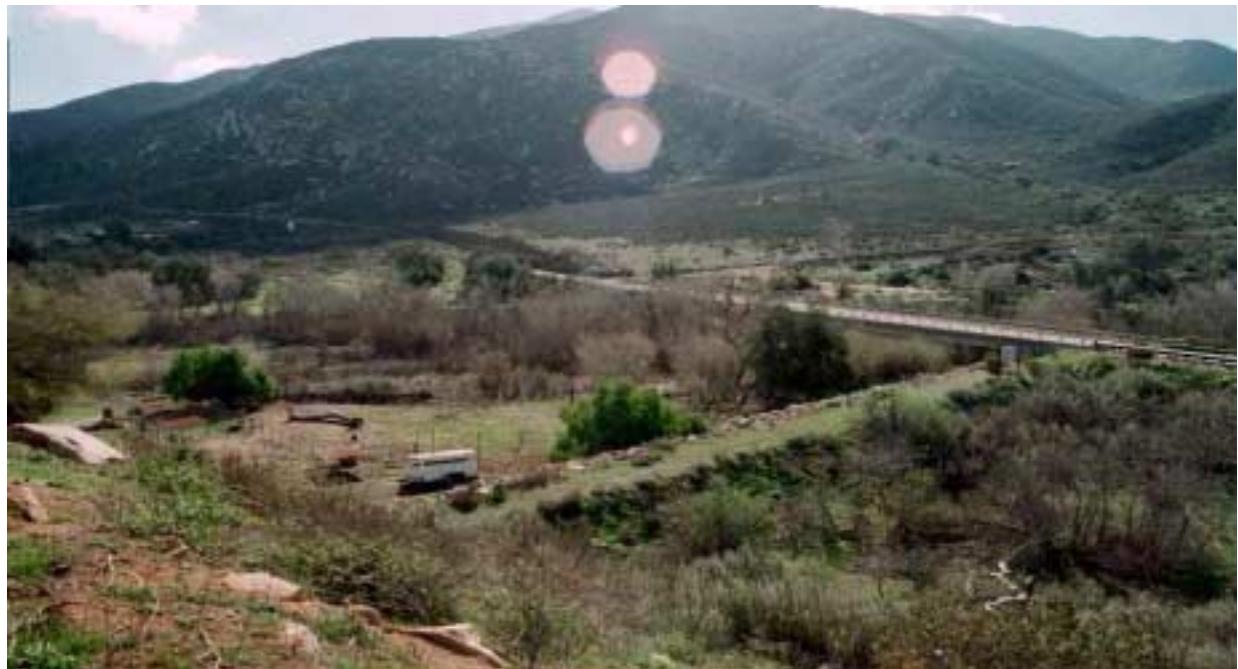
Figure L-28. San Ysidro Mountains East (same as L-29 Marron Valley).

The specific corridor intended for monitoring is not clear from the original MSCP Biological Monitoring Plan (Ogden 1996). Based on the name, we believe it is intended to monitor movement from the San Ysidro Mountains (e.g., Otay Mountain, Little Tecate Peak, Tecate Peak) east to conserved lands outside of the MSCP. Habitat along Cottonwood Creek appears to provide a significant regional linkage from Marron Valley to Barrett Lake and the surrounding National Forest lands. This corridor is being studied as part of the South Coast Wildlands Missing Linkages project. The SR-94 bridge over Cottonwood Creek, near Barrett Junction (Figure L-28), represents a chokepoint in this linkage. CBI recommends monitoring at this bridge for wildlife movement along the creek.

SR-94 bridge over Cottonwood Creek looking north from south and west side of bridge.

SR-94 bridge over Cottonwood Creek looking south from north and east side of bridge.

Marron Valley is part of core habitat associated with the San Ysidro Mountains. This linkage is the same as L-28 (Figure L-28), and we do not recommend Marron Valley as a linkage monitoring location. However, the area should be monitored as part of habitat management efforts in Marron Valley to determine use by wildlife.

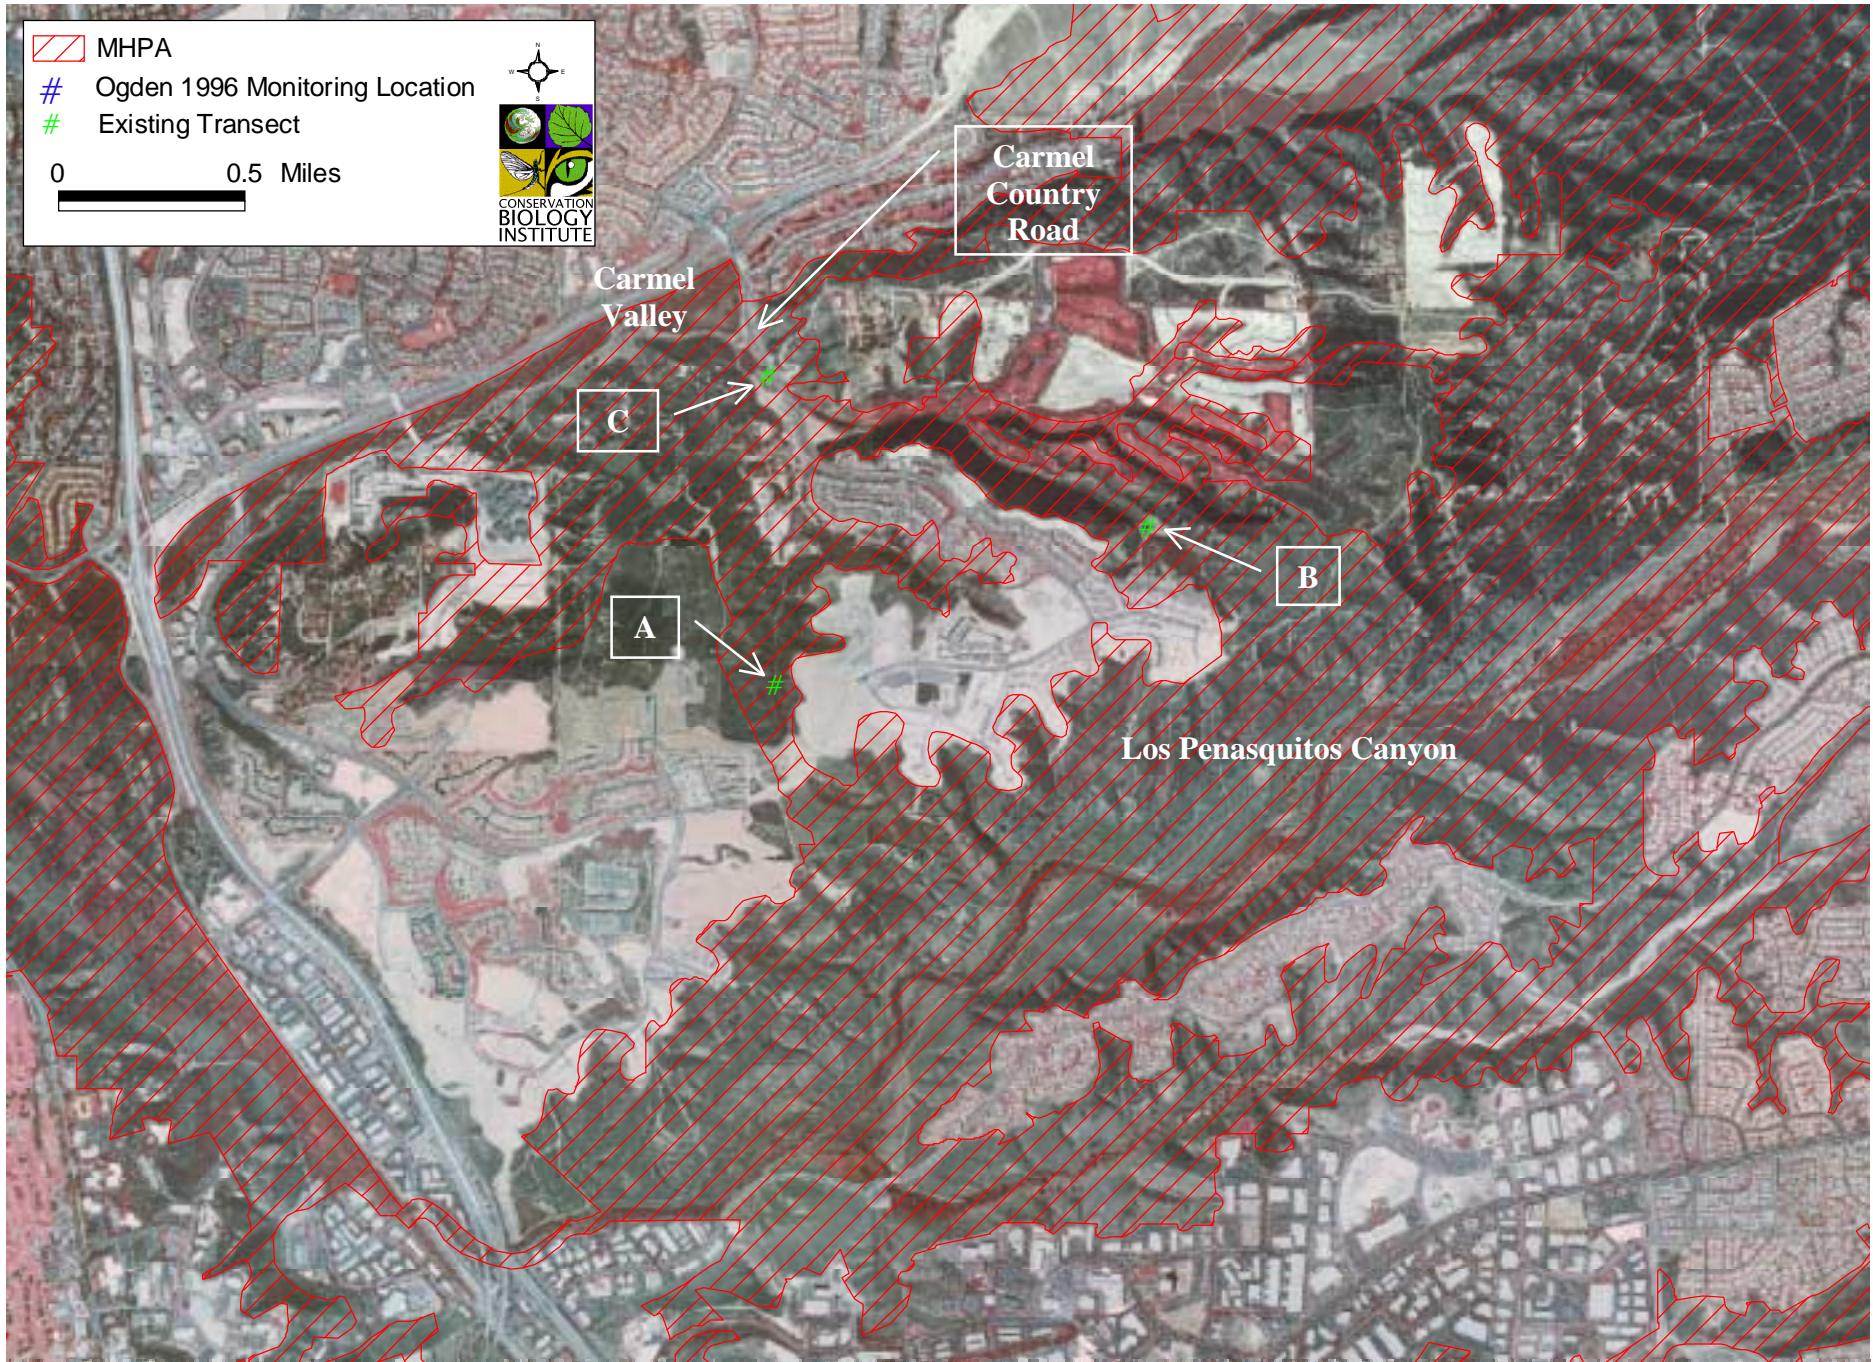
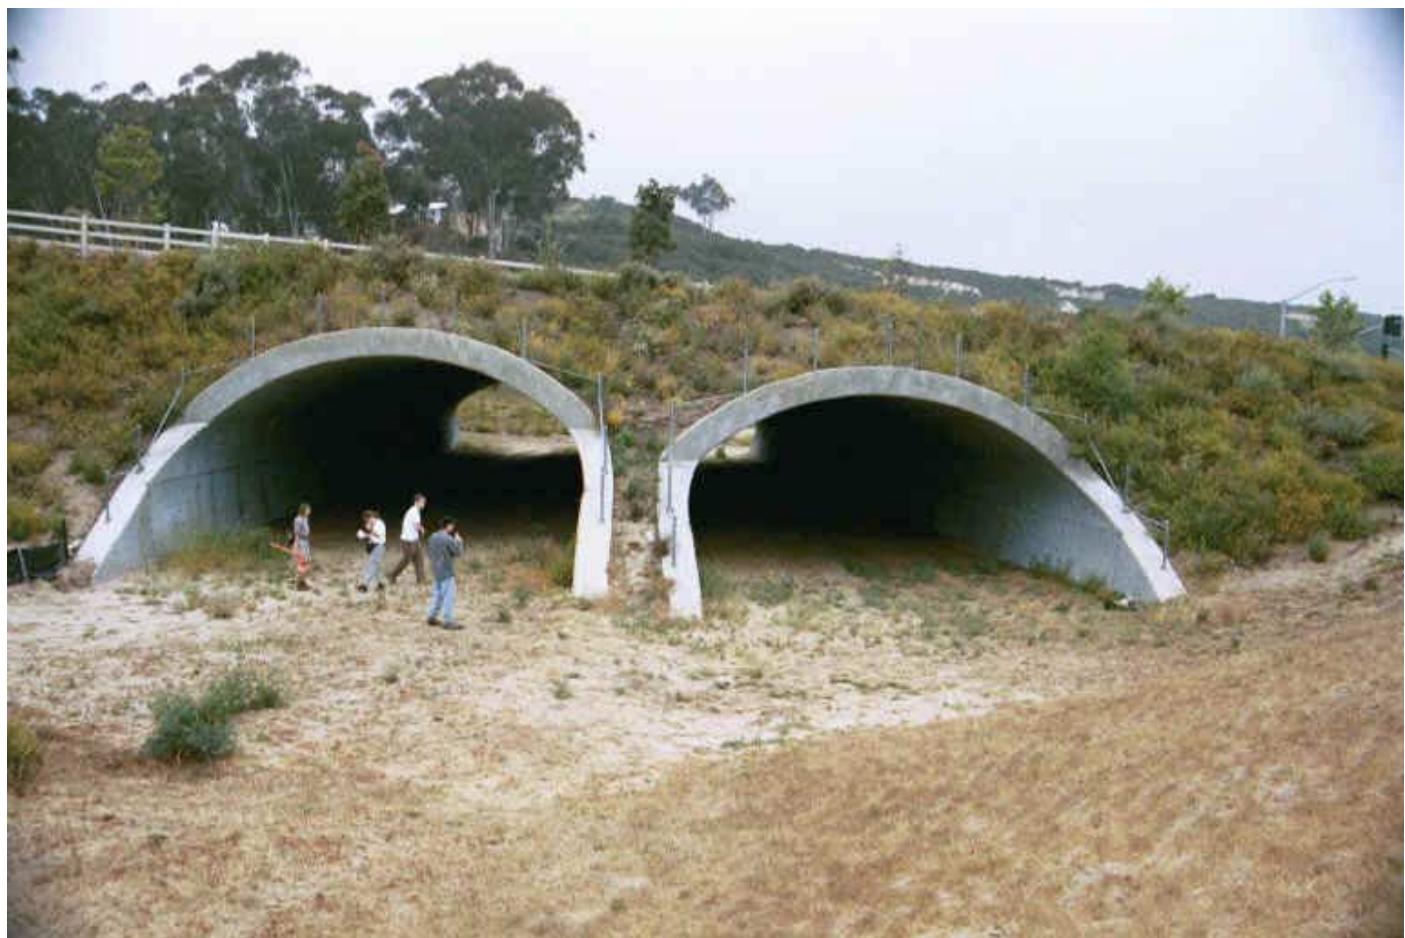
Figure L-30. Del Mar Mesa. **A** – Little Shaw Valley, **B** – Big Shaw Valley, and **C** – lower Shaw Valley (culverts under Carmel Country Road).

Culverts under Carmel Country Rd in lower Shaw Valley looking west.
