**South San Diego Bay
Coastal Wetland Restoration
and Enhancement Project**

Year 2 Postconstruction Monitoring Report

May 2014

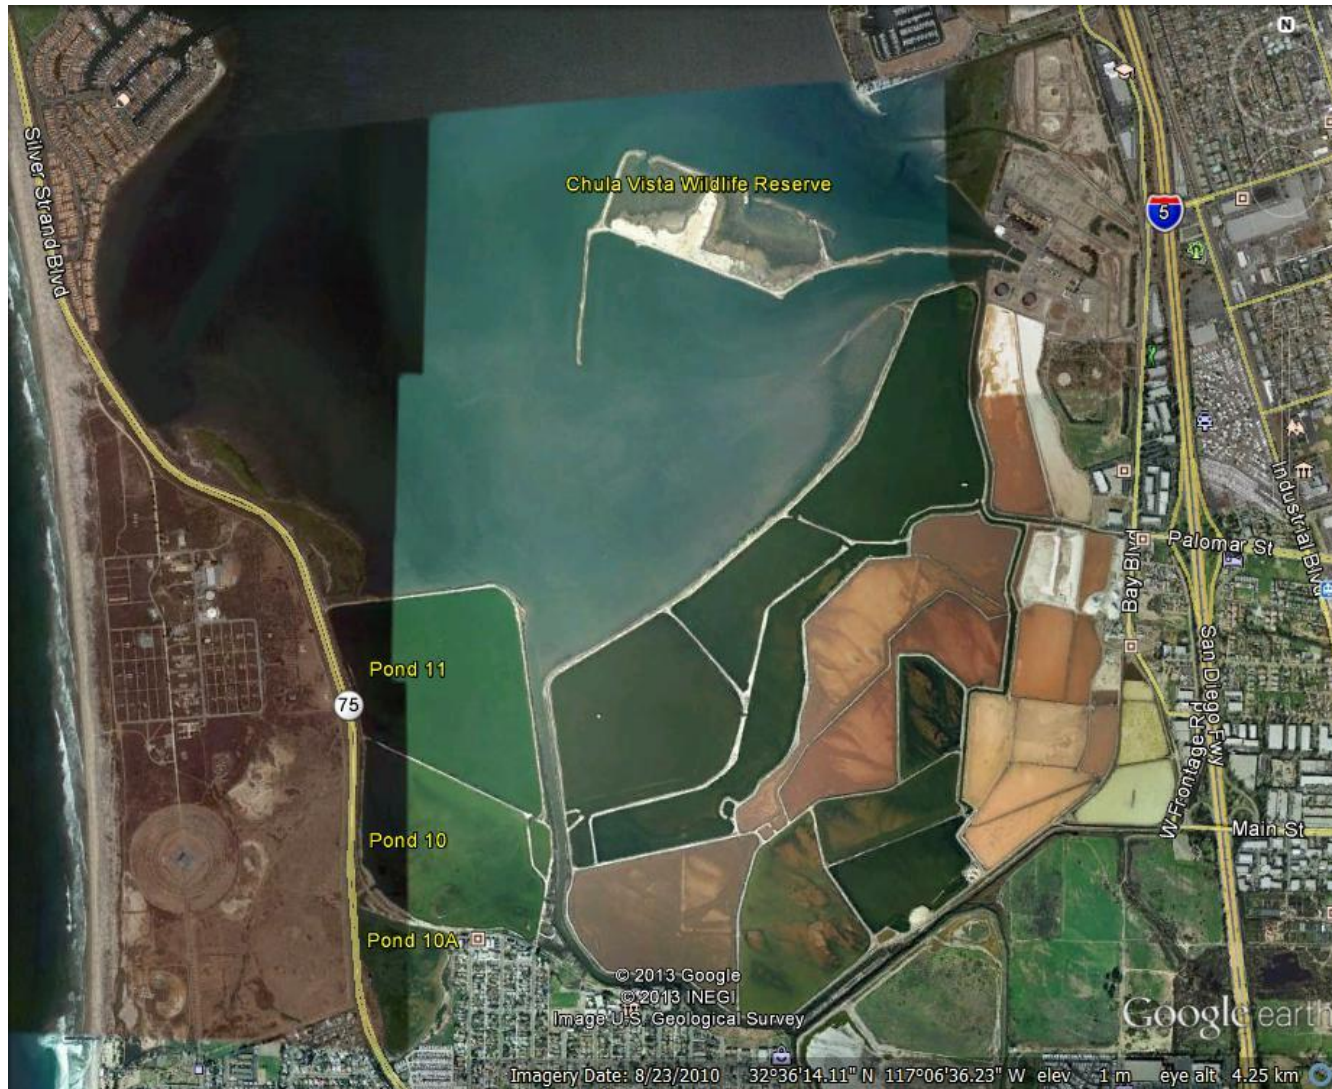
Figure 1. South San Diego Bay Coastal Wetland Restoration and Enhancement Project Locations

The U.S. Fish and Wildlife Service (USFWS) San Diego National Wildlife Refuge (NWR) Complex and the Port of San Diego (Port) completed construction of the South San Diego Bay Coastal Wetland Restoration and Enhancement Project (“Project”) in December 2011. Funding support was provided by the California Coastal Conservancy (Conservancy) and National Oceanic and Atmospheric Administration (NOAA)/National Marine Fisheries Service (NMFS) through the American Recovery and Reinvestment Act of 2009; the USFWS Wildlife and Sport Fish Restoration Program and Coastal Program and National Coastal Wetland Conservation (NCWC) Program; and the U.S. Environmental Protection Agency (EPA). The Project included the restoration and enhancement of approximately 261 acres of coastal wetland habitat within the south end of San Diego Bay, San Diego County, California. The project consisted of restoration activities at two locations: 1) restoration of 230 acres (including 12 acres of upland) of solar salt evaporation ponds 10, 10A and 11 (western salt ponds) located at the southwestern edge of San Diego Bay within the South San Diego Bay Unit of the San Diego Bay NWR; and 2) the 43-acre Chula Vista Wildlife Reserve (CVWR) located to the west of the South Bay Power Plant (Figure 1).

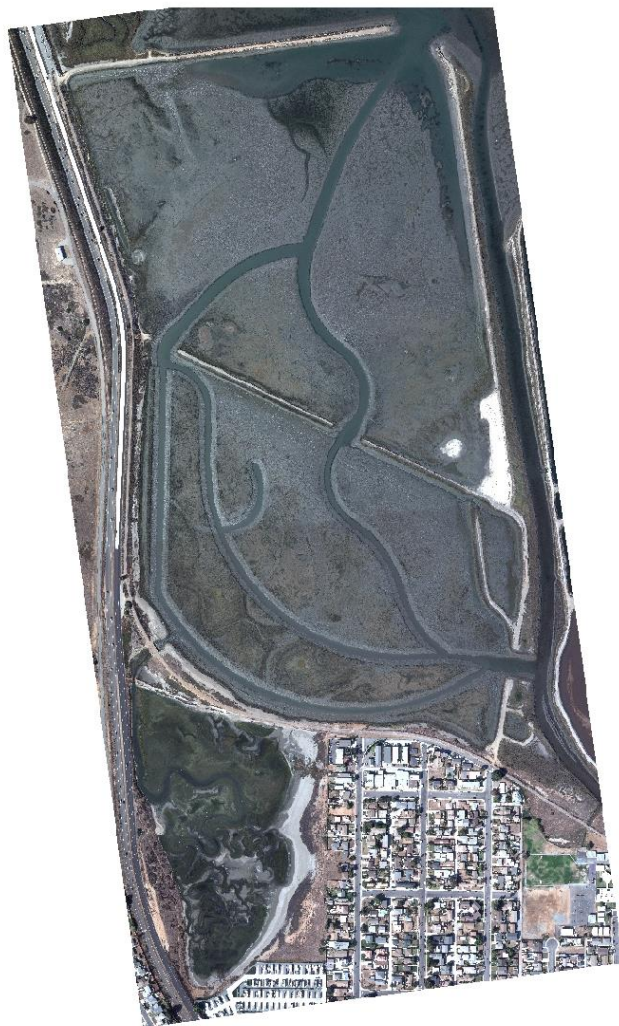
Figure 3. Orthophotograph and Elevation Contours of the Western Salt Ponds – 2013.

October 2013 Orthophoto
Derived from R,G,B and NIR digital imagery
taken on October 04, 2013

October 2013 Elevation Contours
Digital elevation contours created using photogrammetry from R,G,B
and NIR digital photos taken on October 04, 2013

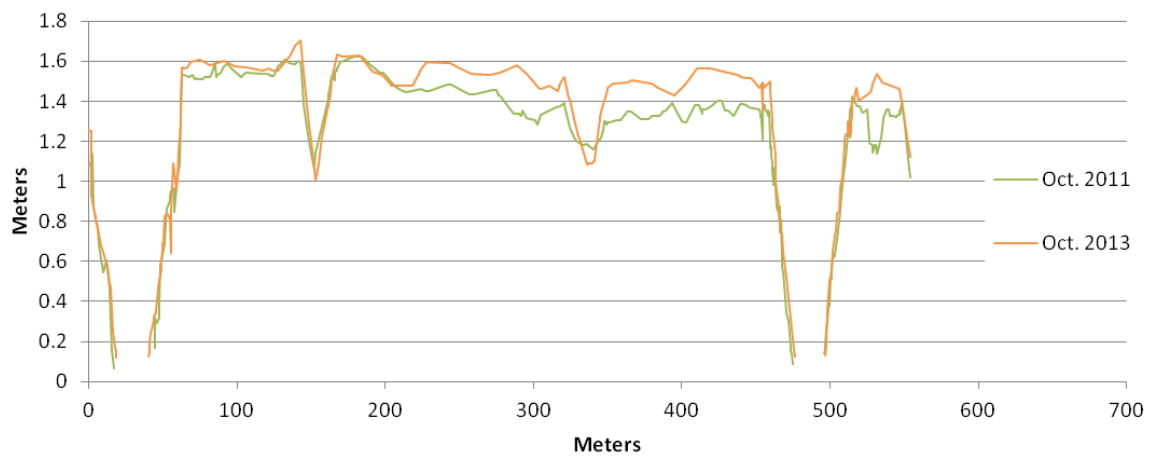
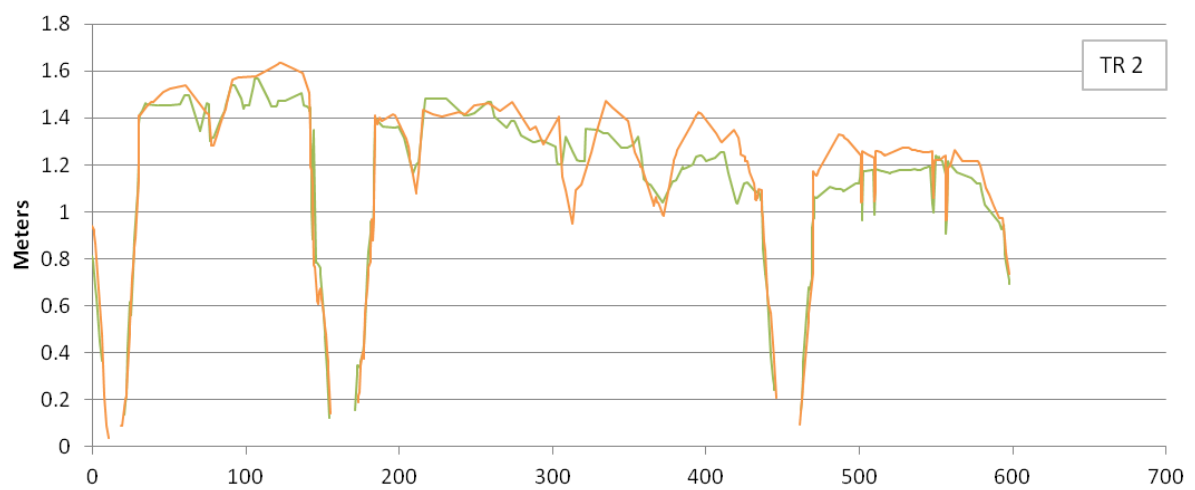
Figure 5. Elevations Along Transects in Pond 10. (X Axes Represent Length in Meters of the Transect From West to East).

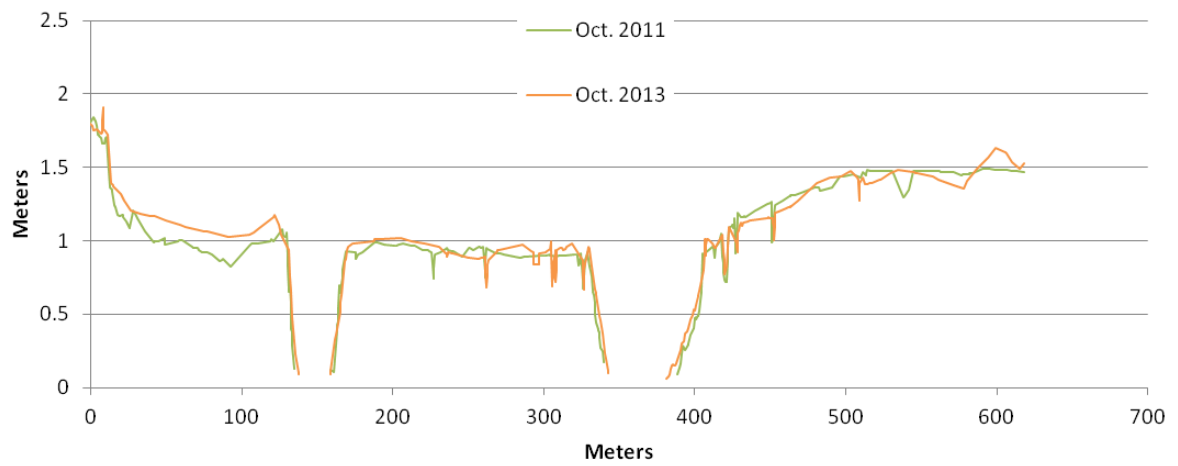
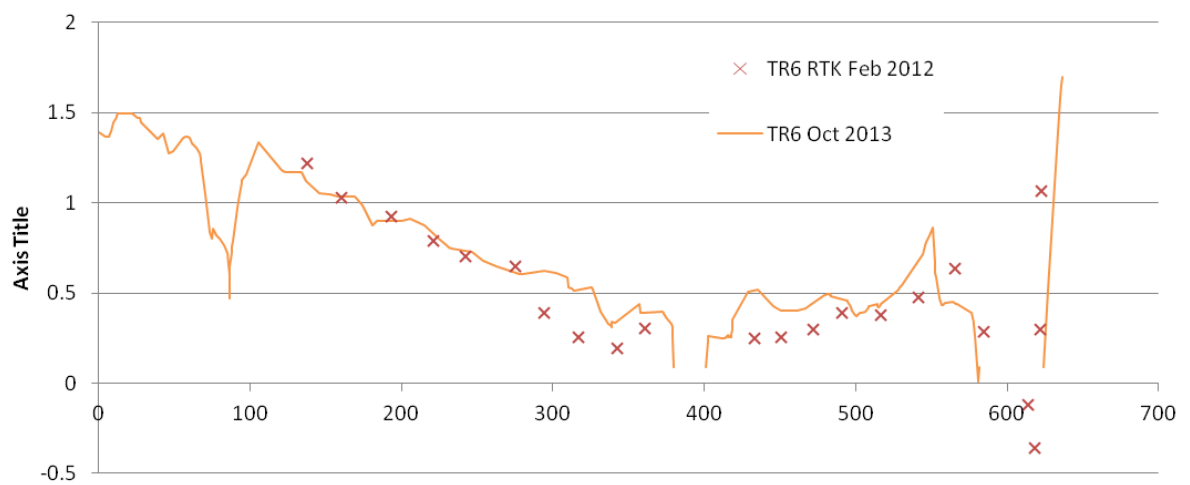
Figure 6. Elevations Along Transects in Pond 11. (X Axes Represent Length in Meters of the Transect From West to East).

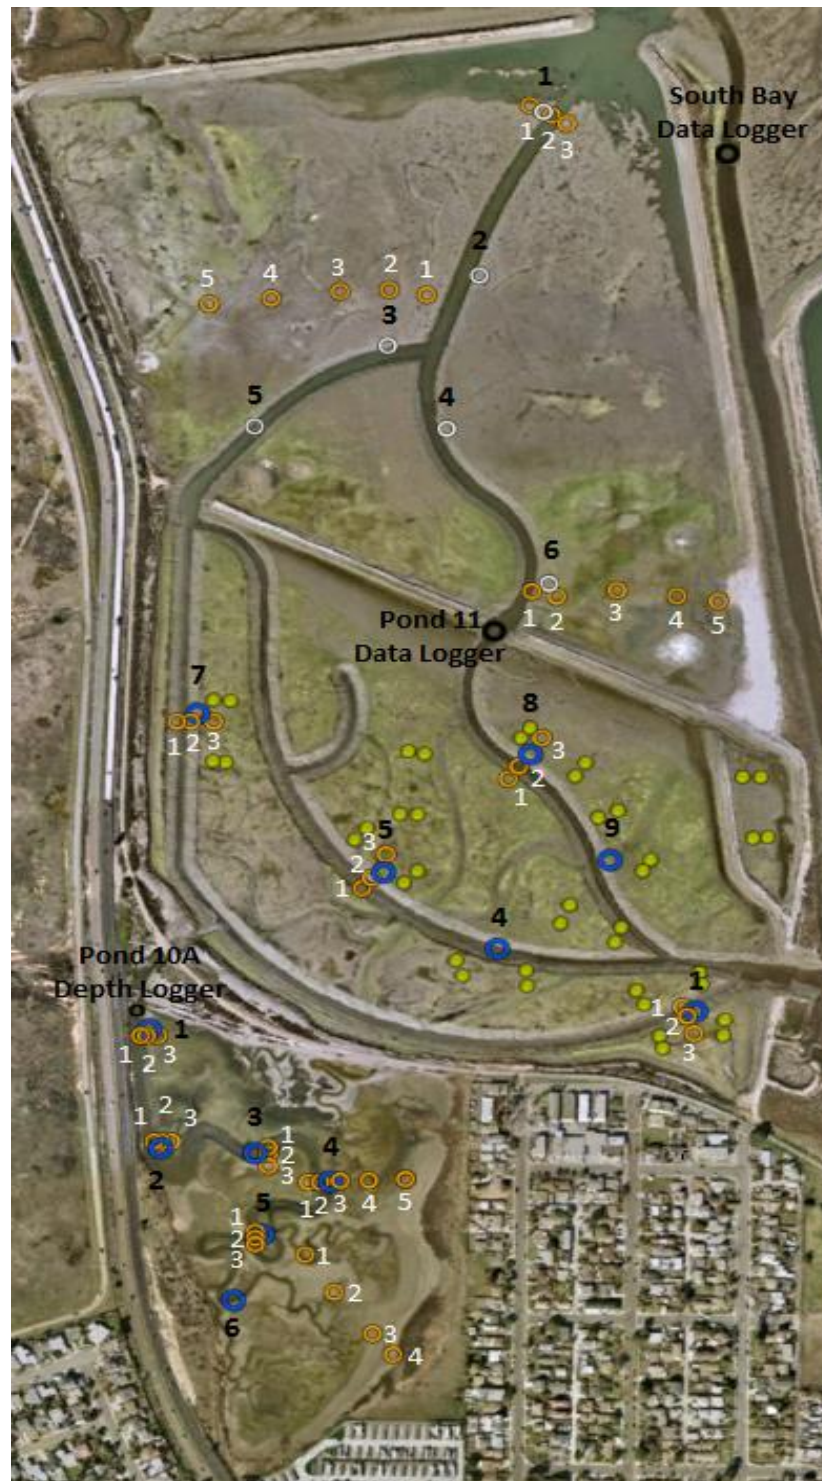
Figure 7. Monitoring Stations - Western Salt Ponds. Locations of water quality data-loggers are shown in black. Green dots = corners of experimental vegetation plots. Blue circles = enclosure traps and invertebrates. White circles = invertebrates only, both channel-bottom and tidal flat. Brown circles = sediment.

Soils of Ponds 10A, 10, and 11 were collected at the stations shown in Figure 7 on September 16 through September 18, 2013. Soil sampling locations were designed to correlate with monitoring of the experimental planting blocks in Pond 10 and fish enclosure traps/invertebrate sampling stations. Soils were collected using a 6 cm long PVC pipe with an interior diameter of 4.8 cm and were analyzed in the laboratory for grain size, salinity, and organic matter content. Two samples were taken at each site and dried in an oven at 105°C. One sample was wet-sieved through 2-mm and 63-µm mesh screens to obtain weight percentages of silt/clay, sand, and pebbles/shell hash.

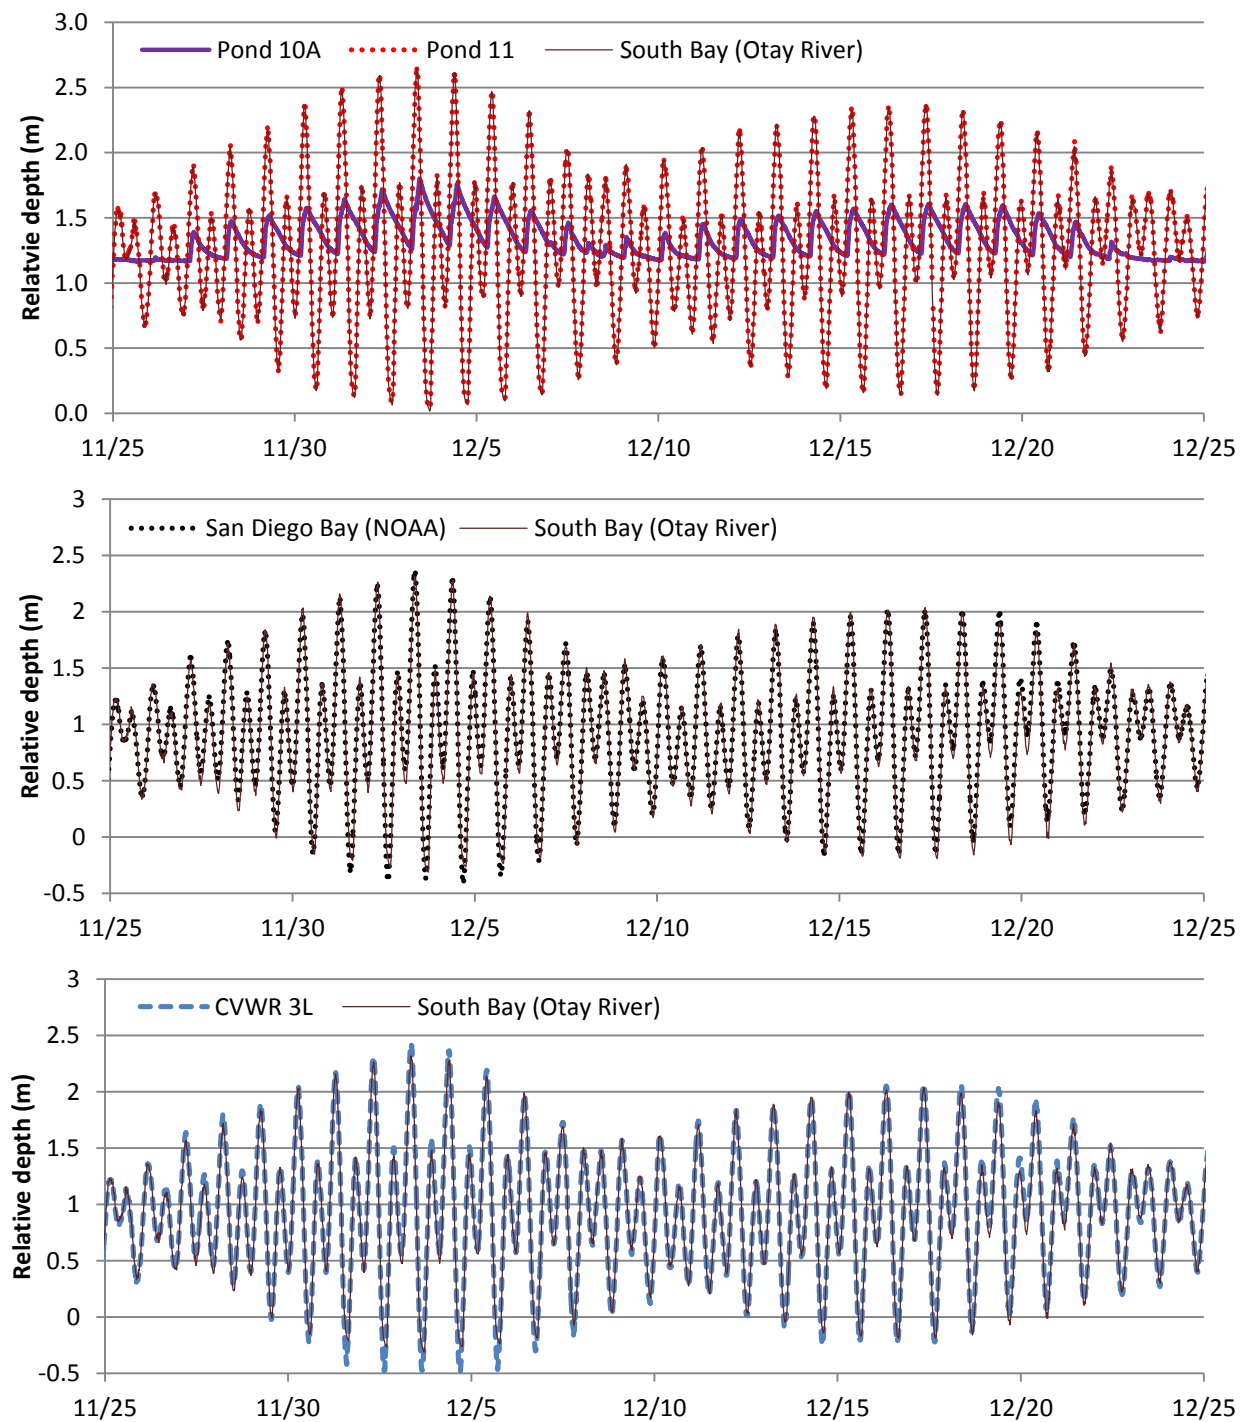
A comparison of the tidal amplitude in the breach between Pond 10 and Pond 11 with that at the mouth of the Otay River and at Pond 10A is presented in Figure 8. Also shown in Figure 8 are tidal comparisons of the Otay River mouth with the NOAA tide gauge at the Broadway Pier in mid-San Diego Bay and the Otay River mouth with CVWR site 3L. Comparisons included a typical 2-week spring tide series representing the higher tide scenario and a typical 2-week neap tide series representing the lower tidal cycle. During both the neap and spring tide series, tidal amplitude within the western salt ponds closely mirrors tides at both reference sites. Note that, because the loggers are not tied to any vertical datum, the values have been shifted manually along the y-axis so that comparisons can be made.

Figure 8. Tidal amplitudes: Pond 11 logger site compared to South Bay (Otay River) logger and Pond 10A depth logger sites (top), South Bay (Otay River) logger site compared to NOAA's mid-bay site (middle), and CVWR site 3L compared to South Bay (Otay River) logger site.

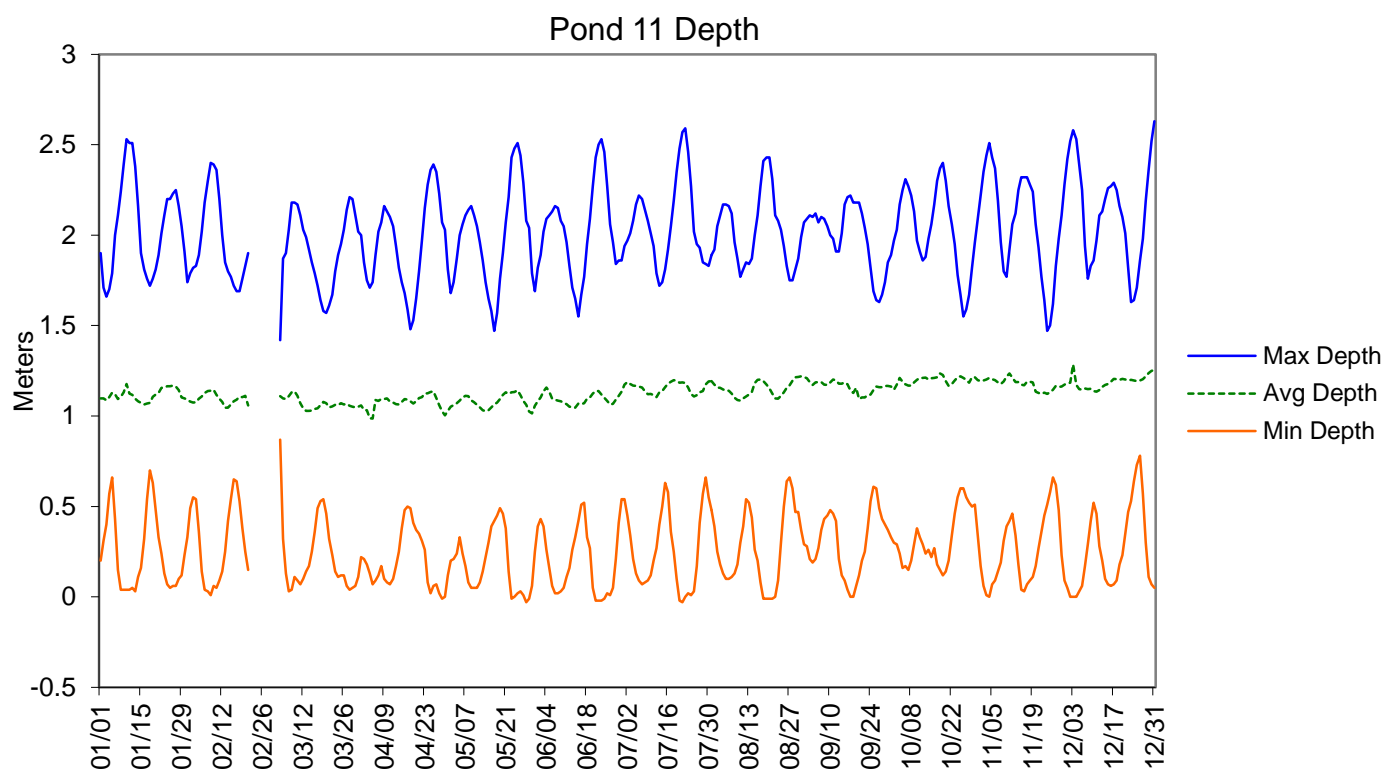
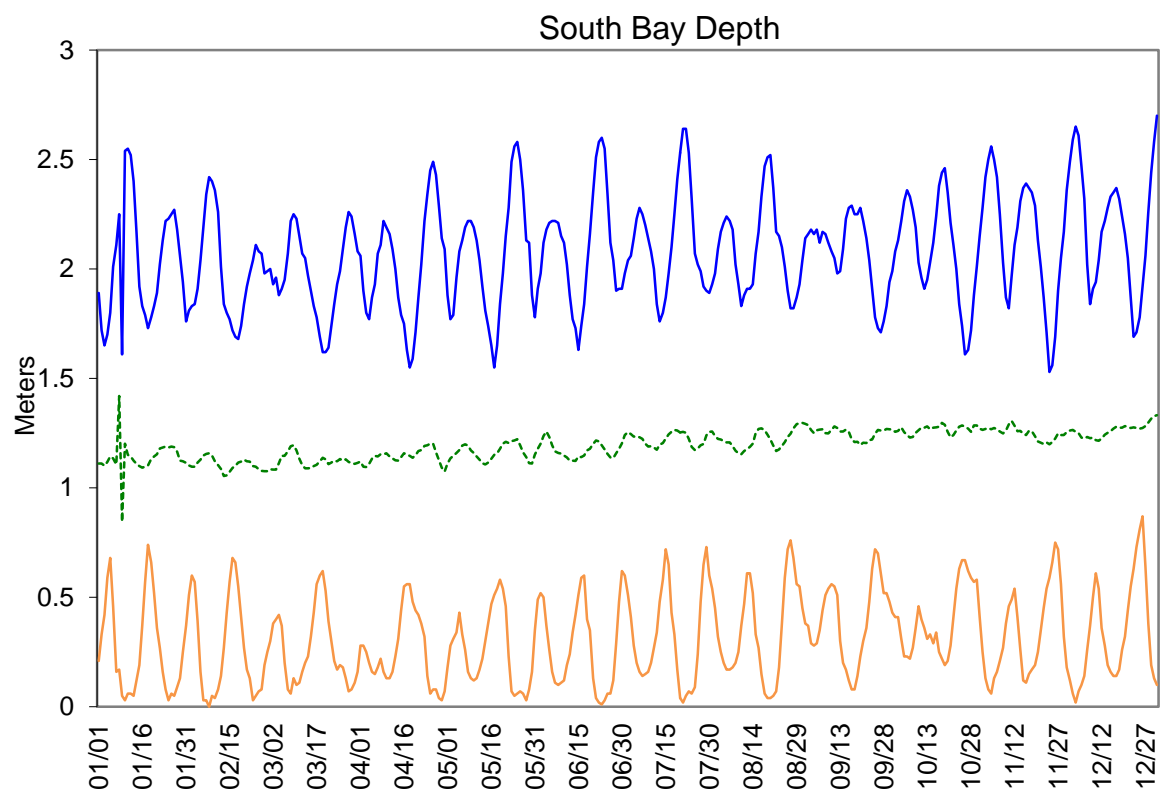
Water Quality monitoring results as measured by the datalogger in the eastern breach between Ponds 10 and 11 (Pond 11) and the Otay River Mouth (Otay River) during 2013 are presented in figures 11 through 19. Water depths were similar at both sites with similar maximum and minimum readings (Figure 11). Gaps in Otay River water quality data during February were the result of failure of the temperature/conductivity probe. This probe affects all other sensors and all data collected during that time period were rejected.

Figure 11. Water Depth in Pond 11 (above) and at the Otay River Mouth (below).

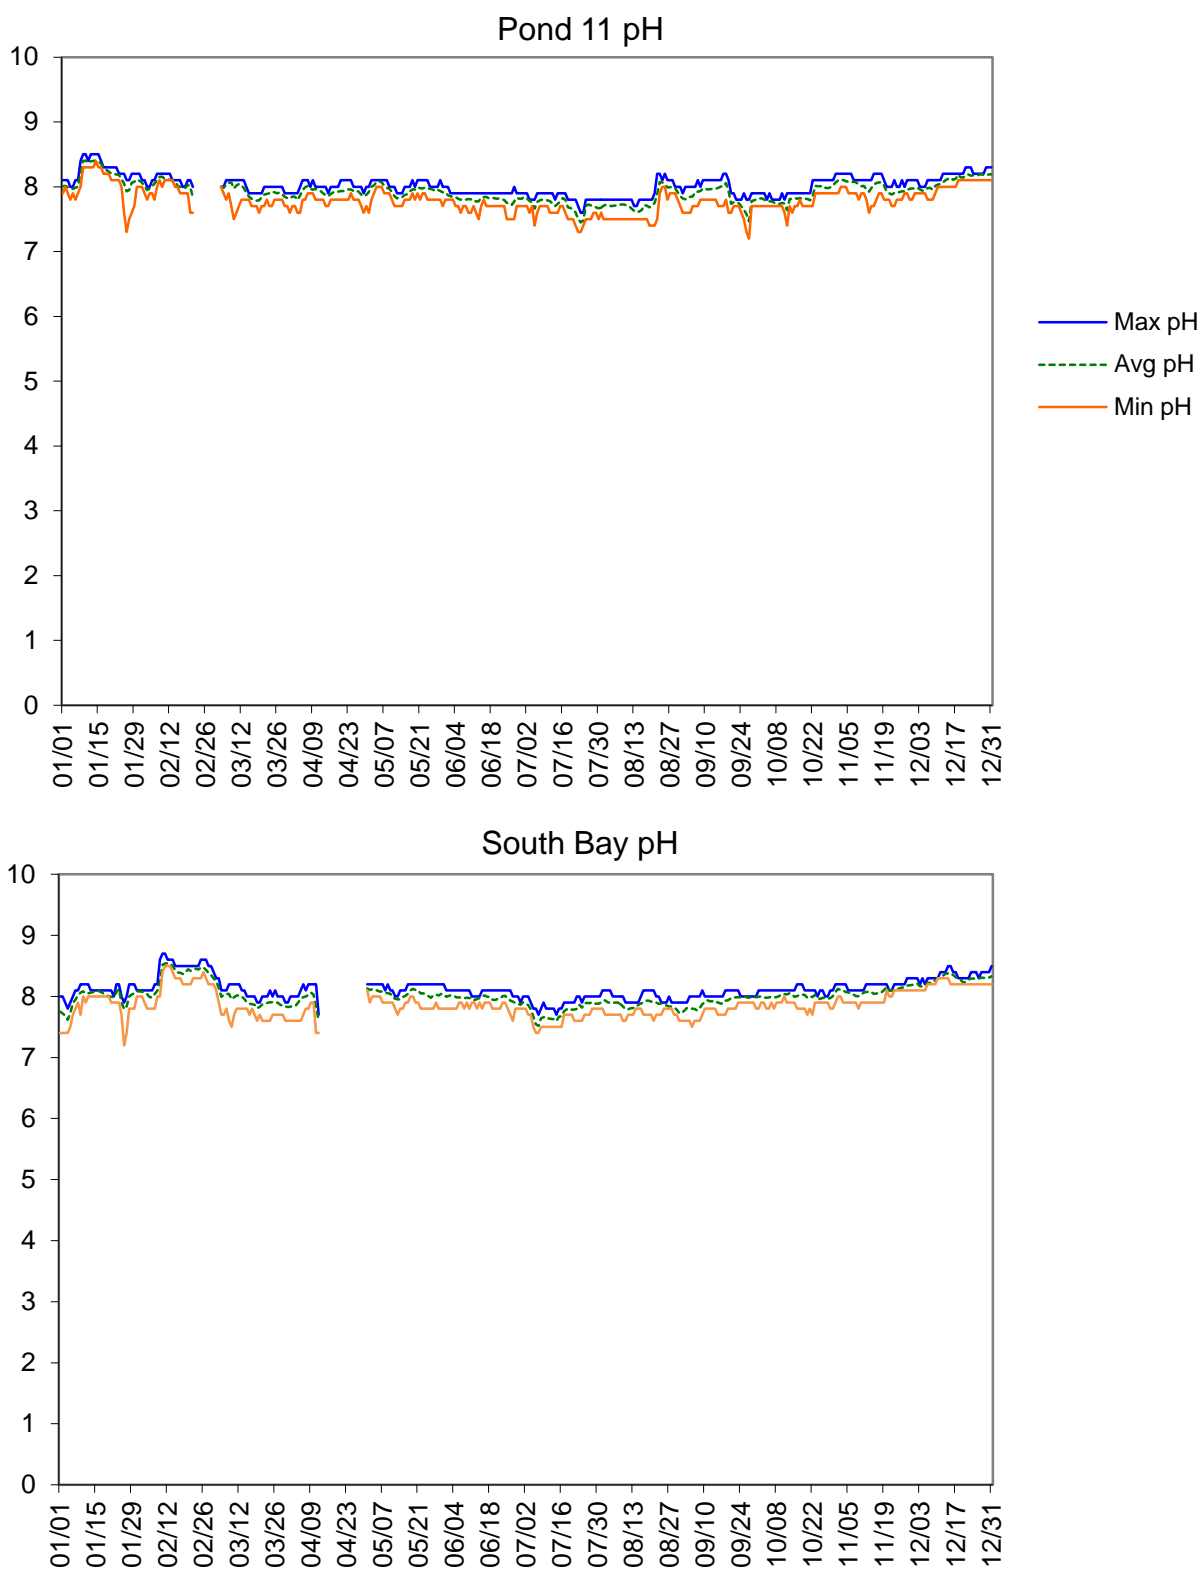
Recorded pH levels were similar at both datalogger locations (Figure 17). Minimum, average and maximum pH at both dataloggers were generally around 8.0. Orthophosphate levels varied considerably but were generally similar in Pond 11 and the Otay River (Figure 18). Ammonia and nitrate levels were considerably higher in the Otay River than Pond 11, presumably in response to upstream inputs from the Otay River watershed (Figures 18 and 19). Chlorophyll levels as measured in the laboratory were always highest in Pond 11 (Figure 19).

Figure 17. Water pH in Pond 11 (above) and the Otay River Mouth (below).

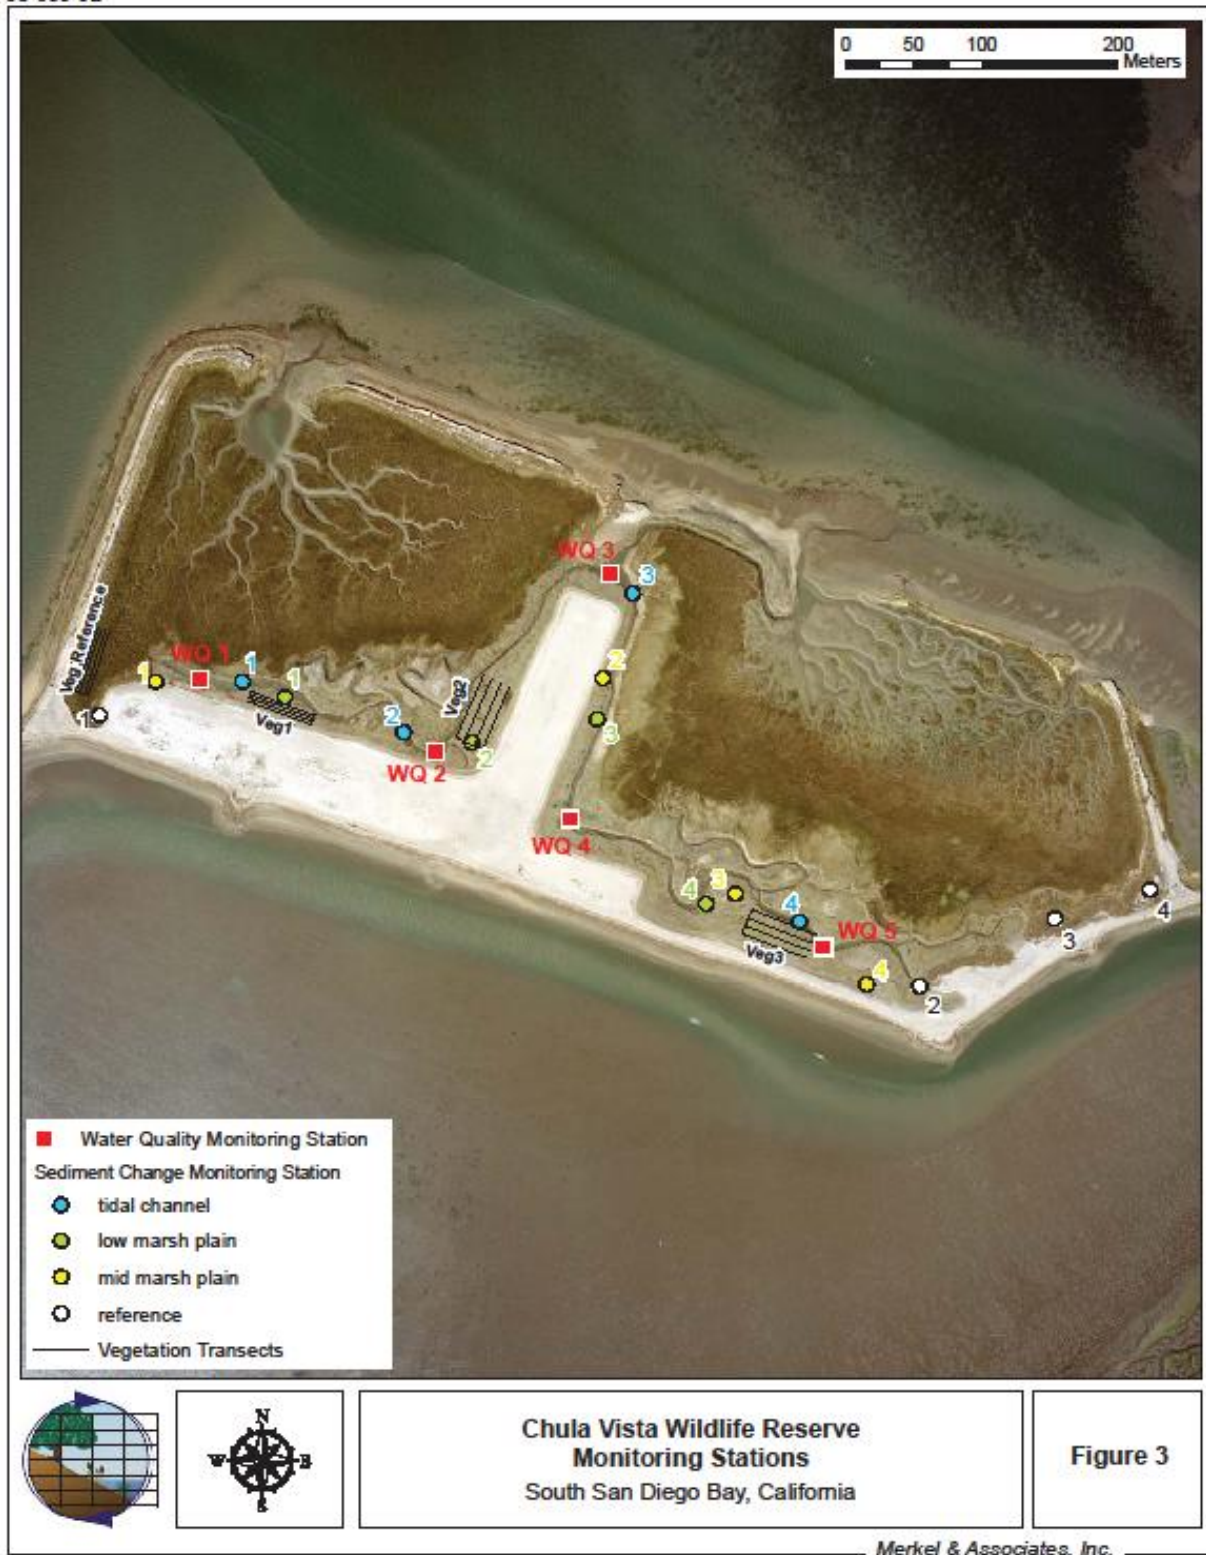
Figure 20. Monitoring Stations Chula Vista Wildlife Reserve.

Water quality data at the CVWR were collected by Merkel & Associates under contract to the San Diego Unified Port District. Data on dissolved oxygen, temperature, turbidity, pH were collected from five tidal channel stations (Figure 20) just prior to low tide on March 7, 2013 using a Hydrolab Quanta multiprobe water quality meter. Water samples were collected from tidal channels on the same date prior to low tide for laboratory analysis of nitrogen (as total Kjeldahl Nitrogen), total phosphorus and ammonia.

The success of the salt marsh plantings at the CVWR was assessed at four monitoring stations: three restoration stations and one reference station (see Figure 20). At each station a baseline was established perpendicular to the tidal channel, extending from the low marsh up to the mid-marsh. Four 50-m transects were established perpendicular to the baseline. Two extended across low marsh plain and two across the mid-marsh plain. Point intercept data were recorded along each transect at 1-m intervals and data was presented as percent cover.

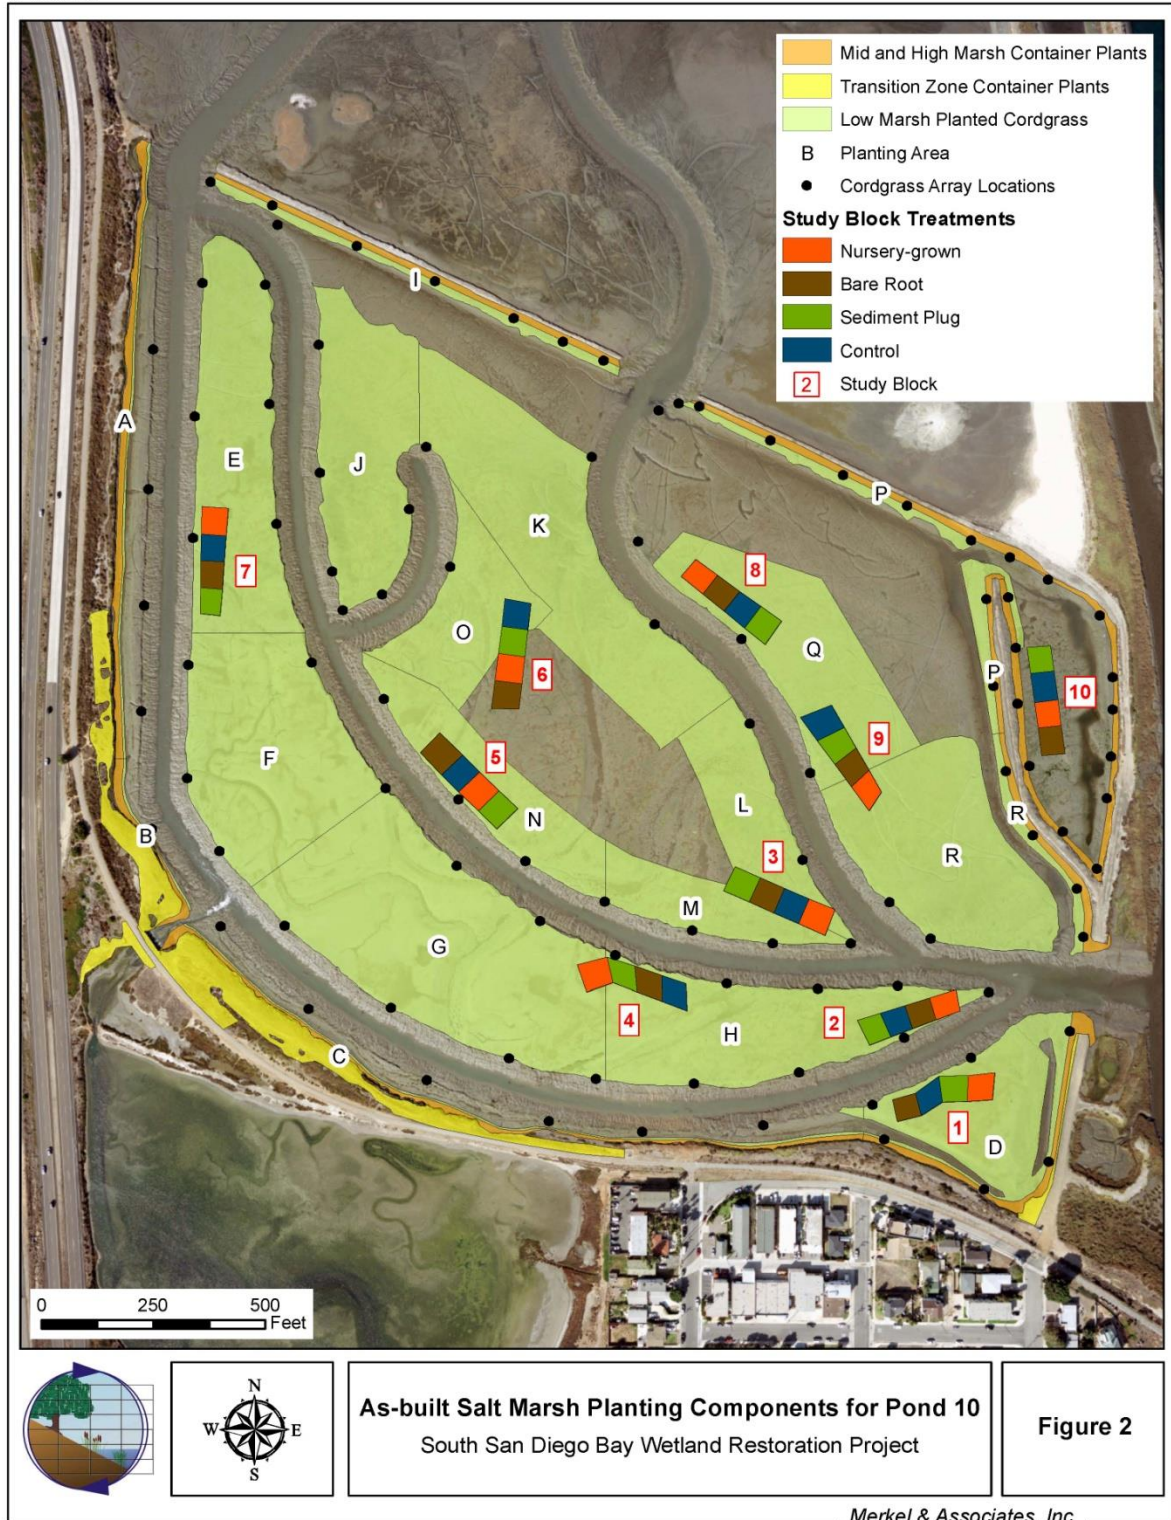
Planting of mid- and high salt marsh species and transition zone was conducted by Merkel & Associates under contract to SWIA. These plantings were completed on October 17, 2011. The areas planted are depicted in Figure 21 (Figure 2 of the as-built report Merkel & Associates, December 2011). Mid-marsh species were planted between +4.6 and +5.8 ft NAVD88. High marsh species were planted between +5.8 and + 7.6 ft NAVD88. Transition zone plantings were installed above +7.6 ft NAVD88. All transition zone plants were installed with two quart size DriWater© time release gel packs to provide moisture for approximately 90 days. All plants were installed on approximately 6-foot centers.

Figure 21. As-built Salt Marsh Planting in Pond 10 (Figure 2 from As-built Report)

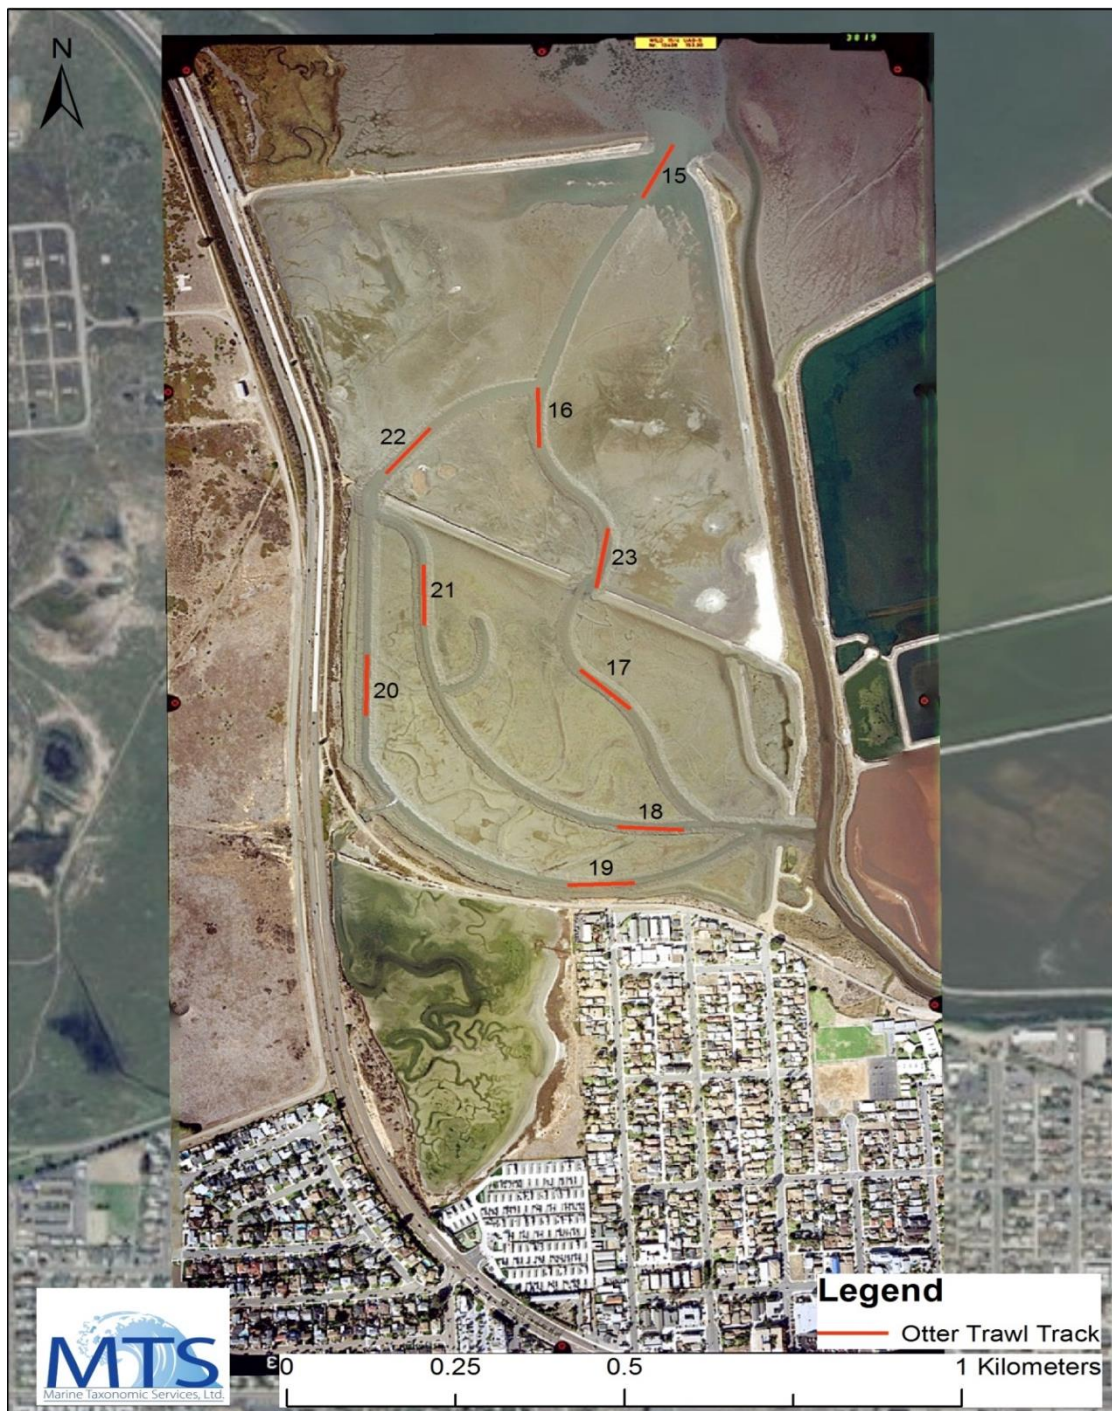
Figure 22

A total of 11 otter trawls were collected (Figure 22). The otter trawls were designated as stations 15-23. Stations 1 – 12 were sampled with a beam trawl in 2012. That methodology was dropped for the current effort. All stations were performed as planned except for station 18 which was moved slightly relative to the 2012 sampling.

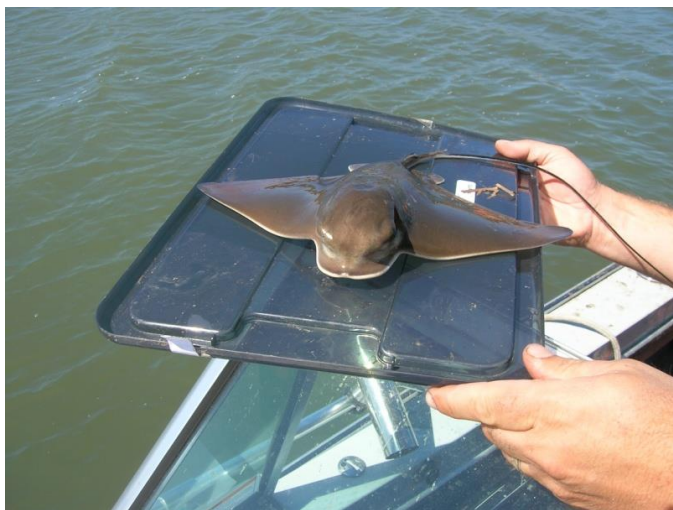
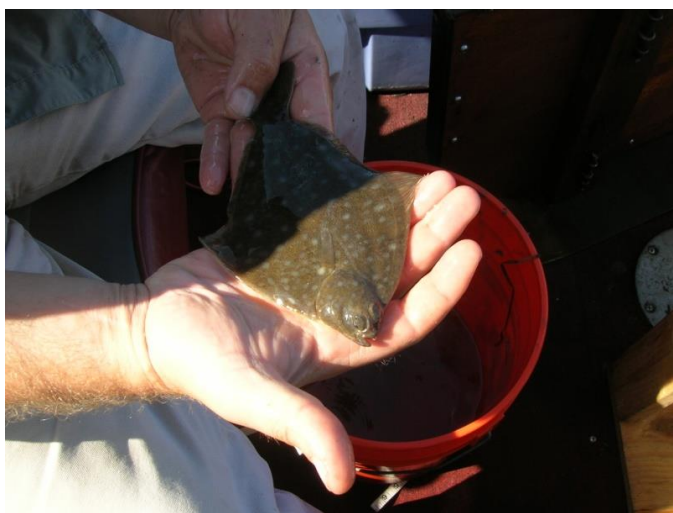
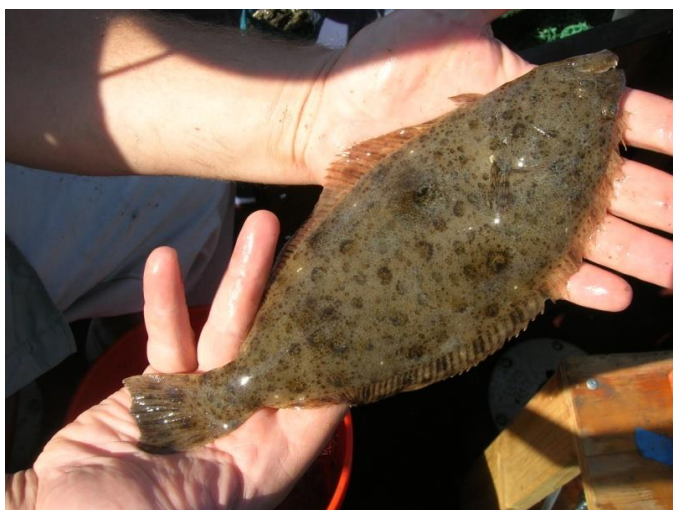
Figure 23. Photograph of Trawl Results [bat ray (top); diamond turbot (middle) and California halibut (bottom)]
