PERFORMANCE AUDIT  
CITY OF OCEANSIDE  
MYER'S PROPERTY  
GRANT 5001329

March 2, 2011

Katie Levy  
SANDAG  
Environmental Planning Intern  
Land Use & Transportation Planning

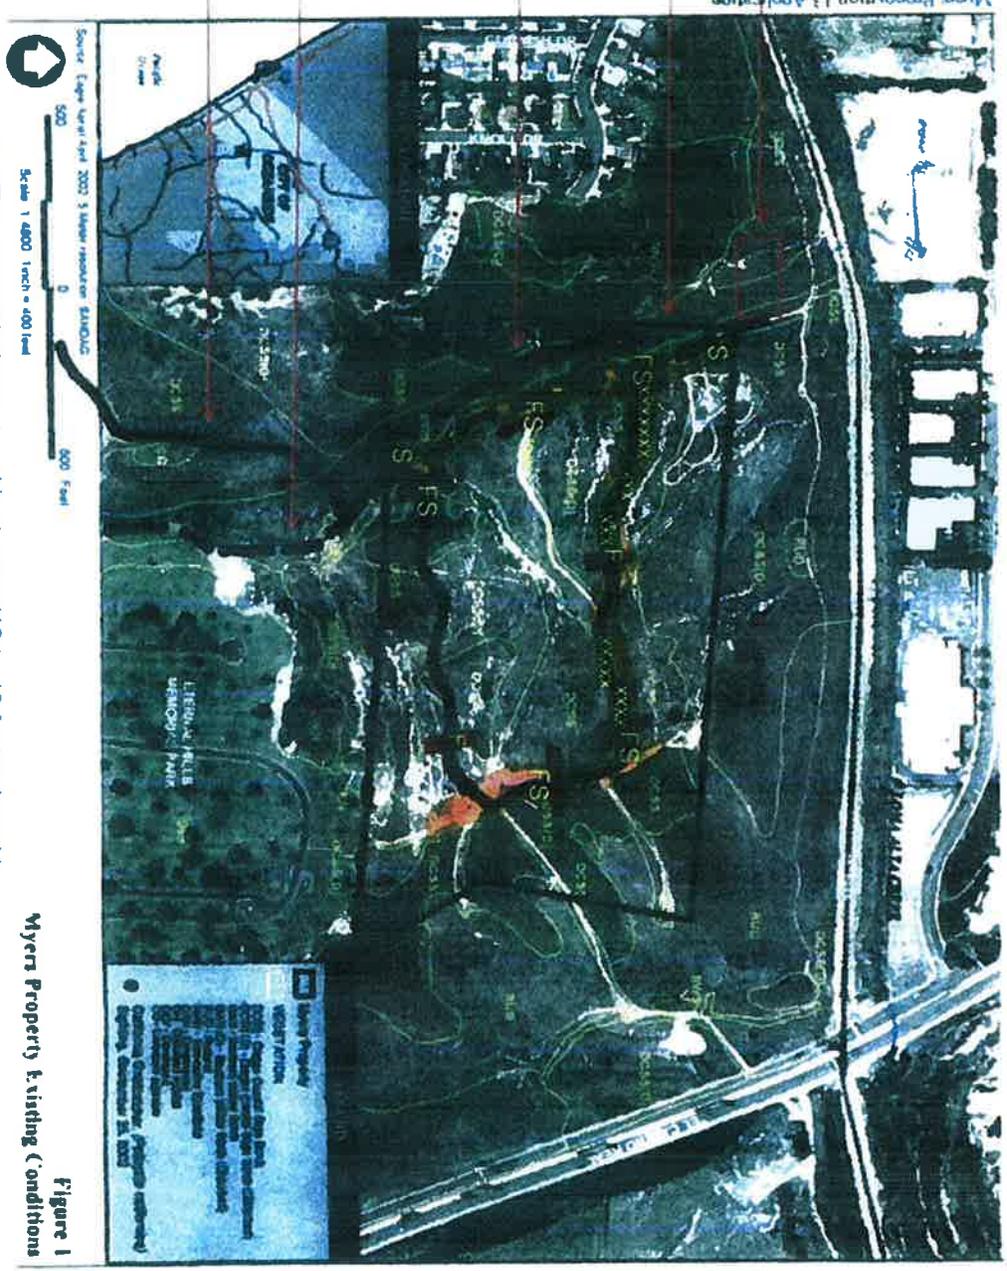
Figure 1  
 Myers Property Restoring Conditions

- Fenced Desilting Basin
- Property Line
- Wood Check Dam Repair Area
- Access Road
- Walking Trail Area Including Access Road

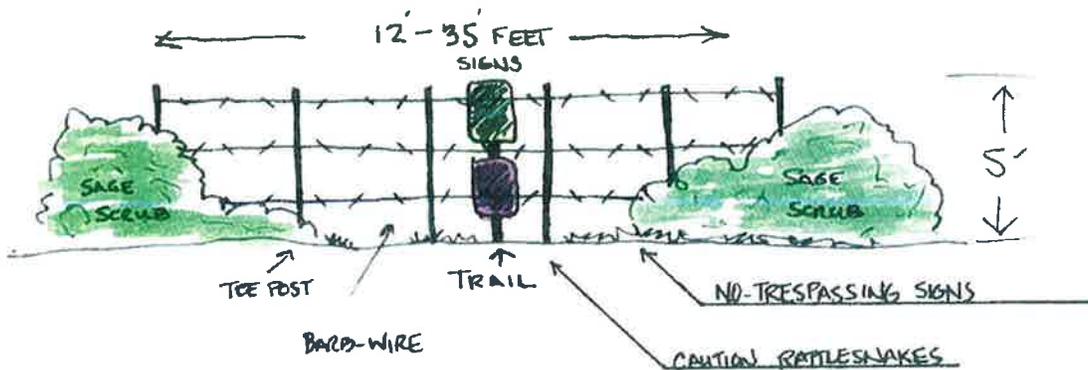
### Fencing and Sign Detail:

- F = Tee post with three strand barb-wire (12 to 40 feet in length)
- FS = Tee post with three strand barb-wire including 1 sign post, 1 No-Trespassing and 1 Rattlesnake Caution Sign
- S = Sign post with 1 No-Trespassing and 1 Rattlesnake Caution Sign
