SA-PAL survey

| Project | SA-PAL project |
| ID | 42130 |
| Survey Date | 04/03/2019 |

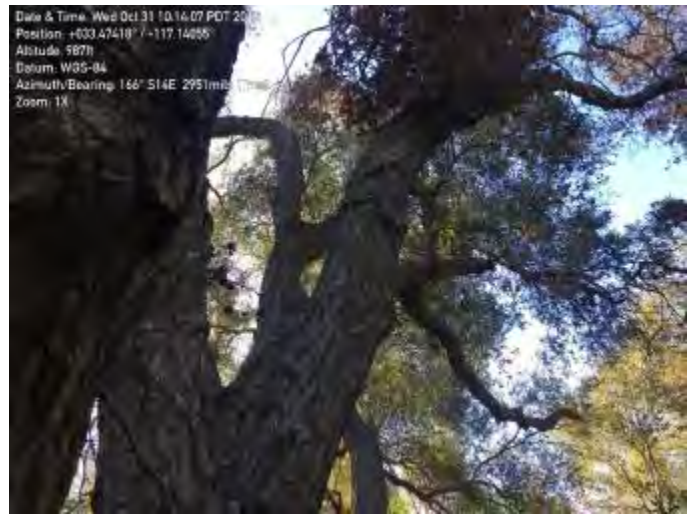
Camera # NF 3 placed 10-31-18. Up in tree facing west approx. 300 yards west of Temecula Creek overpass

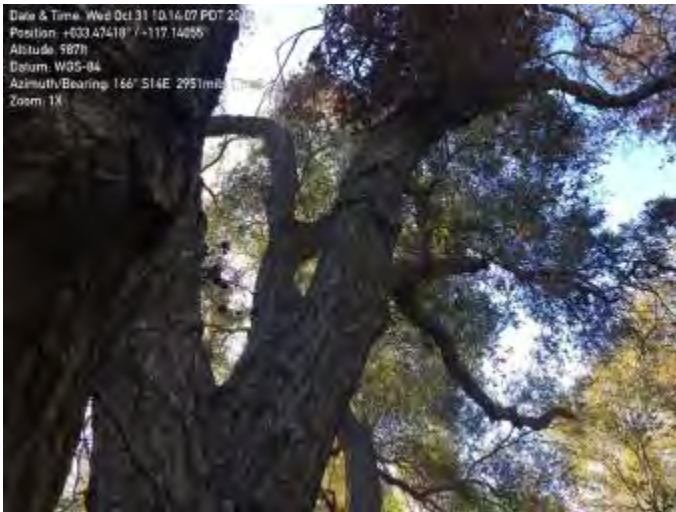
Camera NF 3 placed 10-31-18. Located up in tree facing west approx. 300 meters west of Temecula Creek Bridge.

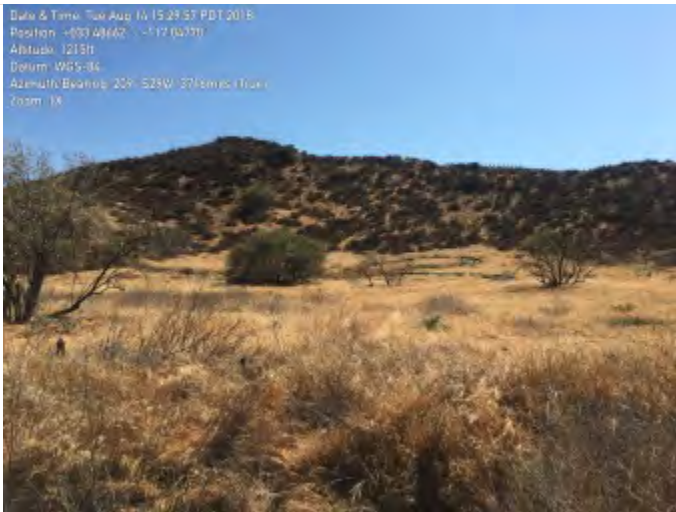
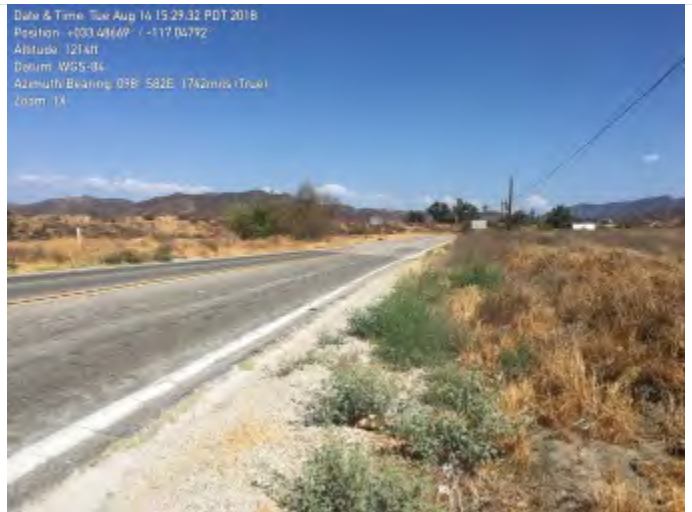
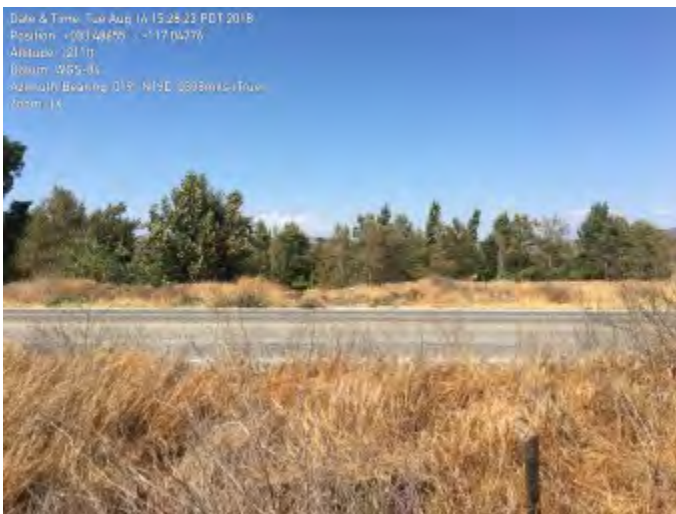
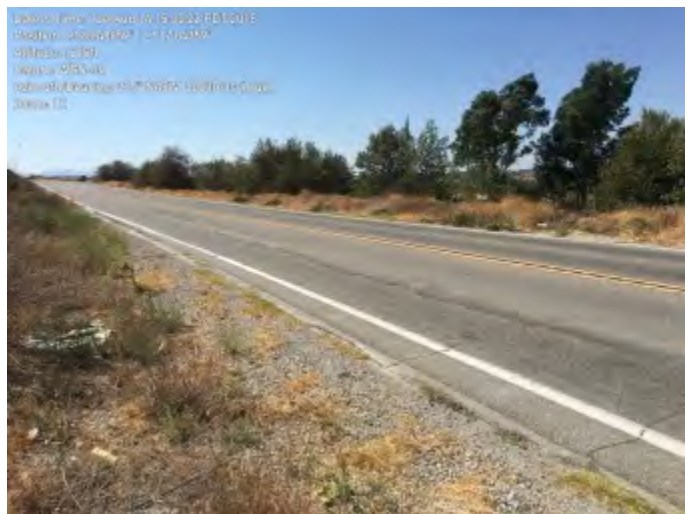
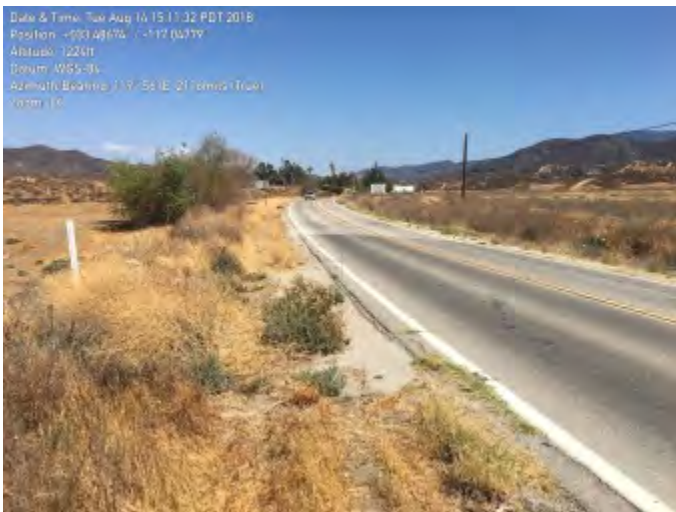
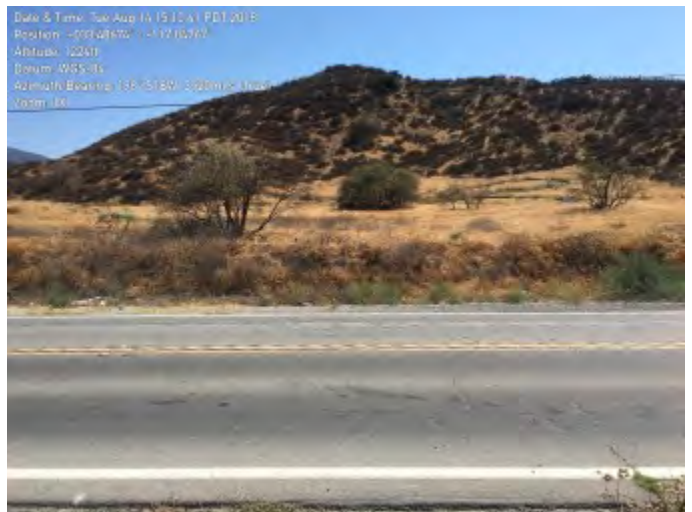
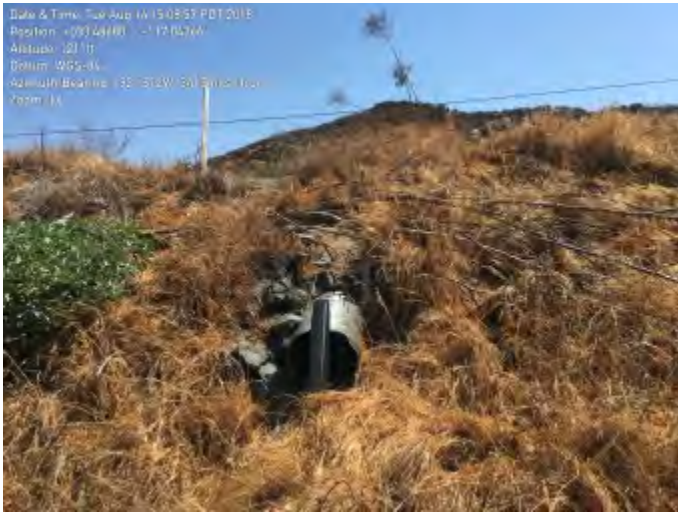
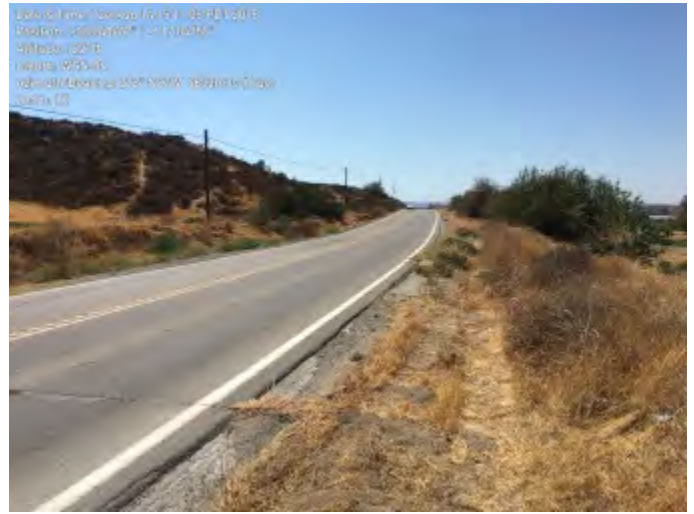
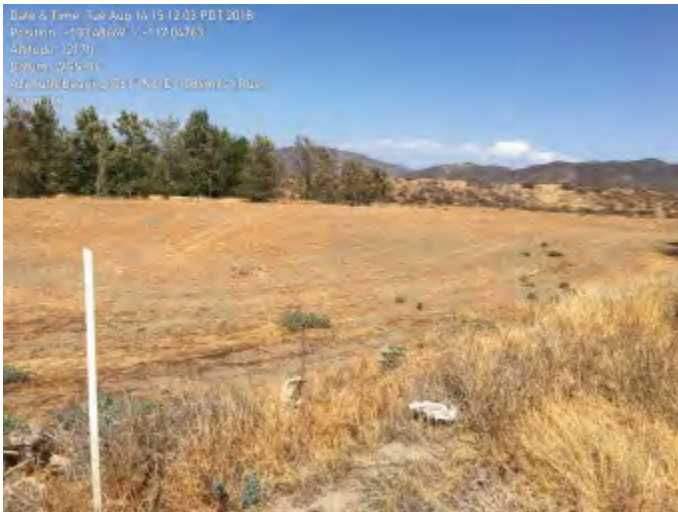
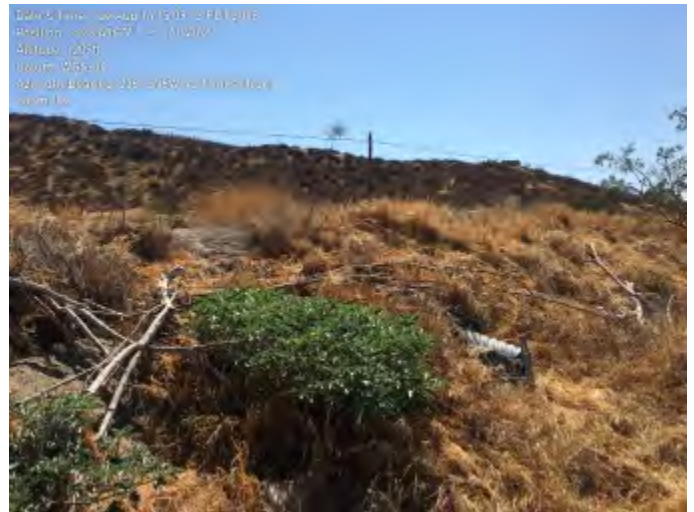
Residence approx. 150 meters directly north of WB 79. To the Southwest is open land. Although I was able to see through culvert from WB side, I was unable to locate culvert access on EB side of 79. Sparse chaparral north and south of 79 here. Roadbed is raised only a few feet above grade on WB side, and is essentially at grade on EB side. Access for larger culvert is poor. There was a culvert access observed on EB side approx. 20 meters west of location. However it is also 1 foot in diameter and essentially at grade of 79. No corresponding outlet observed on WB side of 79.

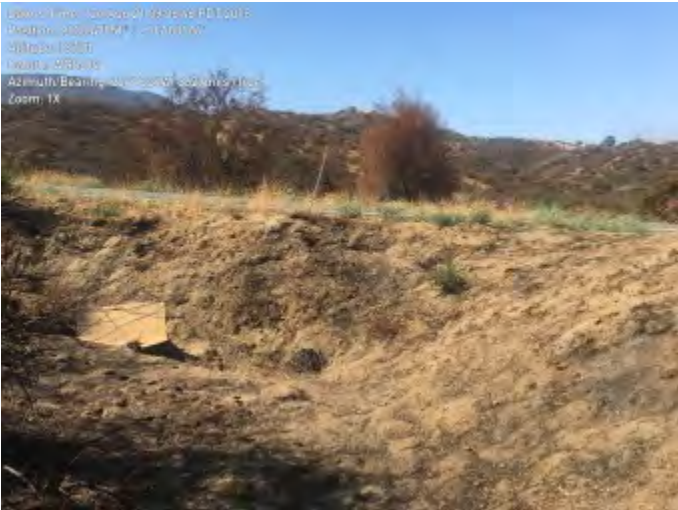
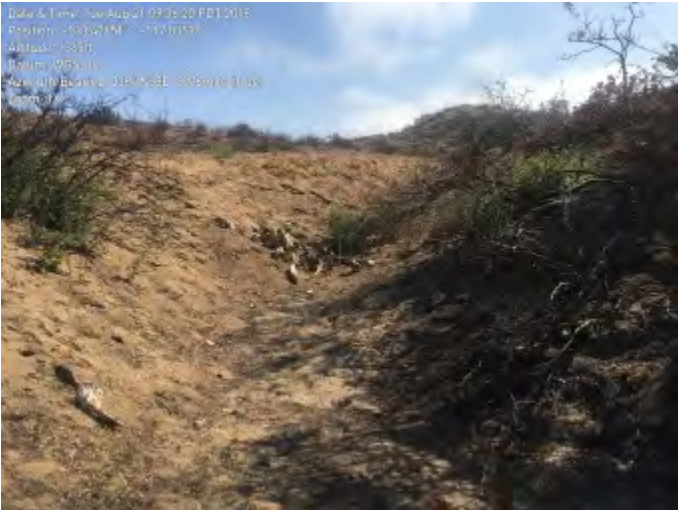
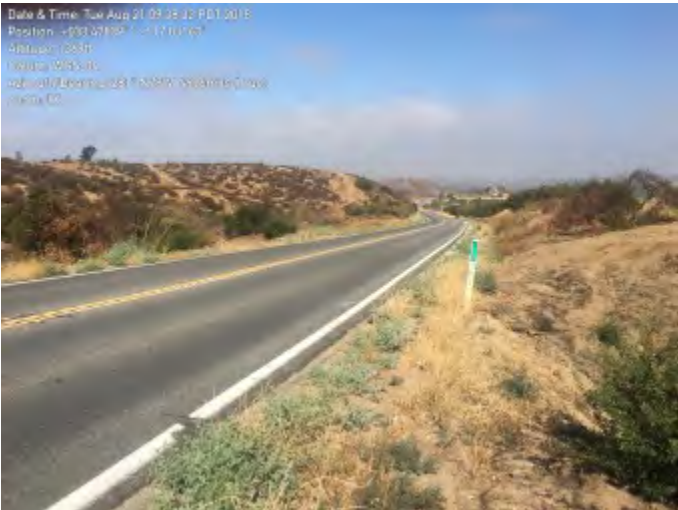
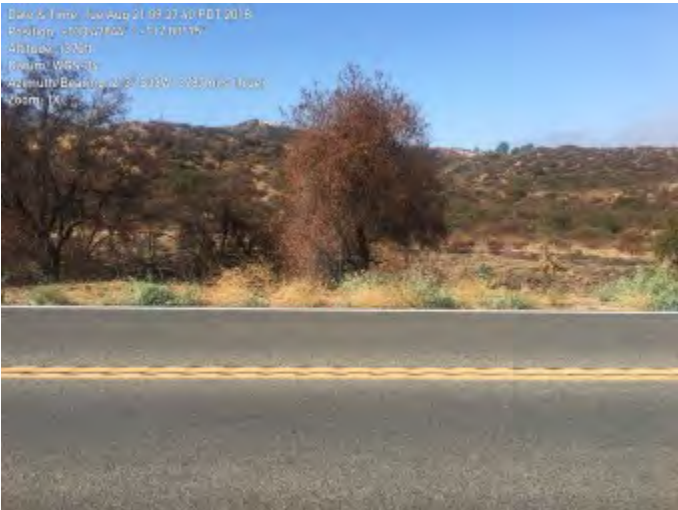
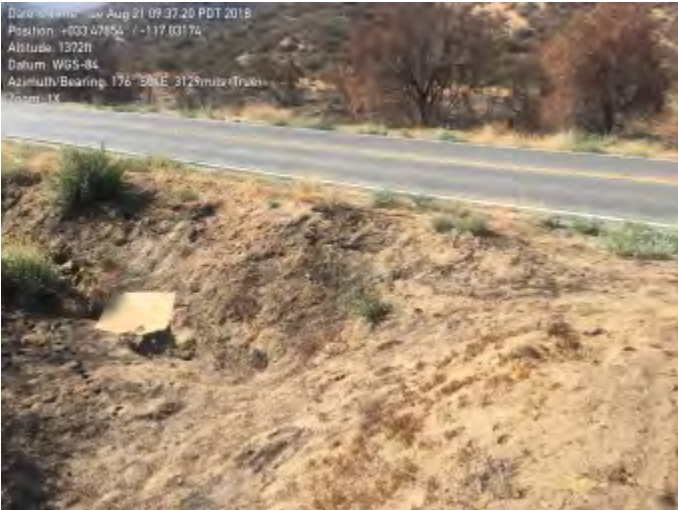
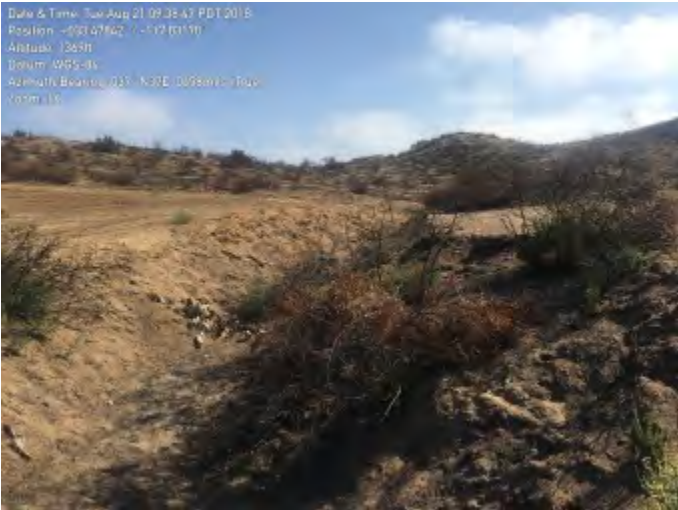
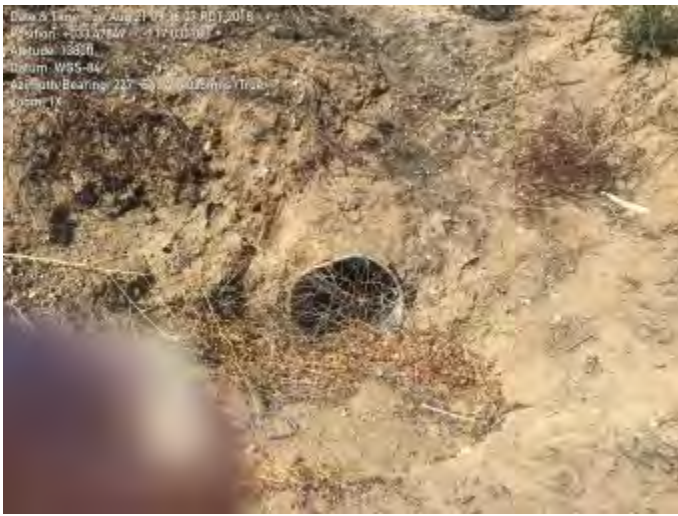
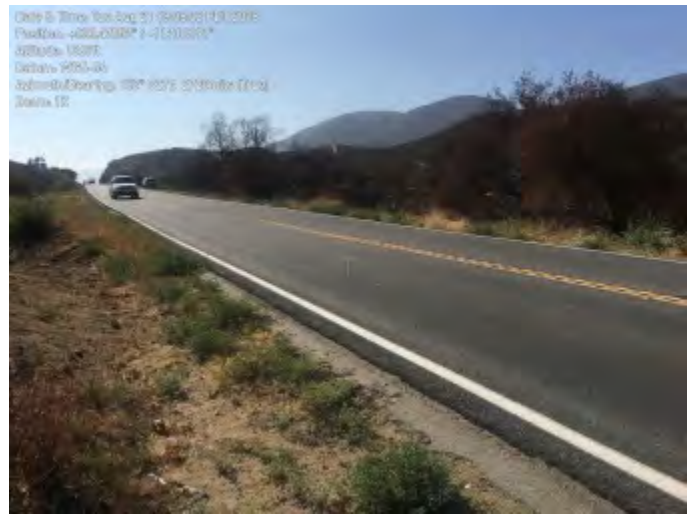
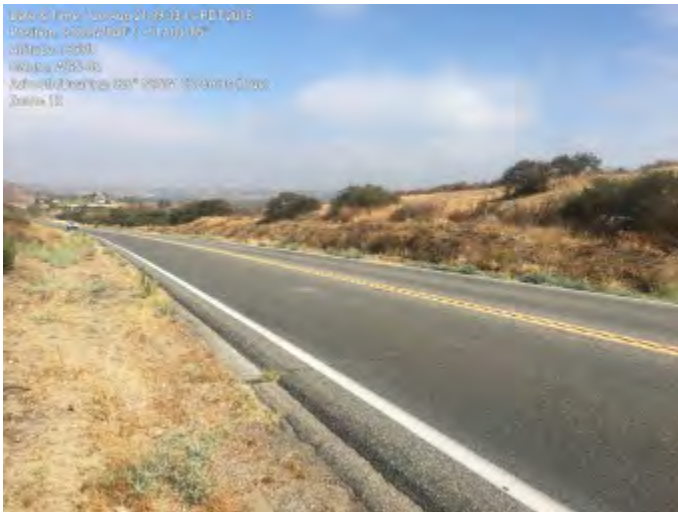
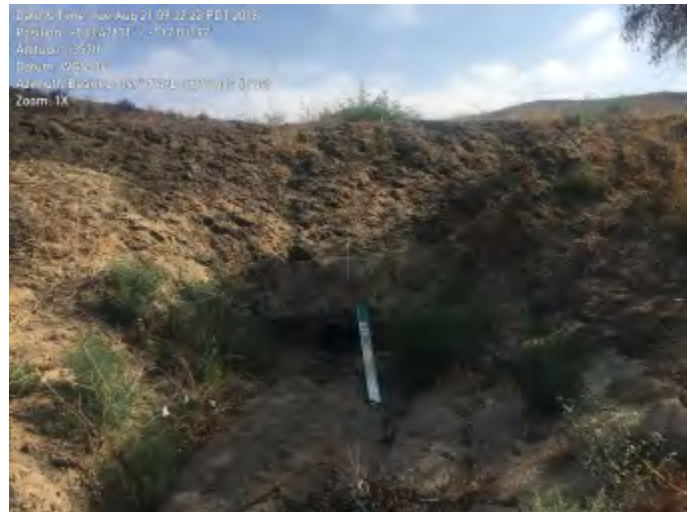
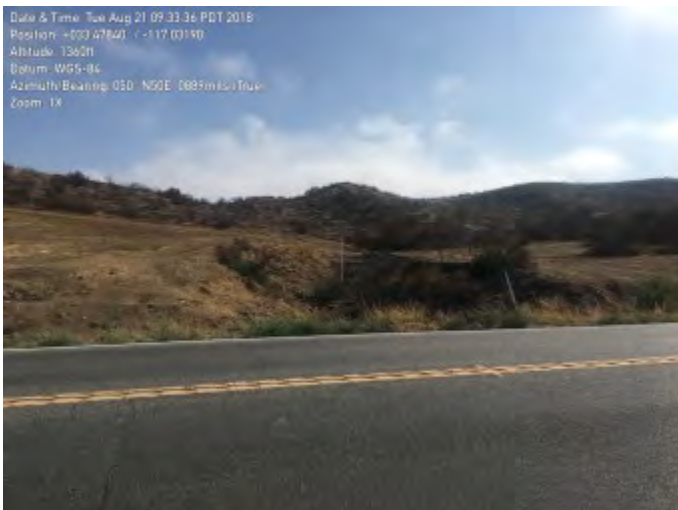
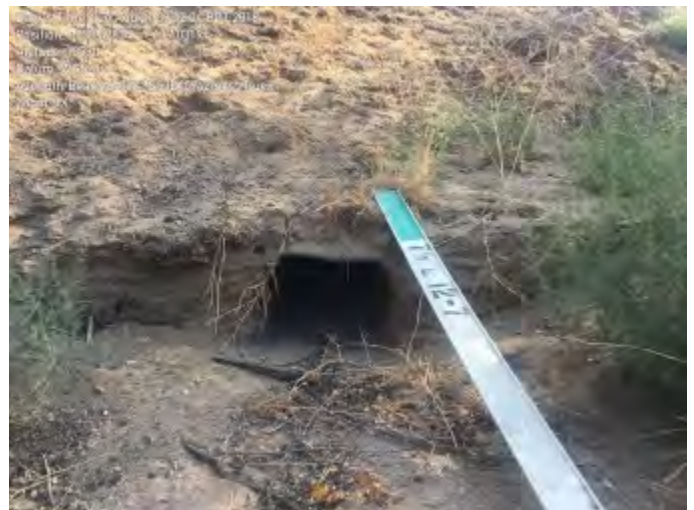
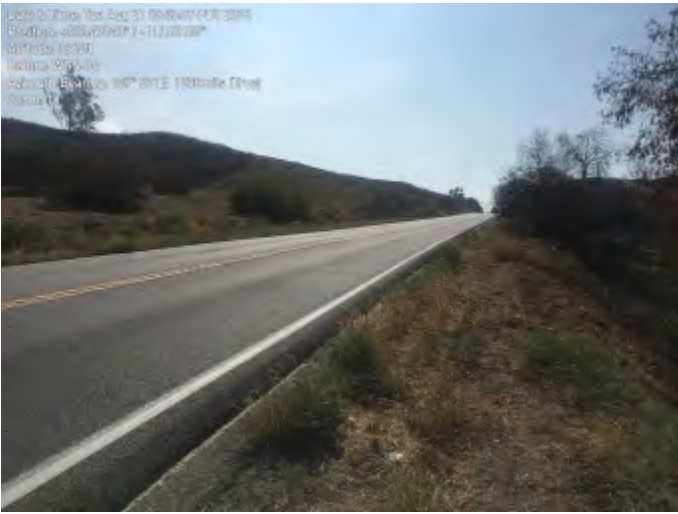
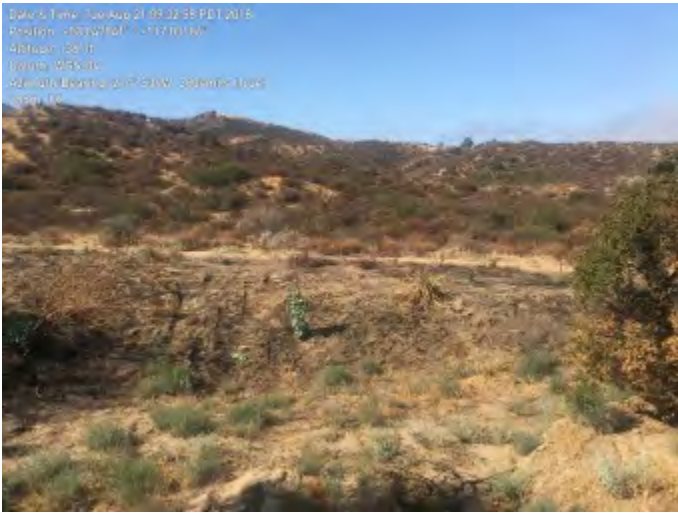
Eastbound side is post burn. Downslope on eastbound side. 45 degrees and 20 foot drop to dry creek bed below. Small culvert access here. 75 meters to the south is chaparral scrub. Open post burn chaparral to the north of WB 79 here. Good access to small level culvert on WB side of 79 here. 10 foot downslope to culvert on WB side. Location surveyed is approx. 20 meters west of suggested 50P GPS point. Culvert located at GPS point marked in this survey.

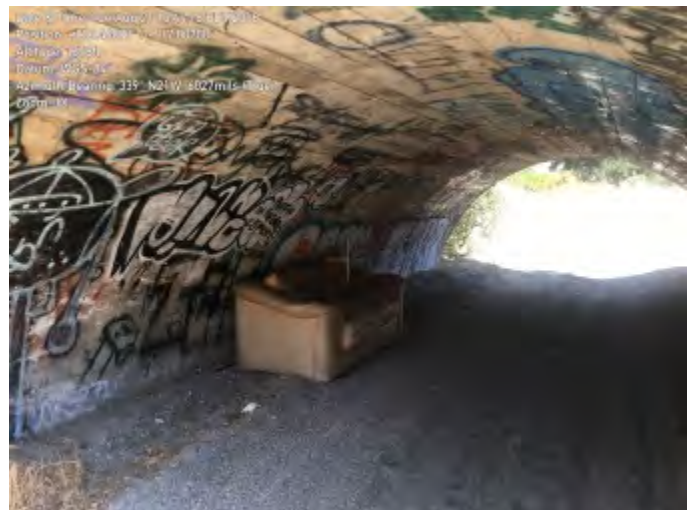
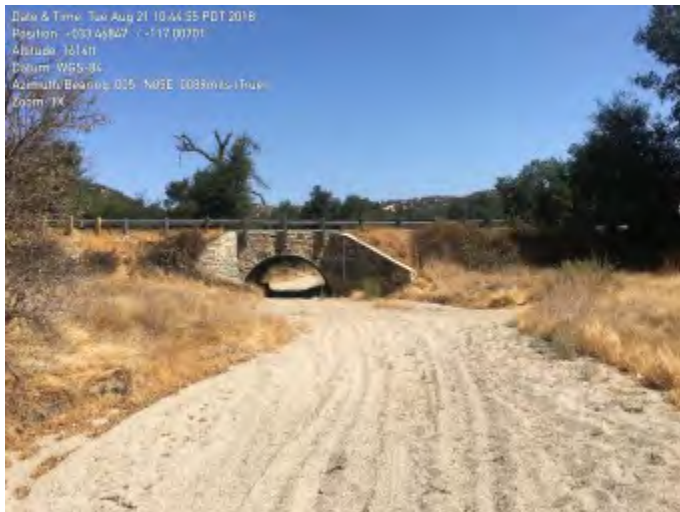
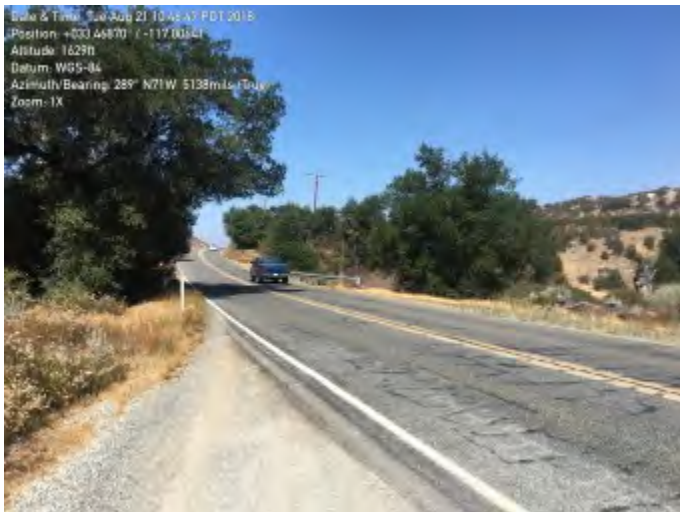
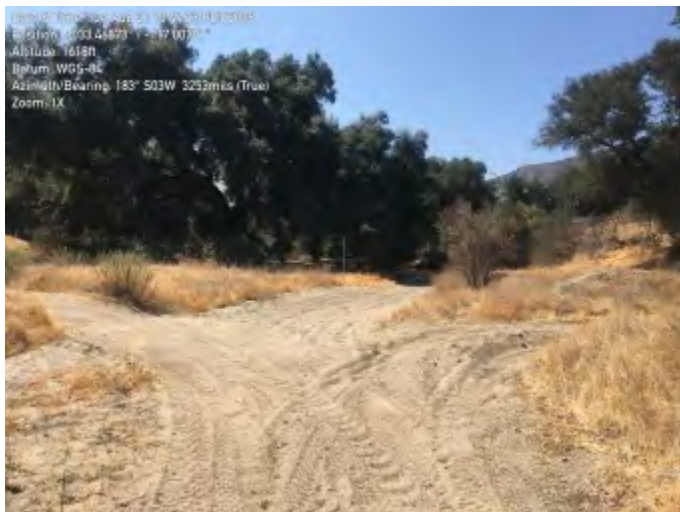
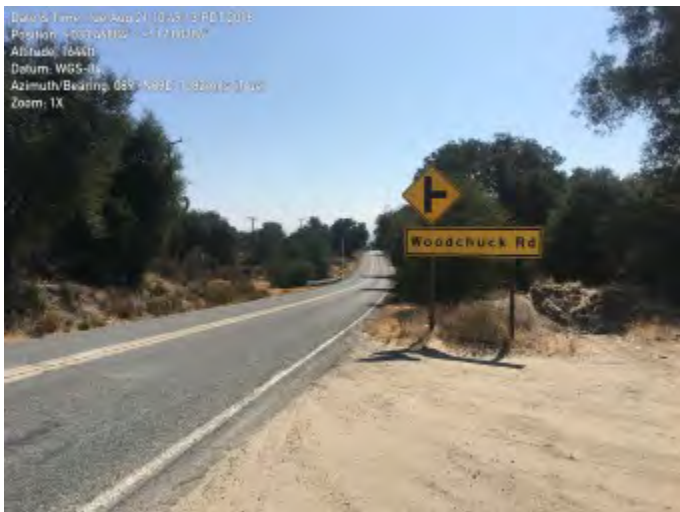
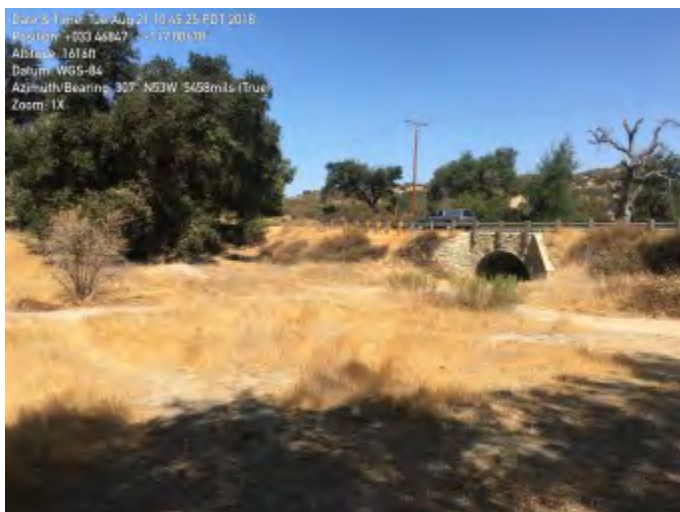
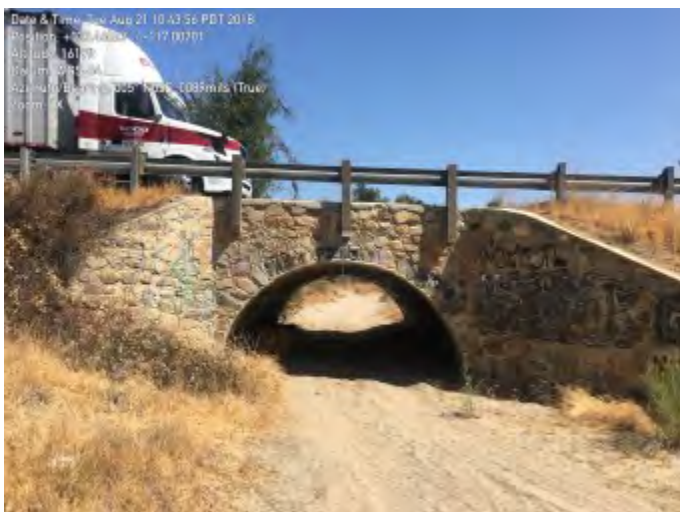
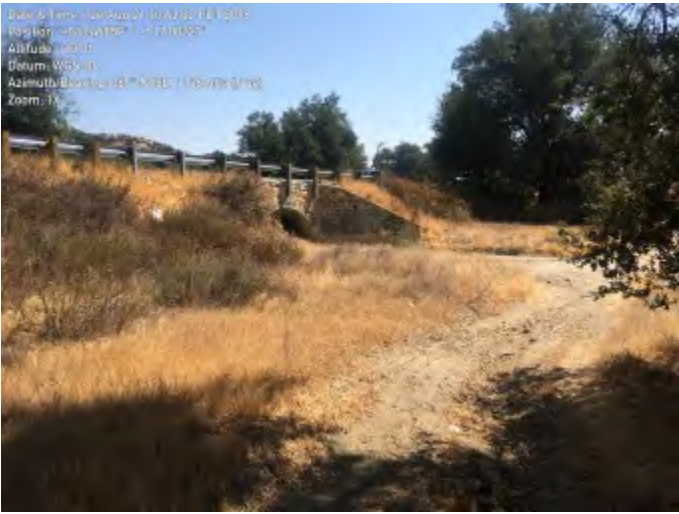
| Comments | This bridge undercrossing is in an area of moderate traffic only. Corridor to north and south consists of a minimally travelled gravel/sand road. This is no sign of significant seasonal water flow under bridge. It does not appear to be a drainage area. There is good natural cover lateral to gravel roads approaching underpass. There is private ranch property some distance to the south. Not visible from 79. Multiple dirt roads on north and south accessing main undercrossing. |

| Management recommendations | Directional fencing. Fencing to prevent human presence. Barrier fencing at grade level. Sound insulation. |

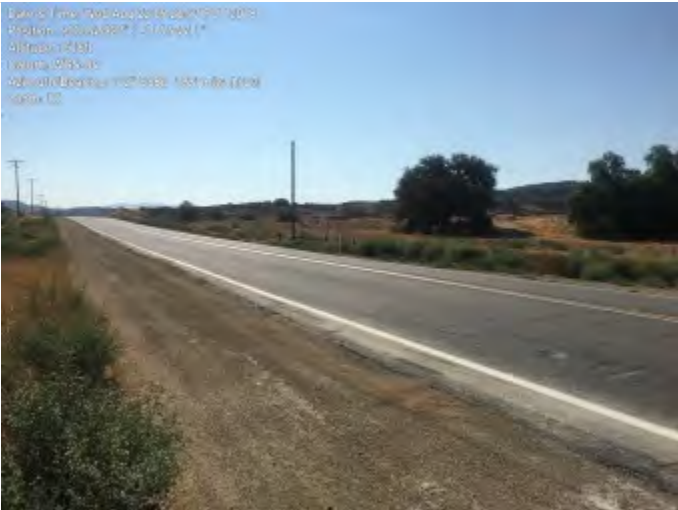
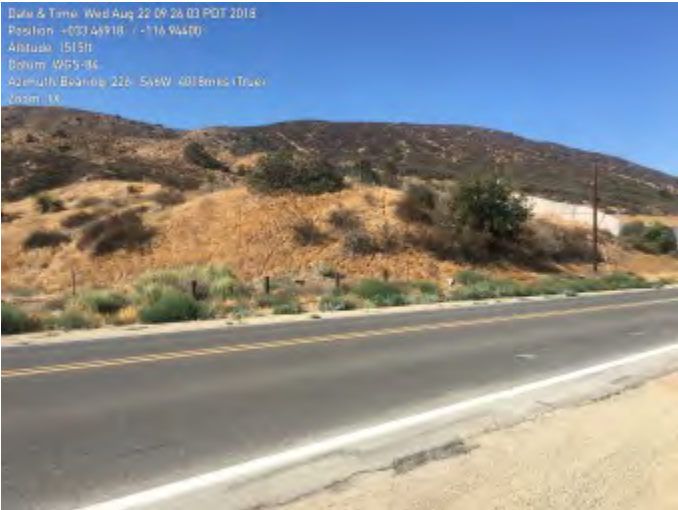
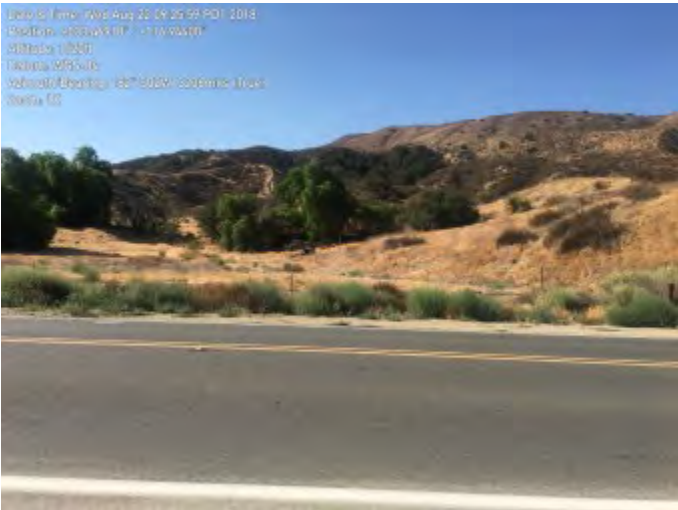
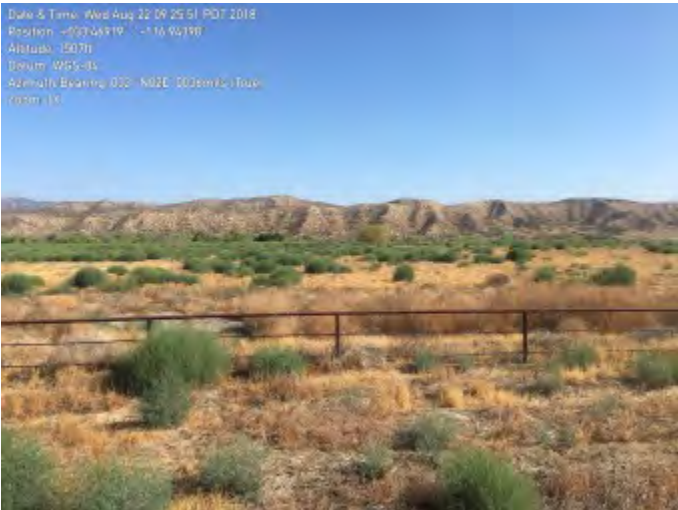
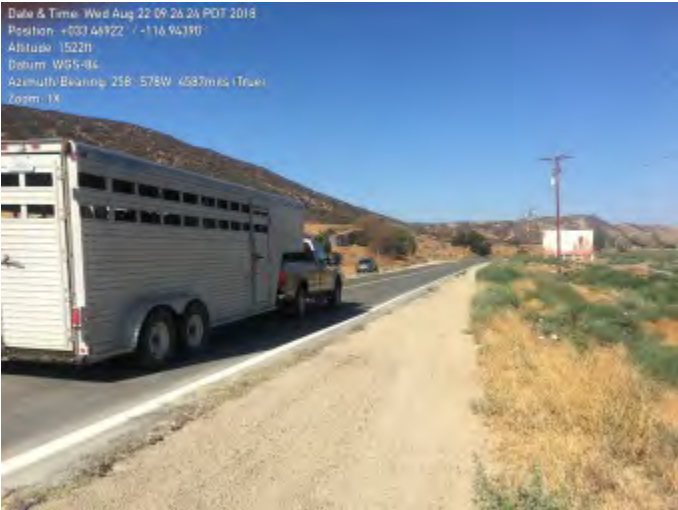
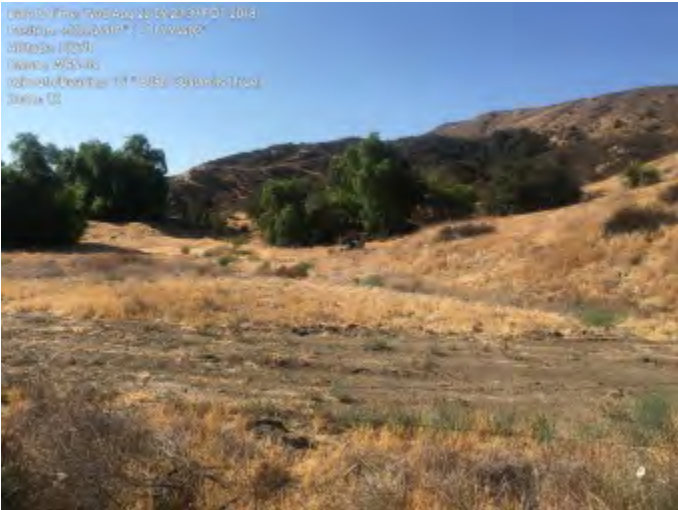
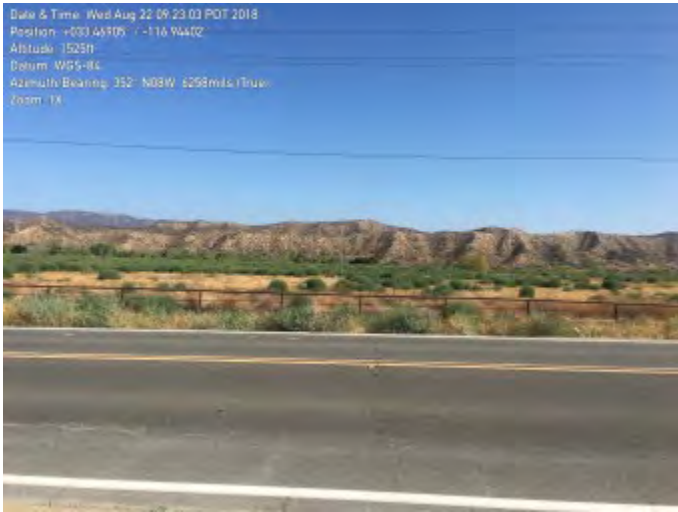
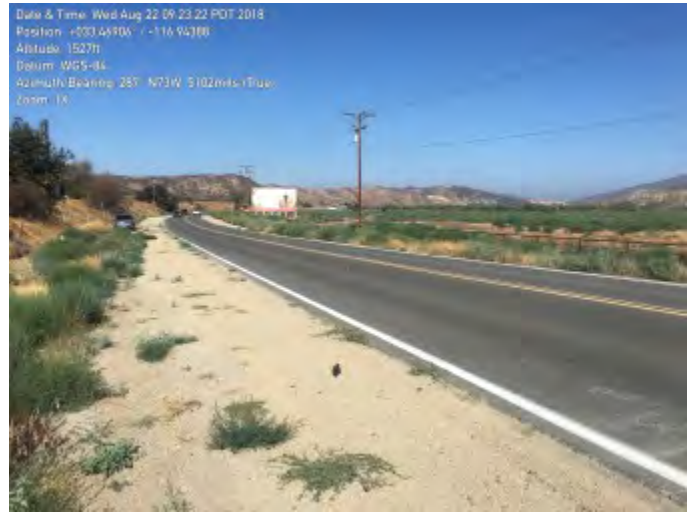
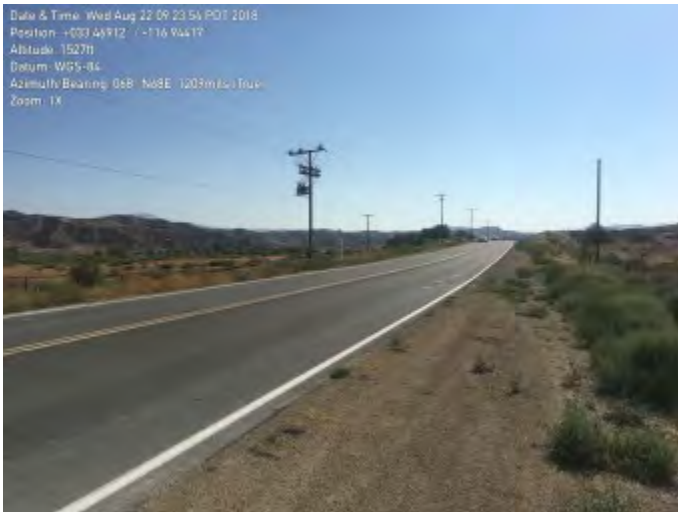
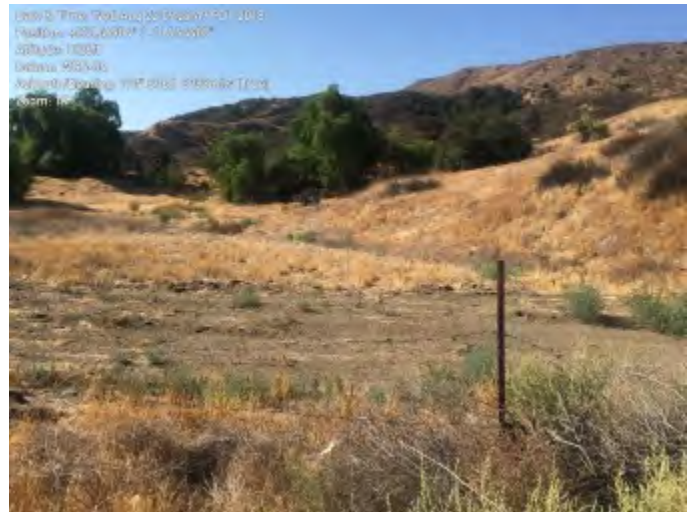
| Describe fencing type and height | 3 bar iron fence parallel to 79 on WB side. 4 feet high. 8 foot slatted chain link on E.B. 79 bordering west side of this location. This is an enclosure for business. 3 foot barbed wire parallel to 79 on E.B. 79 in disrepair. |

The area surveyed is approx. 50 meters east of suggested GPS heading for 55P. That location is at the commercial property mentioned above. The area surveyed has natural habitat conducive to wildlife approach. However, the crossing point is at grade on busy highway. 79 is at grade of adjacent land on E.B. side, and approx. 3 feet above grade of adjacent land on WB 79. Probably inadequate space for creation of undercrossing.

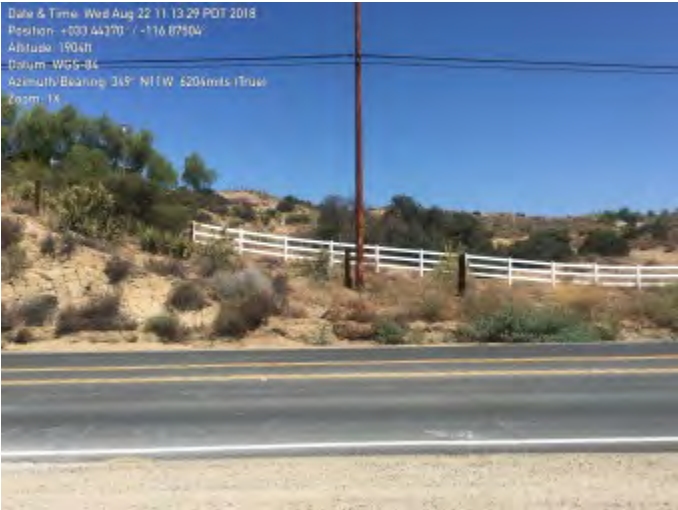
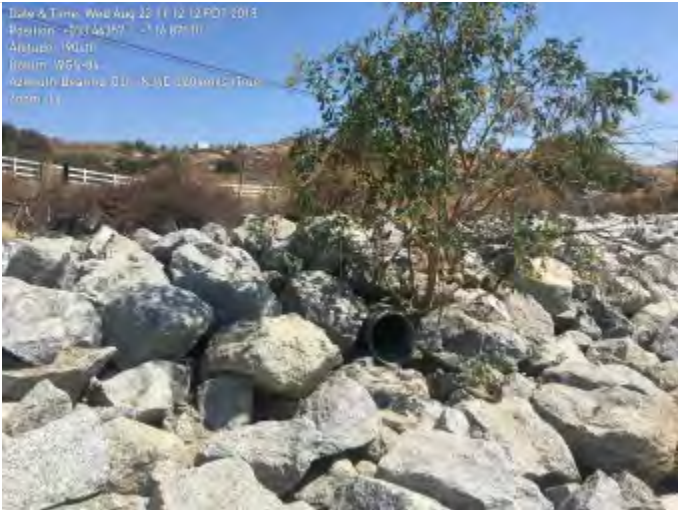
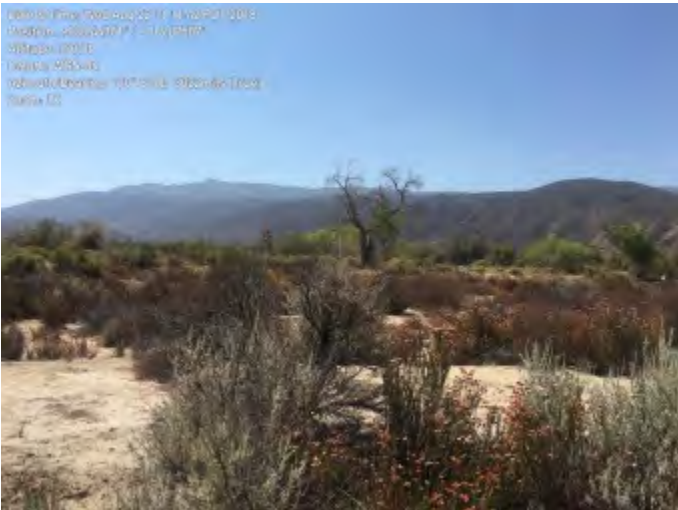
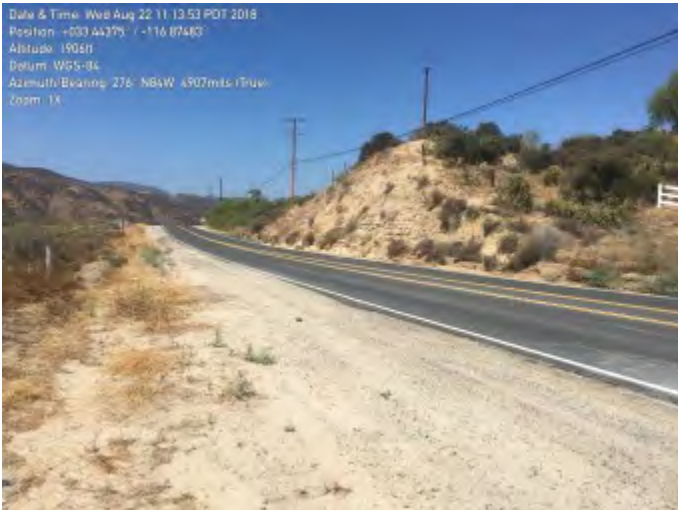
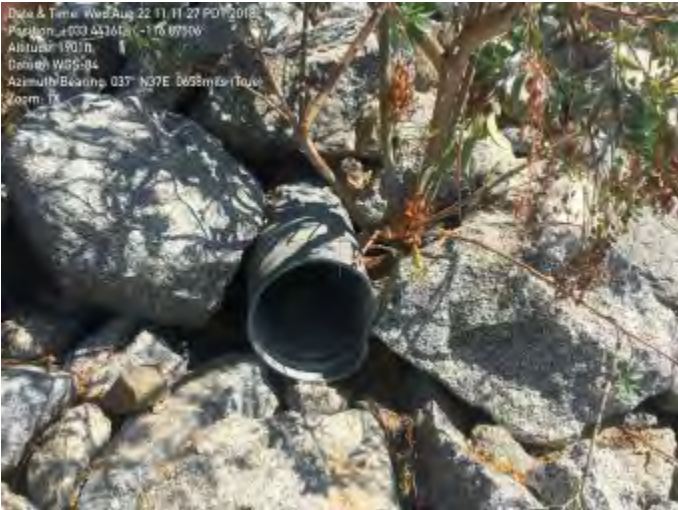
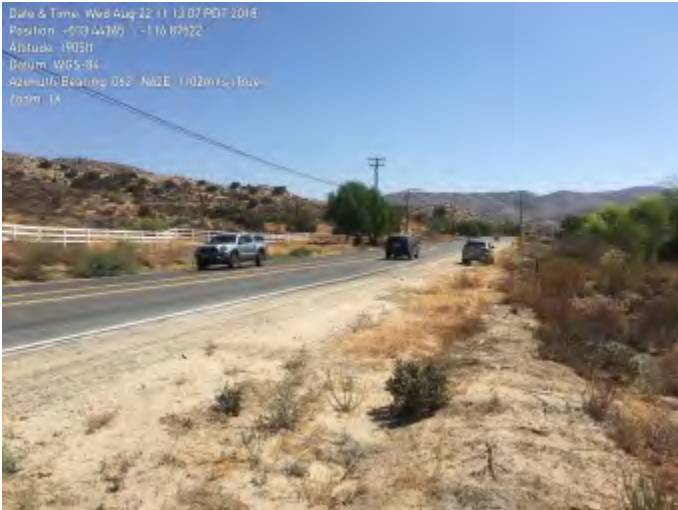
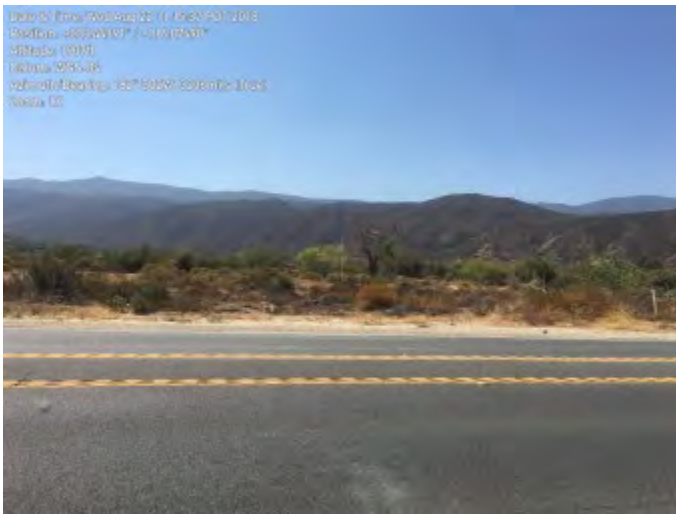
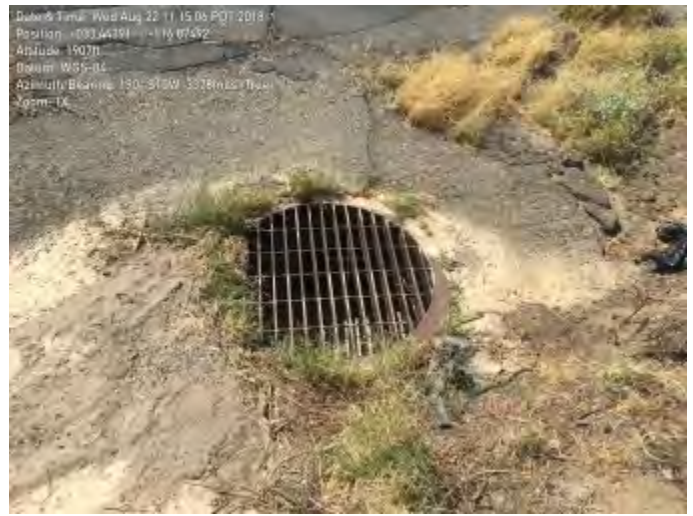
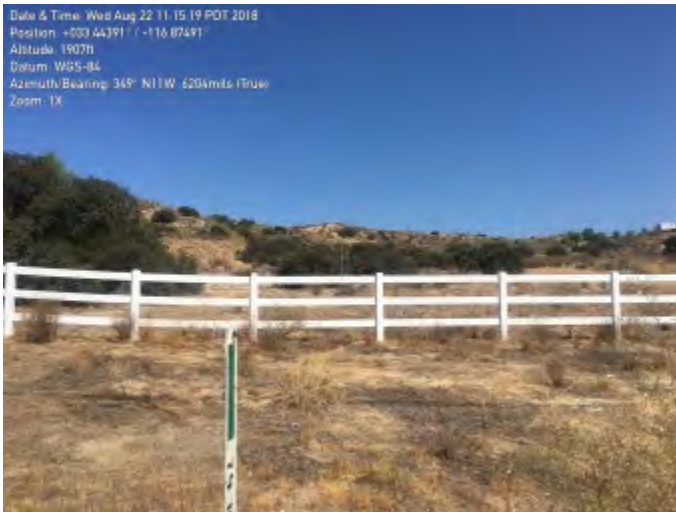
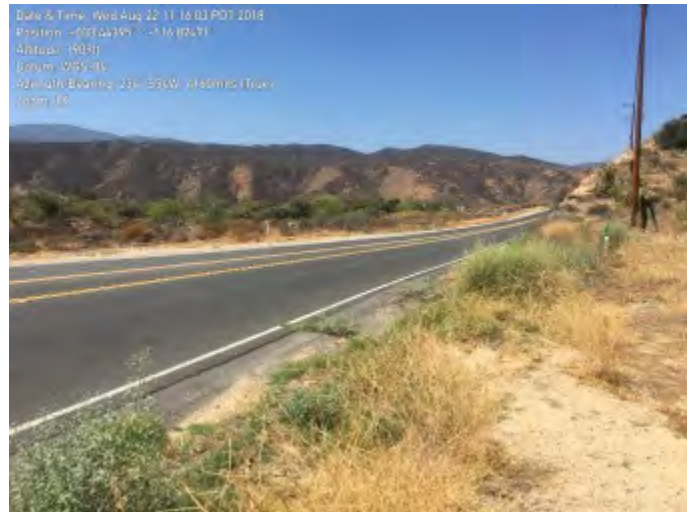
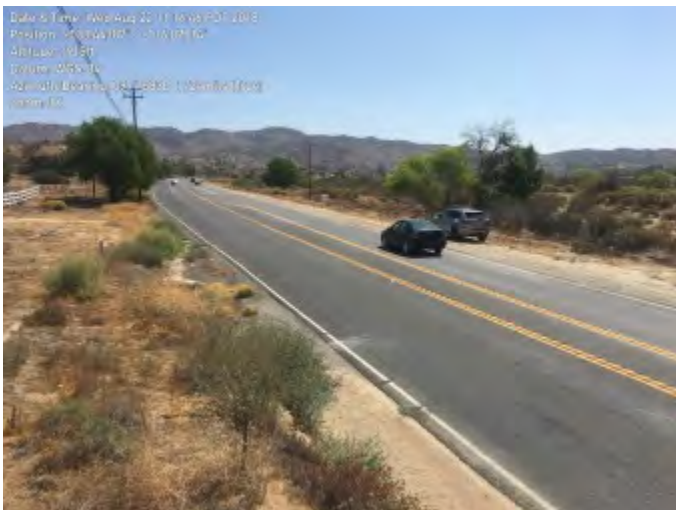
| Describe fencing type and height | Horsefence and intermittent 5 foot barbed wire parallel to WB 79. 5 foot barbed wire approx. 40 meters west of location running perpendicular to the south of EB 79. |

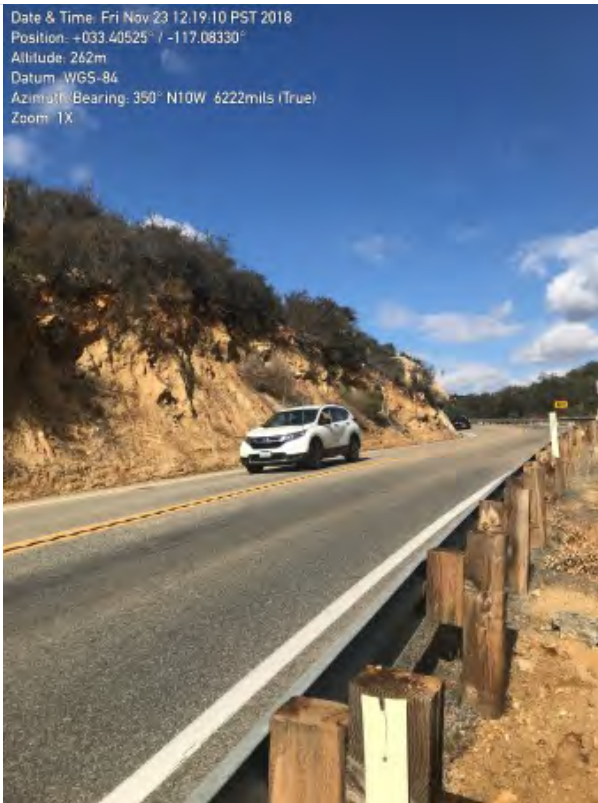
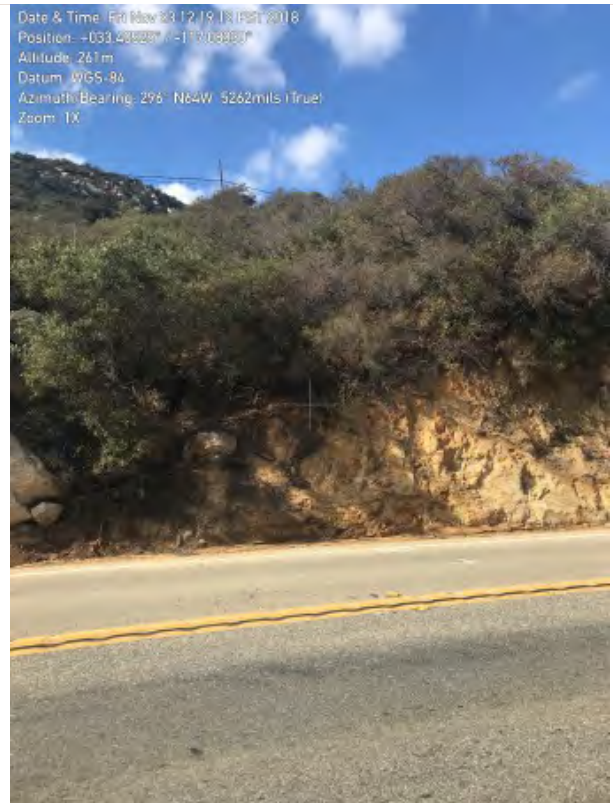
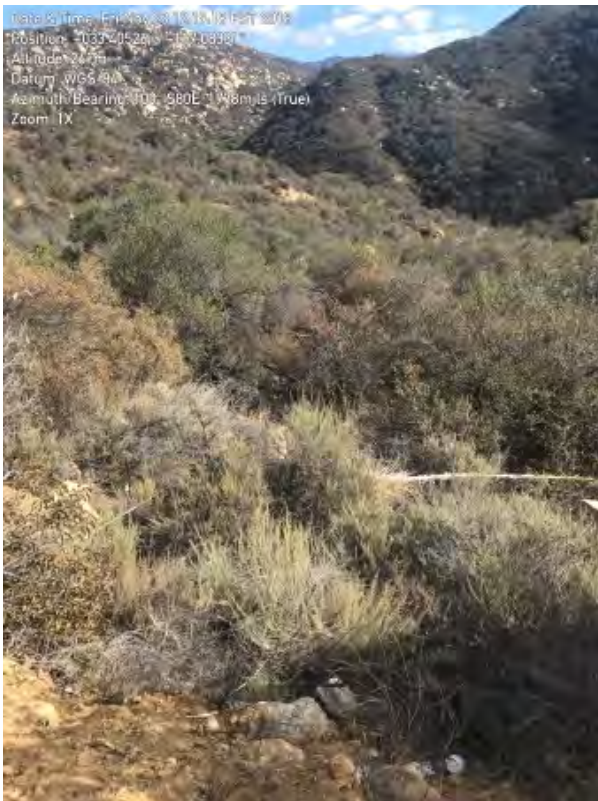
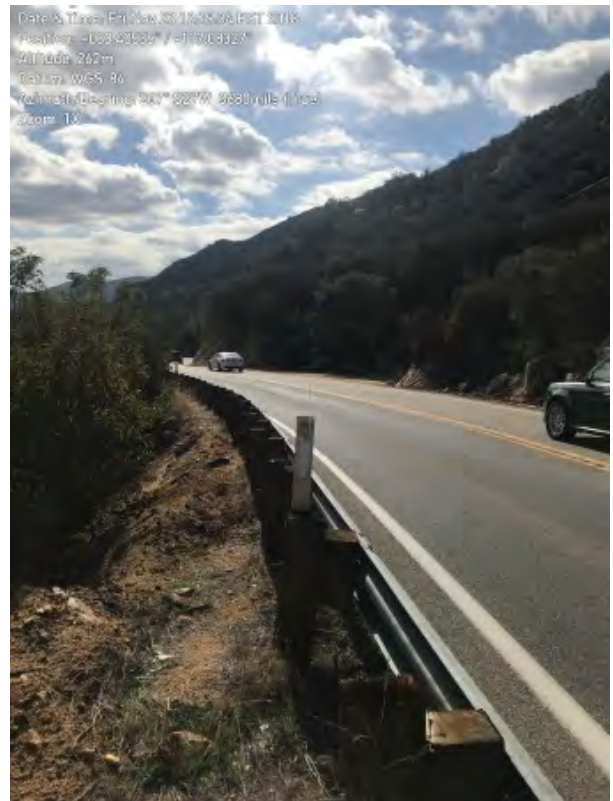
This is crossing points A47 & A48. Approx 100m south of eastern corridor that we know lions travel. West side at this spot is dangerous. There is good corridor on west side
