SA-PAL survey

| Project | SA-PAL project |
| ID | 42130 |
| Survey Date | 04/03/2019 |

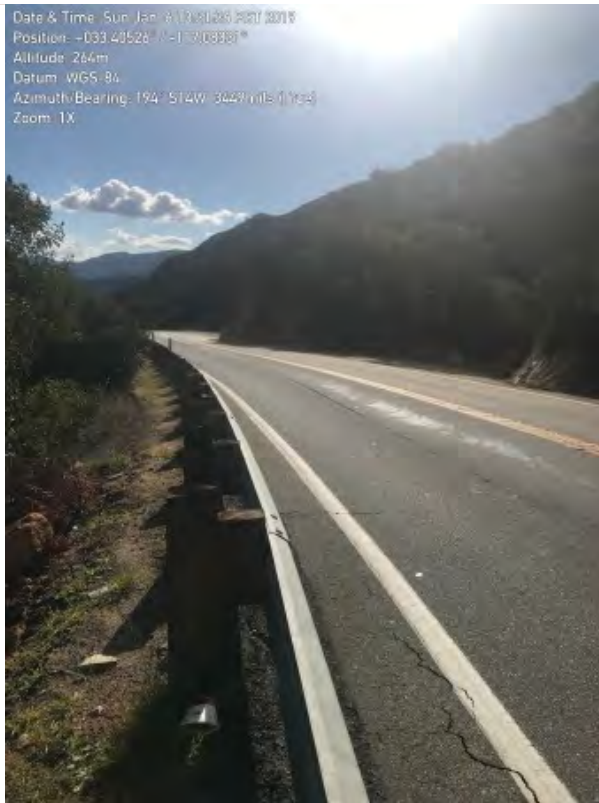
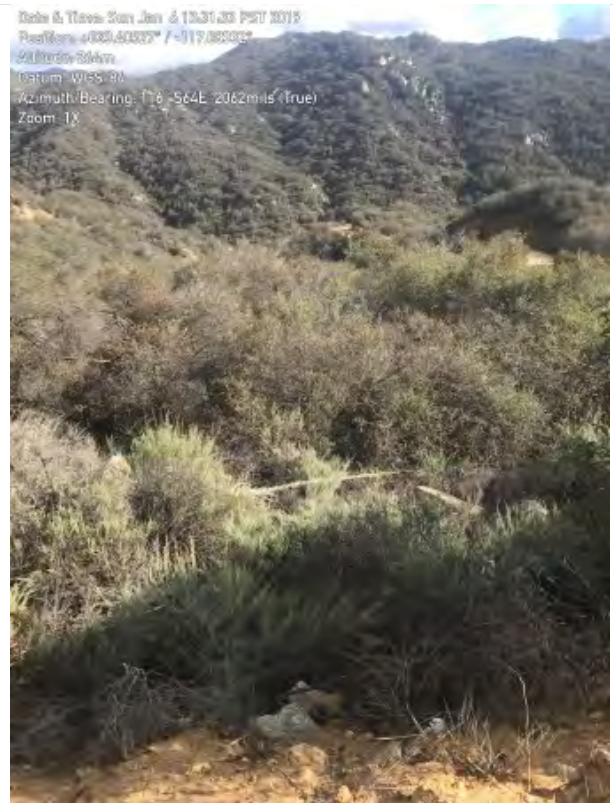
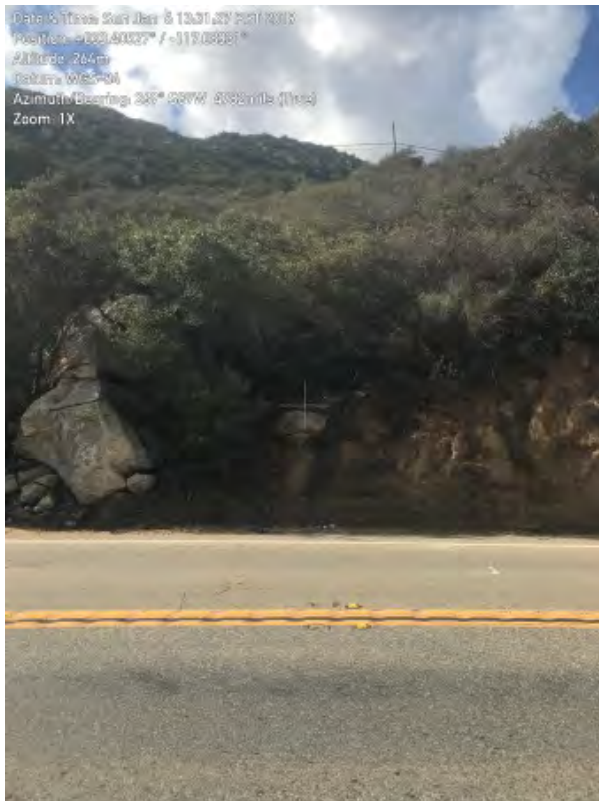
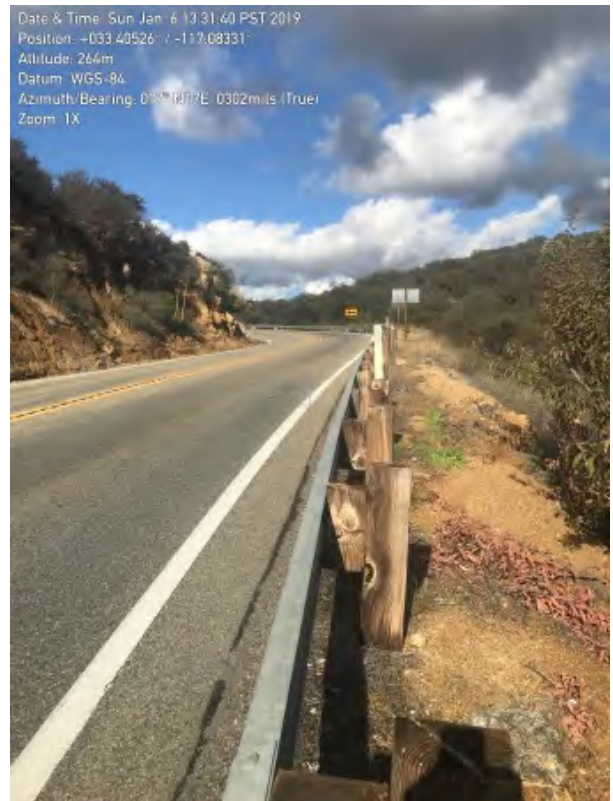
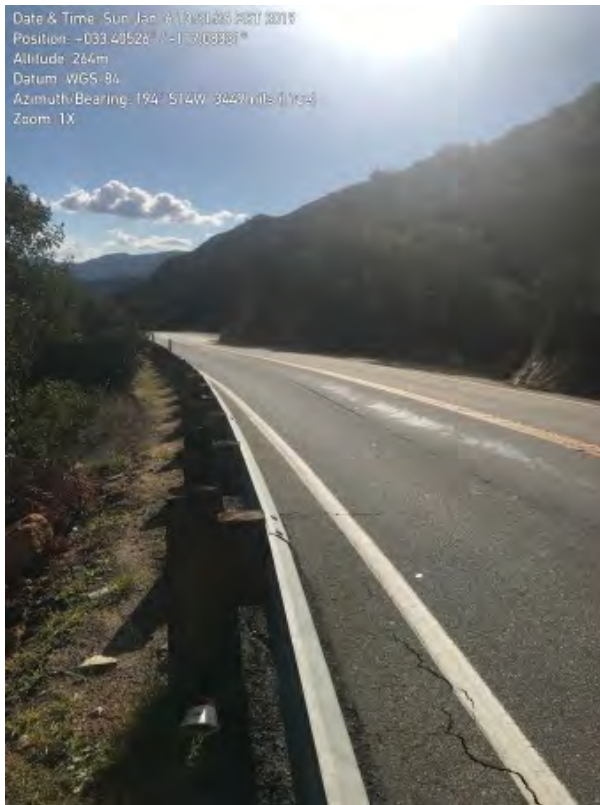
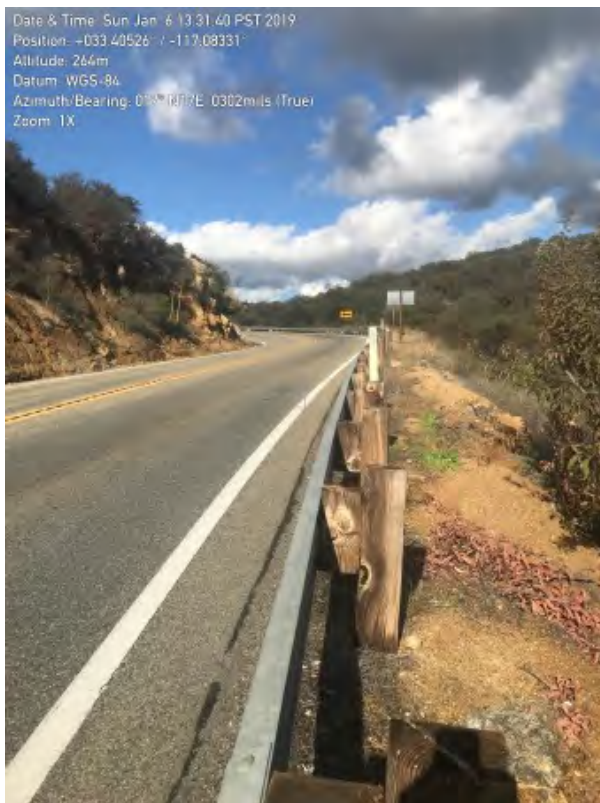
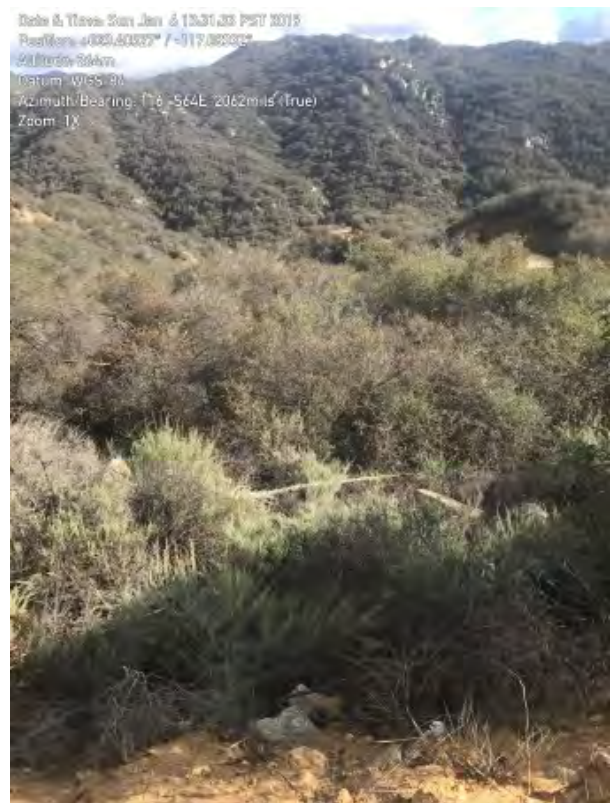
50-100 meters north much better corridors on both sides of the road including culverts at these better corridors

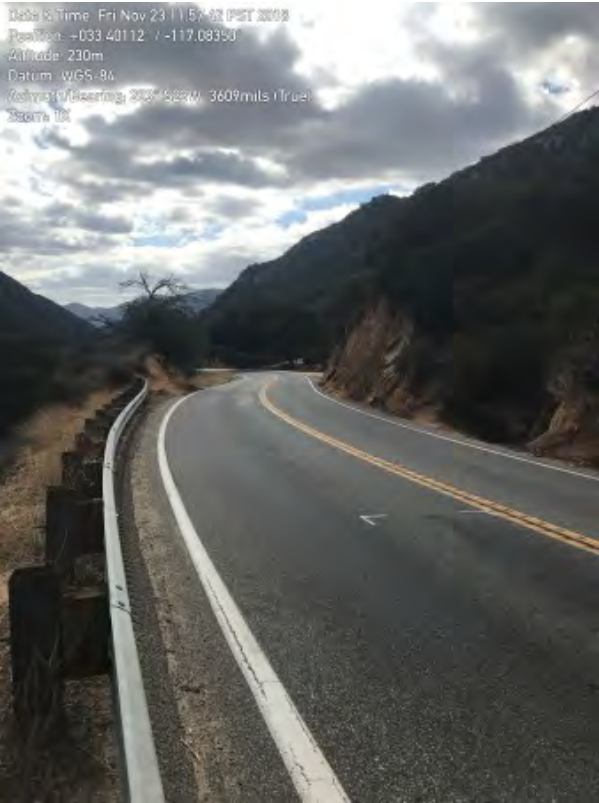
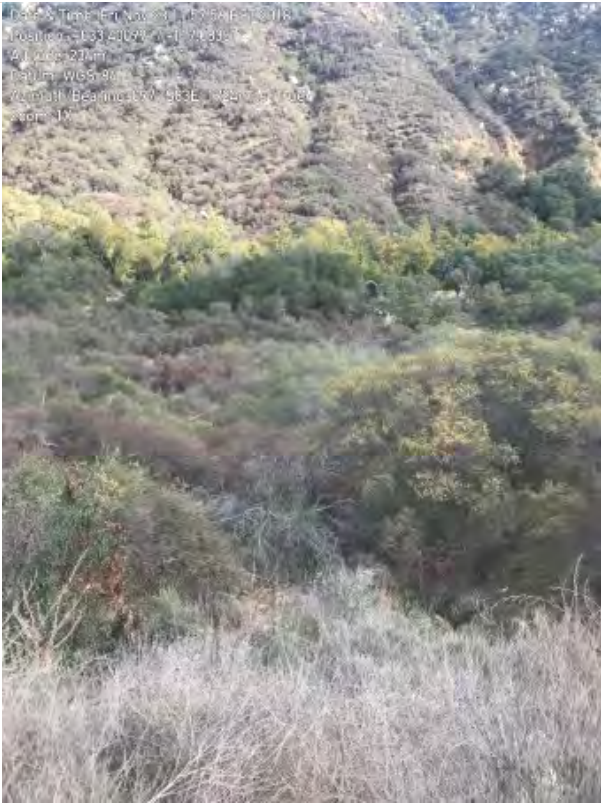
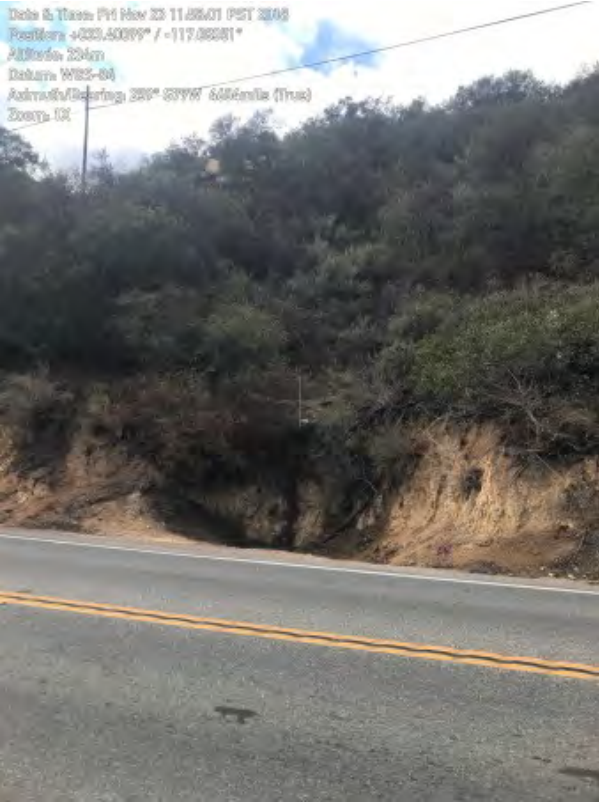
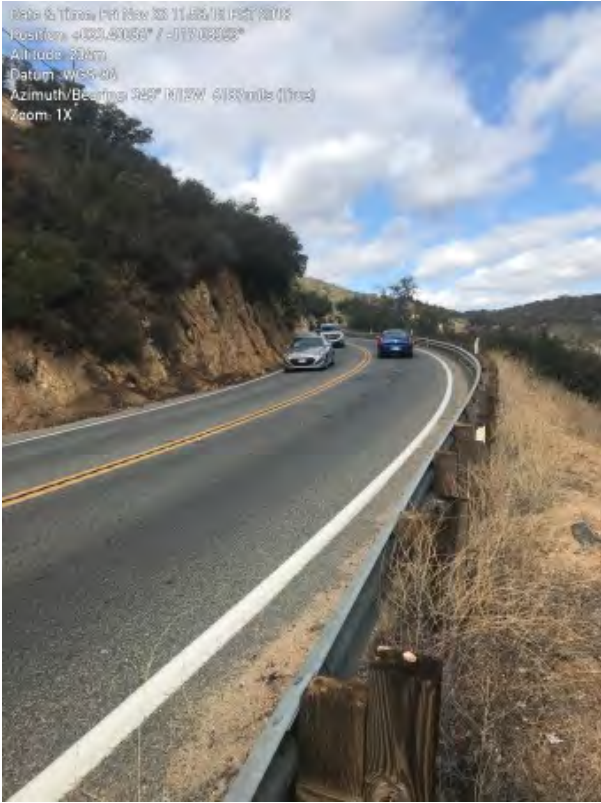
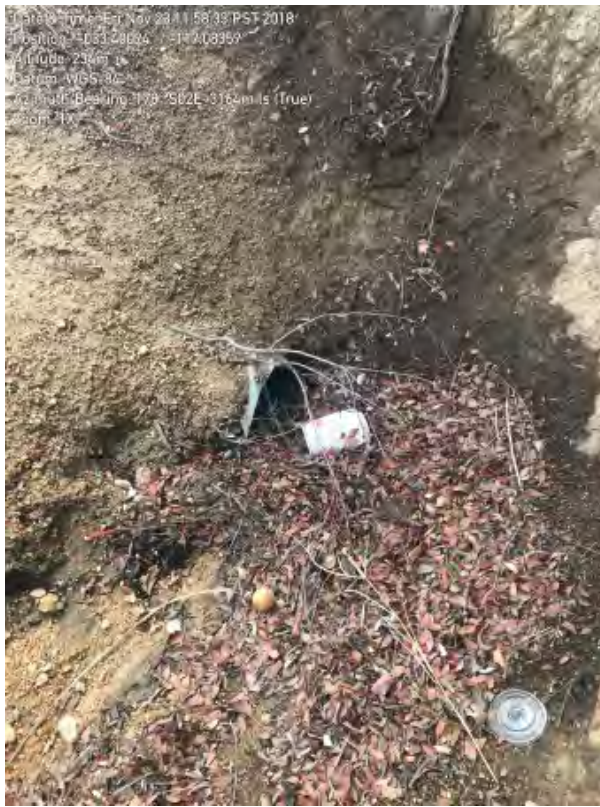
Dangerous curve at crossing on west side. Blind spot on west side. Small drainage culvert that slopes down from west to east from 2' below road on west to about 25' below road on east. Sharp slope on west side at shoulder for about 25m to south and a couple hundred meters to north. Better corridor on west side to the south at Mt. Olympus service rd entrance.

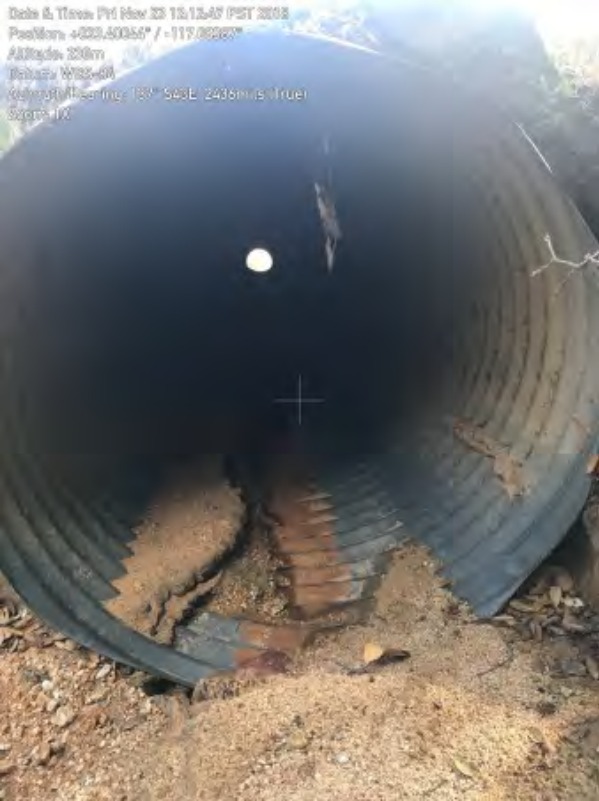
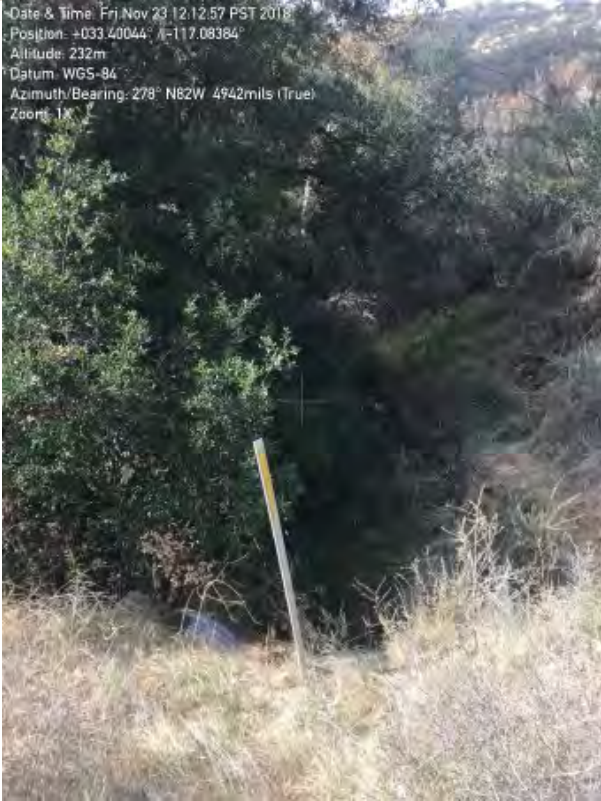
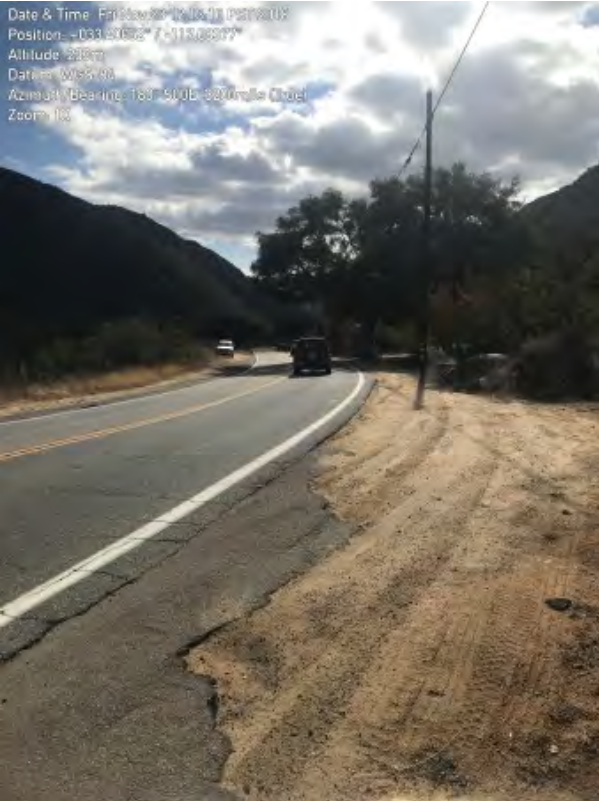
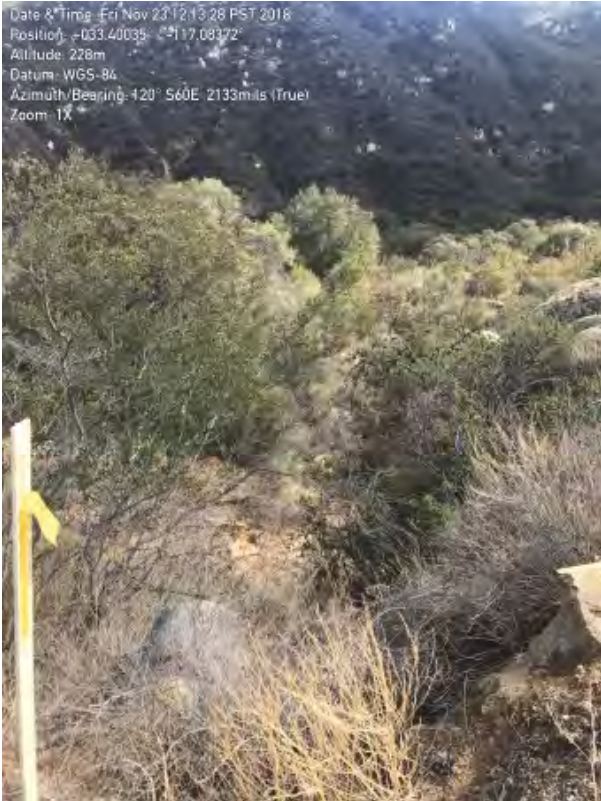
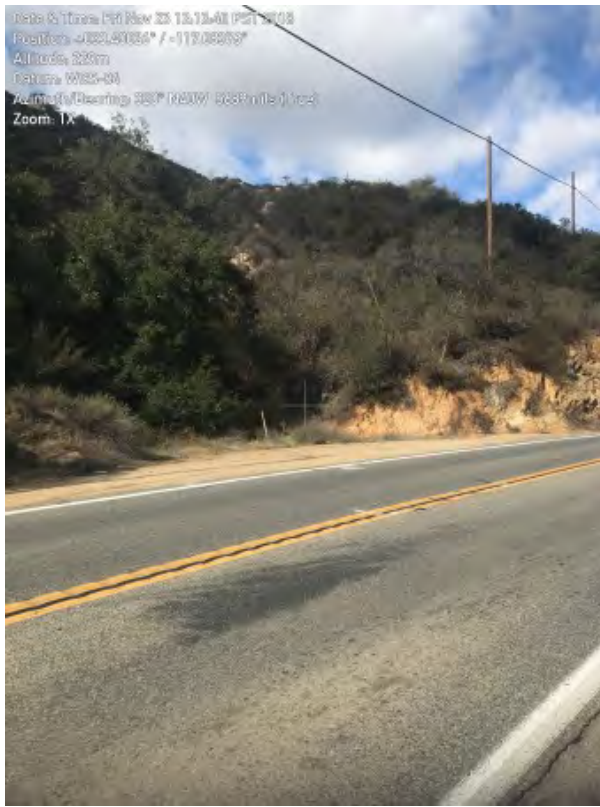
Located approx 25m south of A50. Good corridor on both sides. Spray painting on road at culvert indicates future road work.

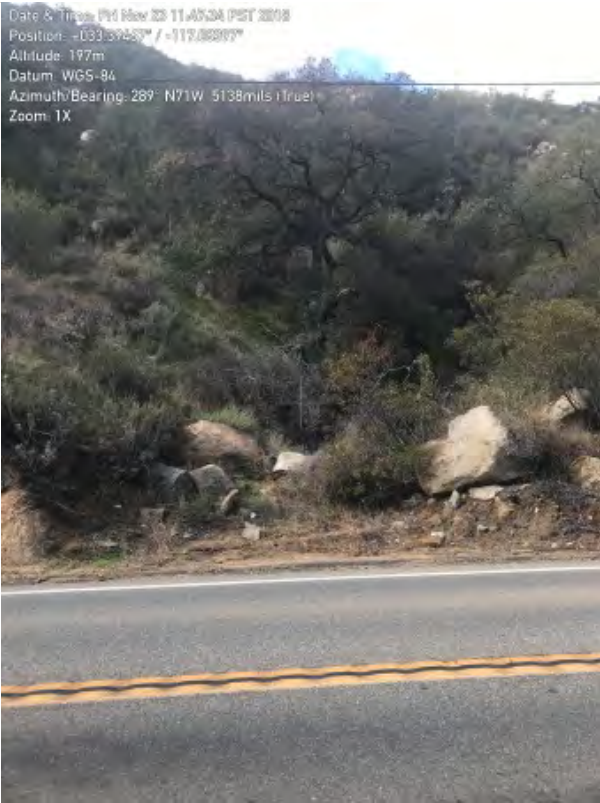
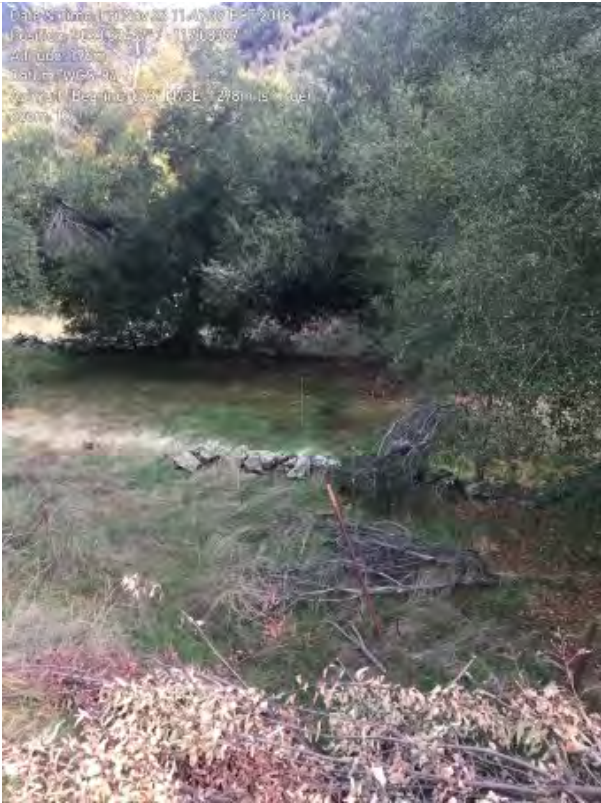
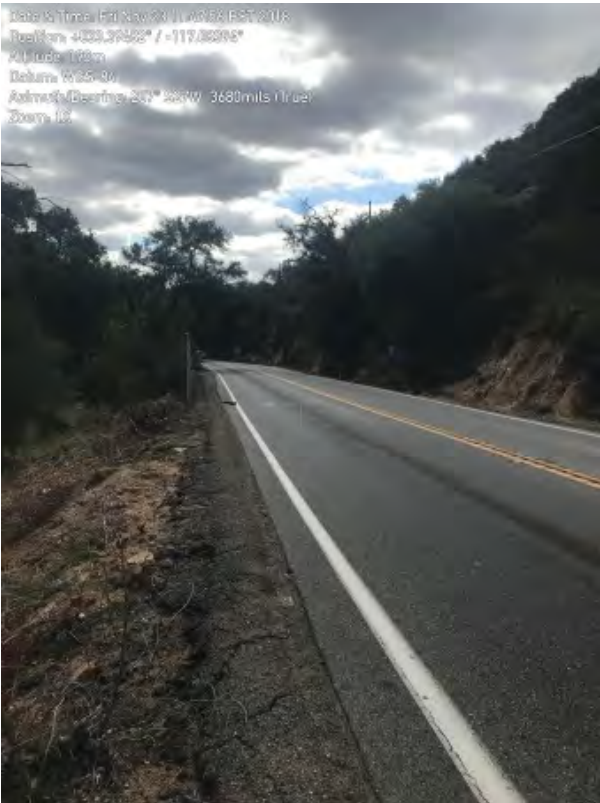
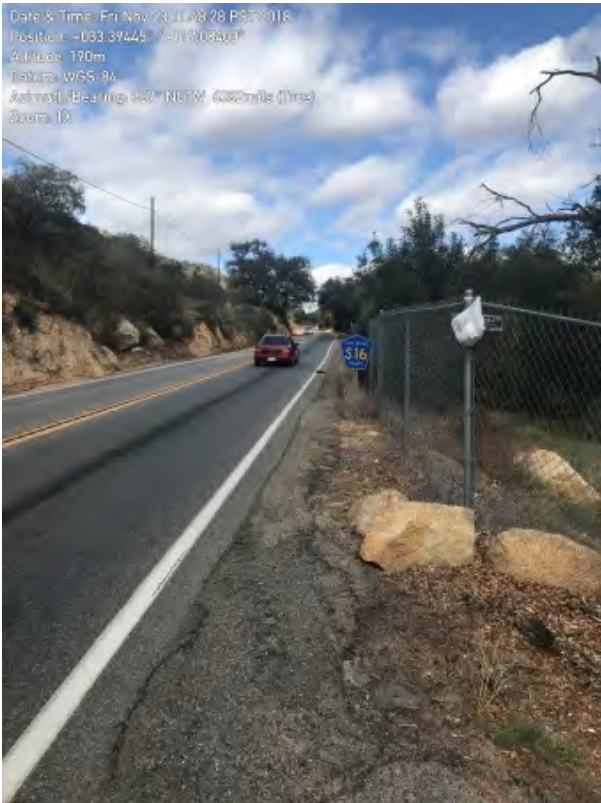
| Comments | Good corridors on both sides of road 2' drainage culvert approx 25m south of crossing. West side culvert opening is against rock face, provides drainage, does not provide connectivity to any corridor. |

| Management recommendations | Large culvert and directional fencing. |

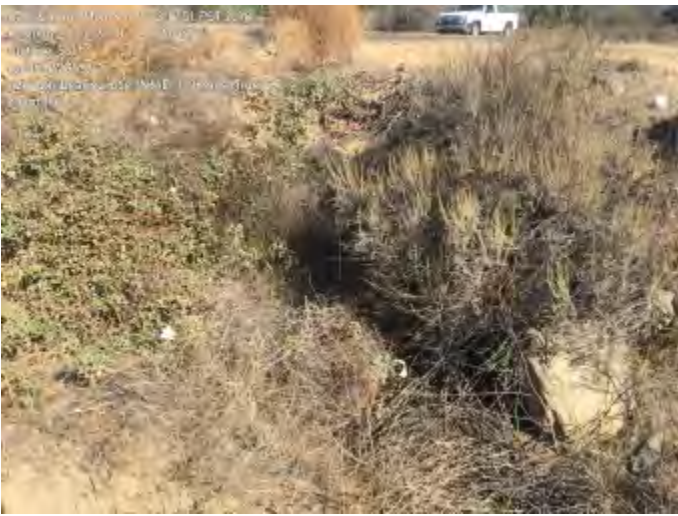
eastbound Culvert exit not accessible.

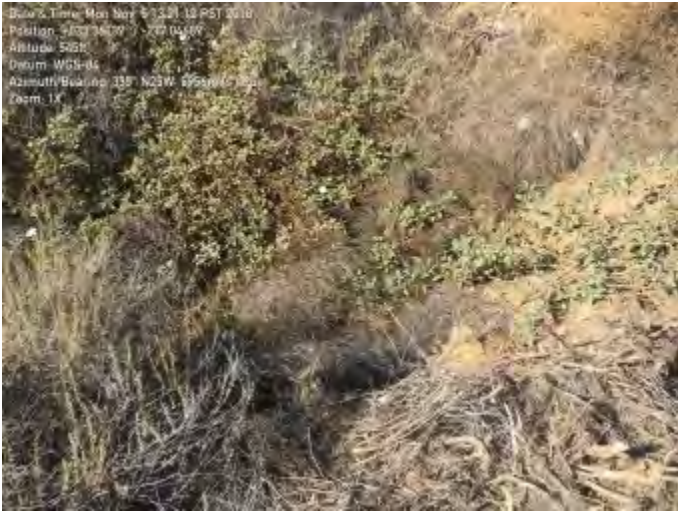
eastbound culvert exit not accessible

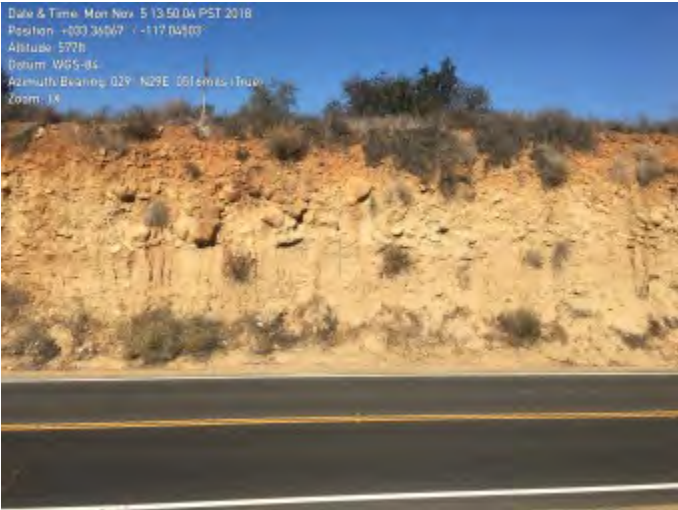
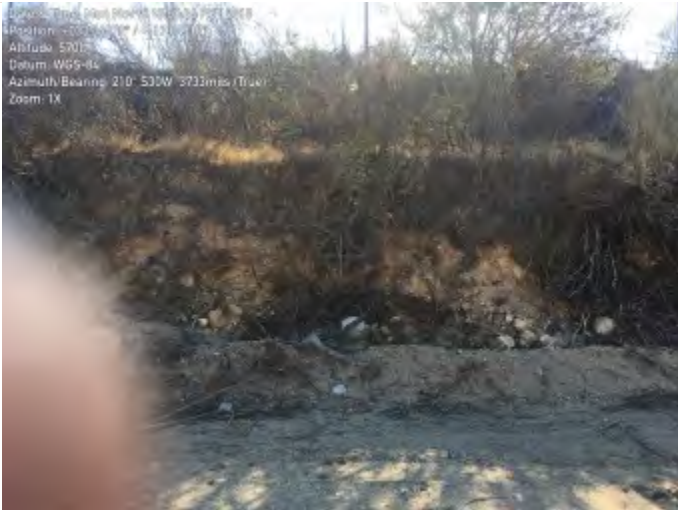
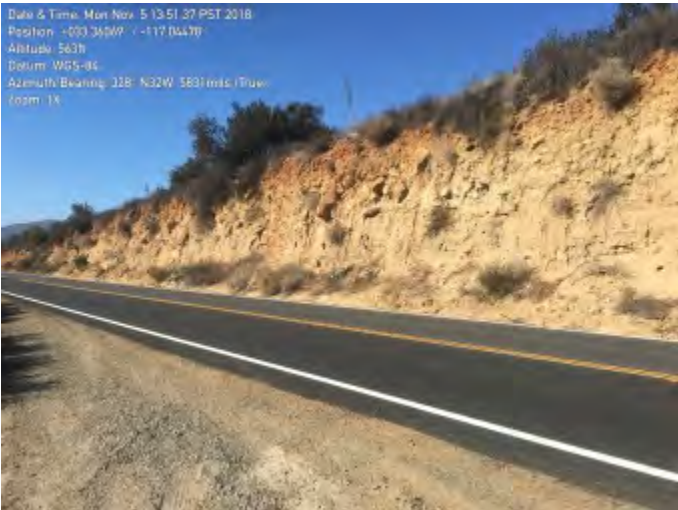
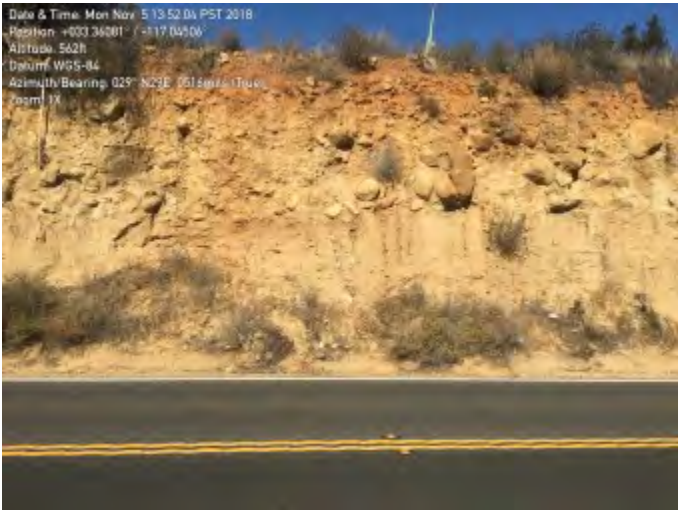
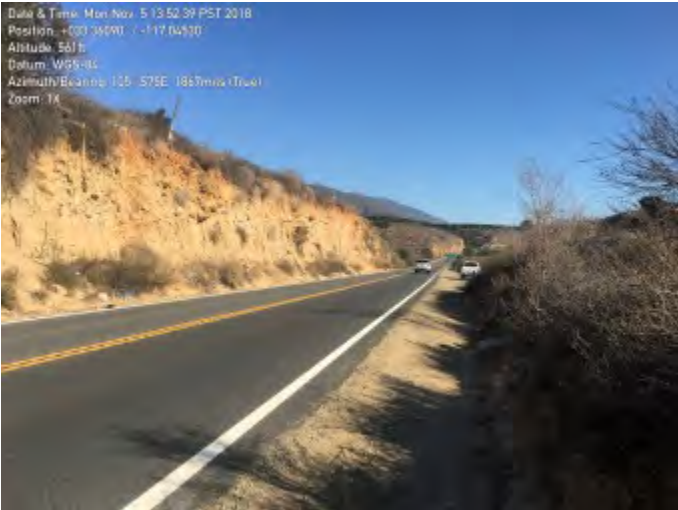
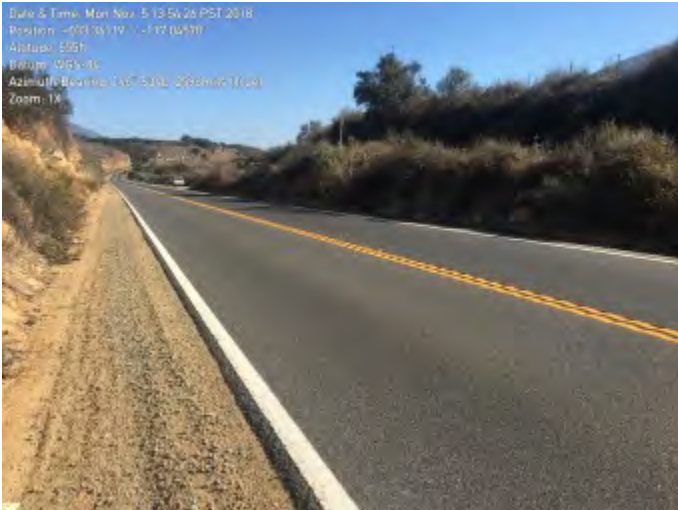
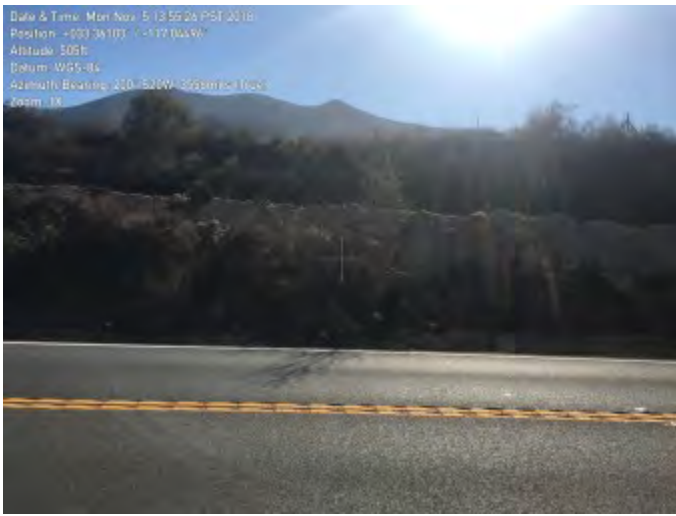
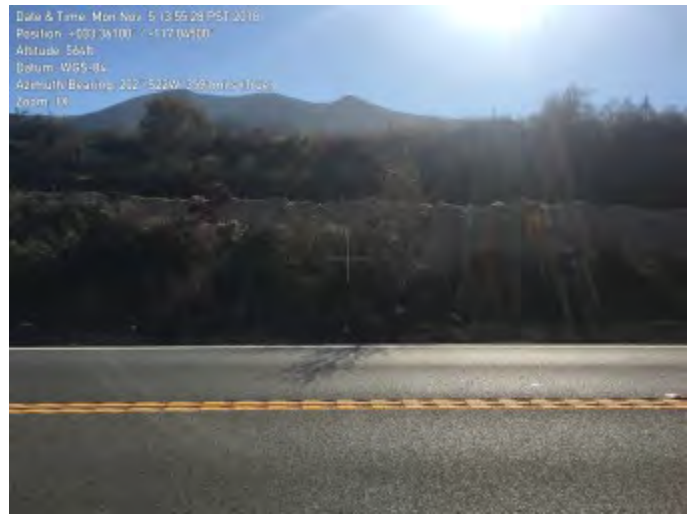
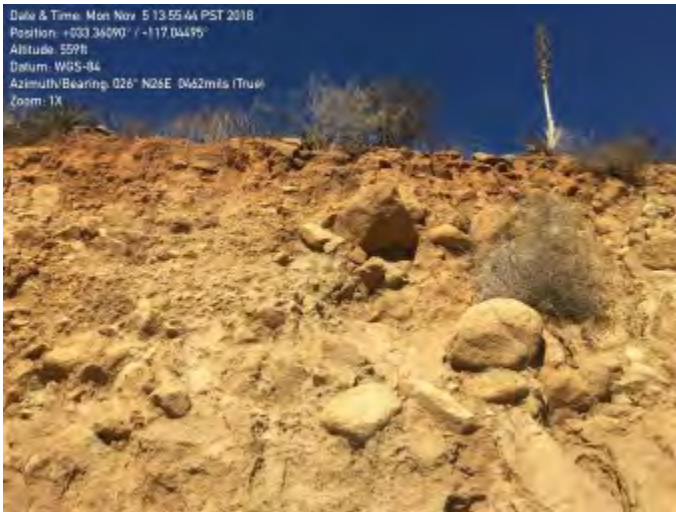
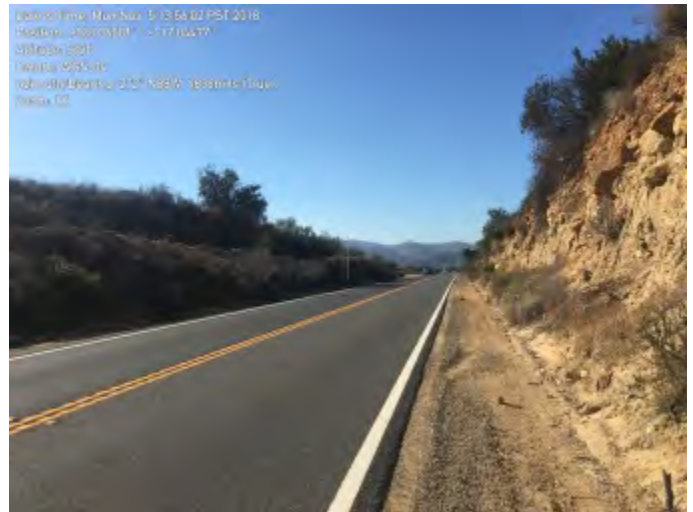
| Describe fencing type and height | Four foot barbed wire at top of eastbound embankment. Parallel to road. None on westbound side. |

Barrier fencing. There is an excellent crossing location approximately 100 meters east of this location at Marion Canyon. I would recommend trails and directional fencing to direct wildlife away from A53 toward the Marion Canyon location.

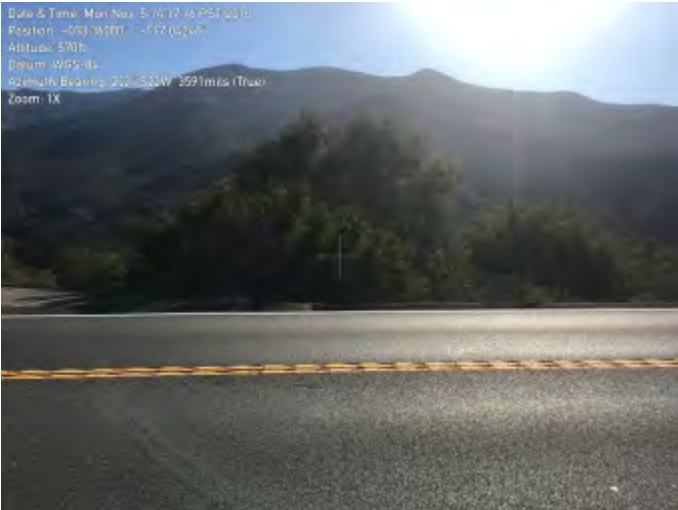
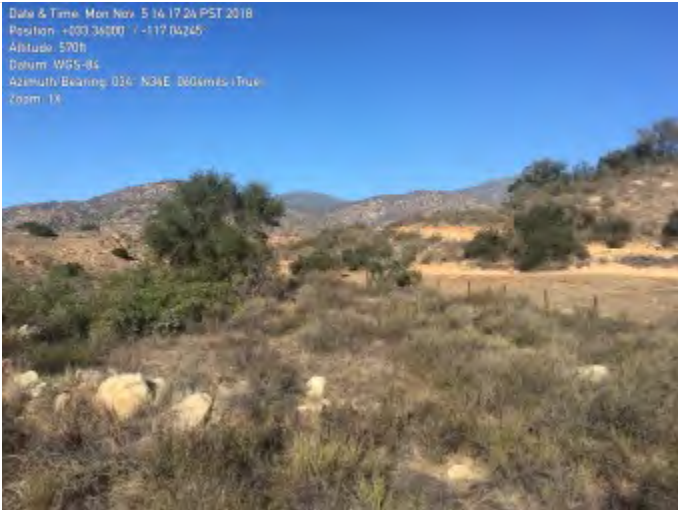
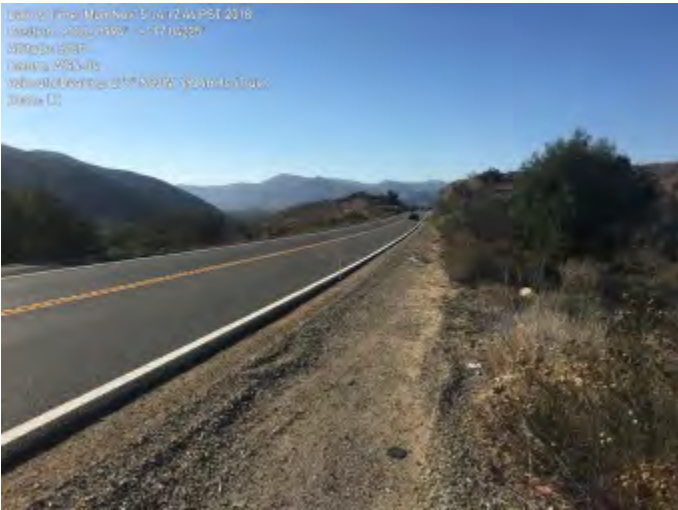
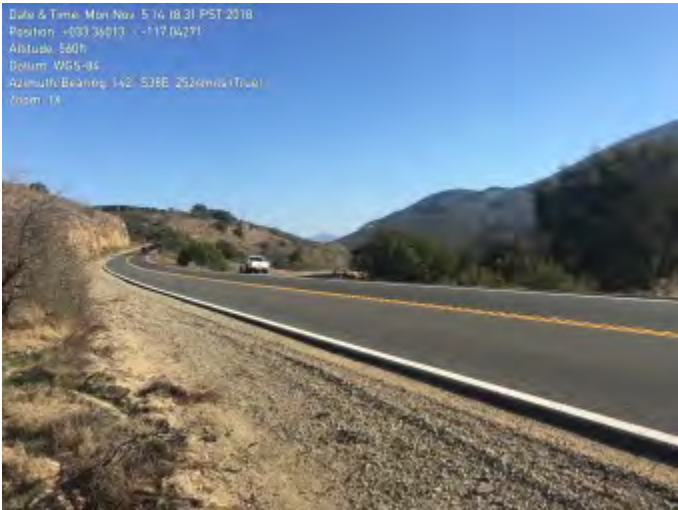
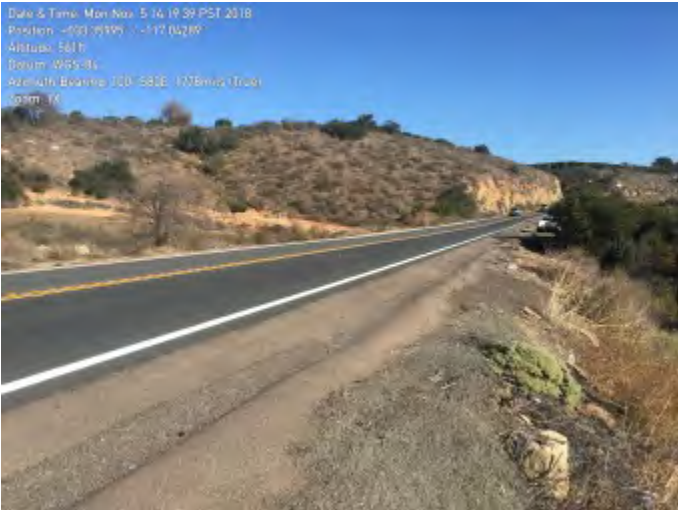
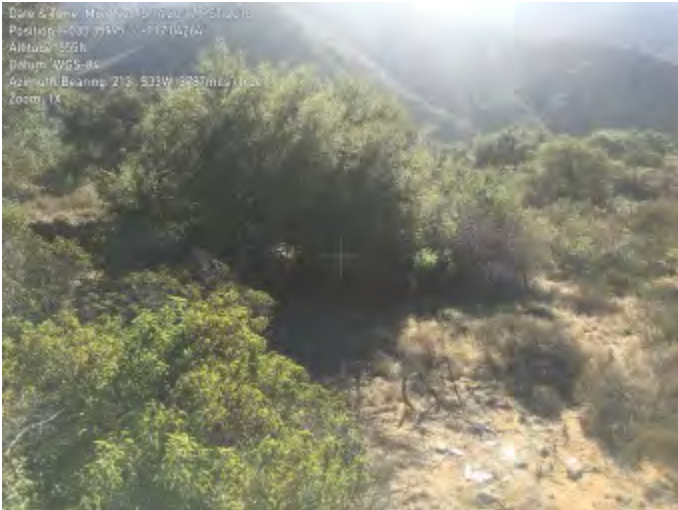
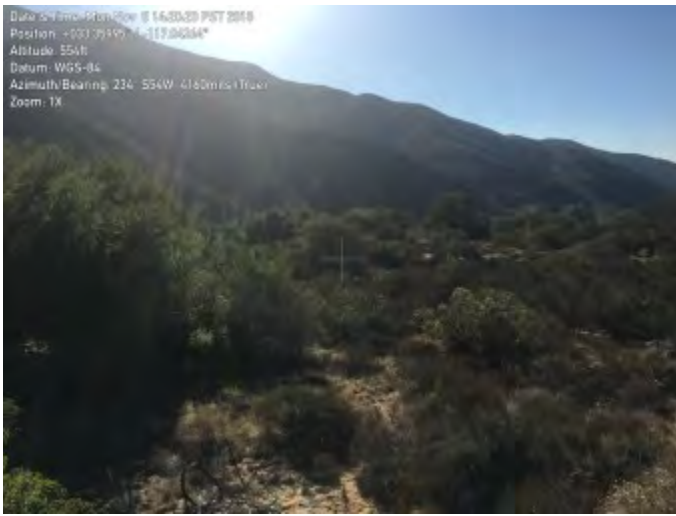
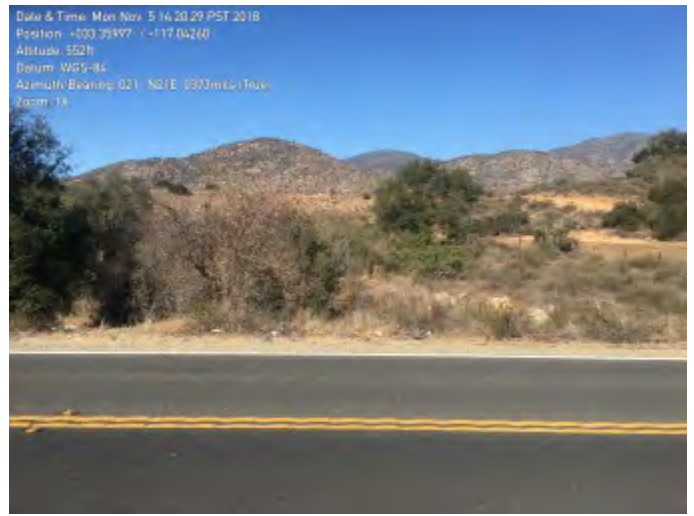
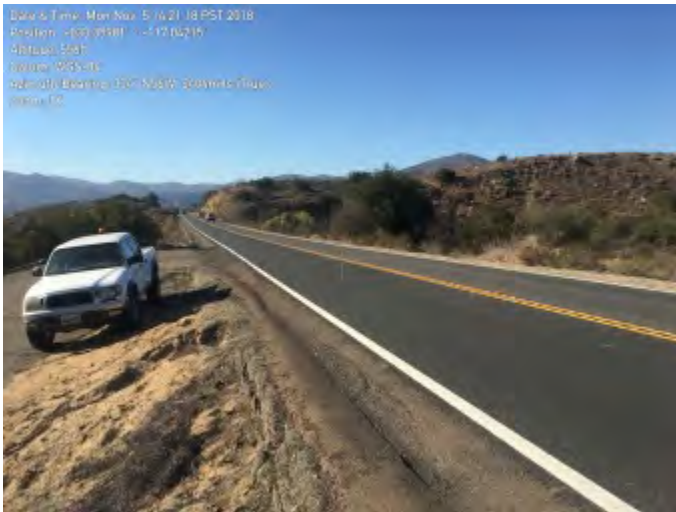
| Comments | Excellent crossing location approx. 100 meters north of here at Marion Canyon. |

| Management recommendations | Fencing and trails funneling wildlife to undercrossing 100 meters north at Marion Canyon. Barrier fencing to prevent crossing at A54. |

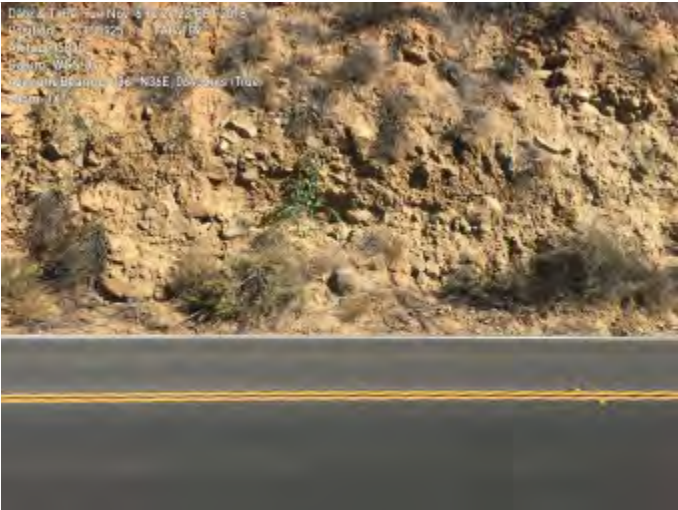
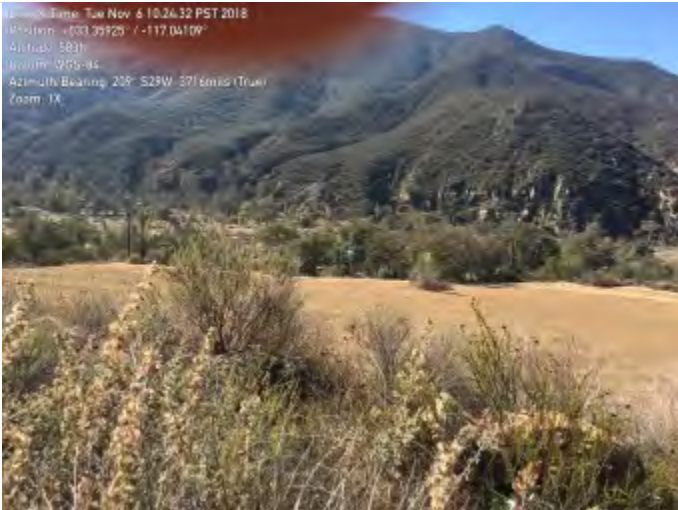
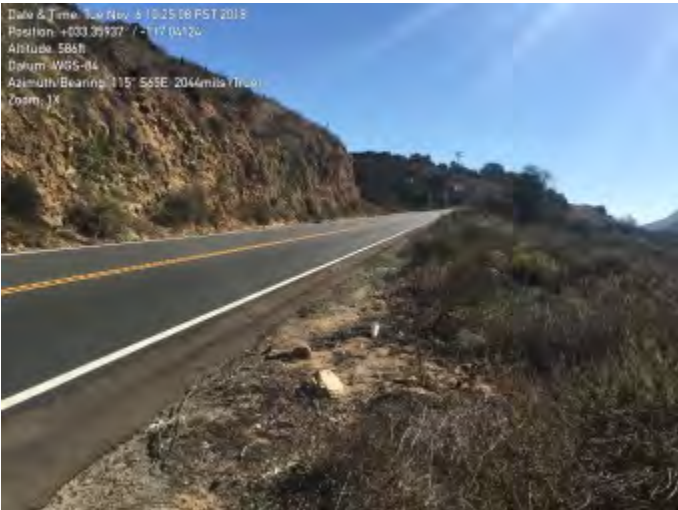
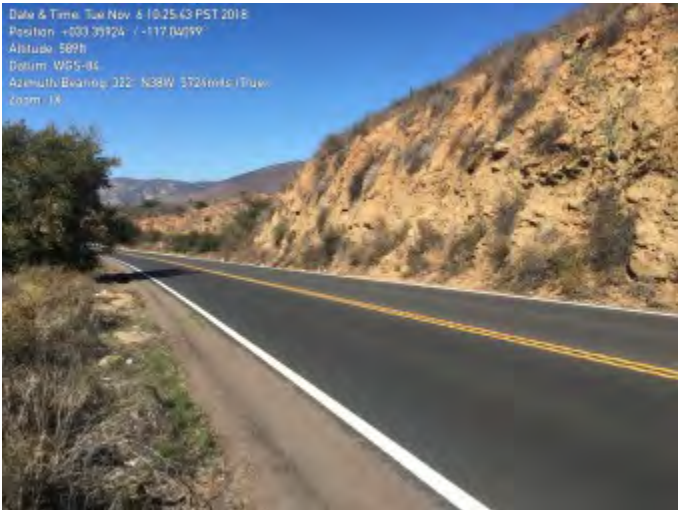
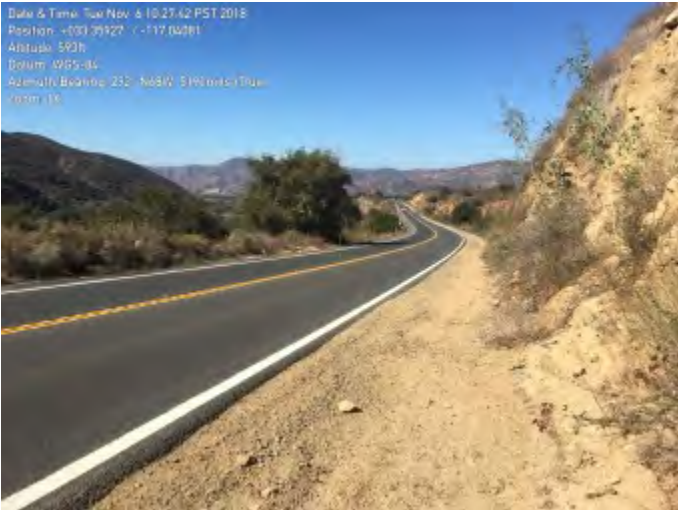
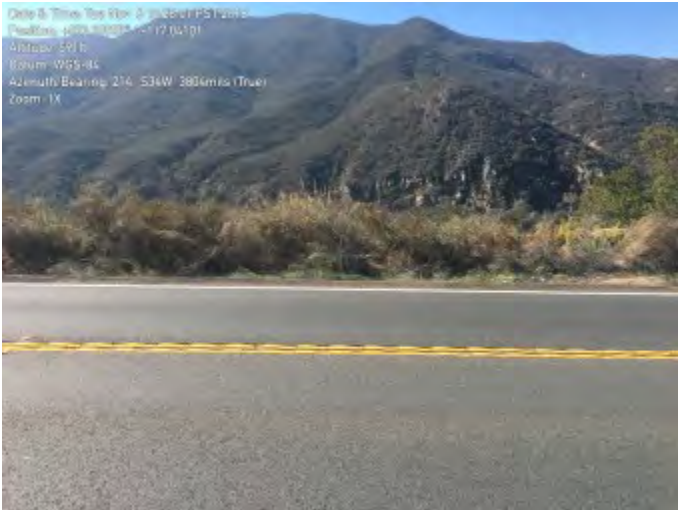
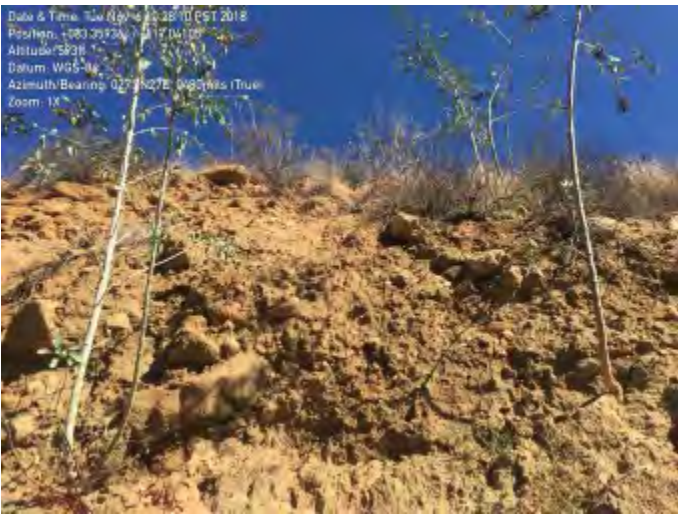
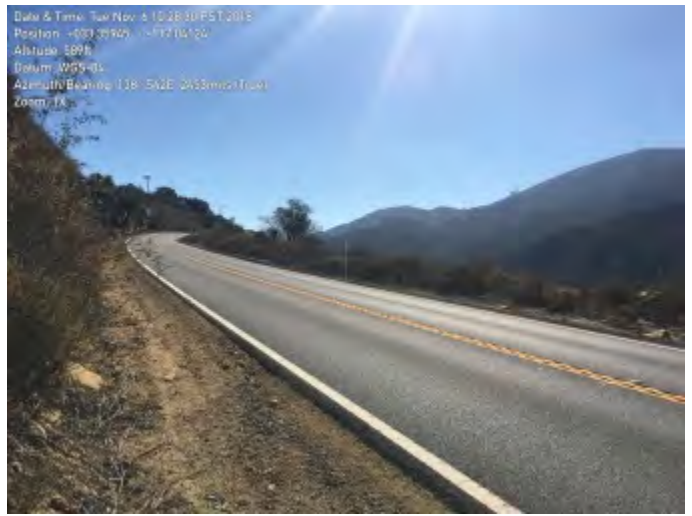
| Describe constraint | Prohibitive high embankment as noted above. Wildlife cannot cross at this location due to that constraint unless the animal travelled east or west from adjacent site first. Traffic noise is significant here. No shoulders on roadsides, and this site is in the middle |

| Describe fencing type and height | Barbed wire at top of westbound embankment. |

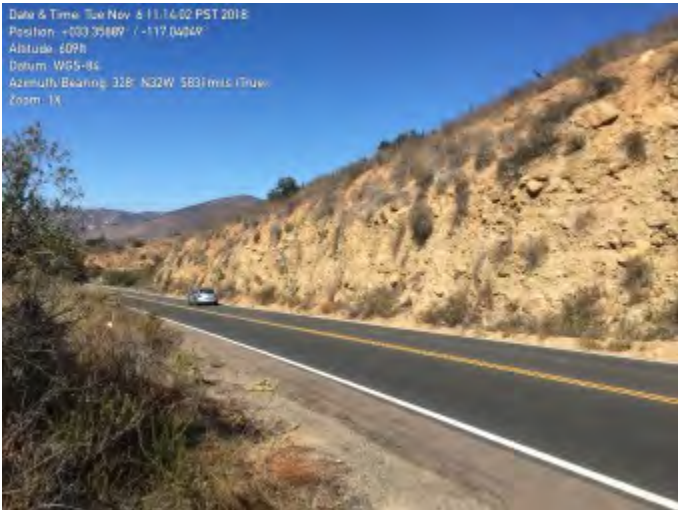
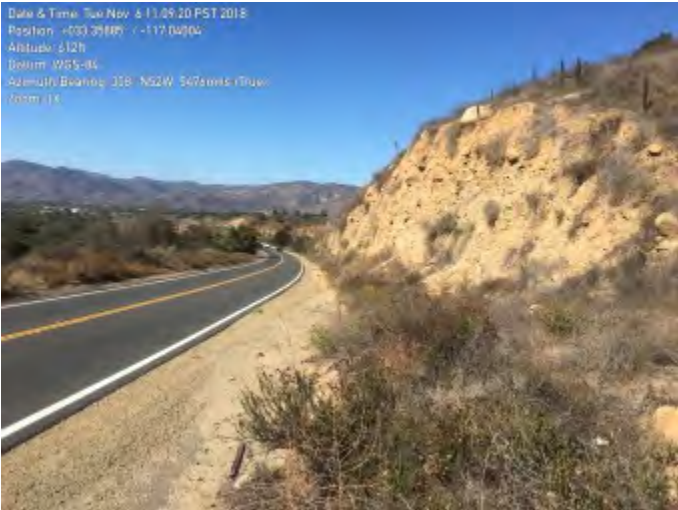
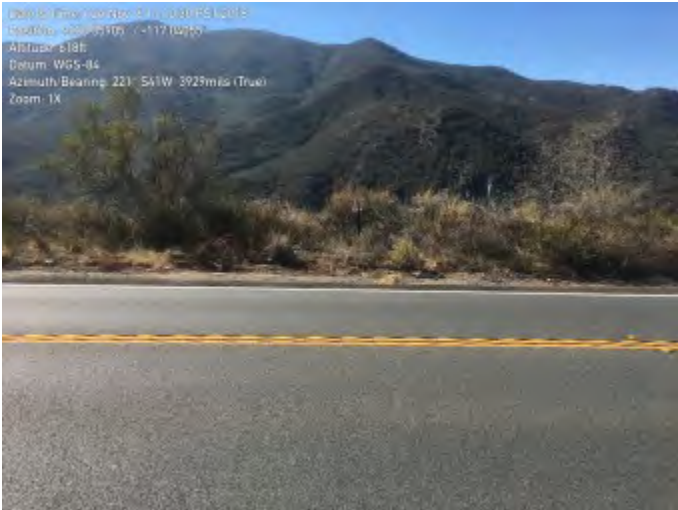
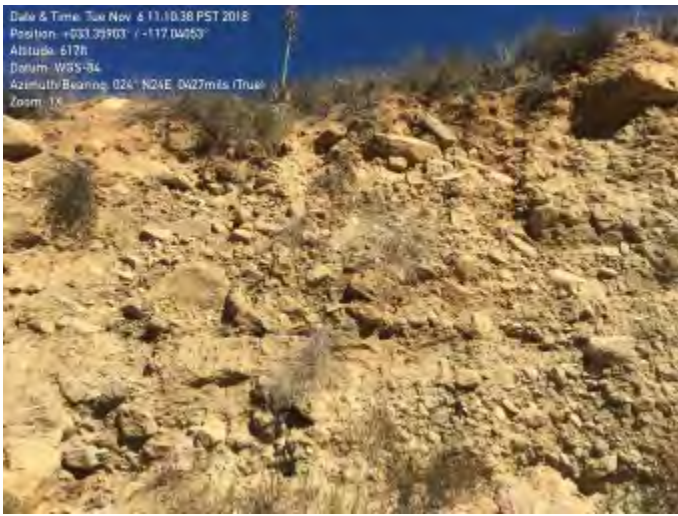
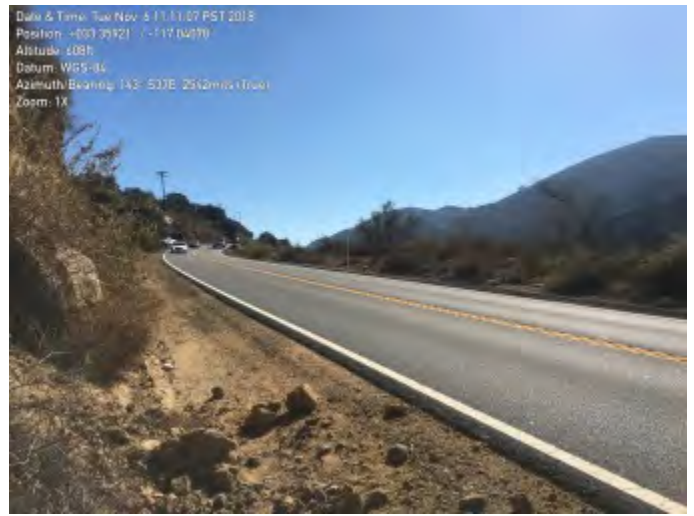
| Comments | Poor crossing location due to prohibitive embankment and ag land to the north. |

| Management recommendations | Barrier fencing. Wildlife trails and fencing to facilitate travel to adjacent areas more conducive to crossing. |

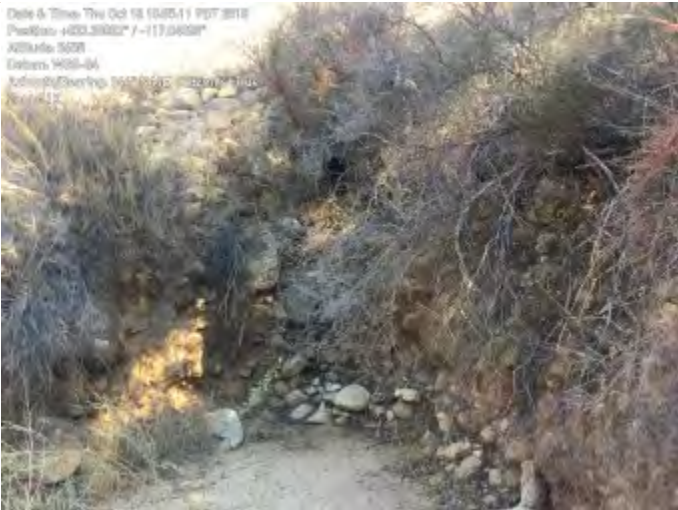
eastbound Note elevated culvert exit

| Comments | Current crossing at grade for larger animals. Good location for increasing diameter of existing culvert. North and south sides amenable to wildlife corridor. |

| Management recommendations | Wildlife crossing signs. Rumble strip. Increase diameter of existing culvert. Barrier fencing. Directional fencing. Culvert would need to be placed lower on eastbound side, or ramp added at this culvert exit due to its height off the ground. |
