SA-PAL survey

| Project | SA-PAL project |
| ID | 42130 |
| Survey Date | 04/03/2019 |

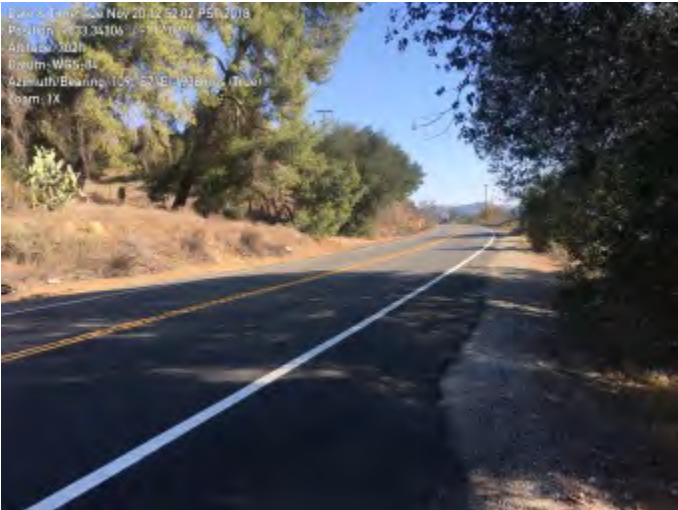
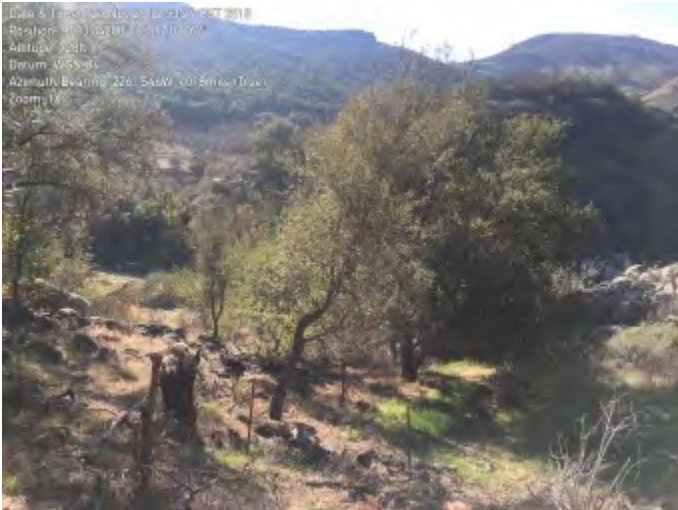
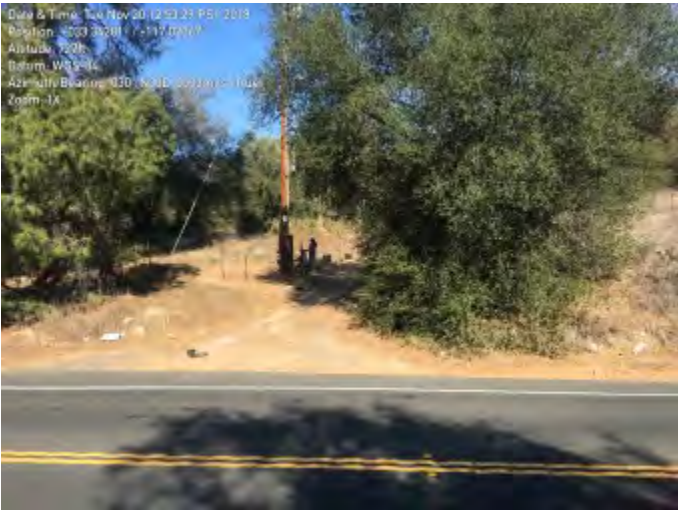
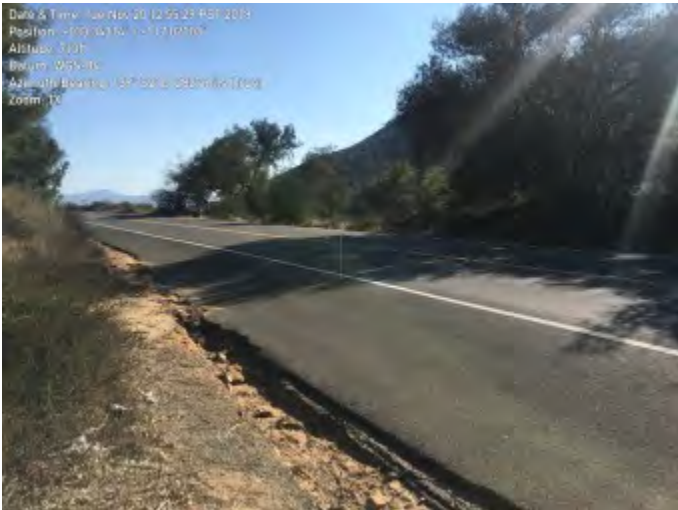
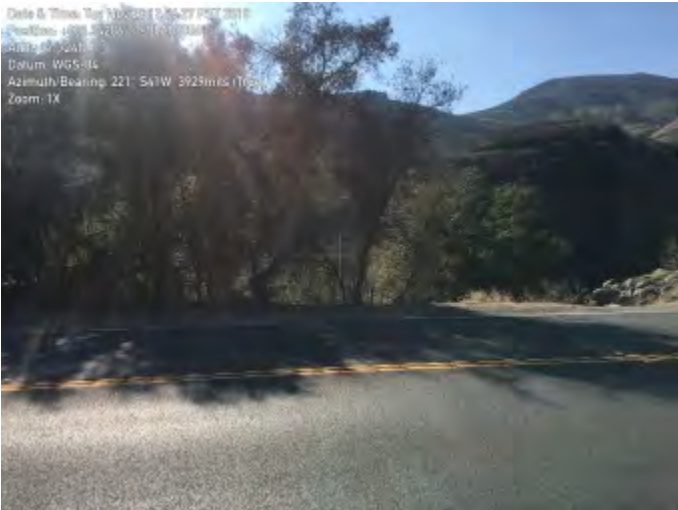
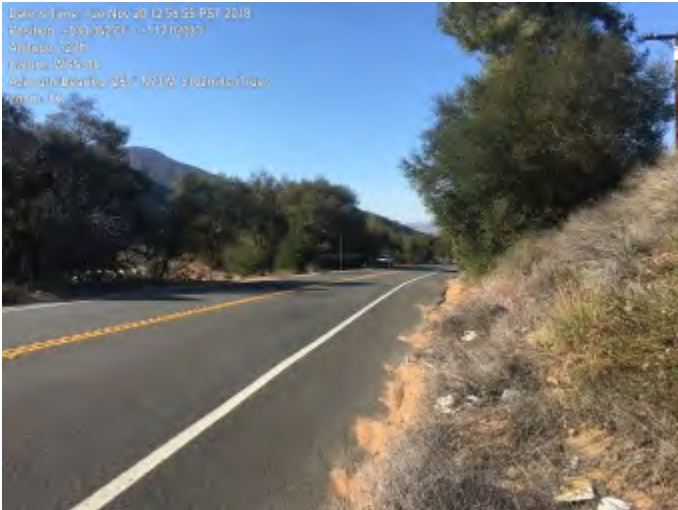
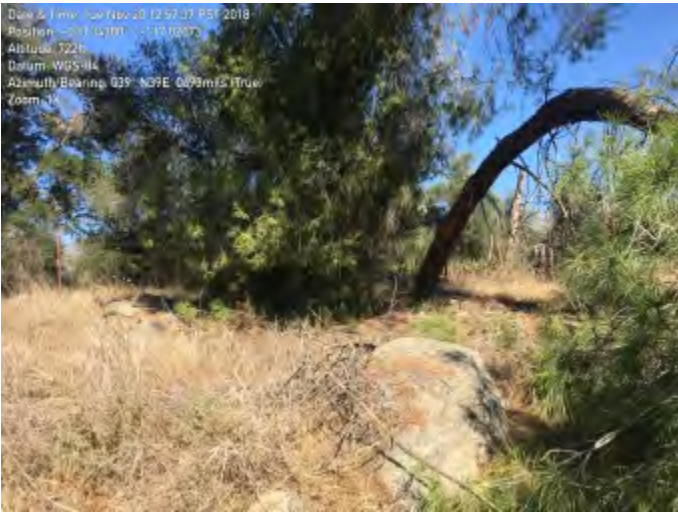
| Comments | This location is approximately 50 meters east of Frey Creek Bridge. That location completed as a separate survey. In this general area, the Frey Creek Bridge is the most acceptable crossing location. There is no separate culvert or structure associated with A62 or A63. There is a private residence on the north side of the road here. |

| Management recommendations | Barrier fencing. Directional fencing and trails to funnel animals toward Frey Creek Bridge undercrossing. |

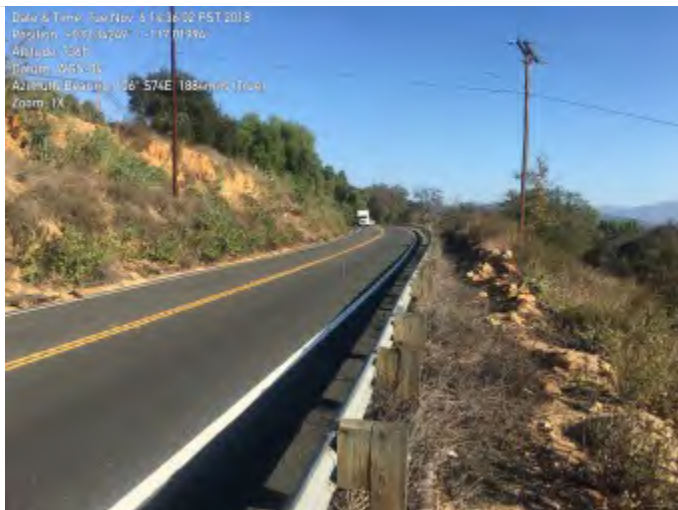
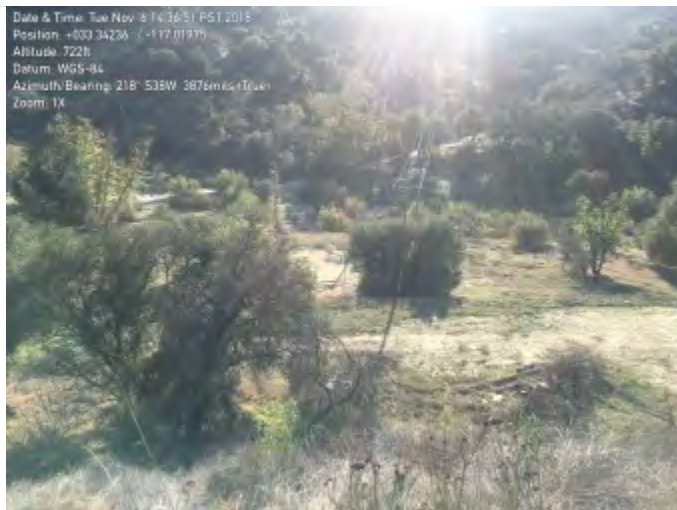
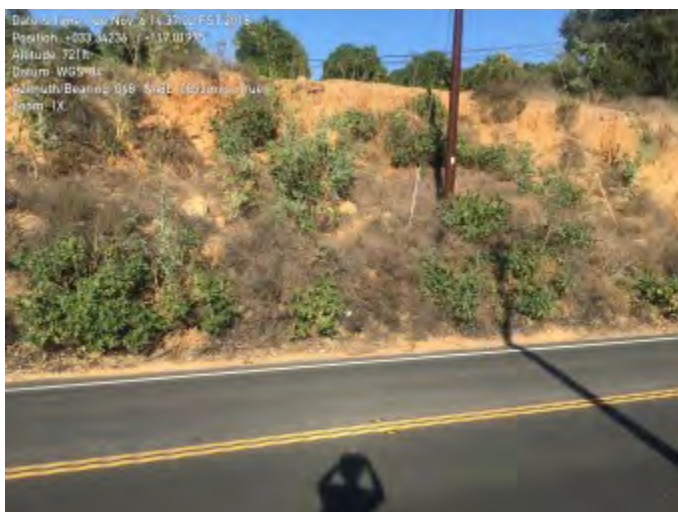
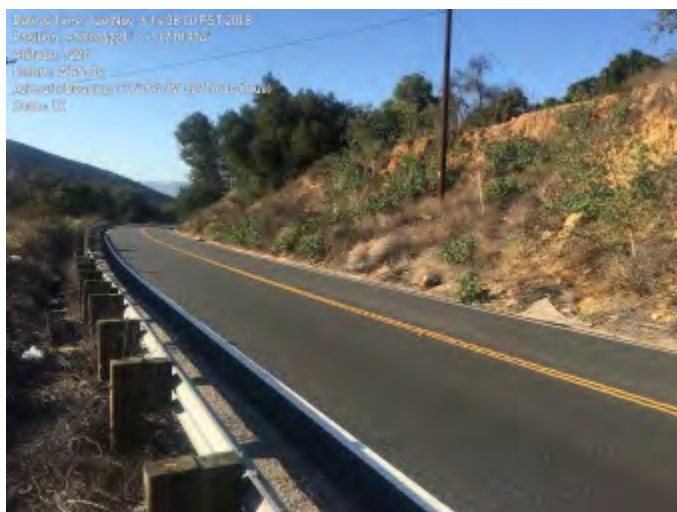
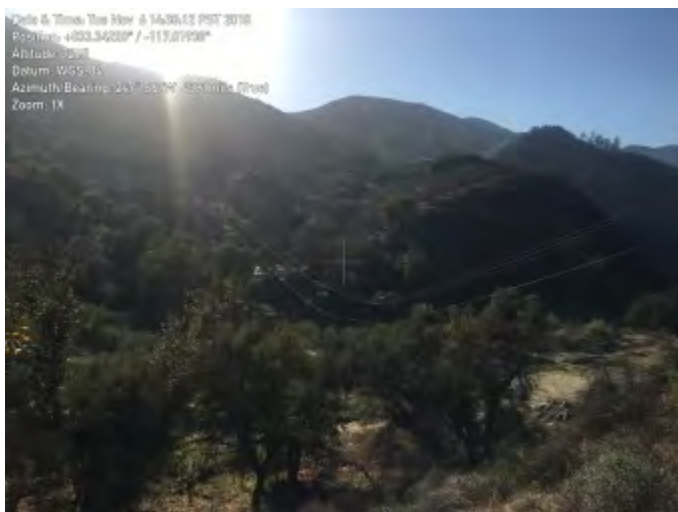
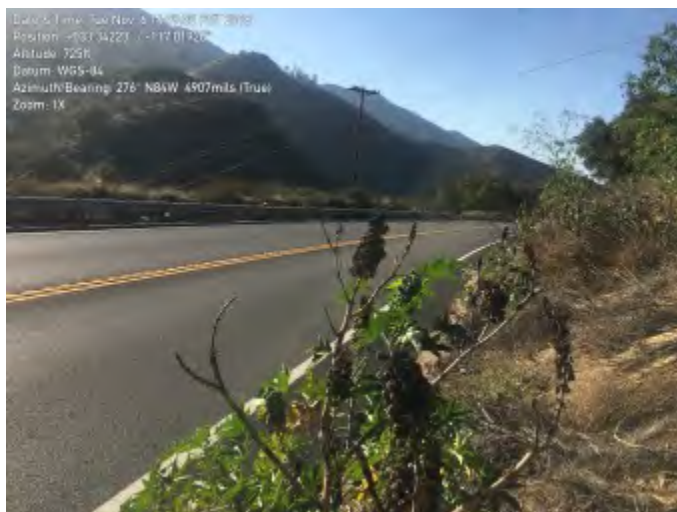
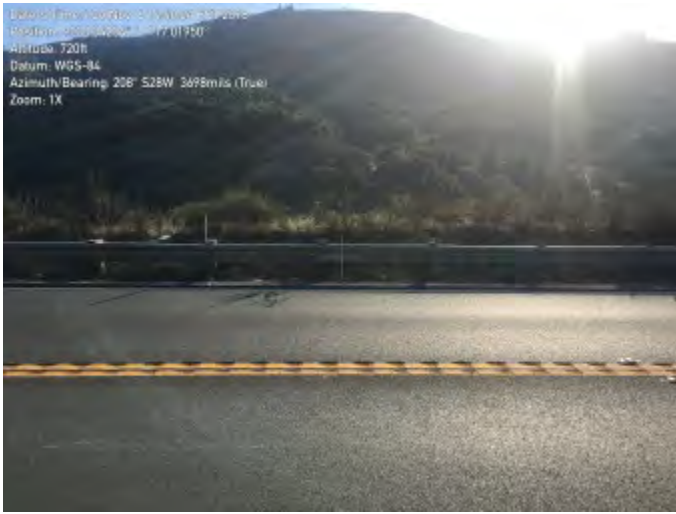
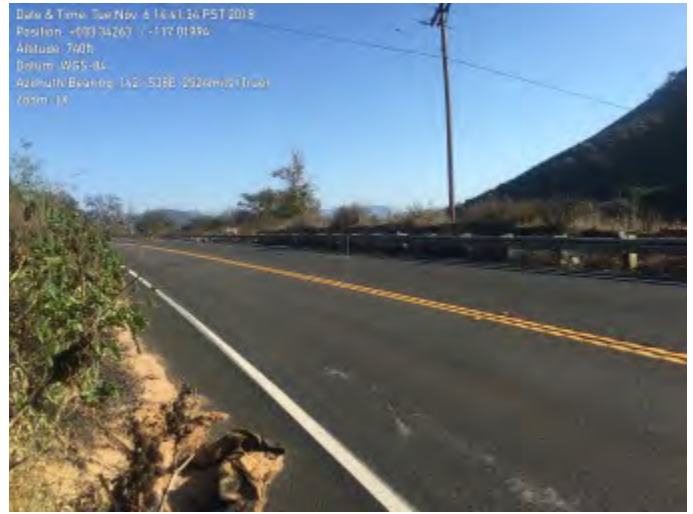
This is an inadequate crossing area with poor road access on the westbound side due to embankment and on eastbound side due to steep downslope embankment. This location is at the apex of a blind turn from both directions. There is some traffic on small residential road approx. 100 to the south. (Pauma Ridge Rd.) No access for culvert or wildlife bridge here. 76 is on the side of a hill at this location.

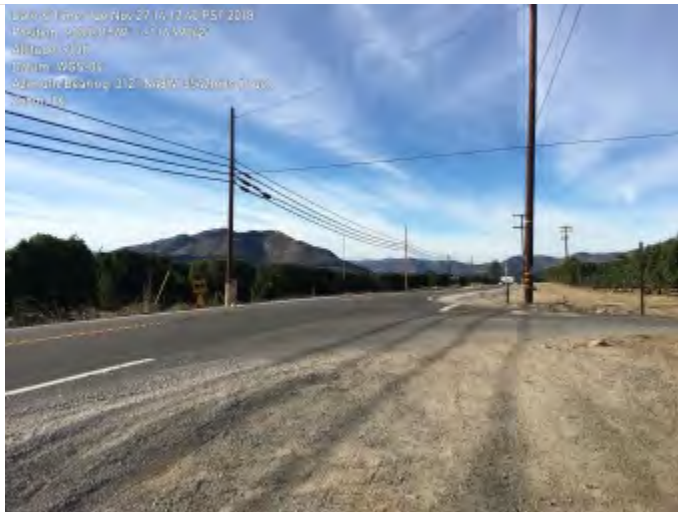
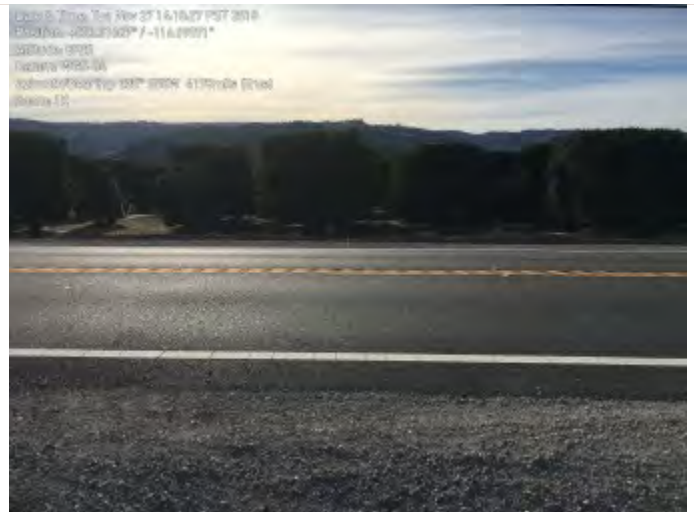
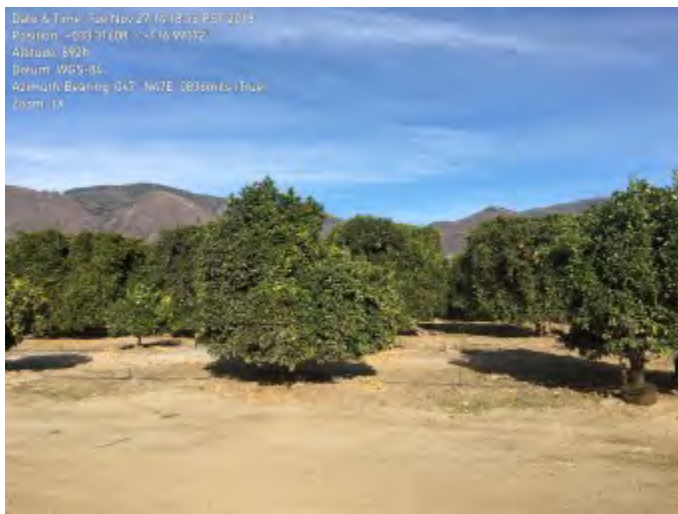
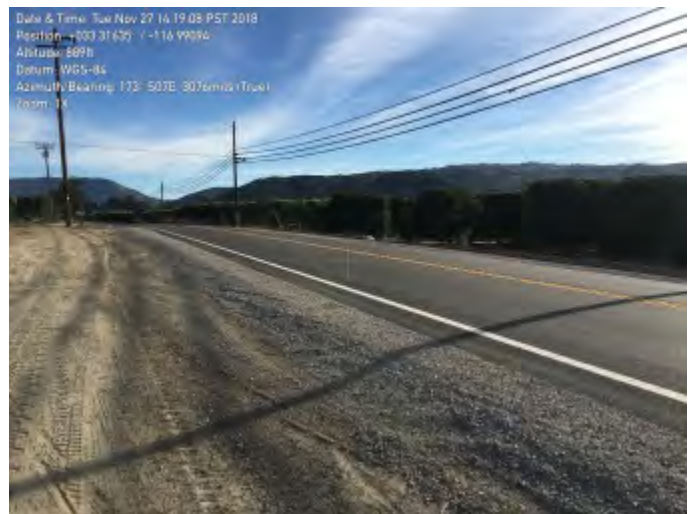
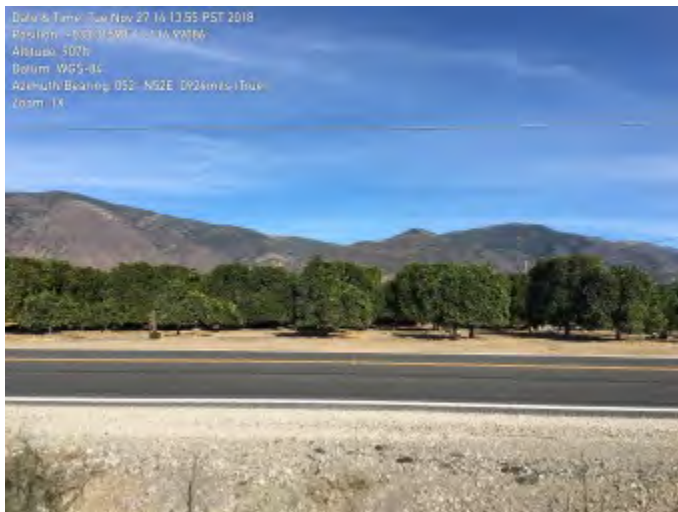
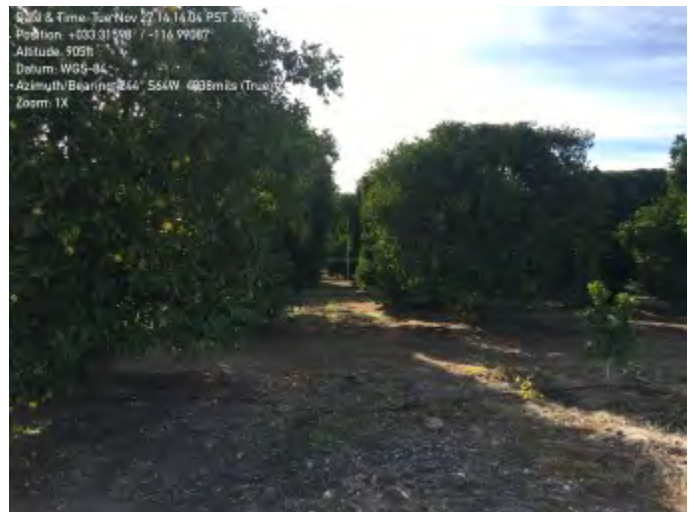
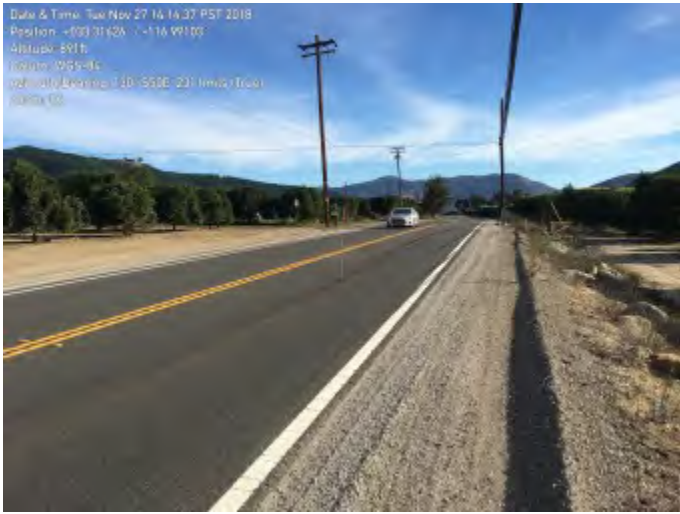
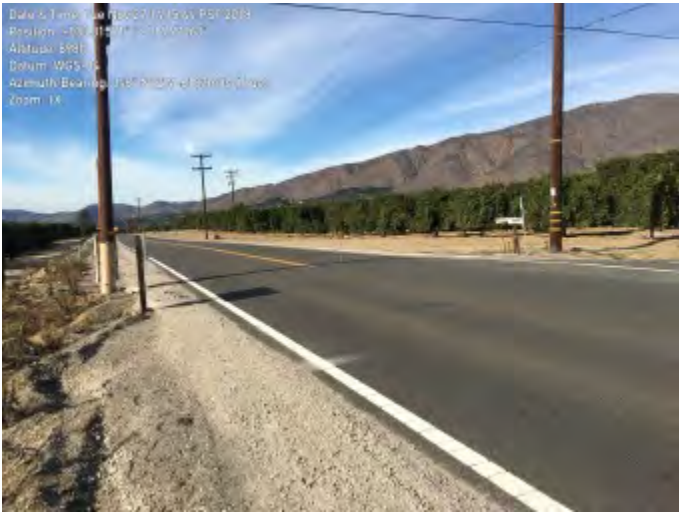
| Comments | Heavy traffic on 76 here. No culvert or bridge present. Therefore, no current alternative to crossing at grade. There are large citrus groves EB and WB sides, but no significant human presence. No significant residential or commercial structures in the immediate vicinity. |

| Management recommendations | Barrier fencing to prevent crossing here. Wildlife crossing signage. |

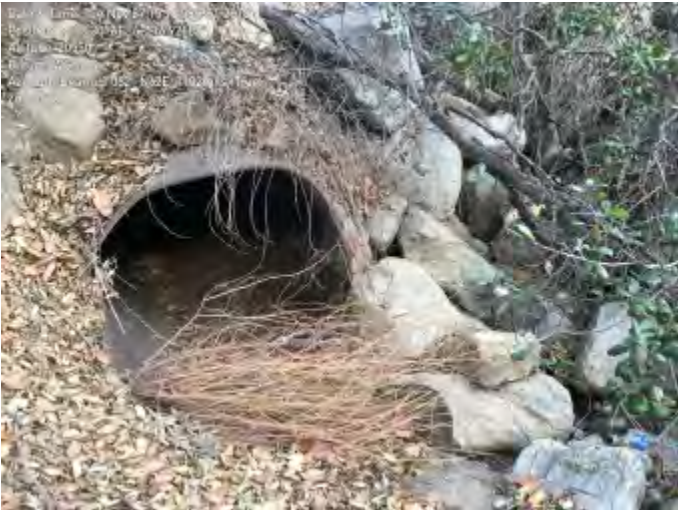
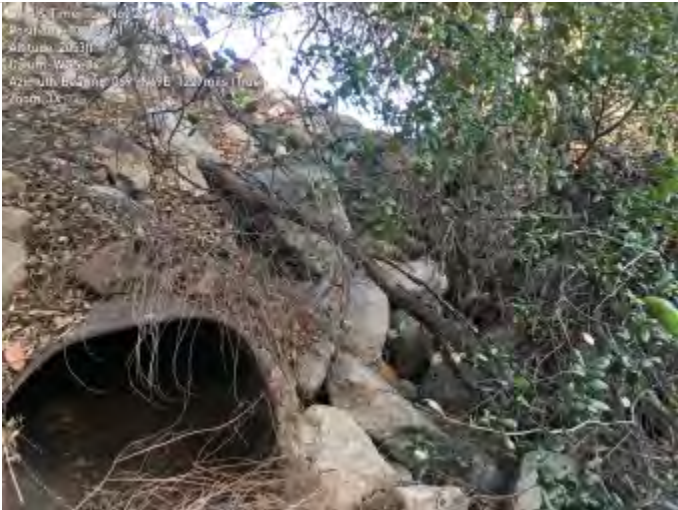
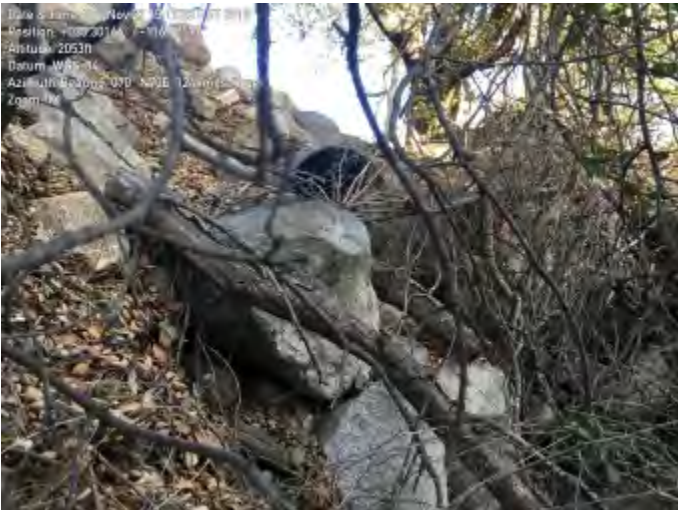
There are 2 parallel culverts traveling from northeast to southwest. They both drop from north to south at a fairly shallow angle. They are patent on the south end, but about 30% blocked on north end by natural debris. The easternmost culvert is buried less deeply, averaging about 5 feet beneath road. The westernmost culvert, separated from the other by 4 meters, lies, on average, approx. 10 feet below road. There is a natural streambed/ riparian area on both sides of road here. Connection made under road by 2 culverts as noted. There would appear to be adequate space under the road and on north and south to increase culvert diameter. Drainage runs diagonally under road from northeast to southwest.

Barrier fencing. Directional fencing and trails leading wildlife to cross in this area if culvert enlarged. Place one larger diameter culvert beneath road to replace 2 of lesser diameter.

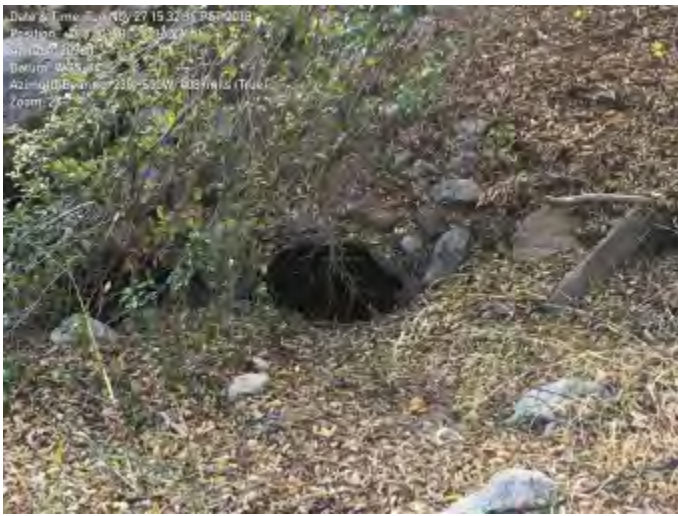
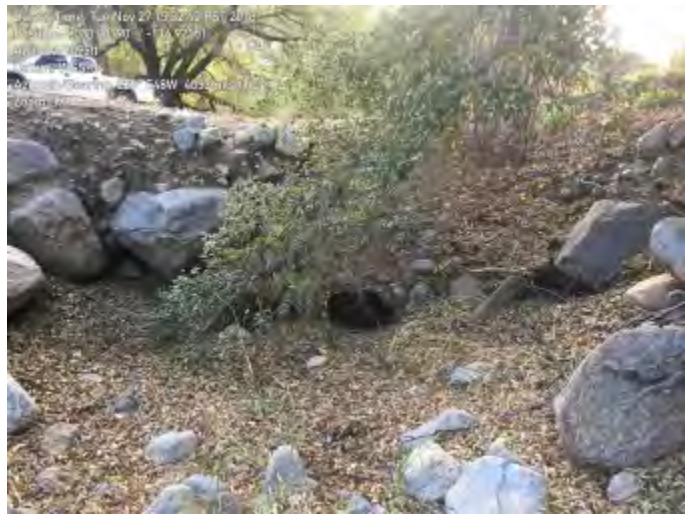
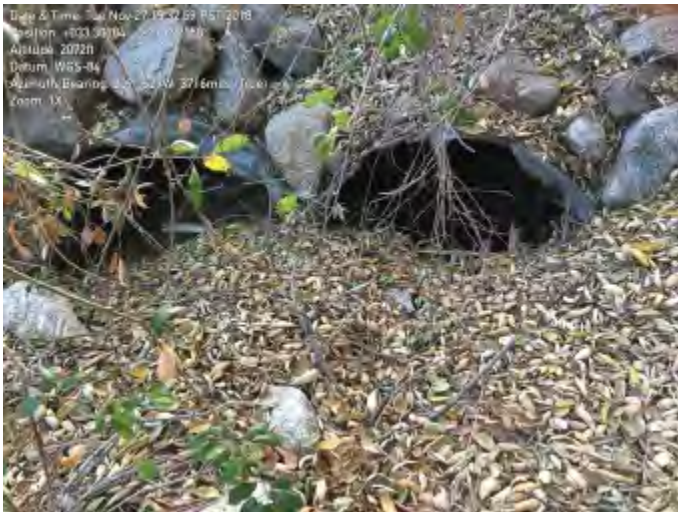
westbound two culvert entrances

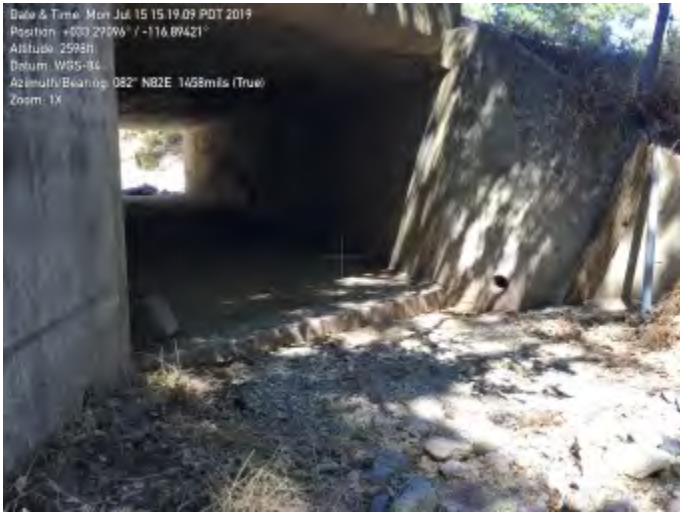
Camera C 22 View from camera on eastbound facing culvert.

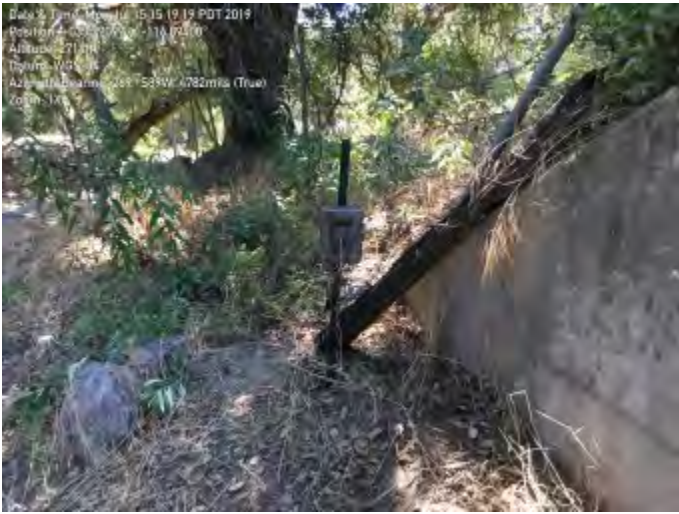
Camera C 22 Camera placed on eastbound side on post southwest of culvert exit 5 meters from culvert.

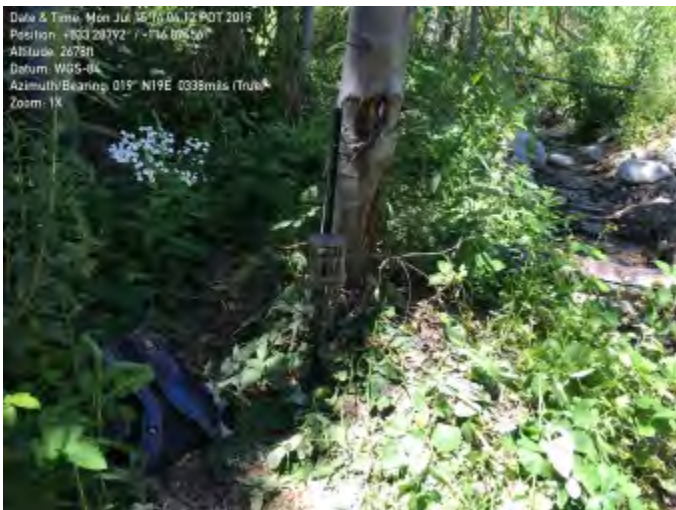
Camera BHD 96 View from camera looking south under bridge.

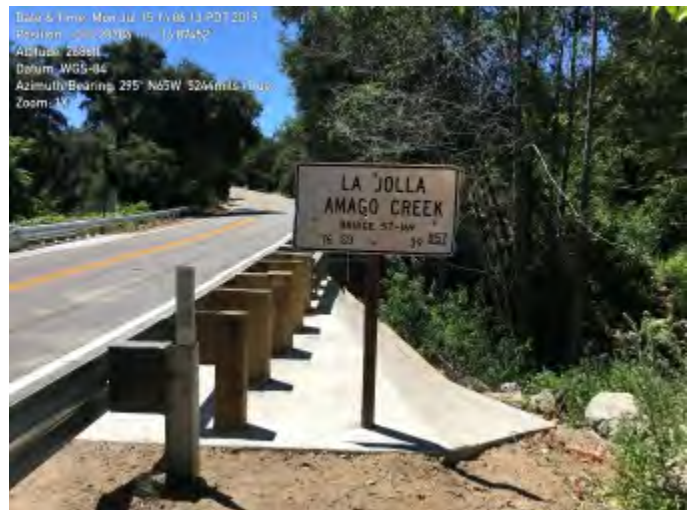
Camera BHD 96 Placed on westbound side of bridge. On west side of stream approx. 5 meters from bridge underpass opening facing bridge.

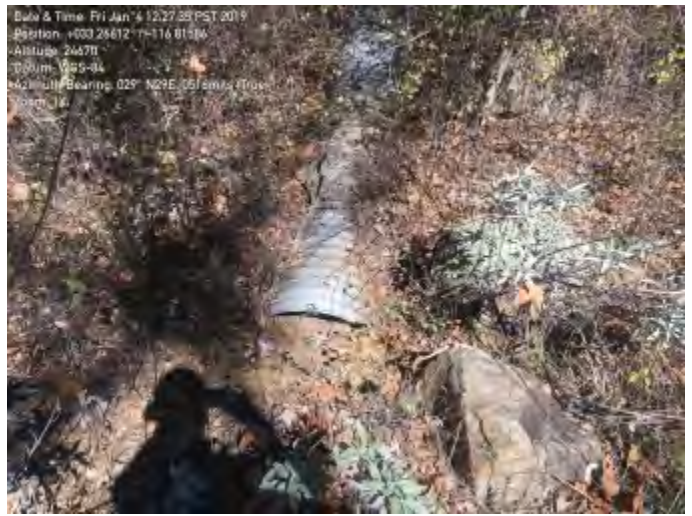
eastbound blocked culvert exit

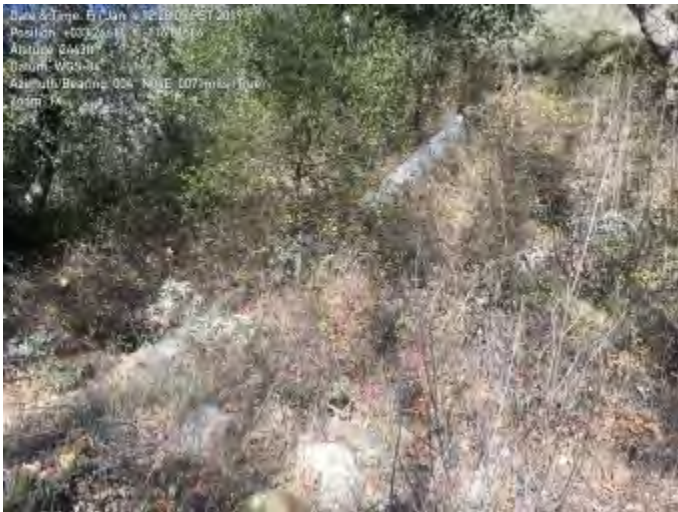
eastbound steep angle of blocked culvert

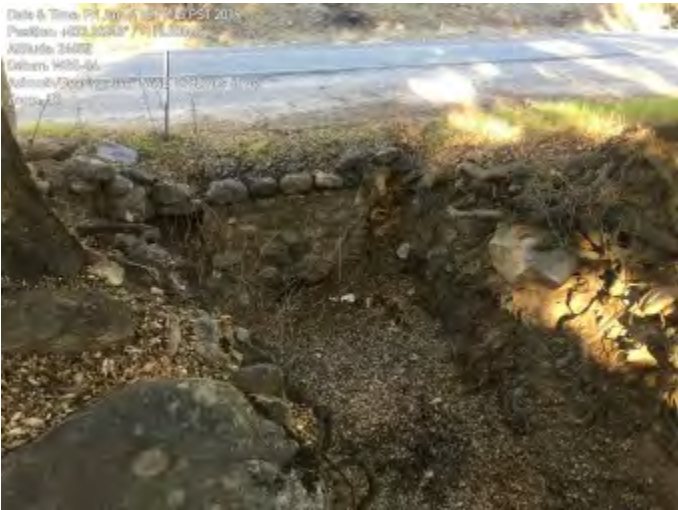
eastbound blocked culvert

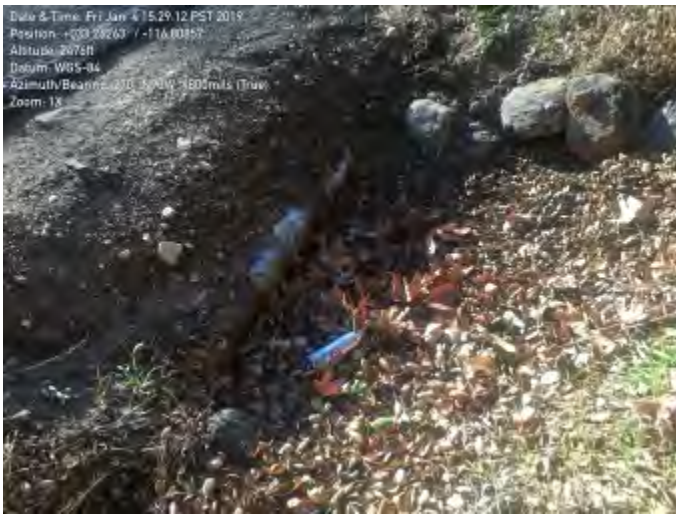
westbound blocked culvert

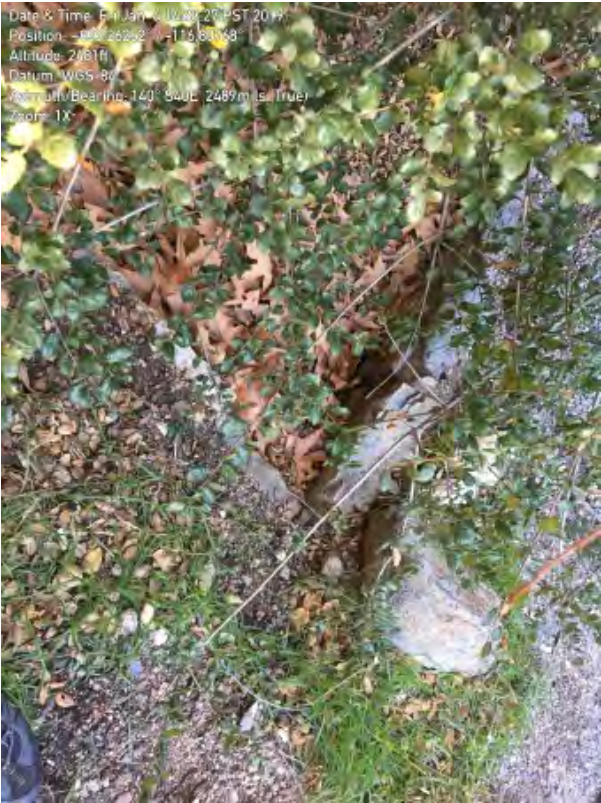
westbound culvert entrance blocked

The location surveyed is approx. 10 meters west of true A81 waypoint. As noted, culvert almost completely blocked At survey site. There is excellent access to culvert on south side, but poor access to grade level culvert on north side.

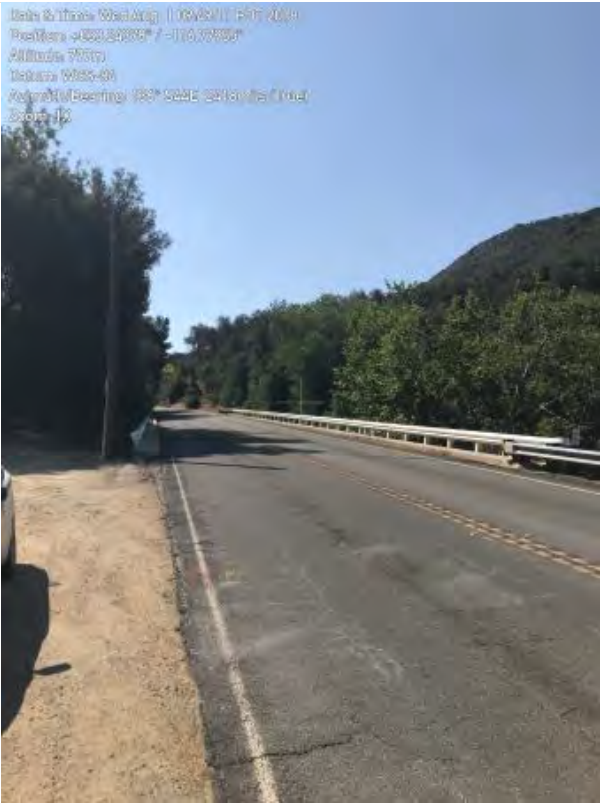
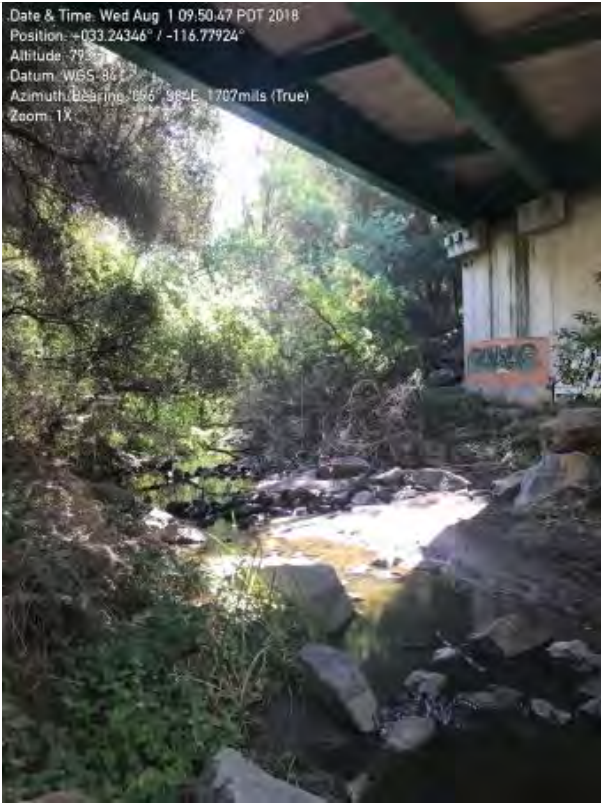
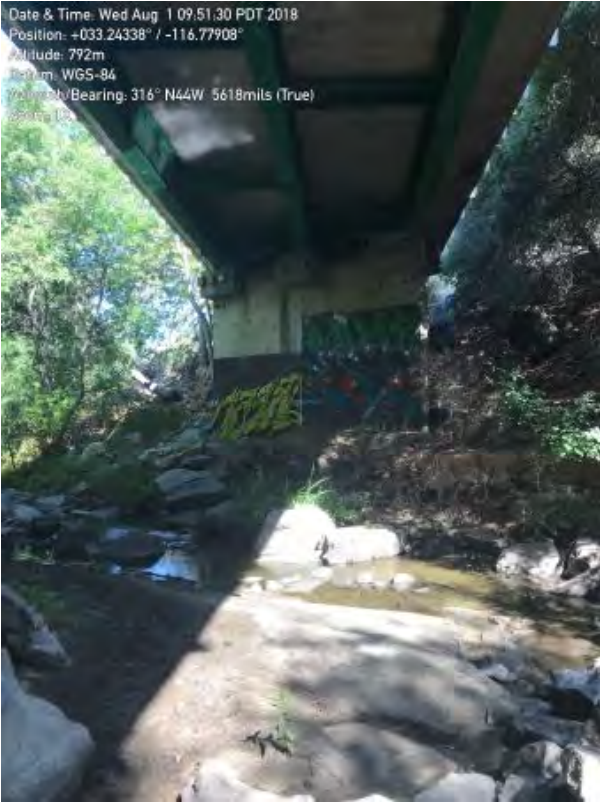
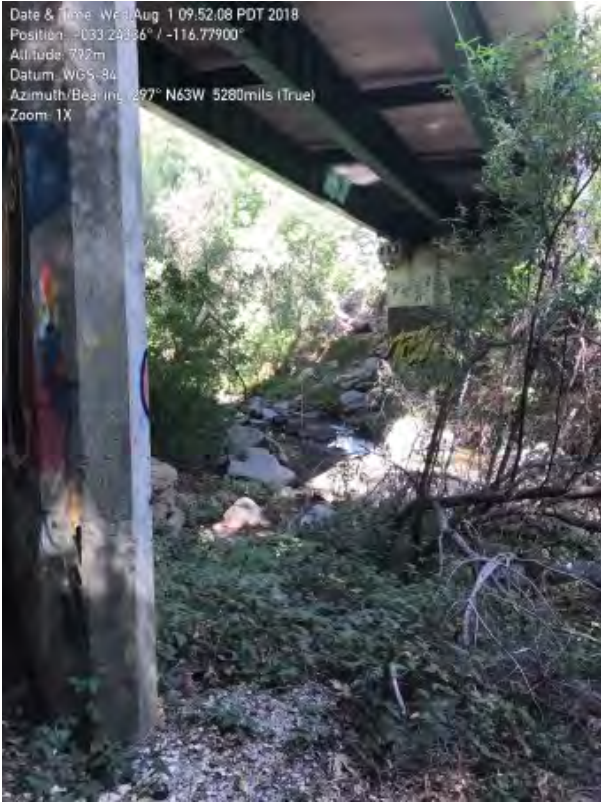
| Comments | Bridge over San Luis Rey. Good undercrossing. |

| Management recommendations | Directional fencing. Occasional security patrol to deter trespassing. |

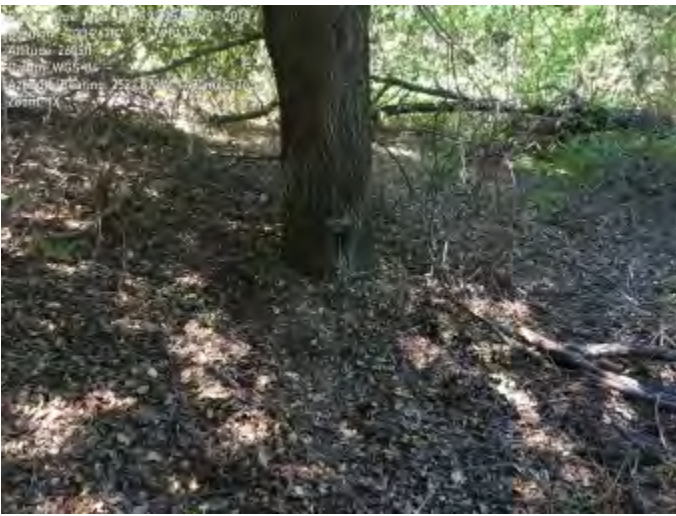
camera SANDAG 10 Placed at southeast corner under bridge 15 meters south of east abutment

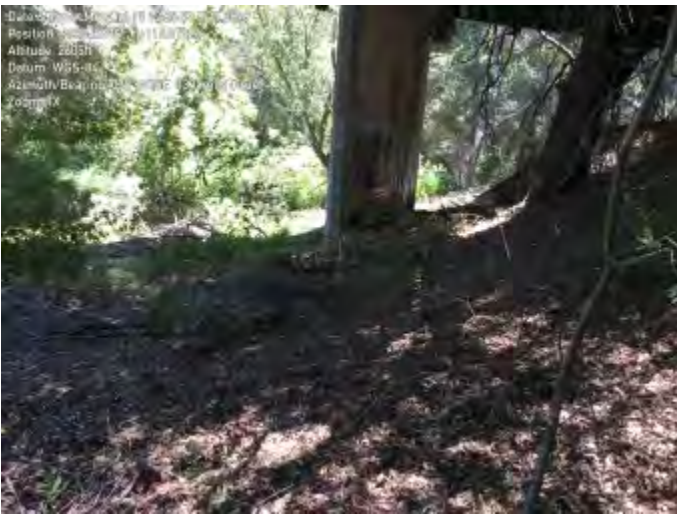
camera SANDAG 10 Camera view to north.

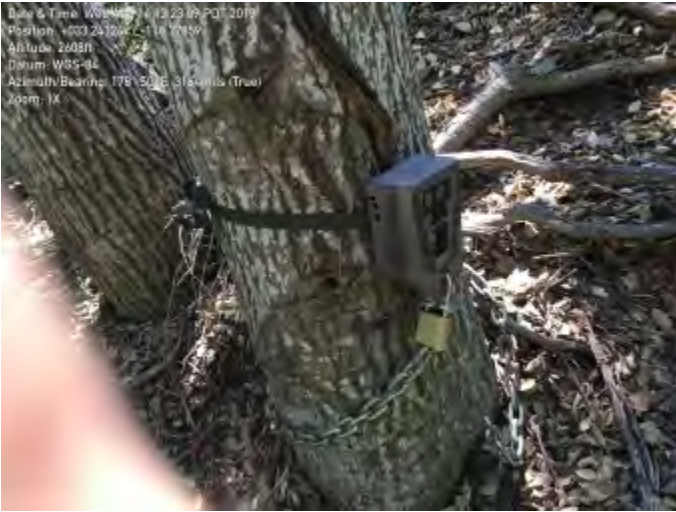
camera SANDAG 10 new placement

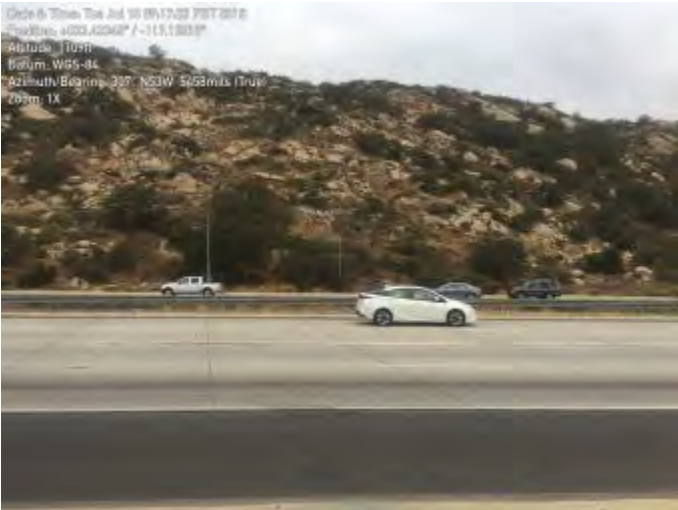
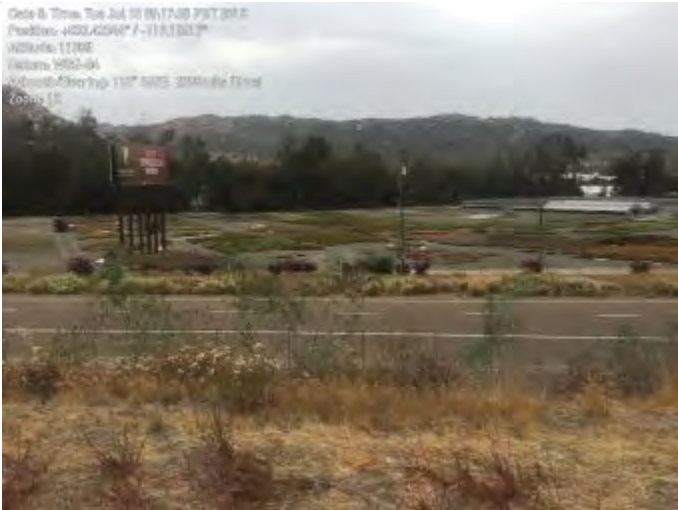
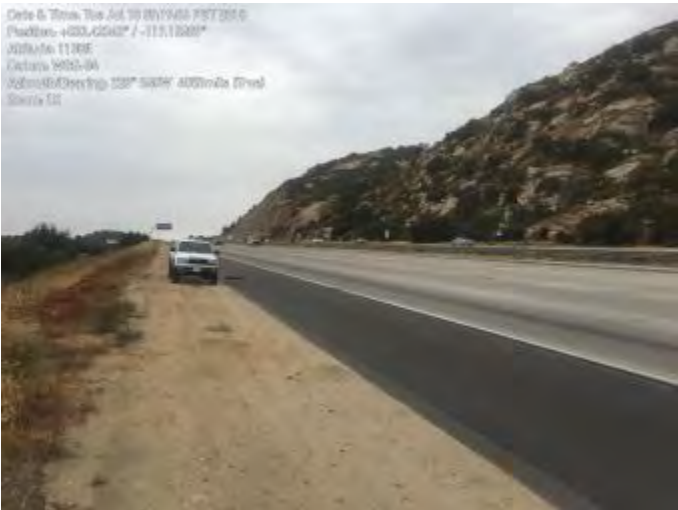
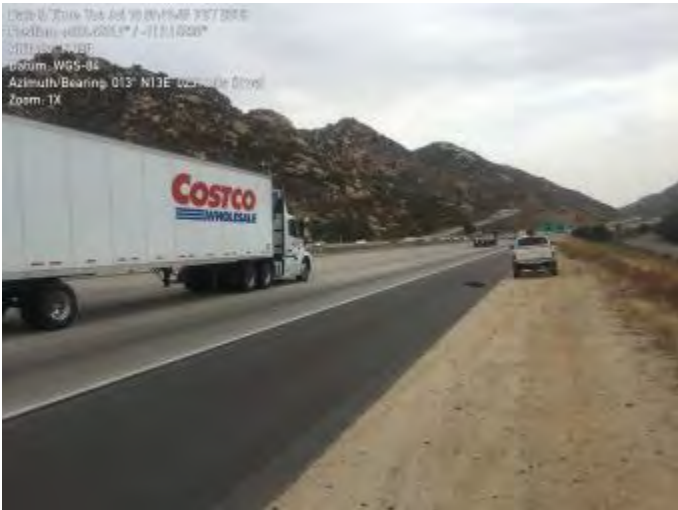
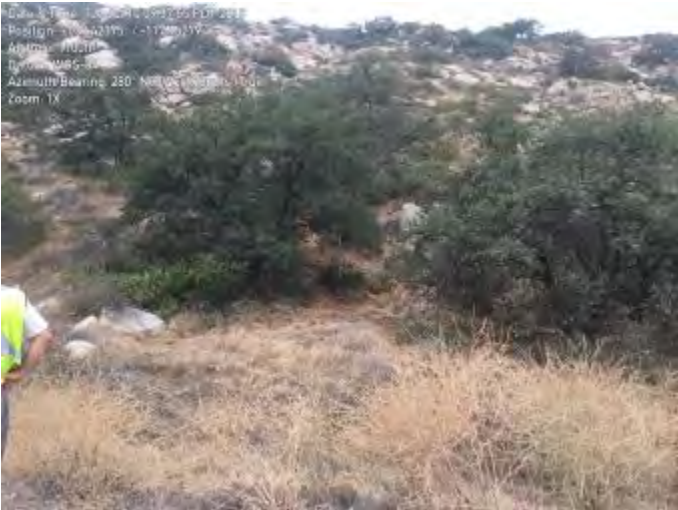
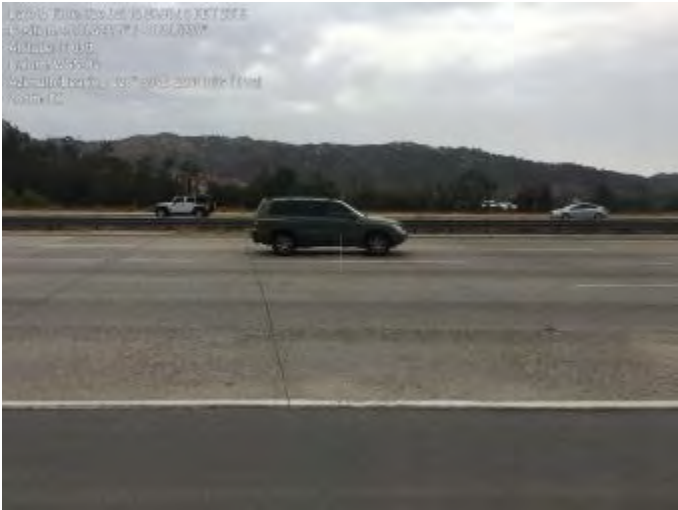
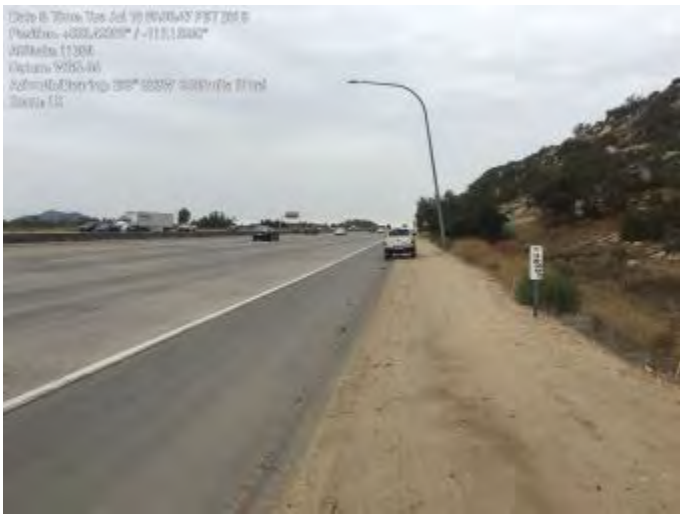
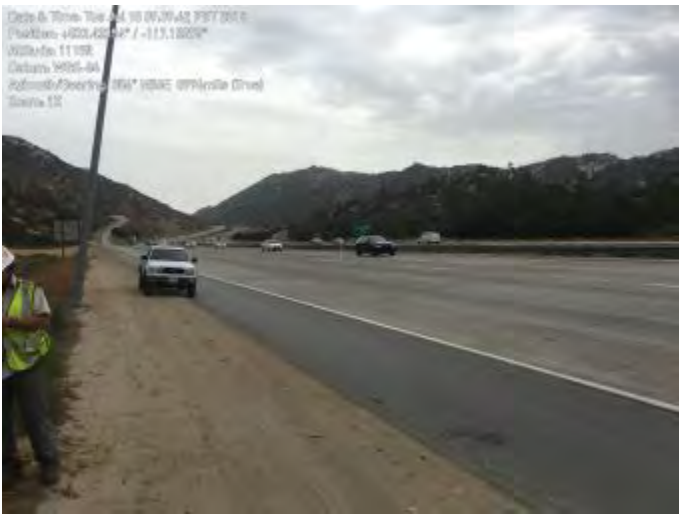
| Comments | West side of I15 rocky vegetated slope with good corridor habitat 1/4 mile to north and to south. Evidence of game Trails on west side. |

| Management recommendations | Minimal due to development on east side beyond 395. Consider barrier fencing on west side to prevent crossing. |
