SA-PAL survey

| Project | SA-PAL project |
| ID | 42130 |
| Survey Date | 04/03/2019 |

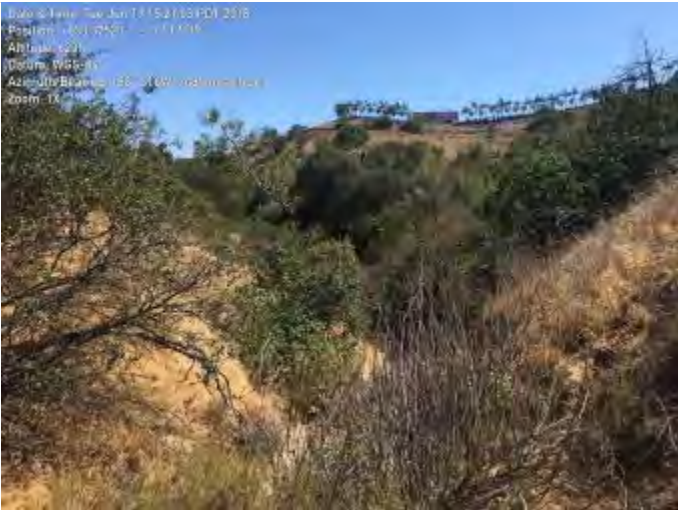
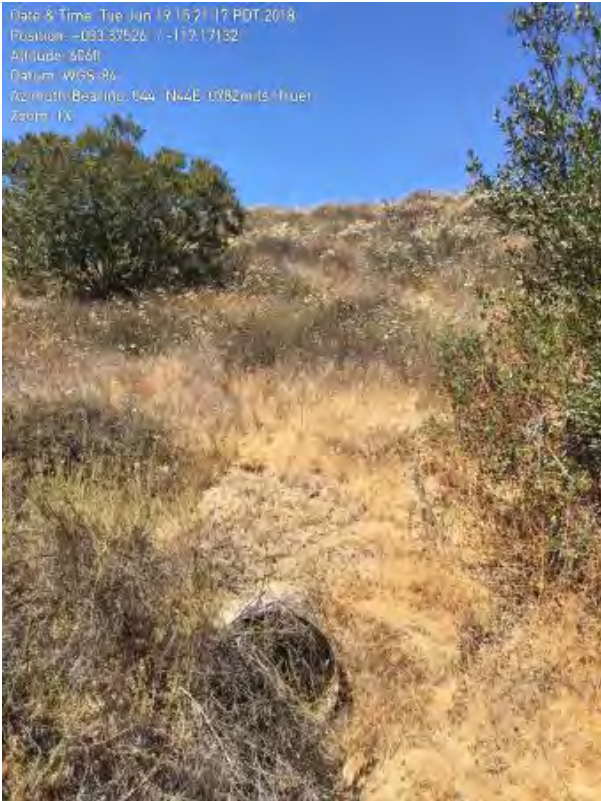
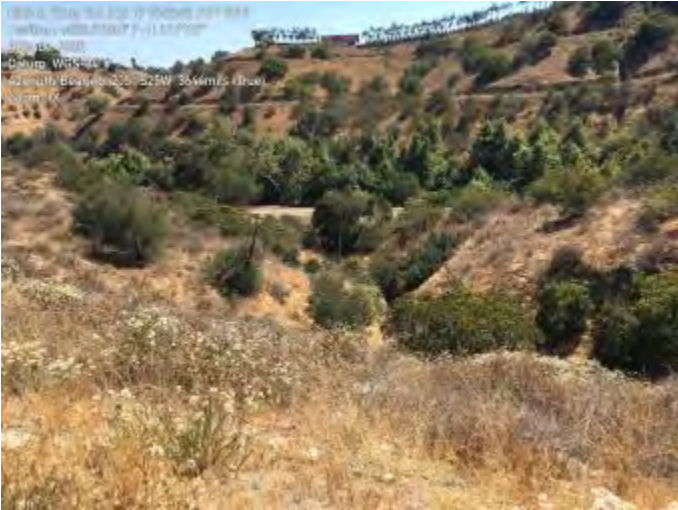
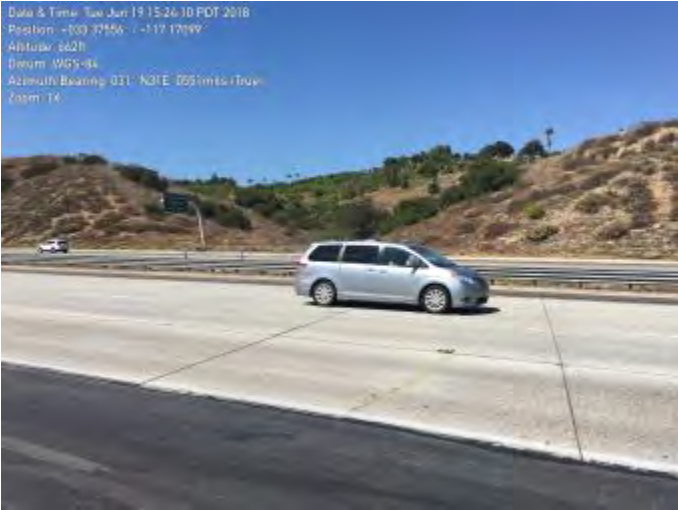
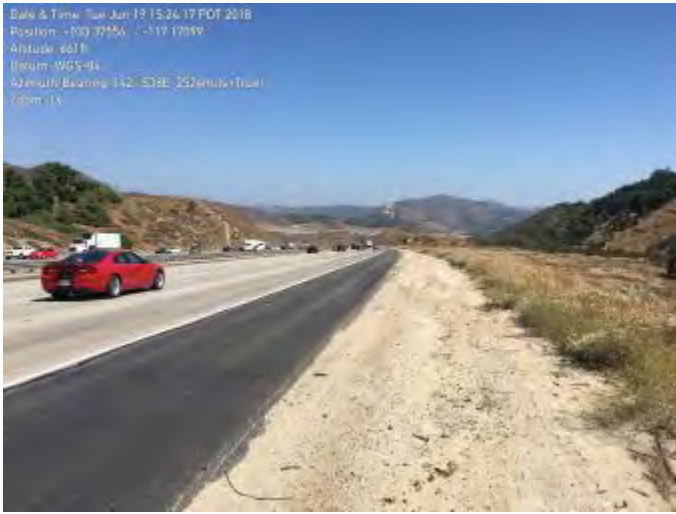
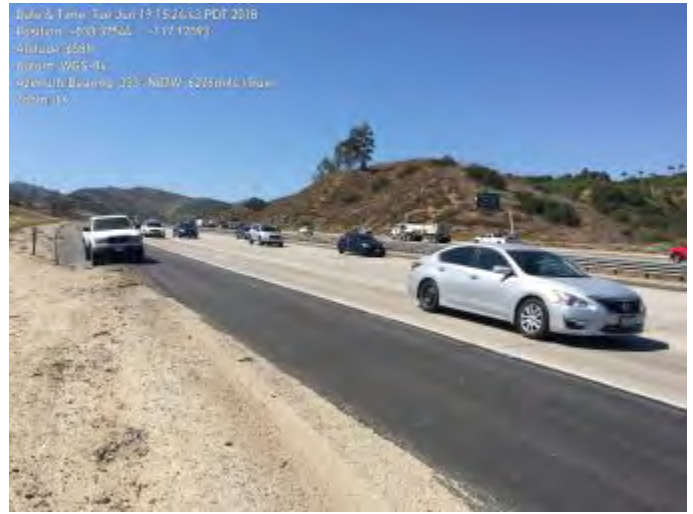
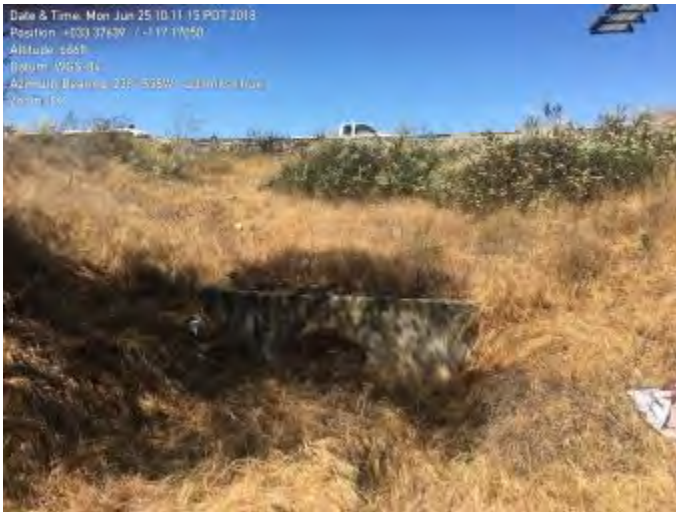
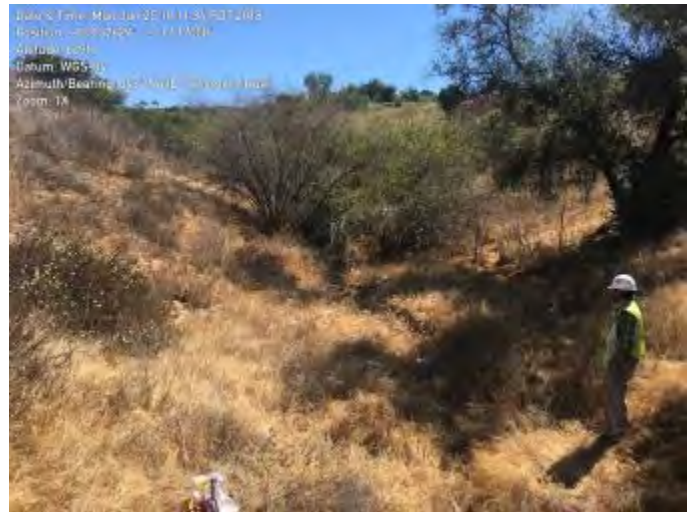
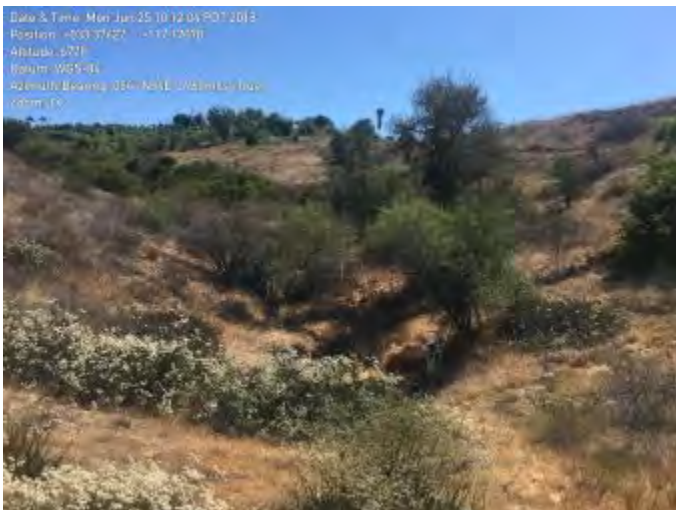
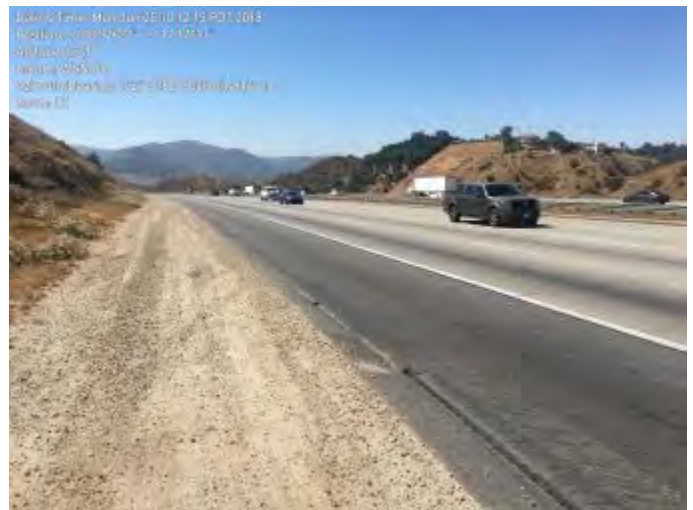
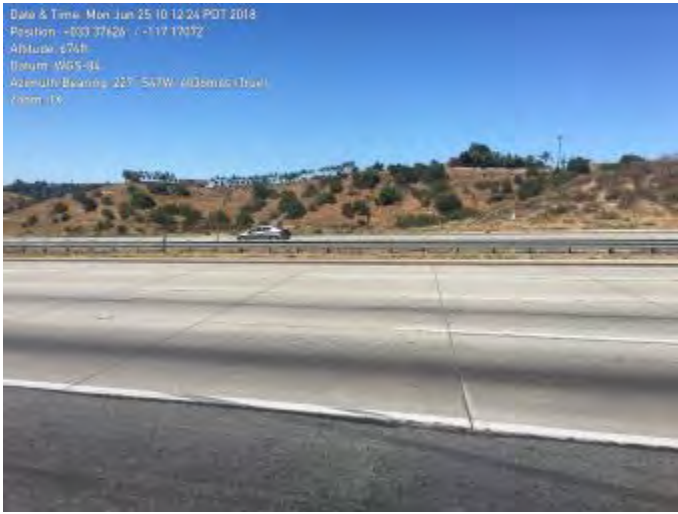
west approach. 4 feet high barbed wire traverses east side 75 feet from road.

| Comments | <p>Site is located .25 mile south of WS10. Obvious travel corridor from west to east. Upon inspecting western approach, observed 3 foot culvert at base of slope. Western culvert location 33.3753,-117.1713. Culvert is approx 100 feet from road and at least 50 feet below grade. Western access to the western approach is more difficult via the 395 than WS10 in this location. East side culvert approx 60 from road and 20 feet below grade. Steep culvert gradient below road. East canyon/corridor terminates into agricultural land based on satellite and onsite survey, limited practical travel corridor to the East.</p> |

| Management recommendations | <p>In terms of I-15 undercrossing in this vicinity, due to presence of culvert this has potential for undercrossing, however due to culvert gradient and east canyon corridor, there are limitations for undercrossing. Directional fencing required both sides.</p> |

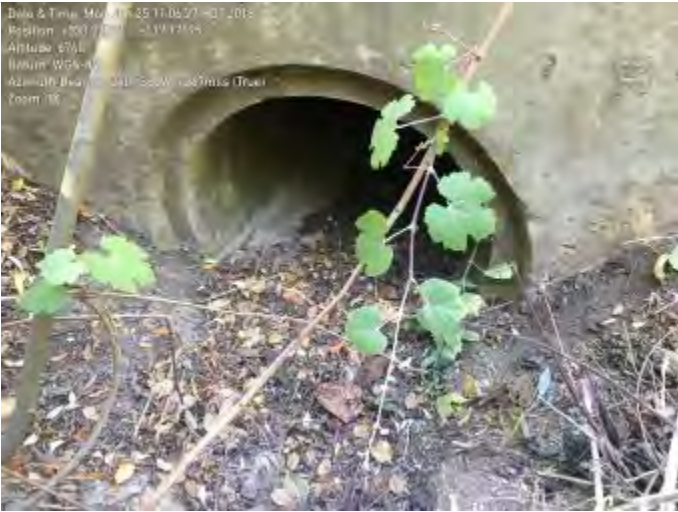
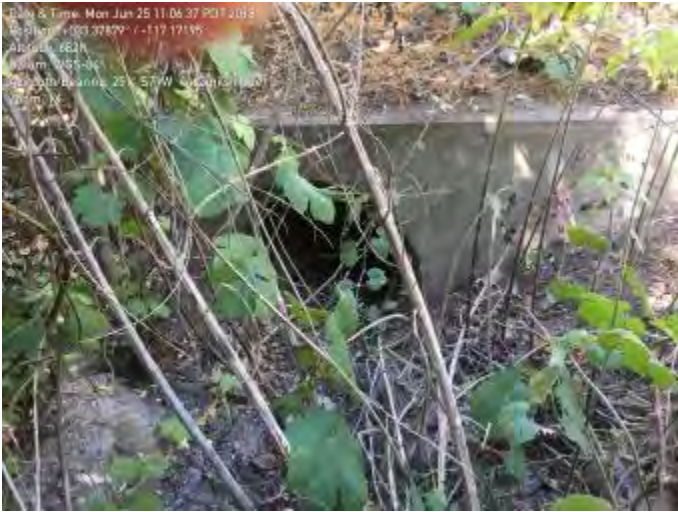
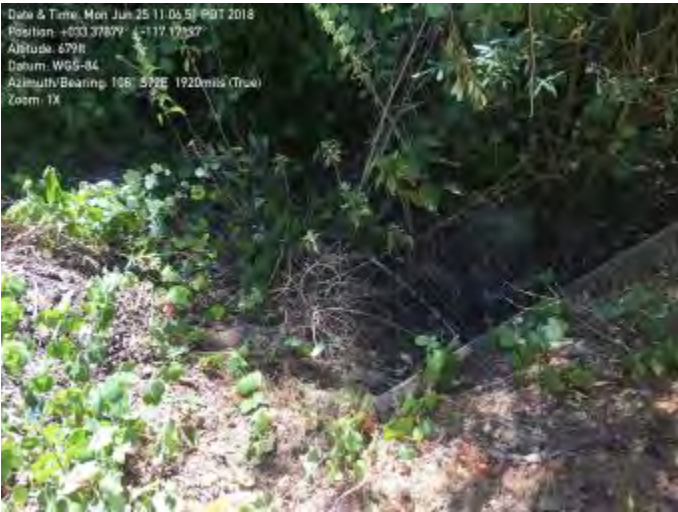
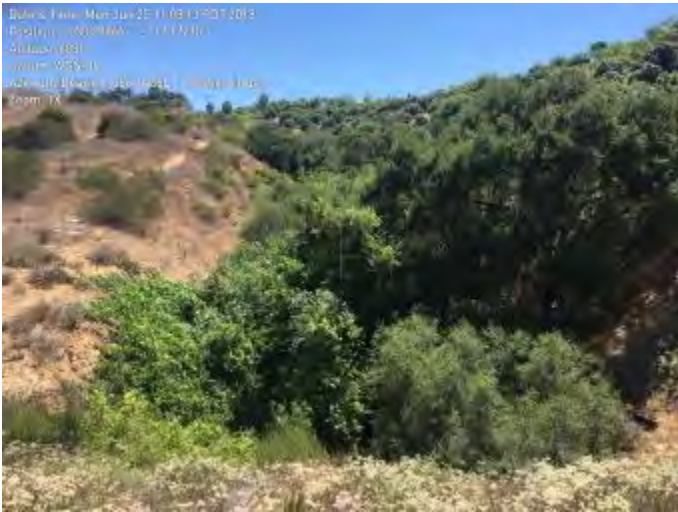
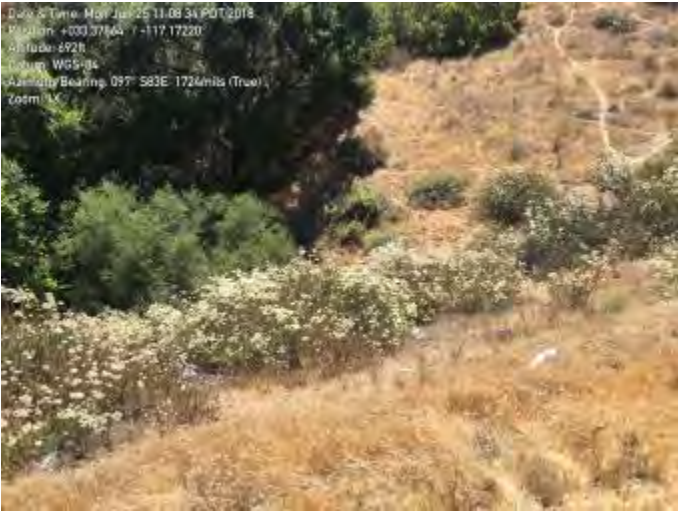
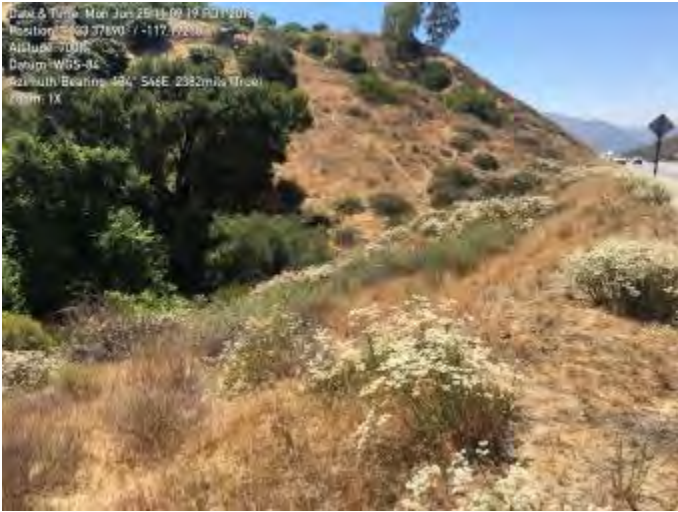
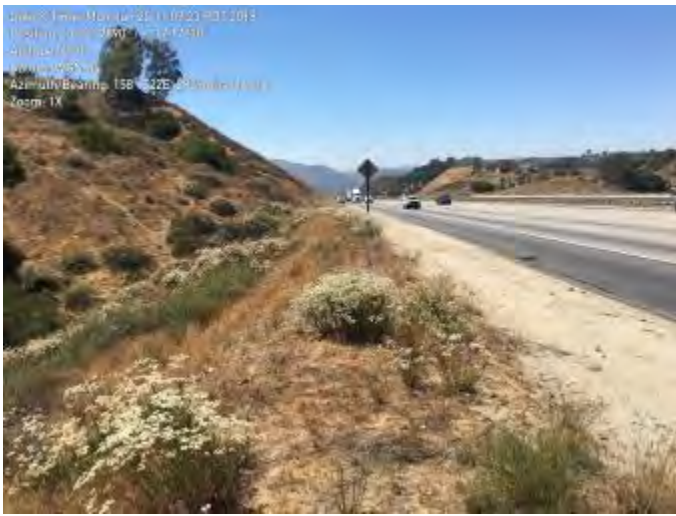
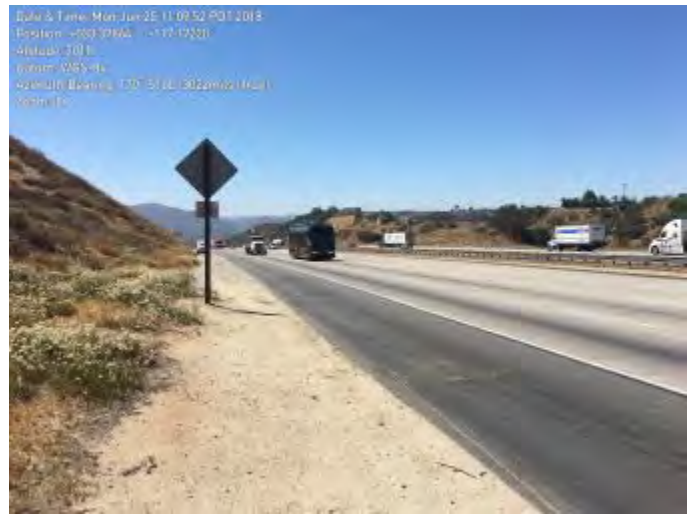
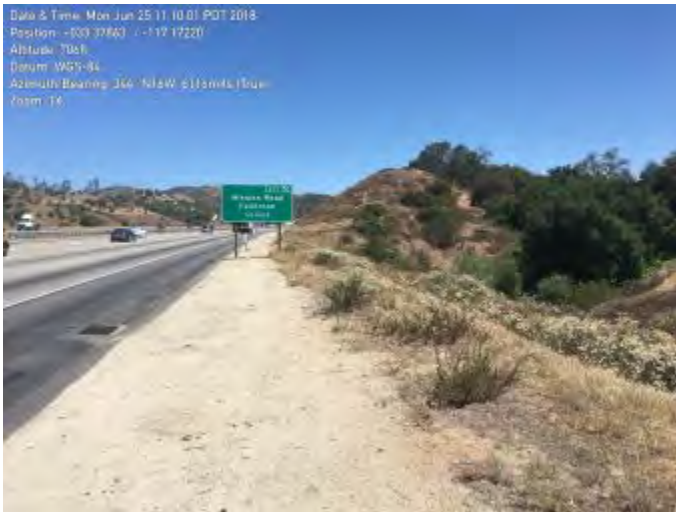
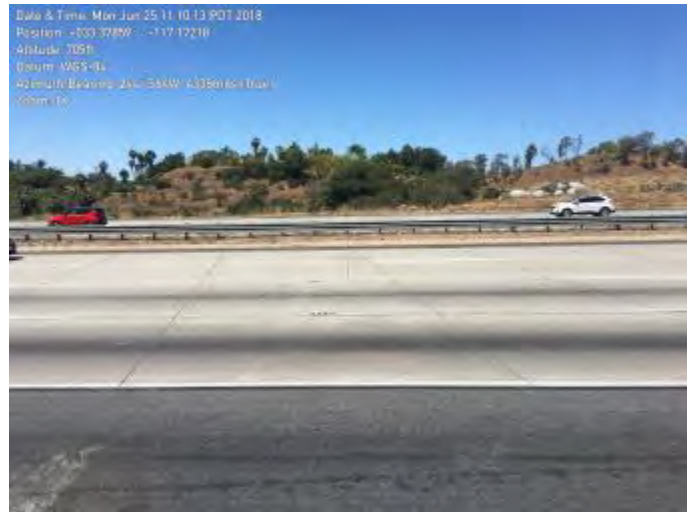
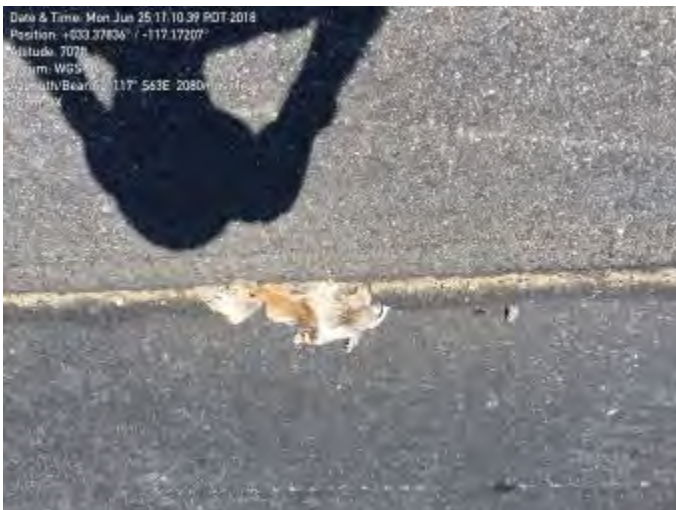
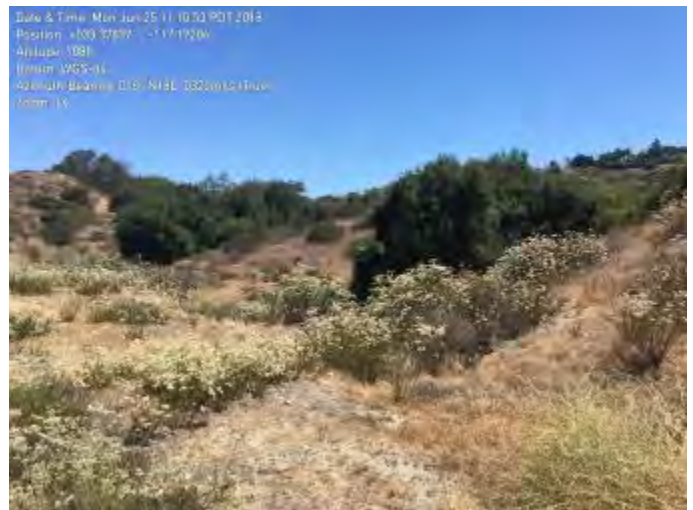
| Describe fencing type and height | 4 ft. Barbed wire 75 100 feet off road running north south. |

| Management recommendations | Large culvert and directional fencing isolating protective canyon to the east and directional fencing to culvert entrances on east and west sides. |

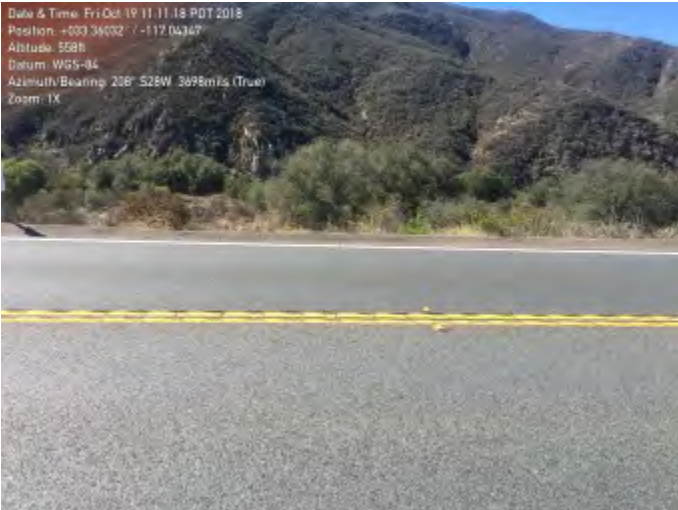
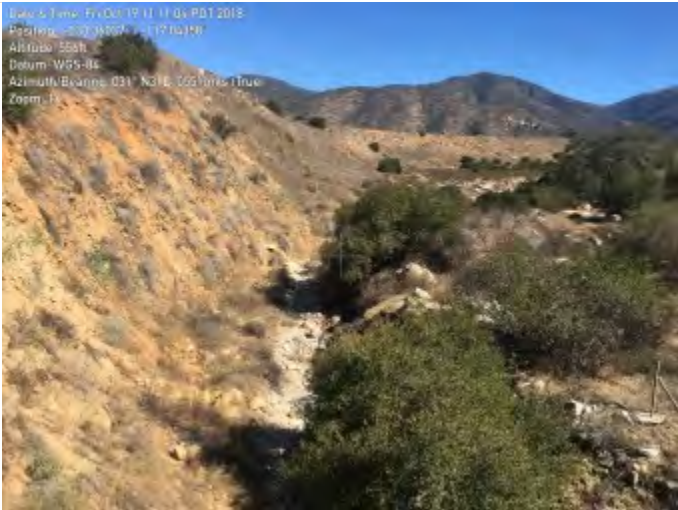
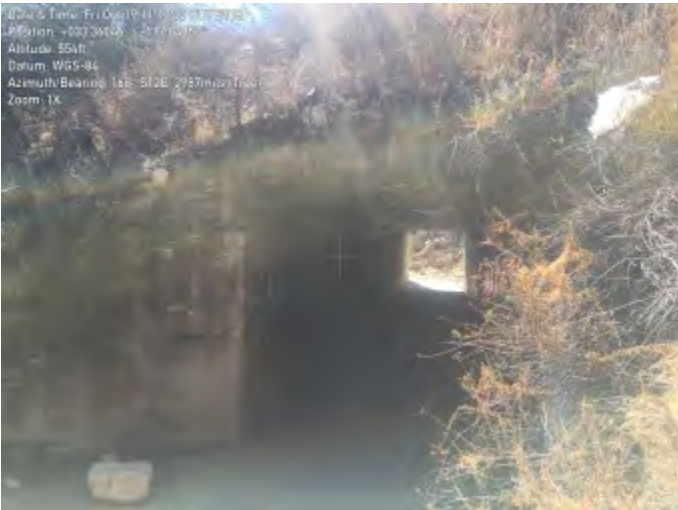
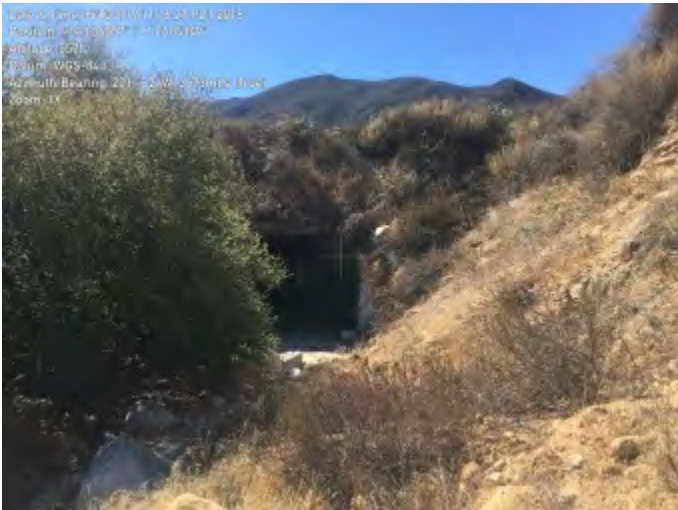
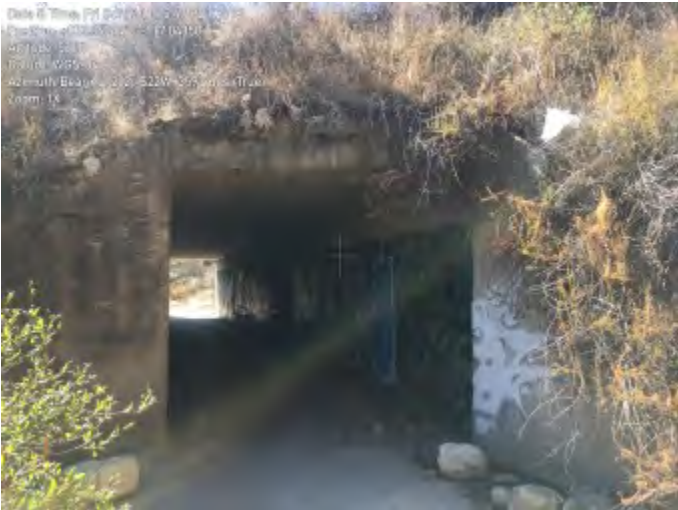
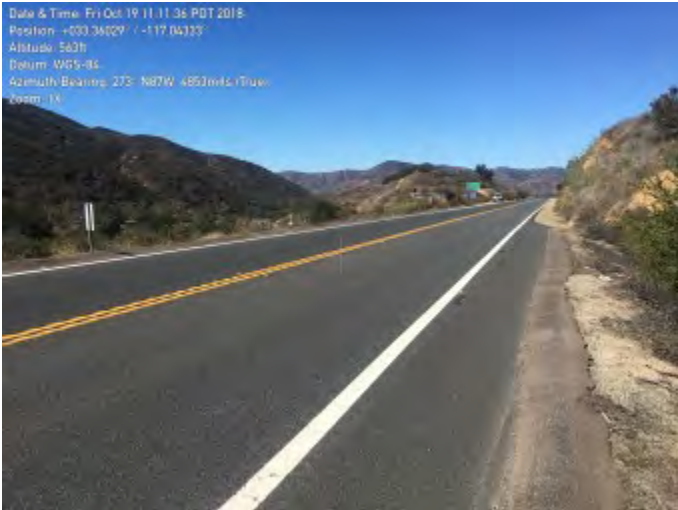
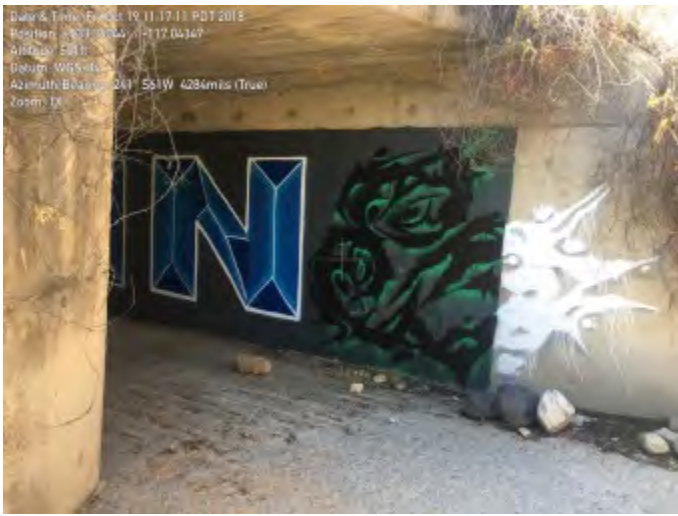
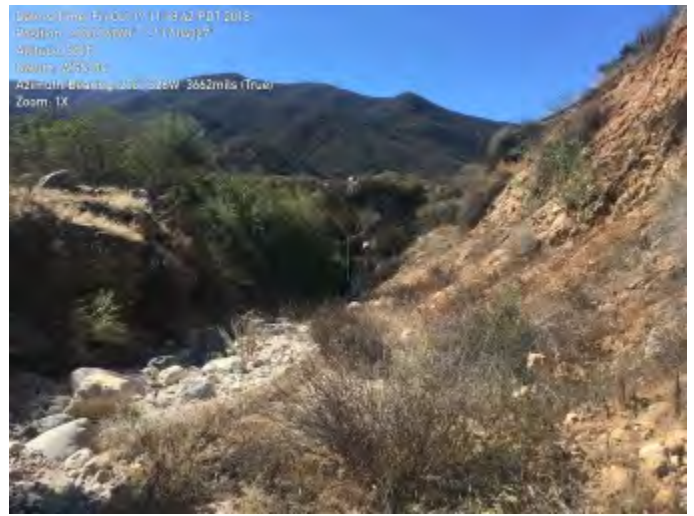
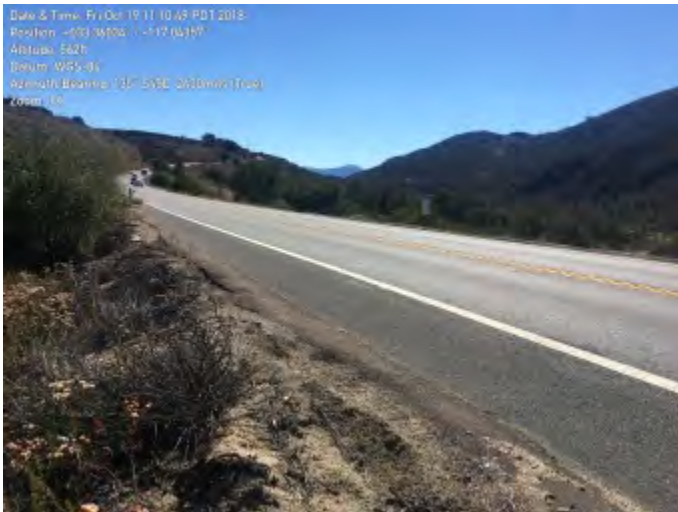
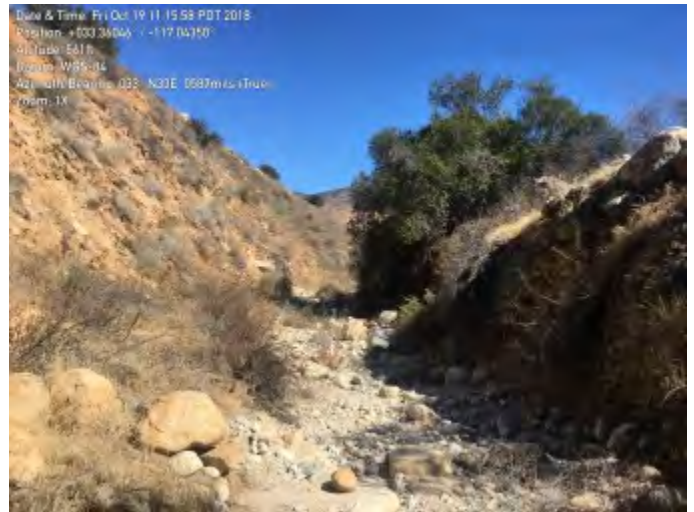
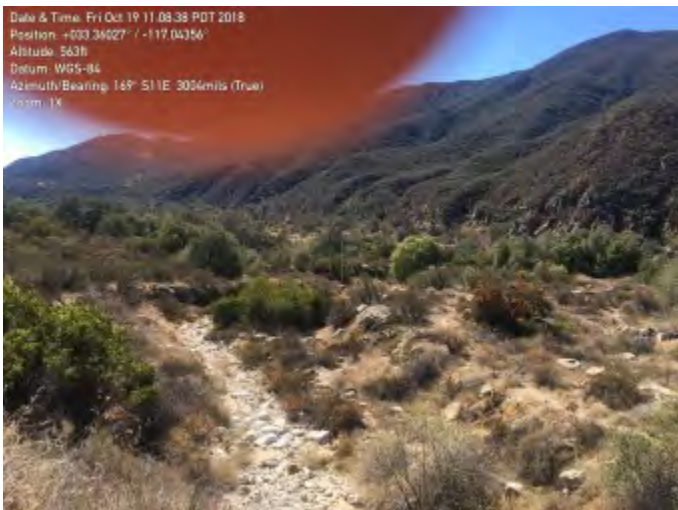
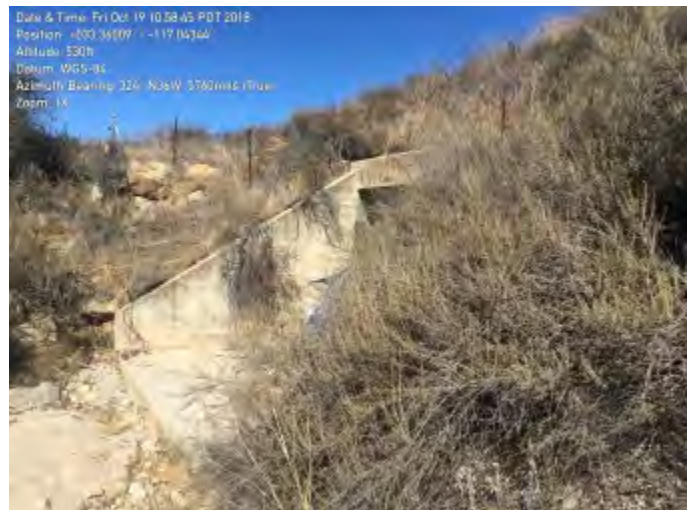
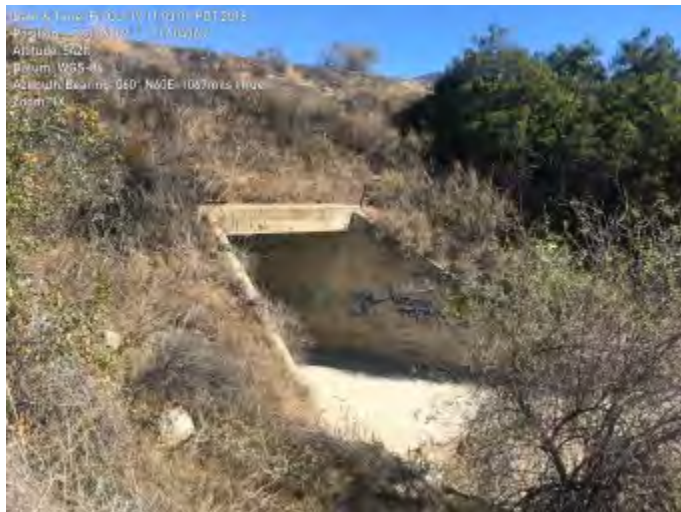
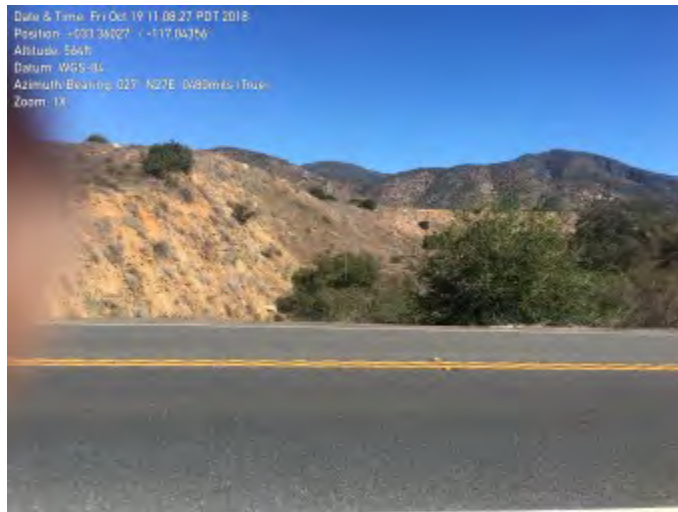
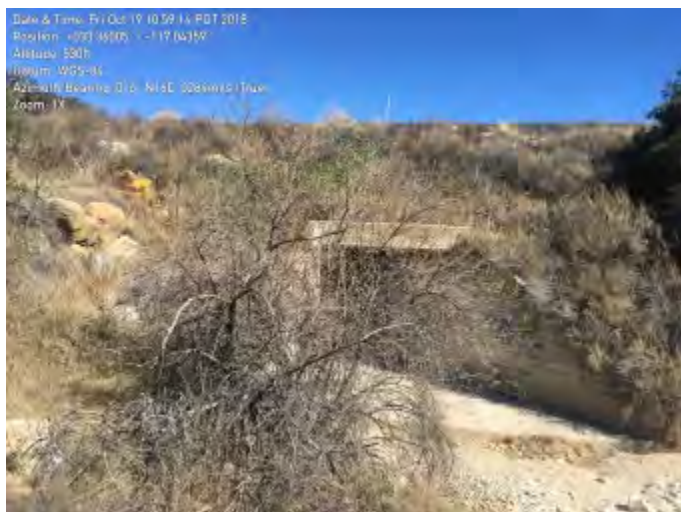
This is an excellent crossing area with natural streambed habitat on eastbound and westbound sides of 76. This is a new area located near Marion Canyon on 76. Immediately to the east of A53. GPS location noted via pin drop and Nav Cam headings. This location is immediately east of "Entering Pala Indian Reservation" sign as photographed facing east on the shoulder of the eastbound lane on 76. Camera JO 25 placed here on 7-17-19. It is positioned at the southwest corner of the culvert facing inward and chained to the tree in that location.

| Camera suggestions | Culvert entrance, exit. Surrounding game Trails. |

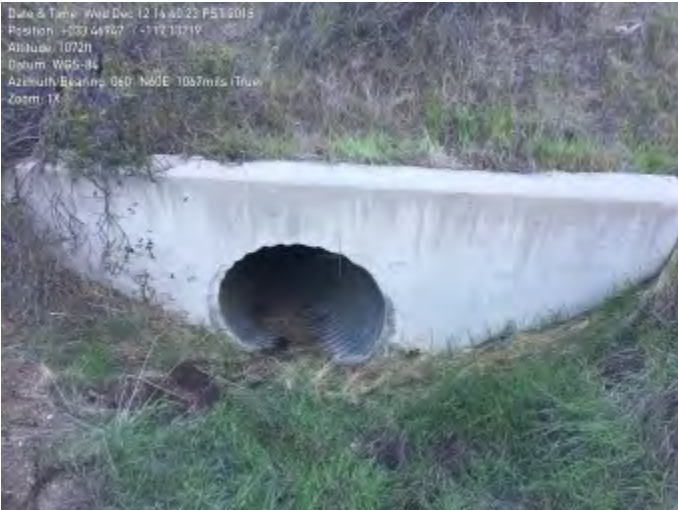
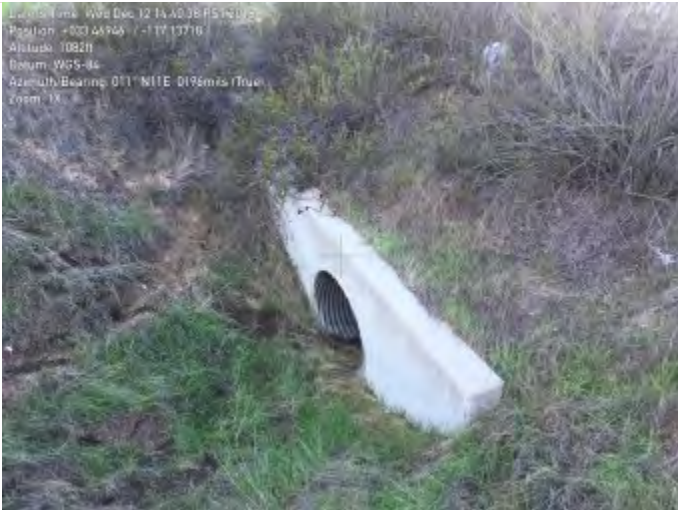
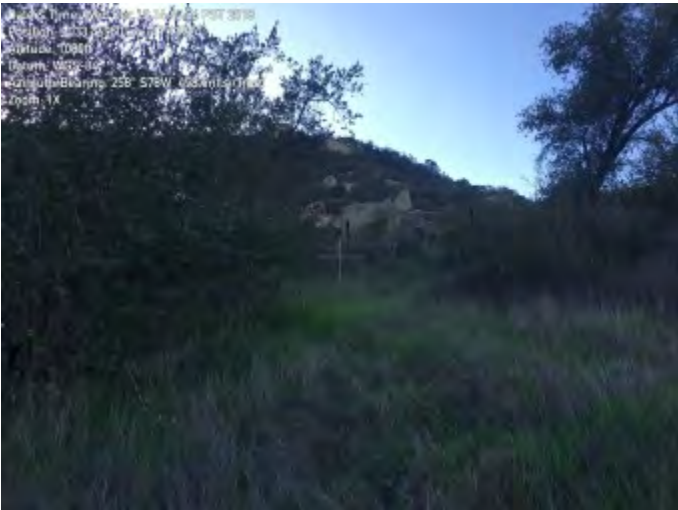
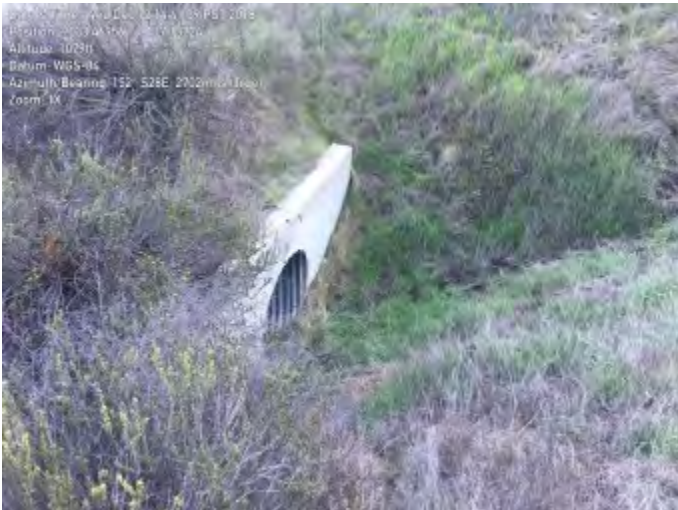
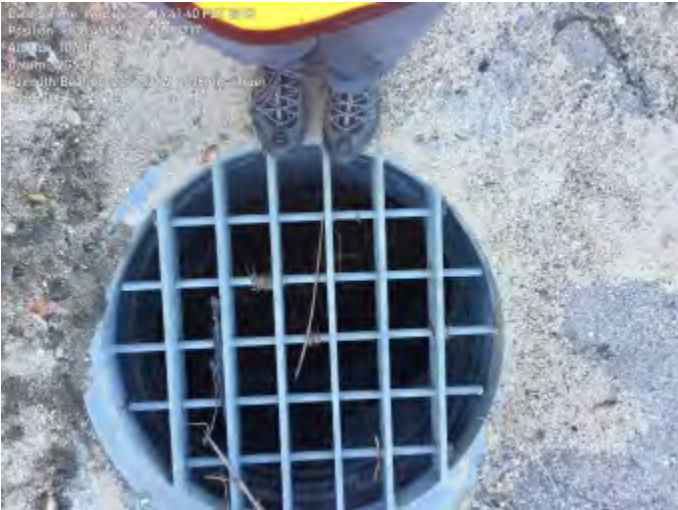
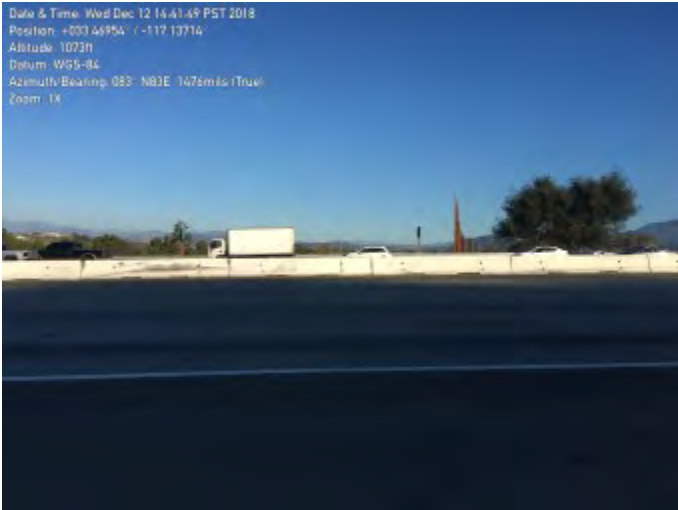
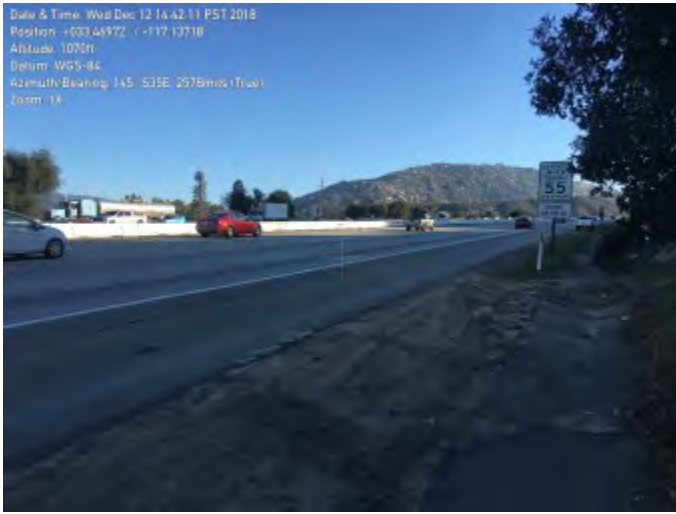
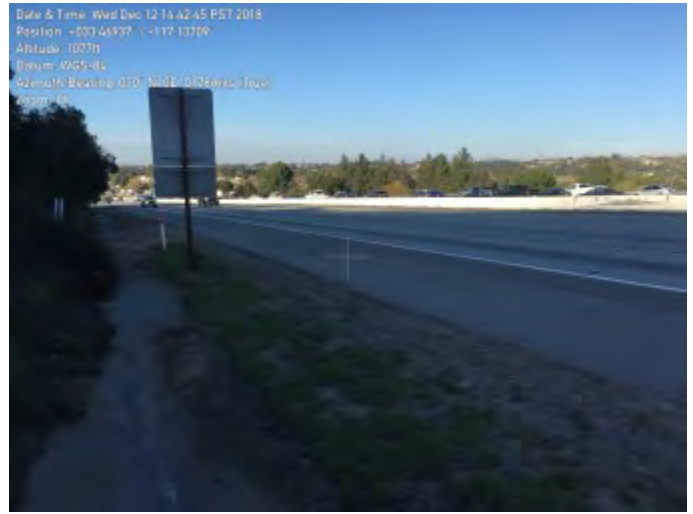
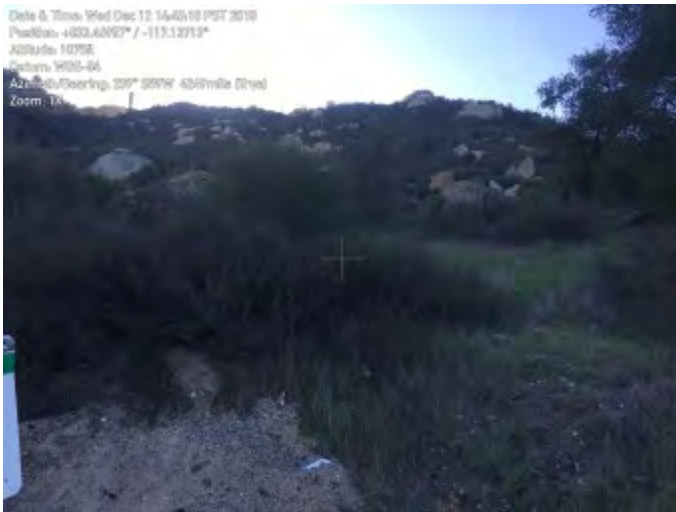
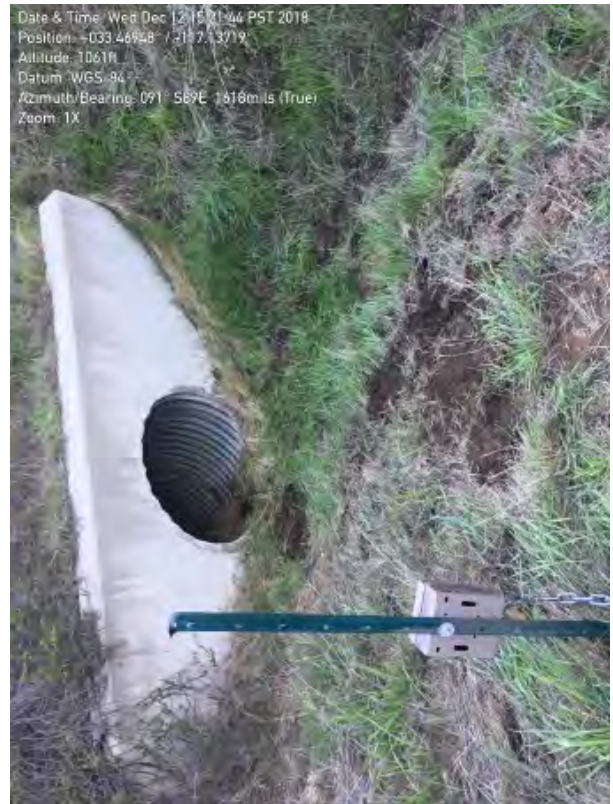
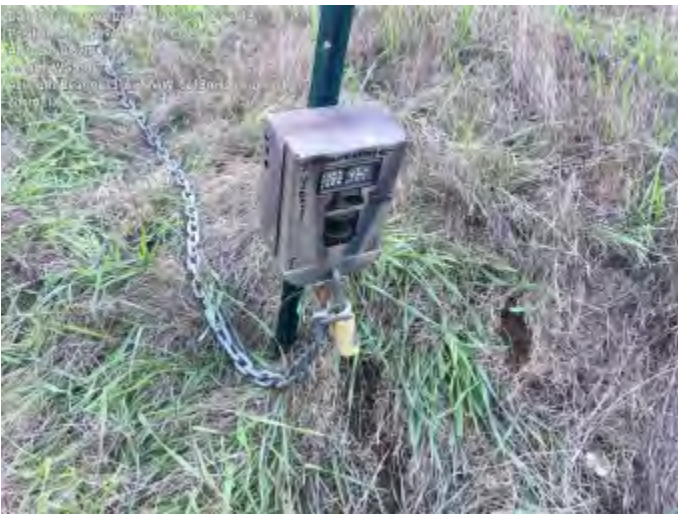
southbound. Vertical access to culvert at edge of freeway.

| Comments | <p>Natural landscape and vegetation provides good corridor to the west. Narrow culvert. Unable to determine slope Of culvert from west to east.</p> <p>This location is about 30 meters north of Temecula Creek Golf Course culvert on SB I-15. It is directly across freeway from end of golf course driving range fencing on NB I-15. Culvert on NB I 15 is inaccessible. It is on Pachanga property. As of 12-14-18, the survey for this location on the Northbound side of I-15 has not been completed. There is a vertical shaft at the edge of the freeway allowing light to penetrate into the culvert here. Unable to see through culvert to east side.</p> |

| Management recommendations | <p>Enlarge culvert diameter. Increase depth of culvert. Level angle of culvert slope SB to NB I 15. Barrier fencing. Directional fencing. Trails to direct wildlife to culvert. Probably not a good crossing point due to commercial/Pechanga property on Northbound side.</p> |
