SA-PAL survey

| Project | SA-PAL project |
| ID | 42130 |
| Survey Date | 04/03/2019 |

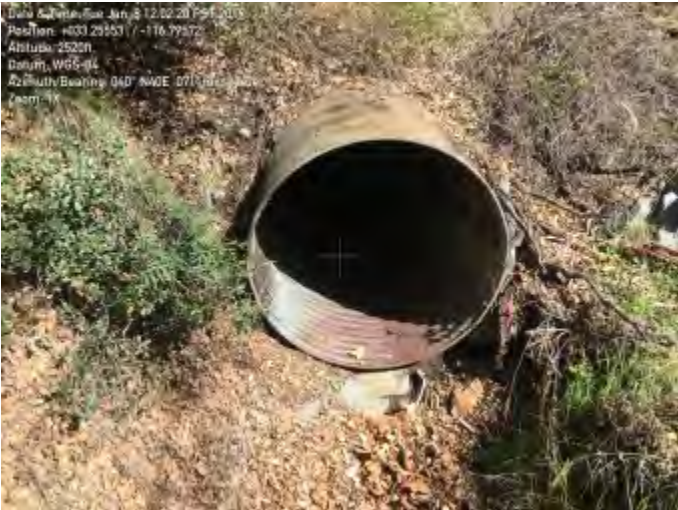
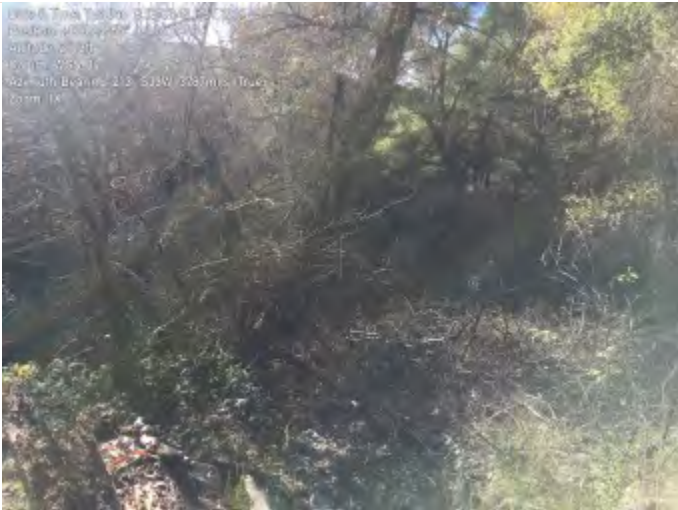
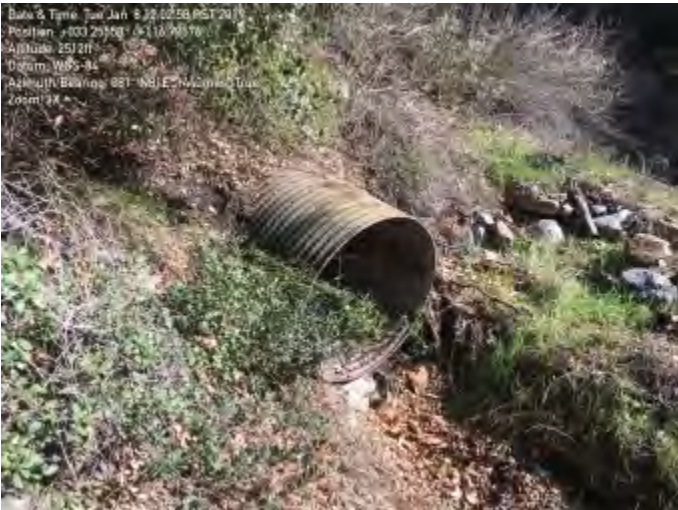
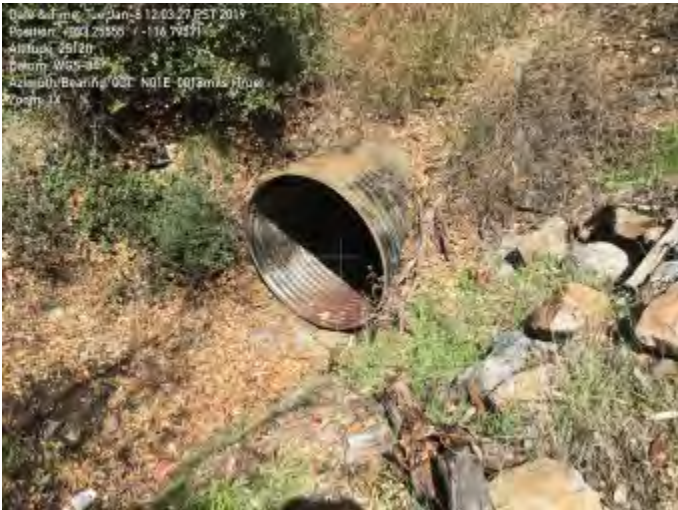
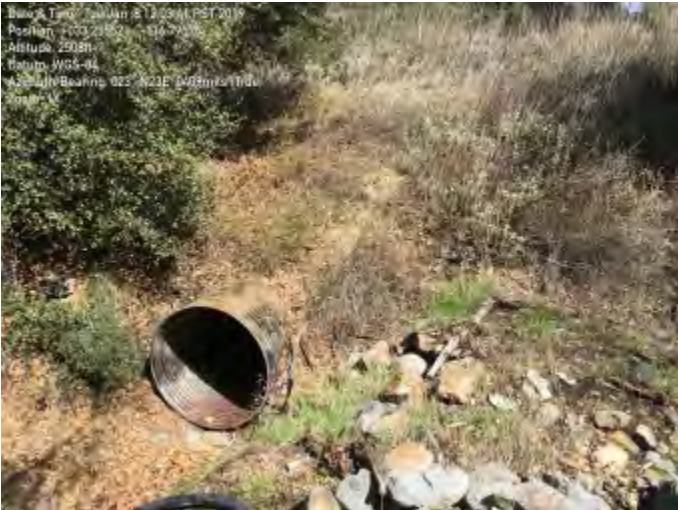
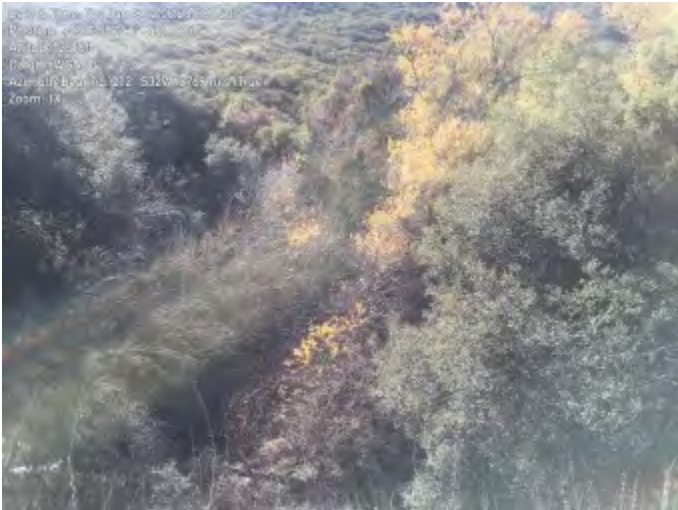
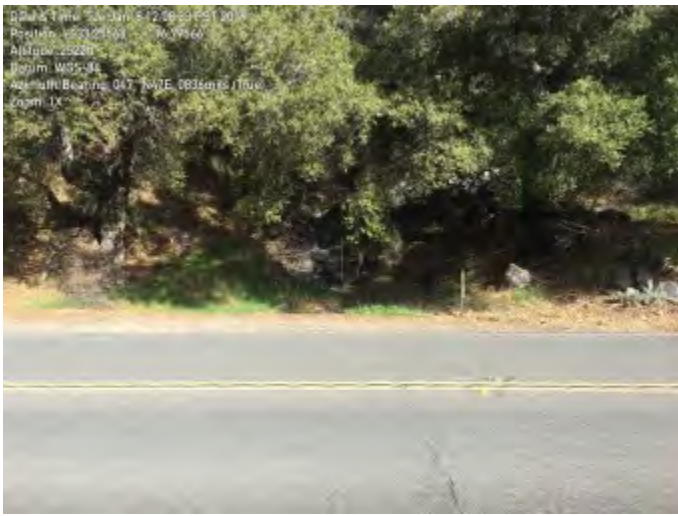
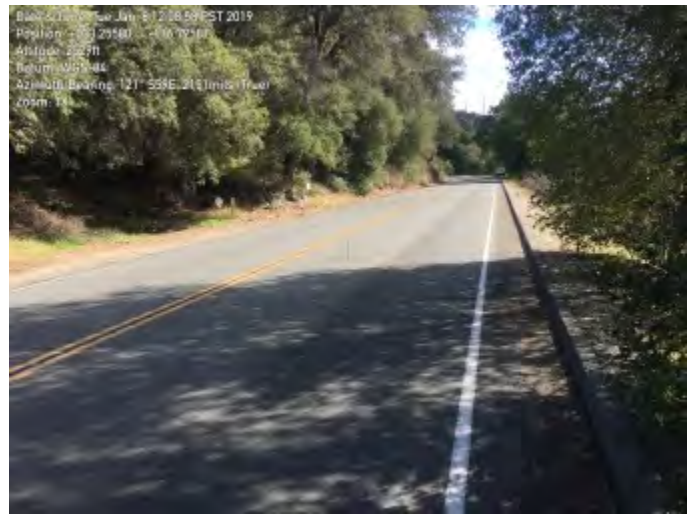
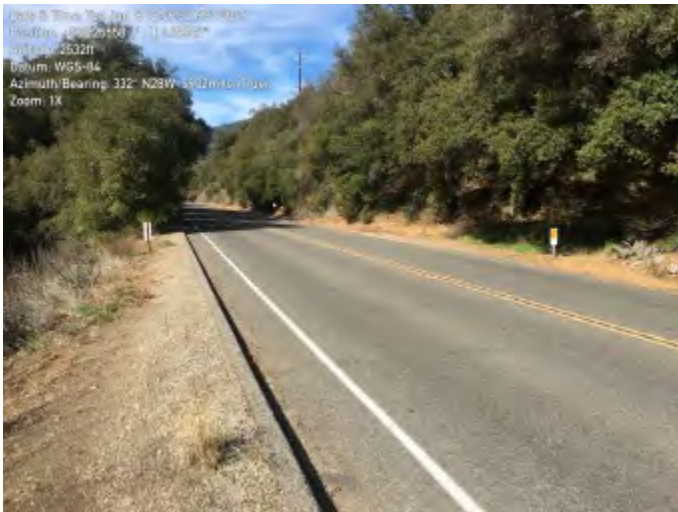
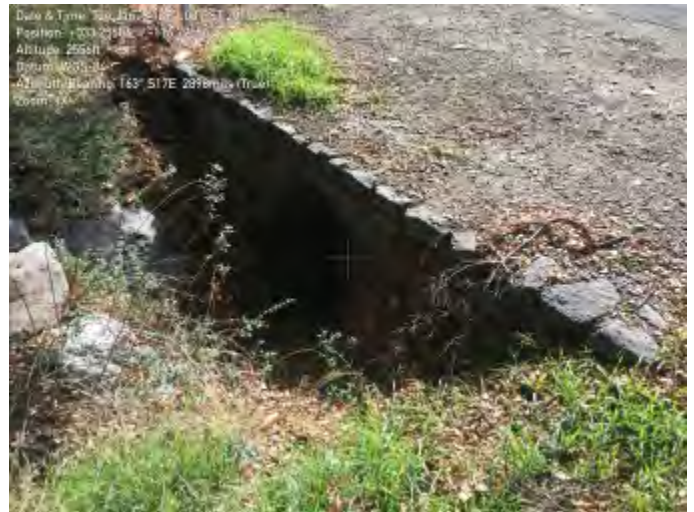
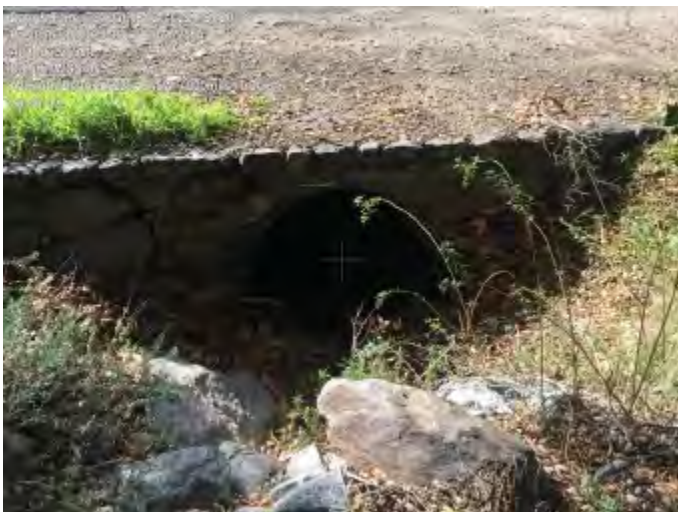
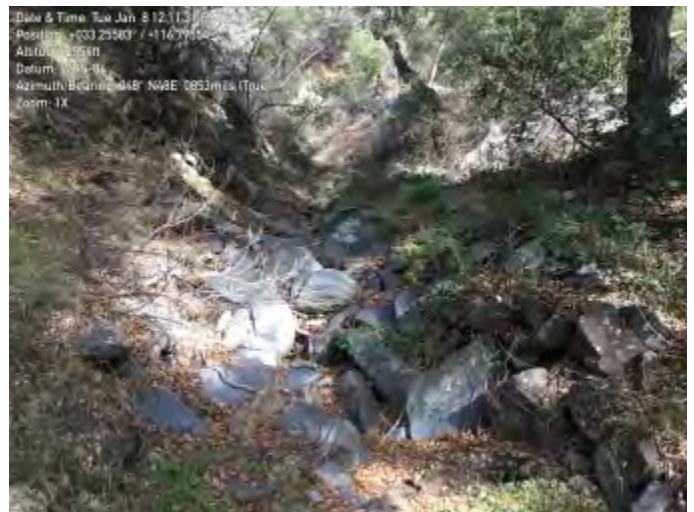
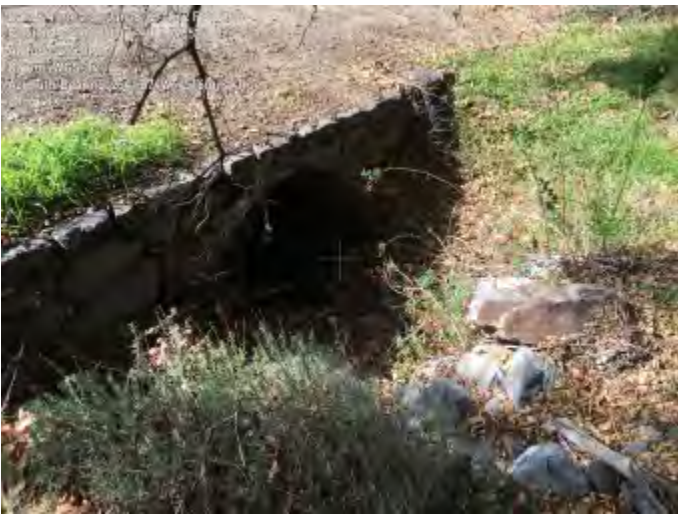
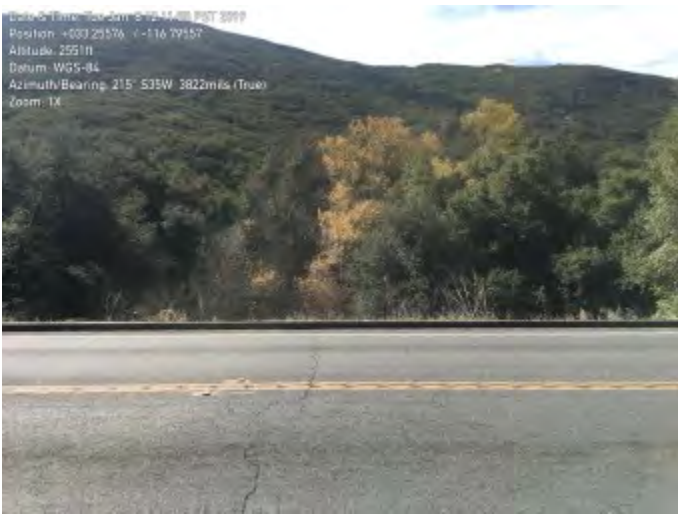
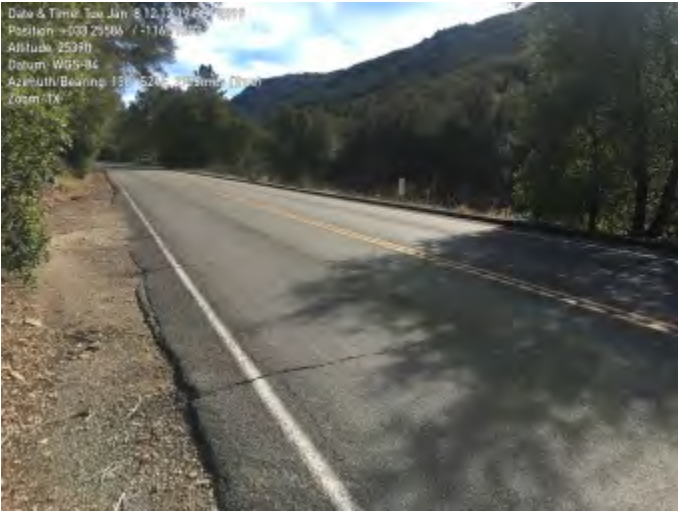
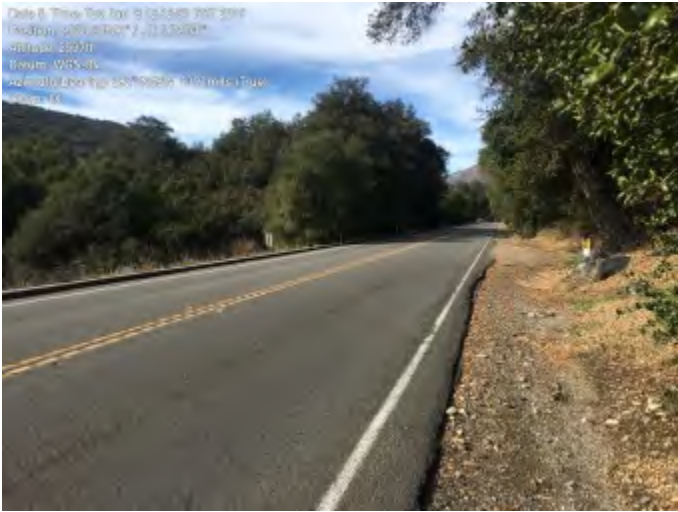
| Comments | Larger diameter culvert with good access. This location amenable to wildlife crossing. Natural landscape to north and south. |

| Management recommendations | Barrier fencing. Directional fencing. Increase culvert diameter. |

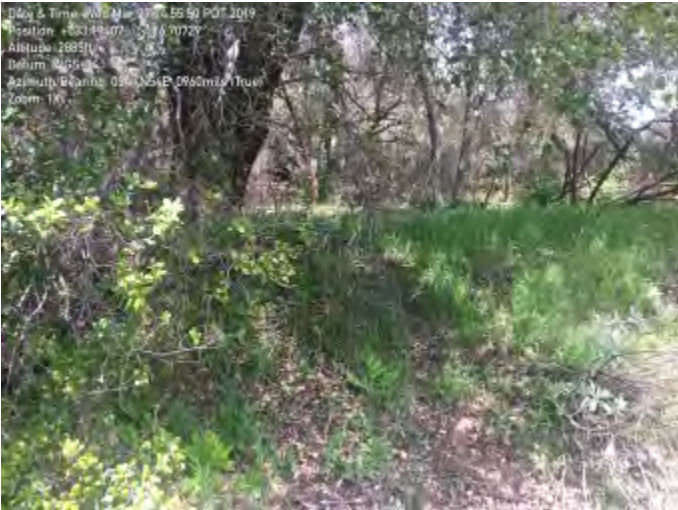
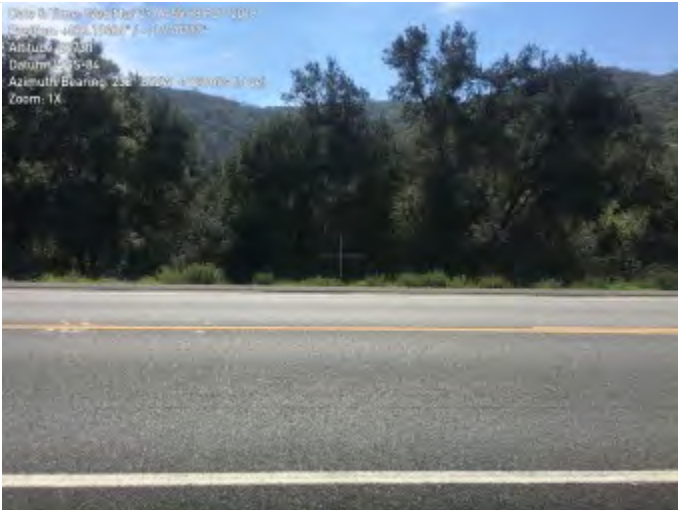
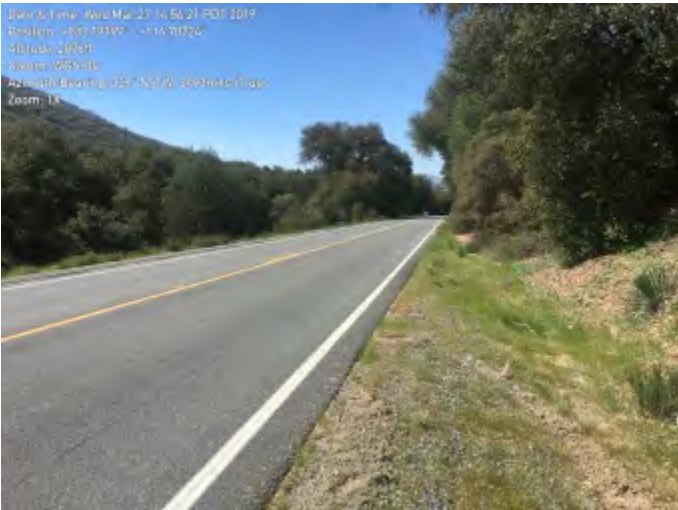
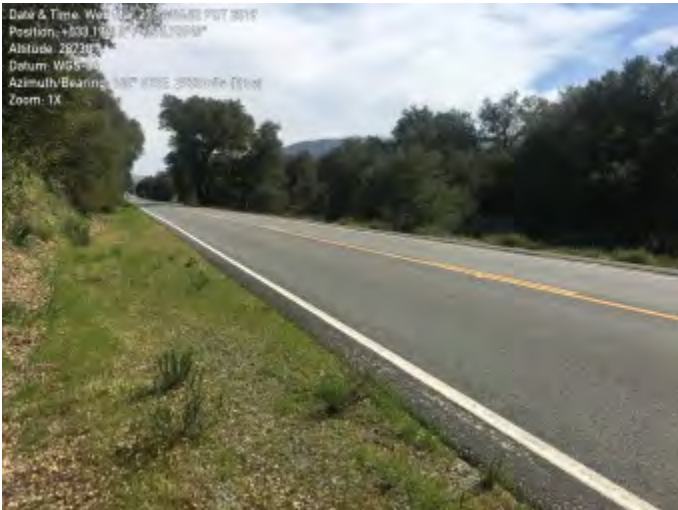
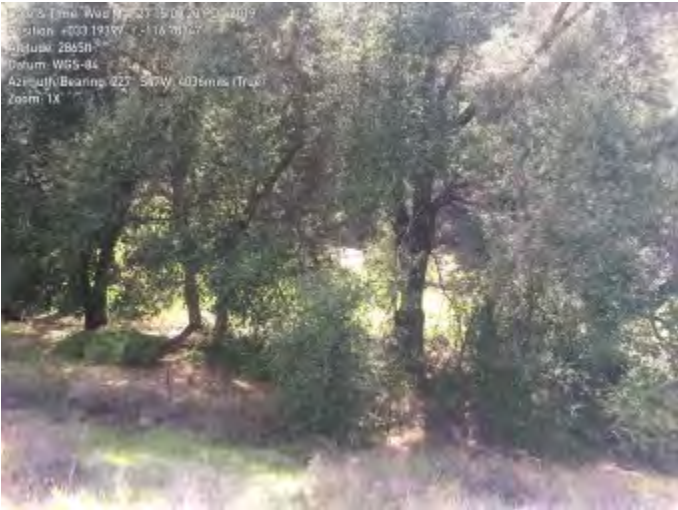
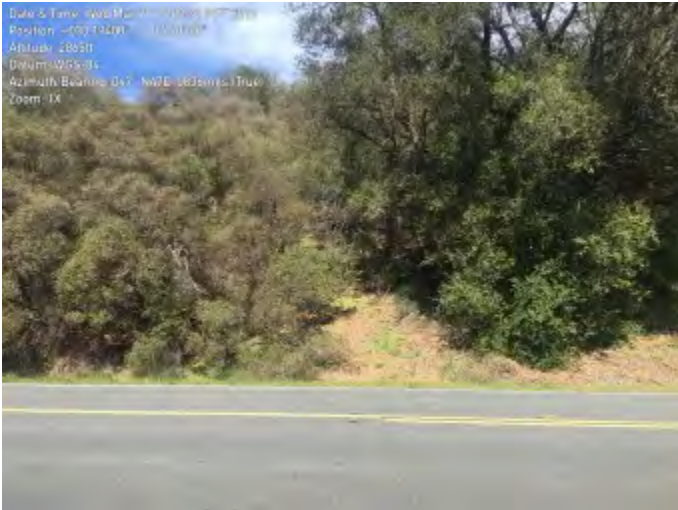
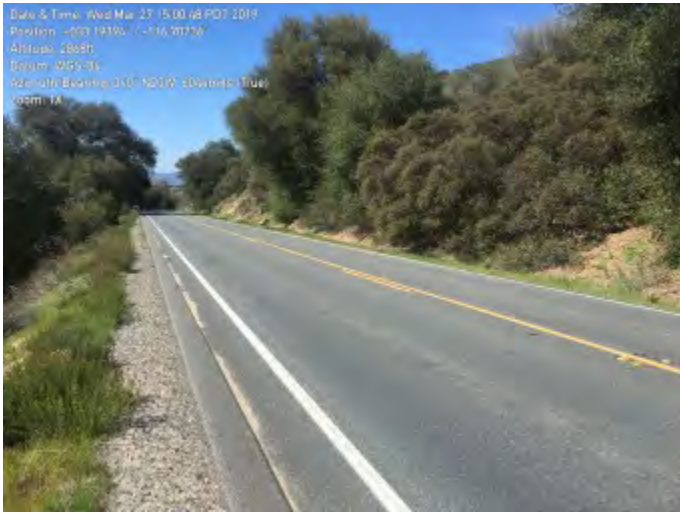
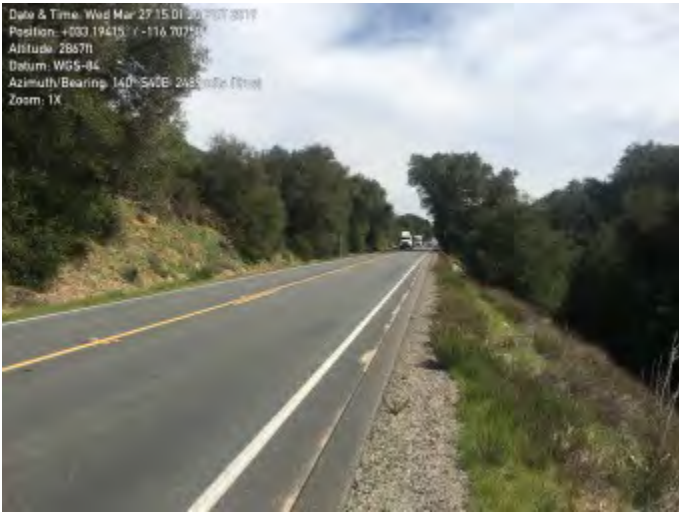
| Comments | Landscape and terrain conducive to crossing, but absence of crossing structure creates dangerous crossing situation. Steep embankment dropping to edge of northbound lane precludes construction of undercrossing here. Steep embankment drops off from southbound lane to Carrista Creek drainage. |

| Management recommendations | Barrier fencing. Wildlife crossing signs. |

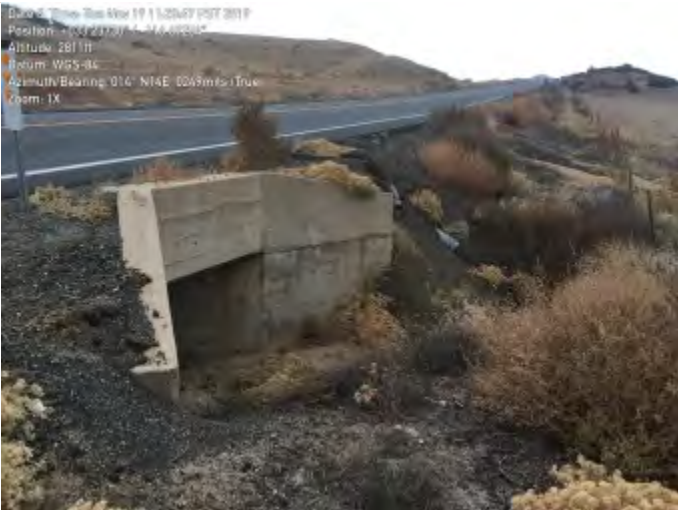
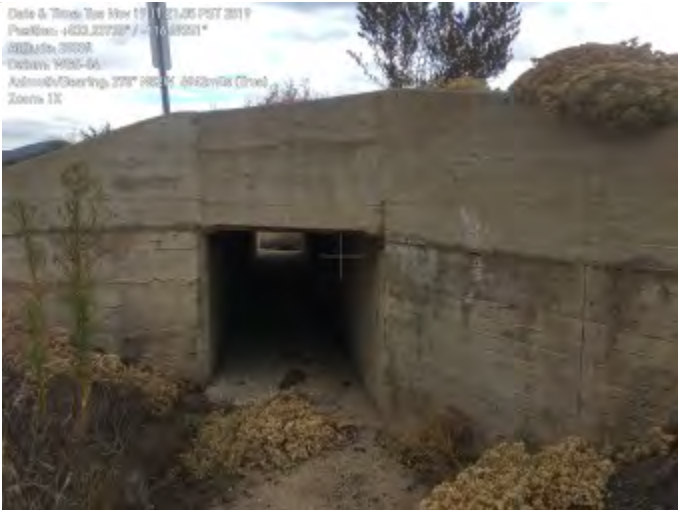
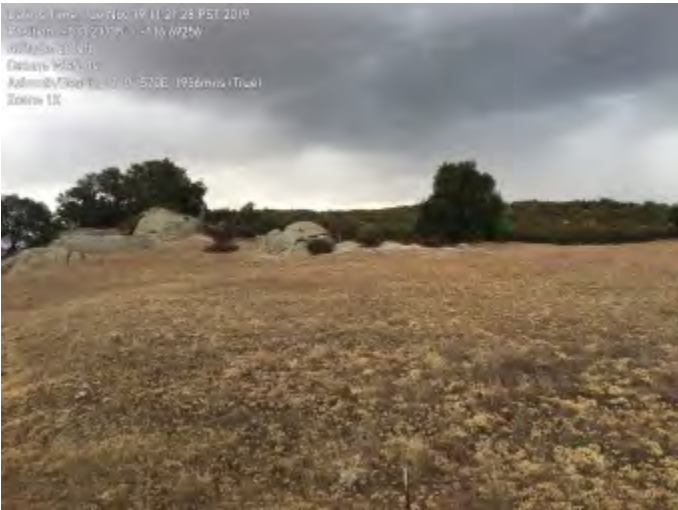
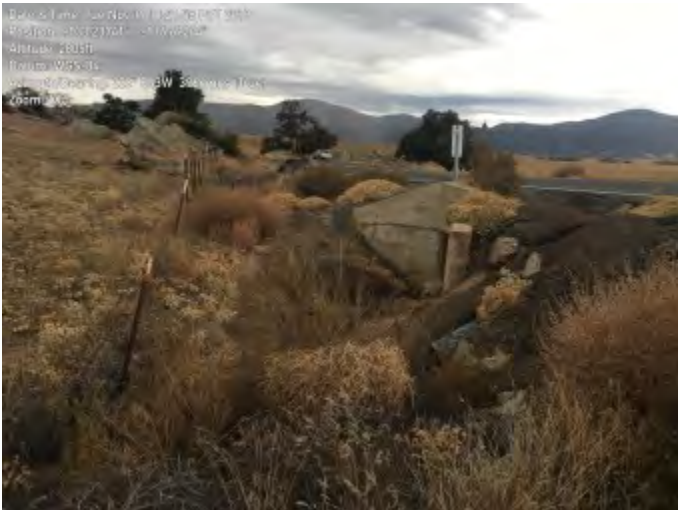
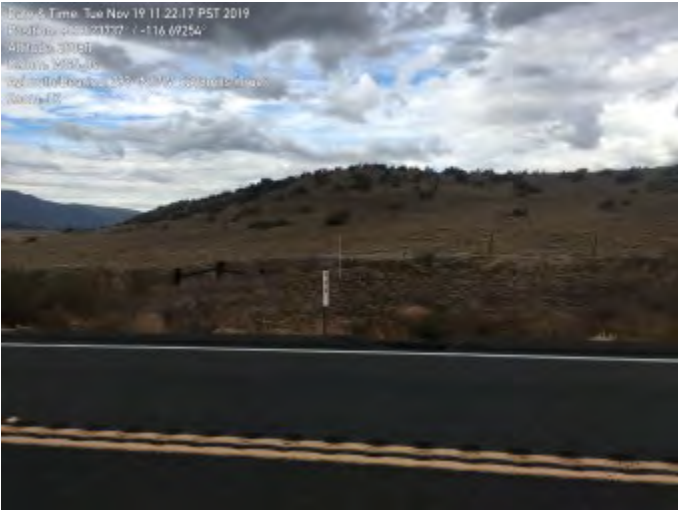
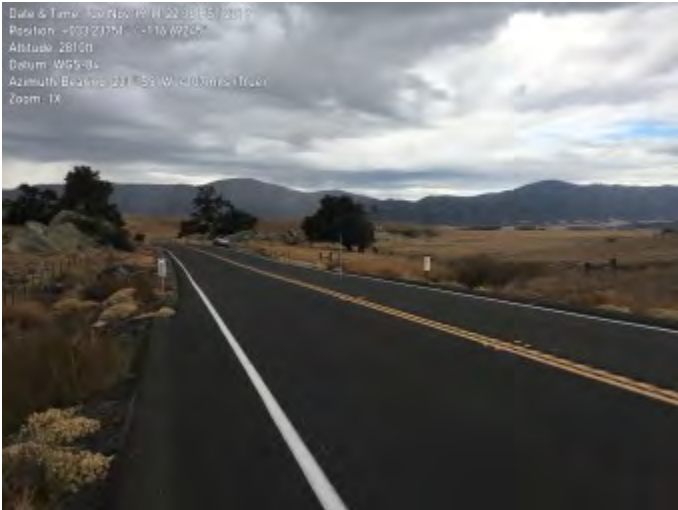
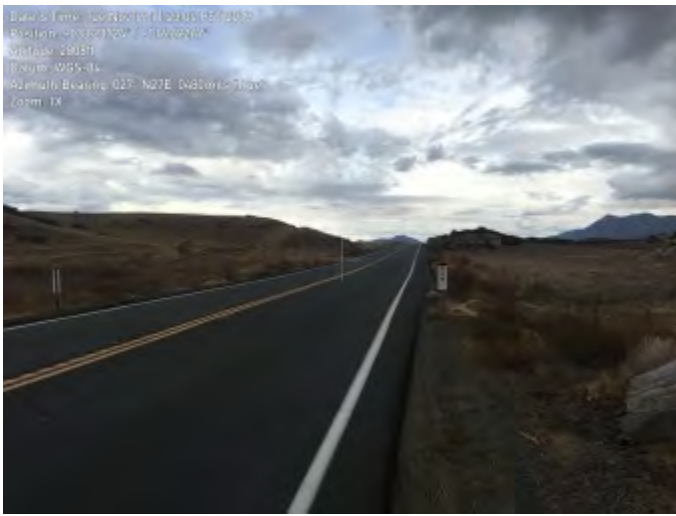
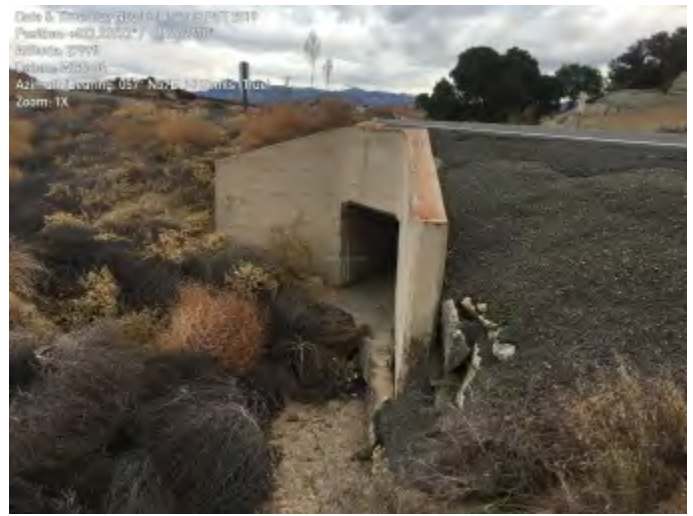
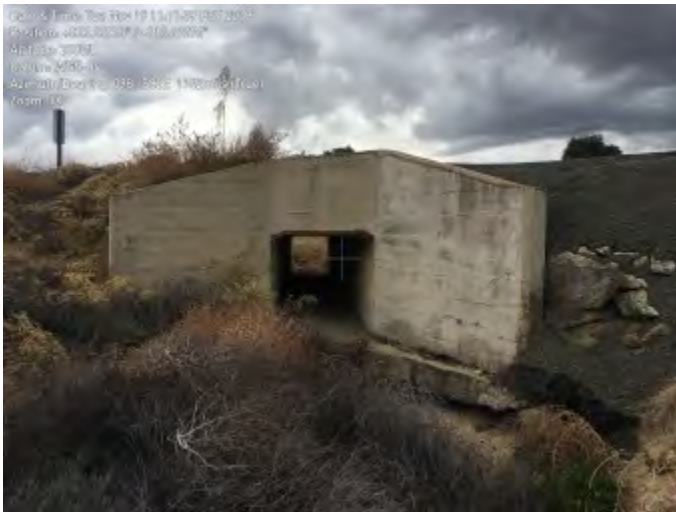
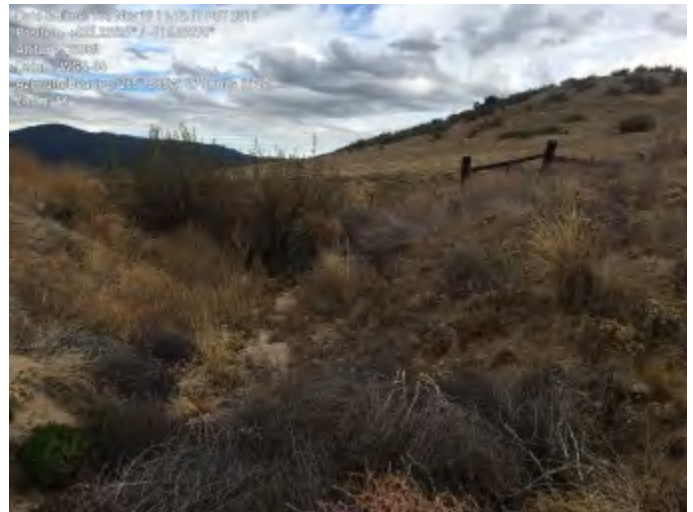
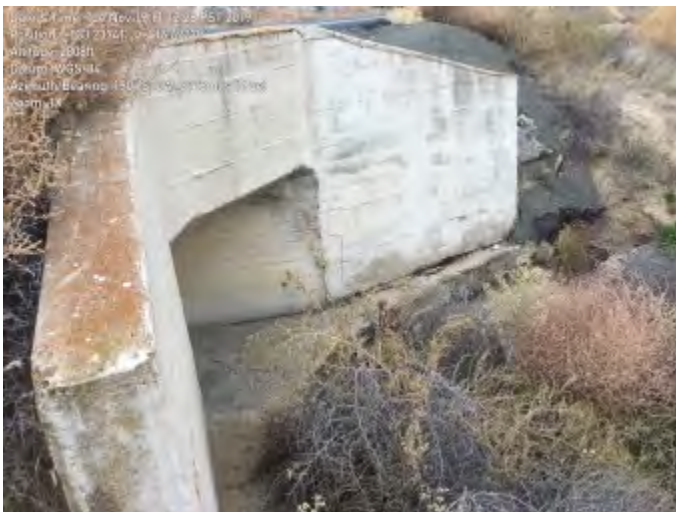
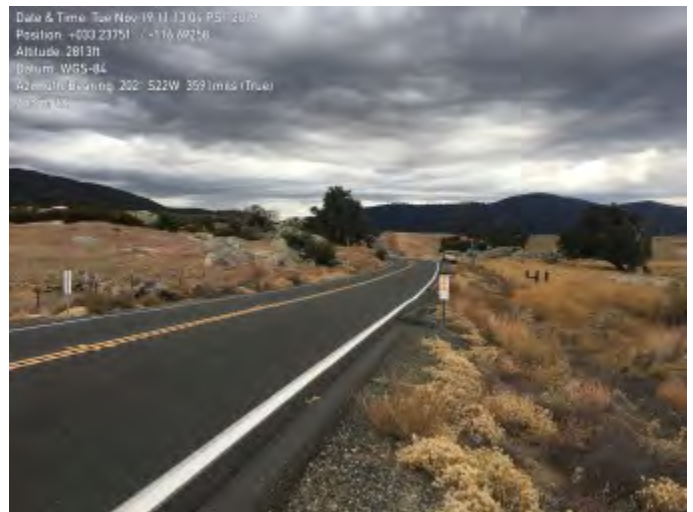
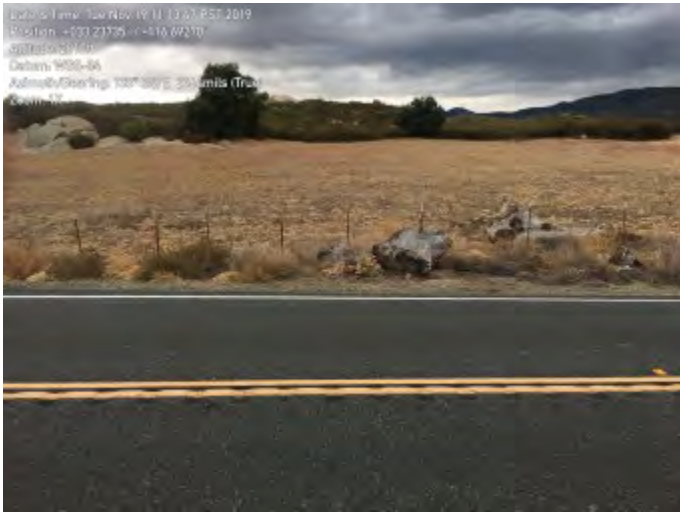
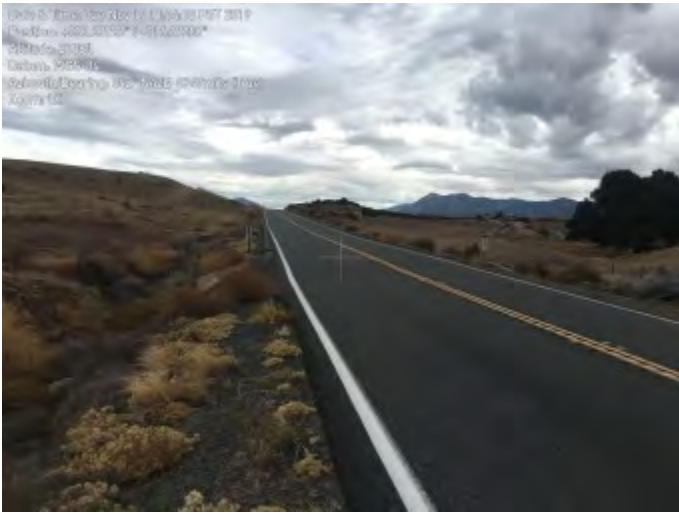
| Comments | Open, natural landscape to east and west. Good wildlife access to this large culvert. Culvert is close to highway so traffic noise is significant. |

| Management recommendations | Barrier fencing. Directional fencing. Sound dampening. |

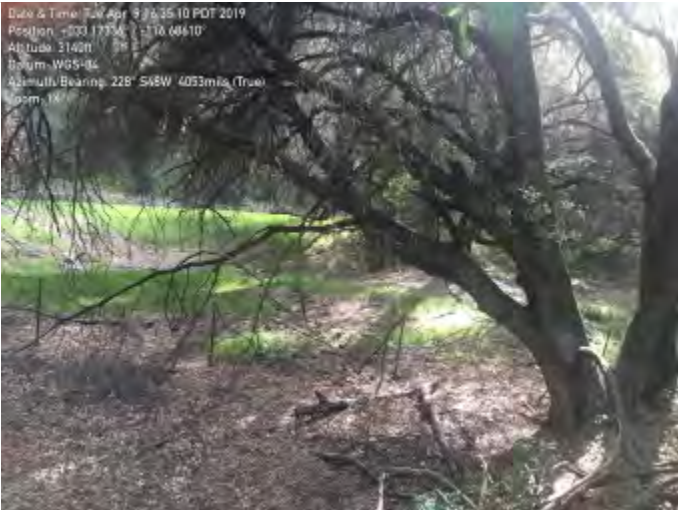
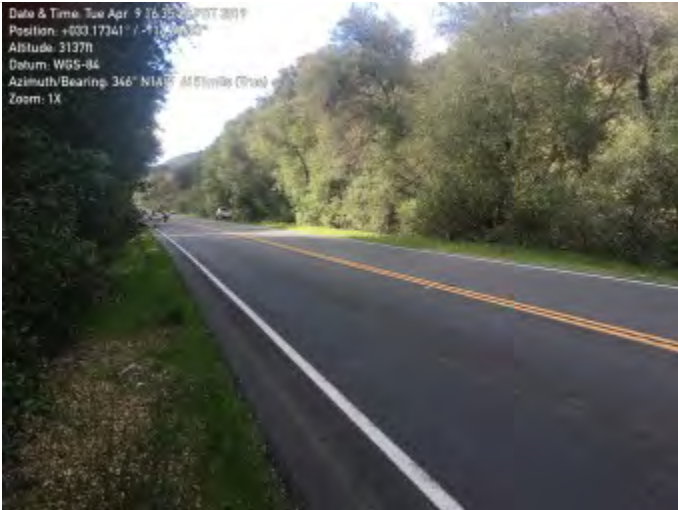
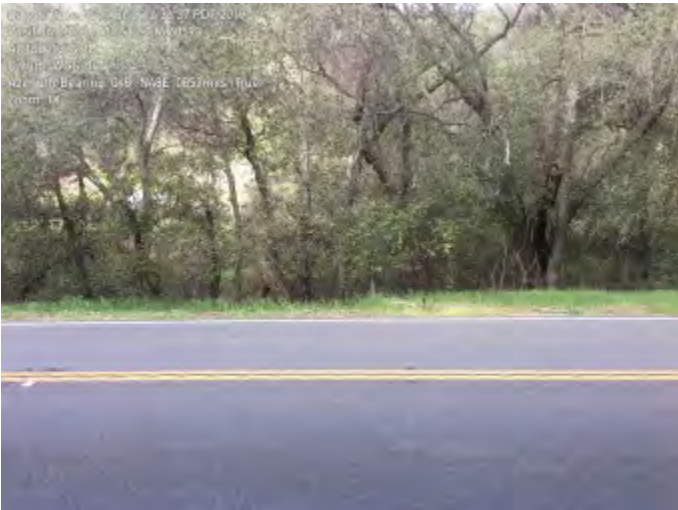
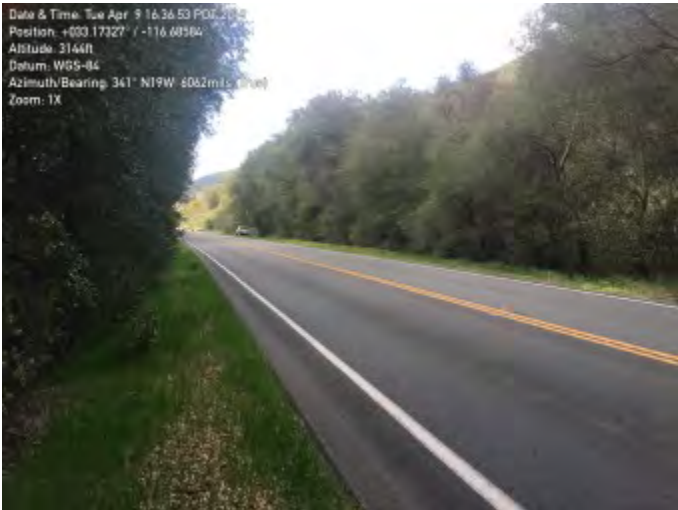
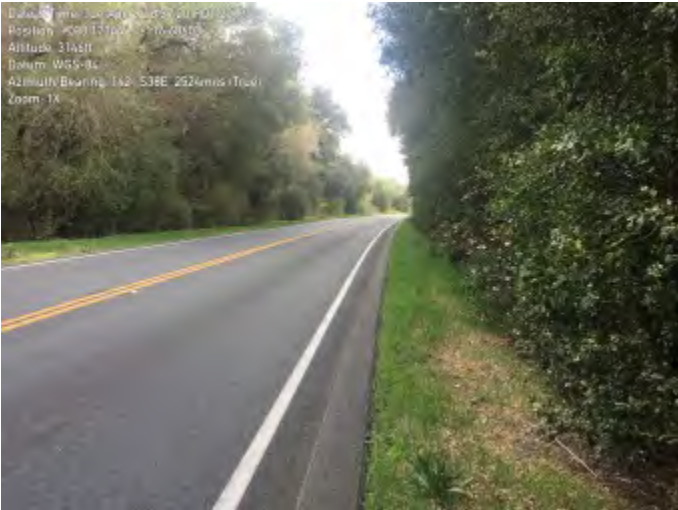
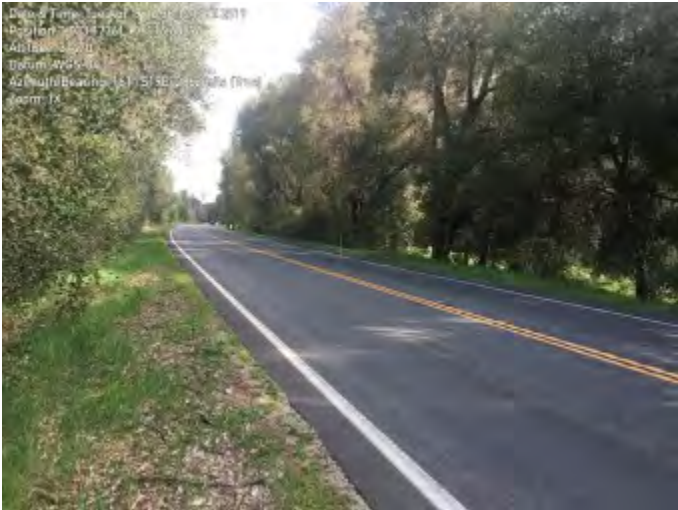
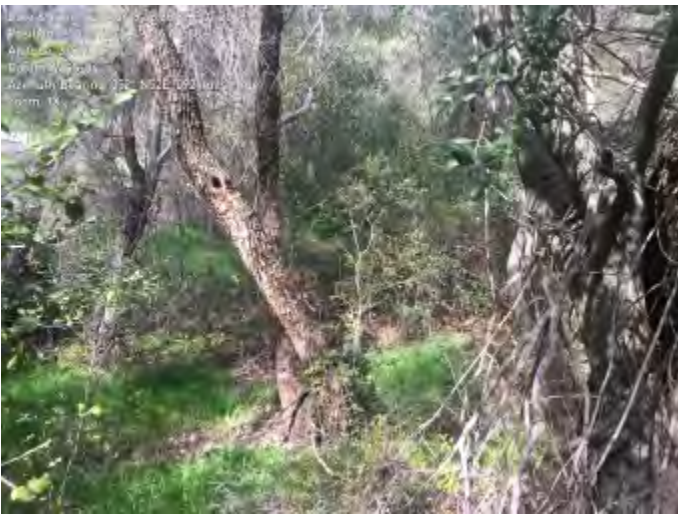
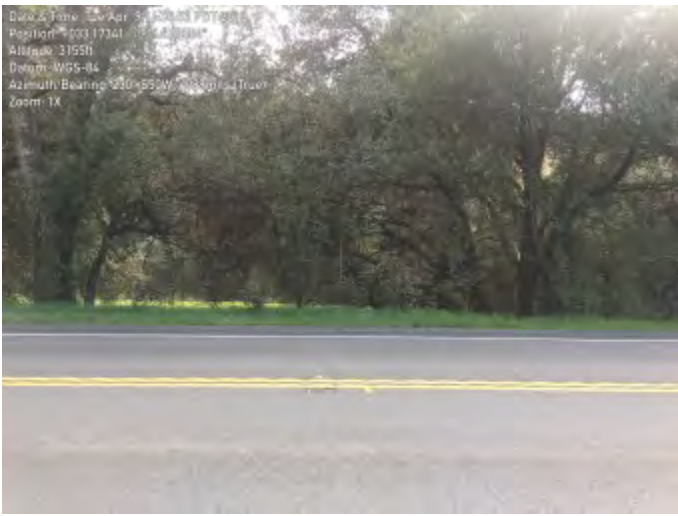
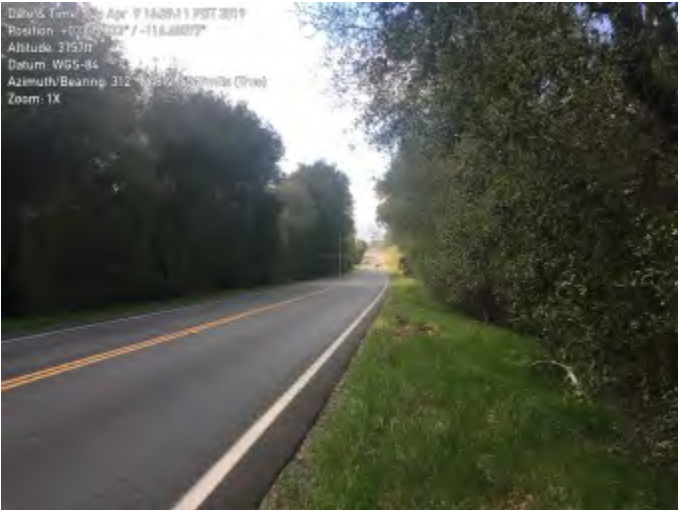
| Comments | Poor crossing area due to absence of crossing structure. Potential for construction of undercrossing structure due to dropoff embankments southbound and northbound. |

| Management recommendations | Construction of undercrossing structure. Barrier fencing. |

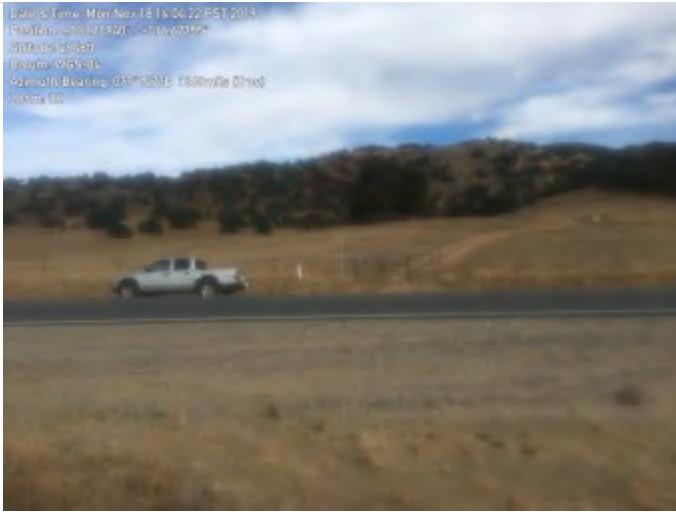
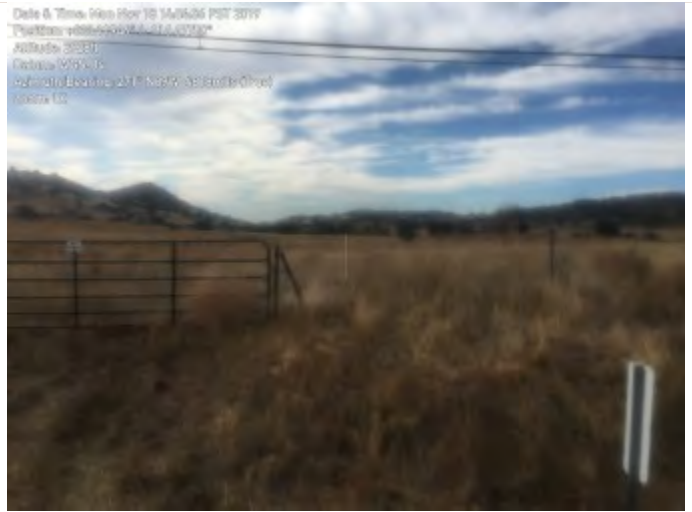
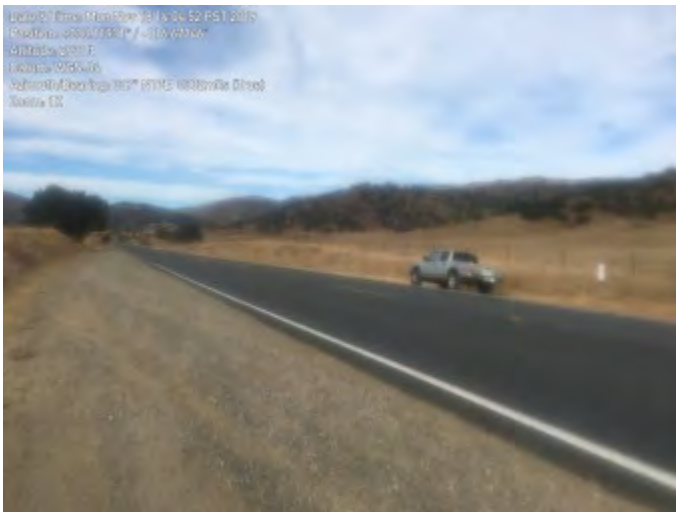
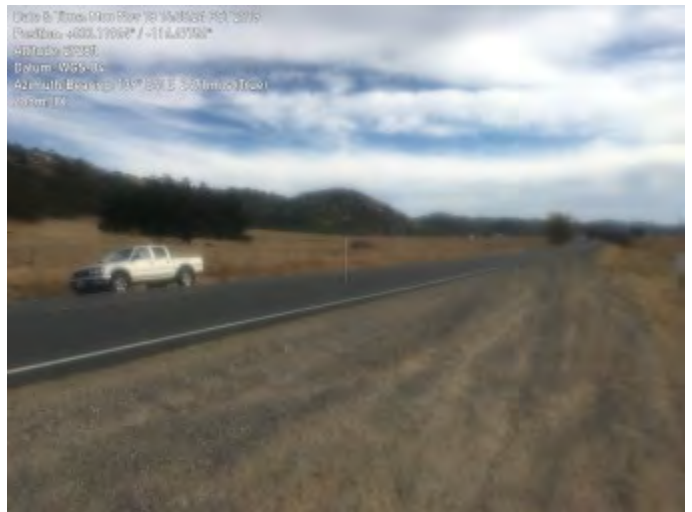
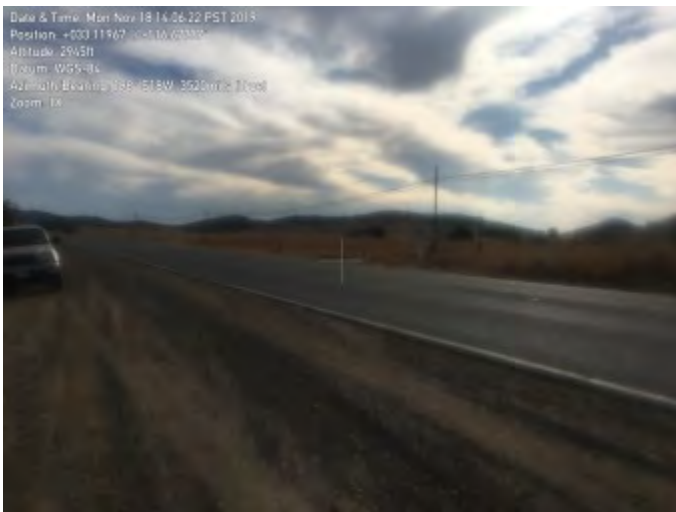
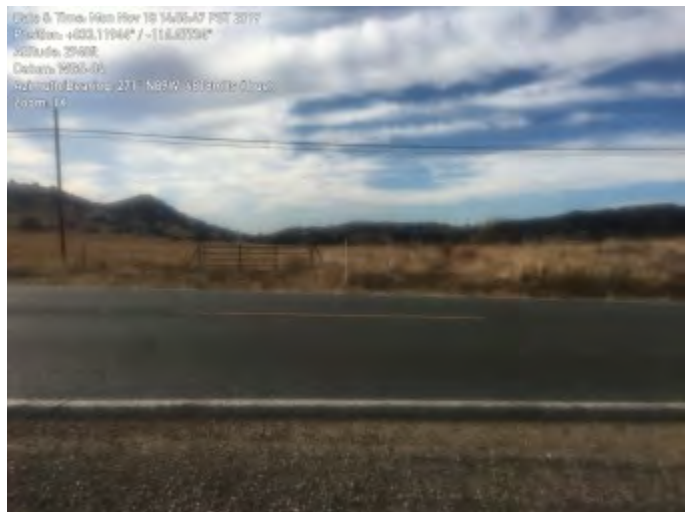
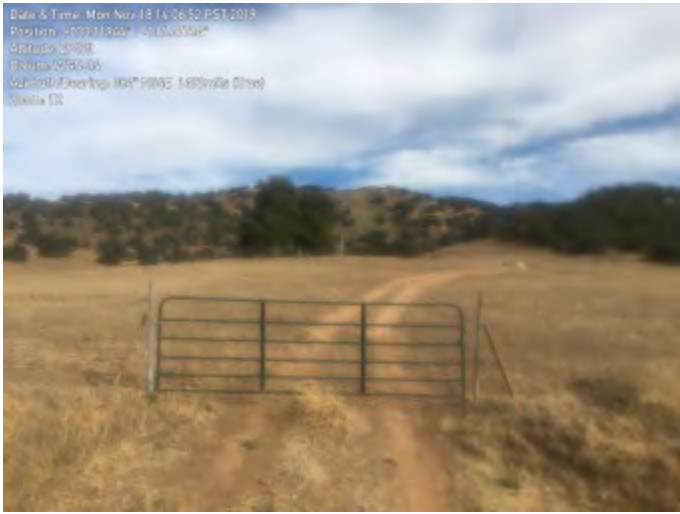
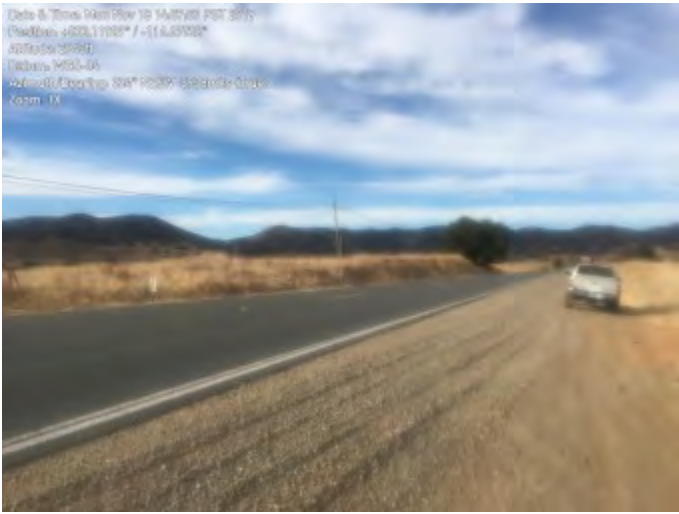
| Comments | No crossing structure here. Although wide open natural landscape to the east and west, it is open grasslands. |

| Management recommendations | Wildlife crossing signs. Rumble strip. |
