SA-PAL survey

| Project | SA-PAL project |
| ID | 42130 |
| Survey Date | 04/03/2019 |

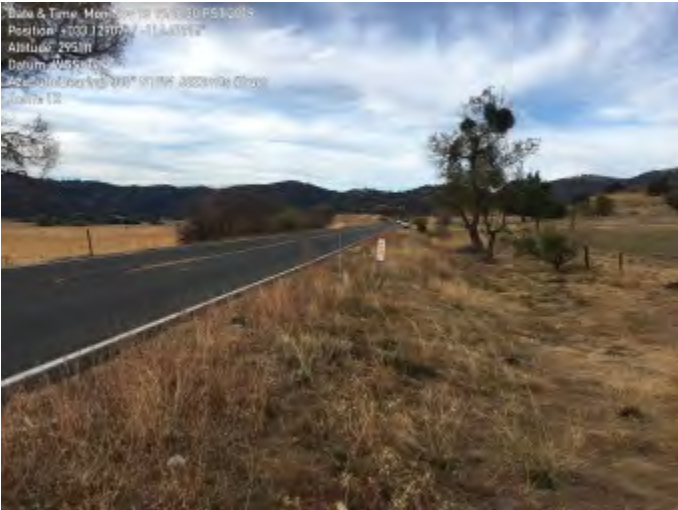
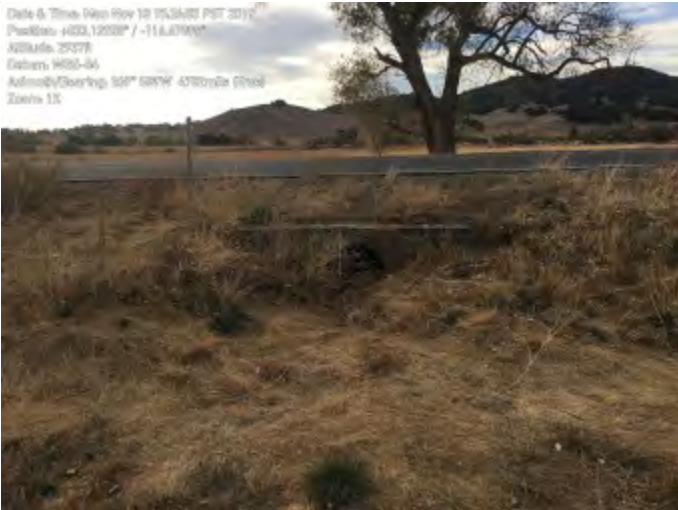
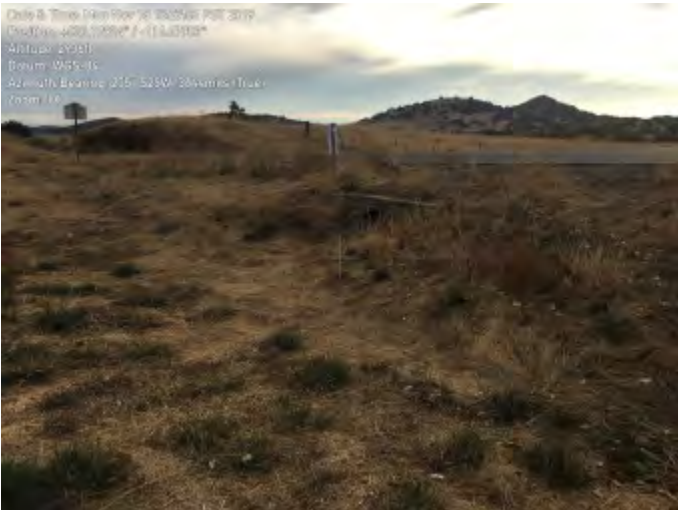
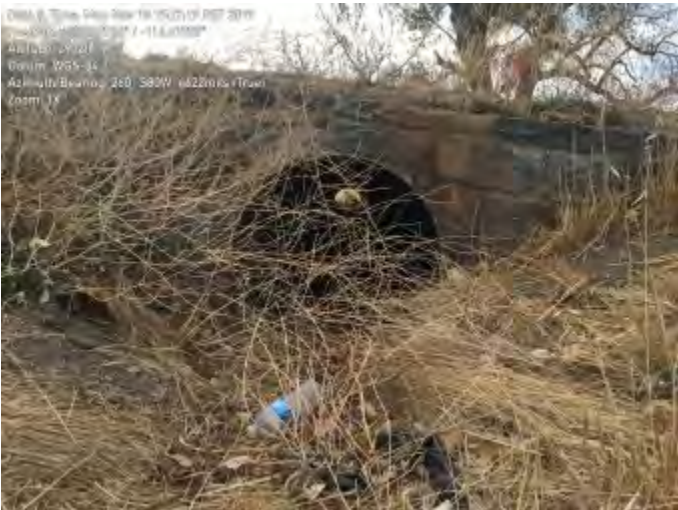
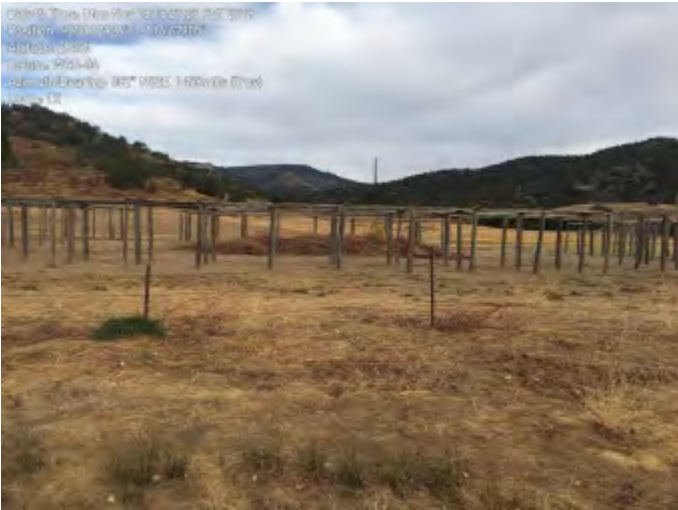
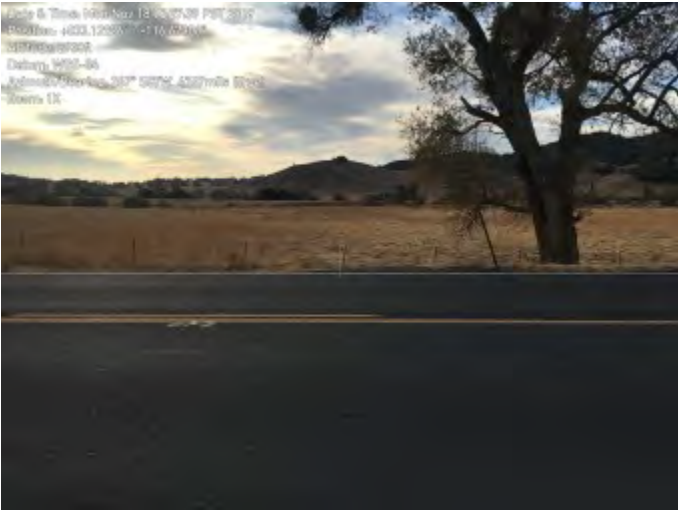
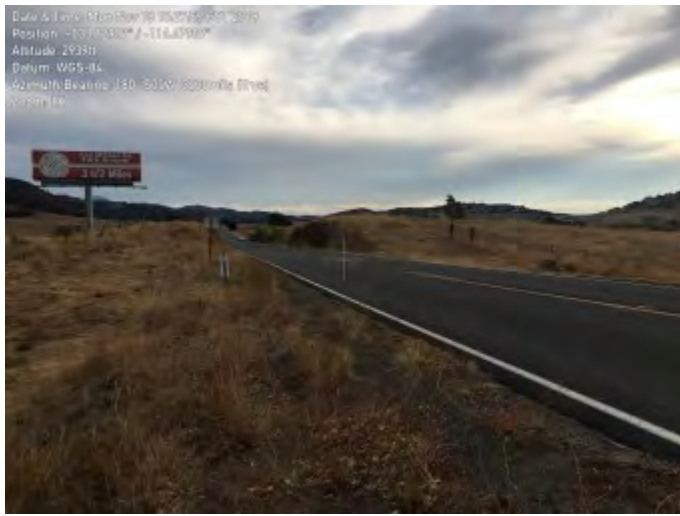
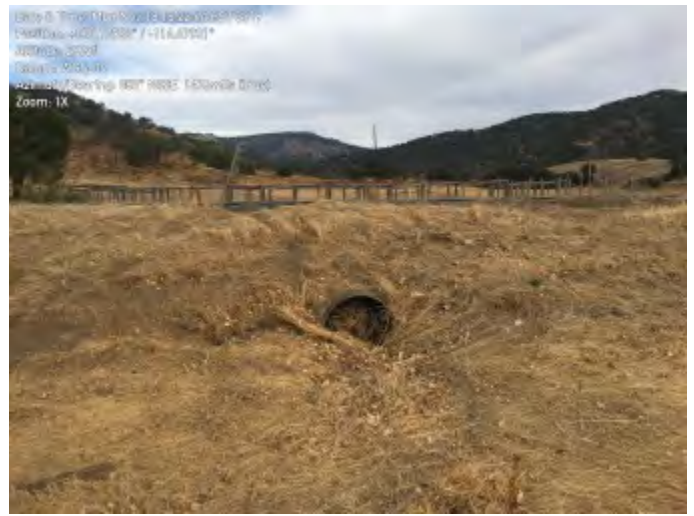
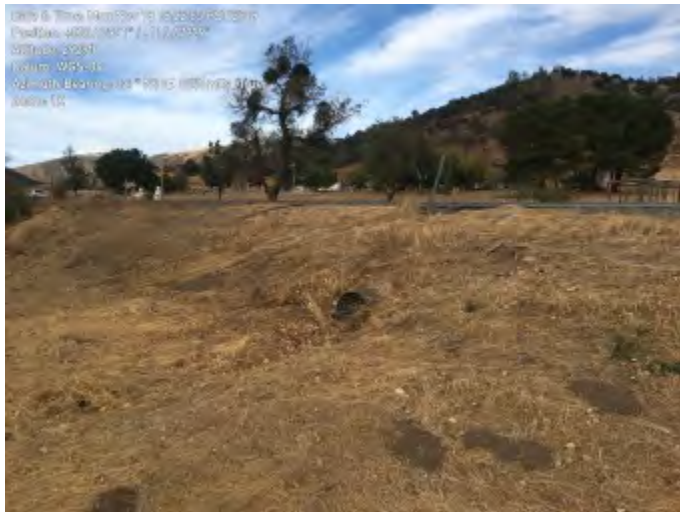
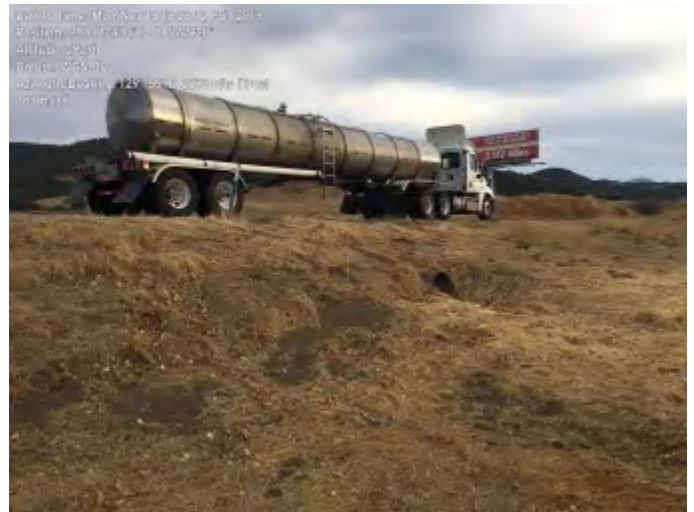
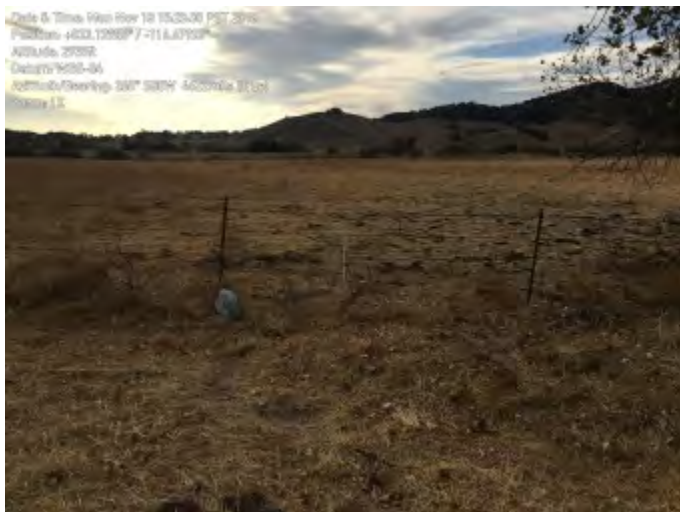
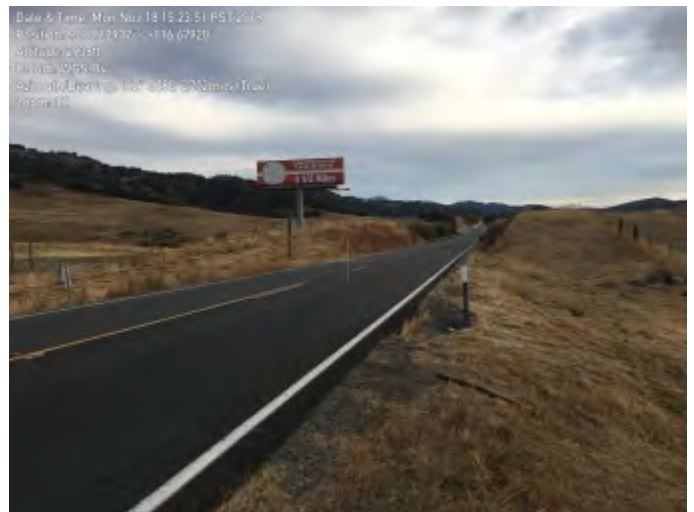
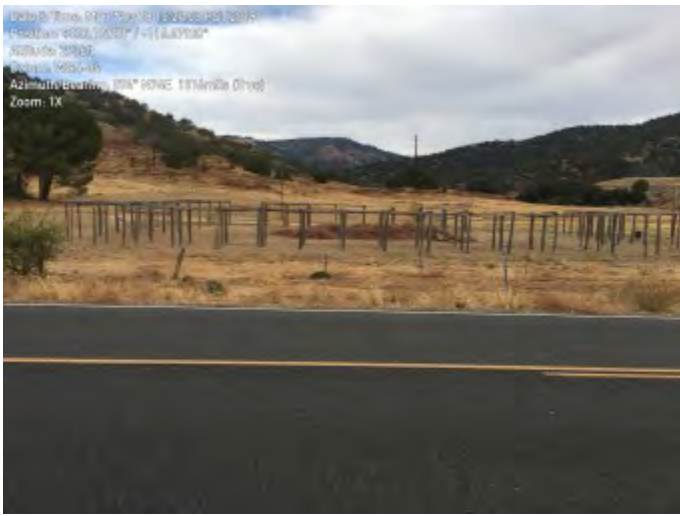
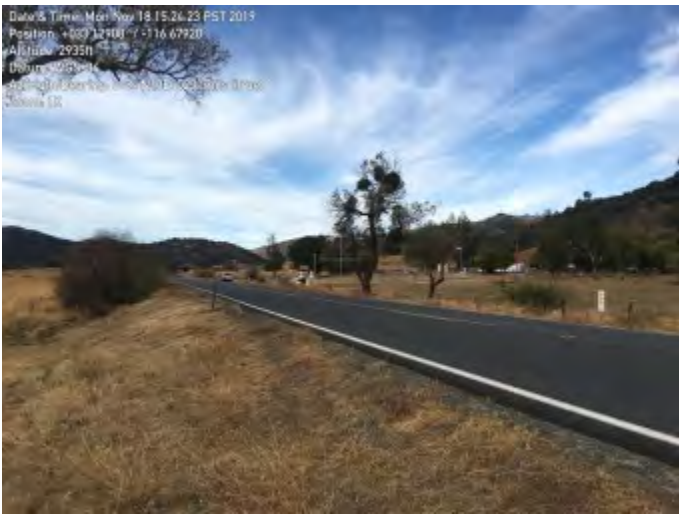
| Describe fencing type and height | 3 foot barbed wire parallel to highway northbound and southbound. |

| Comments | Approx. 100 meters south of Mission Santa Ysabel. Not a consideration for larger wildlife. Too close to highway to be a consideration for most wildlife. Moderate traffic and noise. Open landscape to east and west. Adjacent to Santa Ysabel Preserve. This location is approx. 75 meters north of P108 North Bridge. |

| Management recommendations | Directional fencing and trails to bridge at P108 north. Wildlife crossing signs. |

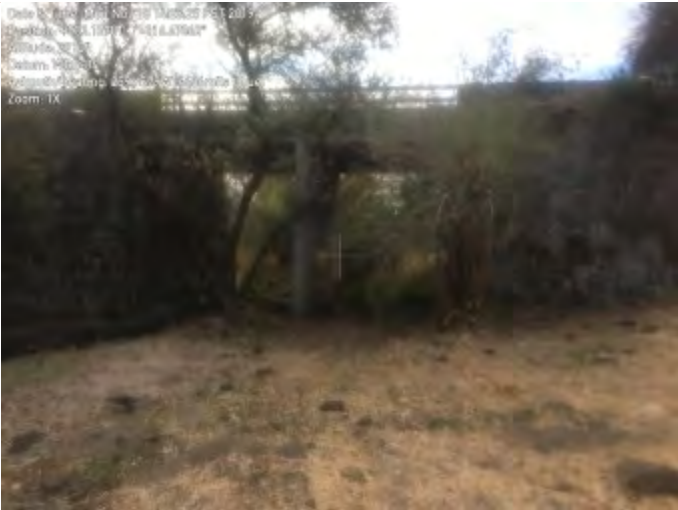
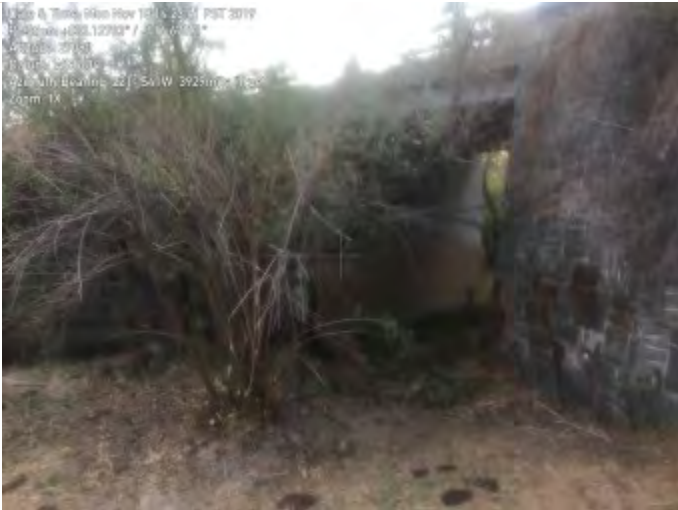
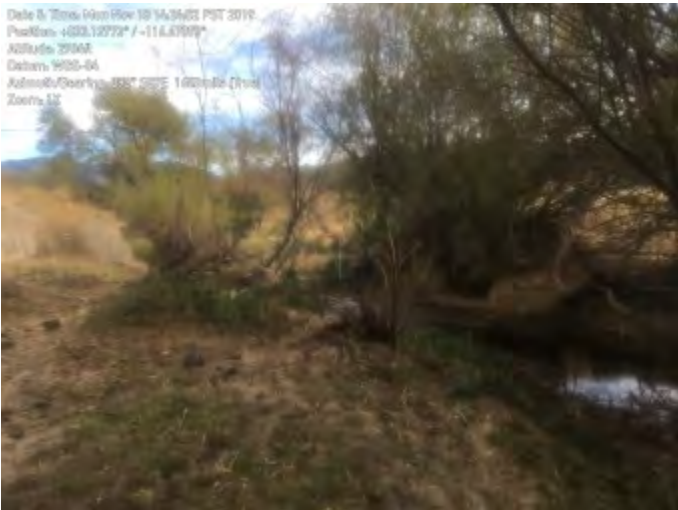
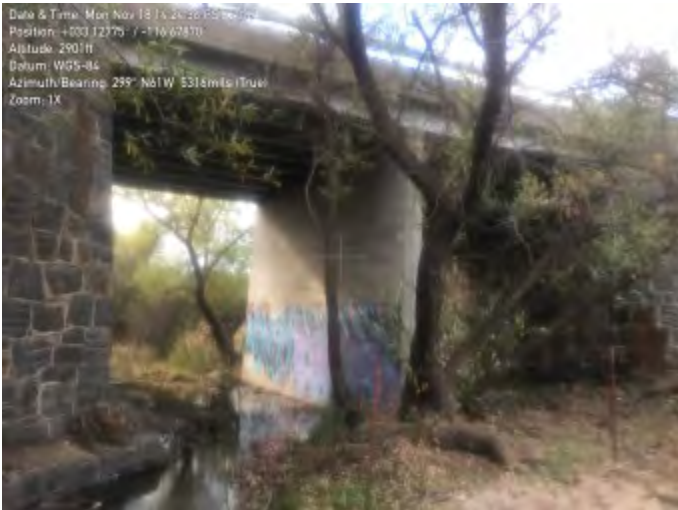
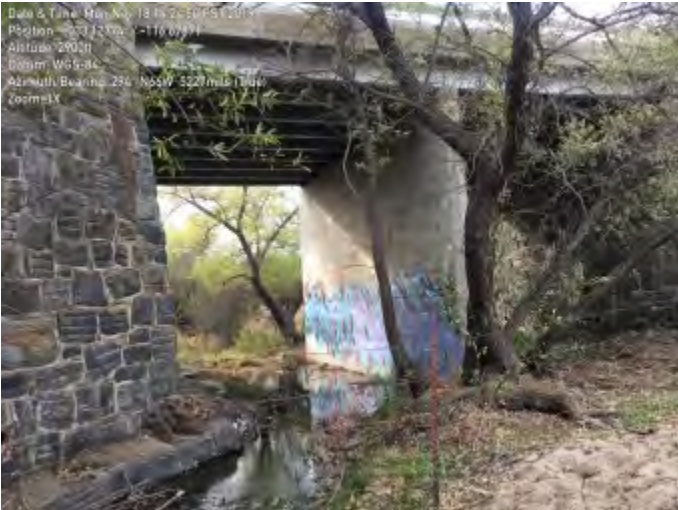
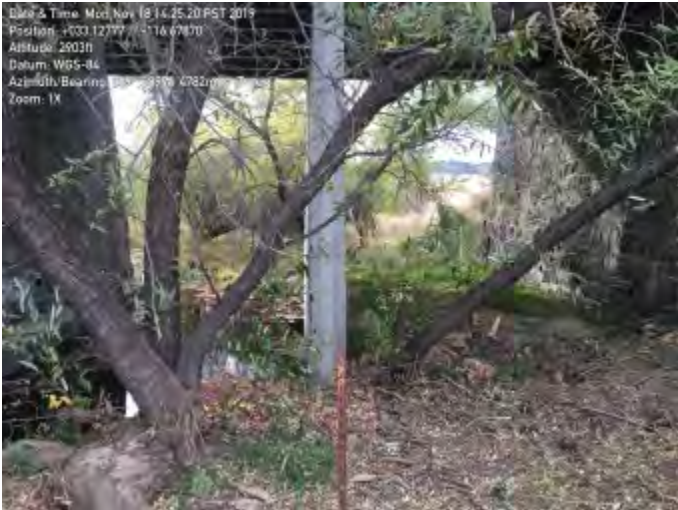
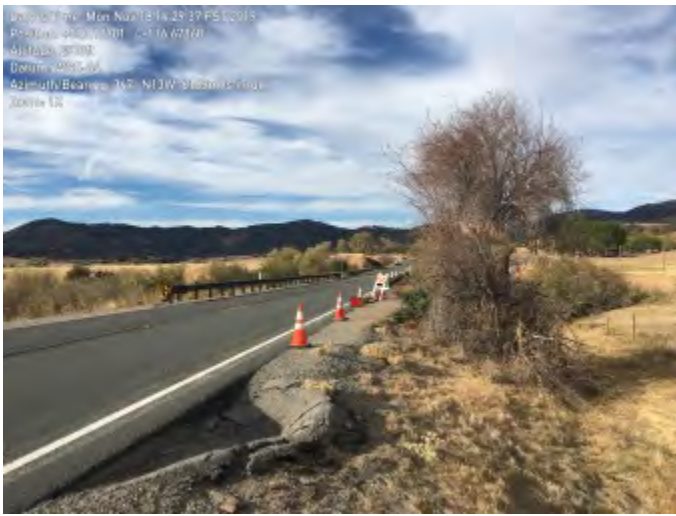
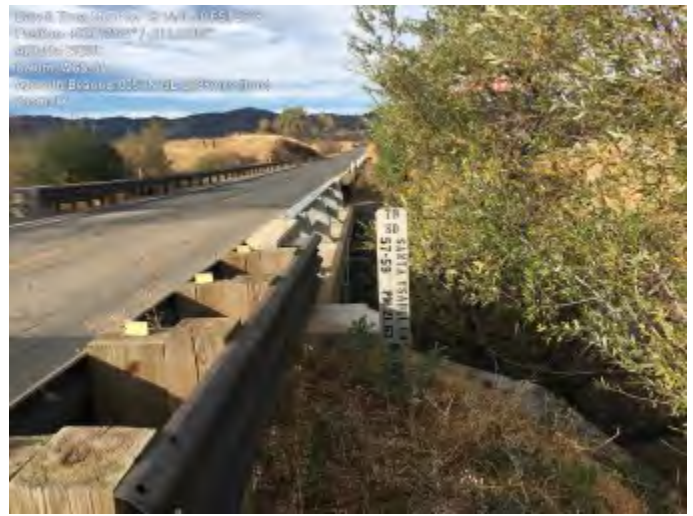
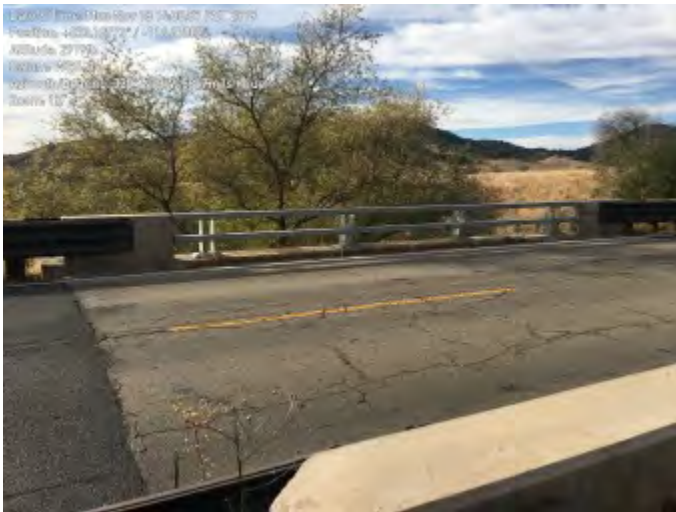
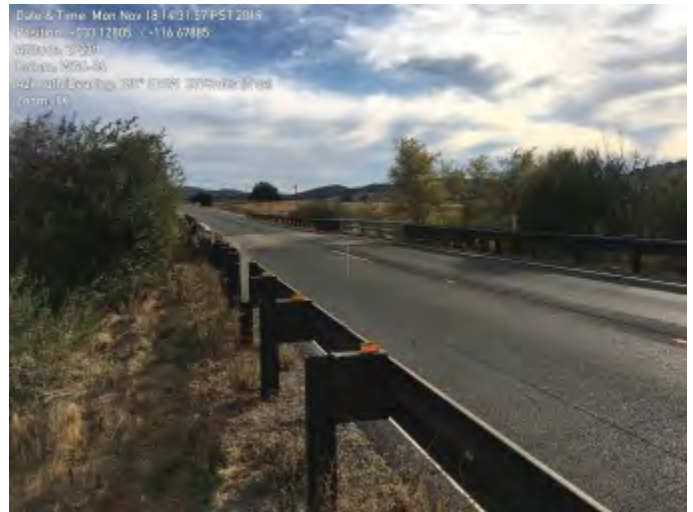
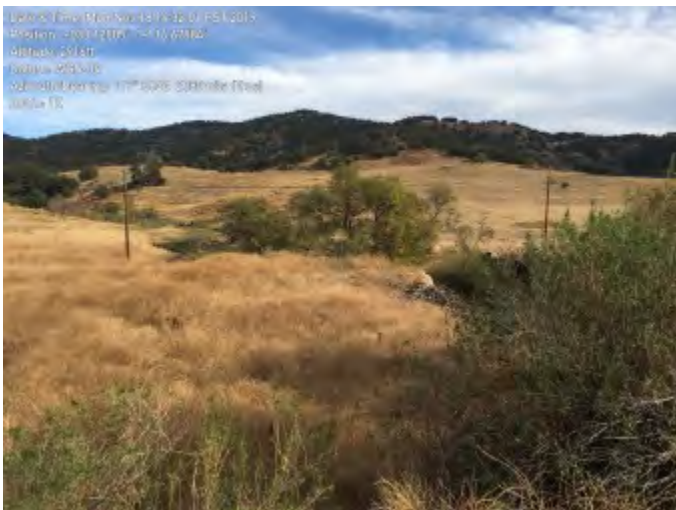
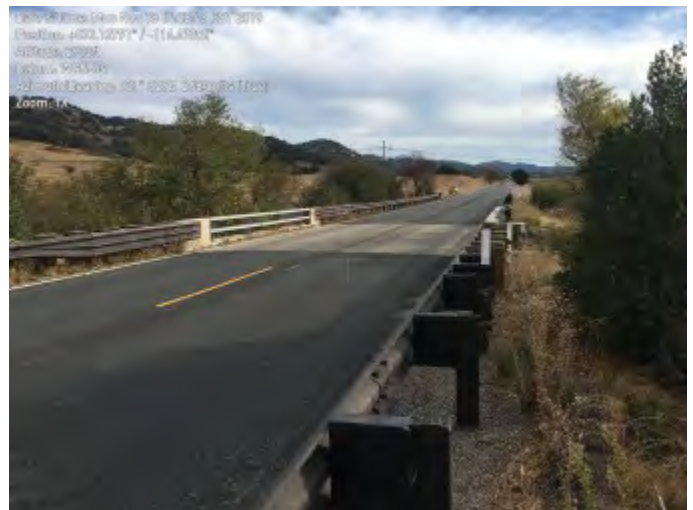
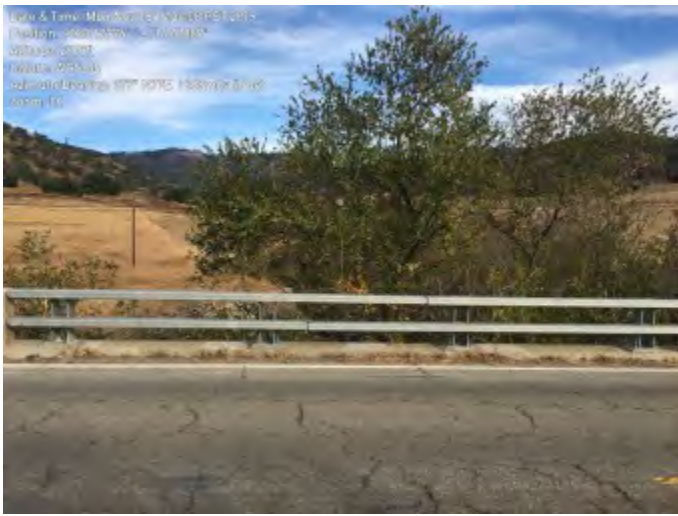
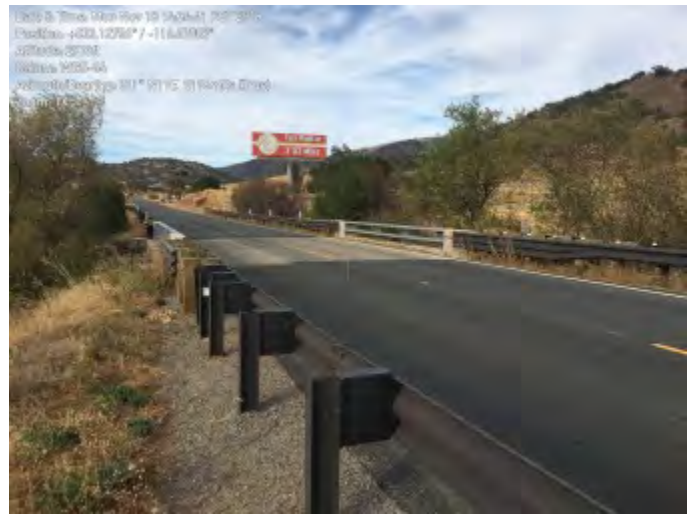
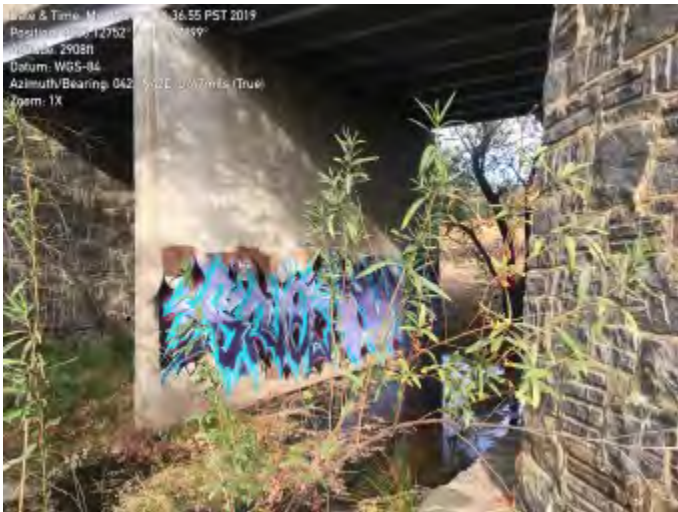
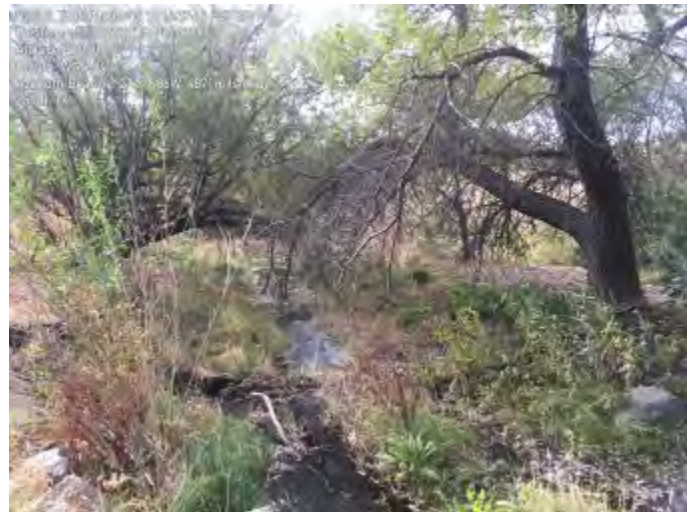
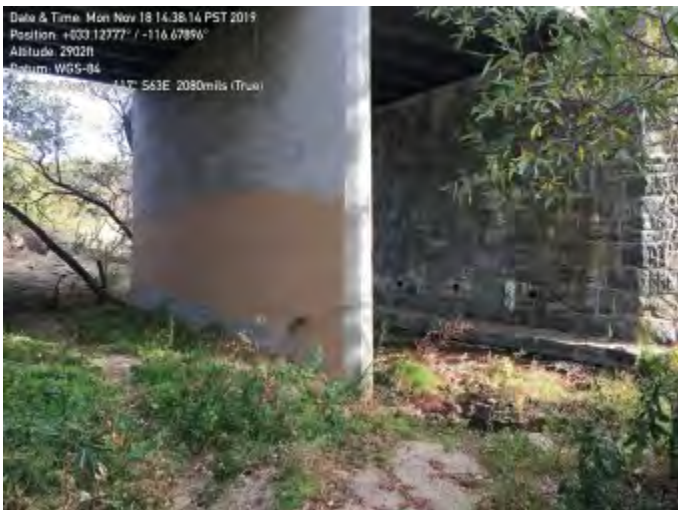
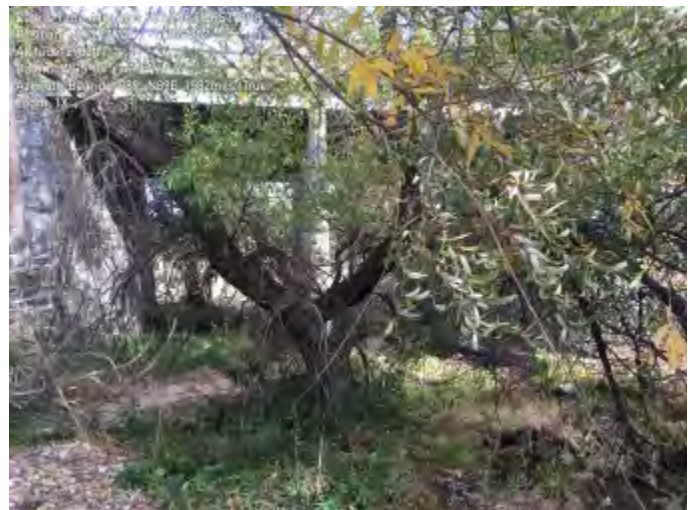
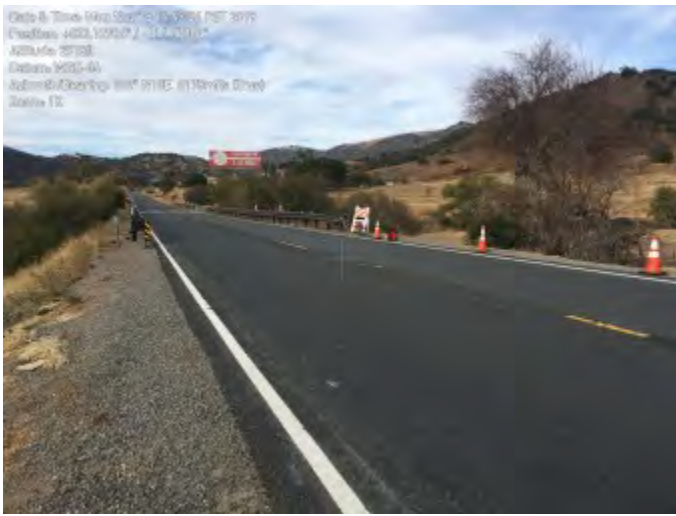
| Describe fencing type and height | Four foot barbed wire limiting access to underpass from northbound and southbound. |

| Comments | Large bridge with excellent space for transit of wildlife. Landscape amenable to travel east and west. This is Santa Ysabel Preserve. Moderate traffic flow and noise. Height of bridge moderates traffic noise to some extent. |

| Management recommendations | Barrier fencing. Direction fencing and trails to guide wildlife to this location for crossing. |

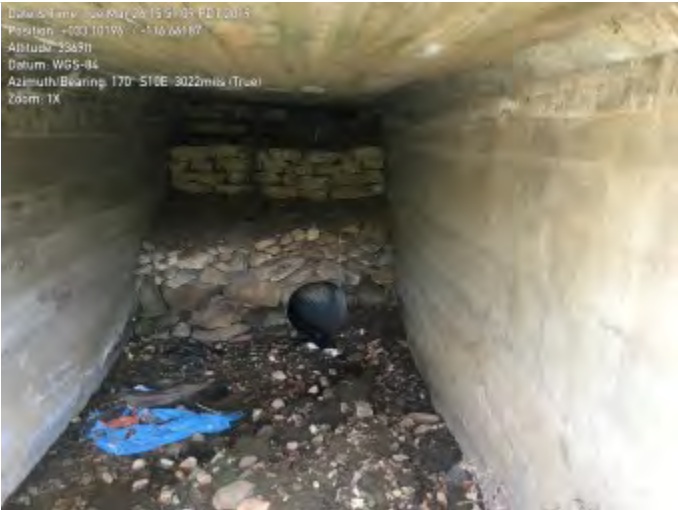
westbound Entrance to culvert which transitions to small diameter pipe culvert

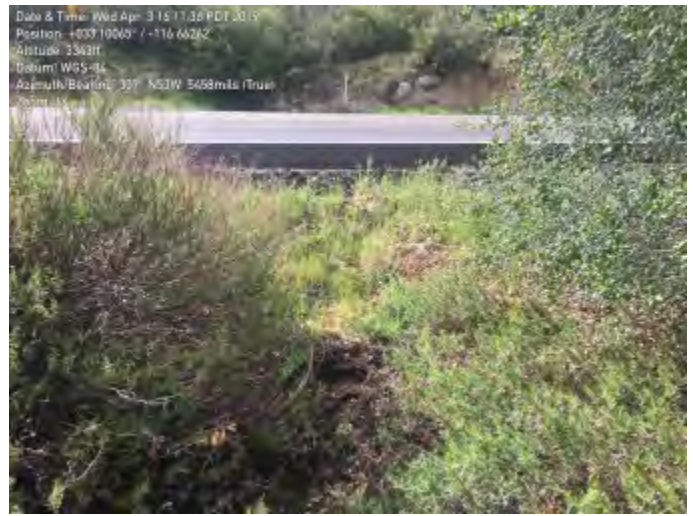
eastbound Blocked culvert exit on eastbound side

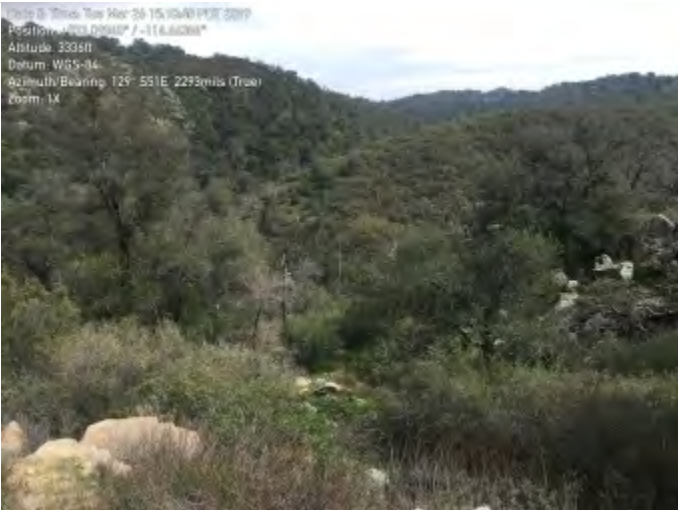
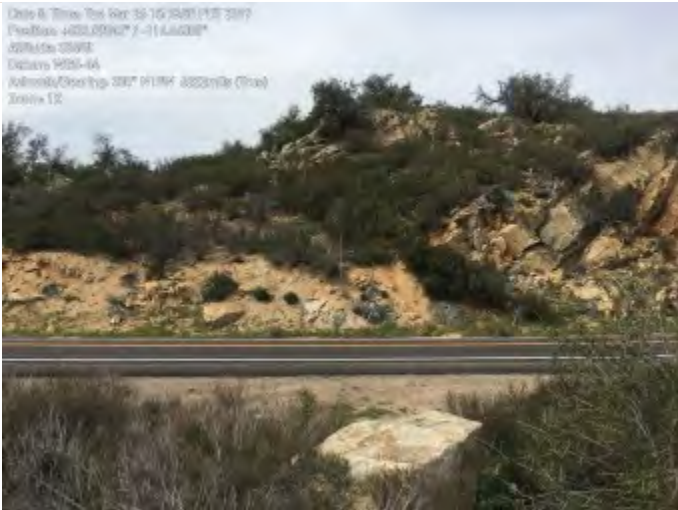
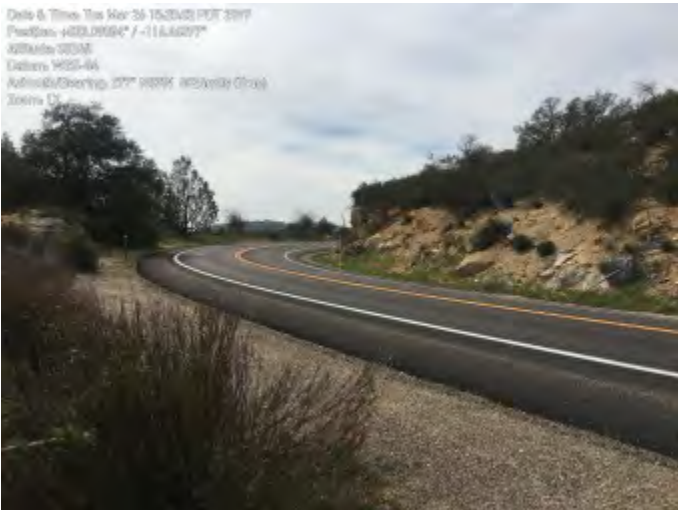
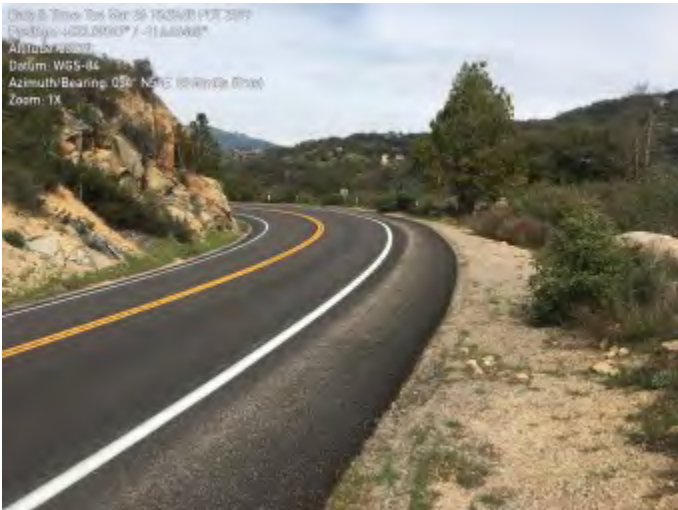
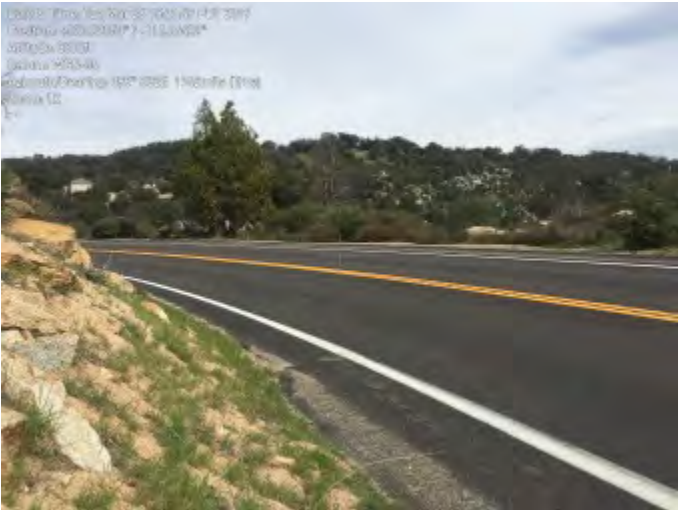
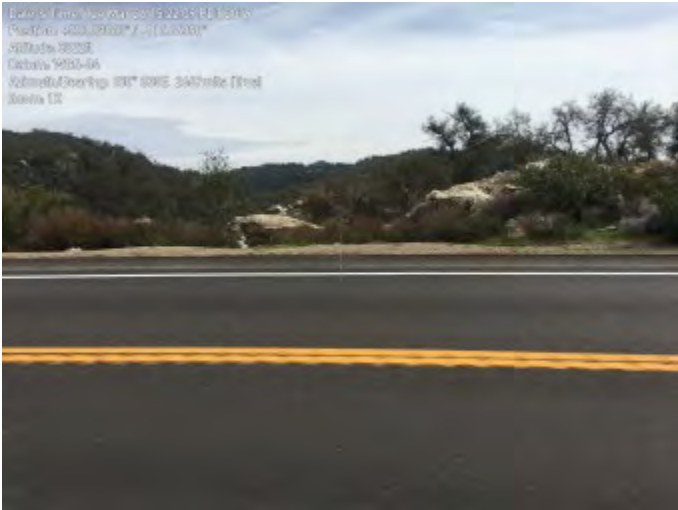
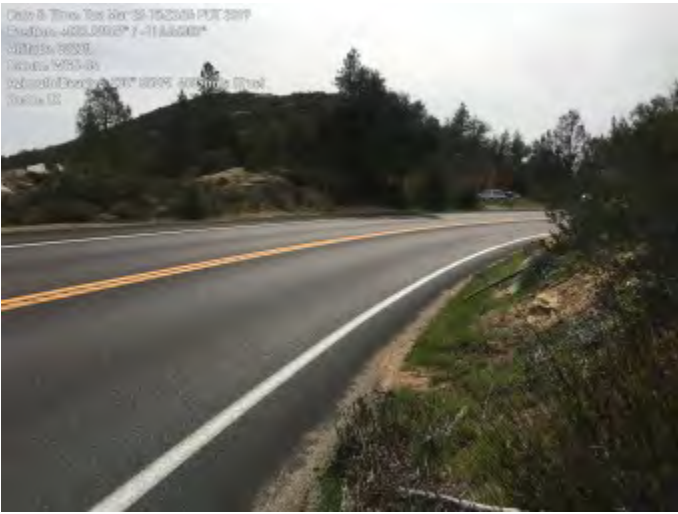
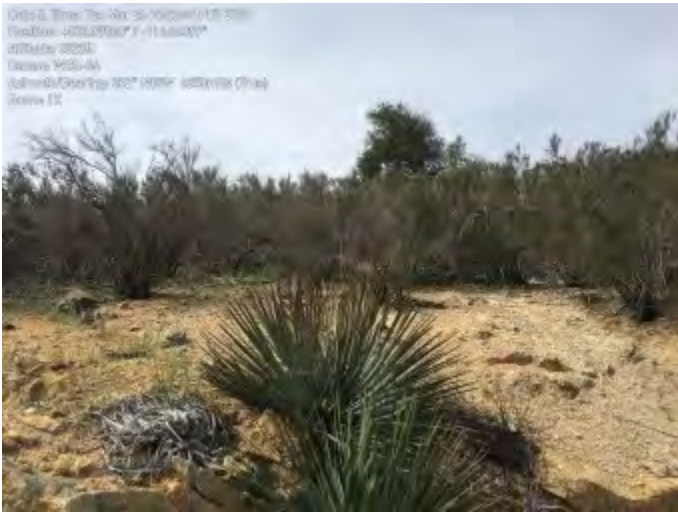
| Comments | Natural habitat with good cover to north and south, but poor location to cross road. No crossing structure, blind curves, crossing at grade. No adequate area for placing culvert beneath road. Steep embankment to edge of westbound lane precludes this construction. |

| Management recommendations | Wildlife crossing signs. Barrier fencing. |

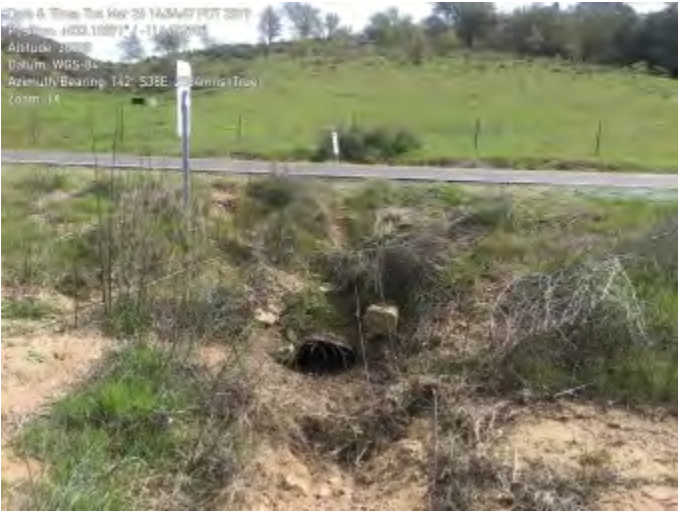
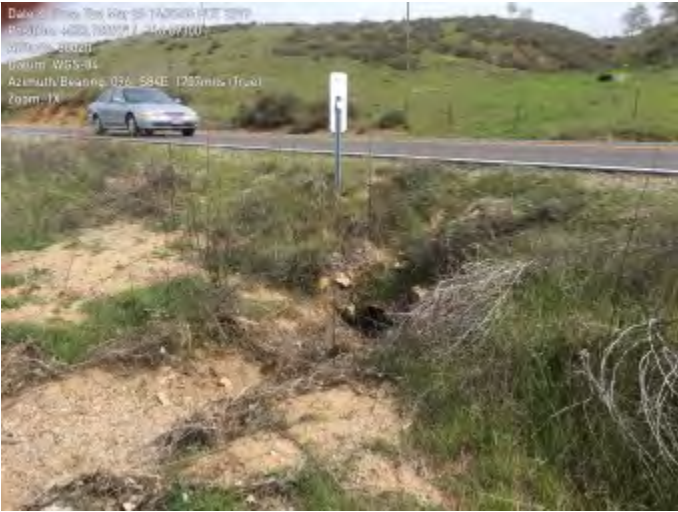
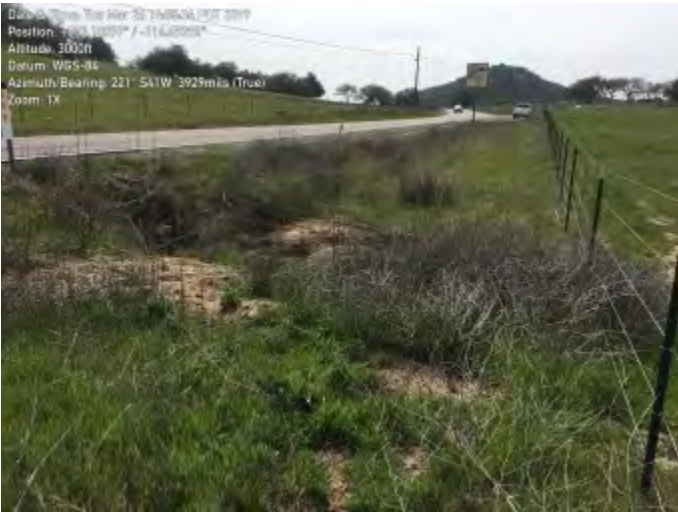
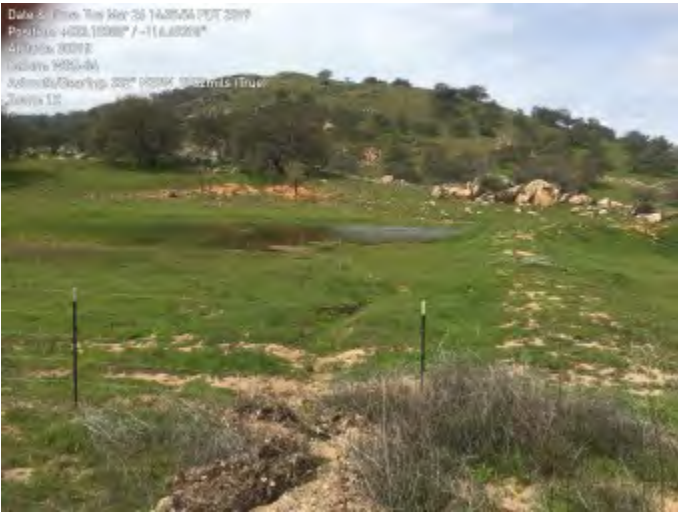
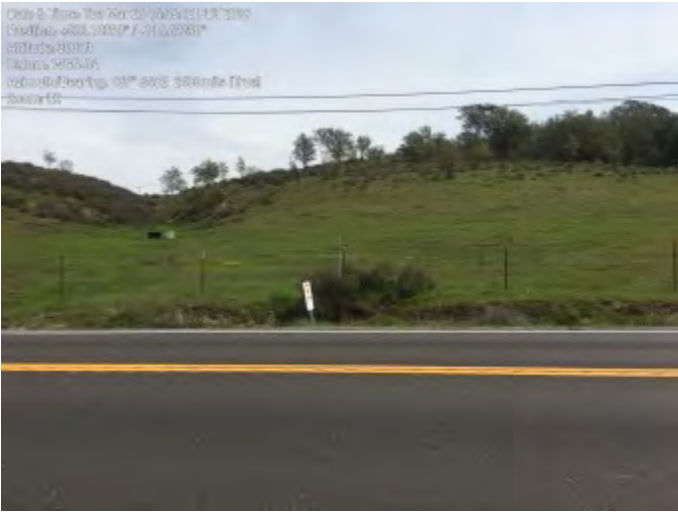
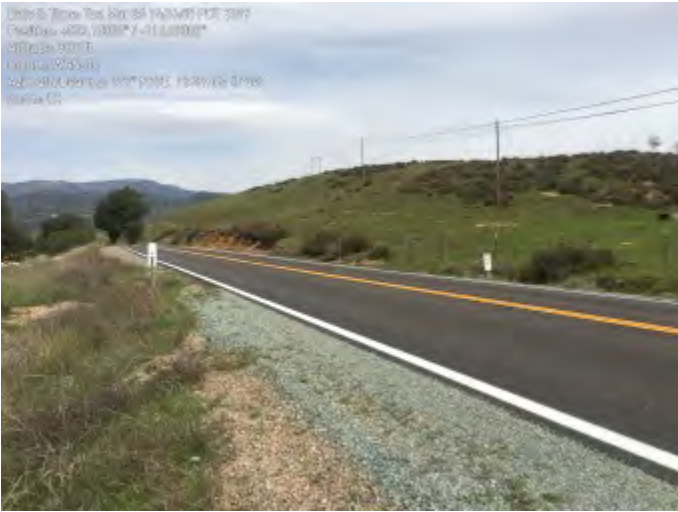
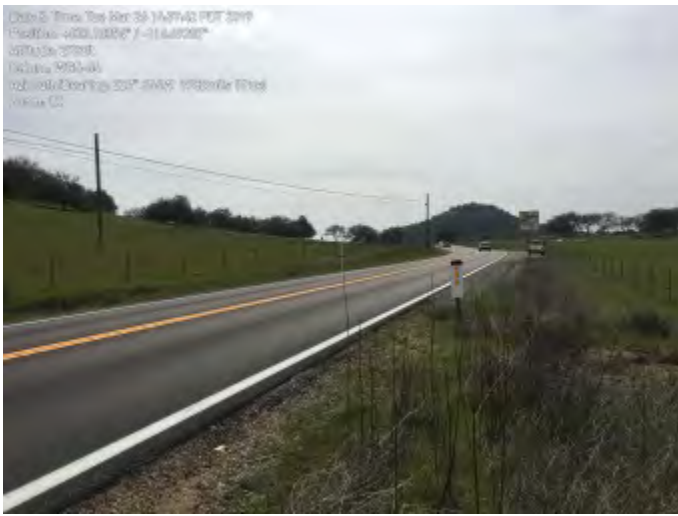
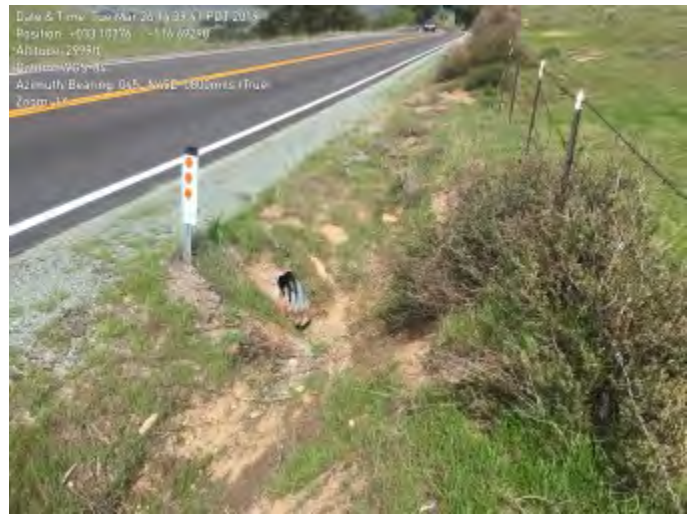
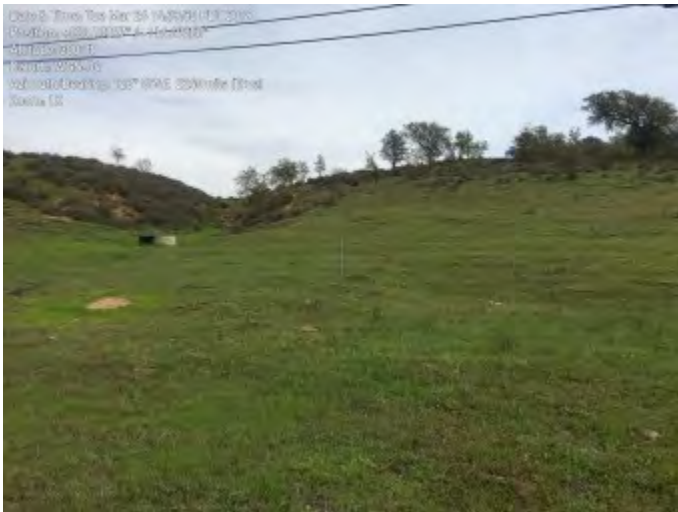
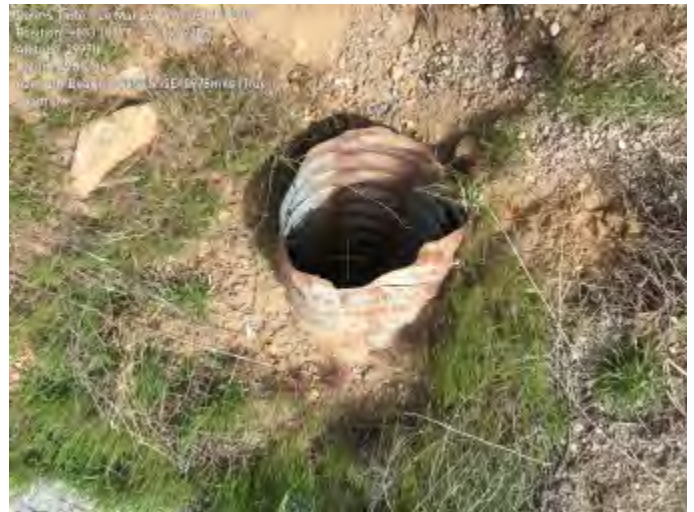
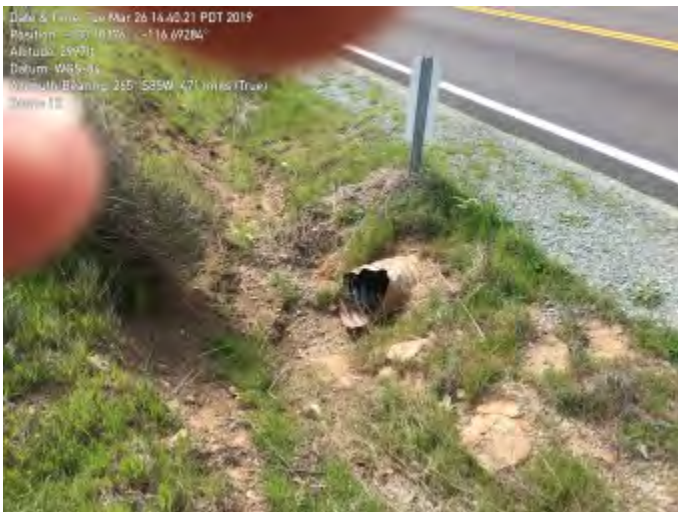
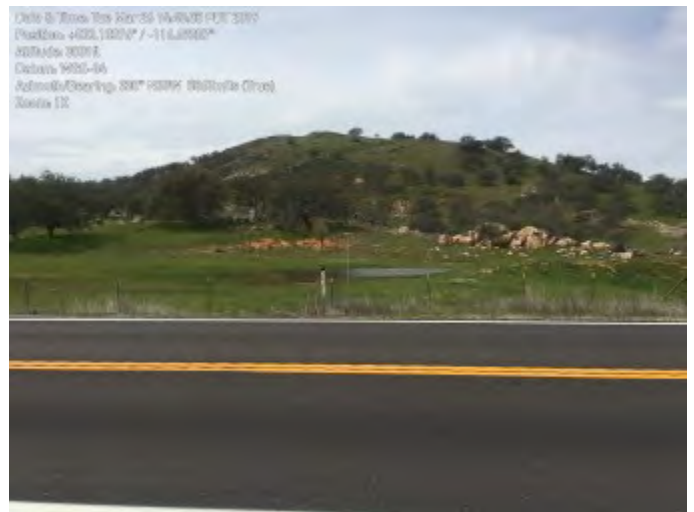
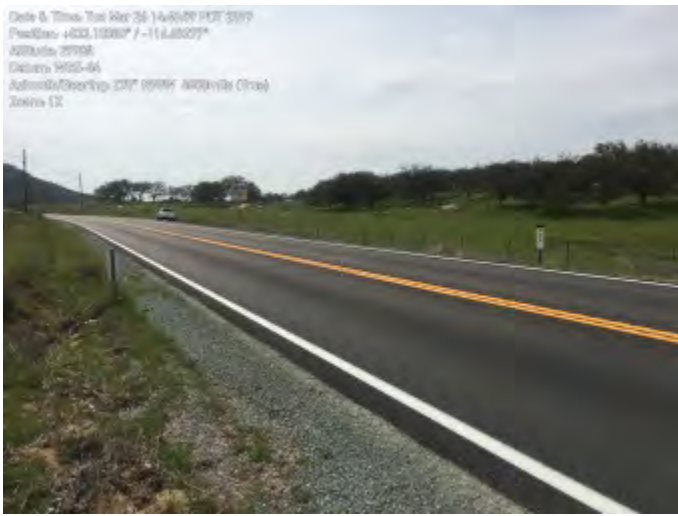
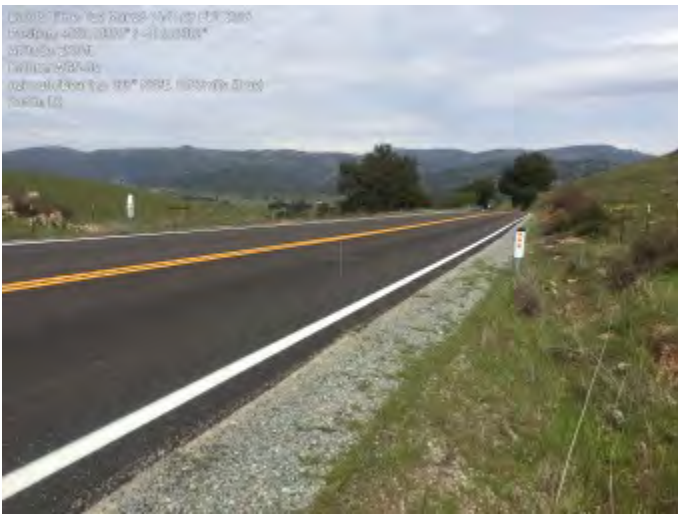
| Comments | Landscape on both sides of 78 conducive to wildlife travel. Although culvert diameter currently too small for passage of larger wildlife, the topography to north and south is conducive to making a crossing structure more conducive to travel of larger wildlife. Minimal landscape cover to the north. |

| Management recommendations | Increase diameter of culvert. Place entrance and exit further away from road. Barrier fencing. Sound dampening. Directional fencing to funnel wildlife toward larger culvert in this location. |
