SA-PAL survey

| Project | SA-PAL project |
| ID | 42130 |
| Survey Date | 04/03/2019 |

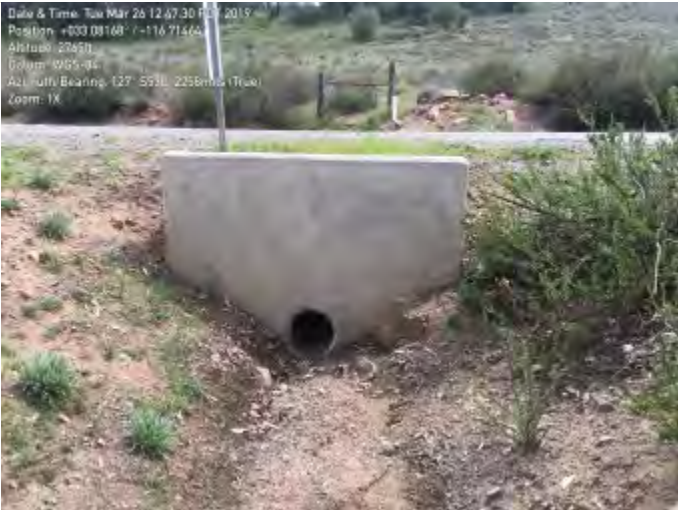
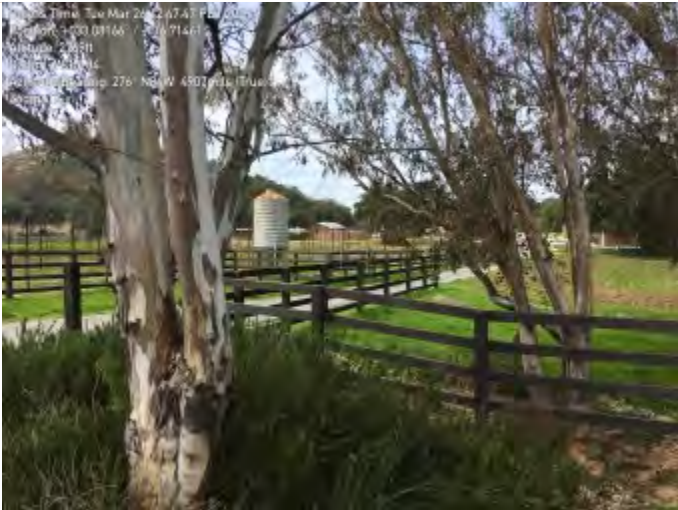
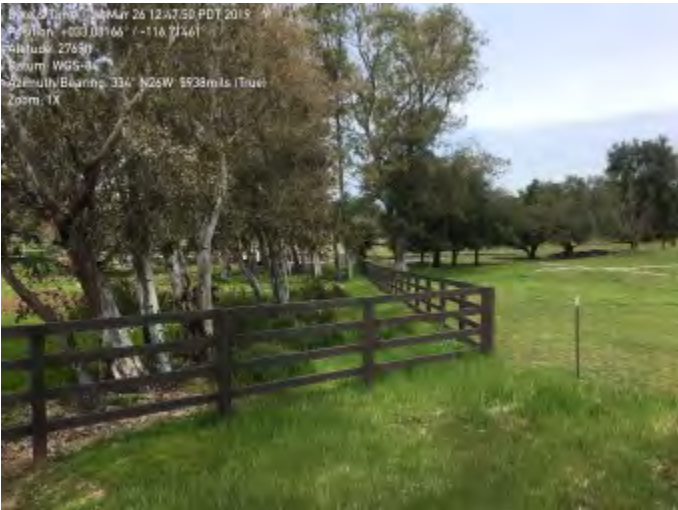
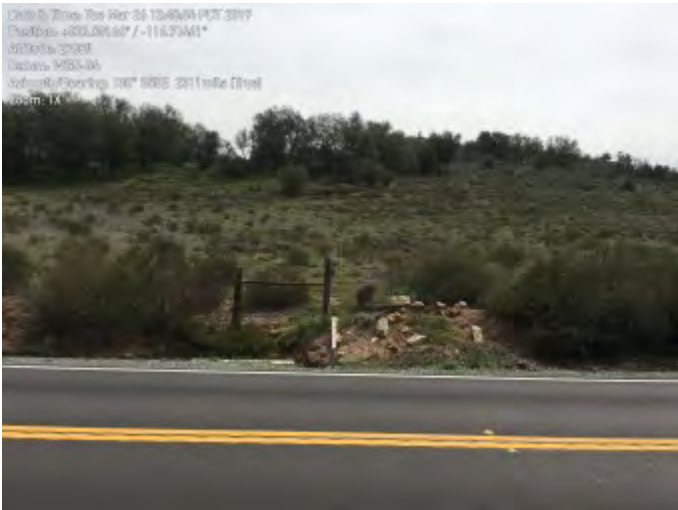
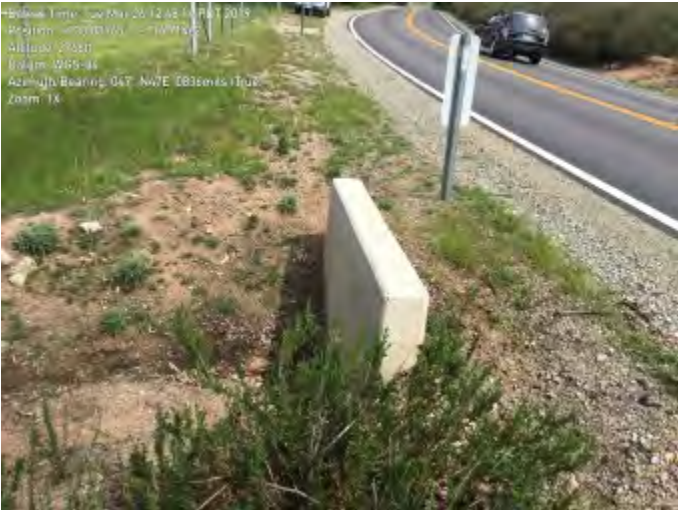
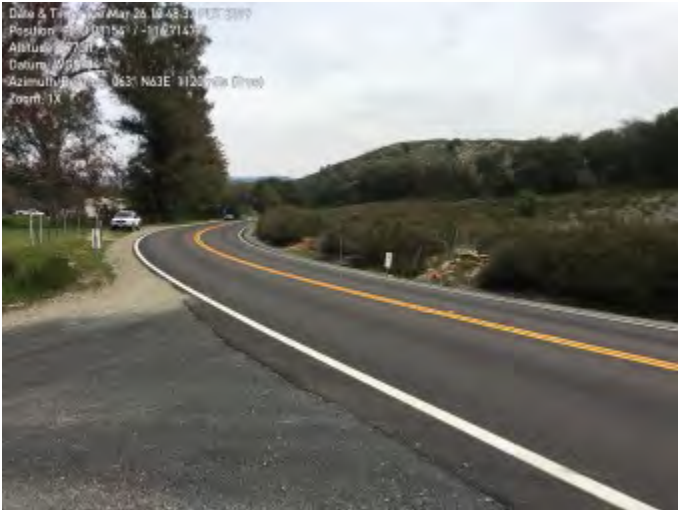
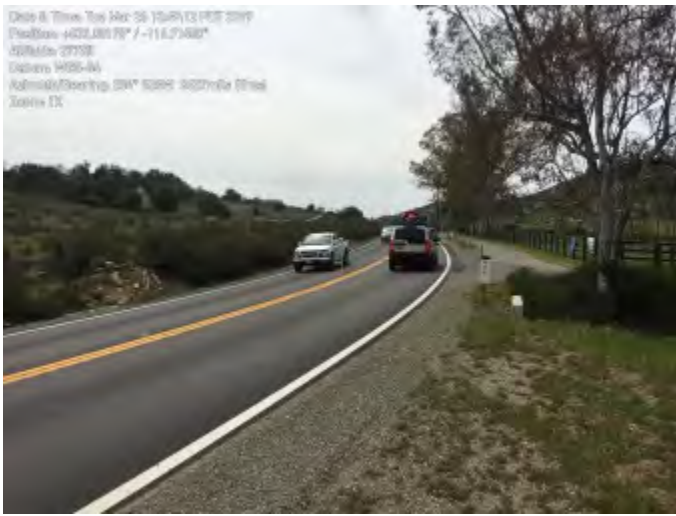
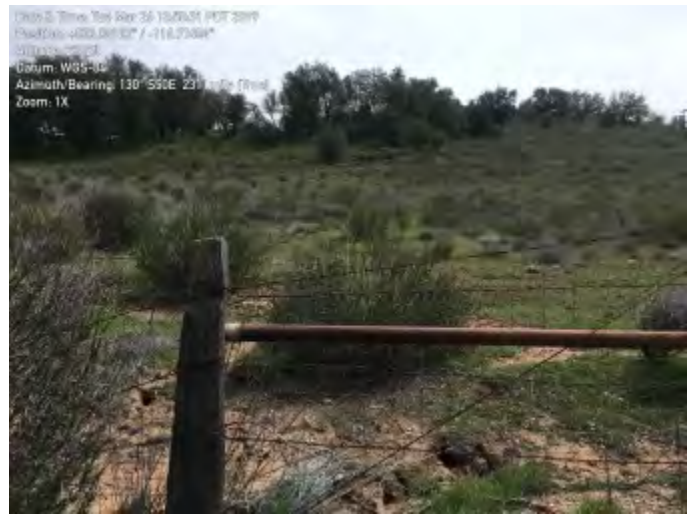
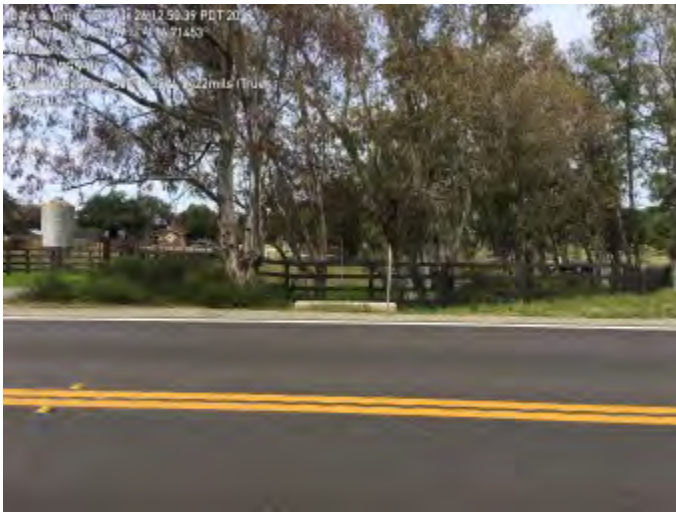
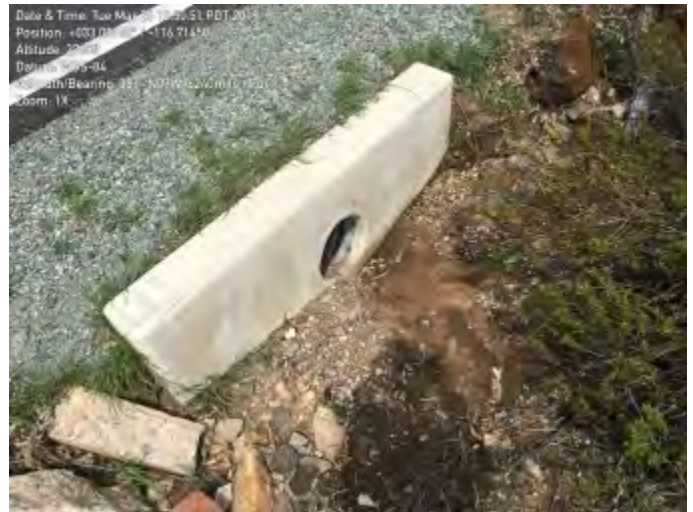
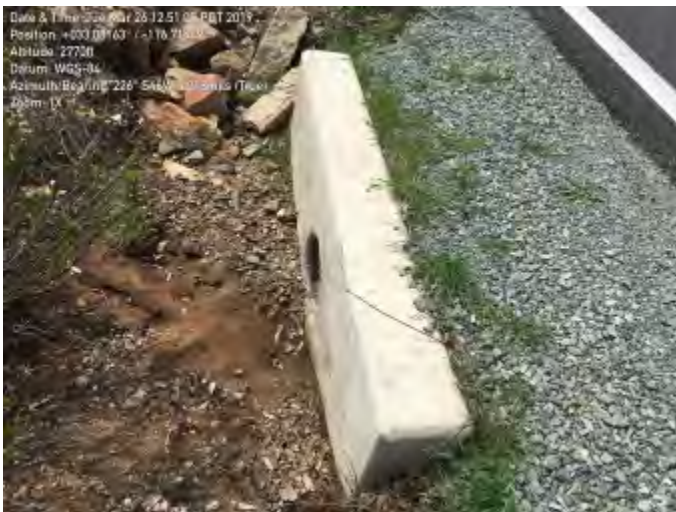
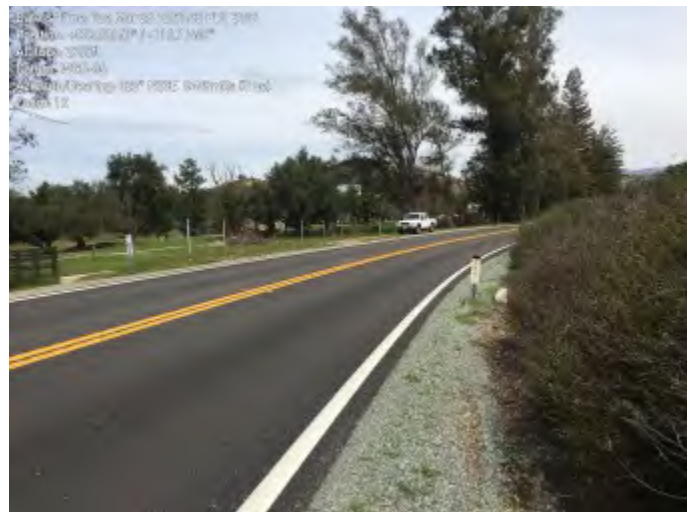
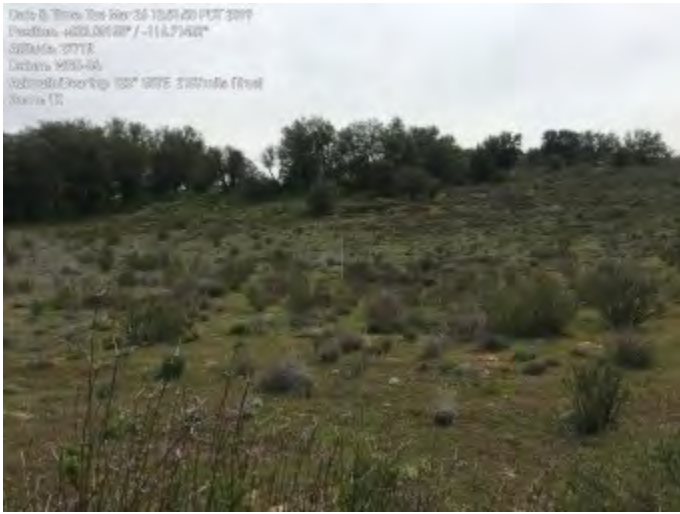
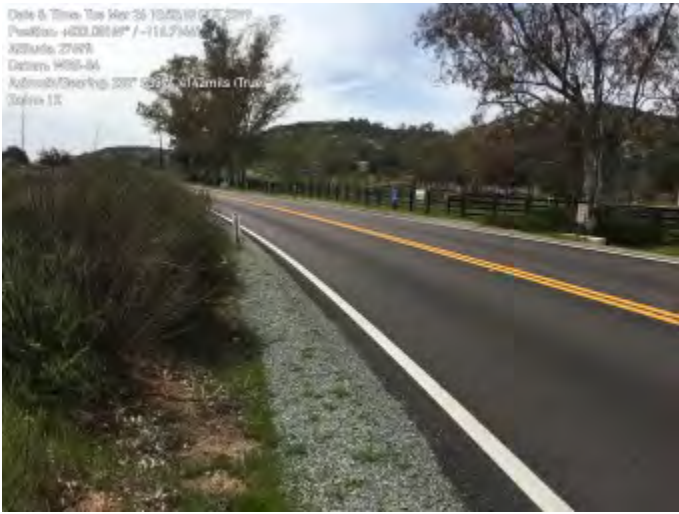
| Comments | This location not conducive to wildlife travel due to constraints mentioned above, although landscape to south would offer an excellent corridor. |

| Management recommendations | Barrier fencing. Wildlife crossing signs. |

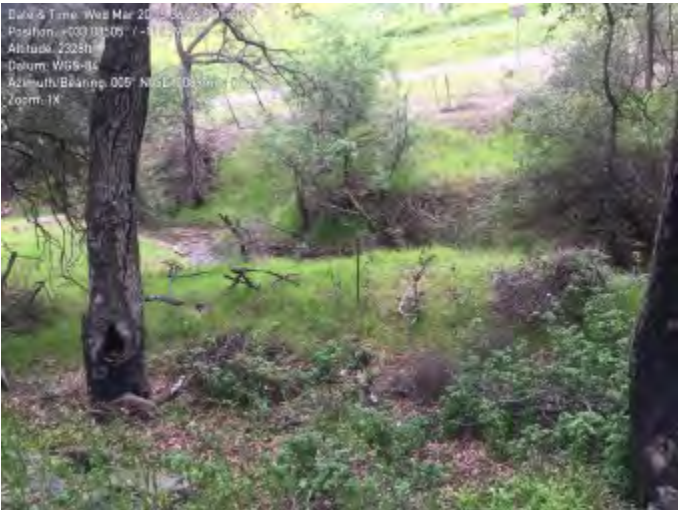
westbound Note stream paralleling SR 78 between road and development to the north.

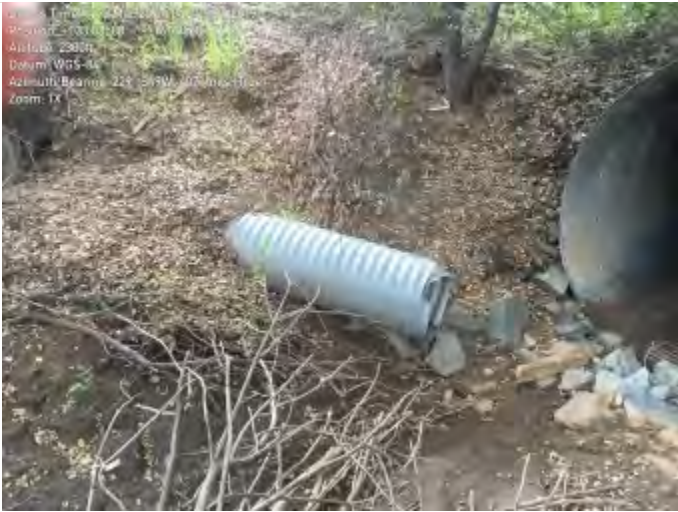
westbound. Large culvert opening to the right allows stream to pass beneath Sutherland Dam RD. It does not pass beneath SR 78

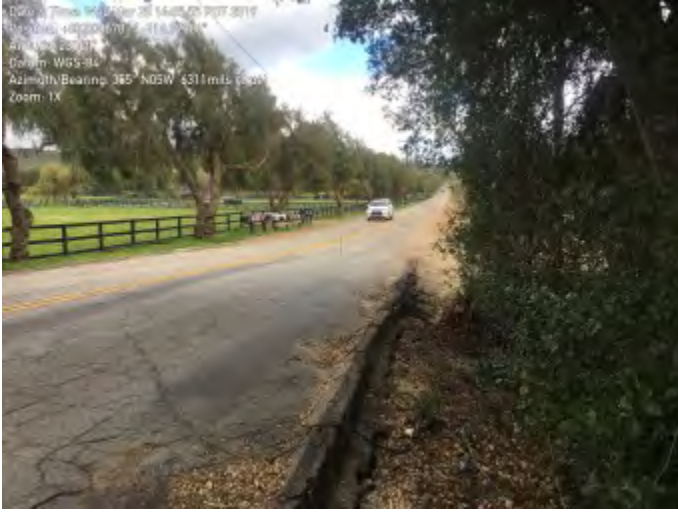
westbound. This is Southerland Dam Road heading north from SR 78

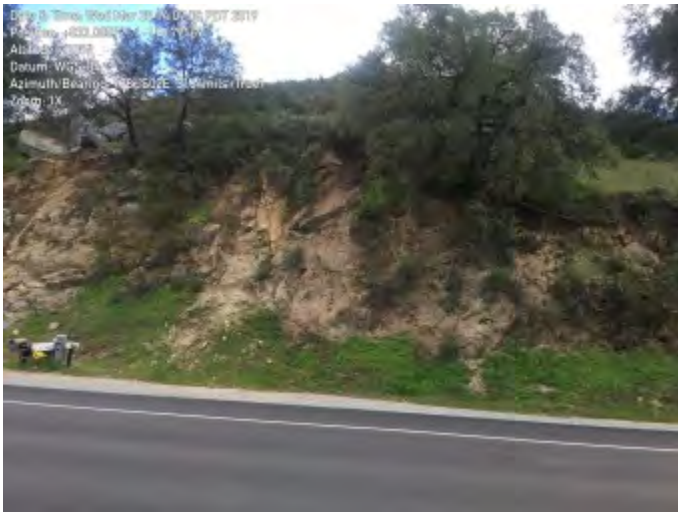
westbound Note steep embankment on eastbound side

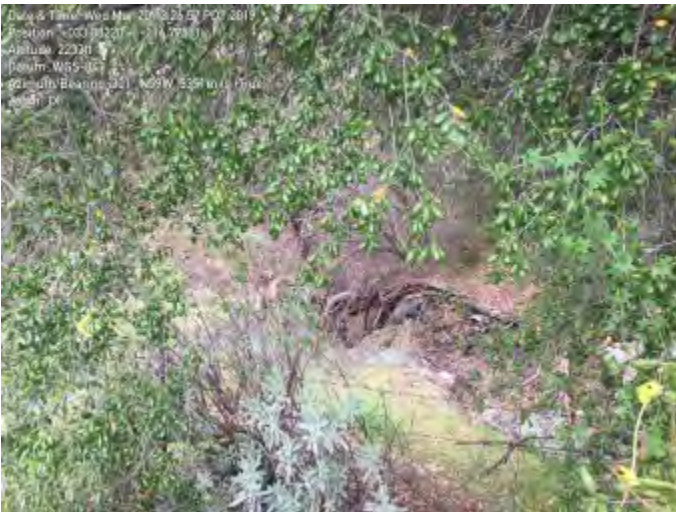
westbound Looking toward stream into which this culvert drains.
Stream parallels SR 78

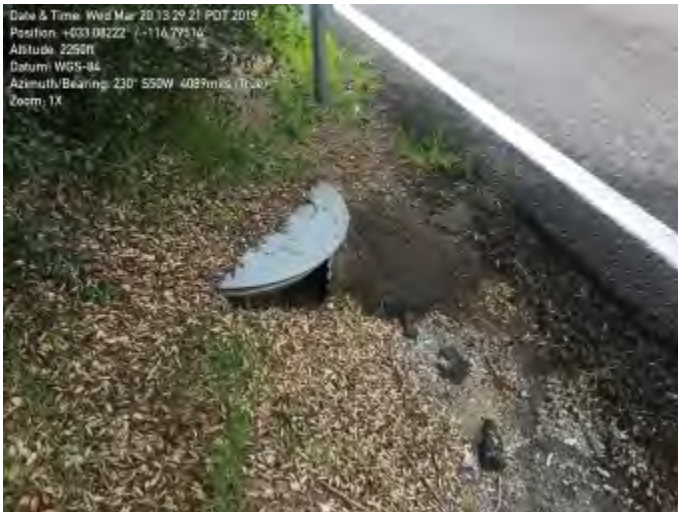
eastbound Culvert entrance

| Comments | Landscape to north and south makes this an excellent crossing location. However, this location is not currently viable. Heavy and high speed traffic preclude safe crossing at grade. Culvert is narrow diameter and not accessible to entry on eastbound side. |

| Management recommendations | Rumble strip, wildlife crossing signs, barrier fencing. |

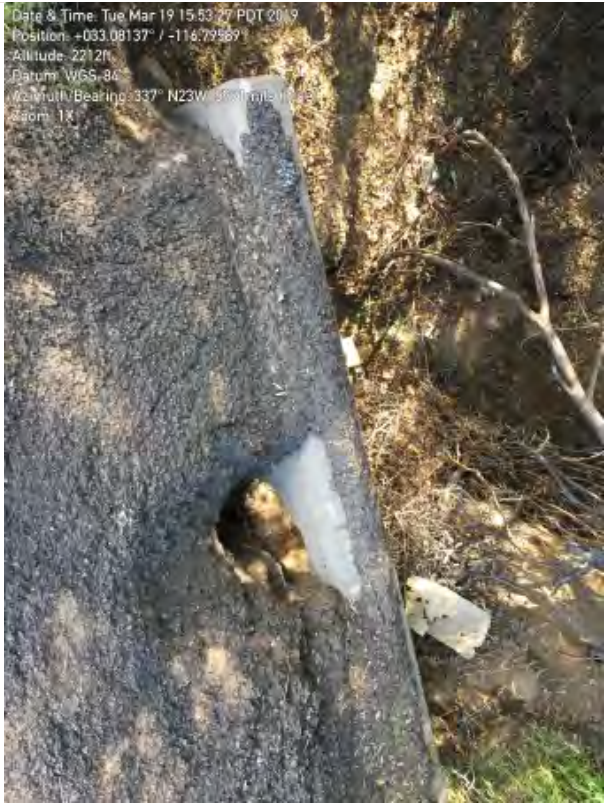
westbound culvert exit viewed from above

| Comments | Crossing structure is inaccessible on eastbound side due to being vertical and covered. Landscape to north and south conducive to wildlife travel. Stream parallels westbound 78 in large natural drainage running to the west. |

| Management recommendations | Barrier fencing. Wildlife crossing signs. |

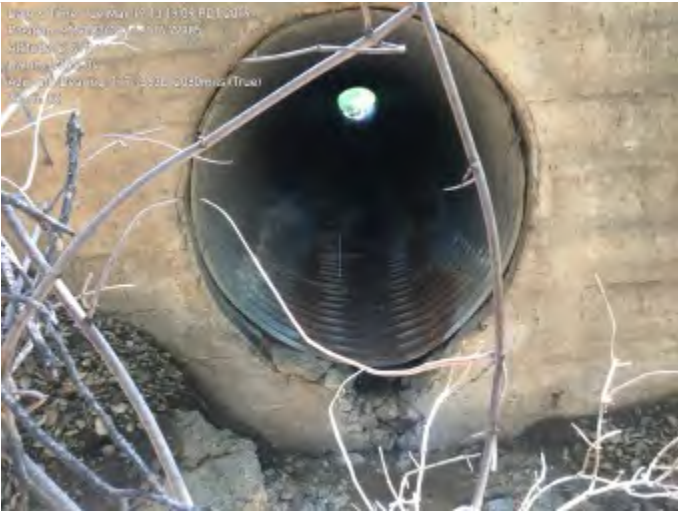
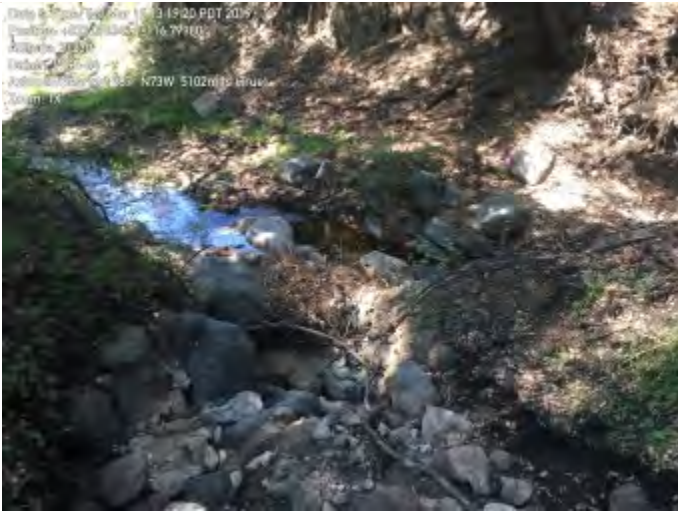
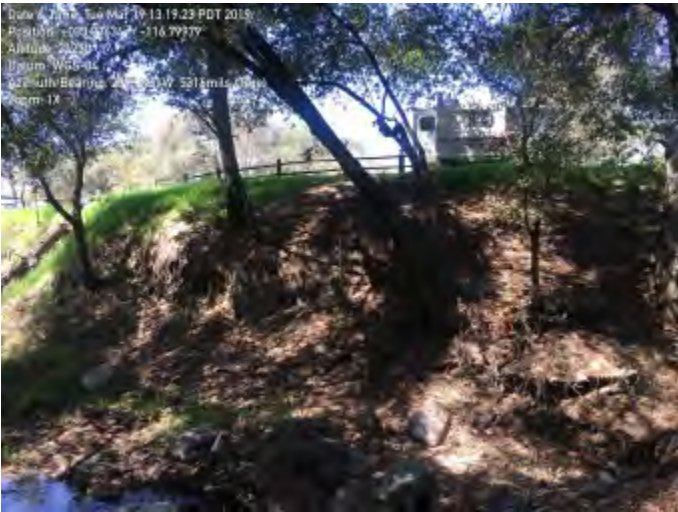
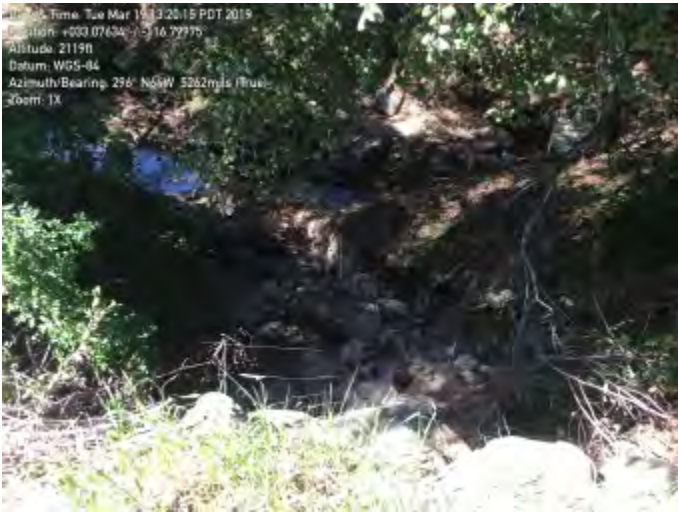
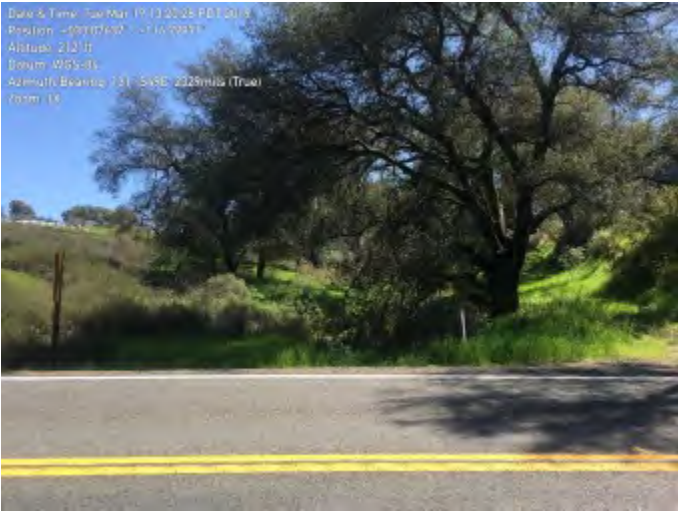
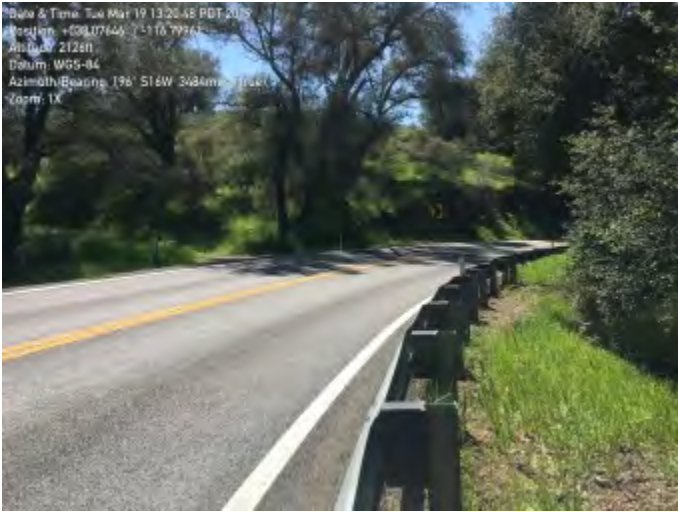
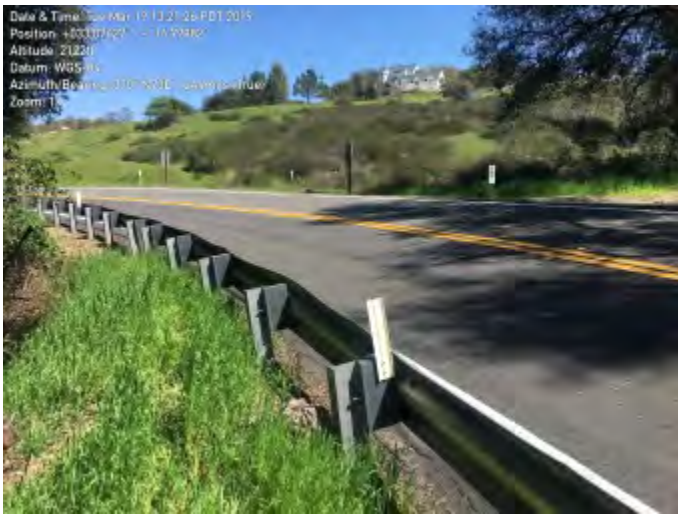
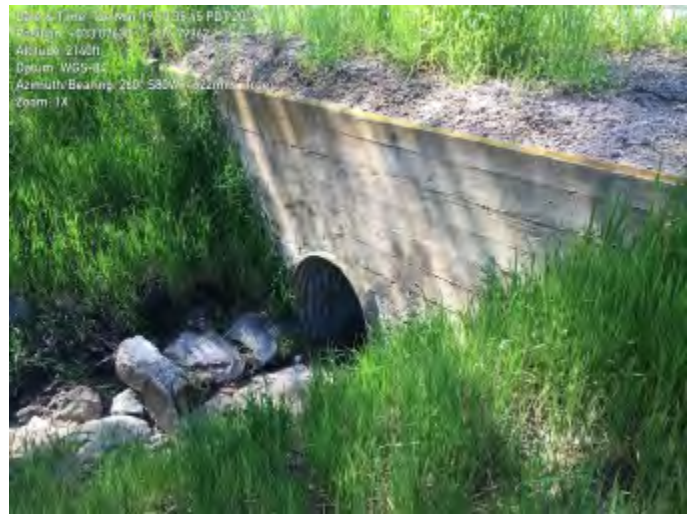
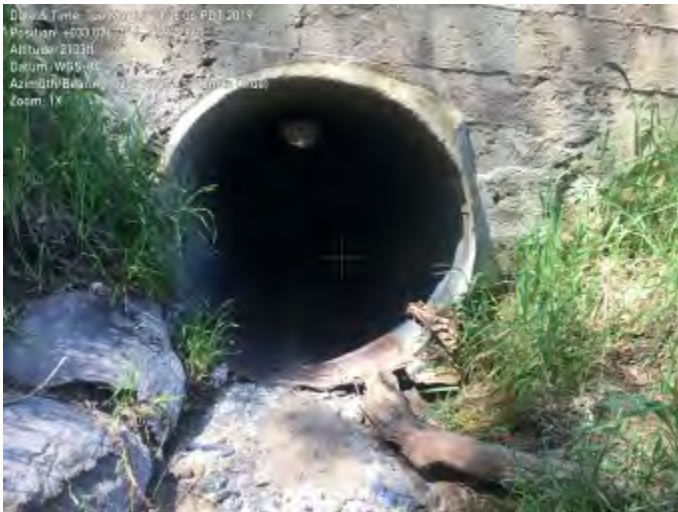
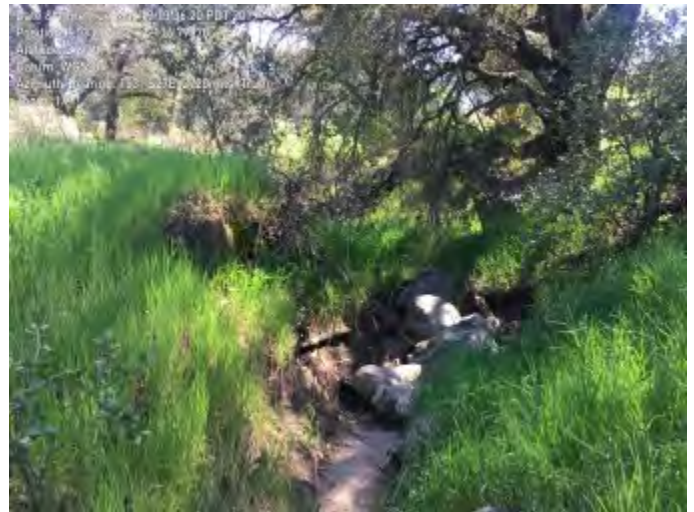
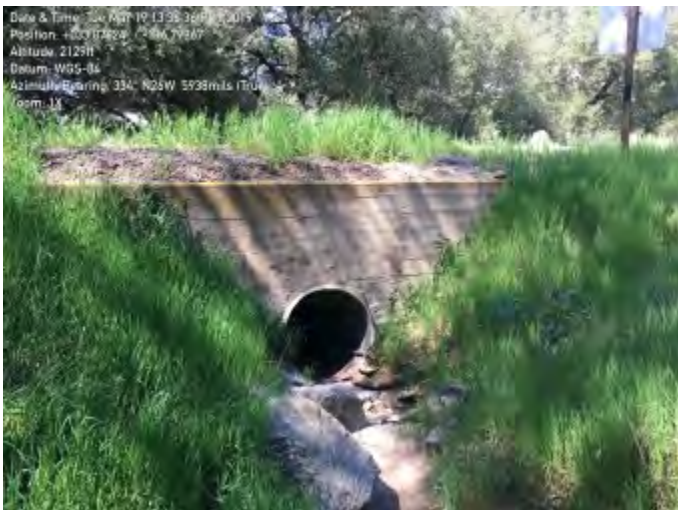
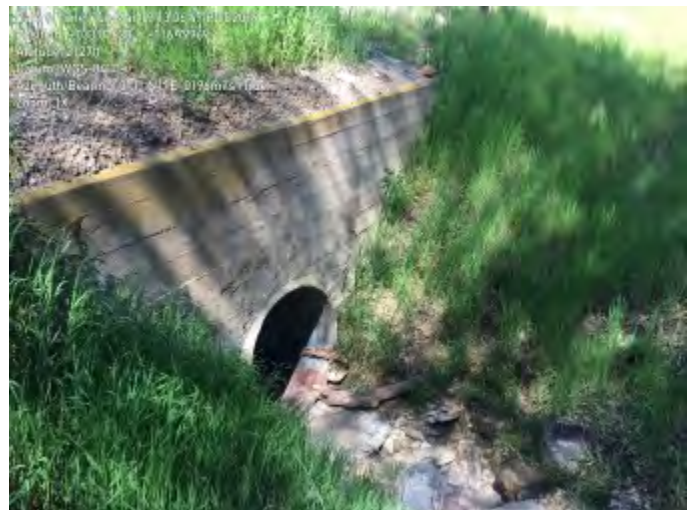
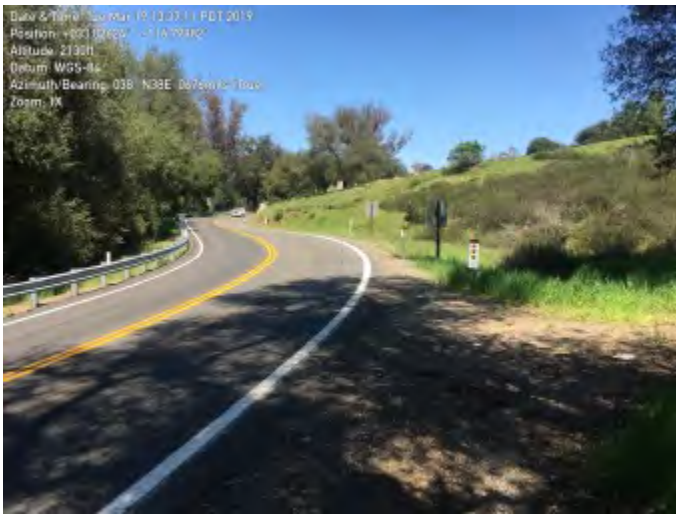
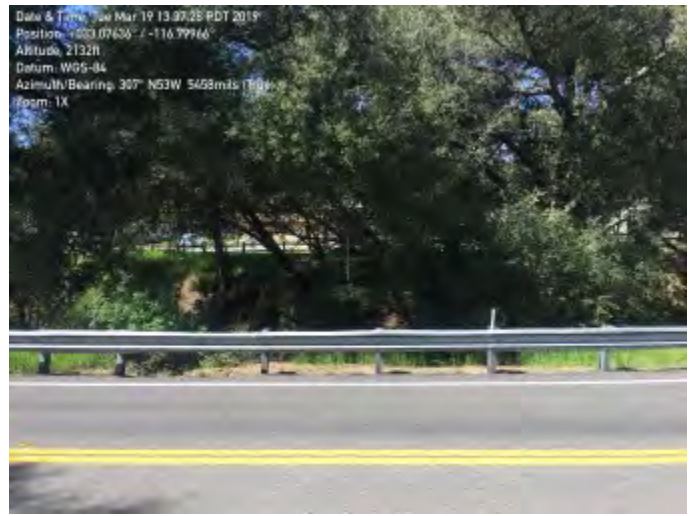
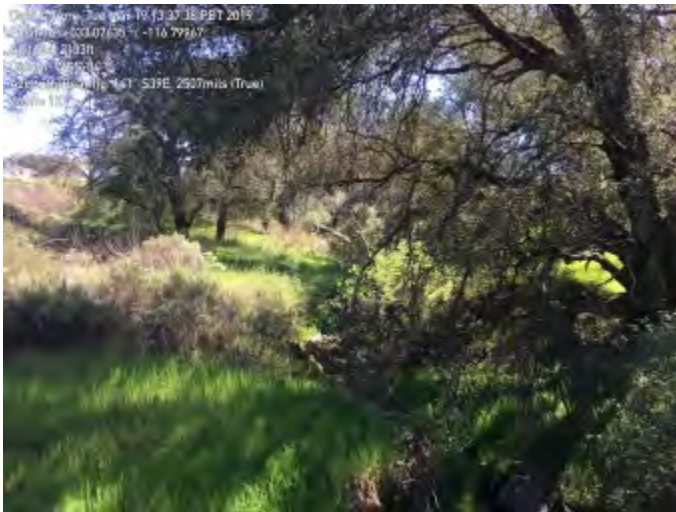
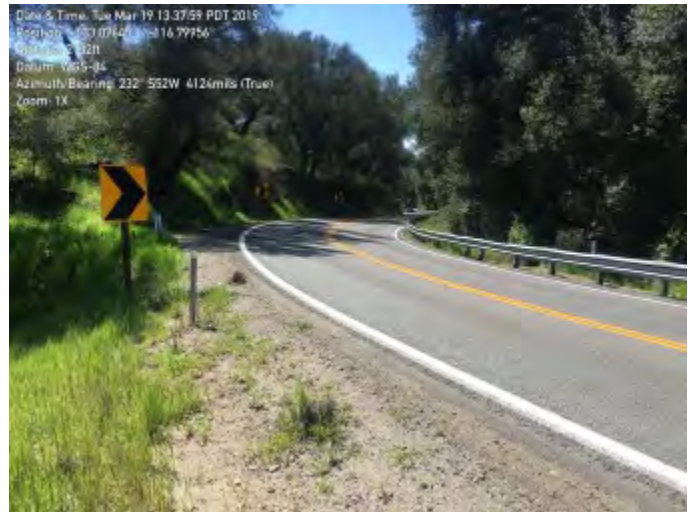
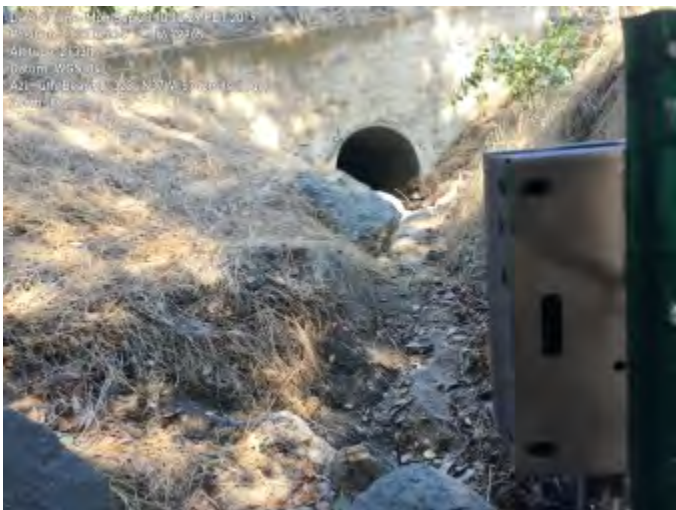
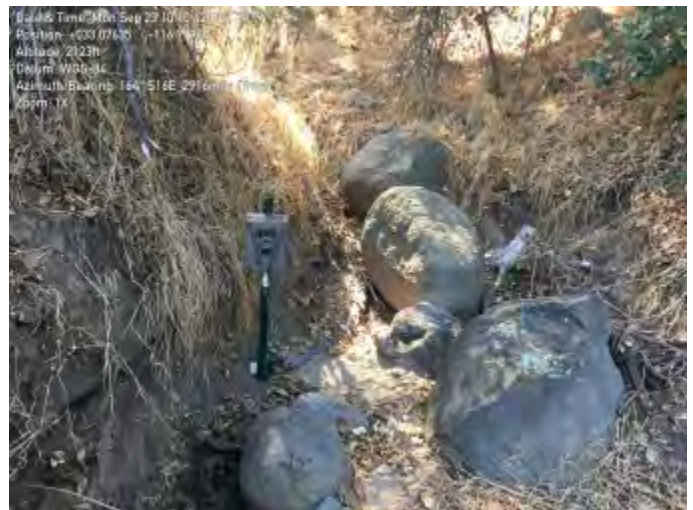
Culvert diameter, at 3 feet, too small for larger wildlife, but conditions are amenable to enhancement of this conduit by increasing diameter of existing culvert. Blind corners here. Residential and commercial structures on the westbound side are moderate

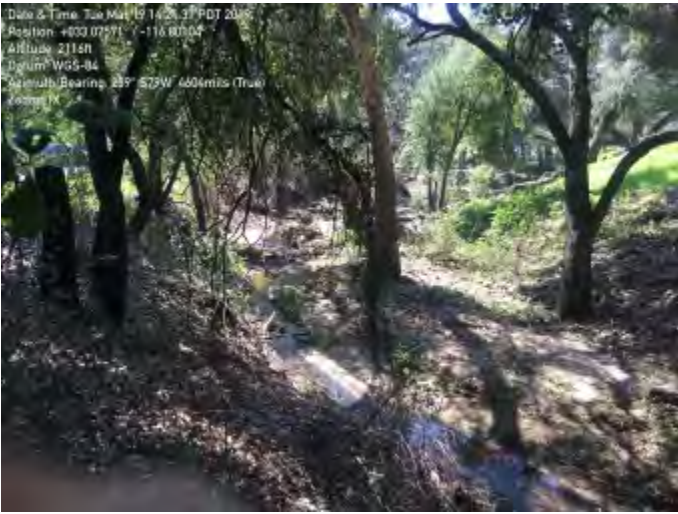
stream flowing parallel to SR 78 north of road

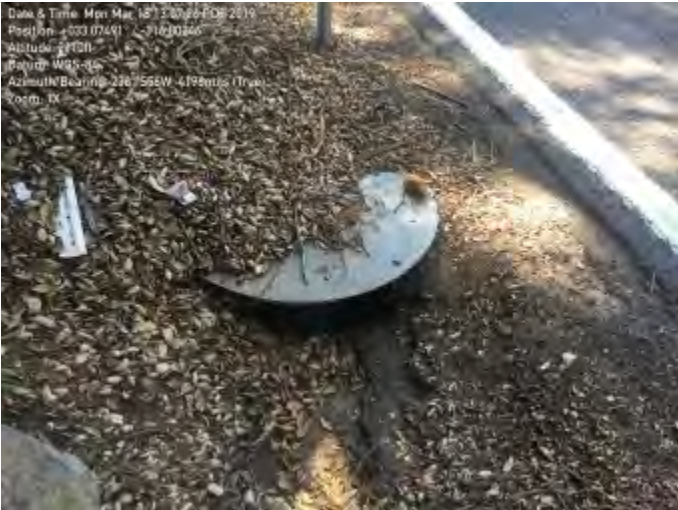
eastbound culvert entrance

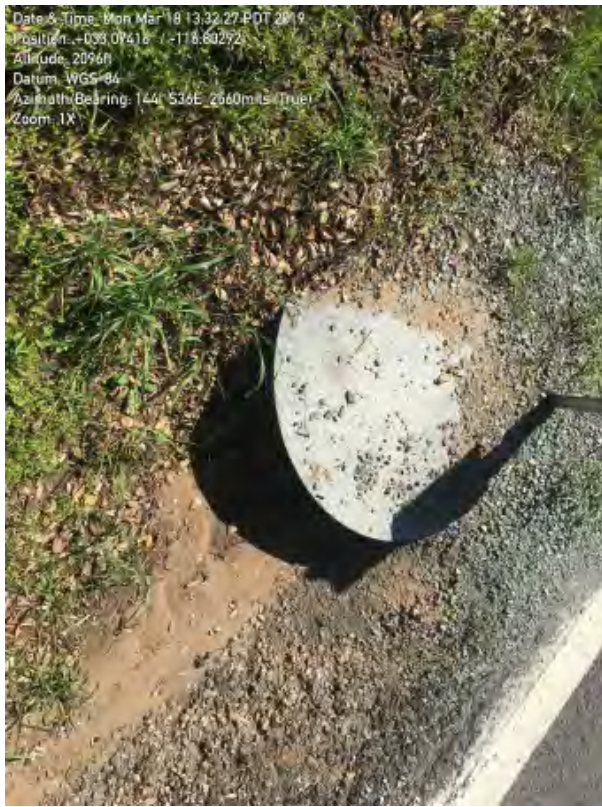
eastbound vertical culvert entrance

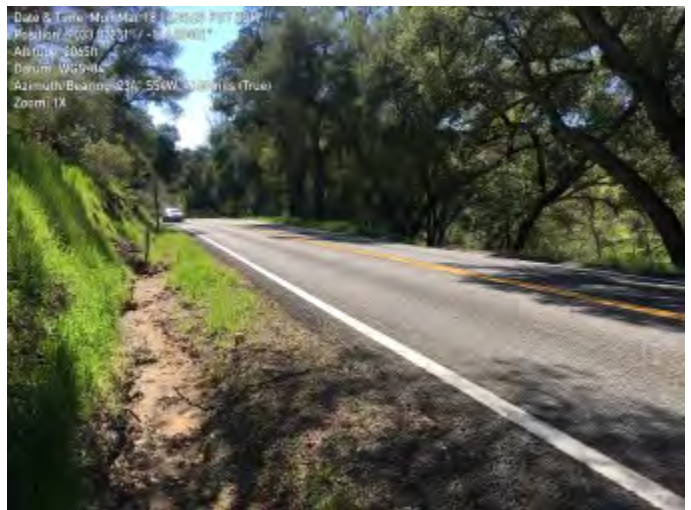
Landscape to north and south conducive to wildlife travel, but current one foot diameter culvert is inadequate for transit. Hillside on south side of road approaches closely to edge of road, allowing minimal room to increase diameter and depth of culvert. Location

Management
recommendations

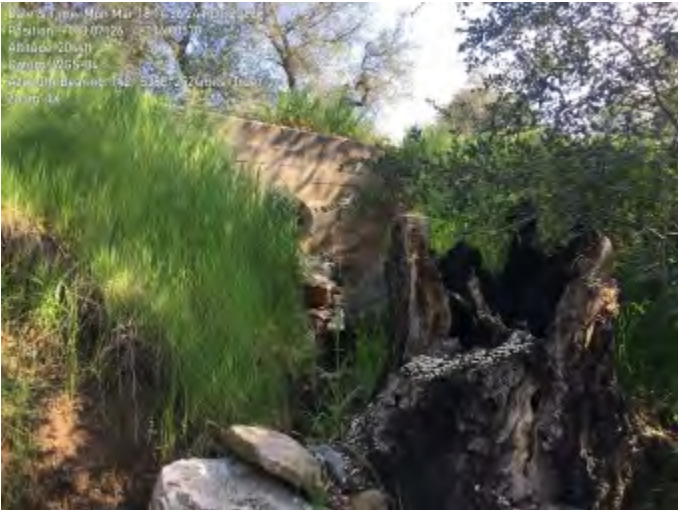
westbound culvert exit to steep rocky downslope

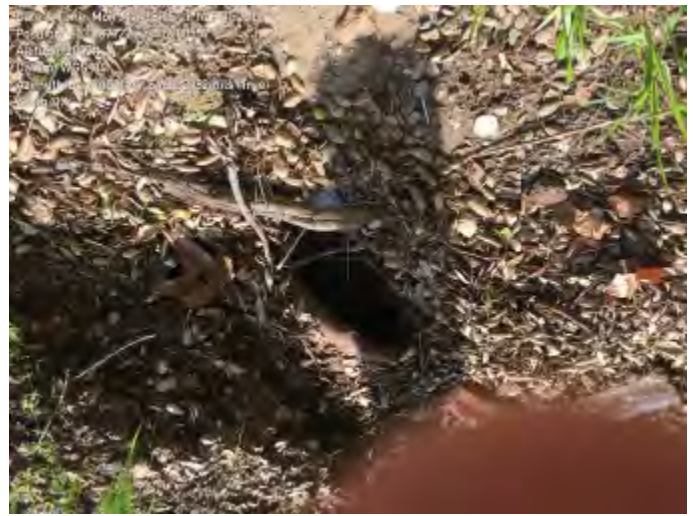
eastbound culvert entrance

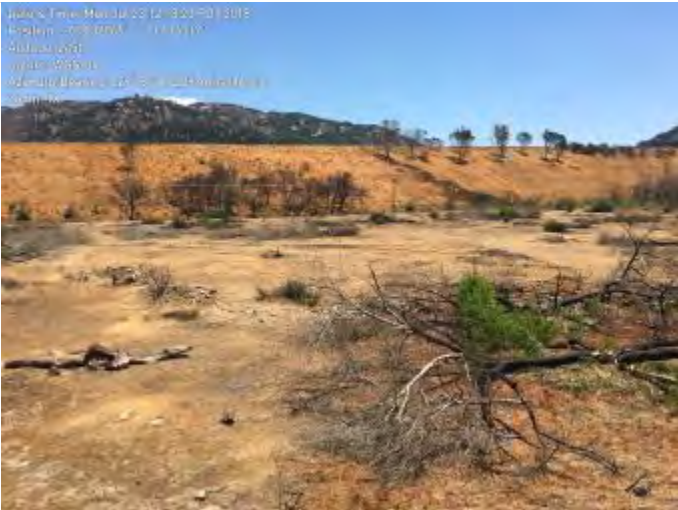
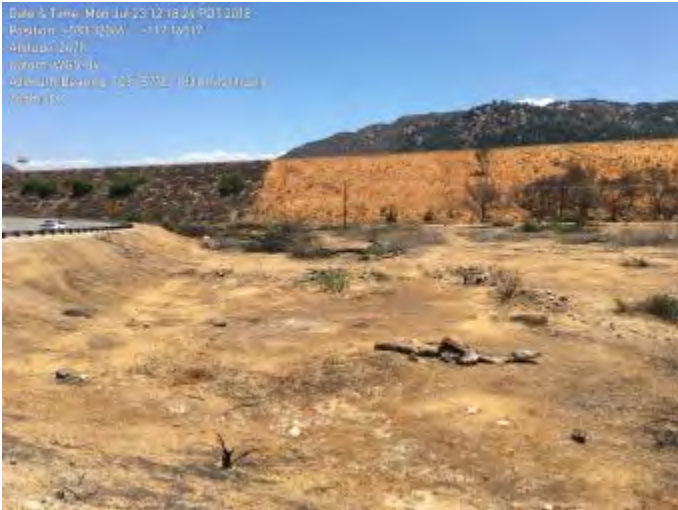
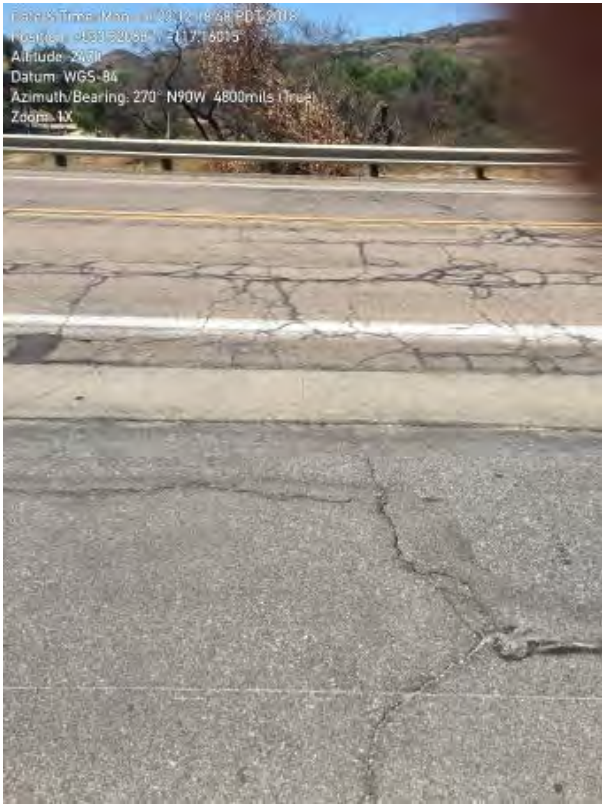
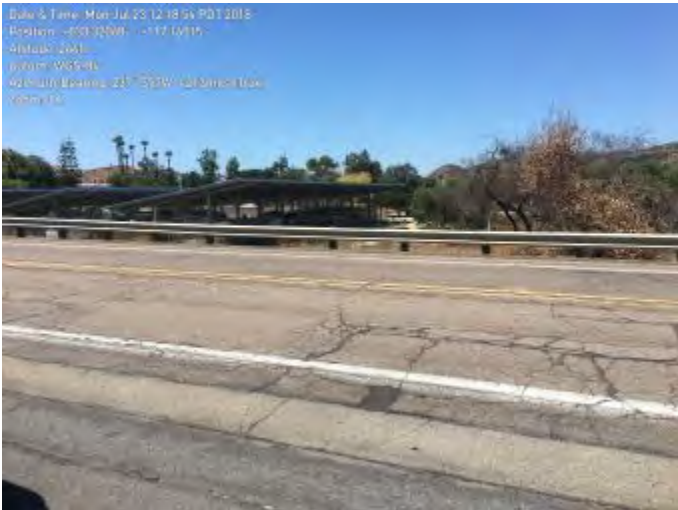
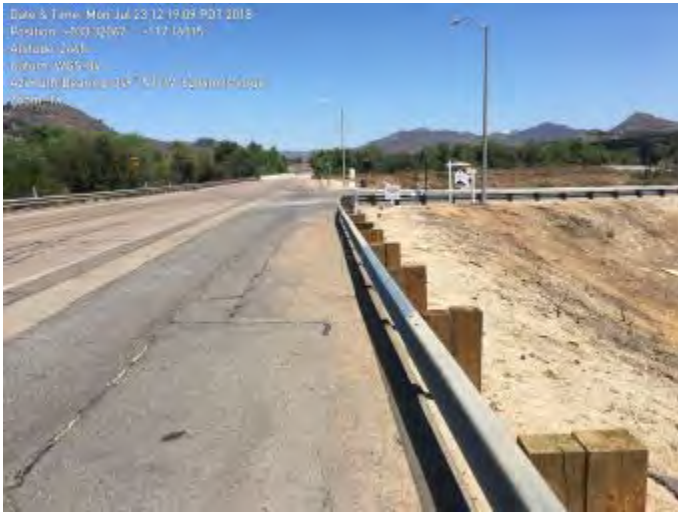
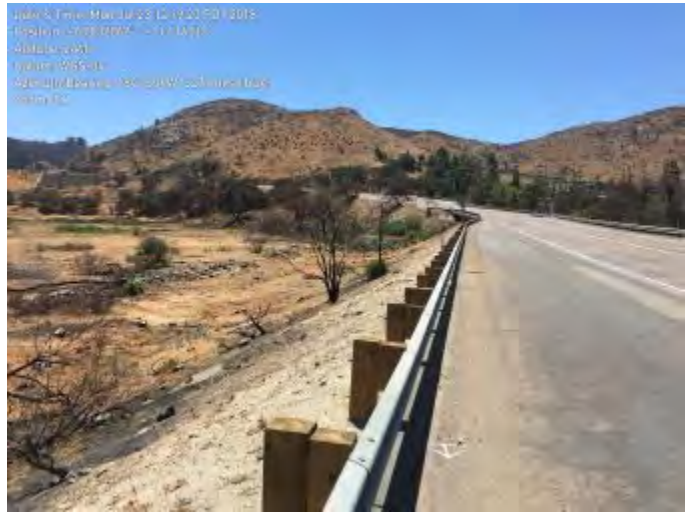
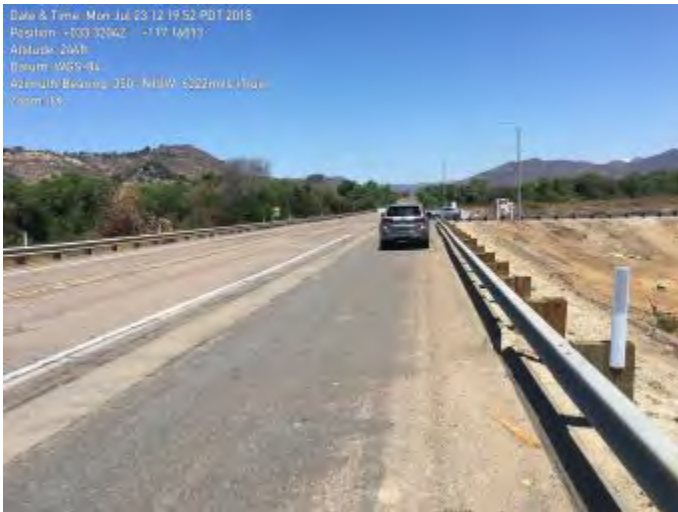
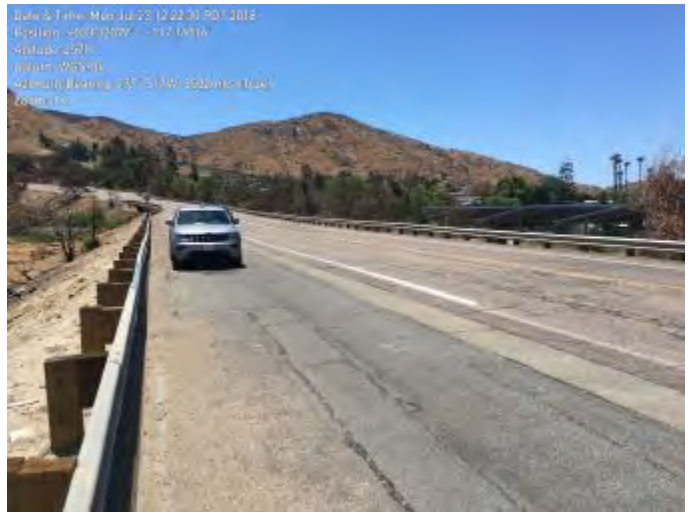
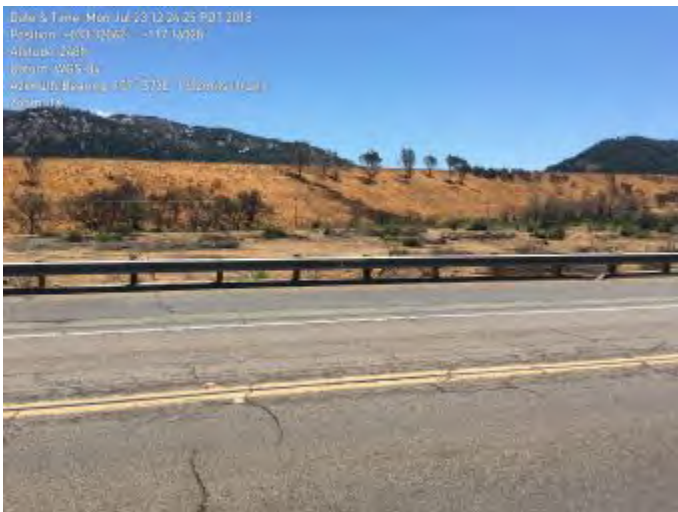
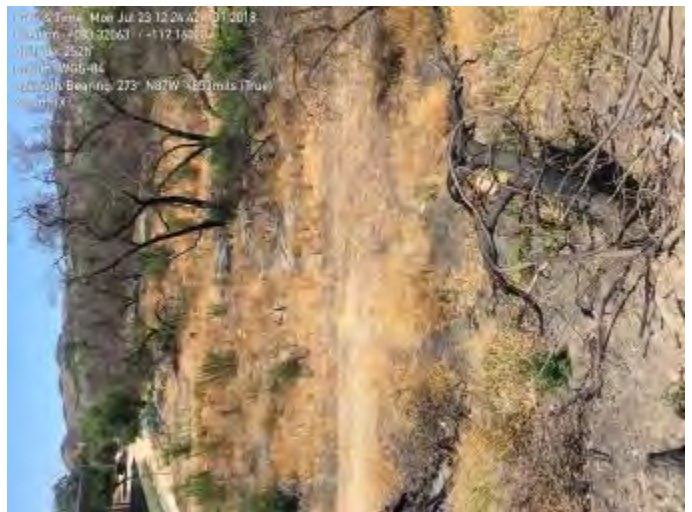
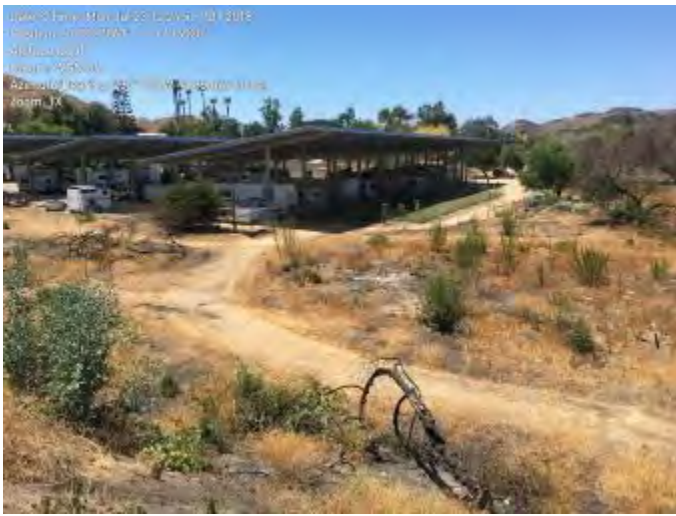
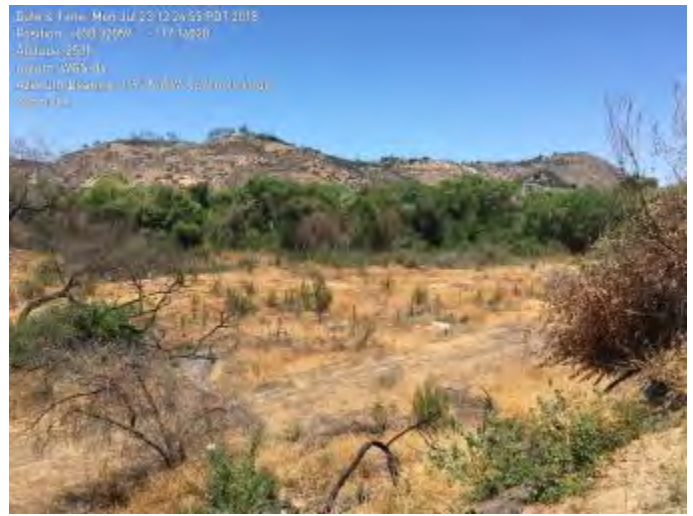
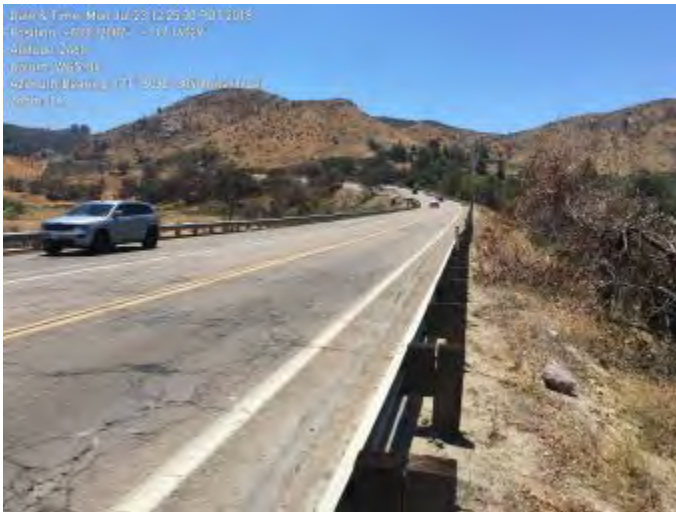
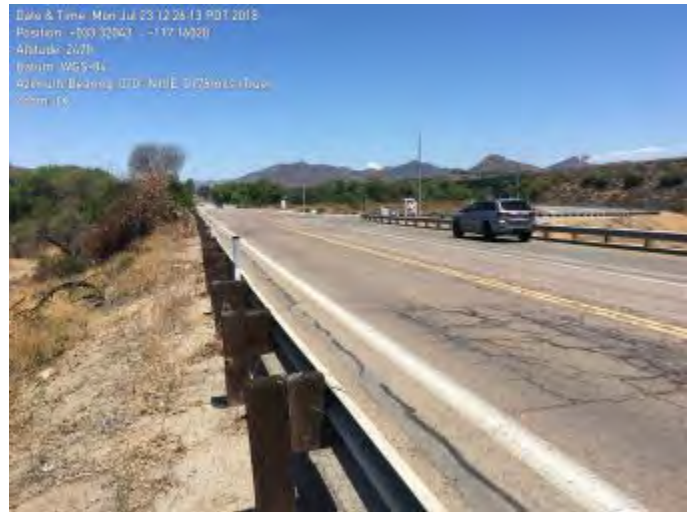
Open/barren landscape east side. Embankments rising to meet 395 on southbound and northbound sides are 45 degree, decomposed granite, barren, rise approx. 30 ft. to road. Southbound side of this site is also post-burn area. Bordered on south and in close proximity to mobile home parking and golf course. Bordered on north by San Luis Rey River. This site approx. 200 south of P35.
