SA-PAL survey

| Project | SA-PAL project |
| ID | 42130 |
| Survey Date | 04/03/2019 |

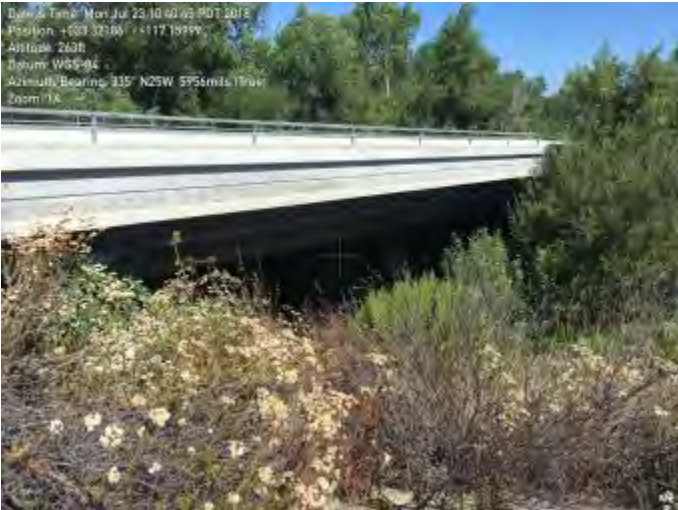
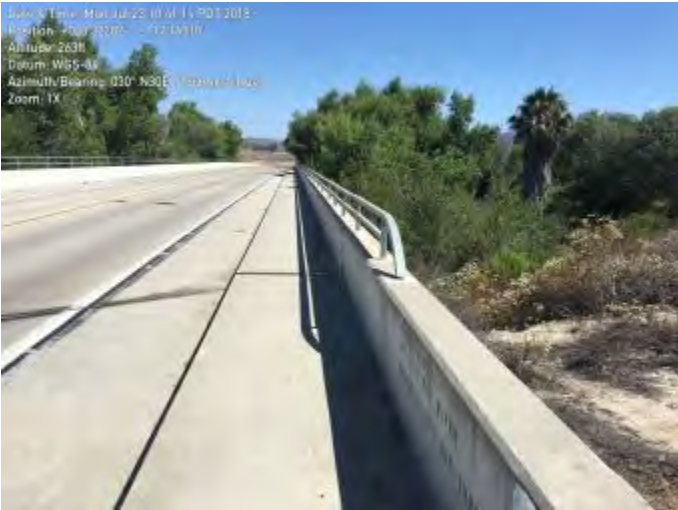
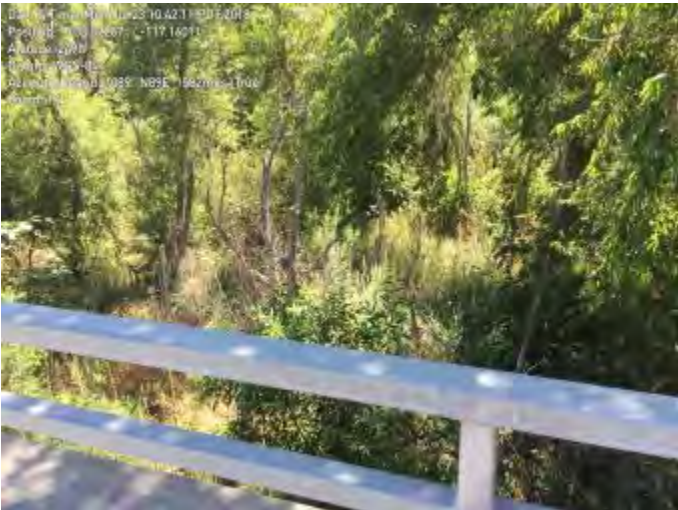
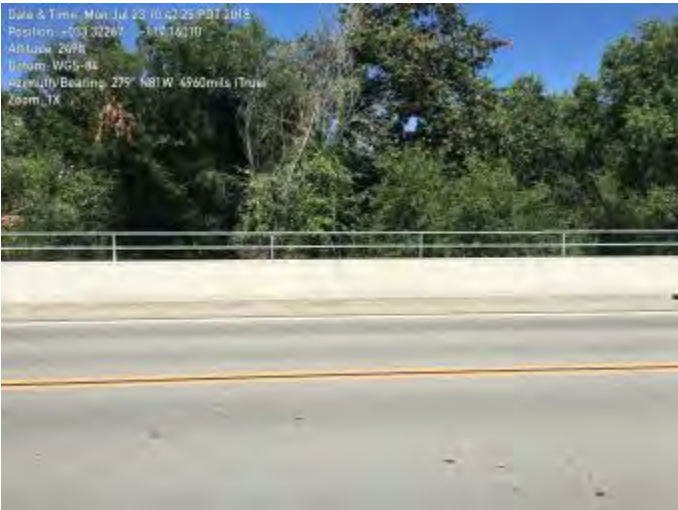
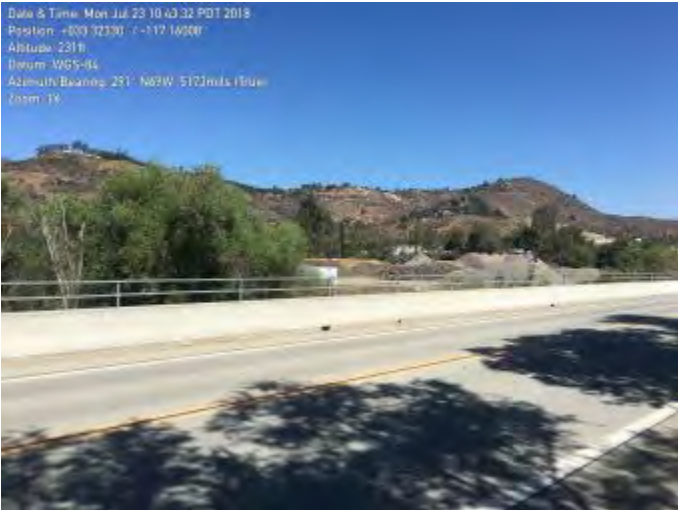
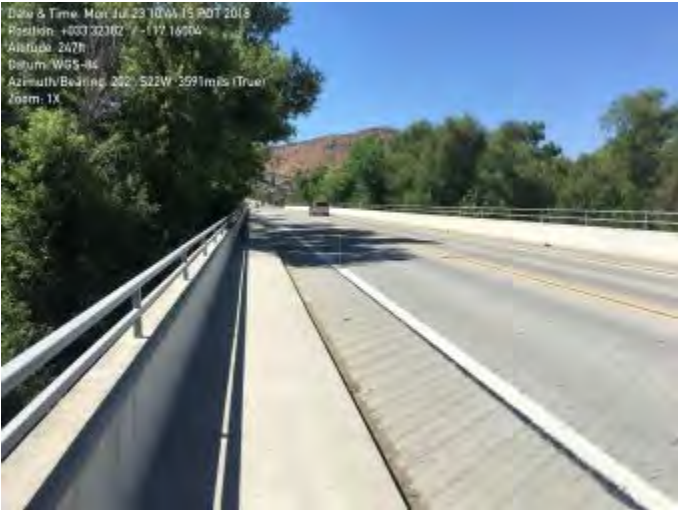
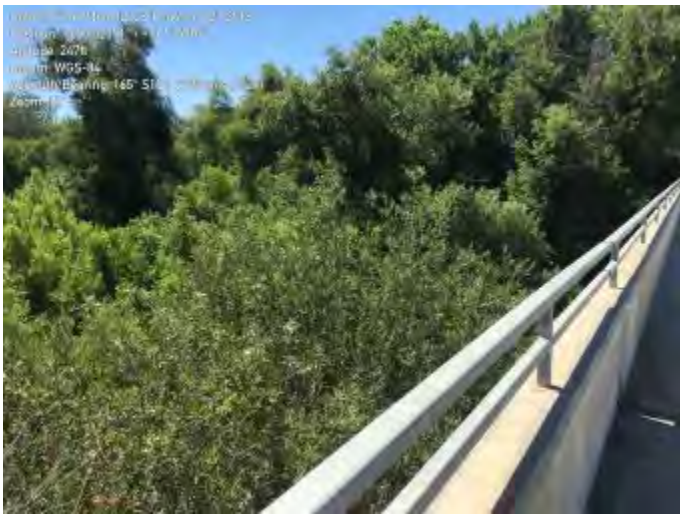
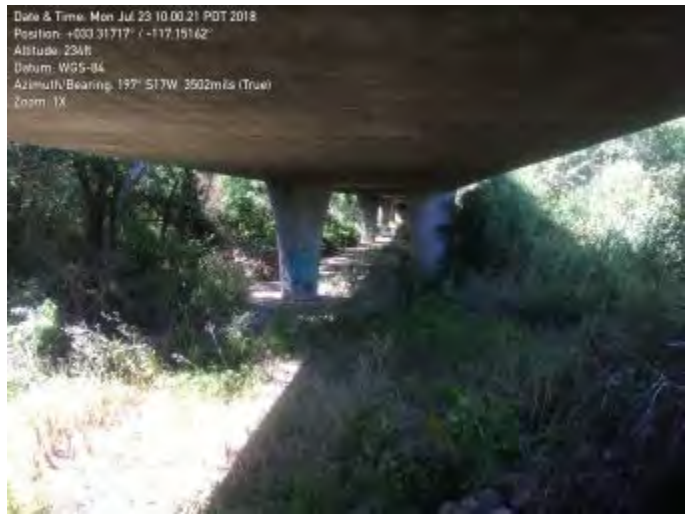
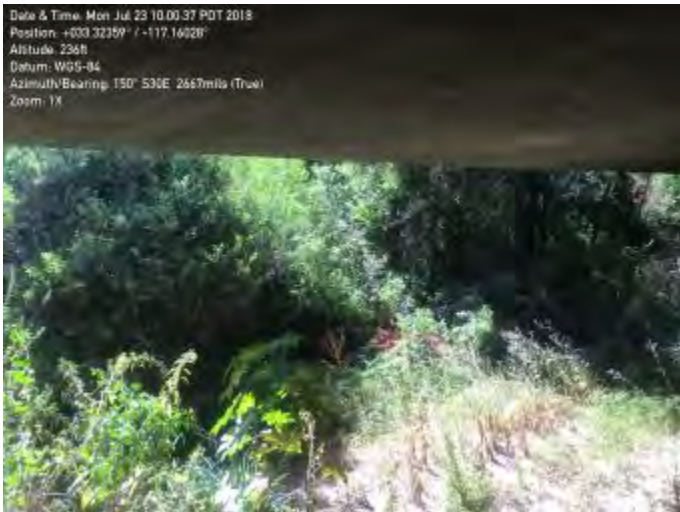
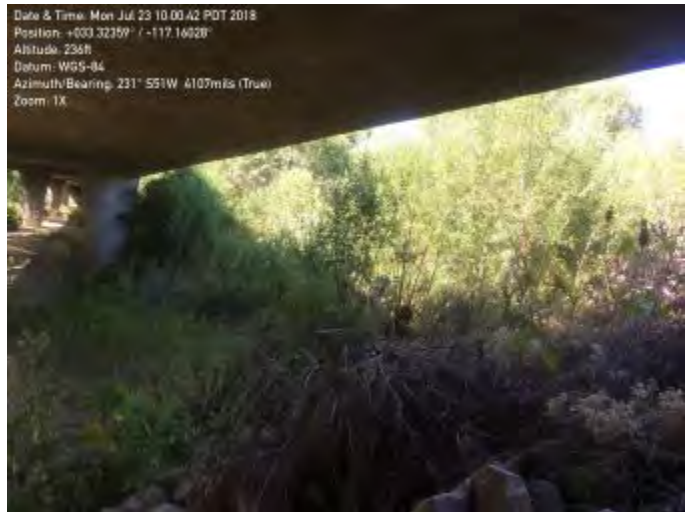
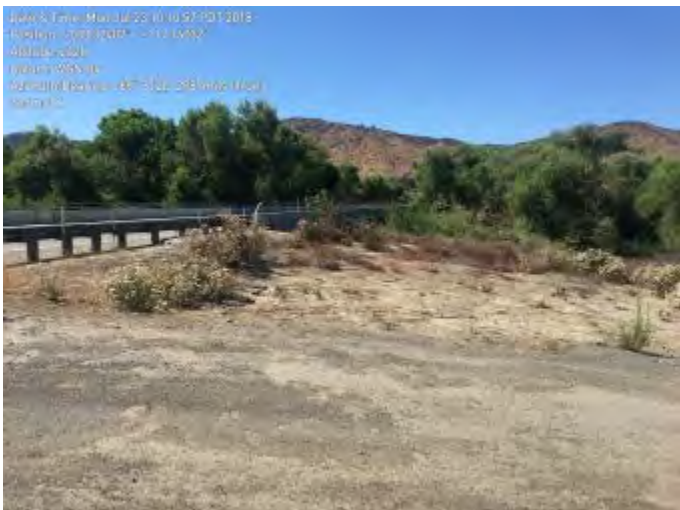
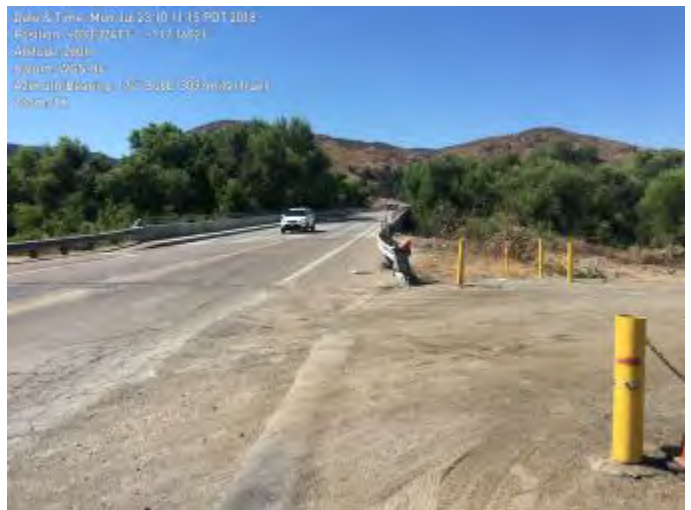
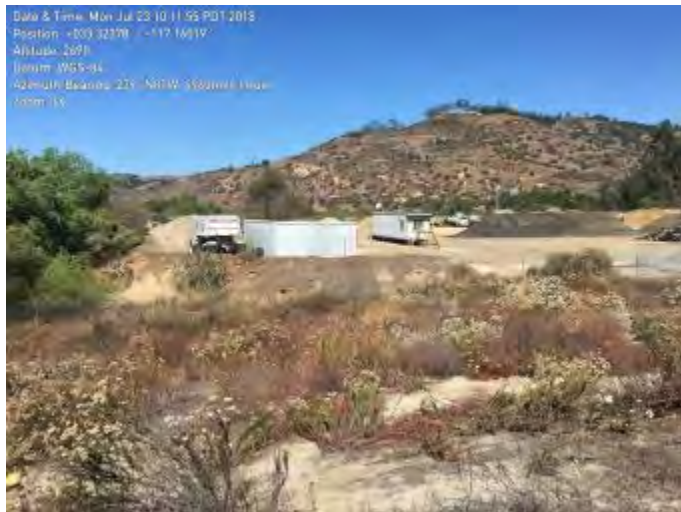
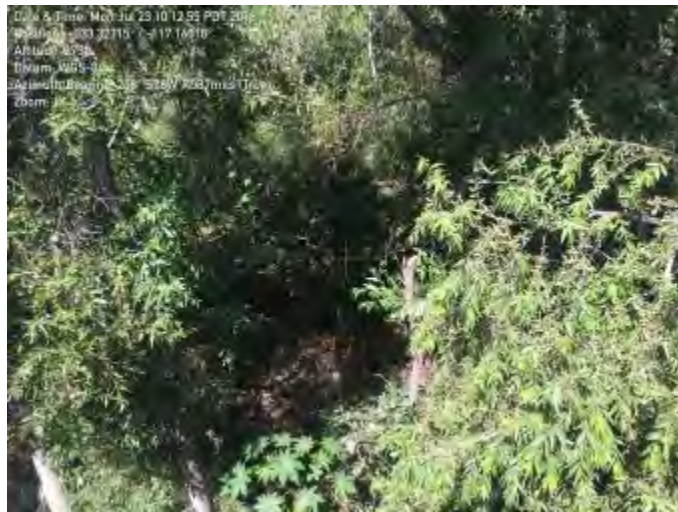
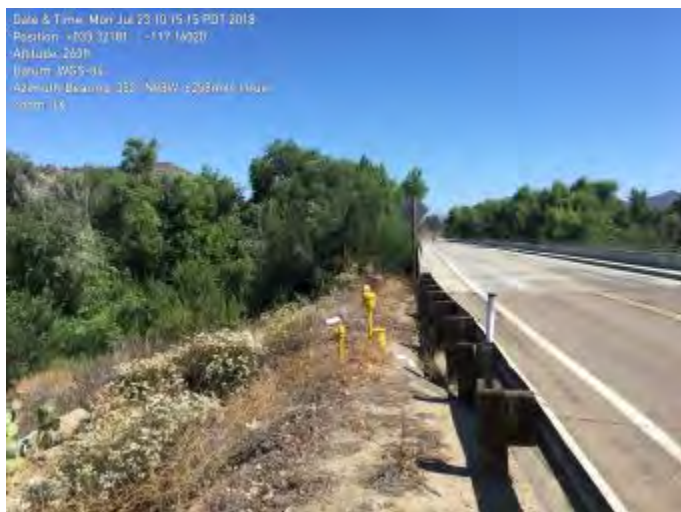
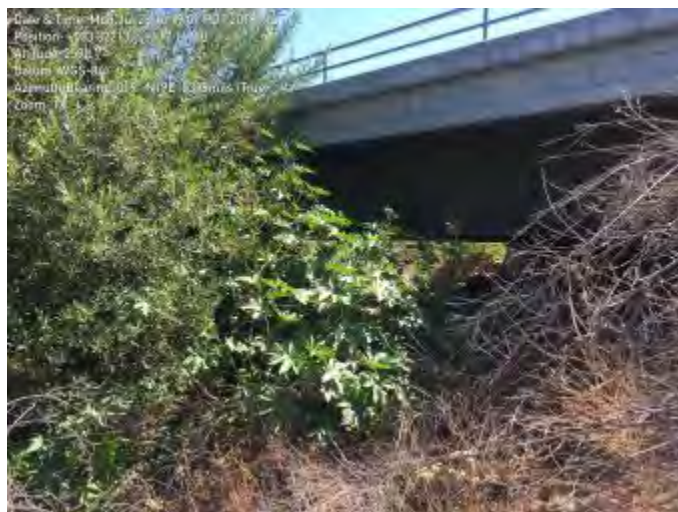
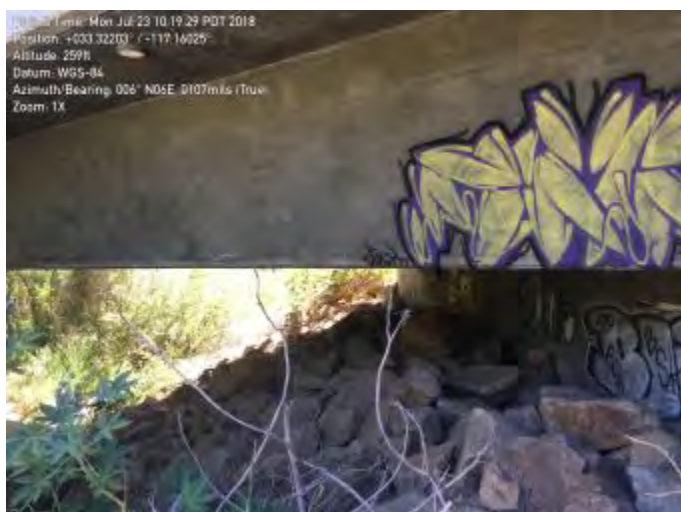
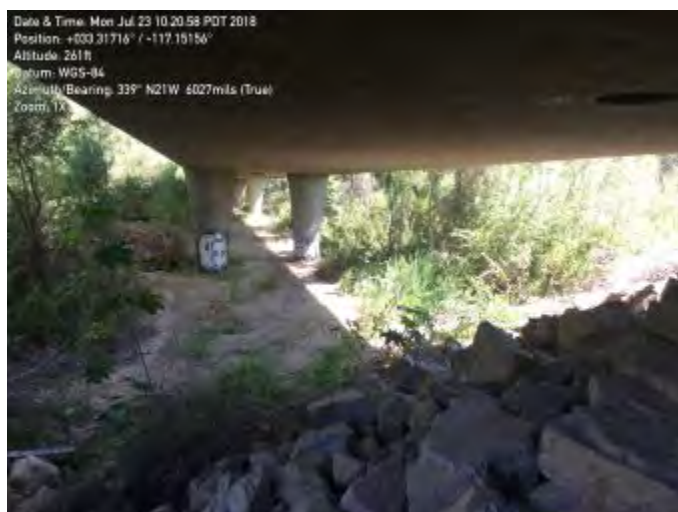
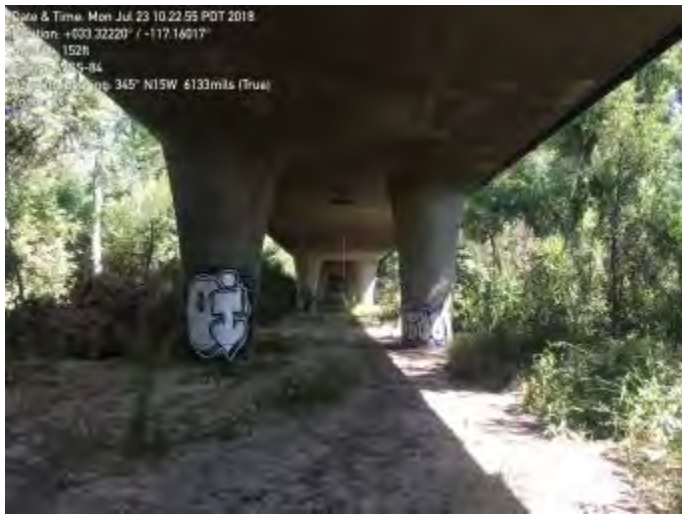
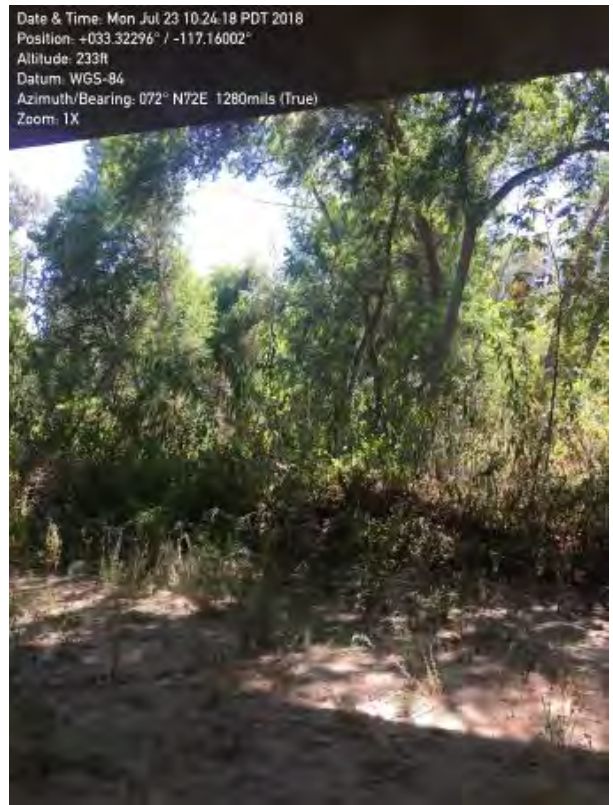
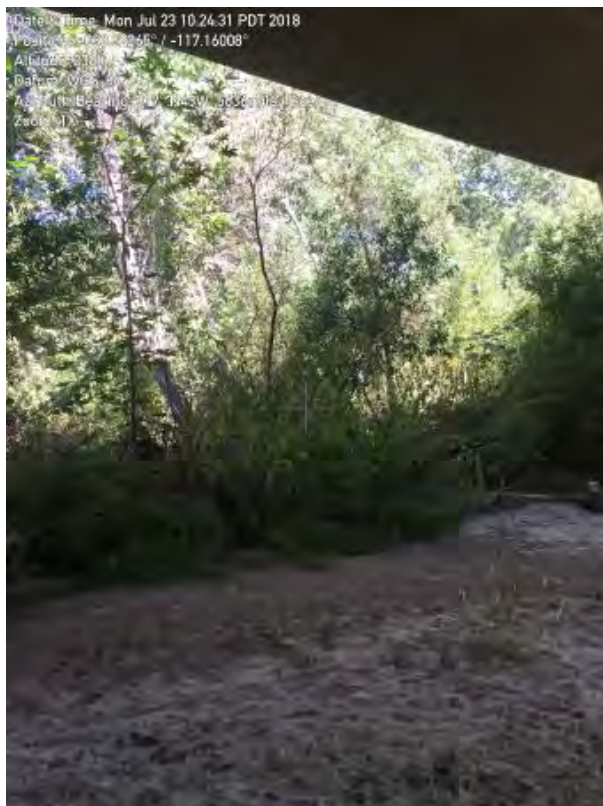
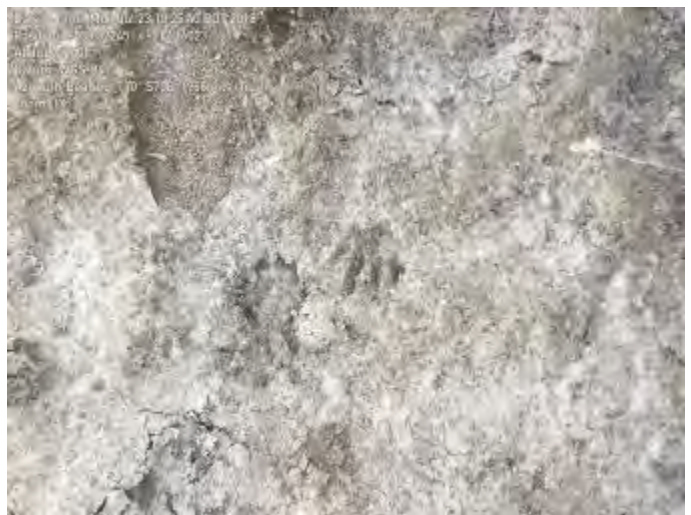
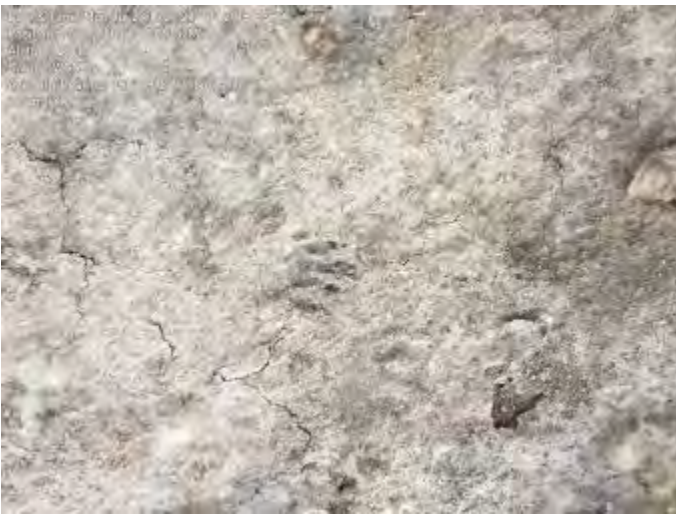
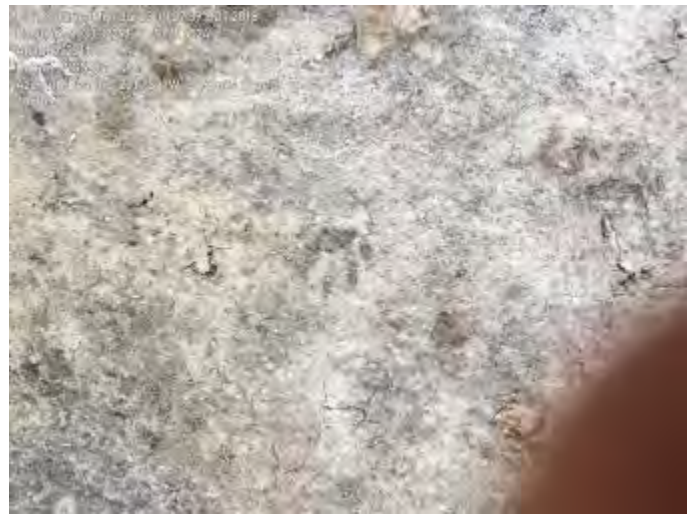
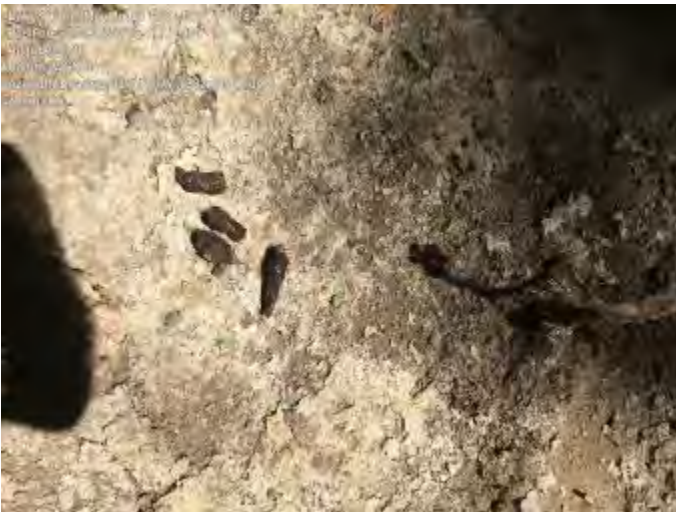
| Describe evidence of other animals present | Bobcat was observed traveling from south to north under the 385 overpass here. It then turned and moved off to the east through the vegetation. Multiple animal tracks. Coyote and rodent scat. |

As noted, active wildlife presence noted at this location. Presence of graffiti on columns under overpass. Relatively sparse vegetation under overpass, but thick vegetation on east and west side in the riverbed. Many human and animal tracks under bridge here. This is an east west crossing under the 395 bridge which crosses the San Luis Rey River.

| Camera suggestions | Due to observation of active wildlife travel here, I would recommend camera placement under overpass. |

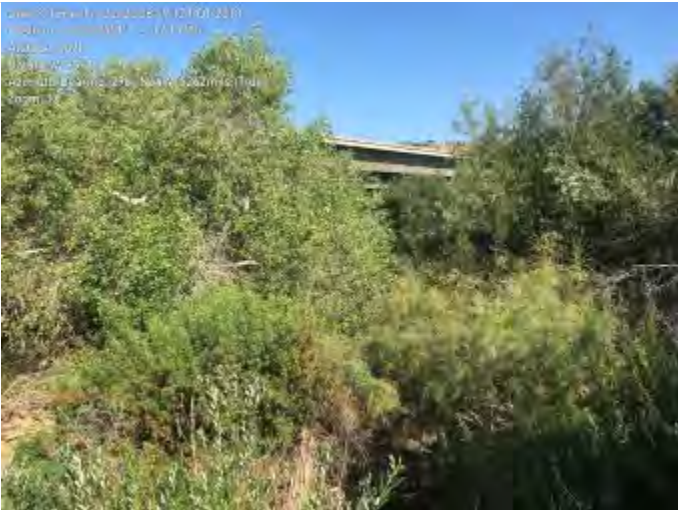
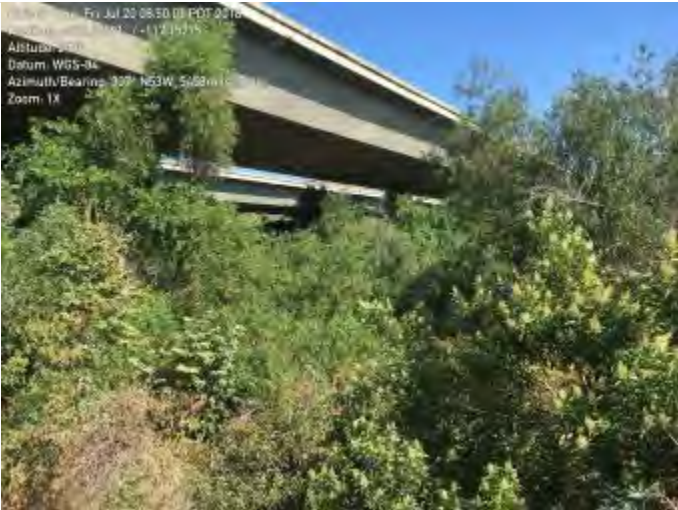
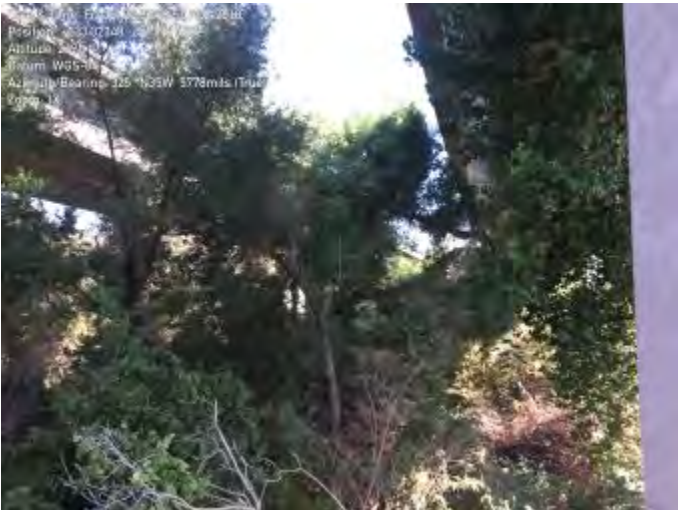
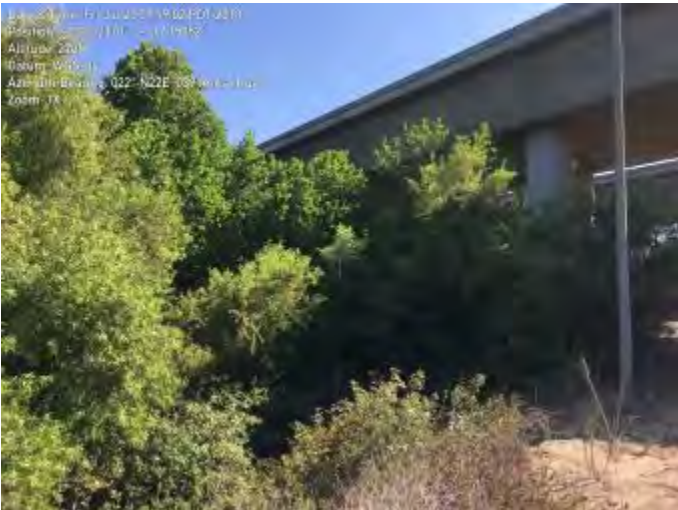
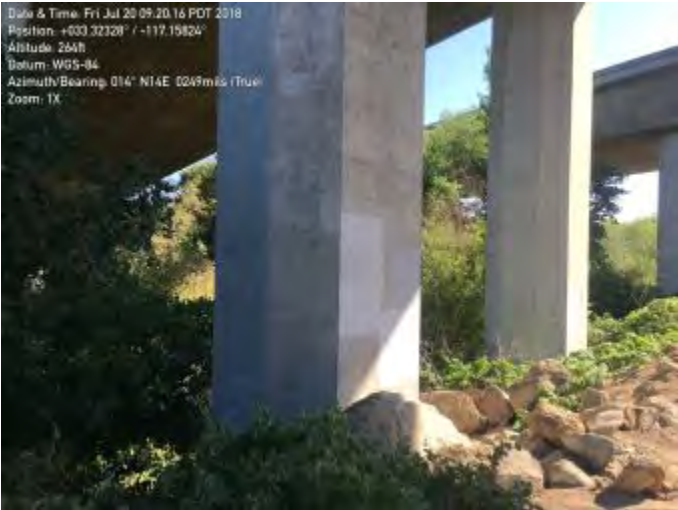
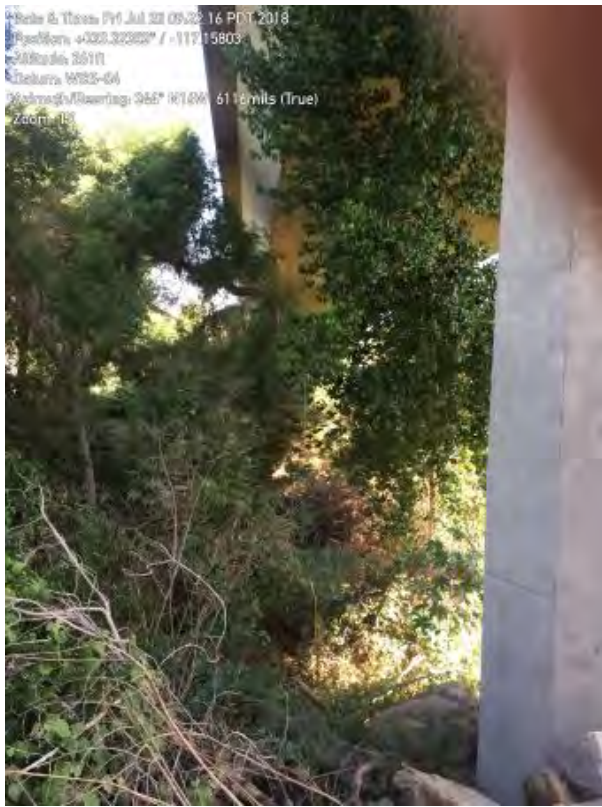
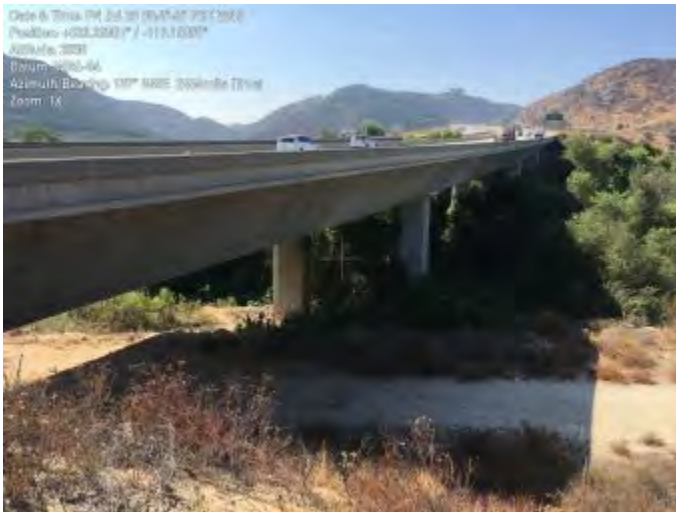
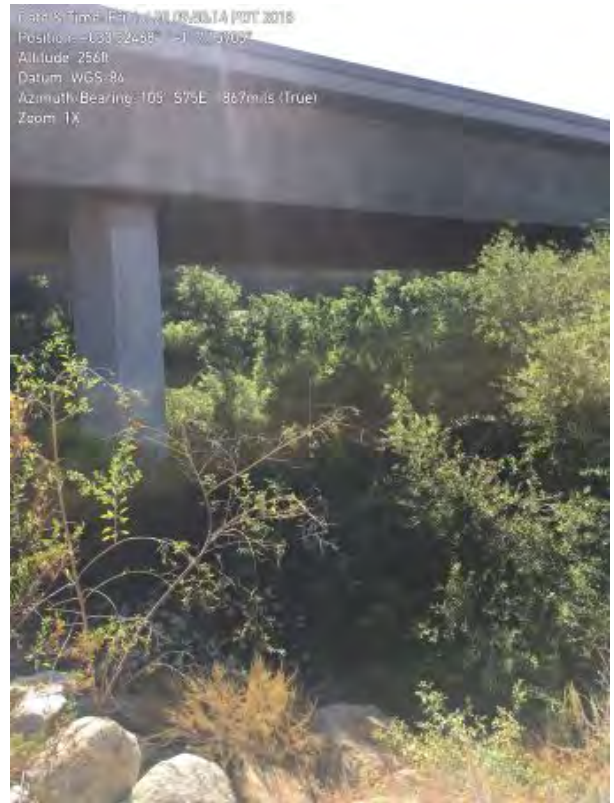
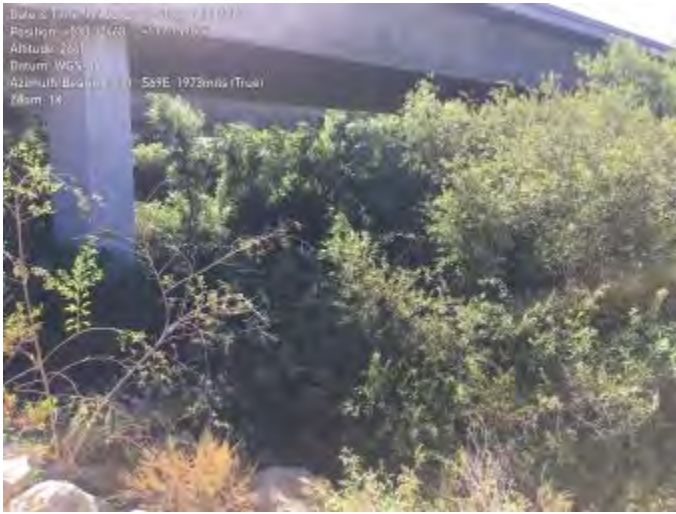
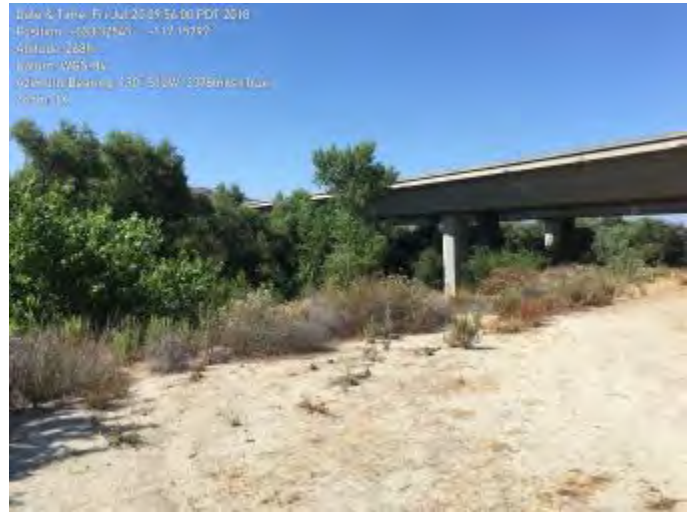
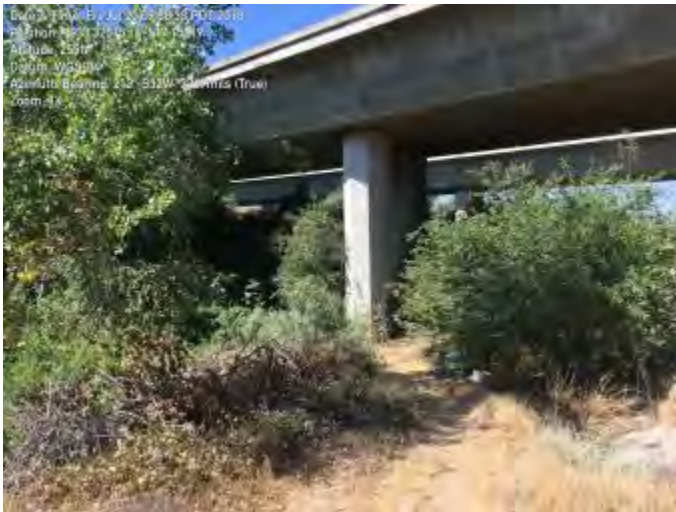
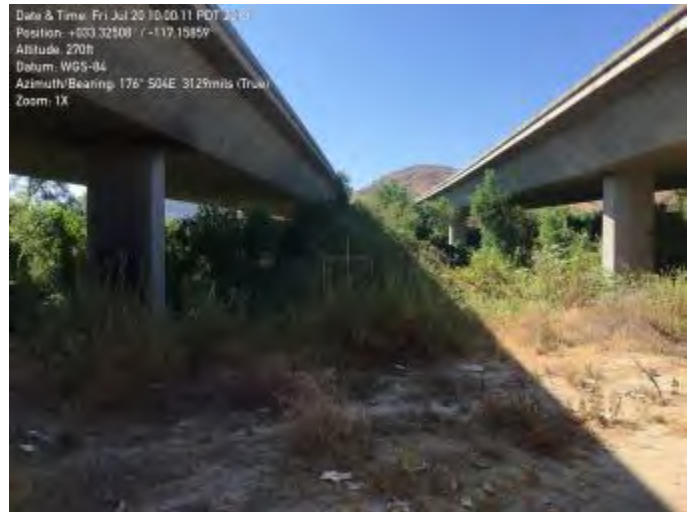
| Describe fencing type and height | On north side there is 5 foot barbed wire fence in poor condition running parallel to undercrossing between I-15 and 395 approx 50 feet from riverbed. |

| Camera suggestions | Under overpass 395 and I 15. |

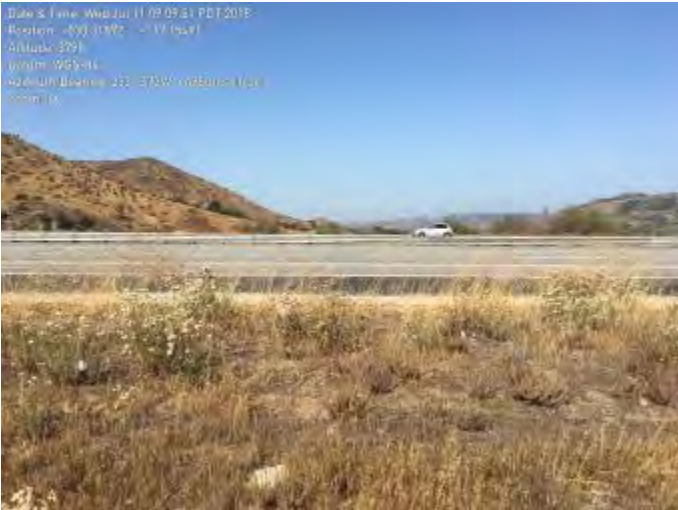
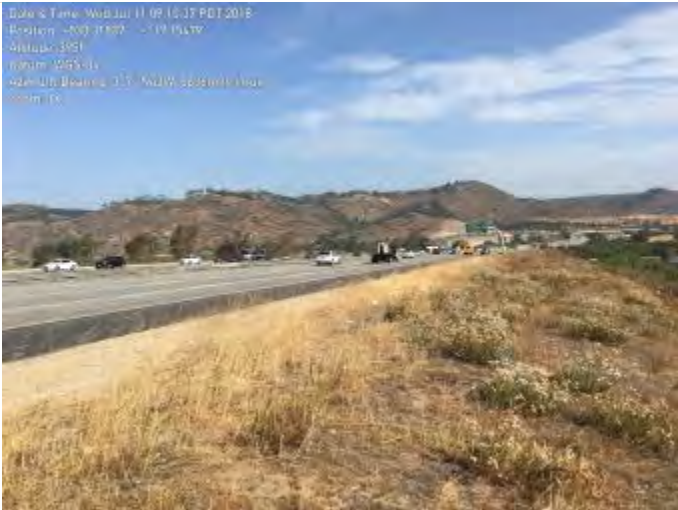
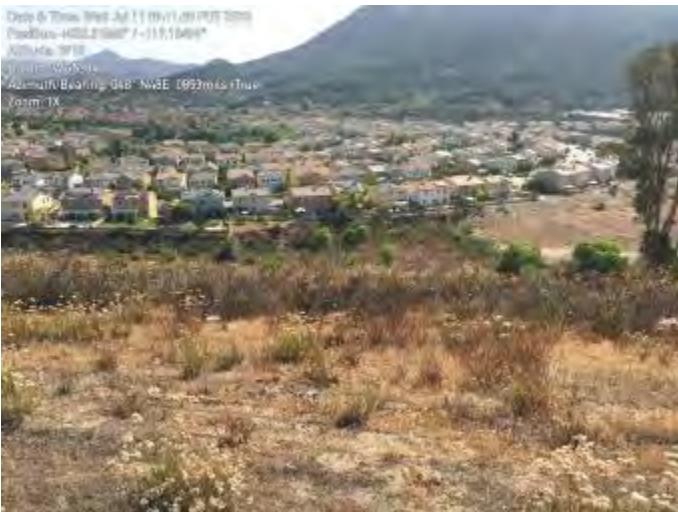
| Describe fencing type and height | 4 foot, 5 strand barbed wire at bottom of west side slope. This parallels the freeway and extends for some distance to north and south. See comments. On west side, there is 5 foot barbed wire fencing parallel to I-15 running several hundred yards to north and south approx. 200 yards west of I-15. |

As noted, there is a steep slope on east side of freeway with approx. 100+ foot drop in elevation from I-15. Since the slope on the west side of this I-15 crossing is equivalent, there would be potential for wildlife crossing. A large culvert placed underneath the I-15 just to the south of this location could be considered. That location bears further evaluation, as well as the corresponding location on the east side of I-15.

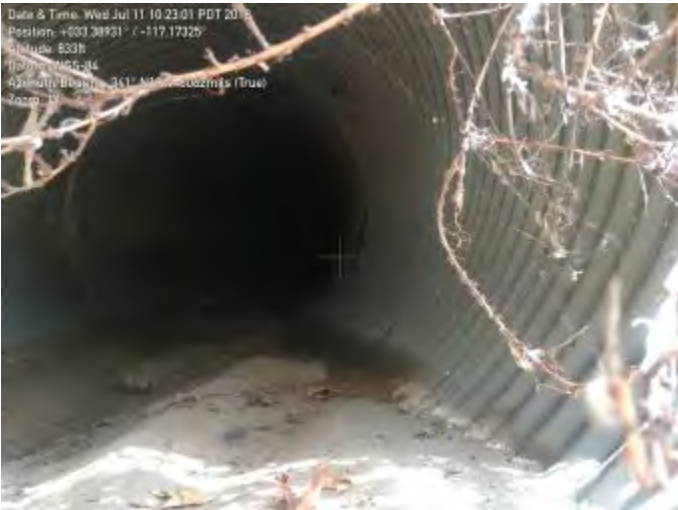
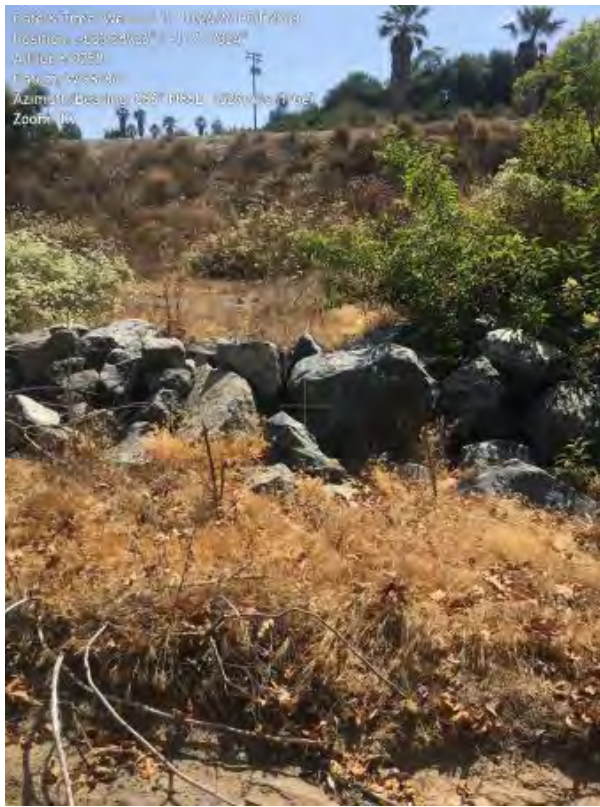
| Describe limitation of landscape and veg and which side of road | Approximately 200 meters east of I 15 is 395. East of 395 is residential/agricultural property. Culvert in place is probably inadequate for large mammal access. |

NB culvert

NB toward culvert

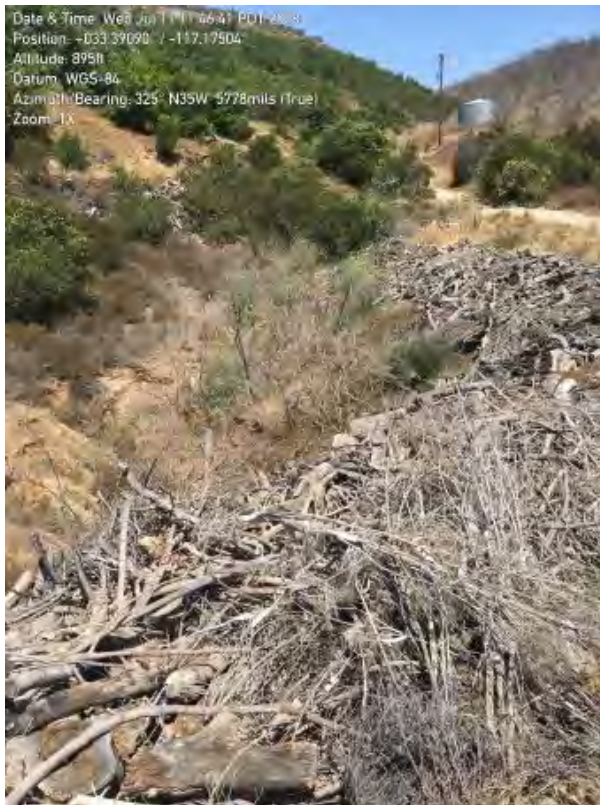
SB potential culvert

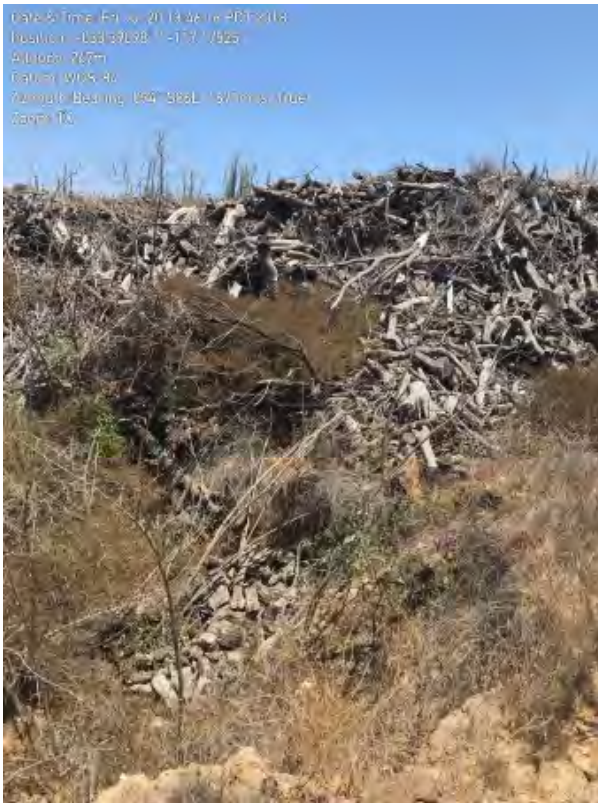
Obstructed culvert (middle of photo)

access road goes off to the west from west side of I-15. Appears to be access to avocado grove. Dry streambed approaches I-15 here from the west. It is approx. 15 feet deep. There is a culvert at its terminus before I-15, but is currently blocked to a significant degree. Crossing from west side currently at grade. Further evaluation of crossing at 395 recommended.

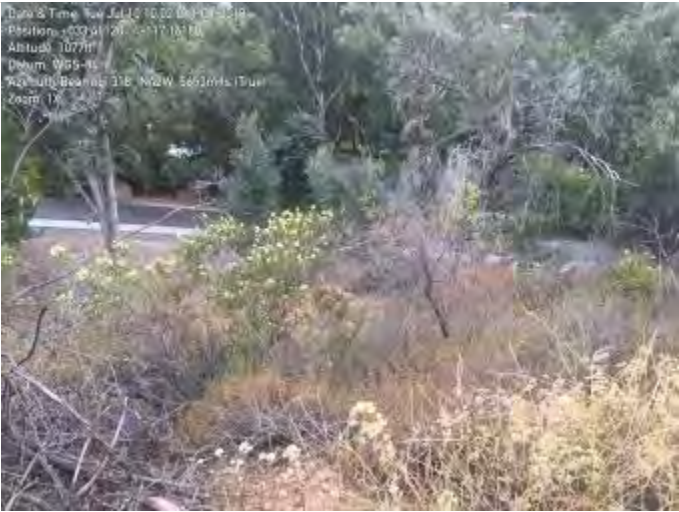
I15 southbound. view down to trailer park

| Comments | Survey incomplete. Need to access mobile home park to complete survey. Potential undercrossing approx 300 meters north at Rainbow Creek. |

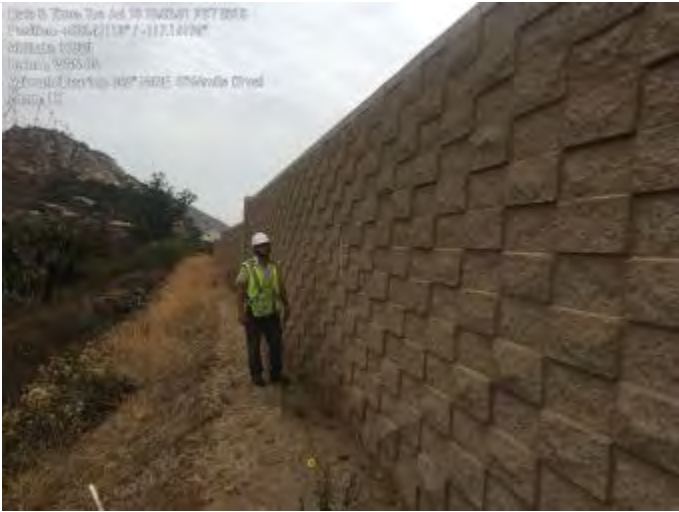
SB. Wall next to I15.
