SA-PAL survey

| Project | SA-PAL project |
| ID | 42130 |
| Survey Date | 04/03/2019 |

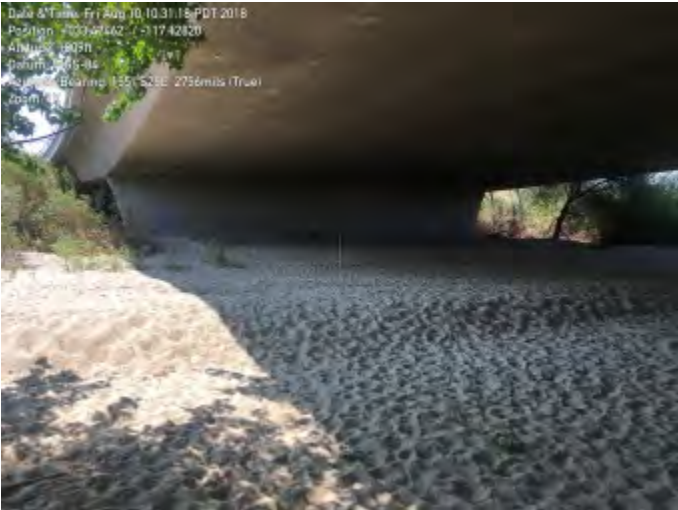
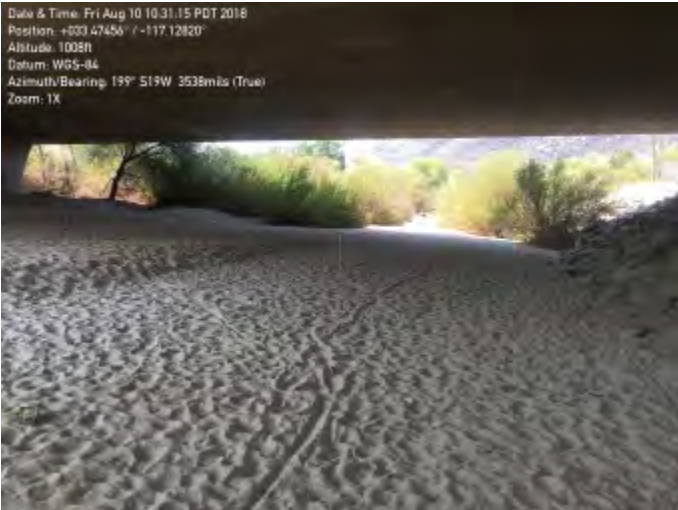
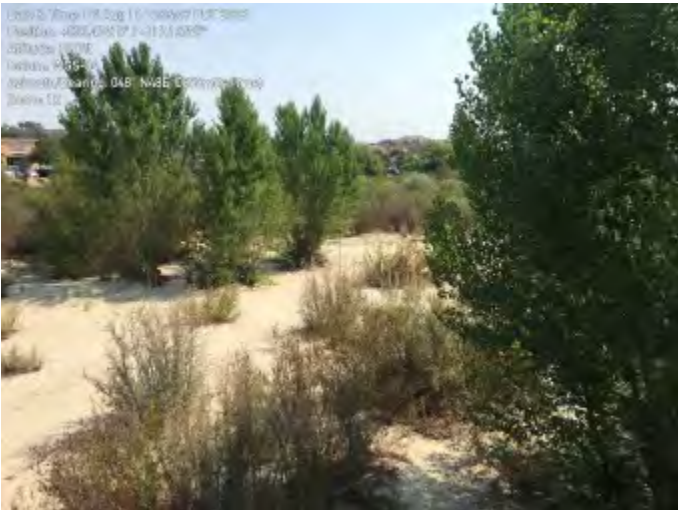
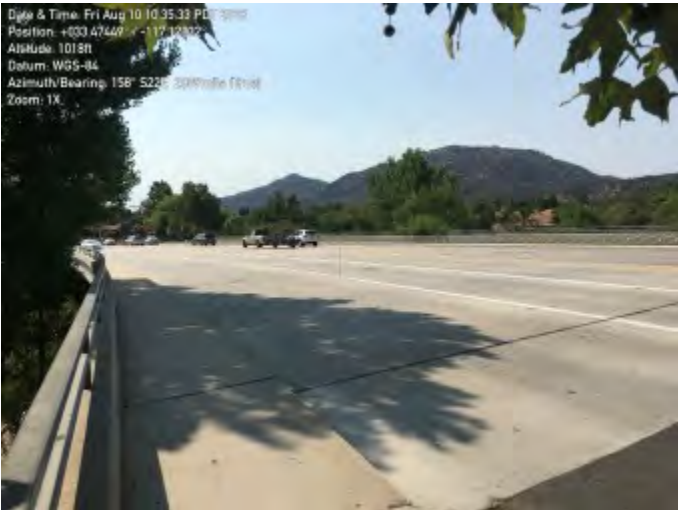
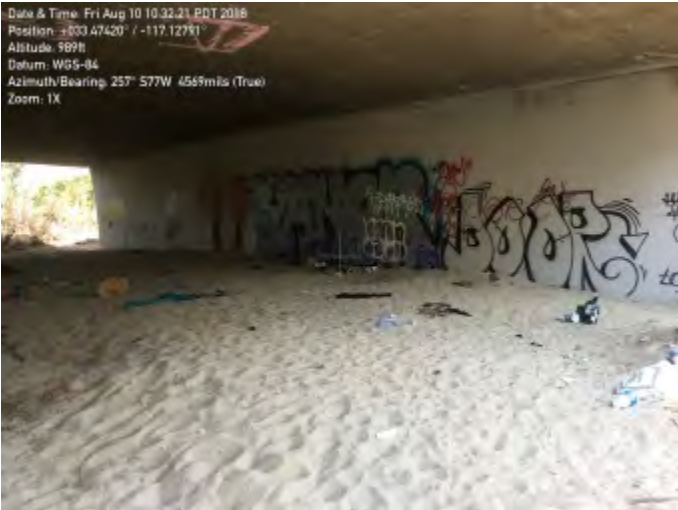
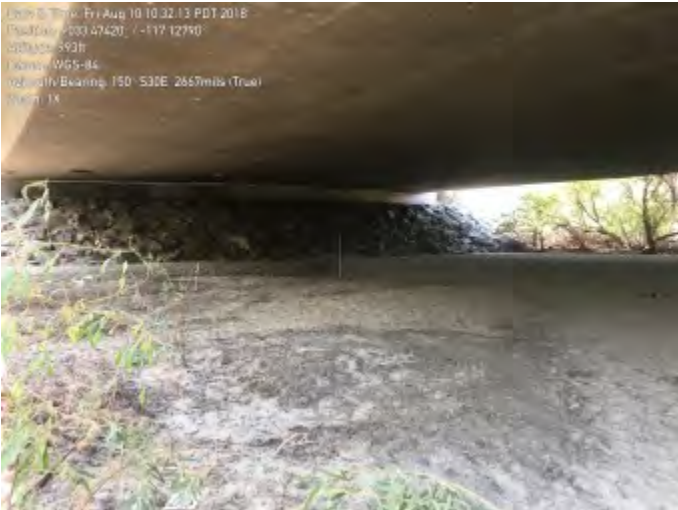
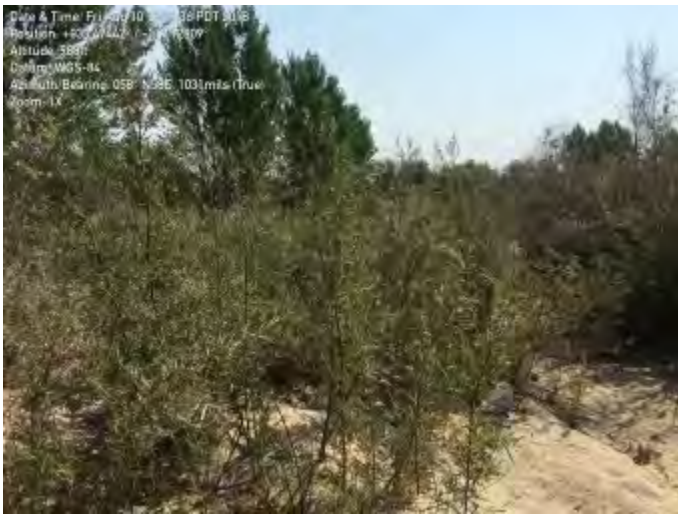
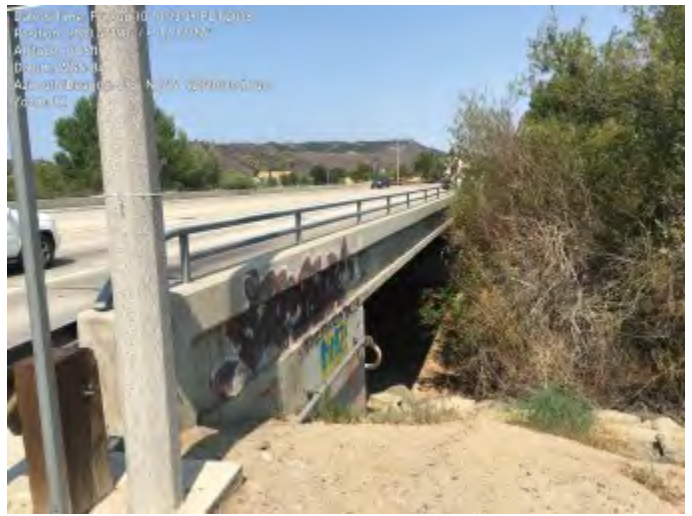
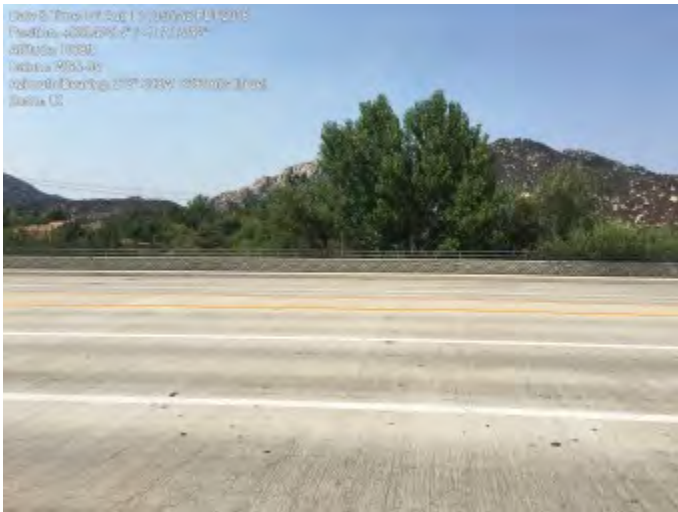
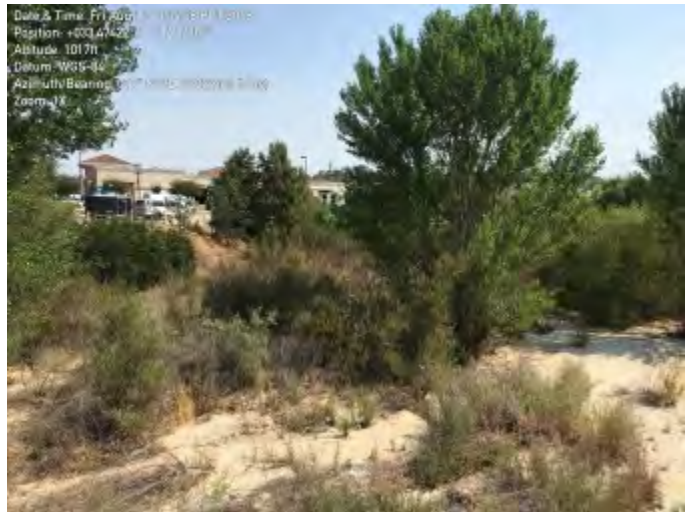
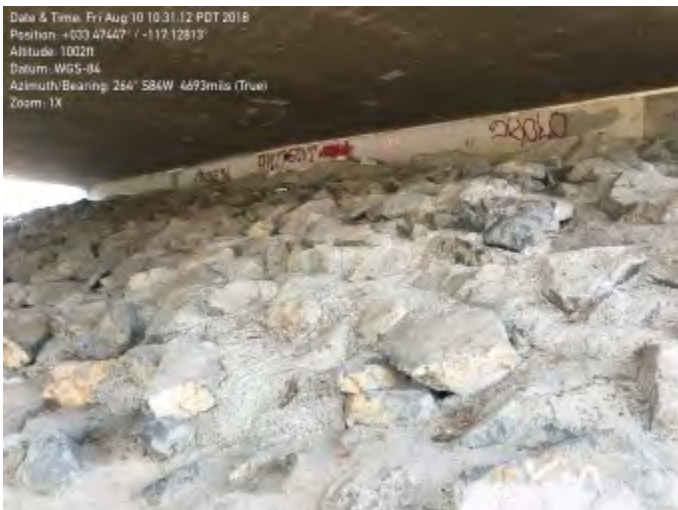
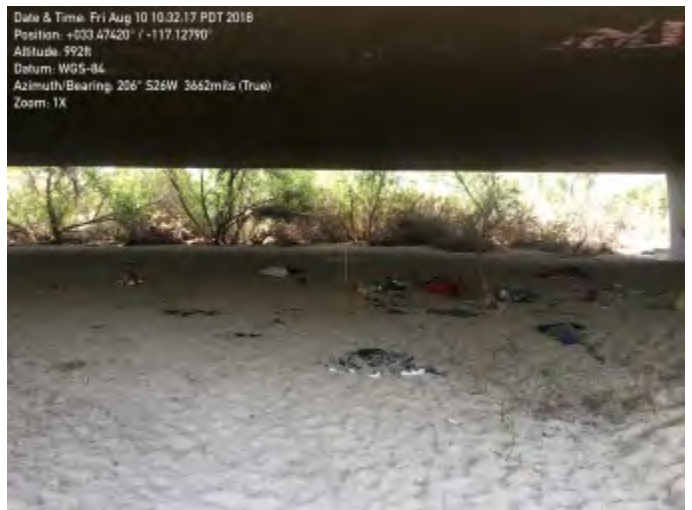
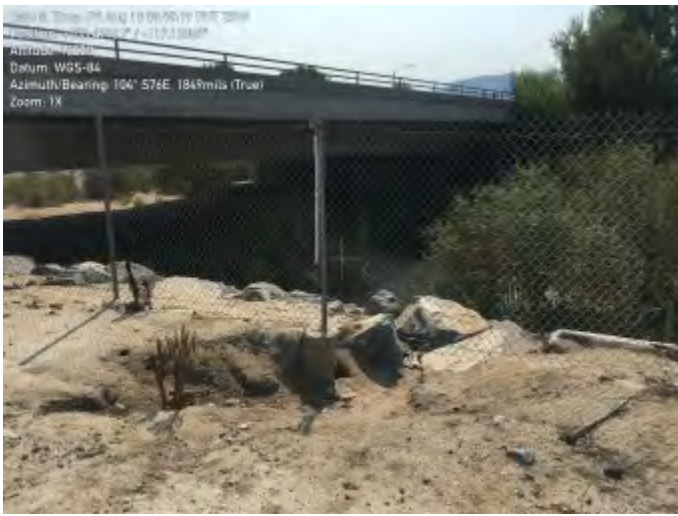
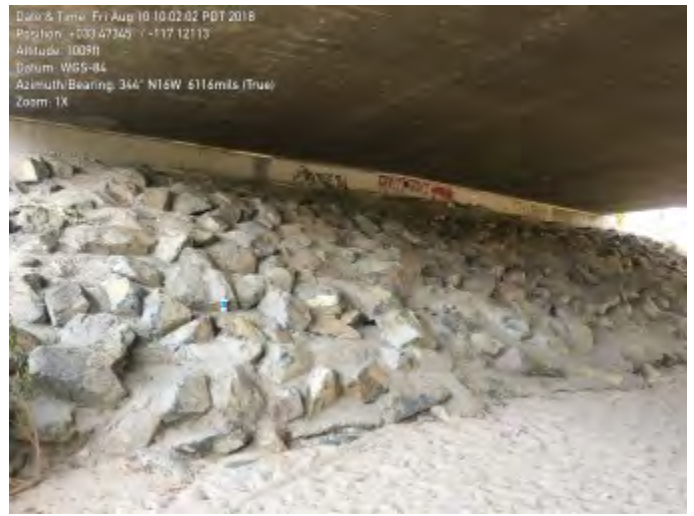
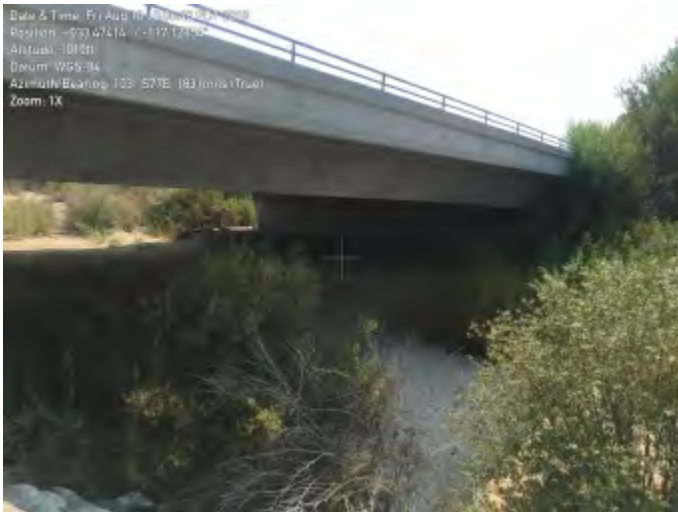
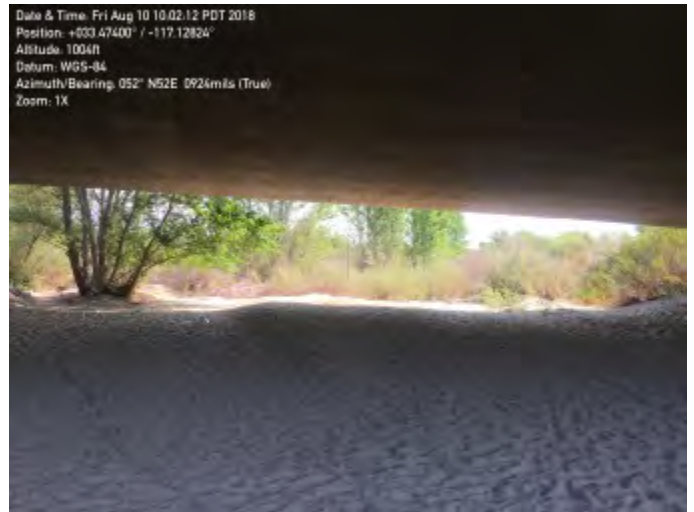
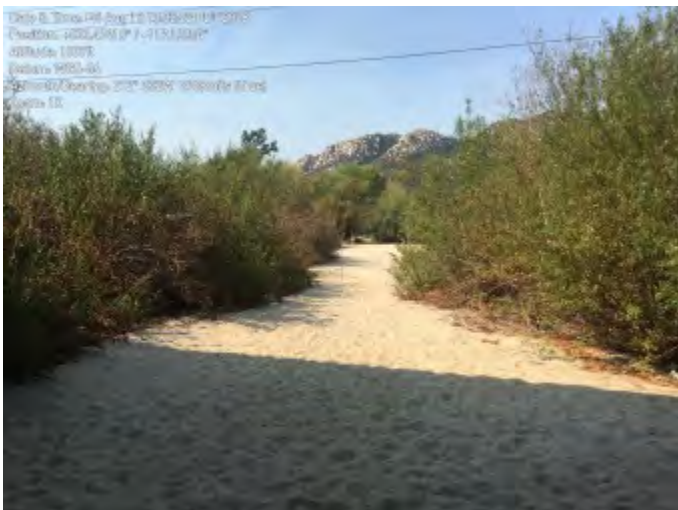
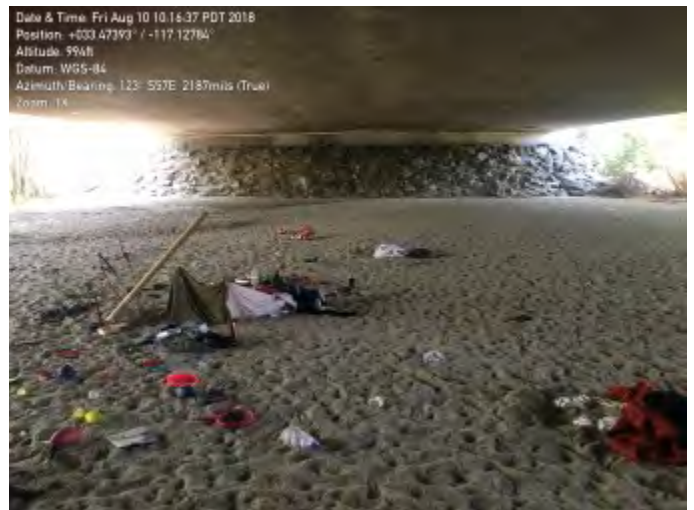
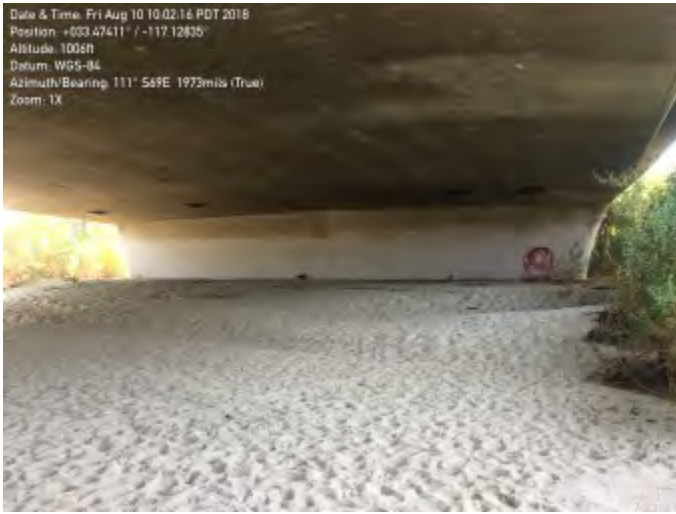
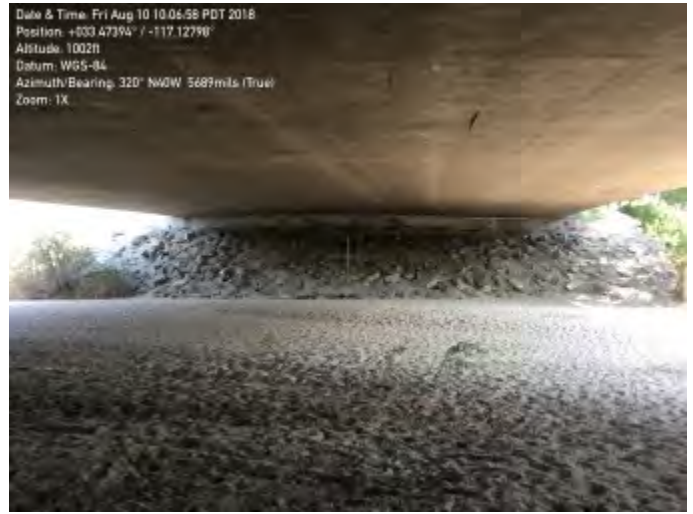
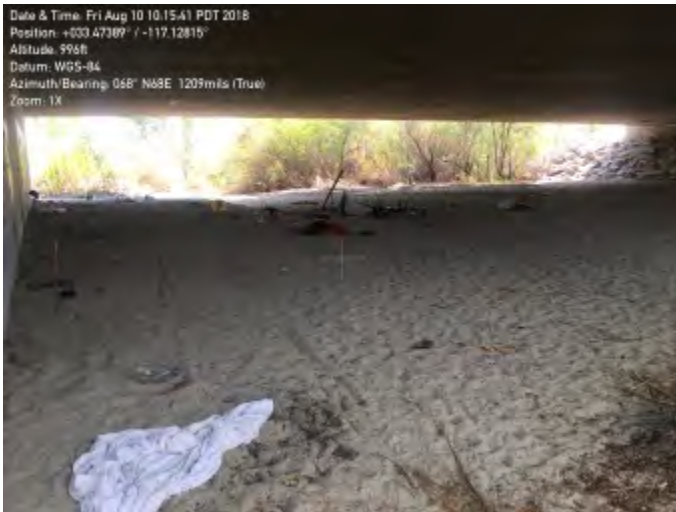
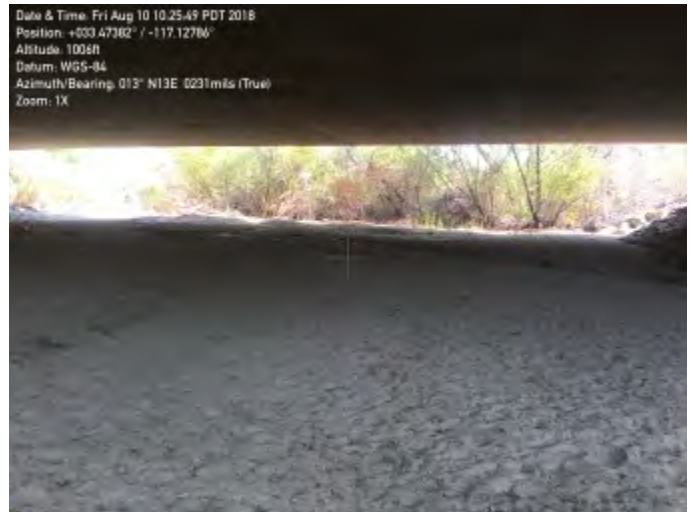
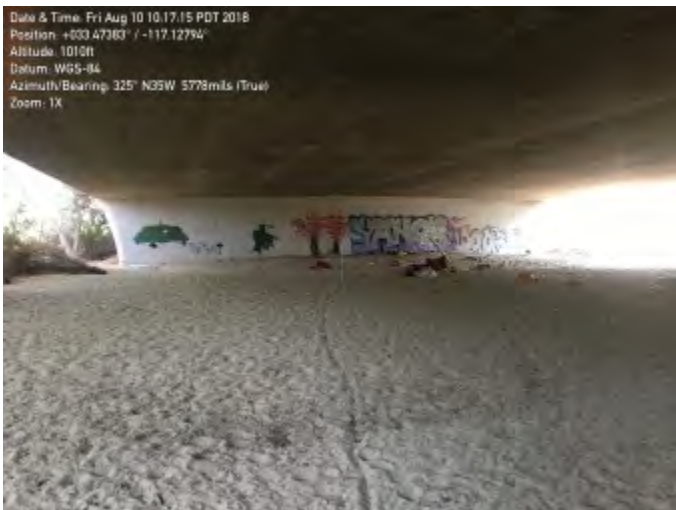
| Describe human presence potential | Easy access below roadway through broken fence. Many footprints. Graffiti beneath bridge. Human encampment. No barrier fencing on NB side north and south of overpass allowing east human access here. |

There are two undercrossings beneath this bridge, both of equal size, separated by concrete bridge support. This is a good east west crossing location, but with the constraints noted above. Sandy under bridge and to the west. Heavy undergrowth to the

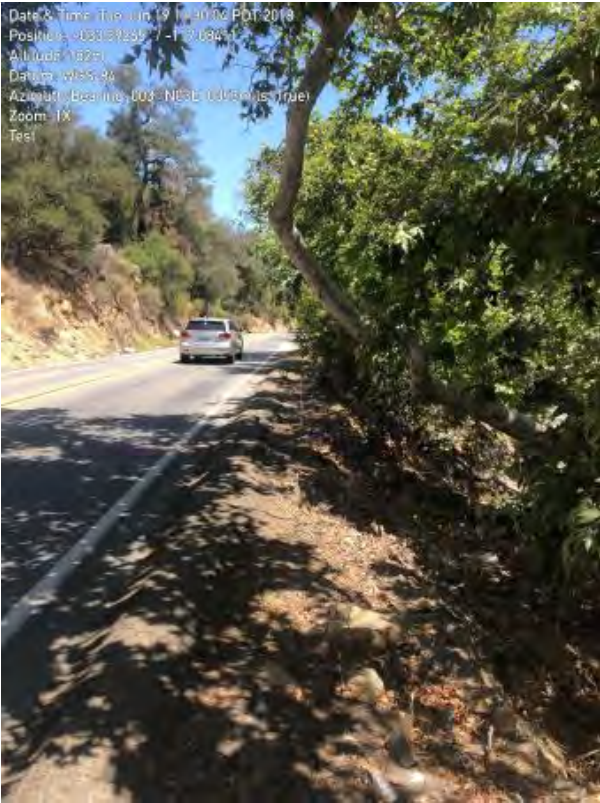
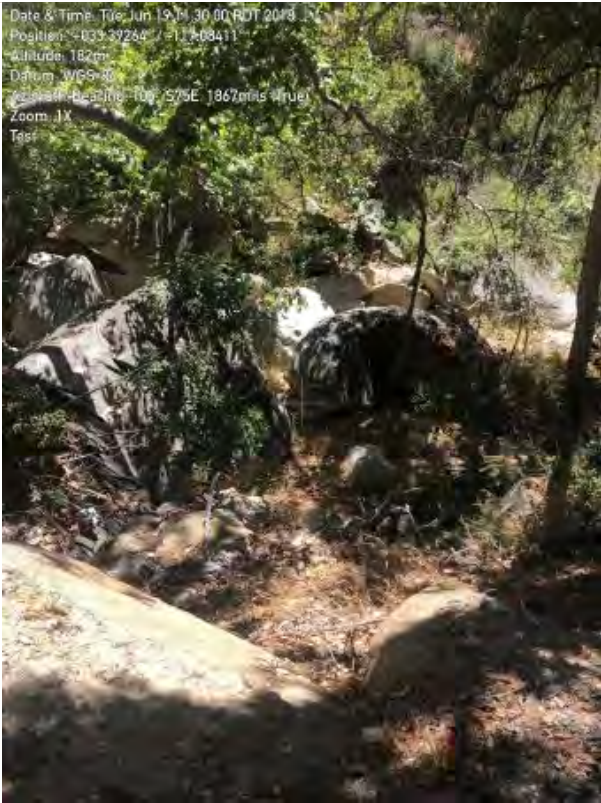
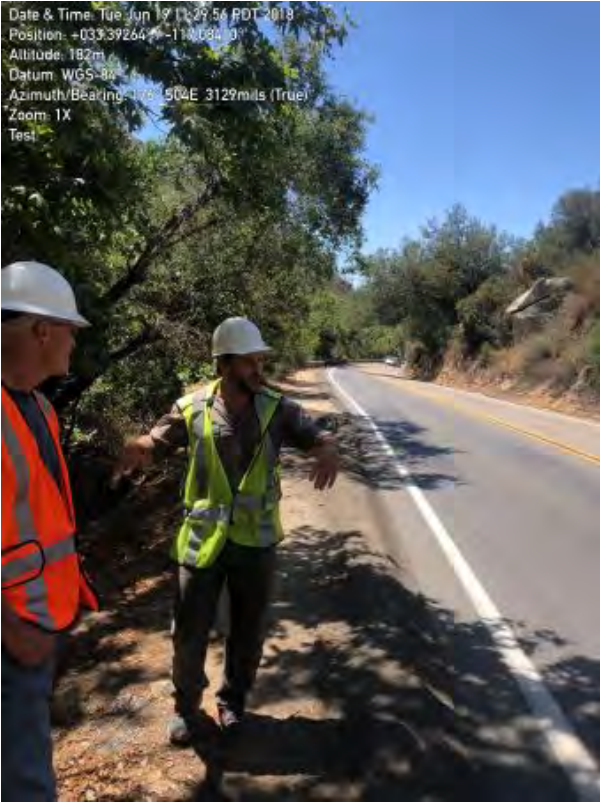
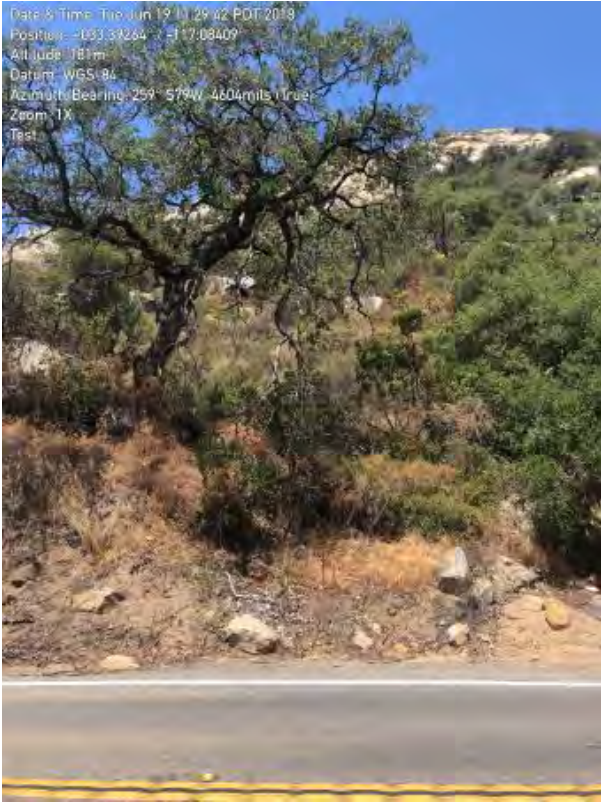
No culvert option readily evident - water runs across road

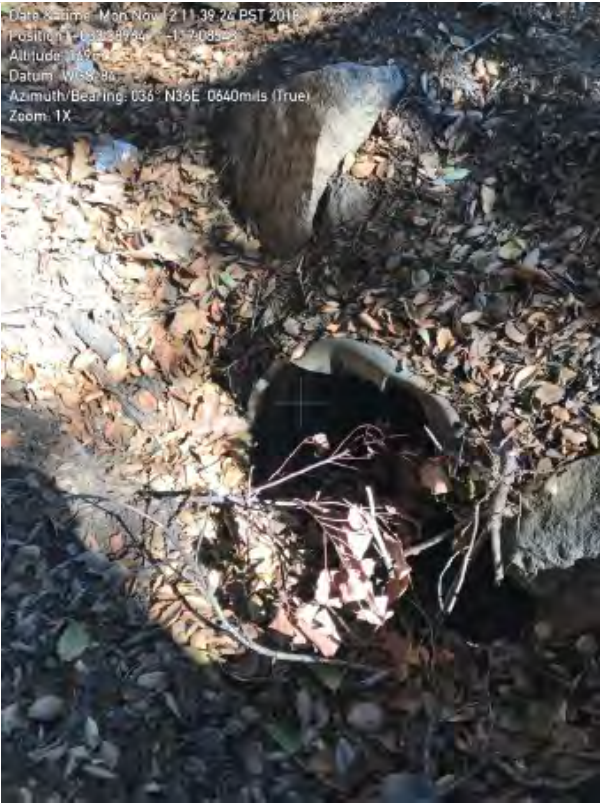
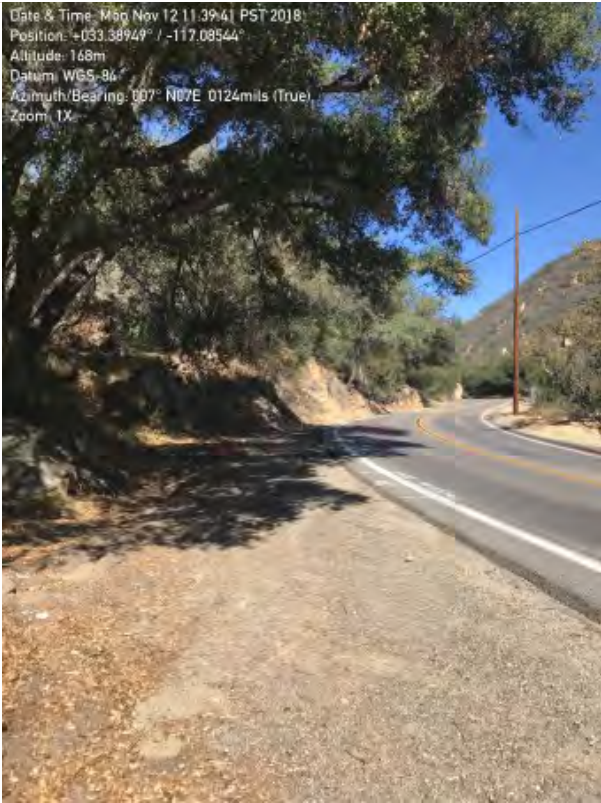
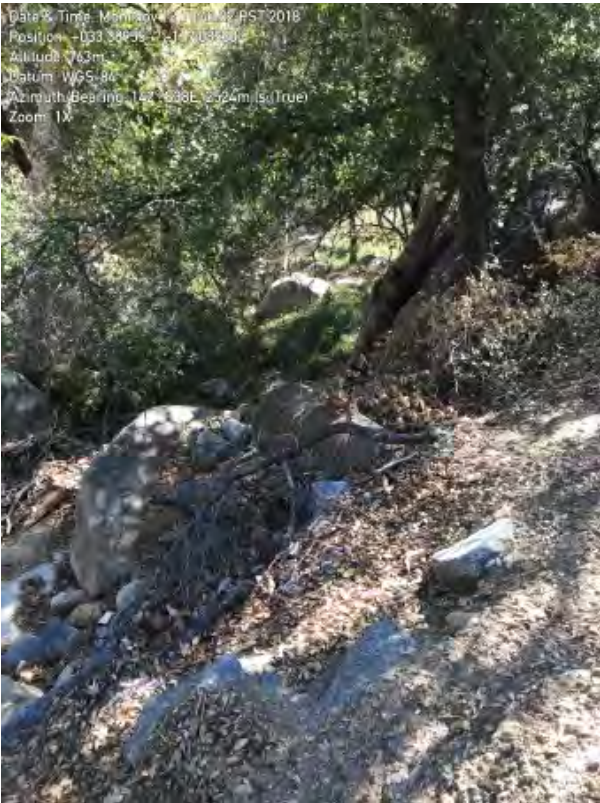
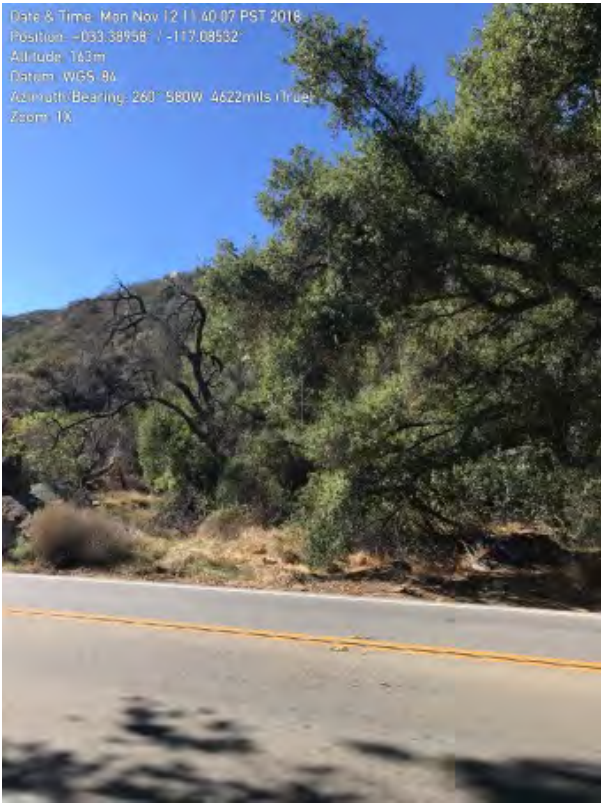
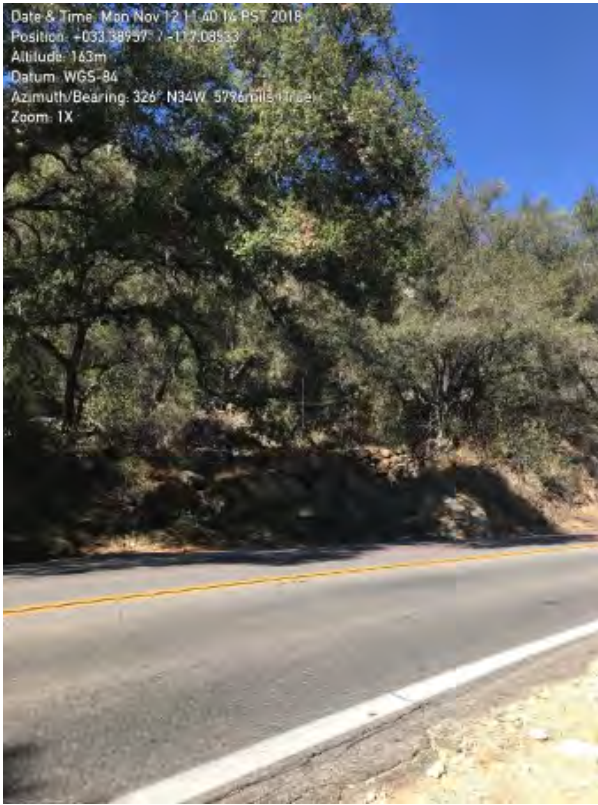
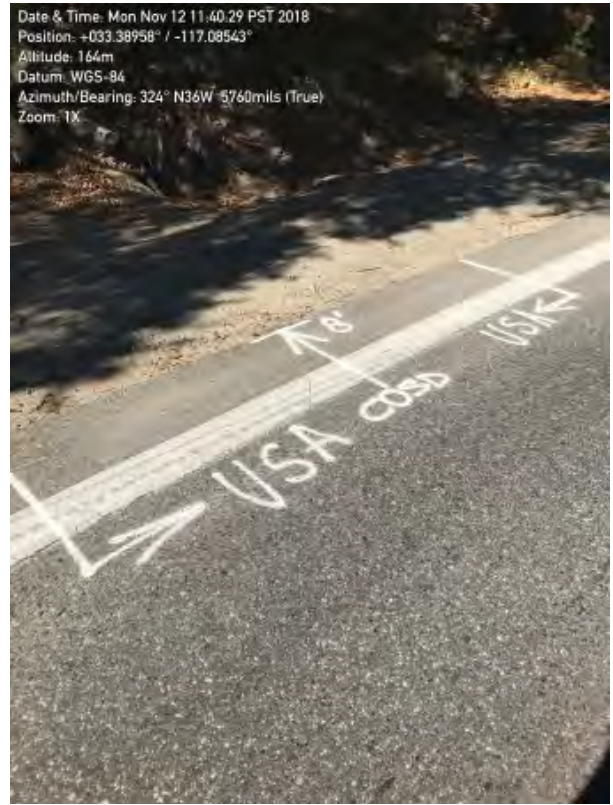
Good landscape on West side as terrain slopes to road grade. Possible expansion of culvert or other road work scheduled based on survey marking on road. In this southern portion of road, there are numerous small 2' culverts indicating common erosion and

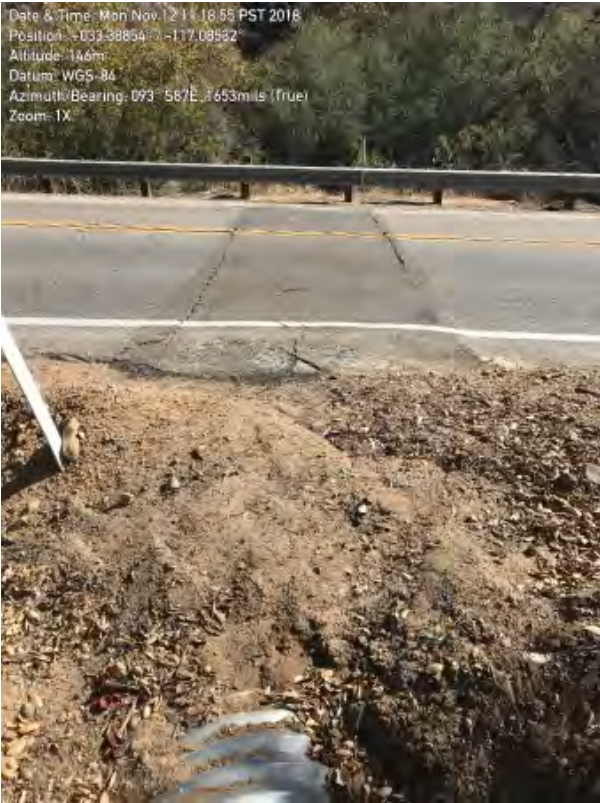
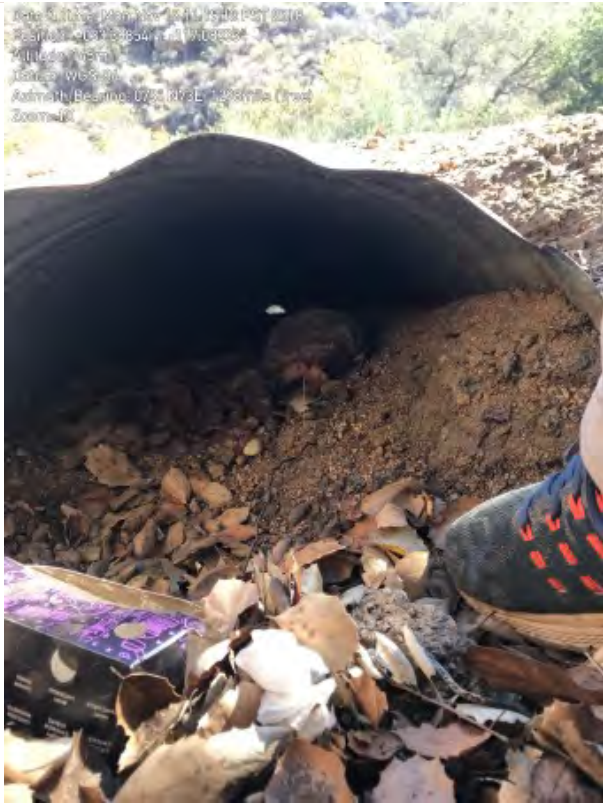
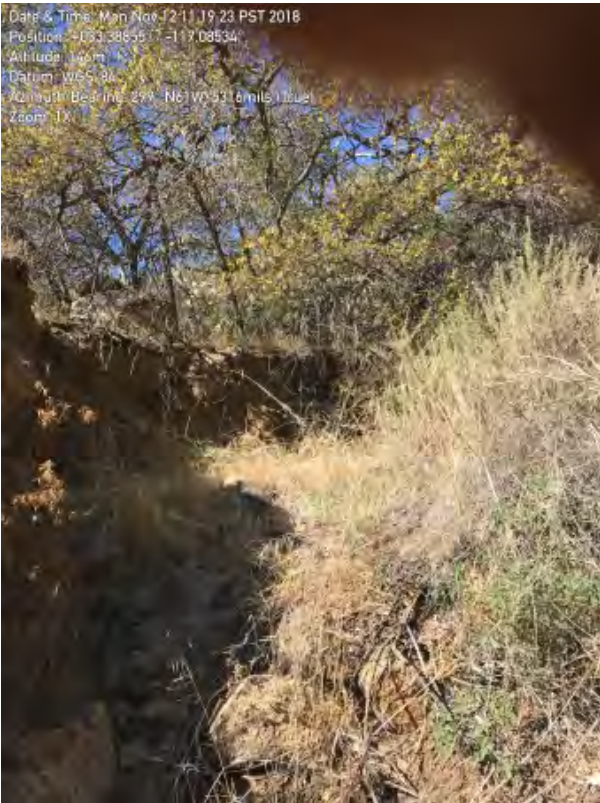
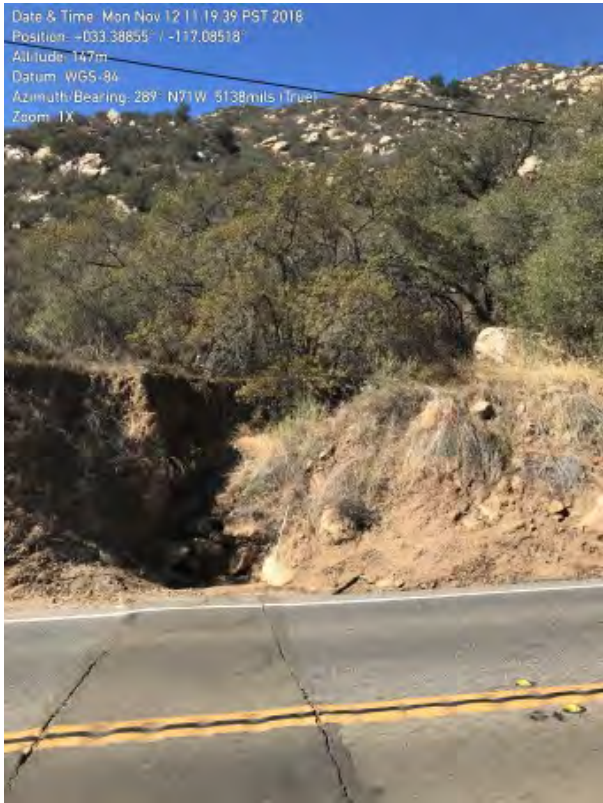
| Comments | Seasonal runoff provides some access to road west to east. Only likely travel, doubtful from East West. But would only be at road level. |

| Management recommendations | Fencing that prevents access to road. |

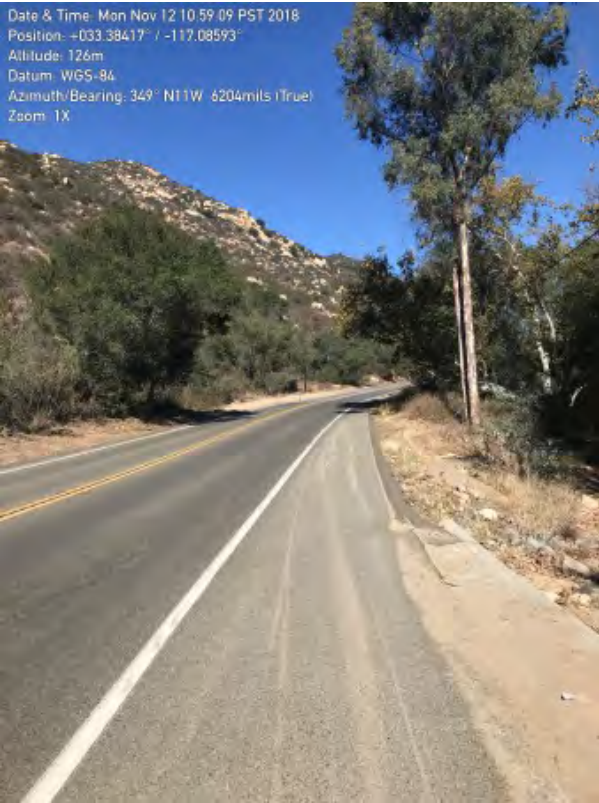
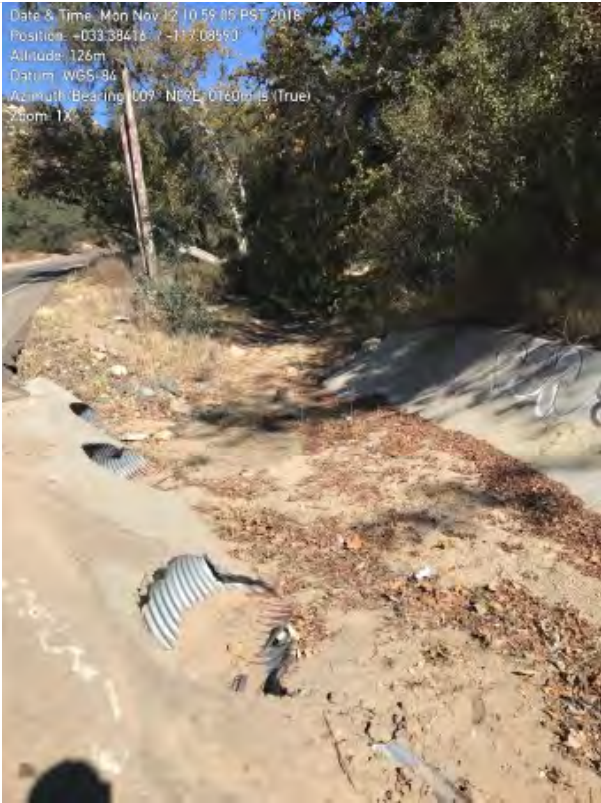
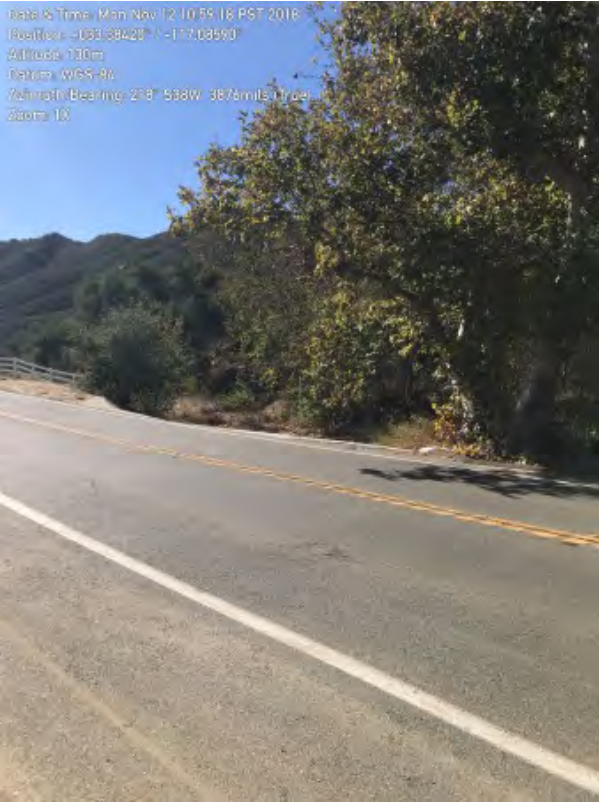
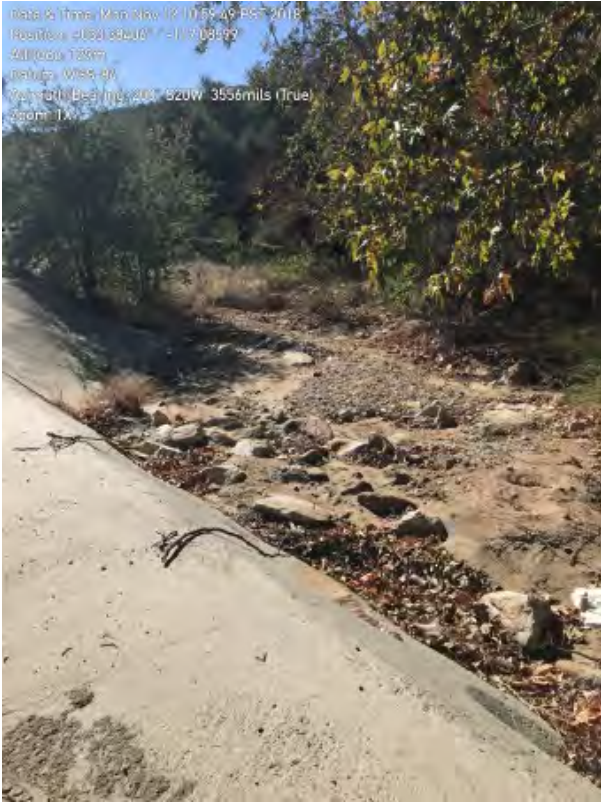
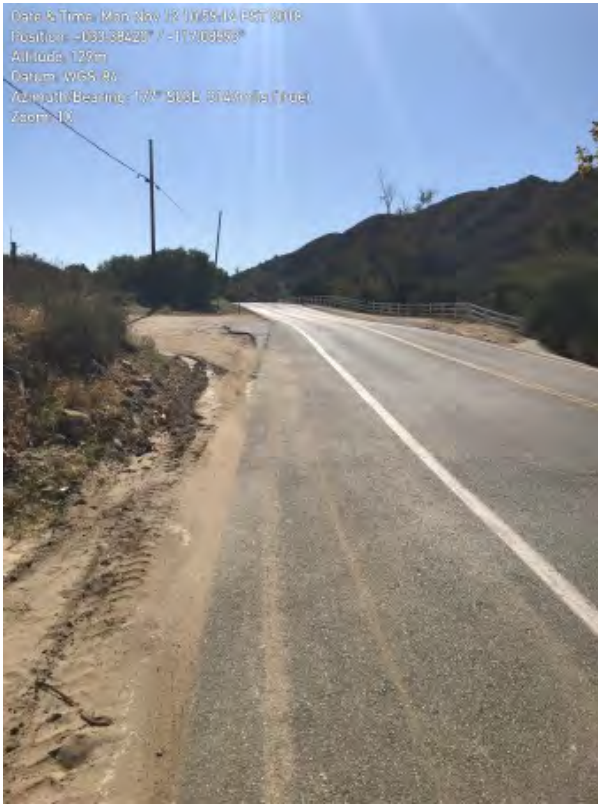
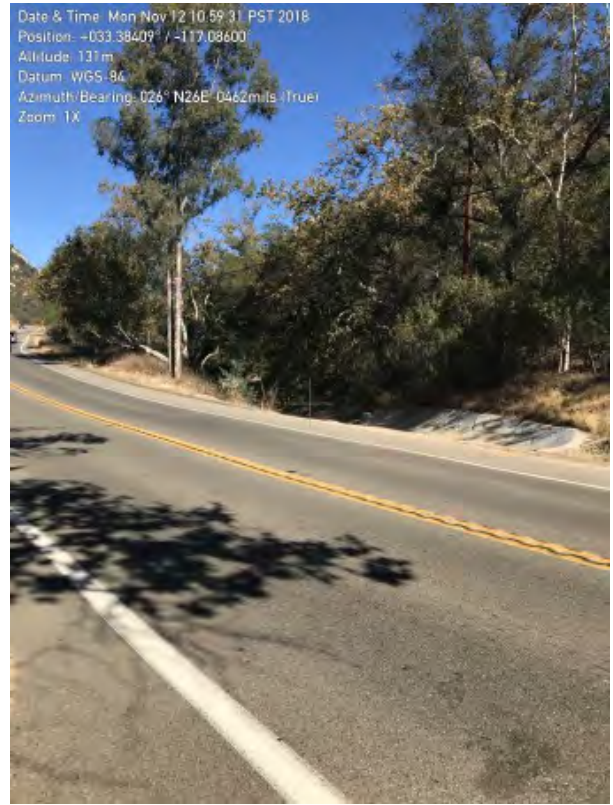
(4) adjacent 3' culverts crossing 45 degree angle across rd. Culverts are providing continuity of Pala Creek as it crosses under rd.

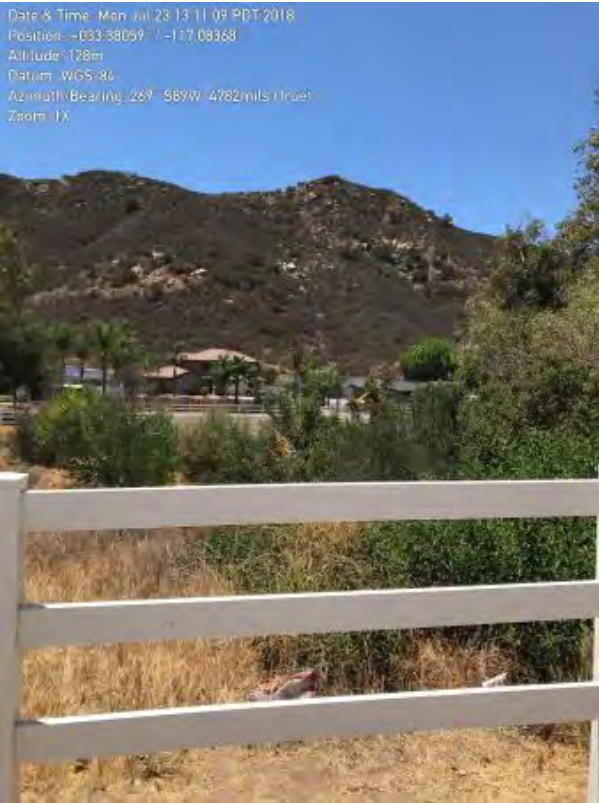
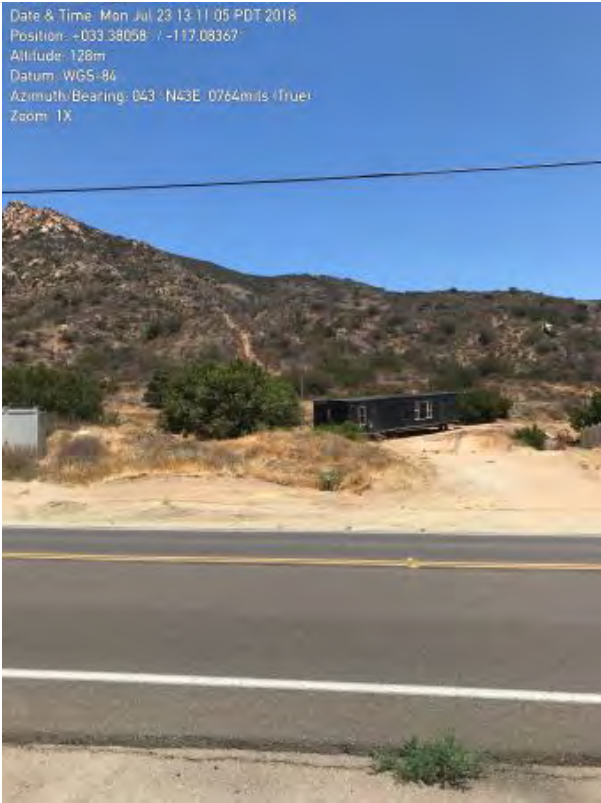
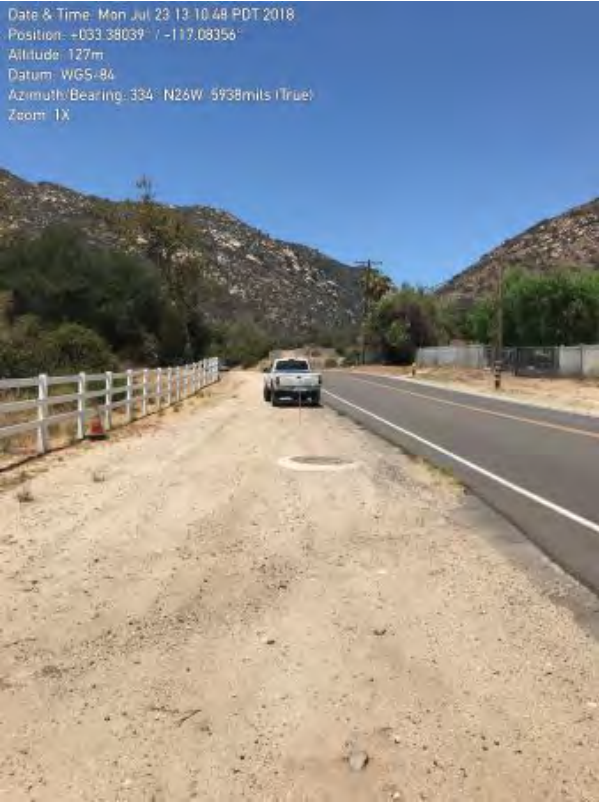
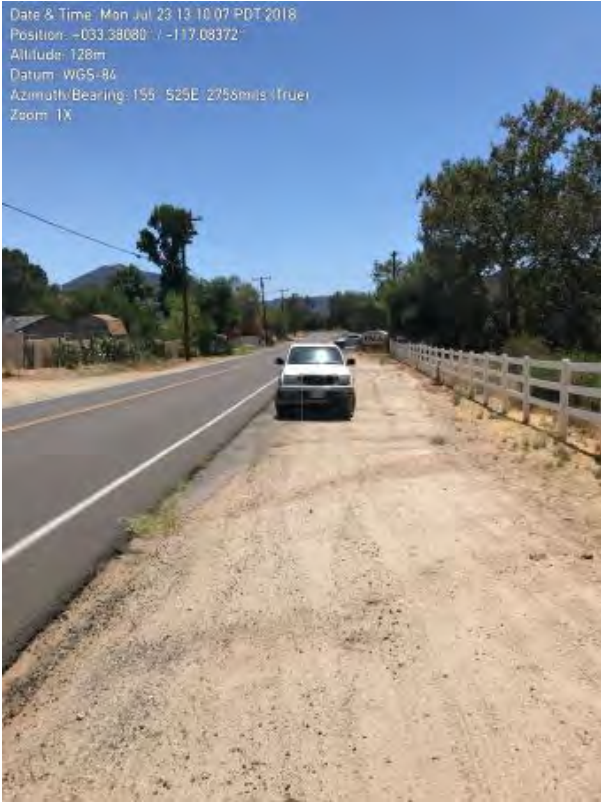
Private property on both sides of the road. No undercrossing present, all crossing currently at grade level. Likely crossing by Mtn Lion due to opportunistic predation on

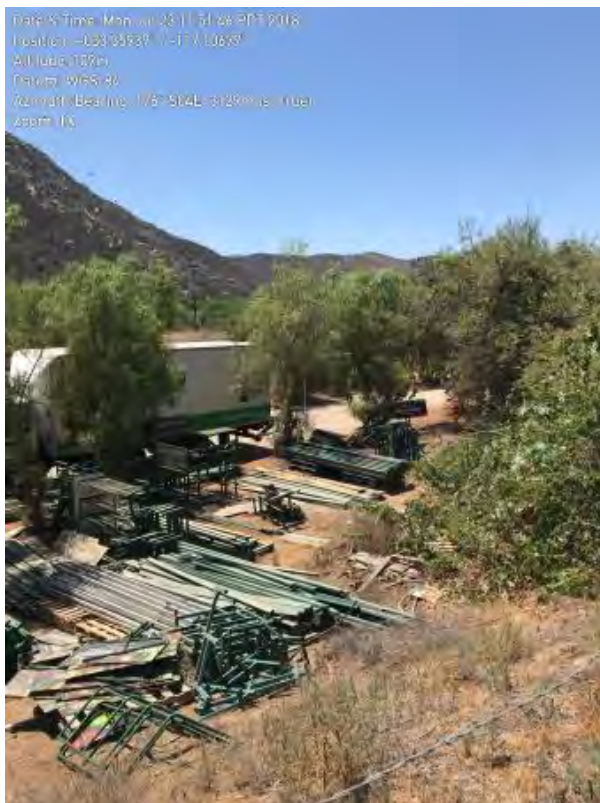
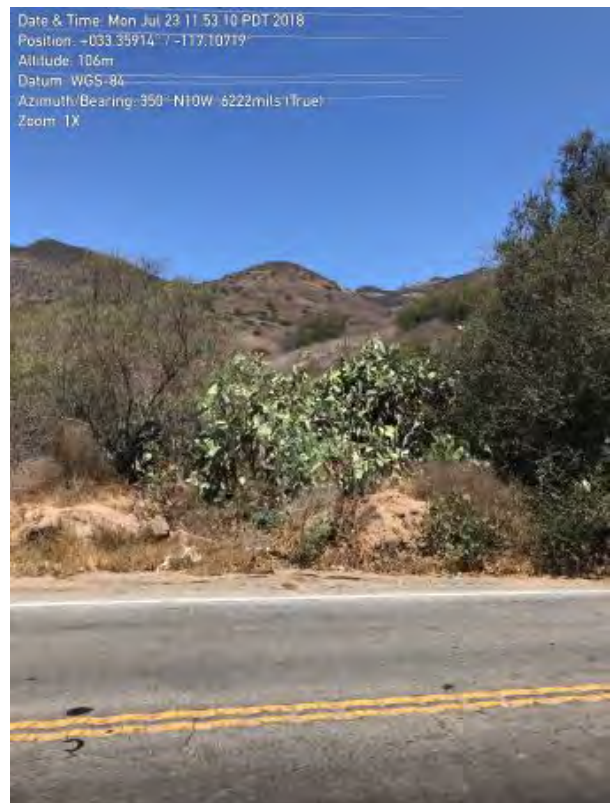
| Comments | Blind curve just East of culvert. Dangerous crossing point at grade. Lake/reservoir (Pala water supply?) just south of culvert which is likely attractant for all wildlife. |

| Management recommendations | Directional fencing. Expand culvert. |
