SA-PAL survey

| Project | SA-PAL project |
| ID | 42130 |
| Survey Date | 04/03/2019 |

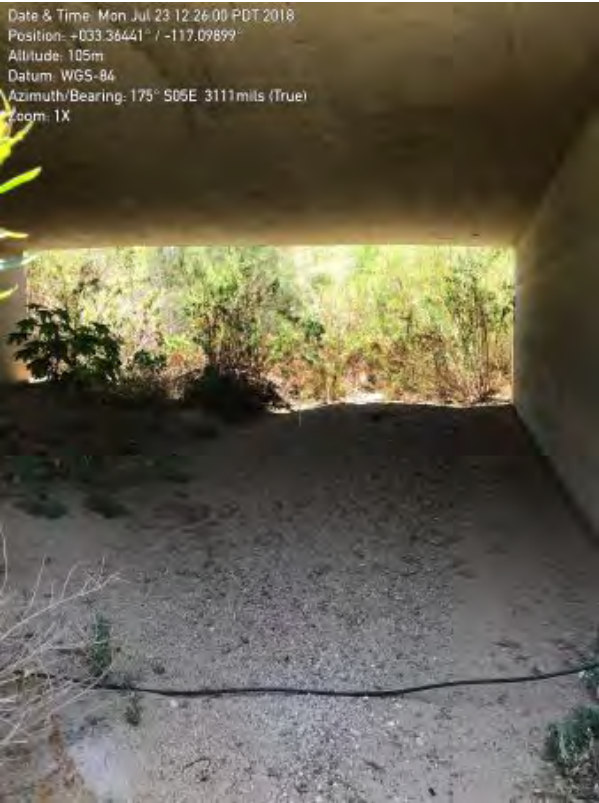
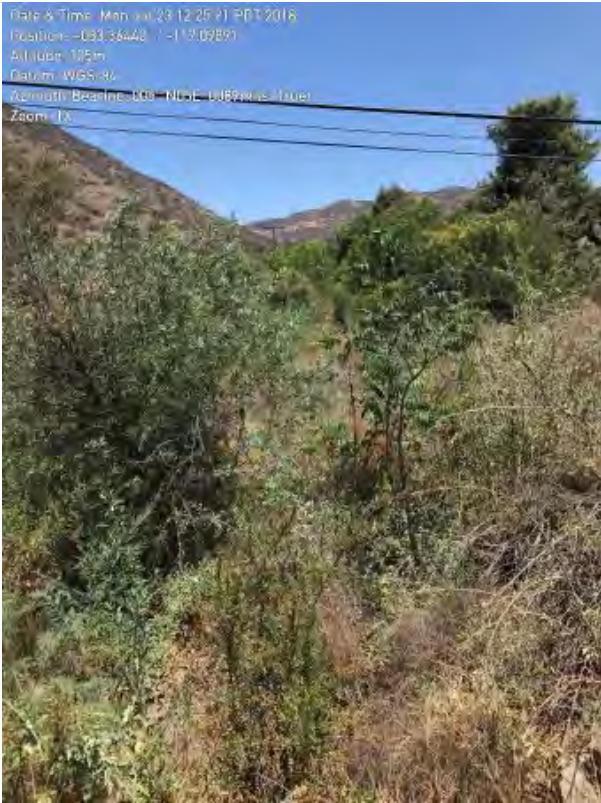
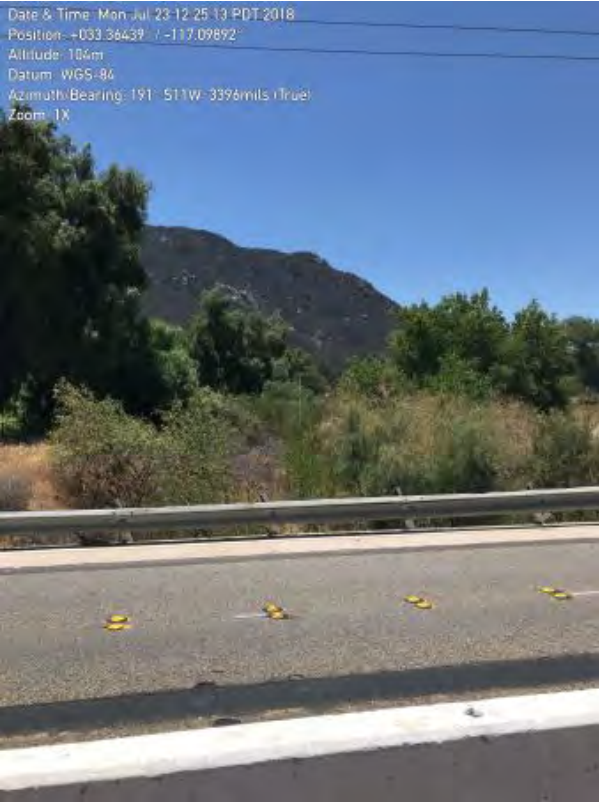
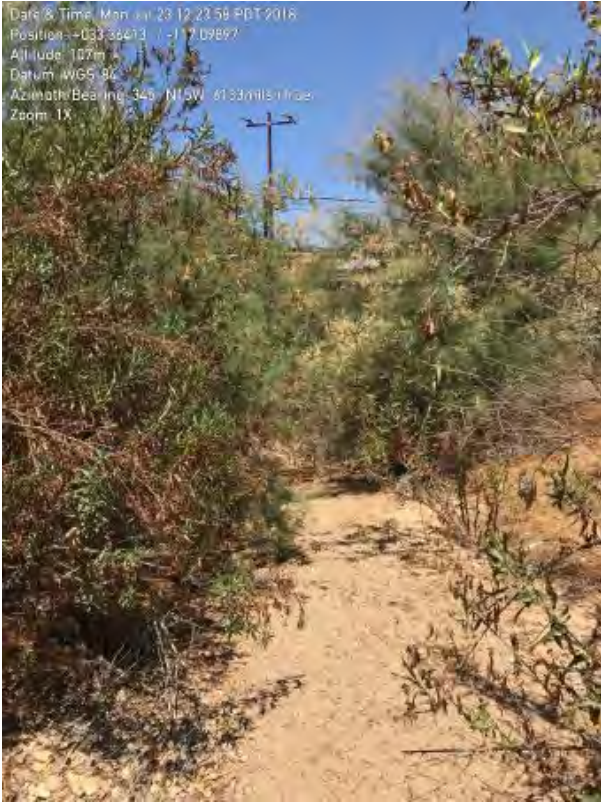
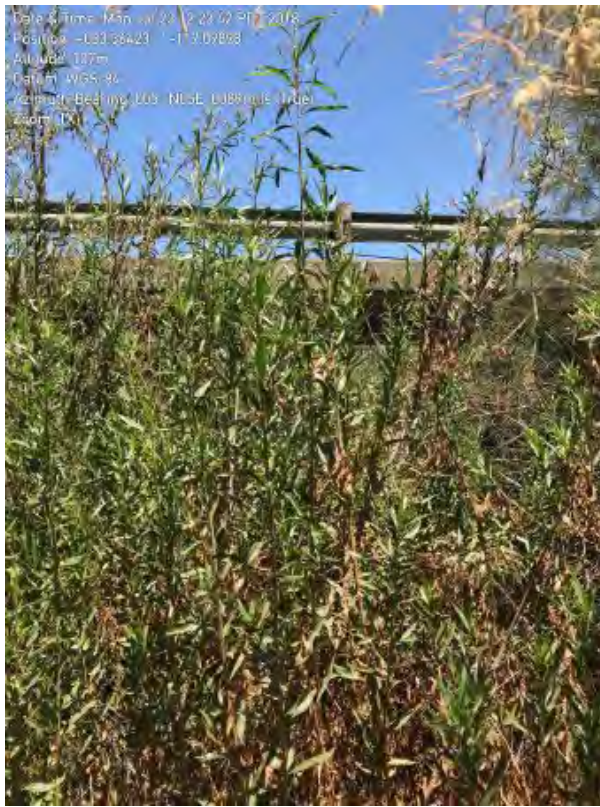
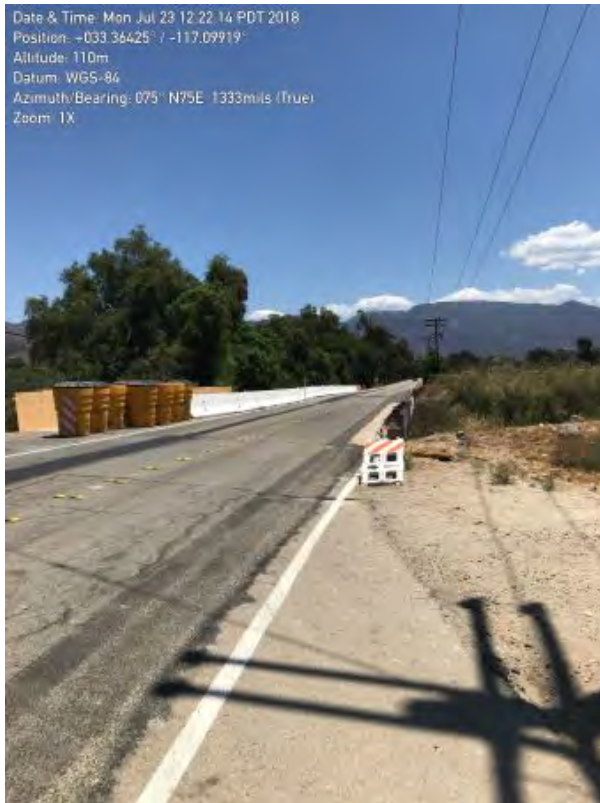
Adequate wildlife under crossing. Corridor to south may end in agricultural and/or private land. Game trails come out of the creek bed and lead up highway grade.

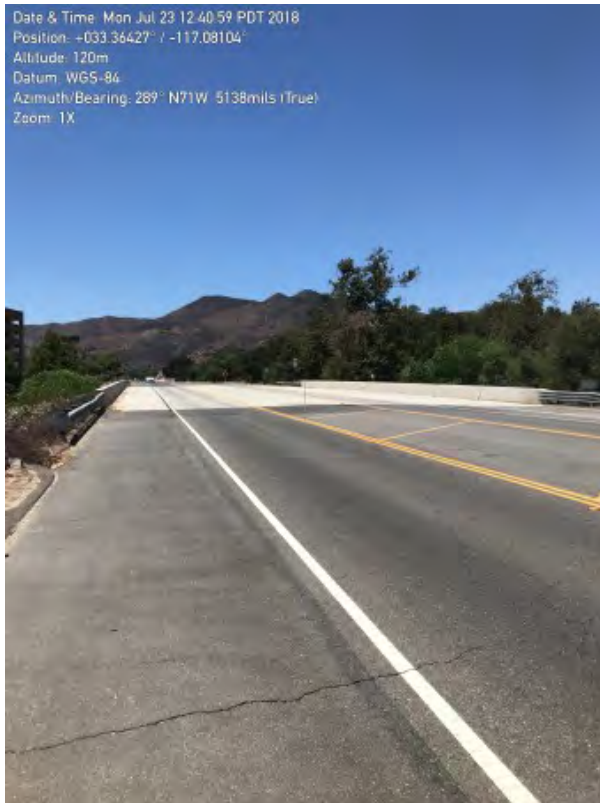
Pala Creek bridge. Adequate animal under crossing. Good vegetation on both sides. Creek bed is adjacent to Casino's parking garage.

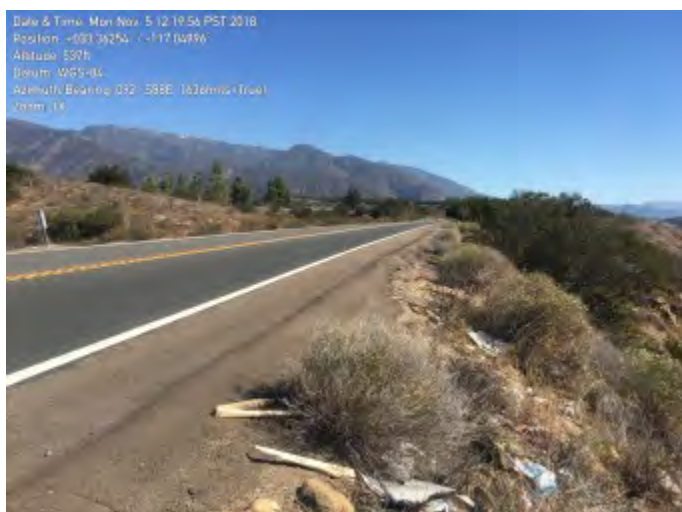
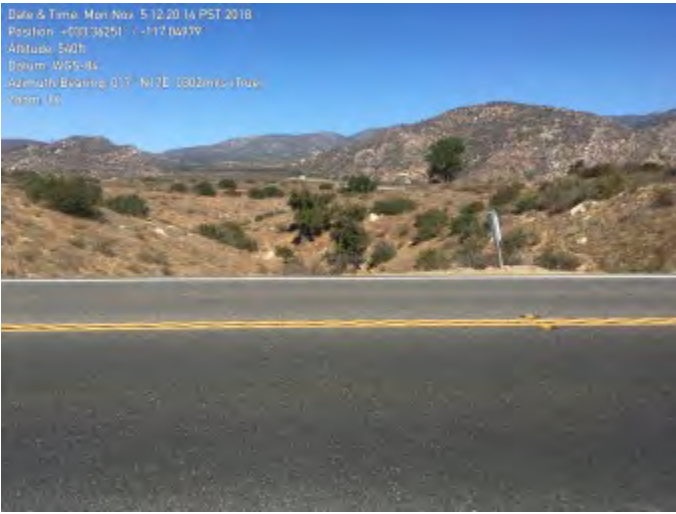
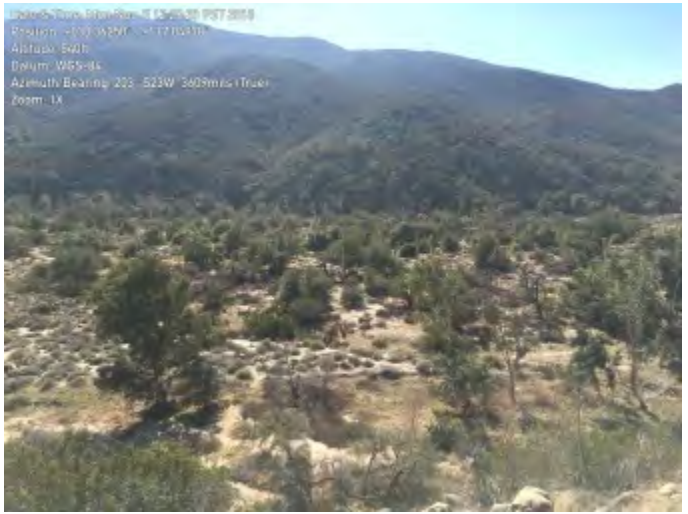
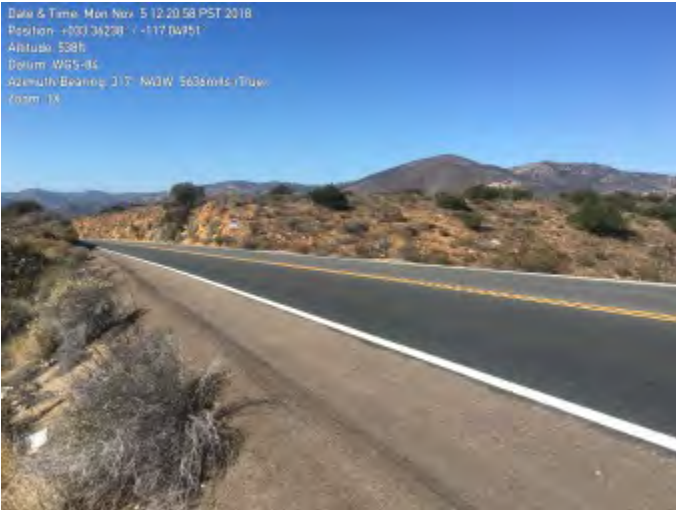
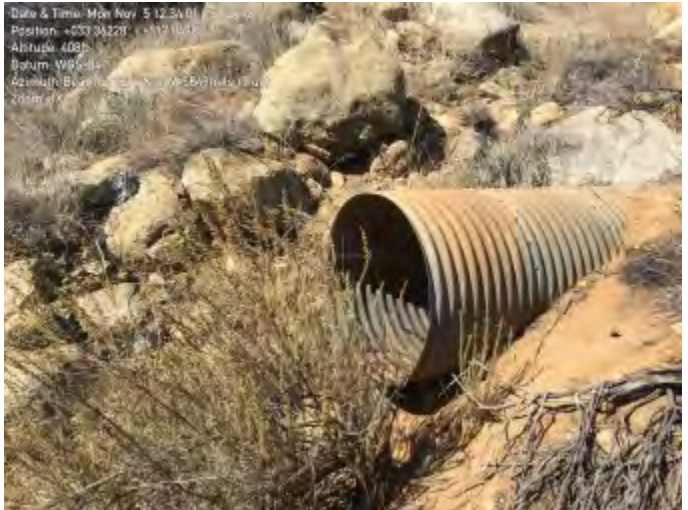
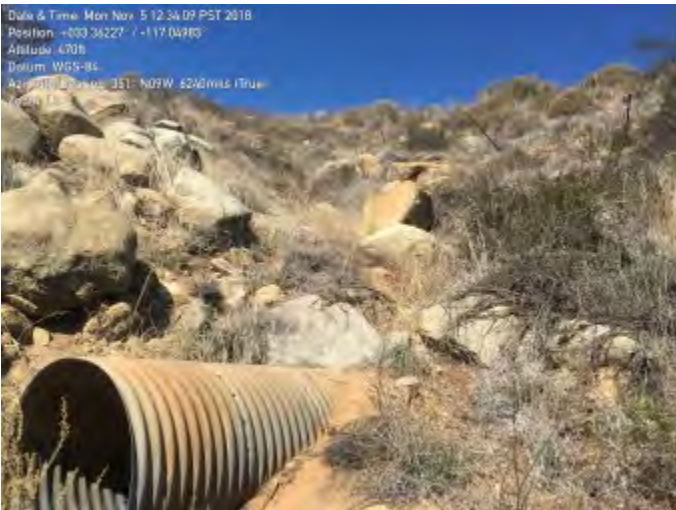
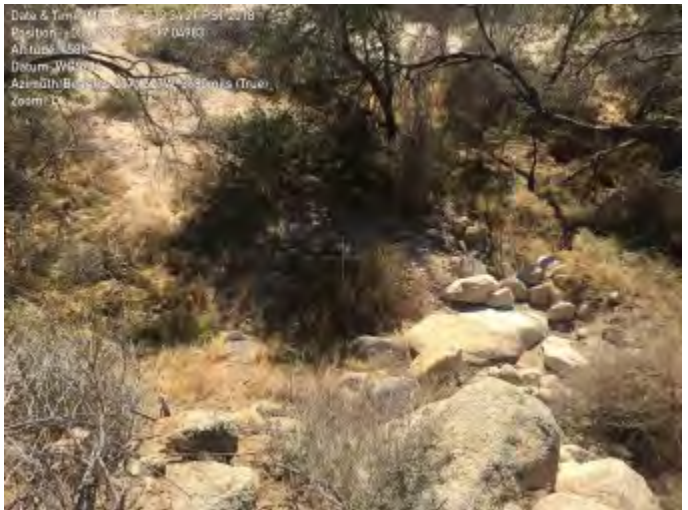
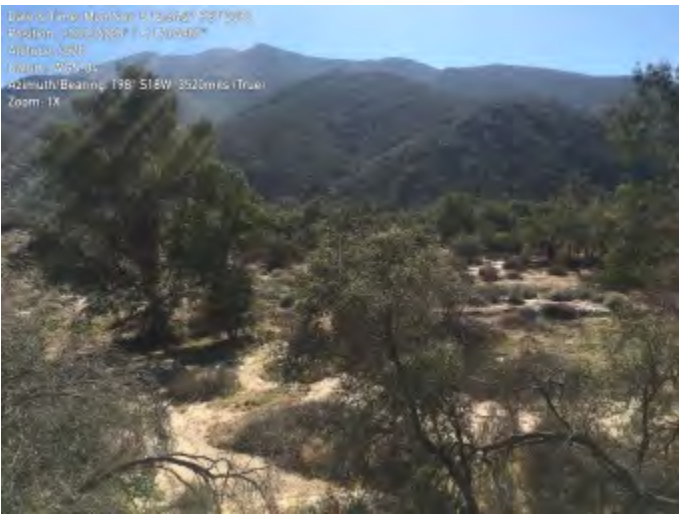
| Comments | Good landscape/approach to the north for wildlife travel. Culvert currently blocked. There is a 2 foot diameter vertical shaft next to westbound culvert entrance. Corrugated steel rising 10 feet above ground. Culvert exit on eastbound has poor access. |

| Management recommendations | Consider increasing diameter of culvert. Due to its depth beneath the road and steepness Of banks dropping 40 plus feet on either side of road, there is adequate space for larger structure beneath road. |

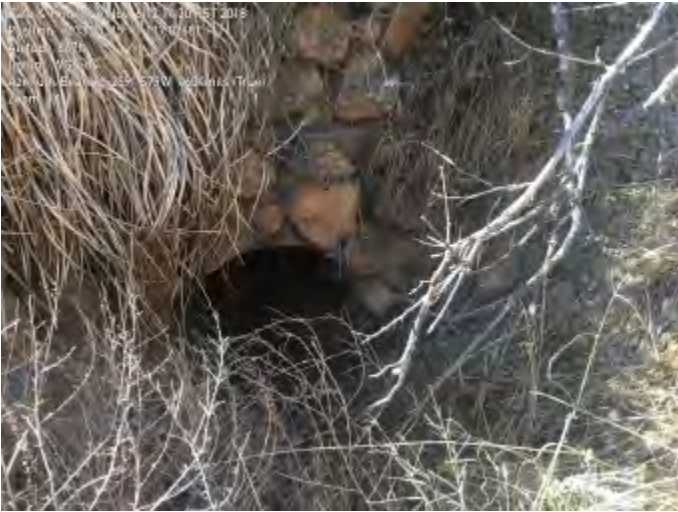
westbound: Small culvert east of this location. This is culvert entrance on north side. The culvert exit on the south side of 76 is not accessible.

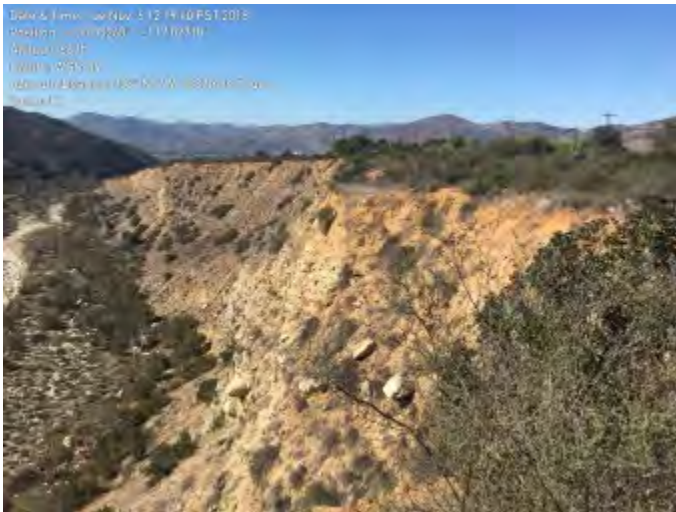
eastbound: Cliff which lies to the south of eastbound 76

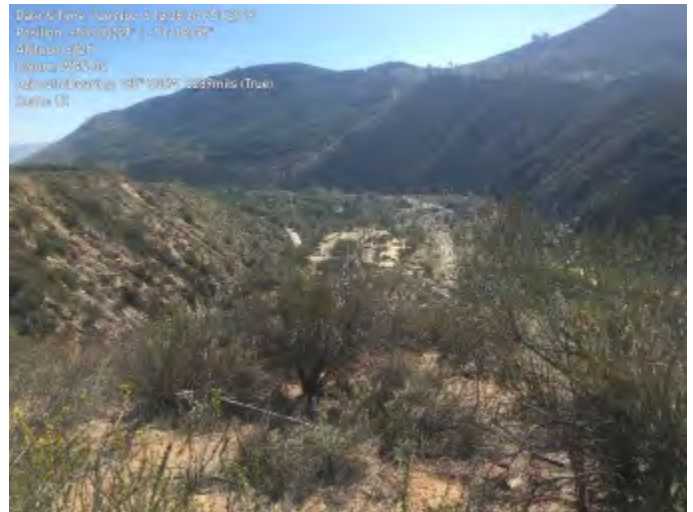
eastbound: This is the eastward extension of the large steep slope on the southern side of 76. View toward Wilderness Gardens

Approximately 150 meters east of P77 there is a 2 foot diameter metal culvert on the westbound side of 76. No ability to see through this. It is partially blocked by debris and vegetation. It passes about 5 feet beneath the road and empties into a narrow ravine on the south side of 76. This ravine lies at the top of a 200 foot drop off. It is a poor conduit for larger wildlife. There is a small peninsula on the eastbound side of 76 approximately 150 meters east of P77. It is bordered by the road and on all southern sides by the cliff noted above. This culvert exit is not accessible for photos.

Barrier fencing. There is nowhere for wildlife to travel on the eastbound side of 76 as is, other than parallel to the road for up to 1/2 to 1 mile. I would not recommend culvert expansion here. The exit is in a non negotiable location at the top of the cliff.

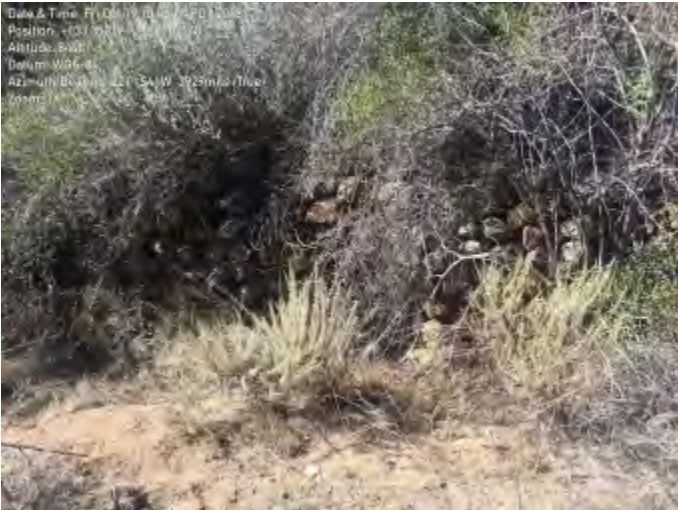
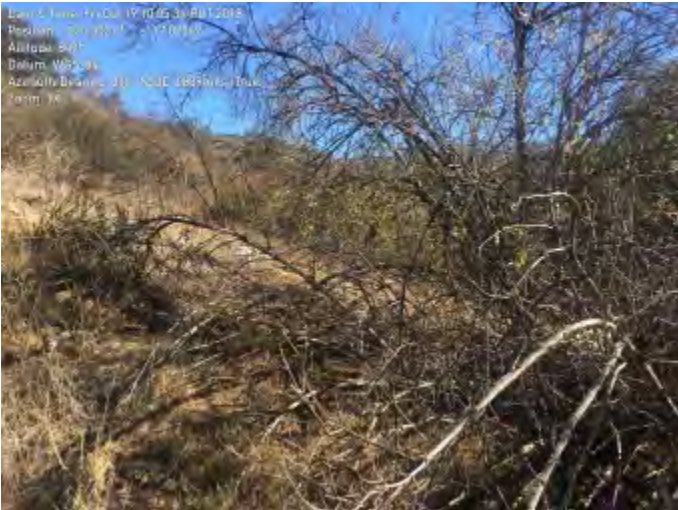
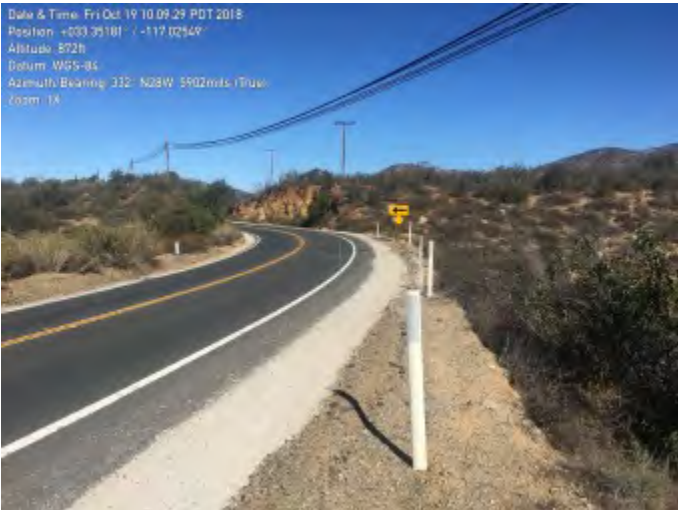
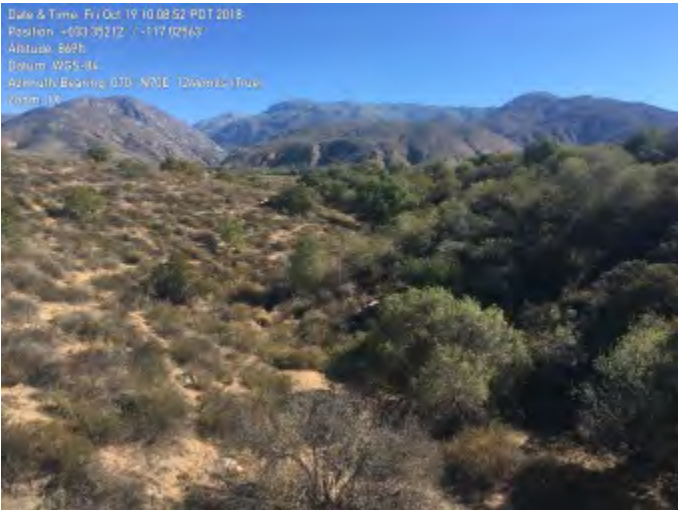
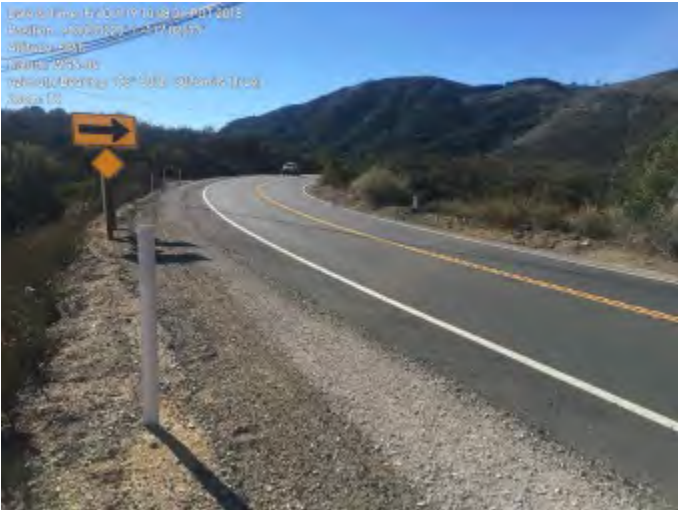
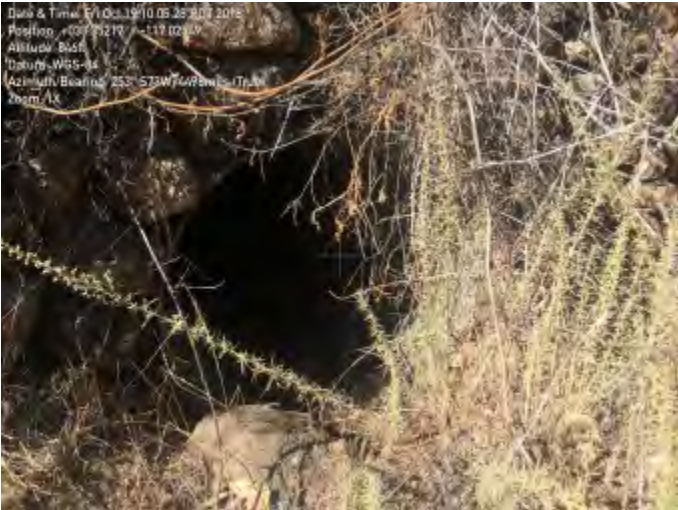
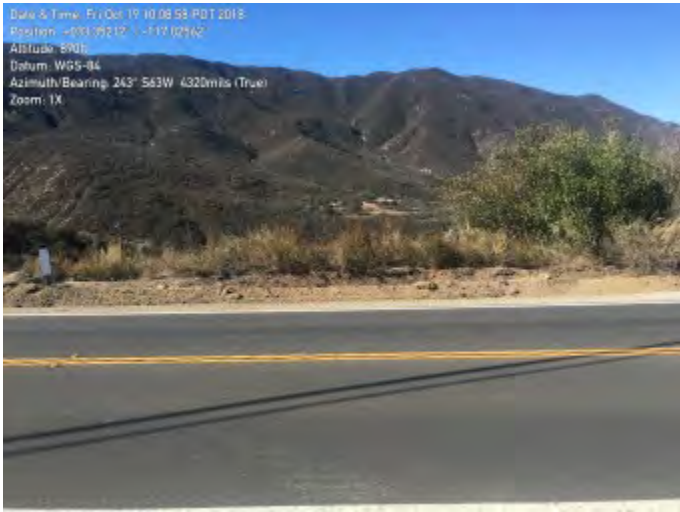
| Comments | This is not a KLM marked location. GPS marked above. East of P77 on SR 76. Survey incomplete. No eastbound photos taken. |

| Management recommendations | Good location for larger undercrossing/ culvert expansion. |

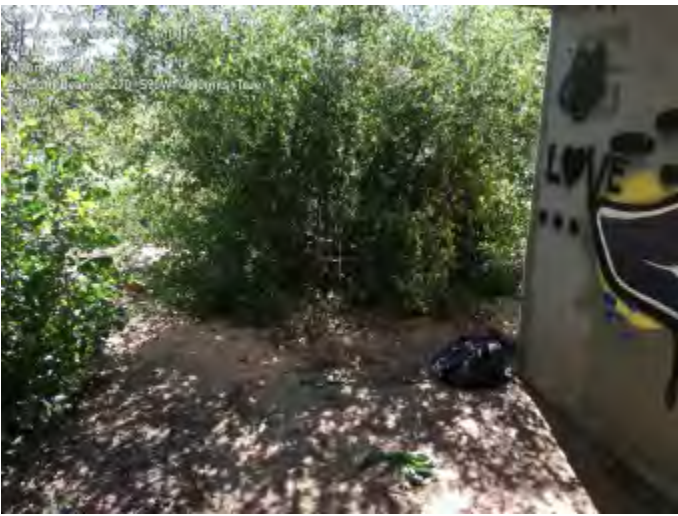
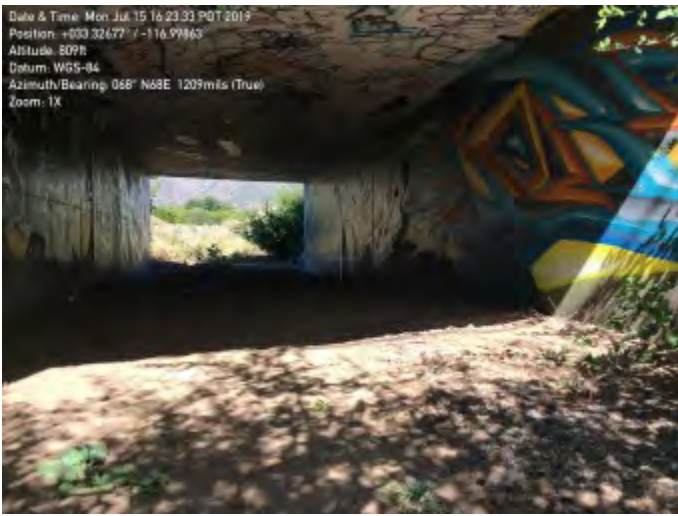
Camera BHD 68 Camera placed on Eastbound side just beyond exit of underpass facing under bridge. Access this camera by climbing down at southwest corner of bridge.

| Comments | This is a good area for wildlife to cross beneath 76 in this area. Although there is extensive graffiti here, there are minimal signs of ongoing encampment. The bridge here consists of two main passages separated by one abutment wall traversing undercrossing north to south. Some repair work is currently taking place on this bridge. CAmera BHD 68 placed on 7-15-19. |

| Management recommendations | Fencing to exclude human presence. Barrier fencing. Directional fencing and trails to funnel animals in this direction. |

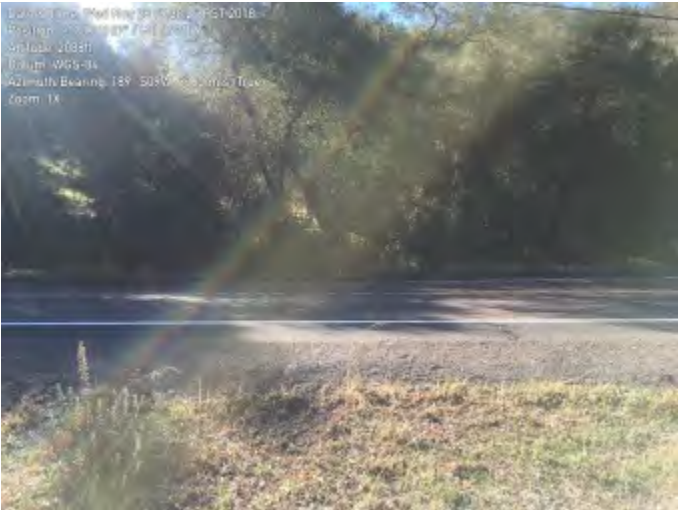
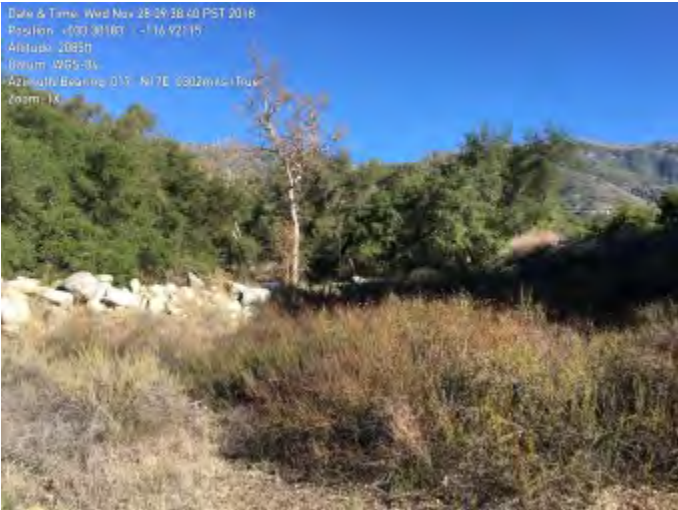
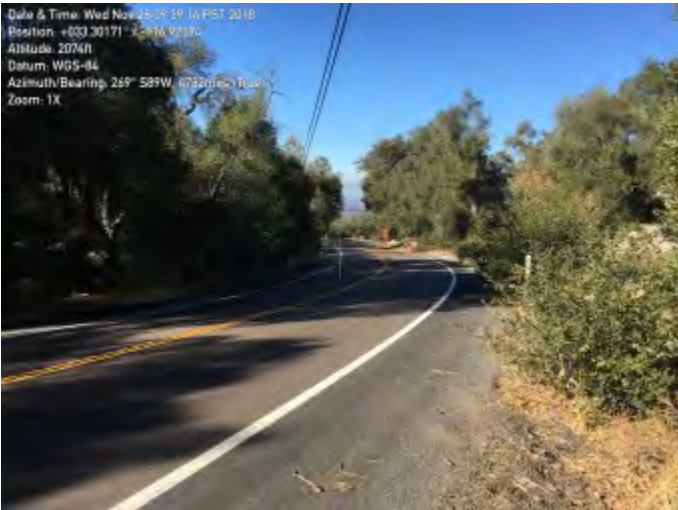
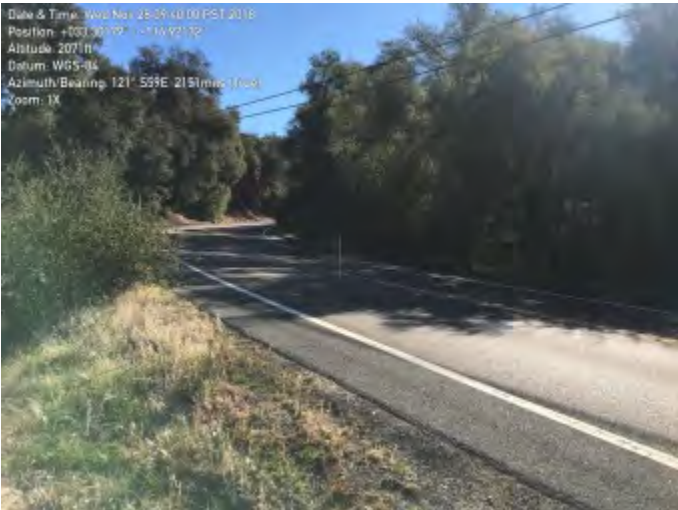
| Describe fencing type and height | Five foot barbed wire approx 10 meters south of eastbound lane. Parallel to road. |

| Management recommendations | Barrier fencing. Wildlife crossing signs. Does not appear conducive to undercrossing construction due to grade levels. |

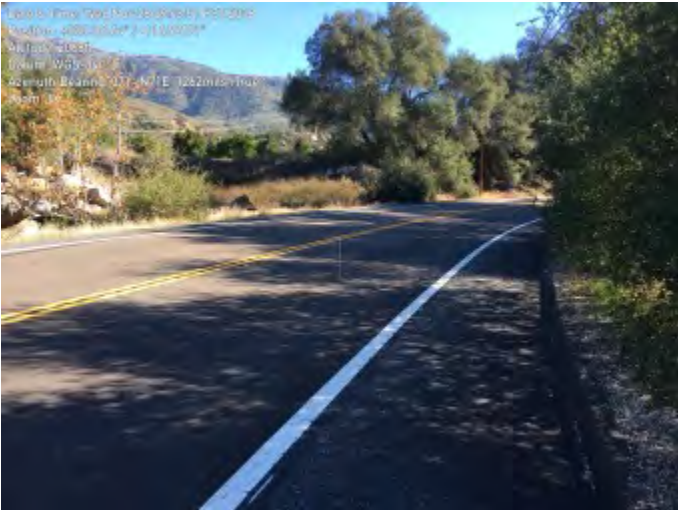
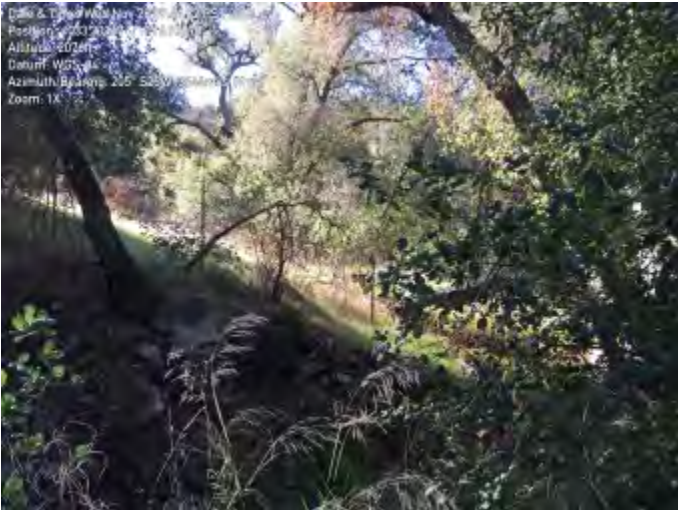
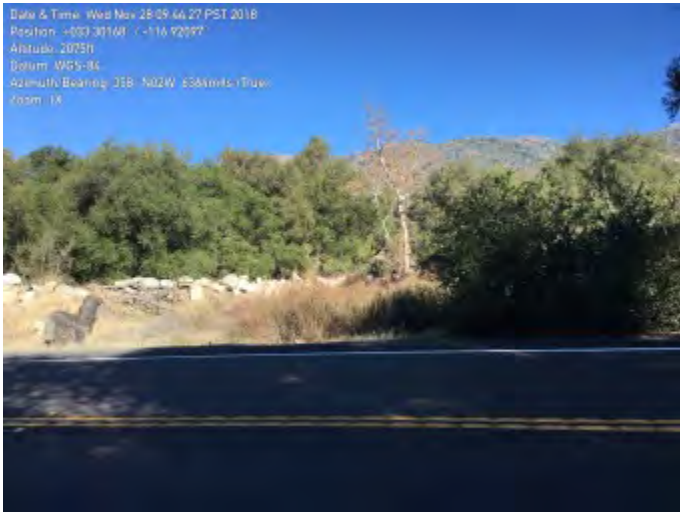
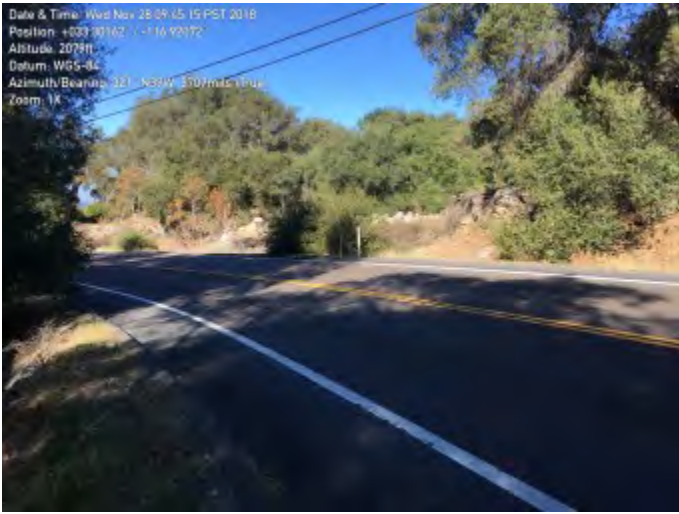
| Comments | Landscape north of westbound lane is at same grade as road. There is a streambed which is adjacent to and parallel to eastbound lane. It is approx. 5 feet below road grade. Notes from 7-10-19 reassessment: I would not change anything regarding data or comments from original evaluation. |

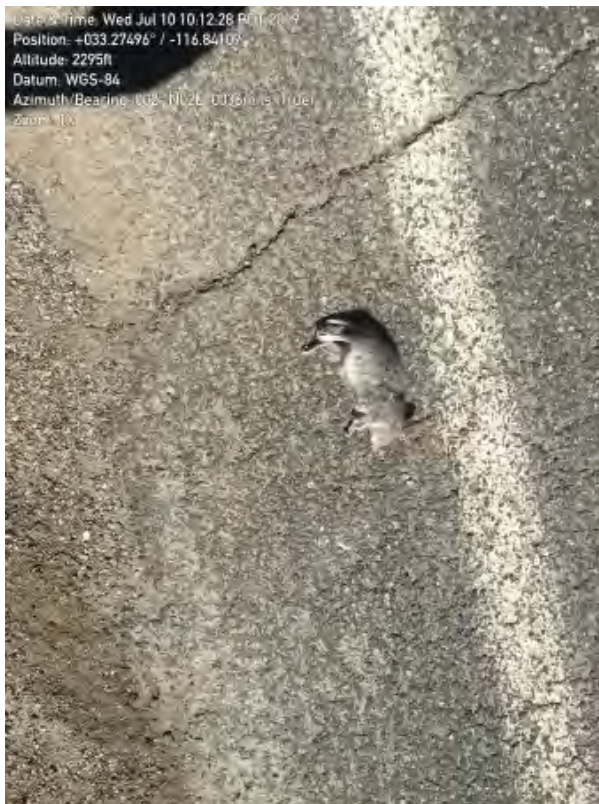
eastbound Roadkill at crossing location

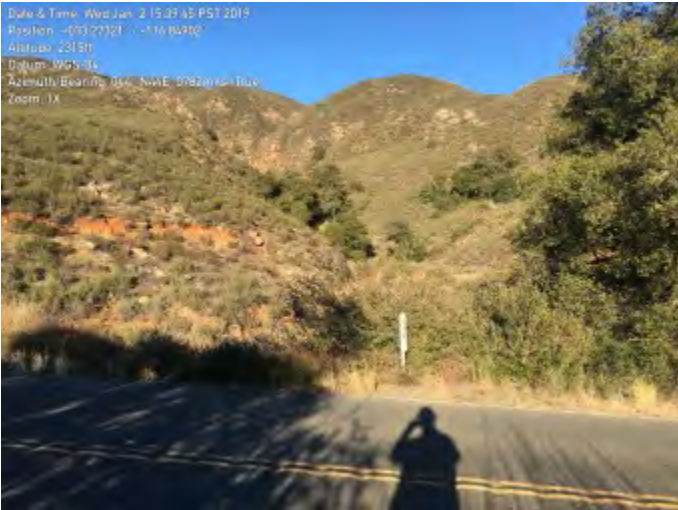
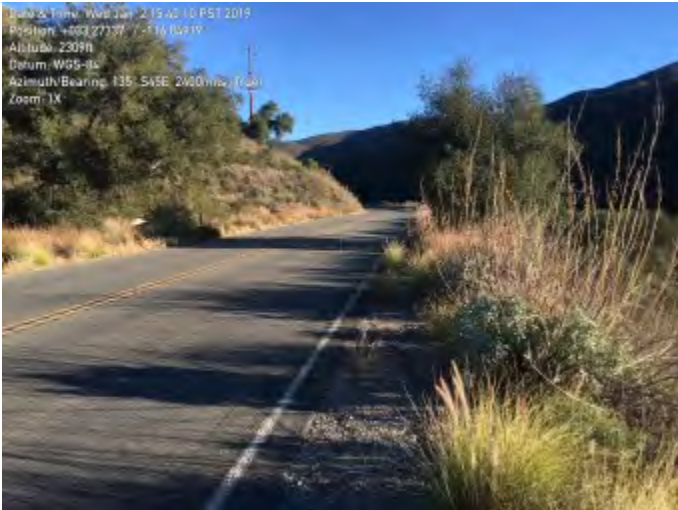
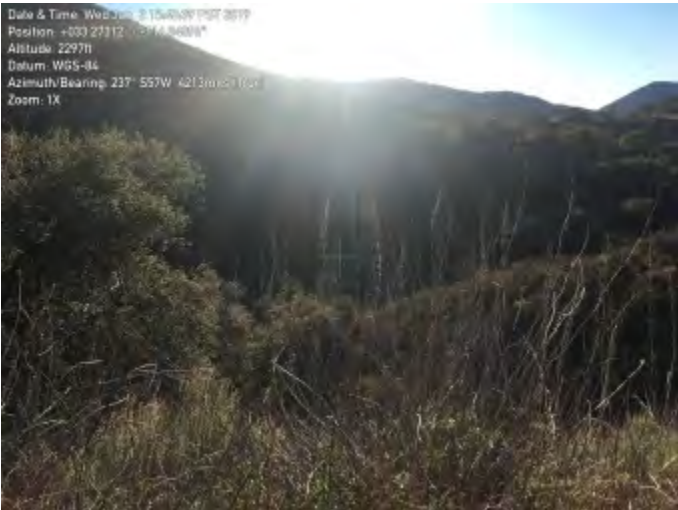
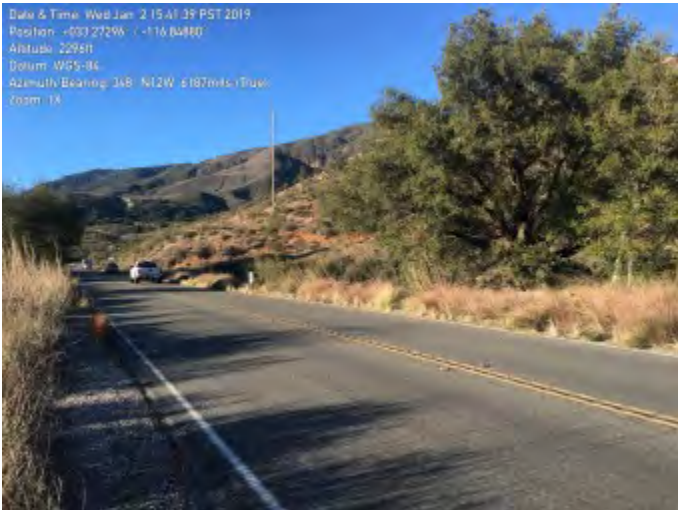
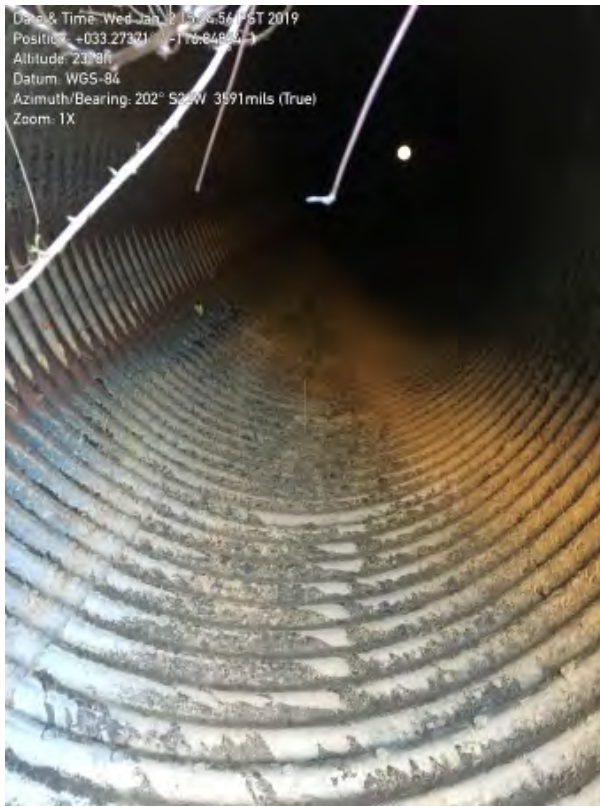
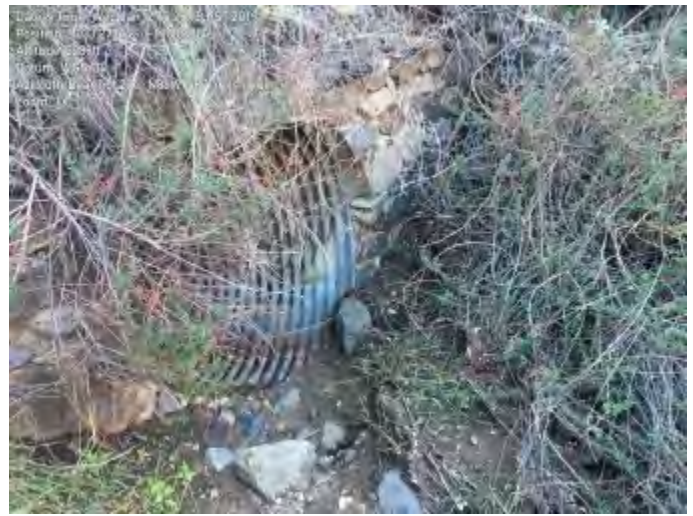
| Comments | Unable to visualize or access culvert exit on eastbound side. It is located in heavy brush on steep slope. Open natural landscape to north and south. Corridor in natural drainage. Culvert diameter moderate at four feet. Traffic noise moderated due to large distance between grade level and depth of culvert. Consider team effort to locate culvert exit on eastbound side if deemed appropriate. This report is incomplete due to absence of data regarding this culvert exit. |

| Management recommendations | Increase diameter of culvert. Investigate terrain around eastbound culvert exit. Rumble strip. Wildlife crossing signs. Barrier and directional fencing. |

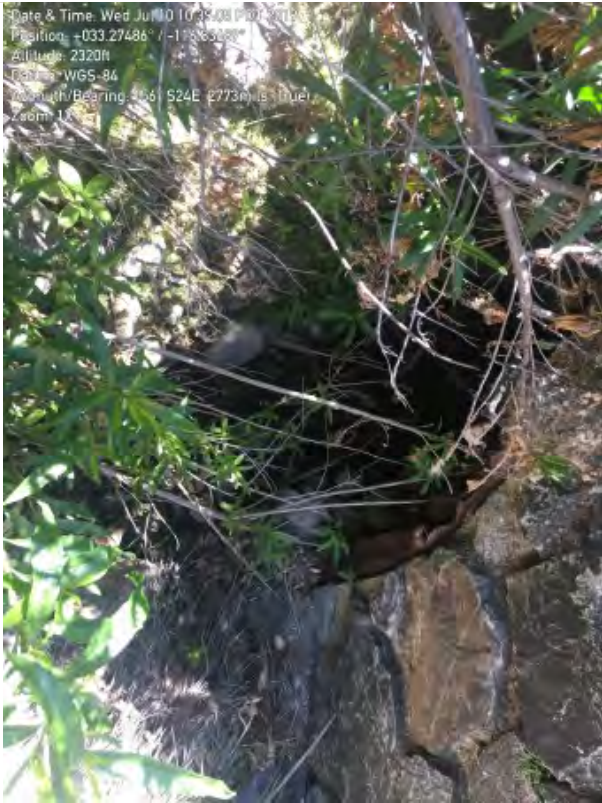
westbound partially blocked culvert entrance

| Management recommendations | Increase diameter of culvert and improve access. Clear culvert of current blockage. Barrier fencing. Rumble strip. Wildlife crossing signs. |

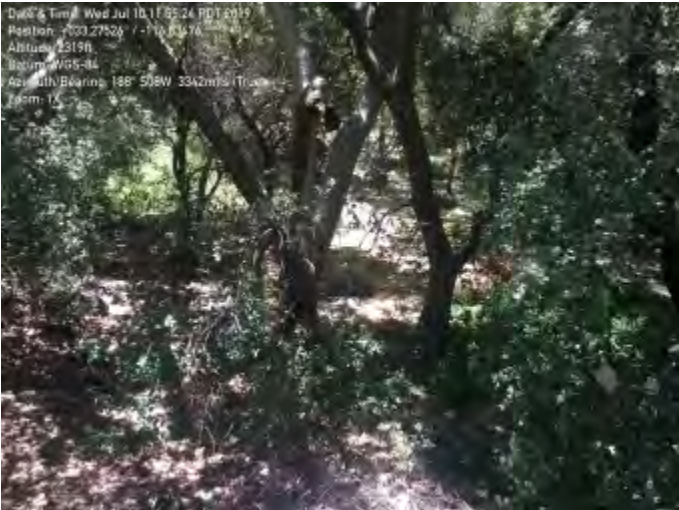
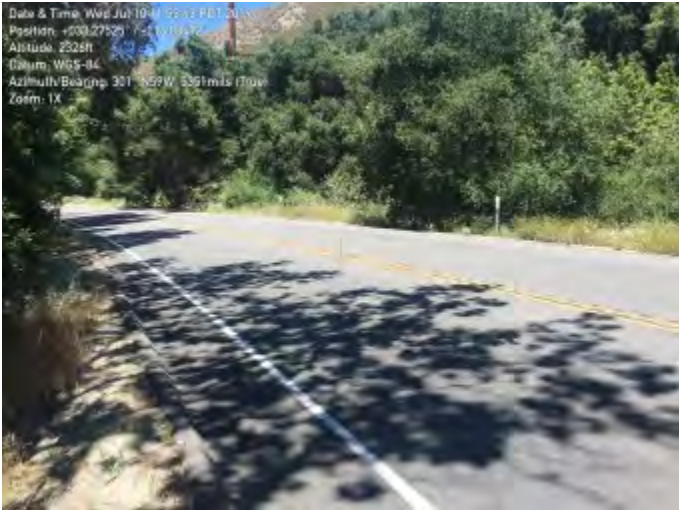
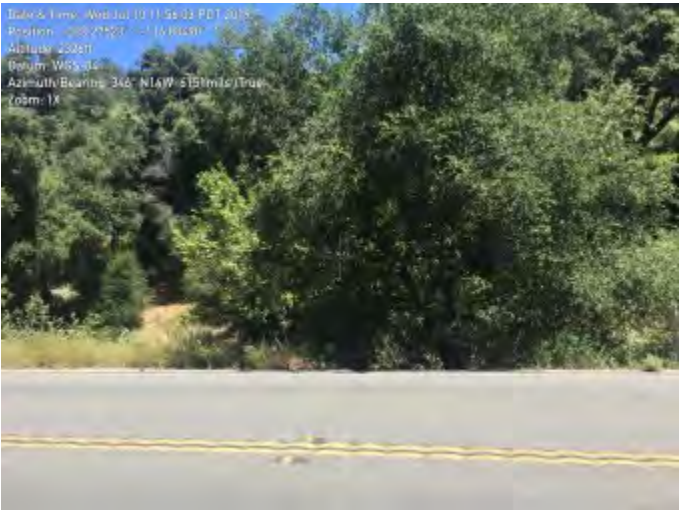
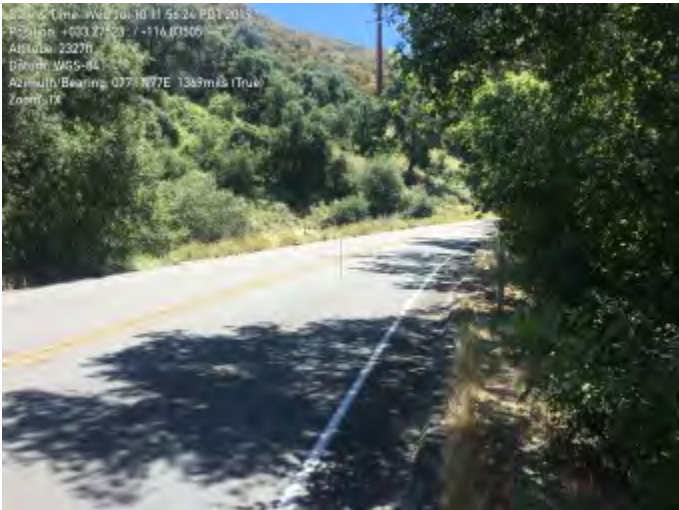
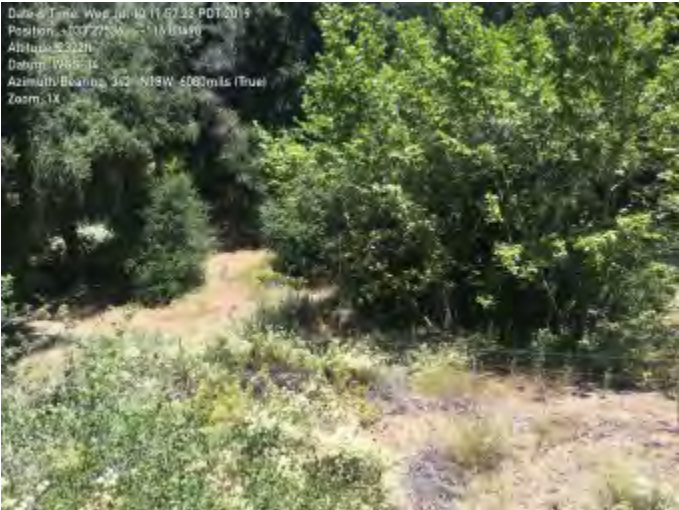
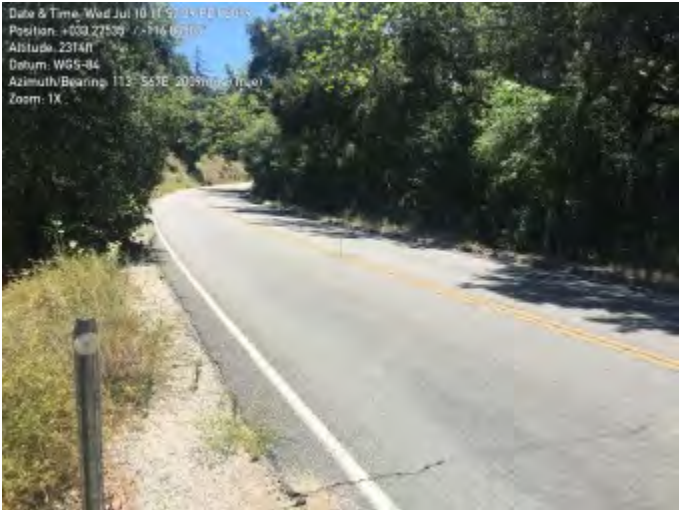
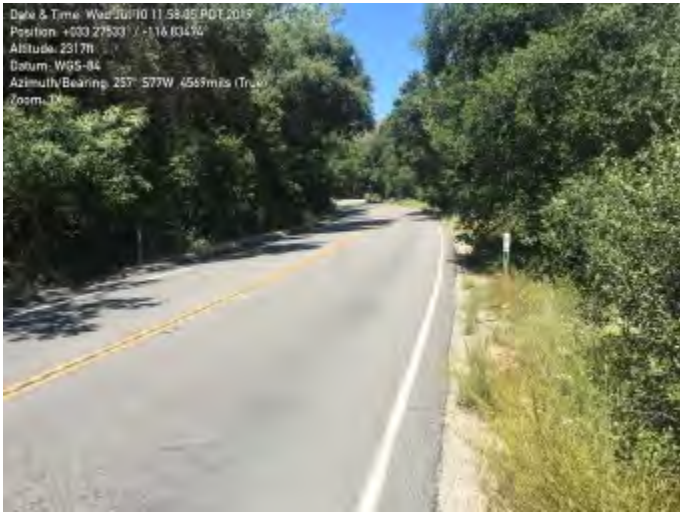
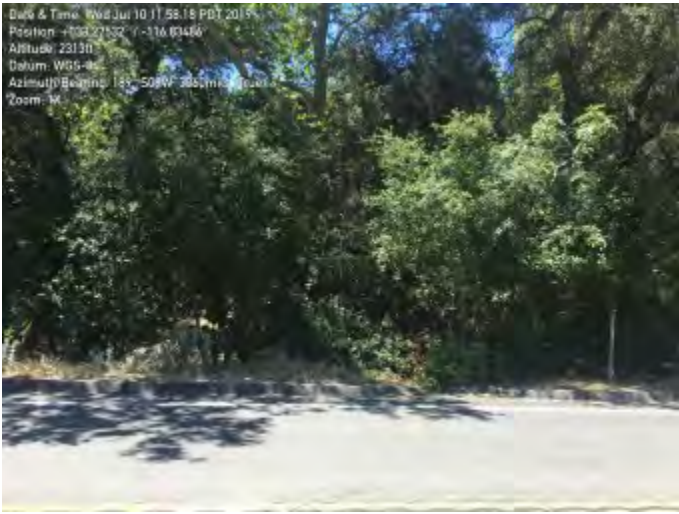
| Comments | Good corridor to north and south, but crossing currently at grade. |

| Management recommendations | There is space to place a moderate sized culvert under the road here. Barrier fencing. Rumble strip. Wildlife crossing signs. |

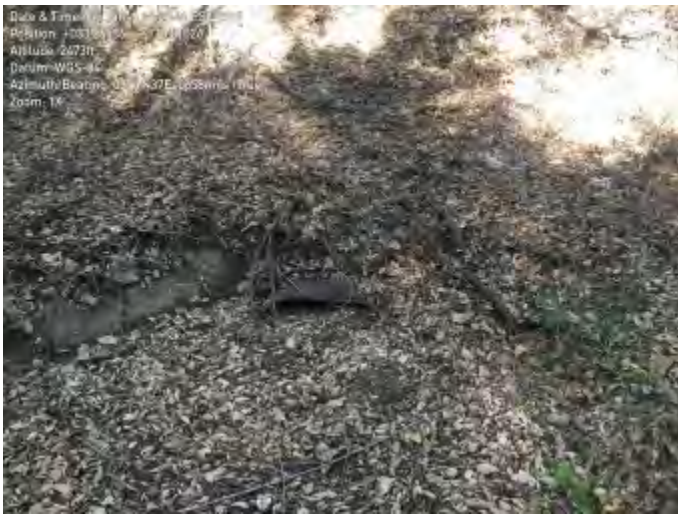
eastbound blocked culvert

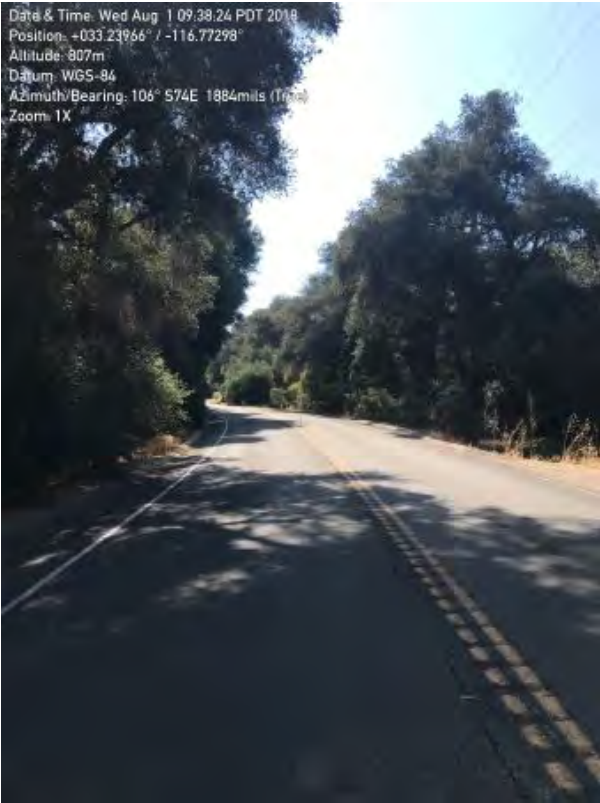
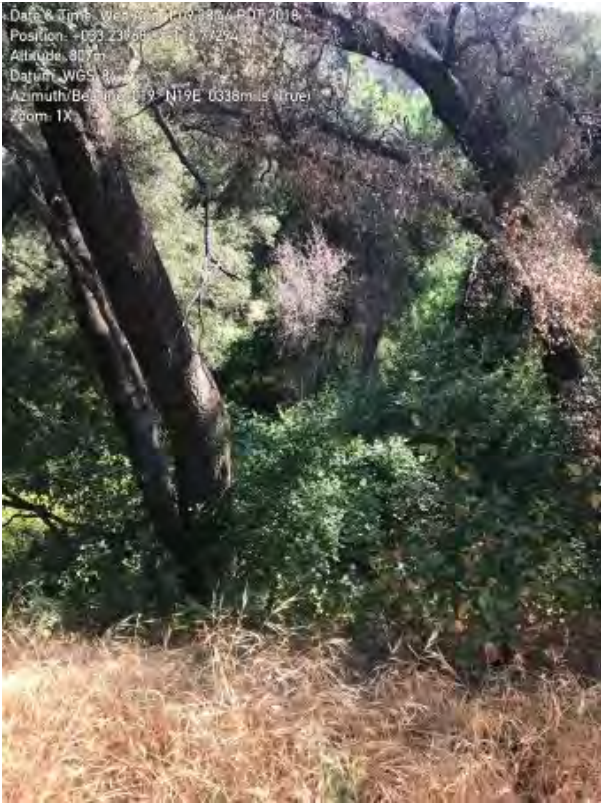
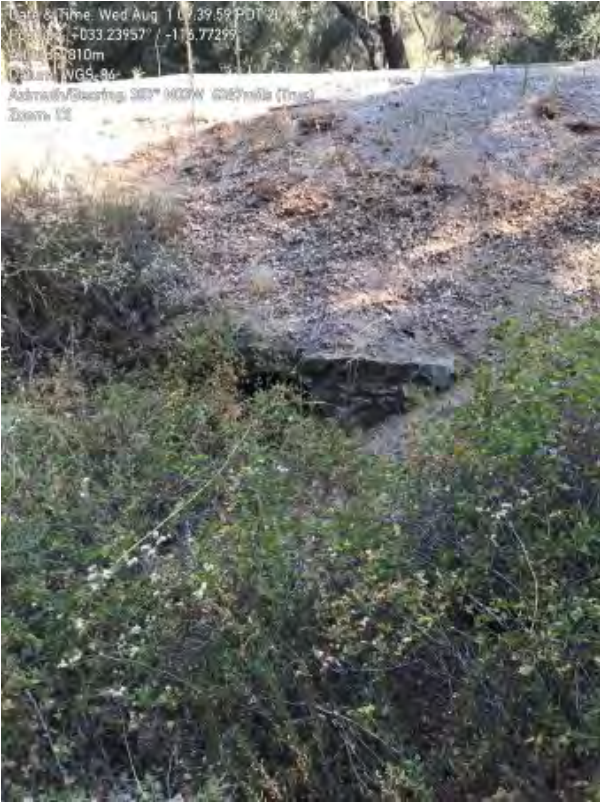
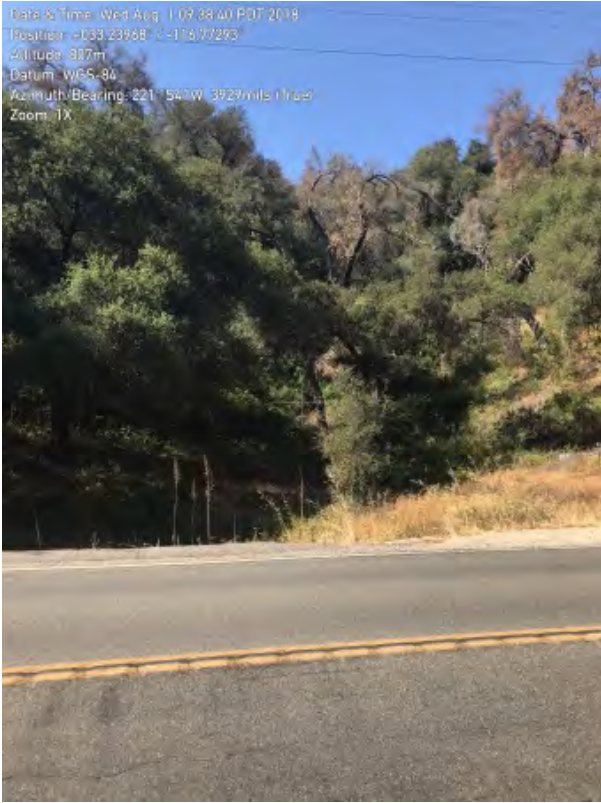
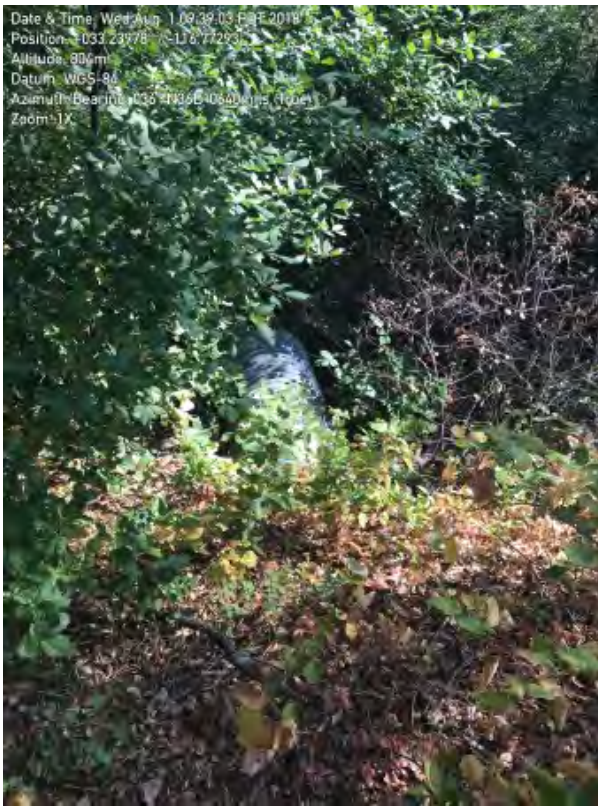
Due to culvert constraints, crossing will be at road.
