SA-PAL survey

| Project | SA-PAL project |
| ID | 42130 |
| Survey Date | 04/03/2019 |

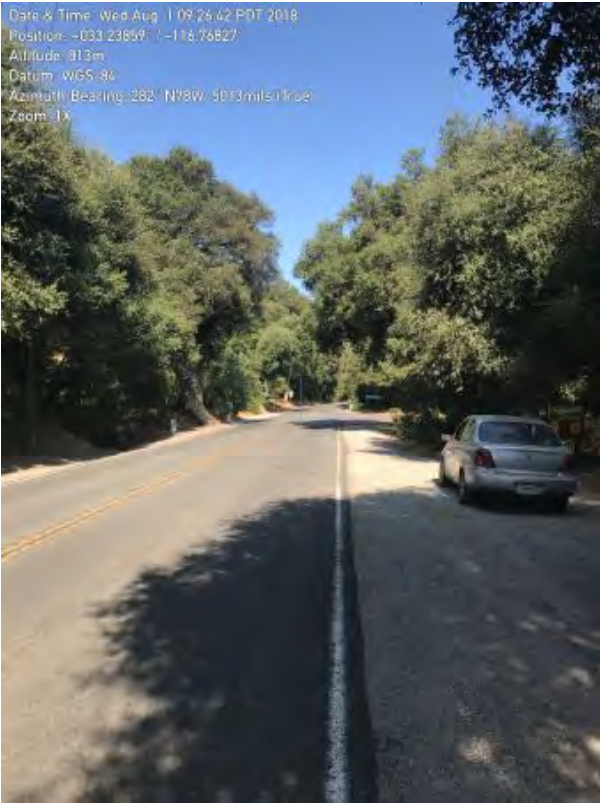
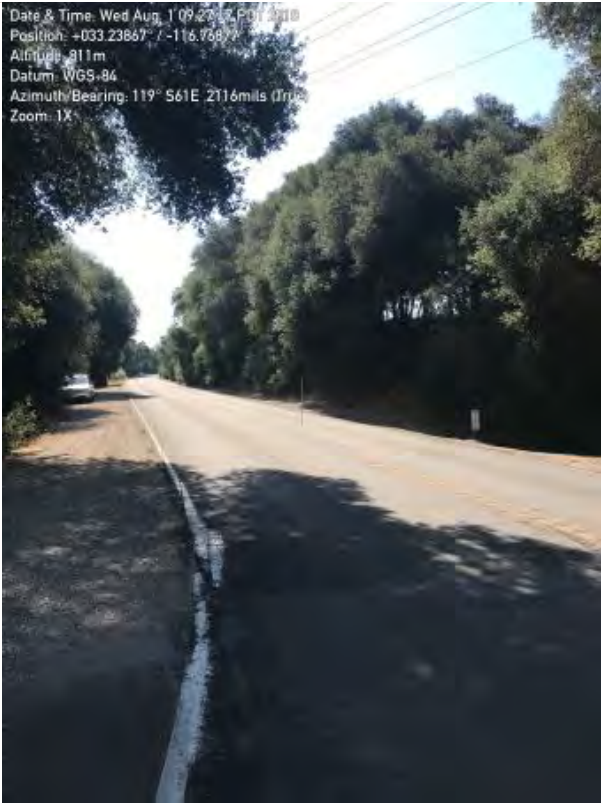
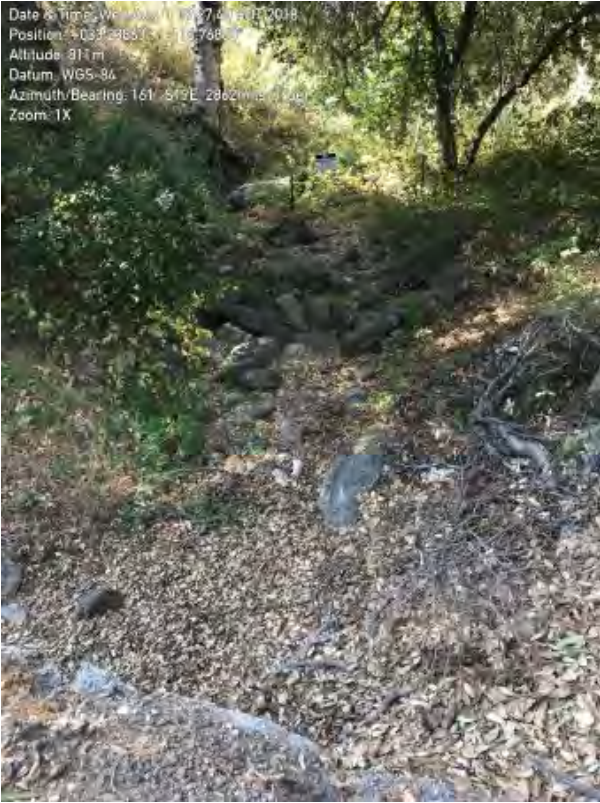
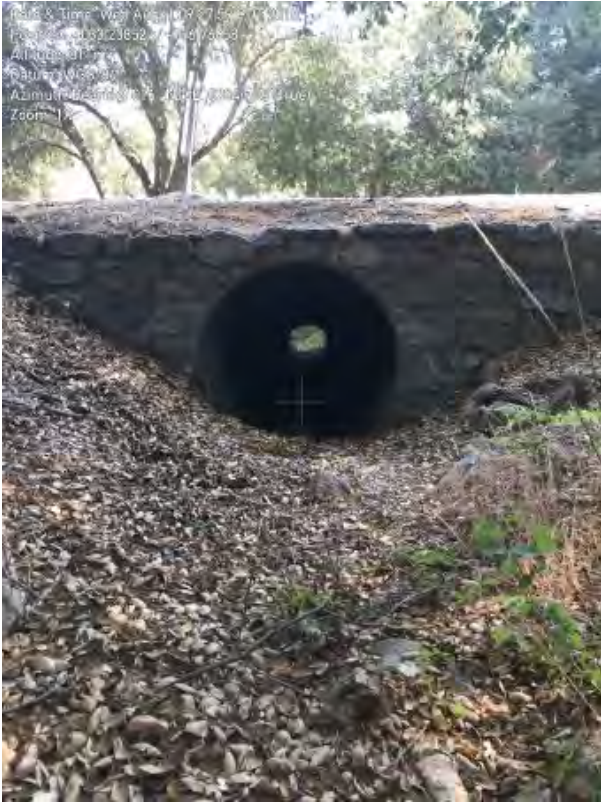
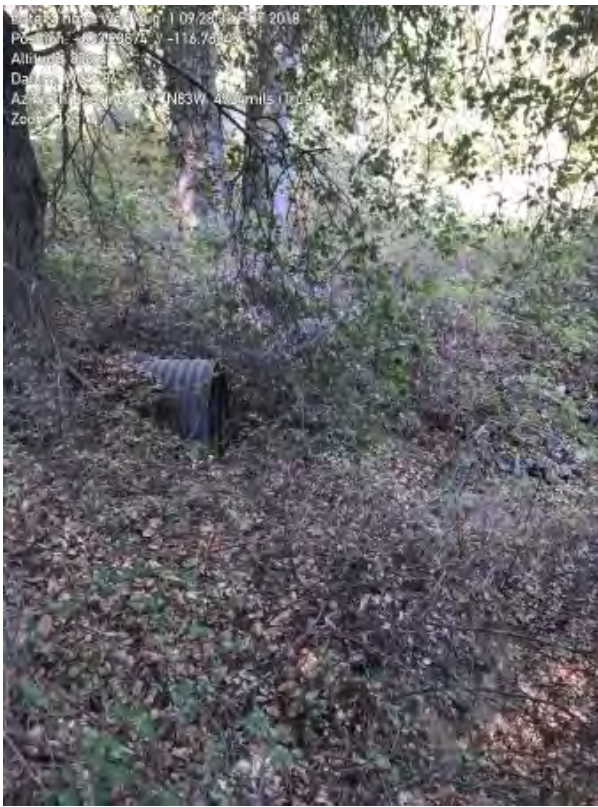
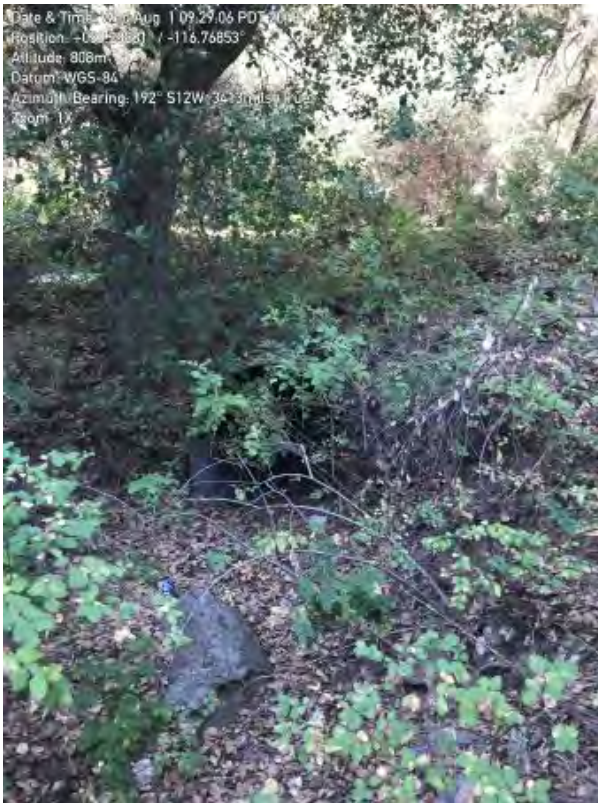
Culvert and access good.

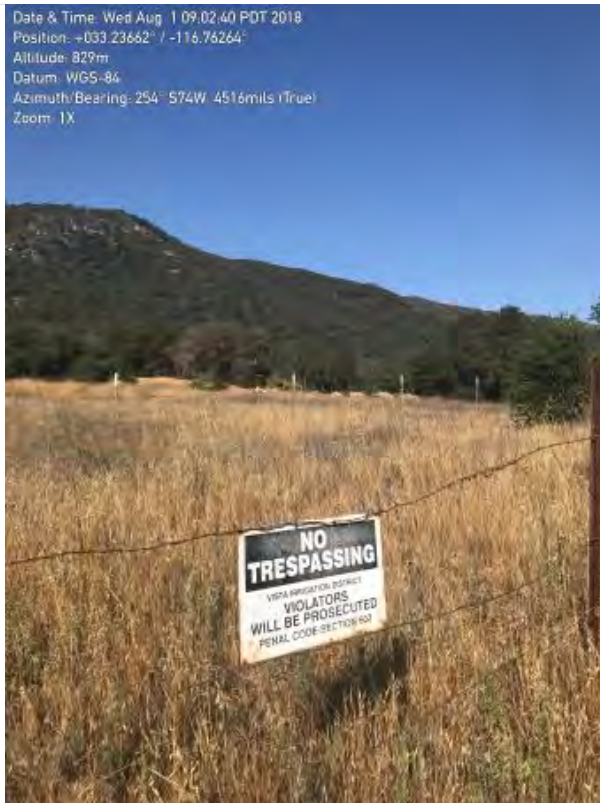
oak trees in distance: location of P95

Vista irrigation district land to South. P95 location along corridor to south. Great corridors to north and south. Visible game trails both sides of road. Adequate drainage and terrain for larger culvert. Caltranse at Lake Henshaw maintenance yard confirmed

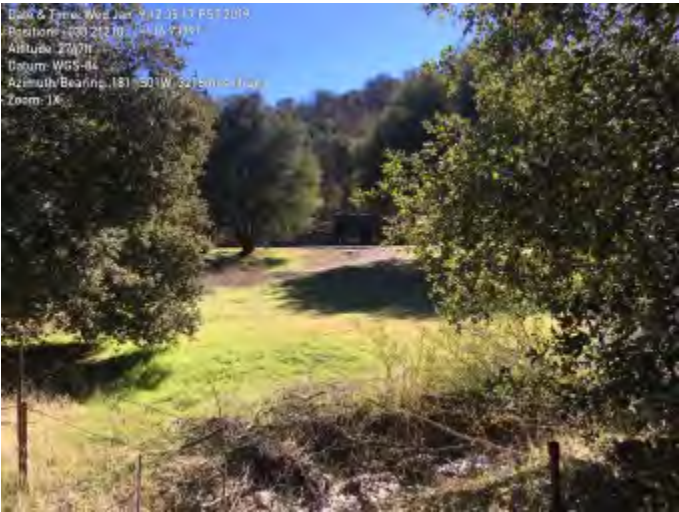
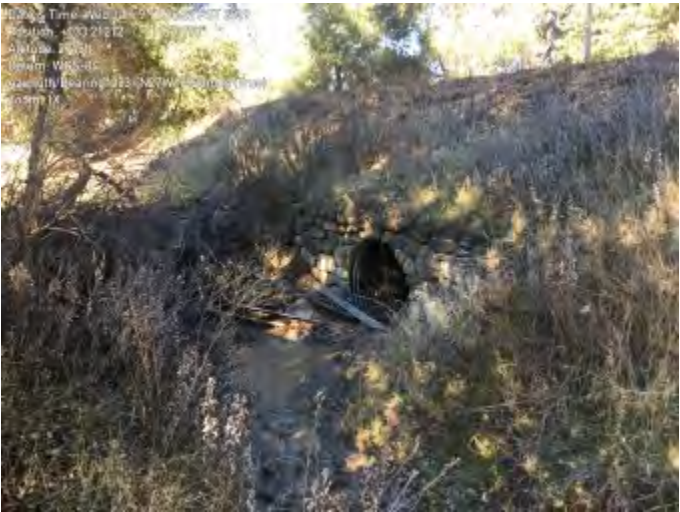
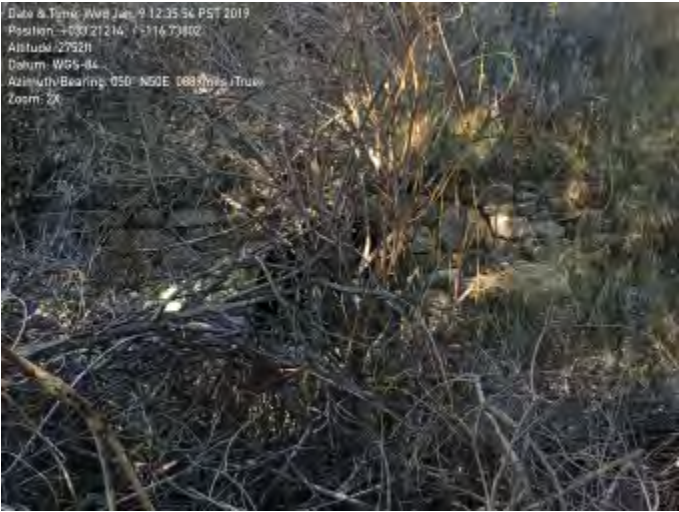
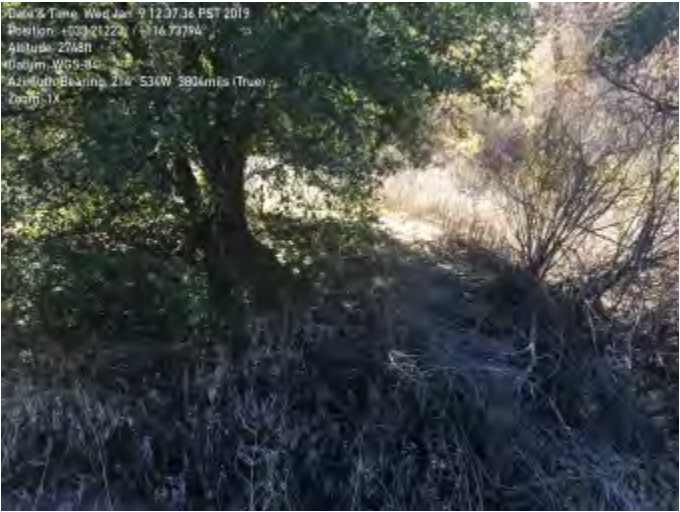
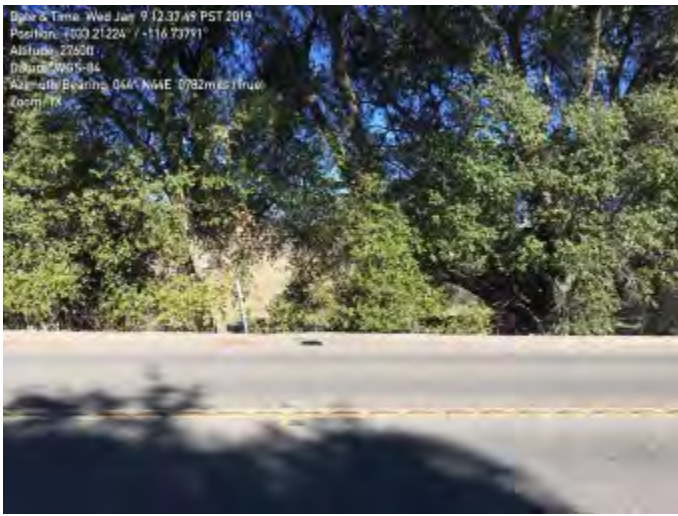
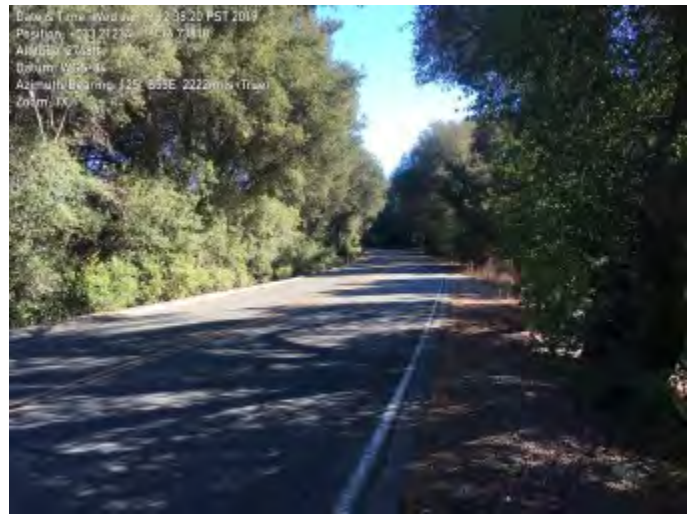
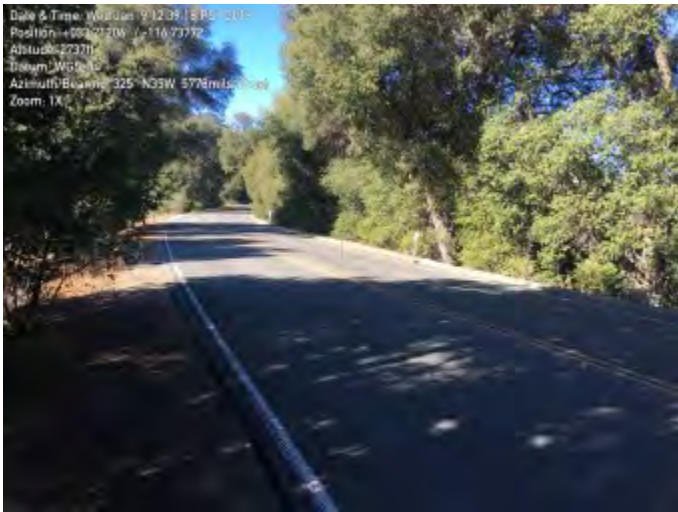
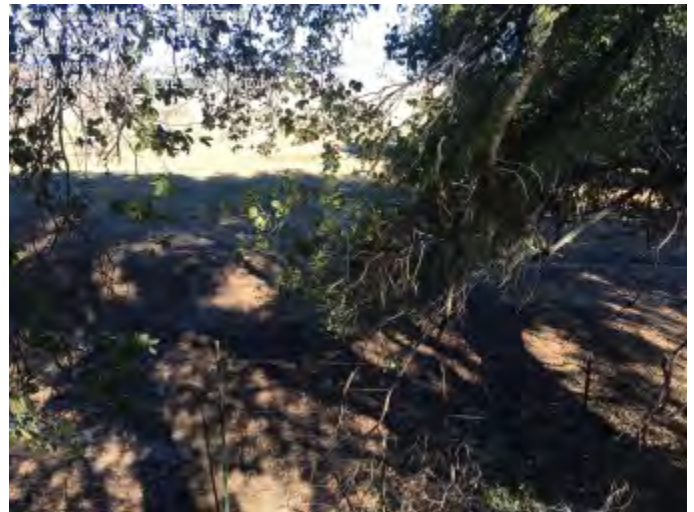
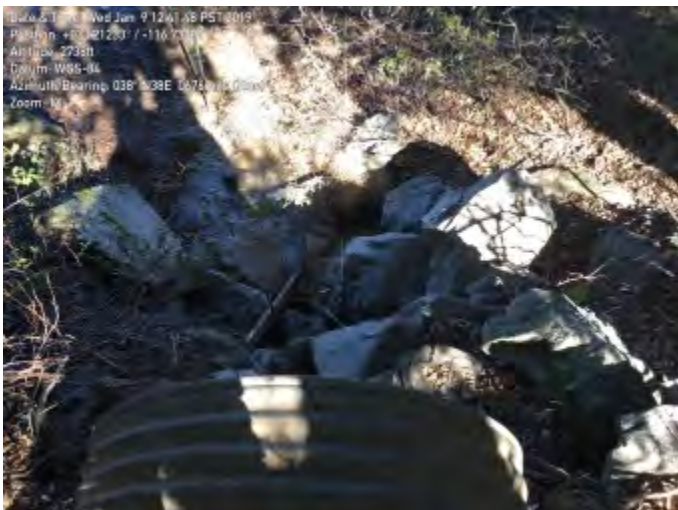
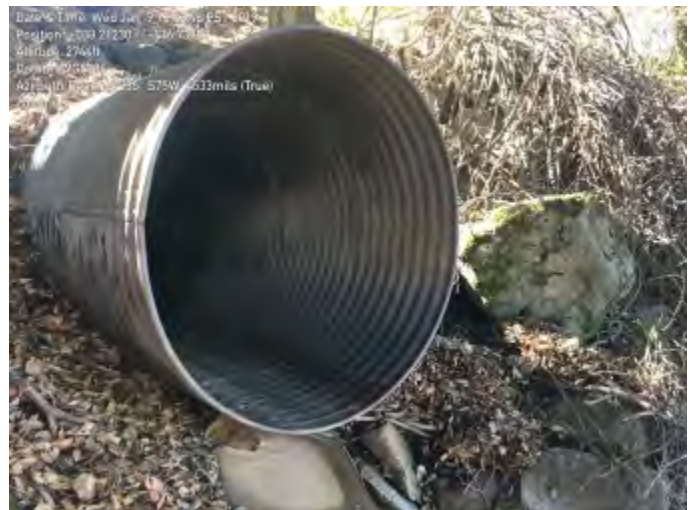
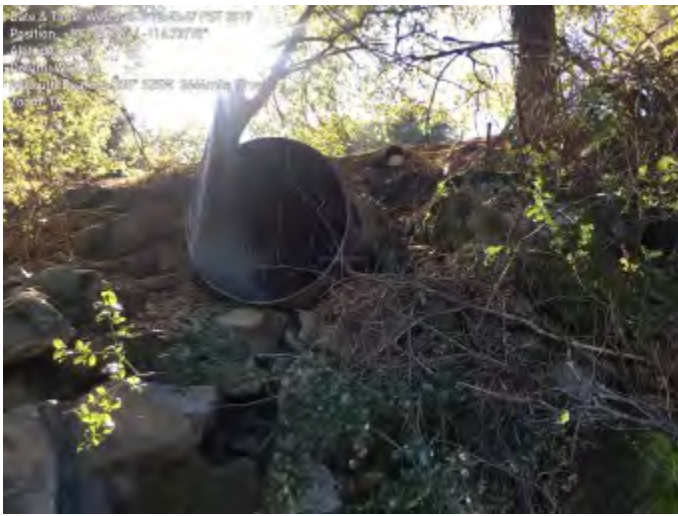
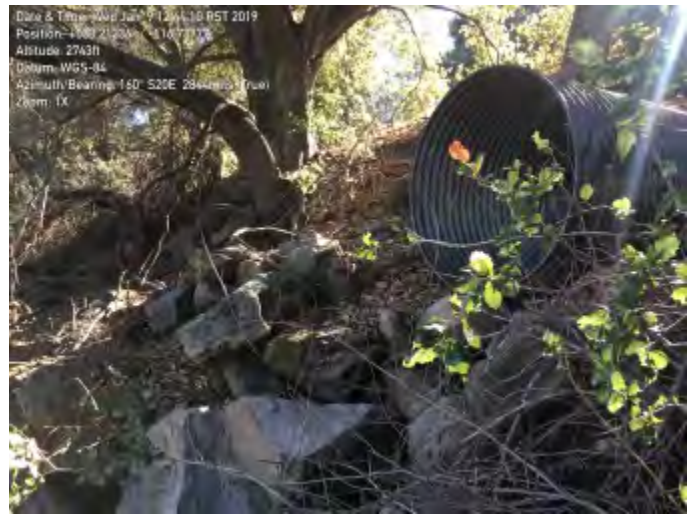
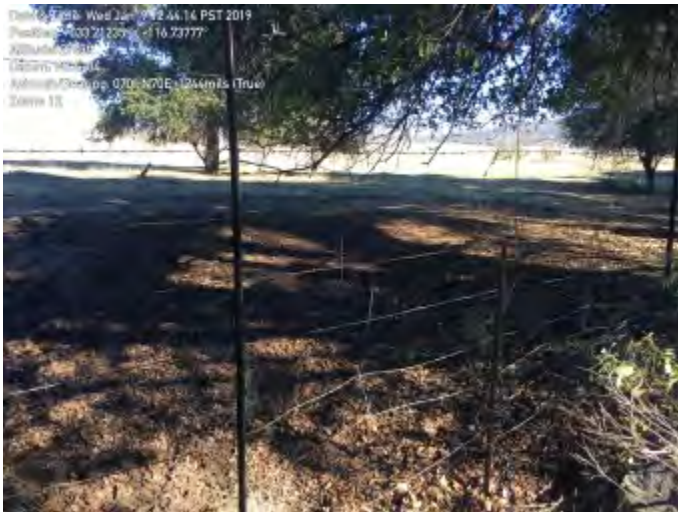
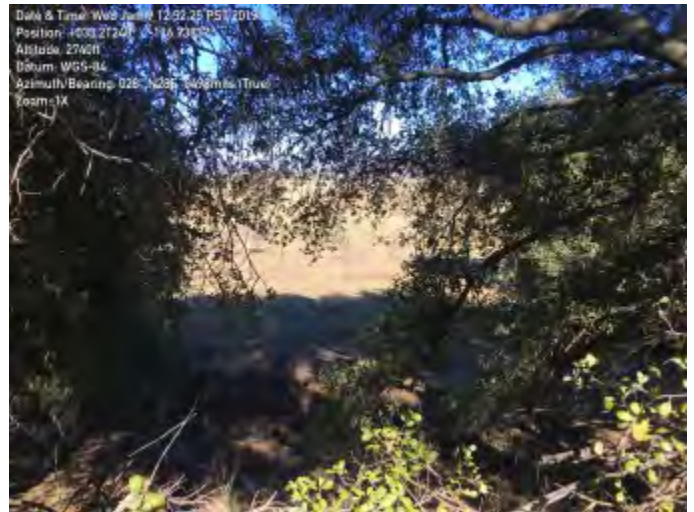
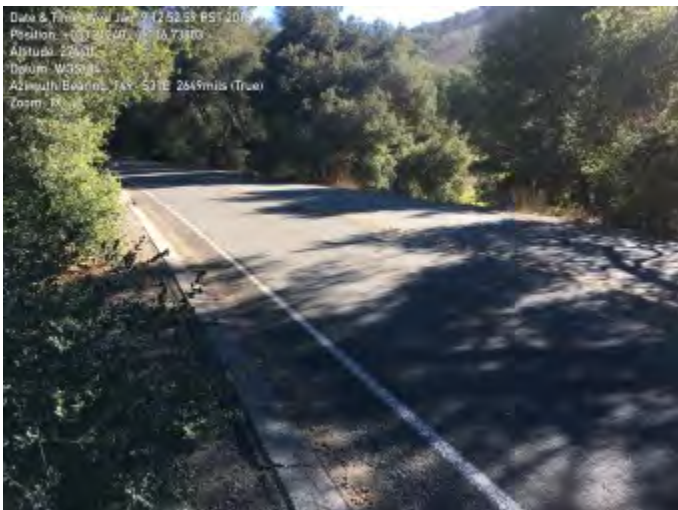
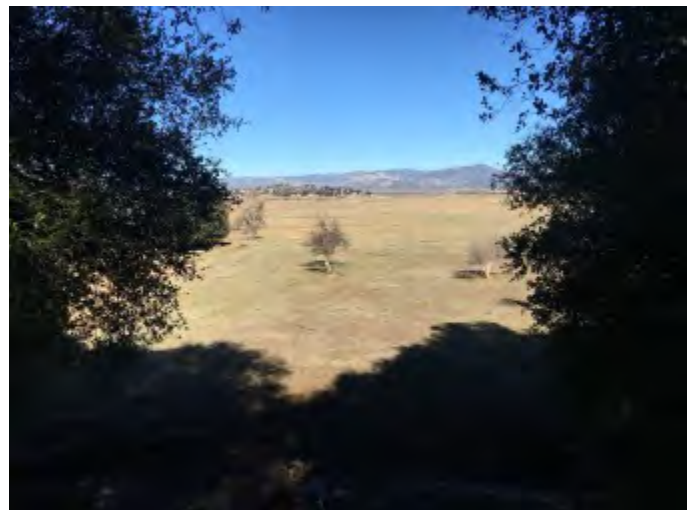
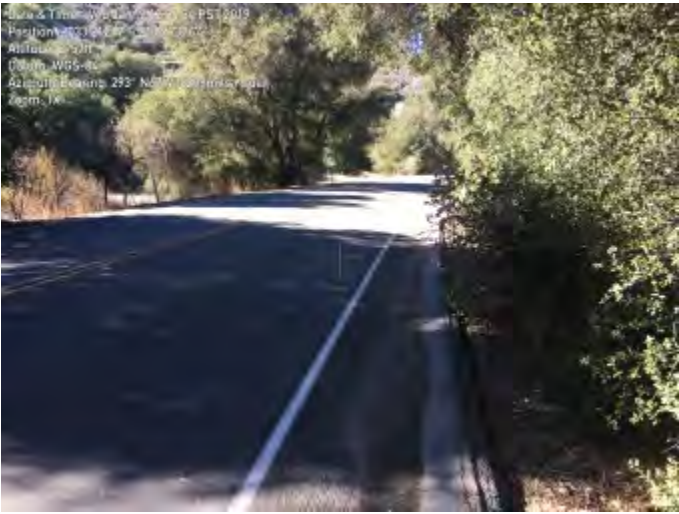
| Comments | Note elevation of north side culvert exit. Culvert drains south to north here. |

| Management recommendations | Increase diameter of culvert. Level the approach to westbound culvert exit. Barrier fencing. |

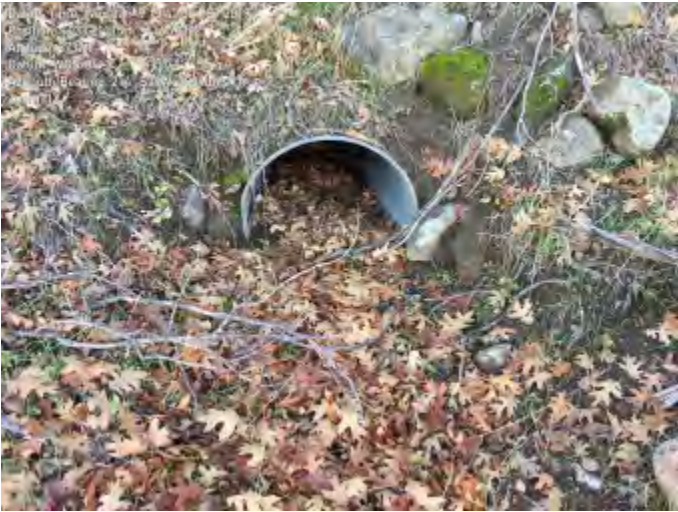
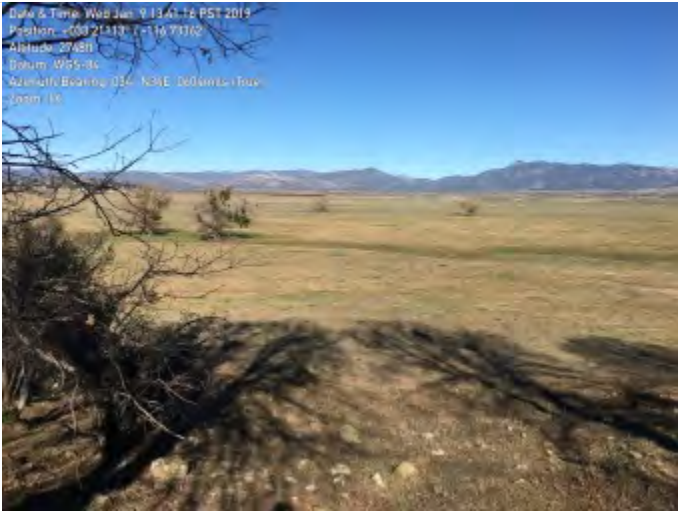
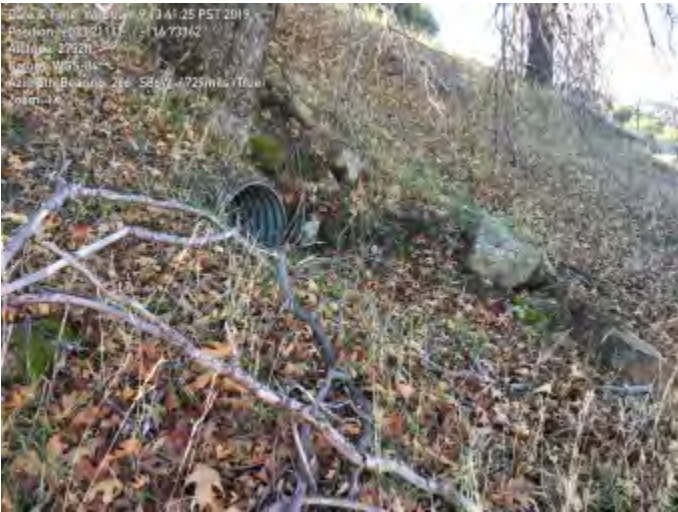
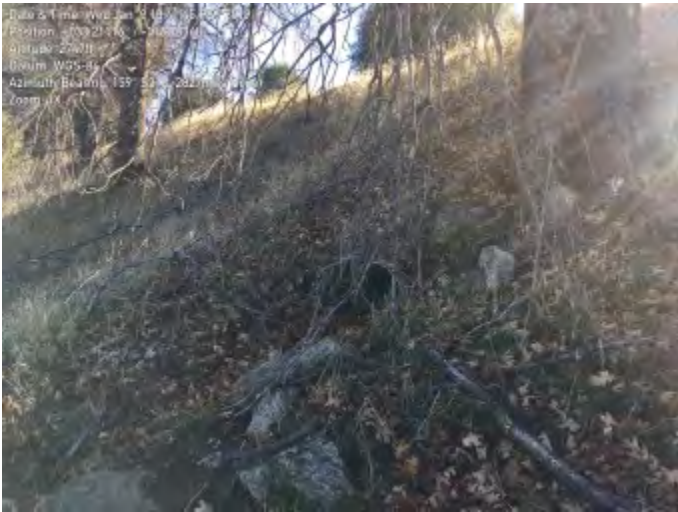
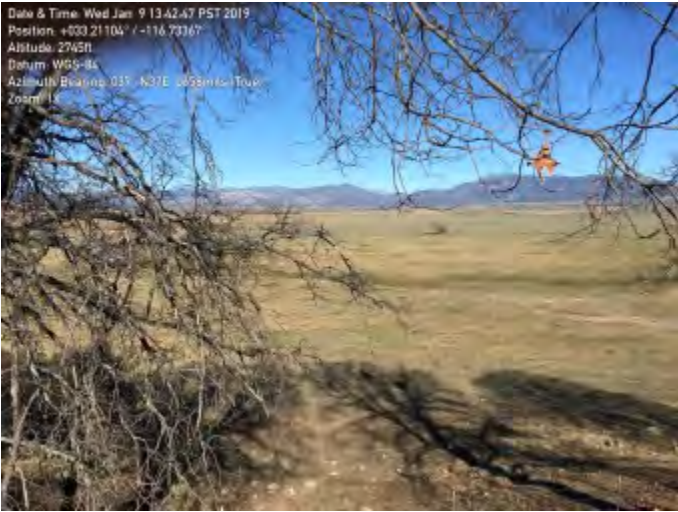
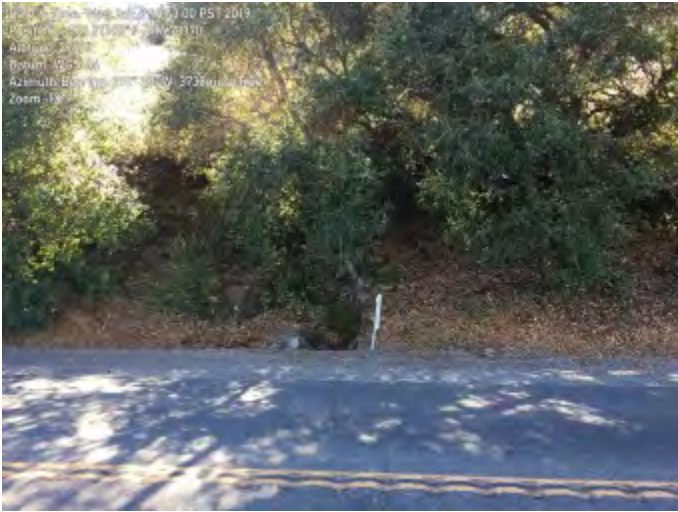
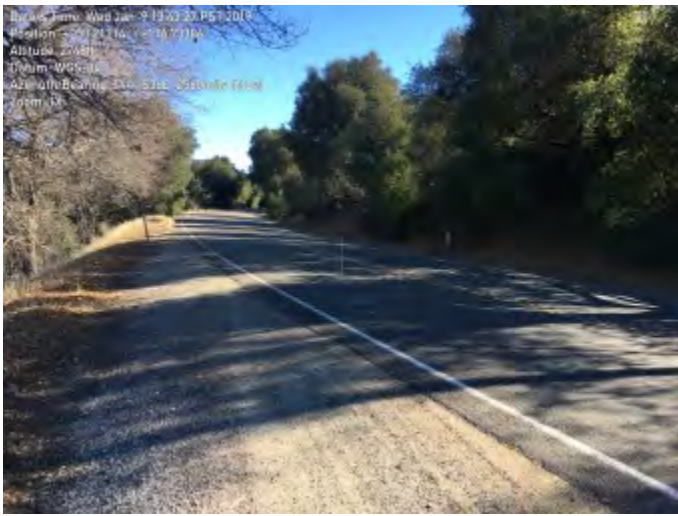
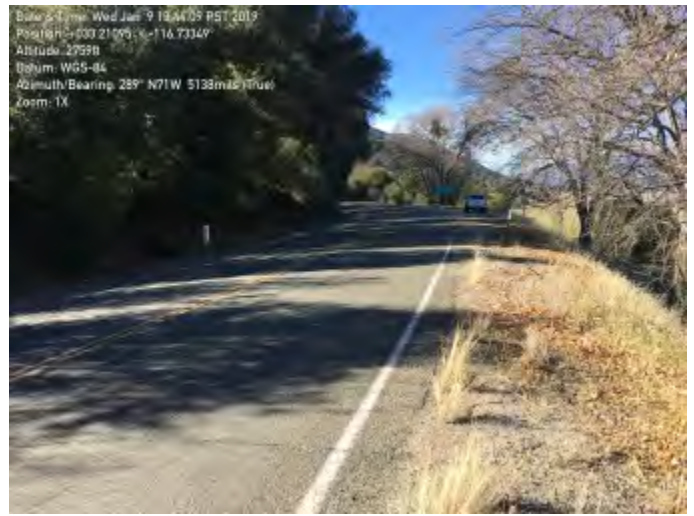
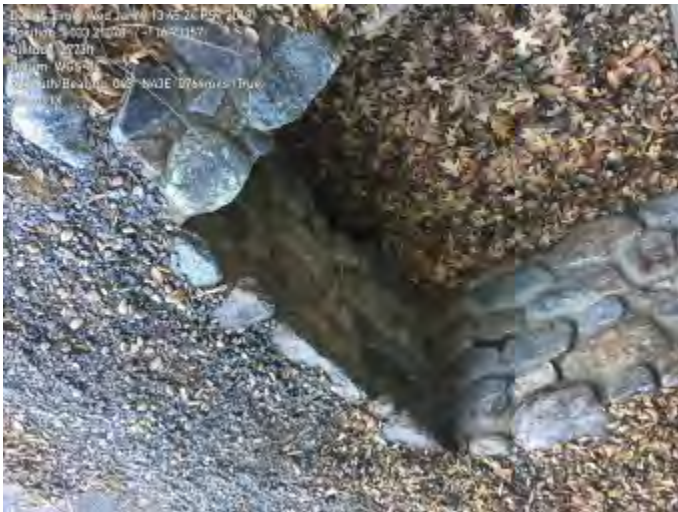
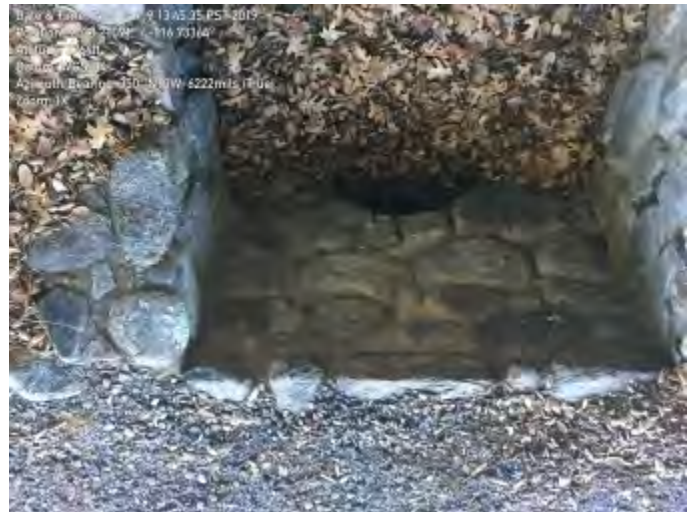
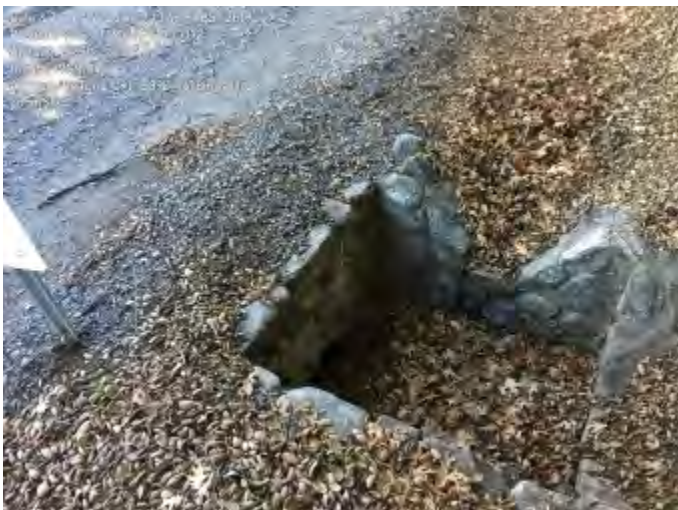
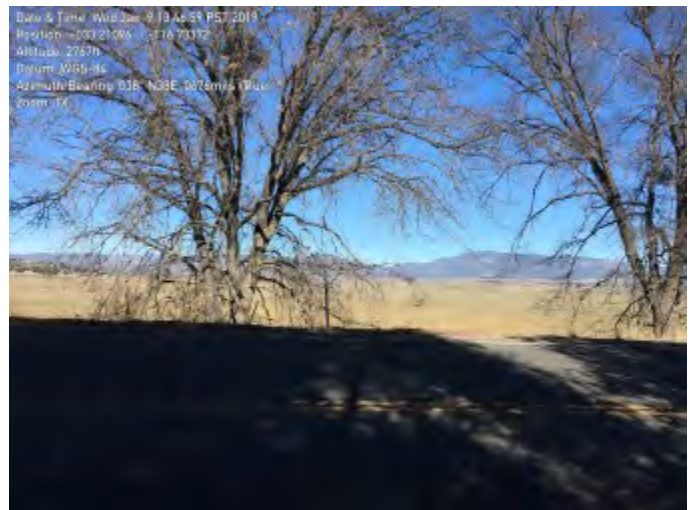
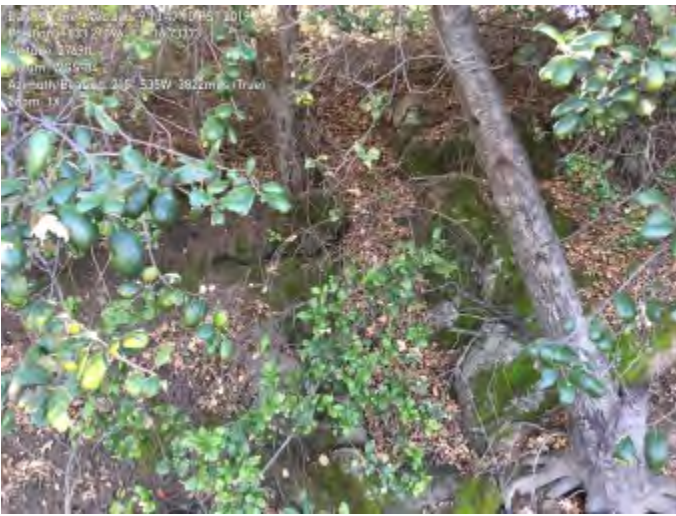
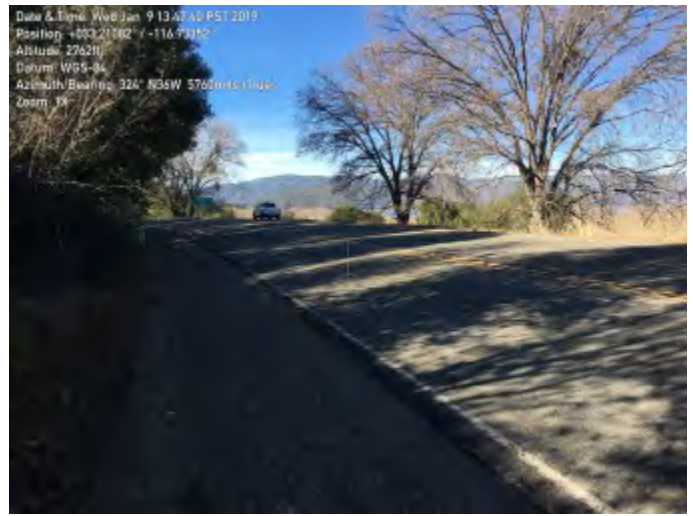
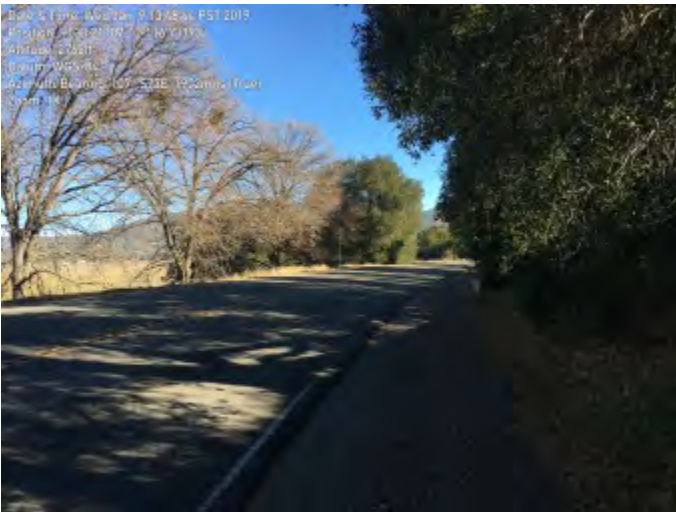
| Comments | Steep embankment rises from eastbound roadside approx. 20 feet. Eastbound culvert entrance adjacent to road with difficult access. |

| Management recommendations | Barrier fencing. Rumble strip. Wildlife crossing sign. |

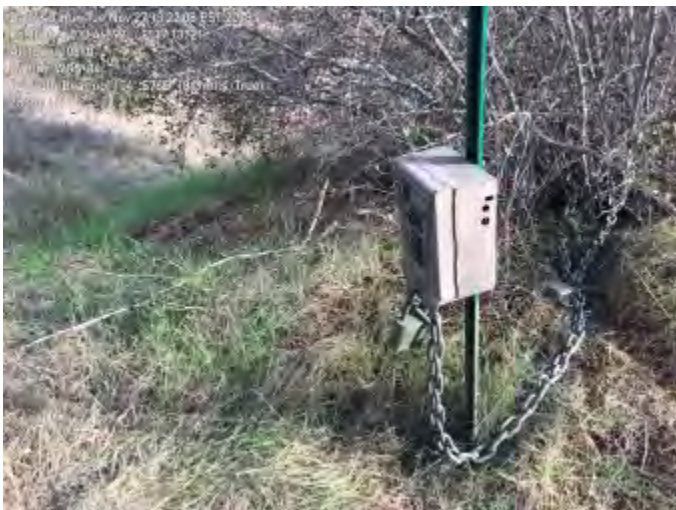
BHD 68 SB This camera was moved on 6-10-19 as follows: Uphill from culvert on west side of shrubs facing uphill. This location is on the southbound side of I15.

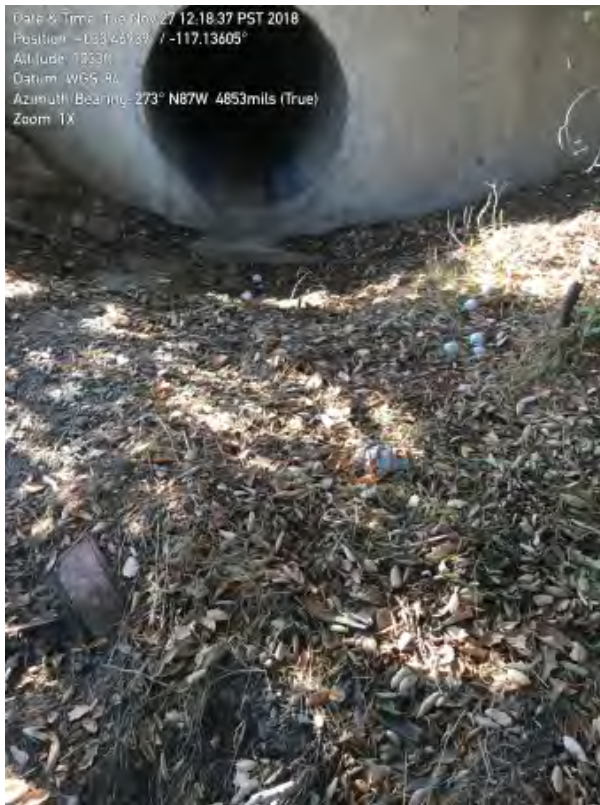
BHD 161 NB This camera was removed on 12-13-18.

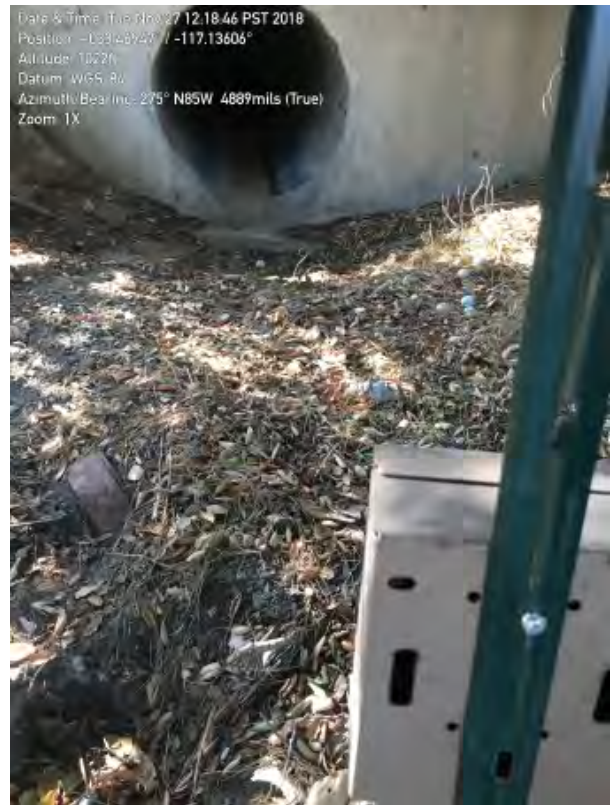
BHD 161 NB This camera was removed on 12-13-18.

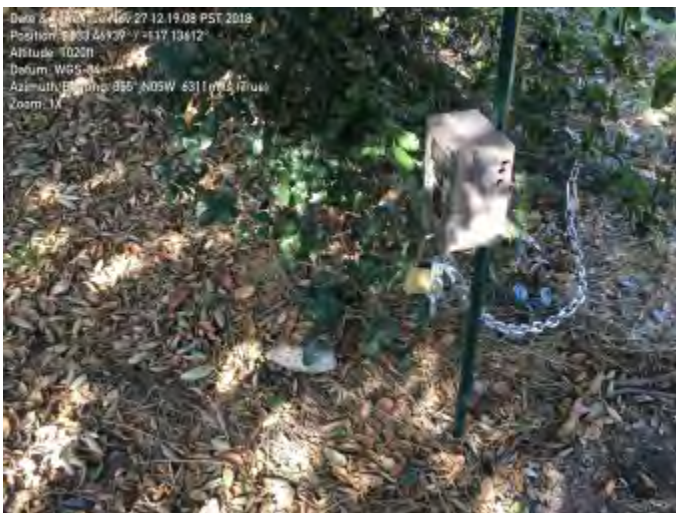
BHD 161 NB. This camera was removed on 12-13-18.

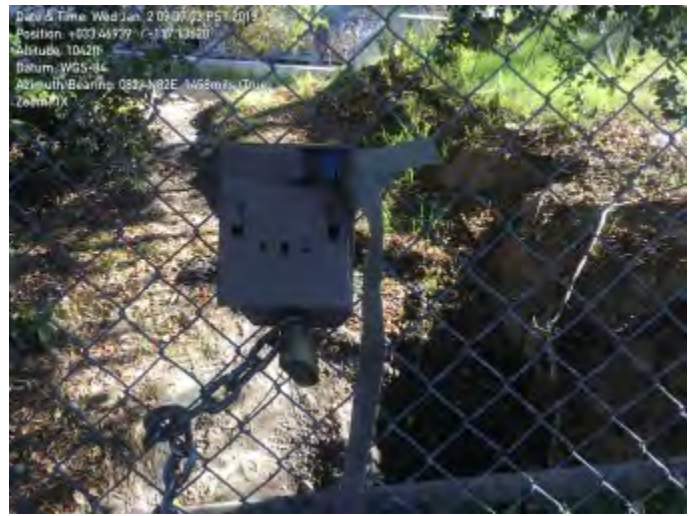
BHD 161 new location west of fence. northbound

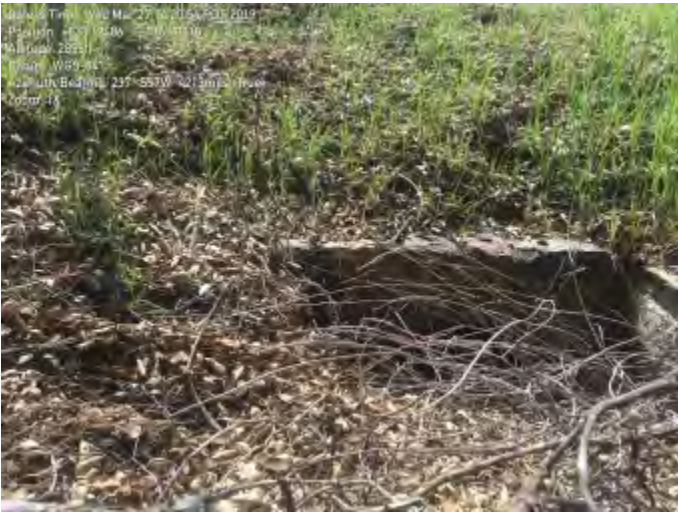
northbound Blocked, small diameter culvert entrance

Terrain and landscape conducive to wildlife travel east and west. However, inadequate crossing structure allows for crossing at grade only at this time. Steep embankment on east side creates difficult situation for construction of larger culvert under road. Culvert opening on west side is more accessible. The location surveyed is approximately 30 meters south of coordinates given for U079. Culvert mostly blocked at both ends by leaves and debris. Carrista Creek drainage lies to the west of SR79.

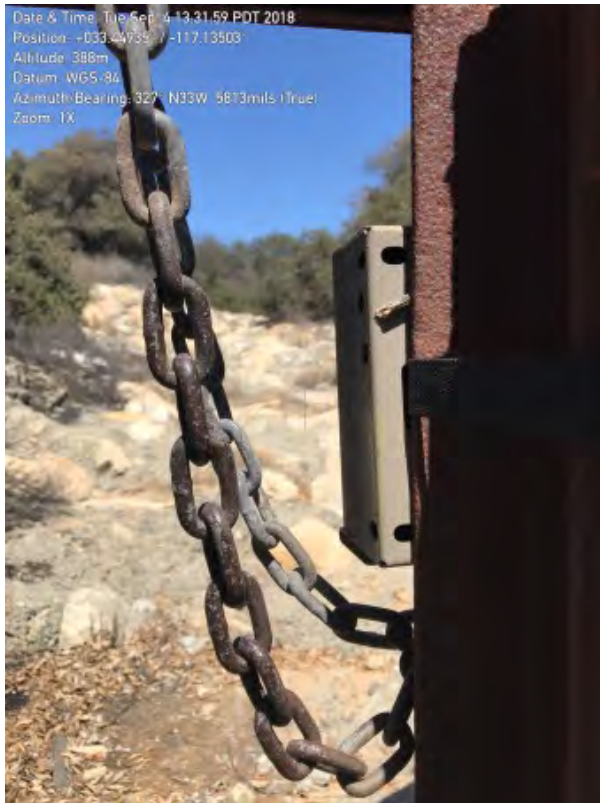
Camera C-18. Outside culvert SE of U148 This camera replaced with CAM 12 on 9-10-19.

Site U148 was evaluated essentially as three locations. One, at the specific GPS location noted in the file for U148. Two, at the culvert location slightly south of the file location for U148, and three, approx. 200 yards north of the U148 location where camera C49 is positioned. Northbound: Crossing here currently at grade. Culvert 50 meters south of crossing point running to south, and has narrow access. May just parallel I15. Unknown outlet location. Steep embankment rises approx. 25 feet above fwy on NB side to a heavily vegetated , but open, area at approx. same elevation as equivalent area on SB side of I-15. The CHP/ Border Patrol Station lies on NB I15 side approx. 300 meters south of U148. On southbound shoulder, 10 meters from fwy., there is a vertical culvert 3 feet in diameter which descends 10 feet to horizontal 3 foot diameter metal culvert. This culvert appears to be directed underneath the freeway to the east and underneath the steep upward embankment to the west. Landscape on east and west sides of freeway here provides excellent habitat for travel corridor. An additional camera was placed, approximately 200 yards north of the culvert location previously described, in a streambed to the east of the freeway. This is camera C49. Camera C18 failed and was replaced with CAM 12 on 9-10-19.

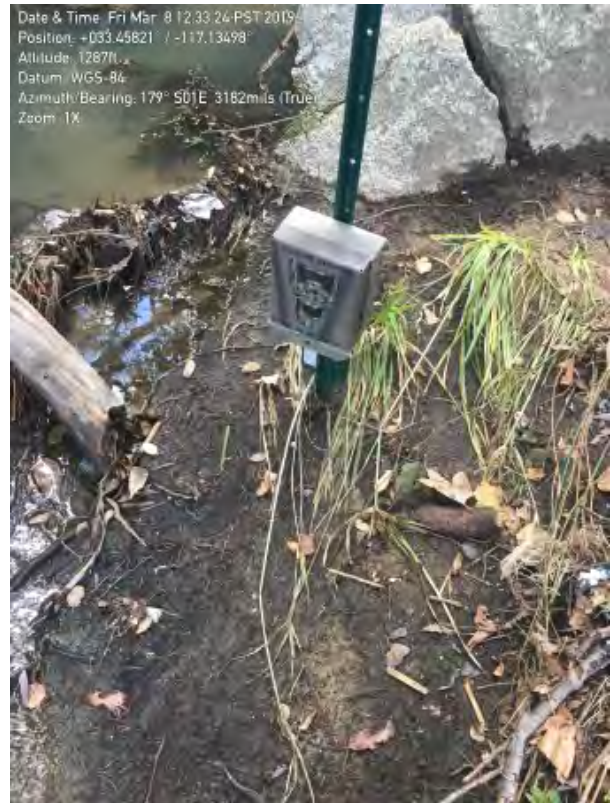
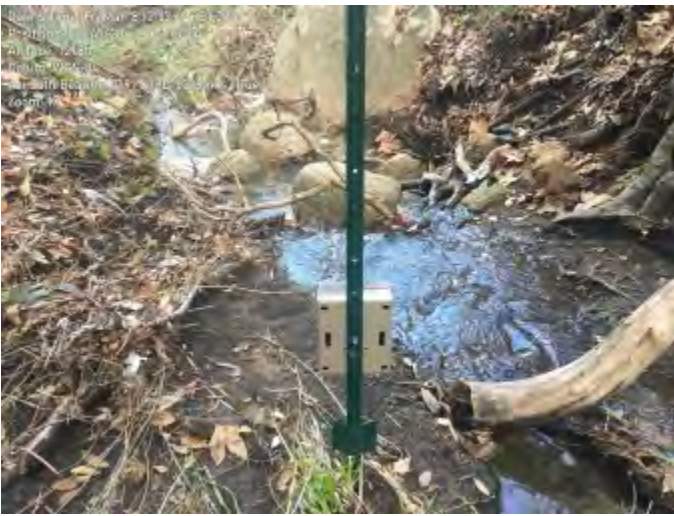
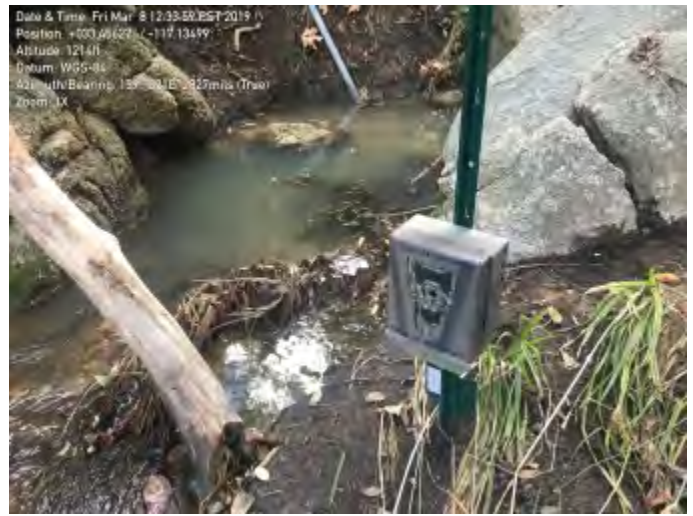
cam C49 new location

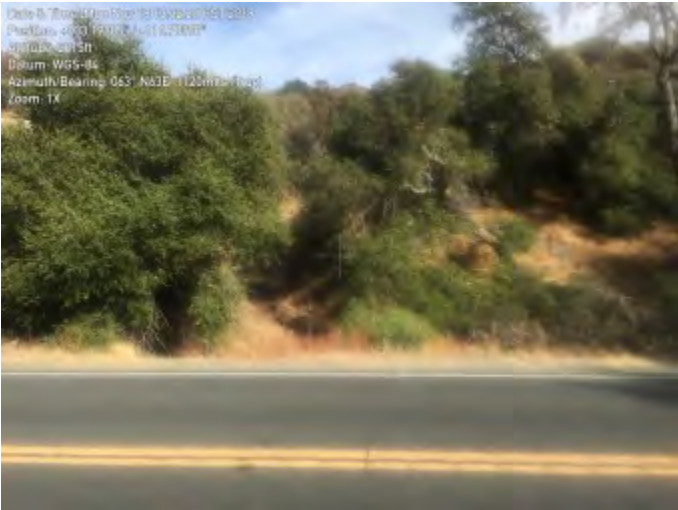
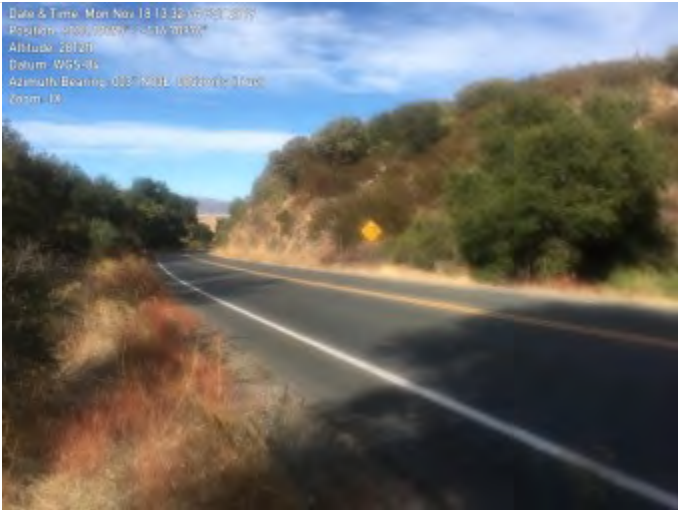
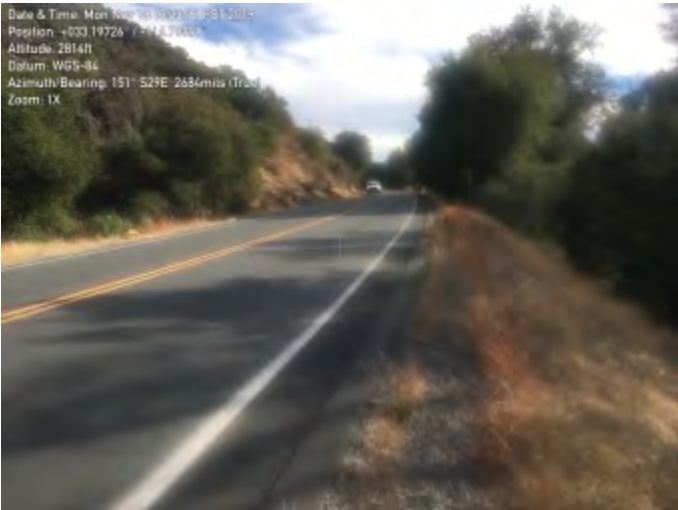
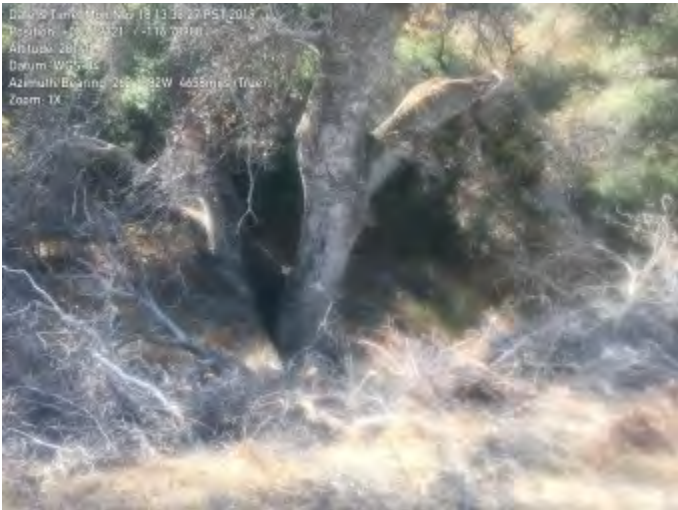
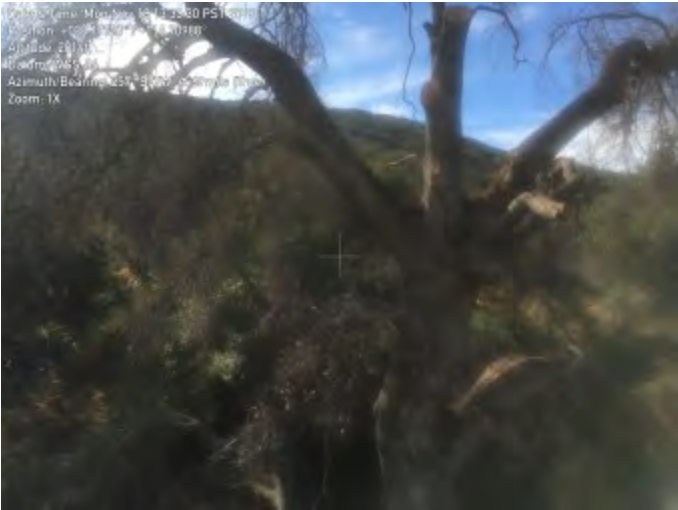
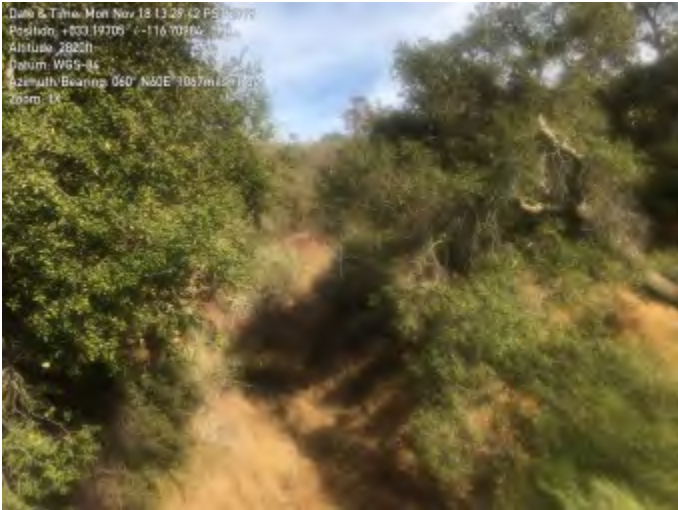
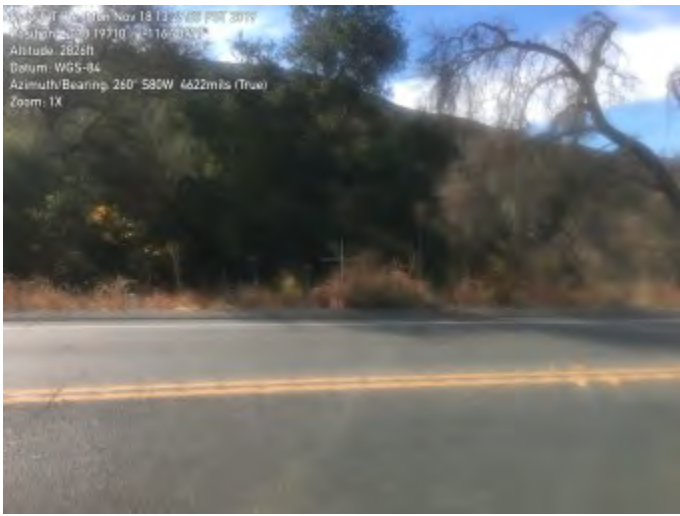
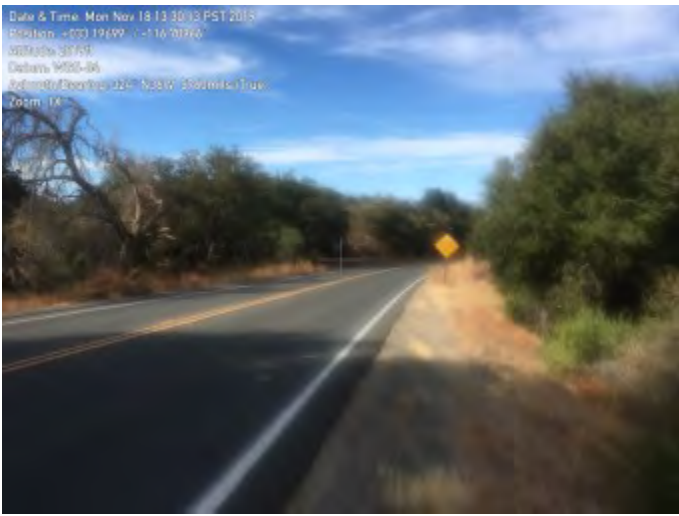
southbound

northbound

| Comments | Currently inadequate corridor due to lack of crossing structure. Traffic is fairly light in this area, although traveling at high speeds. Good crossing at P100 approx. 300 meters north. Embankment too shallow on northbound side to consider construction of wildlife undercrossing here. |

| Management recommendations | Wildlife crossing signs, barrier fencing. Directional fencing to P99, P100. |

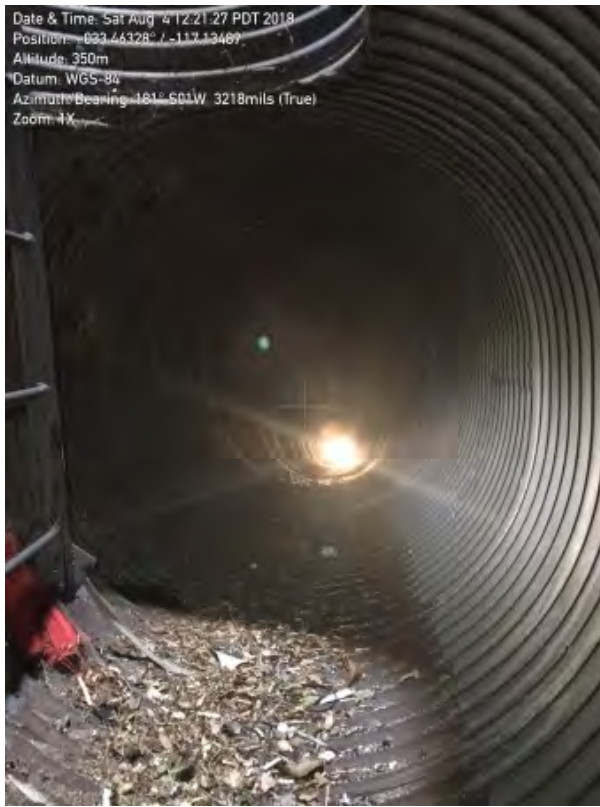
3/4 through culvert before 15 degree drop to eastern side.
 Potential camera placement
