SA-PAL survey

| Project | SA-PAL project |
| ID | 42130 |
| Survey Date | 04/03/2019 |

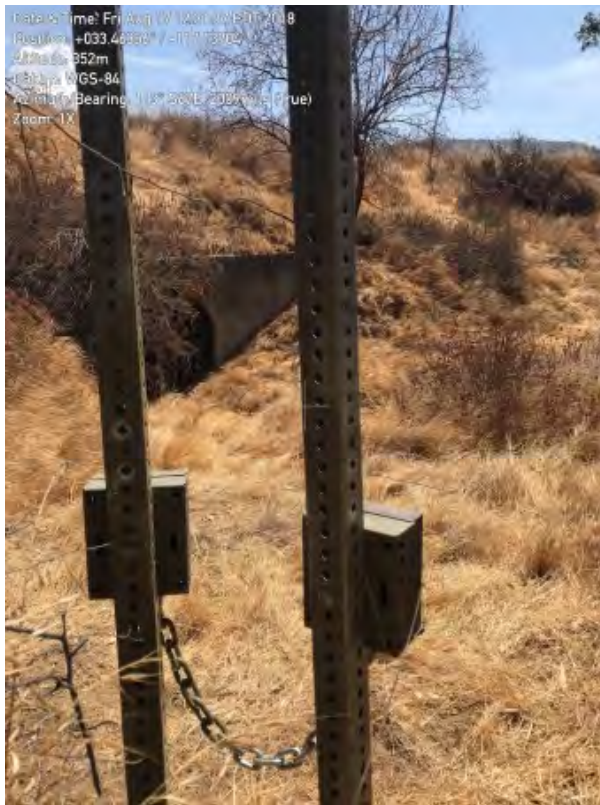
West side Cameras: C-18 & C-22. Removed due to mass triggers.

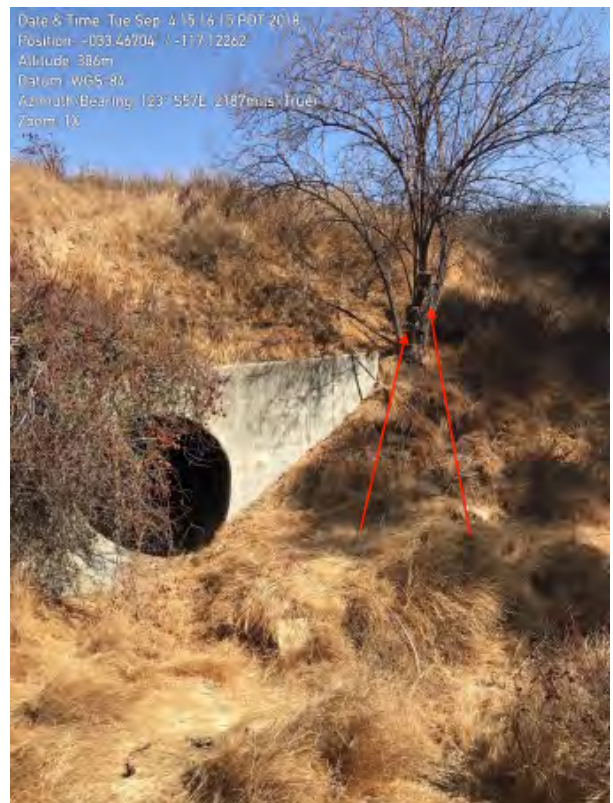
New camera locations for cameras: BHD 96, JO25

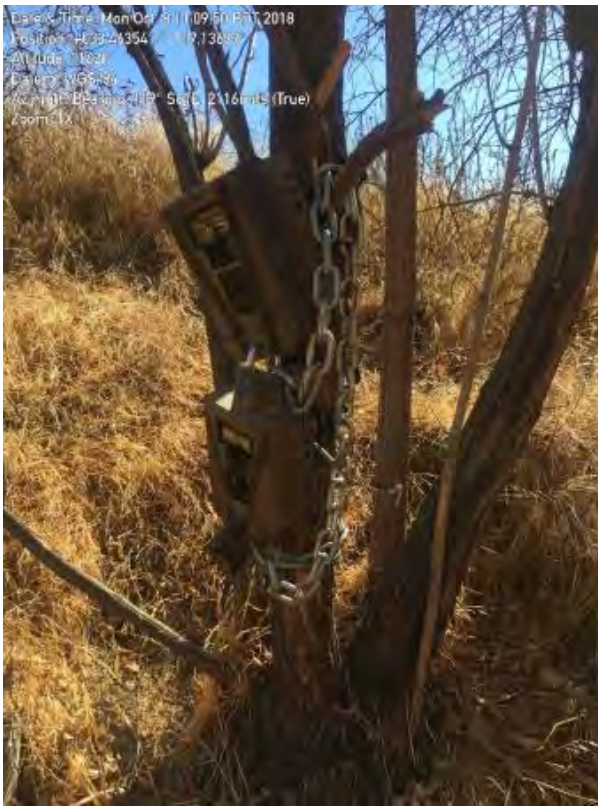
camera location for BHD 96 and JO 25

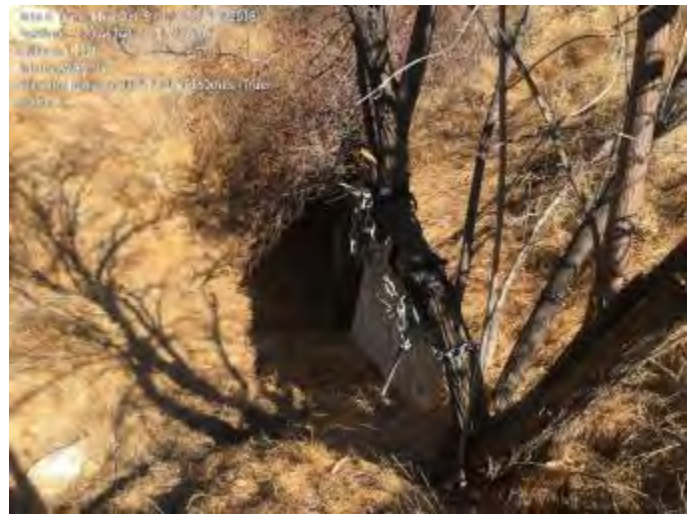
camera location for BHD 96 and JO 25. Aimed at culvert access.

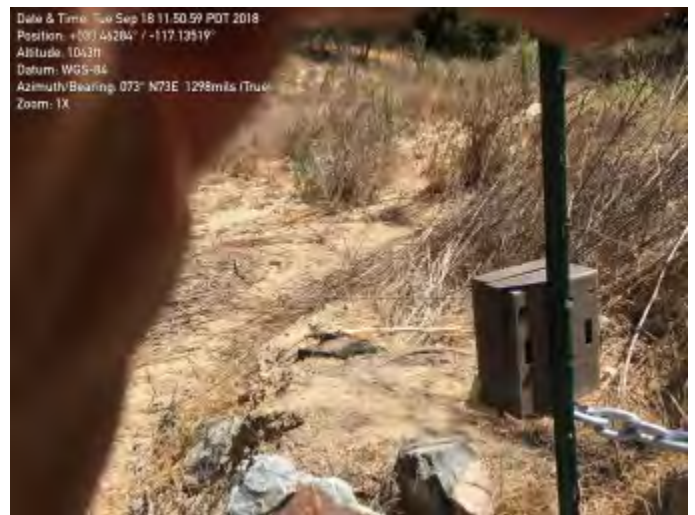
East side camera northbound camera # JO 09

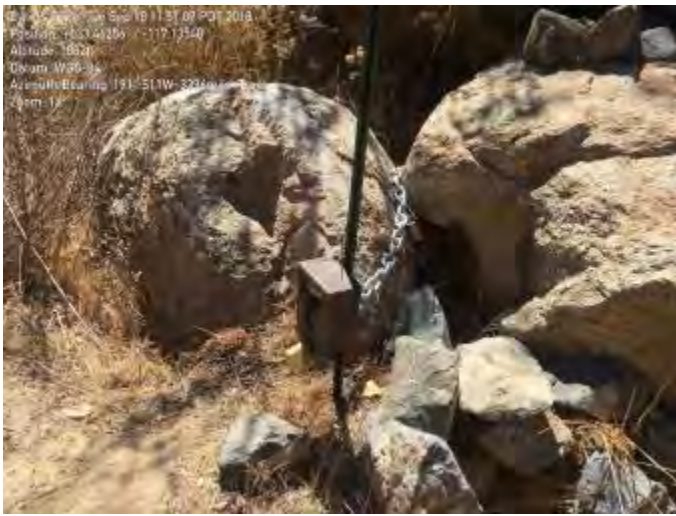
east side camera (NB) camera # JO 09. Repositioned 3-9-19. Now facing toward culvert.

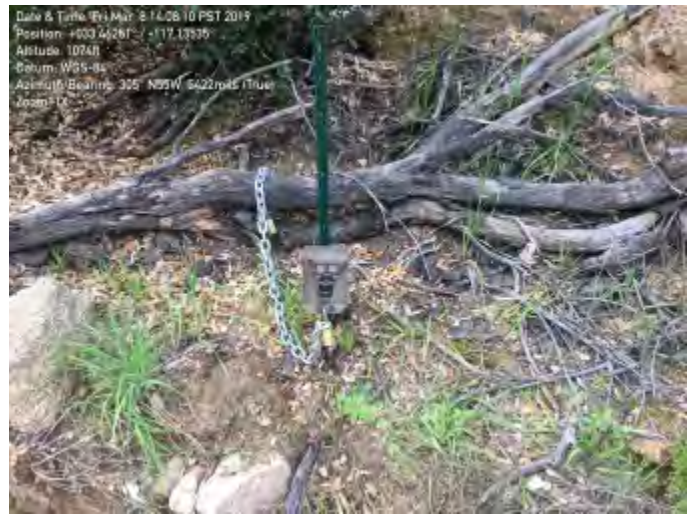
JO 09 new location as of 3-9-19 This camera, JO-09, was moved 6-10-19. New placement is as follows: follow streambed to east of riprap by culvert approximately 40 meters. Where it bends to the north (left) at the east end, look to the left. Camera is on green post on right side of of sand pointed to the southwest. Chained and locked to bush. see new photo for Nav cam co-ordinates

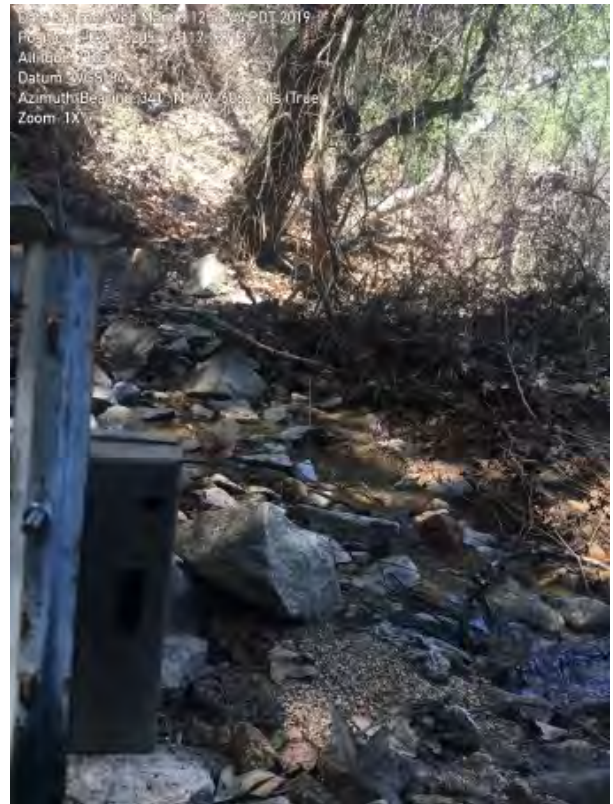
BHD 202 new camera southbound. Placed 3-13-19, replacing camera C25

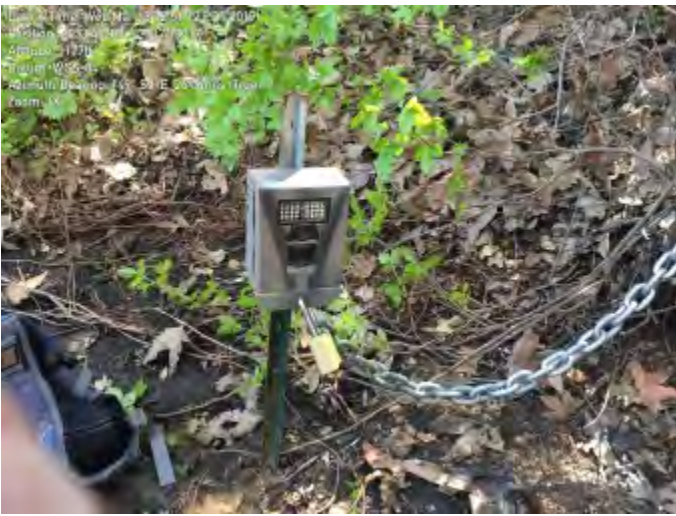
BHD 202 new camera southbound. Placed 3-13-19, replacing Camera C25

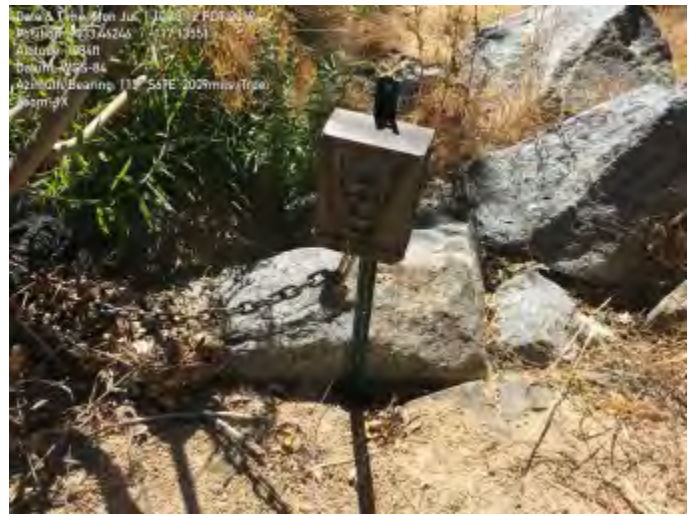
New placement of JO 09 as of 6-10-19 Description of location in notes above.

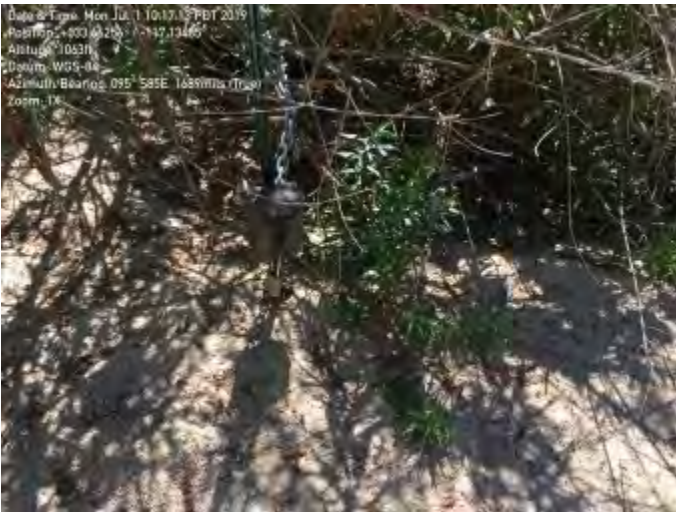
Photo of camera C30. This was old camera C20 which has been renamed to C30. It was placed on 7-1-19 to replace Camera BHD 153 which had become non functional

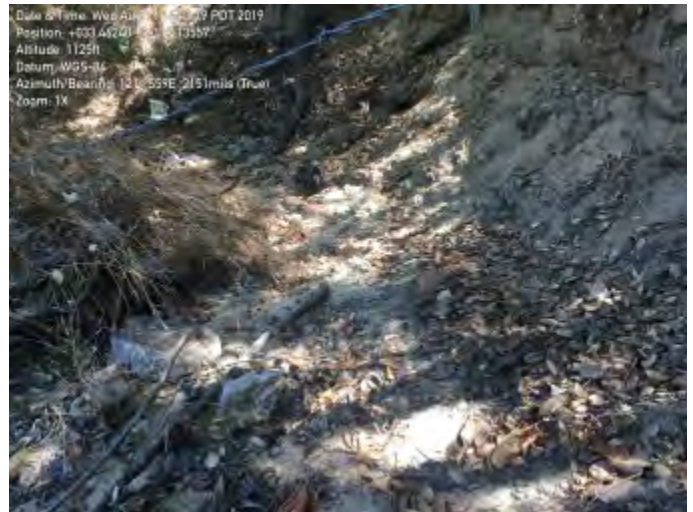
camera view JO 09 new placement as of 8-21-19

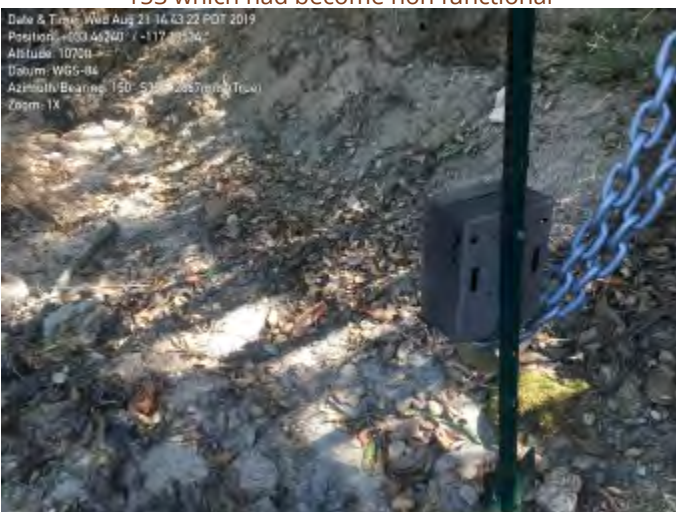
camera JO 09 as of 8-21-19

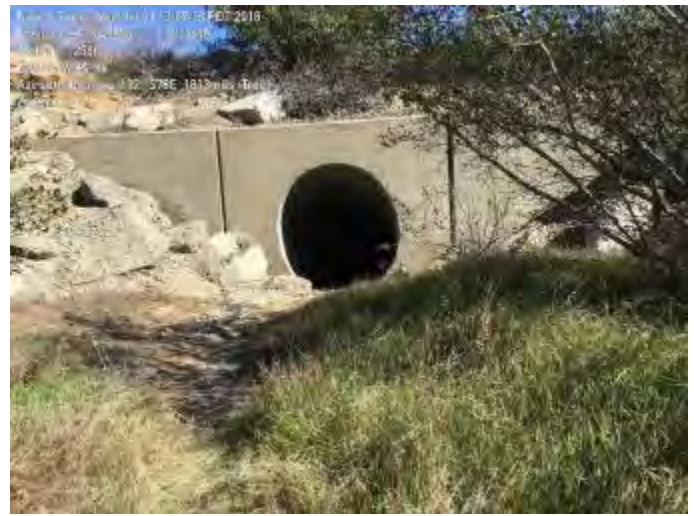
Southbound culvert (camera view)

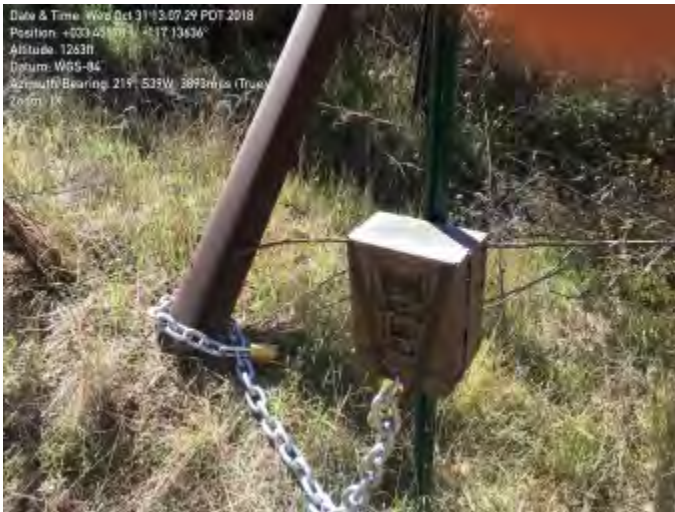
Camera # C5 facing culvert on Southbound side WS3 This camera replaced as of 3-13-19

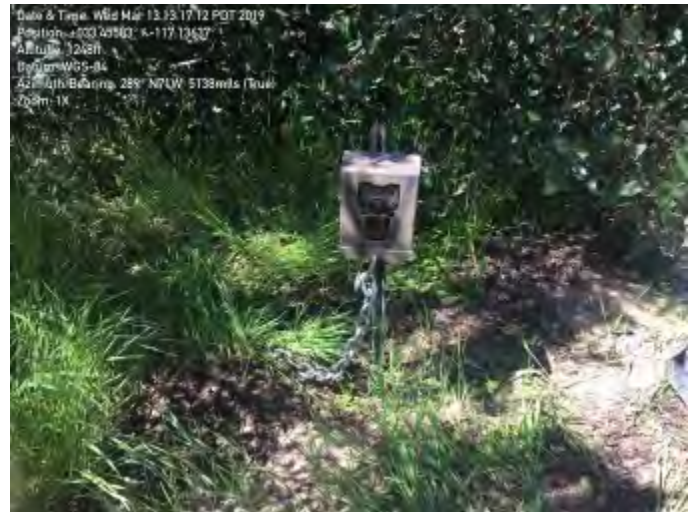
camera # 3 new placement southbound. replaces C5

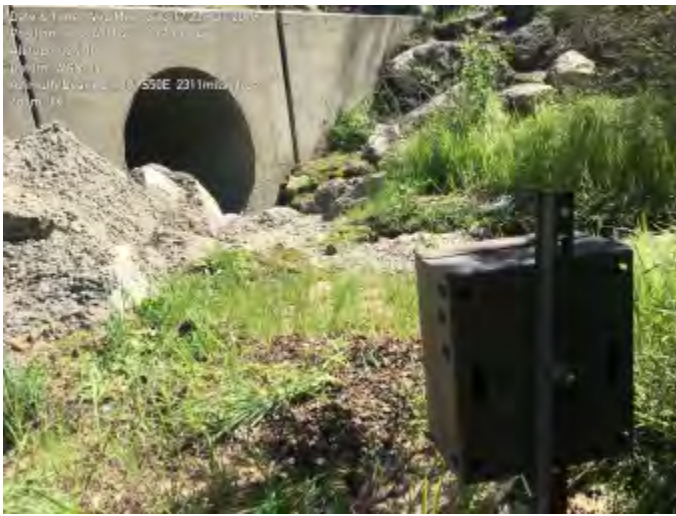
Camera # C3 southbound. replaces C5

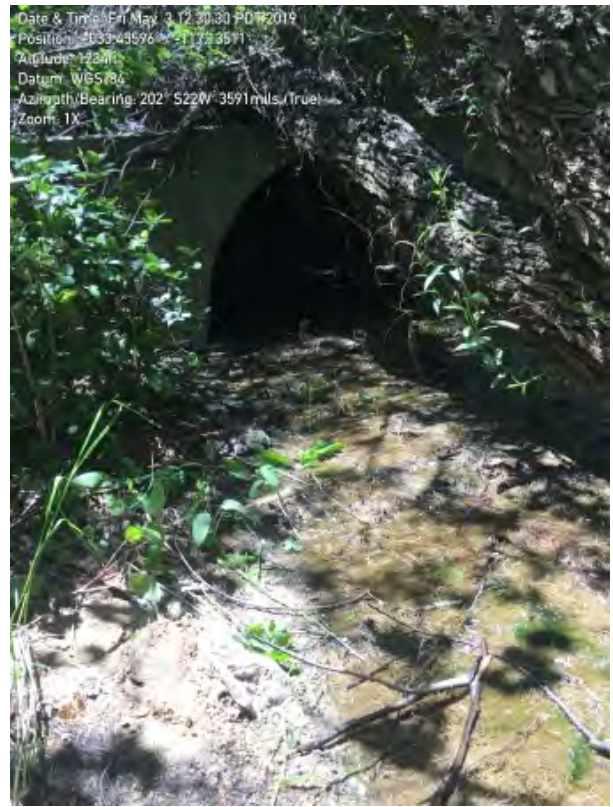
WS3 northbound camera view into culvert DOC6

On SB side, there is a culvert potentially accessed by vertical approach. Covered with barred grate. Appears to drain east-west. It is about 5 meters from edge of SB I 15. Approx. 25 meters to the west of this grate on the other side of embankment to west lies horizontal opening to the culvert. The vertical shaft I noted adjacent to SB side allows penetration of daylight. Although there is no through and through culvert visibility, this shaft of illumination allows daytime visibility from culvert entrance to that lit area. There is a drainage leading westward up a well vegetated and bouldered hillside. This climbs several hundred feet to the west and appears to be amenable to wildlife travel. Culvert opening is approx 50 feet to east of NB I-15, and 50 feet below grade of freeway. Opening here is 5 feet wide, but 3.5 feet high due to sedimentation accumulation. To the east-lies a good corridor of heavy chaparral. There is a vertical access shaft to this culvert similar to that one on SB side which lights the culvert at this point adjacent to the NB freeway. Light is visible at this point from east side culvert opening. Camera DOC6 placed

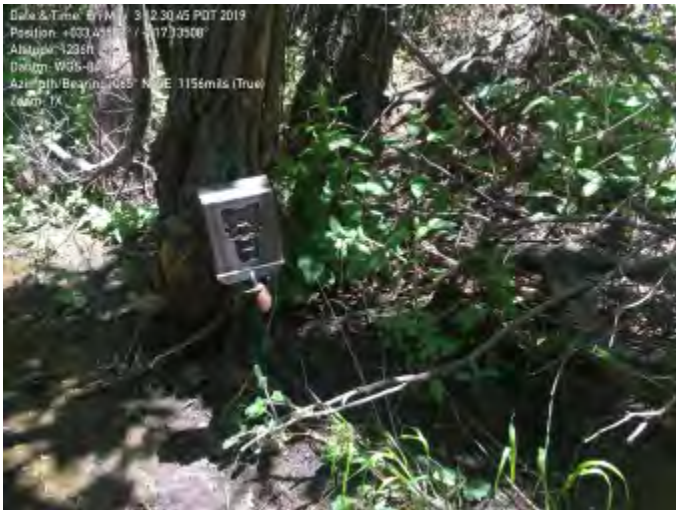
WS3 Northbound camera DOC6

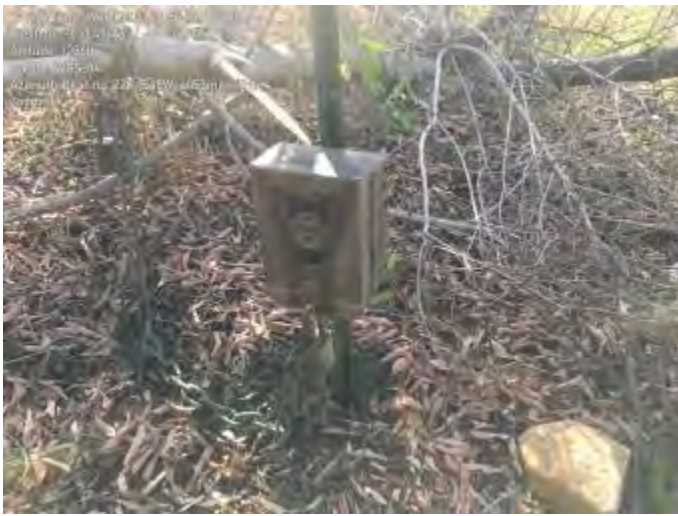
southbound camera at culvert WS4 #B78

Replaced camera number 701 with # B78 on 12-10-18. #701 was Amy's camera. It was returned to her.

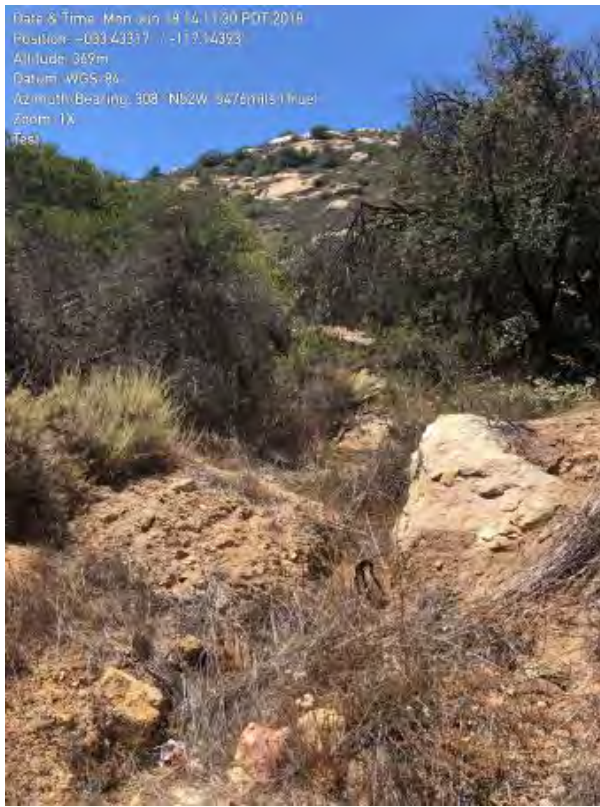
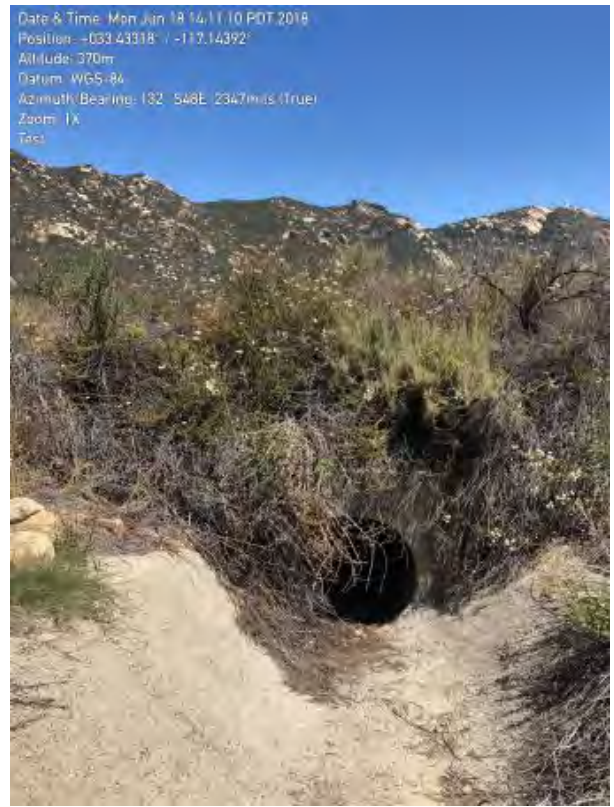
33.43030,-117.14793
Culvert mouth is uphill from roadside at base of small

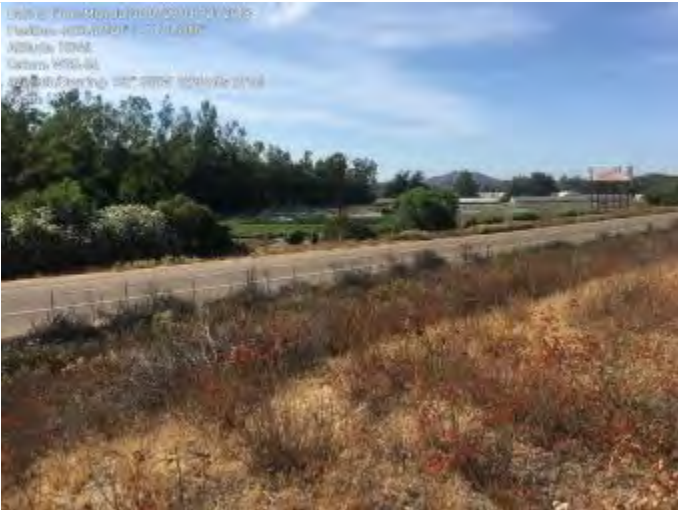
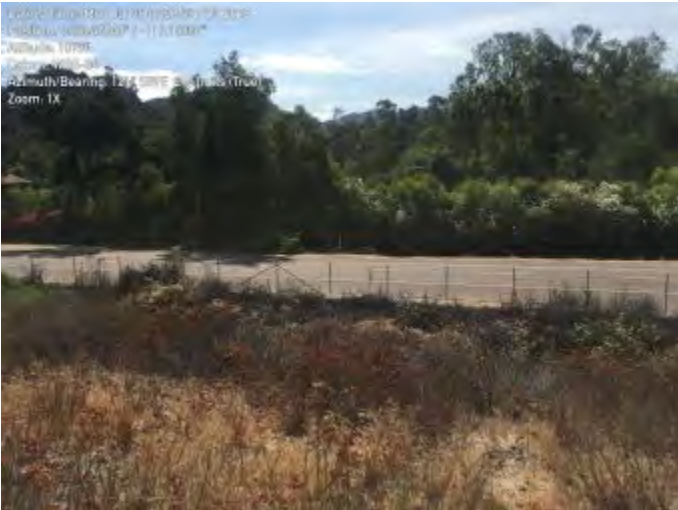
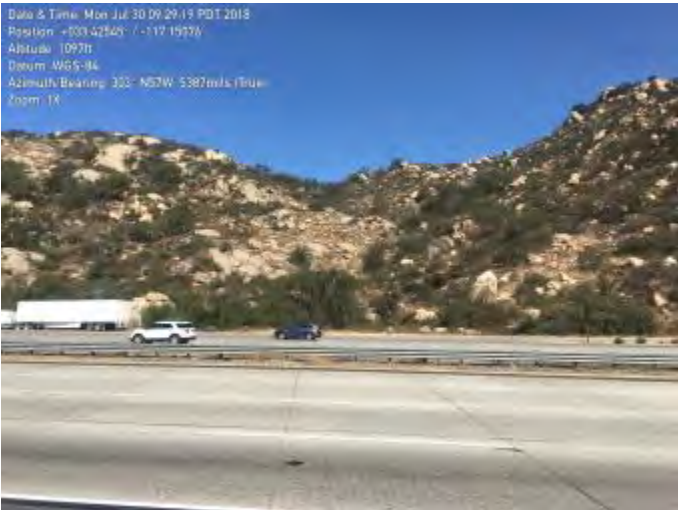
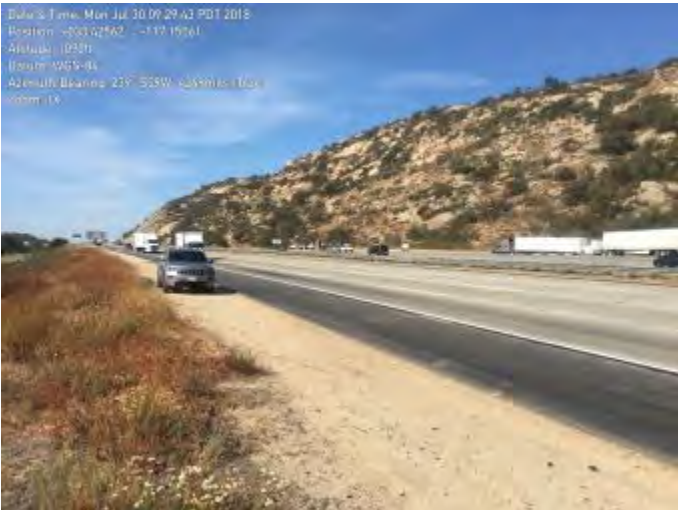
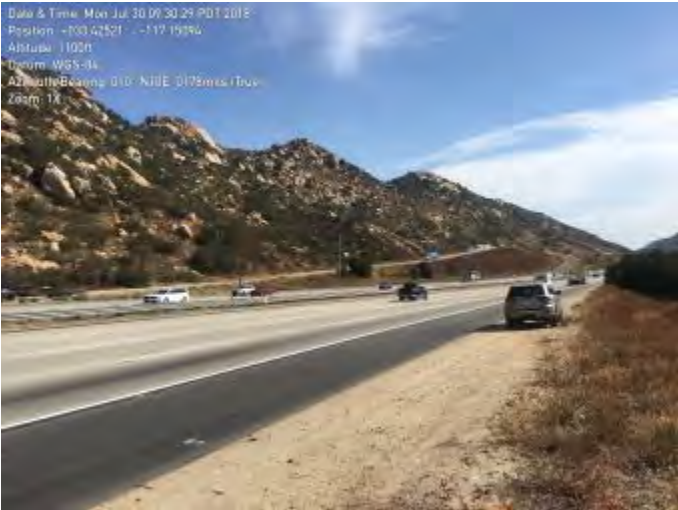
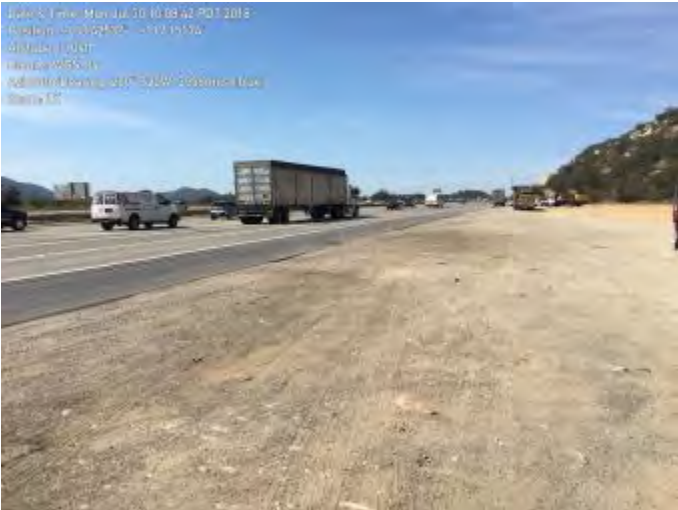
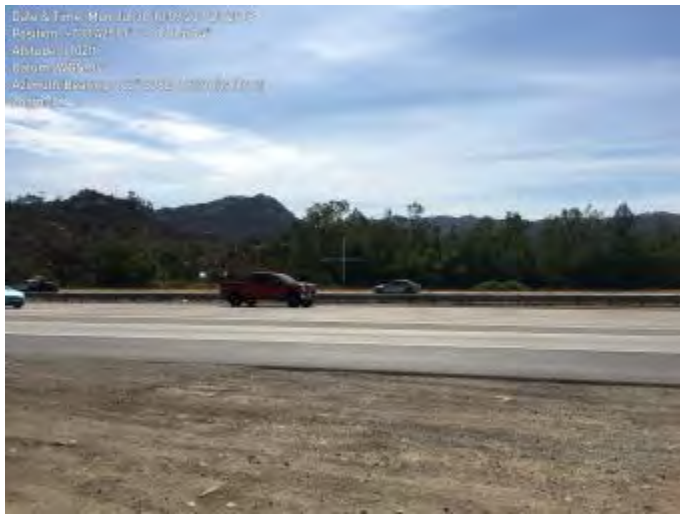
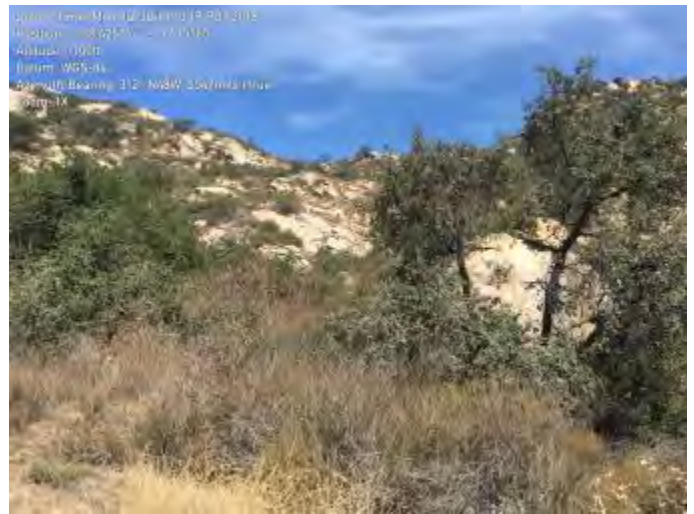
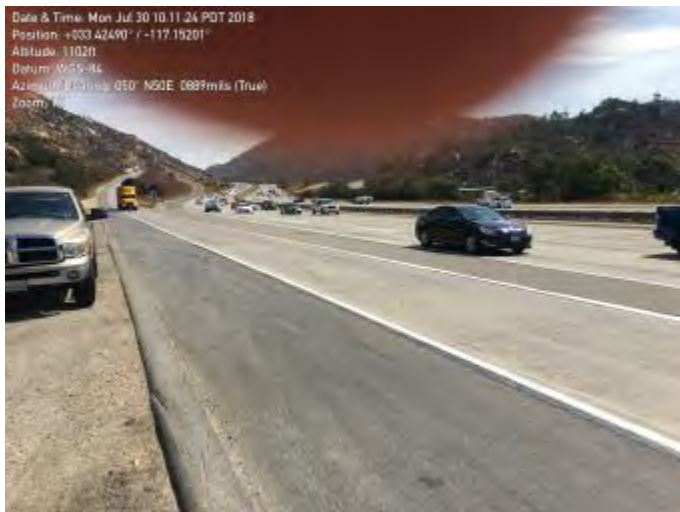
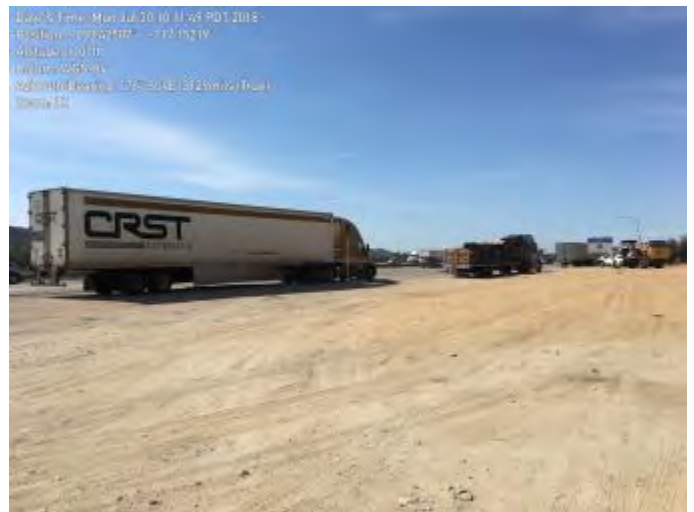
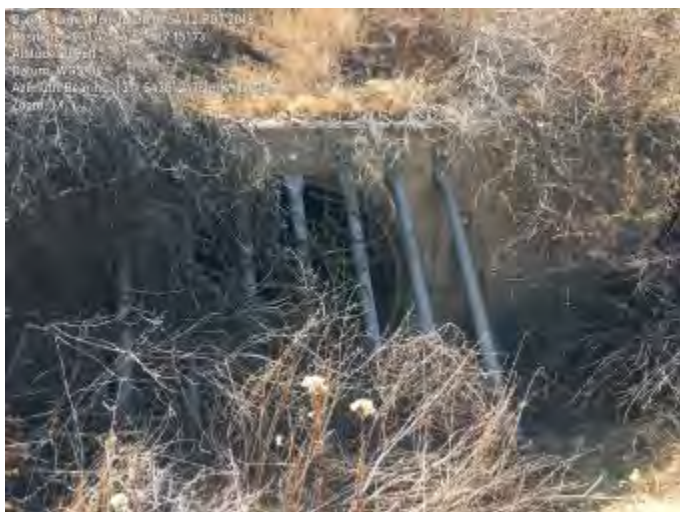
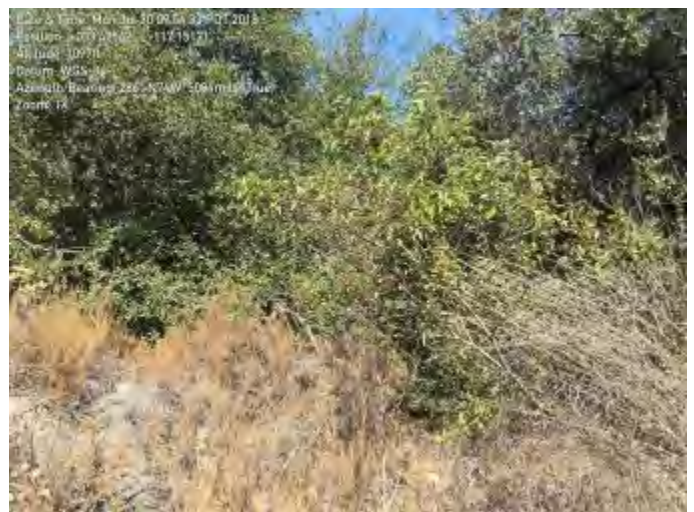
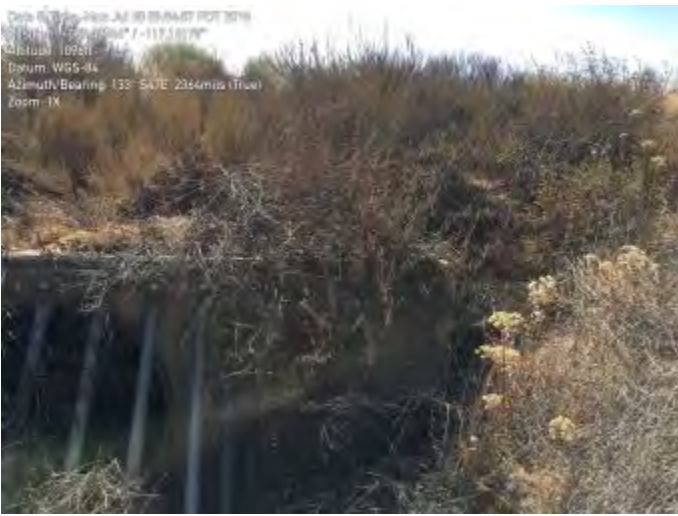
Northbound side of this location not conducive to crossing due to commercial property on east side. There is no indication of culvert opening on the northbound side. Unable to locate. I would recommend re-assessing the NB side for culvert exit. The elevation change from I 15 to bottom of slope on NB side is only approx. 7 meters. Landscape on SB side appears conducive to crossing. Culvert entrance located SB side which may be conducive to crossing, but NB limitations make this a poor crossing site.

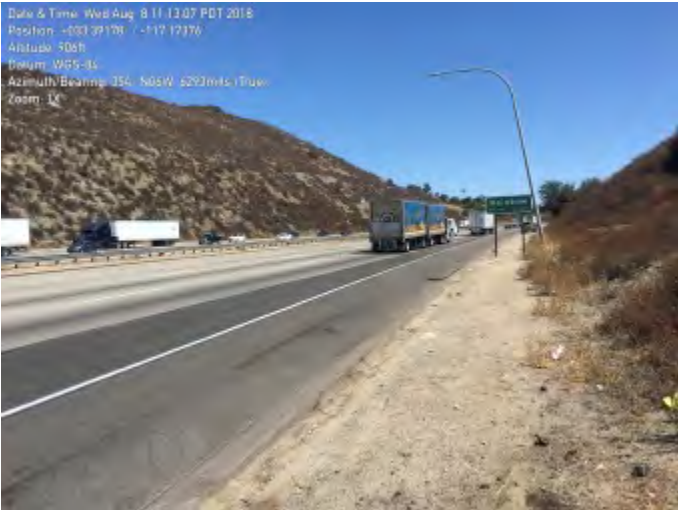
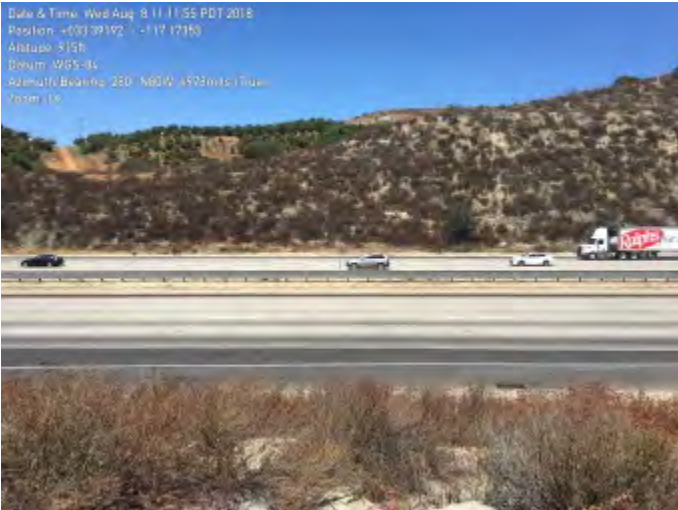
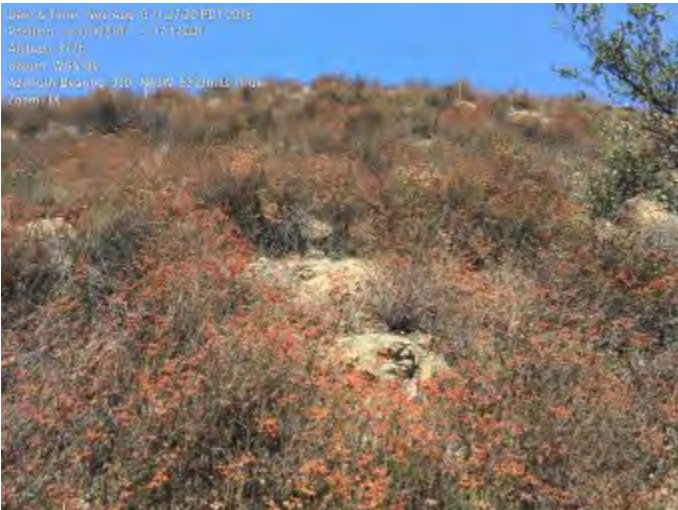
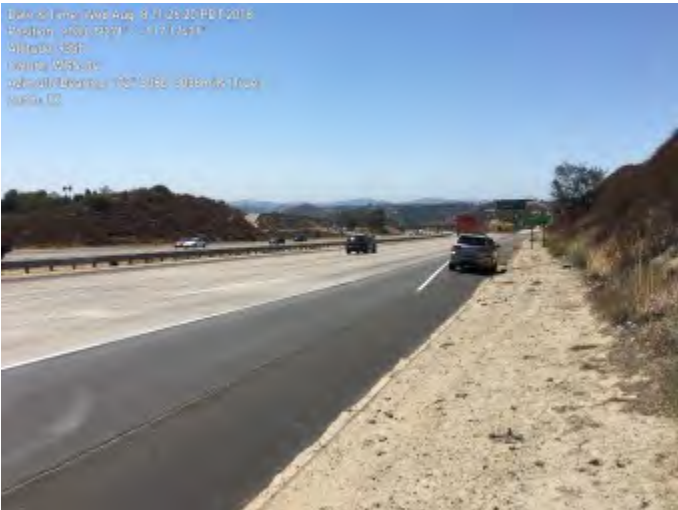
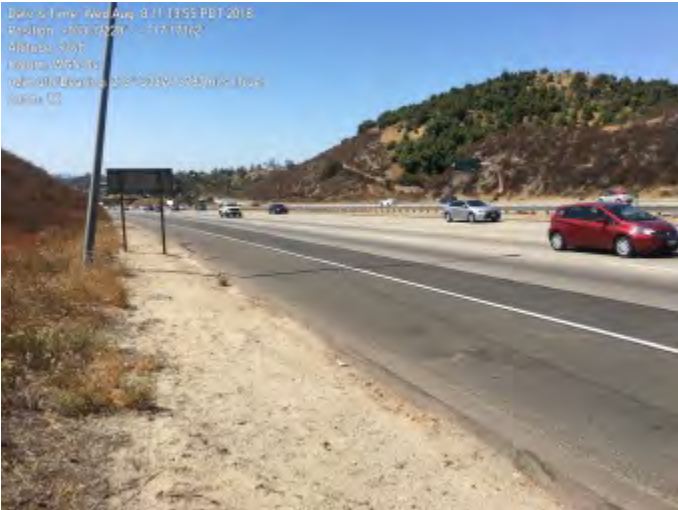
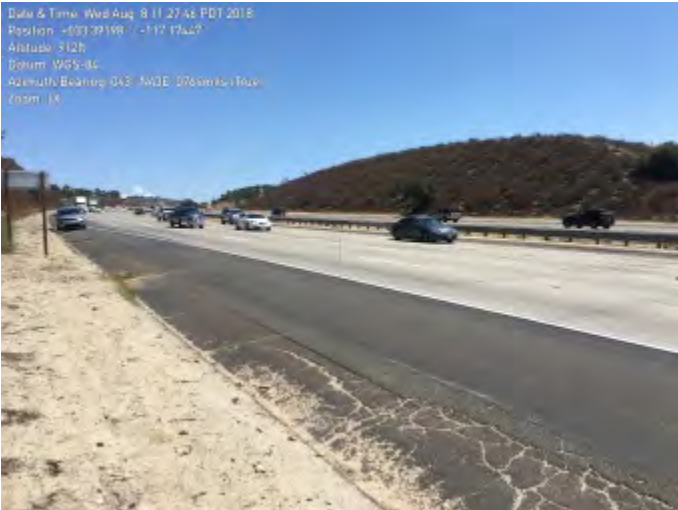
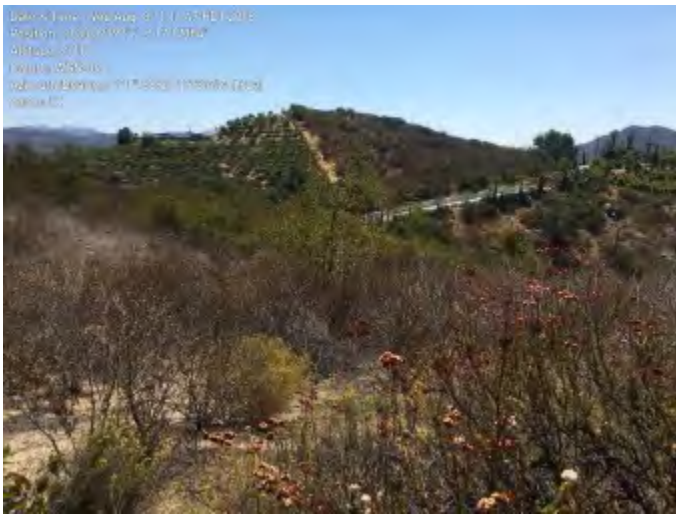
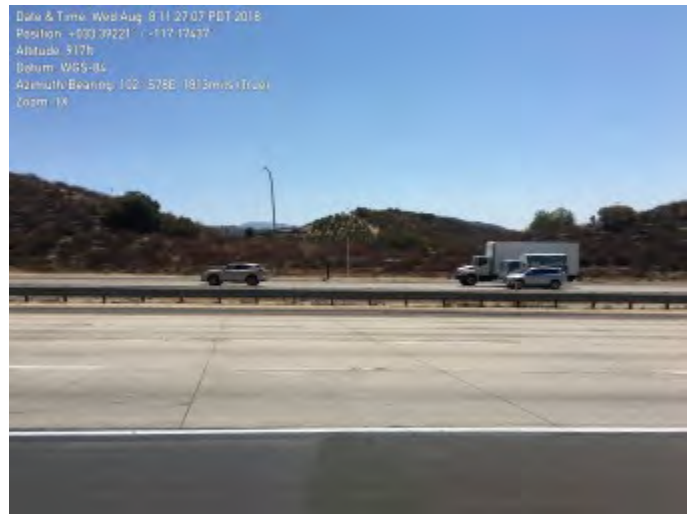
| Comments | Due to steep embankment SB side, not conducive to culvert placement. Development NB and SB. Dangerous at -grade crossing currently. |

| Management recommendations | Barrier fencing. |

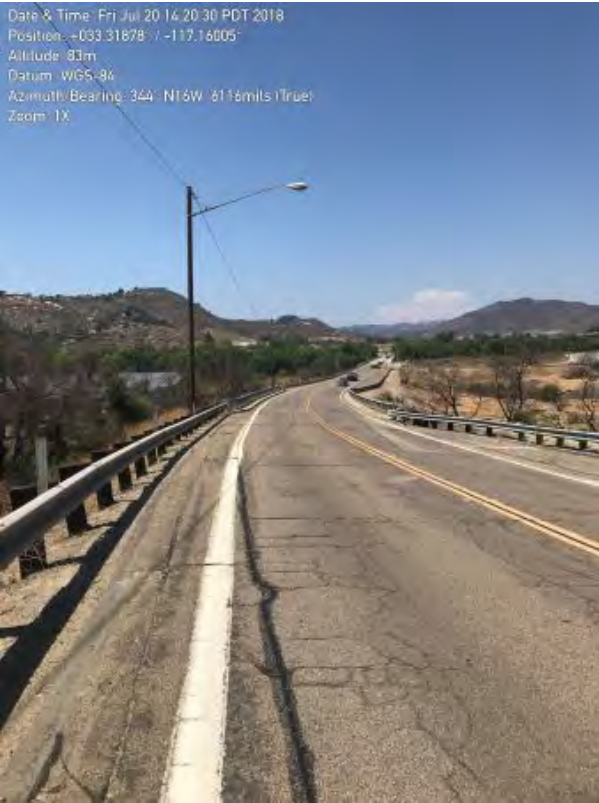
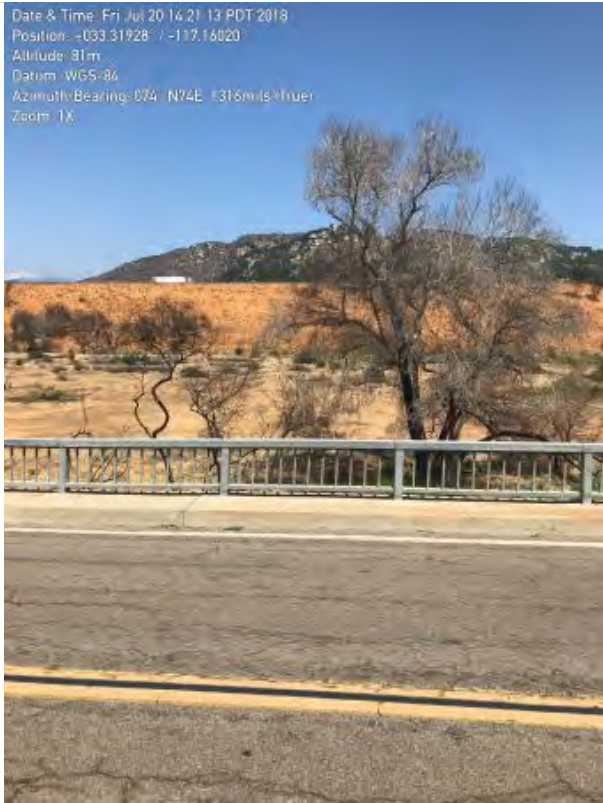
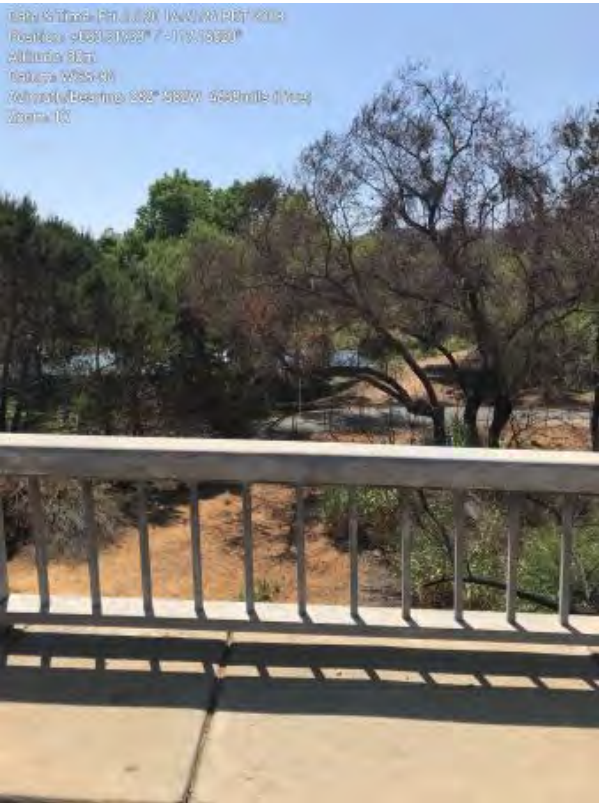
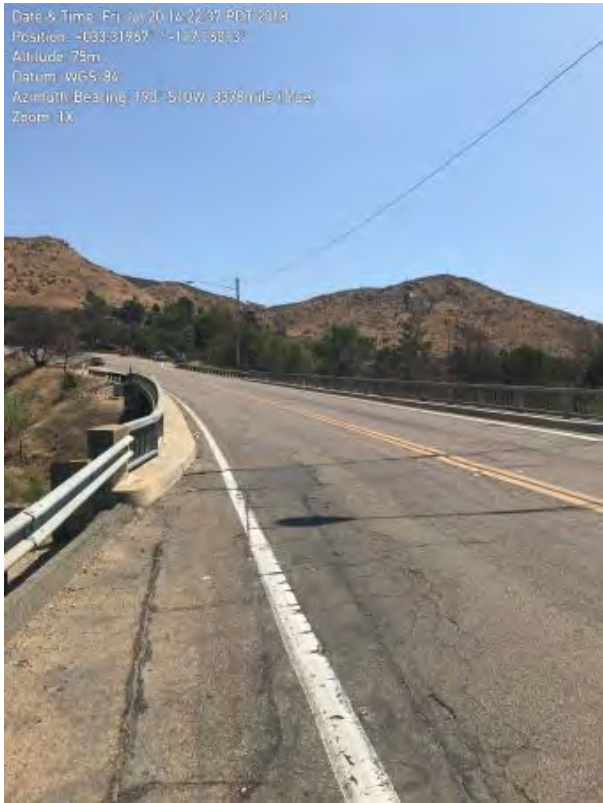
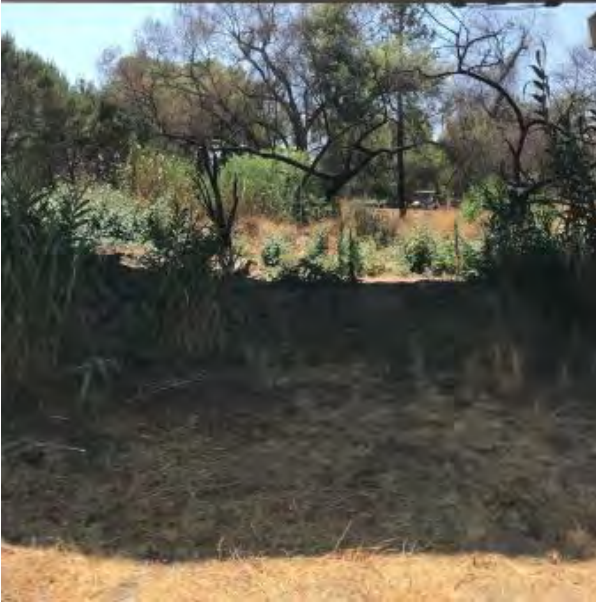
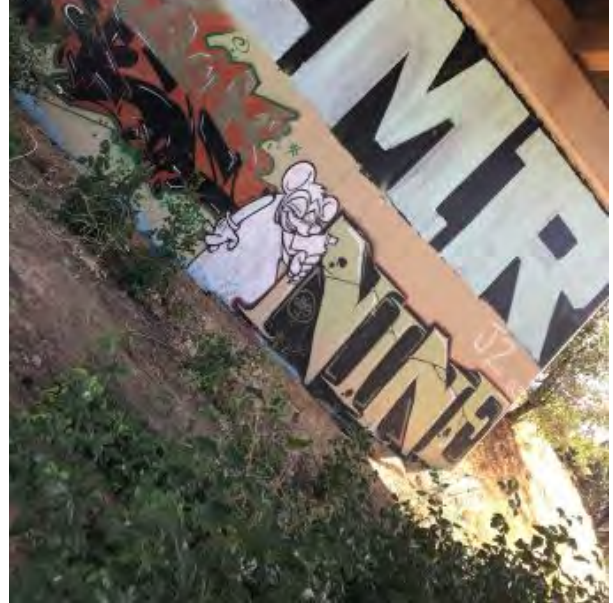
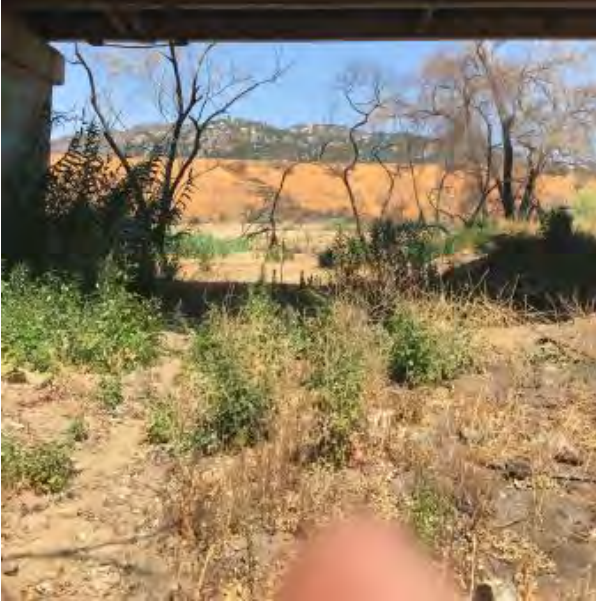
This bridge is for seasonal flooding and does not provide east-west corridor. San Luis Rey river is 1/2 north.
