SA-PAL survey

| Project | SA-PAL project |
| ID | 42130 |
| Survey Date | 04/03/2019 |

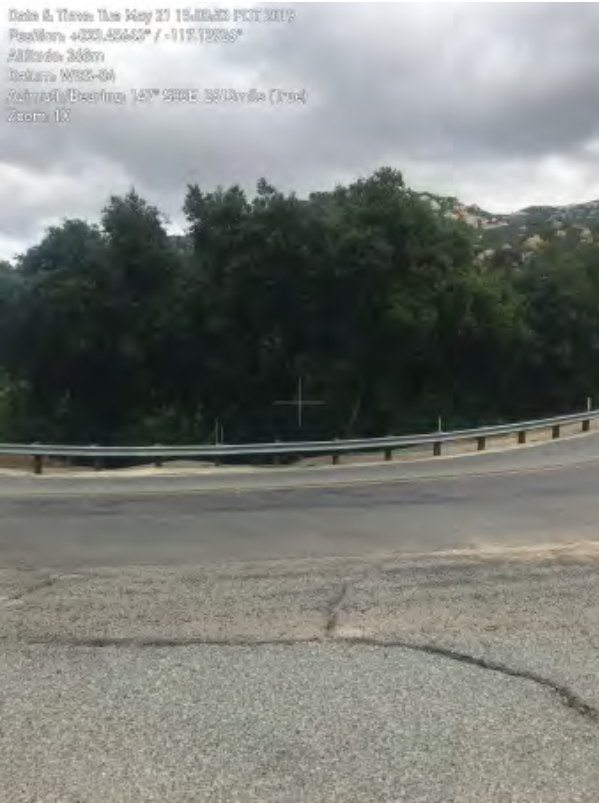
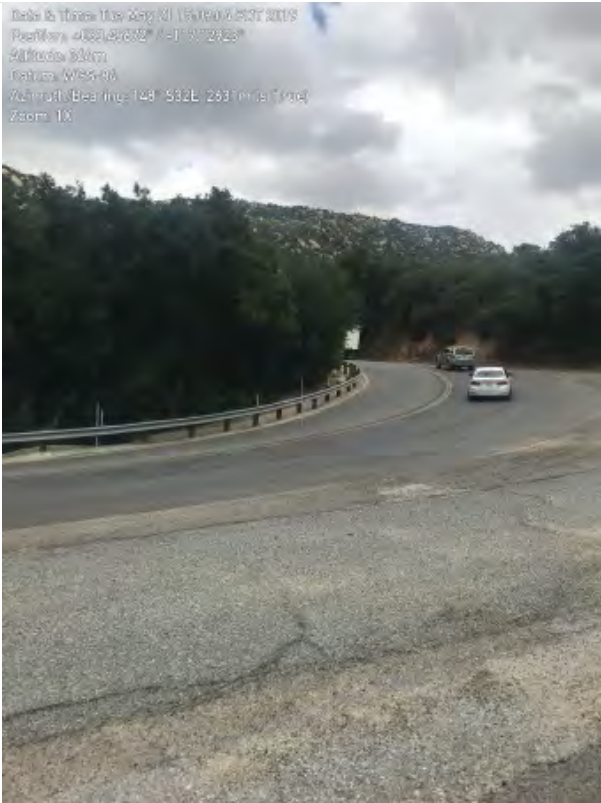
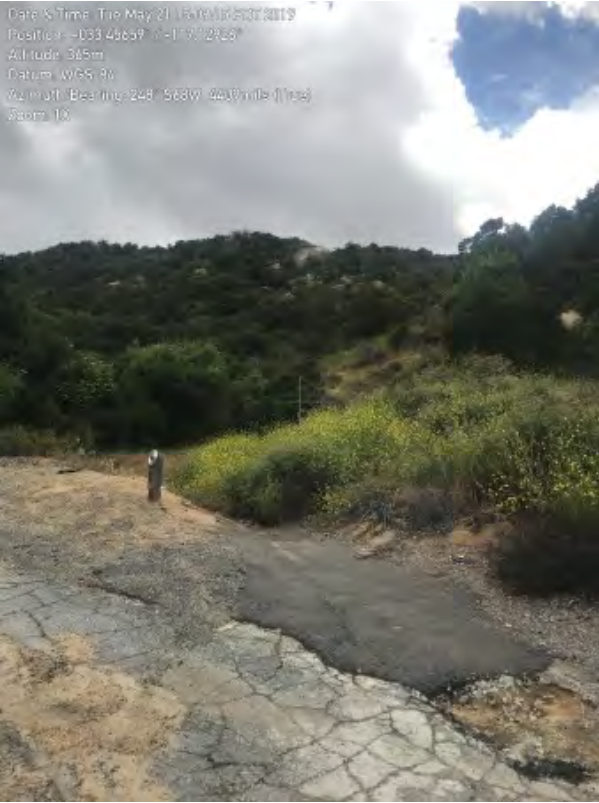
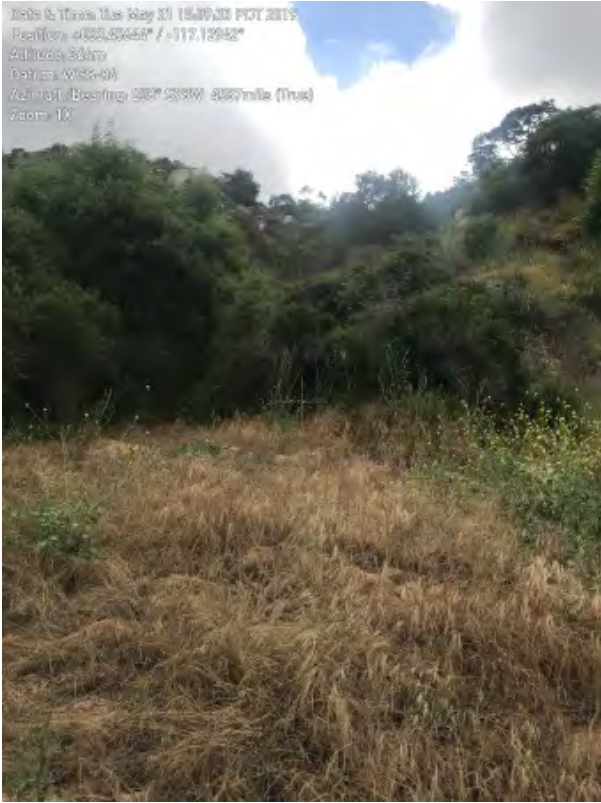
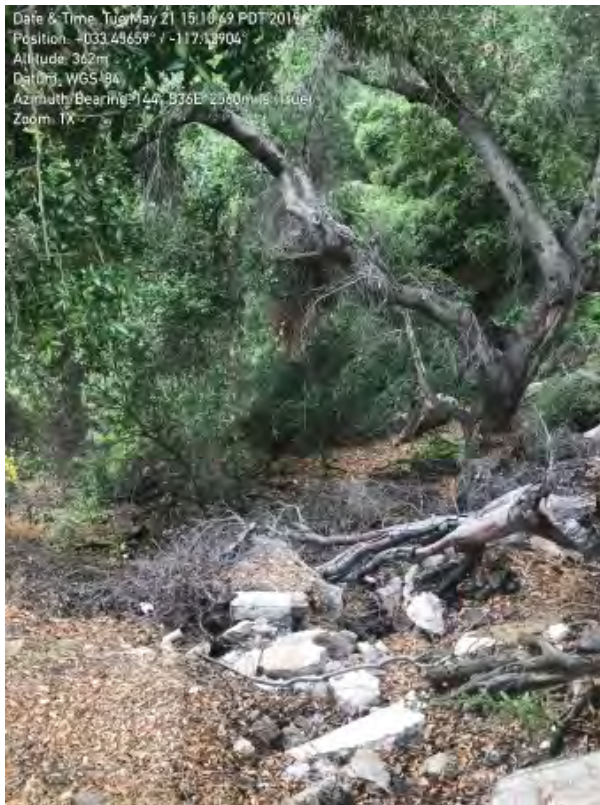
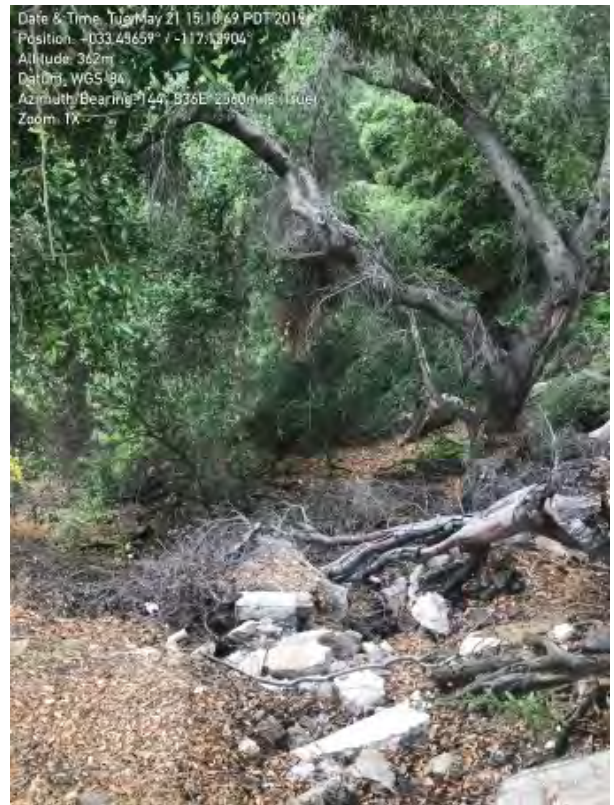
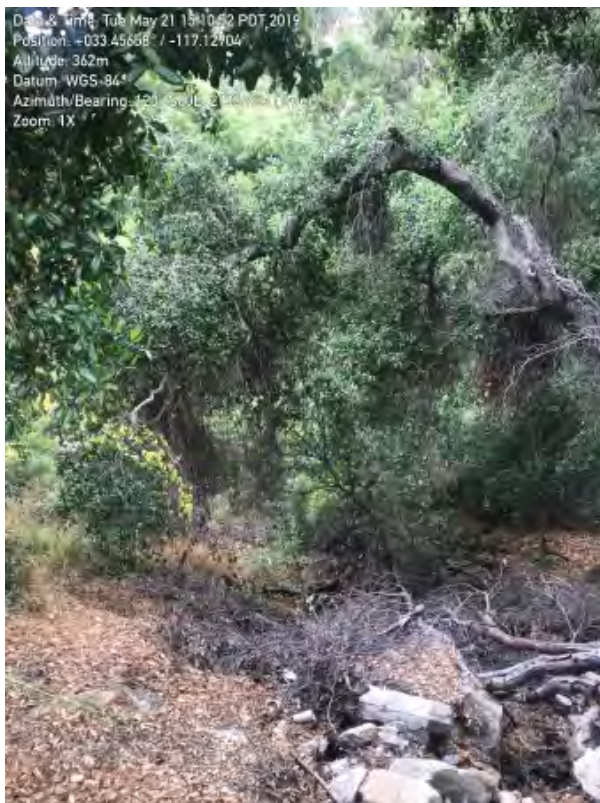
Most likely access corridor on north side of Applegate property to traverse rainbow canyon road

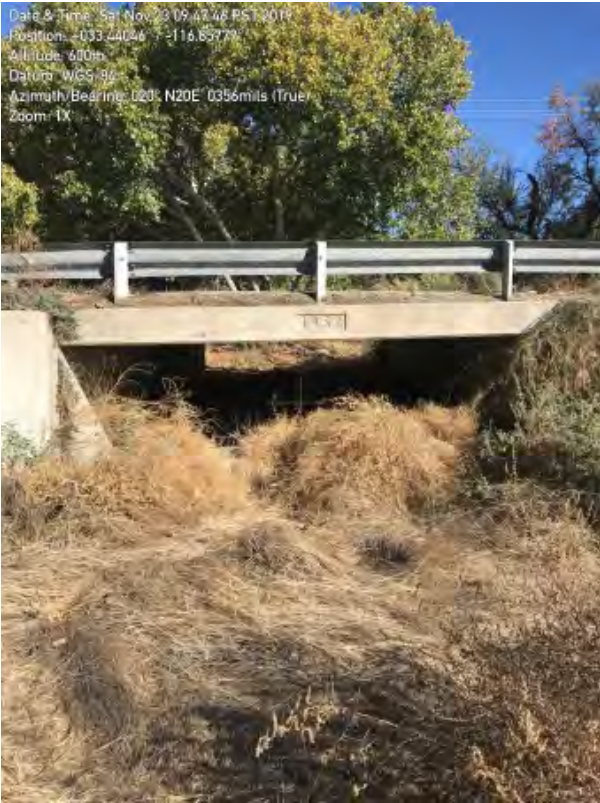
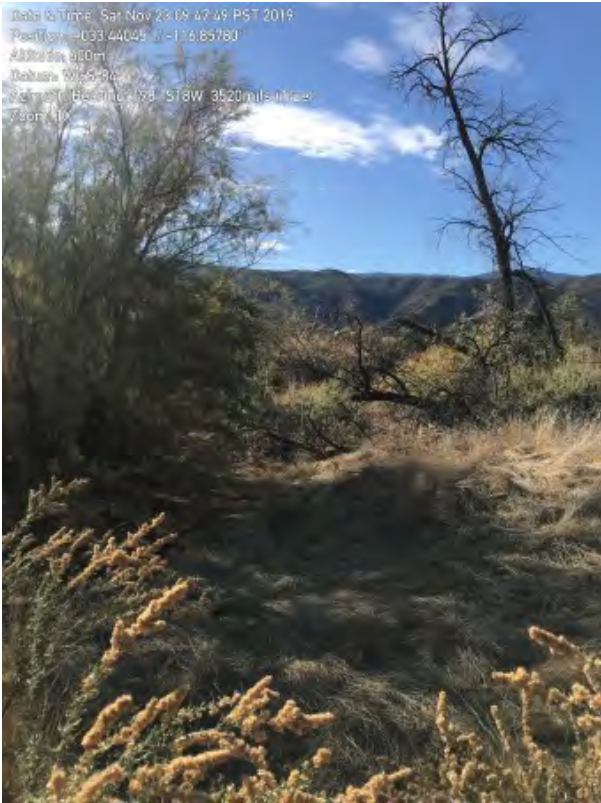
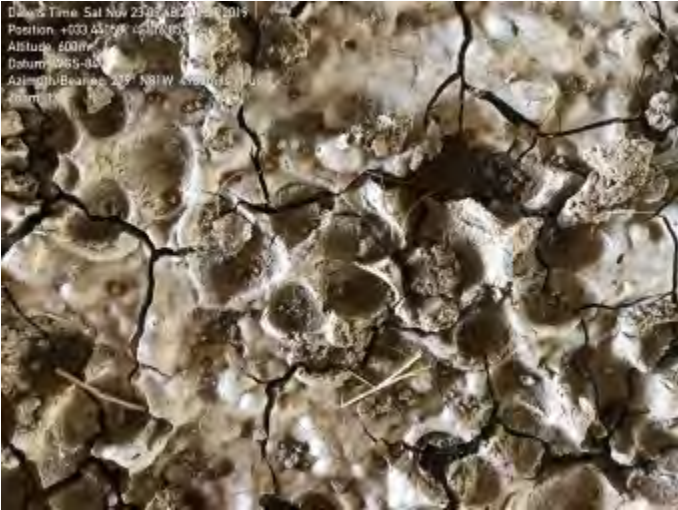
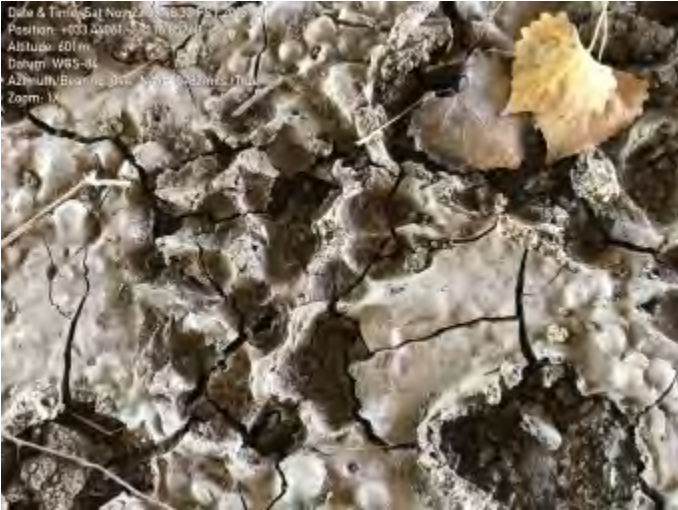
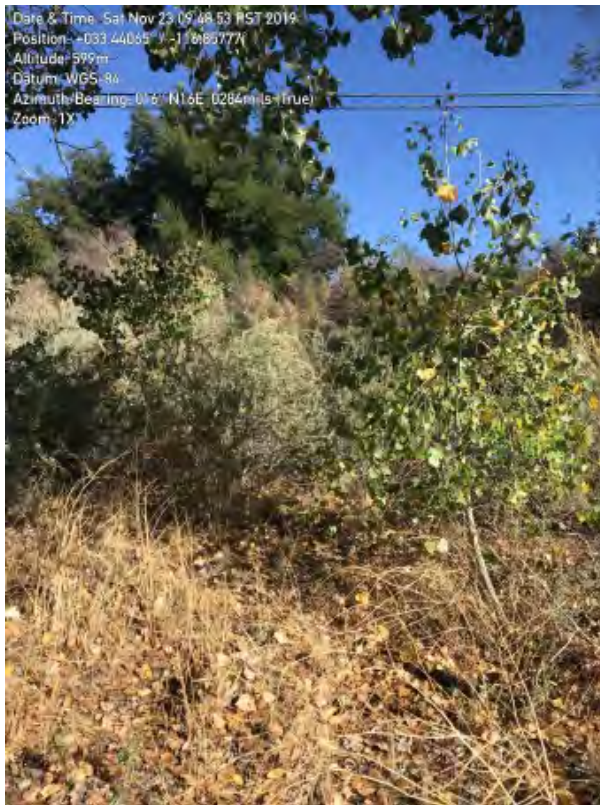
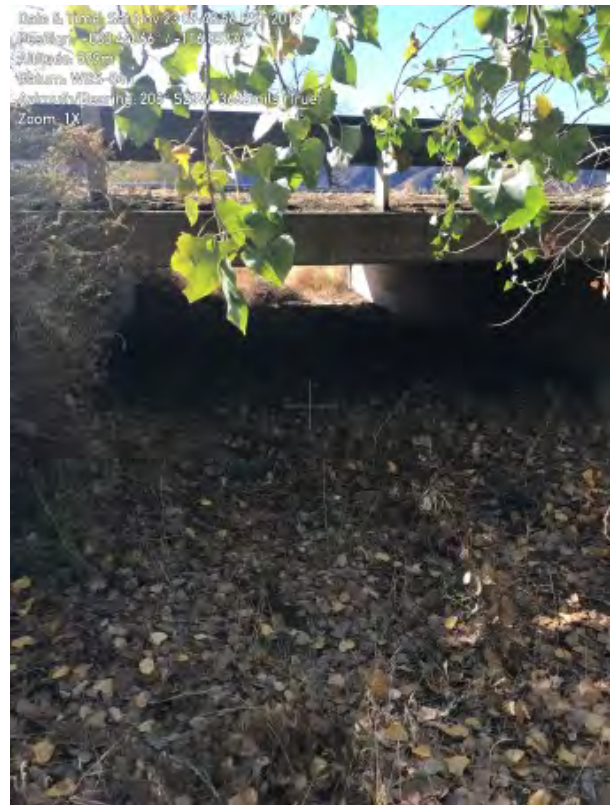
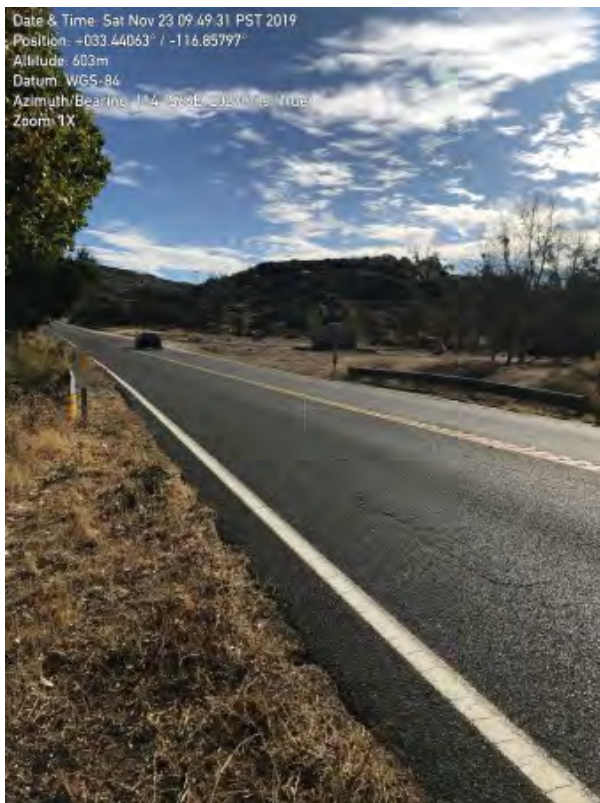
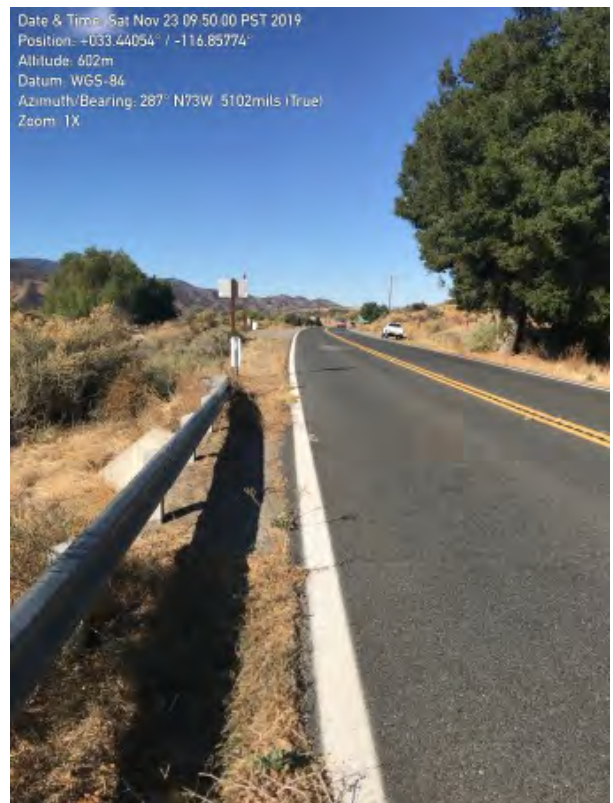
| Describe fencing type and height | 4' 3 strand barbed wire on north side. Intermittent. |

Possible good corridor heading north. South side becomes more open scrub land but travel to south would likely be networks meandering around and through ranchitas. No signs of heavy game trails in either direction approaching bridge.
